Your Ref: SNM23D200948/C01/LEWLC
Our Ref : CS4/CTI23001276/P

M/s CHINA TAIPING INSURANCE (S) PTE LTD

**TECHNICAL INVESTIGATION REPORT OF FIRE INCIDENT INVOLVING THE
INSURED VEHICLE YQ 3448L ON 5th February 2023**

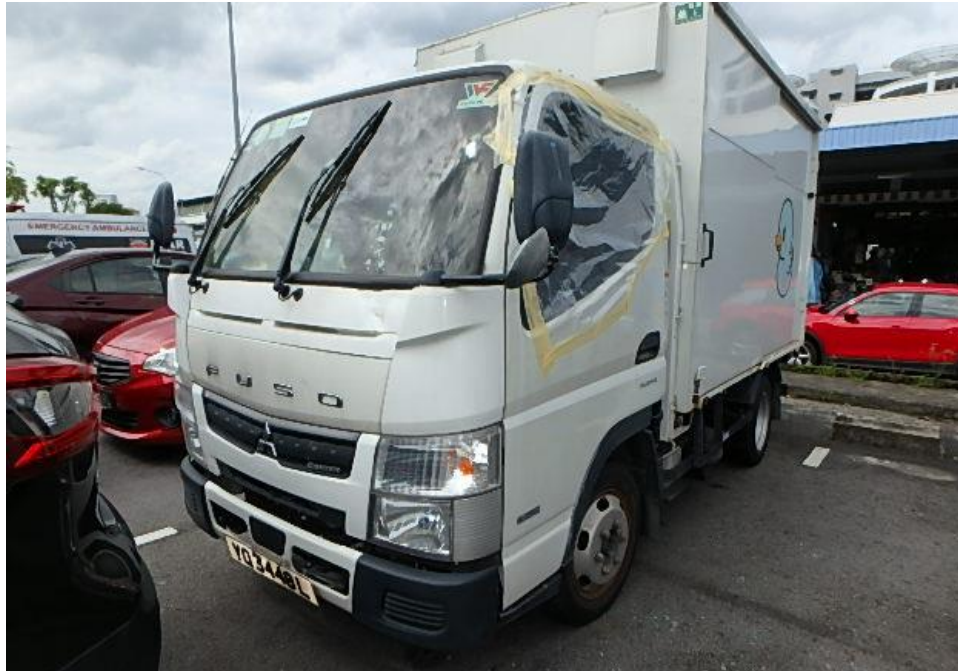
Photo 1 shows the general view of the front portion of the Insured Vehicle at the time of our inspection. The fire damage to the Insured Vehicle was confined to its interior portion. Its exterior is observed to be unaffected by the fire.

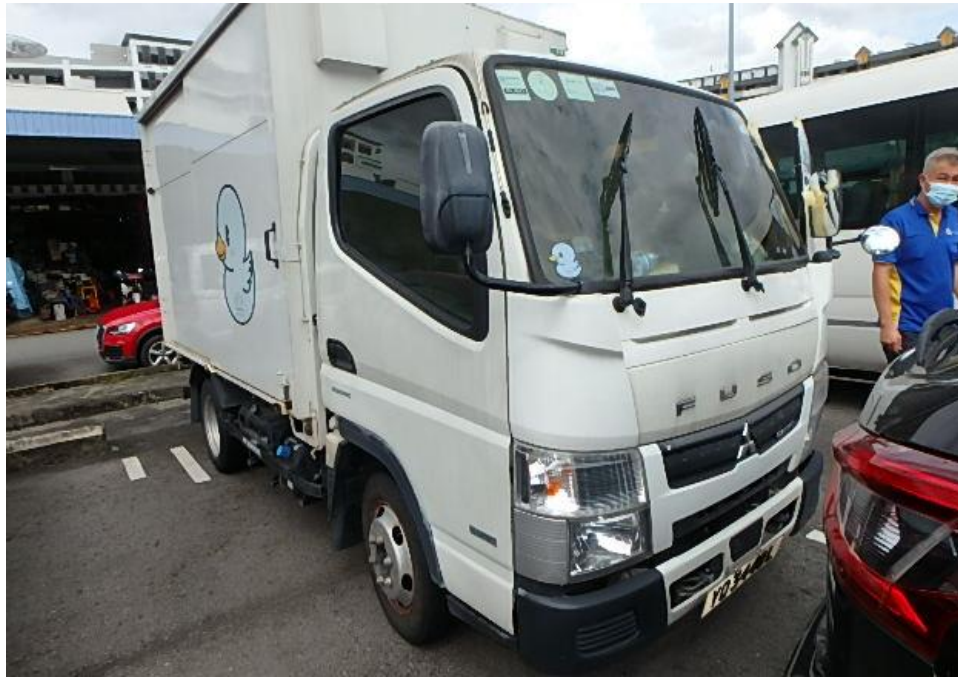
Photo 2 shows the general view of the right portion of the Insured Vehicle at the time of our inspection. The fire damage to the Insured Vehicle was confined to its interior portion. Its exterior is observed to be unaffected by the fire.

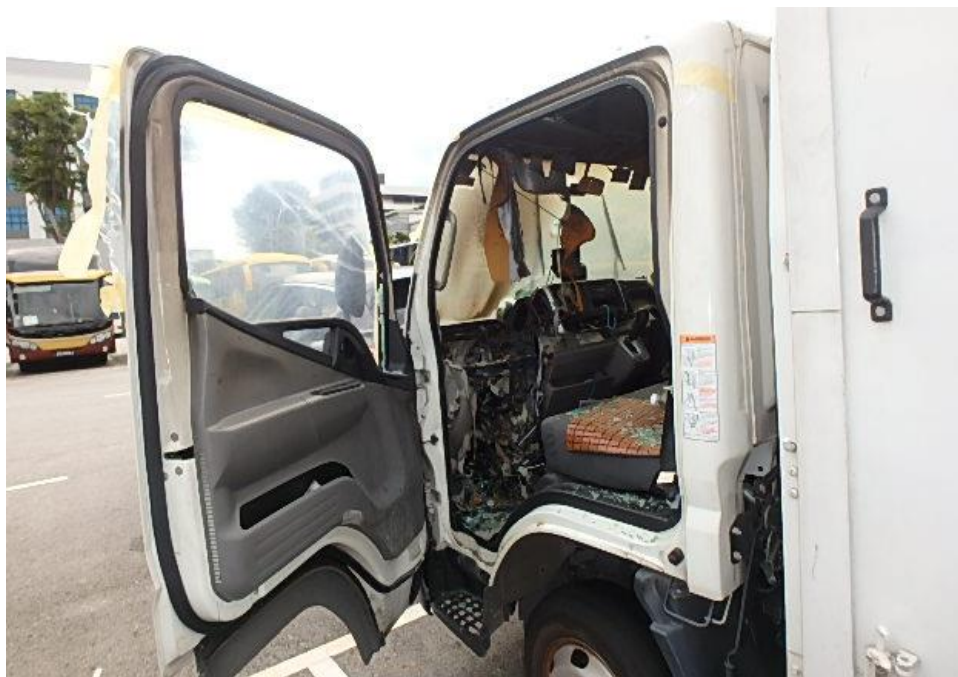
Photo 3 shows the general view of the interior compartment of the Insured Vehicle at the time of our inspection. The fire was confined to its front left dashboard portion, however the fire had resulted in the various components located in the interior of the Insured Vehicle suffer from heat and smoke damages, this includes the front windscreen and several parts at the front dashboard that were also observed to sustain damages included electronic components & wirings.

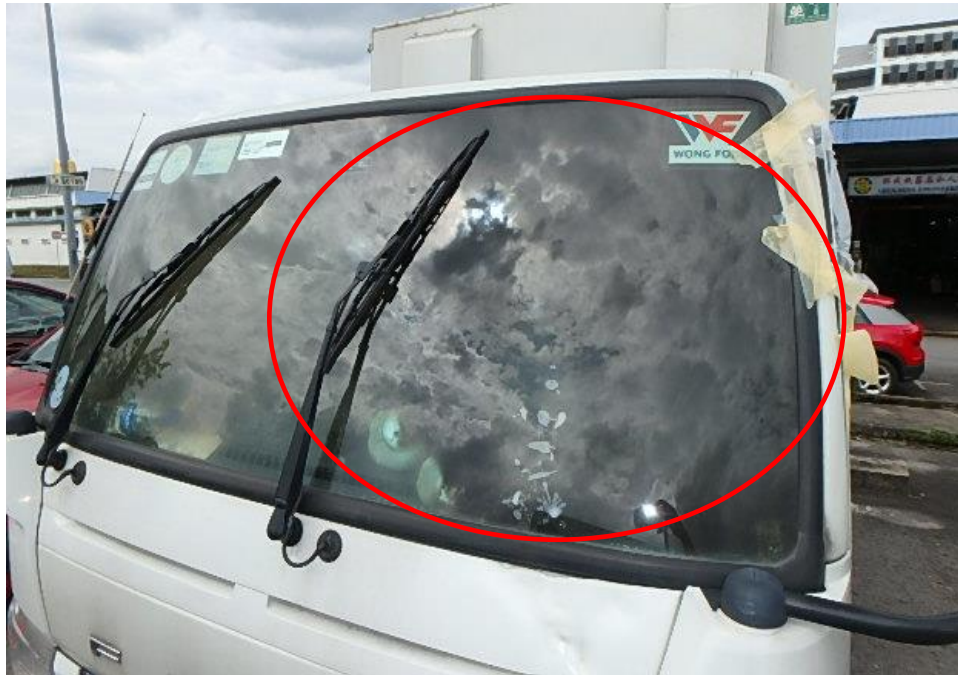
Photo 4 shows the general view of the interior compartment of the Insured Vehicle at the time of our inspection. The fire was confined to its front left dashboard portion, however the fire had resulted in the various components located in the interior of the Insured Vehicle suffer from heat and smoke damages, this includes the front windscreen (circled) and several parts at the front dashboard that were also observed to sustain damages included electronic components & wirings.

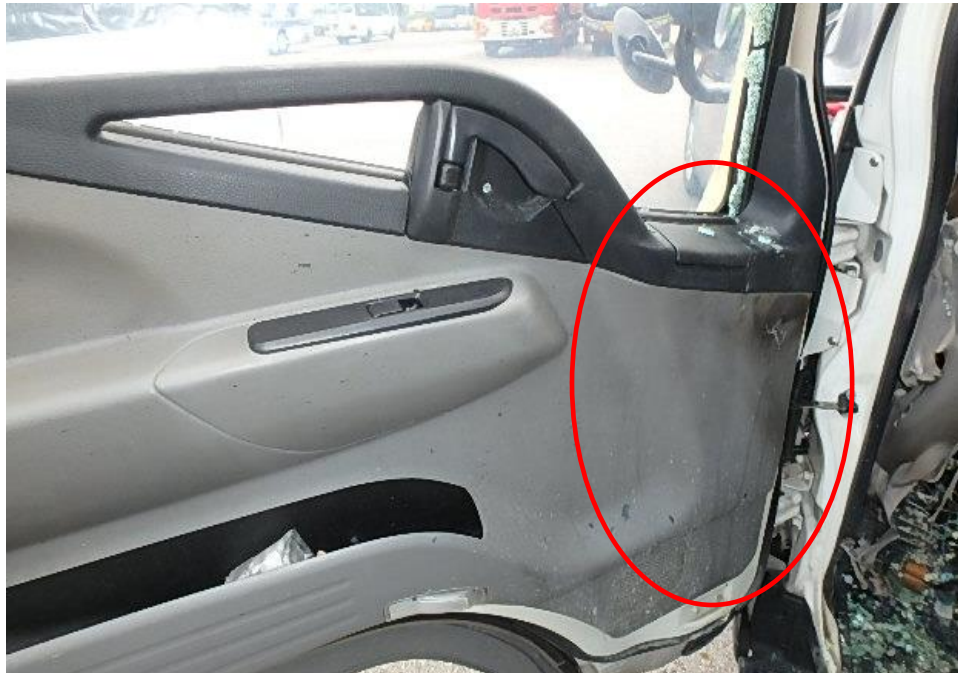
Photo 5 shows the close up view of the interior compartment of the Insured Vehicle at the time of our inspection. Its left door (circled) was observed to sustain smoke and heat damages as a result of the fire.

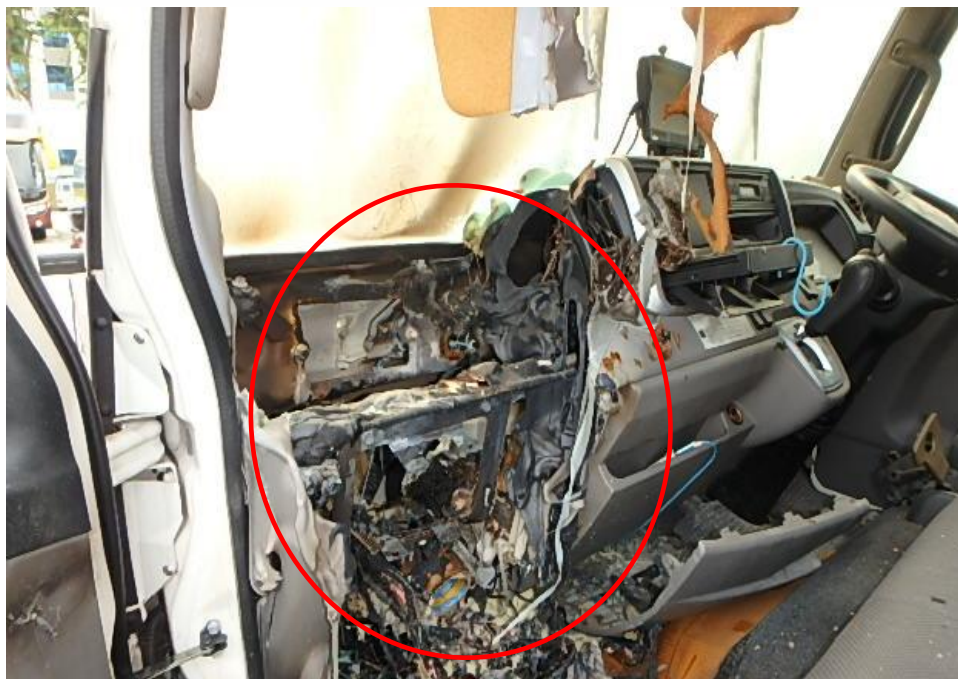
Photo 6 shows the close up view of the interior compartment of the Insured Vehicle at the time of our inspection. The fire was confined to its front left dashboard portion, its front dashboard, electronic components & wirings (circled) were observed to sustain heat and smoke damages as a result of the fire.

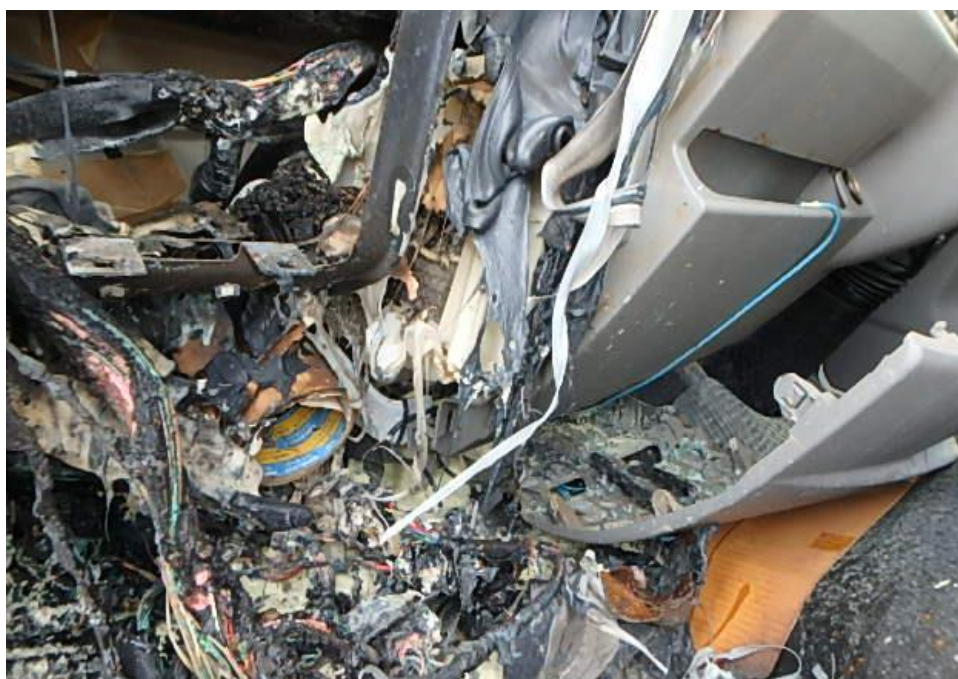
8. Based on the circumstances for this particular case, the fire appears to have originated from the interior portion of the Insured Vehicle, somewhere in the front left dashboard portion. This can be determined basing on the area where the extent of fire damage was most severe, the circumstances of the fires' origin at the material time of incident and also the burn marks and melting of material that were found at the front left dashboard portion.

Photo 7 shows the general inside view of the front left dashboard portion of the Insured Vehicle at the time of our inspection. Observed that the items & electrical components in the front left dashboard portion had sustain heat & smoke damaged.

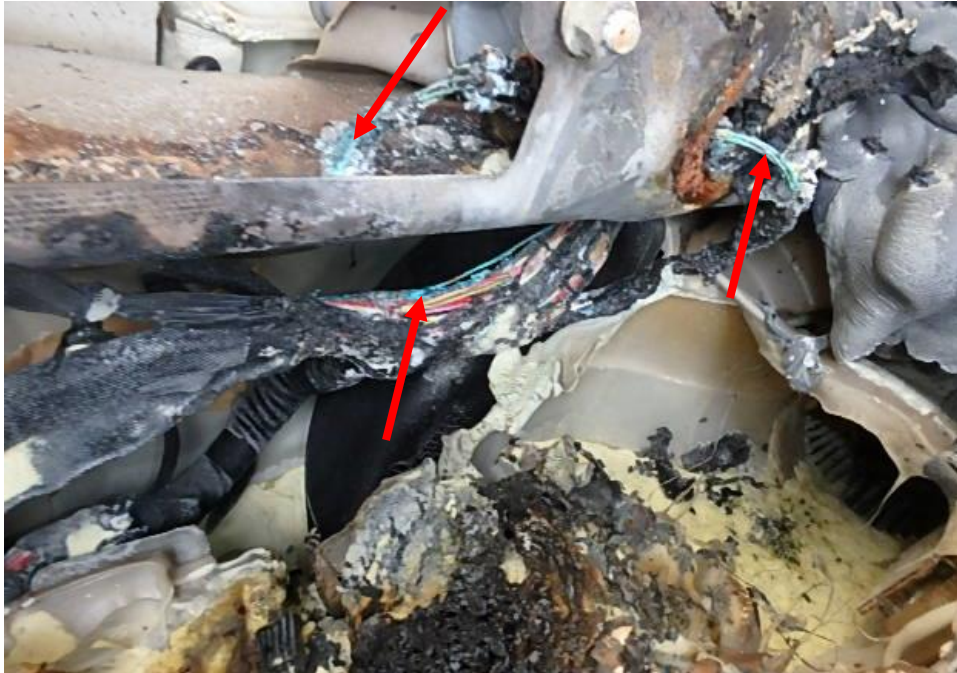
9. Upon closer observations, the wirings in the front left dashboard portion were observed to be where the fire had started, we had found traces of greenish residue on the original wirings leading from the electrical components to the fuse box. The wirings were original wirings fitting from manufacturer. The presence of greenish residue indicates internal heating of copper wires, a sign of an electrical short circuit occurring. The greenish residue is normally left behind from the oxidation as a result of chemical reaction involving the copper wires. This physical evidence would then appear to suggest that the cause of fire to the Insured Vehicle could have possibly been due to electrical in nature. See photo 7-9 below.

Photo 8 shows a close up view of the original wiring harness leading from the fuse box to the electrical components. The original wiring harness (arrowed) was observed with greenish residue on the surface. The presence of greenish residue indicates internal heating of copper wires, a sign of an electrical short circuit occurring. The greenish residue is normally left behind from oxidation as a result of chemical reaction involving the copper wires. This is likely where the fire had started from.

20. The possibility of the fire being due to electrical in nature would then seem more likely given that engine overheating and external factors would both seem unlikely. The fire being due to electrical nature is also supported by the condition of the wirings that were found leading from the original wirings from the electrical components to the fuse box on the Insured Vehicle, which was earlier discussed in paragraph 9 above.

22. Having investigated and technically analysed the damages of burnt nature to the Insured Vehicle, we are of the view that the cause of fire to the Insured Vehicle was of electrical nature being pre-mature failure of product. For this particular case, the fire had originated along the original manufacturer wirings leading from the electrical components to the fuse box of the Insured Vehicle.
23. We did not find any evidence which had suggested that the cause of fire to the Insured Vehicle was due to poor maintenance and/or recurring electrical problem.

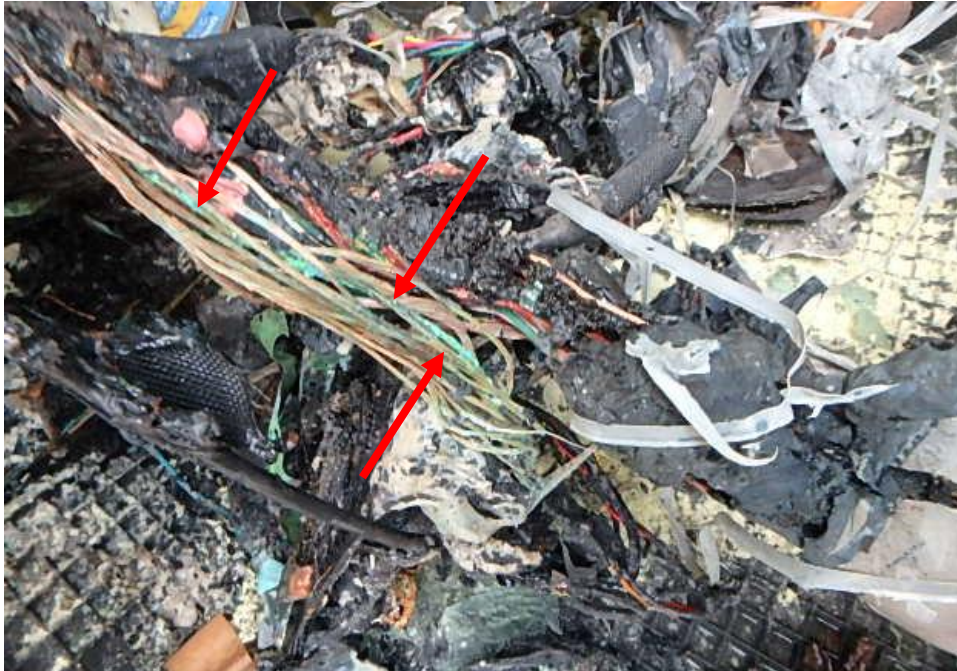
Photo 9 shows a close up view of the original wiring harness leading from the fuse box to the electrical components. The original wiring harness (arrowed) was observed with greenish residue on the surface. The presence of greenish residue indicates internal heating of copper wires, a sign of an electrical short circuit occurring. The greenish residue is normally left behind from oxidation as a result of chemical reaction involving the copper wires. This is likely where the fire had started from.
