Your Ref: TP/IP/34802/2022
Our Ref : CI/TPD23001375/N

Fatal Accident Investigation Team

MECHANICAL INSPECTION REPORT OF MOTOR VAN GBE 478E

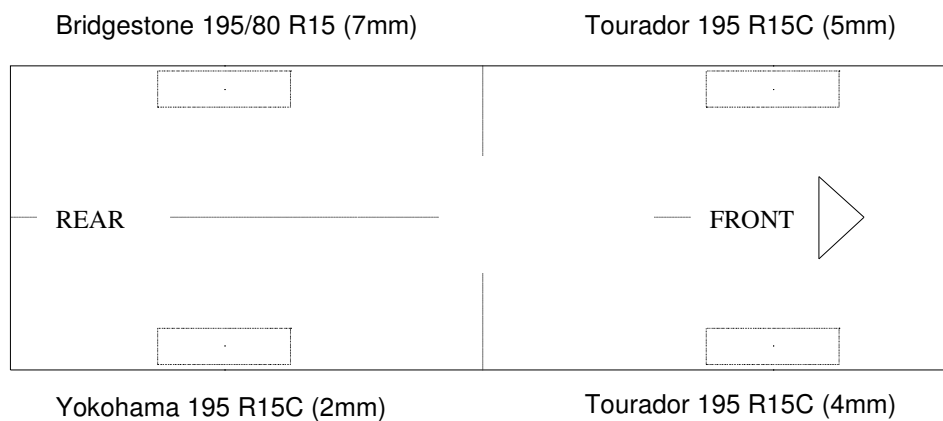
7. Upon examination of the rear left tyre of the Insured Vehicle, the pattern at the centre portion of the tread was observed to be flushed with the tyre wear indicator. Upon examination of the front left tyre of the Insured Vehicle, the reinforcing belts that are found within the tyre were exposed at the time of our inspection. The tyre brand, tyre size and remaining tread depth of the 4 tyres were recorded as follows:-

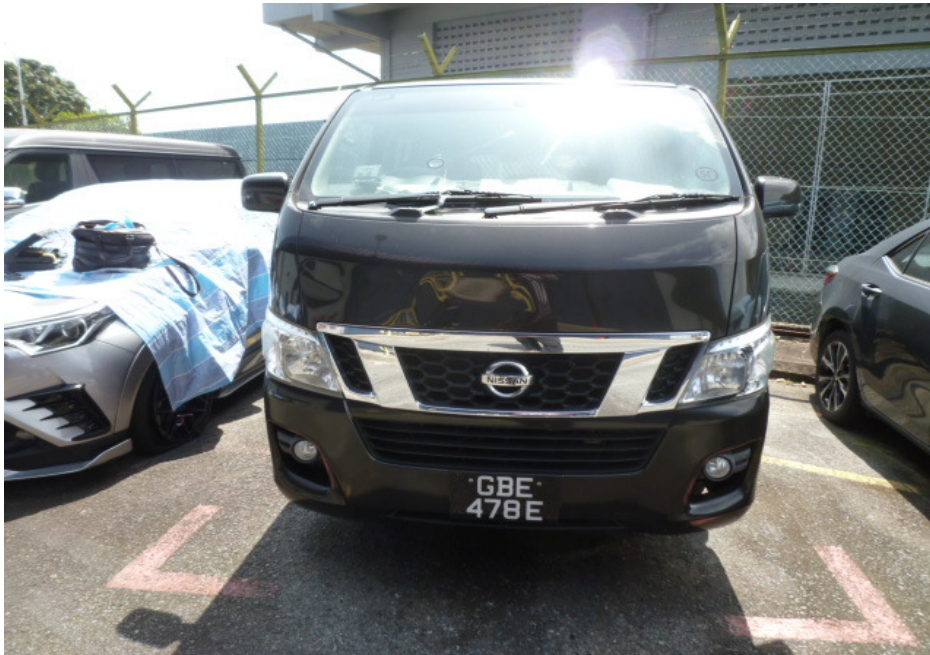
4. The mileage of the Motor Van at the time of our inspection was 170, 323km.
5. The Motor Van was observed to have sustained minimal impact damage at its frontal portion. Its front bonnet was dented as a result of the accident.

Photo 1 shows a general view of the frontal portion of the Motor Van at the time of our inspection. The Motor Van was observed to have sustained minimal impact damage that was confined to its frontal portion. The mileage of the Motor Van was recorded to be 170, 323km.

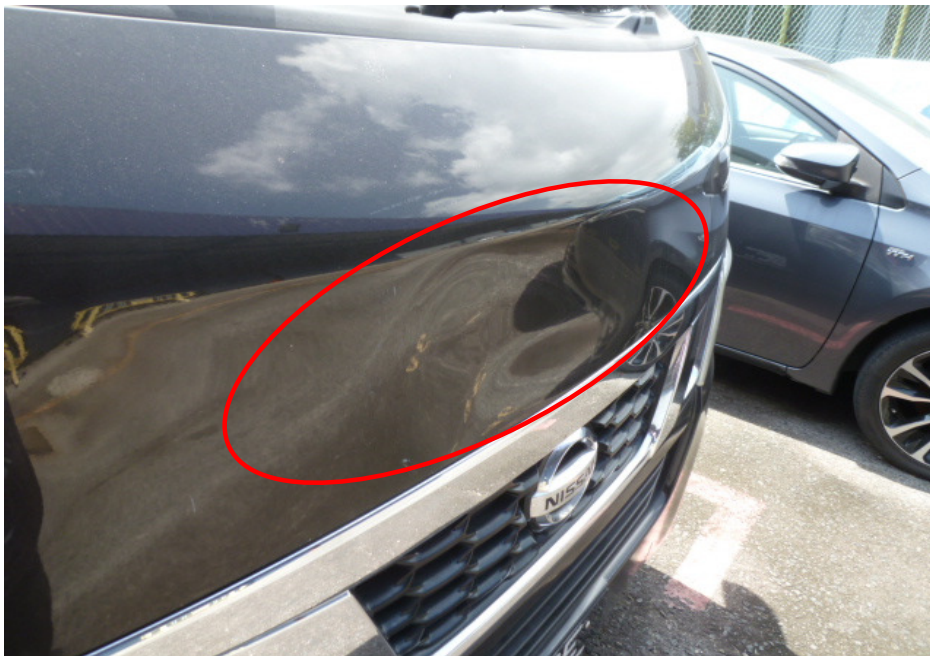
Photo 2 shows a closer view of the frontal portion of the Motor Van at the time of our inspection. The Motor Van was observed to have sustained minimal impact damage that was confined to its frontal portion. Its front bonnet was dented as a result of the accident (circled).

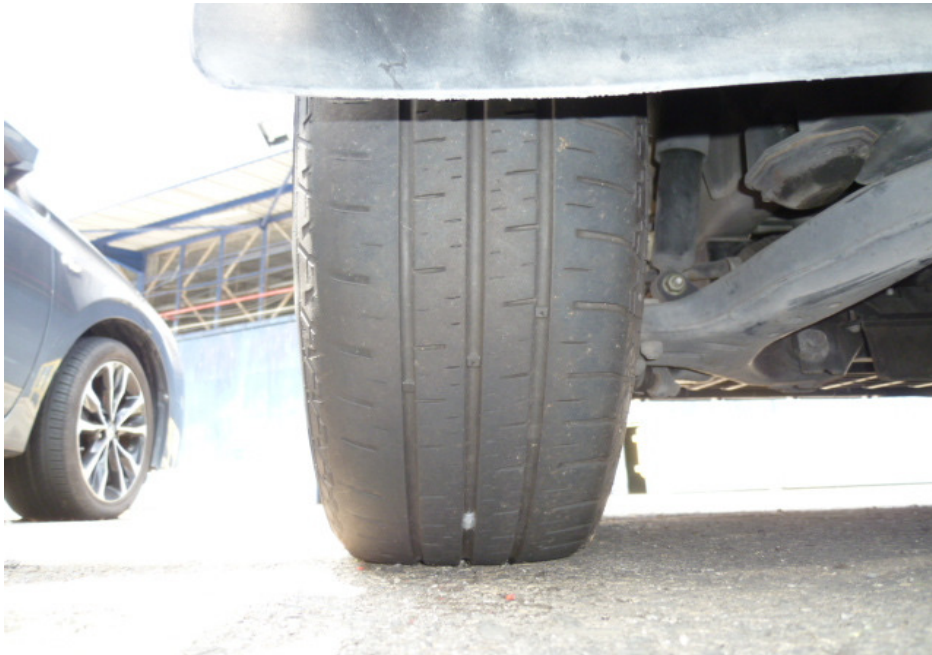
Photo 3 shows the condition of the front left tyre of the Motor Van, which was observed to be have remaining tread depth of approximately 5mm. However the reinforcing belts that are found within the tyre were exposed at the time of our inspection. The tyre, which was wrapped around standard steel wheel rim, was also observed to be sufficiently inflated for vehicular operation. There was no tear, cut or burst mark(s) on the outer and the inner sidewalls as well as across the tread of the 4 tyres.

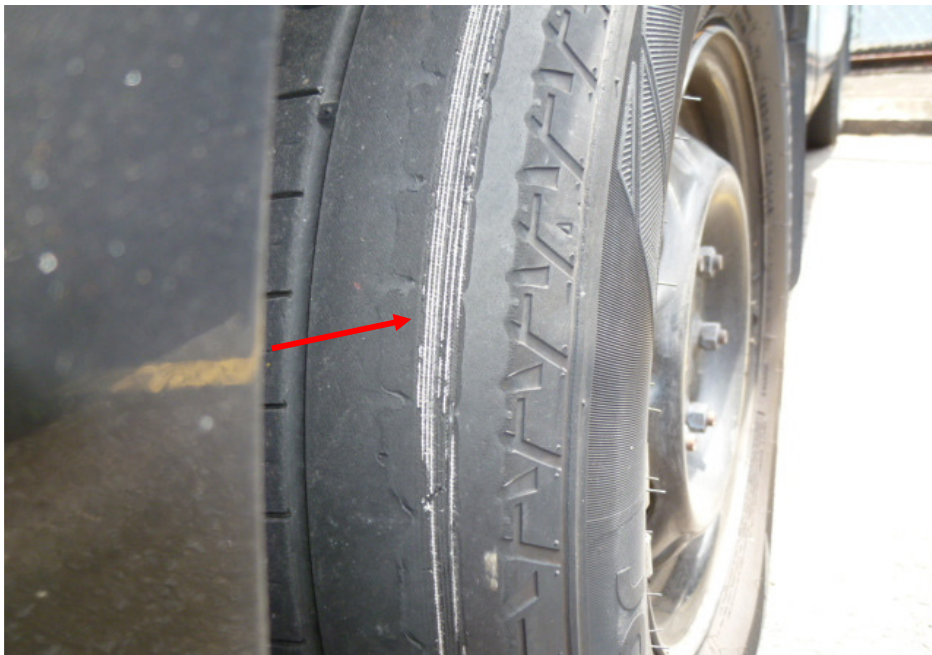
Photo 4 shows the exposed reinforcing belts that are found within the front left tyre of the Motor Van at the time of our inspection (arrowed).

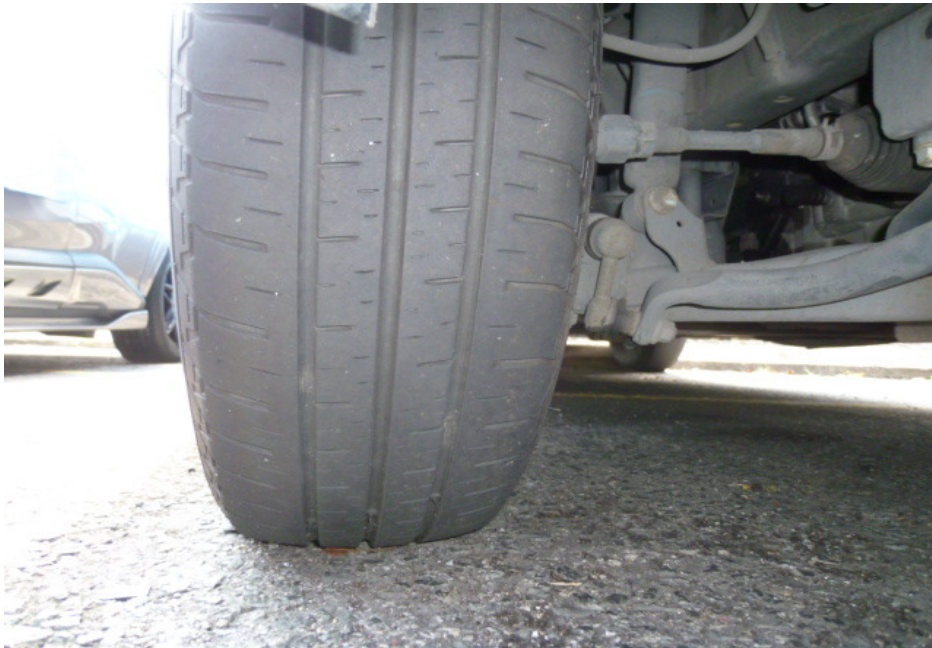
Photo 5 shows the condition of the front right tyre of the Motor Van, which was observed to be in serviceable condition with remaining tread depth of approximately 4mm. The tyre, which was wrapped around a standard steel wheel rim, was also observed to be sufficiently inflated for vehicular operation.

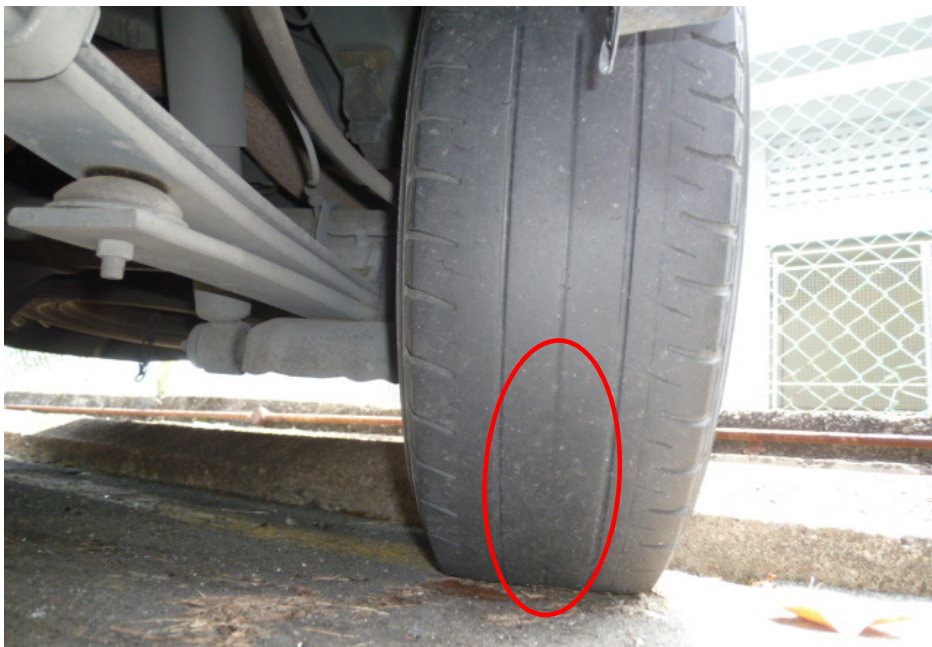
Photo 6 shows the condition of the rear left tyre of the Motor Van, which was observed to be in serviceable condition with remaining tread depth of approximately 7mm. However the pattern at the centre portion of the tread was observed to be flushed with the tyre wear indicator (circled). The tyre, which was wrapped around standard steel wheel rim, was also observed to be sufficiently inflated for vehicular operation.

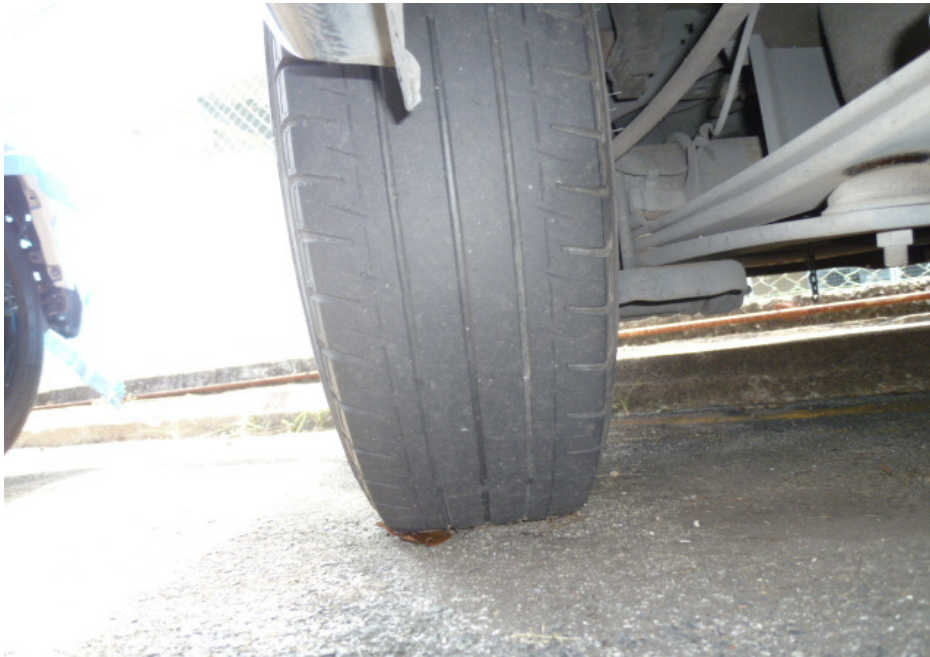
Photo 7 shows the condition of the rear right tyre of the Motor Van, which was observed to be in serviceable condition with remaining tread depth of approximately 2mm. The tyre, which was wrapped around standard steel wheel rim, was also observed to be sufficiently inflated for vehicular operation. There was also no tear, cut or burst mark(s) on the outer and the inner sidewalls as well as across the tread of the 4 tyres.

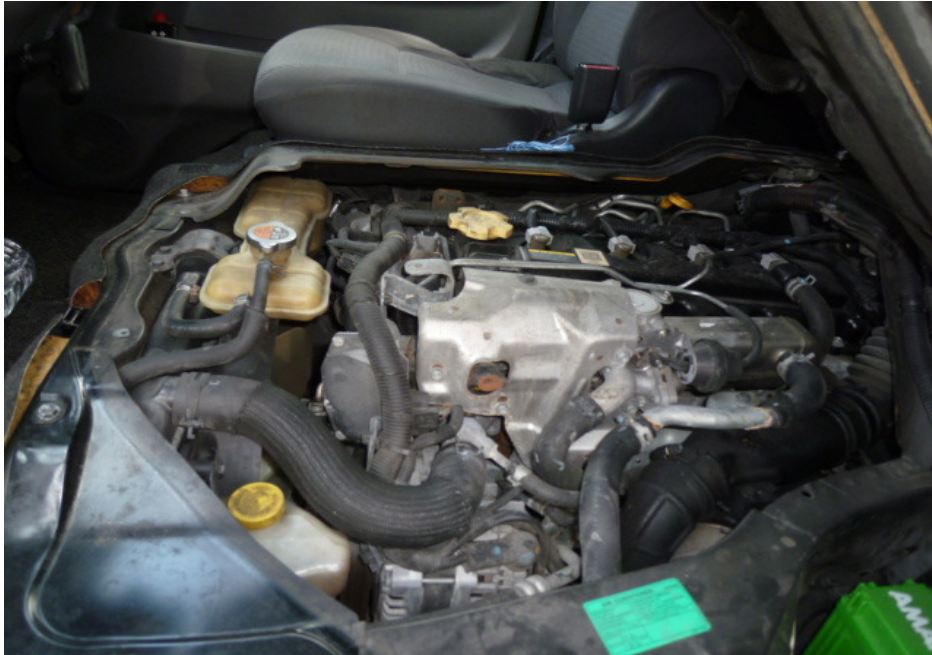
Photo 8 shows a general view of the Motor Van's engine compartment. The various parts and components inside the engine compartment were unaffected by the accident. There was also no sign(s) or indication(s) of fluid leakage and/or fluid stain within the engine compartment. The wirings and cables were all observed to be intact and adequately secured to their respective connectors and/or connecting ports.

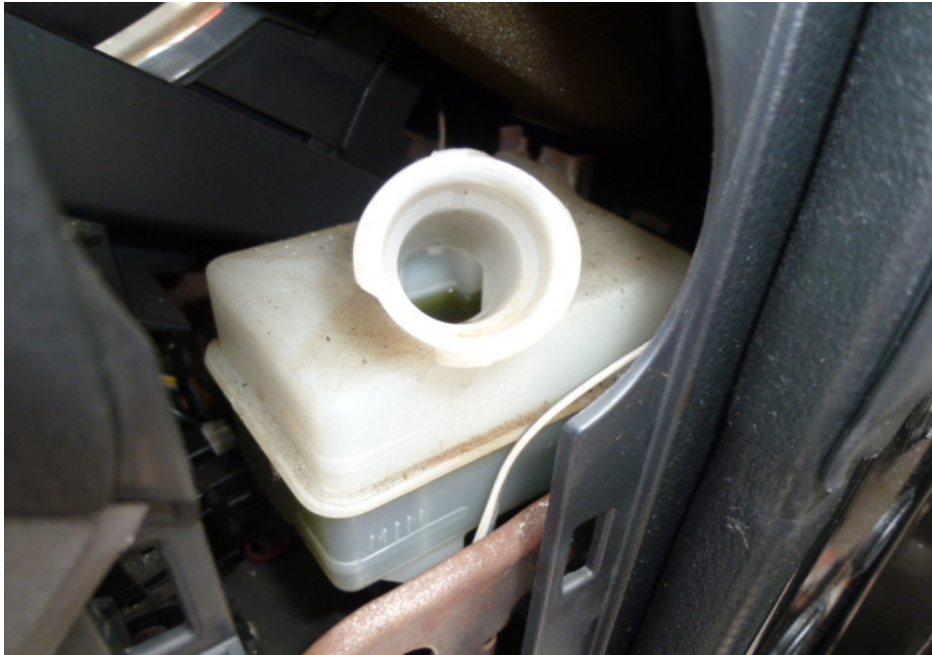
Photo 9 shows the brake fluid reservoir of the Motor Van at the time of our inspection. The brake fluid was observed to be of sufficient level for operating purposes and without any visible contamination.

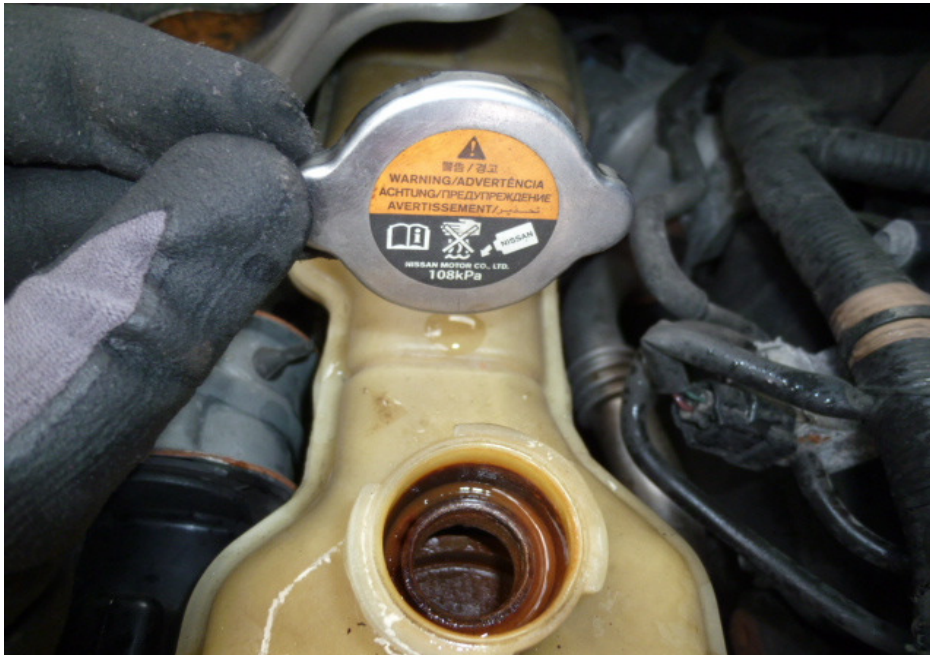
Photo 10 shows the engine coolant reservoir of the Motor Van at the time of our inspection. The engine coolant was observed to be of sufficient level for operating purposes and without any visible contamination.

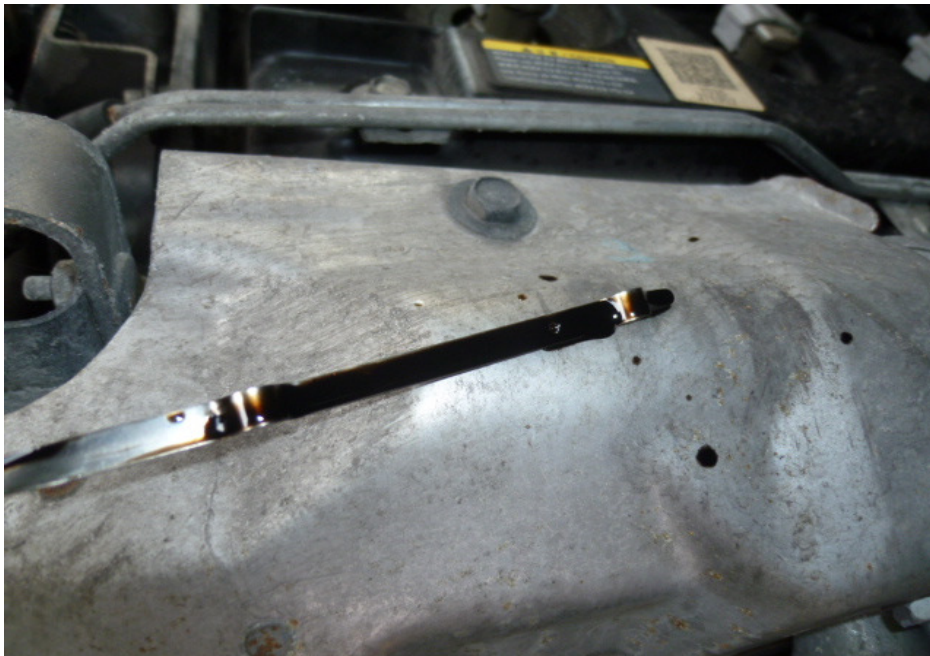
Photo 11 shows the engine dip stick of the Motor Van at the time of our inspection. The engine oil was observed to be of sufficient level for operating purposes and without any visible contamination.

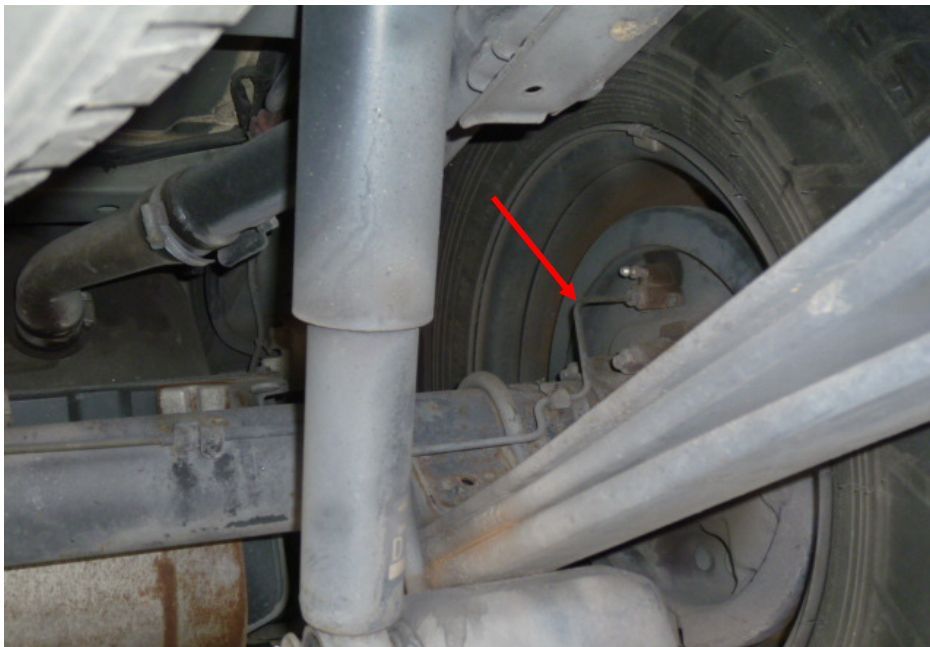
12. Static brake tests conducted on the Motor Van revealed no abnormality. The brake booster had responded well to the various tests conducted. There was also no abnormal movement of the brake pedal when it was depressed. In general, the static brake tests had suggested that there was no internal leakage of pressure/vacuum in the braking system of the Motor Van. The braking system of the Motor Van was likely to be in serviceable condition at the material time. This was also taking into consideration that the brake fluid was of sufficient level, and also that there was no sign(s) of brake fluid leakage along the brake hoses and brake pipes.

Photo 12 shows the brake pipe (arrowed) at the rear right wheel of the Motor Van. We did not observe any leakage of brake fluid at the time of our inspection of the Motor Van. Our static tests of the Motor Van's braking system had indicated that there was no internal leakage of pressure/vacuum. Hence the braking system was likely to be in serviceable condition at the material time of accident.

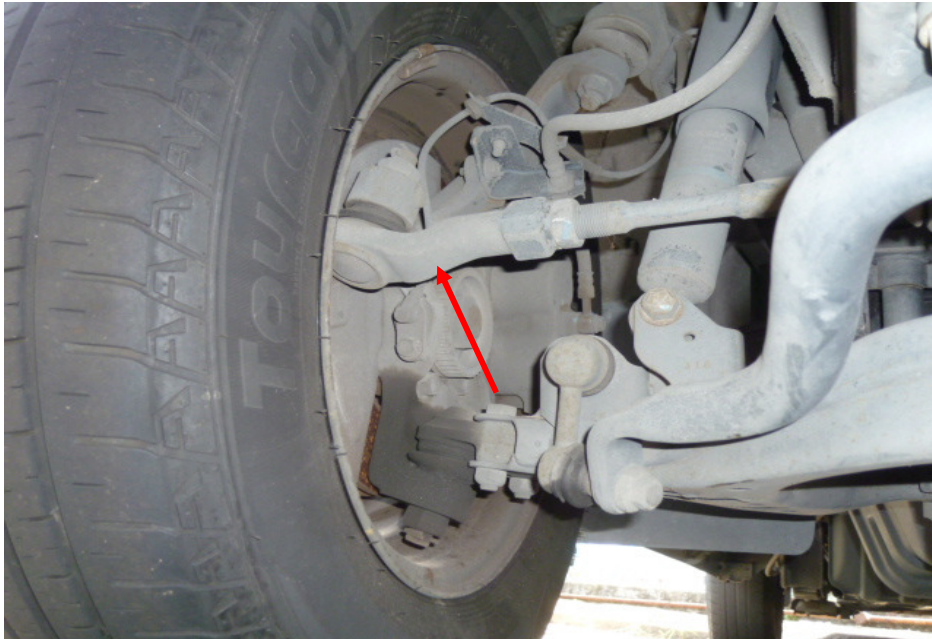
Photo 15 shows the various undercarriage components at the front right wheel of the Motor Van, in particular the steering tie rod (arrowed). The various steering components were all found to be intact, suggesting that the steering system of the Motor Van was likely to be in serviceable condition at the material time of accident. There was also no sign of fluid stain(s) observed on the various undercarriage components.

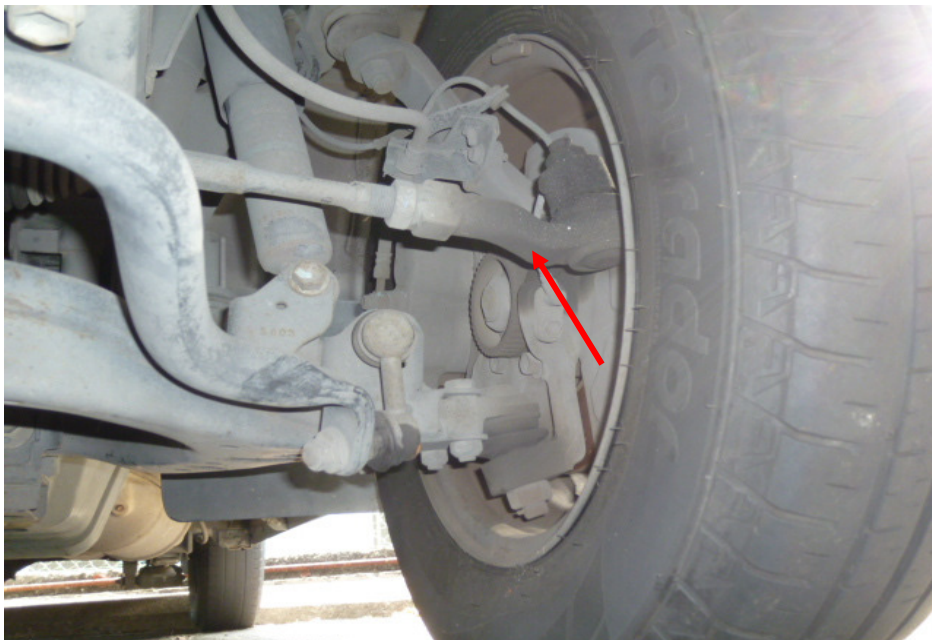
Photo 16 shows the various undercarriage components at the front left wheel of the Motor Van, in particular the steering tie rod (arrowed). The various undercarriage components of the Motor Van were all found to be intact without any visible damage. There was also no sign of fluid stain(s) observed on the various undercarriage components.

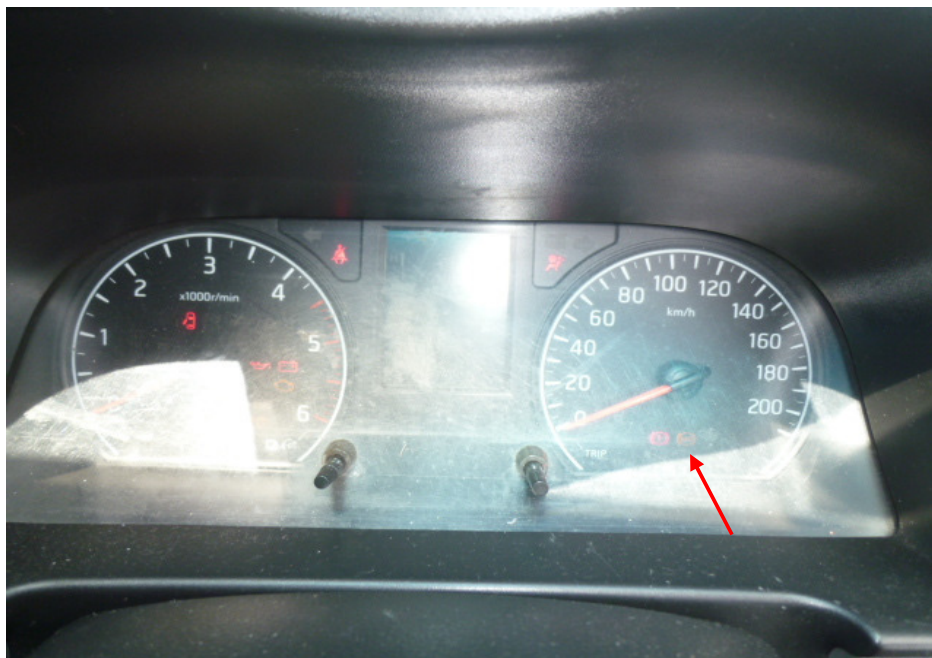
Photo 17 shows the warning lights for the various electronic operating systems of the Motor Van appearing on its instrument panel during the self-test when the engine is cranked, in particular the Antilock Braking System (ABS) light (arrowed).

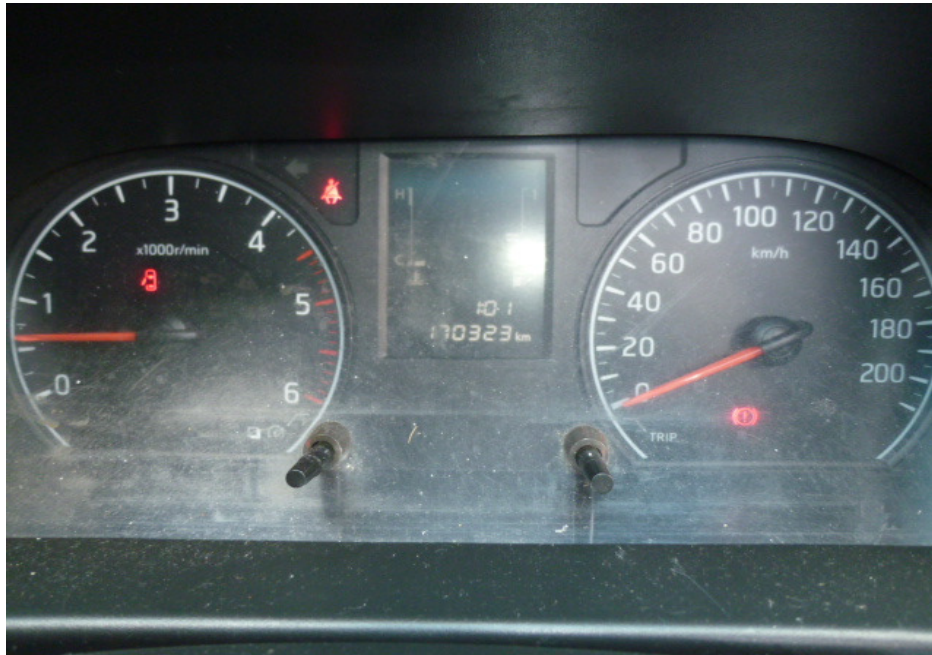
Photo 18 shows no warning lights illuminated on the instrument panel of the Motor Van after the engine was cranked. This would suggest that there was no abnormality to the various electronic operating systems of the Motor Van, like the ABS.
