**INSPECTION REPORT OF BICYCLE (YELLOW) - TRAFFIC POLICE POUND
REPORT NO. 5026/22**

1. We refer to your request dated 7 February 2023 to conduct a physical inspection of a Bicycle bearing Traffic Police Pound Report no. 5026/22 (herein referred to as "**Bicycle**"), which was involved in a fatal road traffic accident on 24 December 2022.
2. The purpose of this inspection is to primarily determine if there was any possible mechanical failure to the Bicycle that may have contributed to the accident.
3. Following the request, we had carried out a physical inspection of the Bicycle on 19 April 2023 at the premises of Traffic Police vehicle pound, 517 Airport Road Singapore 539942. We now set out below our observations and comments with respect to this inspection.

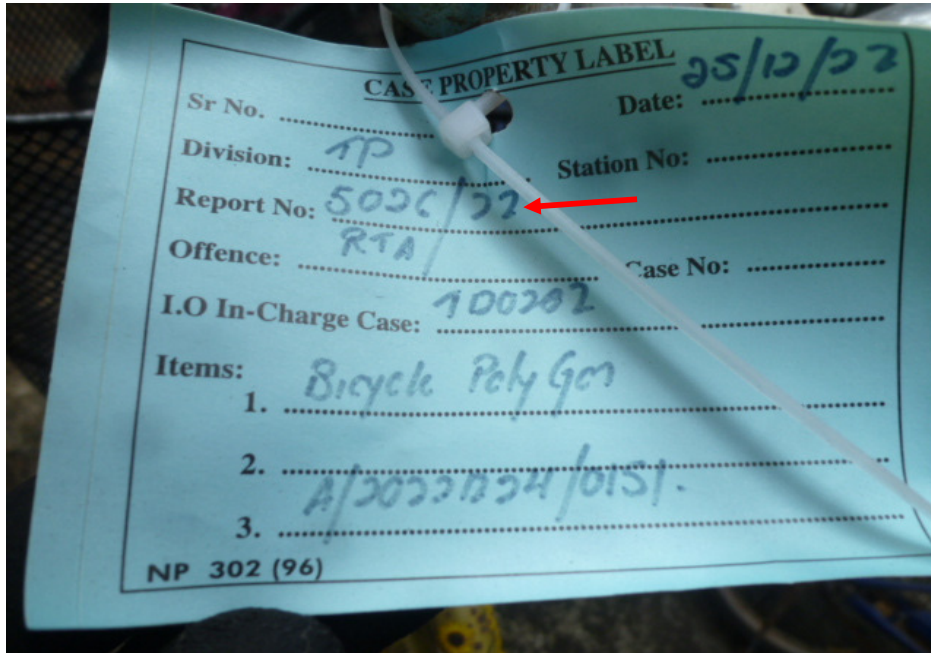
Photo 1 shows the identification of the Bicycle with reference to Traffic Police Pound Report No. 5026/22 (arrowed).

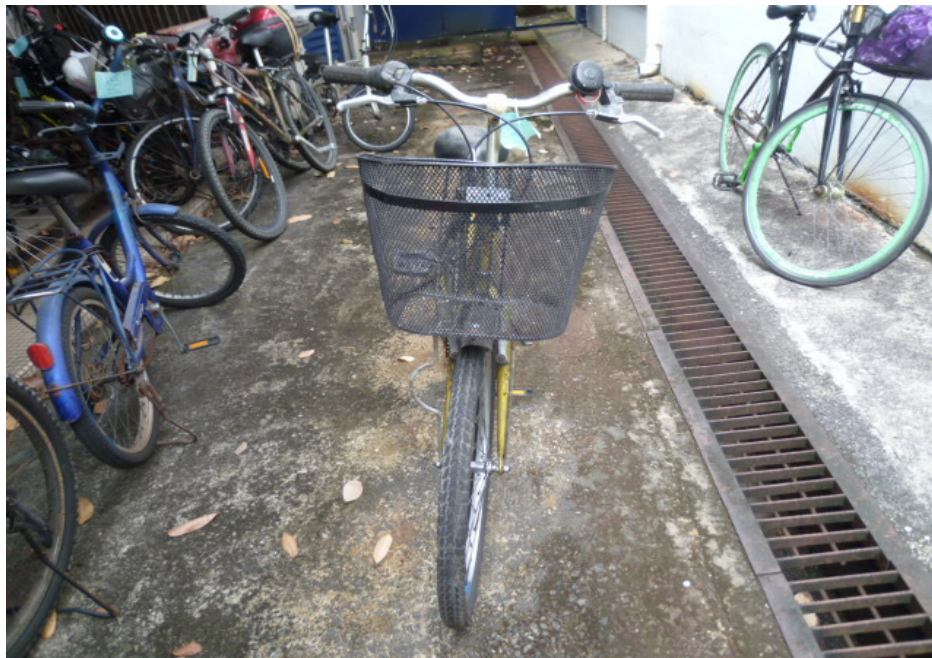
Photo 2 shows the frontal portion of the Bicycle at time of our inspection. The Bicycle had sustained damages at its right body.

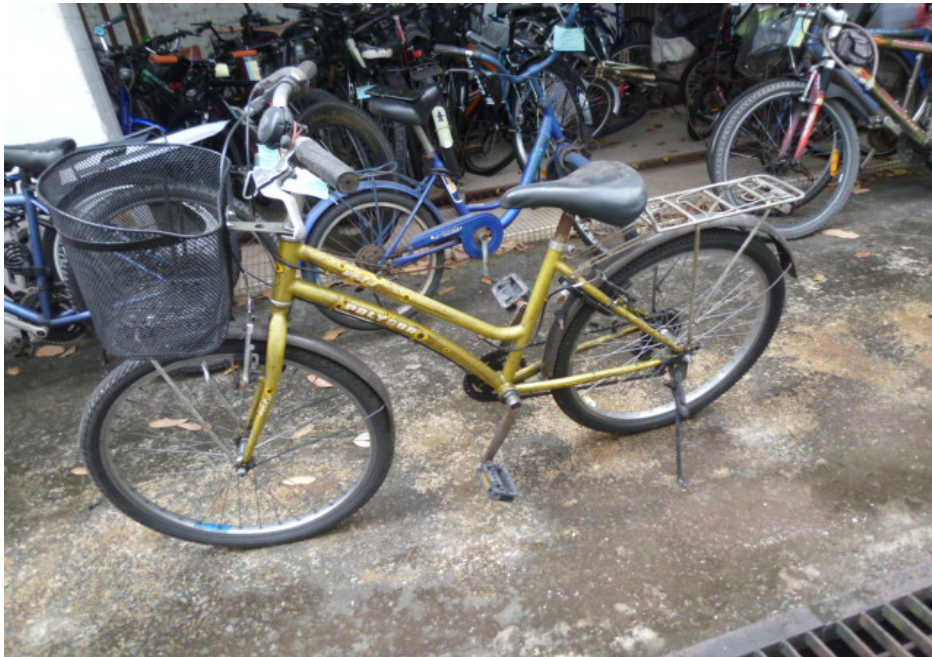
Photo 3 shows the left body of the Bicycle at time of our inspection. The Bicycle had sustained damages at its right body.

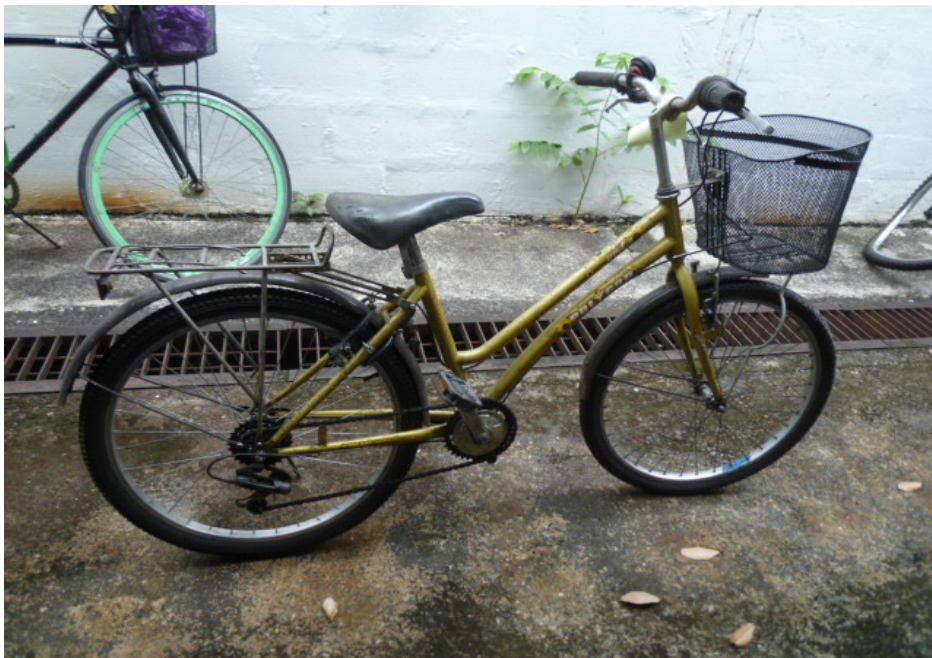
4. The Bicycle was observed to have sustained damages at its right body. The body parts that were found to have been damaged include its front basket, right handlebar grip, front mudguard, right hand brake lever, right pedal and seat, amongst others as a result of the accident. See photos 1 – 10 below.

Photo 4 shows the right body of the Bicycle at time of our inspection. The Bicycle had sustained damages at its right body. The body parts that were found to have been damaged include its front basket, right handlebar grip, front mudguard, right hand brake lever, right pedal and seat, amongst others as a result of the accident.

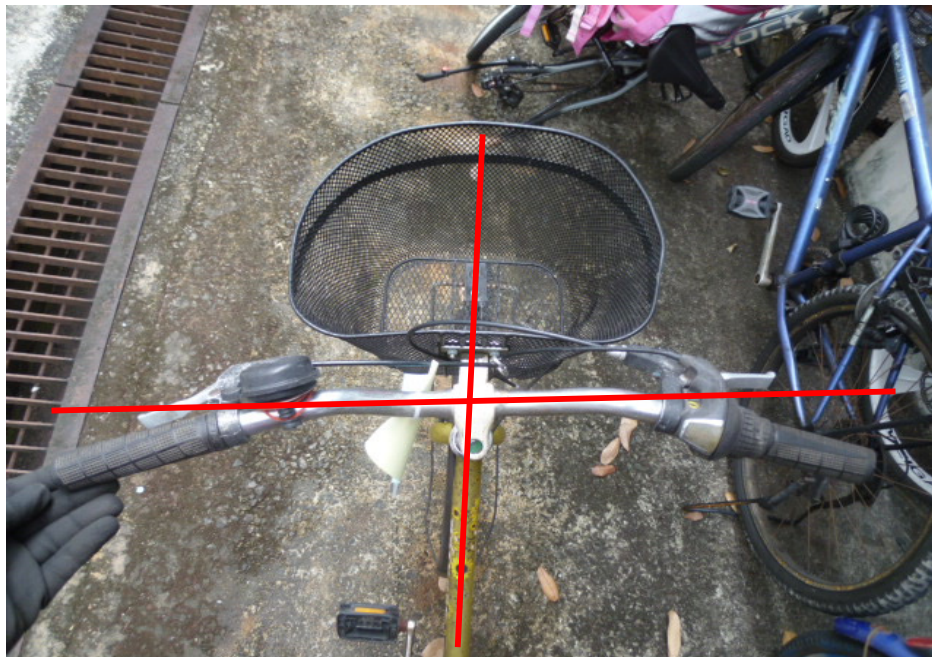
Photo 5 shows the frontal portion of the Bicycle (top view) at the time of our inspection. There was a misalignment of the handle bar & front tyre observed as a result of the accident.

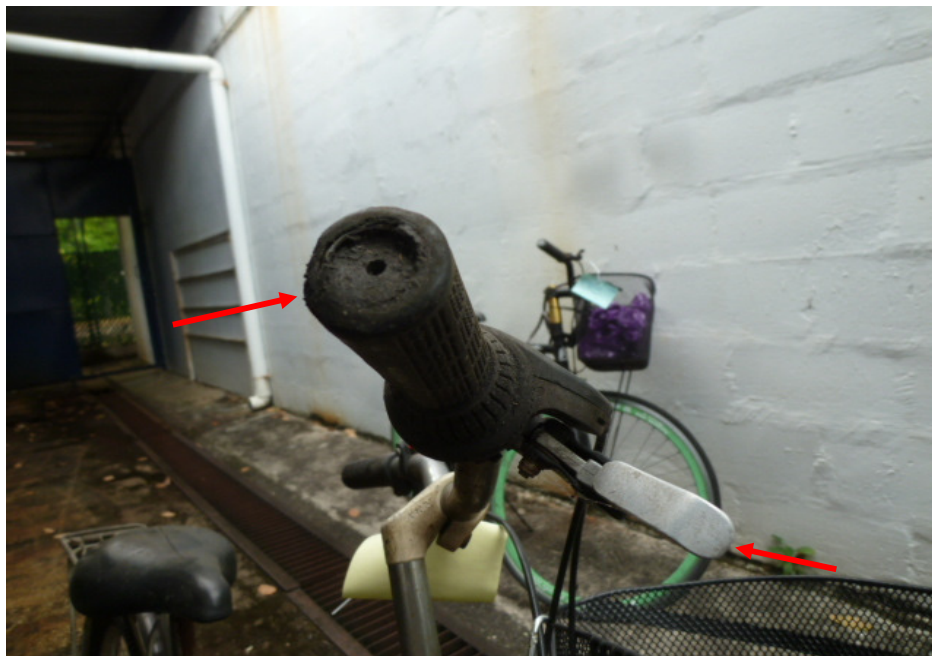
Photo 6 shows the damaged right handlebar grip and right hand brake lever (arrowed) of the Bicycle at the time of our inspection.

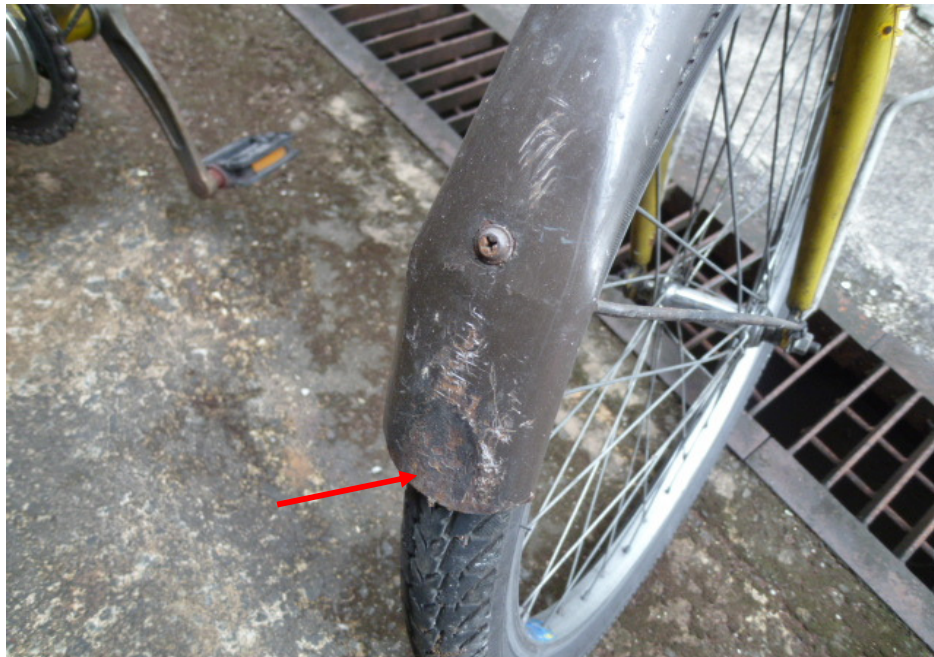
Photo 7 shows the damaged front mudguard (arrowed) of the Bicycle at the time of our inspection.

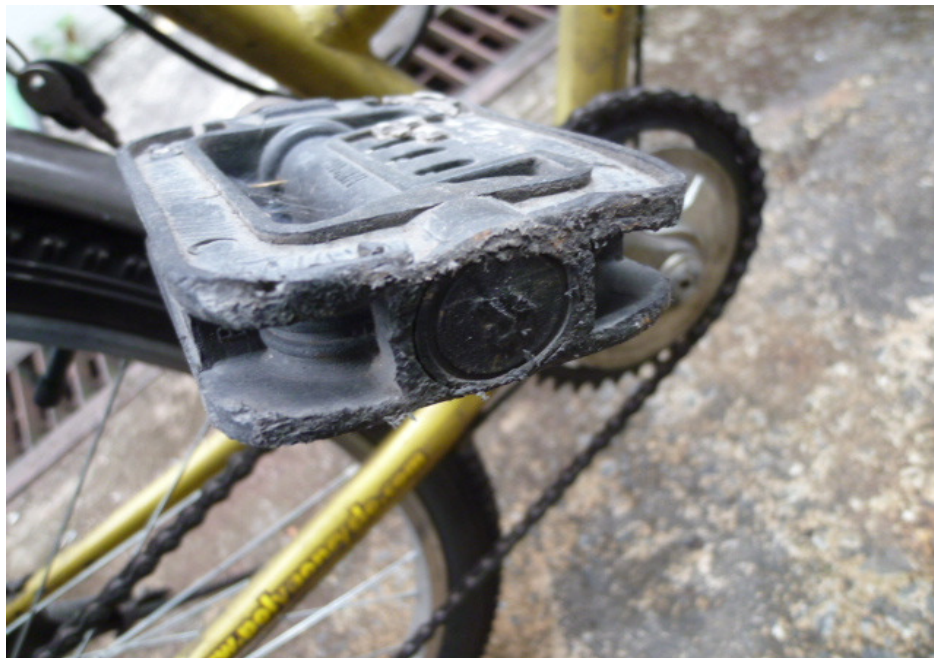
Photo 8 shows the damages of grazing nature on the right pedal of the Bicycle at the time of our inspection.

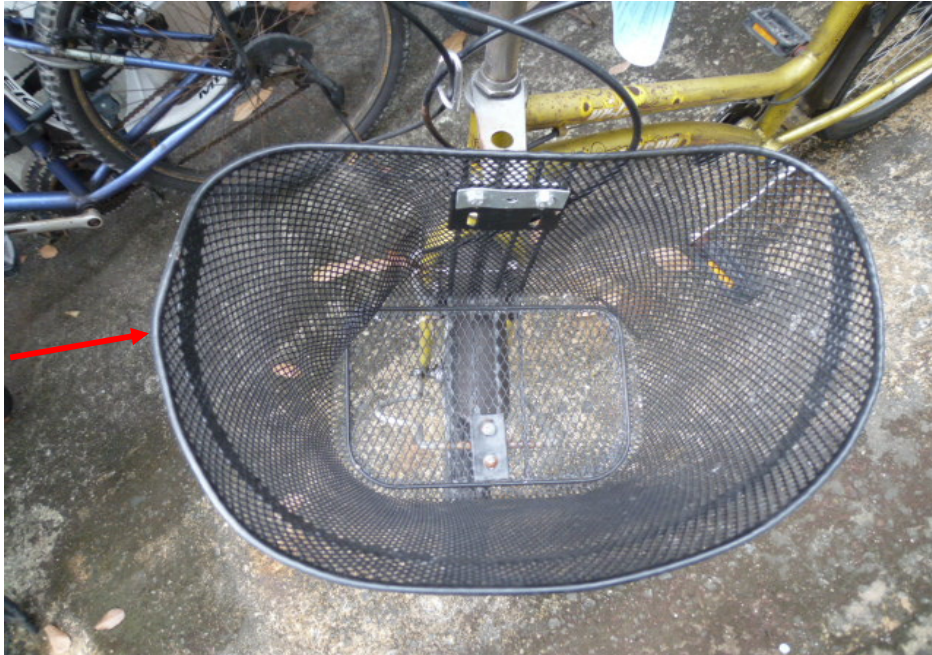
Photo 9 shows the deformed front basket of the Bicycle at the time of our inspection (arrowed).

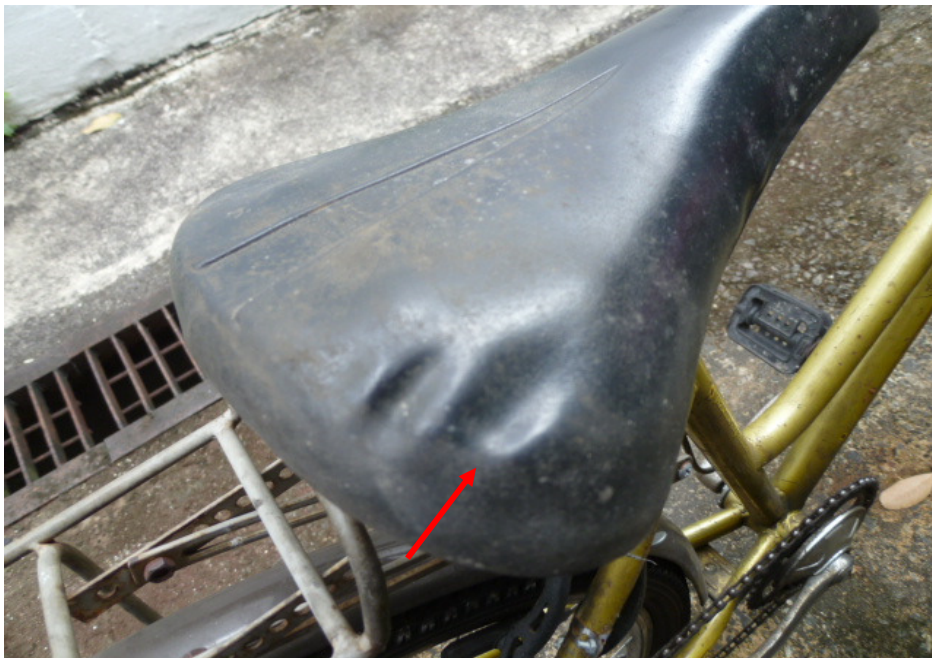
Photo 10 shows a close-up view of the deformed seat (arrowed) of the Bicycle as a result of the accident.

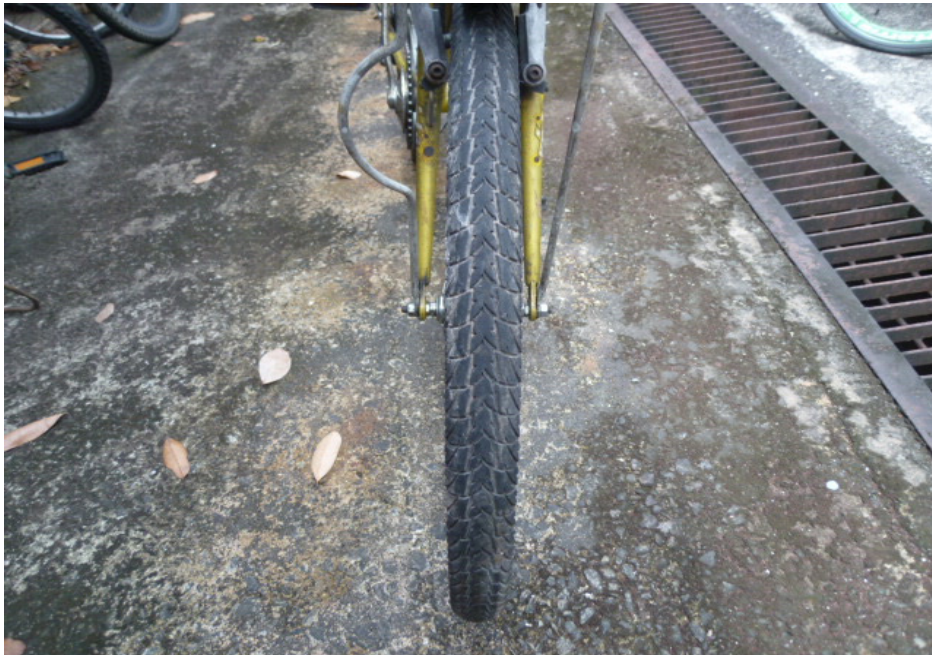
Photo 11 shows the front tyre of the Bicycle. The pattern of the tread was clearly visible. There was no tear, burst mark(s) and/or punctured hole(s) on the sidewalls as well as across the tread of the front tyre. The front tyre was also observed to be sufficiently inflated for vehicular operation.

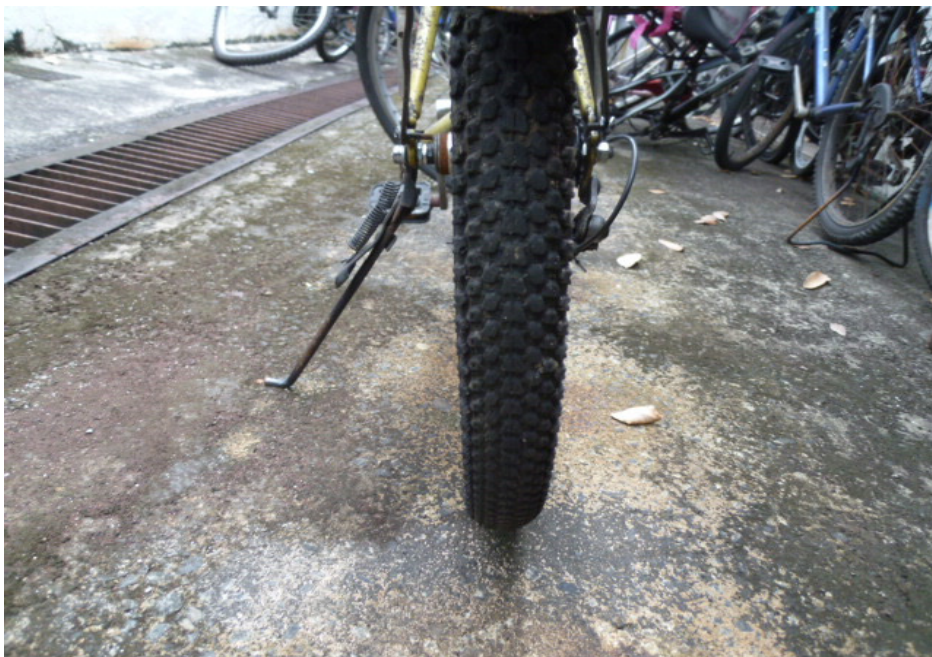
Photo 12 shows the rear tyre of the Bicycle. The pattern of the tread was clearly visible. There was no tear, burst mark(s) and/or punctured hole(s) on the sidewalls as well as across the tread of the rear tyre. The rear tyre was also observed to be sufficiently inflated for vehicular operation.

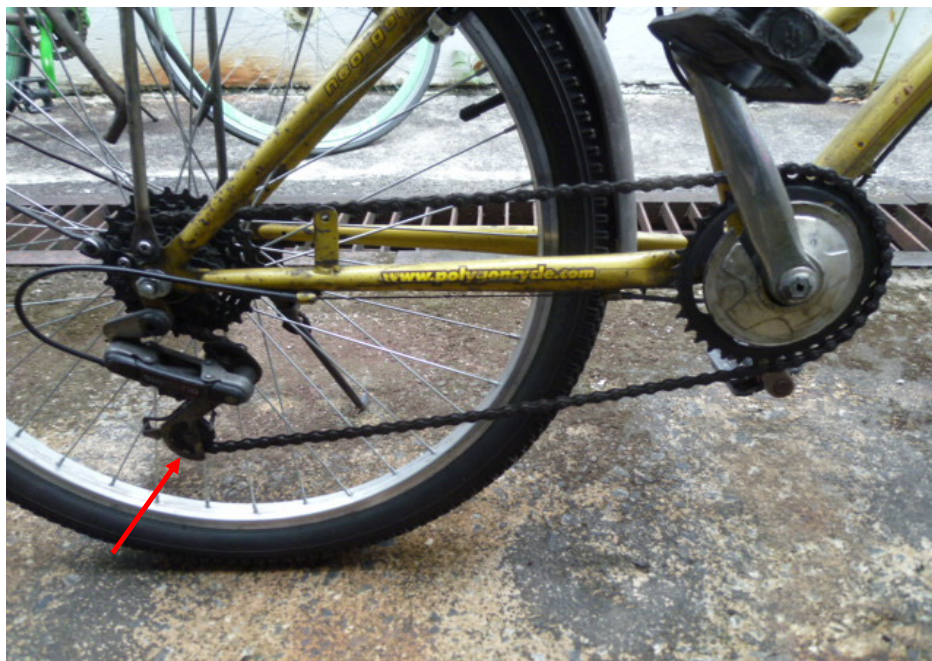
Photo 13 shows the general view of the gear train of the Bicycle, which was observed to be intact with no misalignment. It was also adequately lubricated for operating purposes. However the chain was observed to be dislodged from the gear train most likely as a result of the accident (arrowed).

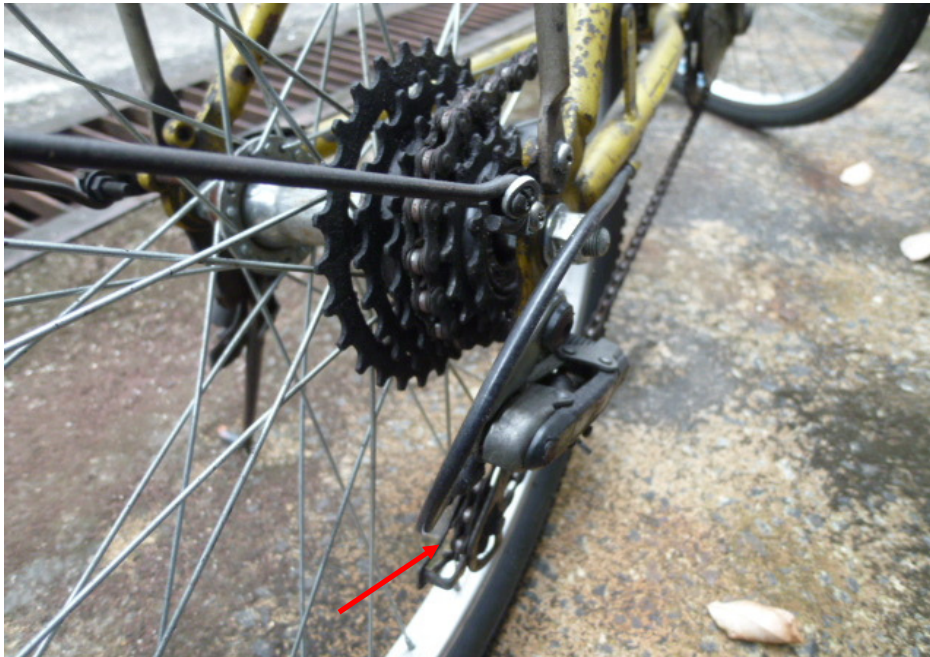
Photo 14 shows a closer view of the dislodged chain from the gear train of the Bicycle, most likely as a result of the accident. It was found to be adequately lubricated for operating purposes (arrowed).

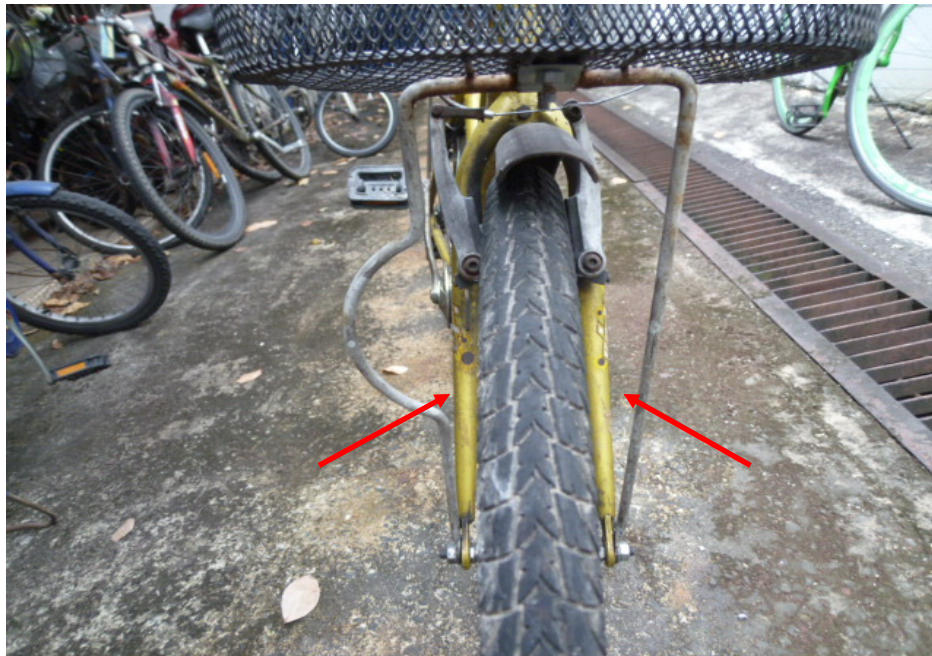
8. Our checks on the various steering components of the Bicycle revealed that its steering system was in serviceable condition. Its front fork was found to be intact and undamaged. Turning the handle bar towards the left and right did not produce any abnormal free play and/or resistance.

Photo 15 shows the front forks (arrowed) of the Bicycle. The front forks and fork bracket of the Bicycle were both found to be intact and undamaged. Turning the Bicycle's handle bar towards the left and right did not produce any abnormal free play. The steering system of the Bicycle was in serviceable condition at the time of our inspection.

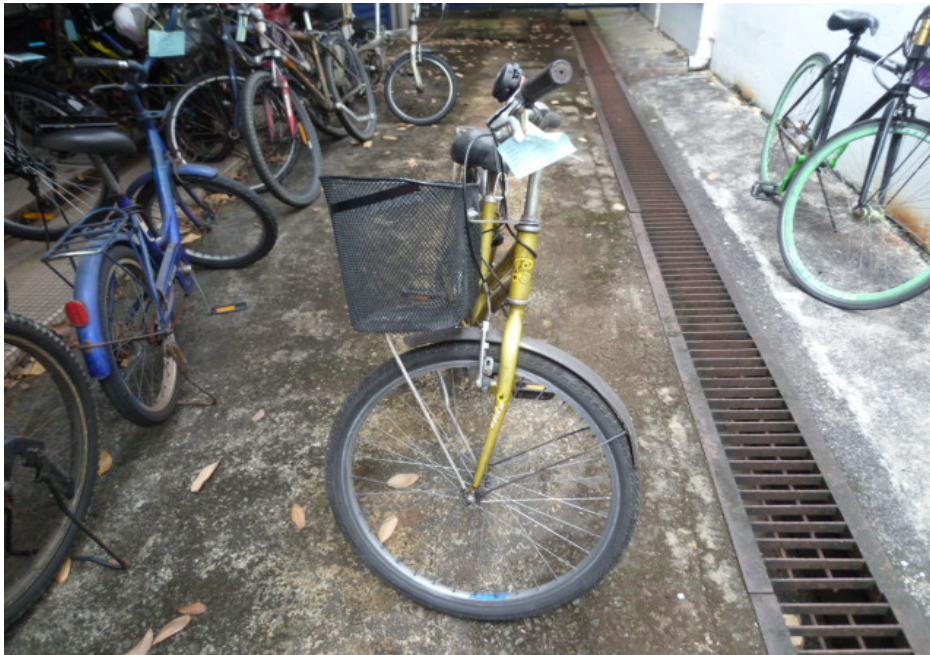
Photo 16 shows the front wheel of the Bicycle turned towards its full right. Turning the Bicycle's handle bar towards the right did not produce any abnormal free play and/or resistance. This would indicate that the steering system of the Bicycle was in serviceable condition at the time of our inspection.

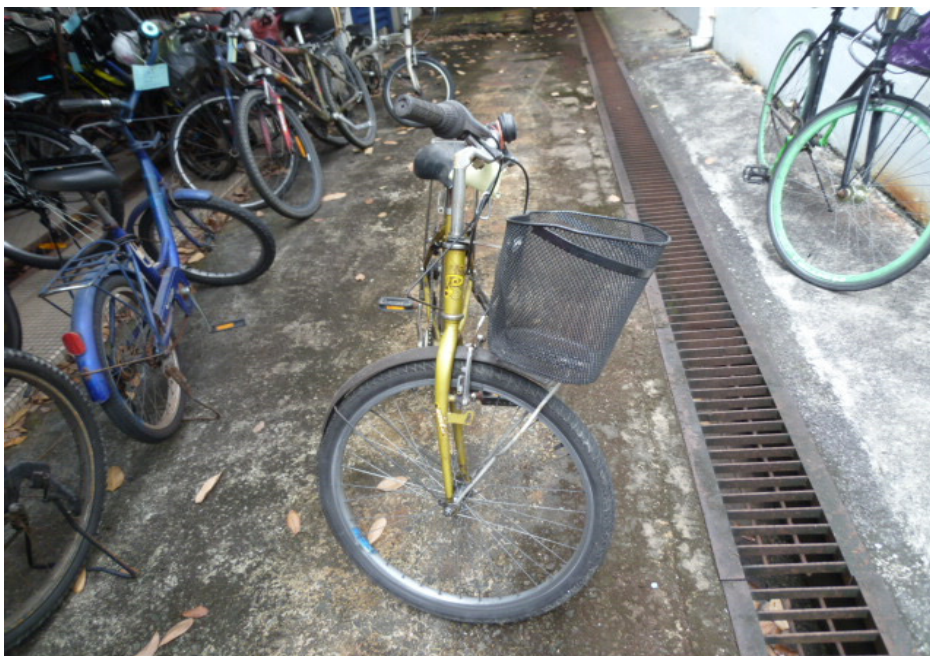
Photo 17 shows the front wheel of the Bicycle turned towards its full left. Turning the Bicycle's handle bar towards the left did not produce any abnormal free play and/or resistance. This would indicate that the steering system of the Bicycle was in serviceable condition at the time of our inspection.

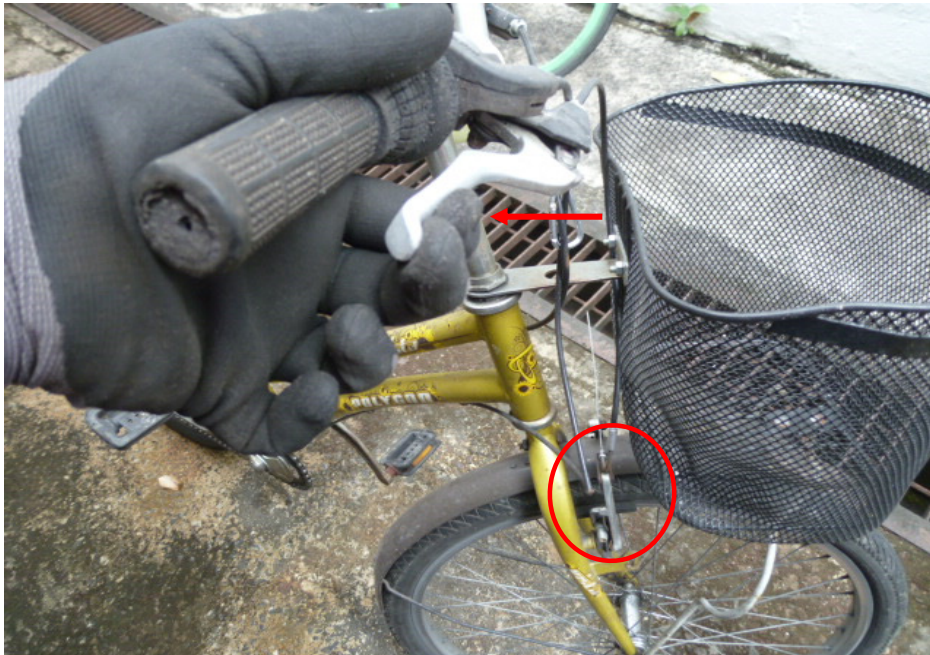
10. A static brake test was conducted on the front brake of the Bicycle. There was some resistance felt upon pressing the right hand brake lever. This was further confirmed by looking at the front brake clamps while we pressed the right hand brake lever. It shows that the front brake clamps responded to the gripping action. The rubber brake blocks pressed against the front wheel rim. This had appeared to indicate that the front brake of the Bicycle was in serviceable condition.

Photo 18 shows a static brake test conducted on the Bicycle's front brake. There was some resistance felt upon pressing the right hand brake lever (arrowed). It also shows that the front brake clamps responded to the gripping action (circled) after depressing the right hand brake lever.

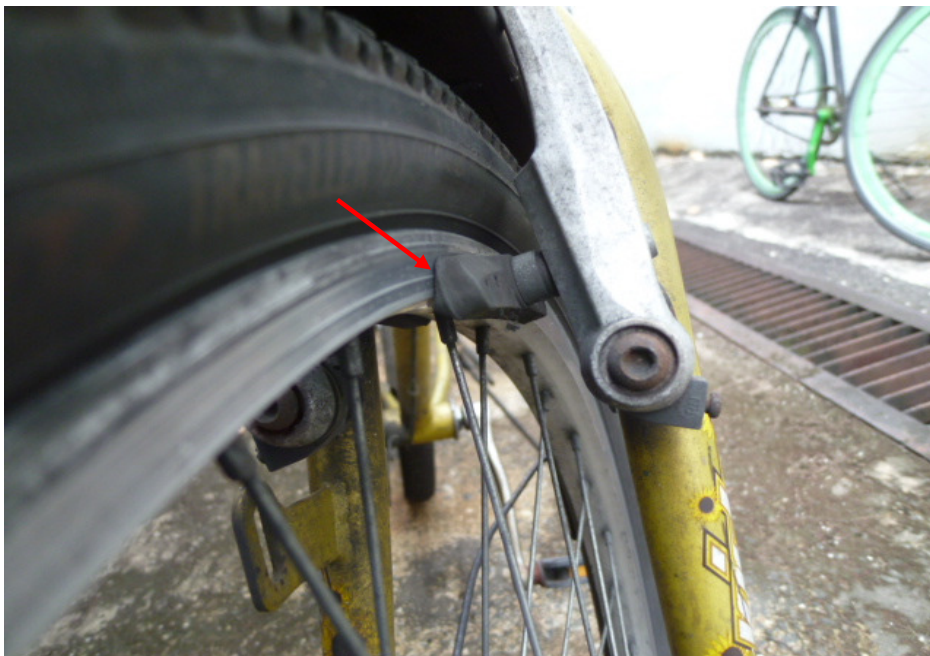
Photo 19 shows a close up view of the front brake clamps responding to the gripping action. The rubber brake blocks pressed against the front wheel rim upon depressing the right hand brake lever (arrowed). This had appeared to indicate that the front brake of the Bicycle was in serviceable condition.

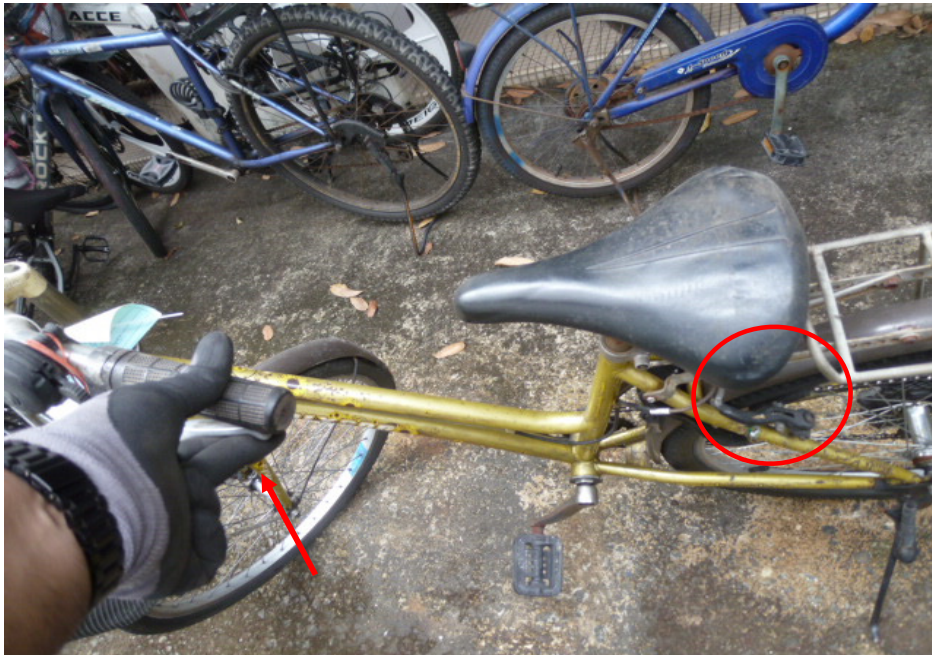
11. A static brake test was conducted on the rear brake of the Bicycle. There was some resistance felt upon pressing the left hand brake lever. This was further confirmed by looking at the rear brake clamps while we pressed the left hand brake lever. It shows that the rear brake clamps responded to the gripping action. The rubber brake blocks pressed against the rear wheel rim. This had appeared to indicate that the rear brake of the Bicycle was in serviceable condition.

Photo 20 shows a static brake test conducted on the Bicycle's rear brake. There was some resistance felt upon pressing the left hand brake lever (arrowed). It also shows that the rear brake clamps responded to the gripping action (circled) after depressing the left hand brake lever.

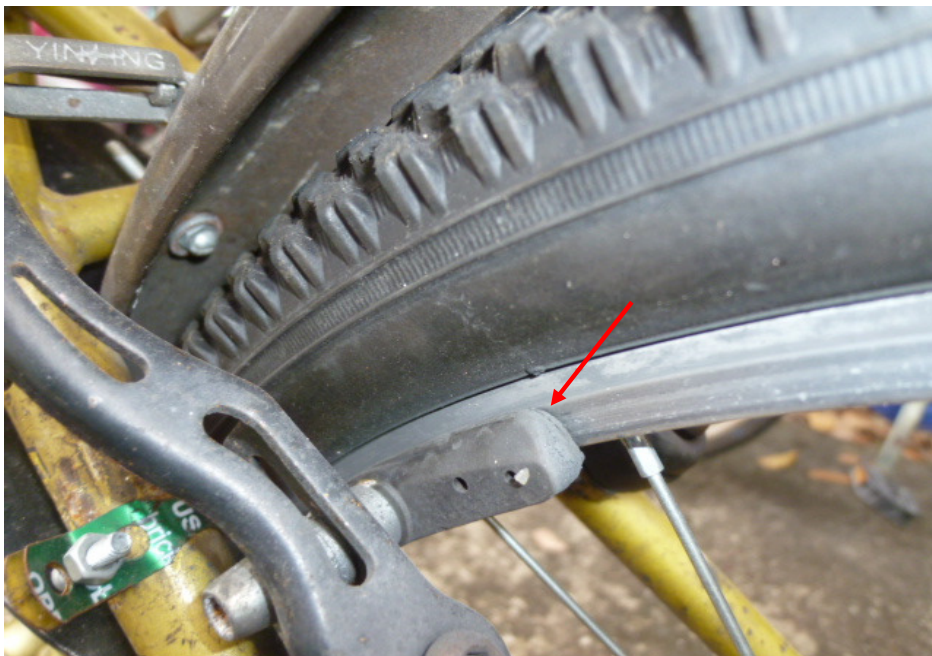
Photo 21 shows a close up view of the rear brake clamps responding to the gripping action. The rubber brake blocks pressed against the rear wheel rim upon depressing the left hand brake lever (arrowed). This had appeared to indicate that the rear brake of the Bicycle was in serviceable condition.
