Your Ref: TP/IP/000305/2023  
Our Ref : CI/TPD23001377/N

**Fatal Accident Investigation Team**

**MECHANICAL INSPECTION REPORT OF MOTOR CAR SMQ 764K**

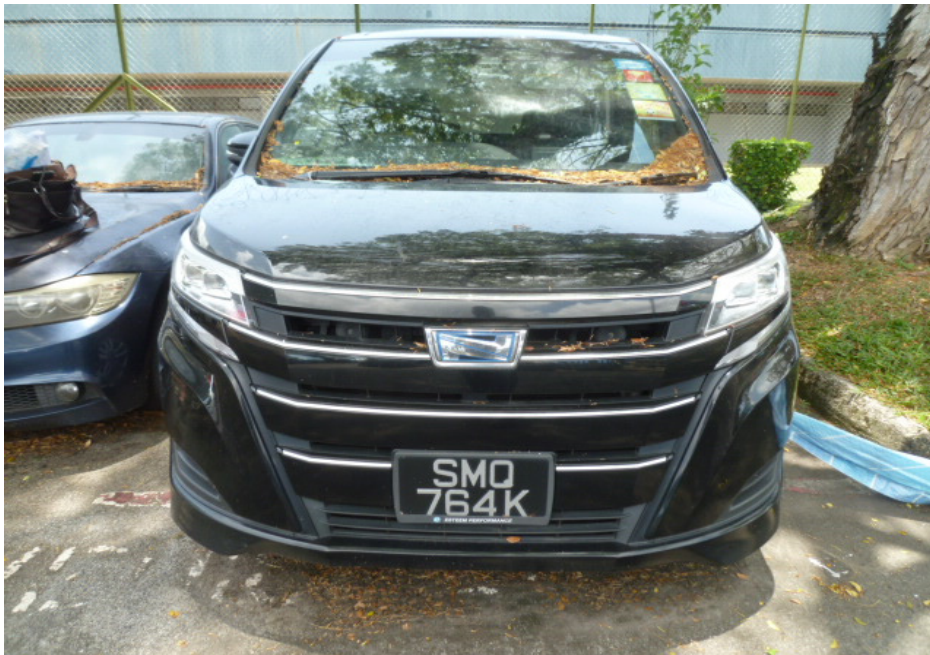
4. The mileage of the Motor Car at the time of our inspection was 266, 010km.
5. The Motor Car had sustained impact damage that was confined to its left body. Its left front fender and left front door were observed to be dented. Its left rear door was found to be dislodged. Its left side mirror was observed to be broken.

**Photo 1** shows a general view of the frontal portion of the Motor Car at the time of our inspection. The Motor Car was observed to be in good general condition except for impact damage at its left body. The mileage of the Motor Car was recorded to be 266, 010km.

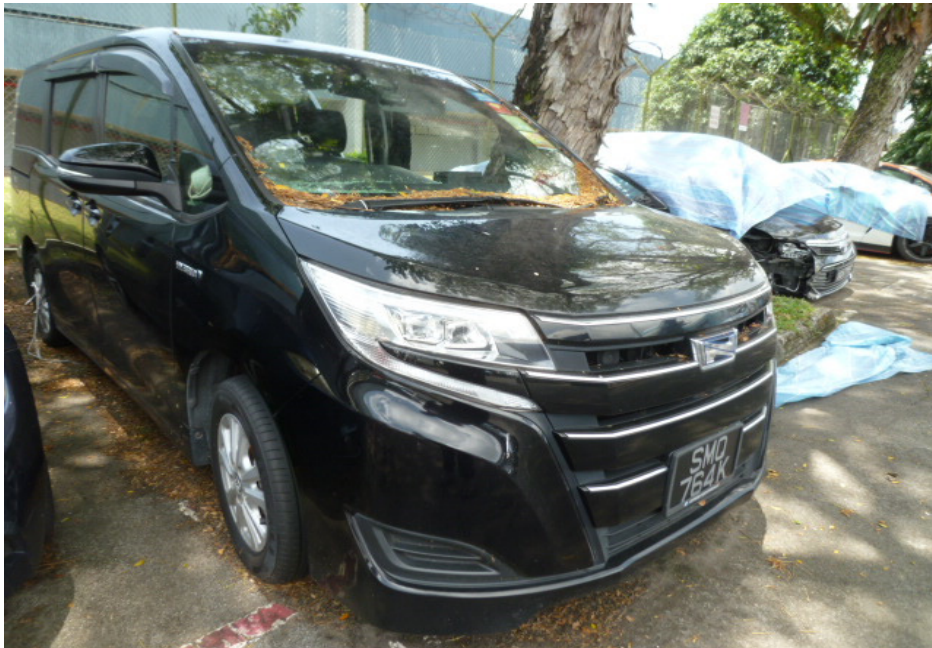
**Photo 2** shows a general view of the right body of the Motor Car at the time of our inspection. The Motor Car was observed to be in good general condition. However we had observed impact damage that was confined to its left body.

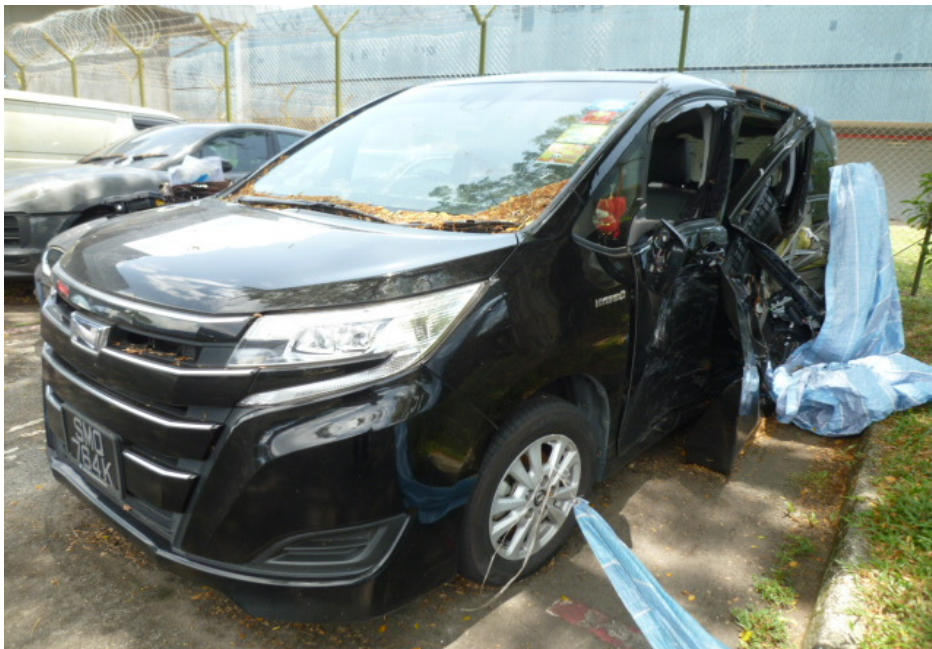
**Photo 3** shows a general view of the left body of the Motor Car at the time of our inspection. The Motor Car was observed to be in good general condition. However we had observed impact damage that was confined to its left body. Its left front fender and left front door were observed to be dented. Its left rear door was found to be dislodged. Its left side mirror was observed to be broken.

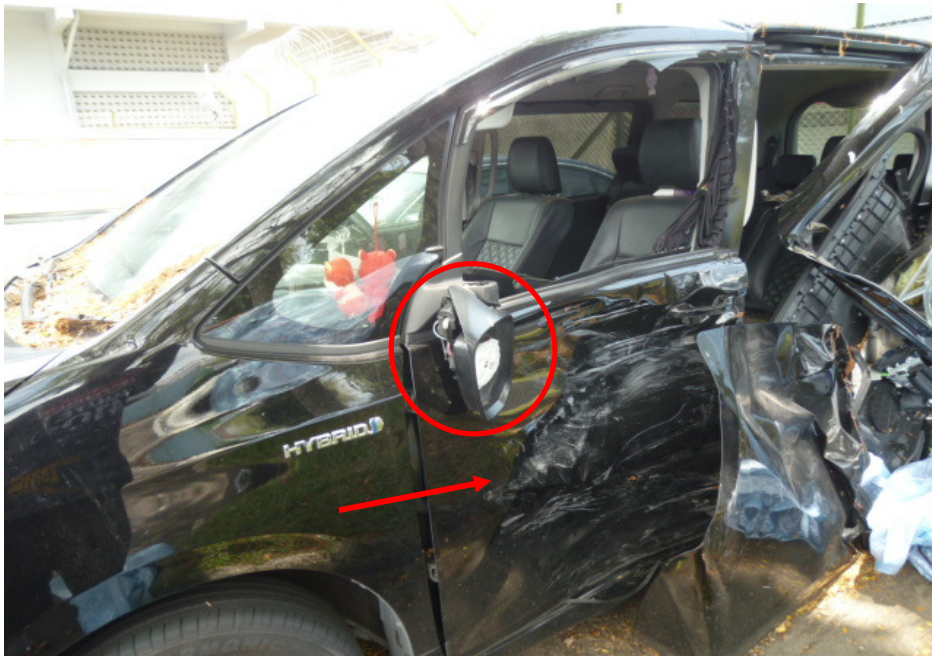
**Photo 5** shows a closer view of the broken left side mirror (circled) and dented left front door (arrowed) of the Motor Car at the time of our inspection

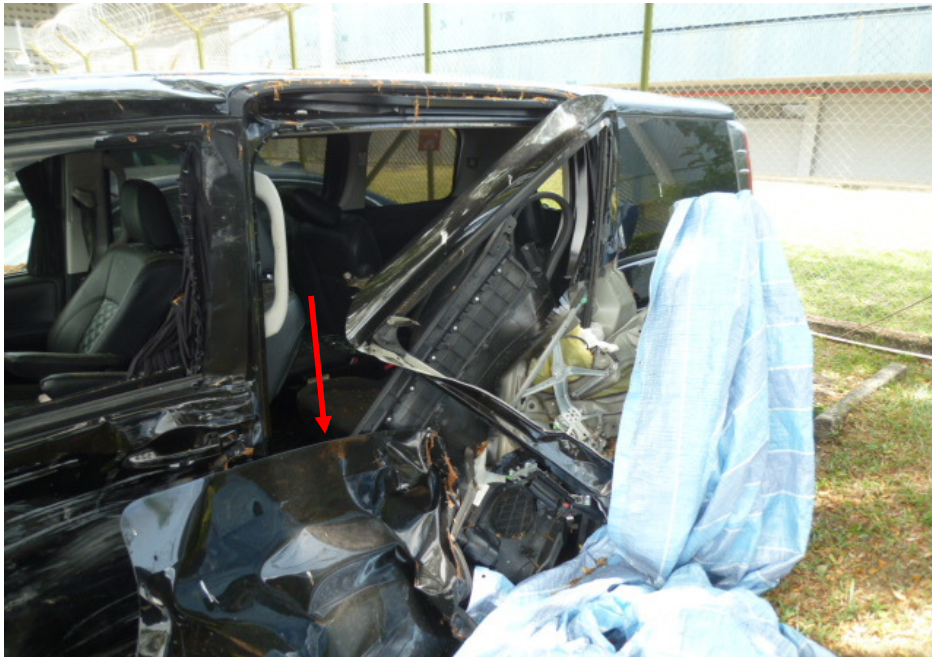
**Photo 6** shows the dislodged left rear door (arrowed) of the Motor Car at the time of our inspection.

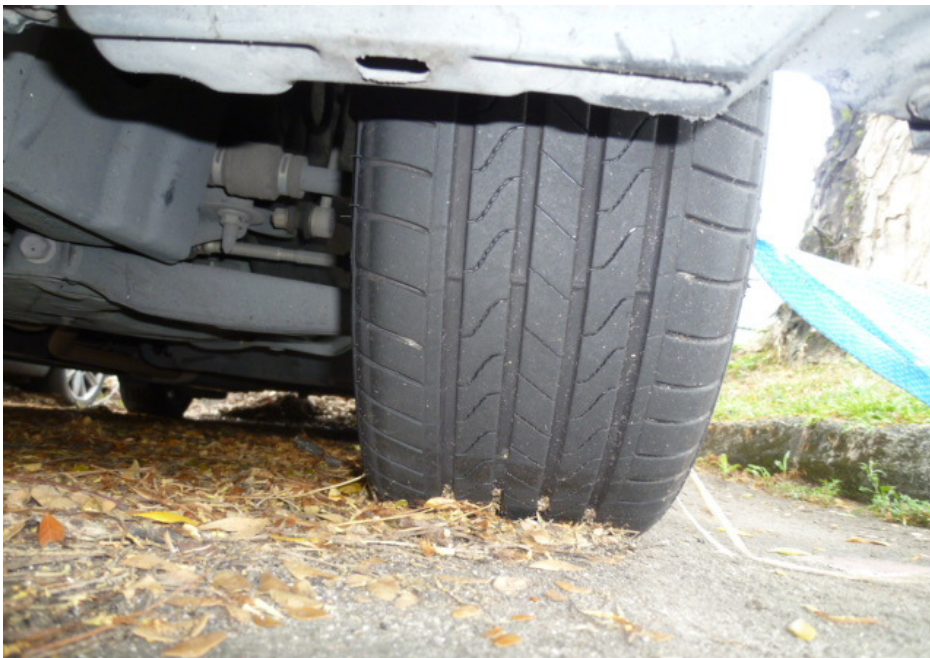
**Photo 7** shows the condition of the left front tyre of the Motor Car, which was observed to be in serviceable condition with remaining tread depth of approximately 7mm. The tyre, which was wrapped around alloy wheel rim, was also observed to be sufficiently inflated for vehicular operation. There was no tear, cut or burst mark(s) on the outer and the inner sidewalls as well as across the tread of the 4 tyres.

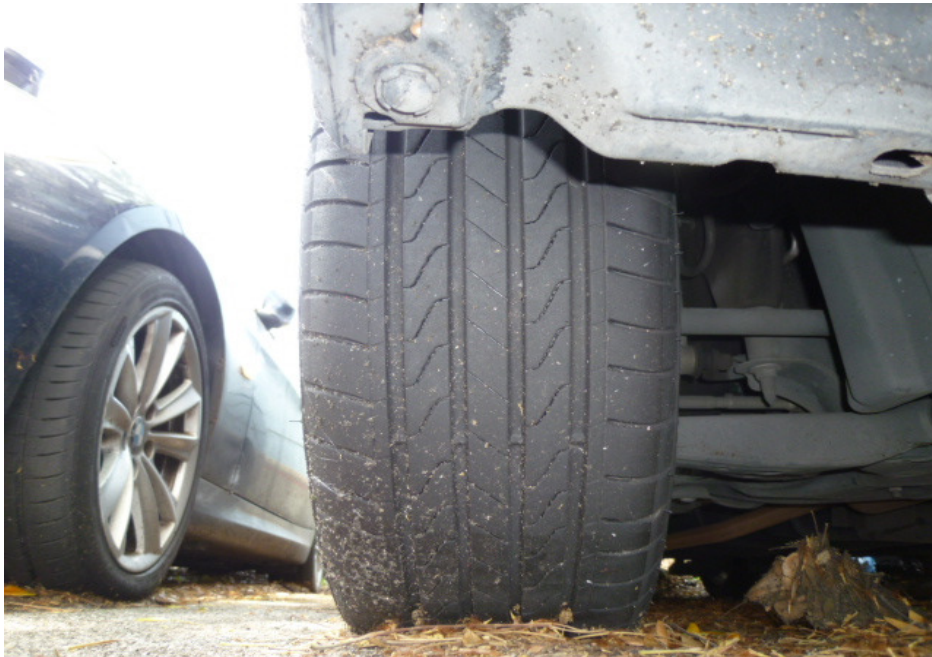
**Photo 8** shows the condition of the right front tyre of the Motor Car, which was observed to be in serviceable condition with remaining tread depth of approximately 7mm. The tyre, which was wrapped around alloy wheel rim, was also observed to be sufficiently inflated for vehicular operation.

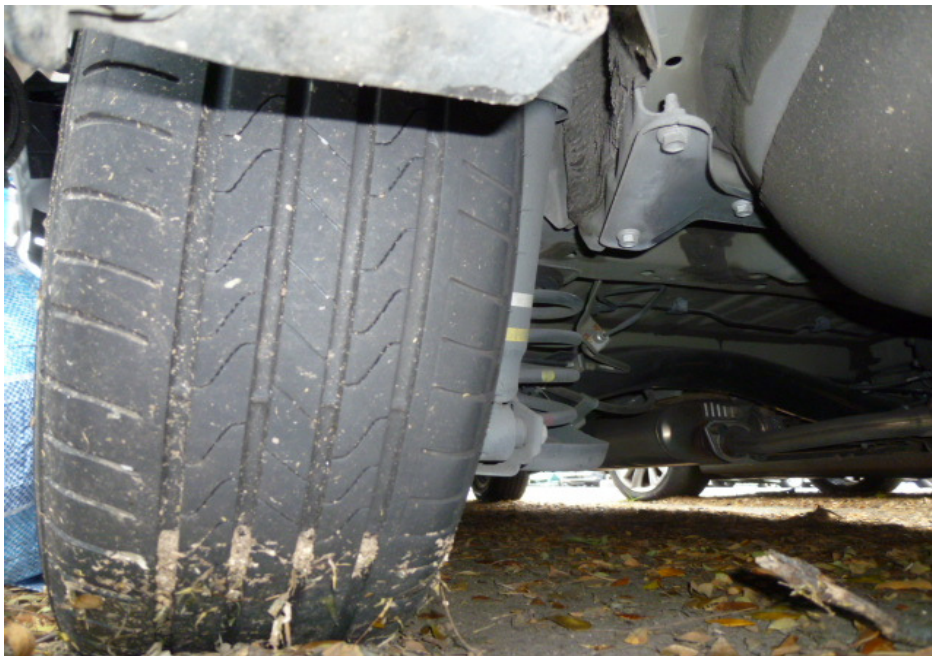
**Photo 9** shows the condition of the left rear tyre of the Motor Car, which was observed to be in serviceable condition with remaining tread depth of approximately 5mm. The tyre, which was wrapped around alloy wheel rim, was also observed to be sufficiently inflated for vehicular operation. There was also no damage found on the 4 wheel rims of the Motor Car.

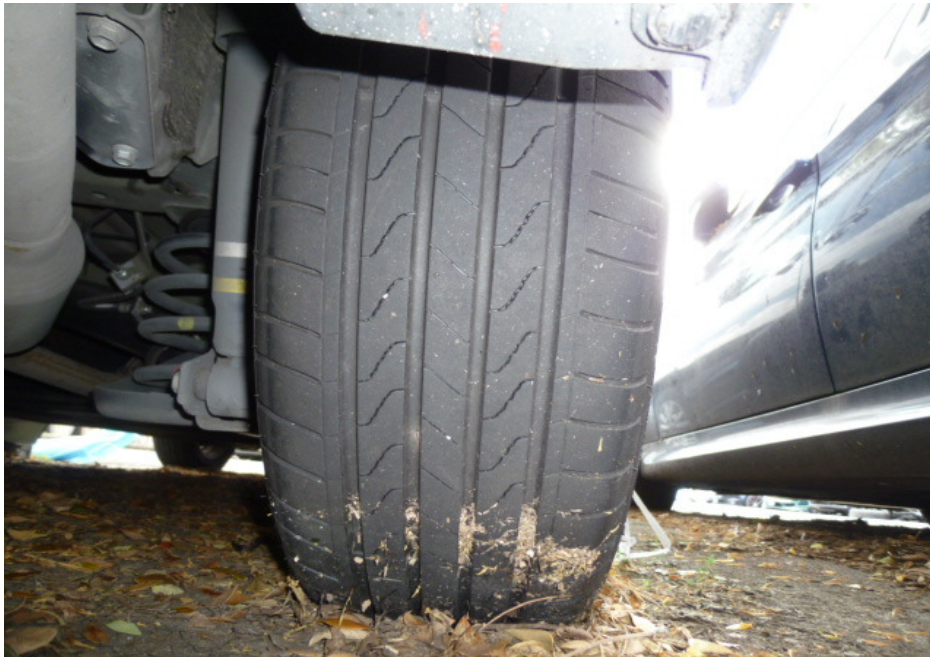
**Photo 10** shows the condition of the right rear tyre of the Motor Car, which was observed to be in serviceable condition with remaining tread depth of approximately 5mm. There was also no tear, cut or burst mark(s) on the outer and the inner sidewalls as well as across the tread of the 4 tyres.

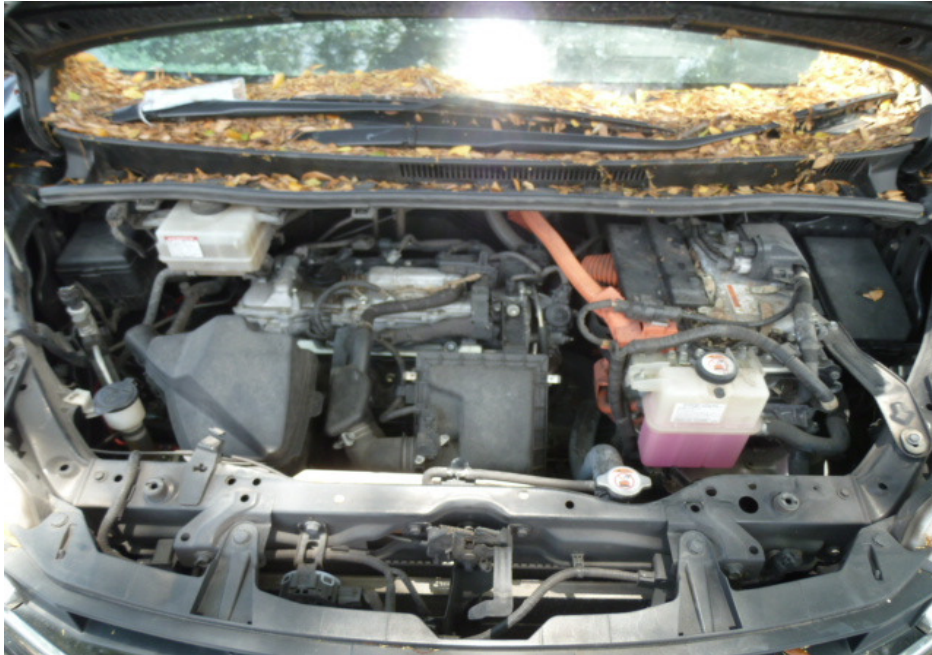
**Photo 11** shows a general view of the Motor Car's engine compartment. The various parts and components inside the engine compartment were unaffected by the accident. The wirings and cables for the hybrid system were all further observed to be intact and adequately secured to their respective terminals and/or connecting ports. There was also no sign(s) or indication(s) of fluid leakage and/or fluid stain within the engine compartment.

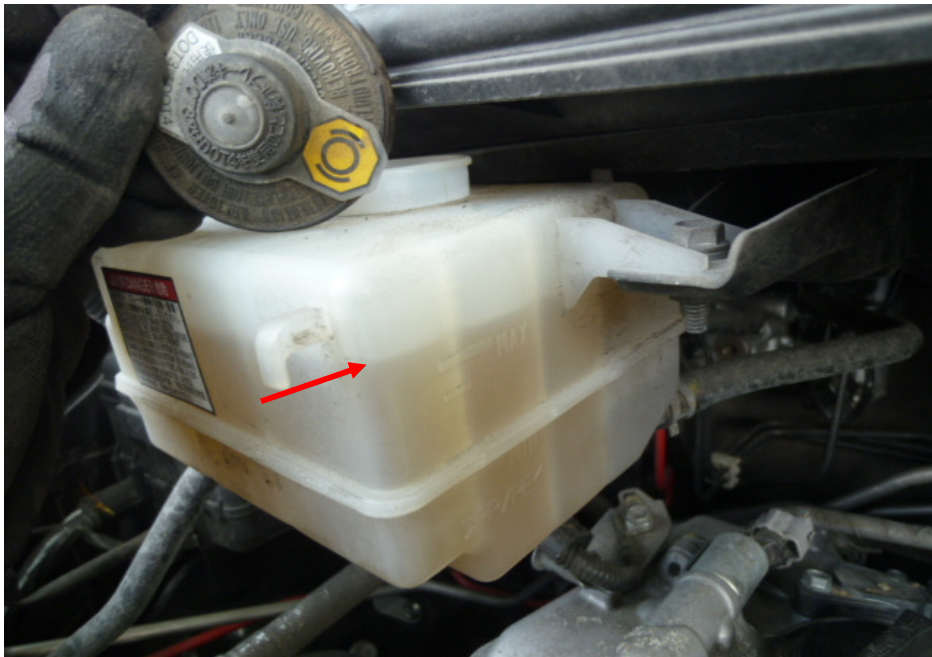
**Photo 12** shows the brake fluid reservoir of the Motor Car at the time of our inspection. The brake fluid was observed to be of sufficient level for operating purposes and without any visible contamination.

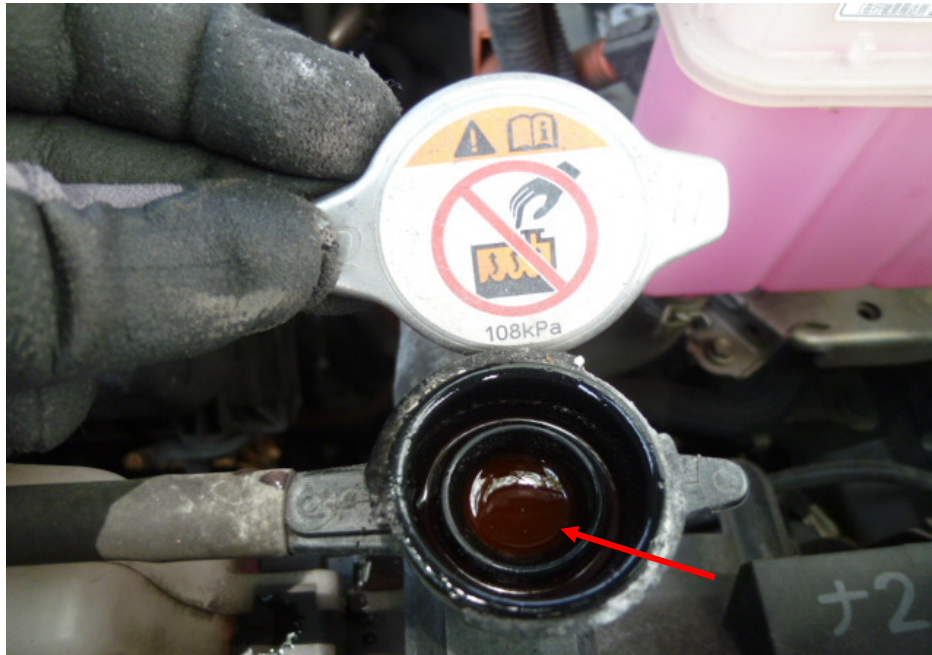
**Photo 13** shows checks being carried out to the engine coolant of the Motor Car at the time of our inspection. The engine coolant was observed to be of sufficient level for operating purposes and without any visible contamination (arrowed).

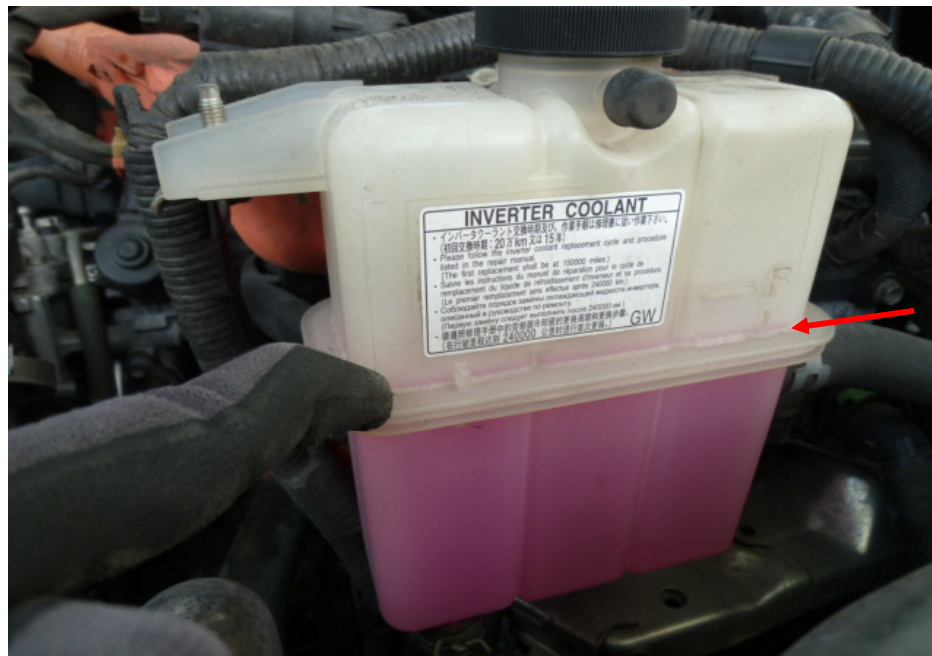
**Photo 14** shows the coolant reservoir for the hybrid system of the Motor Car at the time of our inspection. The hybrid system coolant was observed to be of sufficient level for operating purposes and without any visible contamination (arrowed).

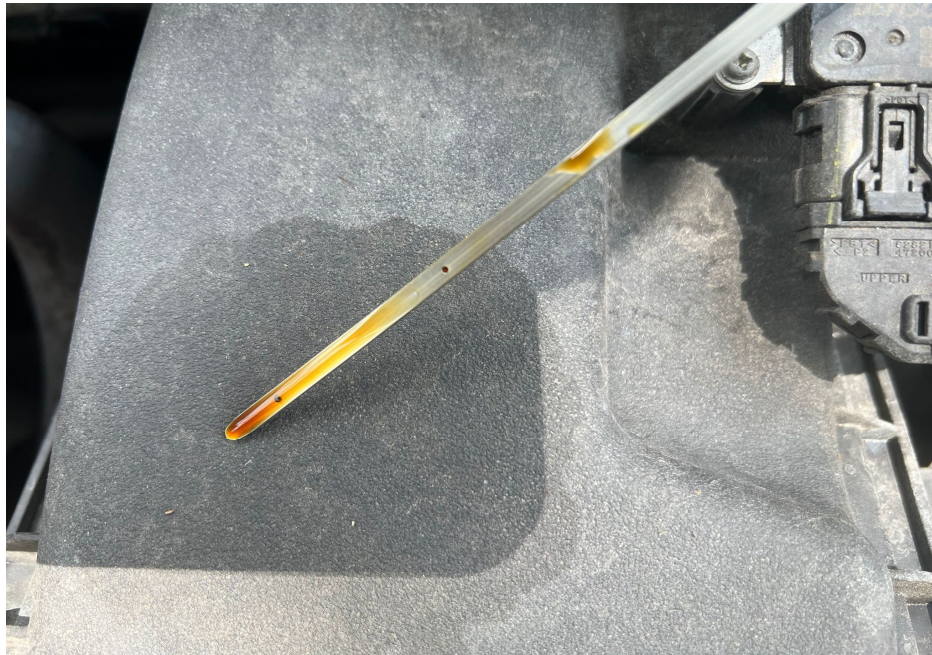
**Photo 15** shows the engine oil dip stick of the Motor Car at the time of our inspection. The engine oil was observed to be of sufficient level for operating purposes and without any visible contamination.

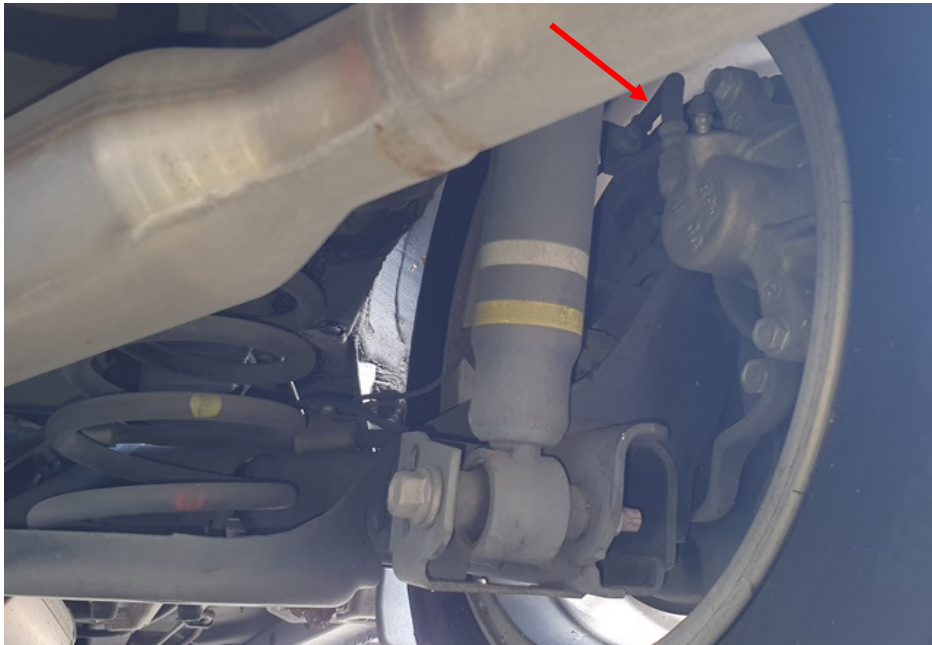
**Photo 16** shows the brake hose/pipe (arrowed) at the rear right wheel of the Motor Car. We did not observe any leakage of brake fluid at the time of our inspection of the Motor Car. Static tests of the Motor Car's braking system had indicated that there was no internal leakage of pressure/vacuum. Hence the braking system was likely to be in serviceable condition at the material time of accident. The undercarriage components of the Motor Car were also all found to be intact and without any visible damage.

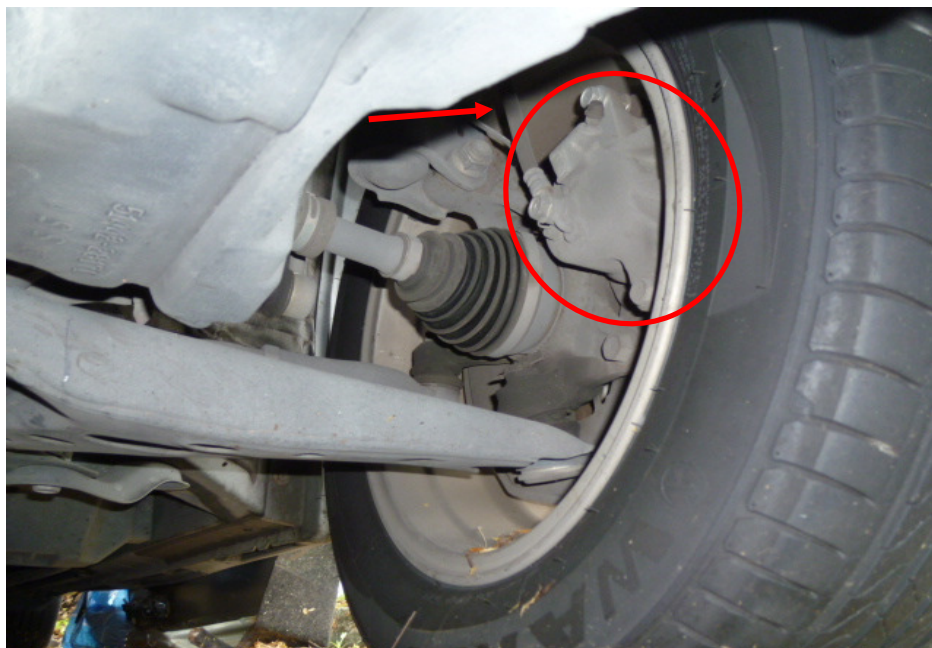
**Photo 17** shows the brake hose/pipe (arrowed) at the front left wheel of the Motor Car. No leakage of brake fluid was observed. Visual examination of the various components of the braking system like the brake caliper (circled), brake pedal etc. had revealed all to be intact and without visible damage.

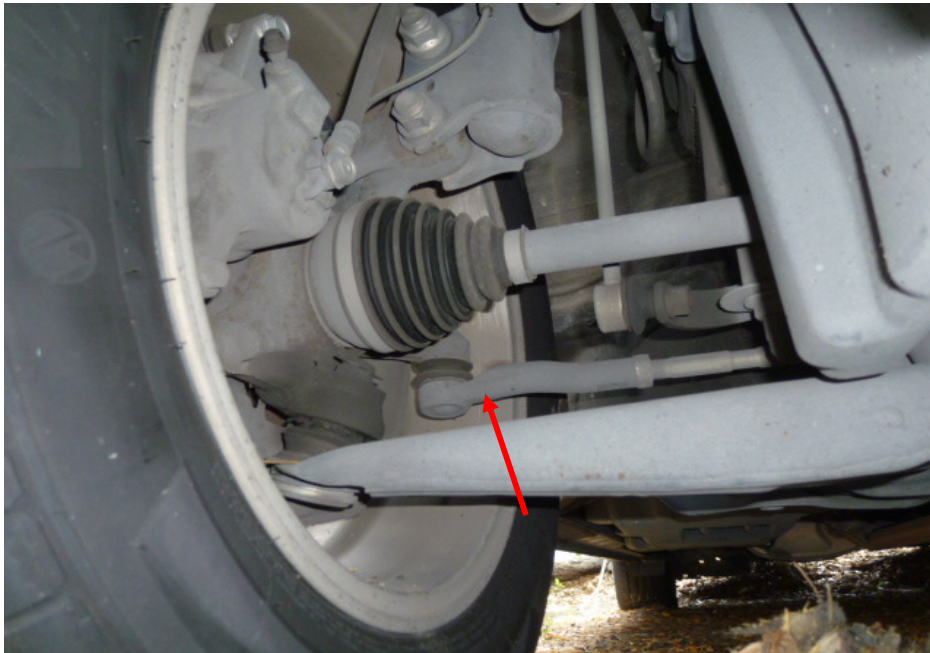
**Photo 18** shows the various undercarriage components at the front right wheel of the Motor Car, in particular the steering tie rod (arrowed). The various steering components were all found to be intact, suggesting that the steering system of the Motor Car was likely to be in serviceable condition at the material time of accident. There was also no sign of fluid stain observed on the various undercarriage components at the front right wheel of the Motor Car.

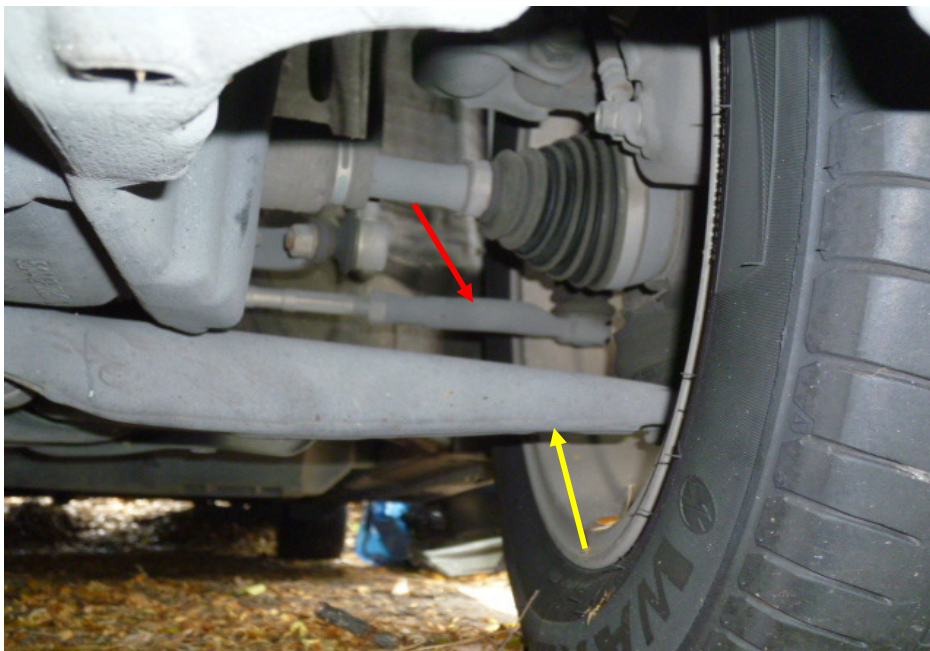
**Photo 19** shows the various undercarriage components at the front left wheel of the Motor Car, which had included the steering tie rod (red arrow) and left drive shaft (yellow arrow). The various undercarriage components of the Motor Car were all found to be intact without any visible damage.

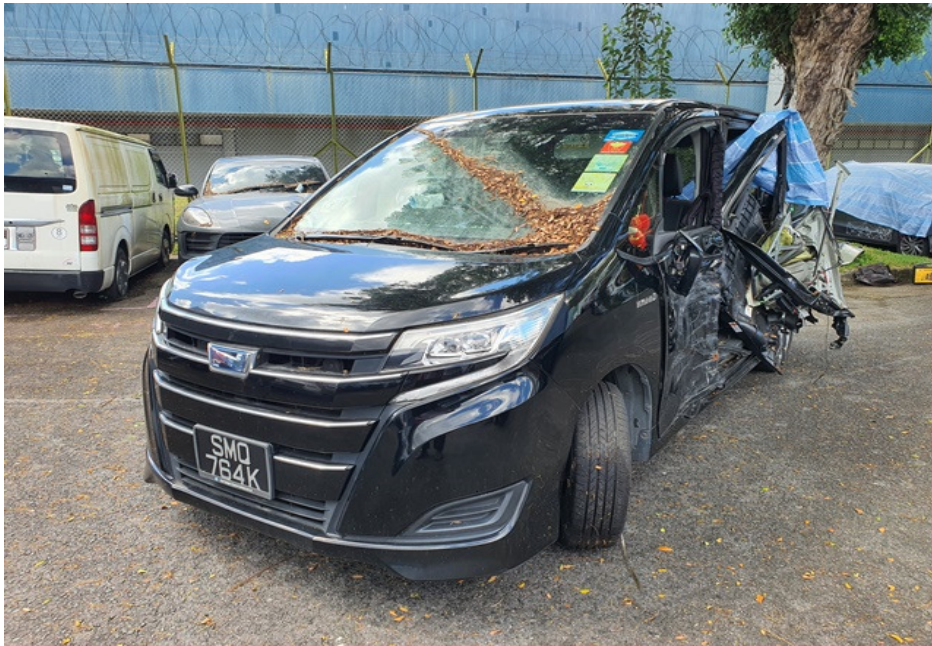
**Photo 20** shows the front left wheel of the Motor Car turned to its full left. During our steering system test, we did not experience any abnormal free play and/or resistance when we had turned the steering wheel towards the left and right. This would suggest that the steering system of the Motor Car was likely to be in serviceable condition at the material time of accident.

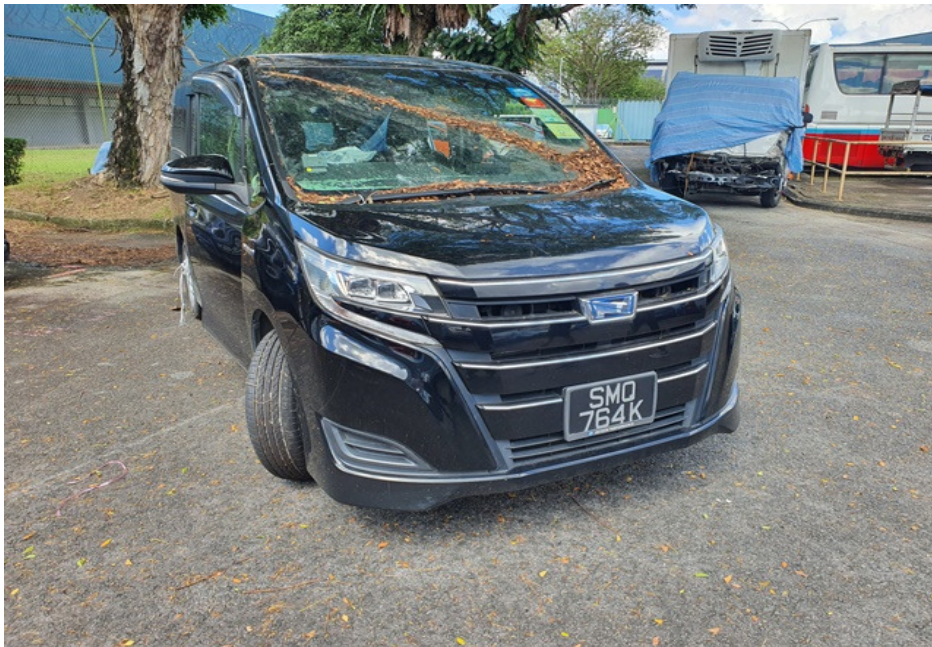
**Photo 21** shows the front right wheel of the Motor Car turned to its full right. During our steering system test, we did not experience any abnormal free play and/or resistance when we had turned the steering wheel towards the left and right. This would suggest that the steering system of the Motor Car was likely to be in serviceable condition at the material time of accident.

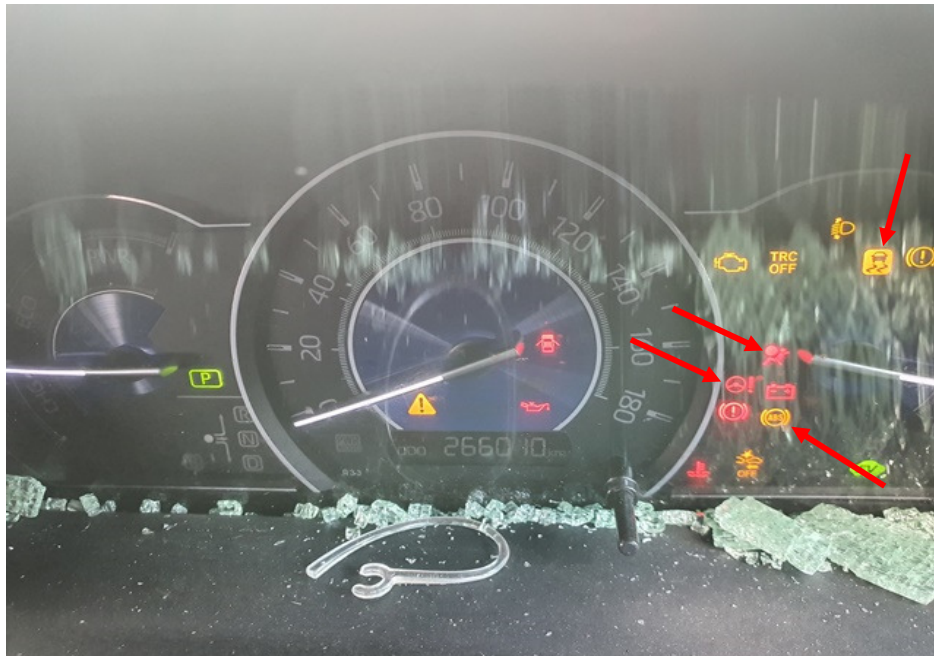
**Photo 22** shows the warning lights for the various electronic operating systems of the Motor Car appearing on its instrument panel during the self-test when the engine is cranked, in particular the ABS light, EPS light, ESC light and SRS light (arrowed).

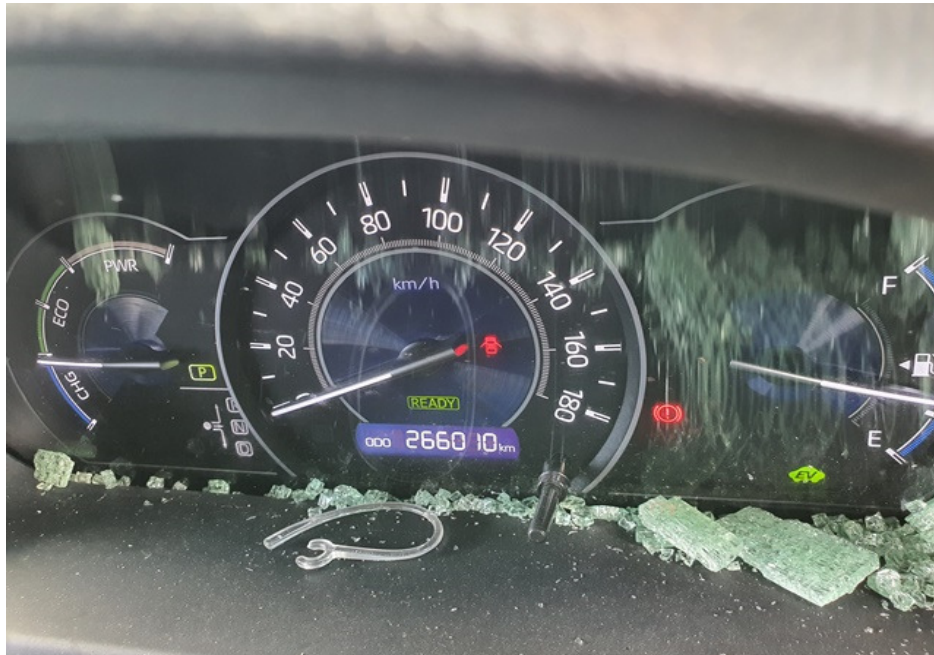
**Photo 23** shows no warning lights illuminated on the instrument panel of the Motor Car after the engine was cranked. This would suggest that there was no abnormality to the various electronic operating systems of the Motor Car, like the ABS, EPS, ESC and SRS etc.
