Your Ref: TP/IP/000305/2023
Our Ref : CI/TPD23001378/N

17 March 2023

INSPECTION REPORT OF MOTORCYCLE FBK 265X

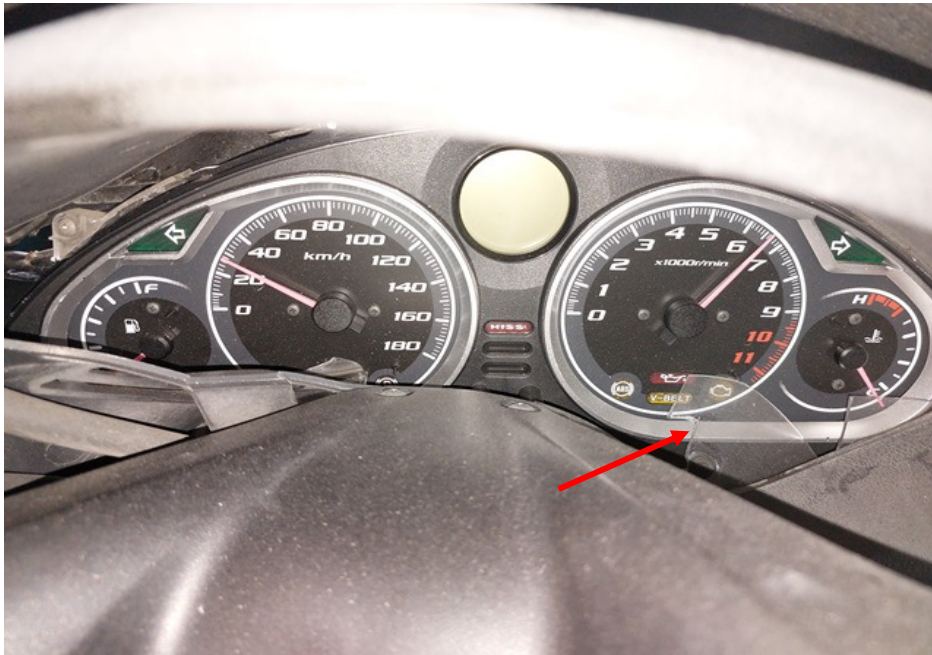
Photo 1 shows the speedometer of the Motorcycle. The mileage of the Motorcycle could not be recorded at the time of our inspection due to damages sustained to the speedometer gauge (arrowed).

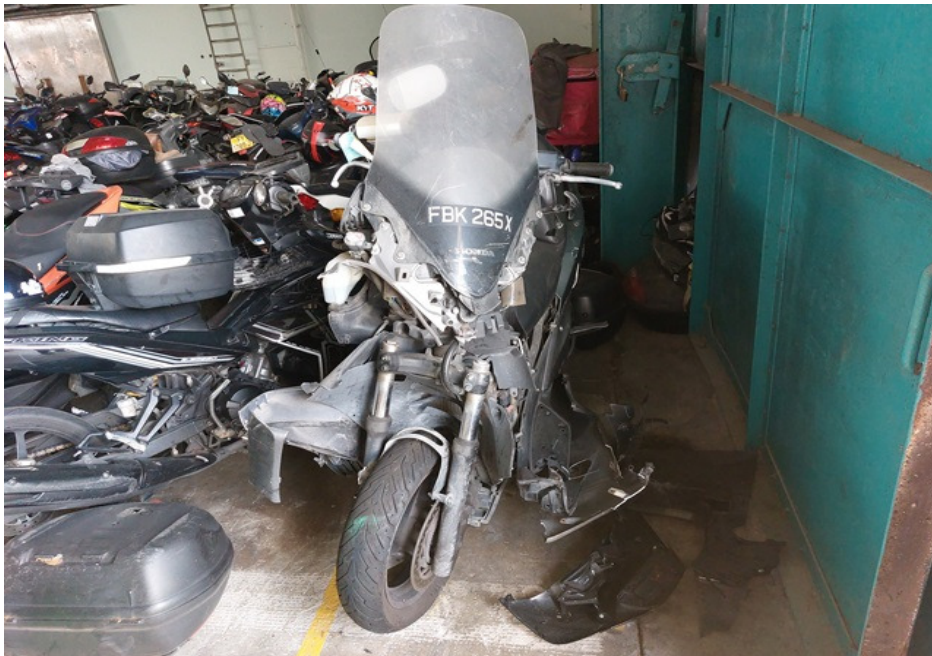
Photo 2 shows a general view of the frontal portion of the Motorcycle at the time of our inspection. The Motorcycle was observed to have sustained damages all around.

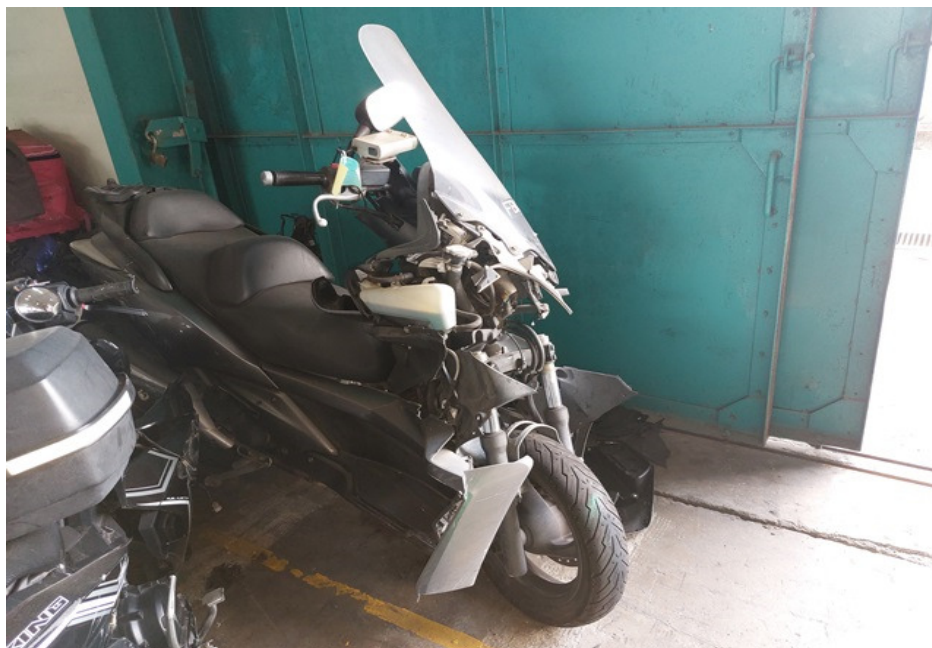
Photo 3 shows a general view of the right body of the Motorcycle at the time of our inspection. The Motorcycle was observed to have sustained damages all around.

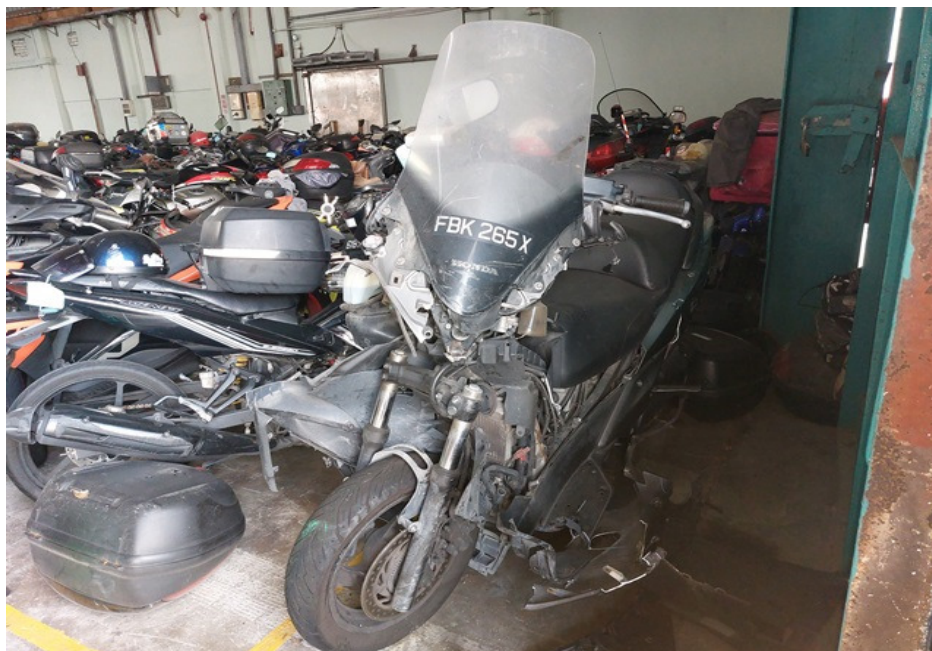
Photo 4 shows a general view of the left frontal portion of the Motorcycle at the time of our inspection. The Motorcycle was observed to have sustained damages all around. The body parts that were found to have been damaged include its windshield, head cowl, front mudguard, steering stem, right side mirror, side cowlings, inner centre cowl, lower side cowlings, right centre side cover, left rear side cover and left rear signal lamp, amongst others as a result of the accident.

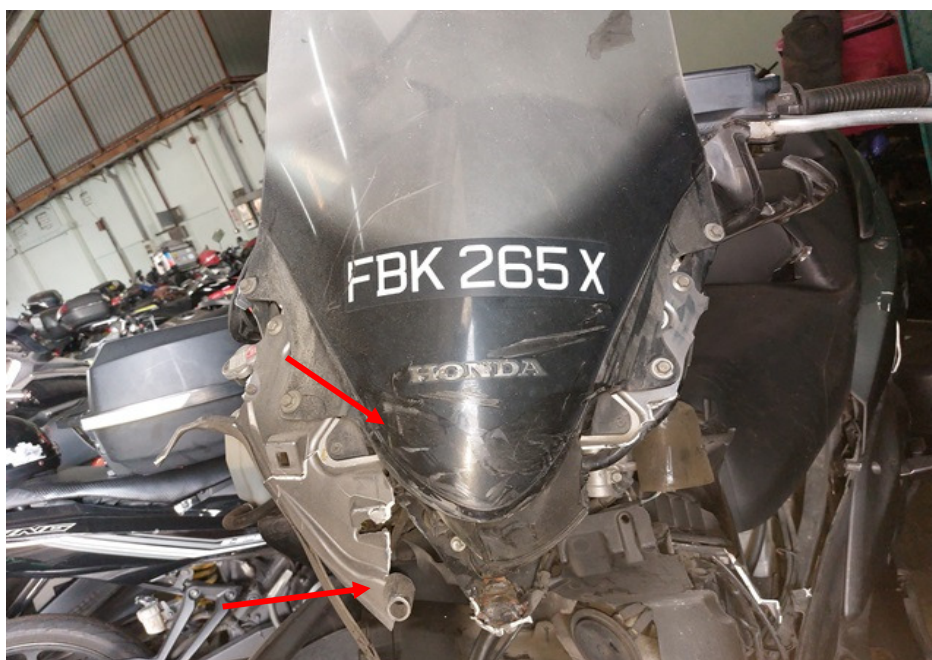
Photo 5 shows a closer view of the cracked windshield and head cowling of the Motorcycle at the time of our inspection (arrowed).

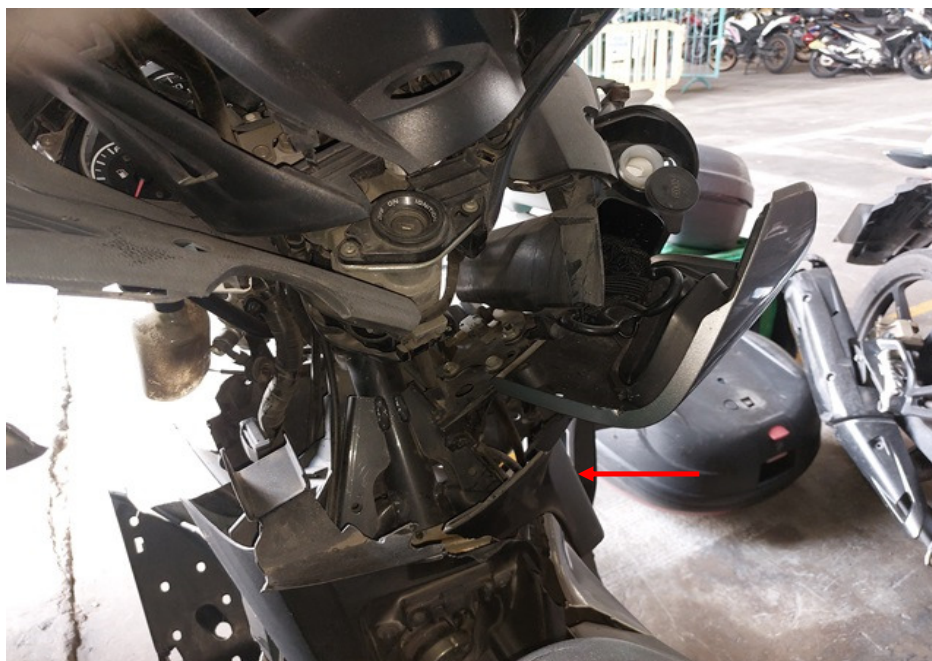
Photo 6 shows a closer view of the cracked inner centre cowling of the Motorcycle as a result of the accident (arrowed).

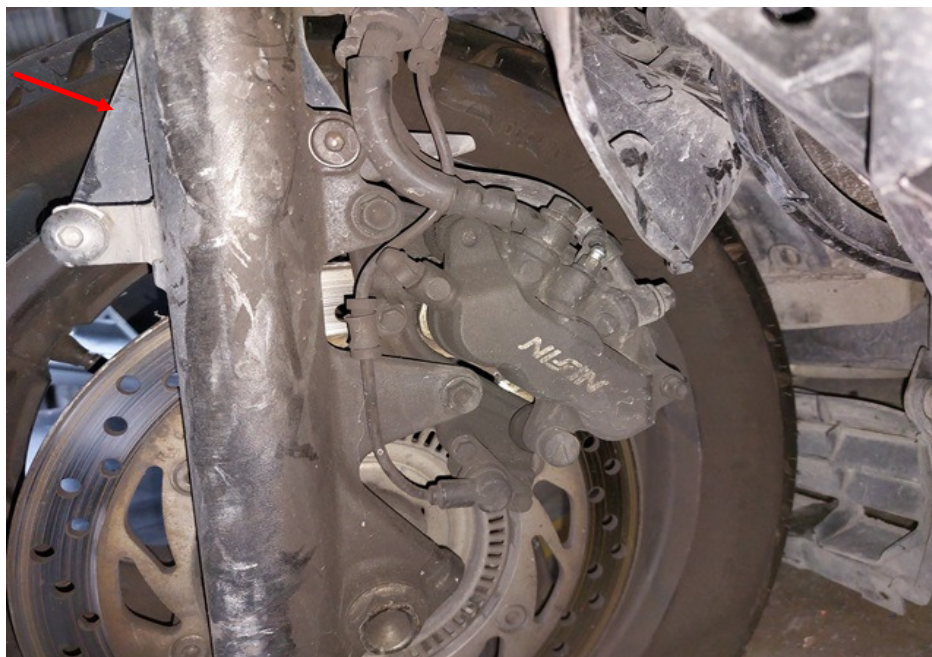
Photo 7 shows a closer view of the cracked front mudguard of the Motorcycle as a result of the accident (arrowed).

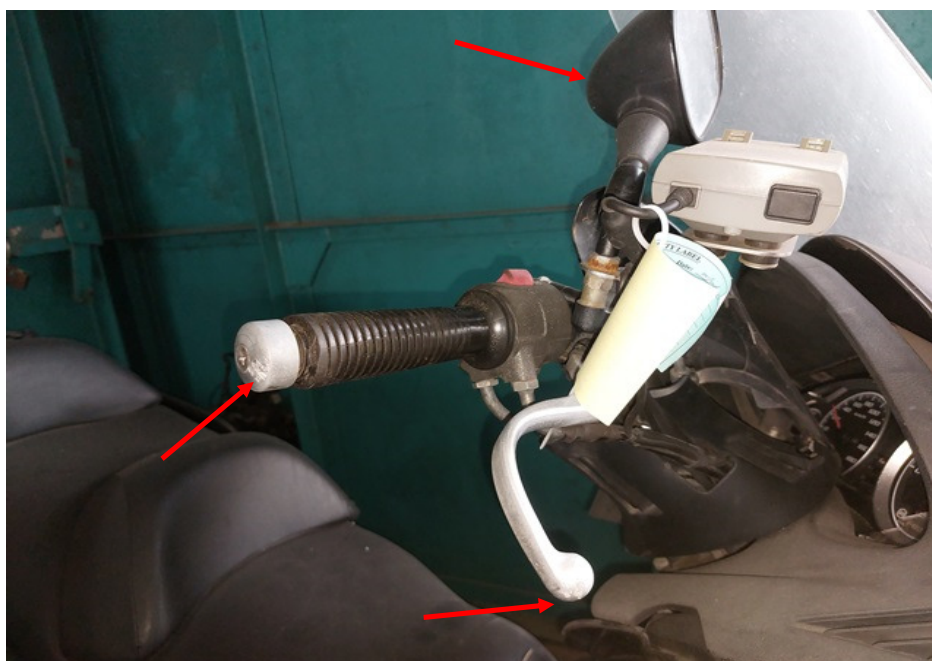
Photo 8 shows a closer view of the right side mirror, right handlebar end and front brake lever of the Motorcycle which were observed to be damaged due to the accident (arrowed).

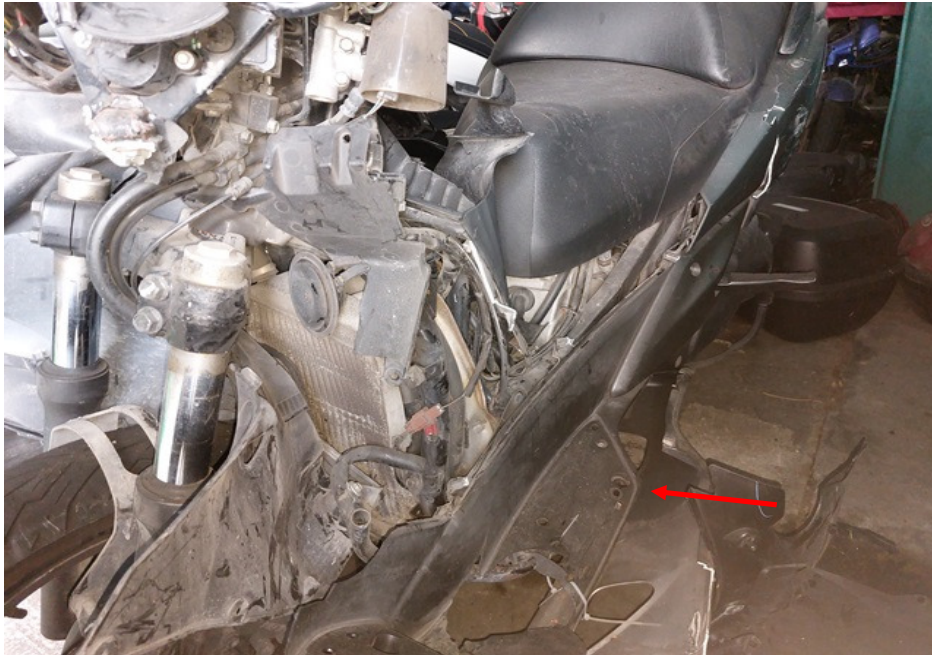
Photo 9 shows the cracked left side cowling of the Motorcycle as a result of the accident (arrowed).

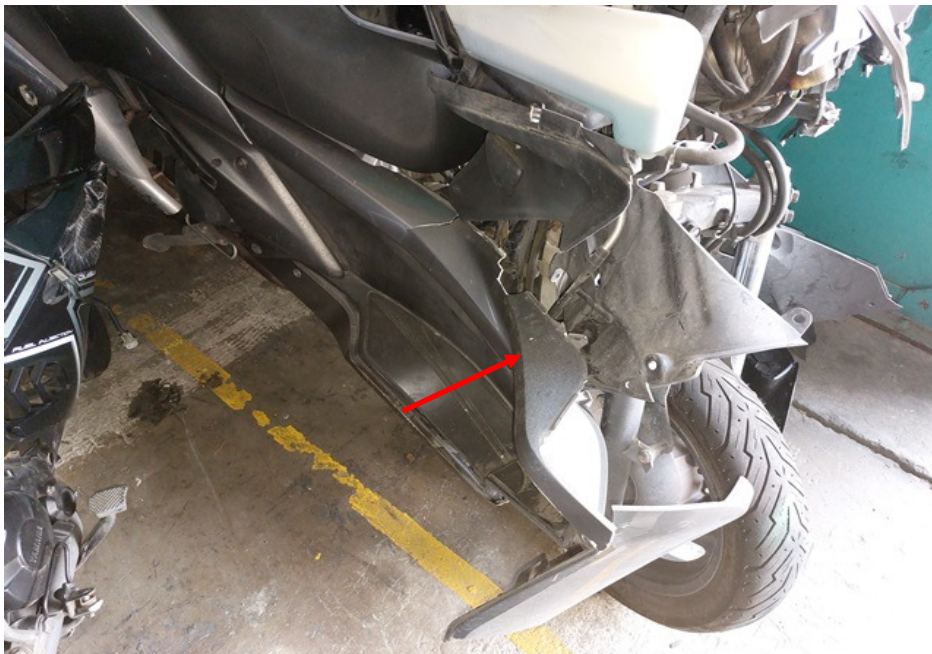
Photo 10 shows the cracked right side cowling of the Motorcycle as a result of the accident (arrowed).

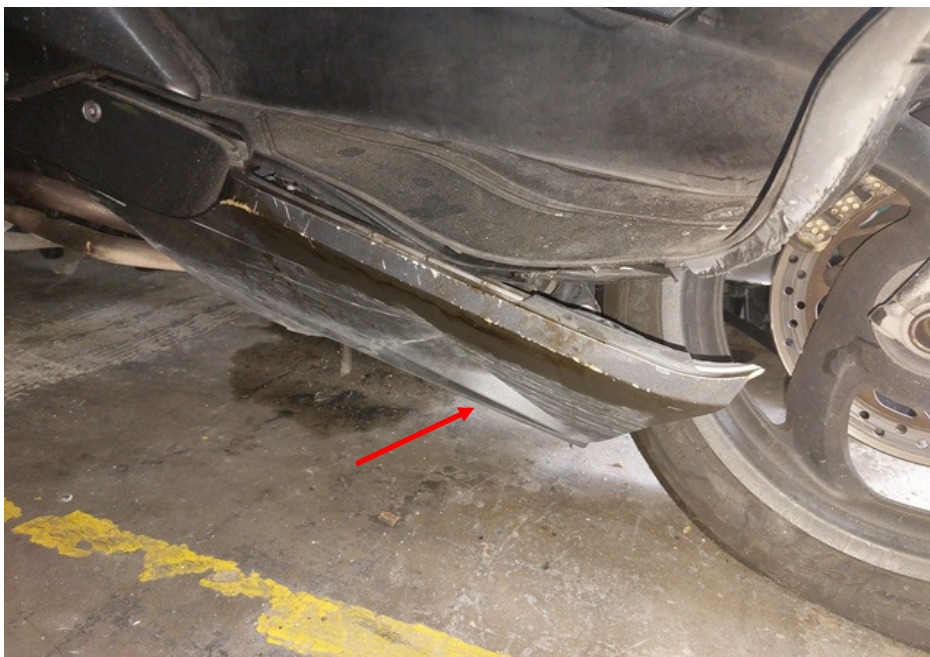
Photo 11 shows a close-up view of the cracked right lower side cowling of the Motorcycle as a result of the accident.

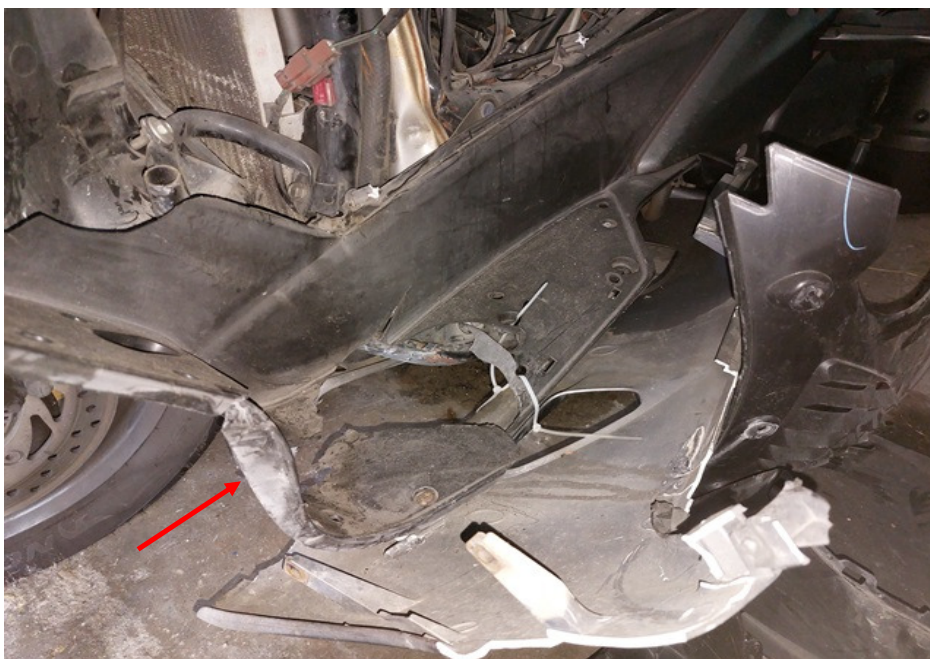
Photo 12 shows a close-up view of the cracked left lower side cowling of the Motorcycle as a result of the accident (arrowed).

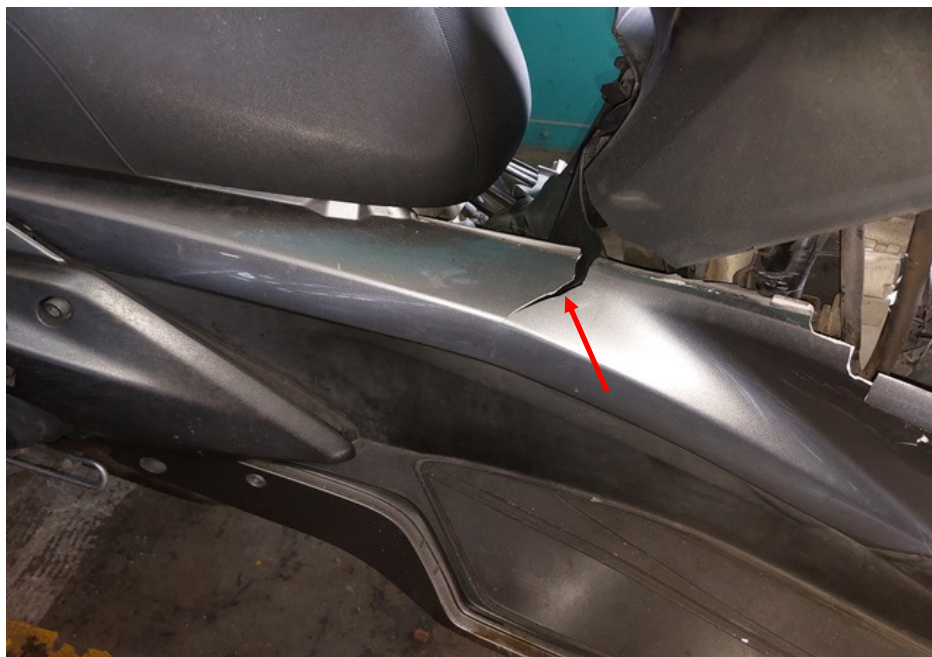
Photo 13 shows a general view of the cracked right centre cover of the Motorcycle as a result of the accident (arrowed).

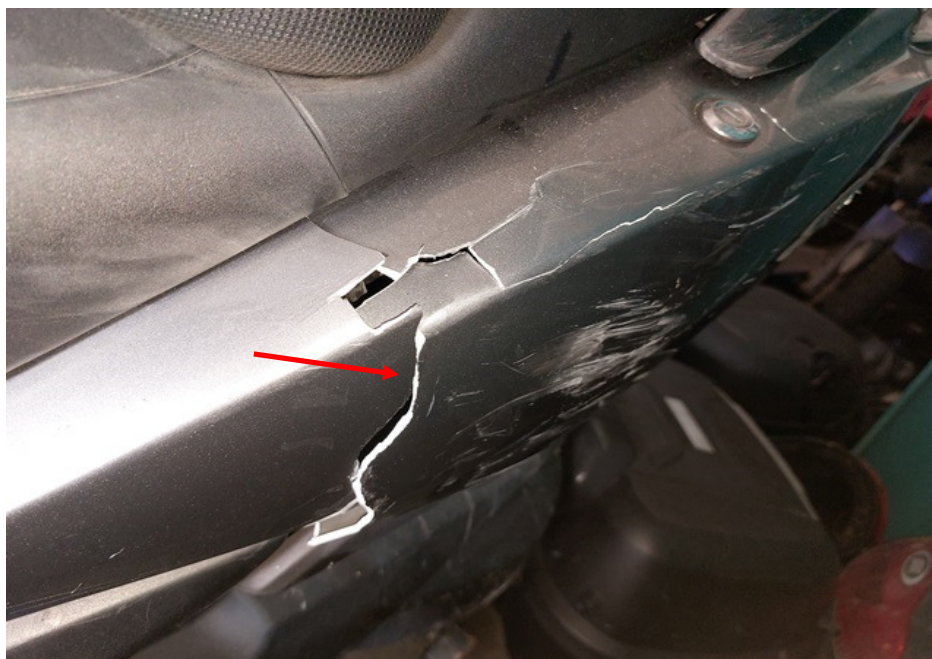
Photo 14 shows a close-up view of the cracked left rear side cover of the Motorcycle as a result of the accident (arrowed).

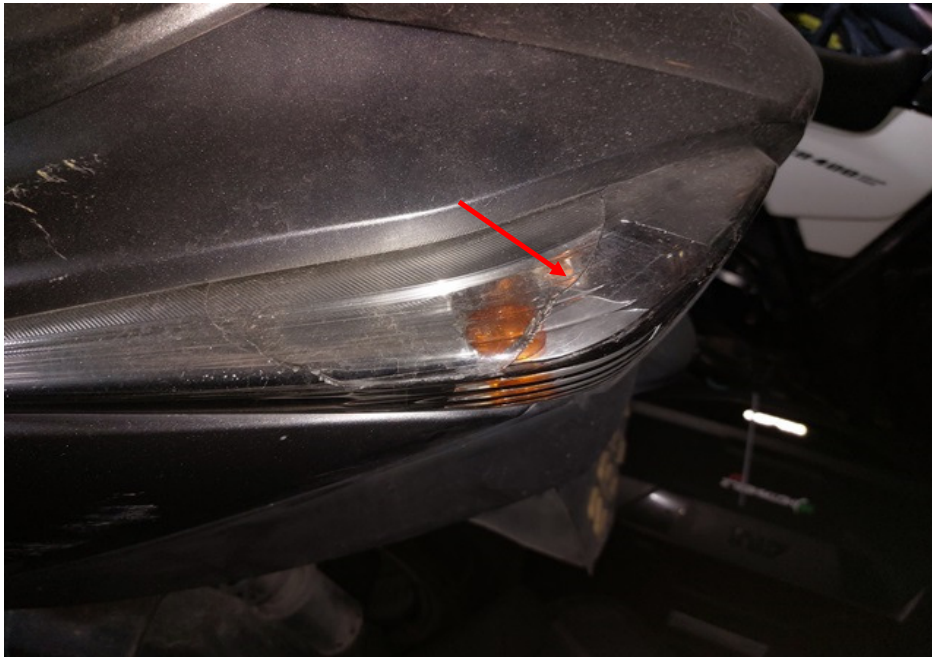
Photo 15 shows a close-up view of the cracked left rear signal lamp of the Motorcycle as a result of the accident (arrowed).

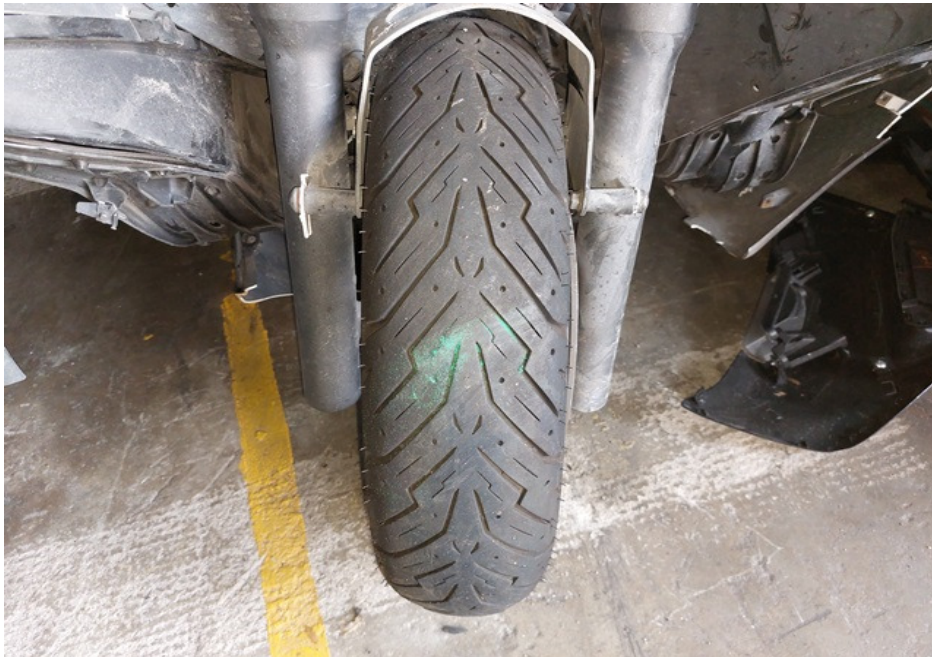
Photo 16 shows the condition of the Motorcycle's front tyre. The front tyre was observed to be in serviceable condition with remaining tread depth of approximately 4mm. There was no tear, burst mark(s) and/or punctured hole(s) on the sidewalls as well as across the tread of the front tyre. The tyre was also observed to be sufficiently inflated for vehicular operation.

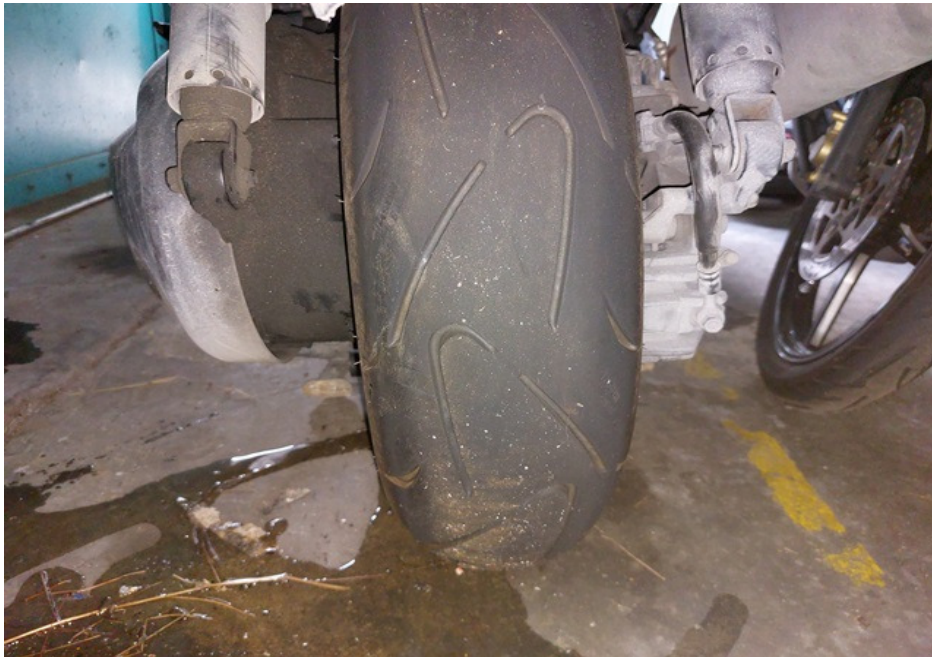
Photo 17 shows the condition of the Motorcycle's rear tyre. The rear tyre was observed to be in serviceable condition with remaining tread depth of approximately 4mm. The tyre was also observed to be sufficiently inflated for vehicular operation. We did not observe any tear, burst mark(s) and/or punctured hole(s) on the sidewalls as well as across the tread of the rear tyre.

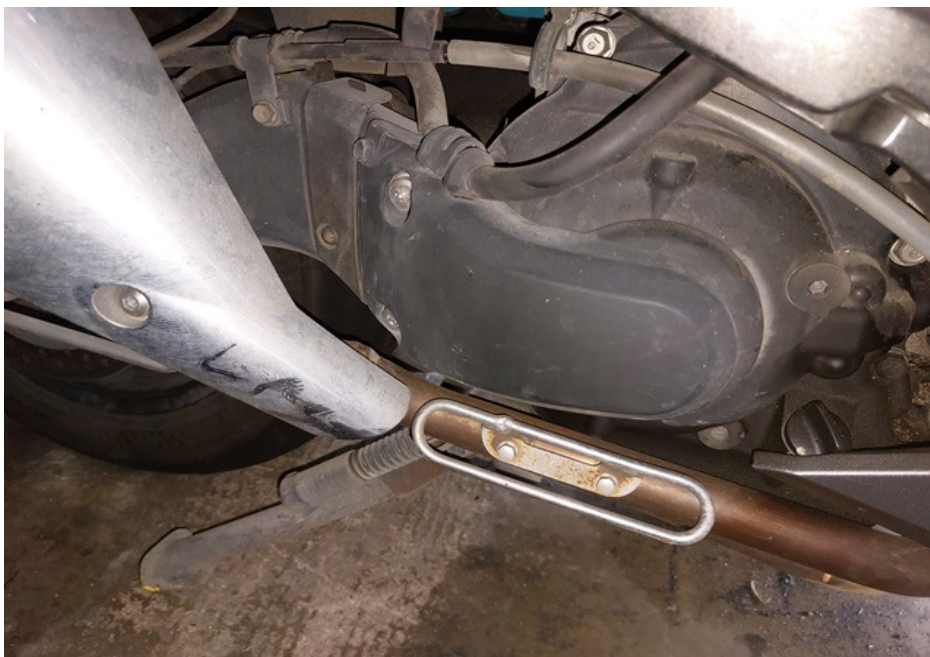
Photo 18 shows the right side of the engine of the Motorcycle at the time of our inspection. The various engine related parts and components were found to be intact with no visible damage. There was also no sign(s) or indication(s) of fluid leak observed around the right engine area of the Motorcycle.

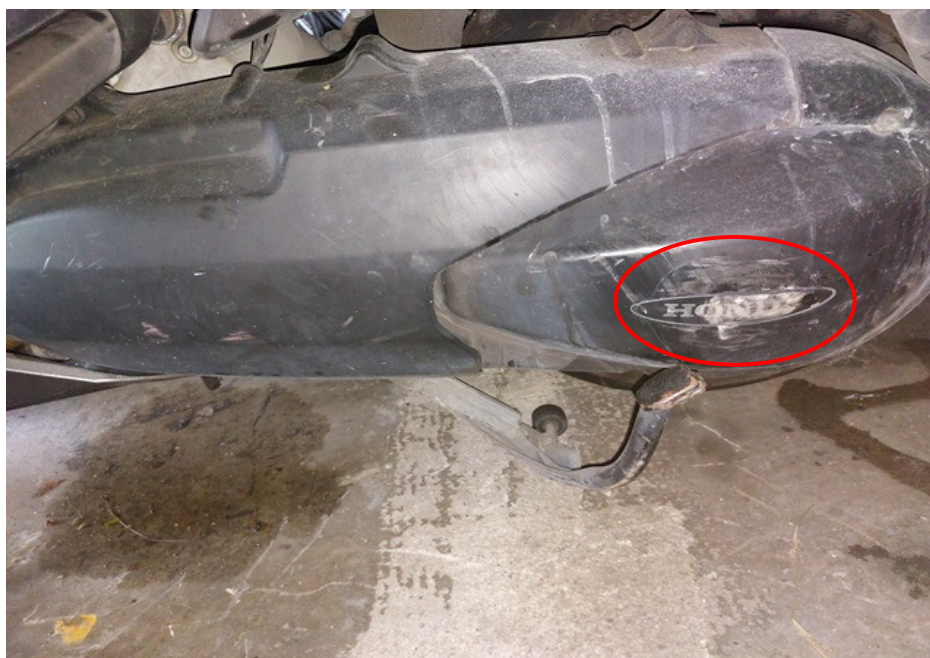
Photo 19 shows the drive train of the Motorcycle which was found to be intact without any misalignment. However the drive train cover had sustained damages of grazing nature as a result of the accident (circled).

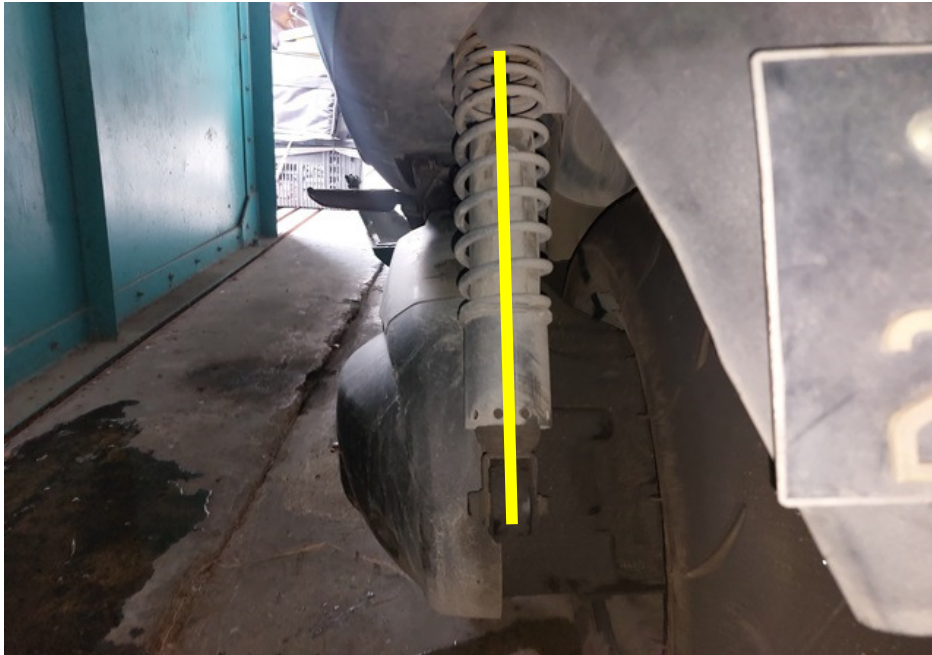
Photo 20 shows the left shock absorber of the Motorcycle which was found to be intact without any misalignment.

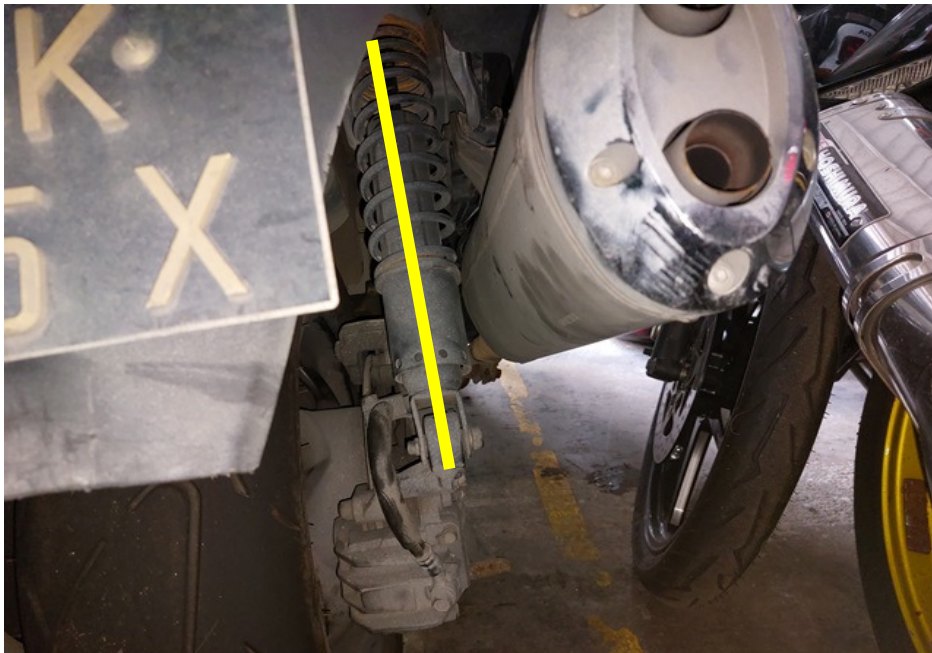
Photo 21 shows the right shock absorber of the Motorcycle which was found to be intact without any misalignment.

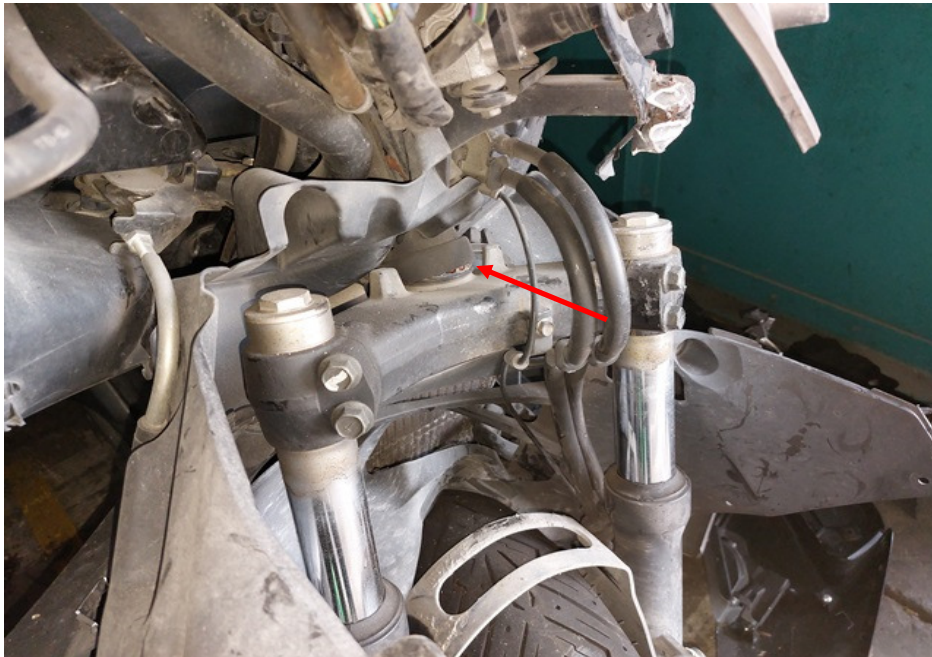
10. For this case, we were not able to conduct any test(s) on the steering system of the Motorcycle due to the damage of its steering stem. The steering stem was found to be bent as a result of the accident.

Photo 22 shows the steering stem of the Motorcycle. The steering stem (arrowed) was observed to be bent as a result of the accident. We were hence not able to conduct any tests on the steering system of the Motorcycle.

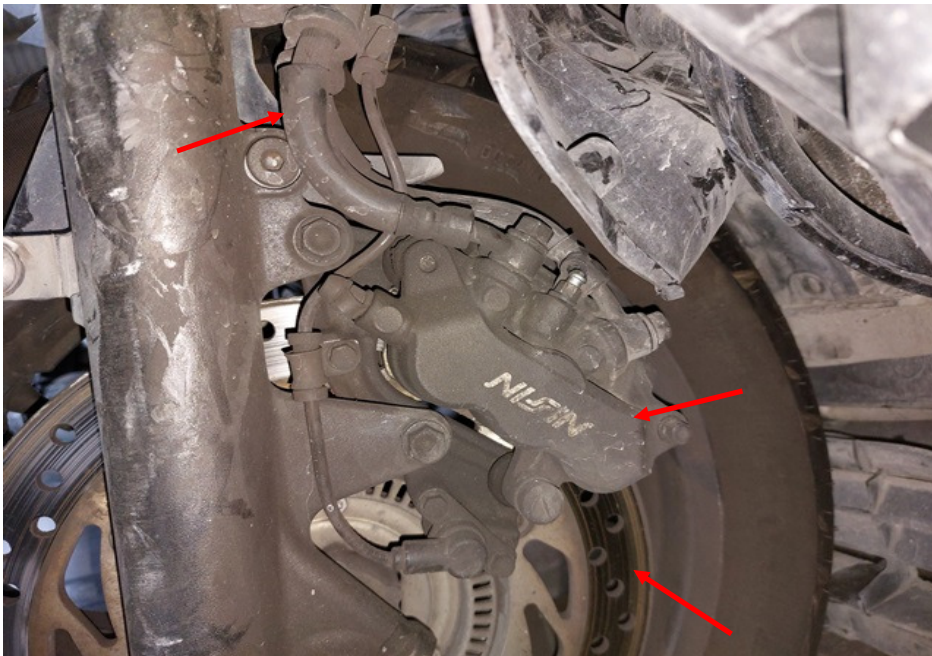
Photo 23 shows a close up view of the front brake caliper, front brake disc and front brake hose (arrowed) of the Motorcycle, which are all part of the components in the hydraulic front brake system of the Motorcycle. Our visual checks of these various components had revealed all to be intact with no visible damage. No leakage of brake fluid was also observed.

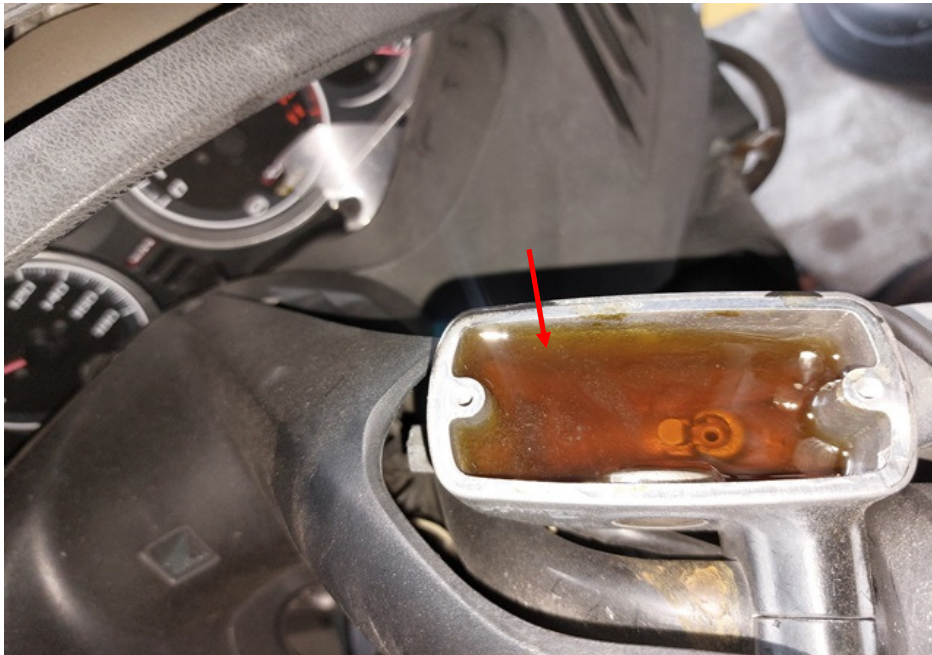
Photo 24 shows the brake fluid reservoir for the front brake of the Motorcycle. The brake fluid was observed to be of sufficient level for operational purposes. However it was found to be contaminated (arrowed).

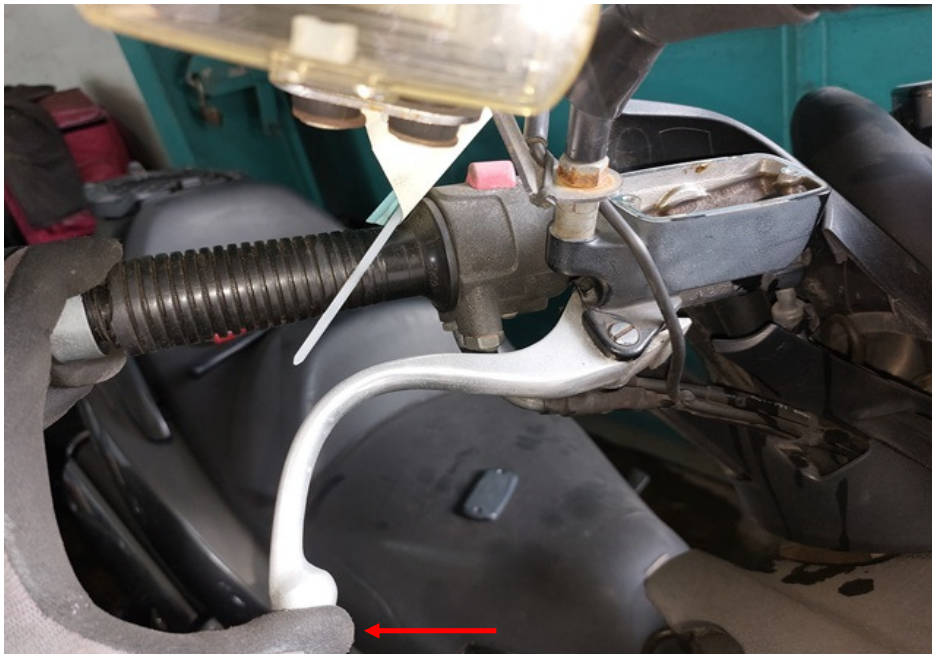
Photo 25 shows the front brake lever being depressed. There was some resistance felt (spongy like feel) upon pressing the front brake lever (arrowed). This would indicate that there is no leakage of pressure/vacuum in the front brake system.

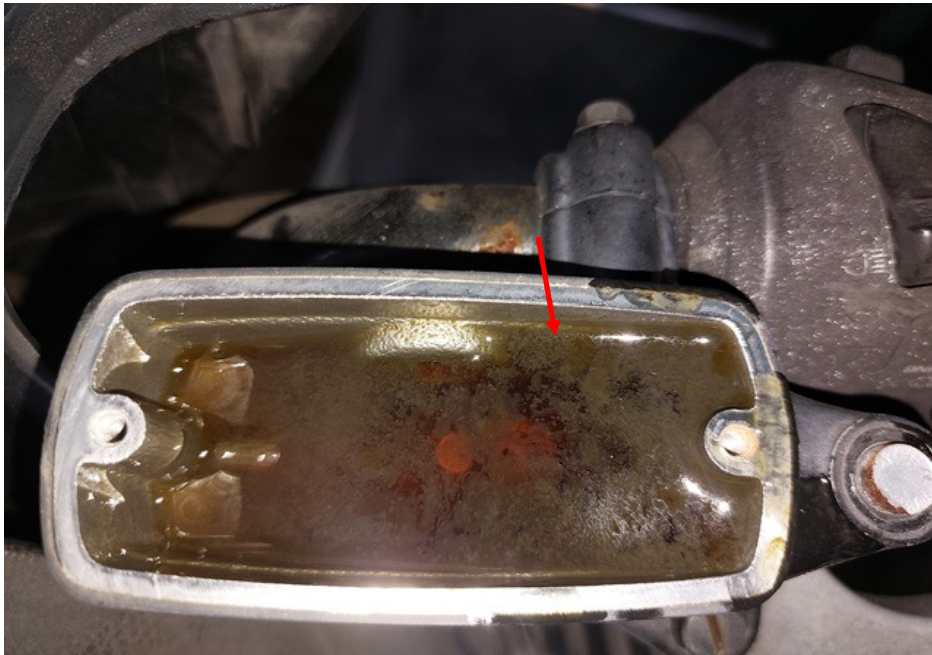
Photo 26 shows the brake fluid reservoir for the rear brake of the Motorcycle. The brake fluid was observed to be of sufficient level for operational purposes. However it was found to be contaminated (arrowed).

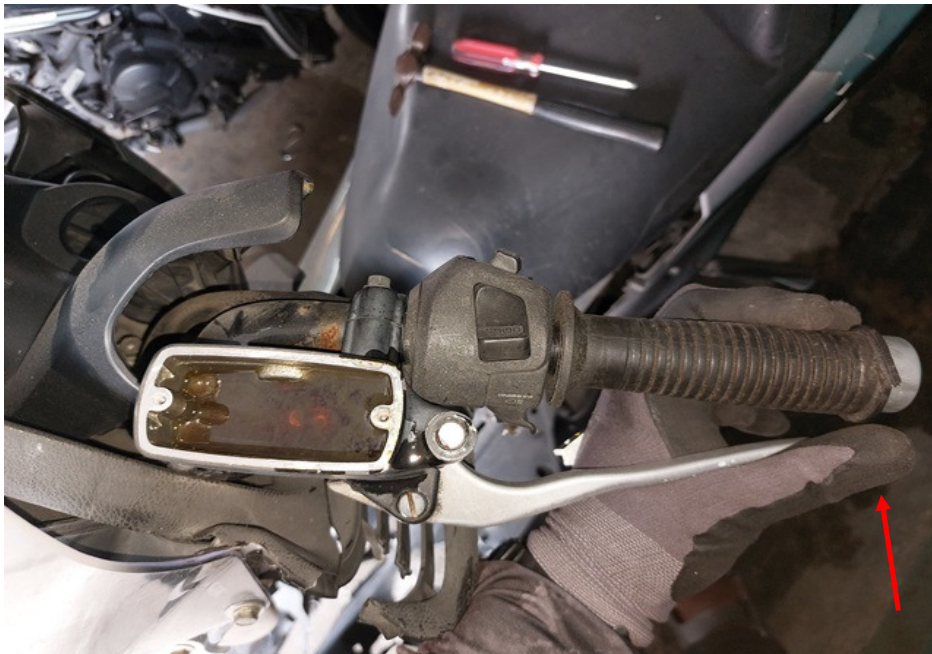
Photo 27 shows the rear brake lever being depressed. There was some resistance felt (spongy like feel) upon pressing the front brake lever (arrowed). This would indicate that there is no leakage of pressure/vacuum in the rear brake system.

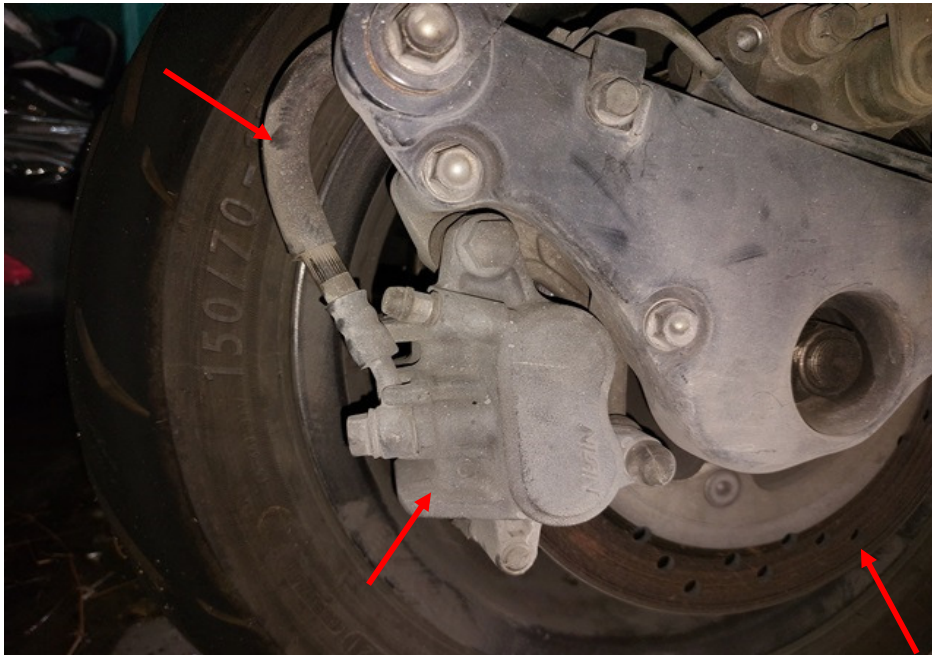
Photo 28 shows a close up view of the rear brake caliper, rear brake disc and rear brake hose (arrowed) of the Motorcycle, which are all part of the components in the hydraulic rear brake system of the Motorcycle. Our visual checks of these various components revealed all to be intact with no visible damage. No leakage of brake fluid was also observed.
