Your Ref: TP/IP/34342/2022  
Our Ref : CI/TPD23001381/N

21 February 2023

**Fatal Accident Investigation Team**

**INSPECTION REPORT OF MOTORCYCLE FBD 3473D**

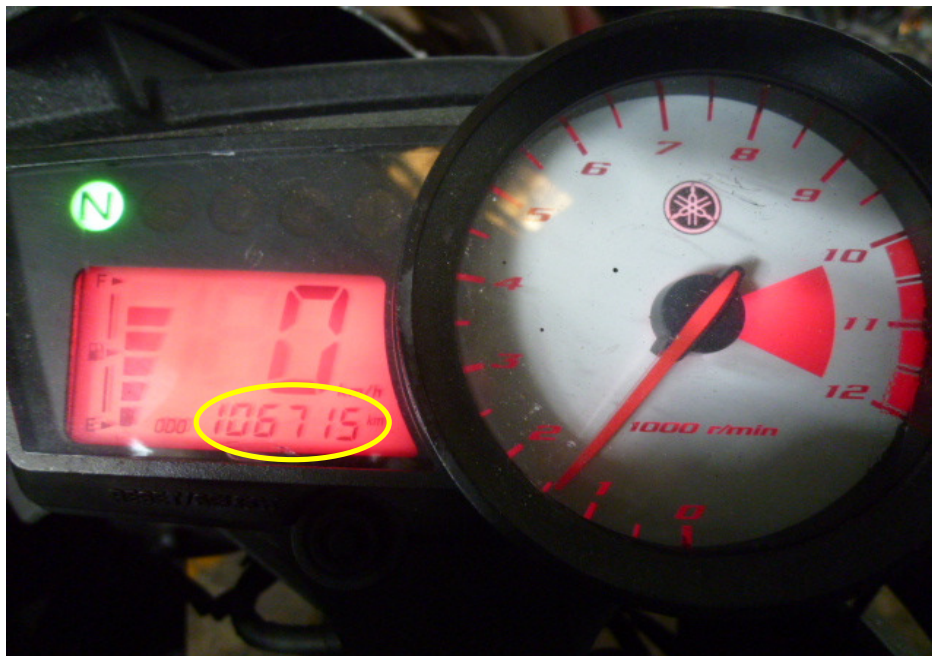
**Photo 1** shows the speedometer gauge of the Motorcycle where the mileage recorded at the time of our inspection was 106, 715km (circled).

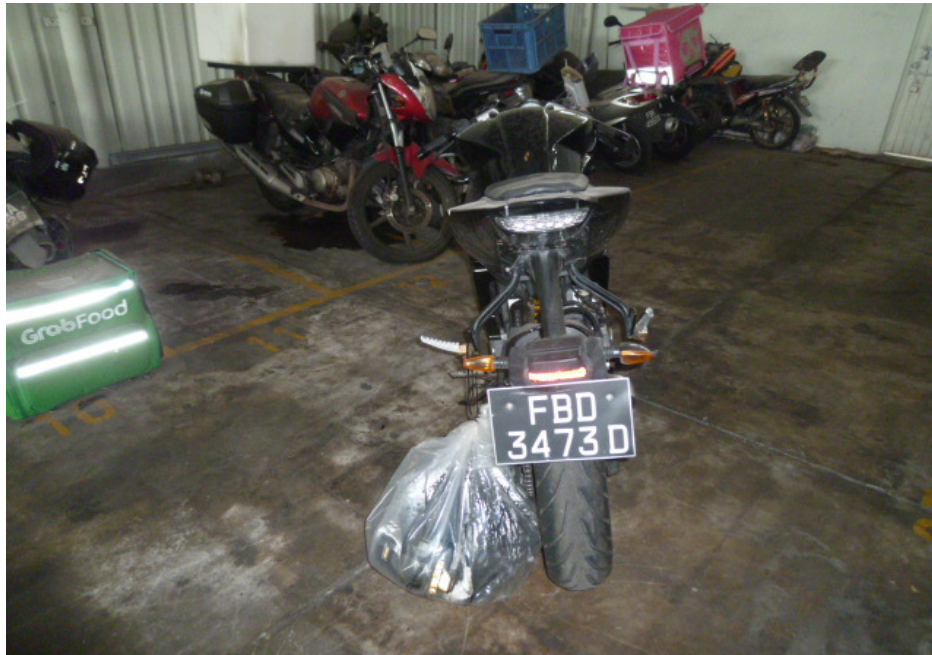
**Photo 2** shows a general view of the rear portion of the Motorcycle at the time of our inspection. The Motorcycle was observed to have sustained damages all around.

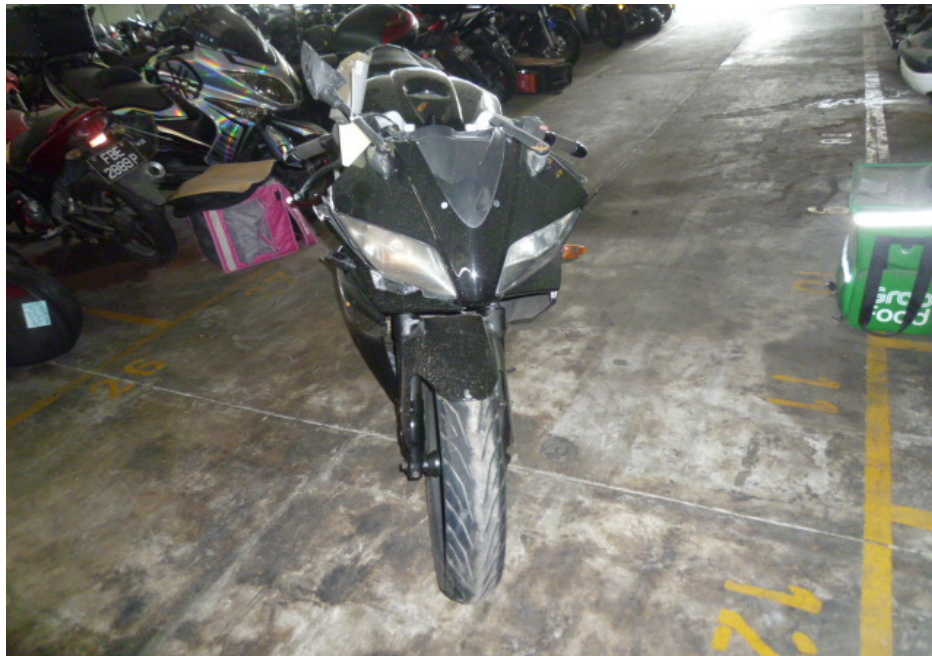
**Photo 3** shows a general view of the frontal portion of the Motorcycle at the time of our inspection. The Motorcycle was observed to have sustained damages all around.

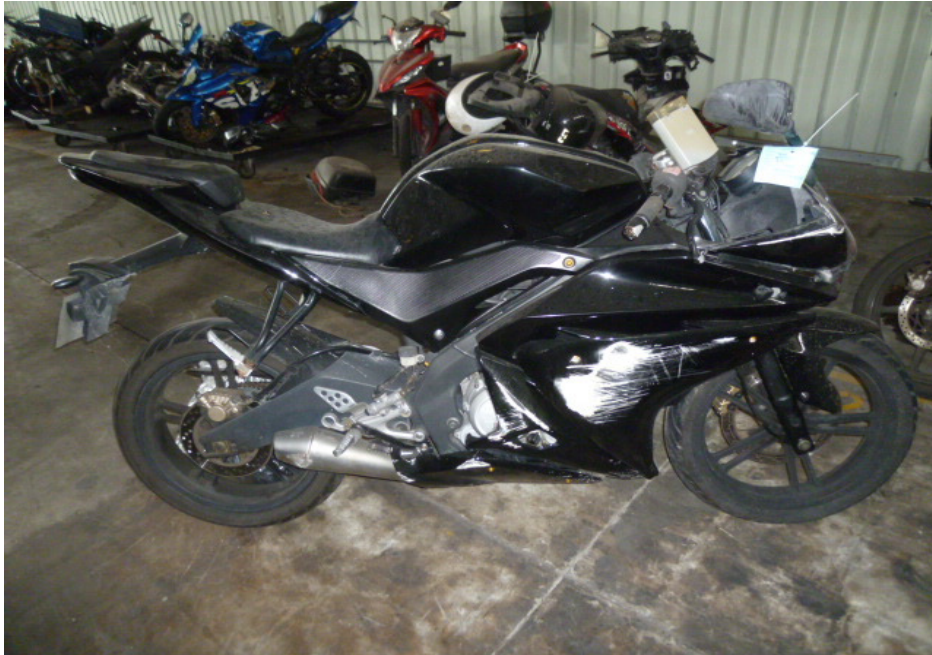
**Photo 4** shows a general view of the right body of the Motorcycle at the time of our inspection. The Motorcycle was observed to have sustained damages all around. Amongst the body parts that were found to have been damaged include its front mudguard, head cowlings, side cowlings, handlebar ends, front brake lever, clutch lever, side mirrors, petrol tank, rear brake pedal, right front footrest, right rear side cover, right pillion foot peg and exhaust muffler, amongst others.

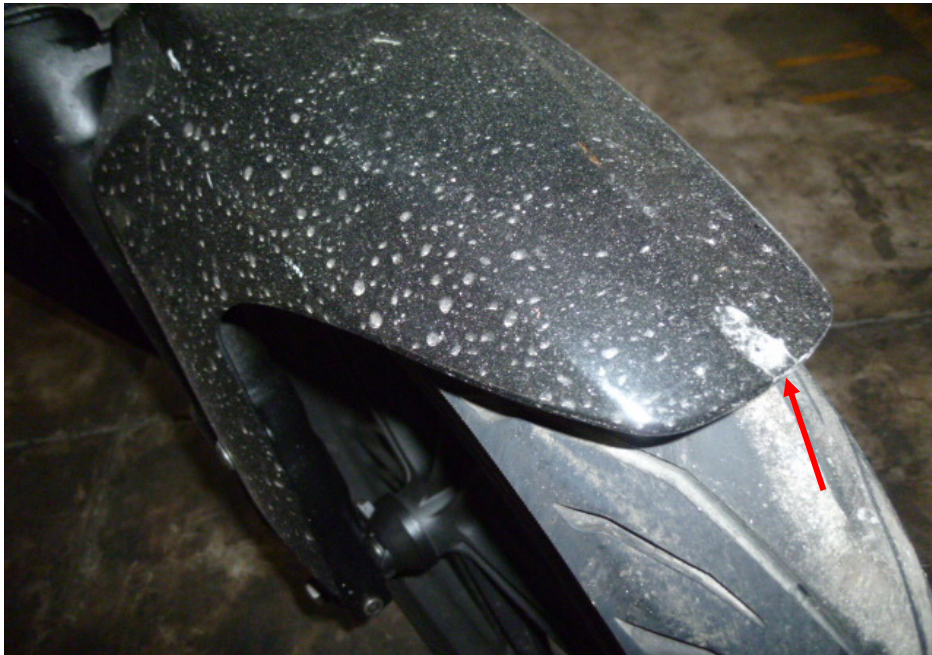
**Photo 5** shows a closer view of the front mudguard (arrowed) which was amongst the body parts at the front body of the Motorcycle that had sustained damage as a result of the accident.

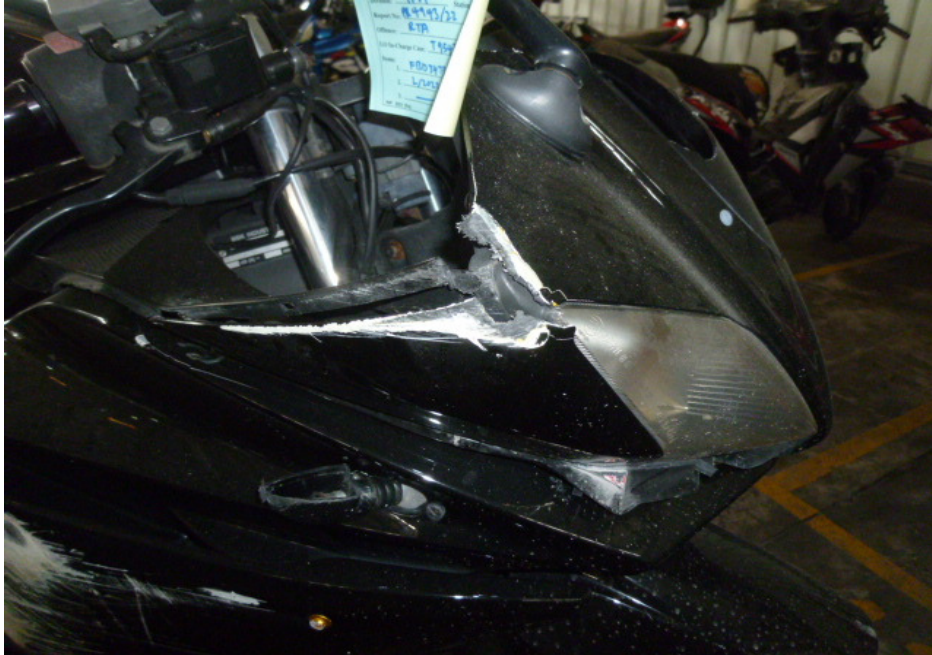
**Photo 6** shows a close up view of the head cowl which was amongst the body parts of the Motorcycle that had sustained damage as a result of the accident.

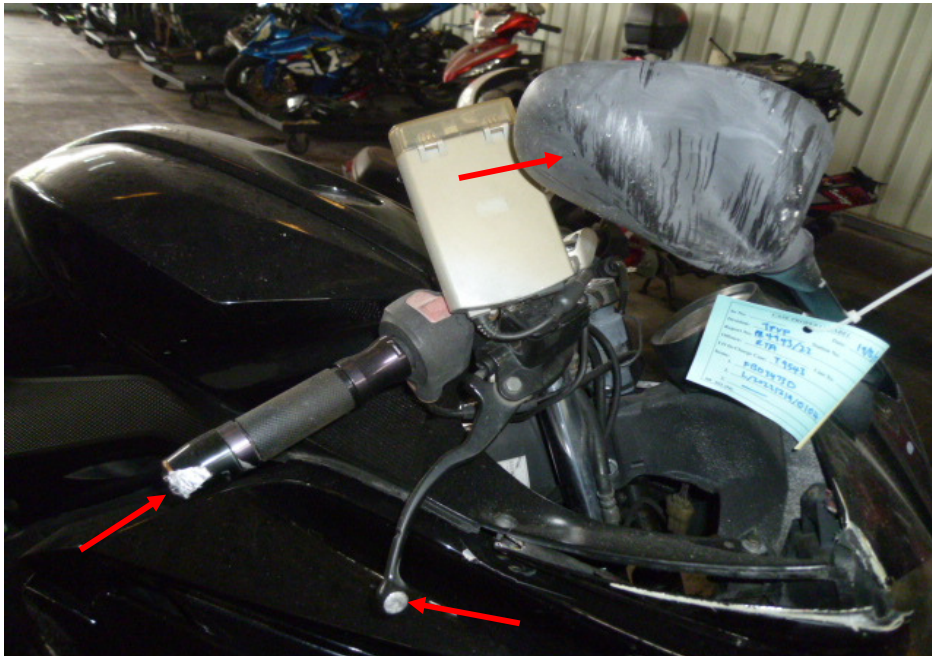
**Photo 7** shows a closer view of right handlebar end, right side mirror and front brake lever (arrowed) which were amongst the body parts at the front body of the Motorcycle that had sustained damage as a result of the accident.

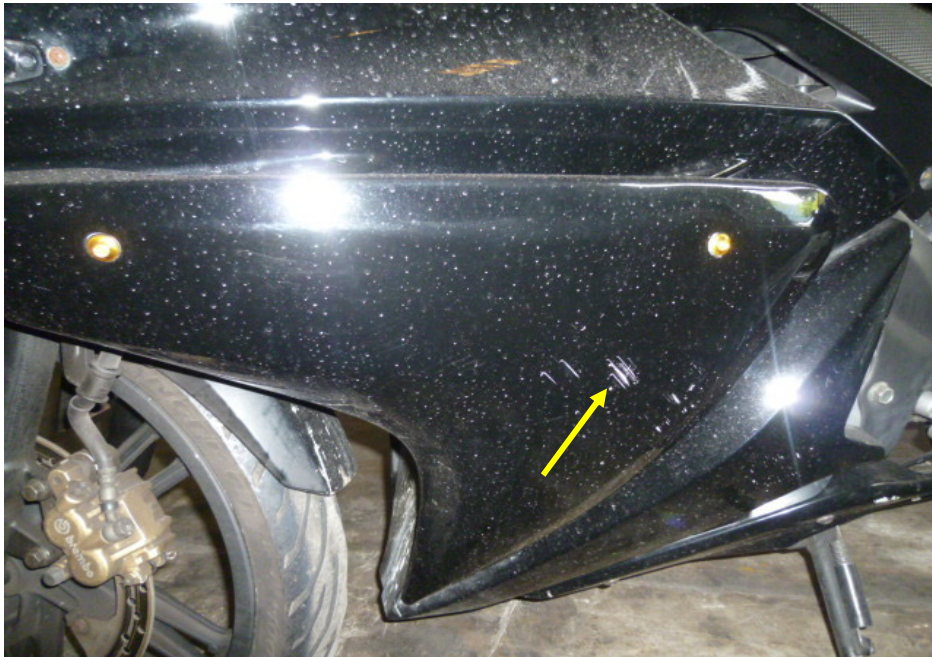
**Photo 8** shows a closer view of the left cowling of the Motorcycle that had sustained damages of grazing nature as a result of the accident (arrowed).

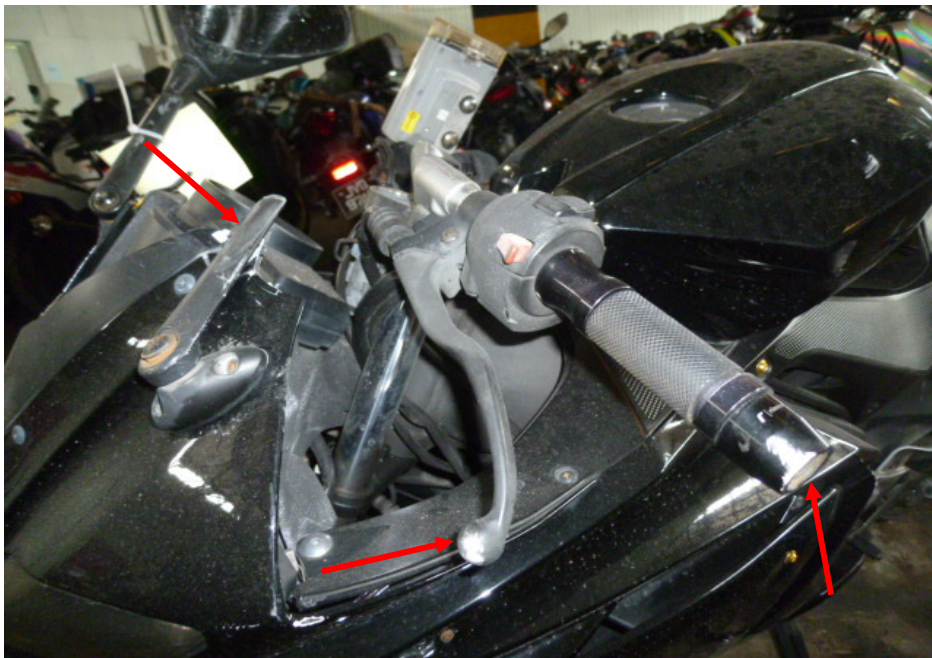
**Photo 9** shows a closer view of the left handlebar end, left side mirror and clutch lever (arrowed) which were amongst the body parts of the Motorcycle that had sustained damage as a result of the accident.

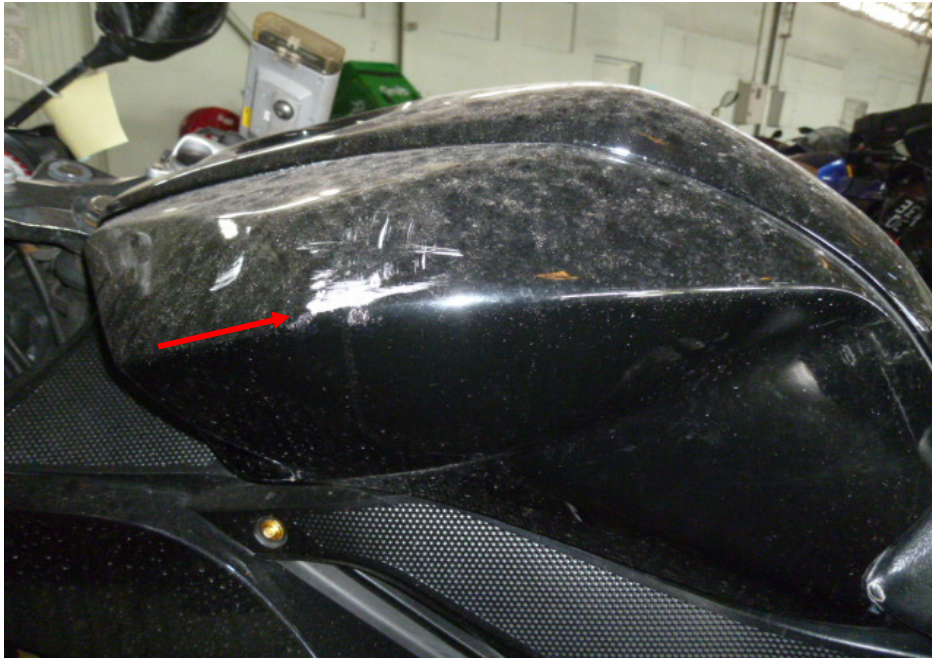
**Photo 10** shows a closer view of the grazed petrol tank of the Motorcycle as a result of the accident (arrowed).

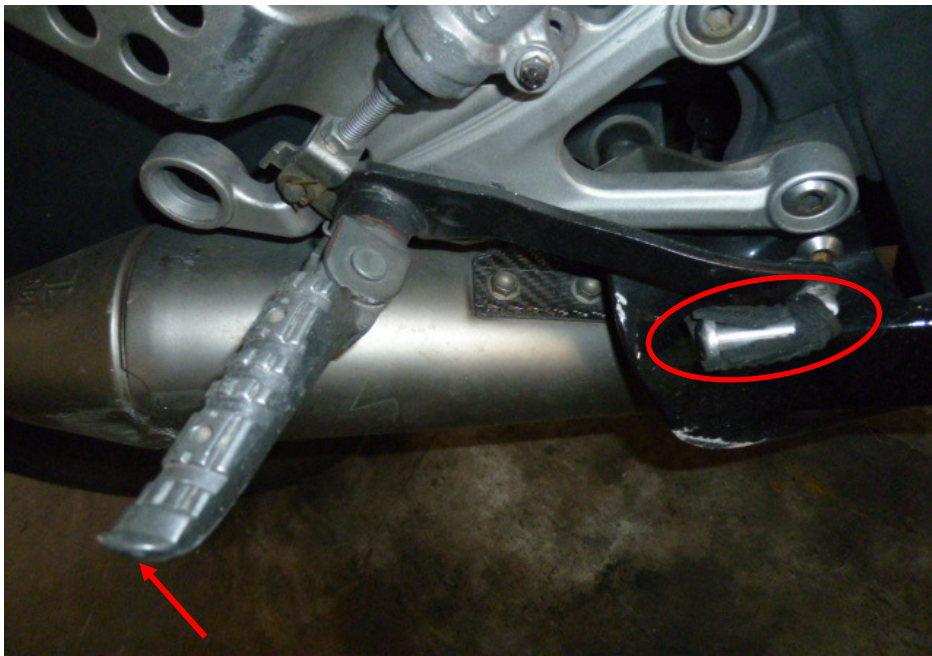
**Photo 11** shows a closer view of the rear brake pedal (circled) and right front footrest (arrowed) which were amongst the body parts of the Motorcycle that had sustained damage as a result of the accident

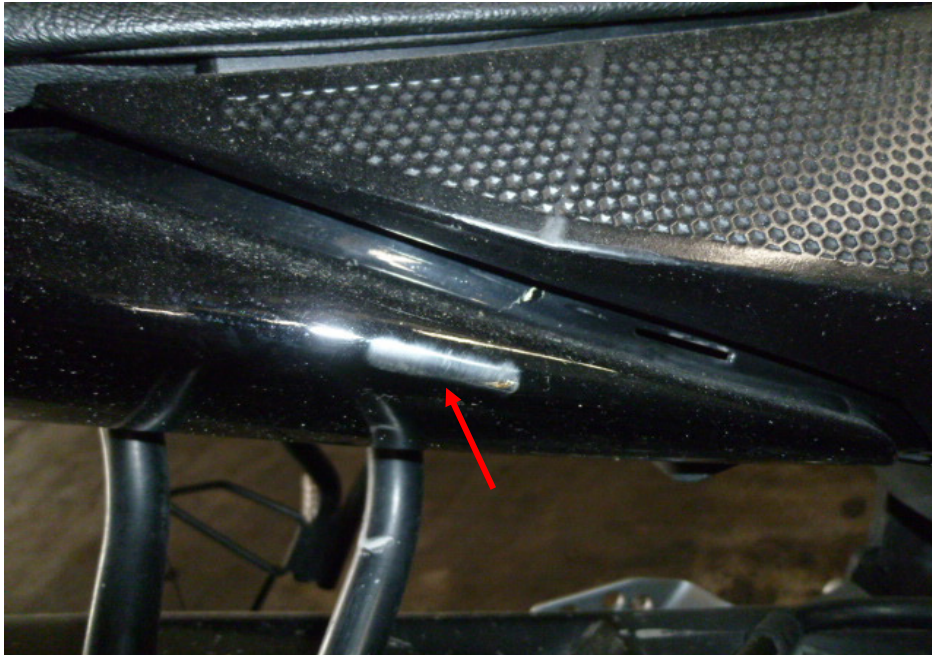
**Photo 12** shows the grazed right rear side cover of the Motorcycle as a result of the accident.

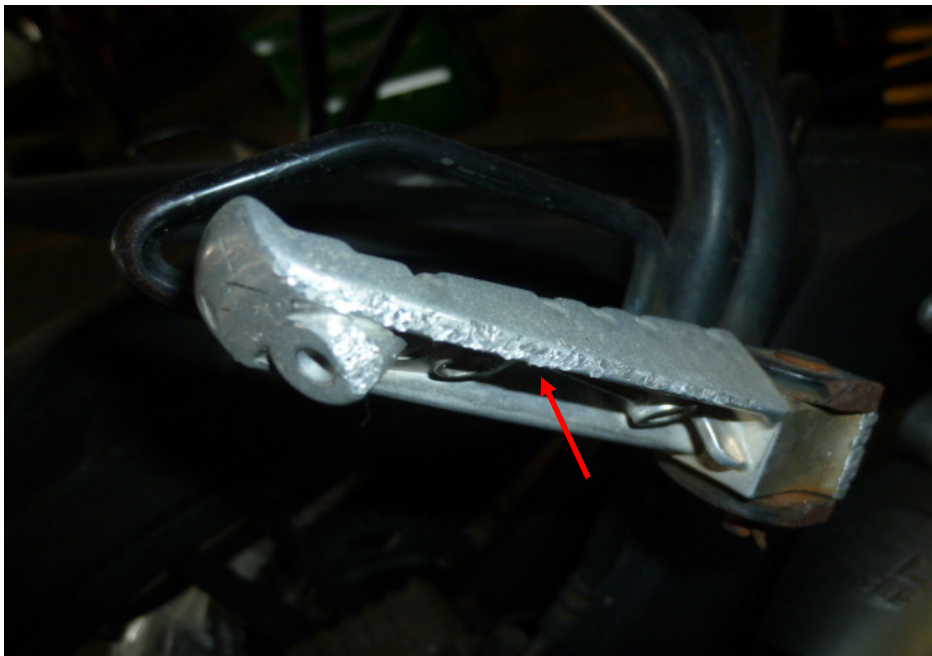
**Photo 13** shows a closer view of the grazed right pillion foot peg of the Motorcycle as a result of the accident (arrowed).

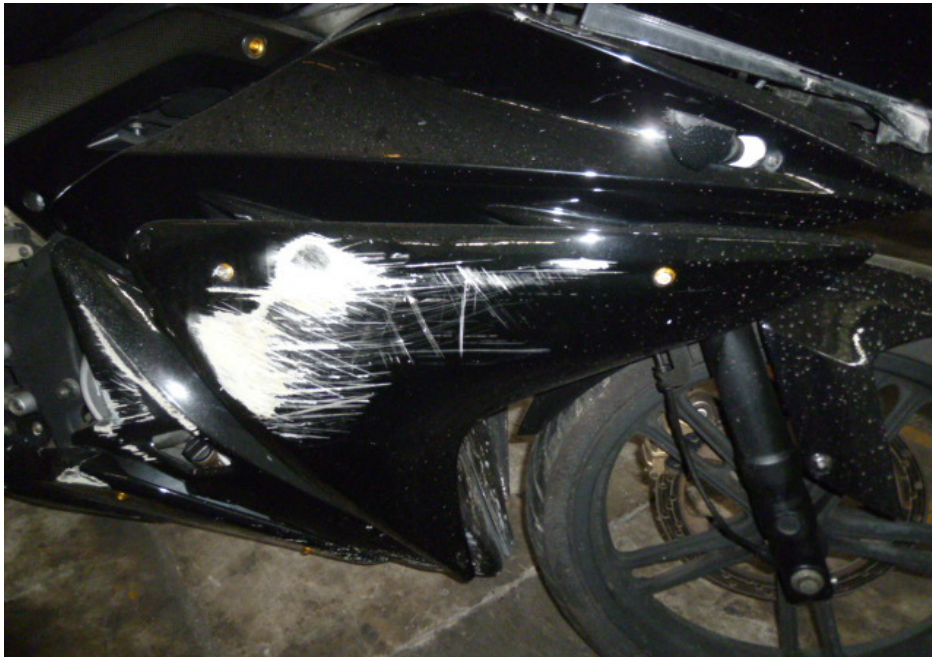
**Photo 14** shows a closer view of the right cowling of the Motorcycle that had sustained damages of grazing nature as a result of the accident.

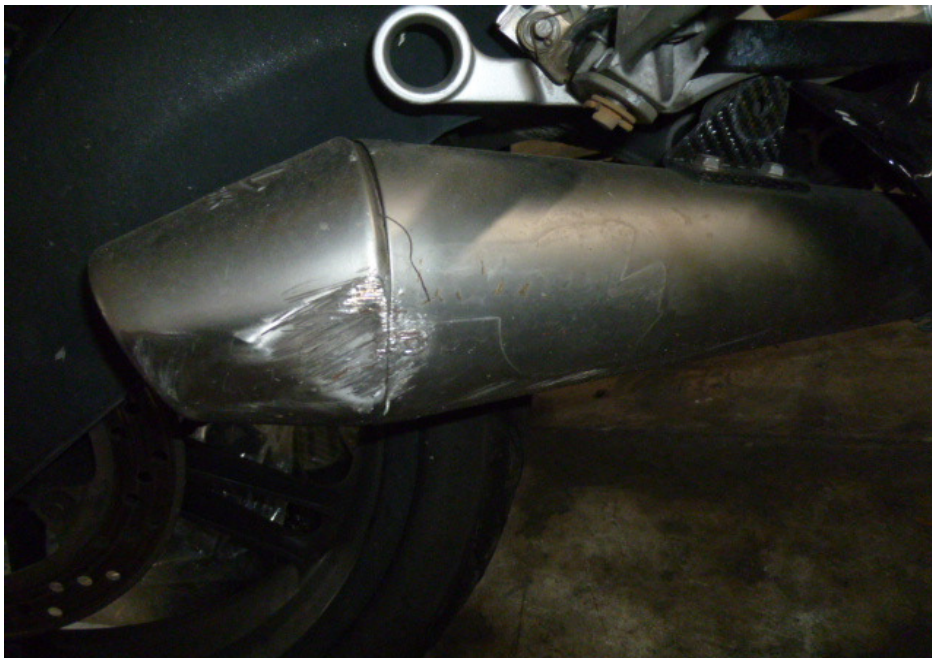
**Photo 15** shows a closer view of the dented exhaust muffler of the Motorcycle as a result of the accident.

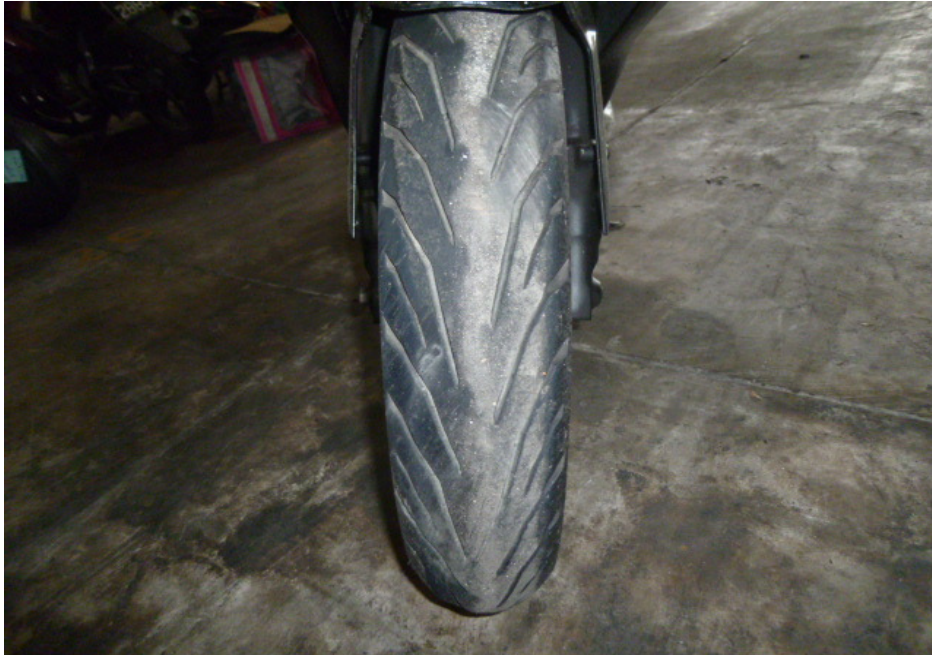
**Photo 16** shows the condition of the Motorcycle's front tyre. The front tyre was observed to be in serviceable condition with remaining tread depth of approximately 4mm. There was no tear, burst mark(s) and/or punctured hole(s) on the sidewalls as well as across the tread of the front tyre.

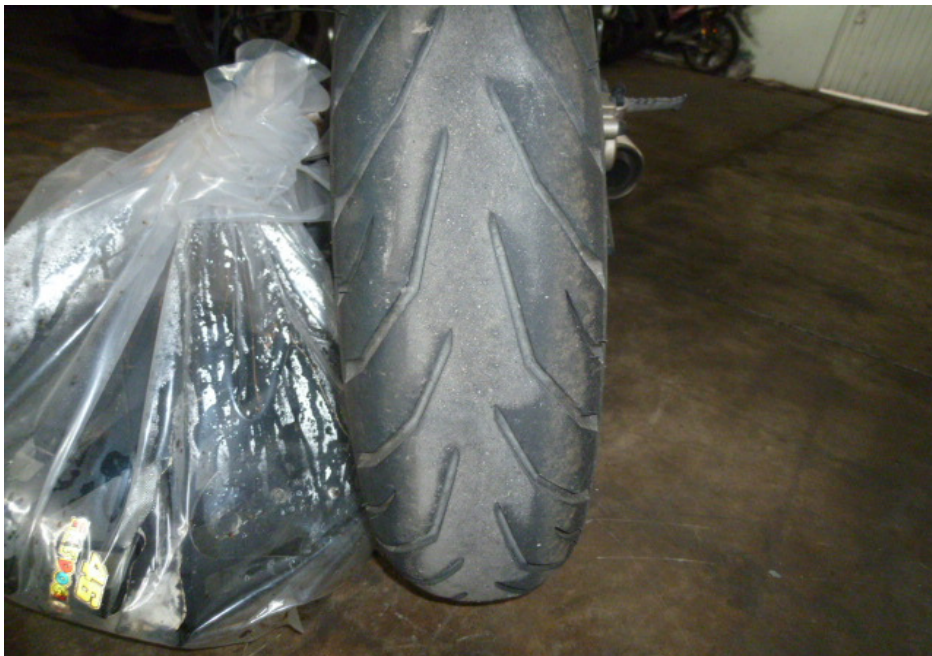
**Photo 17** shows the condition of the Motorcycle's rear tyre. The rear tyre was observed to be in serviceable condition with remaining tread depth of approximately 3mm. The tyre was also observed to be sufficiently inflated for vehicular operation. We did not observe any tear, burst mark(s) and/or punctured hole(s) on the sidewalls as well as across the tread of the rear tyre.

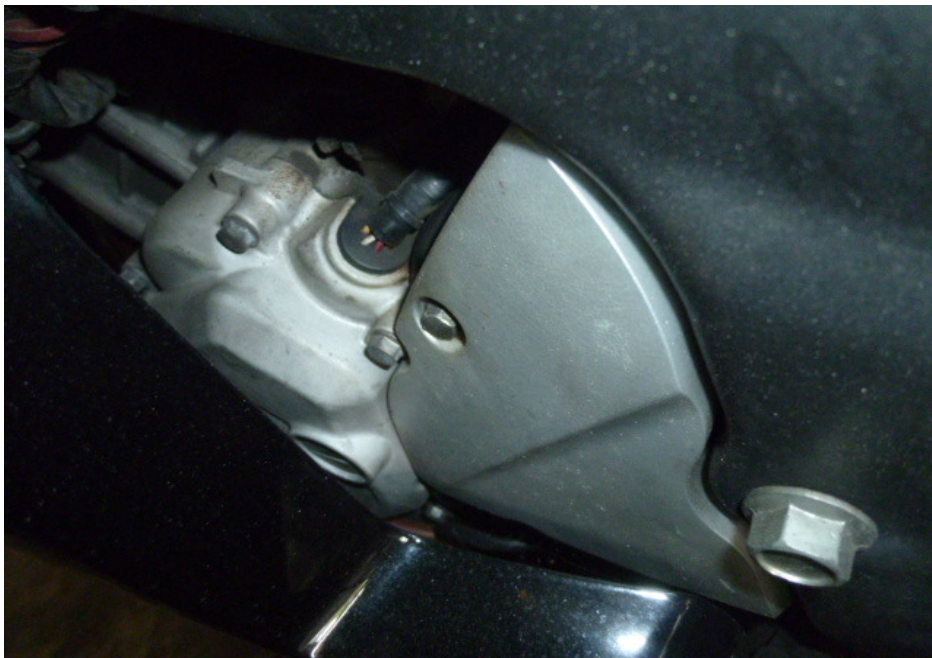
**Photo 18** shows the left side of the engine of the Motorcycle at the time of our inspection. The various engine related parts and components were found to be intact with no visible damage. There was also no sign(s) or indication(s) of fluid leak observed around the left engine area of the Motorcycle.

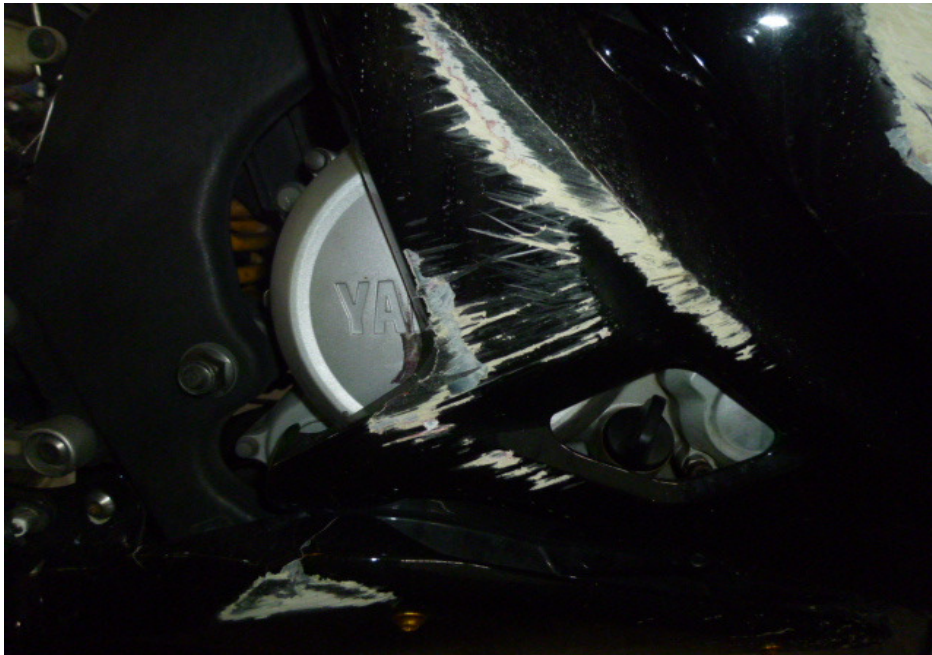
**Photo 19** shows the right side of the engine of the Motorcycle at the time of our inspection. The various engine related parts and components were found to be intact with no visible damage. There was also no sign(s) or indication(s) of fluid leak observed around the right engine area of the Motorcycle.

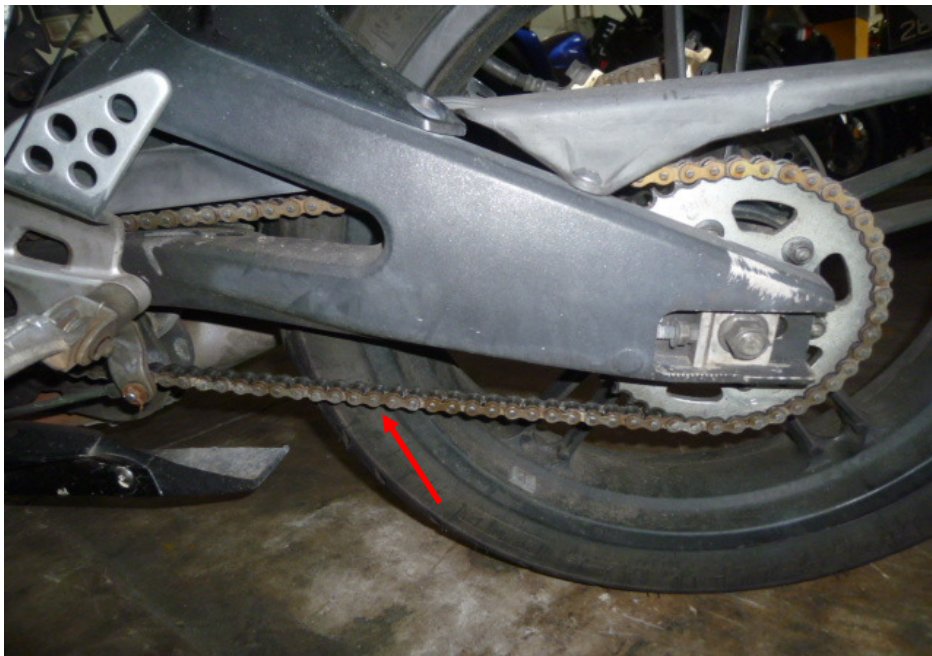
**Photo 20** shows the general view of the gear train (arrowed) of the Motorcycle, which was observed to be intact with no misalignment. It was also adequately lubricated for operating purposes.

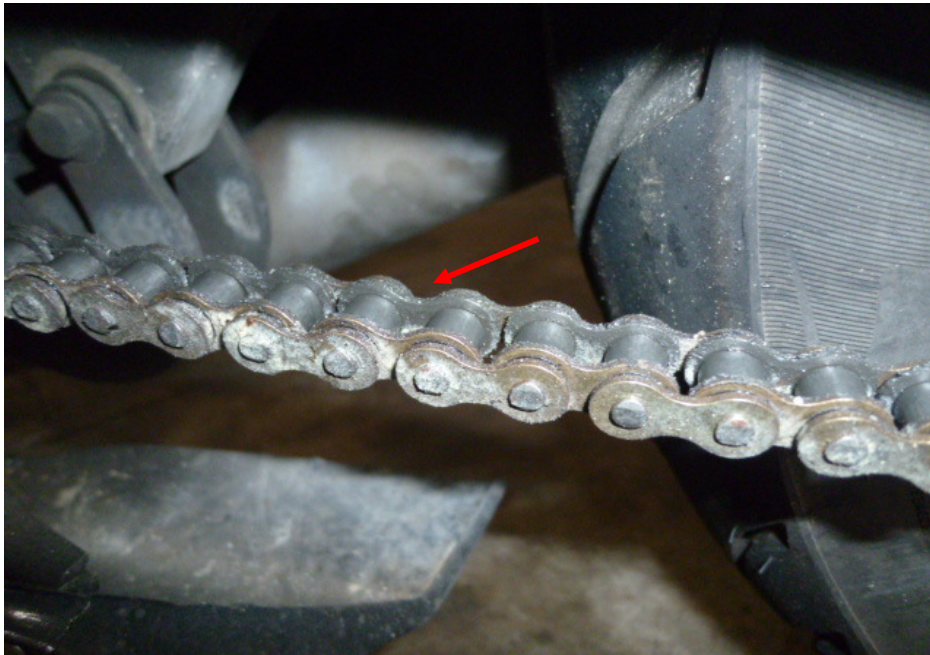
**Photo 21** shows a closer view of the gear train (arrowed) of the Motorcycle, which was observed to be intact with no misalignment. It was also adequately lubricated for operating purposes.

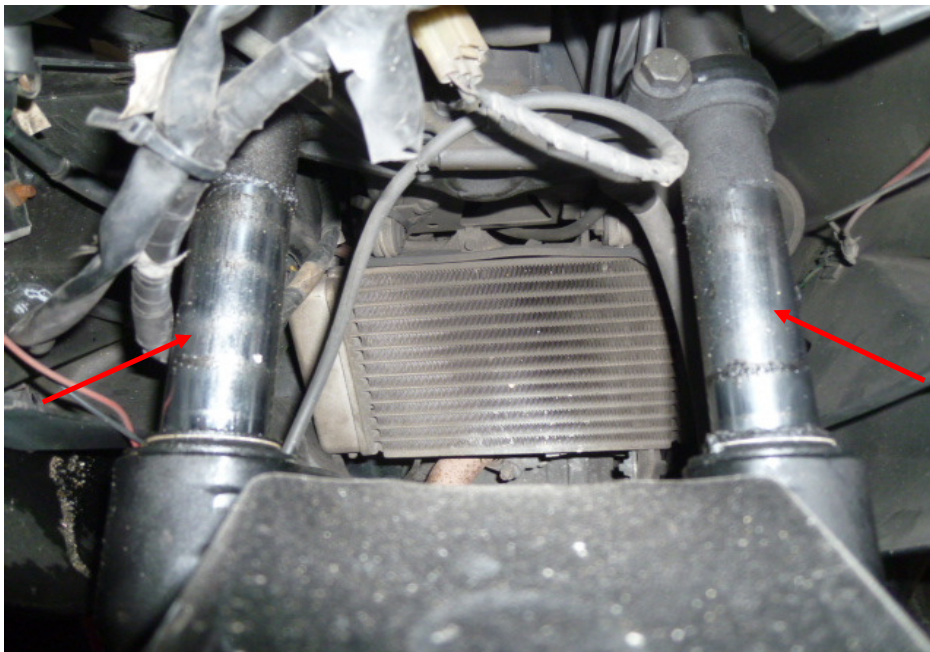
**Photo 22** shows the front forks (arrowed) of the Motorcycle. The front forks and fork bracket of the Motorcycle were both found to be intact and undamaged. Turning the Motorcycle's handle bar towards the left and right did not produce any abnormal free play and/or resistance. The steering system of the Motorcycle was in serviceable condition at the time of our inspection.

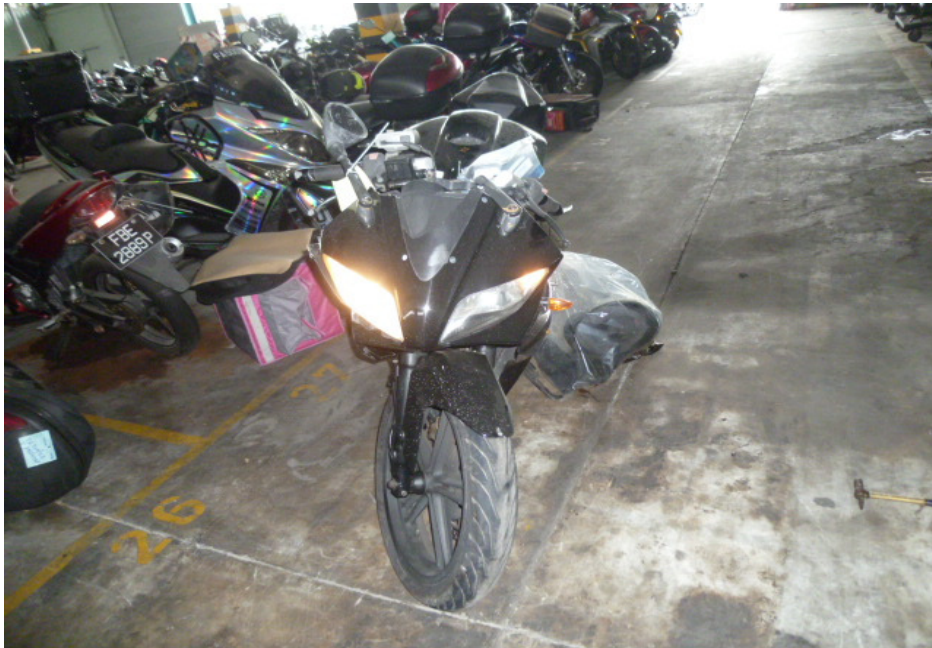
**Photo 23** shows the front wheel of the Motorcycle turned towards its full left. Turning the Motorcycle's handle bar towards the left and right did not produce any abnormal free play and/or resistance. This would indicate that the steering system of the Motorcycle was in serviceable condition at the time of our inspection.

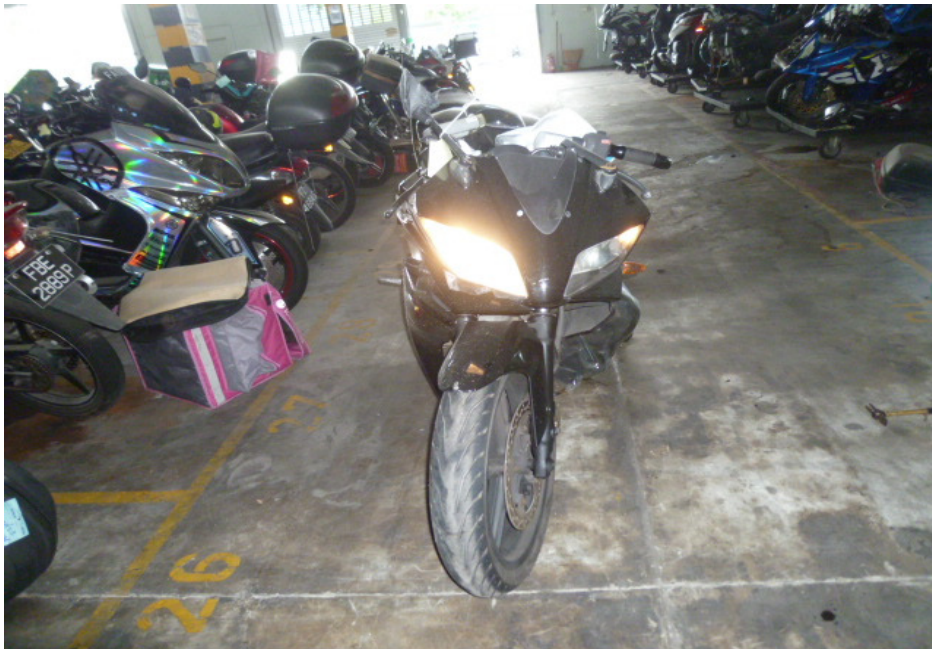
**Photo 24** shows the front wheel of the Motorcycle turned towards its full right. Turning the Motorcycle's handle bar towards the left and right did not produce any abnormal free play and/or resistance. This would indicate that the steering system of the Motorcycle was in serviceable condition at the time of our inspection.

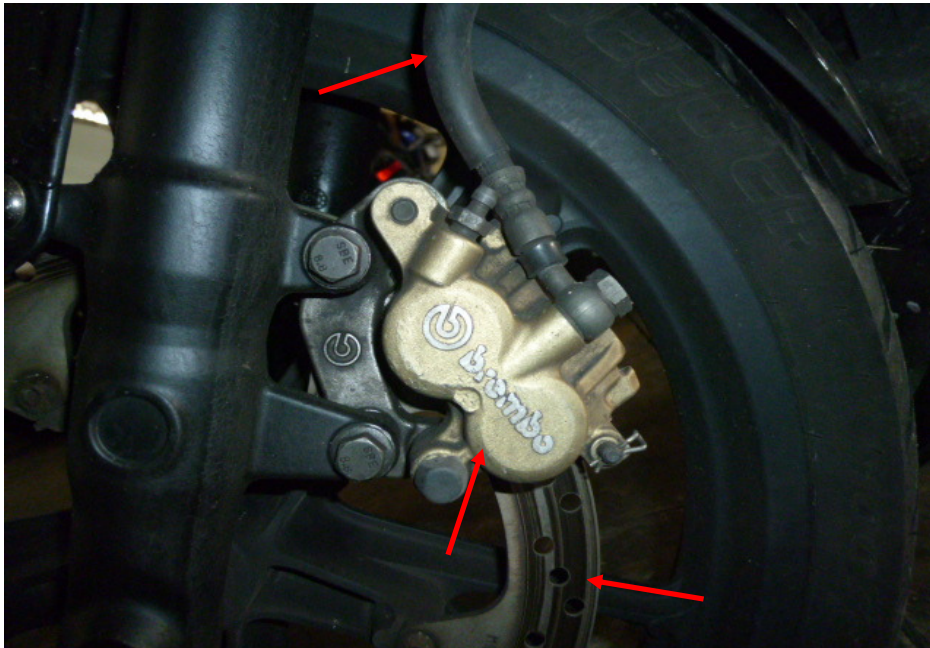
**Photo 25** shows a close up view of the front brake caliper, front brake disc and front brake hose (arrowed) of the Motorcycle, which are all part of the components in the hydraulic front brake system of the Motorcycle. Our visual checks of these various components had revealed all to be intact with no visible damage. No leakage of brake fluid was also observed.

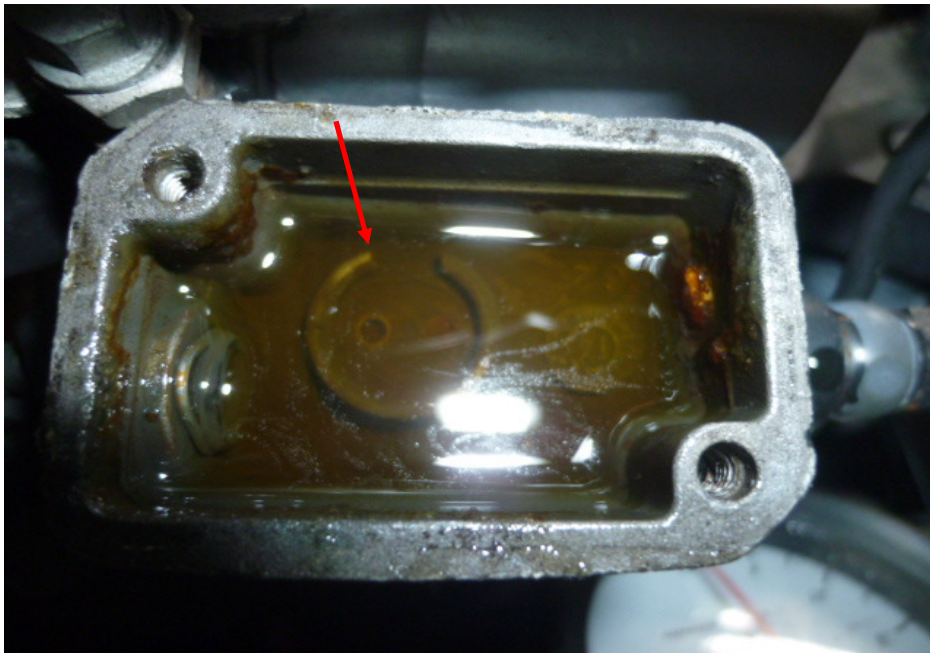
14. The brake fluid for the front brake was observed to be of sufficient level for operational purposes. However it was found to be slightly contaminated. The brake fluid for the rear brake was observed to be of sufficient level for operational purposes. However it was found to be slightly contaminated.

**Photo 26** shows a close up view of the brake fluid reservoir for the front brake of the Motorcycle. The brake fluid for the front brake was observed to be of sufficient level for operational purposes. However it was found to be slightly contaminated (arrowed).

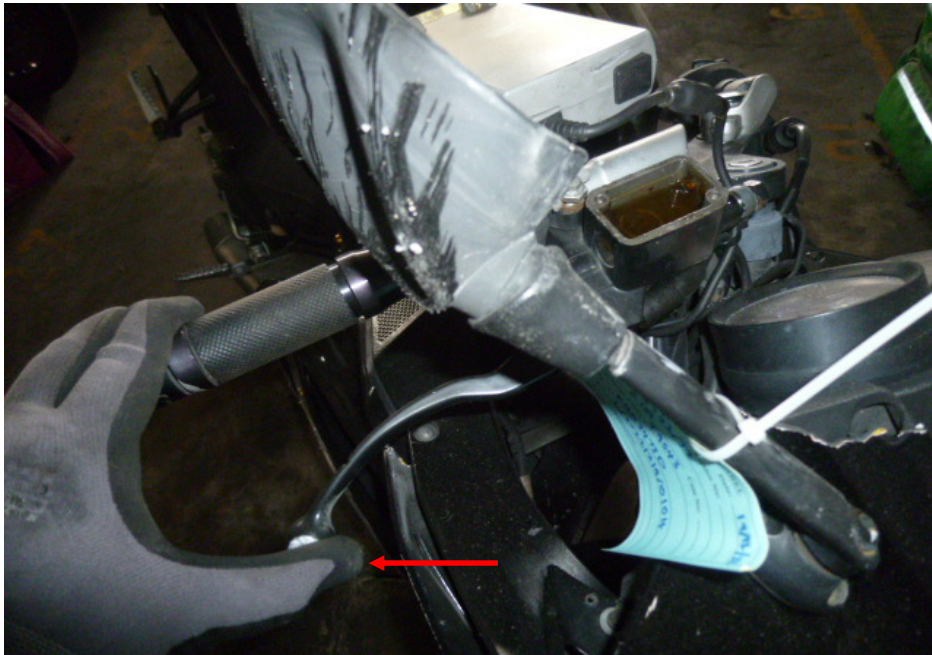
15. Static brake tests conducted on the Motorcycle had appear to indicate that the braking system of the Motorcycle was in serviceable condition. There was some resistance felt (spongy like feel) upon pressing the brake lever and upon stepping on the brake pedal. This would indicate that there was no leakage of pressure/vacuum in the brake system.

**Photo 27** shows the front brake lever being depressed. There was some resistance felt (spongy like feel) upon pressing the front brake lever (arrowed). This would indicate that there is no leakage of pressure/vacuum in the front brake system.

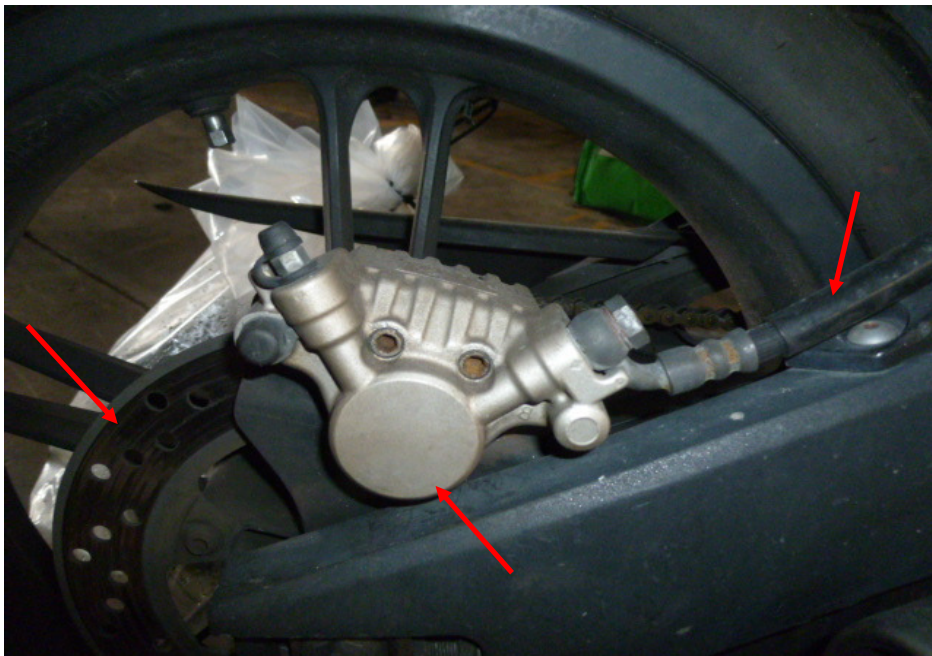
**Photo 28** shows a close up view of the rear brake caliper, rear brake disc and rear brake hose (arrowed) of the Motorcycle, which are all part of the components in the hydraulic rear brake system of the Motorcycle. Our visual checks of these various components had revealed all to be intact with no visible damage. No leakage of brake fluid was also observed.

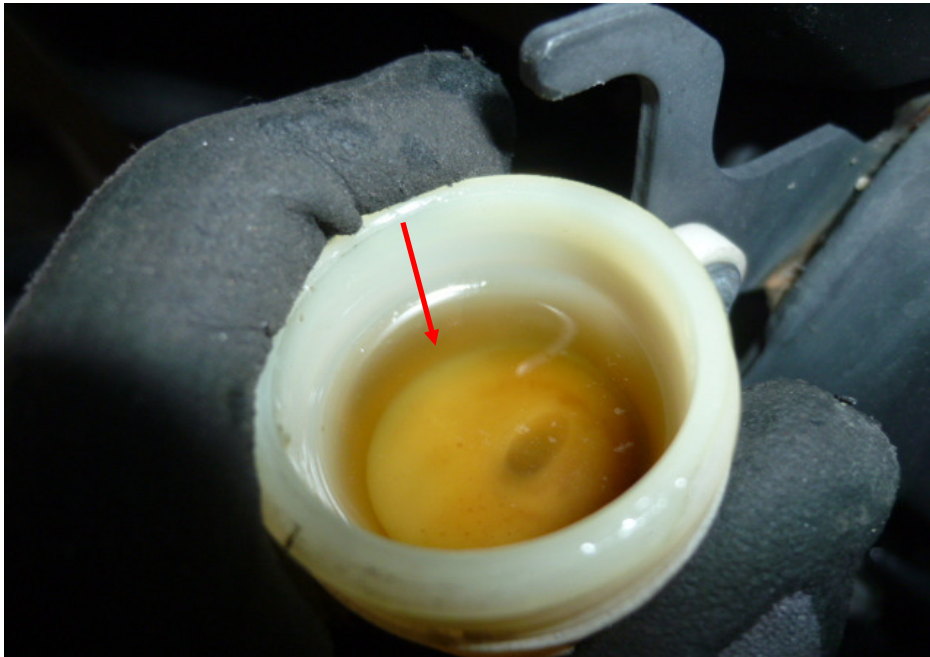
**Photo 29** shows a close up view of the brake fluid reservoir for the rear brake of the Motorcycle. The brake fluid for the rear brake was observed to be of sufficient level for operational purposes. However it was found to be slightly contaminated (arrowed).
