Your Ref: TP/IP/22827/2022  
Our Ref : CI/TPD23001383/N

**Fatal Accident Investigation Team**

**MECHANICAL INSPECTION REPORT OF MOTOR VAN GBL 5084M**

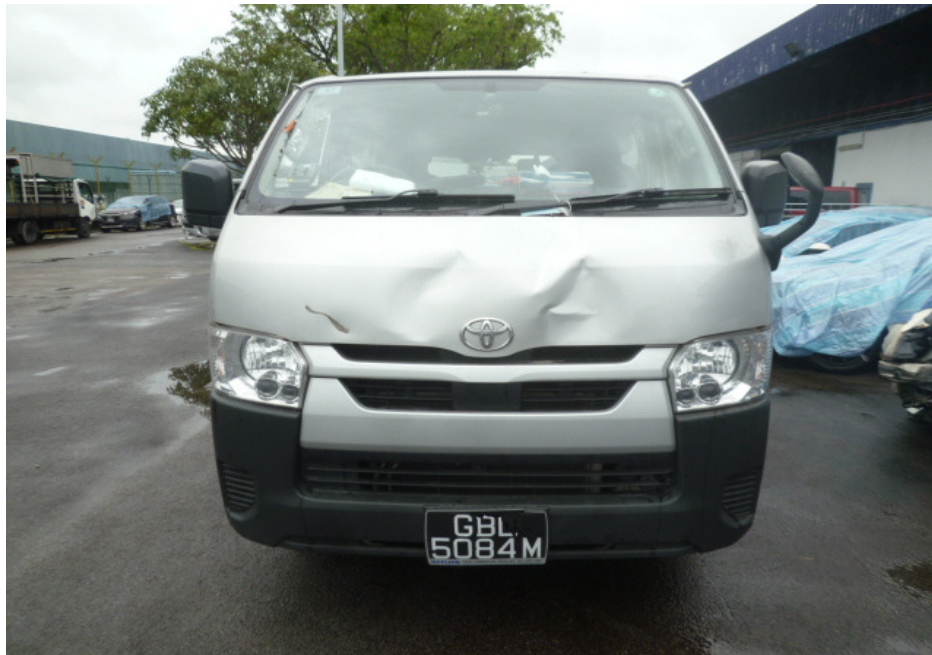
4. The mileage of the Motor Van at the time of our inspection was 53, 785km.
5. The Motor Van was observed to have sustained minimal impact damage at its frontal portion. Its front bonnet was dented and its front number plate as well as its front number plate holder was cracked as a result of the accident.

**Photo 1** shows a general view of the frontal portion of the Motor Van at the time of our inspection. The Motor Van was observed to have sustained minimal impact damage that was confined to its frontal portion. The mileage of the Motor Van was recorded to be 53, 785km.

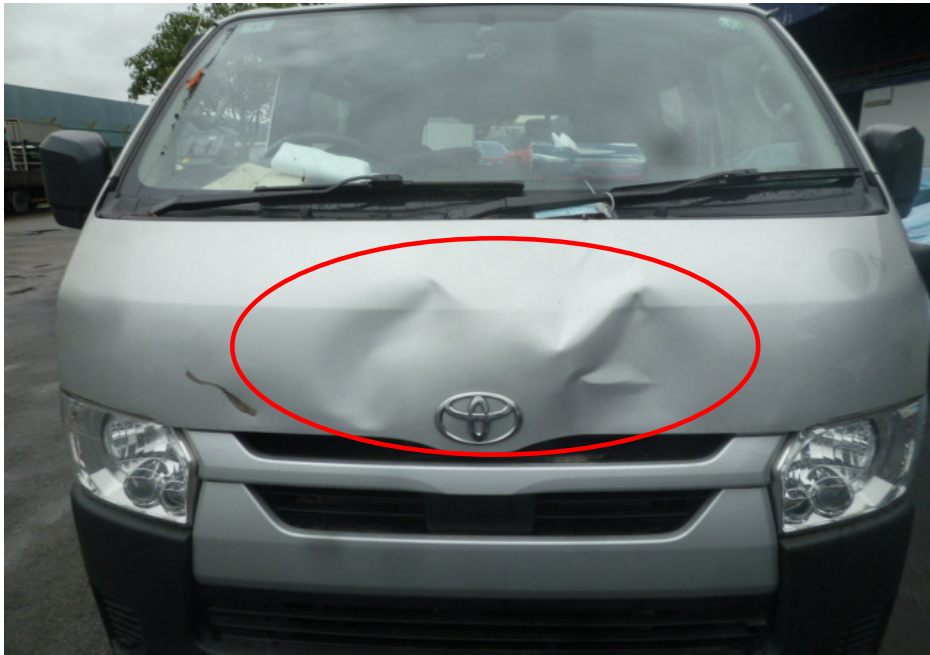
**Photo 2** shows a closer view of the frontal portion of the Motor Van at the time of our inspection. The Motor Van was observed to have sustained minimal impact damage that was confined to its frontal portion. Its front bonnet was dented as a result of the accident (circled).

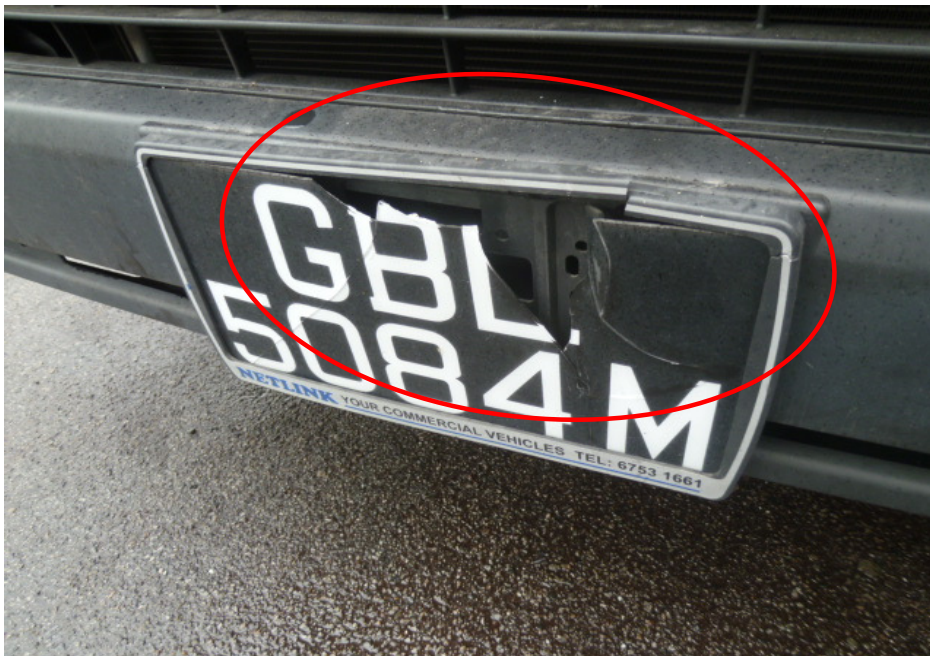
**Photo 3** shows a close up view of the cracked front number plate and front number plate holder of the Motor Van at the time of our inspection (circled).

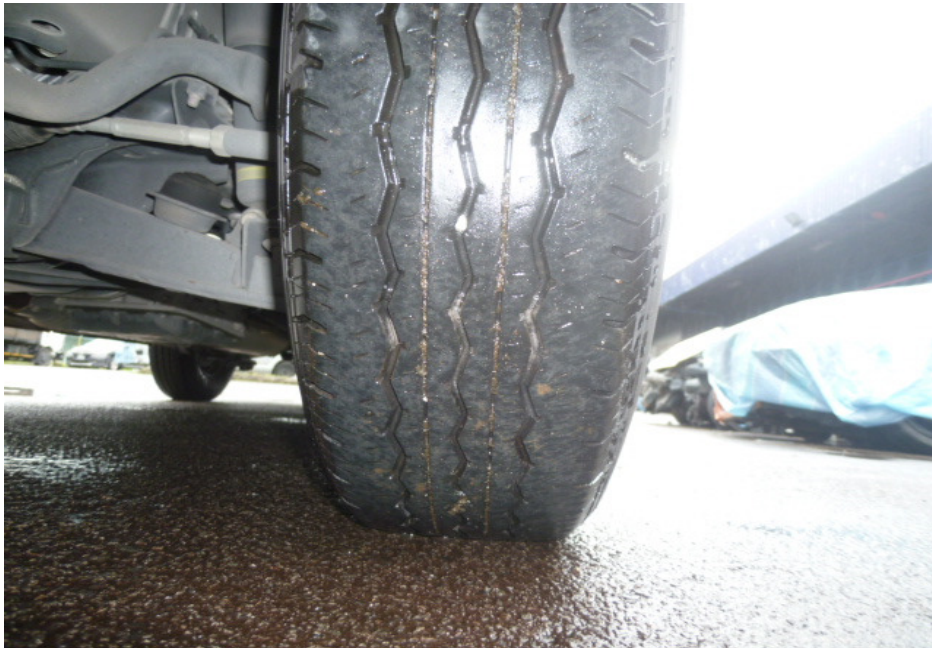
**Photo 4** shows the condition of the front left tyre of the Motor Van, which was observed to be in serviceable condition with remaining tread depth of approximately 5mm. The tyre, which was wrapped around standard steel wheel rim, was also observed to be sufficiently inflated for vehicular operation. There was no tear, cut or burst mark(s) on the outer and the inner sidewalls as well as across the tread of the 4 tyres.

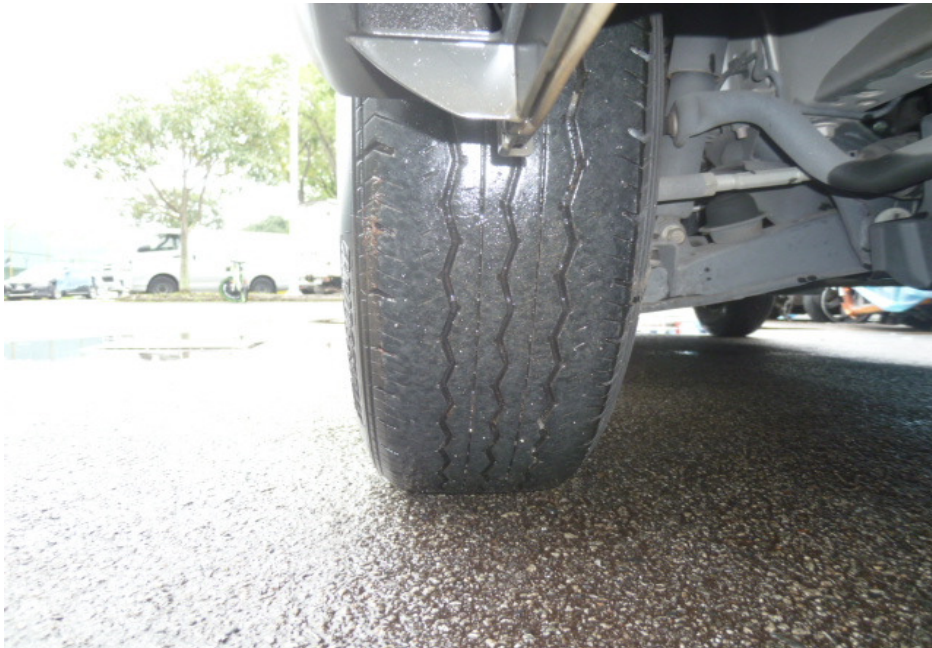
**Photo 5** shows the condition of the front right tyre of the Motor Van, which was observed to be in serviceable condition with remaining tread depth of approximately 6mm. The tyre, which was wrapped around standard steel wheel rim, was also observed to be sufficiently inflated for vehicular operation.

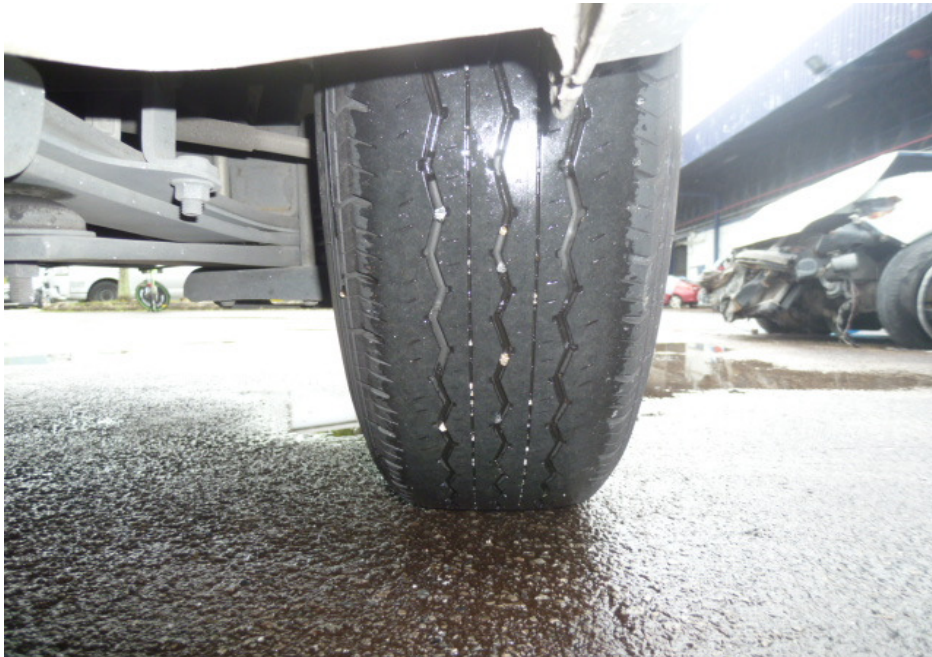
**Photo 6** shows the condition of the rear left tyre of the Motor Van, which was observed to be in serviceable condition with remaining tread depth of approximately 7mm. The tyre, which was wrapped around standard steel wheel rim, was also observed to be sufficiently inflated for vehicular operation. There was also no damage found on the 4 wheel rims of the Motor Van.

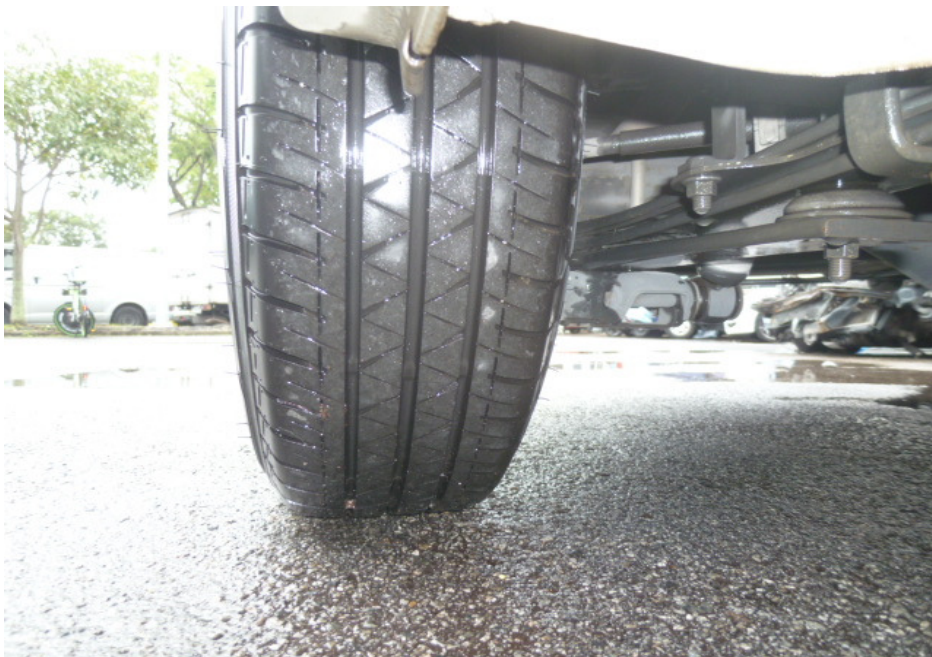
**Photo 7** shows the condition of the rear right tyre of the Motor Van, which was observed to be in serviceable condition with remaining tread depth of approximately 7.5mm. There was also no tear, cut or burst mark(s) on the outer and the inner sidewalls as well as across the tread of the 4 tyres.

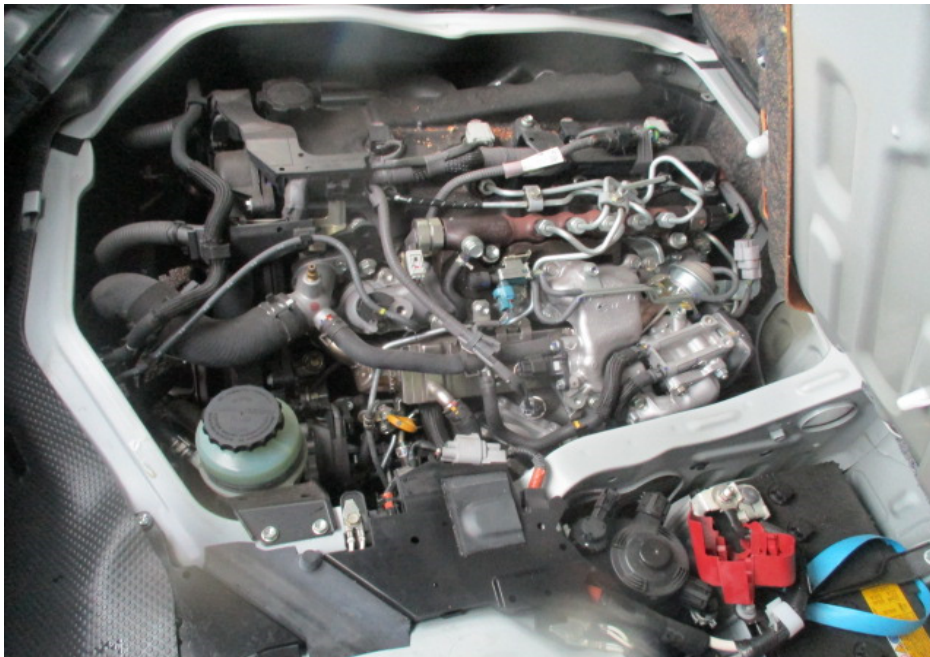
**Photo 8** shows a general view of the Motor Van's engine compartment. The various parts and components inside the engine compartment were unaffected by the accident. There was also no sign(s) or indication(s) of fluid leakage and/or fluid stain within the engine compartment. The wirings and cables were all observed to be intact and adequately secured to their respective connectors and/or connecting ports.

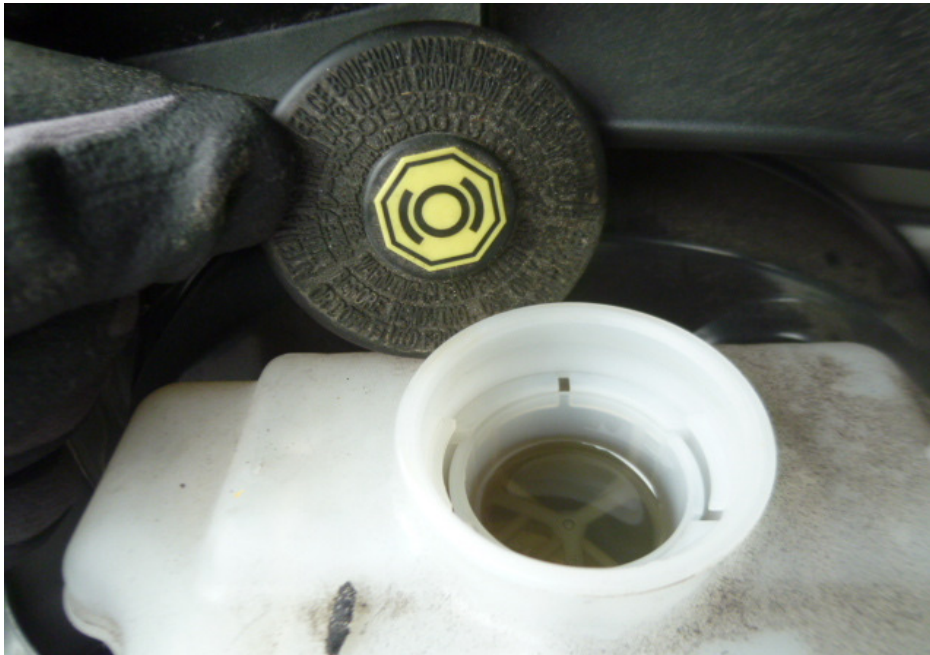
**Photo 9** shows the brake fluid reservoir of the Motor Van at the time of our inspection. The brake fluid was observed to be of sufficient level for operating purposes and without any visible contamination.

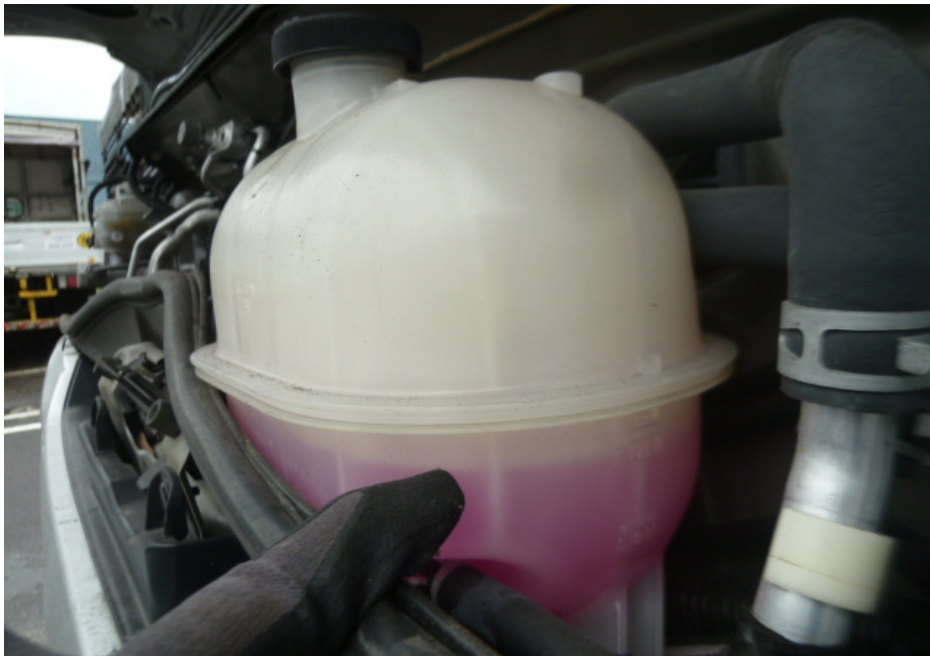
**Photo 10** shows the engine coolant reservoir of the Motor Van at the time of our inspection. The engine coolant was observed to be of sufficient level for operating purposes and without any visible contamination.

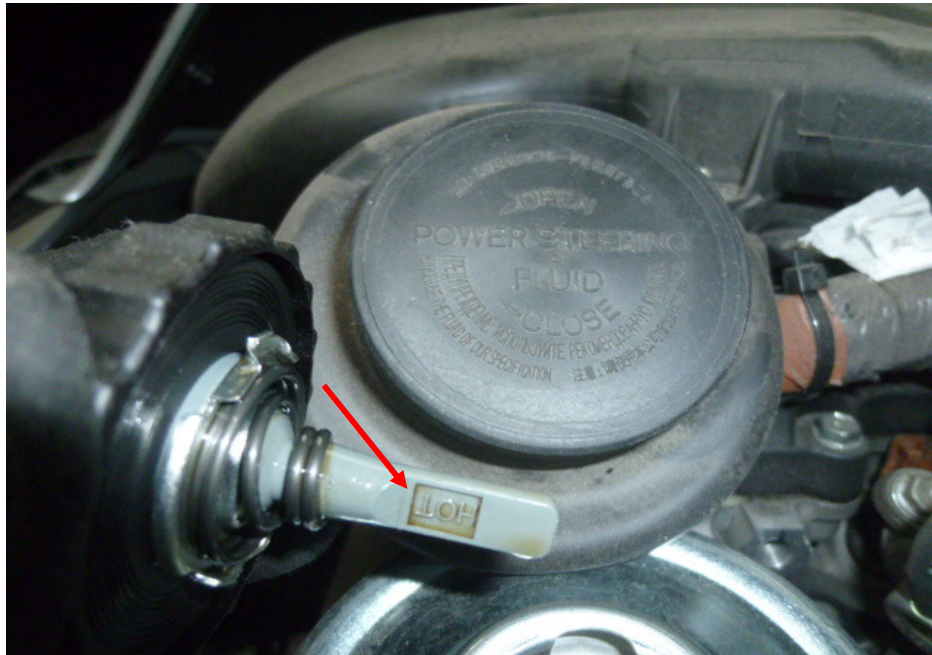
**Photo 11** shows the power steering fluid reservoir of the Motor Van at the time of our inspection. The power steering fluid was observed to be of sufficient level for operating purposes and without any visible contamination (arrowed).

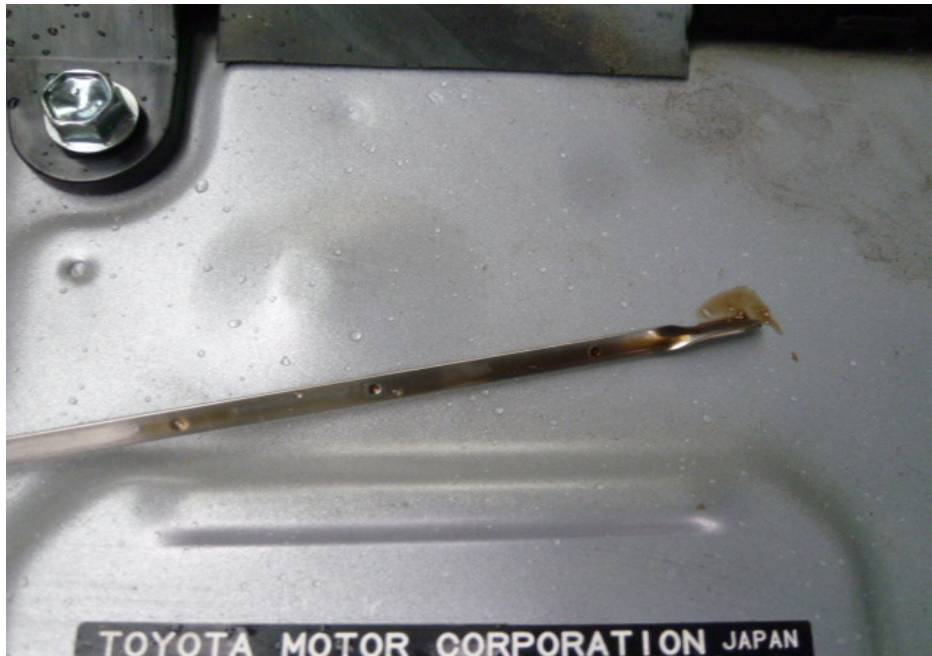
**Photo 12** shows the engine dip stick of the Motor Van at the time of our inspection. The engine oil was observed to be of sufficient level for operating purposes and without any visible contamination.

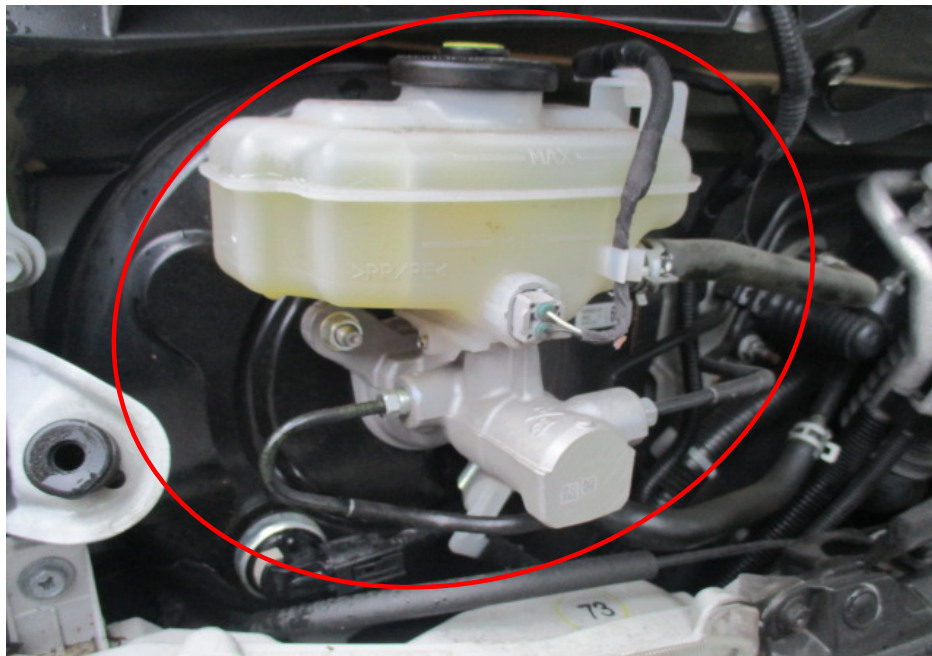
**Photo 13** shows the brake master pump, brake reservoir tank, brake booster and brake pipes (circled). These components, which are part of the braking system of the Motor Van, were all observed to be intact, with no sign(s) or indication(s) of brake fluid leakage.

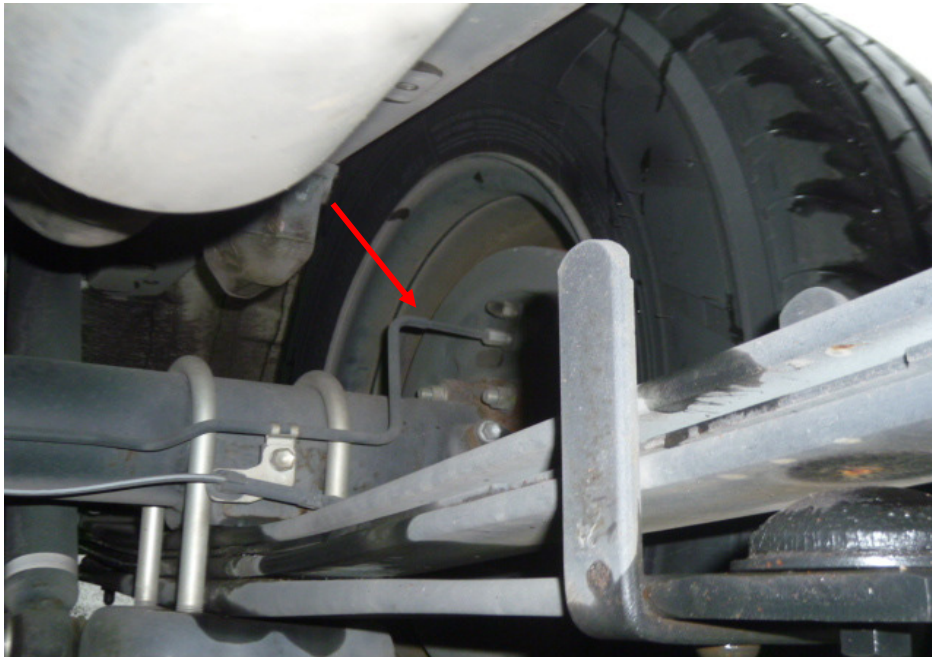
**Photo 14** shows the brake pipe (arrowed) at the rear right wheel of the Motor Van. We did not observe any leakage of brake fluid at the time of our inspection of the Motor Van. Our static tests of the Motor Van's braking system had indicated that there was no internal leakage of pressure/vacuum. Hence the braking system was likely to be in serviceable condition at the material time of accident.

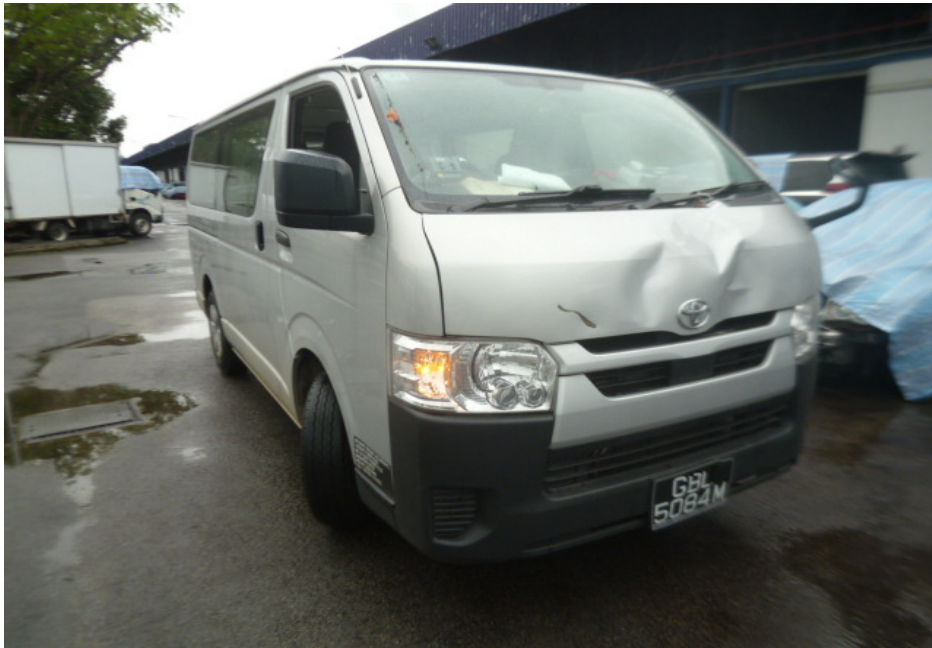
**Photo 15** shows the front right wheel of the Motor Van turned to its full right. During our steering system test, we did not experience any abnormal free play and/or resistance when we had turned the steering wheel towards the left and right. This would suggest that the steering system of the Motor Van was likely to be in serviceable condition at the material time of accident.

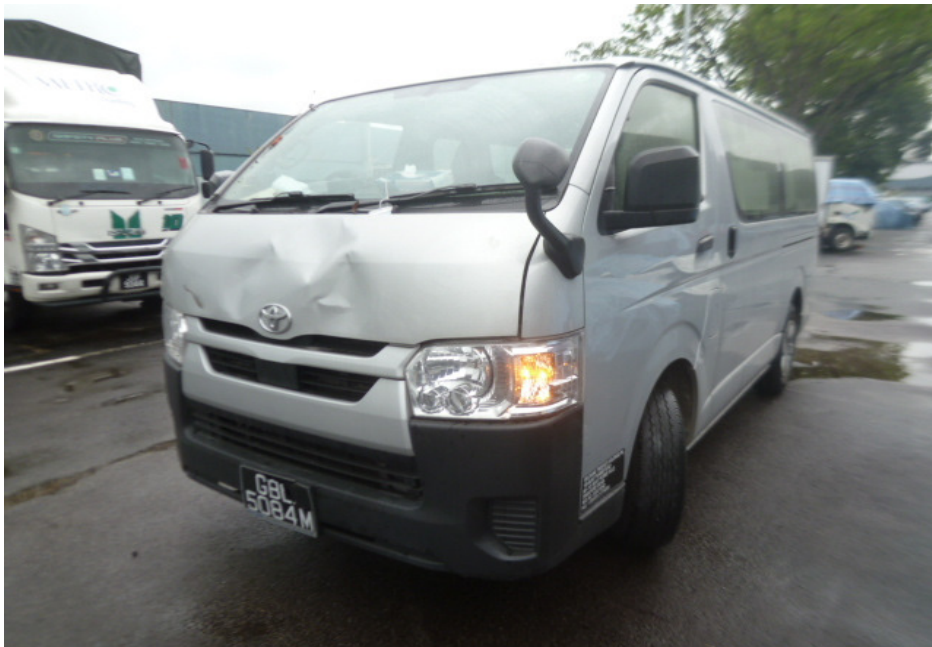
**Photo 16** shows the front left wheel of the Motor Van turned to its full left. During our steering system test, we did not experience any abnormal free play and/or resistance when we had turned the steering wheel towards the left and right. This would suggest that the steering system of the Motor Van was likely to be in serviceable condition at the material time of accident.

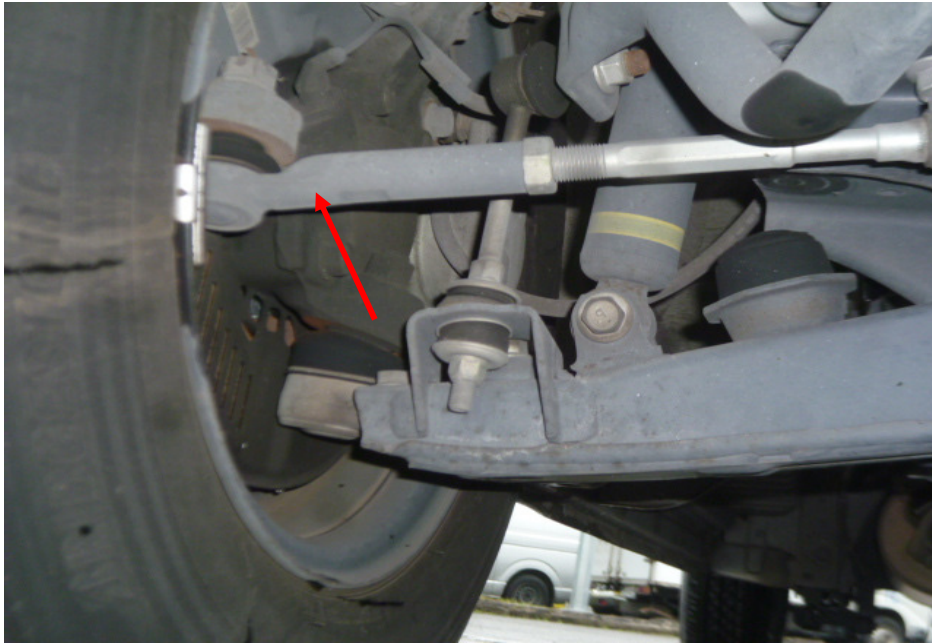
**Photo 17** shows the various undercarriage components at the front right wheel of the Motor Van, in particular the steering tie rod (arrowed). The various steering components were all found to be intact, suggesting that the steering system of the Motor Van was likely to be in serviceable condition at the material time of accident. There was also no sign of fluid stain(s) observed on the various undercarriage components.

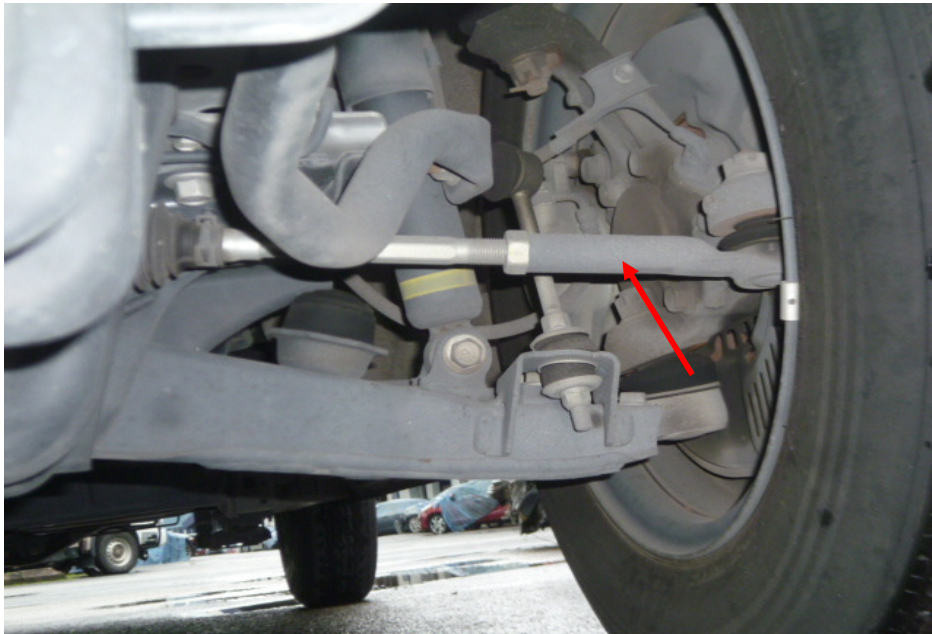
**Photo 18** shows the various undercarriage components at the front left wheel of the Motor Van, in particular the steering tie rod (arrowed). The various undercarriage components of the Motor Van were all found to be intact without any visible damage. There was also no sign of fluid stain(s) observed on the various undercarriage components.

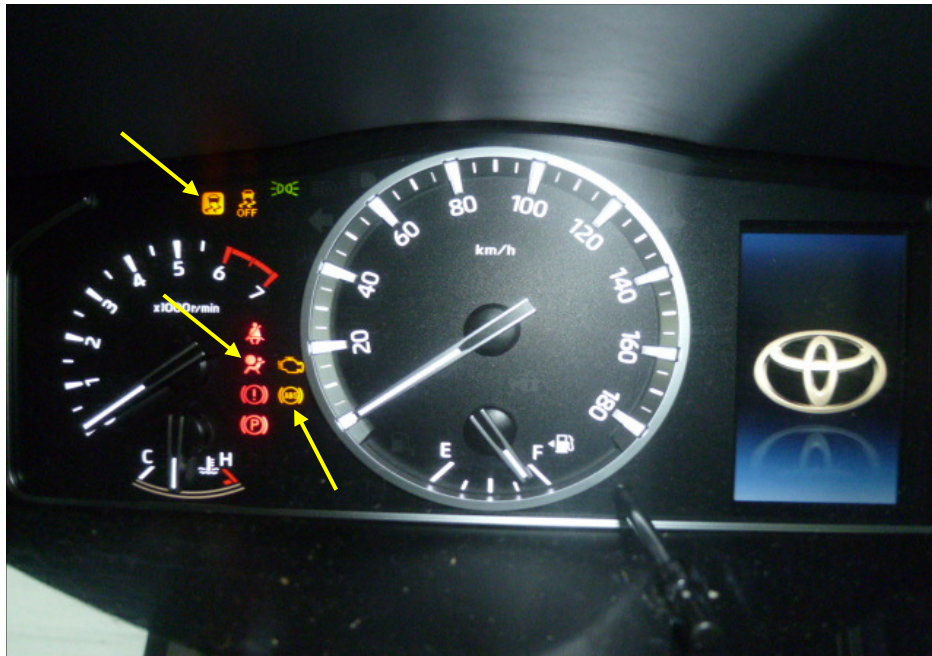
**Photo 19** shows the warning lights for the various electronic operating systems of the Motor Van appearing on its instrument panel during the self-test when the engine is cranked, in particular the Vehicle Stability Control (VSC) light, Supplemental Restraint System (SRS) light and Antilock Braking System (ABS) light (arrowed).

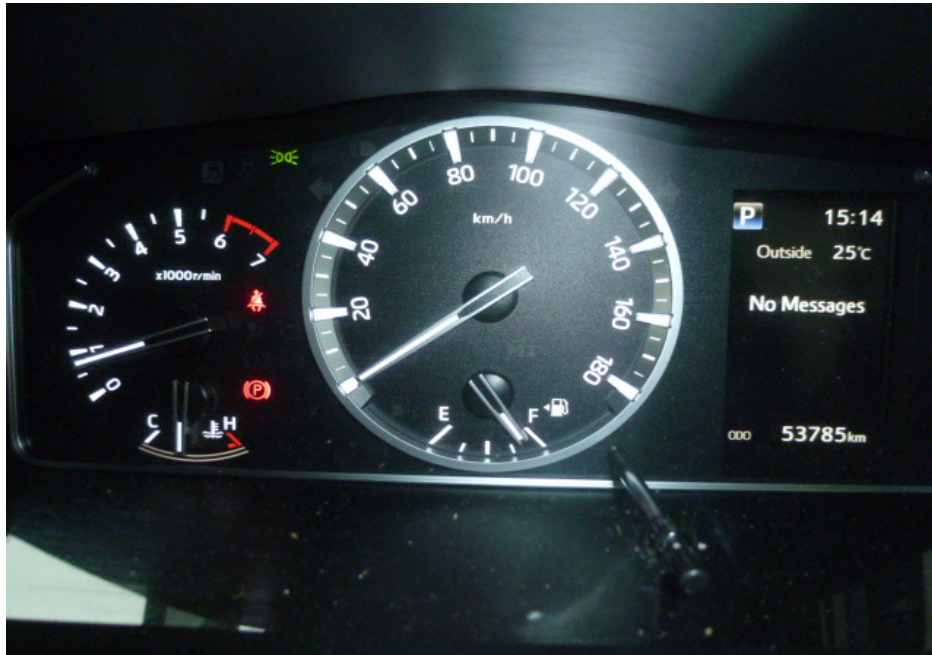
**Photo 20** shows no warning lights illuminated on the instrument panel of the Motor Van after the engine was cranked. This would suggest that there was no abnormality to the various electronic operating systems of the Motor Van, like the VSC, SRS and ABS.
