Your Ref: TP/IP/22827/2022
Our Ref : CI/TPD23001384/N

Fatal Accident Investigation Team

**INSPECTION REPORT OF BICYCLE (ALPOLA BLACK) - TRAFFIC POLICE
POUND REPORT NO. 3181/2022**

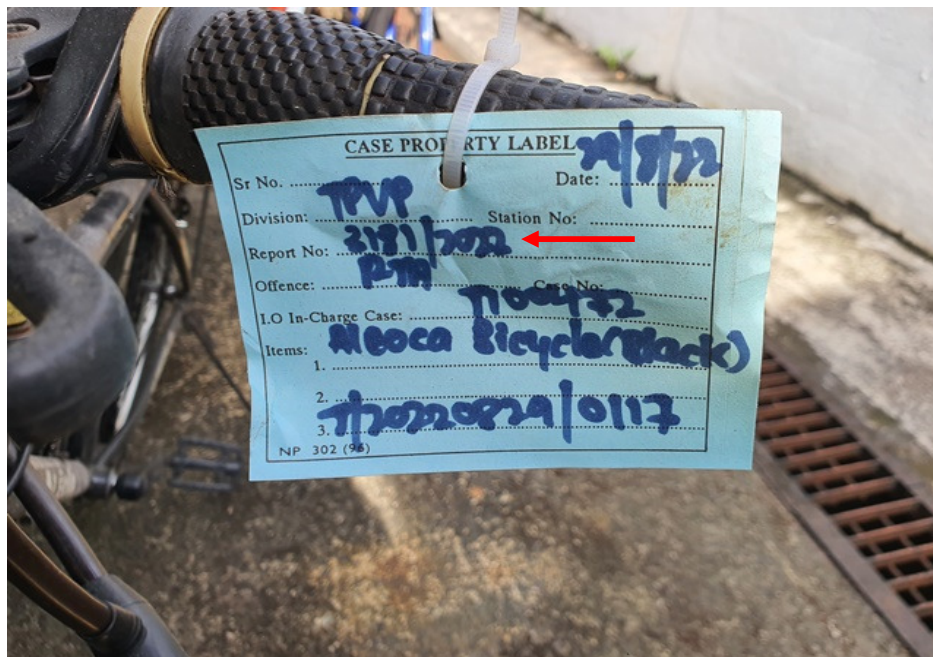
Photo 1 shows the identification of the Bicycle with reference to Traffic Police Pound Report No. 3181/2022 (arrowed).

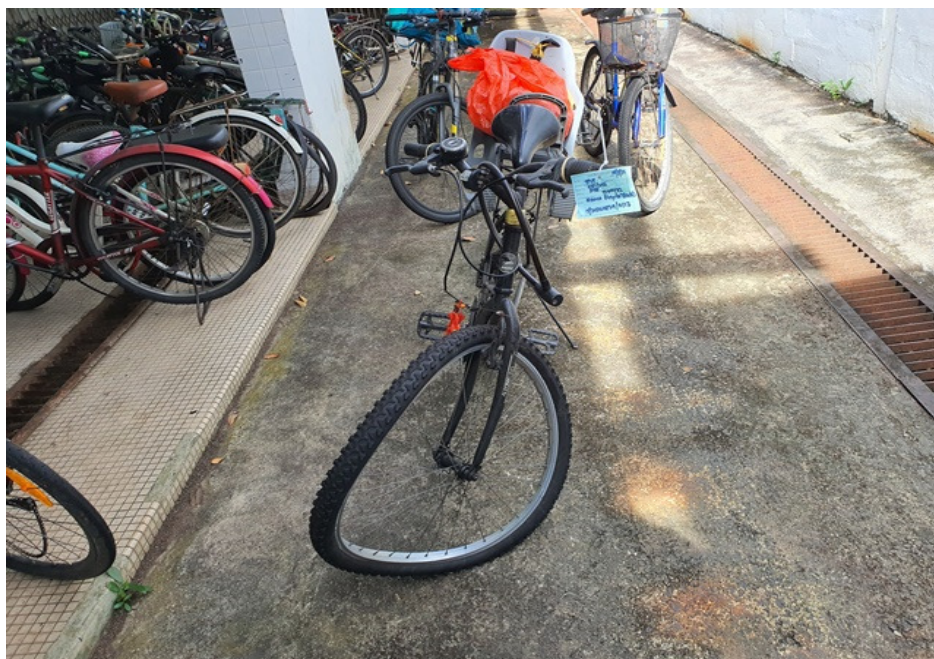
Photo 2 shows the frontal portion of the Bicycle at the time of our inspection. The Bicycle had sustained damages at its right body.

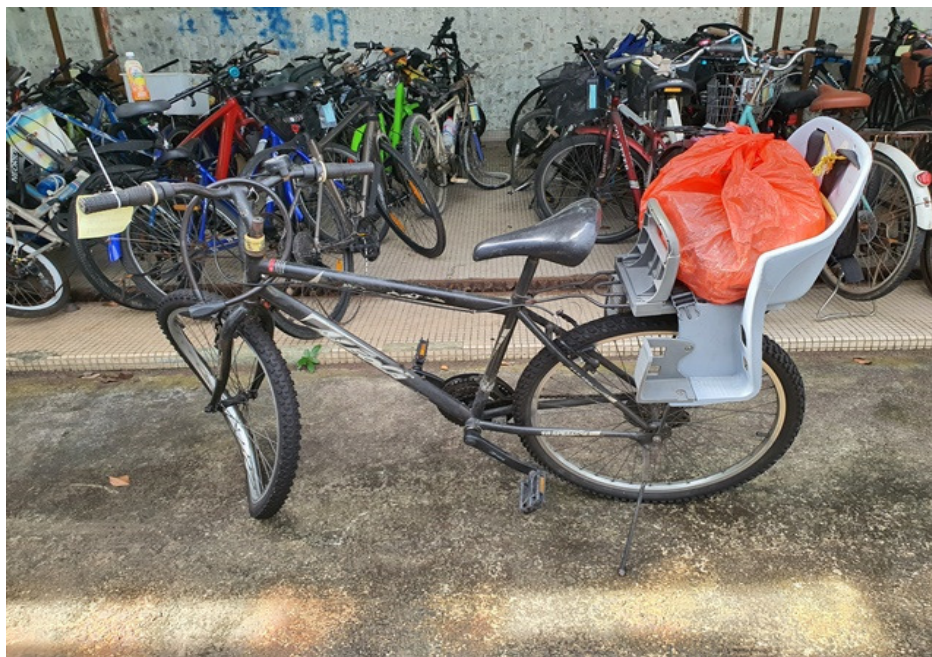
Photo 3 shows the left body of the Bicycle at the time of our inspection. The Bicycle had sustained damages at its right body.

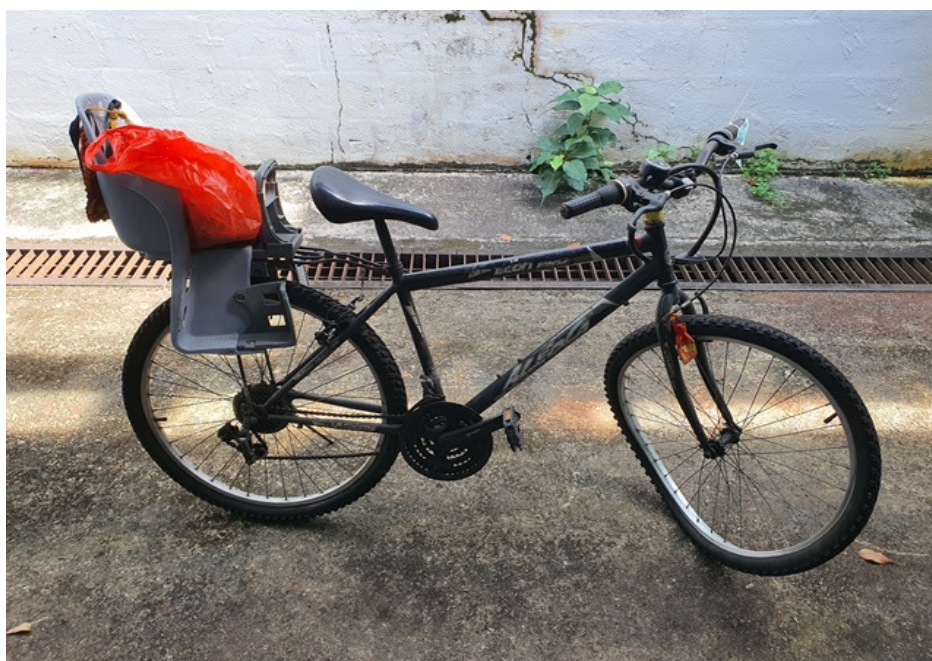
4. The Bicycle was observed to have sustained damages at its right body. The body parts that were found to have been damaged include its front brake clamp assembly, right handlebar grip, right pedal and baby seat, amongst others as a result of the accident. See photos 1 – 8 below.

Photo 4 shows the right body of the Bicycle at time of our inspection. The Bicycle had sustained damages at its right body. The body parts that were found to have been damaged include its front brake clamp assembly, right handlebar grip, right pedal and baby seat, amongst others as a result of the accident.

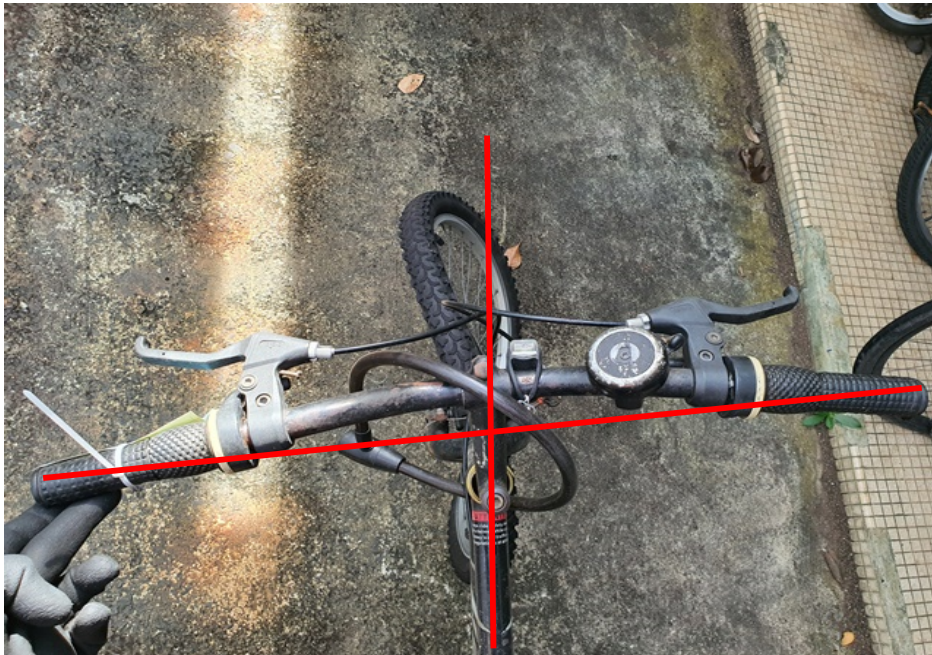
Photo 5 shows the frontal portion of the Bicycle (top view) at the time of our inspection. There was a misalignment of the handle bar & front tyre observed as a result of the accident.

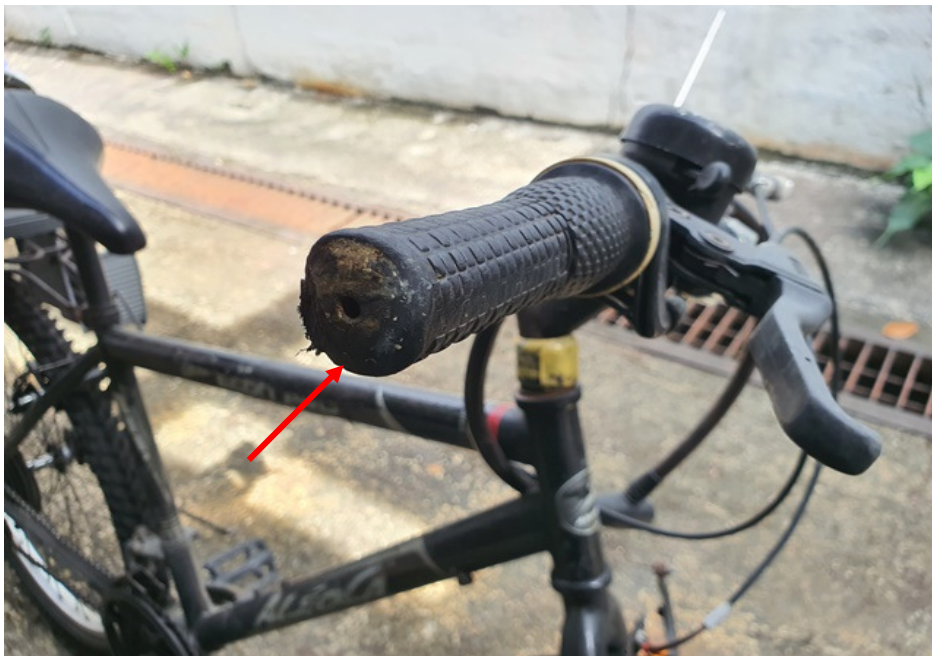
Photo 6 shows the damaged right handlebar grip (arrowed) of the Bicycle at the time of our inspection.

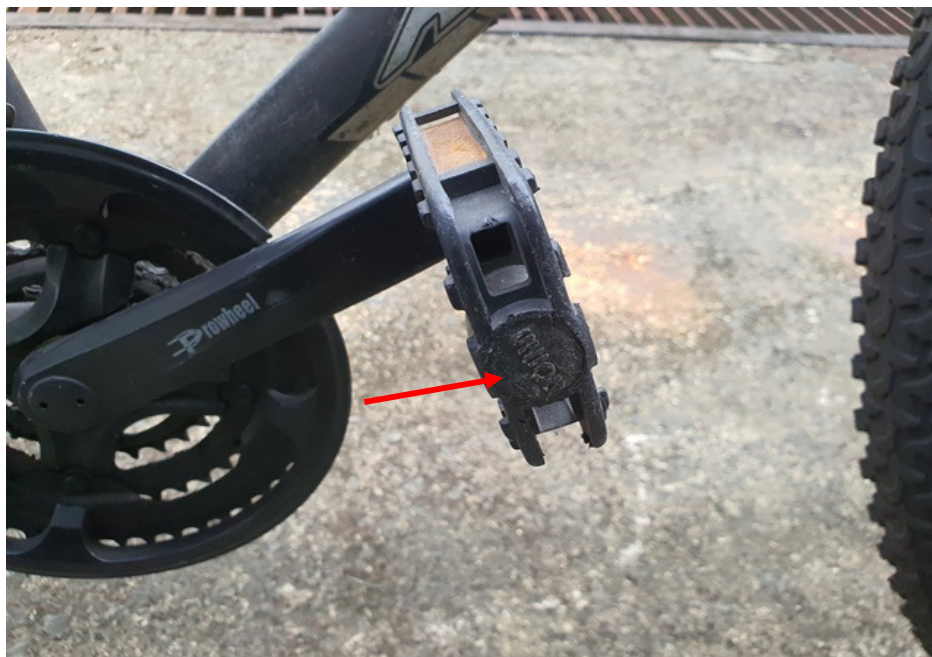
Photo 7 shows the damages of grazing nature on the right pedal of the Bicycle at the time of our inspection (arrowed).

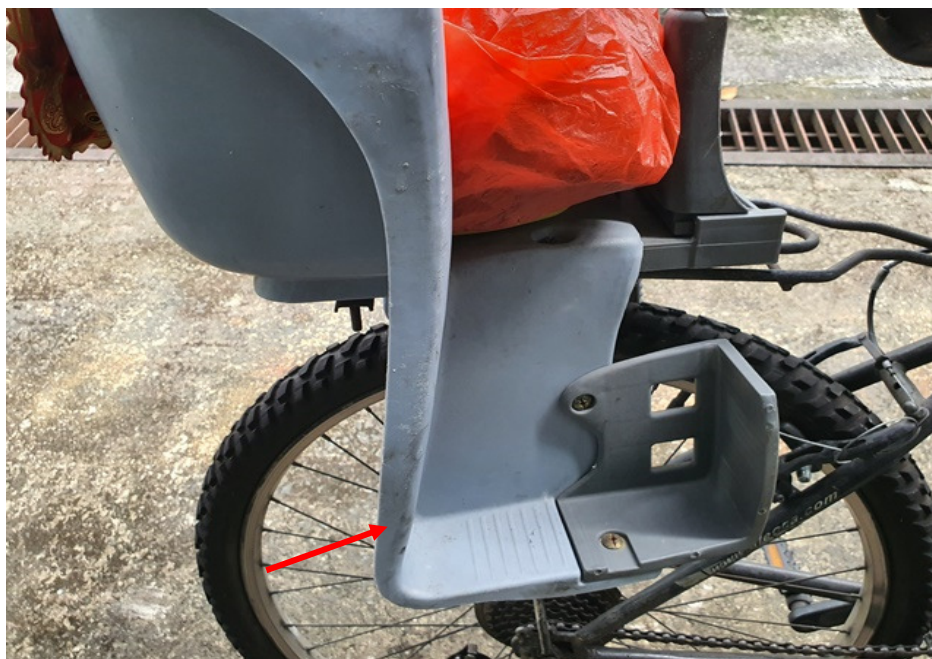
Photo 8 shows a close-up view of the damaged baby seat (arrowed) of the Bicycle as a result of the accident.

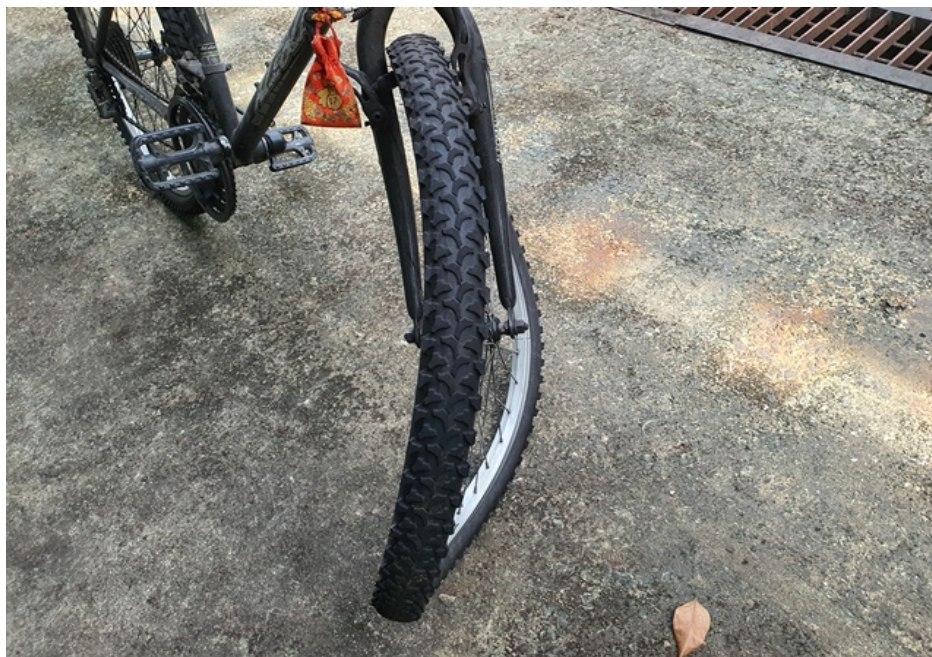
Photo 9 shows the front tyre of the Bicycle. The pattern of the tread was clearly visible. There was no tear, burst mark(s) and/or punctured hole(s) on the sidewalls as well as across the tread of the front tyre. However the front tyre was observed to be deflated at the time of our inspection.

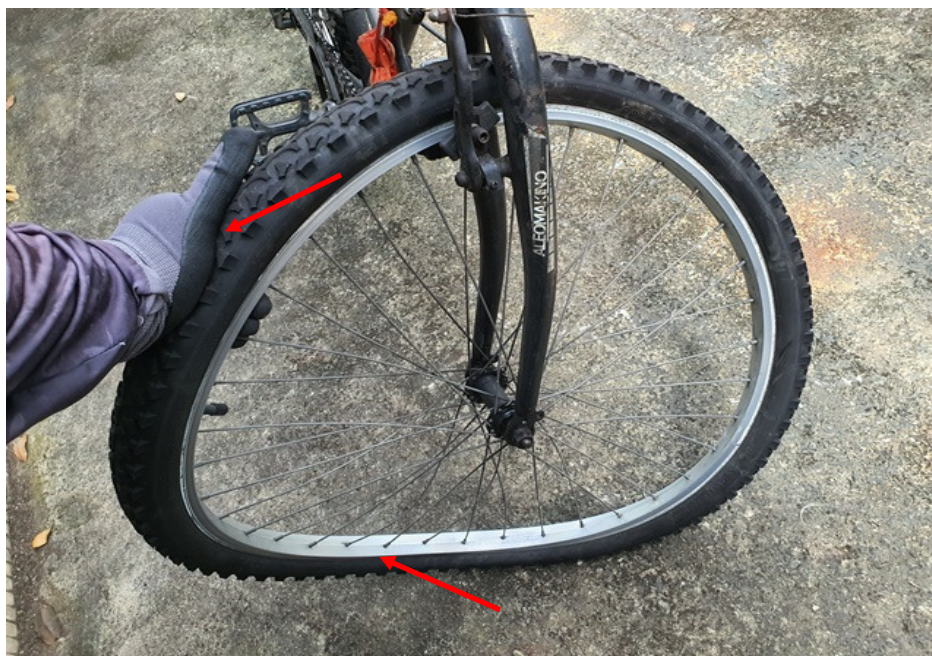
6. Both tyres were wrapped around alloy spoke wheel rims. At the time of our inspection, we did not observe any visible damage on the rear wheel rim of the Bicycle. However the front wheel rim was observed to be bent. See photos 9 - 11 below.

Photo 10 shows the deflated front tyre and bent front wheel rim of the Bicycle (arrowed).

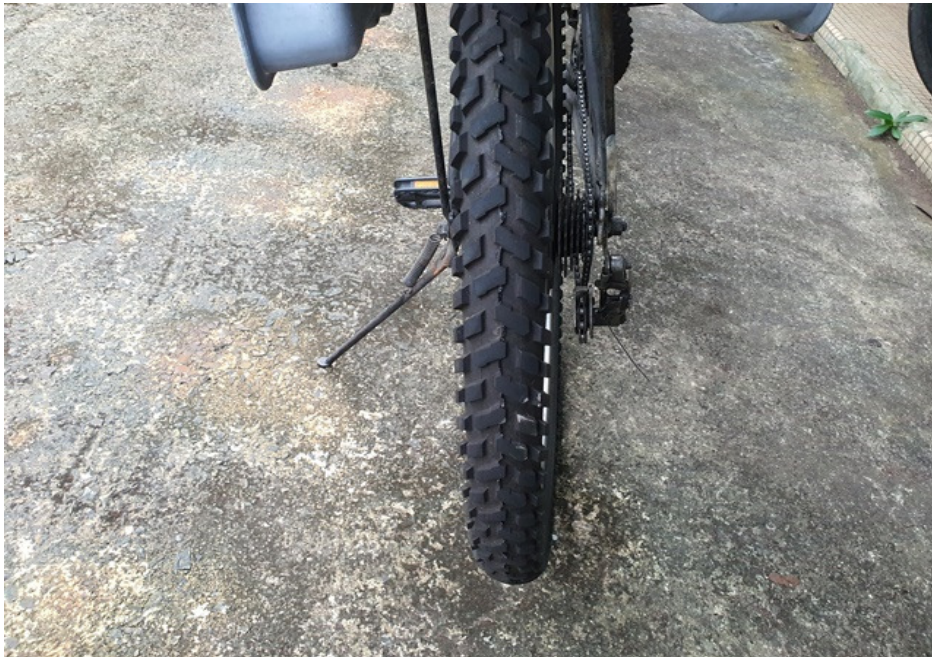
Photo 11 shows the rear tyre of the Bicycle. The pattern of the tread was clearly visible. There was no tear, burst mark(s) and/or punctured hole(s) on the sidewalls as well as across the tread of the rear tyre. The rear tyre was observed to be sufficiently inflated for vehicular operation.

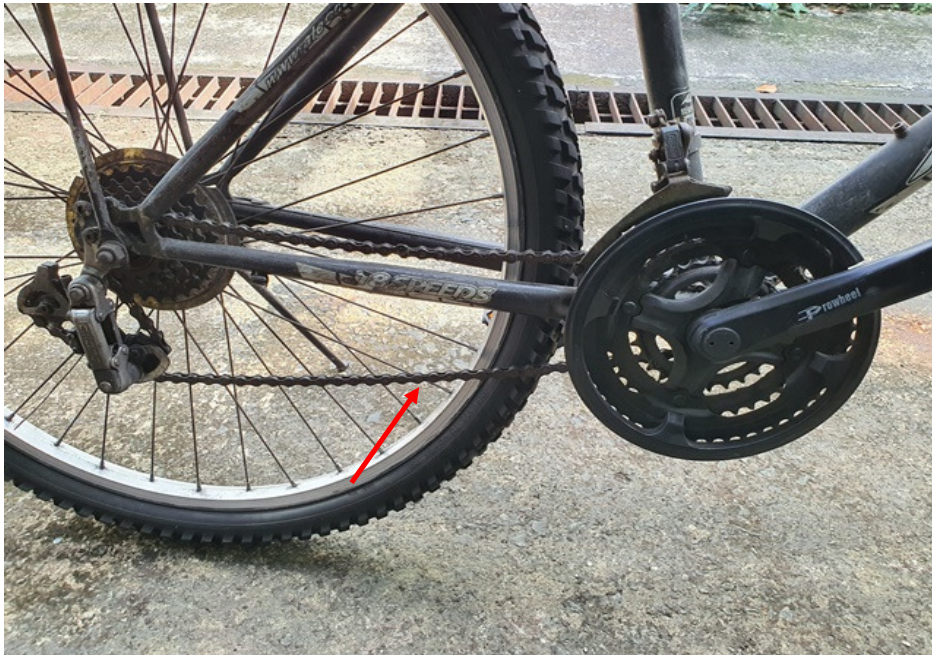
Photo 12 shows the general view of the gear train of the Bicycle, which was observed to be intact with no misalignment. It was also adequately lubricated for operating purposes. However the chain was observed to be dislodged from the gear train most likely as a result of the accident (arrowed).

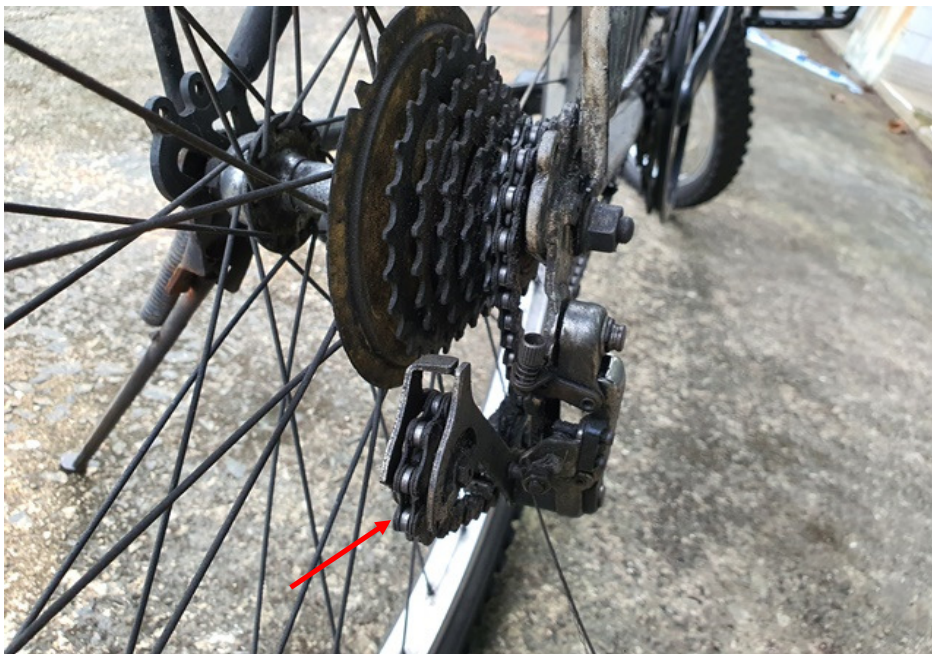
Photo 13 shows a closer view of the gear train of the Bicycle, which was observed to be intact with no misalignment (arrowed). It was also adequately lubricated for operating purposes.

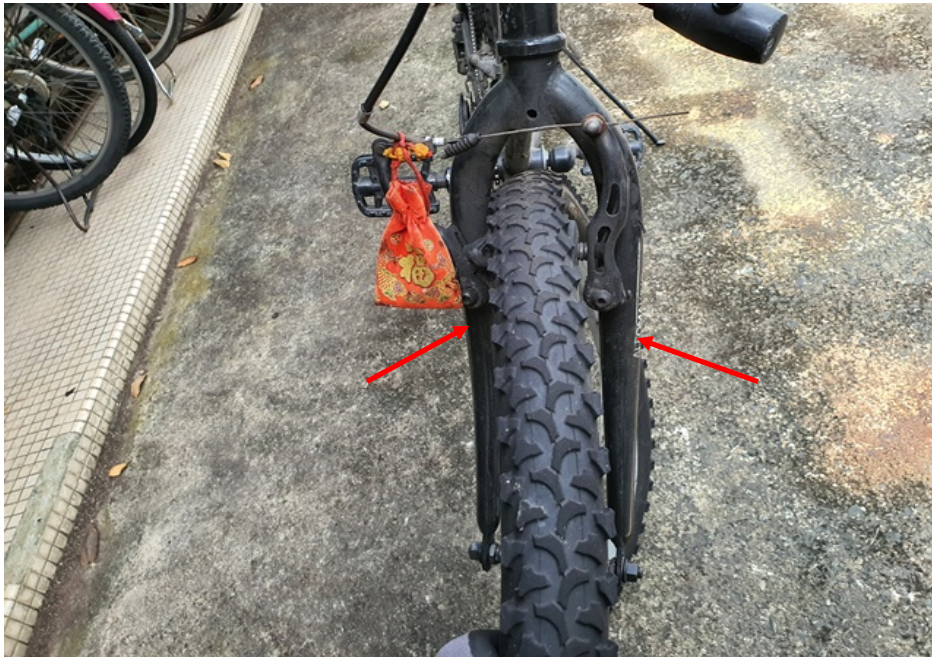
8. For this case, we were not able to conduct any test(s) on the steering system of the Bicycle due to the damages on its front forks. The front forks were found to be bent as a result of the accident, hence causing the whole steering system to be out of alignment and rendering the Bicycle immobile for any static or operational tests.

Photo 14 shows the front forks (arrowed) of the Bicycle. The front forks of the Bicycle were found to be bent as a result of the accident, hence causing the whole steering system to be out of alignment and rendering the Bicycle immobile for any static or operational tests.

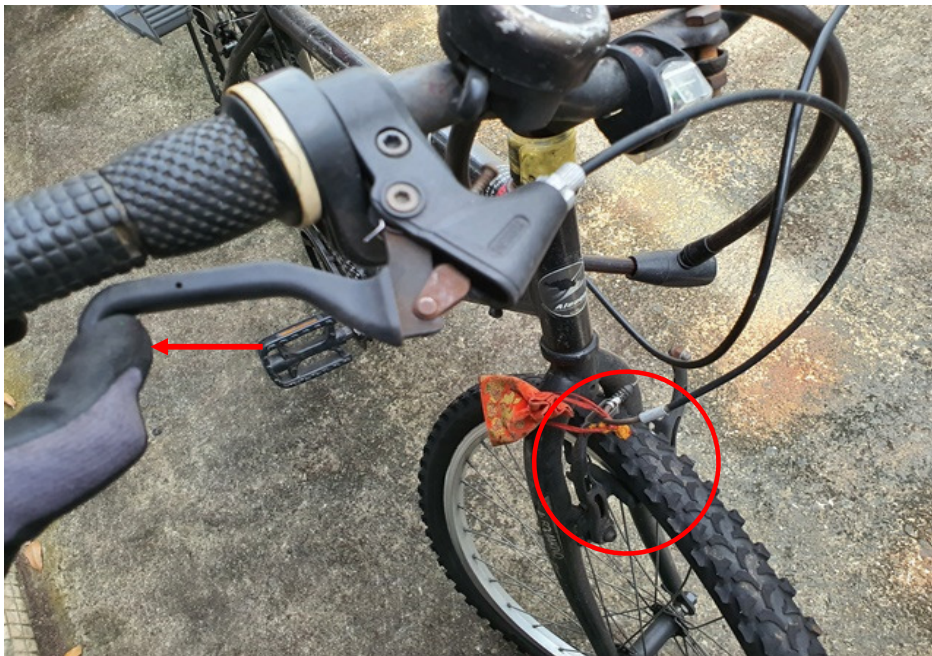
10. A static brake test was conducted on the front brake of the Bicycle. There was some resistance felt upon pressing the right hand brake lever. However the front brake clamp had not responded to the gripping action. Upon closer examination, we observed that the front brake clamp assembly was misaligned as a result of the accident. Hence the rubber brake blocks had pressed against the front tyre instead of the front wheel rim. This had appeared to indicate that the front brake of the Bicycle was not in serviceable condition.

Photo 15 shows a static brake test conducted on the Bicycle's front brake. There was some resistance felt upon pressing the right hand brake lever (arrowed). However the front brake clamps had not responded to the gripping action (circled) after depressing the right hand brake lever.

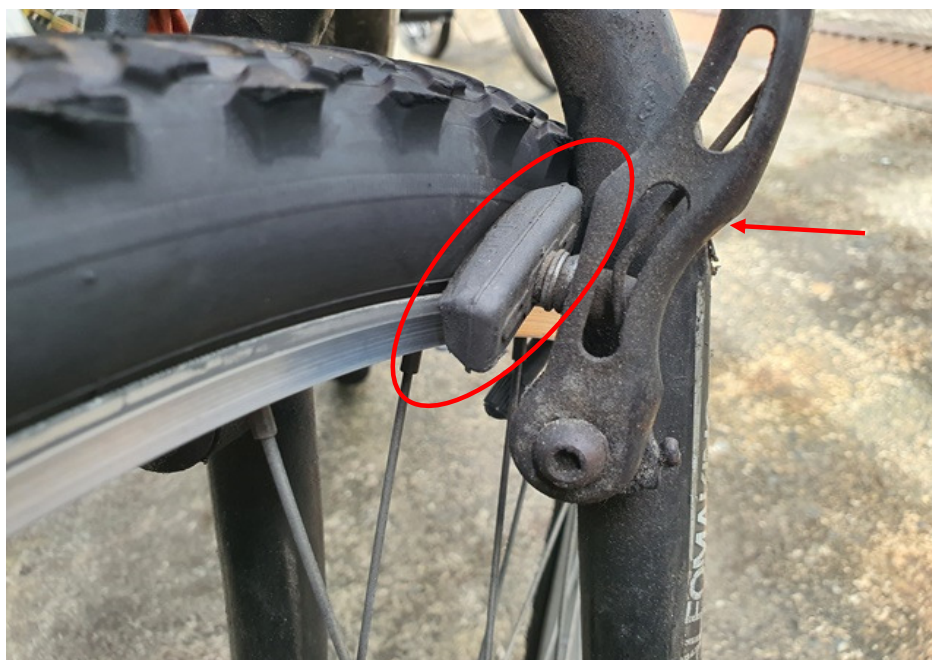
Photo 16 shows a close up view of the front brake clamp assembly of the Bicycle. There was some resistance felt upon pressing the right hand brake lever. However the front brake clamp had not responded to the gripping action. Upon closer examination, we observed that the front brake clamp assembly was misaligned as a result of the accident (circled). Hence the rubber brake blocks had pressed against the front tyre instead of the front wheel rim (arrowed). This had appeared to indicate that the front brake of the Bicycle was not in serviceable condition.

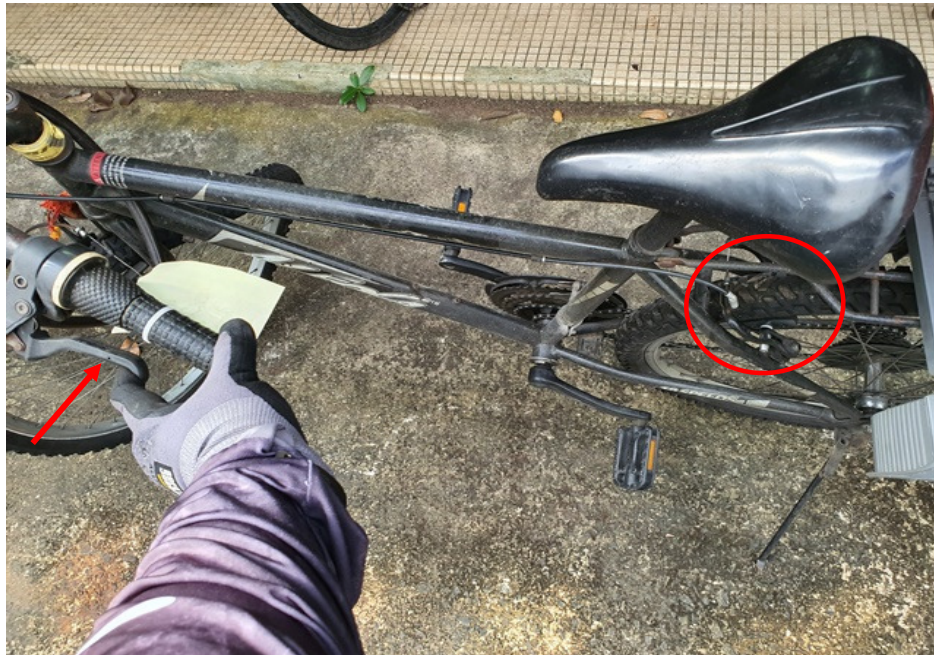
11. A static brake test was conducted on the rear brake of the Bicycle. There was some resistance felt upon pressing the left hand brake lever. The rear brake clamps had responded to the gripping action. The rubber brake blocks pressed against the rear wheel rim upon depressing the left hand brake lever. This had appeared to indicate that the rear brake of the Bicycle was in serviceable condition.

Photo 17 shows a static brake test conducted on the Bicycle's rear brake. There was some resistance felt upon pressing the left hand brake lever (arrowed). It also shows that the rear brake clamps responded to the gripping action (circled) after depressing the left hand brake lever.

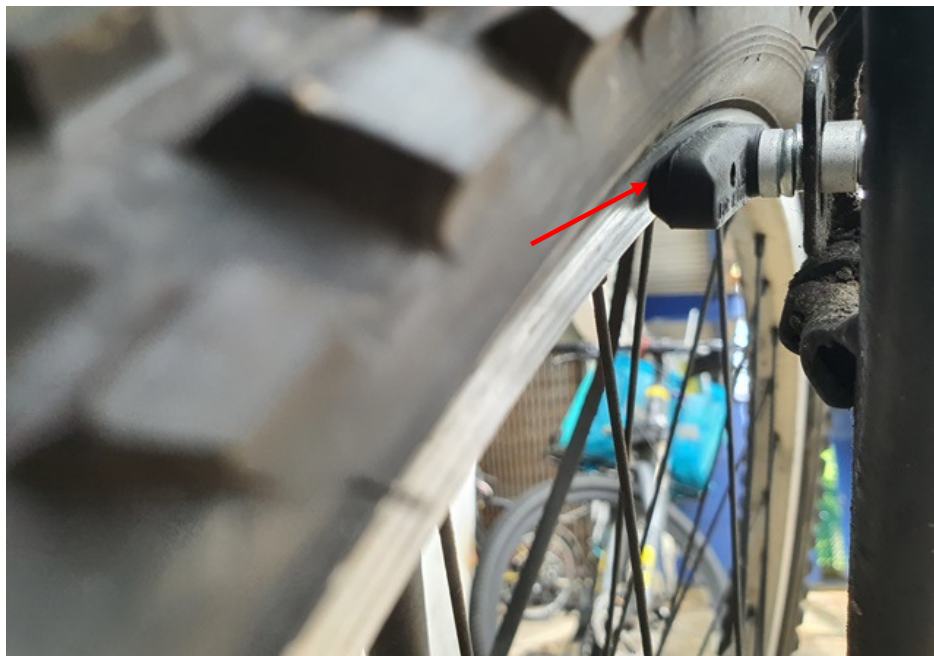
Photo 18 shows a close up view of the rear brake clamps responding to the gripping action. The rubber brake blocks pressed against the rear wheel rim upon depressing the left hand brake lever (arrowed). This had appeared to indicate that the rear brake of the Bicycle was in serviceable condition.
