Your Ref: TP/IP/25487/2022
Our Ref : CI/TPD23001386/N

Fatal Accident Investigation Team

MECHANICAL INSPECTION REPORT OF MOTOR CAR SMZ 5135X

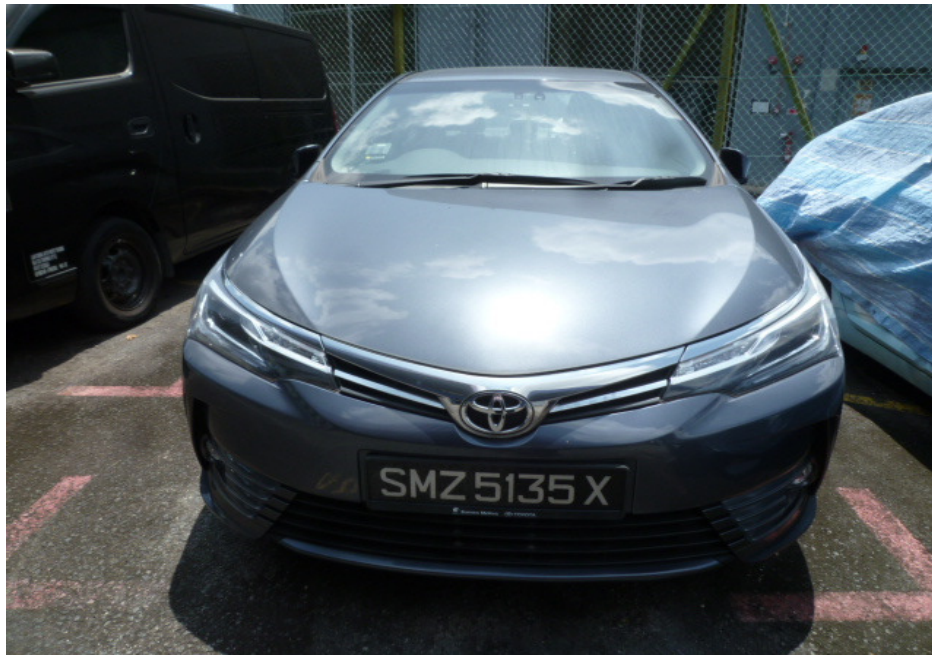
Photo 1 shows a general view of the frontal portion of the Motor Car at the time of our inspection. The Motor Car was observed to be in good general condition except for some relatively minor impact damage at its left portion. The mileage of the Motor Car could not be recorded at the time of our inspection despite several attempts to jumpstart the battery.

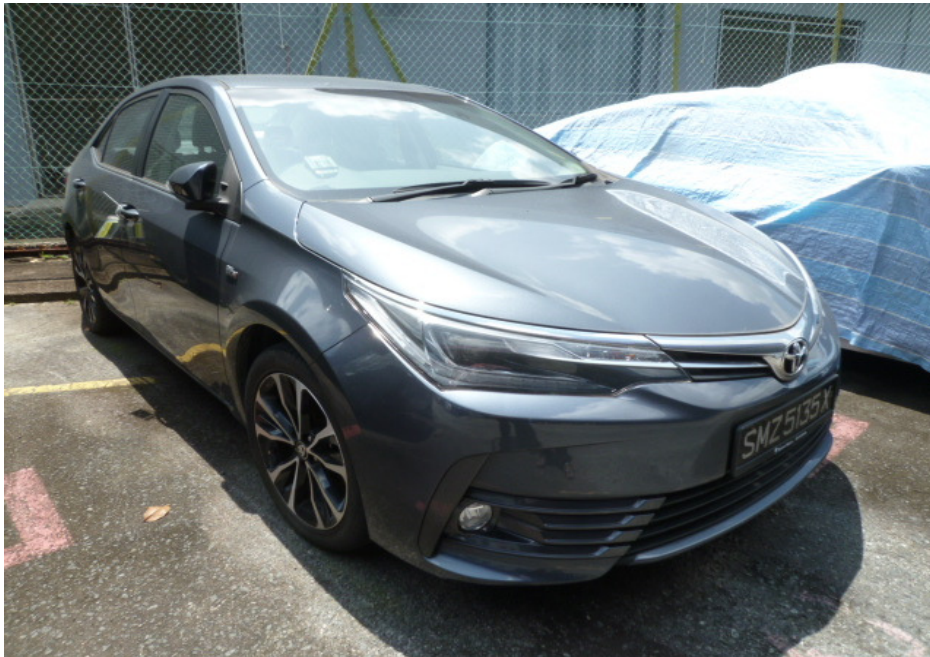
Photo 2 shows a general view of the front right body of the Motor Car at the time of our inspection. The Motor Car was observed to be in good general condition. However we had observed relatively minor impact damage that was confined to its left portion.

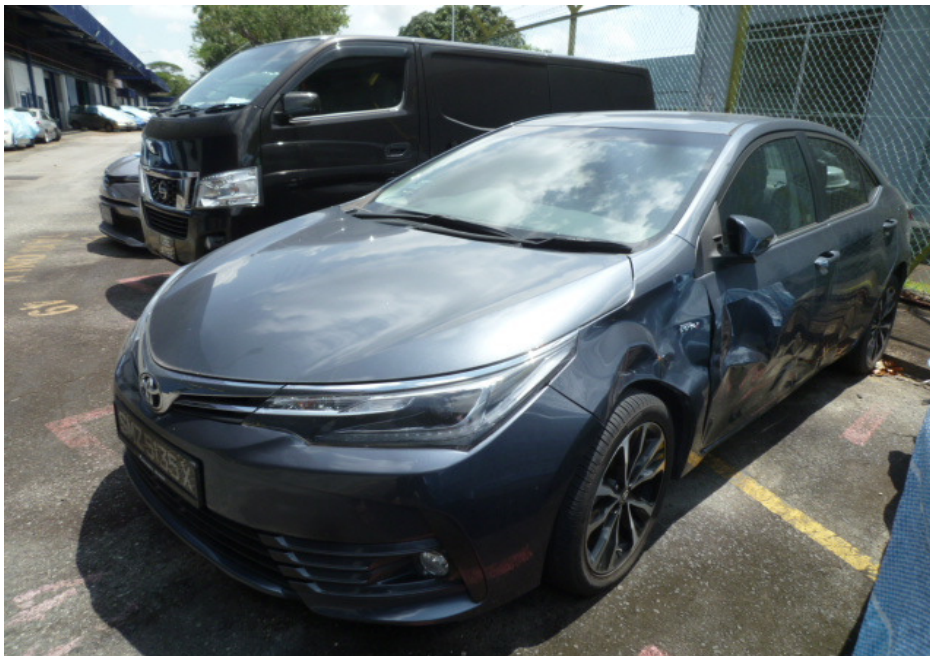
4. The mileage of the Motor Car could not be recorded at the time of our inspection despite several attempts to jumpstart the battery.
5. The Motor Car had sustained relatively minor impact damage that was confined to its left portion. Its front left fender, left front door and left rear door were observed to have been dented.

Photo 3 shows a general view of the front left body of the Motor Car at the time of our inspection. The Motor Car was observed to be in good general condition. However we had observed relatively minor impact damage that was confined to its left portion. Its front left fender, left front door and left rear door were observed to have been dented.

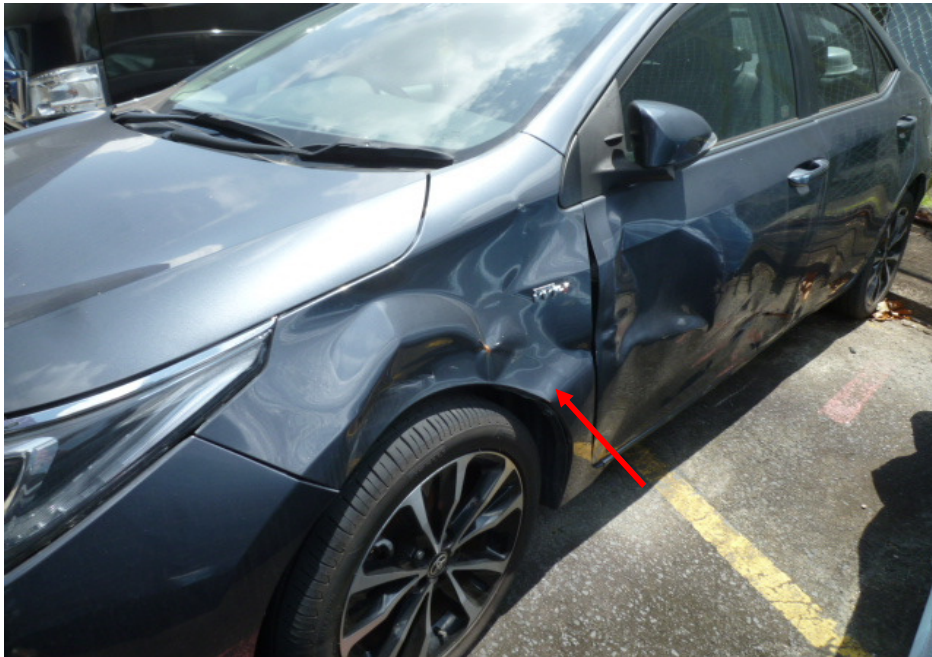
Photo 4 shows a closer view of the dented left front fender of the Motor Car at the time of our inspection (arrowed).

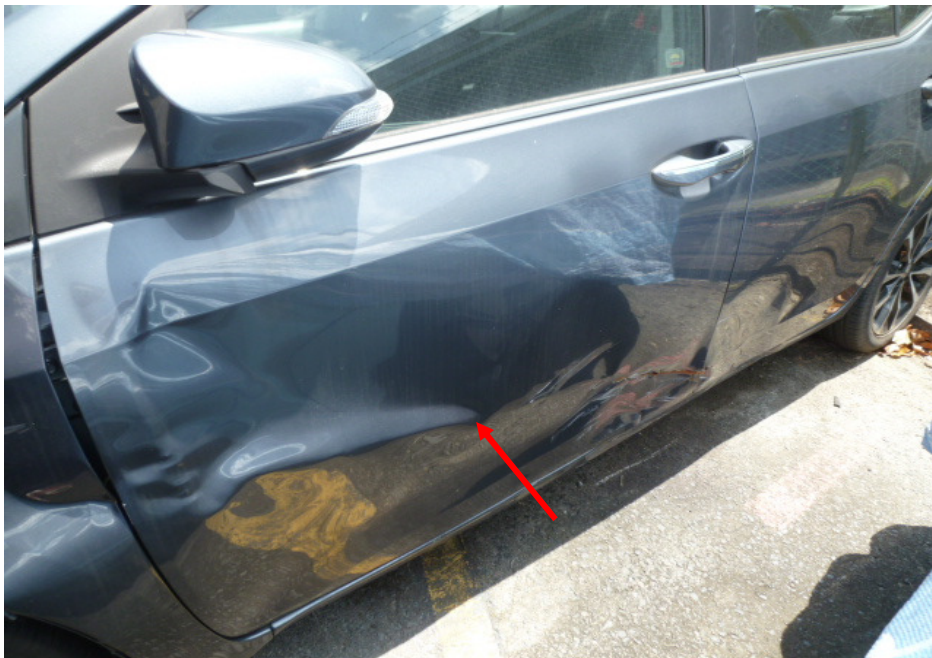
Photo 5 shows a closer view of the dented left front door of the Motor Car at the time of our inspection (arrowed).

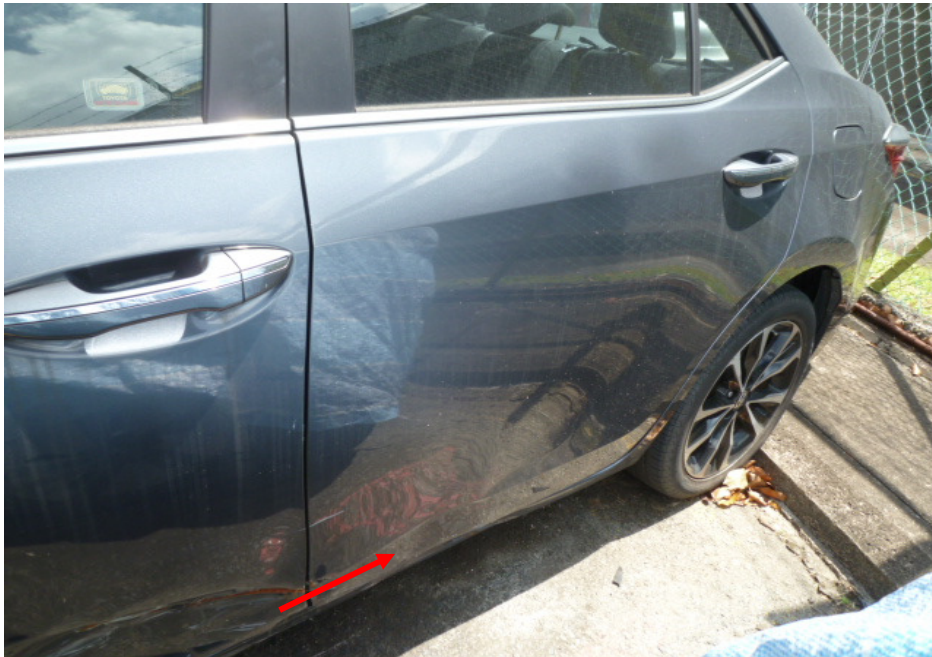
Photo 6 shows a closer view of the dented left rear door of the Motor Car at the time of our inspection (arrowed).

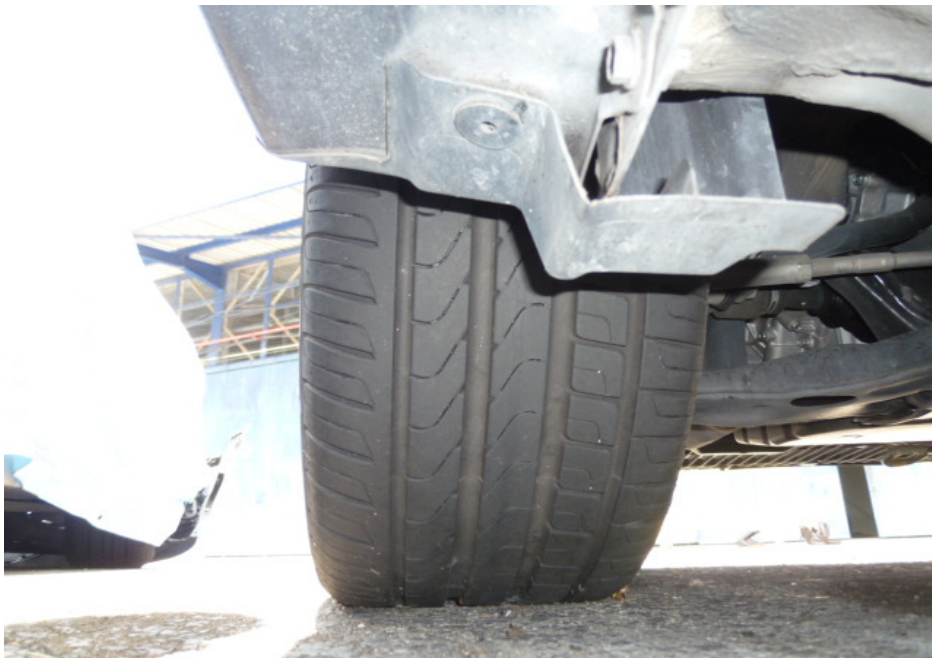
Photo 7 shows the condition of the front left tyre of the Motor Car, which was observed to be in serviceable condition with remaining tread depth of approximately 7mm. The tyre, which was wrapped around alloy wheel rim, was also observed to be sufficiently inflated for vehicular operation. There was no tear, cut or burst mark(s) on the outer and the inner sidewalls as well as across the tread of the 4 tyres.

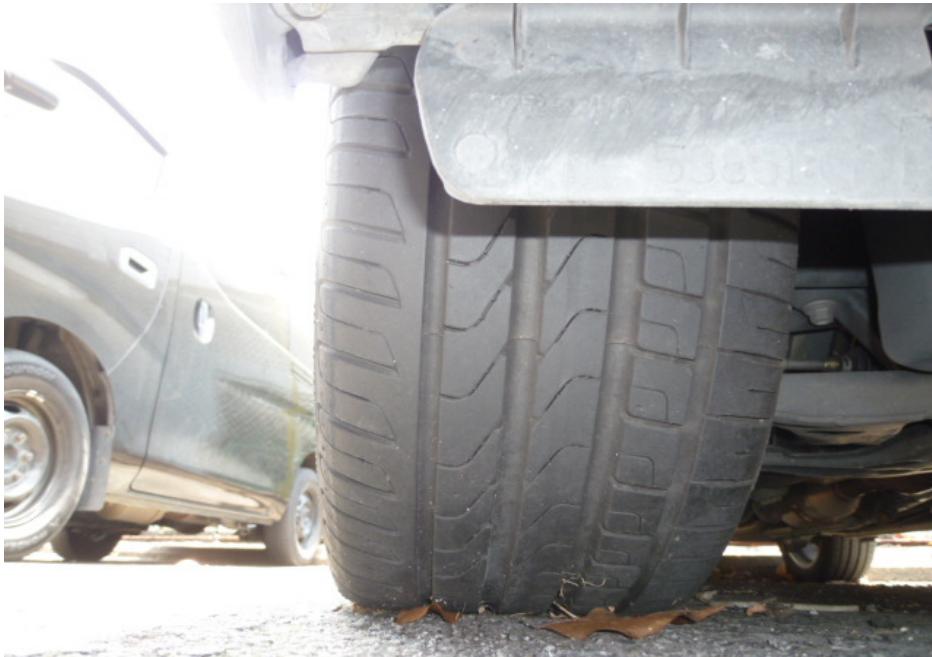
Photo 8 shows the condition of the front right tyre of the Motor Car, which was observed to be in serviceable condition with remaining tread depth of approximately 7mm. The tyre, which was wrapped around alloy wheel rim, was also observed to be sufficiently inflated for vehicular operation.

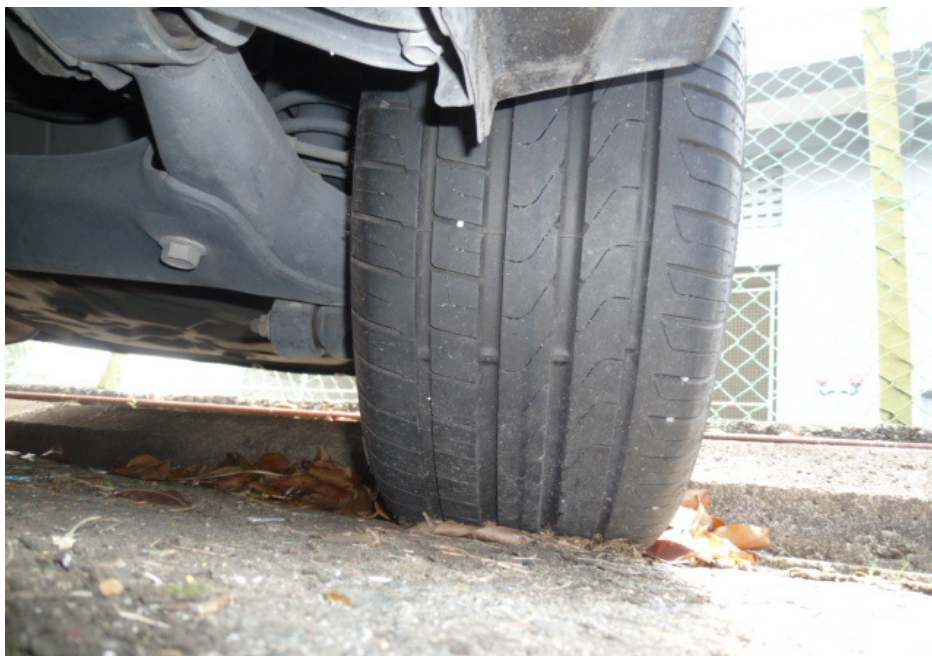
Photo 9 shows the condition of the rear left tyre of the Motor Car, which was observed to be in serviceable condition with remaining tread depth of approximately 8mm. The tyre, which was wrapped around alloy wheel rim, was also observed to be sufficiently inflated for vehicular operation. There was also no damage found on the 4 wheel rims of the Motor Car.

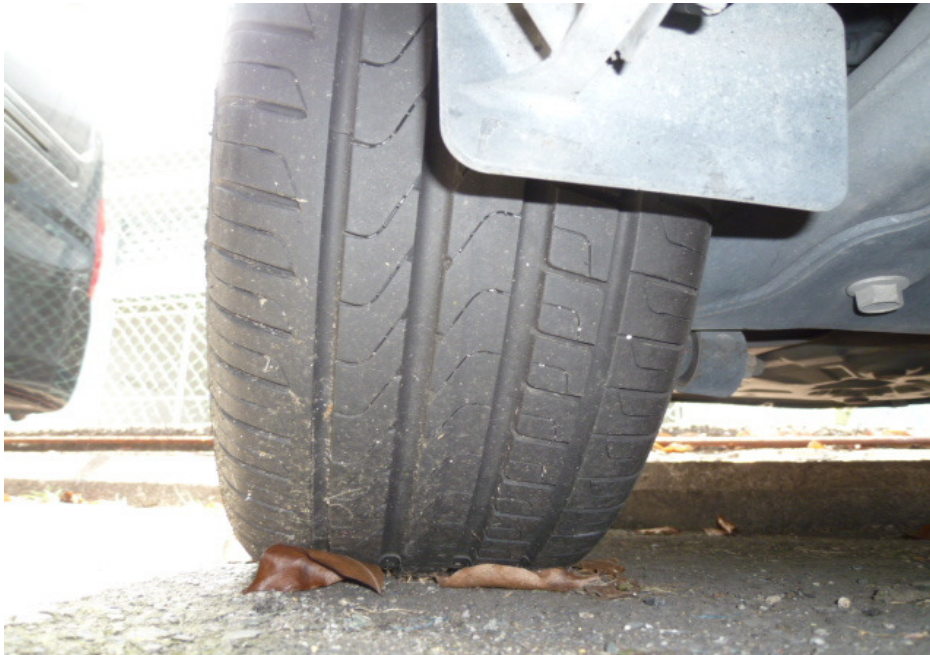
Photo 10 shows the condition of the rear right tyre of the Motor Car, which was observed to be in serviceable condition with remaining tread depth of approximately 8mm. There was also no tear, cut or burst mark(s) on the outer and the inner sidewalls as well as across the tread of the 4 tyres.

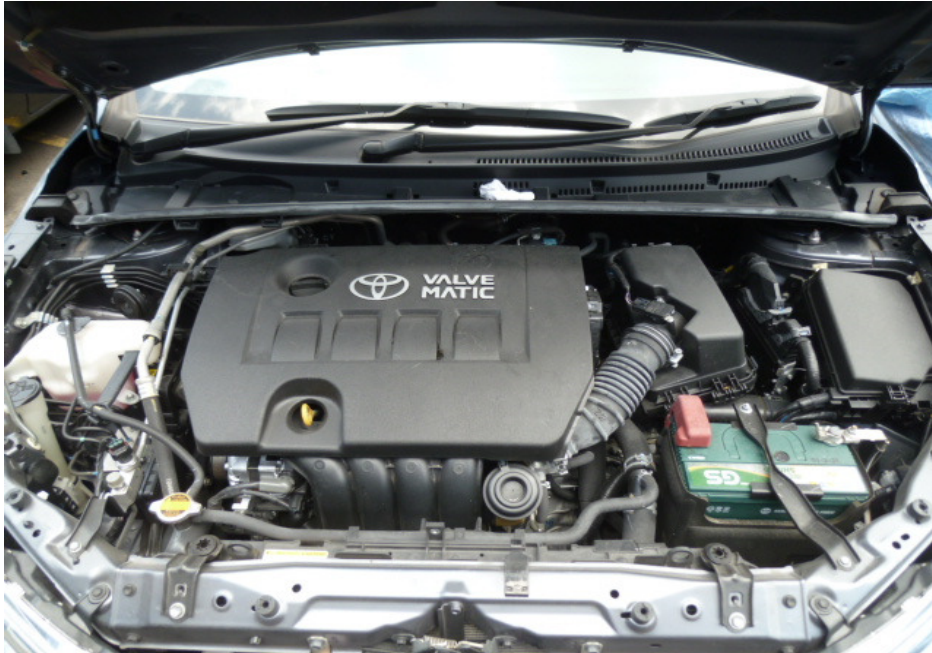
Photo 11 shows a general view of the Motor Car's engine compartment. The various parts and components inside the engine compartment were unaffected by the accident. There was also no sign(s) or indication(s) of fluid leakage and/or fluid stain within the engine compartment.

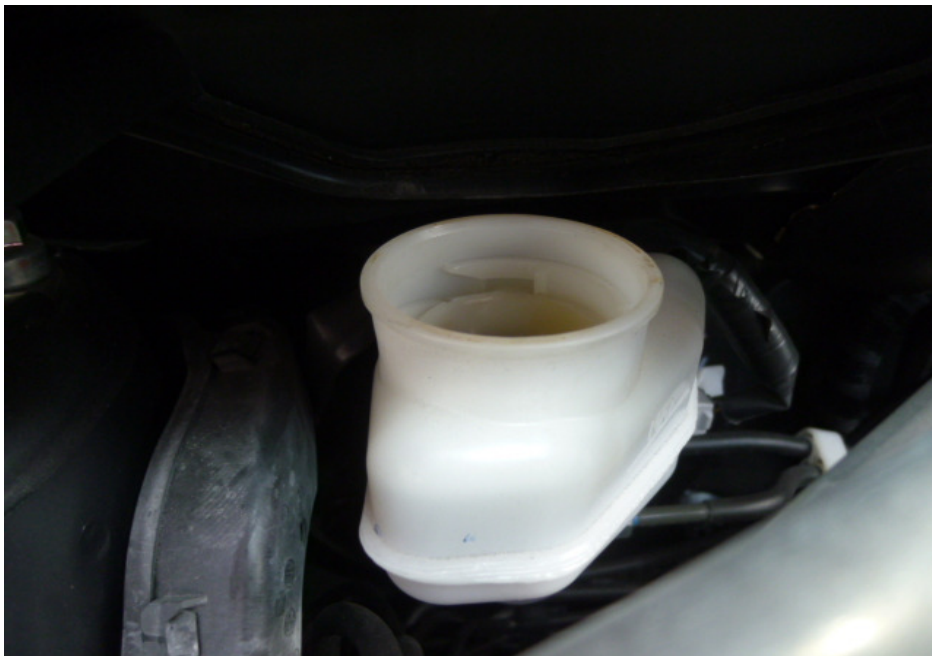
Photo 12 shows the brake fluid reservoir of the Motor Car at the time of our inspection. The brake fluid was observed to be of sufficient level for operating purposes and without any visible contamination.

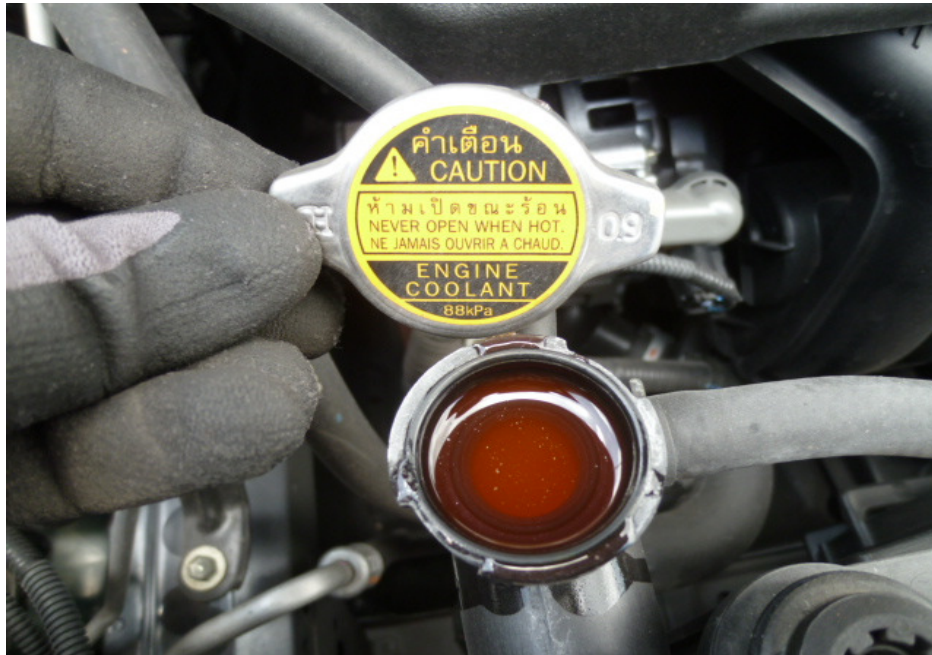
Photo 13 shows checks being carried out to the engine coolant of the Motor Car at the time of our inspection. The engine coolant was observed to be of sufficient level for operating purposes and without any visible contamination.

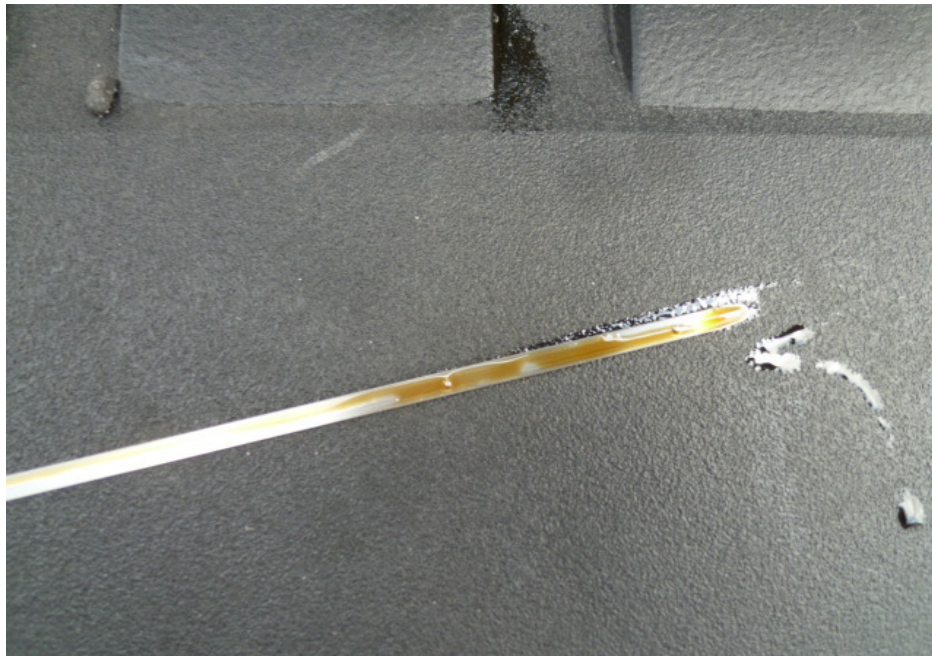
Photo 14 shows the engine oil dip stick of the Motor Car at the time of our inspection. The engine oil was observed to be of sufficient level for operating purposes and without any visible contamination.

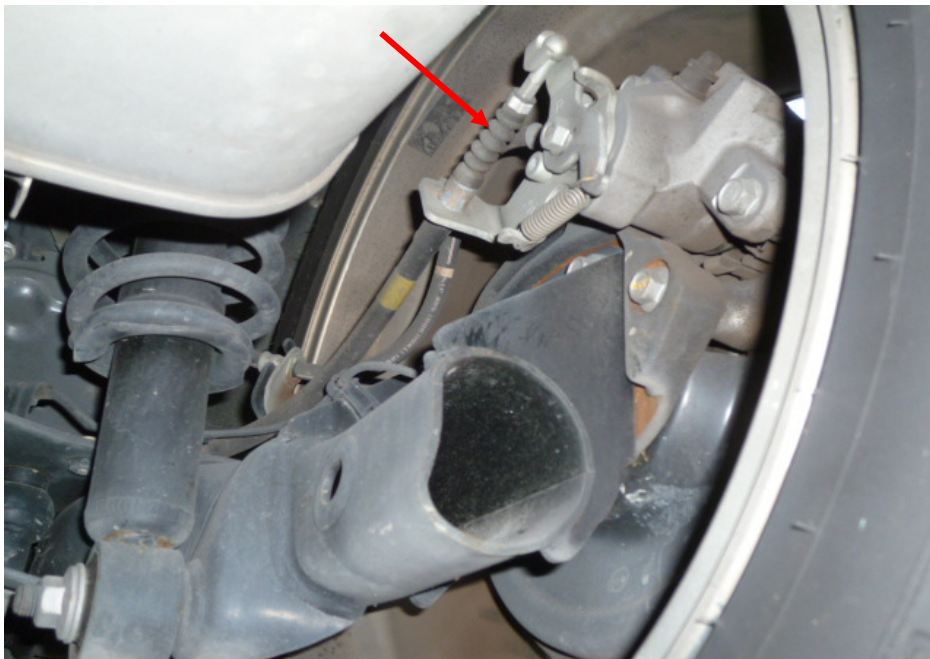
Photo 15 shows the brake hose/pipe (arrowed) at the rear right wheel of the Motor Car. We did not observe any leakage of brake fluid at the time of our inspection of the Motor Car. Static tests of the Motor Car's braking system had indicated that there was no internal leakage of pressure/vacuum. Hence the braking system was likely to be in serviceable condition at the material time of accident. The undercarriage components of the Motor Car were also all found to be intact and without any visible damage.

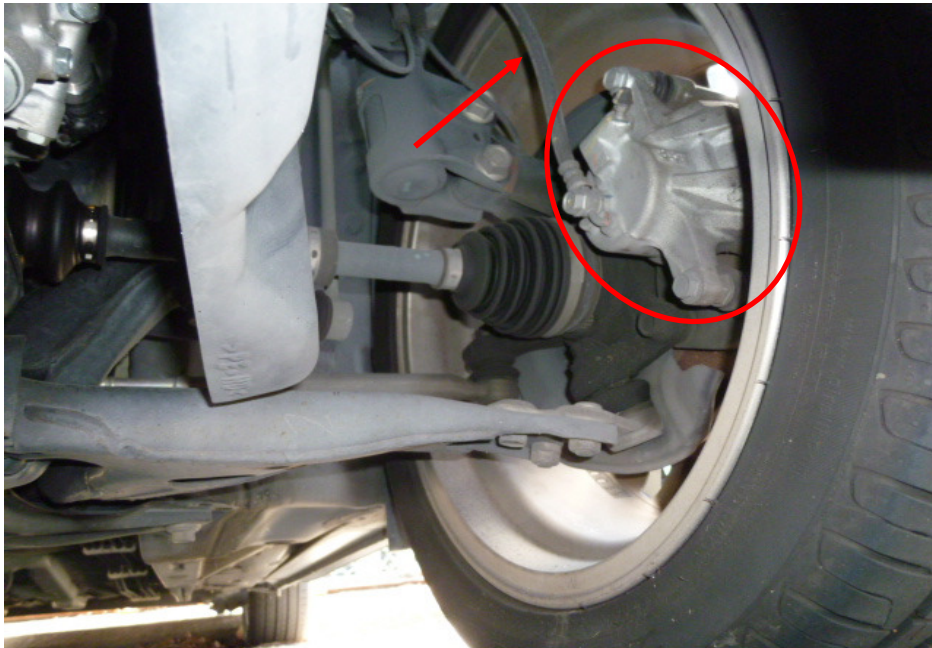
Photo 16 shows the brake hose/pipe (arrowed) at the front left wheel of the Motor Car. No leakage of brake fluid was observed. Visual examination of the various components of the braking system like the brake caliper (circled), brake pedal etc. had revealed all to be intact and without visible damage.

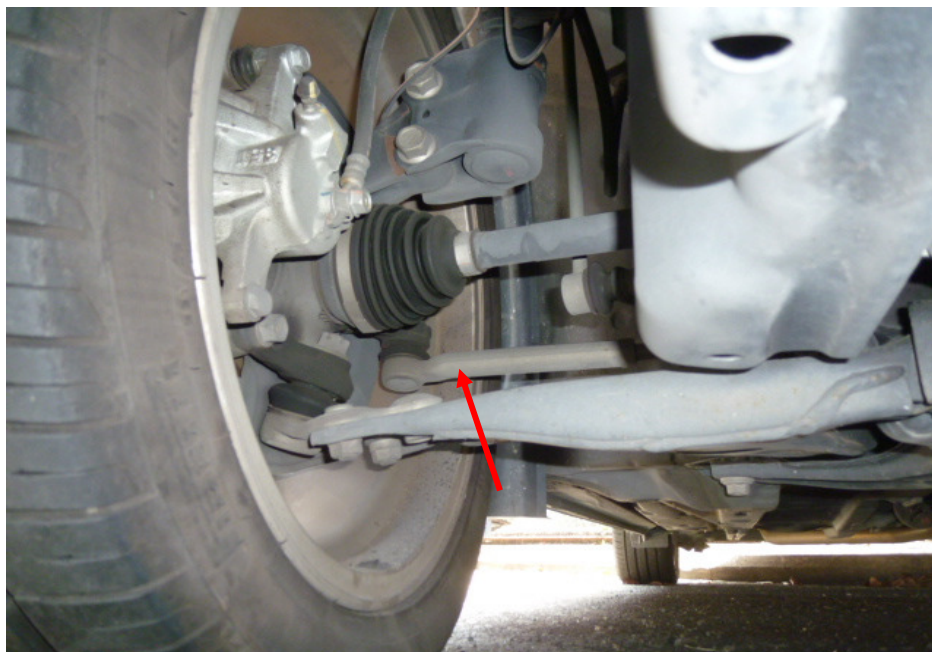
Photo 17 shows the various undercarriage components at the front right wheel of the Motor Car, in particular the steering tie rod (arrowed). The various steering components were all found to be intact, suggesting that the steering system of the Motor Car was likely to be in serviceable condition at the material time of accident. There was also no sign of fluid stain observed on the various undercarriage components at the front right wheel of the Motor Car.

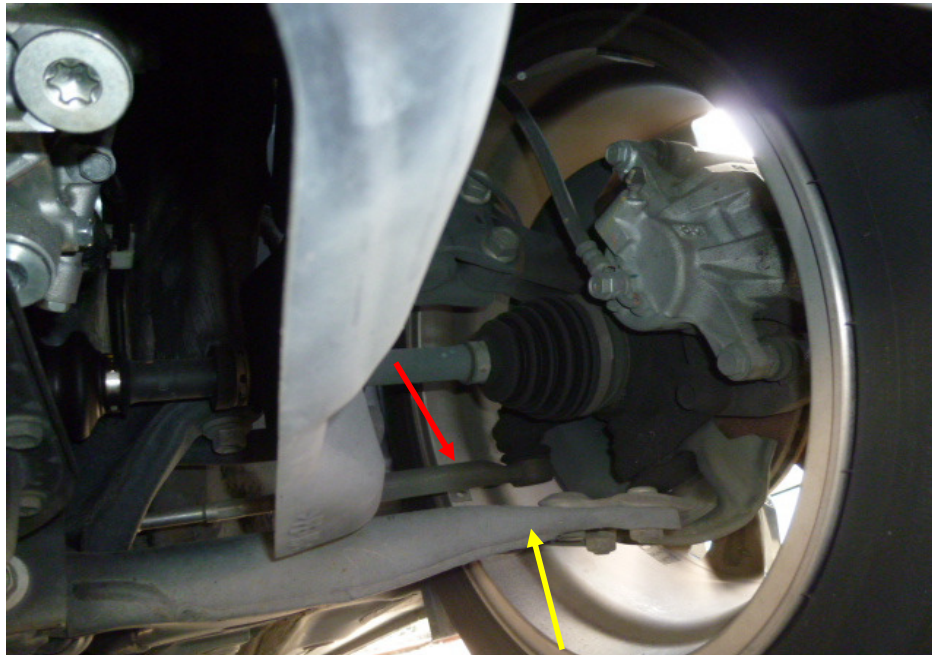
Photo 18 shows the various undercarriage components at the front left wheel of the Motor Car, which had included the steering tie rod (red arrow) and left drive shaft (yellow arrow). The various undercarriage components of the Motor Car were all found to be intact without any visible damage.
