Your Ref: TP/IP/34047/2022  
Our Ref : CI/TPD23001390/N

16 March 2023

**Fatal Accident Investigation Team**

**INSPECTION REPORT OF MOTORCYCLE FBK 6449T**

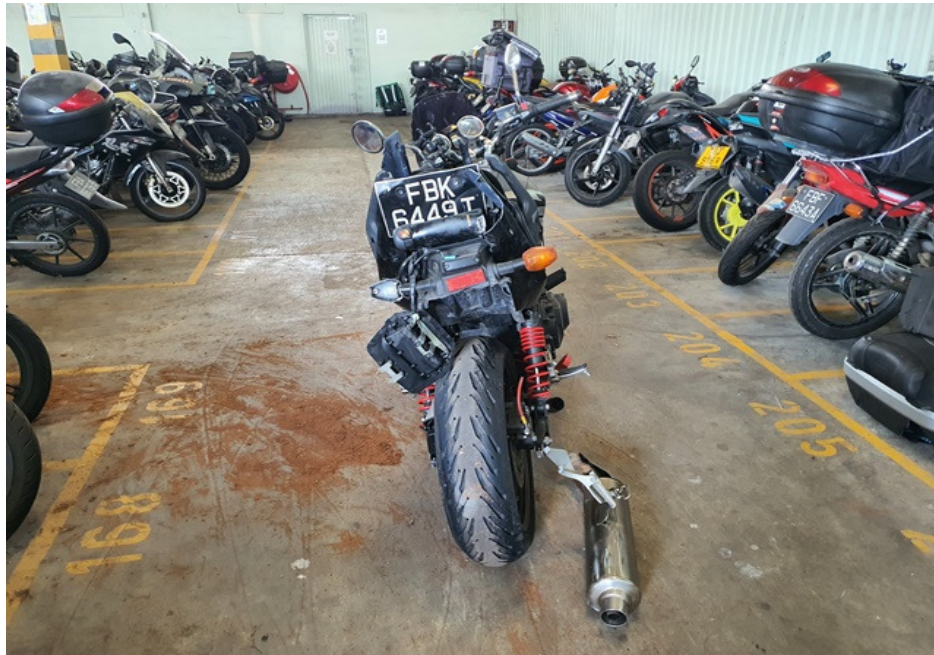
**Photo 1** shows a general view of the rear portion of the Motorcycle at the time of our inspection. The Motorcycle was observed to have sustained damages all around.

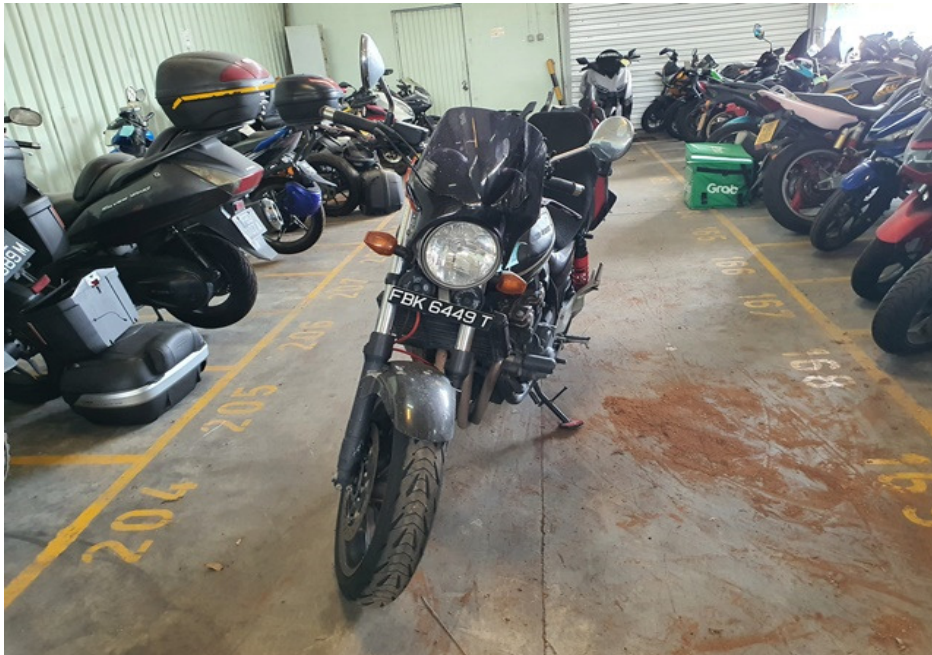
**Photo 2** shows a general view of the frontal portion of the Motorcycle at the time of our inspection. The Motorcycle was observed to have sustained damages all around.

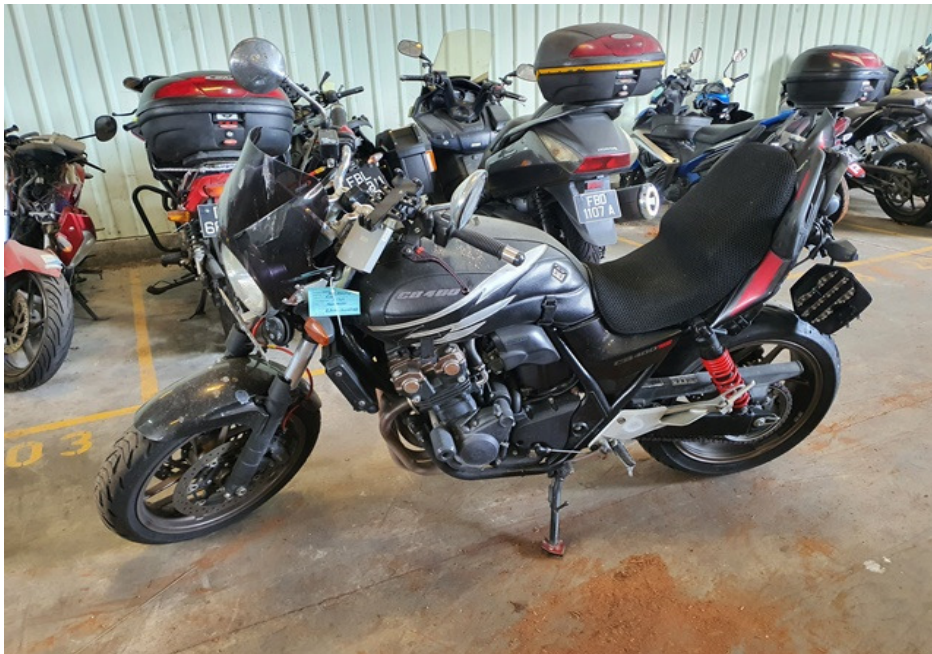
**Photo 3** shows a general view of the left body of the Motorcycle at the time of our inspection. The Motorcycle was observed to have sustained damages all around. The body parts that were found to have been damaged include its head cowling, front mudguard, right handlebar end and exhaust muffler, amongst others.

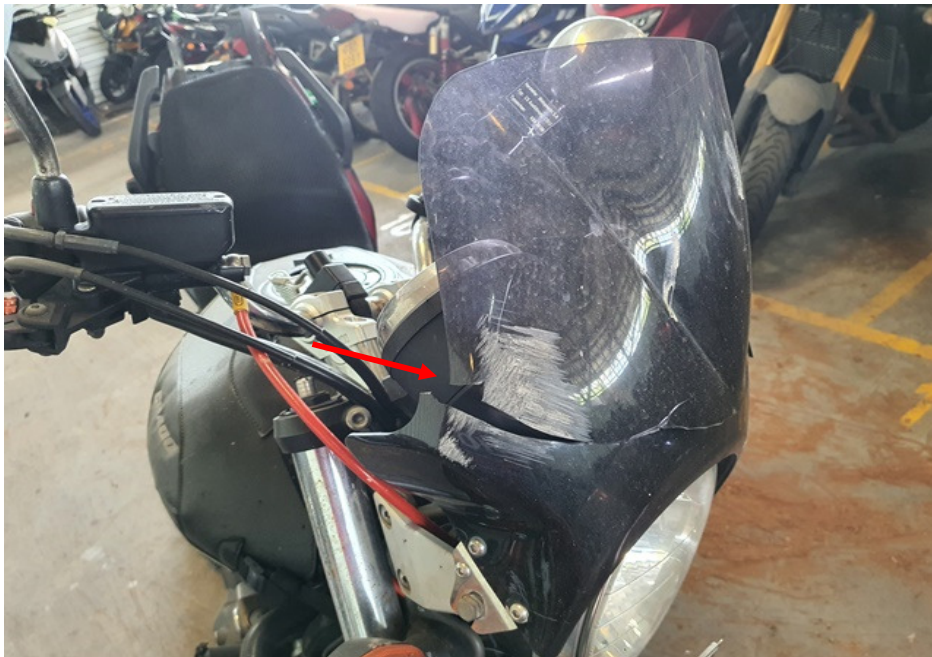
**Photo 4** shows a closer view of the cracked head cowling (arrowed) of the Motorcycle as a result of the accident.

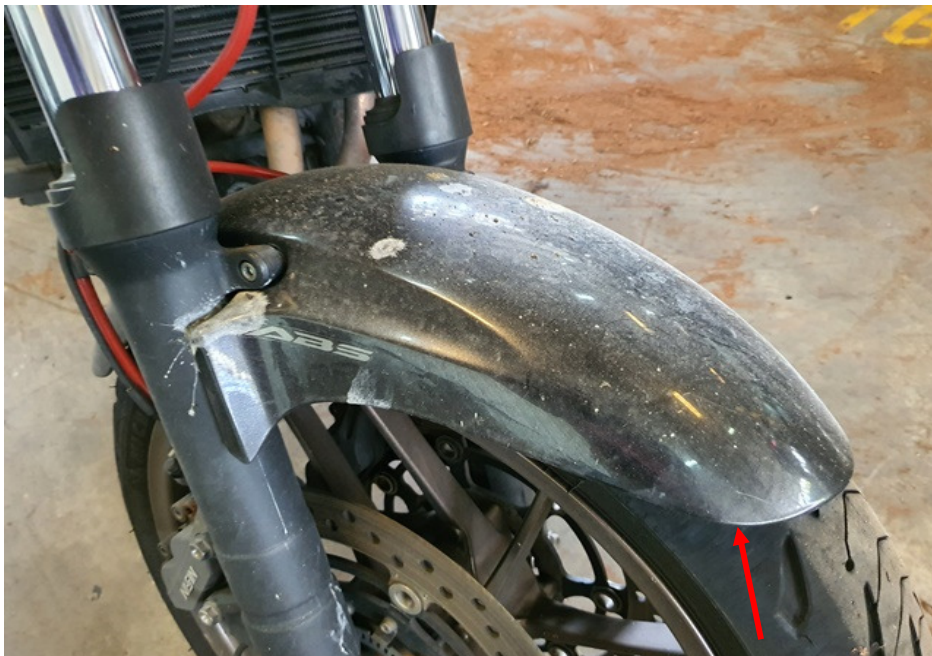
**Photo 5** shows a closer view of the front mudguard which was amongst the body parts at the front body of the Motorcycle that had sustained damage as a result of the accident (arrowed).

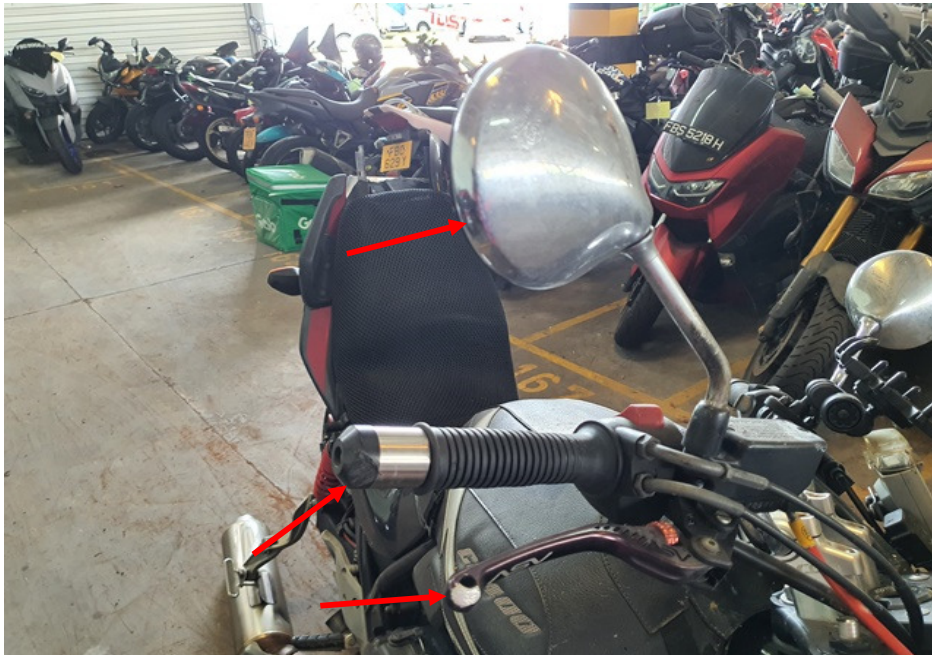
**Photo 6** shows a closer view of the front brake lever, right side mirror and right handlebar end (arrowed) which were amongst the body parts at the front body of the Motorcycle that had sustained damage as a result of the accident.

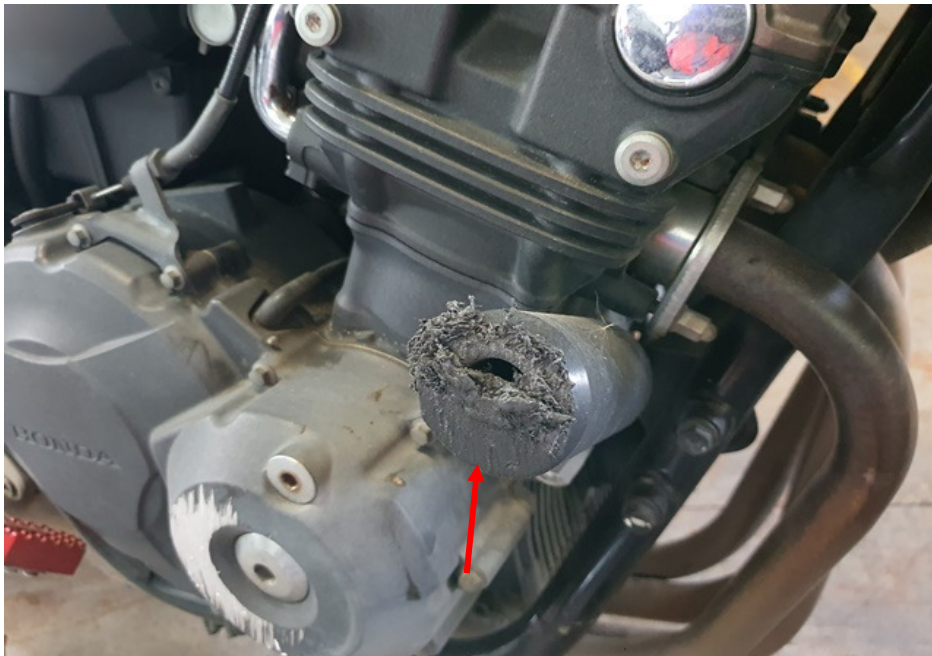
**Photo 7** shows the grazed right frame slider of the Motorcycle as a result of the accident (arrowed).

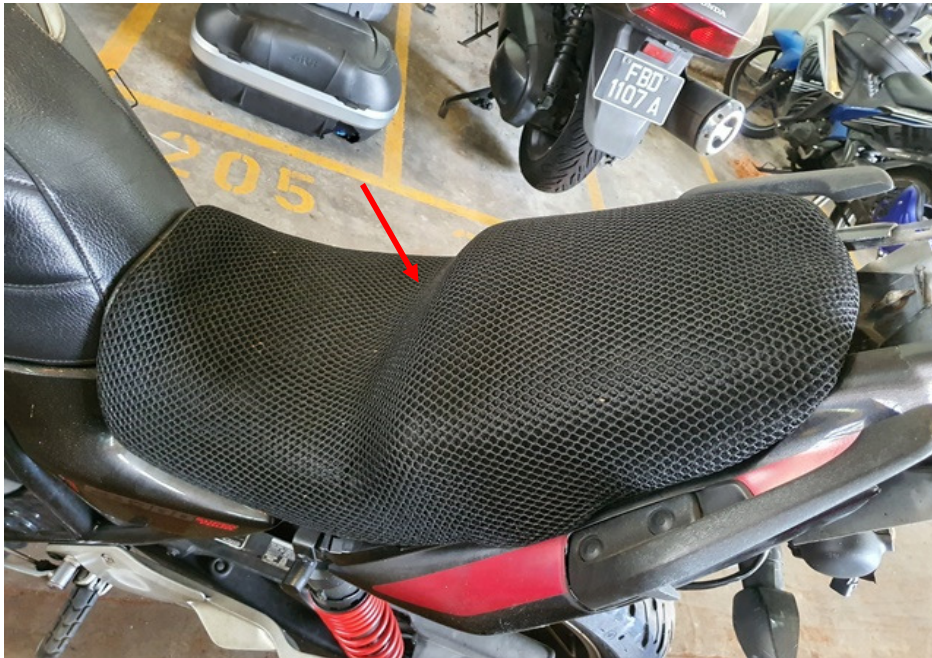
**Photo 8** shows the deformed seat of the Motorcycle as a result of the accident (arrowed).

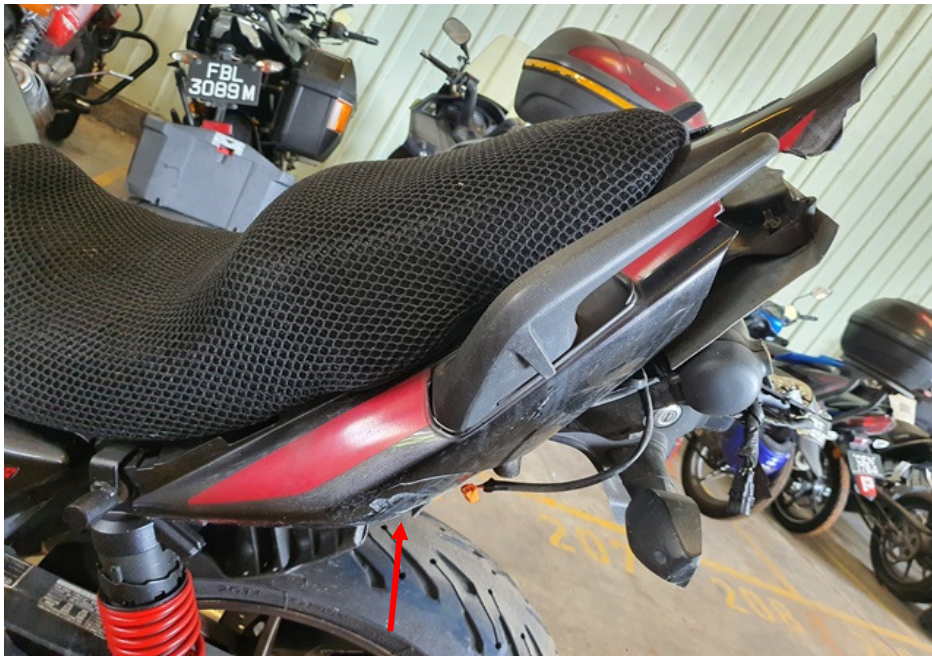
**Photo 9** shows the grazed left rear side cover of the Motorcycle as a result of the accident (arrowed).

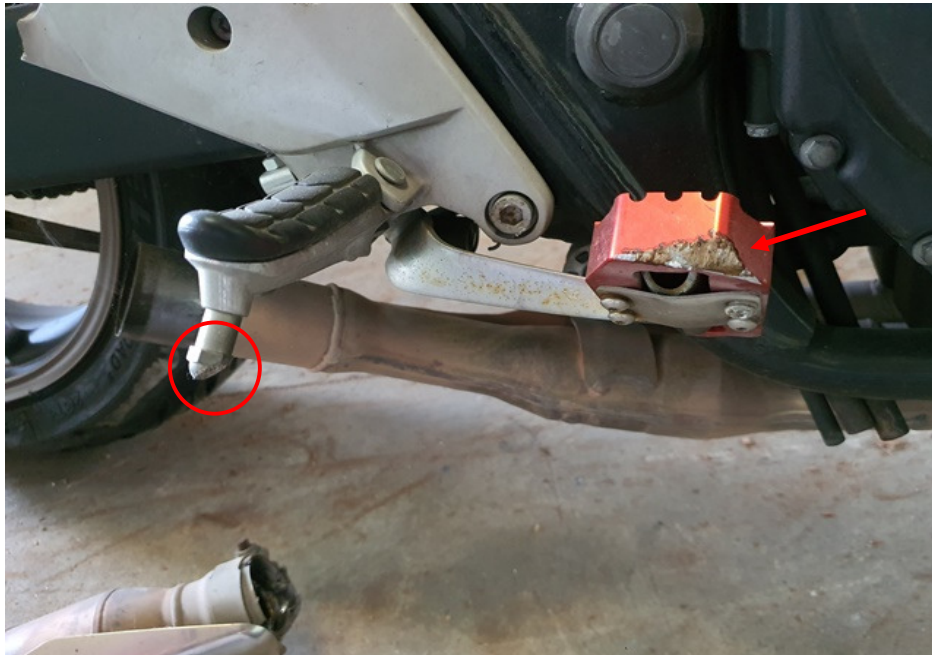
**Photo 10** shows a closer view of the right front footrest (circled) and rear brake pedal (arrowed) which were amongst the body parts of the Motorcycle that had sustained damage as a result of the accident.

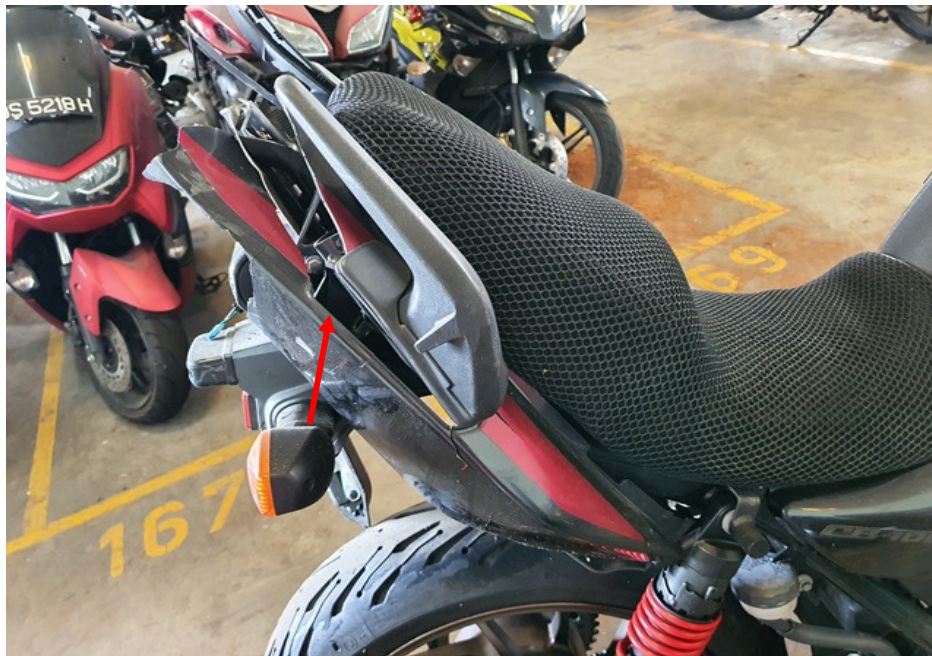
**Photo 11** shows the cracked right rear side cover (arrowed) of the Motorcycle as a result of the accident.

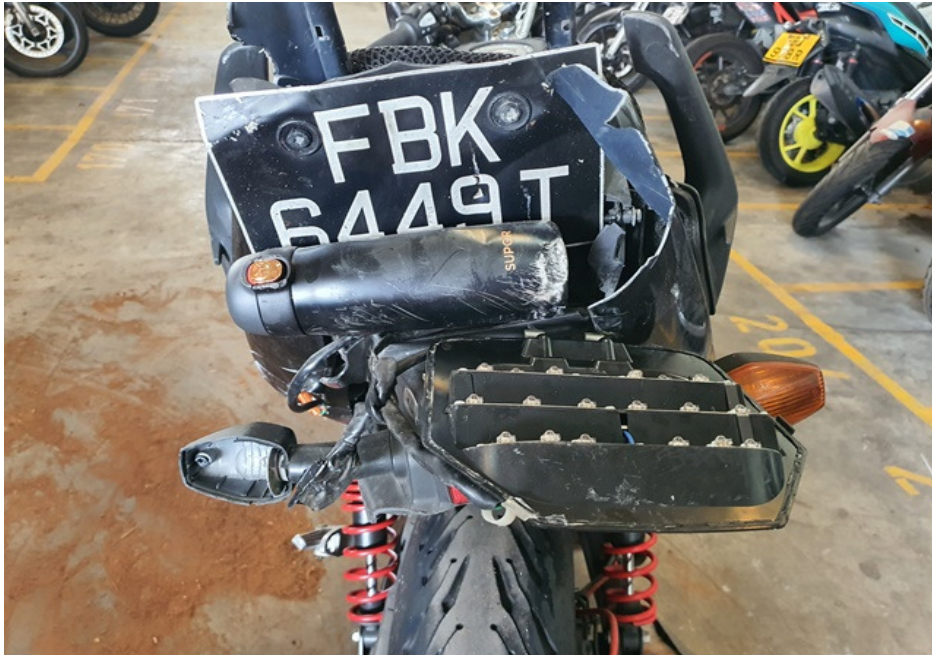
**Photo 12** shows a closer view of the broken tail light assembly of the Motorcycle as a result of the accident.

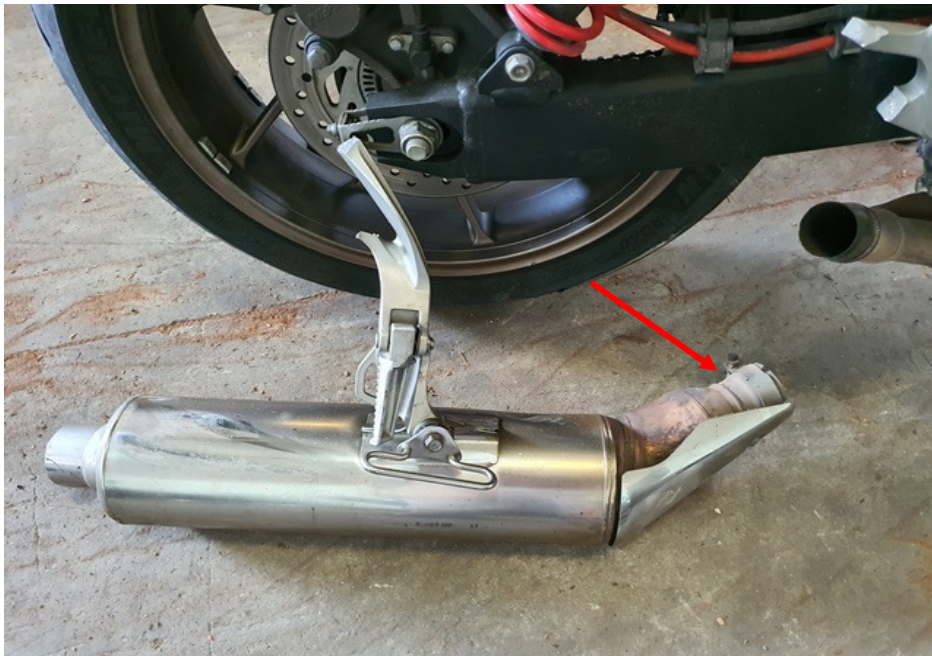
**Photo 13** shows a closer view of the dislodged exhaust muffler (arrowed) which was amongst the body parts at the rear body of the Motorcycle that had sustained damage as a result of the accident.

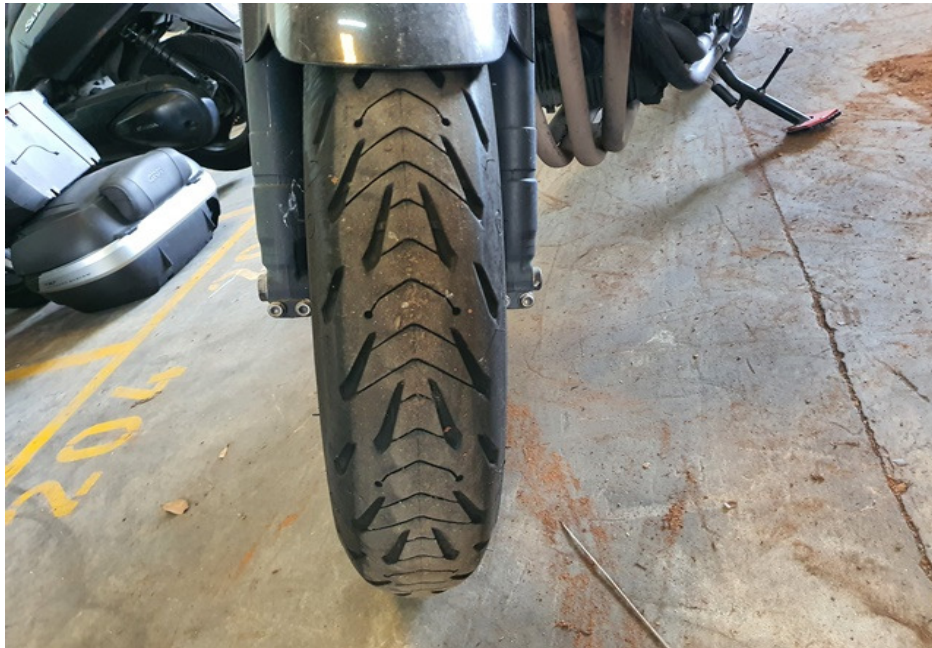
**Photo 14** shows the front tyre of the Motorcycle at the time of our inspection. The front tyre was observed to be in serviceable condition with remaining tread depth of approximately 3mm. The pattern of the tread was also clearly visible. There was no tear, burst mark(s) and/or punctured hole(s) on the sidewalls as well as across the tread of the front tyre.

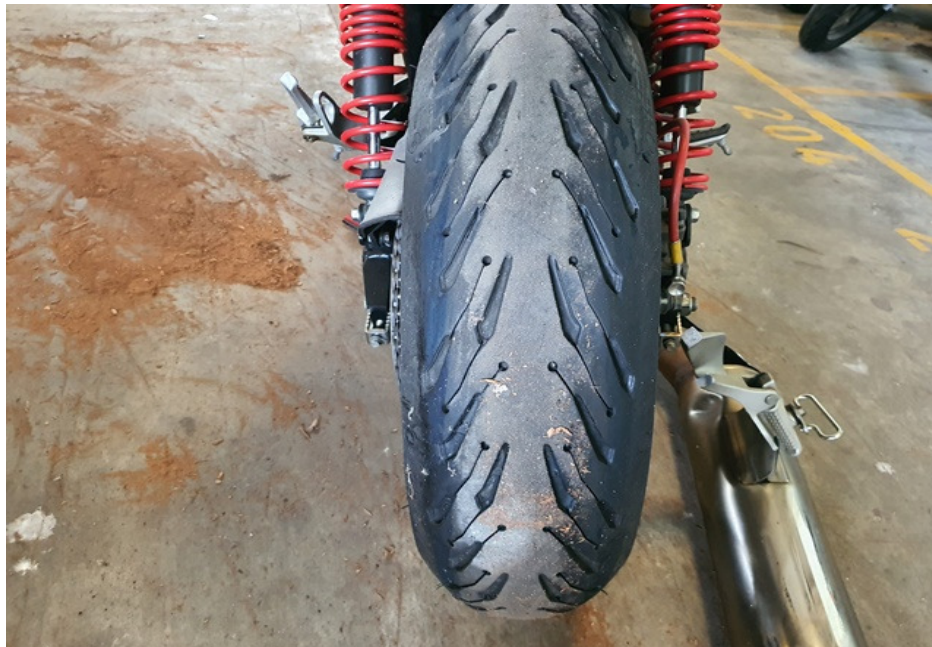
**Photo 15** shows the condition of the Motorcycle's rear tyre. The rear tyre was observed to be in serviceable condition with remaining tread depth of approximately 6mm. The tyre was also observed to be sufficiently inflated for vehicular operation. We did not observe any tear, burst mark(s) and/or punctured hole(s) on the sidewalls as well as across the tread of the rear tyre.

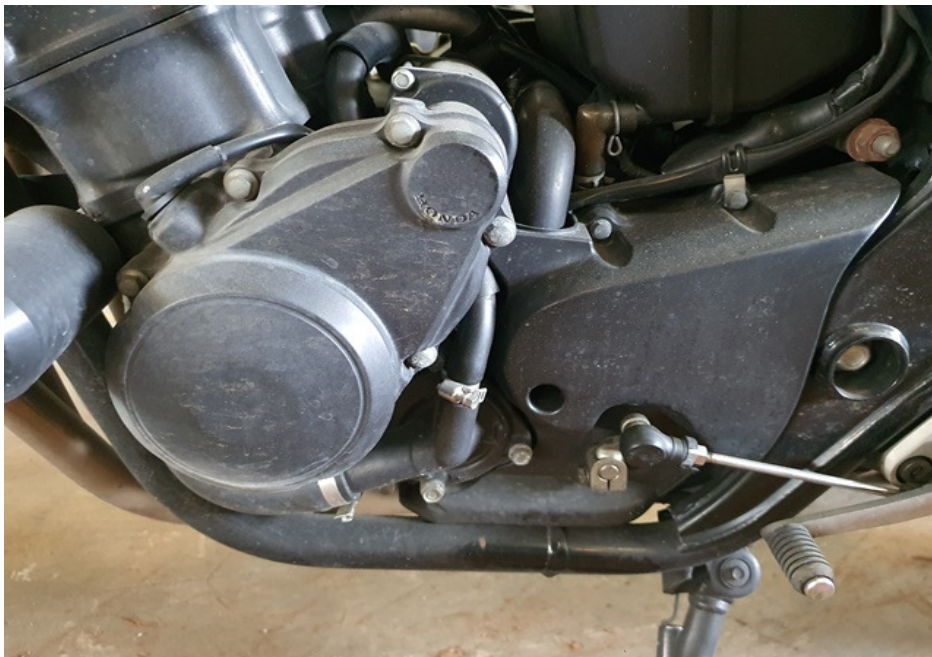
**Photo 16** shows the left side of the engine of the Motorcycle at the time of our inspection. The various engine related parts and components were found to be intact with no visible damage. There was also no sign(s) or indication(s) of fluid leak observed around the left engine area of the Motorcycle.

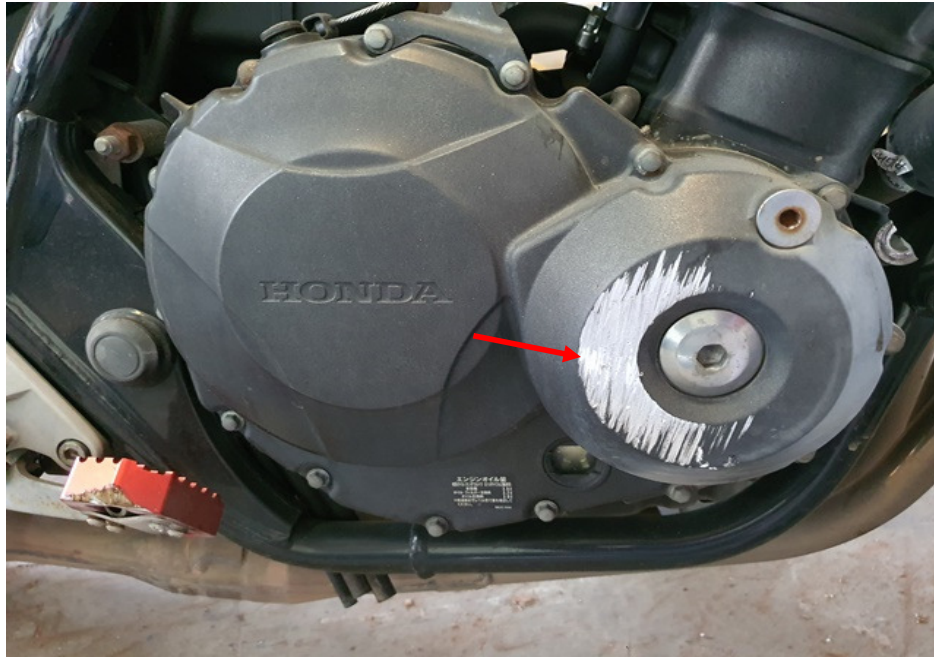
**Photo 17** shows the right side of the engine of the Motorcycle at the time of our inspection. The various right engine components had sustained damage of grazing nature as a result of the accident (arrowed) however the engine components were still intact. There was also no fluid leak and/or fluid stain found around the right engine area of the Motorcycle.

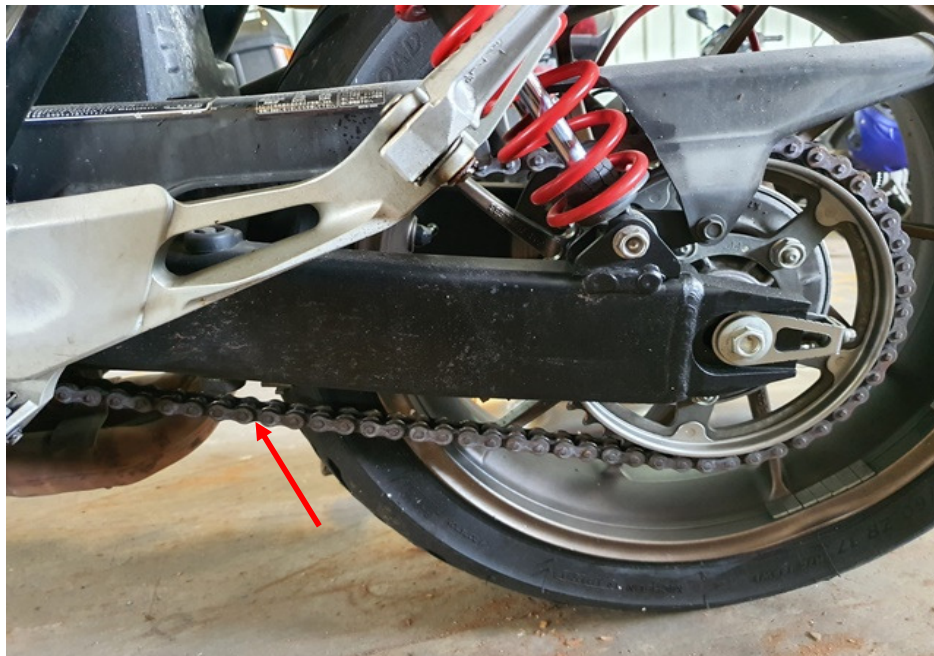
**Photo 18** shows the general view of the gear train (arrowed) of the Motorcycle, which was observed to be intact with no misalignment. It was also adequately lubricated for operating purposes.

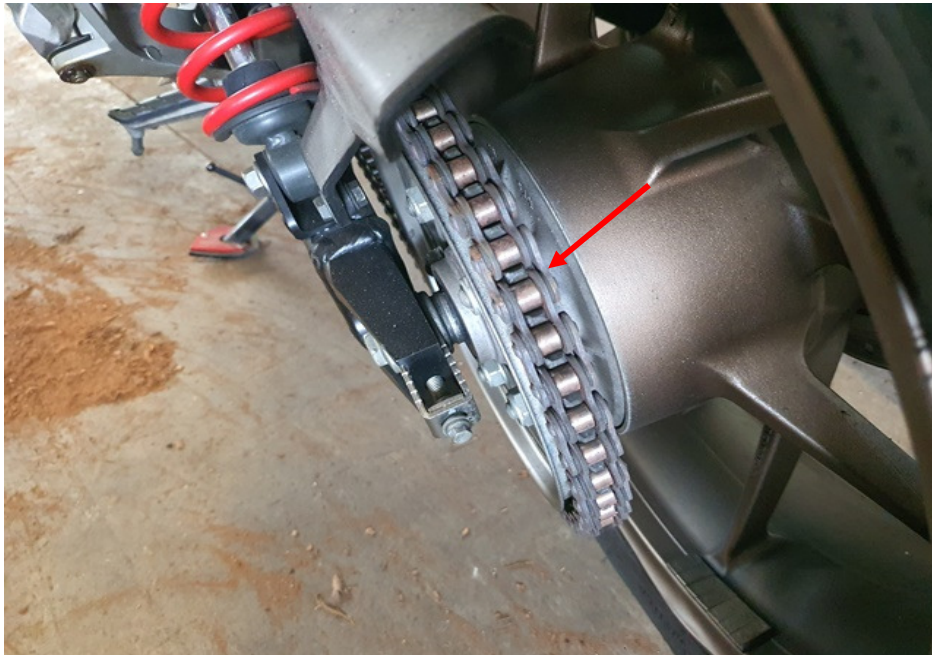
**Photo 19** shows a closer view of the gear train (arrowed) of the Motorcycle, which was observed to be intact with no misalignment. It was also adequately lubricated for operating purposes.

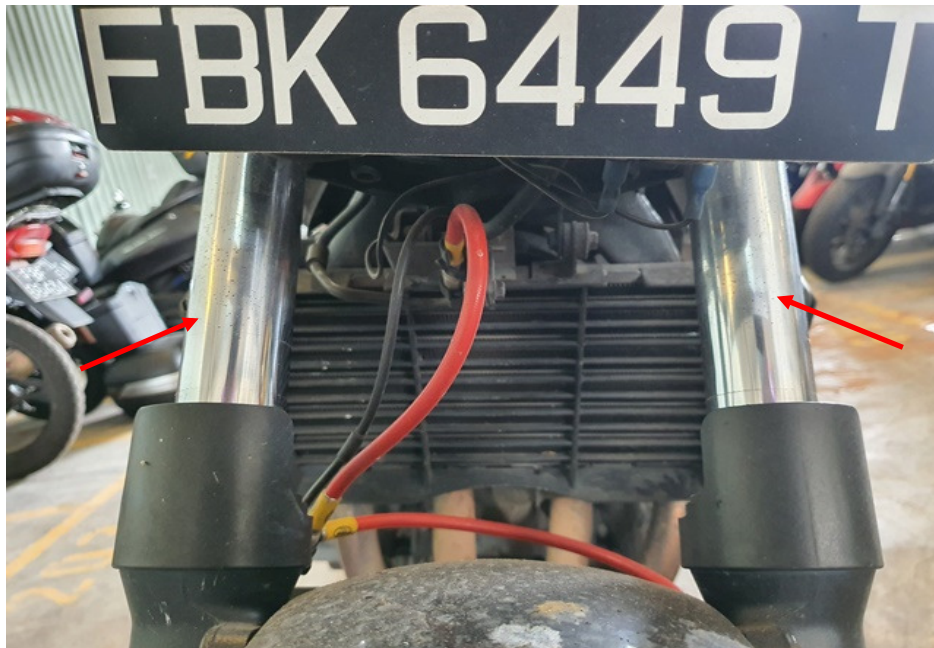
**Photo 20** shows the front forks (arrowed) of the Motorcycle. The front forks and fork bracket of the Motorcycle were both found to be intact and undamaged. Turning the Motorcycle's handle bar towards the left and right did not produce any abnormal free play and/or resistance. The steering system of the Motorcycle was in serviceable condition at the time of our inspection.

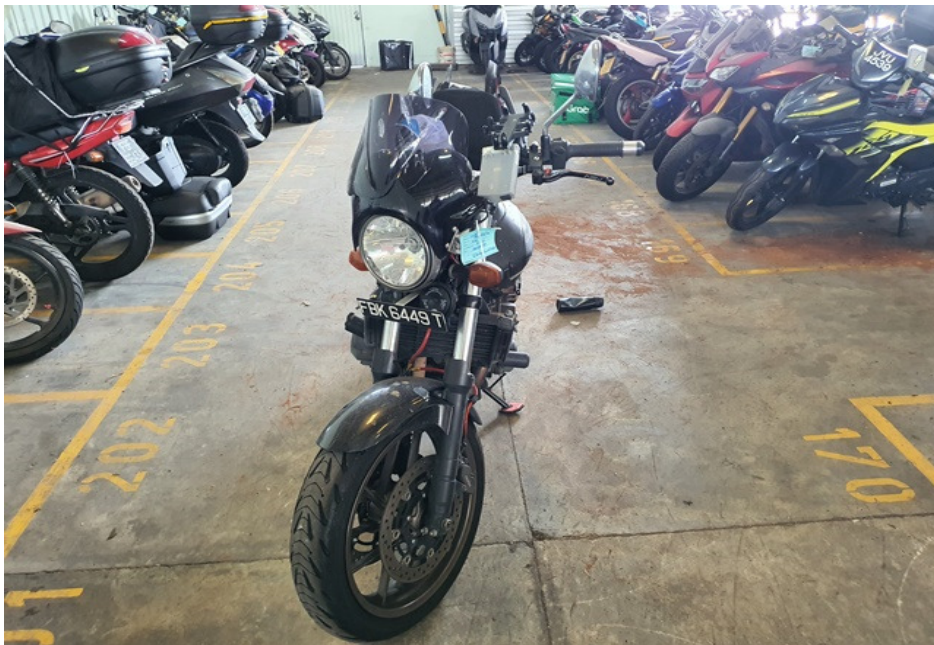
**Photo 21** shows the front wheel of the Motorcycle turned towards its full right. Turning the Motorcycle's handle bar towards the left and right did not produce any abnormal free play and/or resistance. This would indicate that the steering system of the Motorcycle was in serviceable condition at the time of our inspection.

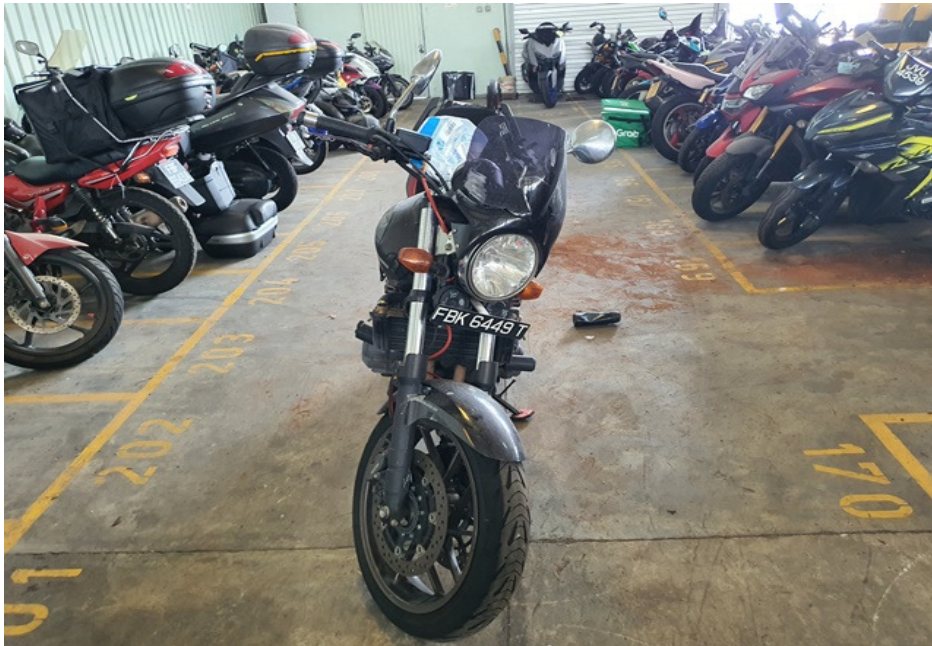
**Photo 22** shows the front wheel of the Motorcycle turned towards its full left. Turning the Motorcycle's handle bar towards the left and right did not produce any abnormal free play and/or resistance. This would indicate that the steering system of the Motorcycle was in serviceable condition at the time of our inspection.

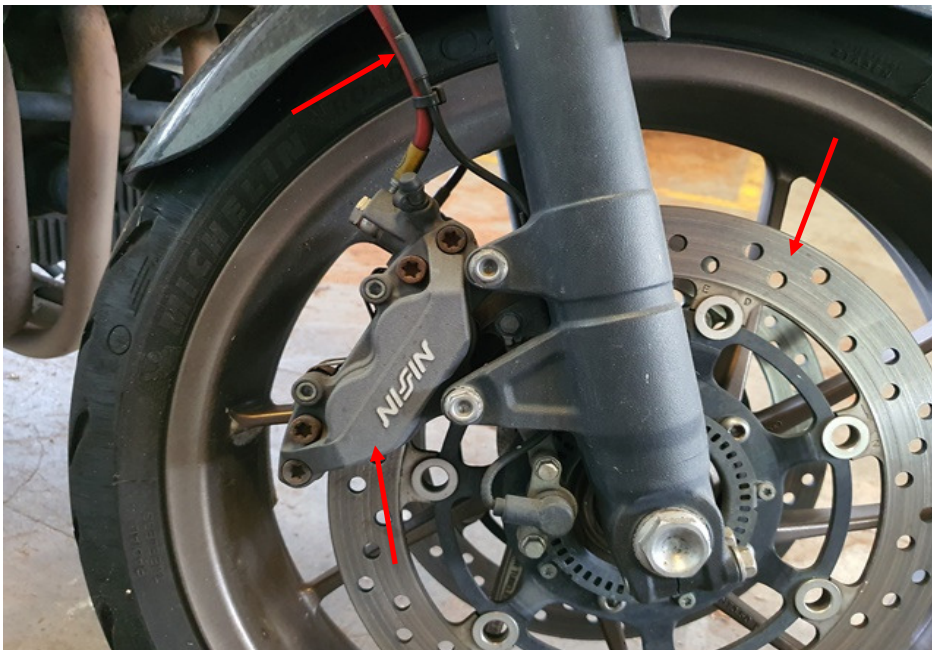
**Photo 23** shows a close up view of the front brake caliper, front brake disc and front brake hose (arrowed) at the right side of the Motorcycle's front wheel, which are all part of the components in the hydraulic front brake system of the Motorcycle. Our visual checks of these various components had revealed all to be intact with no visible damage. No leakage of brake fluid was also observed.

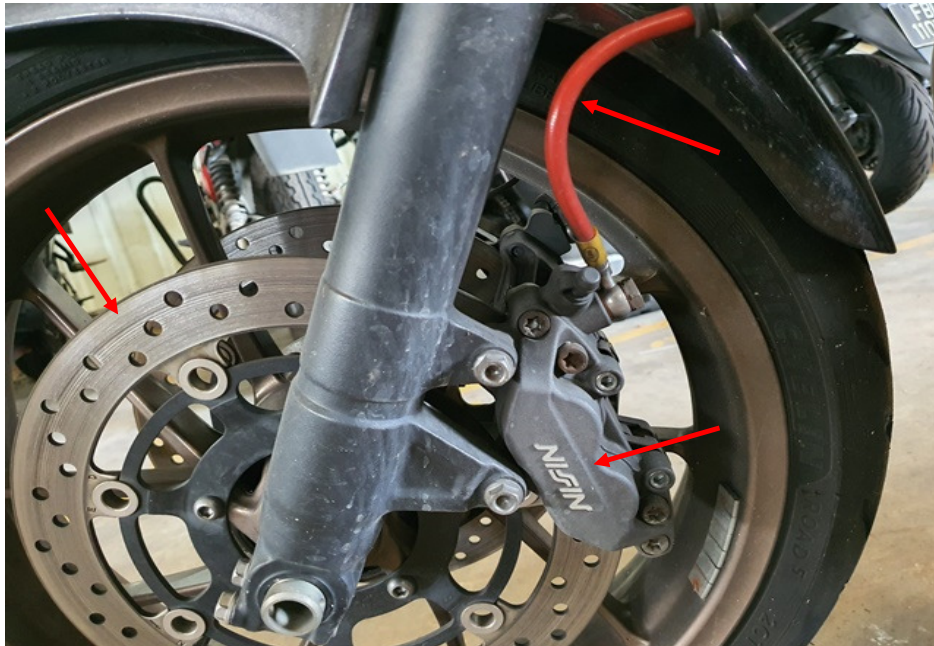
**Photo 24** shows a close up view of the front brake caliper, front brake disc and front brake hose (arrowed) at the left side of the Motorcycle's front wheel, which are all part of the components in the hydraulic front brake system of the Motorcycle. Our visual checks of these various components had revealed all to be intact with no visible damage. No leakage of brake fluid was also observed.

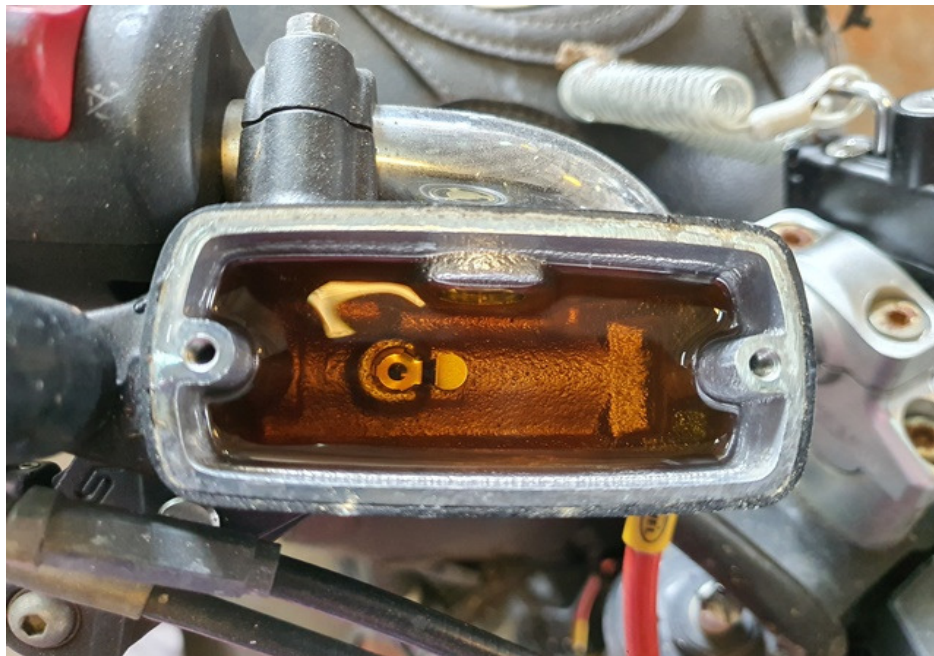
**Photo 25** shows the brake fluid reservoir for the front brake of the Motorcycle. The brake fluid was observed to be of sufficient level for operational purposes and without any contamination.

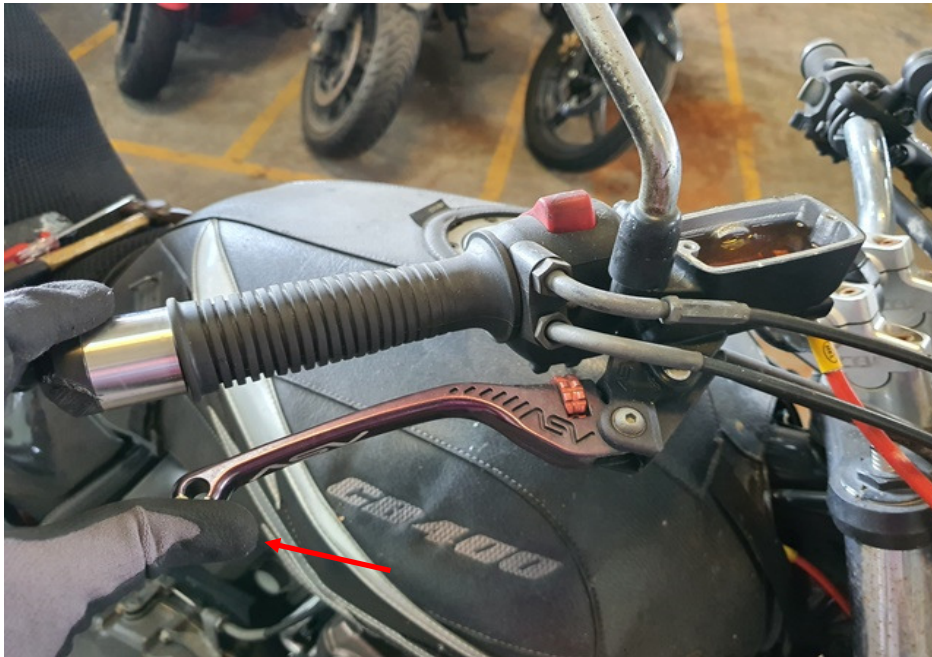
**Photo 26** shows the front brake lever being depressed. There was some resistance felt (spongy like feel) upon pressing the front brake lever (arrowed). This would indicate that there is no leakage of pressure/vacuum in the brake system.

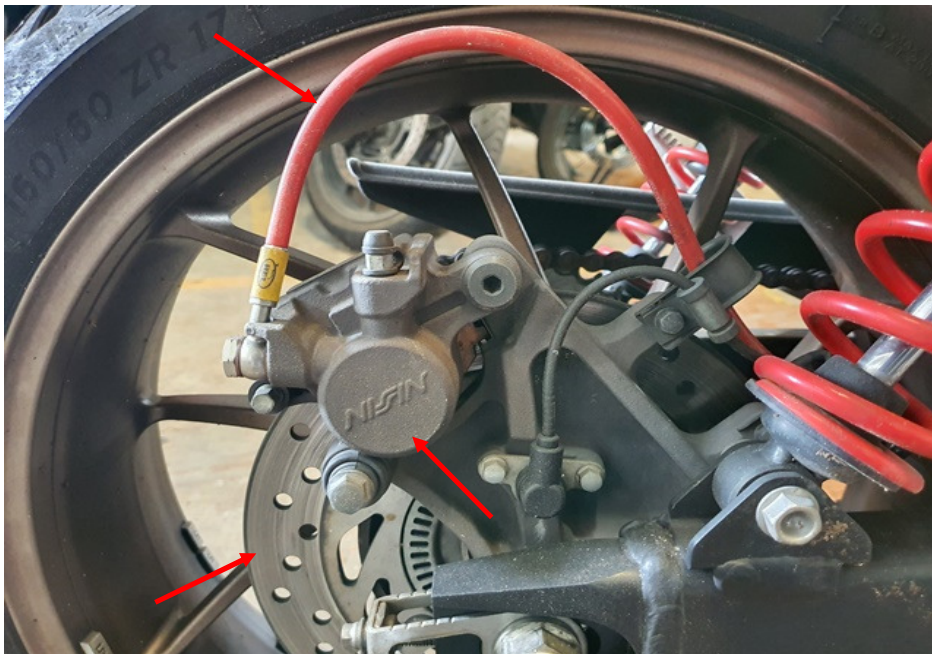
**Photo 27** shows a close up view of the rear brake caliper, rear brake disc and rear brake hose (arrowed) of the Motorcycle, which are all part of the components in the hydraulic rear brake system of the Motorcycle. Our visual checks of these various components had revealed all to be intact with no visible damage. No leakage of brake fluid was also observed.

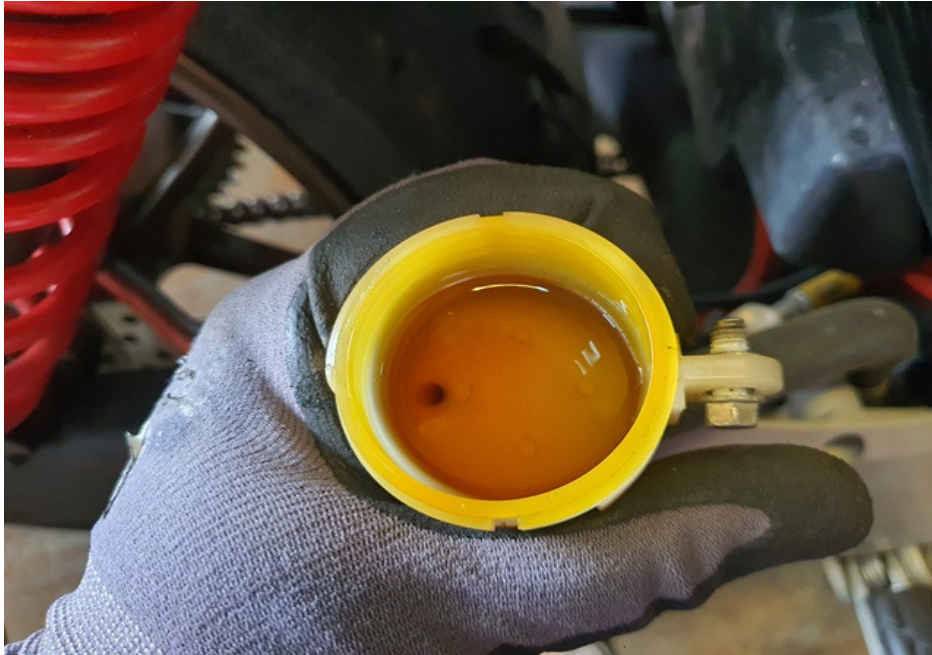
**Photo 28** shows the brake fluid reservoir for the rear brake of the Motorcycle. The brake fluid was observed to be of sufficient level for operational purposes and without any contamination.
