Your Ref: TP/IP/24472/2022
Our Ref : CI/TPD23001392/N

17 March 2023

MECHANICAL INSPECTION REPORT OF MOTOR CAR SMF 4866G

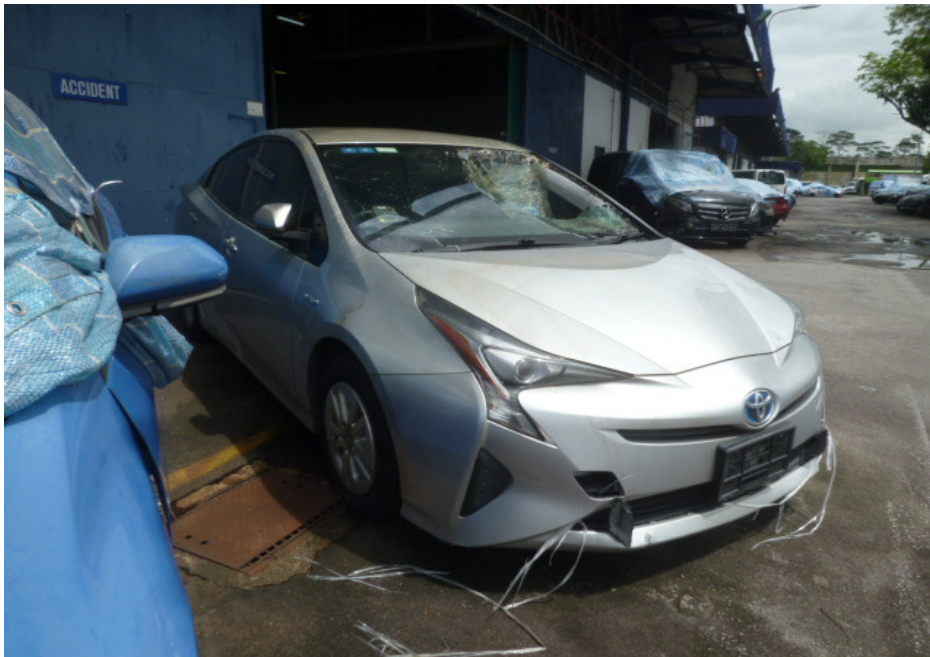
Photo 1 shows a general view of the front right body of the Motor Car at the time of our inspection. The Motor Car was observed to be in good general condition except for some relatively minor impact damage at its left frontal portion. The mileage of the Motor Car was recorded to be 261, 637km.

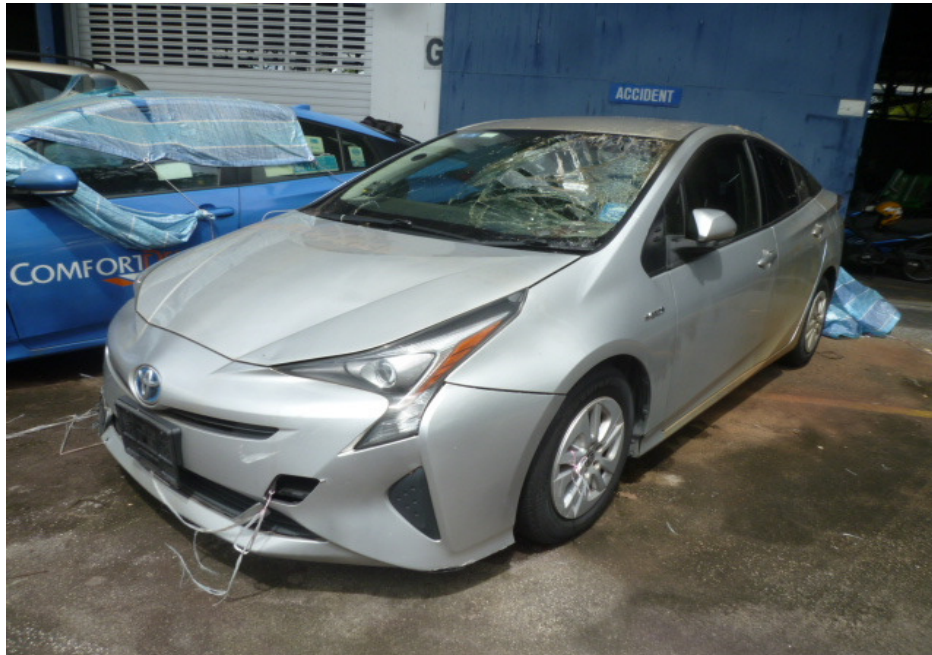
4. The mileage of the Motor Car at the time of our inspection was 261, 637km.
5. The Motor Car had sustained relatively minor impact damage that was confined to its left frontal portion. Its front number plate and front left tow cover were observed to have been missing; its front bumper was observed to have cracked while its front windscreen was observed to have shattered.

Photo 2 shows a general view of the front left body of the Motor Car at the time of our inspection. The Motor Car was observed to be in good general condition. However we had observed relatively minor impact damage that was confined to its left frontal portion. Its front number plate and front left tow cover were observed to have been missing; its front bumper was observed to have cracked while its front windscreen was observed to have shattered.

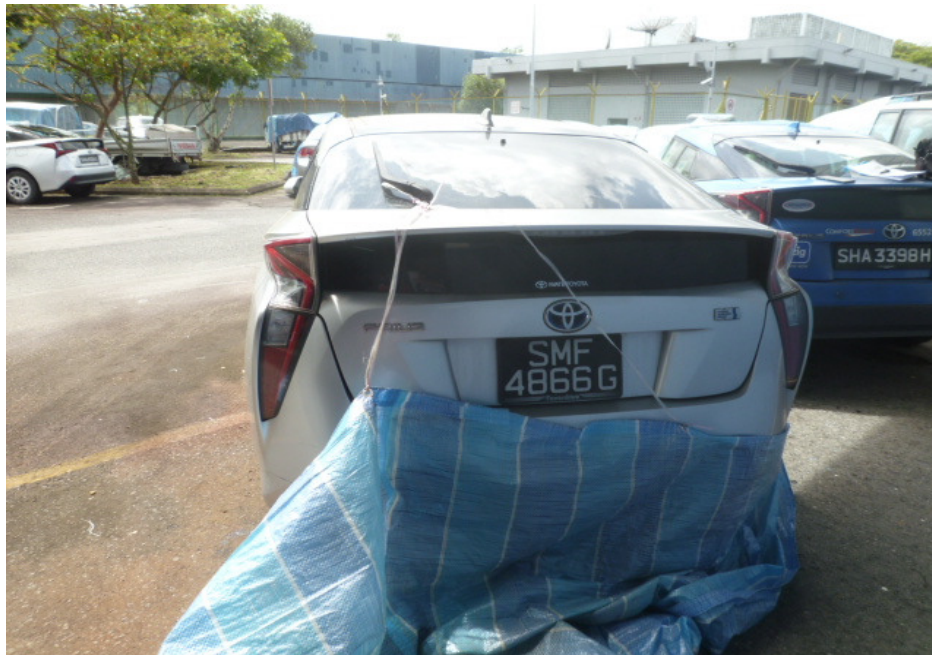
Photo 3 shows a general view of the rear portion of the Motor Car at the time of our inspection. The rear portion of the Motor Car was observed to be relatively unaffected by the accident.

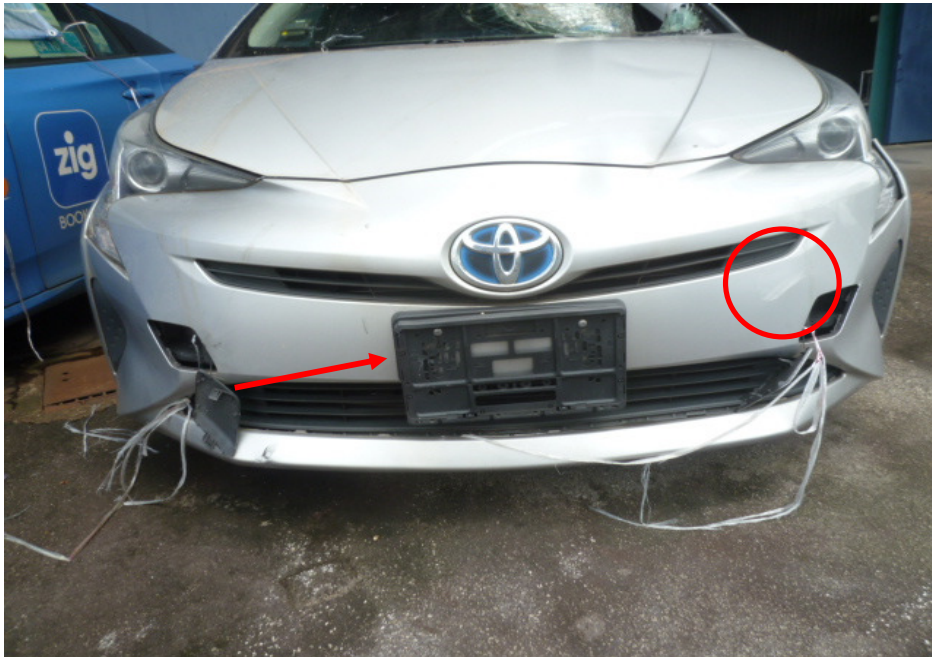
Photo 4 shows a closer view of the cracked front bumper (circled) and missing front number plate (arrowed) of the Motor Car at the time of our inspection

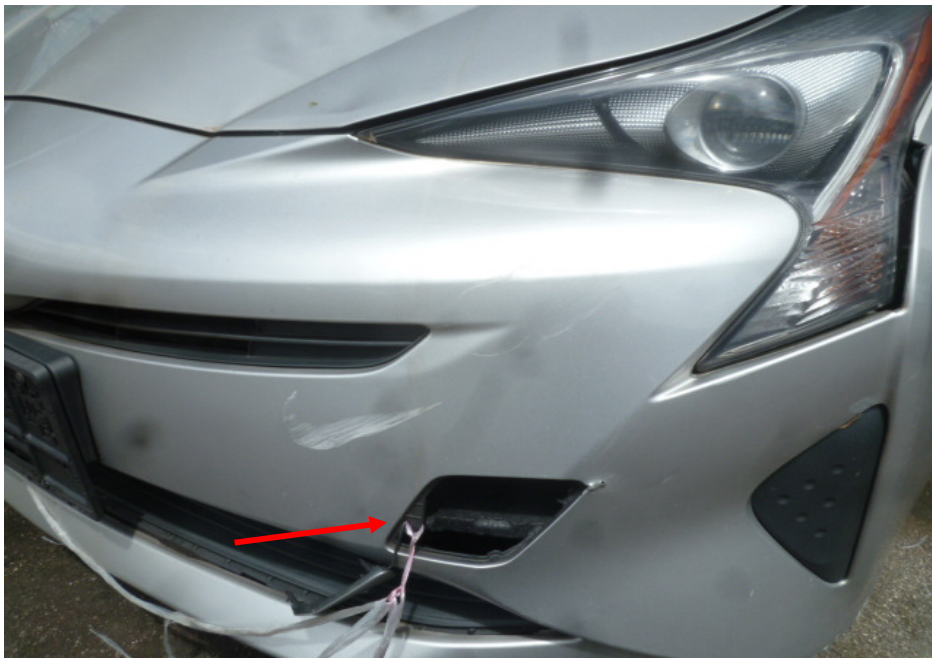
Photo 5 shows a closer view of the missing front left tow cover (arrowed) of the Motor Car at the time of our inspection

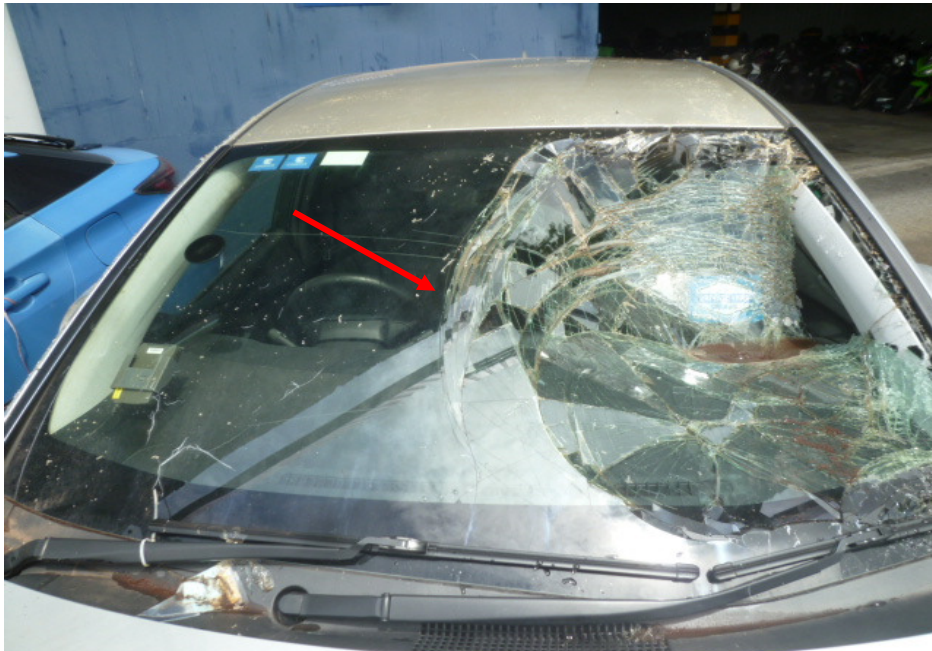
Photo 6 shows a closer view of the shattered front windscreen (arrowed) of the Motor Car at the time of our inspection.

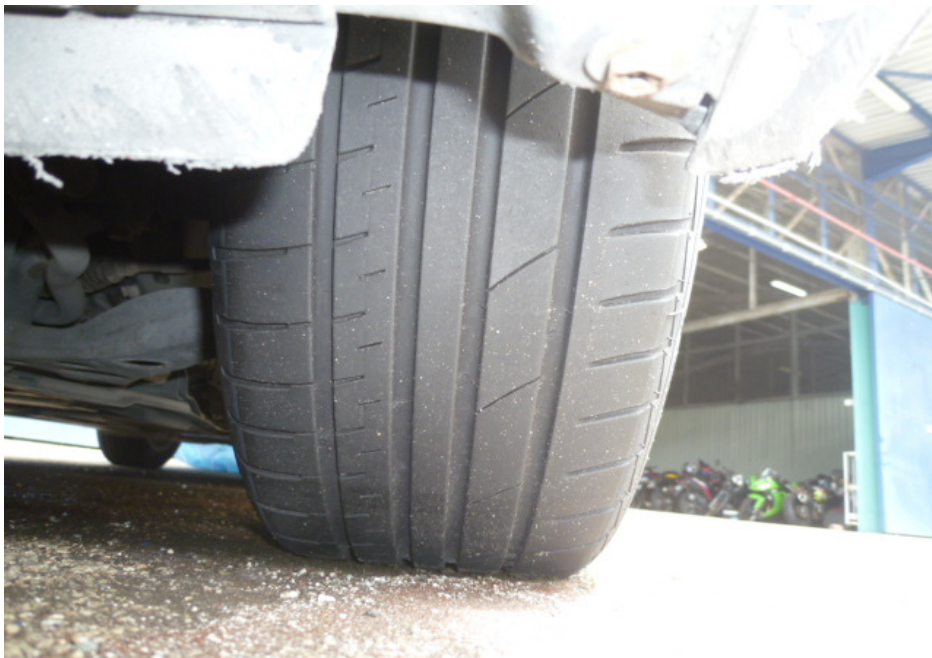
Photo 7 shows the condition of the front left tyre of the Motor Car, which was observed to be in serviceable condition with remaining tread depth of approximately 7mm. The tyre, which was wrapped around alloy wheel rim, was also observed to be sufficiently inflated for vehicular operation. There was no tear, cut or burst mark(s) on the outer and the inner sidewalls as well as across the tread of the 4 tyres.

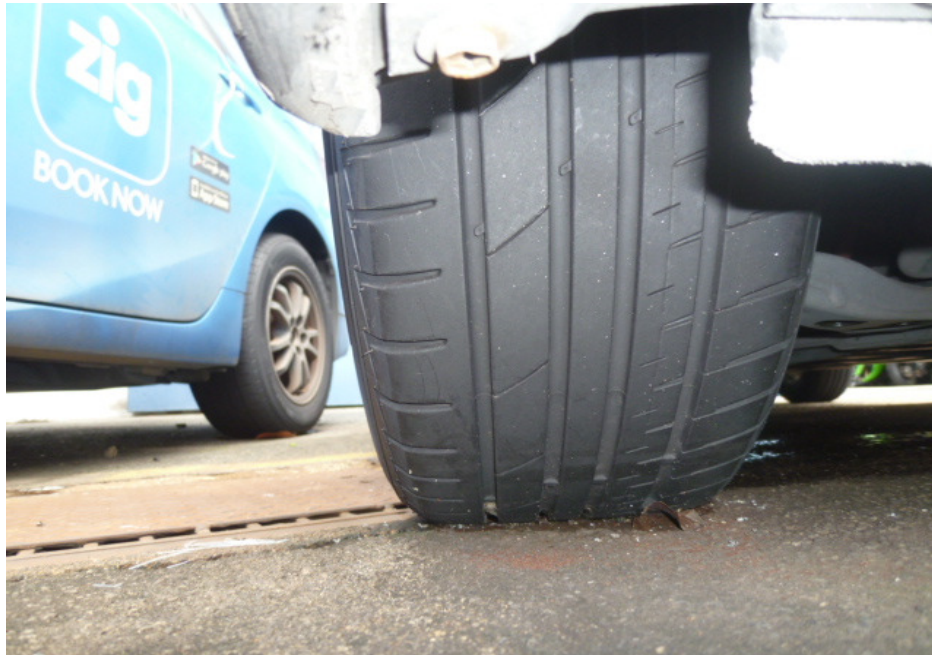
Photo 8 shows the condition of the front right tyre of the Motor Car, which was observed to be in serviceable condition with remaining tread depth of approximately 6mm. The tyre, which was wrapped around alloy wheel rim, was also observed to be sufficiently inflated for vehicular operation.

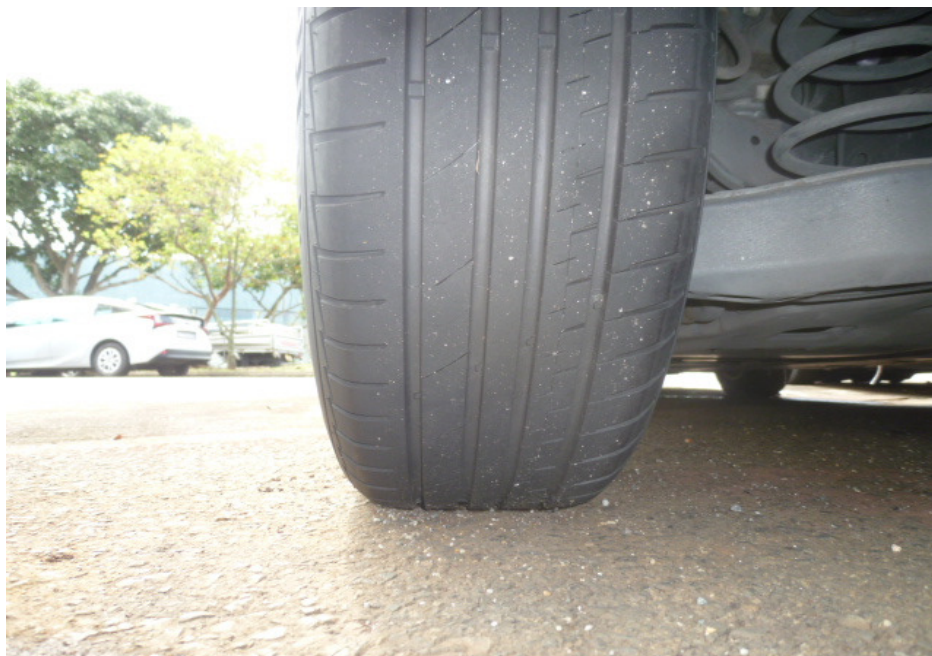
Photo 9 shows the condition of the rear left tyre of the Motor Car, which was observed to be in serviceable condition with remaining tread depth of approximately 8mm. The tyre, which was wrapped around alloy wheel rim, was also observed to be sufficiently inflated for vehicular operation. There was also no damage found on the 4 wheel rims of the Motor Car.

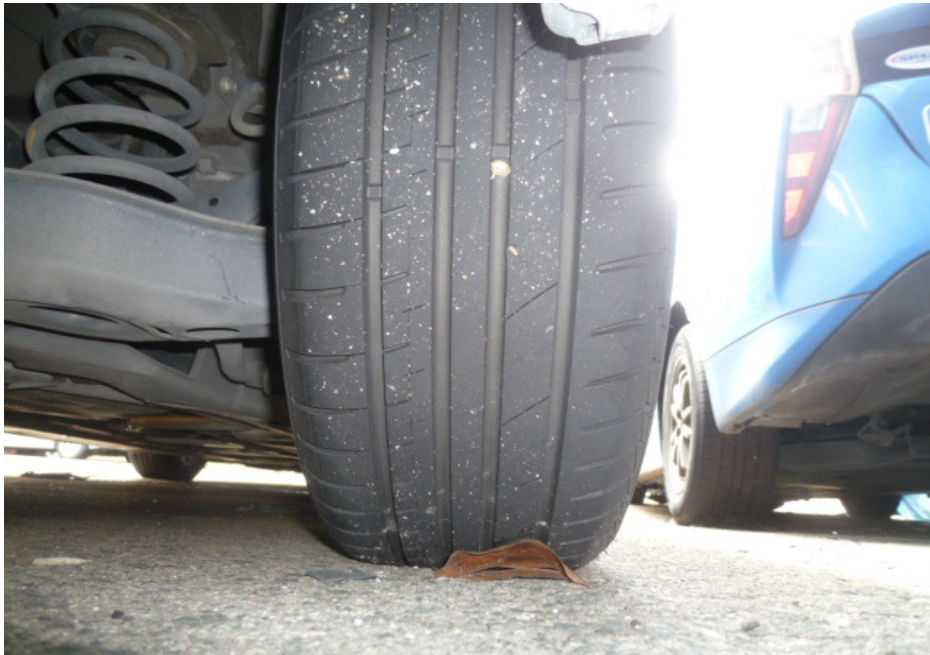
Photo 10 shows the condition of the rear right tyre of the Motor Car, which was observed to be in serviceable condition with remaining tread depth of approximately 8mm. There was also no tear, cut or burst mark(s) on the outer and the inner sidewalls as well as across the tread of the 4 tyres.

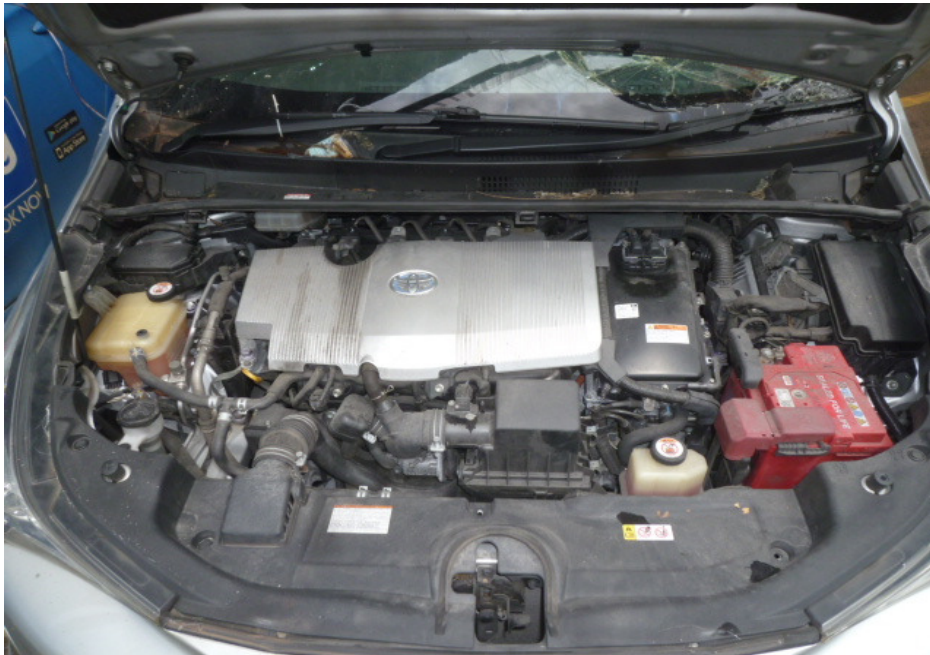
Photo 11 shows a general view of the Motor Car's engine compartment. The various parts and components inside the engine compartment were unaffected by the accident. There was also no sign(s) or indication(s) of fluid leakage and/or fluid stain within the engine compartment.

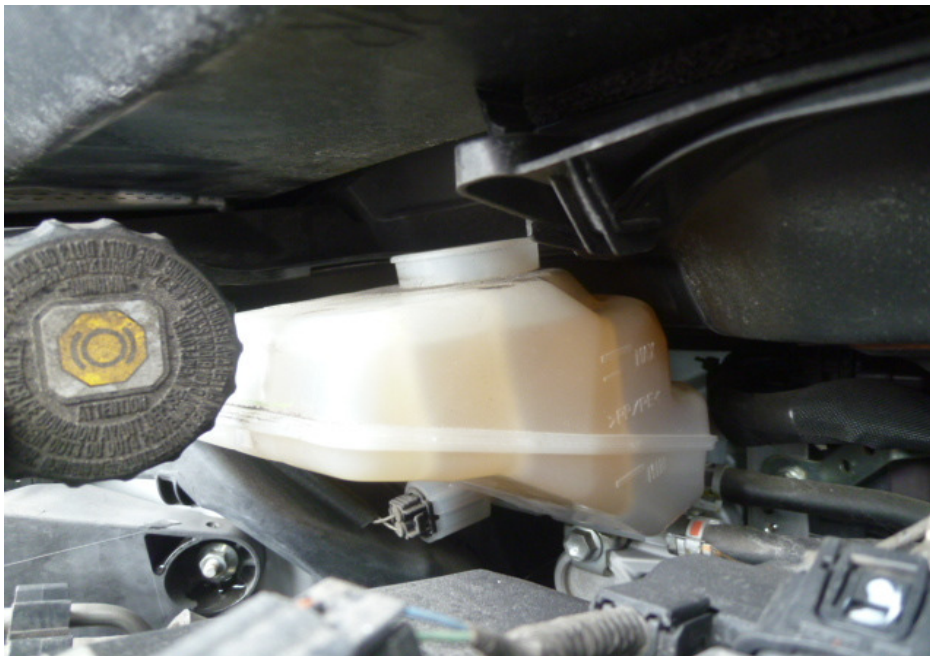
Photo 12 shows the brake fluid reservoir of the Motor Car at the time of our inspection. The brake fluid was observed to be of sufficient level for operating purposes and without any visible contamination.

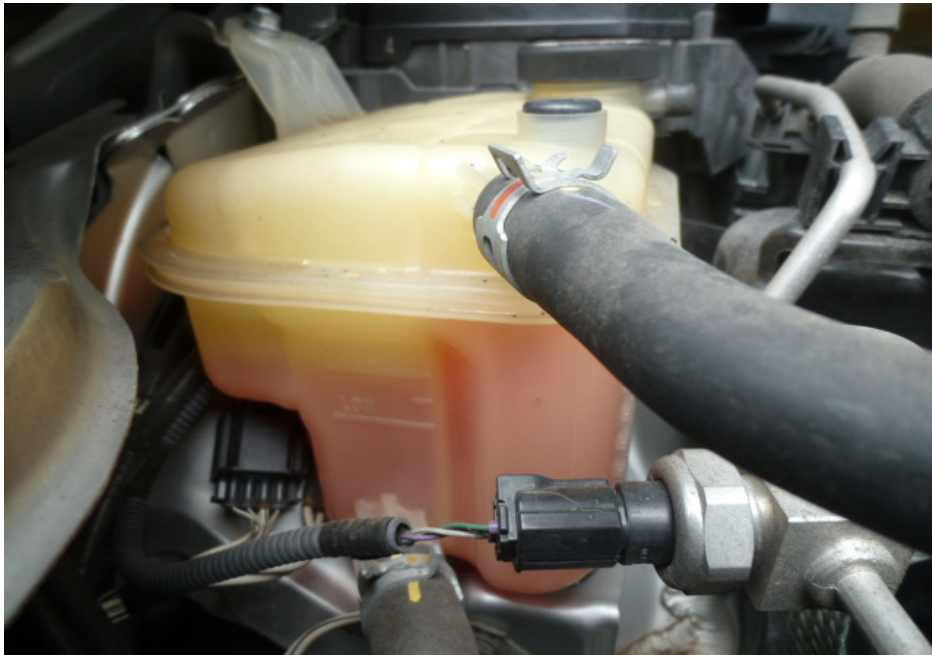
Photo 13 shows checks being carried out to the engine coolant of the Motor Car at the time of our inspection. The engine coolant was observed to be of sufficient level for operating purposes and without any visible contamination.

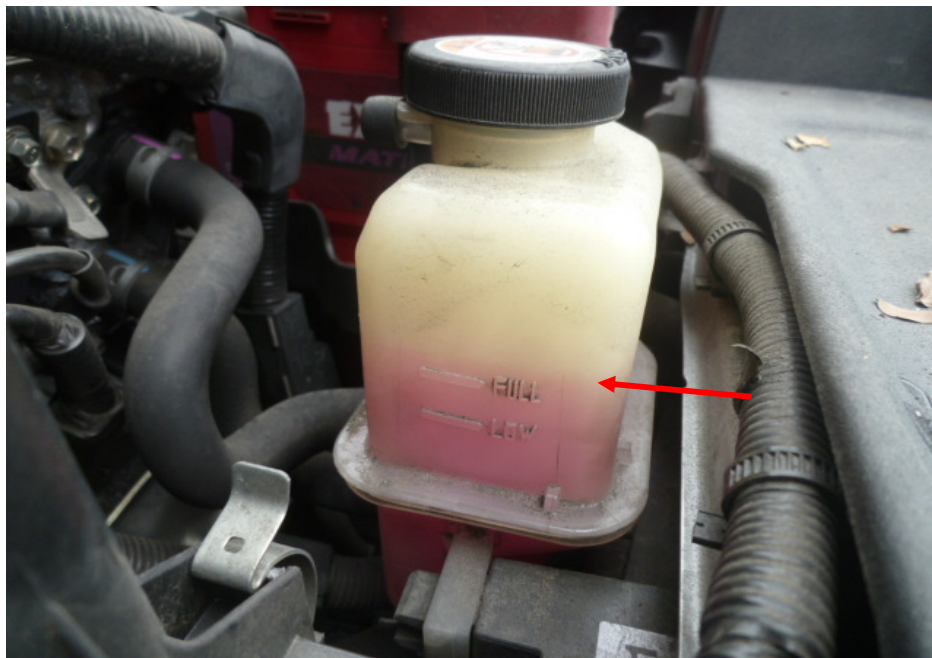
Photo 14 shows the coolant reservoir for the hybrid system of the Motor Car at the time of our inspection. The hybrid system coolant was observed to be of sufficient level for operating purposes and without any visible contamination (arrowed).

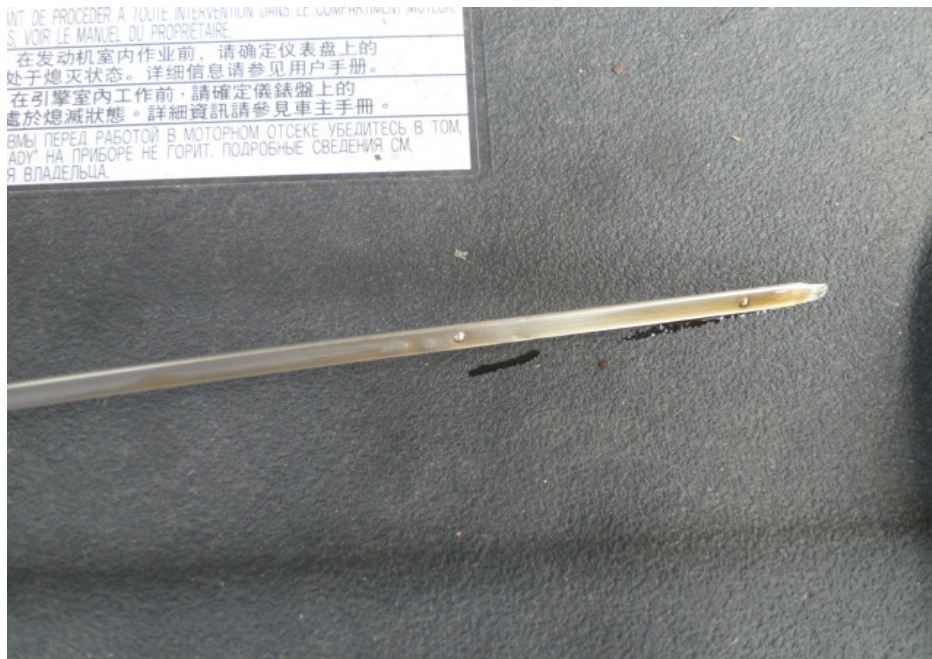
Photo 15 shows the engine oil dip stick of the Motor Car at the time of our inspection. The engine oil was observed to be of sufficient level for operating purposes and without any visible contamination.

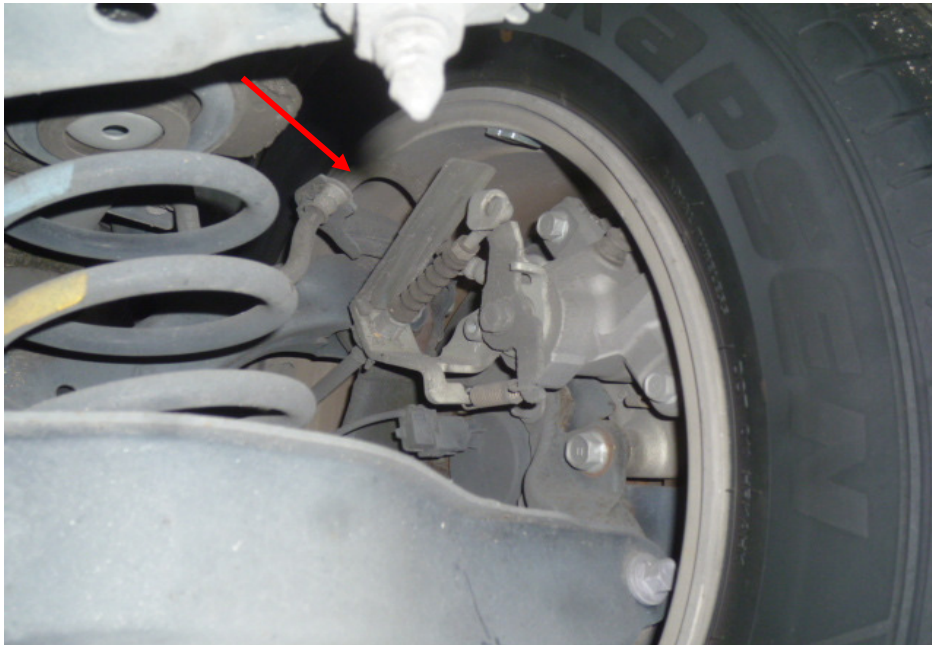
Photo 16 shows the brake hose/pipe (arrowed) at the rear right wheel of the Motor Car. We did not observe any leakage of brake fluid at the time of our inspection of the Motor Car. Static tests of the Motor Car's braking system had indicated that there was no internal leakage of pressure/vacuum. Hence the braking system was likely to be in serviceable condition at the material time of accident. The undercarriage components of the Motor Car were also all found to be intact and without any visible damage.

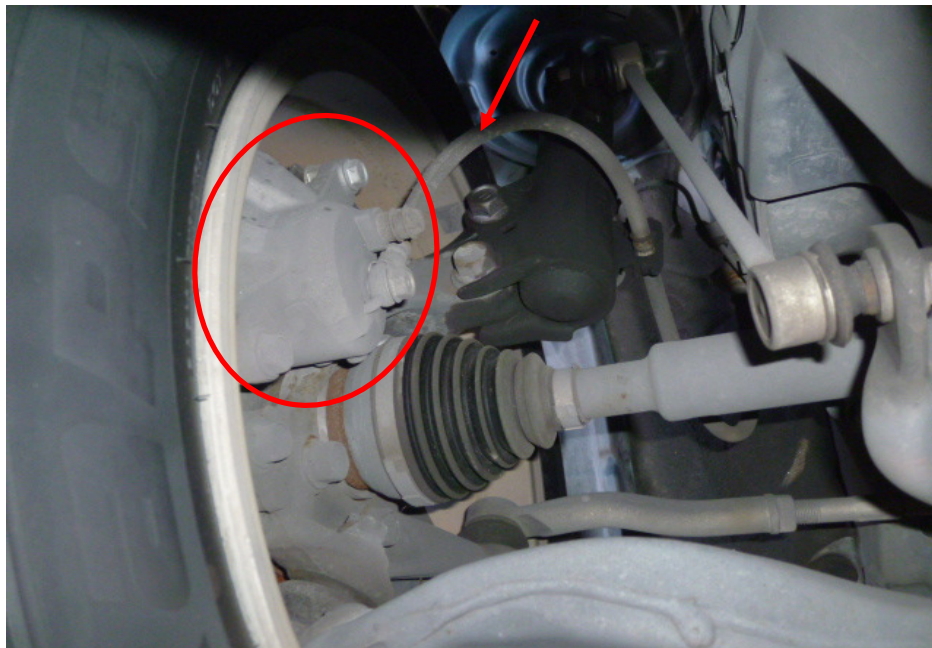
Photo 17 shows the brake hose/pipe (arrowed) at the front right wheel of the Motor Car. No leakage of brake fluid was observed. Visual examination of the various components of the braking system like the brake caliper (circled), brake pedal etc. had revealed all to be intact and without visible damage.

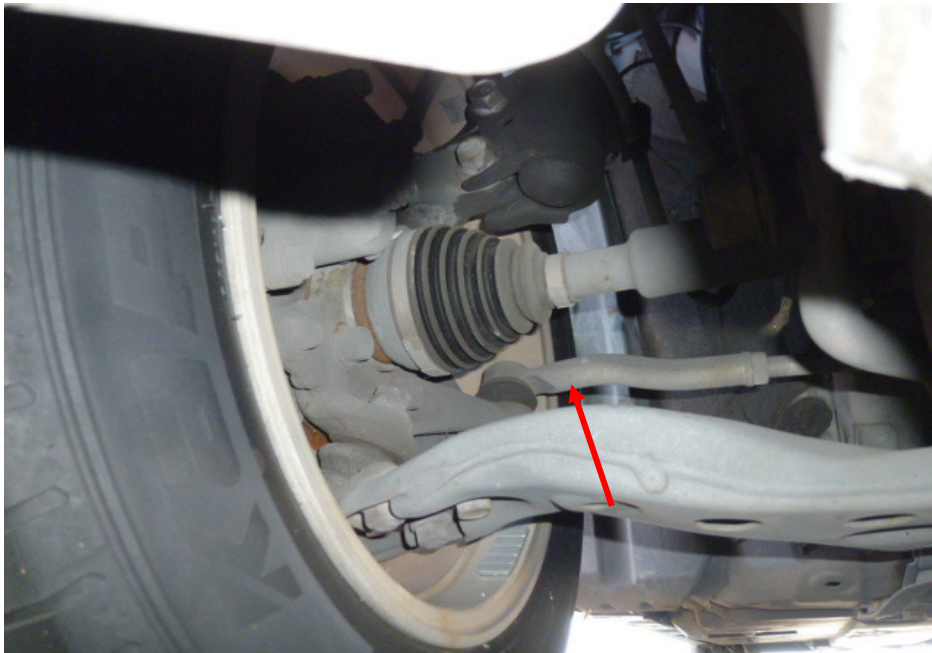
Photo 18 shows the various undercarriage components at the front right wheel of the Motor Car, in particular the steering tie rod (arrowed). The various steering components were all found to be intact, suggesting that the steering system of the Motor Car was likely to be in serviceable condition at the material time of accident. There was also no sign of fluid stain observed on the various undercarriage components at the front right wheel of the Motor Car.

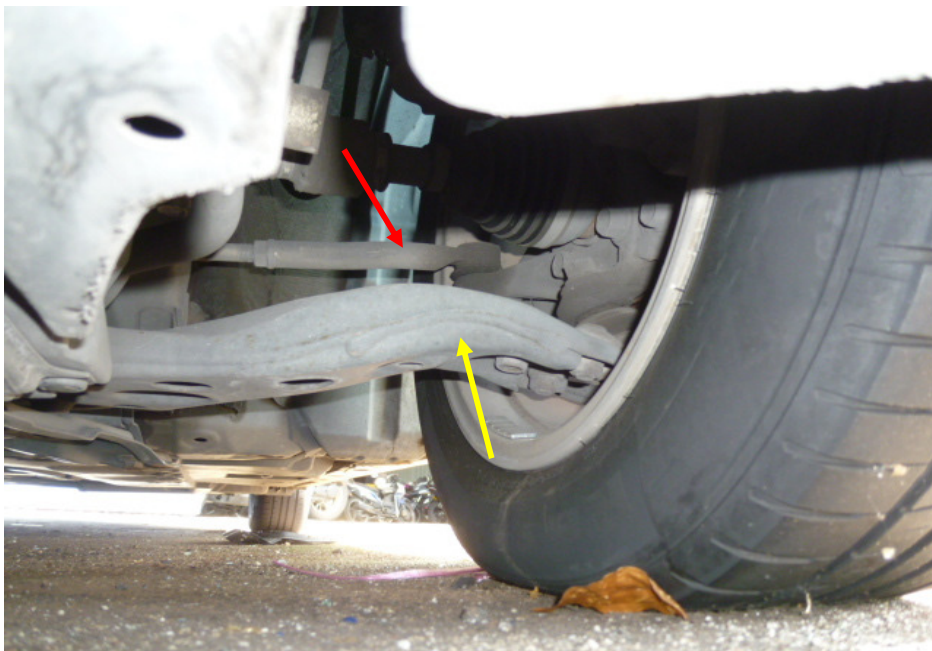
Photo 19 shows the various undercarriage components at the front left wheel of the Motor Car, which had included the steering tie rod (red arrow) and left drive shaft (yellow arrow). The various undercarriage components of the Motor Car were all found to be intact without any visible damage.

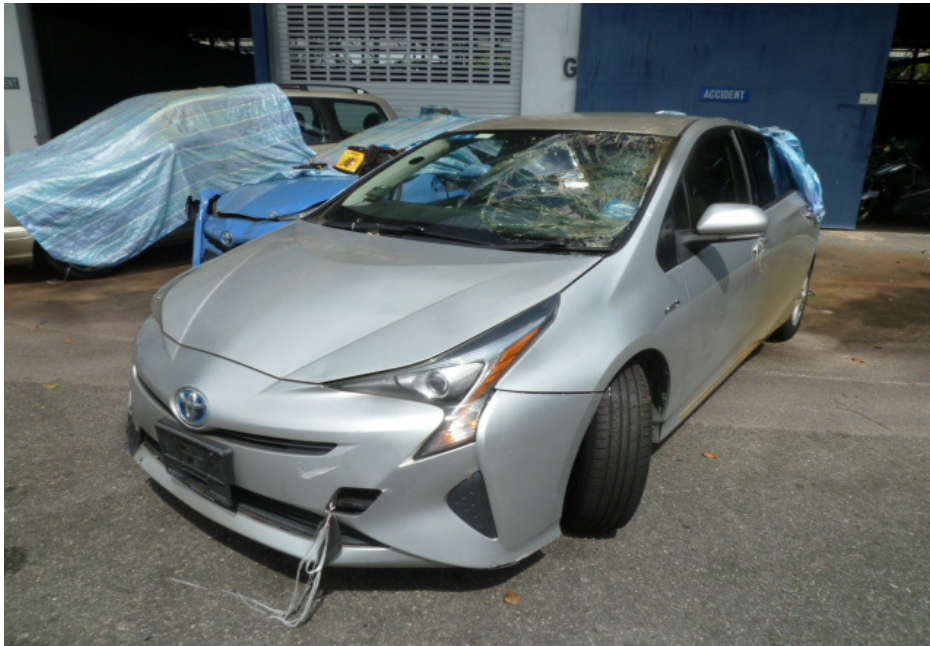
Photo 20 shows the front left wheel of the Motor Car turned to its full left. During our steering system test, we did not experience any abnormal free play and/or resistance when we had turned the steering wheel towards the left and right. This would suggest that the steering system of the Motor Car was likely to be in serviceable condition at the material time of accident.

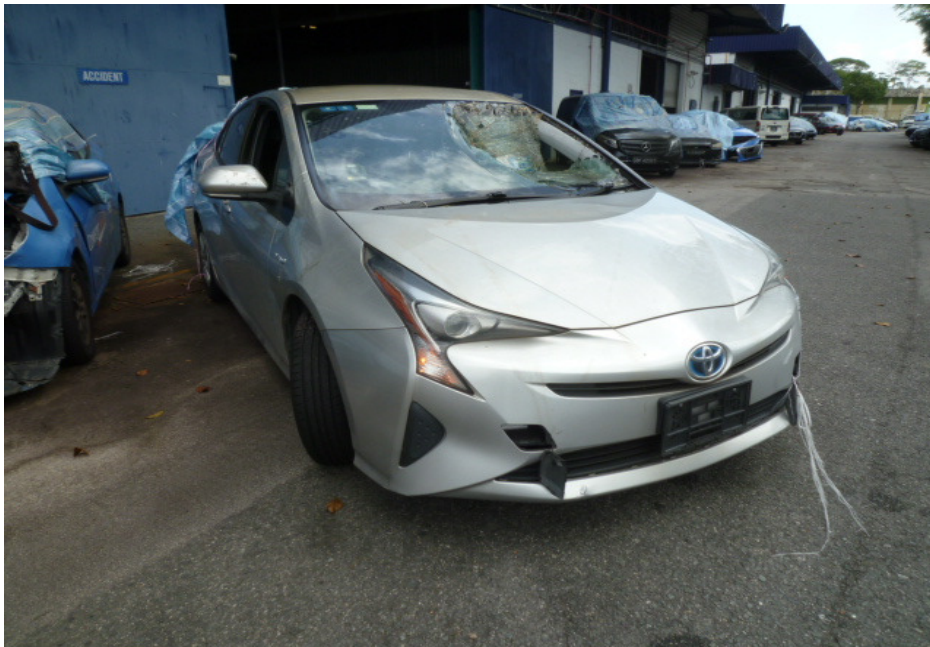
Photo 21 shows the front right wheel of the Motor Car turned to its full right. During our steering system test, we did not experience any abnormal free play and/or resistance when we had turned the steering wheel towards the left and right. This would suggest that the steering system of the Motor Car was likely to be in serviceable condition at the material time of accident.

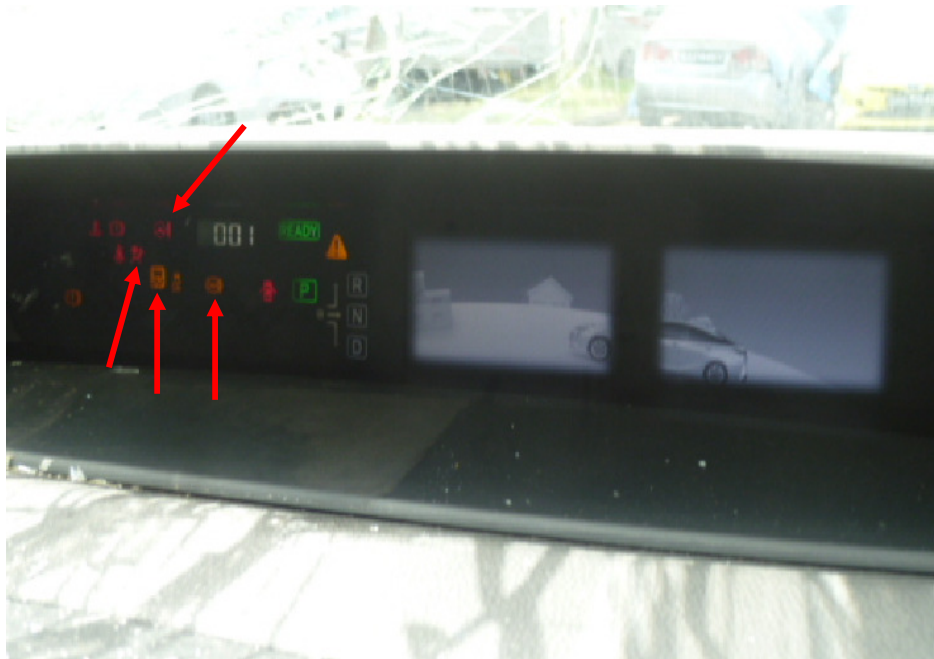
Photo 22 shows the warning lights for the various electronic operating systems of the Motor Car appearing on its instrument panel during the self-test when the engine is cranked, in particular the SRS light, ABS light, EPS light and VSC light (arrowed).

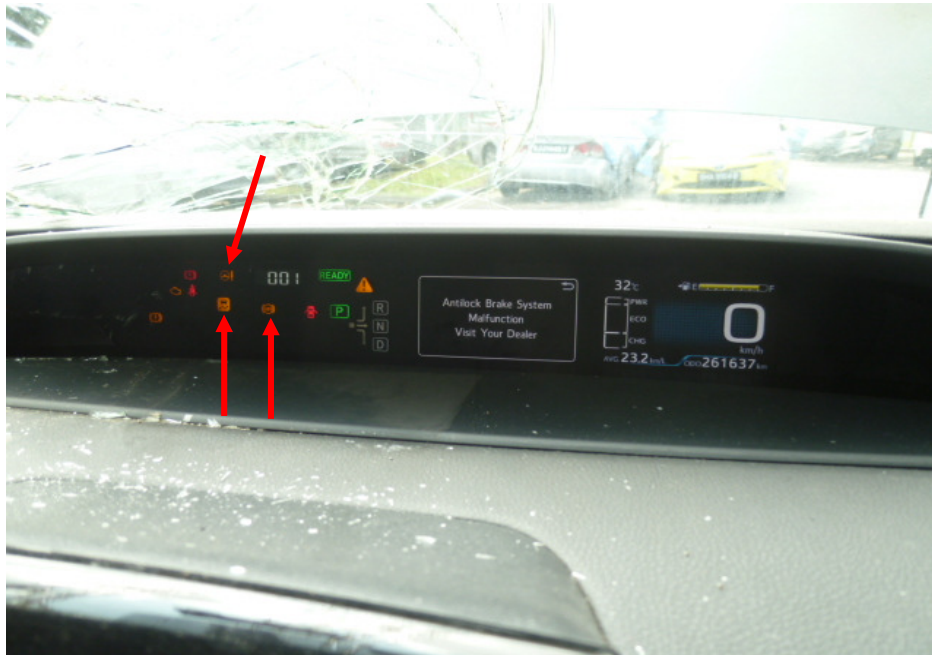
13. The Motor Car's automatic self-test of the functionality of its various electronic operating systems like the Anti-Brake Lock System (ABS), Electronic Power Steering (EPS), Vehicle Stability Control (VSC) and Supplemental Restraint System (SRS) during cranking of the engine had indicated that only the SRS is in working condition and without abnormality. This can be established from the SRS warning light disappearing from the instrument panel after the self-test. The ABS warning light, VSC warning light and EPS warning light had however remained illuminated after the self-test. See photos 22 & 23 below.

Photo 23 shows no SRS warning light illuminated on the instrument panel of the Motor Car after the engine was cranked. This would suggest that there was no abnormality to the SRS of the Motor Car. The ABS warning light, VSC warning light and EPS warning light had however remained illuminated after the self-test (arrowed).
