Your Ref: TP IP/31363/2022  
Our Ref : CI/TPD23001396/N

23 May 2023

**Fatal Accident Investigation Team**

**INSPECTION REPORT OF MOTORCYCLE FBS 7835M**

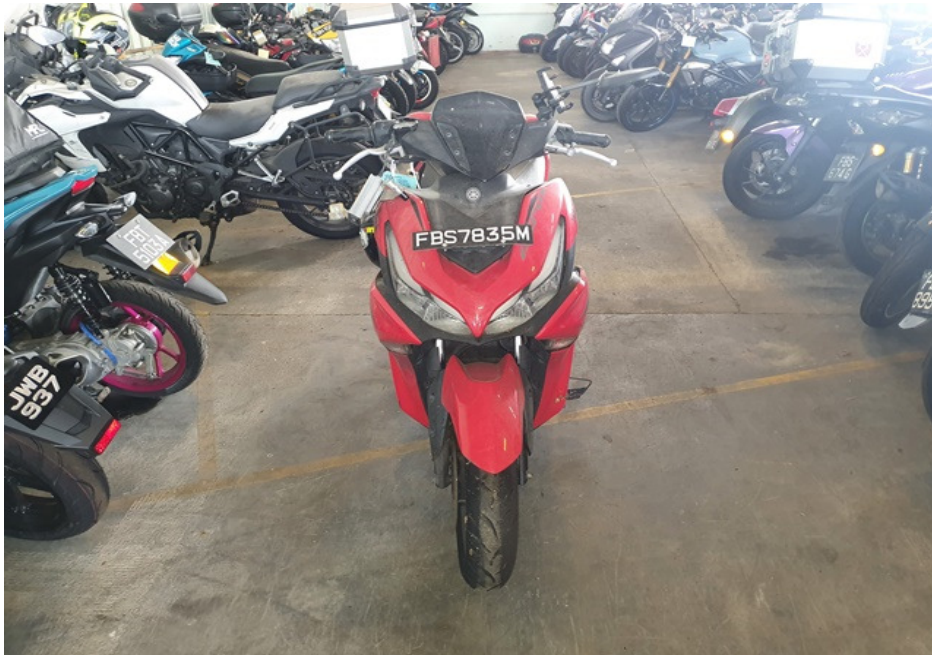
4. The mileage of the Motorcycle could not be recorded at the time of our inspection despite several attempts to jump start the battery.
5. The Motorcycle was observed to have sustained damages all around. The body parts that were found to have been damaged include its front mudguard, side cowlings, front brake lever, right handlebar end, bottom cowlings, left inner panel and exhaust muffler heat shield, amongst others as a result of the accident. See photos 1 – 12 below.

**Photo 1** shows a general view of the frontal portion of the Motorcycle at the time of our inspection. The Motorcycle was observed to have sustained damages all around. The mileage of the Motorcycle could not be recorded at the time of our inspection despite several attempts to jump start the battery.

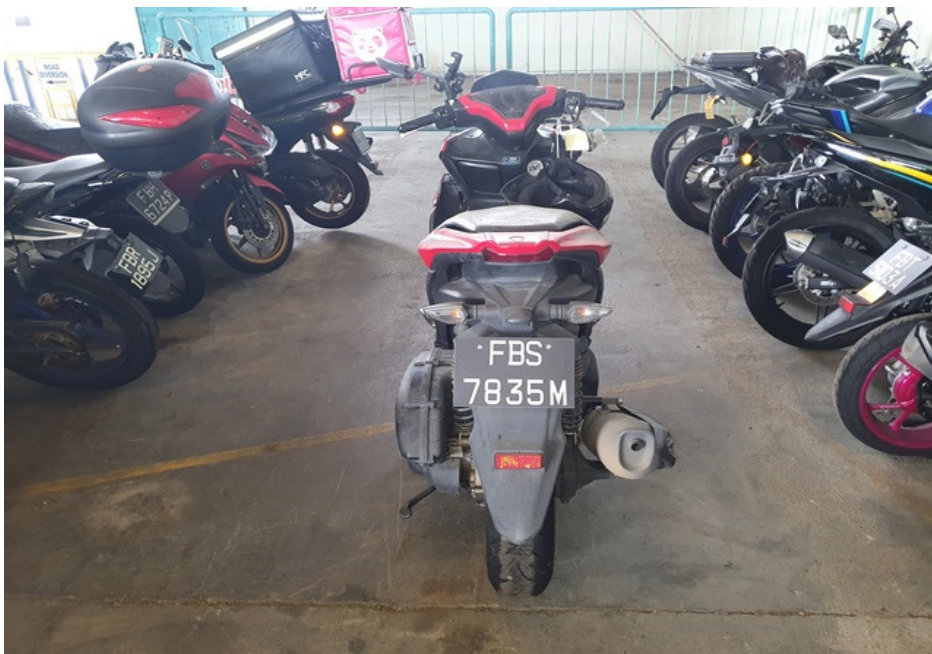
**Photo 2** shows a general view of the rear portion of the Motorcycle at the time of our inspection. The Motorcycle was observed to have sustained damages all around.

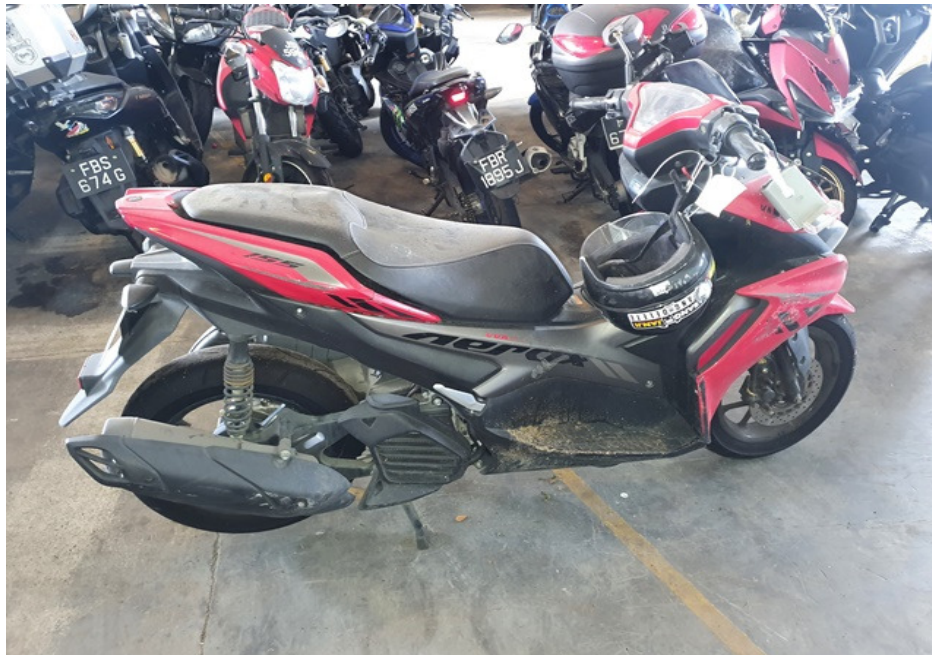
**Photo 3** shows a general view of the right body of the Motorcycle at the time of our inspection. The Motorcycle was observed to have sustained damages all around. The body parts that were found to have been damaged include its front mudguard, side cowlings, front brake lever, right handlebar end, bottom cowlings, left inner panel and exhaust muffler heat shield, amongst others as a result of the accident.

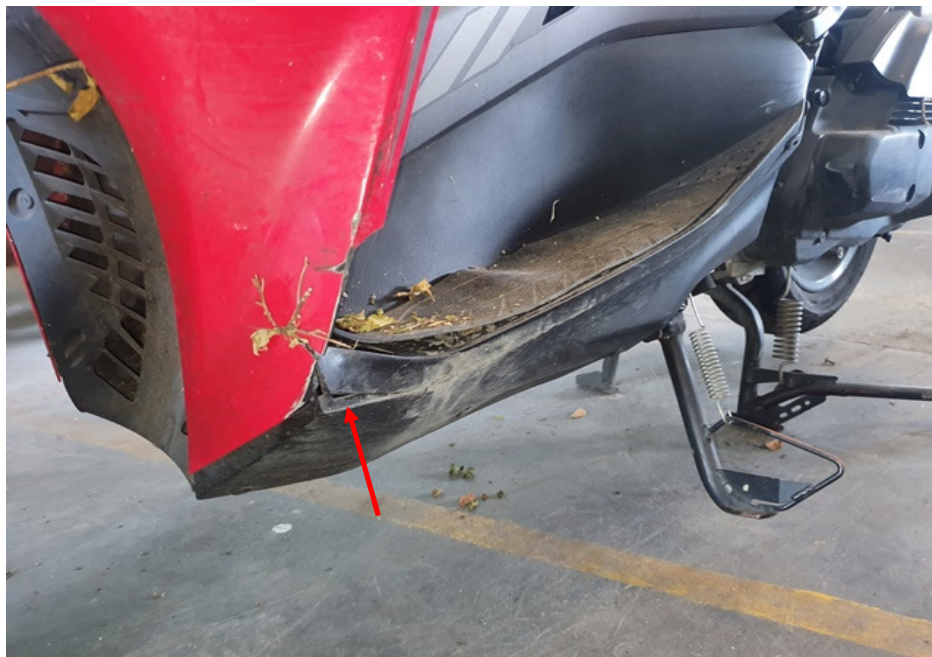
**Photo 4** shows a closer view of the left bottom cowl of the Motorcycle which was observed to be damaged due to the accident (arrowed).

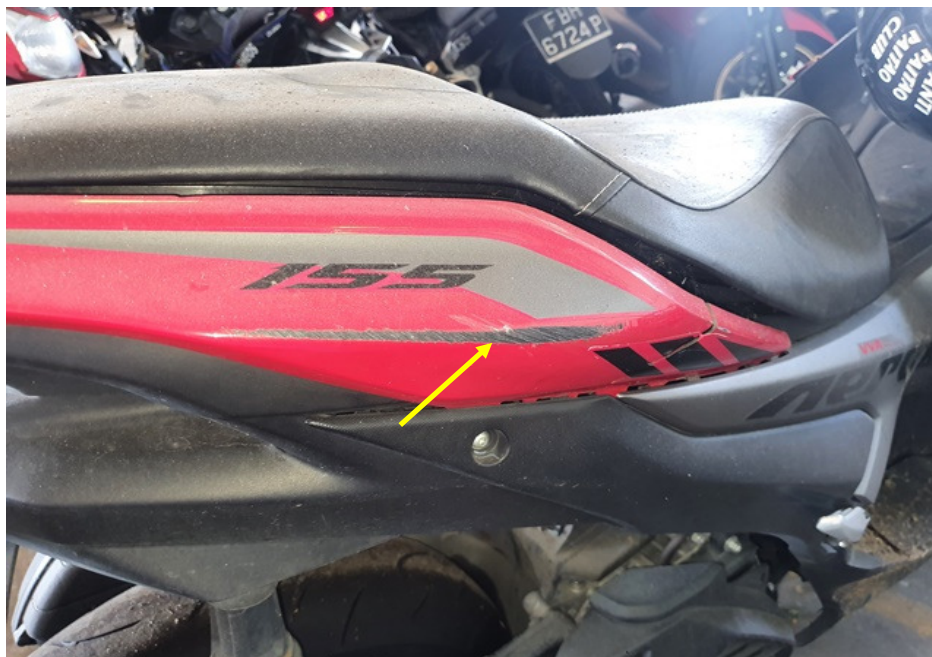
**Photo 5** shows a closer view of the grazed right rear side cover (arrowed) of the Motorcycle at the time of our inspection.

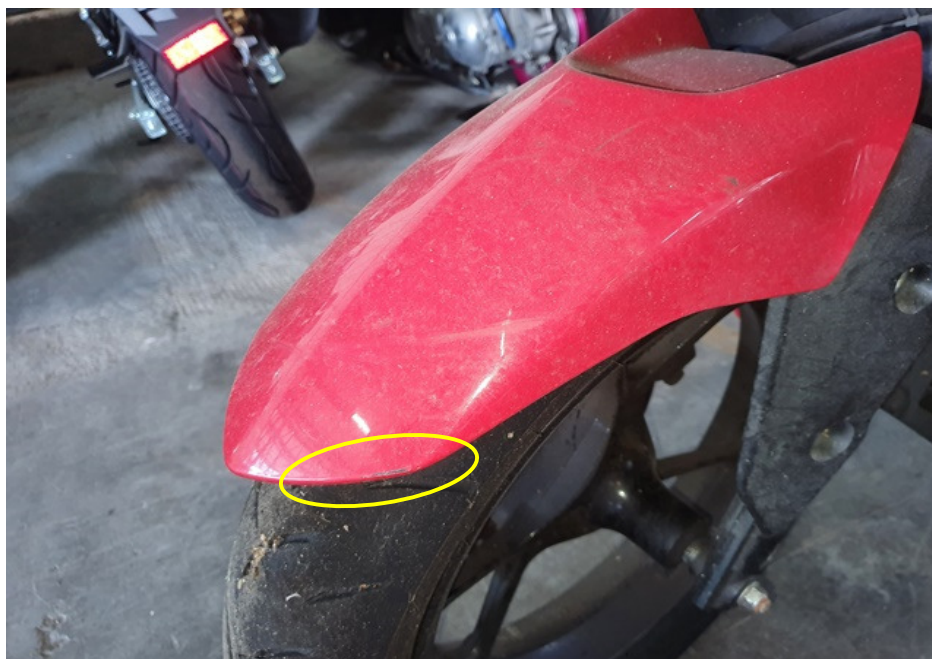
**Photo 6** shows a closer view of the front mudguard (circled) which was amongst the body parts at the front body of the Motorcycle that had sustained damage as a result of the accident.

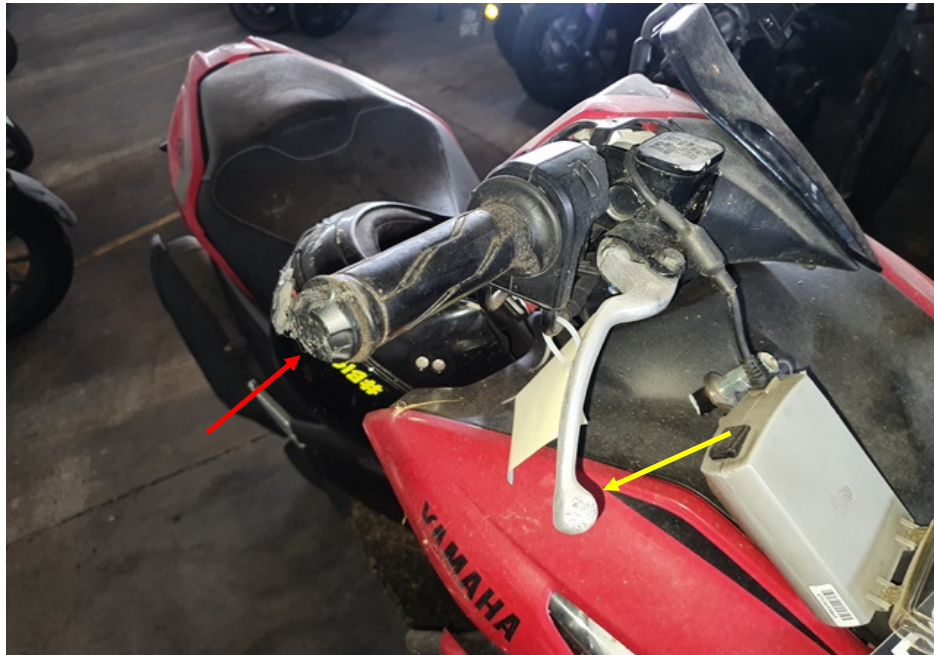
**Photo 7** shows a closer view of the grazed front brake lever and right handlebar end (arrowed) of the Motorcycle as a result of the accident.

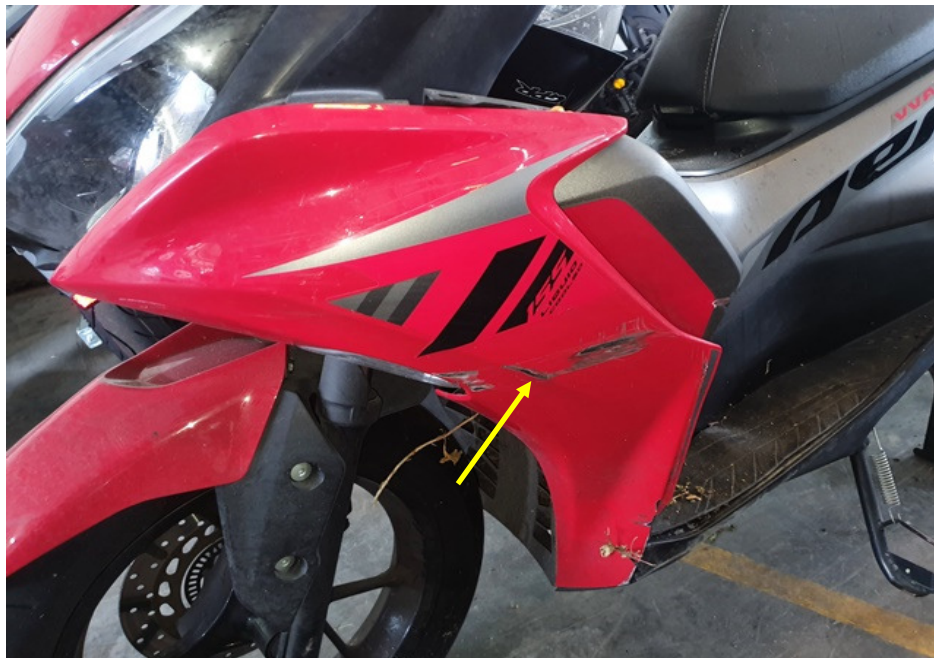
**Photo 8** shows a closer view of the grazed left cowling of the Motorcycle as a result of the accident (arrowed).

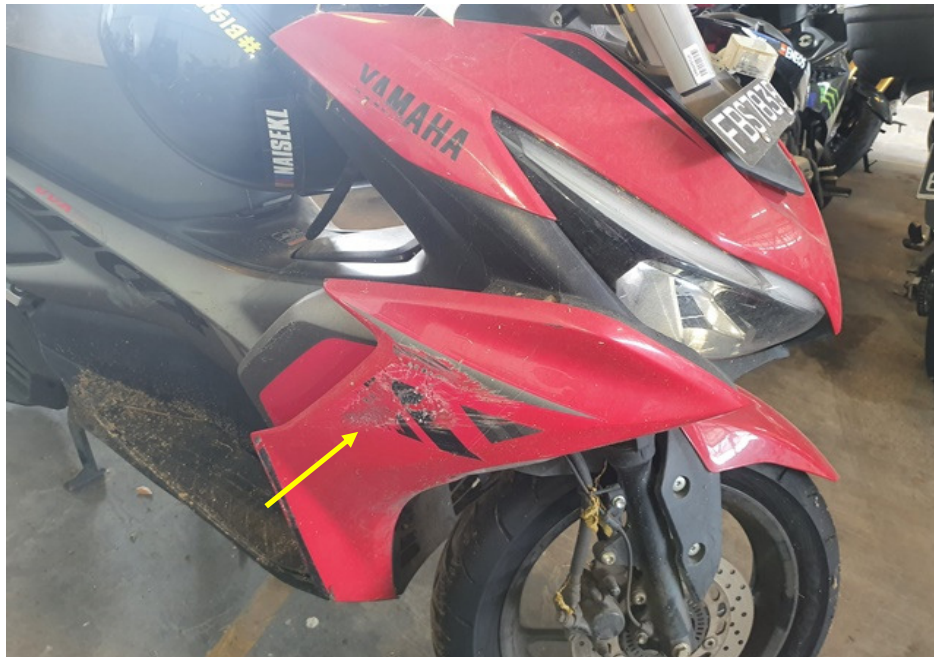
**Photo 9** shows a closer view of the grazed right cowling (arrowed) of the Motorcycle as a result of the accident.

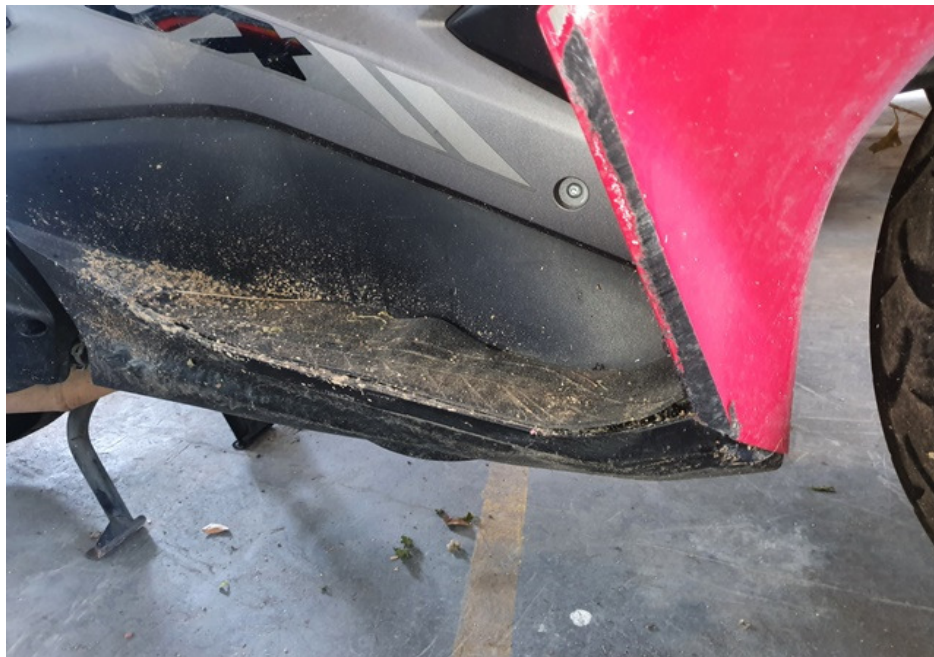
**Photo 10** shows a closer view of the right bottom cowling of the Motorcycle which was observed to be damaged due to the accident.

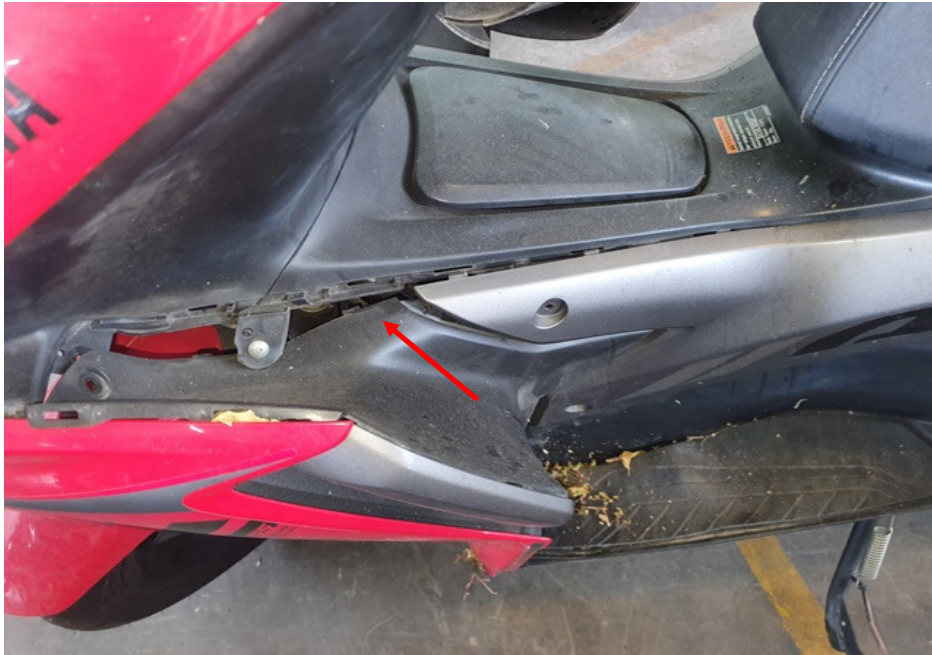
**Photo 11** show a closer view of the left inner panel of the Motorcycle which was observed to be damaged due to the accident (arrowed).

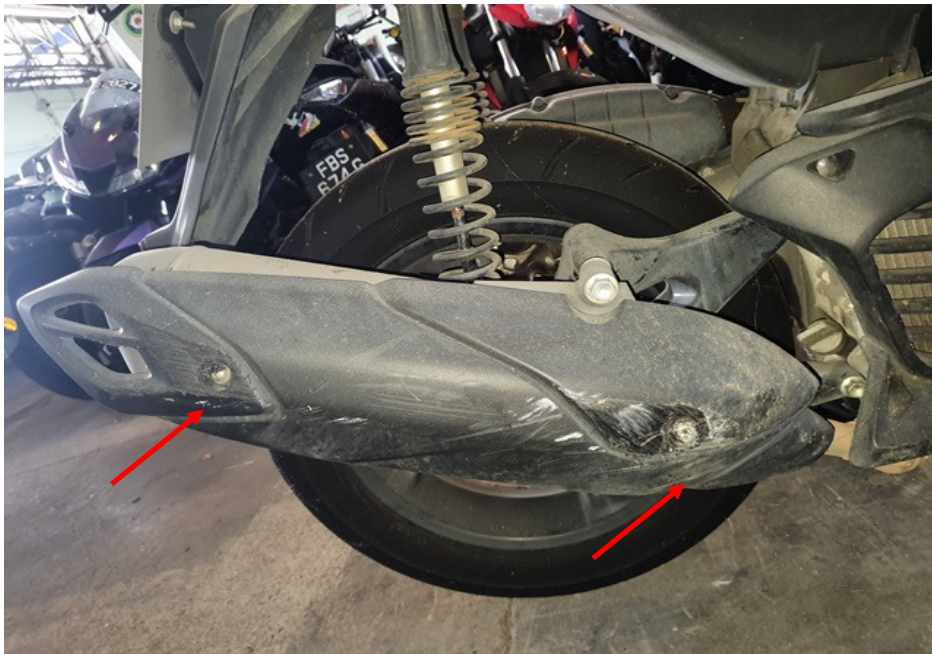
**Photo 12** shows a closer view of the grazed exhaust muffler heat shield (arrowed) of the Motorcycle as a result of the accident.

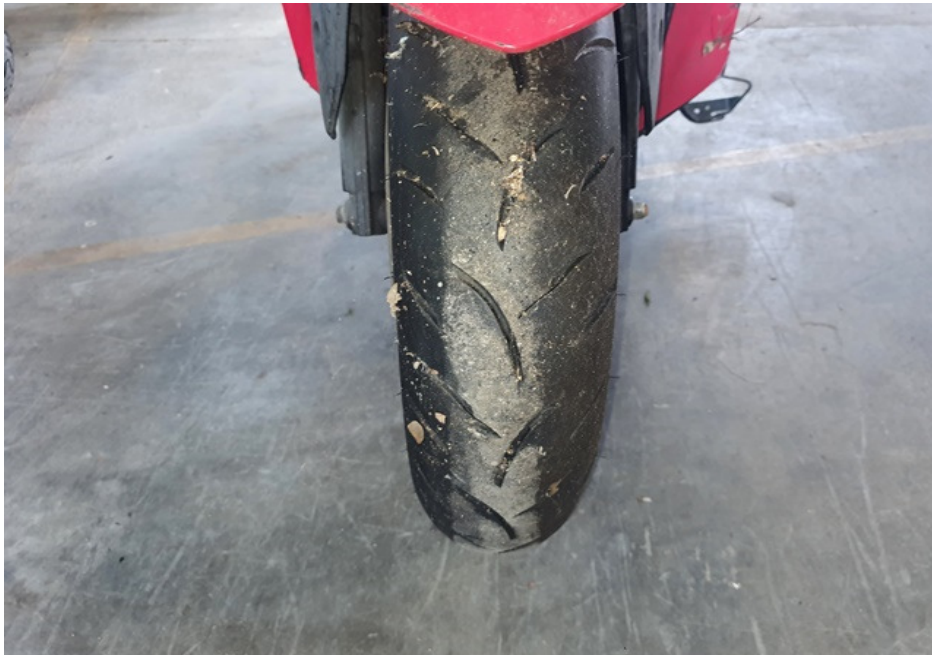
**Photo 13** shows the condition of the Motorcycle's front tyre. The front tyre was observed to be in serviceable condition with remaining tread depth of approximately 4mm. There was no tear, burst mark(s) and/or punctured hole(s) on the sidewalls as well as across the tread of the front tyre.

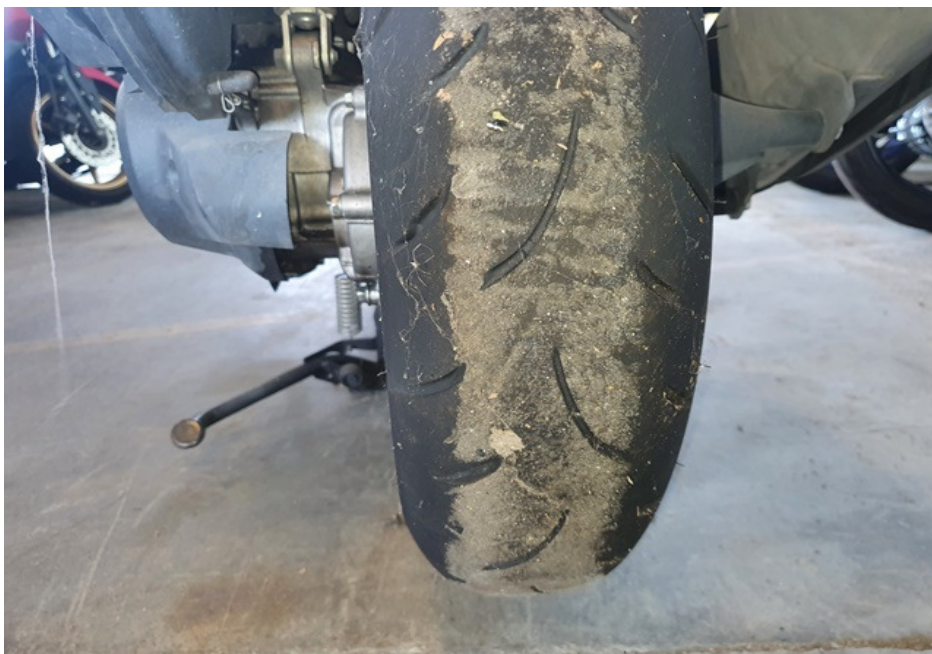
**Photo 14** shows the condition of the Motorcycle's rear tyre. The rear tyre was observed to be in serviceable condition with remaining tread depth of approximately 2mm. The tyre was also observed to be sufficiently inflated for vehicular operation. We did not observe any tear, burst mark(s) and/or punctured hole(s) on the sidewalls as well as across the tread of the rear tyre.

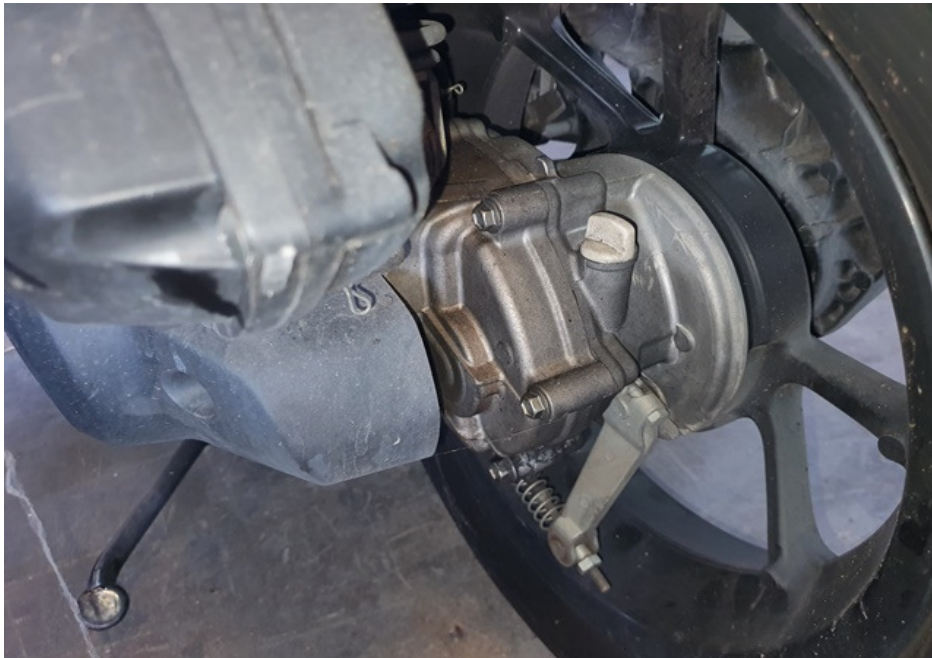
**Photo 15** shows the left side of the engine of the Motorcycle at the time of our inspection. The various engine related parts and components were found to be intact with no visible damage. There was also no sign(s) or indication(s) of fluid leak observed around the left engine area of the Motorcycle.

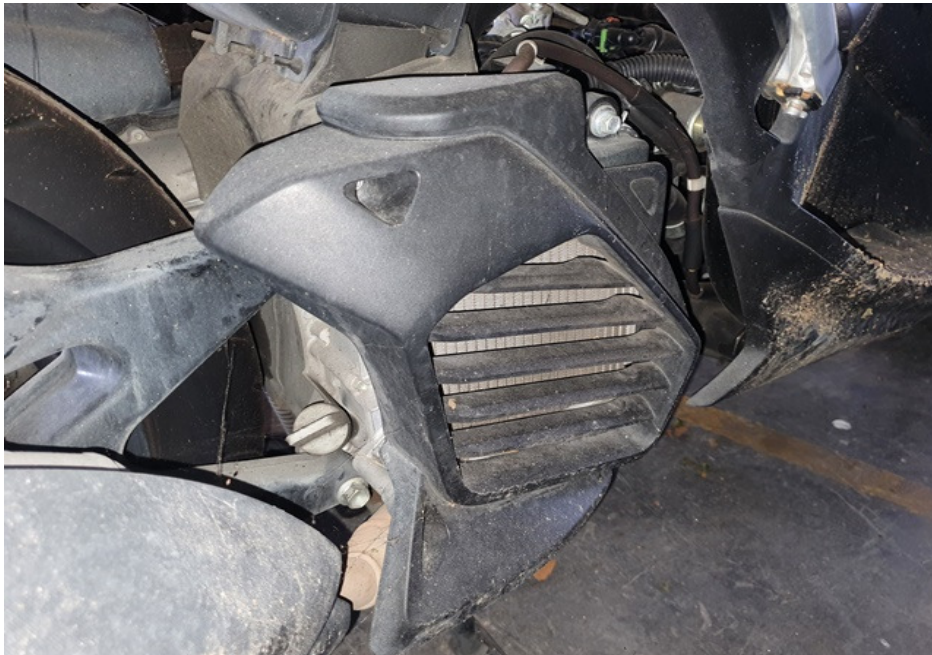
**Photo 16** shows the radiator of the Motorcycle at the time of our inspection. The radiator was found to be intact with no visible damage. There was also no sign(s) or indication(s) of fluid leak observed around the radiator of the Motorcycle.

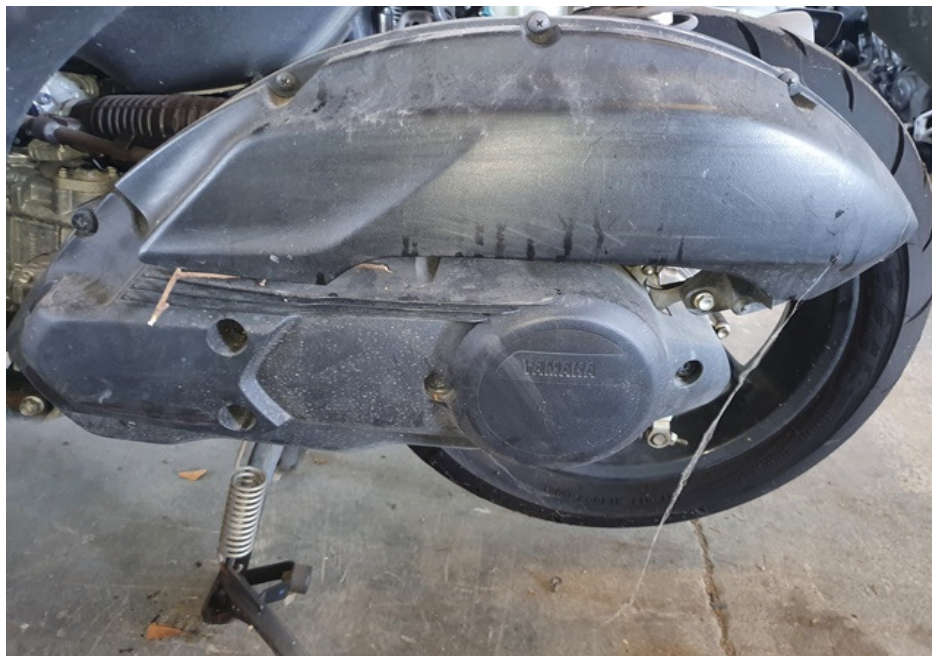
**Photo 17** shows the drive train of the Motorcycle which was found to be intact without any misalignment.

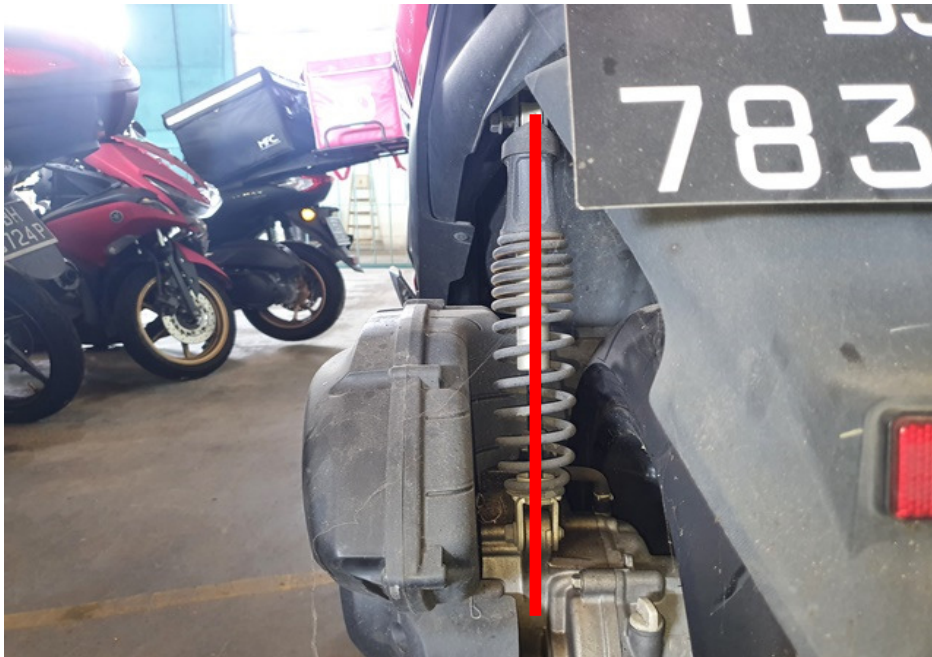
**Photo 18** shows the left shock absorber of the Motorcycle which was found to be intact without any misalignment.

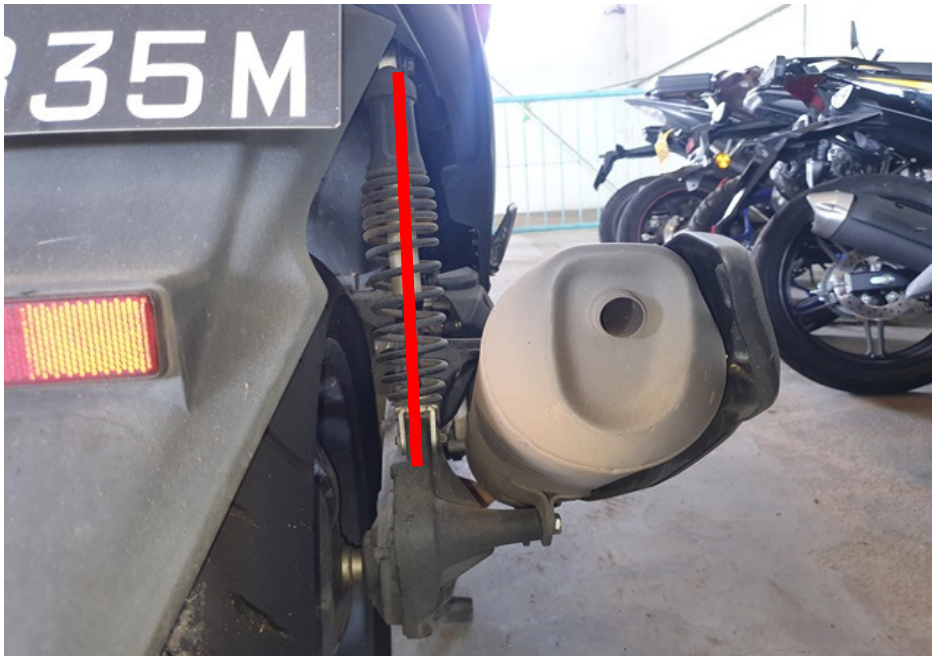
**Photo 19** shows the right shock absorber of the Motorcycle which was found to be intact without any misalignment.

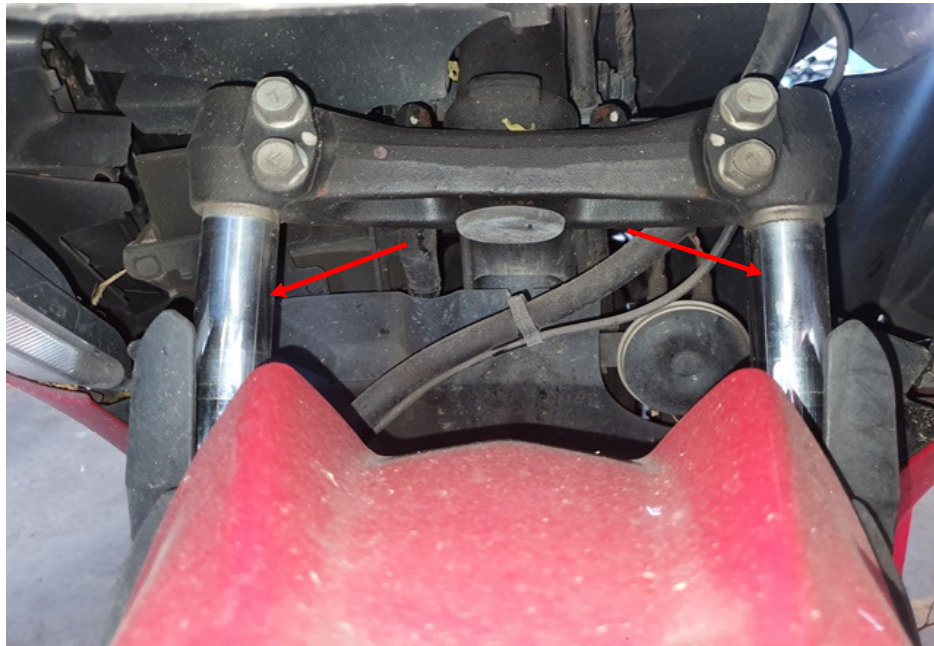
**Photo 20** shows the front forks (arrowed) of the Motorcycle. The front forks and fork brackets of the Motorcycle were both found to be intact and undamaged. Turning the Motorcycle's handle bar towards the left and right did not produce any abnormal free play and/or resistance. The steering system of the Motorcycle was in serviceable condition at the time of our inspection.

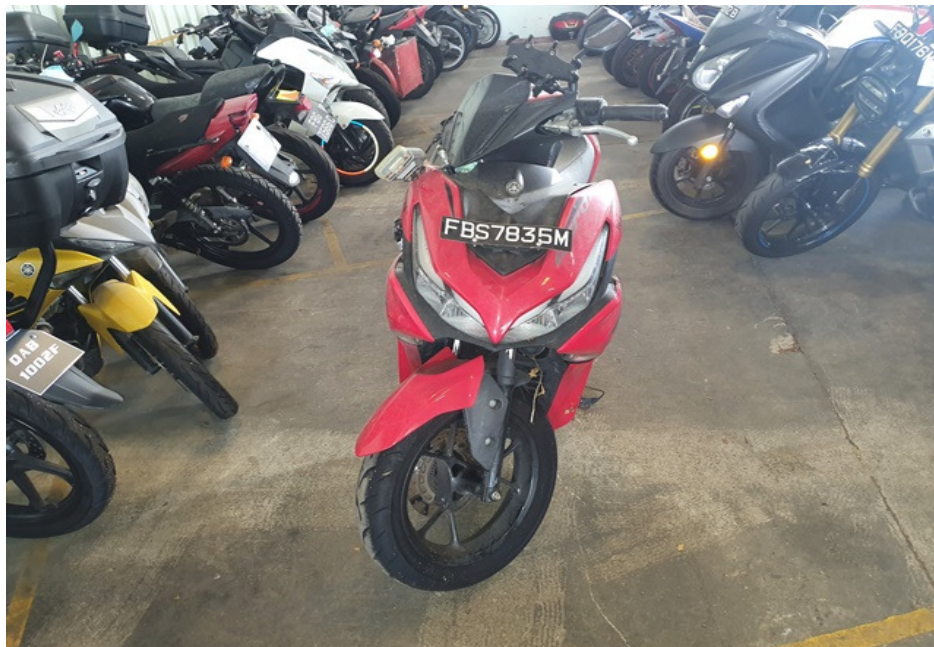
**Photo 21** shows the front wheel of the Motorcycle turned towards its full right. Turning the Motorcycle's handle bar towards the left and right did not produce any abnormal free play and/or resistance. This would indicate that the steering system of the Motorcycle was in serviceable condition at the time of our inspection.

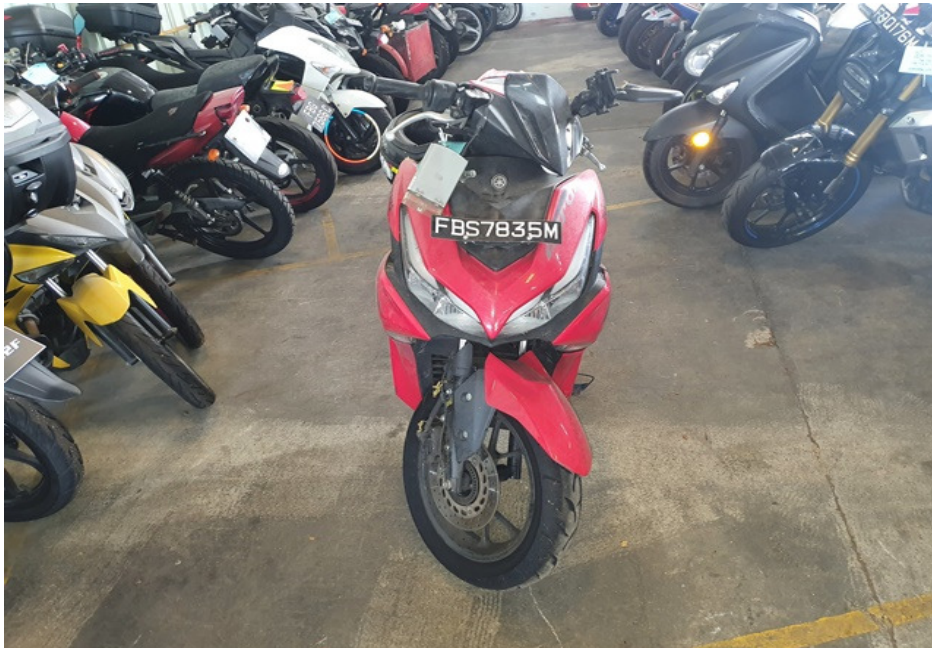
**Photo 22** shows the front wheel of the Motorcycle turned towards its full left. Turning the Motorcycle's handle bar towards the left and right did not produce any abnormal free play and/or resistance. This would indicate that the steering system of the Motorcycle was in serviceable condition at the time of our inspection.

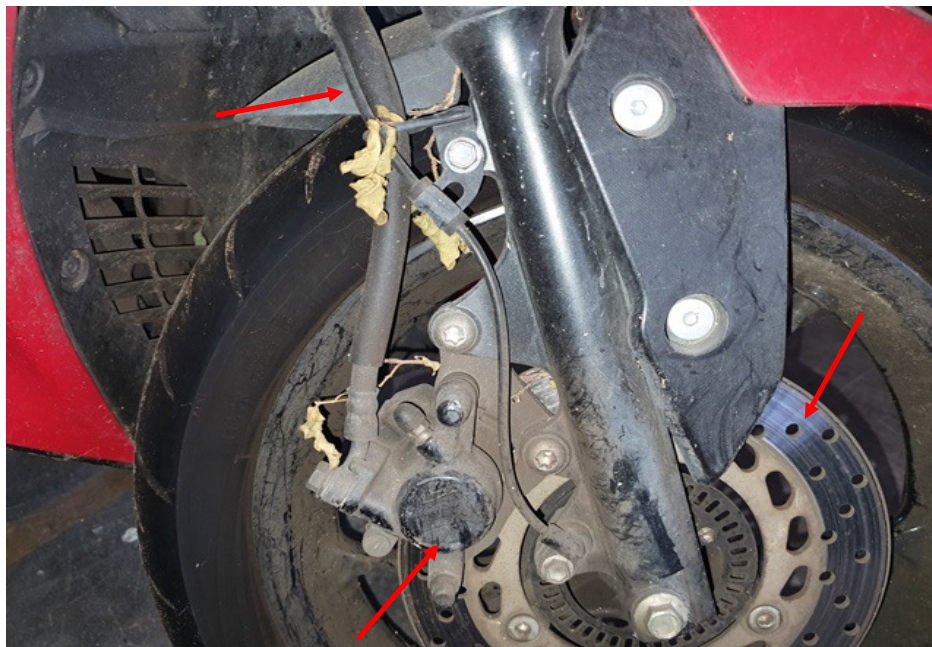
**Photo 23** shows a close up view of the front brake caliper, front brake disc and front brake hose (arrowed) of the Motorcycle, which are all part of the components in the hydraulic front brake system of the Motorcycle. Our visual checks of these various components had revealed all to be intact with no visible damage. No leakage of brake fluid was also observed.

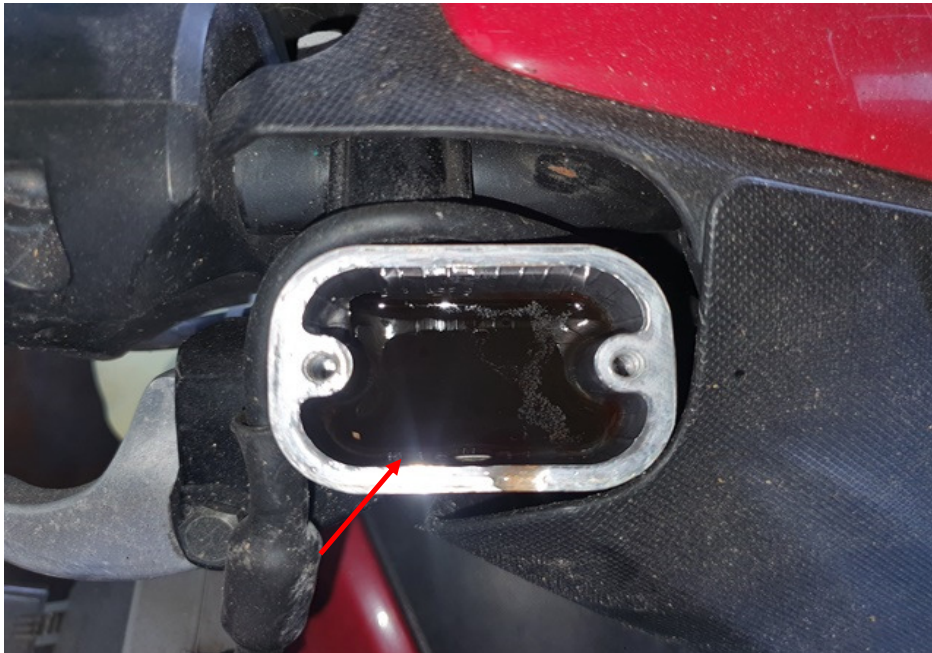
**Photo 24** shows a close up view of the brake fluid reservoir for the front brake of the Motorcycle. The brake fluid was observed to be of sufficient level for operational purposes. However it was found to be slightly contaminated (arrowed).

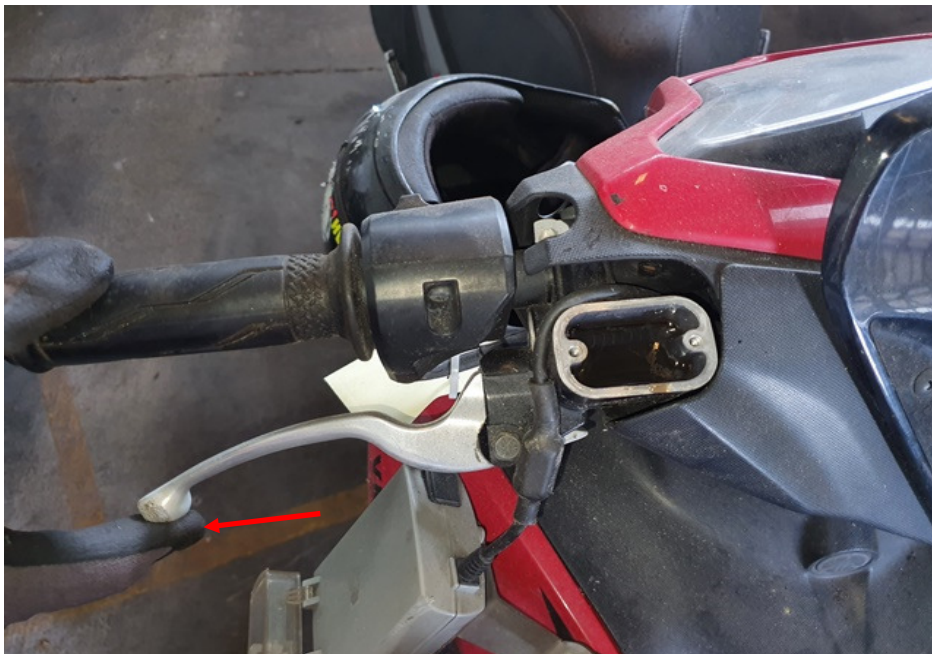
12. Static brake tests conducted on the Motorcycle had appeared to indicate that the brake system of the Motorcycle was in serviceable condition. There was some resistance felt (spongy like feel) upon pressing the front brake lever. This would indicate that there's no leakage of pressure/vacuum in the front brake system.

**Photo 25** shows the front brake lever being depressed. There was some resistance felt (spongy like feel) upon pressing the front brake lever (arrowed). This would indicate that there is no leakage of pressure/vacuum in the front brake system.

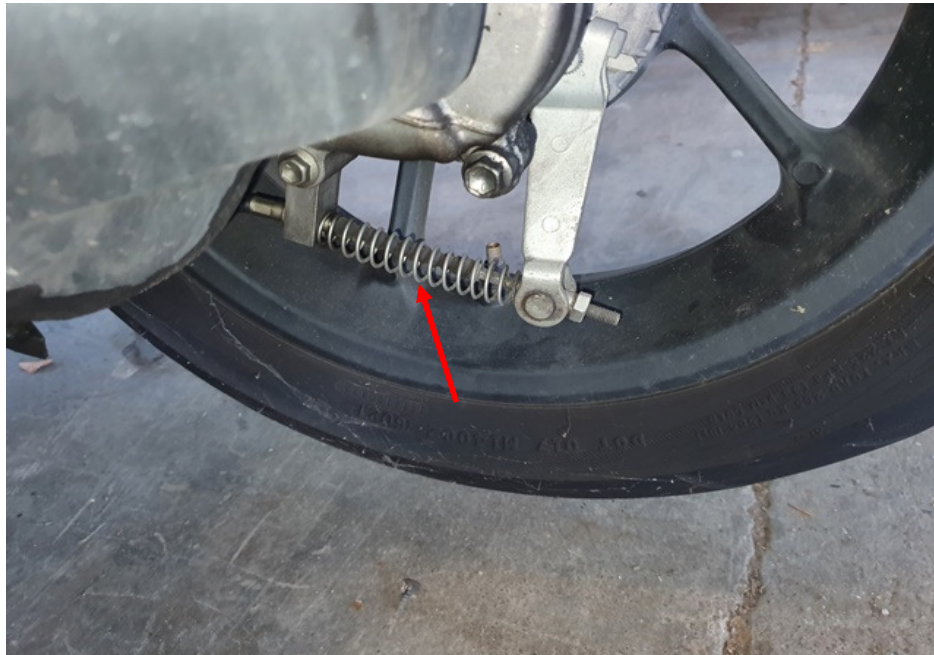
**Photo 26** shows the rear wheel of the Motorcycle. The type of brake system for the rear wheel was of a mechanical type, controlled by the brake foot pedal of the Motorcycle. Our checks of the cable (arrowed), spring and drum which are all part of the components in the rear brake system of the Motorcycle reveal all to be intact and without damage.
