Your Ref: TP IP/03413/2023
Our Ref : CI/TPD23001398/N

Fatal Accident Investigation Team

MECHANICAL INSPECTION REPORT OF MOTOR CAR SKU 6576A

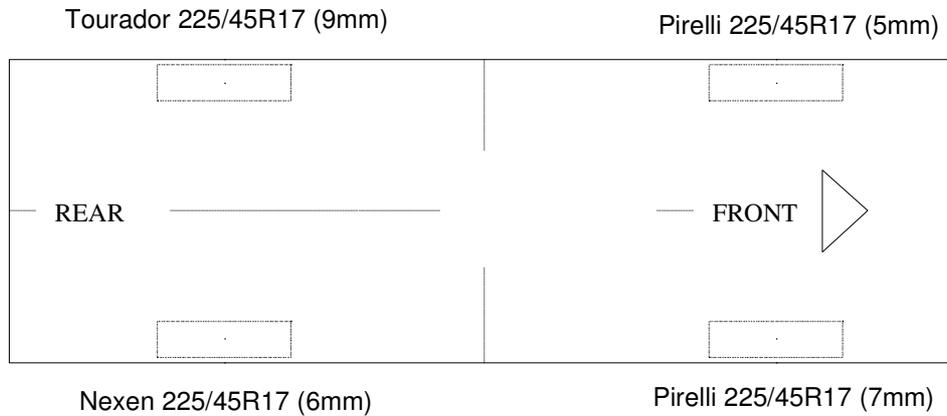
6. The condition of the Motor Car’s 4 tyres was observed to be in serviceable condition. We did not find any tear, cut or burst mark(s) on the outer and the inner sidewalls as well as across the tread of the 4 tyres. The 4 tyres were also observed to be sufficiently inflated for vehicular operation. The tyre brand, tyre size and remaining tread depth of the 4 tyres were recorded as follows:-

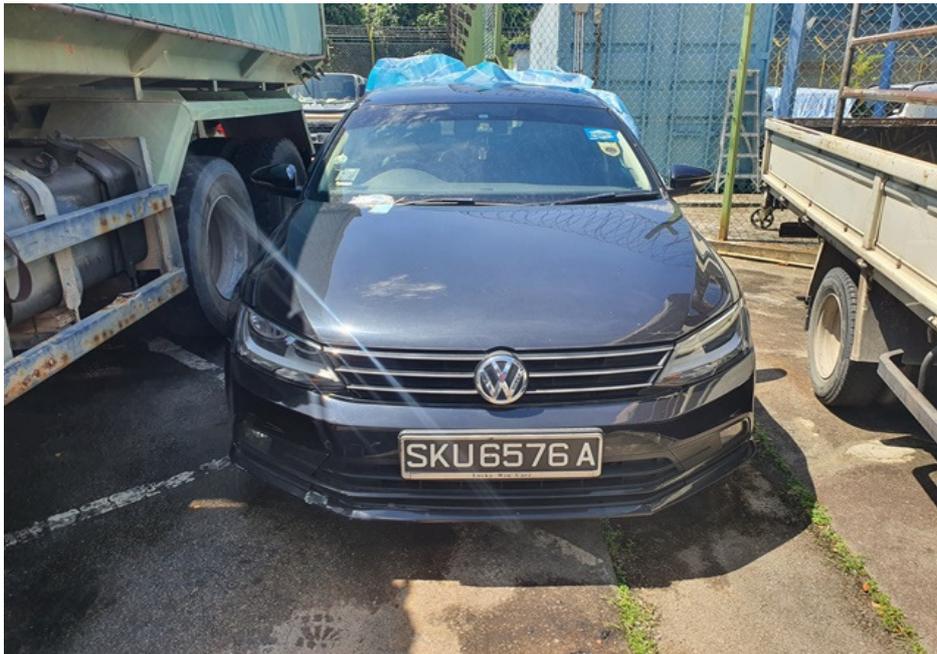
Photo 1 shows a general view of the frontal portion of the Motor Car at the time of our inspection. The Motor Car was observed to be in good general condition except for some relatively minor impact damage at its right frontal portion. The mileage of the Motor Car was recorded to be 188, 690km.

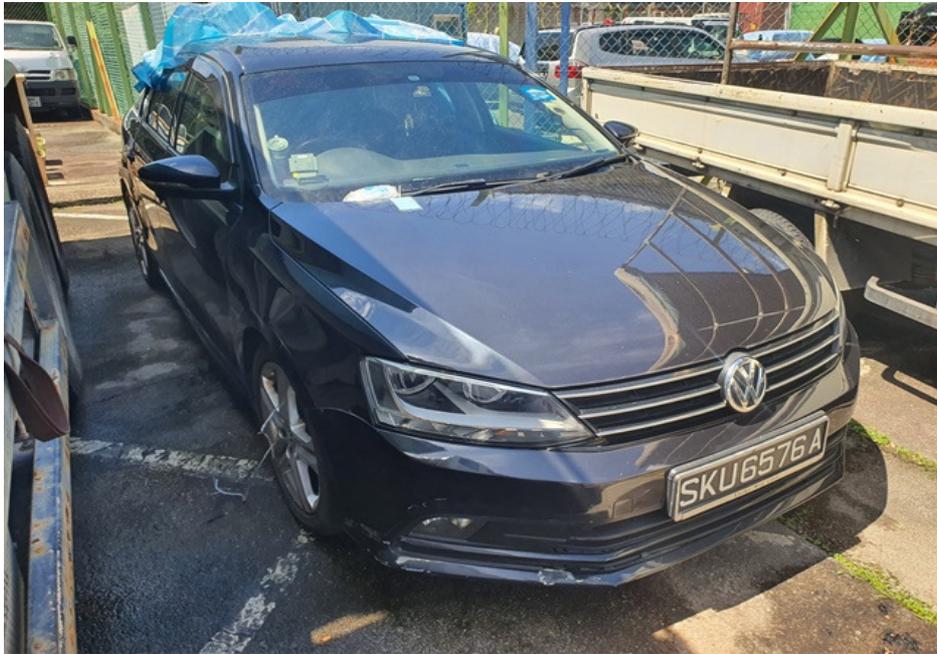
4. The mileage of the Motor Car at the time of our inspection was 188, 690km.
5. The Motor Car had sustained relatively minor impact damage that was confined to its right frontal portion. Its right front fender was observed to have been dented; its front bumper was cracked, its right fog lamp was observed to be grazed while its front number plate holder was observed to be deformed.

Photo 2 shows a general view of the front right body of the Motor Car at the time of our inspection. The Motor Car was observed to be in good general condition. However we had observed relatively minor impact damage that was confined to its right frontal portion. Its right front fender was observed to have been dented; its front bumper was cracked, its right fog lamp was observed to be grazed while its front number plate holder was observed to be deformed.

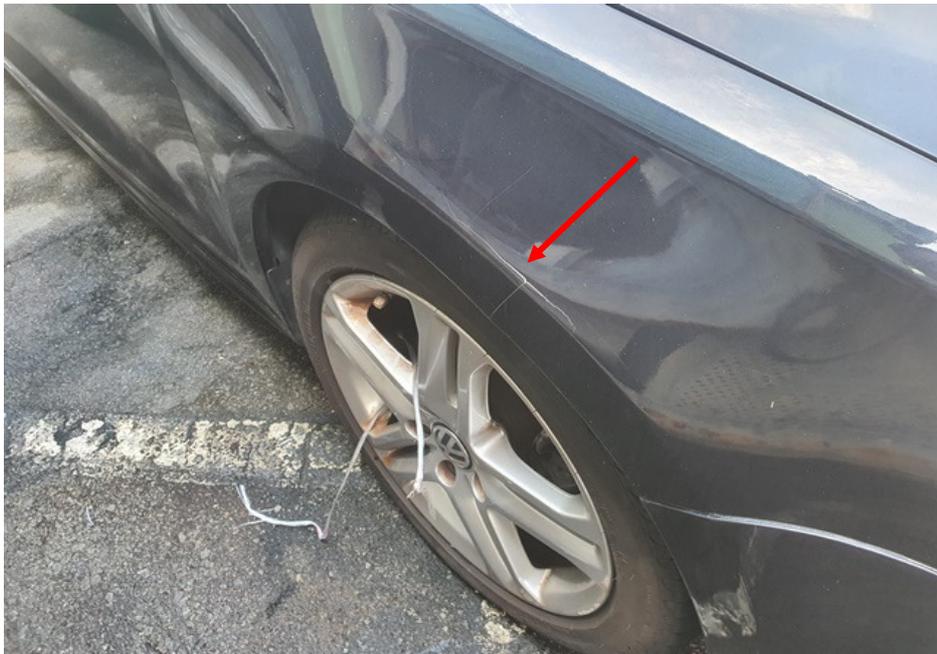
Photo 3 shows a closer view of the dented right front fender of the Motor Car at the time of our inspection (arrowed).

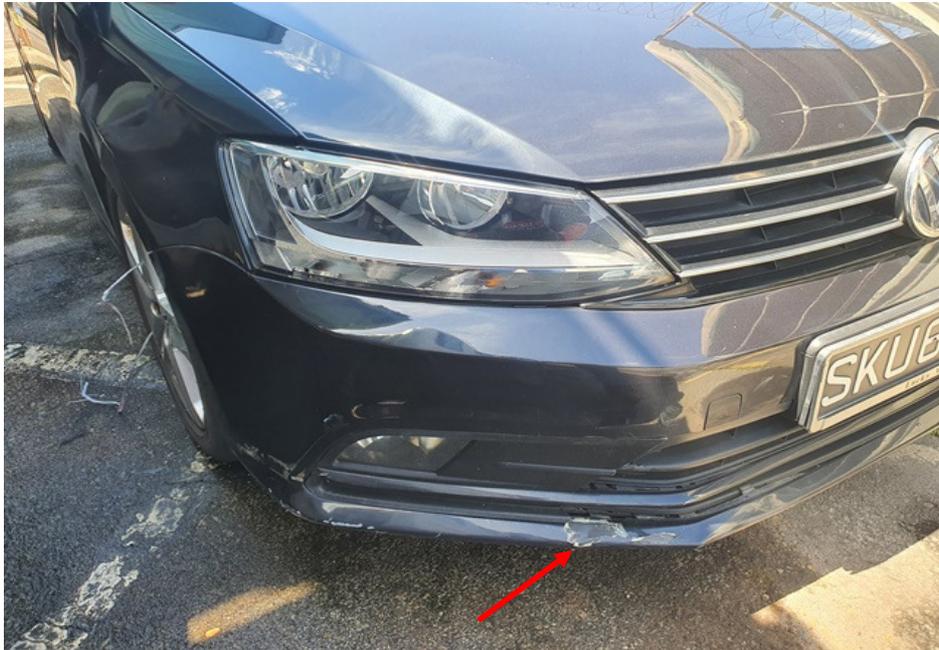
Photo 4 shows a closer view of the cracked front bumper (arrowed) of the Motor Car at the time of our inspection

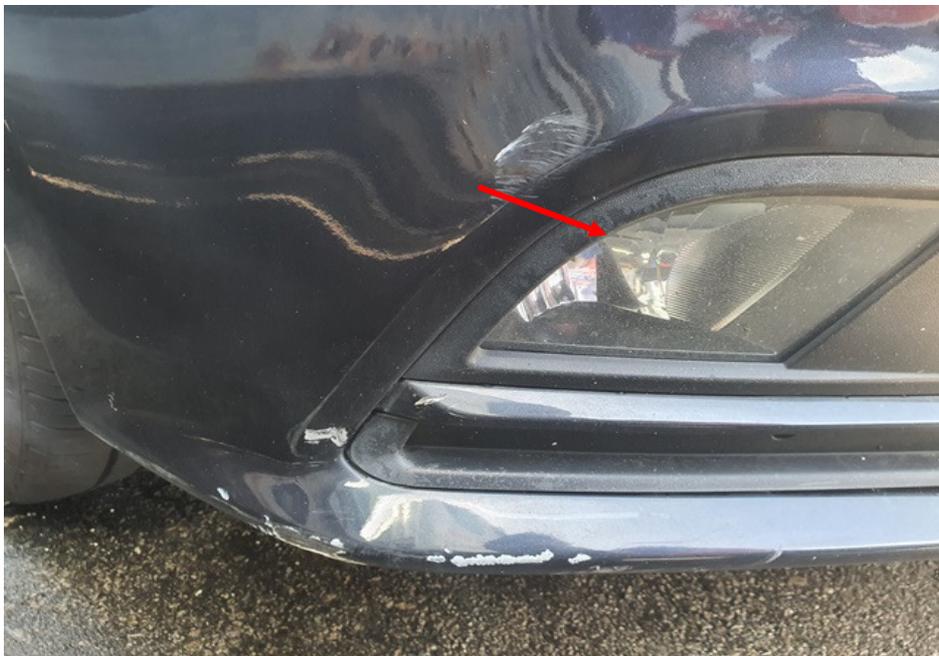
Photo 5 shows a closer view of the grazed right fog lamp (arrowed) of the Motor Car at the time of our inspection

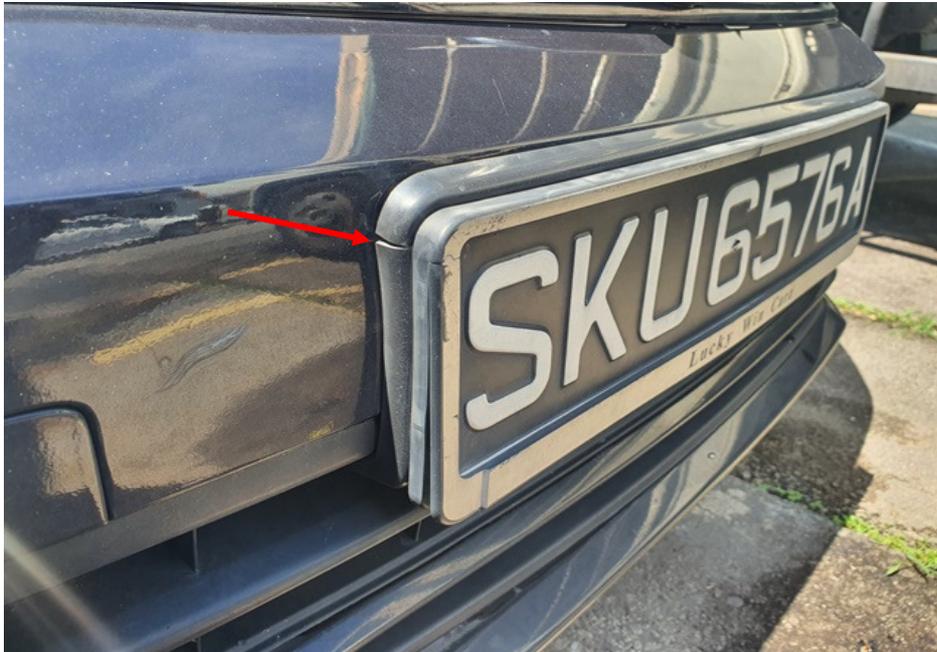
Photo 6 shows a closer view of the deformed front number plate holder (arrowed) of the Motor Car at the time of our inspection.

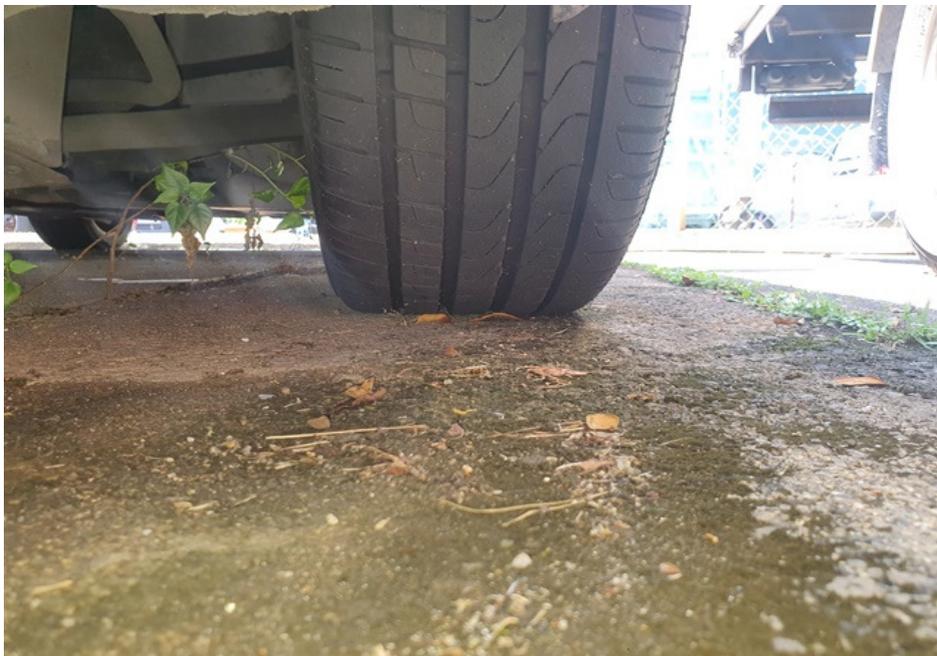
Photo 7 shows the condition of the front left tyre of the Motor Car, which was observed to be in serviceable condition with remaining tread depth of approximately 6mm. The tyre, which was wrapped around alloy wheel rim, was also observed to be sufficiently inflated for vehicular operation. There was no tear, cut or burst mark(s) on the outer and the inner sidewalls as well as across the tread of the 4 tyres.

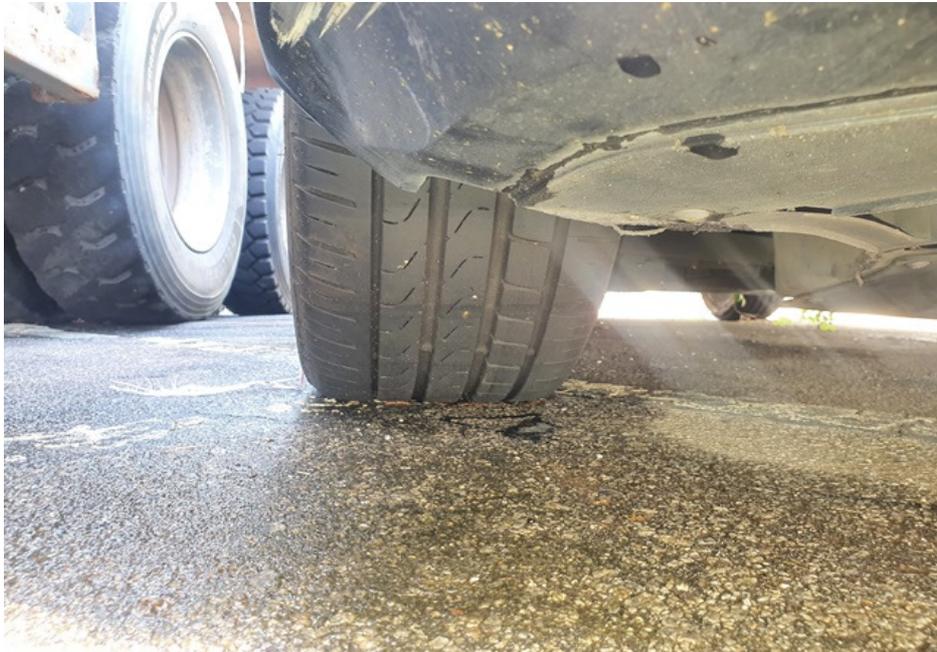
Photo 8 shows the condition of the front right tyre of the Motor Car, which was observed to be in serviceable condition with remaining tread depth of approximately 7mm. The tyre, which was wrapped around alloy wheel rim, was also observed to be sufficiently inflated for vehicular operation.

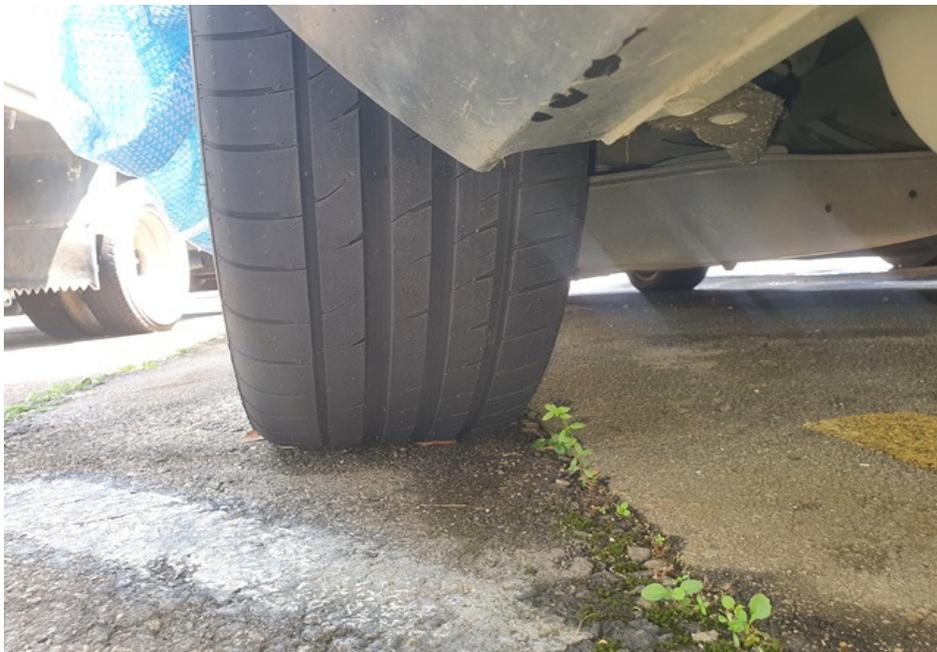
Photo 9 shows the condition of the rear left tyre of the Motor Car, which was observed to be in serviceable condition with remaining tread depth of approximately 5mm. The tyre, which was wrapped around alloy wheel rim, was also observed to be sufficiently inflated for vehicular operation. There was also no damage found on the 4 wheel rims of the Motor Car.

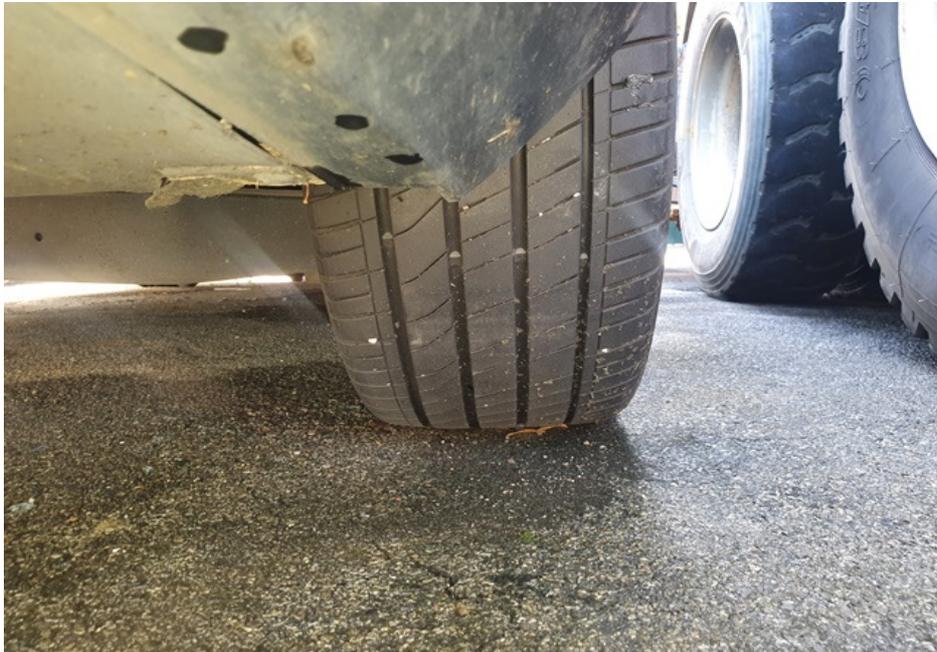
Photo 10 shows the condition of the rear right tyre of the Motor Car, which was observed to be in serviceable condition with remaining tread depth of approximately 9mm. There was also no tear, cut or burst mark(s) on the outer and the inner sidewalls as well as across the tread of the 4 tyres.

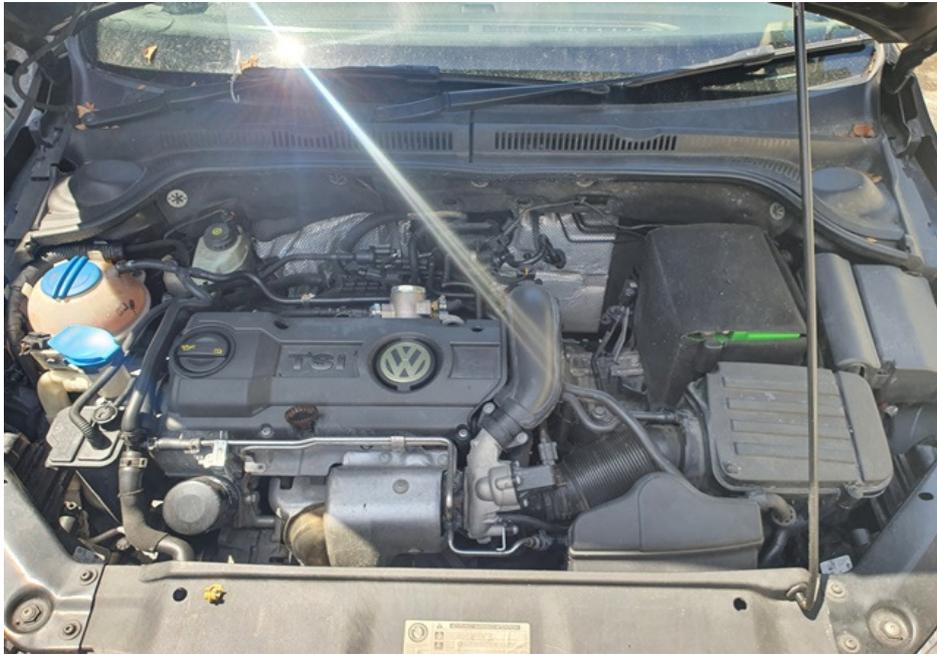
Photo 11 shows a general view of the Motor Car's engine compartment. The various parts and components inside the engine compartment were unaffected by the accident. There was also no sign(s) or indication(s) of fluid leakage and/or fluid stain within the engine compartment.

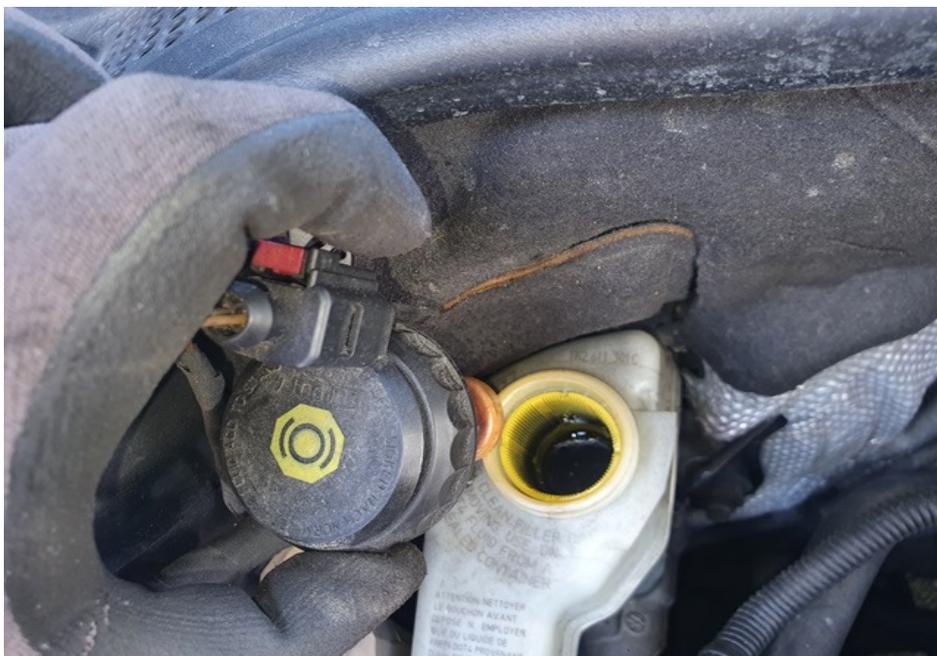
Photo 12 shows the brake fluid reservoir of the Motor Car at the time of our inspection. The brake fluid was observed to be of sufficient level for operating purposes and without any visible contamination.

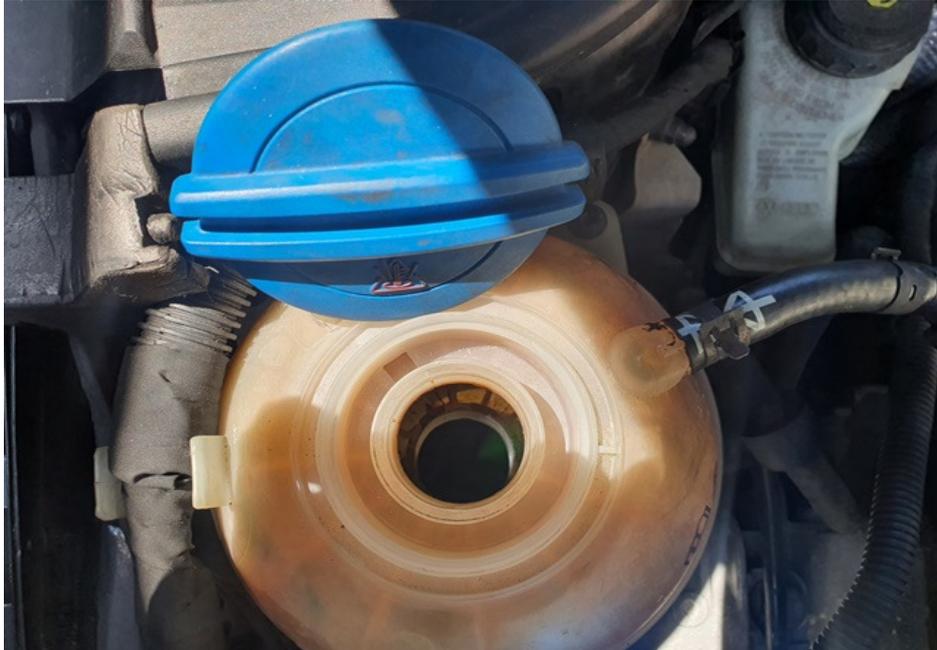
Photo 13 shows checks being carried out to the engine coolant of the Motor Car at the time of our inspection. The engine coolant was observed to be of sufficient level for operating purposes and without any visible contamination.

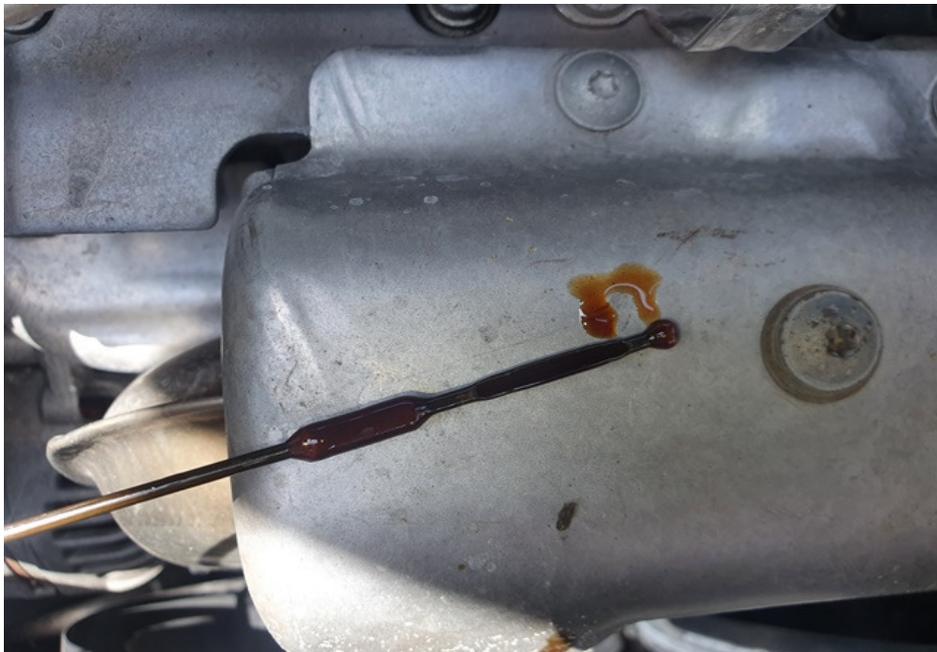
Photo 14 shows the engine oil dip stick of the Motor Car at the time of our inspection. The engine oil was observed to be of sufficient level for operating purposes and without any visible contamination.

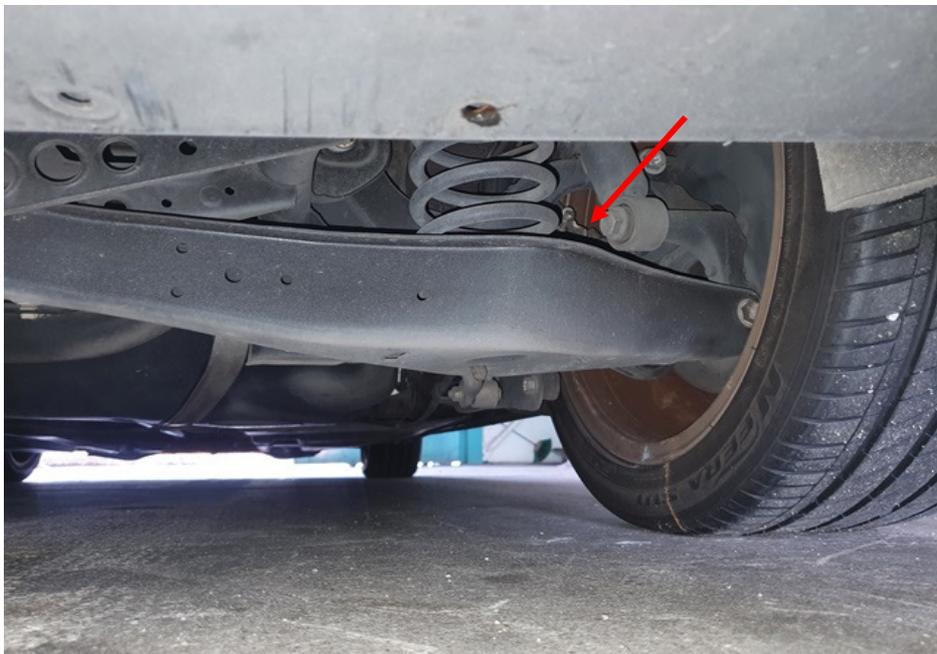
11. Static brake tests conducted on the Motor Car revealed no abnormality. There was no abnormal movement of the brake pedal when it was depressed. In general, the static brake tests had suggested that there was no internal leakage of pressure/vacuum in the braking system of the Motor Car. The braking system of the Motor Car was likely to be in serviceable condition at the material time. This was taking into consideration that the brake fluid was of sufficient level, and also that there was no sign(s) of brake fluid leakage along the brake hoses and brake pipes.

Photo 15 shows the brake hose/pipe (arrowed) at the rear right wheel of the Motor Car. We did not observe any leakage of brake fluid at the time of our inspection of the Motor Car. Static tests of the Motor Car's braking system had indicated that there was no internal leakage of pressure/vacuum. Hence the braking system was likely to be in serviceable condition at the material time of accident. The undercarriage components of the Motor Car were also all found to be intact and without any visible damage.

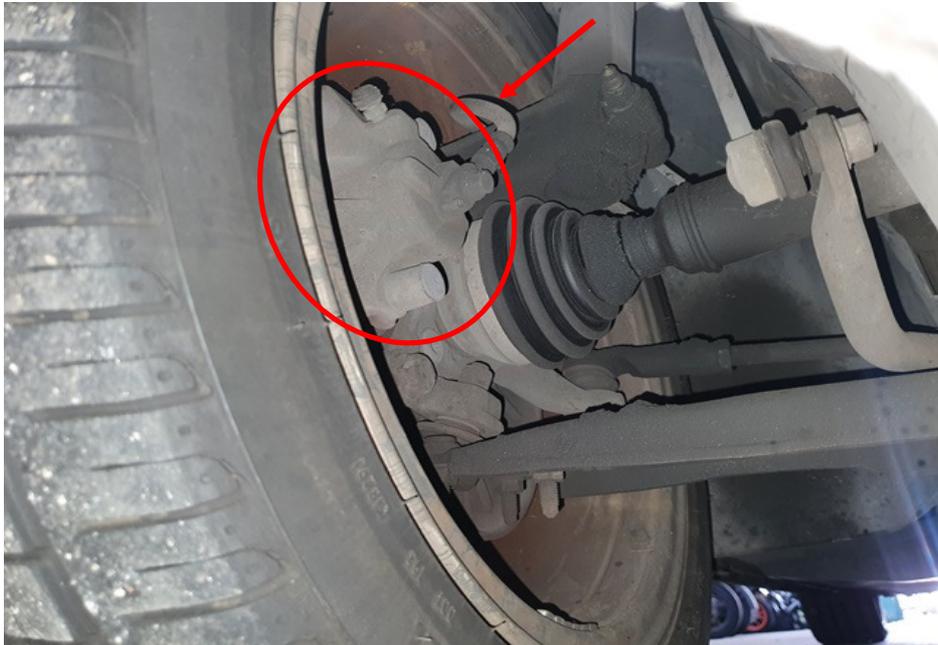
Photo 16 shows the brake hose/pipe (arrowed) at the front right wheel of the Motor Car. No leakage of brake fluid was observed. Visual examination of the various components of the braking system like the brake caliper (circled), brake pedal etc. had revealed all to be intact and without visible damage.

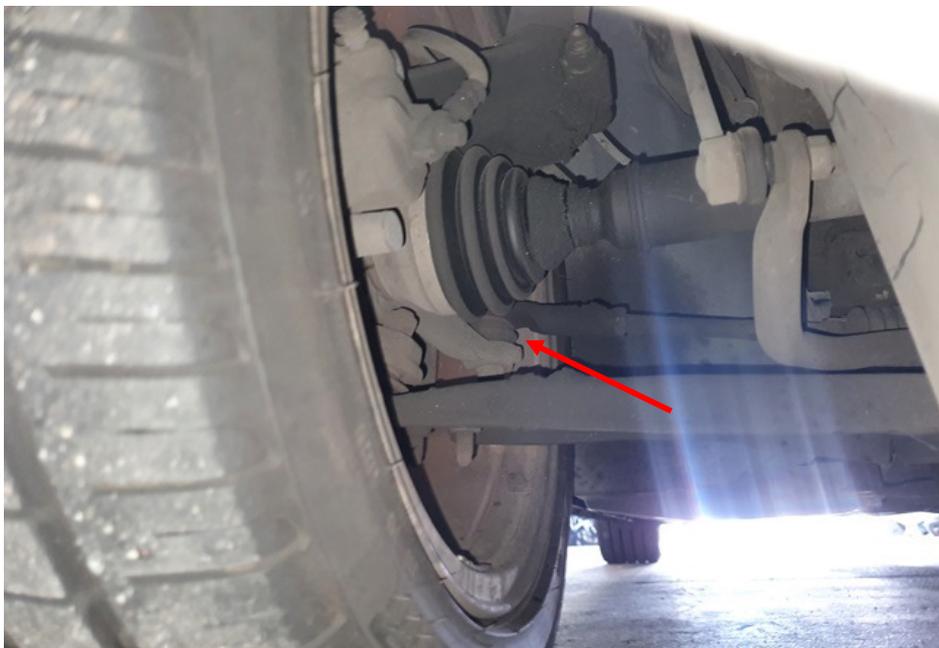
12. Static test on the steering system of the Motor Car also revealed no abnormality to the steering system. We did not experience any abnormal free play and/or other resistance when turning the steering wheel left and right to full lock positions. Our visual examination of the various steering components which had included the steering rack and pinion, tie rods, tie rod ends and ball joints revealed that these components were all generally in good condition. See photos 15 - 20 below.

Photo 17 shows the various undercarriage components at the front right wheel of the Motor Car, in particular the steering tie rod (arrowed). The various steering components were all found to be intact, suggesting that the steering system of the Motor Car was likely to be in serviceable condition at the material time of accident. There was also no sign of fluid stain observed on the various undercarriage components at the front right wheel of the Motor Car.

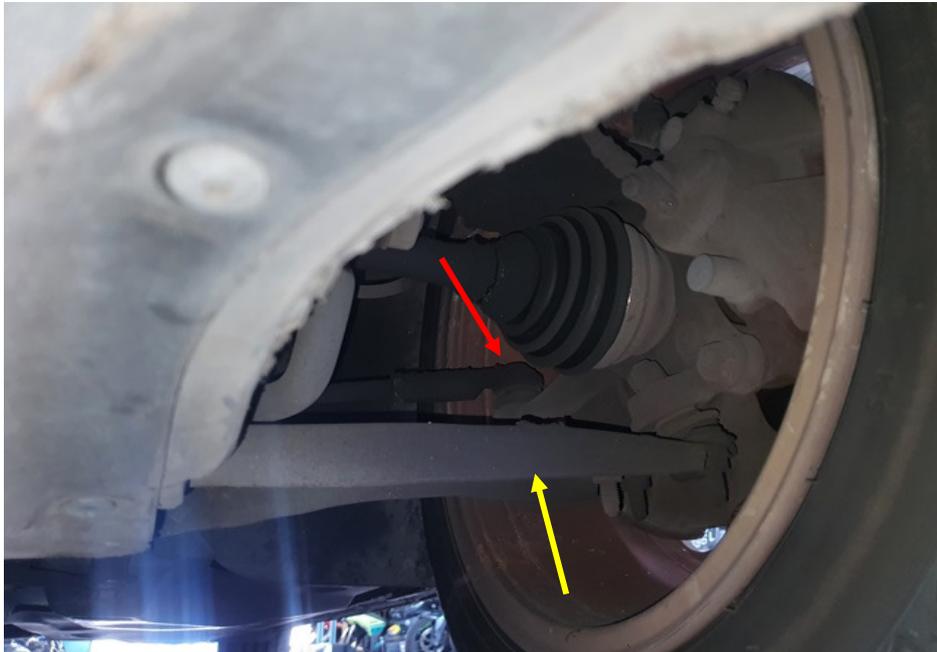
Photo 18 shows the various undercarriage components at the front left wheel of the Motor Car, which had included the steering tie rod (red arrow) and left drive shaft (yellow arrow). The various undercarriage components of the Motor Car were all found to be intact without any visible damage.

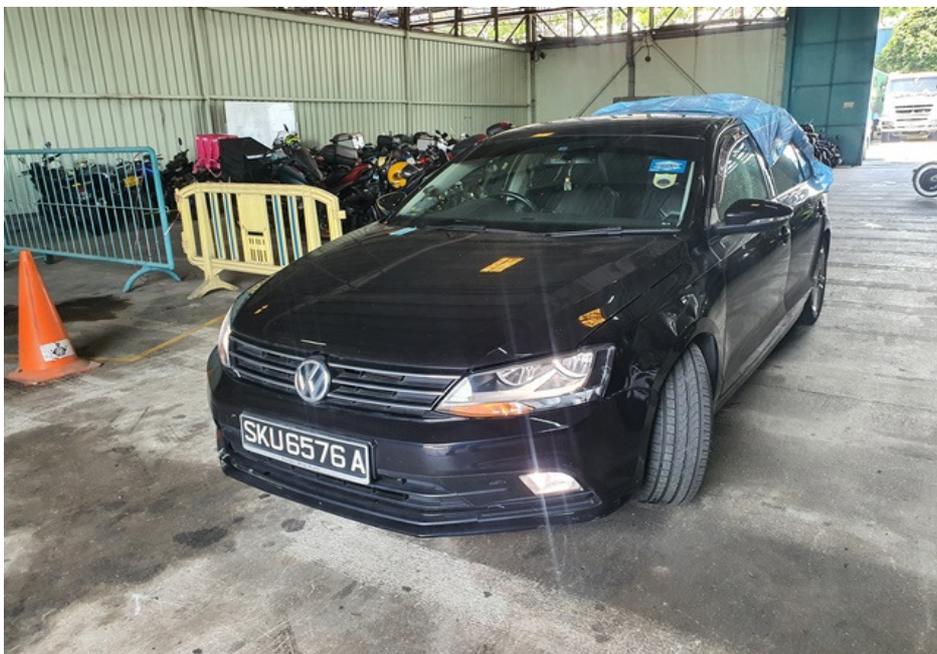
Photo 19 shows the front left wheel of the Motor Car turned to its full left. During our steering system test, we did not experience any abnormal free play and/or resistance when we had turned the steering wheel towards the left and right. This would suggest that the steering system of the Motor Car was likely to be in serviceable condition at the material time of accident.

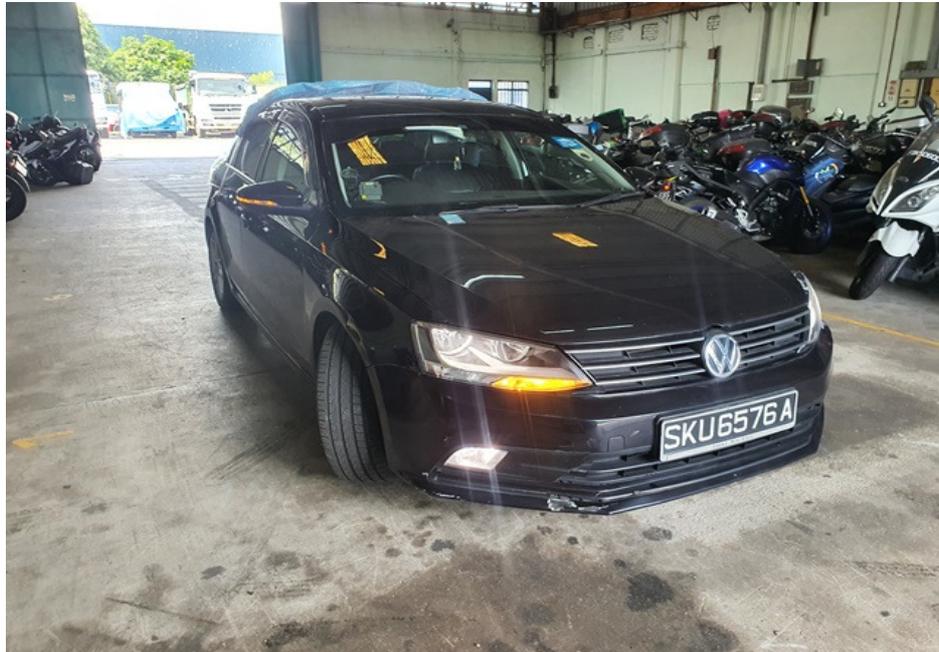
Photo 20 shows the front right wheel of the Motor Car turned to its full right. During our steering system test, we did not experience any abnormal free play and/or resistance when we had turned the steering wheel towards the left and right. This would suggest that the steering system of the Motor Car was likely to be in serviceable condition at the material time of accident.

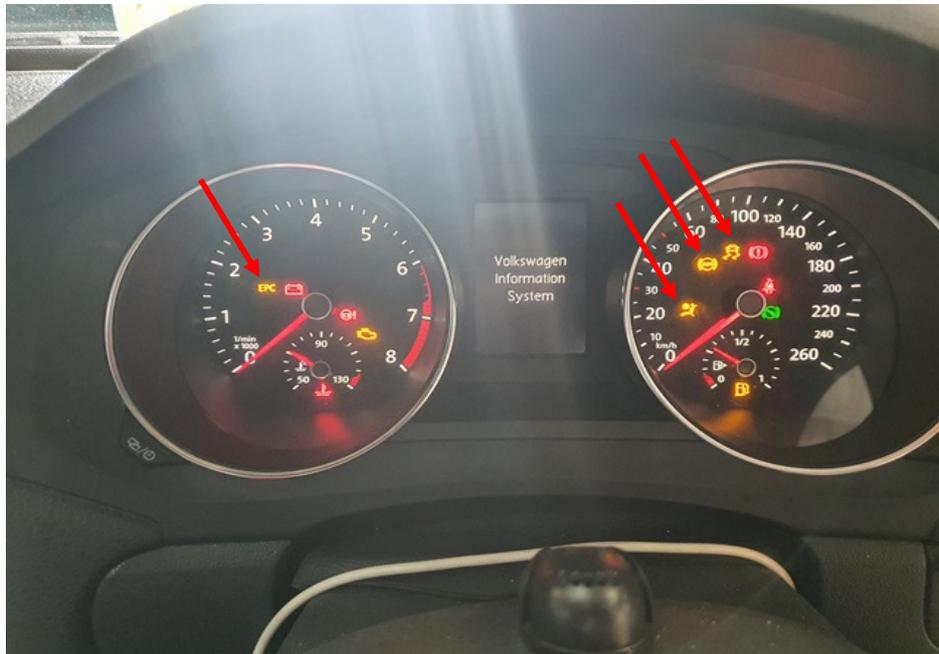
Photo 21 shows the instrument panel Motor Car during the self-test when the engine is cranked.

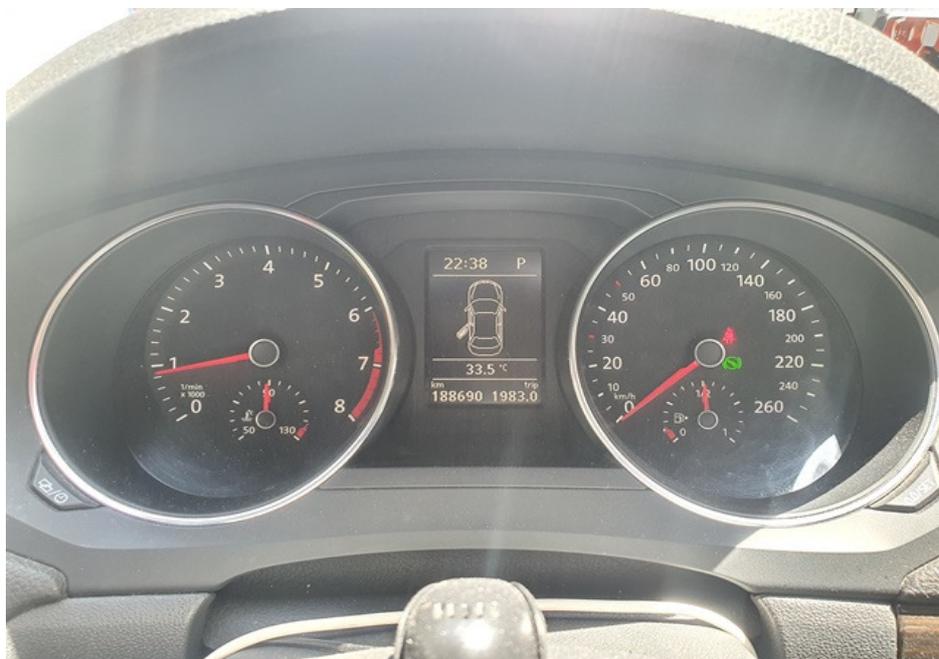
13. The Motor Car's automatic self-test of the functionality of its various electronic operating systems like the Anti-Brake Lock System (ABS), Electronic Power Control (EPC), Electronic Power Steering (EPS) and Supplemental Restraint System (SRS) during cranking of the engine had indicated that these systems were in working condition and without abnormality. This can be established from the warning lights disappearing from the instrument panel after the self-test. See photos 21 & 22 below.

Photo 22 shows no warning lights illuminated on the instrument panel of the Motor Car after the engine was cranked. This would suggest that there was no abnormality to the various electronic operating systems of the Motor Car, like the ABS, EPC, EPS and SRS etc.
