Your Ref: TP IP/03413/2023  
Our Ref : CI/TPD23001399/N

**Fatal Accident Investigation Team**

**INSPECTION REPORT OF POWER ASSISTED BICYCLE PAB X763-  
TRAFFIC POLICE POUND REPORT NO. PR 0651/23**

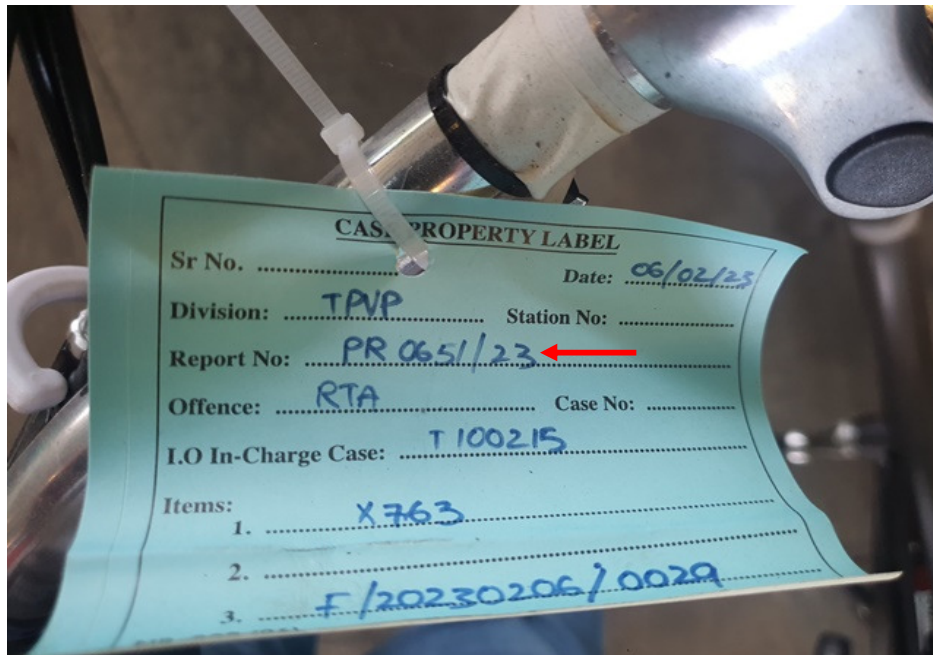
**Photo 1** shows the identification of the PAB with reference to Traffic Police Pound Report No. PR 0651/23 (arrowed).

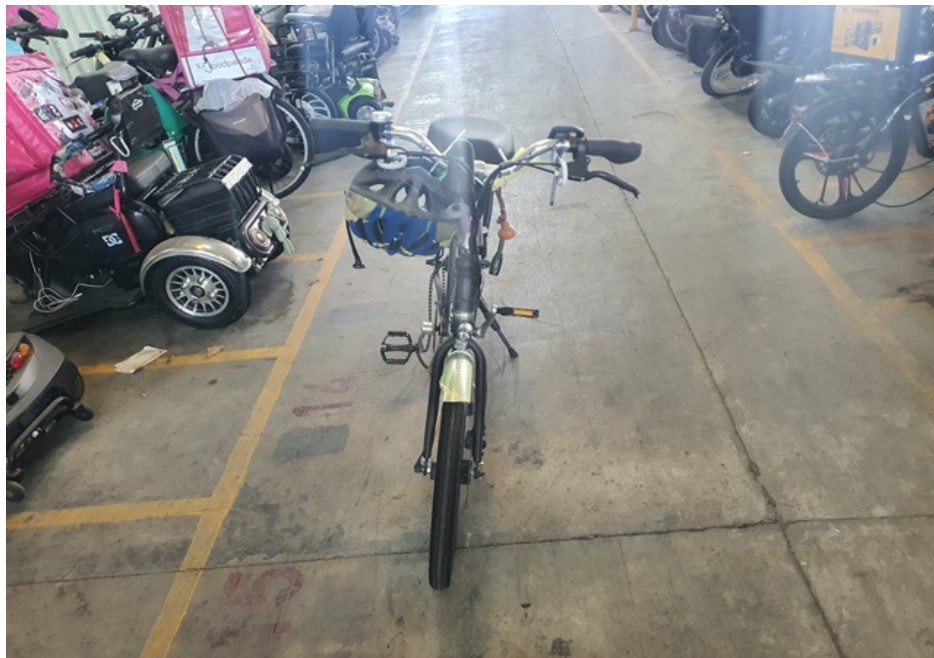
4. The PAB had sustained damages all around. The body parts that were found to have been damaged include its left hand brake lever, pedals, seat and rear number plate, amongst others as a result of the accident. See photos 1 - 11 below.

**Photo 2** shows the frontal portion of the PAB at the time of our inspection. The PAB was observed to have sustained damages all around.

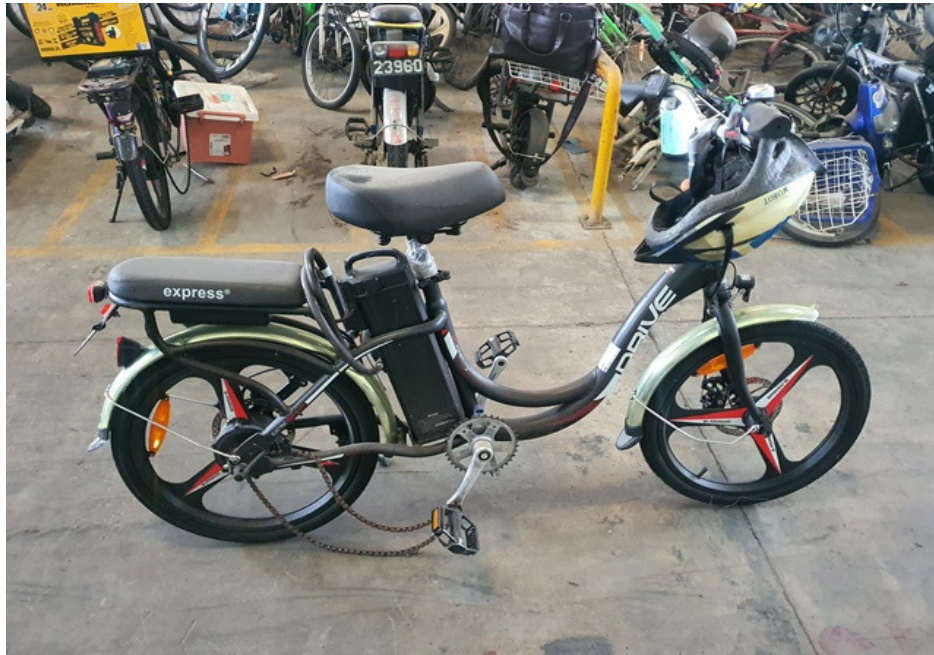
**Photo 3** shows the right body of the PAB at the time of our inspection. The PAB was observed to have sustained damages all around.

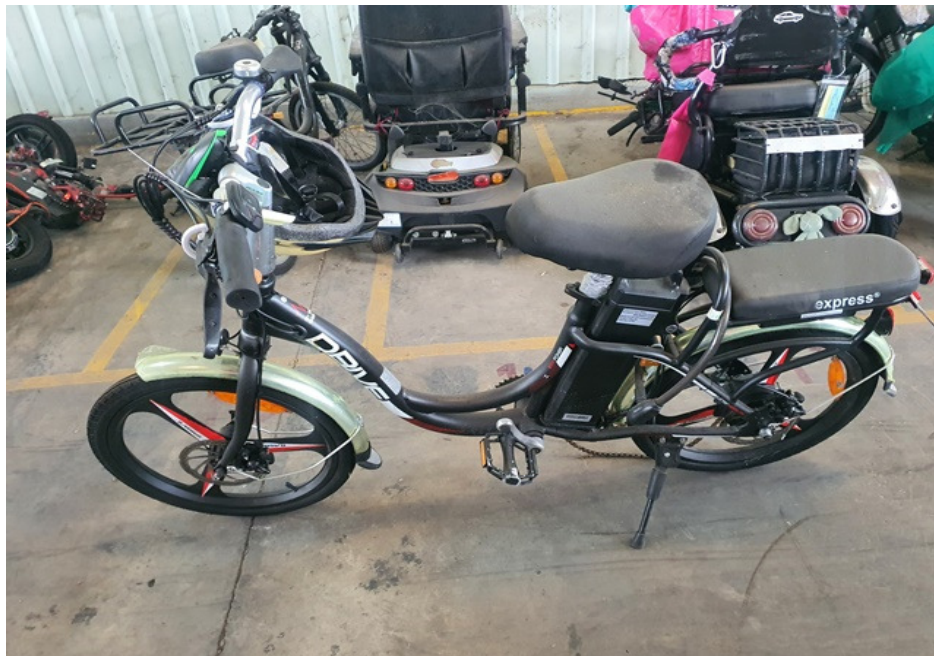
**Photo 4** shows the left body of the PAB at the time of our inspection. The PAB was observed to have sustained damages all around.

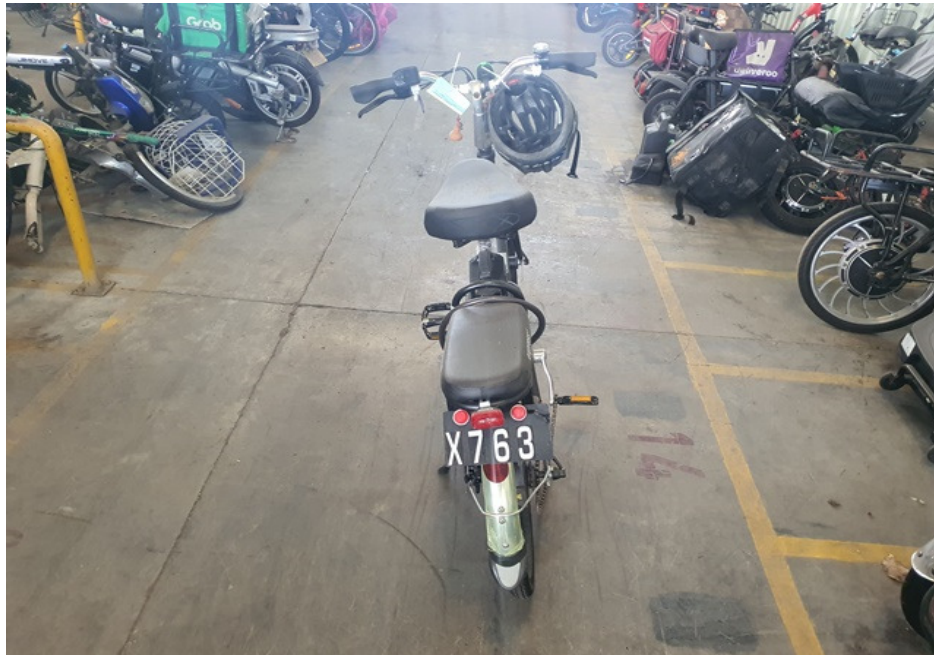
**Photo 5** shows the rear portion of the PAB at the time of our inspection. The body parts that were found to have been damaged include its left hand brake lever, pedals, seat and rear number plate, amongst others as a result of the accident. See photos 1 - 11 below.

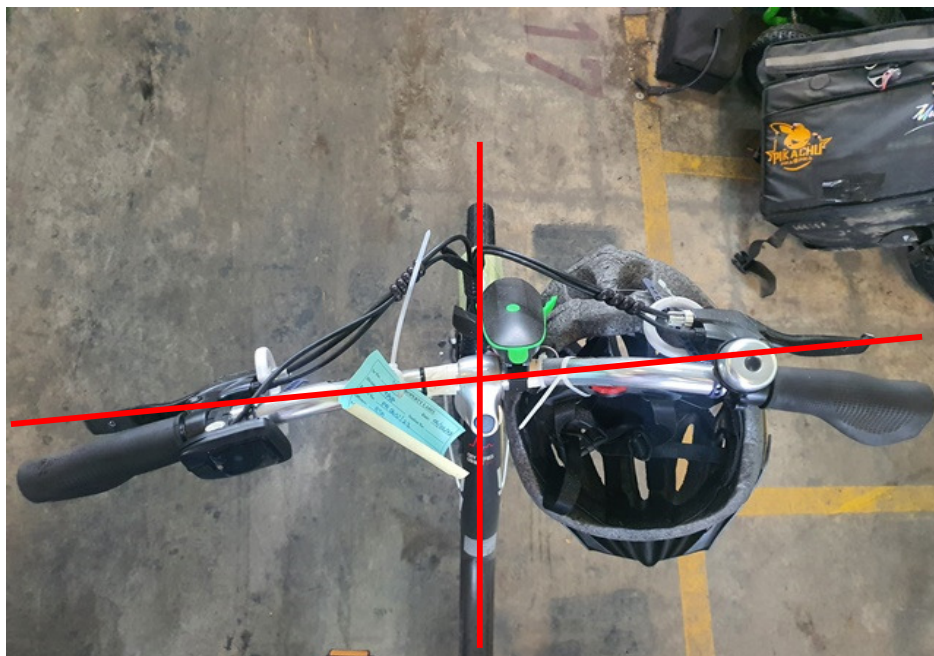
**Photo 6** shows the frontal portion of the PAB (top view) at the time of our inspection. There was a misalignment of the handlebar & front tyre observed.

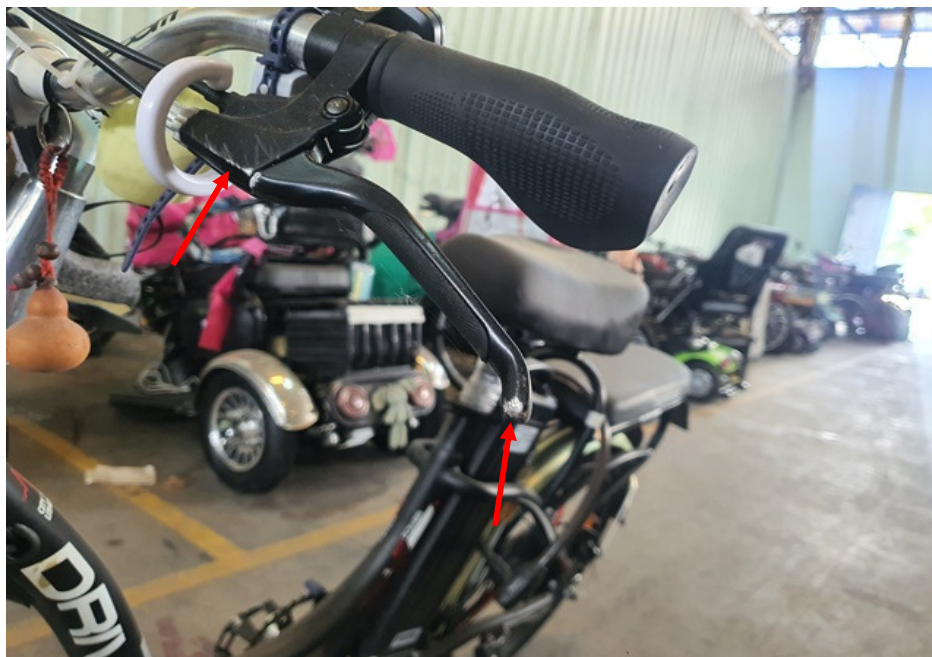
**Photo 7** shows the damages on the left hand brake lever (arrowed) of the PAB as a result of the accident.

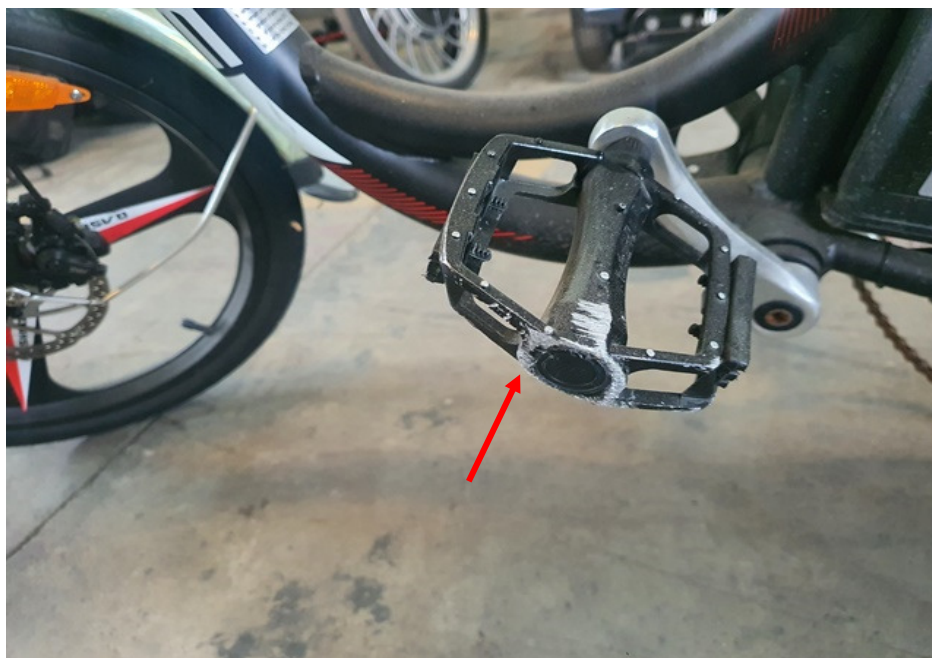
**Photo 8** shows the damages of grazing nature on the left pedal (arrowed) of the PAB as a result of the accident.

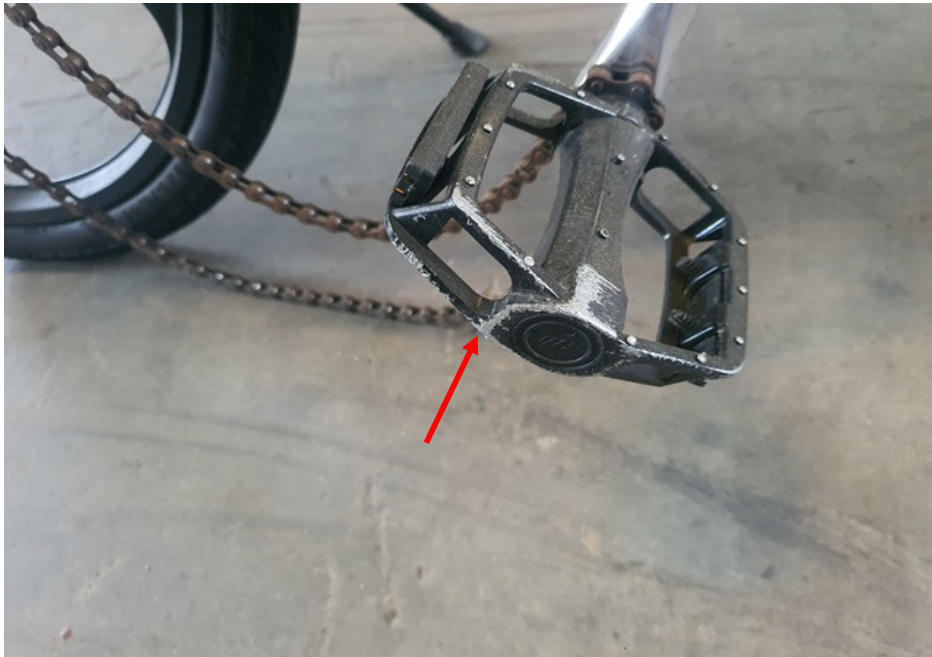
**Photo 9** shows the damages of grazing nature on the right pedal (arrowed) of the PAB as a result of the accident.

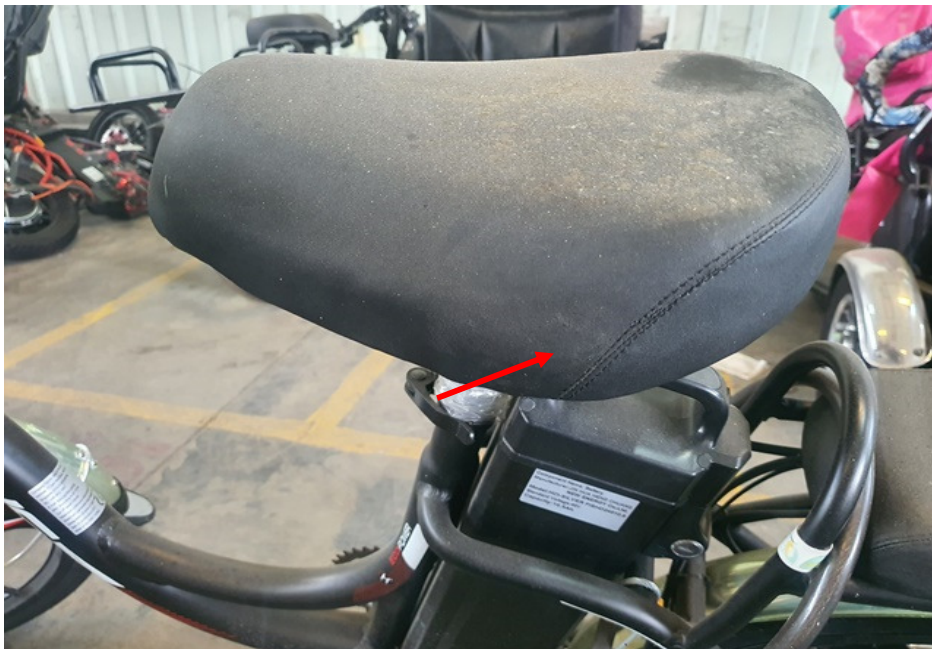
**Photo 10** shows the damages of grazing nature on the seat (arrowed) of the PAB as a result of the accident.

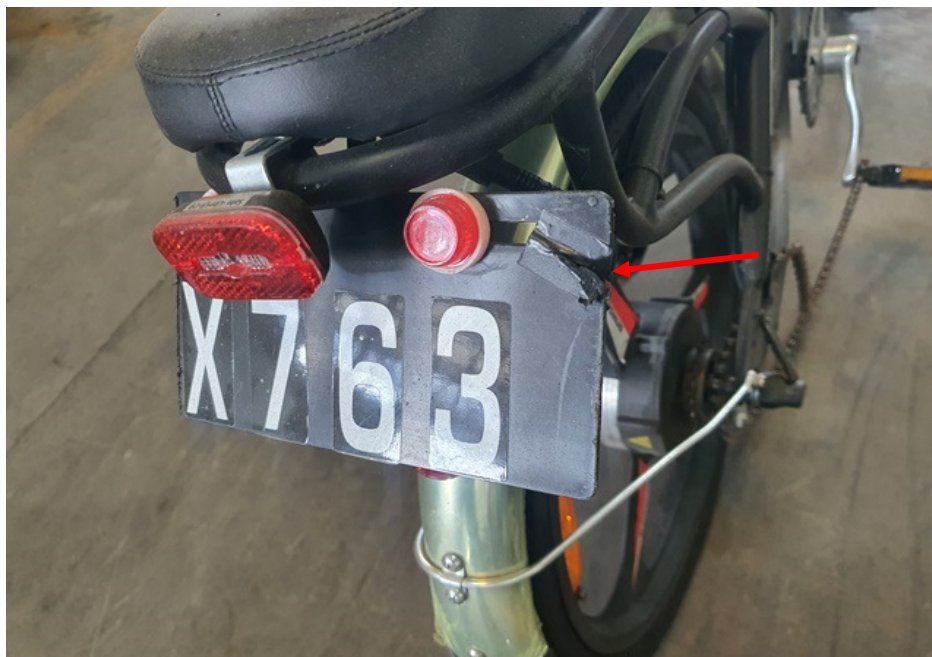
**Photo 11** shows the broken rear number plate (arrowed) of the PAB as a result of the accident.

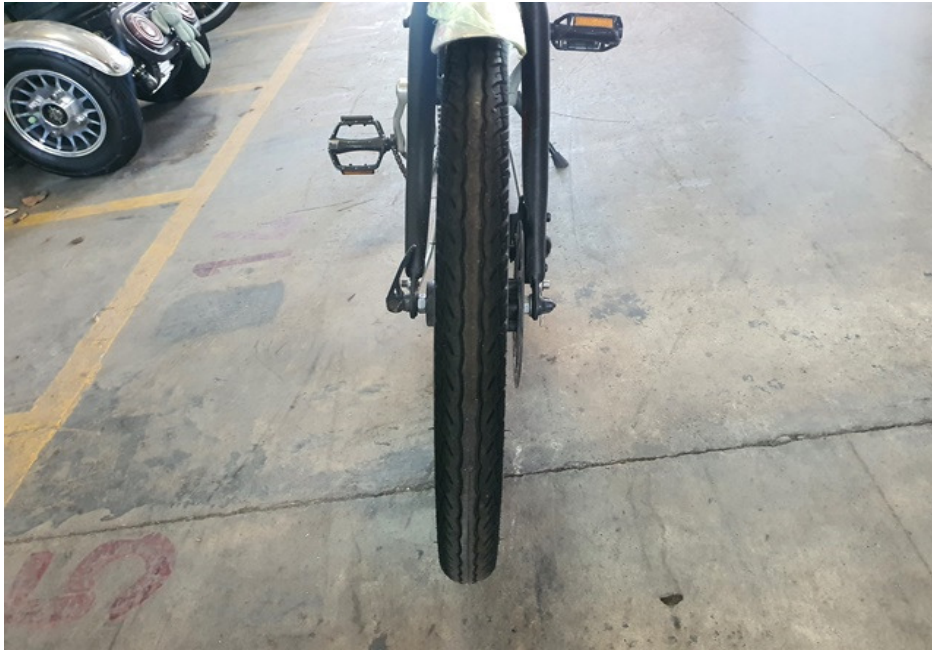
**Photo 12** shows the front tyre of the PAB at the time of our inspection. The front tyre was observed to be in serviceable condition with remaining tread depth of approximately 3mm. The tyre was also observed to be sufficiently inflated for vehicular operation. We did not observe any tear, burst mark(s) and/or punctured hole(s) on the sidewalls as well as across the tread of the front tyre.

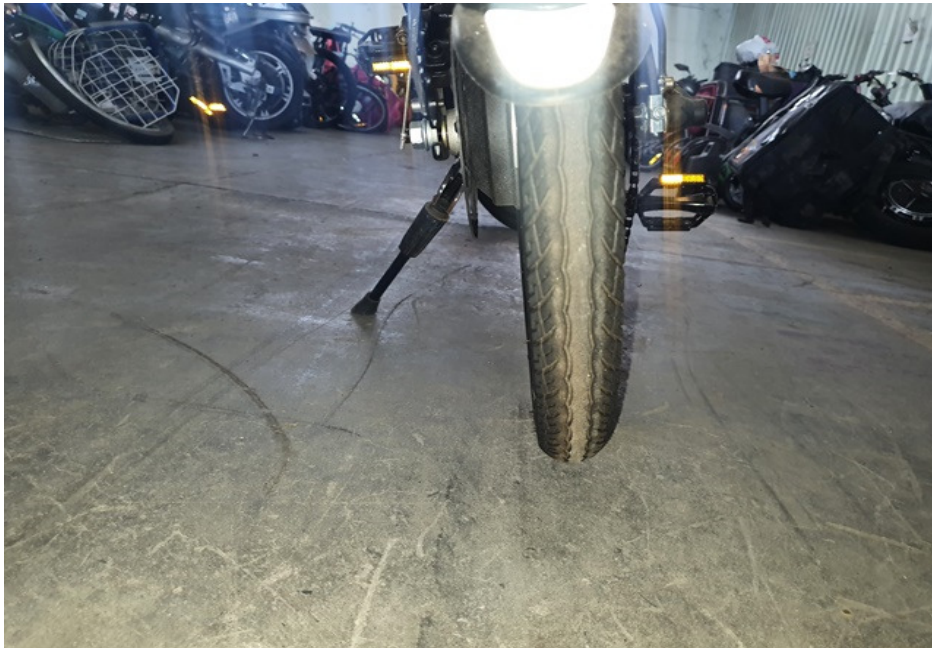
**Photo 13** shows the rear tyre of the PAB at the time of our inspection. The rear tyre was observed to be in serviceable condition with remaining tread depth of approximately 2mm. The tyre was also observed to be sufficiently inflated for vehicular operation. We did not observe any tear, burst mark(s) and/or punctured hole(s) on the sidewalls as well as across the tread of the rear tyre.

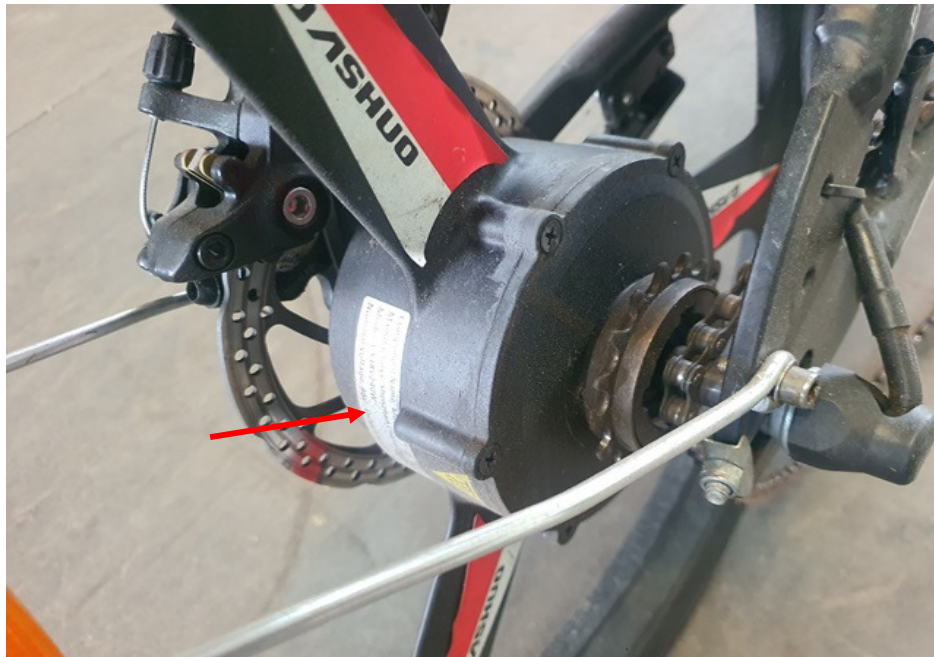
**Photo 14** shows the general view of the drive motor (arrowed) of the PAB which was observed to be intact with no misalignment.

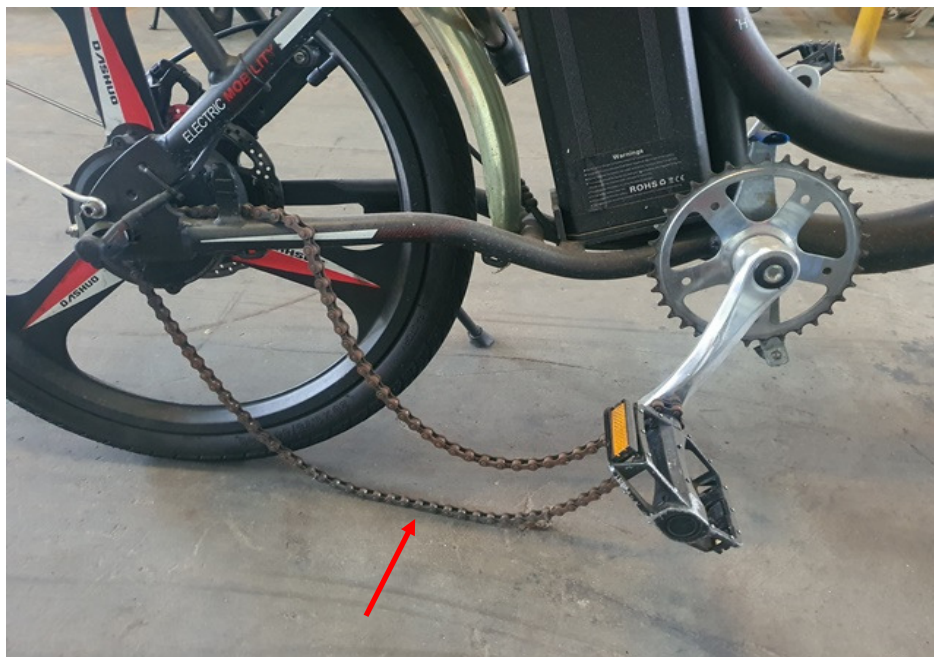
7. The PAB was controlled by a motor and gear train to drive the rear tyre. The motor was originally installed on the rear portion of the rear tyre & found adequately acceptable. The motor of the PAB was found to be intact without any misalignment or damages. It was also observed to be in operational condition. The gear train of the PAB was also found to be intact without any misalignment. It was also adequately lubricated for operating purposes. However the chain was observed to be dislodged from the gear train most likely as a result of the accident. See photos 14 - 16 below.

**Photo 15** shows the general view of the gear train of the PAB, which was observed to be intact with no misalignment. It was also adequately lubricated for operating purposes. However the chain was observed to be dislodged from the gear train most likely as a result of the accident (arrowed).

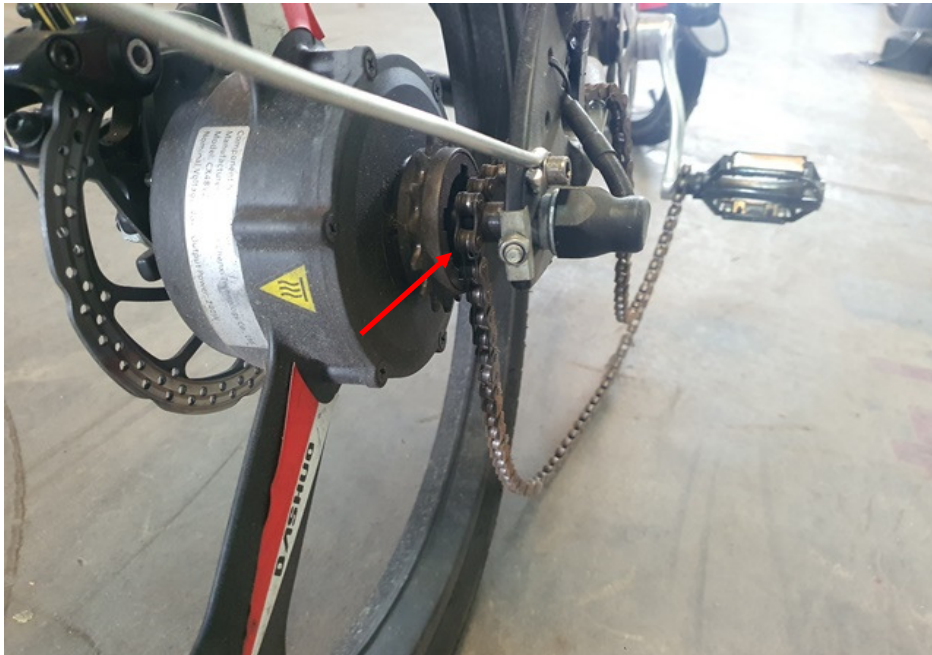
**Photo 16** shows a closer view of the dislodged chain from the gear train of the PAB, most likely as a result of the accident (arrowed). It was found to be adequately lubricated for operating purposes.

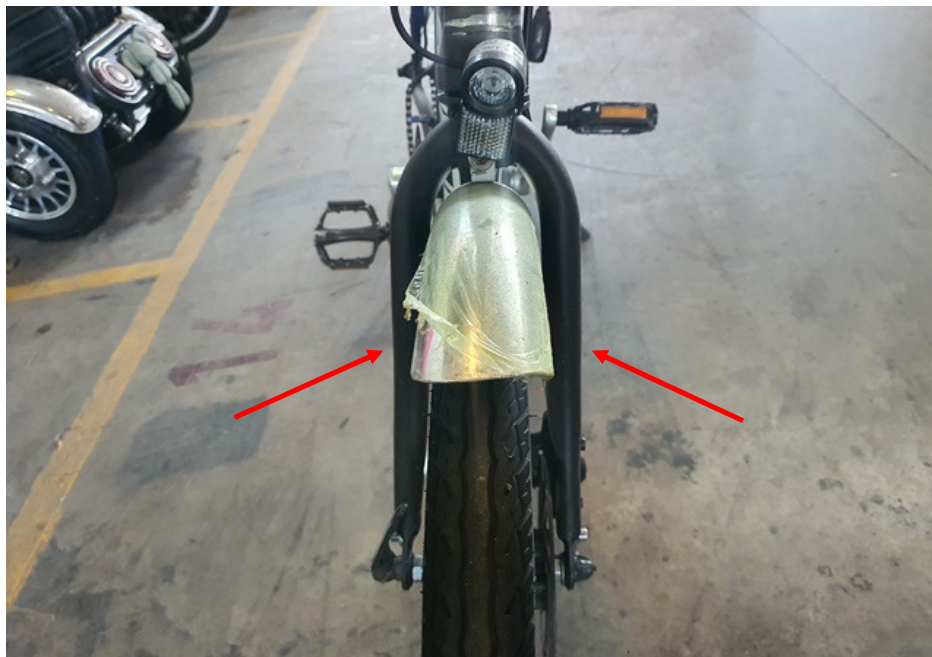
8. Our checks on the various steering components of the PAB revealed that its steering system was in serviceable condition. Its front fork assembly was found to be intact and undamaged. Turning the handle bar towards the left and right did not produce any abnormal free play and/or resistance.

**Photo 17** shows the front fork assembly (arrowed) of the PAB. The front forks and fork bracket of the PAB were both found to be intact and undamaged. Turning the PAB's handle bar towards the left and right did not produce any abnormal free play. The steering system of the PAB was in serviceable condition at the time of our inspection.

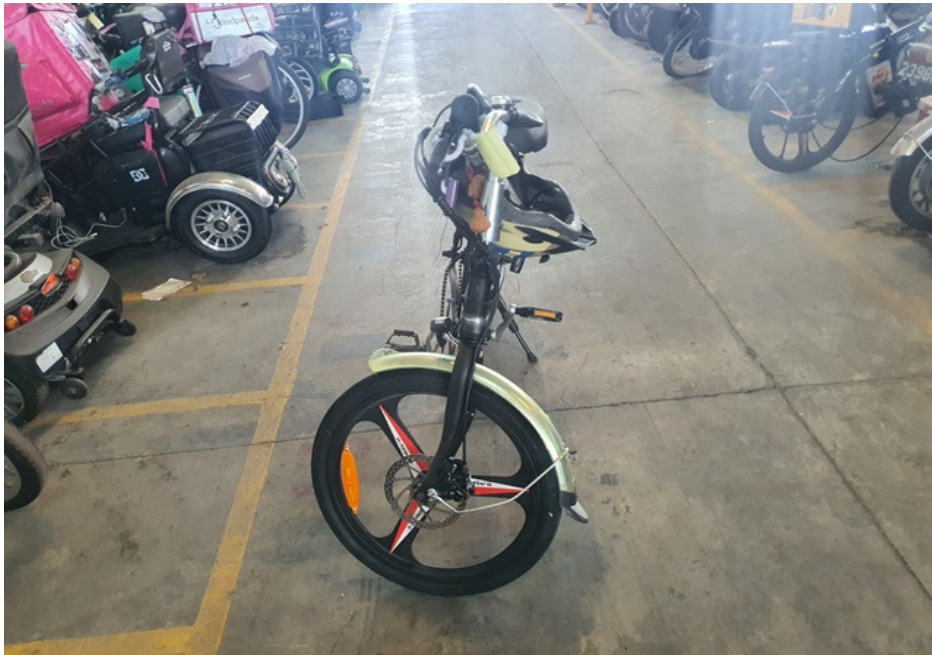
**Photo 18** shows the front wheel of the PAB turned towards its full right. Turning the PAB's handle bar towards the right did not produce any abnormal free play and/or resistance. This would indicate that the steering system of the PAB was in serviceable condition at the time of our inspection.

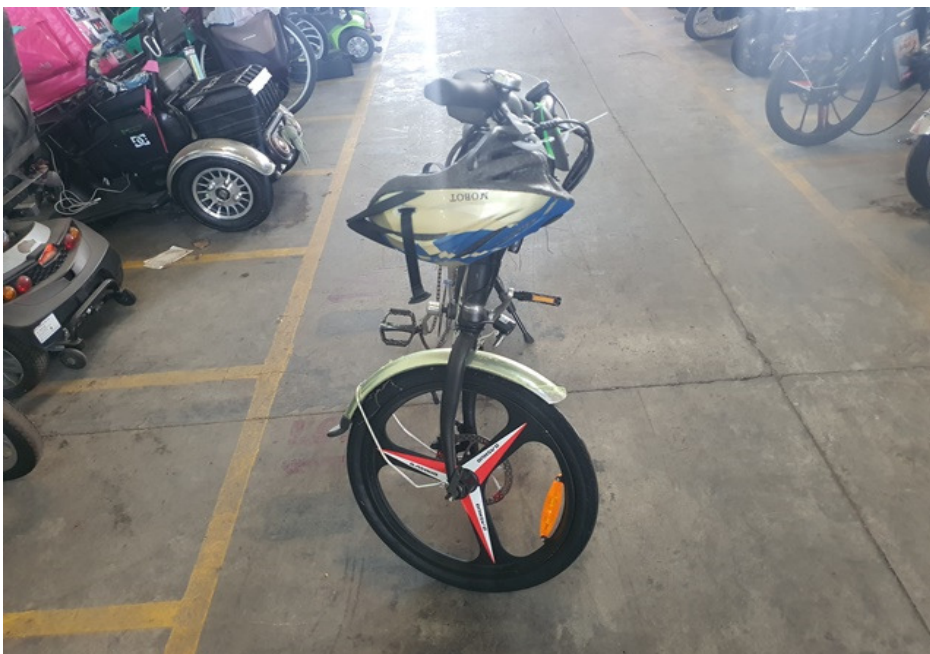
**Photo 19** shows the front wheel of the PAB turned towards its full left. Turning the PAB's handle bar towards the left did not produce any abnormal free play and/or resistance. This would indicate that the steering system of the PAB was in serviceable condition at the time of our inspection.

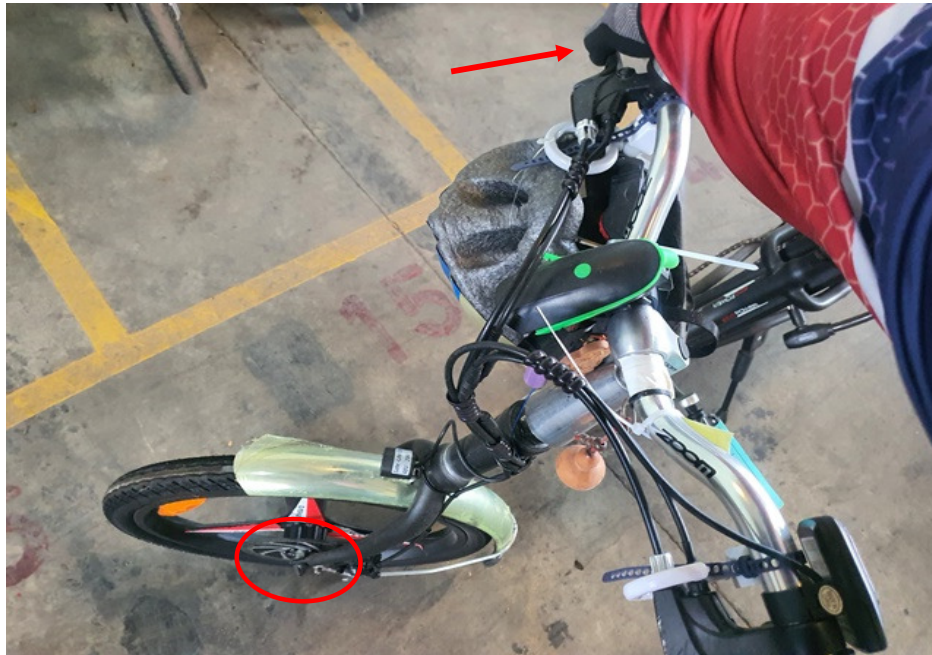
10. A static brake test was conducted on the front brake of the PAB. There was some resistance felt upon pressing the right hand brake lever. This was further confirmed by looking at the front brake pads while we pressed the right hand brake lever. It shows that the front brake pads responded to the gripping action. The front brake pads pressed against the front brake disc. This had appeared to indicate that the front brake of the PAB was in serviceable condition.

**Photo 20** shows a static brake test conducted on the PAB's front brake. There was some resistance felt upon pressing the right hand brake lever (arrowed). It also shows that the front brake pads responded to the gripping action (circled) after depressing the right hand brake lever.

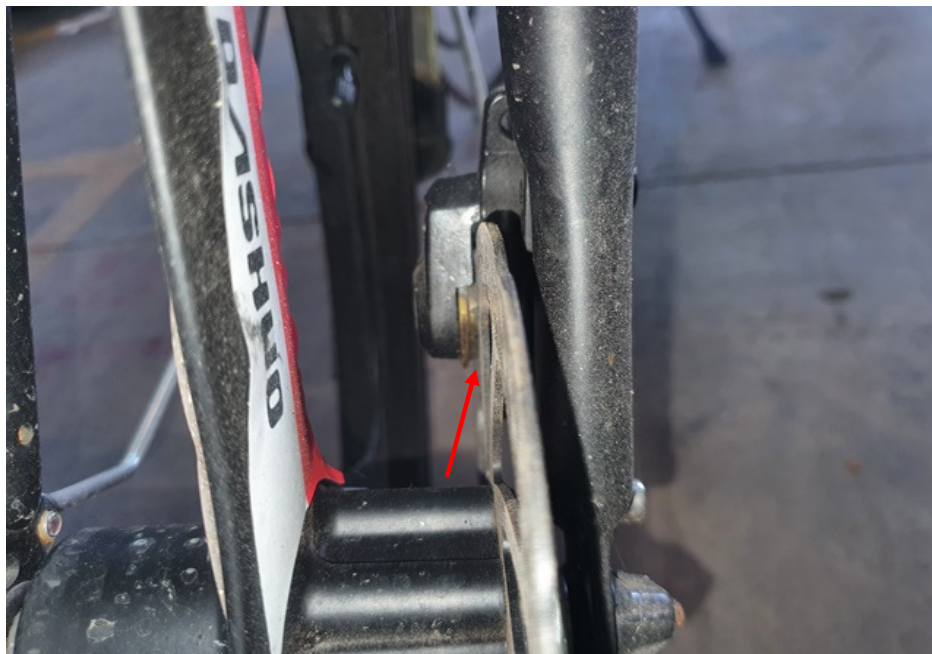
**Photo 21** shows a close up view of the front brake pads responding to the gripping action. The front brake pads pressed against the front brake disc (arrowed) upon depressing the right hand brake lever. This had appeared to indicate that the front brake of the PAB was in serviceable condition.

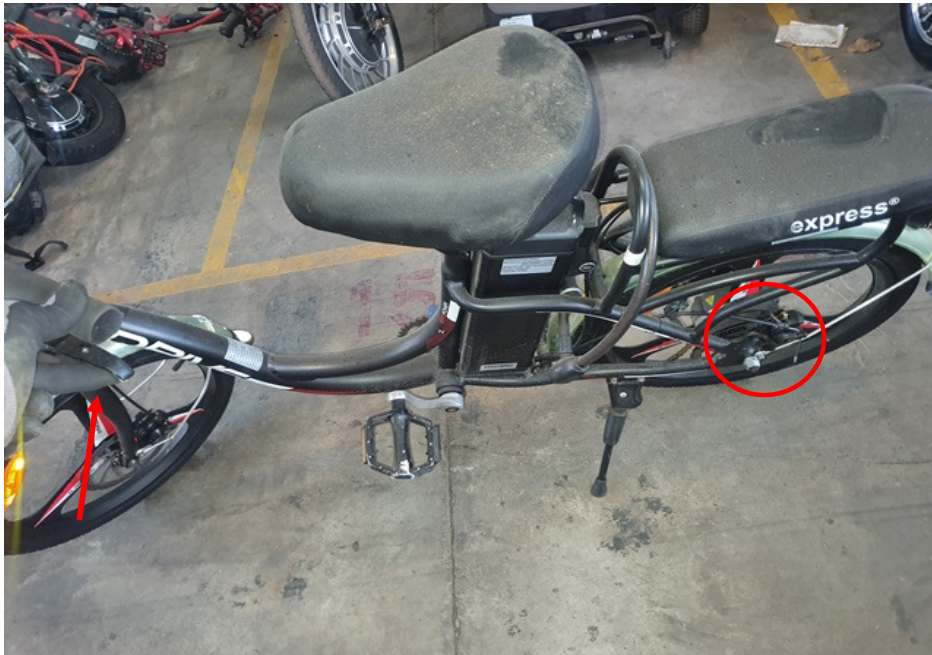
11. A static brake test was conducted on the rear brake of the PAB. There was some resistance felt upon pressing the left hand brake lever. This was further confirmed by looking at the rear brake pads while we pressed the left hand brake lever. It shows that the rear brake pads responded to the gripping action. The rear brake pads pressed against the rear brake disc. This had appeared to indicate that the rear brake of the PAB was in serviceable condition.

**Photo 22** shows a static brake test conducted on the PAB's rear brake. There was some resistance felt upon pressing the left hand brake lever (arrowed). It also shows that the rear brake pads responded to the gripping action (circled) after depressing the left hand brake lever.

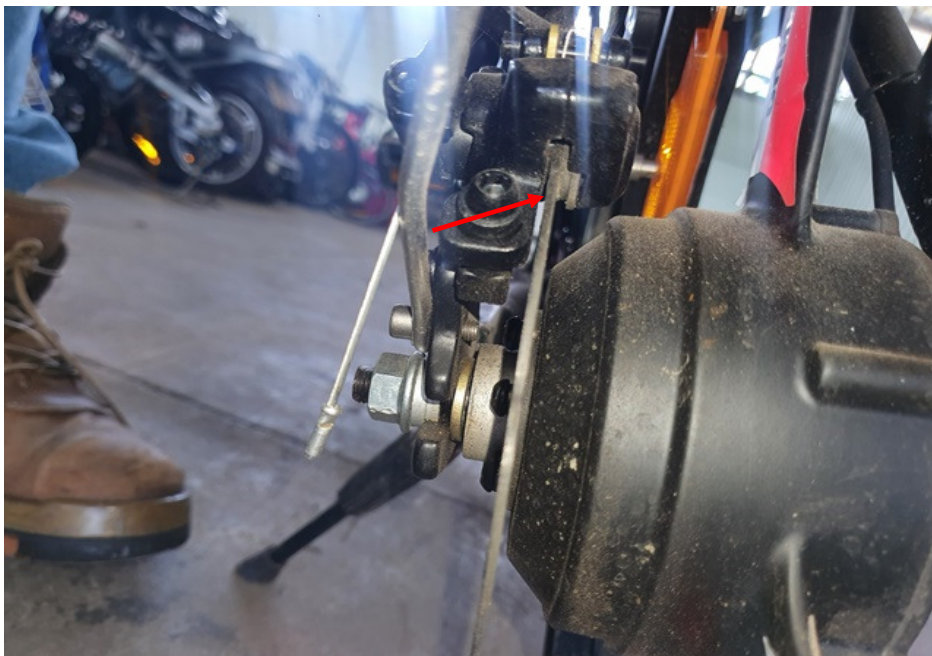
**Photo 23** shows a close up view of the rear brake pads responding to the gripping action. The rear brake pads pressed against the rear brake disc (arrowed) upon depressing the left hand brake lever. This had appeared to indicate that the rear brake of the PAB was in serviceable condition.
