PRE-REPAIR INSPECTION REPORT						
SINGAPORE CIVIL DEFENCE FORCE (MHA05) 91 UBI AVE 4 SINGAPORE 408827 SINGAPORE 408827 ATTN: RALF TAY			Ref: CS3/SCD23001401/Kqy3e2 Date: 13/02/2023  Code: SCD

### PHOTOGRAPHS FOR VEHICLE NO. FBJ 2519G

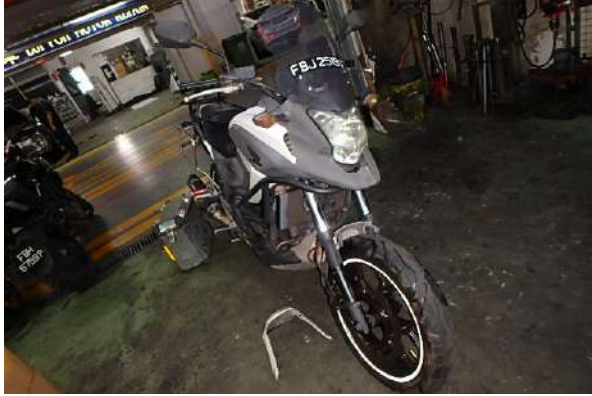
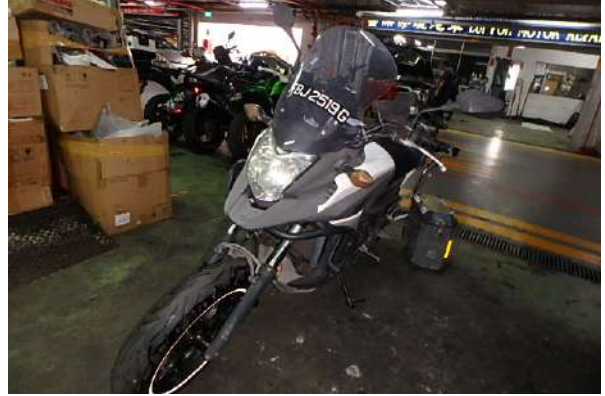
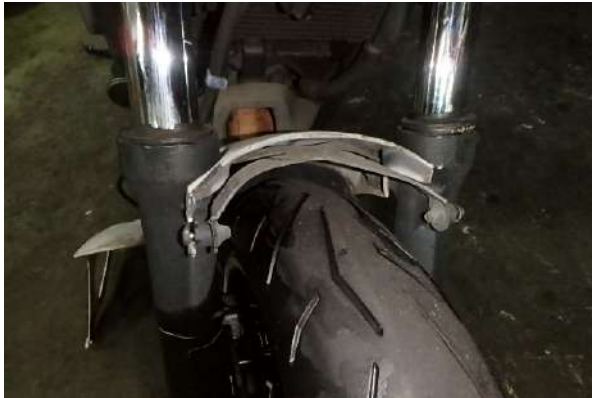
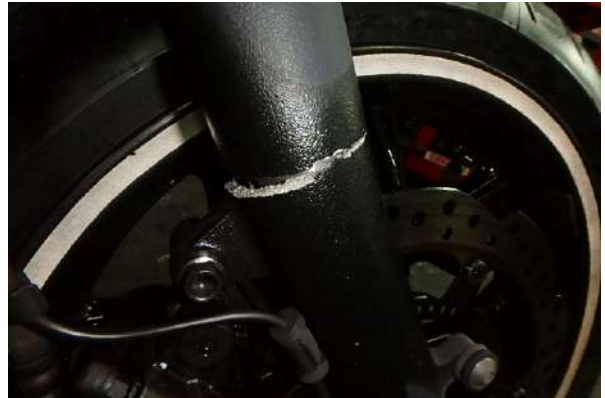
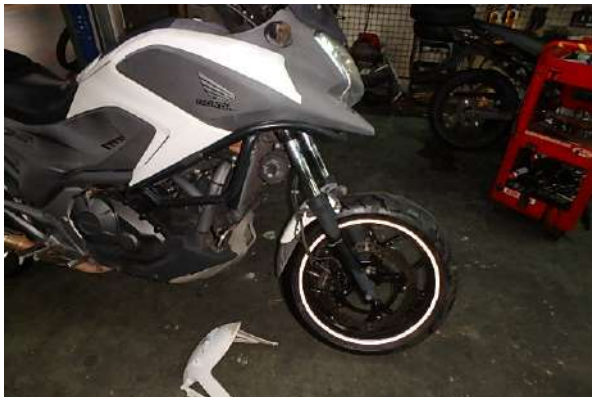
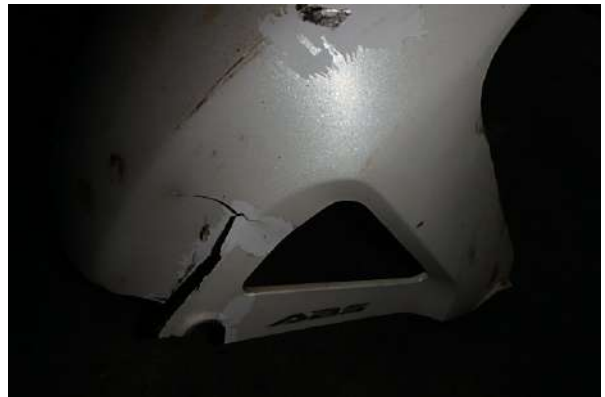
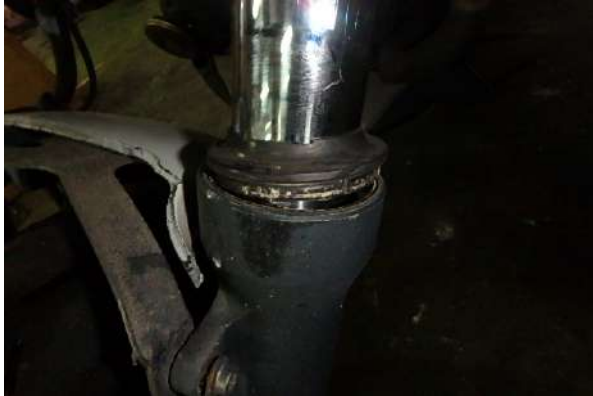
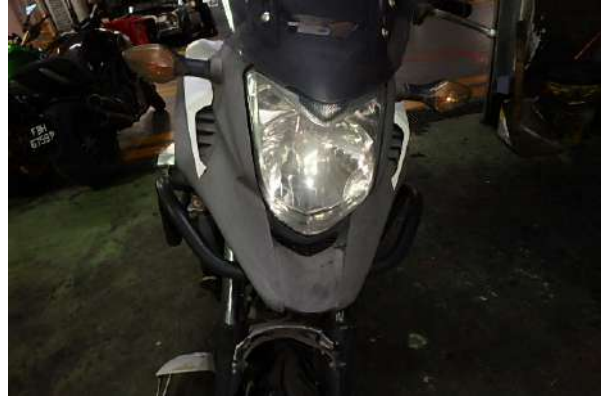
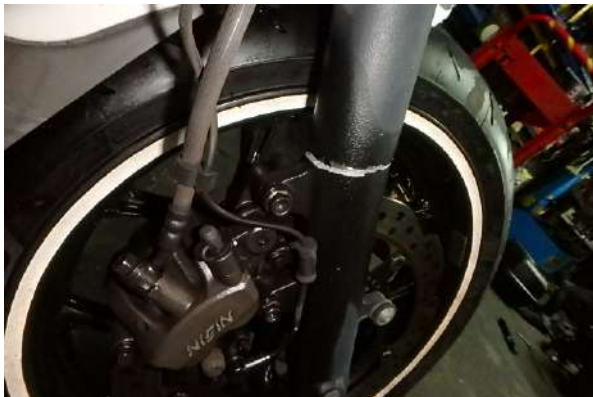
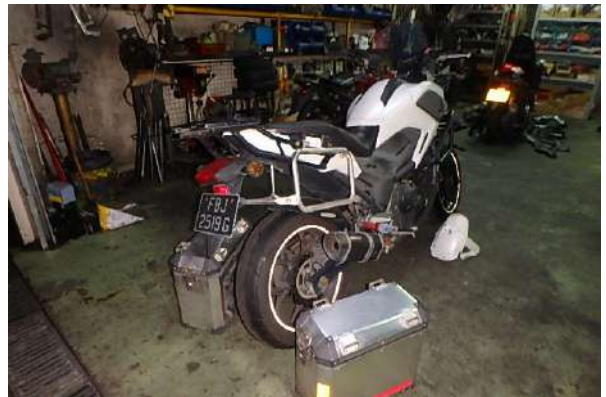
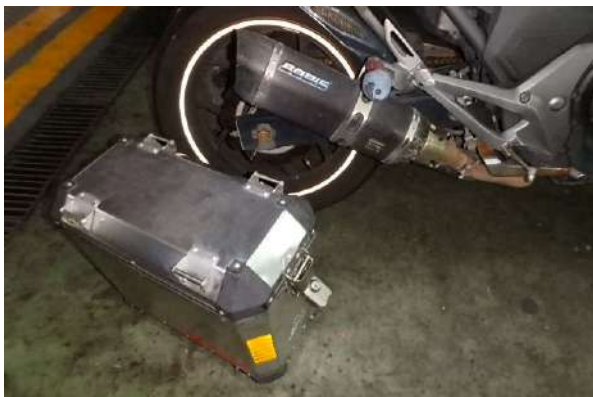
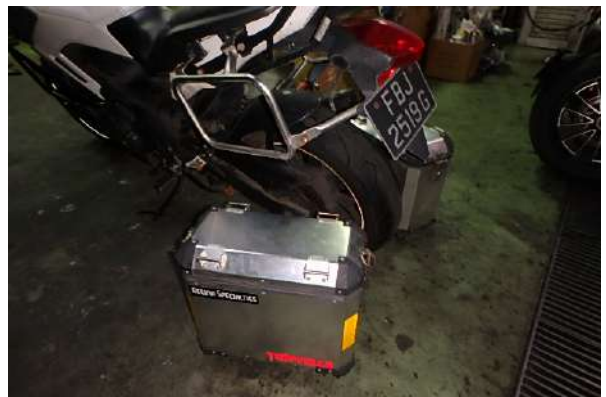
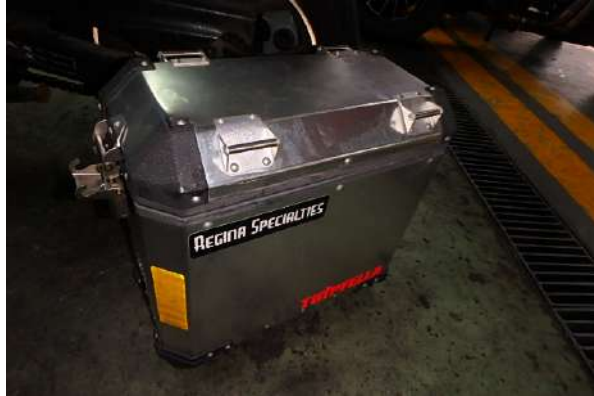
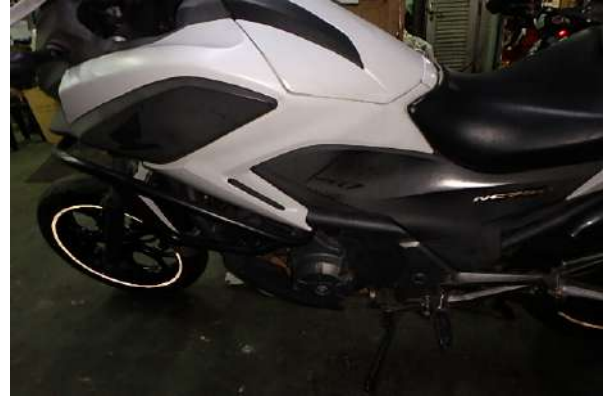
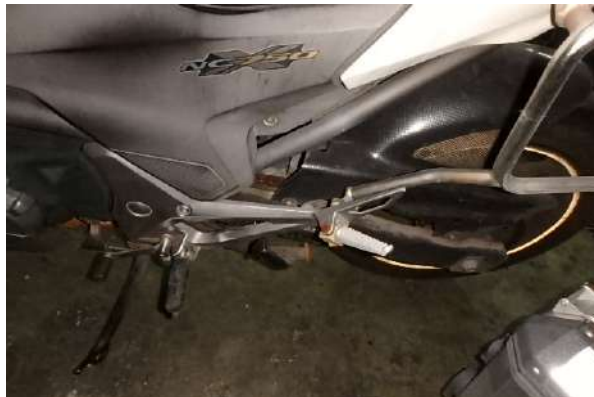
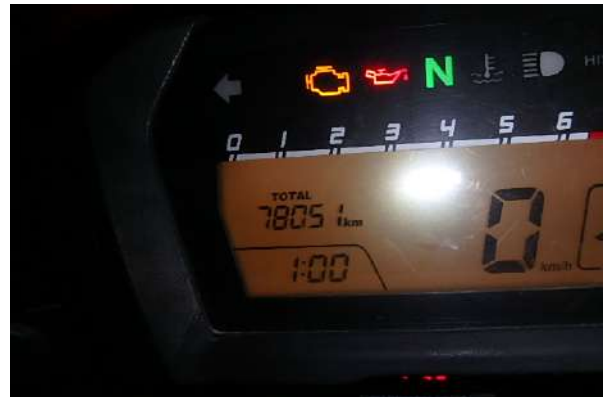
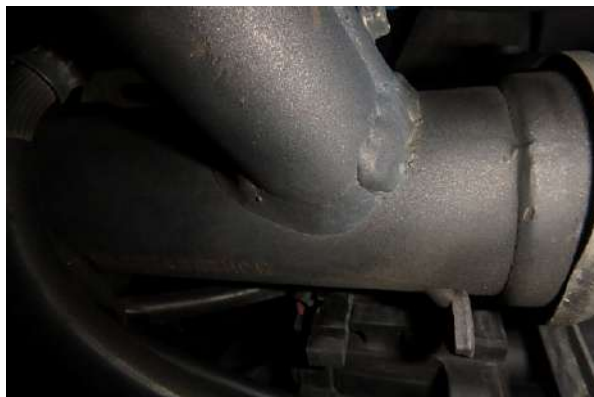
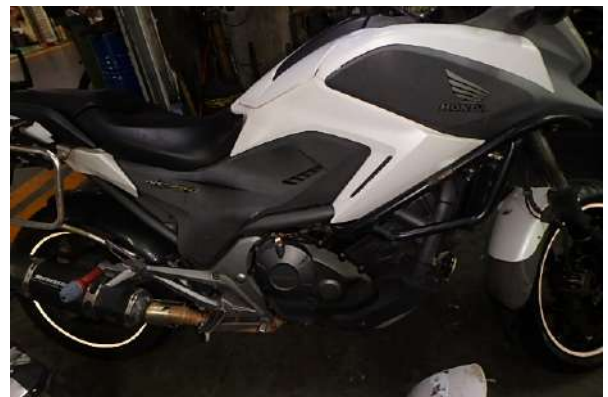
4. Description of Damages						
THE VEHICLE SUSTAINED DAMAGES AT THE FRONT PORTION.
