Your Ref : DM22HO00352  
Our Ref : CI/EQI23001431/D

**EQ Insurance Company Limited**

**DAMAGE CONSISTENCY REPORT OF INCIDENT INVOLVING SGW 1670E  
AND SHB 161M ON 07 MARCH 2022**

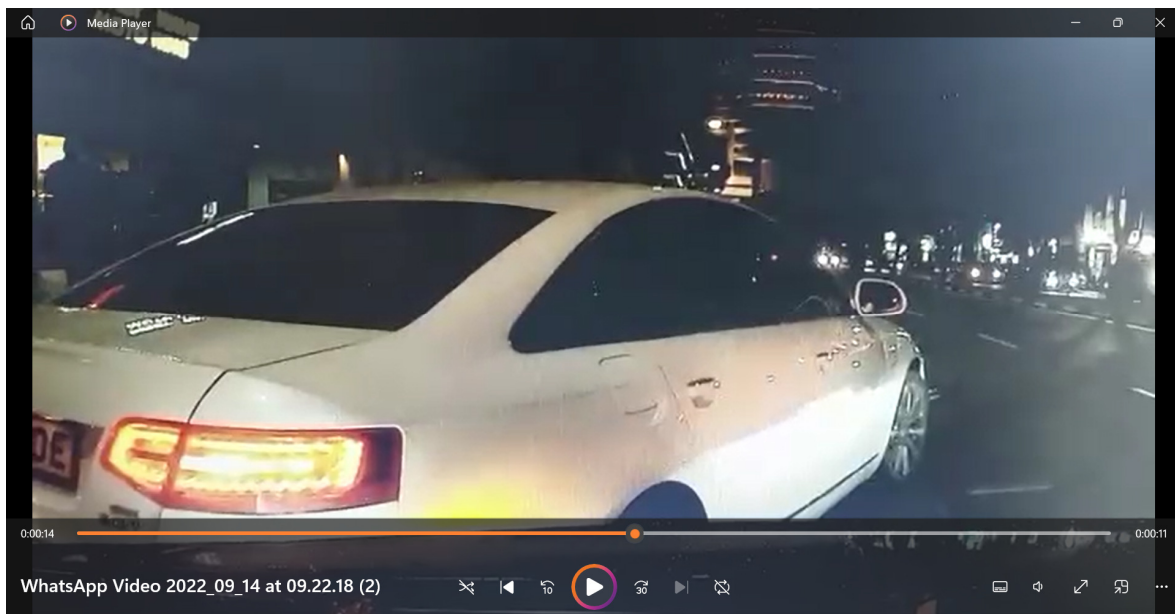
9. At about the 14sec mark of the video recording, the rear right portion of the Motor Car came into very close proximity to the front left portion of the Motor Taxi. It remained stationary at this position before moving forward about 2secs later to stop further in front of the Motor Taxi. Based on my observations, there was no obvious jerk or shaky image captured by the recording device during this 2secs. In other words, the recording device that was mounted directly onto a body part (front windscreen) of the Motor Taxi did not shake when the Motor Car was seen to be very close to the Motor Taxi. Screenshot below shows the 14sec mark of the video recording.

**Screenshot** shows the 14sec mark of the video recording. The rear right portion of the Motor Car came into very close proximity to the front left portion of the Motor Taxi. The Motor Car remained stationary at this position before moving forward about 2secs later and coming to a stop further in front of the Motor Taxi. Based on my observations, there was no obvious jerk or shaky image captured by the recording device during this 2secs.

10. Since the recording device was mounted directly onto a body part of the Motor Taxi, the lack of any obvious jerk or shaky image captured by the recording device would indicate that the Motor Taxi did not shake or jerk. This suggests that the contact from the Motor Car was very slight and minimal. To put things into perspective, the impact force arising from the Motor Car's contact was not significant enough to cause the Motor Taxi to shake or jerk.

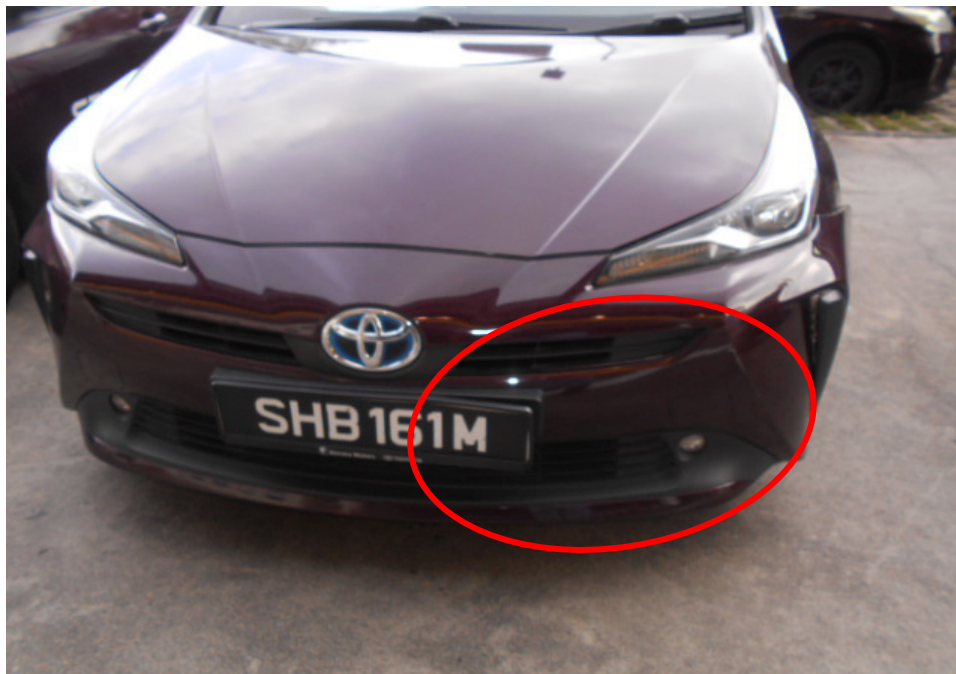
11. The Motor Taxi was inspected by LKK Auto Consultants Pte Ltd on 08 March 2022, a day after the incident. Basing on the photographs taken at the time of inspection, I note that the Motor Taxi had sustained damage at its front left portion. Marks of grazing nature and distortion were seen at the left side of the front bumper. The front number plate was also bent. The area of damage to the Motor Taxi corresponds to the area where the Motor Car came into very close proximity as shown in the screenshot above.

**Photo 1** shows a general view of the frontal portion of the Motor Taxi at the time of inspection by LKK Auto Consultants Pte Ltd. The Motor Taxi was observed to have sustained damage at its front left portion (circled). The area of damage to the Motor Taxi corresponds to the area where the Motor Car came into very close proximity.

19. The height above ground level of the Motor Taxi's damaged area (refer to photograph 1 & 2 above) was between 35cm to 53cm. The height above ground level of the Motor Car's damaged area (refer to photograph 5 above) was between 41cm to 55cm. The Motor Car's damaged area was within the height above ground level of the Motor Taxi's damaged area. The damage to the Motor Taxi is hence consistent and caused by the Motor Car. See photo 6 & 7 below.

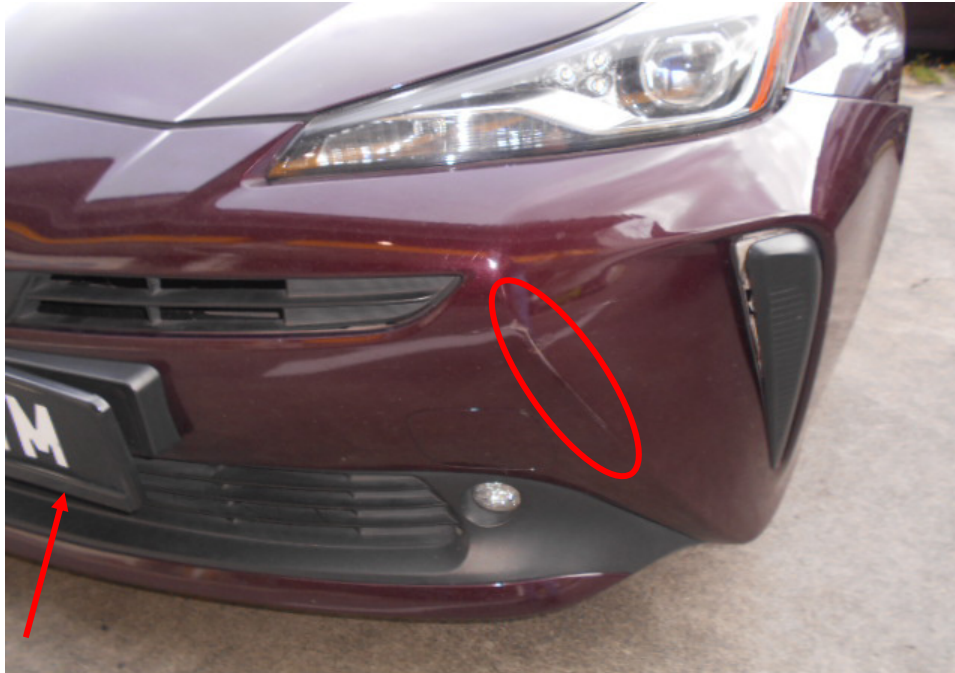
12. Basing on the Vehicle Damage Inspection Report of the Motor Taxi dated 28 March 2022 by LKK Auto Consultants Pte Ltd, body parts of the Motor Taxi that were assessed to be damaged and recommended to be replaced were the front bumper, which was indicated as distorted and the front number plate, which was indicated as bent. The front bumper grille, front bumper lower grille, front bumper reinforcement, front bumper sponge, front bumper left side moulding, front left fog lamp and front left headlamp amongst others were all indicated as not necessary, which would mean that these body parts were undamaged and re-usable. See photo 1 – 4 below.

**Photo 2** shows a closer view of the damaged area of the Motor Taxi at the time of inspection by LKK Auto Consultants Pte Ltd. The Motor Taxi was observed to have sustained damage at its front left portion. Marks of grazing nature was observed at the left side of its front bumper (circled). It was further observed that the front number plate was bent (arrowed).

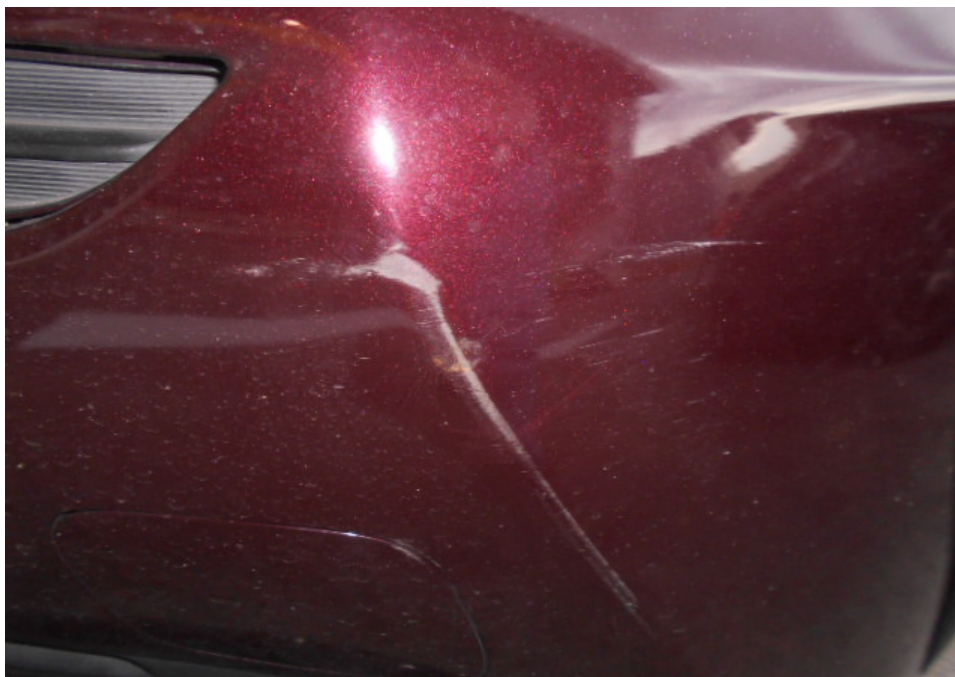
**Photo 3** shows a closer view of the marks of grazing nature that was observed at the left side of the Motor Taxi's front bumper.

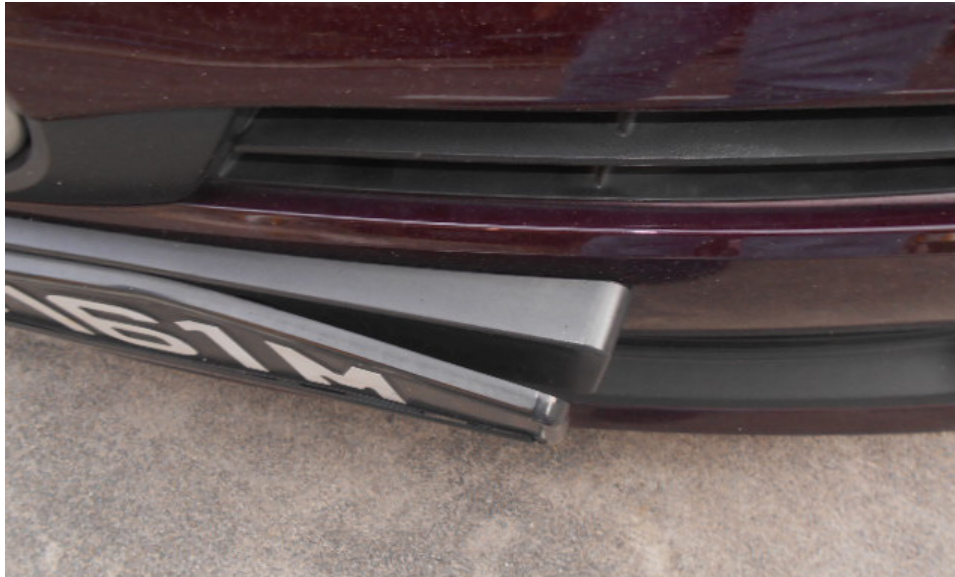
**Photo 4** shows a closer view of the bent front number plate of the Motor Taxi at the time of inspection by LKK Auto Consultants Pte Ltd.

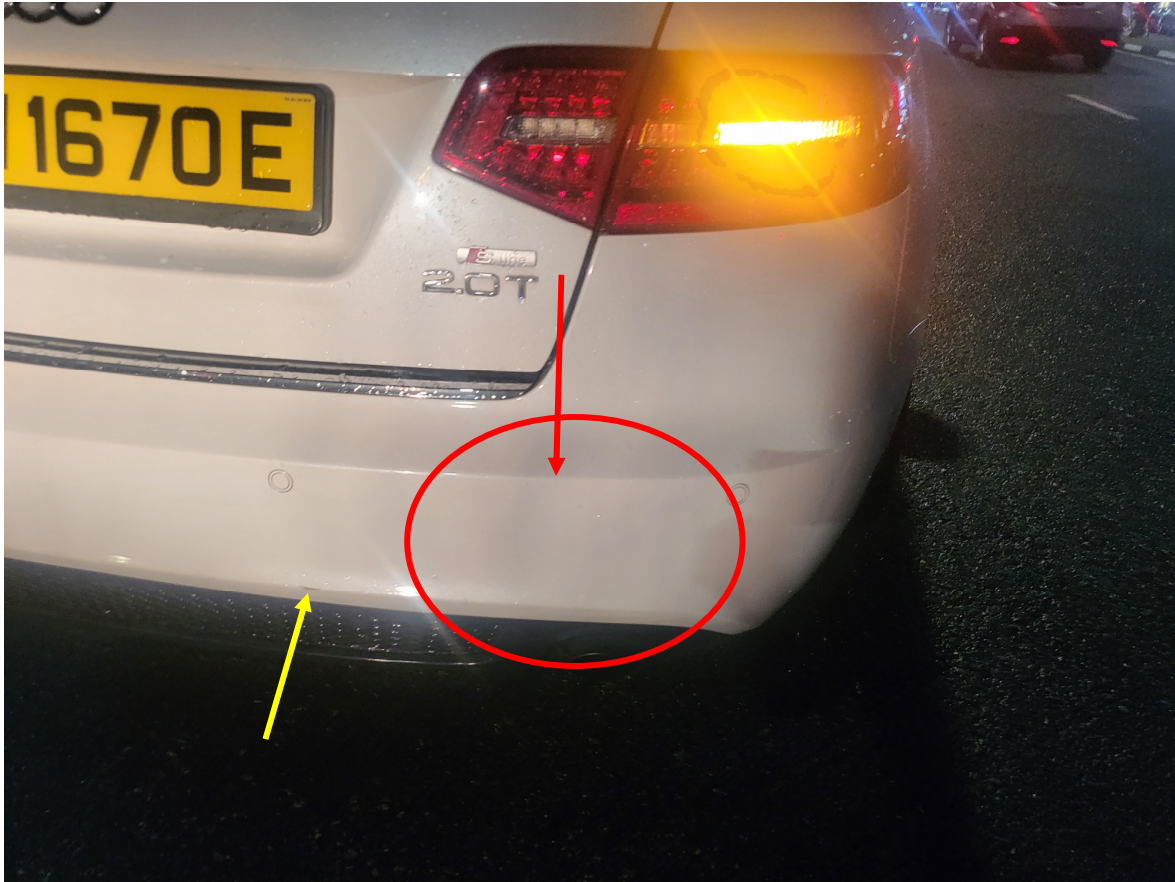
15. The photographs that were taken at the incident scene appears to show that the Motor Car's rear bumper was dented at the right side. A scratch mark was also seen on the lower part of the rear bumper, nearer to the centre of the Motor Car. The area of damage to the Motor Car also corresponds to the area where it came into very close proximity with the Motor Taxi. See photo 5 below.

**Photo 5** shows the Motor Car at the incident location. My examination of the photographs taken at the incident location appears to show that the Motor Car's rear bumper was dented at the right side (circled). This was established by taking reference from the contour line design of the rear bumper highlighted by the red arrow, which was pushed inwards as compared to the same line outside of the red circle. A scratch mark (yellow arrow) was also seen on the lower part of the rear bumper, nearer to the centre of the Motor Car. Overall, the area of damage to the Motor Car corresponds to the area where it came into very close proximity with the Motor Taxi.

16. For completeness, I did not find any dent to the Motor Car's rear bumper at the time of my inspection. This is because the rear bumper may have naturally returned back to its original shape due to the elasticity of the thermoplastic material that it is constructed of. I did however find a faint scratch mark on the Motor Car's rear bumper, which appears to be the same scratch mark on the rear bumper that was seen in the photographs taken at the incident location. This would indicate to me that no repair work was carried out to Motor Car, the rear bumper fitted on the Motor Car at the time of my inspection was the same rear bumper at the time of incident.
17. Since there was no repair work carried out to the Motor Car, it would not be unreasonable to also say that the Motor Car, like the Motor Taxi, was exposed to a relatively light/minor impact force at the time of contact.

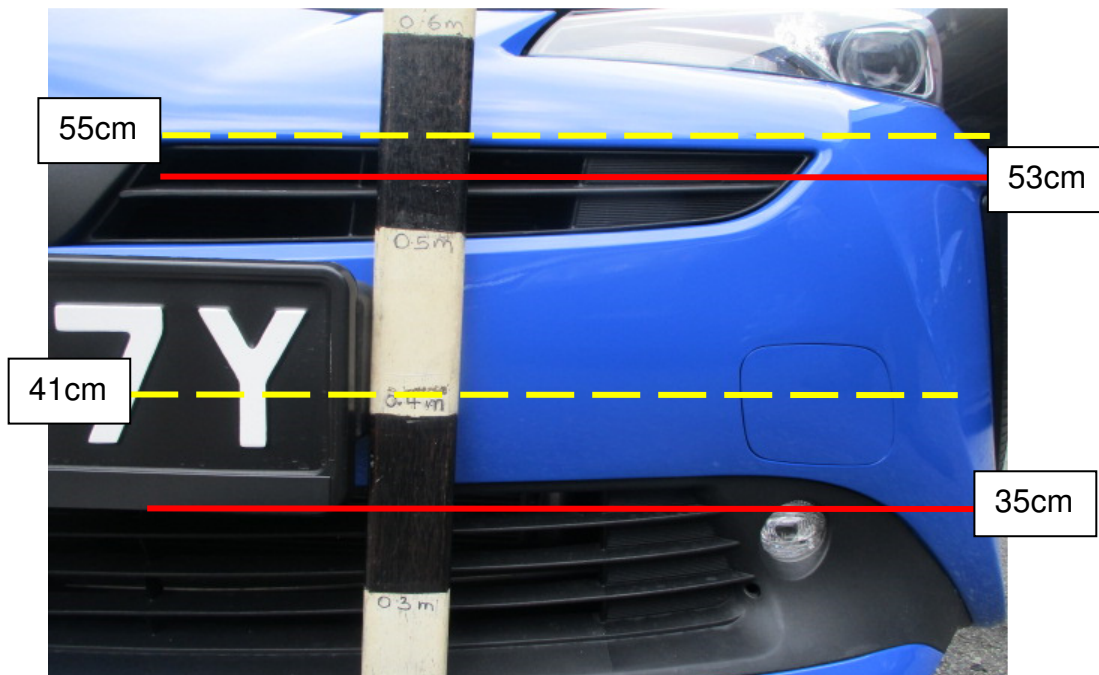
**Photo 6** shows height measurement being conducted on a similar make and model vehicle as the Motor Taxi. The height above ground level of the Motor Taxi's damaged area (refer to photograph 1 & 2 above) was approximately 35cm to 53cm. The height above ground level of the Motor Car's damaged area (refer to photograph 5 above) was between 41cm to 55cm, as highlighted by the yellow dotted lines. Measurements of the Motor Car are shown in photograph 7 below.

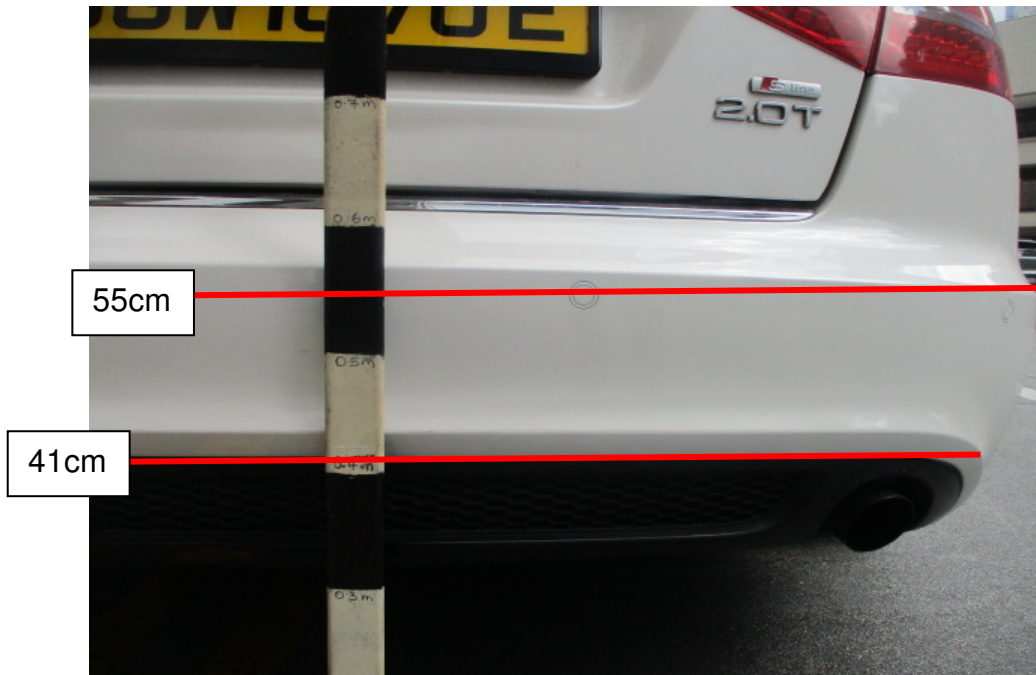
**Photo 7** shows height measurement being conducted on the Motor Car. The height above ground level of the Motor Car's damaged area (refer to photograph 5 above) was approximately 41cm to 55cm. The Motor Car's damaged area was within the height above ground level of the Motor Taxi's damaged area (refer to photograph 1 & 2 above).
