Your Ref: 32004317  
Our Ref : CS4/AIS23001492/N

**AUTOMOBILE INSPECTION REPORT OF INSURED VEHICLE SLG 8067B**

Vehicle Registration No. : SLG 8067B  
Make / Model : VOLKSWAGEN SCIROCCO 1.4L AT TSI  
1372Q5  
Chassis No : WVVZZZ13ZAV427617  
Year of Registration : February 2010  
Mileage : N.A.

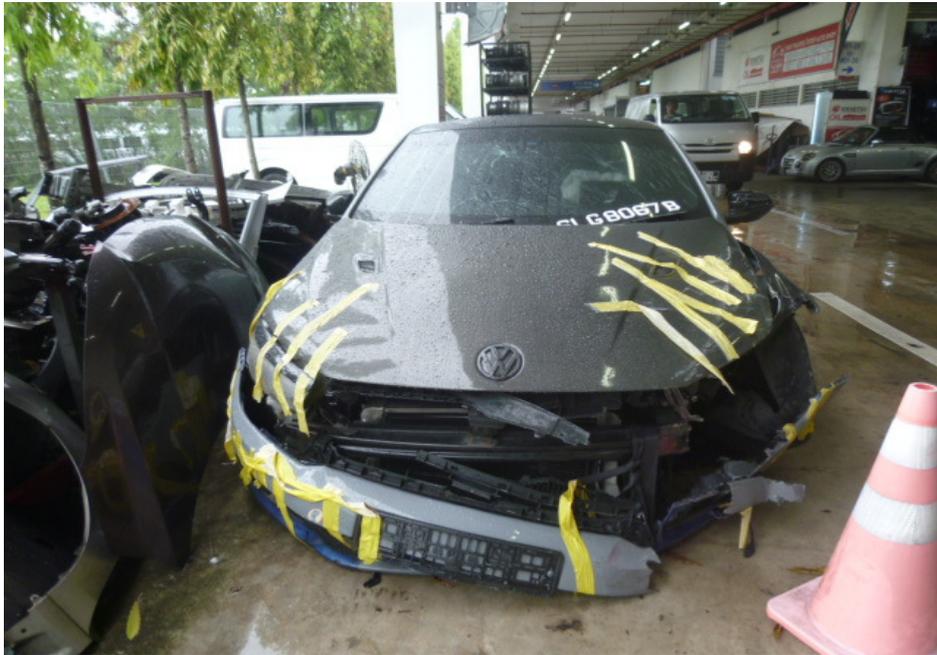
**Photo 1** shows a general view of the Insured Vehicle's front body at the time of our inspection.

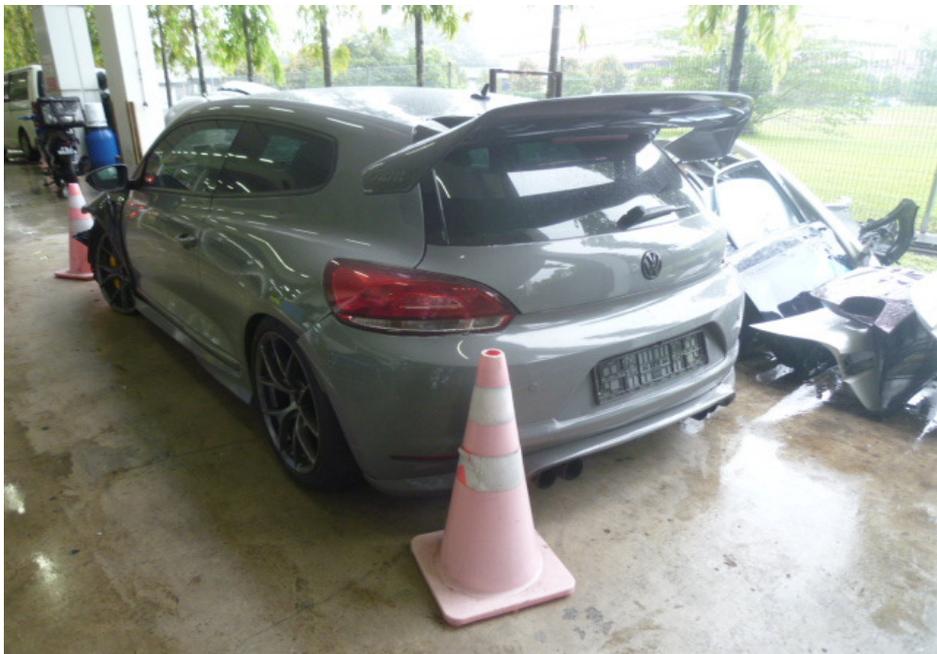
**Photo 2** shows a general view of the Insured Vehicle's left rear portion at the time of our inspection.

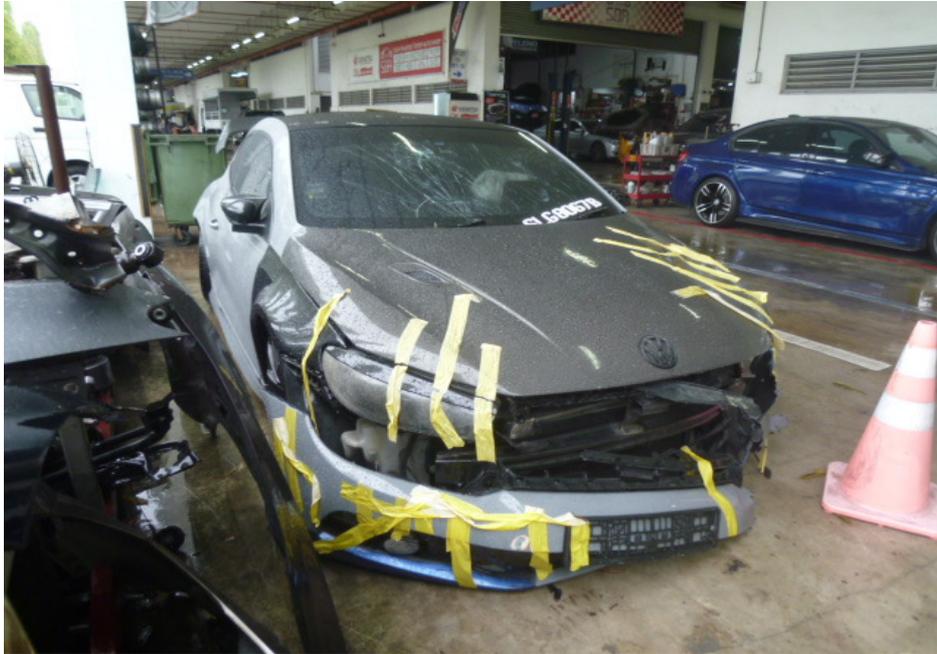
**Photo 3** shows a general view of the Insured Vehicle's right frontal portion at the time of our inspection.

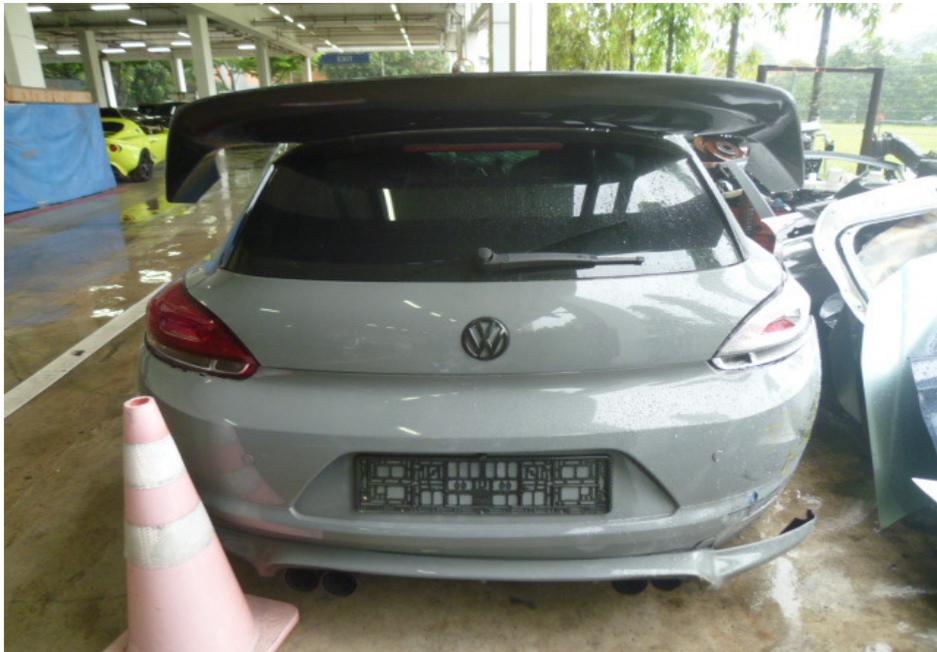
**Photo 4** shows a general view of the Insured Vehicle's rear portion at the time of our inspection.

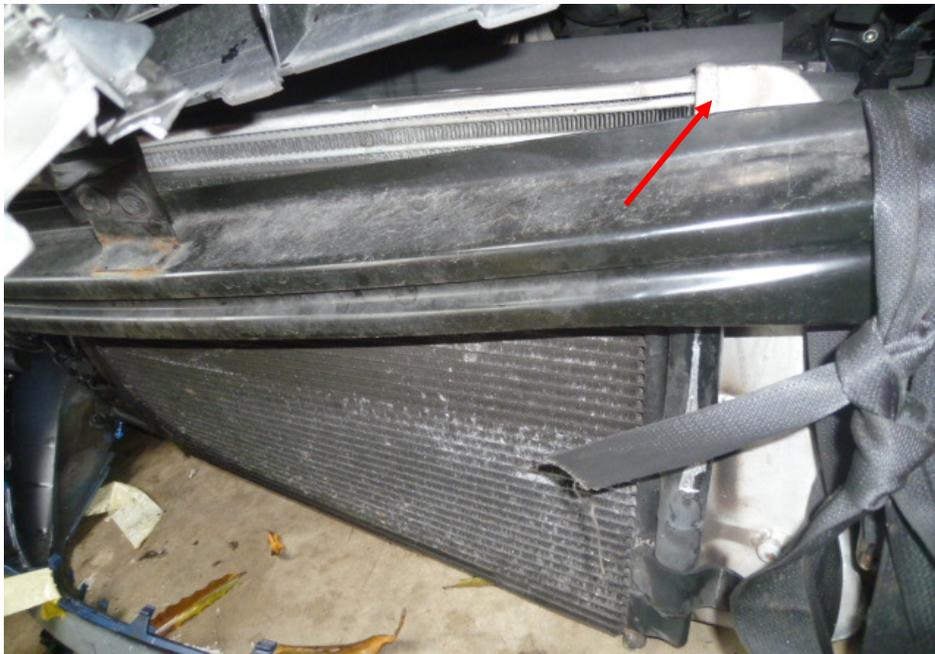
**Photo 5** shows a closer view of the non- standard radiator fitted onto the Insured Vehicle upon our inspection (arrowed).

<b>Modification/ additionally fitted non-standard part</b>	<b>LTA's guideline</b>	<b>Effect(s) on Insured Vehicle</b>
Radiator	Compliant	Eliminate heat from the engine
In- vehicle DVD player	Compliant	Entertainment purposes
Open- pod air filter	Compliant	Improves air intake

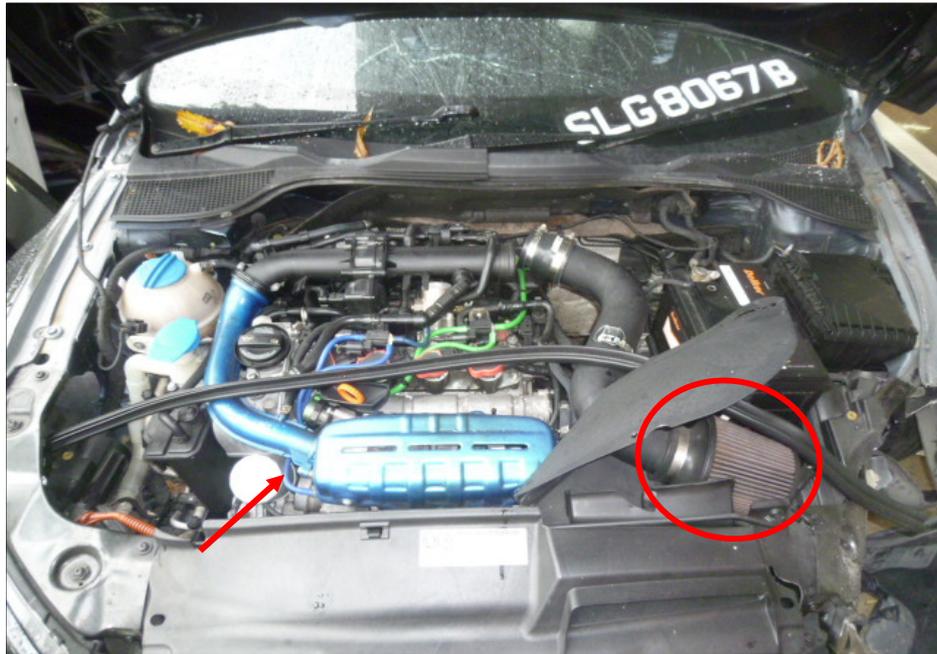
**Photo 6** shows a general view of the engine compartment of the Insured Vehicle. Additional non-standard parts were found fitted. This includes a non- standard open- pod air filter (circled) and turbo blow- off valve (arrowed).

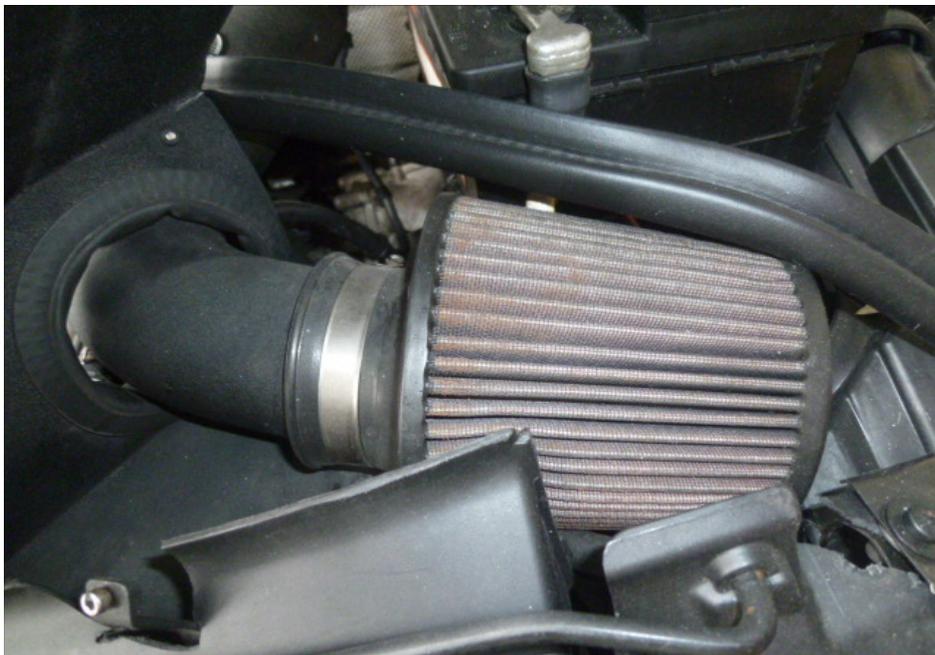
**Photo 7** shows a close up view of the non- standard open- pod air filter fitted onto the Insured Vehicle upon our inspection.

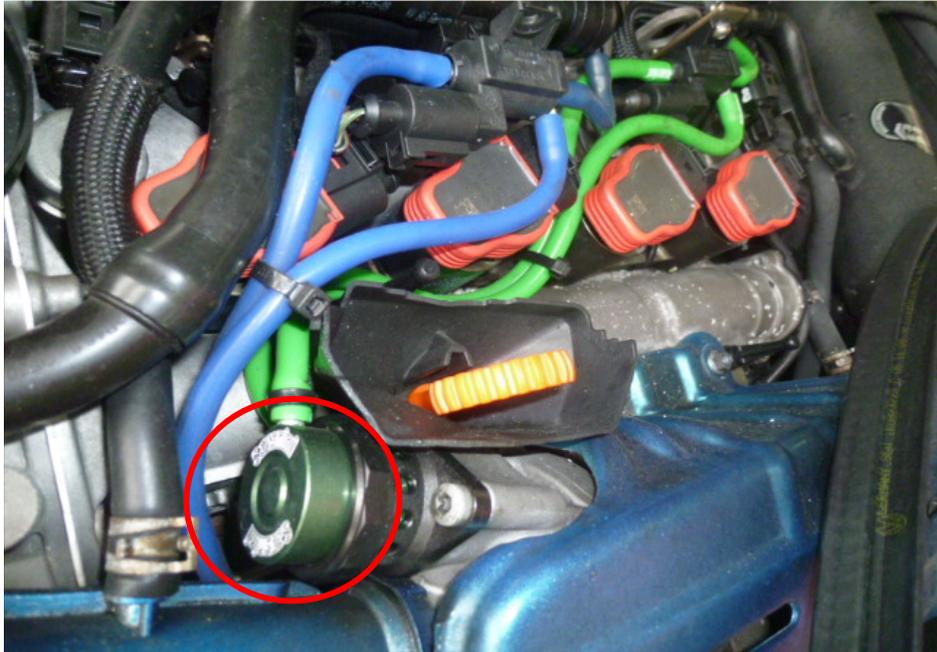
**Photo 8** shows a close up view of the non- standard turbo blow- off valve fitted onto the Insured Vehicle upon our inspection (circled).

Paddle shifter extensions	Compliant	Shift gear while holding the steering wheel without having to use gear lever
Aftermarket blow- off valve	Compliant	Helps regulate pressure in engine by allowing air to escape when needed
Aftermarket on-board diagnostic (OBD) display gauge	Compliant	Scan engine data from car's ECM and display as real-time digital gauges
Aftermarket speedometer gauge display	Compliant	indicates the car's speed and records the distance travelled
Aftermarket rear exhaust mufflers	Non- Compliant	Increase exhaust flow
Aftermarket front bumper	Compliant	Cosmetic type of modification
Aftermarket carbon- fibre front bonnet	Compliant	Cosmetic type of modification
Aftermarket side skirtings	Compliant	Cosmetic type of modification

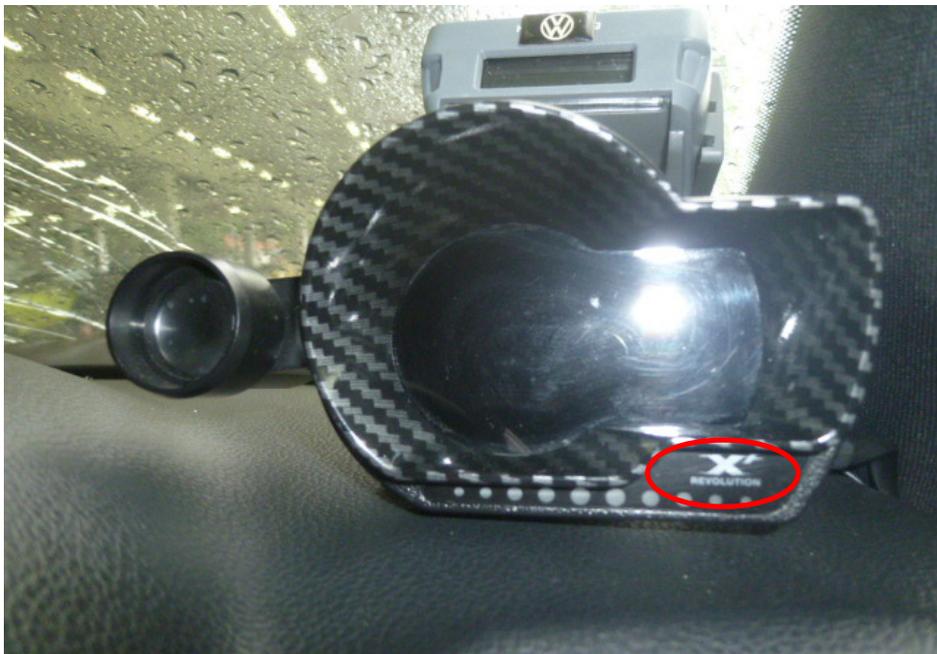
**Photo 9** shows the on-board diagnostic (OBD) display gauge additionally fitted onto the Insured Vehicle upon our inspection. The brand of the (OBD) display gauge was 'LUFIX REVOLUTION' (circled).

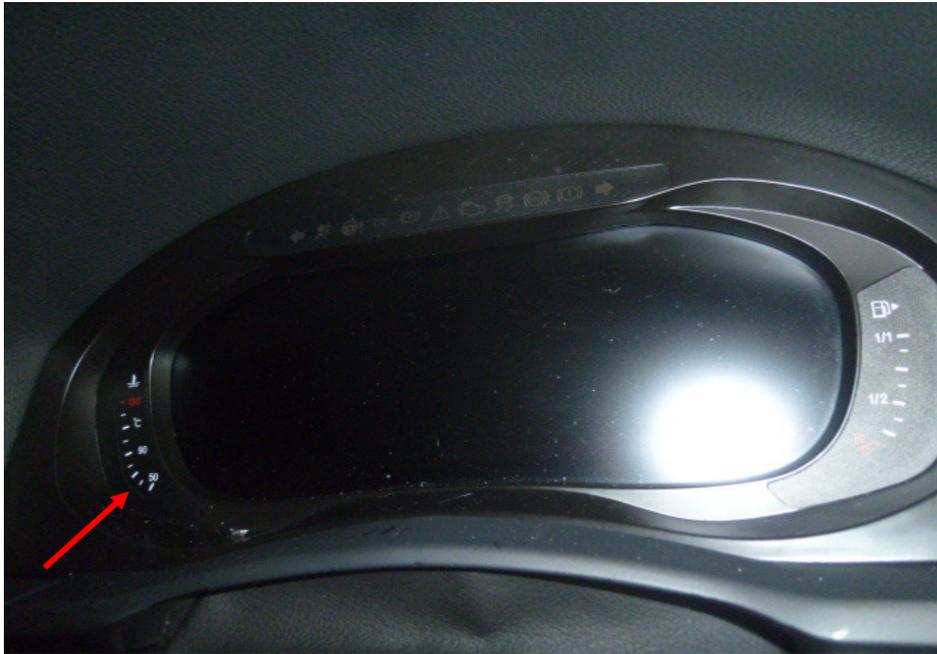
**Photo 10** shows the aftermarket speedometer gauge display fitted onto the Insured Vehicle upon our inspection (arrowed).

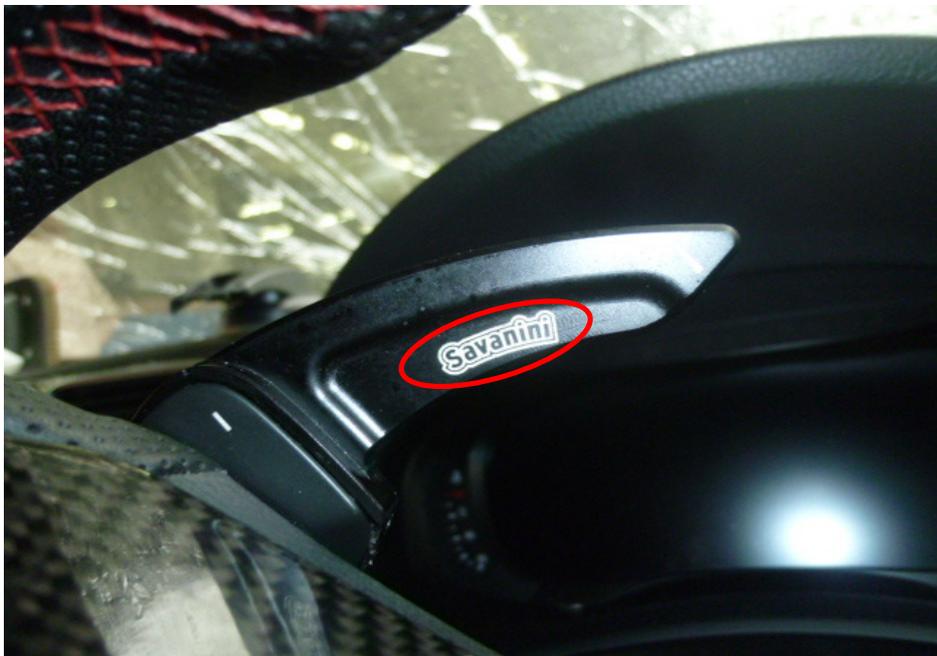
**Photo 11** shows the steering wheel shift paddle extension additionally fitted onto the Insured Vehicle upon our inspection. The brand of the shift paddle extensions was 'SAVANINI' (circled).

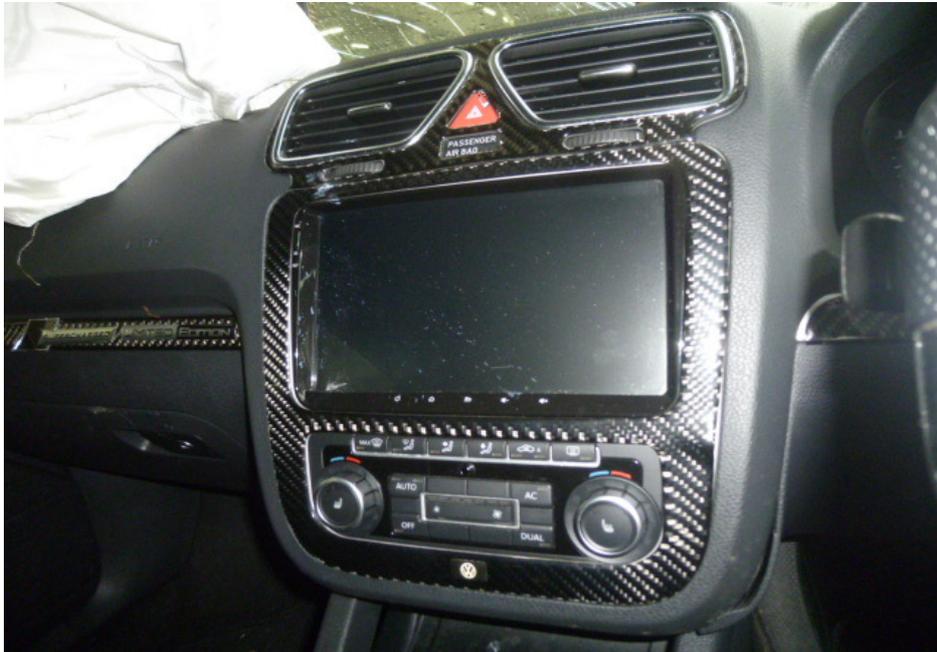
**Photo 12** shows the in- vehicle DVD player additionally fitted onto the Insured Vehicle upon our inspection.

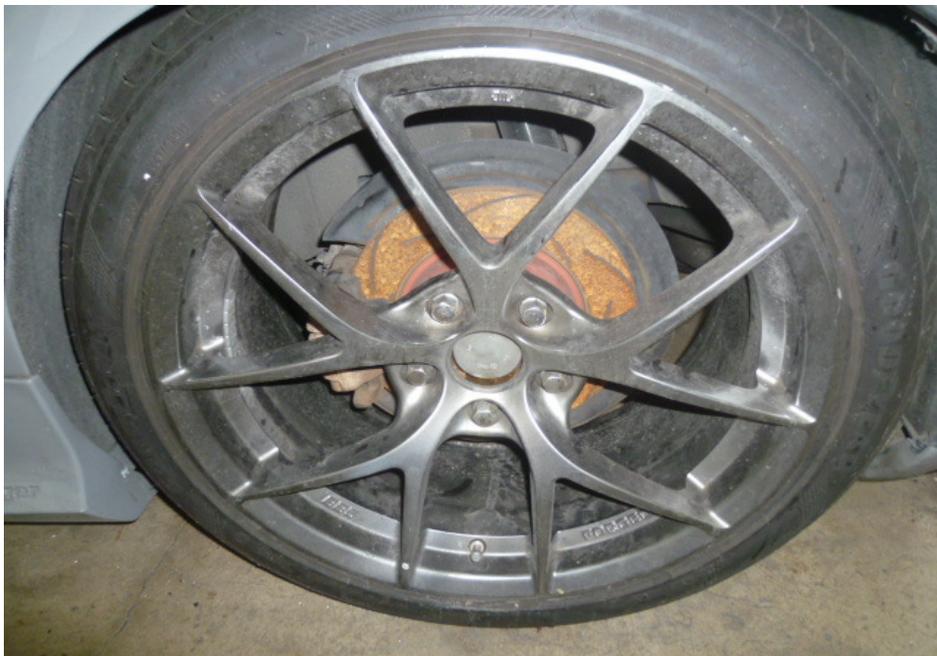
**Photo 13** shows the non-standard rim found to be fitted on the Insured Vehicle at the time of our inspection. The 18- inch alloy rims fitted on the Insured Vehicle were not the standard type for the Insured Vehicle.

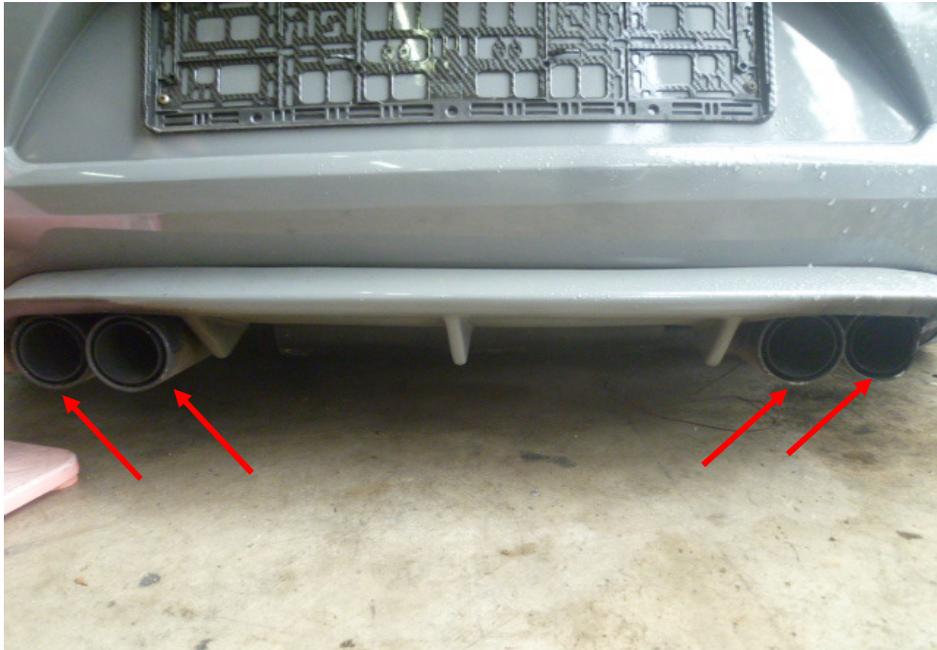
**Photo 14** shows a front view of the non-standard rear exhaust mufflers that were found to be fitted on the Insured Vehicle at the time of our inspection (arrowed).

7. As for the non- standard rear exhaust mufflers, during our interview with the owner of the Insured Vehicle Mr Iskandar bin Abdul Rani (herein referred to as “**Mr Iskandar**”), we were unable to obtain the exhaust authentication certificate as well as the inspection acknowledgement letter issued by the LTA to prove that the after-market rear exhaust mufflers had passed the mandatory inspection. He mentioned that the aftermarket exhaust mufflers were already fitted onto the Insured Vehicle when he purchased it in December 2022. He was informed by the dealer that the exhaust authentication certificate as well as the inspection acknowledgement letter issued by the LTA was already uploaded in the LTA’s online system. Hence Mr Iskandar did not provide documents to prove that the non-standard rear exhaust mufflers have been approved by the LTA.

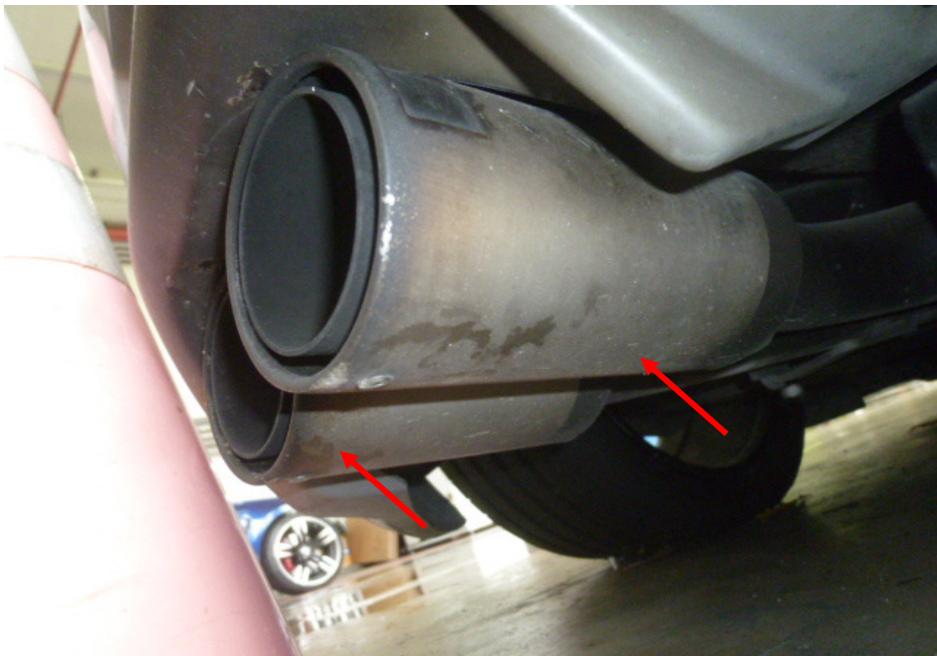
**Photo 15** shows a close up view of the underside of the non-standard left rear exhaust mufflers that were found to be fitted on the Insured Vehicle at the time of our inspection (arrowed).

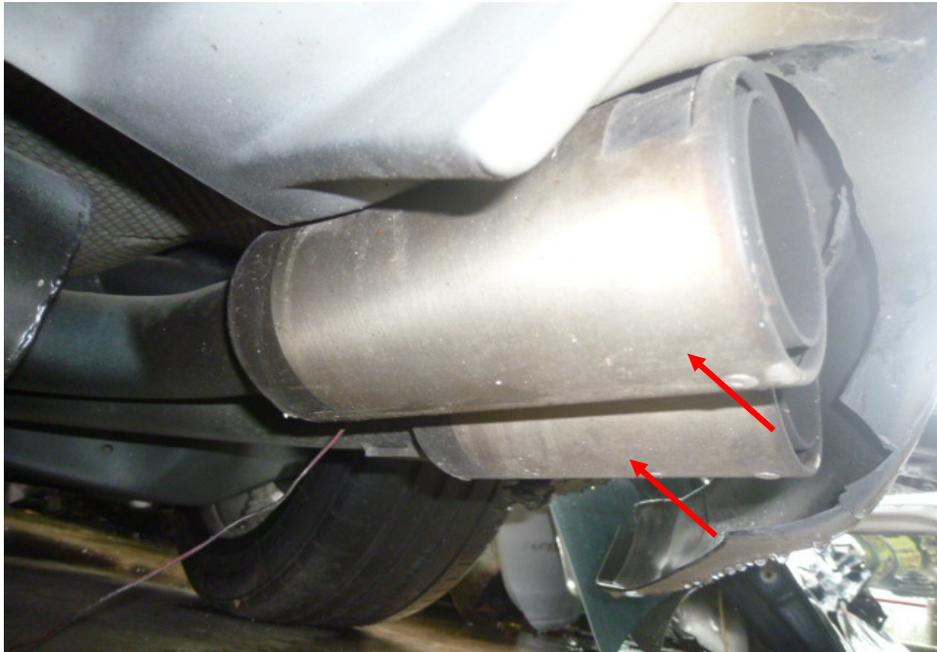
**Photo 16** shows a close up view of the underside of the non-standard right rear exhaust mufflers that were found to be fitted on the Insured Vehicle at the time of our inspection (arrowed).

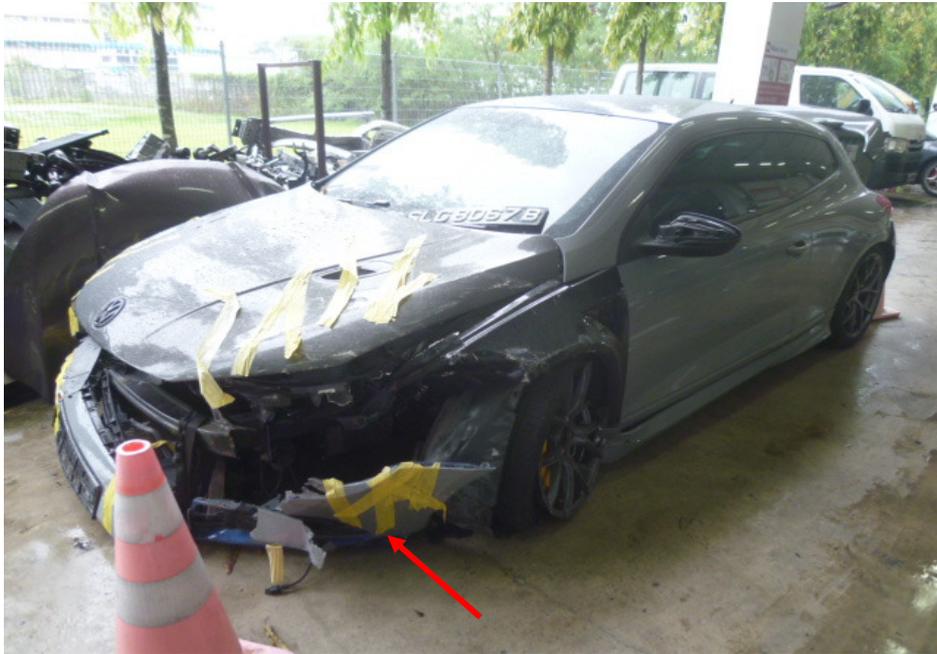
**Photo 17** shows a general view of the aftermarket front bumper found fitted onto the Insured Vehicle at the time of our inspection (arrowed).

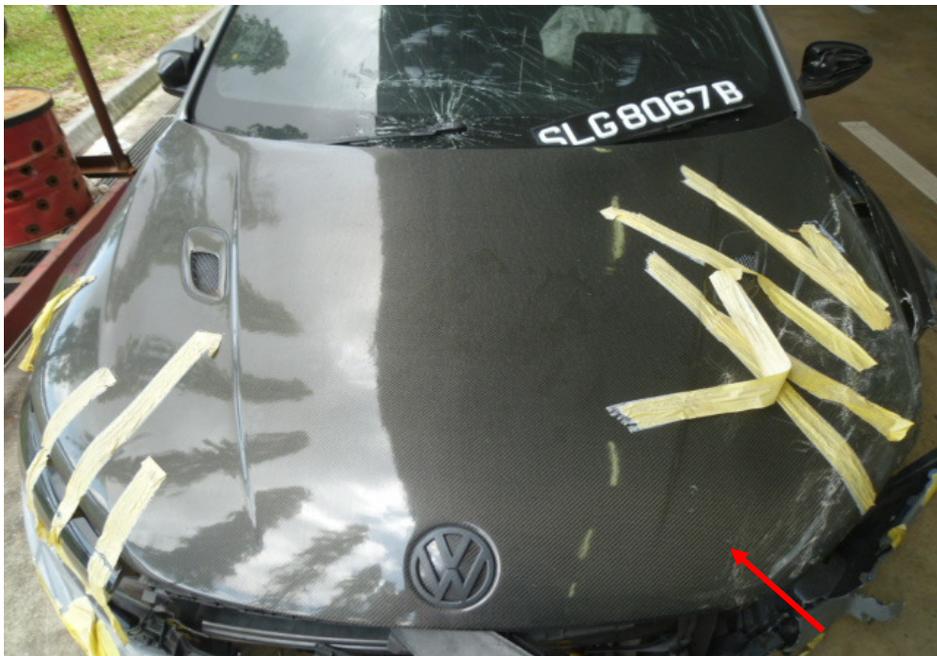
**Photo 18** shows a general view of the aftermarket carbon fibre front bonnet found fitted onto the Insured Vehicle at the time of our inspection (arrowed).

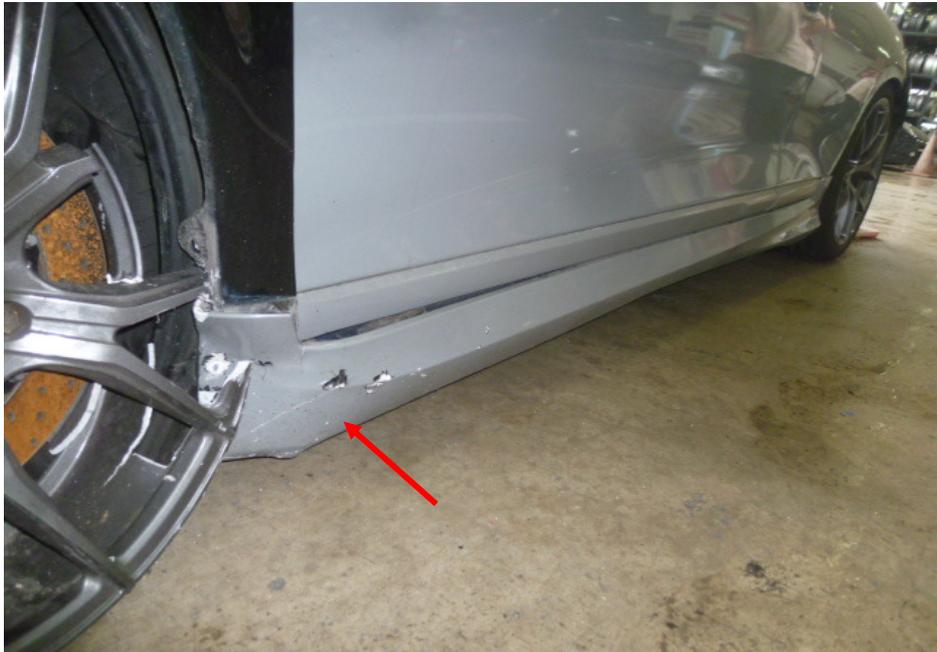
**Photo 19** shows a general view of the aftermarket left side skirting found fitted onto the Insured Vehicle at the time of our inspection (arrowed).

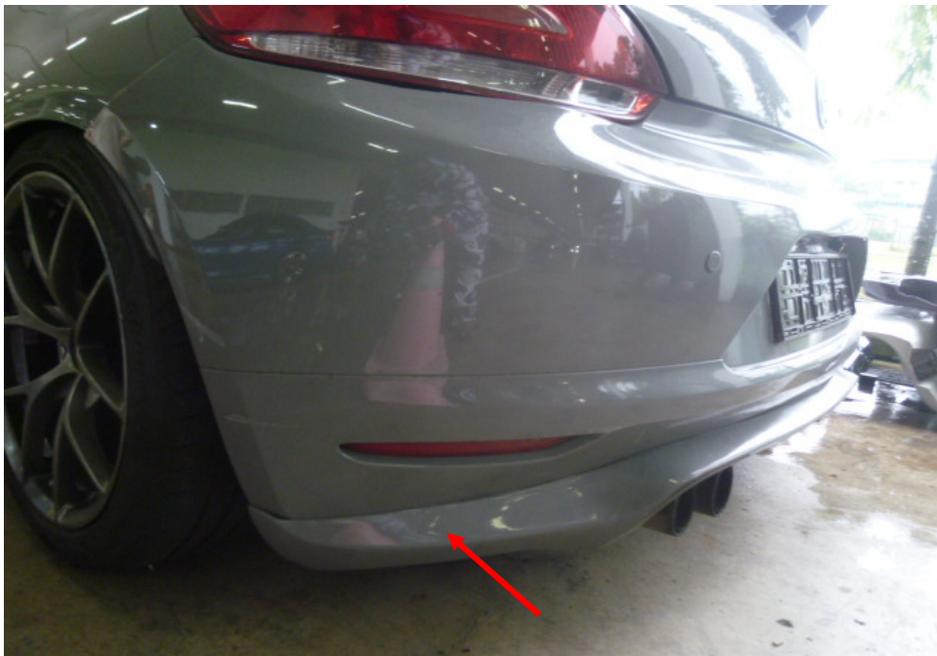
**Photo 20** shows a general view of the aftermarket rear bumper found fitted onto the Insured Vehicle at the time of our inspection (arrowed).

Aftermarket rear bumper	Compliant	Cosmetic type of modification
Aftermarket carbon- fibre rear spoiler	Compliant	Cosmetic type of modification

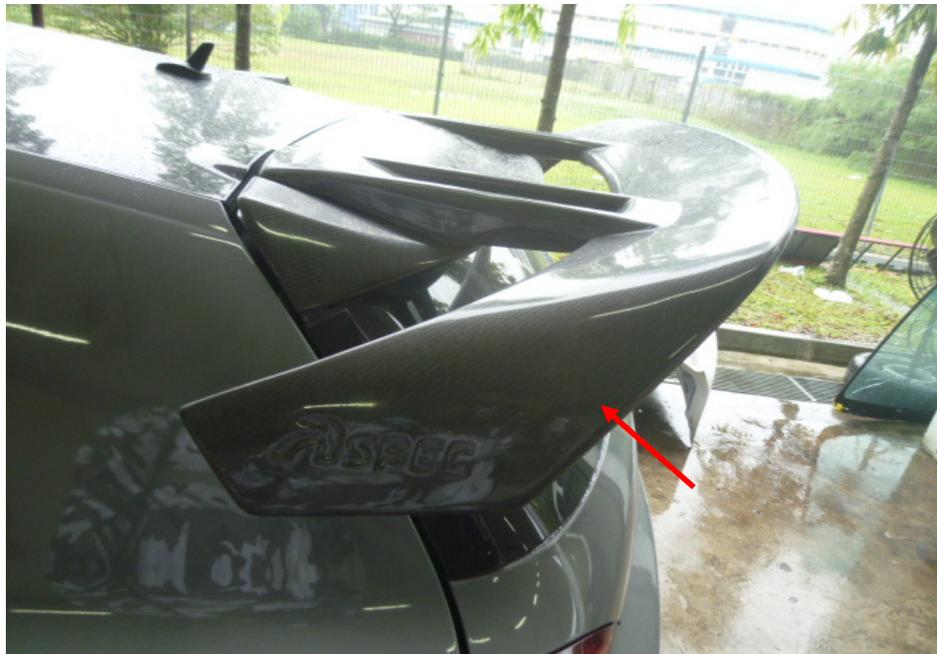
**Photo 21** shows a general view of the aftermarket carbon fibre rear spoiler found fitted onto the Insured Vehicle at the time of our inspection (arrowed).
