: PRE-REPAIR SURVEY

PRE-REPAIR SURVEY REPORT

FBA6091T

Honda Super 4

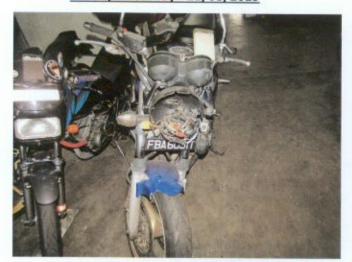
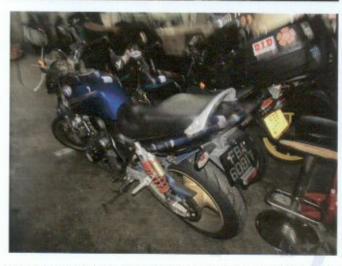
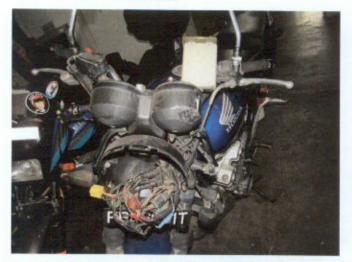
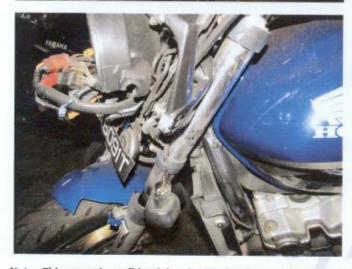
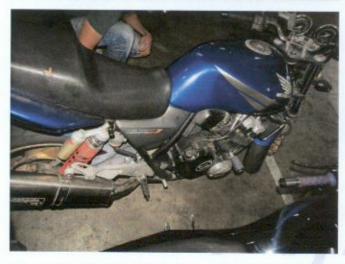
Our Ref: AV\$2019-20409/BL Your Ref: MT/1048939-002 Pre-repair survey - 22/08/2019

The vehicle sustained damage on the front portion.

The front headlamp, front fork, front fairing and front meter were among the items affected.

Based on visual survey of the vehicle without any repair estimate provided, we viewed that the repair cost should not be more than S\$1,800.00 and could take approximately third (3) working days to complete.
