Your Ref: Toyota Alphard  
(chassis number AYH300144116)  
Our Ref : CI/TP23001515/D

13 February 2023

### **INSPECTION REPORT OF AN UNREGISTERED TOYOTA ALPHARD MOTOR CAR WITH CHASSIS NUMBER AYH300144116**

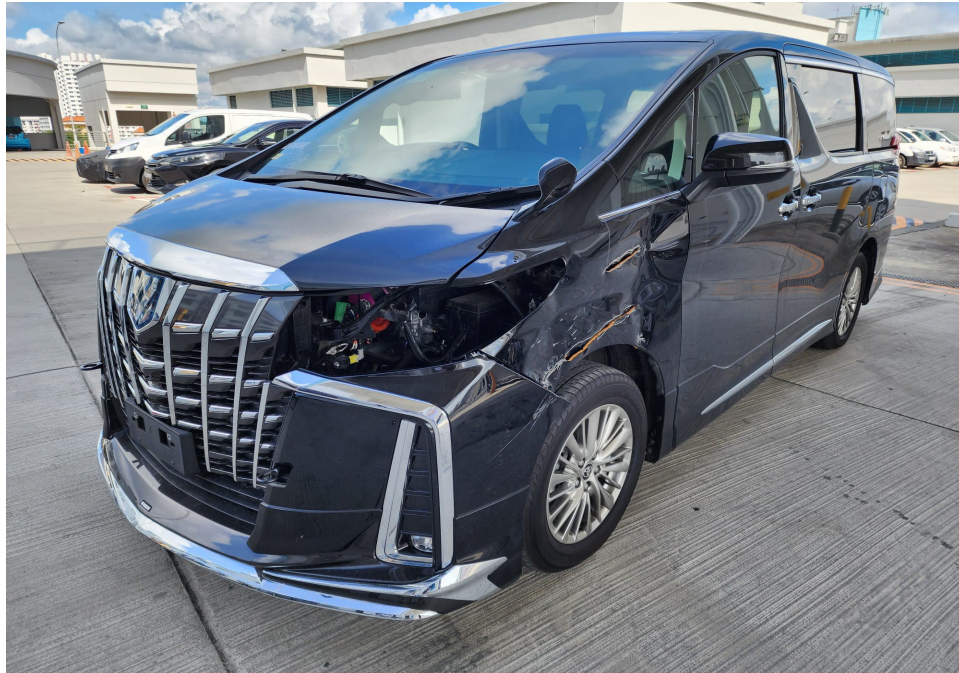
3. The photographs provided to me had showed damage to the left side front portion of the Motor Car. Body parts damaged include the front bumper, front left fender and front left fender inner shield amongst others. The front left headlamp and front left headlamp chrome moulding were observed to be missing/dislodged/damaged.
4. No physical damage was observed to other areas of the Motor Car. The airbag(s) of the Motor Car was not deployed as seen from the photographs that were provided to me. See photo 1 – 5 below.

**Photo 1** shows the front left body of the Motor Car (photograph provided to me). The Motor Car was observed to have sustained damage at its left side front portion. The front bumper, front left fender and front left fender inner shield were amongst the body parts that were observed to have been damaged. The front left headlamp and front left headlamp chrome moulding were observed to be missing/dislodged/damaged.

22. The body parts at the left side front portion of the Motor Car were visually examined and it was noted that the repair/restoration works carried out to the damaged area of the Motor Car (refer to photograph 1 & 2 above) were reasonably adequate and in order.

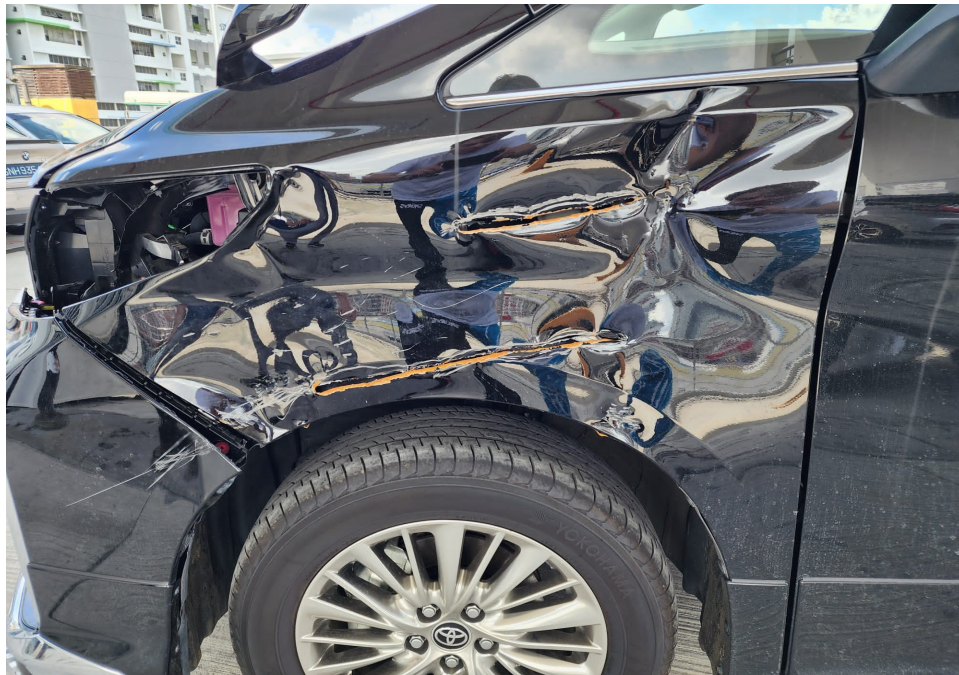
**Photo 2** shows another view of the damage at the left side front portion of the Motor Car (photograph provided to me). The front bumper, front left fender and front left fender inner shield were amongst the body parts that were observed to have been damaged. The front left headlamp and front left headlamp chrome moulding were observed to be missing/dislodged/damaged.

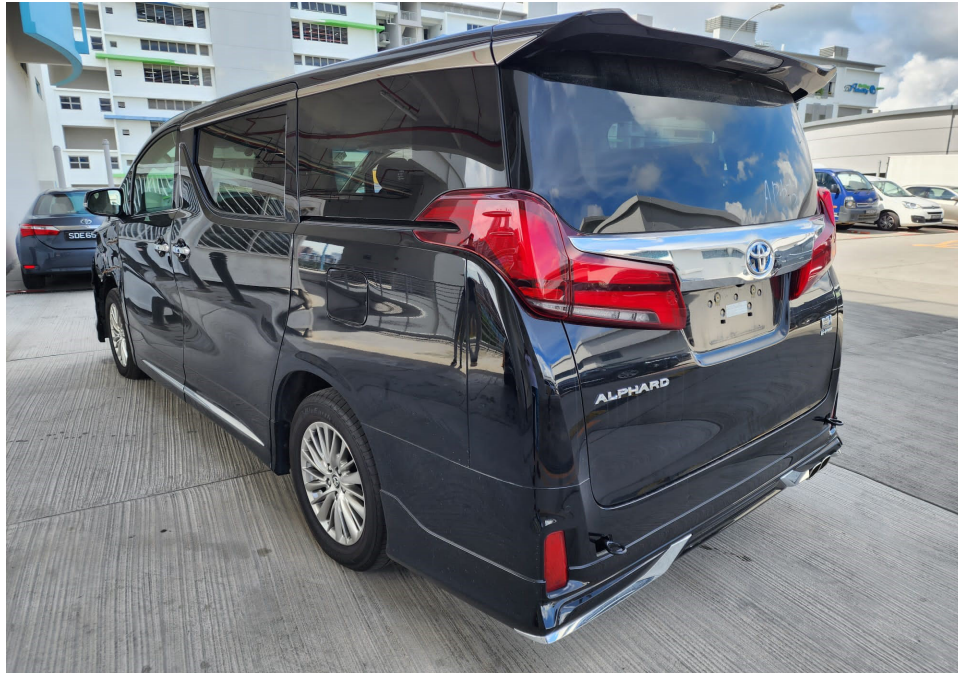
**Photo 3** shows the rear left body of the Motor Car (photograph provided to me). Apart for the left side front portion, the photographs provided to me did not show physical damage to other areas of the Motor Car. The Motor Car's airbag(s) was not deployed.

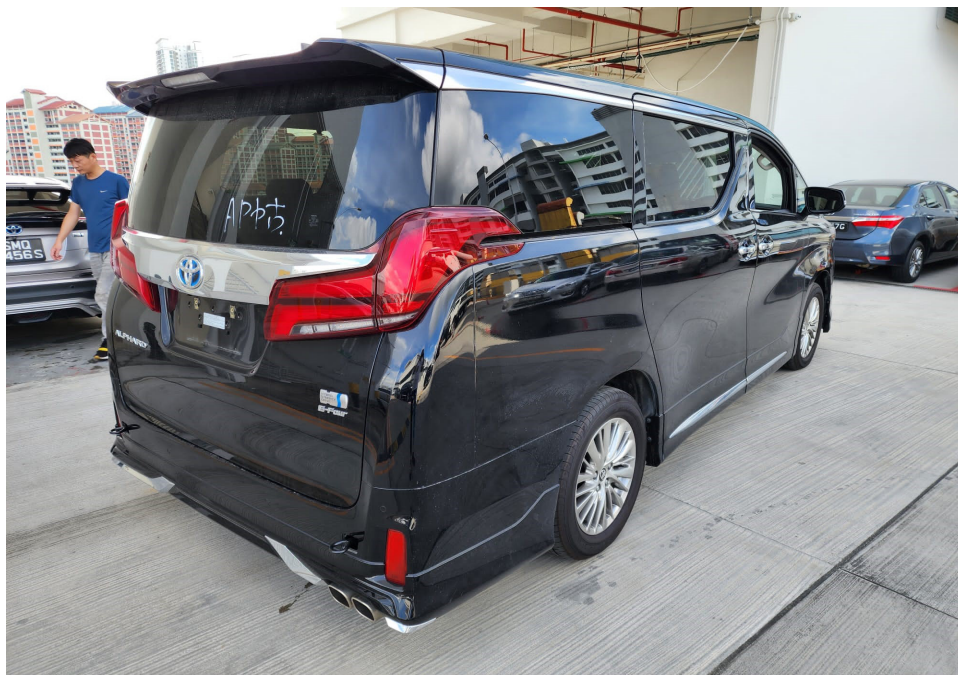
**Photo 4** shows the rear right body of the Motor Car (photograph provided to me). Apart for the left side front portion, the photographs provided to me did not show physical damage to other areas of the Motor Car.

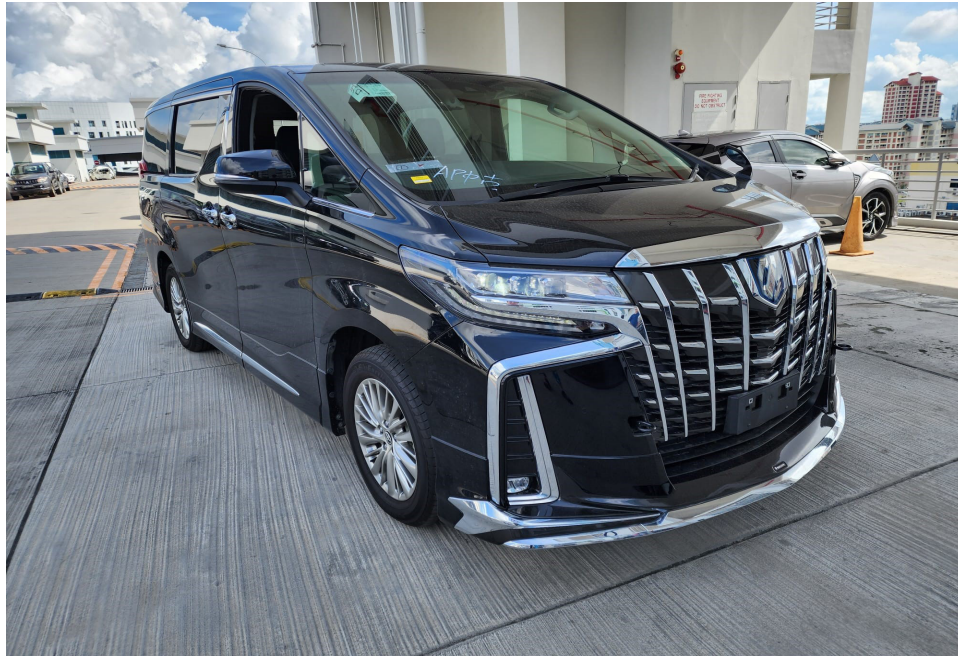
**Photo 5** shows the front right body of the Motor Car (photograph provided to me). Apart for the left side front portion, there was no physical damage observed to other areas of the Motor Car. The Motor Car's airbag(s) was not deployed.

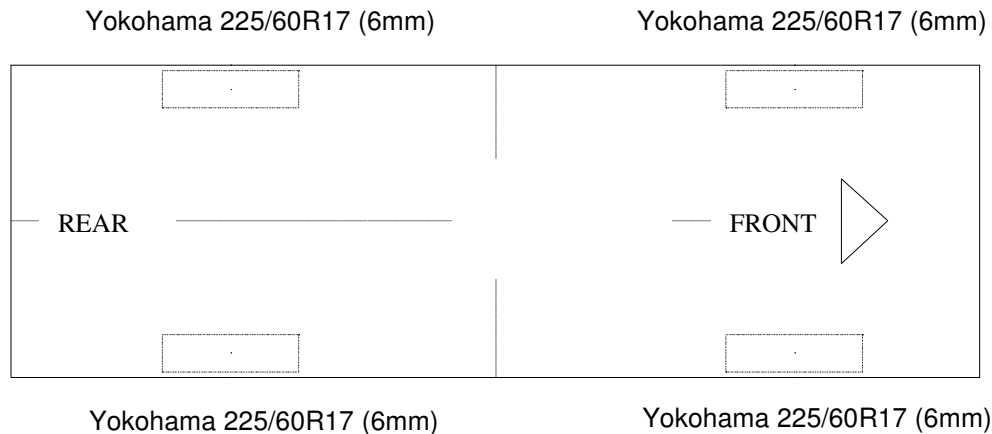
8. It was fitted with 17inch sport wheel rims that were wrapped with tyres that were observed to be of serviceable condition. The tyres were also sufficiently inflated for vehicular operation. The tyre brand, tyre size and approximate remaining tread depth of the 4 tyres of the Motor Car were recorded as follows: -

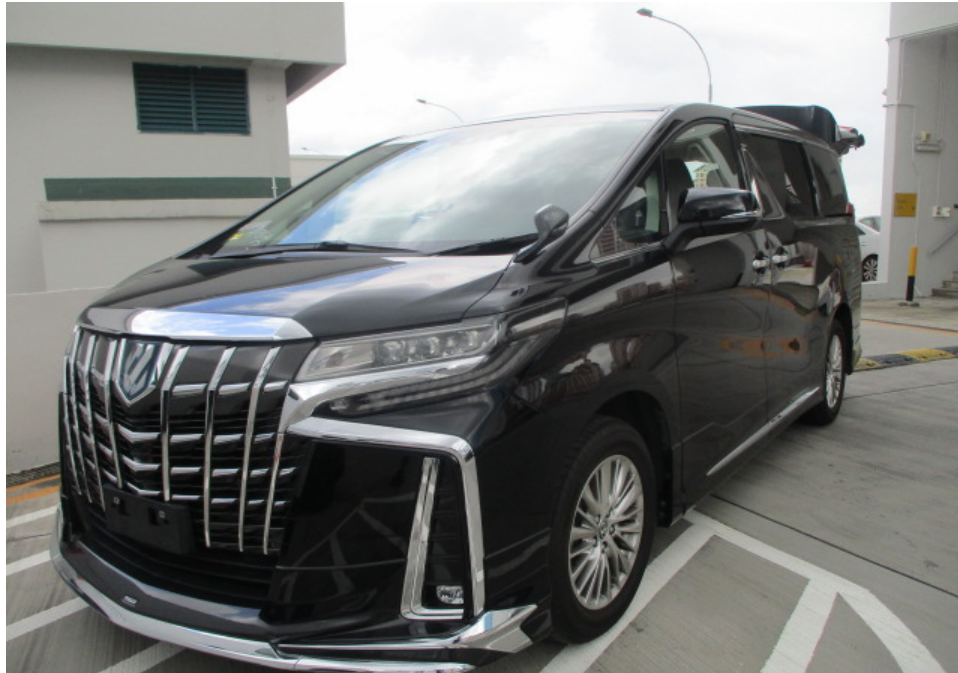
**Photo 6** shows a general view of the front left body of the Motor Car at the time of my inspection. The Motor Car was observed to be in a relatively good general condition with no loose exterior fittings observed. The body parts at the left side front portion of the Motor Car were visually examined and it was observed that the repair/restoration works carried out to the damaged area of the Motor Car (refer to photograph 1 & 2 above) were reasonably adequate and in order.

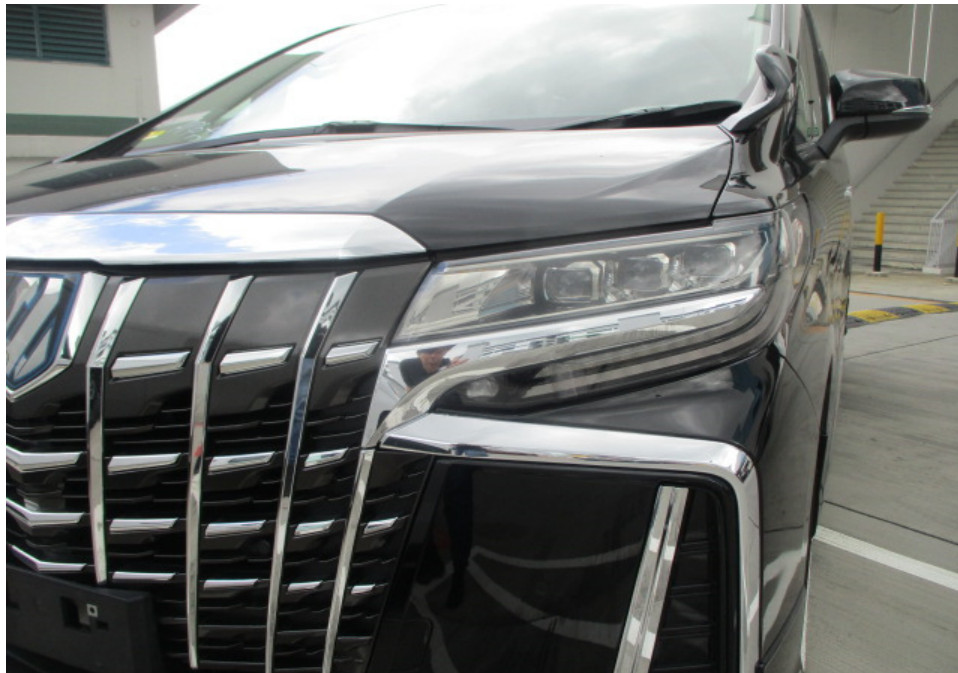
**Photo 7** shows a closer view of the Motor Car's front grille, front left headlamp, front left headlamp chrome moulding and front bonnet. The body parts at the left side front portion of the Motor Car were visually examined and it was observed that the repair/restoration works carried out to the damaged area of the Motor Car (refer to photograph 1 & 2 above) were reasonably adequate and in order.

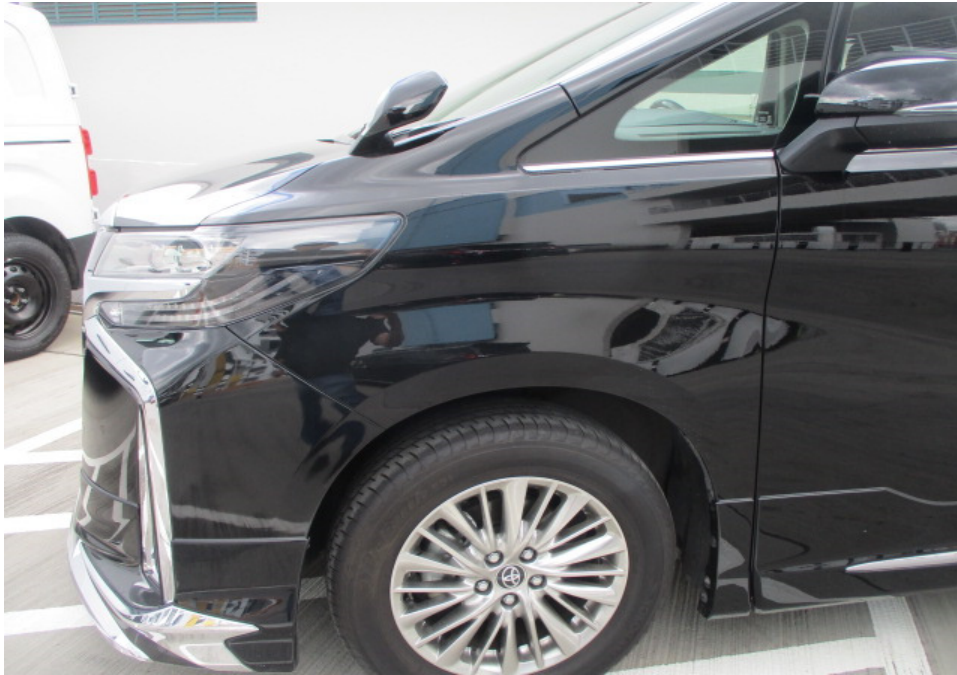
**Photo 8** shows a closer view of the Motor Car's front bumper, front left headlamp, front left fender and front left wheel rim. The body parts at the left side front portion of the Motor Car were visually examined and it was observed that the repair/restoration works carried out to the damaged area of the Motor Car (refer to photograph 1 & 2 above) were reasonably adequate and in order.

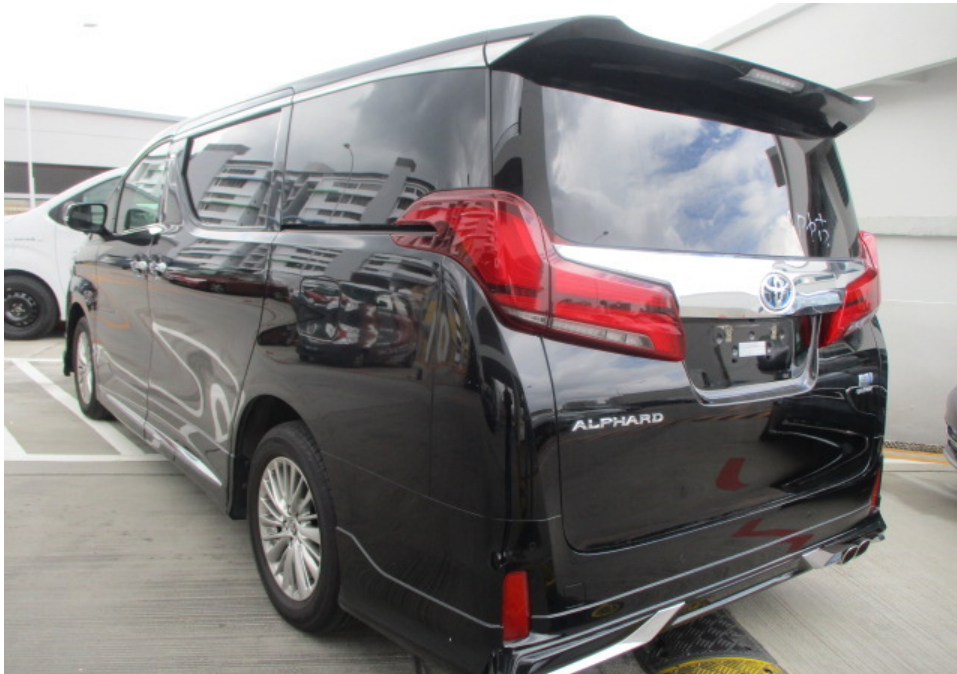
**Photo 9** shows a general view of the rear left body of the Motor Car at the time of my inspection. The Motor Car was observed to be in a relatively good general condition with no loose exterior fittings observed. The mileage of the Motor Car recorded at the time of my inspection was 371km.

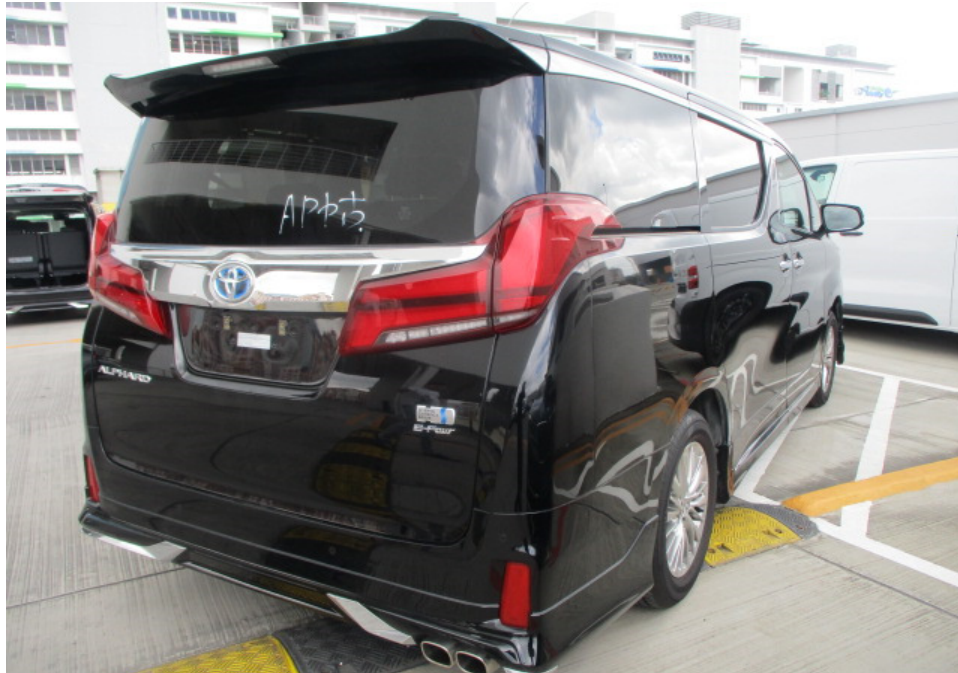
**Photo 10** shows a general view of the rear right body of the Motor Car at the time of my inspection. The Motor Car was observed to be in a relatively good general condition with no loose exterior fittings observed. The mileage of the Motor Car recorded at the time of my inspection was 371km.

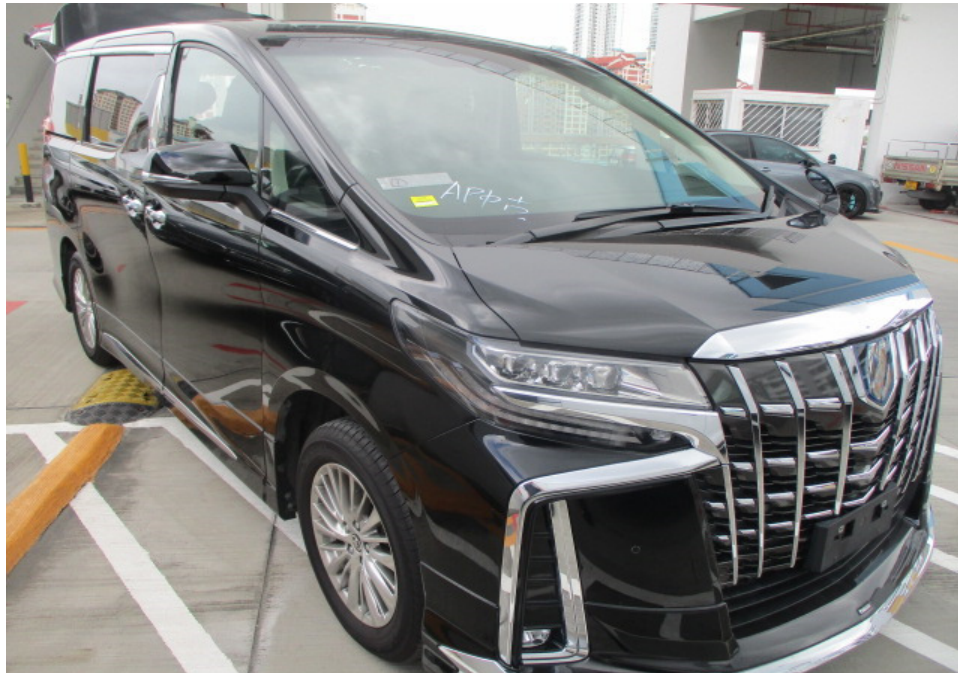
**Photo 11** shows a general view of the front right body of the Motor Car at the time of my inspection. The Motor Car was observed to be in a relatively good general condition with no loose exterior fittings observed. The mileage of the Motor Car recorded at the time of my inspection was 371km.

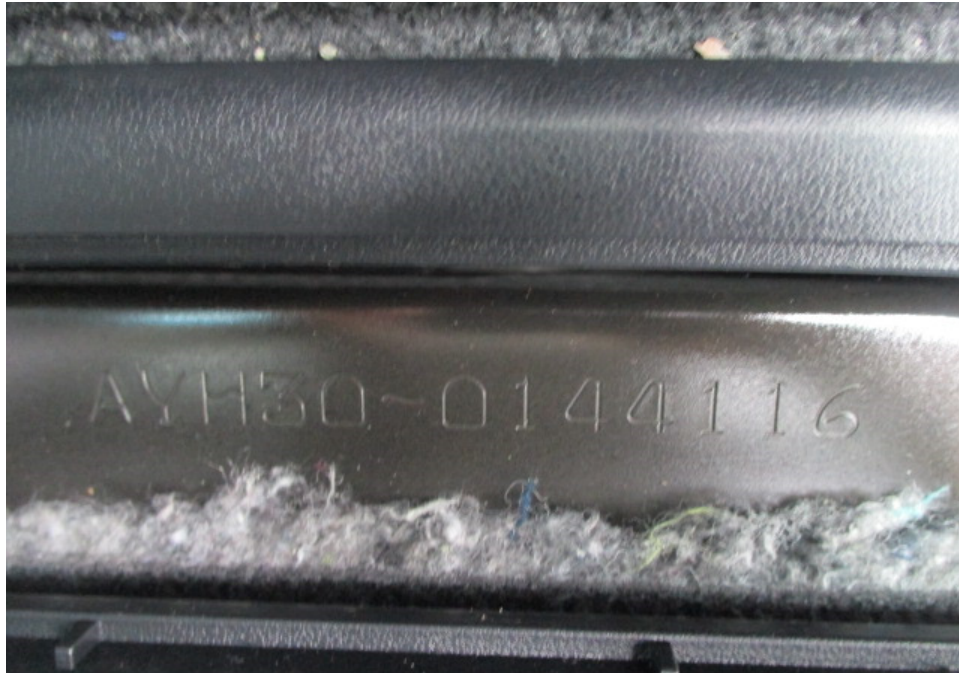
**Photo 12** shows the chassis number of the Motor Car. The chassis number recorded was AYH300144116.

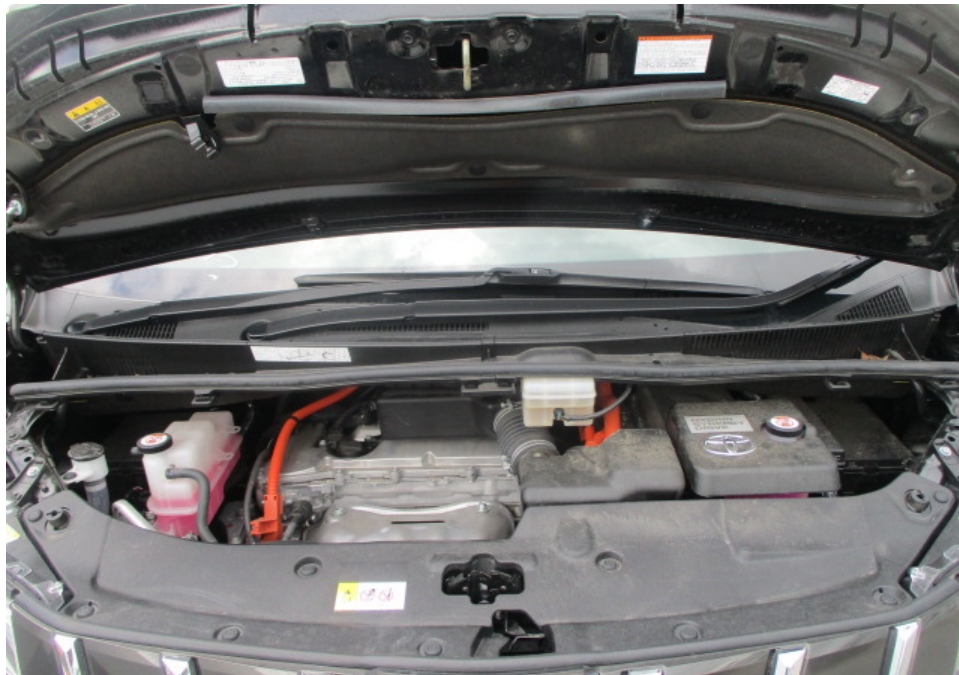
**Photo 13** shows a general view of the engine compartment of the Motor Car at the time of my inspection. The various parts and components inside the engine compartment were all observed to be intact and properly fitted. There was also no sign(s) or indication(s) of fluid leak and/or fluid stain found inside the engine compartment.

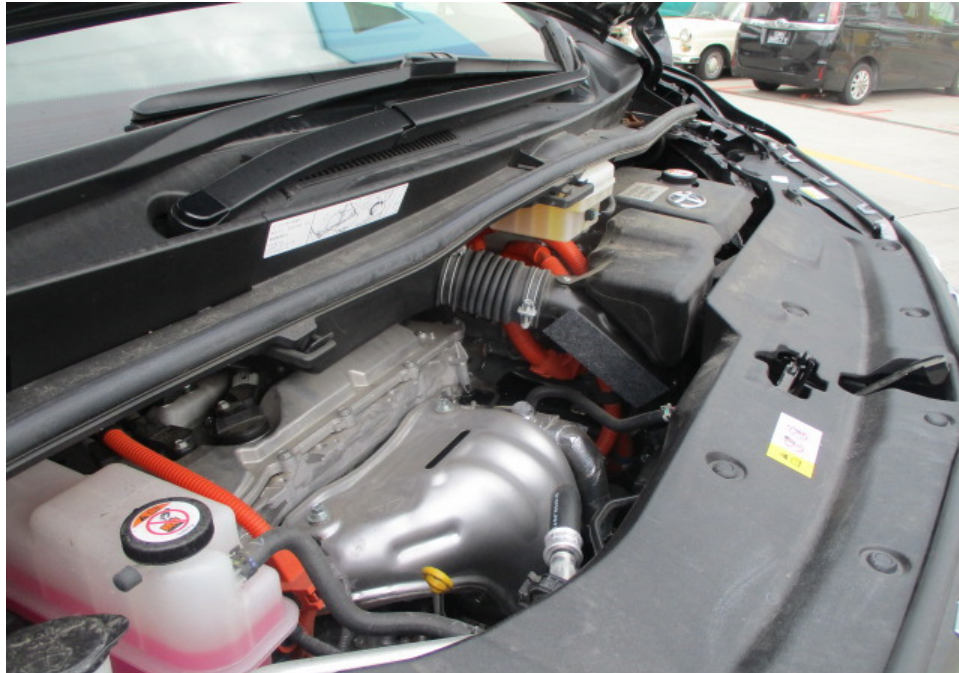
**Photo 14** shows another view of the engine compartment of the Motor Car at the time of my inspection. The various parts and components inside the engine compartment were all observed to be intact and properly fitted. There was also no sign(s) or indication(s) of fluid leak and/or fluid stain found inside the engine compartment.

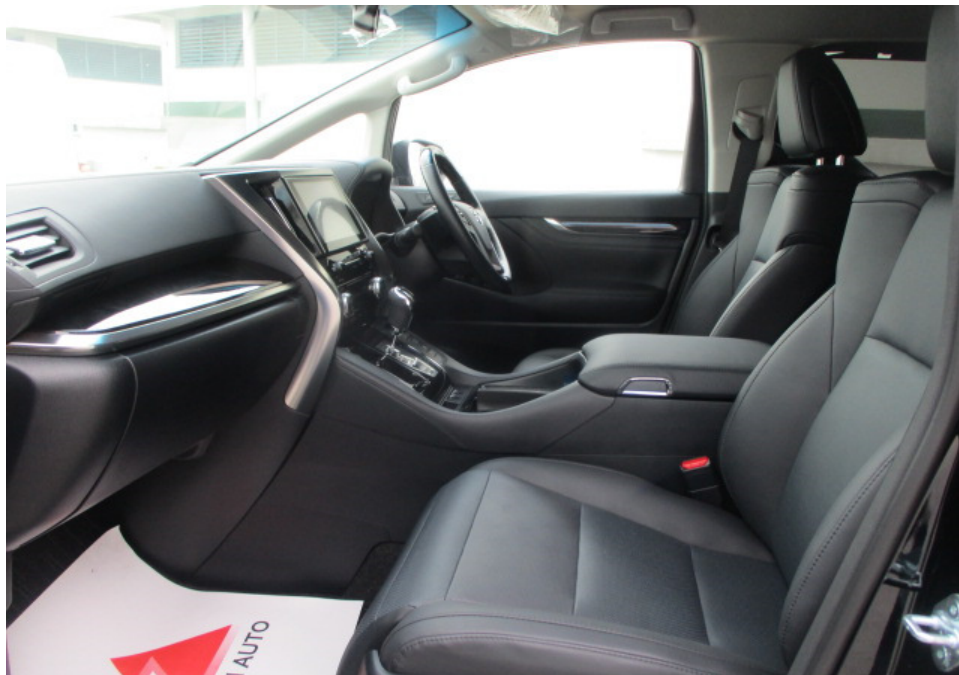
**Photo 15** shows the interior compartment of the Motor Car at the time of my inspection. The various parts and components, trims, carpet and upholstery inside the interior compartment were all observed to be intact and properly fitted.

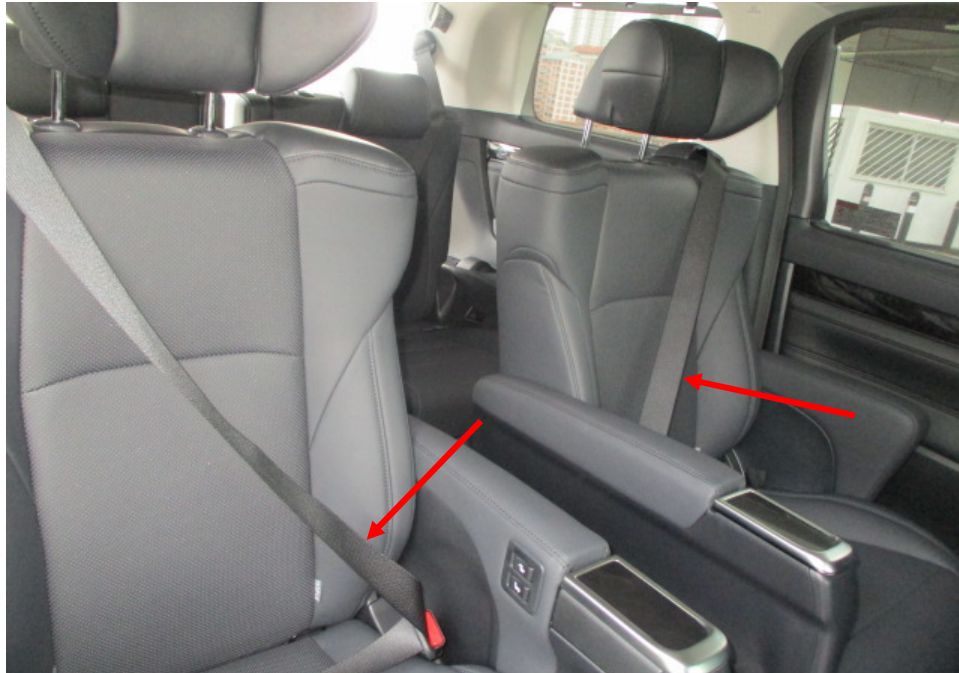
**Photo 16** shows the rear seats at the 1<sup>st</sup> row of the Motor Car. All the seats of the Motor Car were secured via seat rails to the floorboard. They were also fitted with a retractable seat belt reel and a pre-tensioner. The seat belts (arrowed) were tested and were able to be fastened into the respective pre-tensions that were fitted on the side of each individual seat.

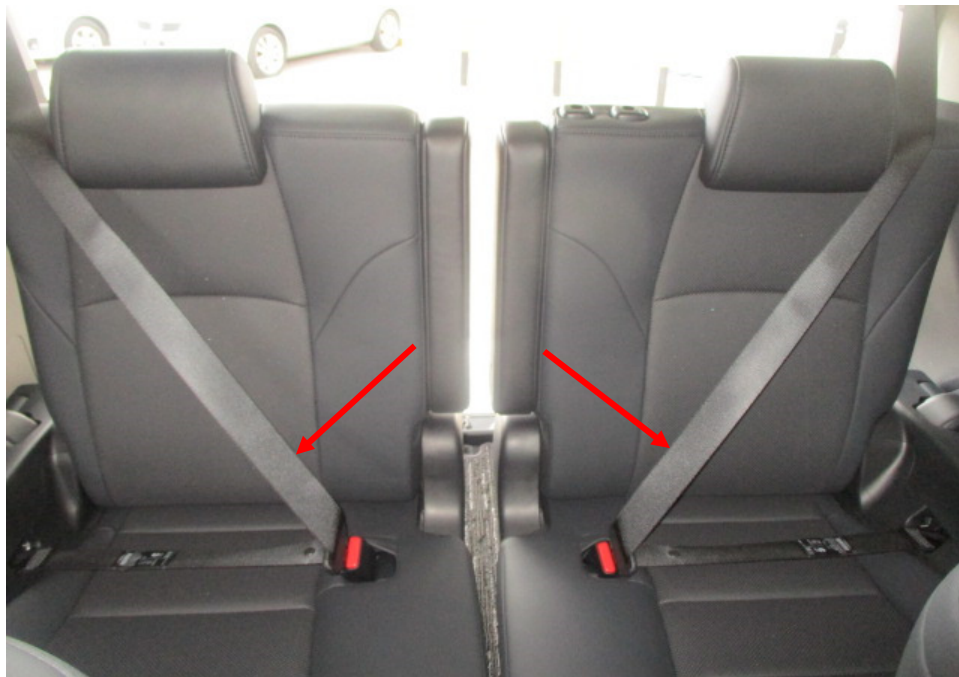
**Photo 17** shows the rear seats at the 2<sup>nd</sup> row of the Motor Car. All the seats of the Motor Car were secured via seat rails to the floorboard. They were also fitted with a retractable seat belt reel and a pre-tensioner. The seat belts (arrowed) were tested and were able to be fastened into the respective pre-tensions that were fitted on the side of each individual seat.

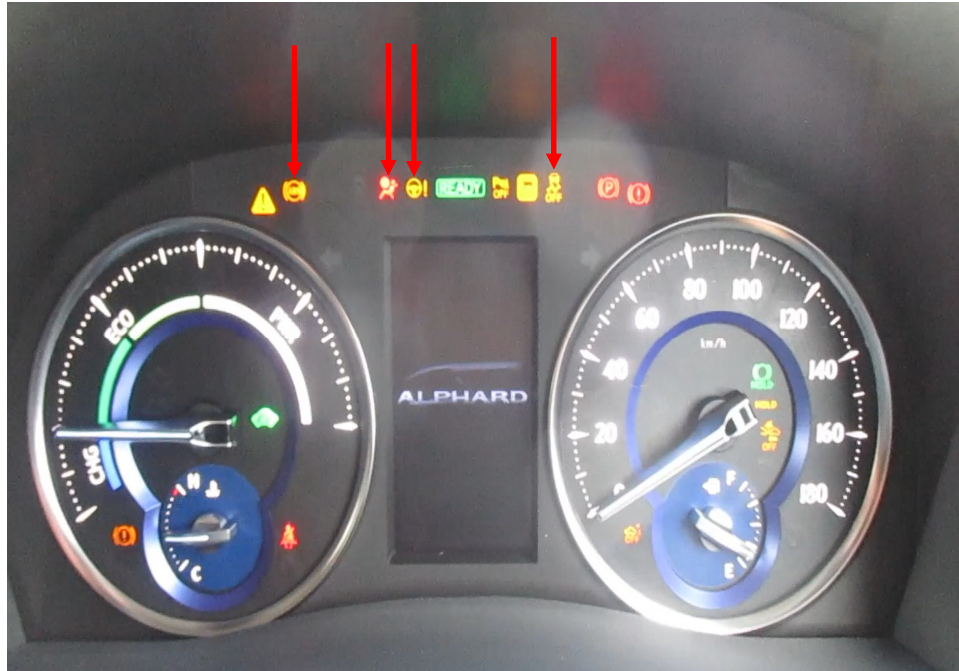
**Photo 18** shows the warning lights for the various electronic safety features appearing on the instrument panel of the Motor Car during its self-test when the engine is cranked, in particular the lights for the ABS, SRS, EPS, VSC (arrowed) and the various collision prevention systems.

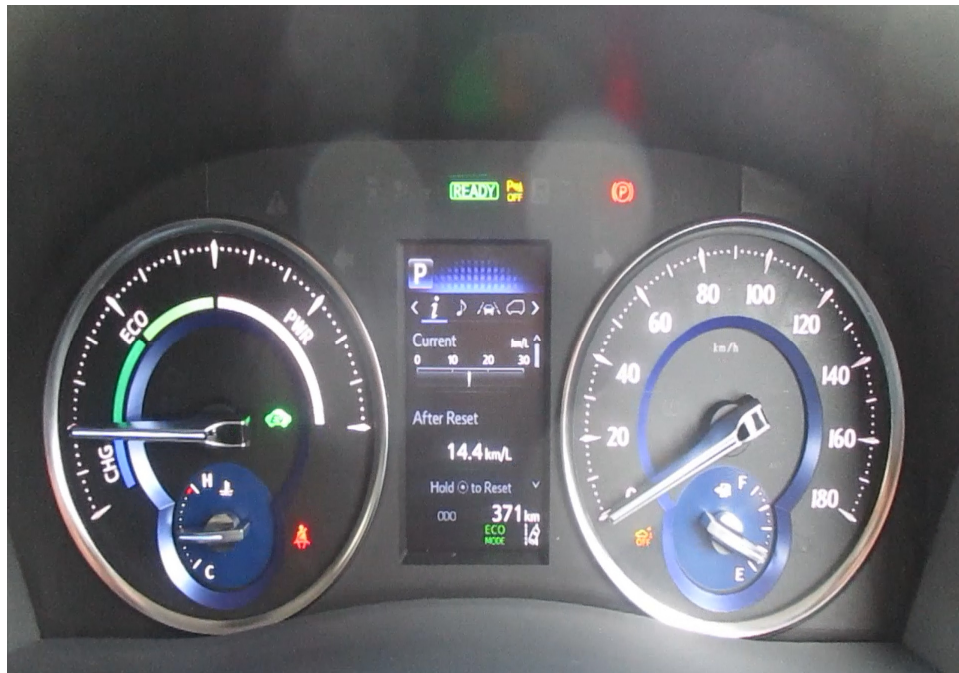
**Photo 19** shows the respective warning lights no longer illuminated, indicating that there is no fault detected to the ABS, SRS, EPS, VSC and the various collision prevention systems of the Motor Car during the self-test. These electronic systems were hence in working condition at the time of my inspection.

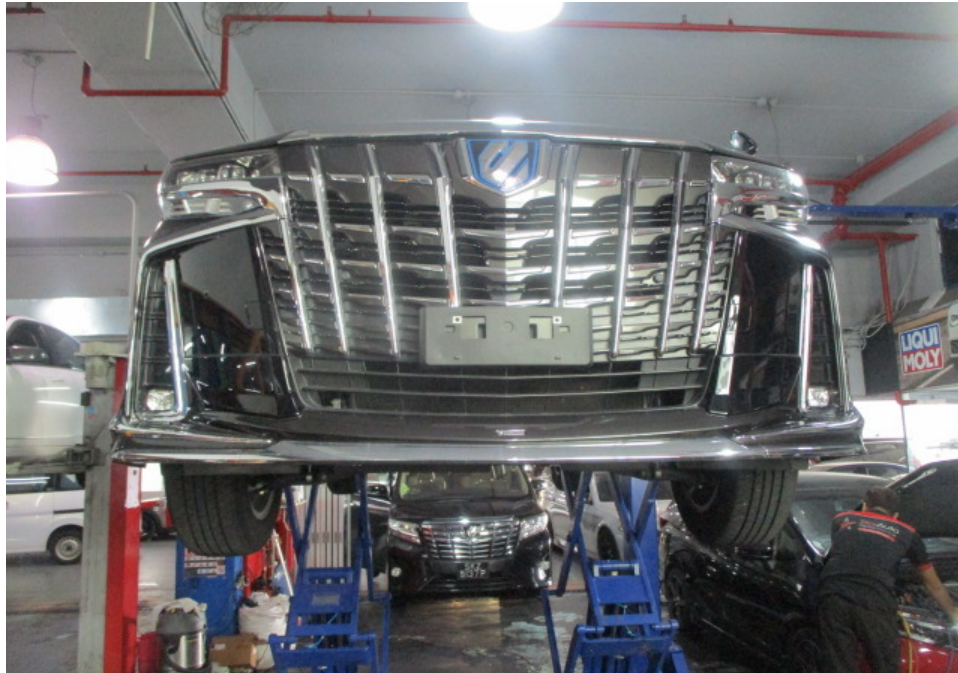
**Photo 20** shows the Motor Car hoisted up for checks on its undercarriage. There was no sign(s) or indication(s) of fluid leakage and/or fluid stain(s) on the underside of the Motor Car. The undercarriage components of the Motor Car were also all observed to be intact and secured in an appropriate manner.

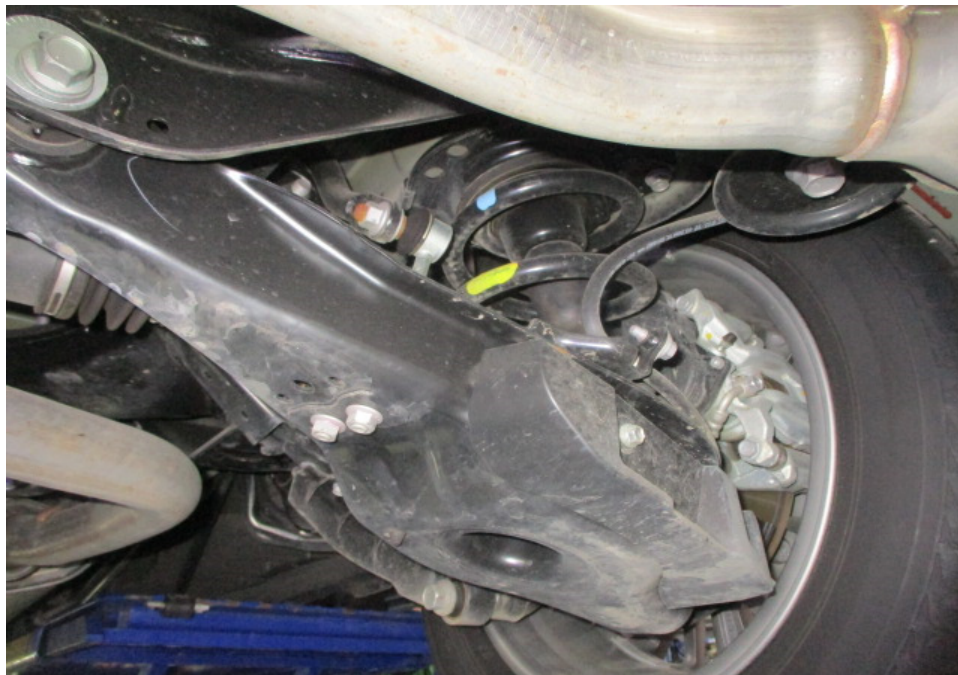
**Photo 21** shows a general view of the control arms and linkages at the rear right wheel of the Motor Car. I did not observe any fluid leak and/or fluid stain on the underside of the Motor Car. All of the Motor Car's undercarriage components were observed to be intact and secured in an appropriate manner.

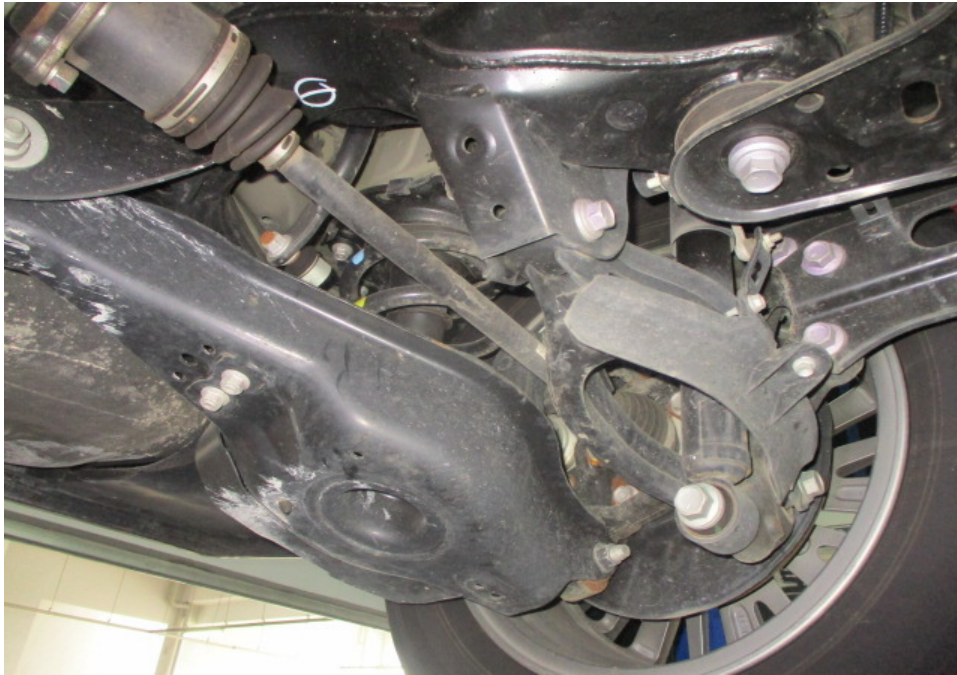
**Photo 22** shows a general view of the control arms and linkages at the rear left wheel of the Motor Car. I did not observe any fluid leak and/or fluid stain on the underside of the Motor Car. All of the Motor Car's undercarriage components were observed to be intact and secured in an appropriate manner.

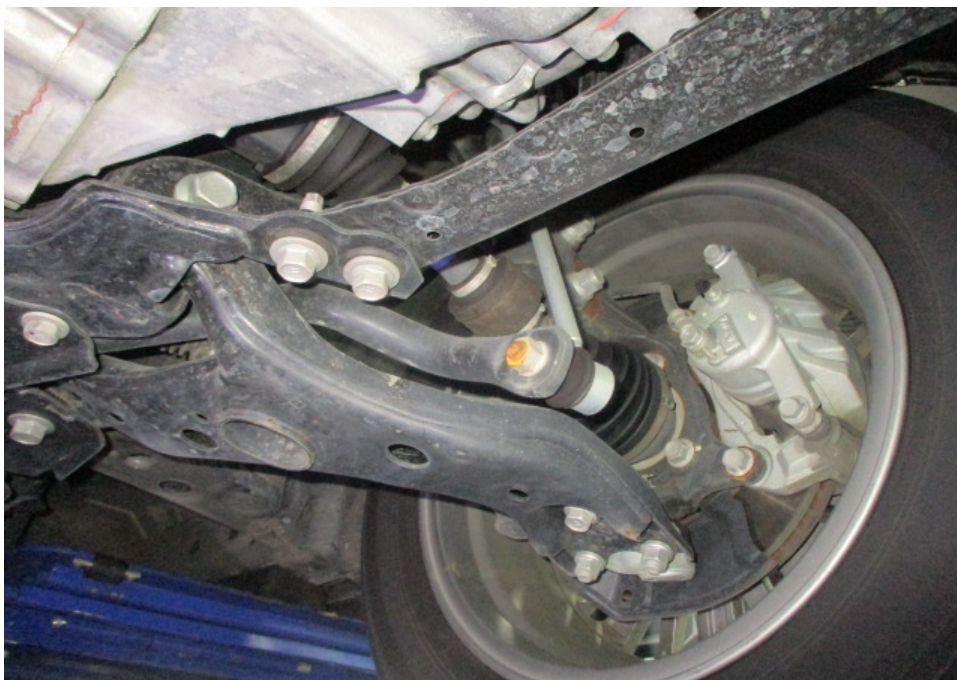
**Photo 23** shows the various undercarriage components at the front left wheel of the Motor Car. The mechanical components, control arms and linkages were all found to be intact and secured in an appropriate manner.

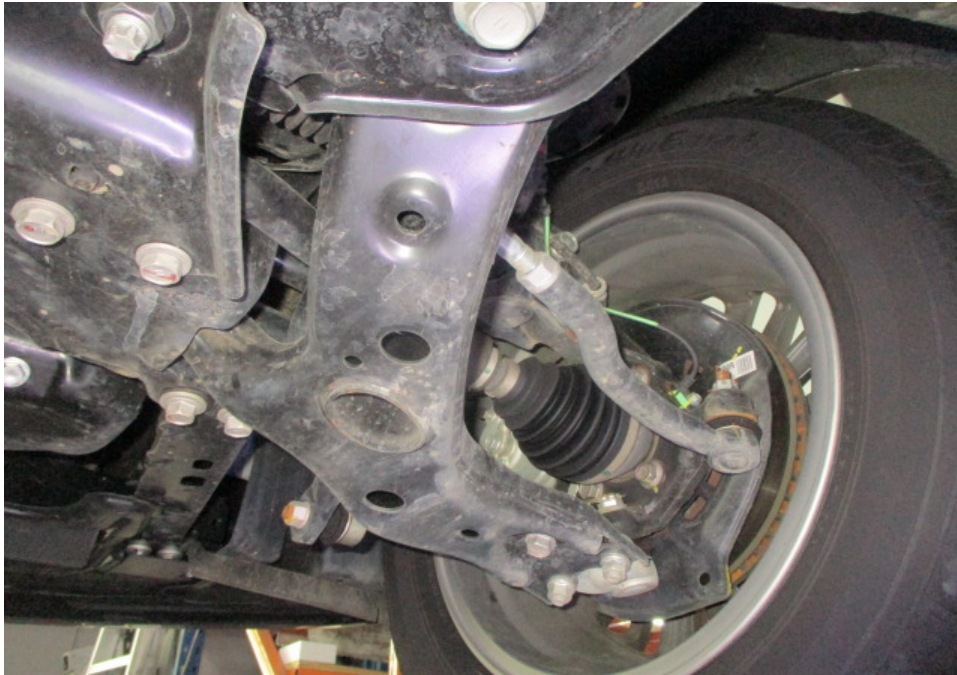
**Photo 24** shows the various undercarriage components at the front right wheel of the Motor Car. The mechanical components, control arms and linkages were all found to be intact and secured in an appropriate manner. I also did not observe any fluid leak and/or fluid stain on the underside of the Motor Car.

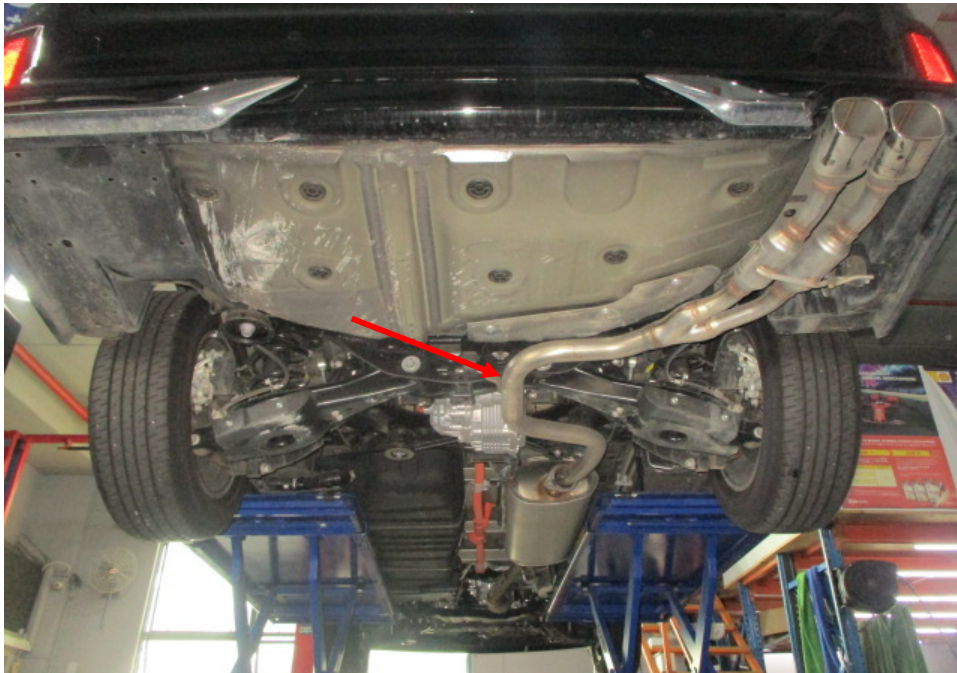
**Photo 25** shows a general view of the rear section of the Motor Car's exhaust system. My examination of the Motor Car's exhaust system revealed no sign(s) or indication(s) of any cut or weld marks along its exhaust pipe (arrowed), on its catalytic converter, on its centre resonator box and on its rear muffler.

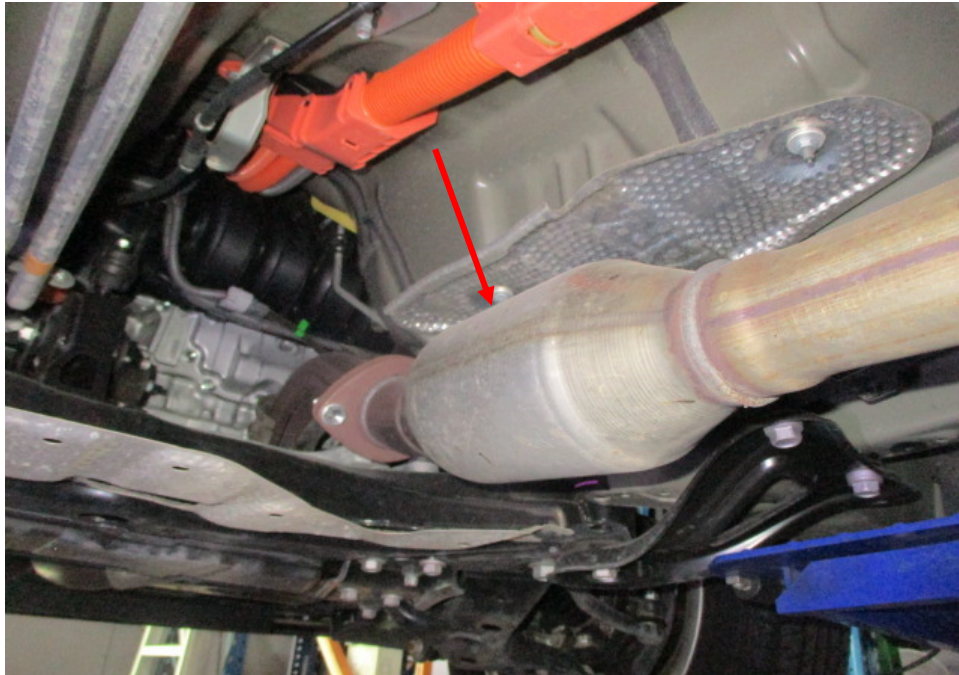
**Photo 26** shows a general view of the front section of the Motor Car's exhaust system. My examination of the Motor Car's exhaust system revealed no sign(s) or indication(s) of any cut or weld marks along its exhaust pipe, on its catalytic converter (arrowed), on its centre resonator box and on its rear muffler.

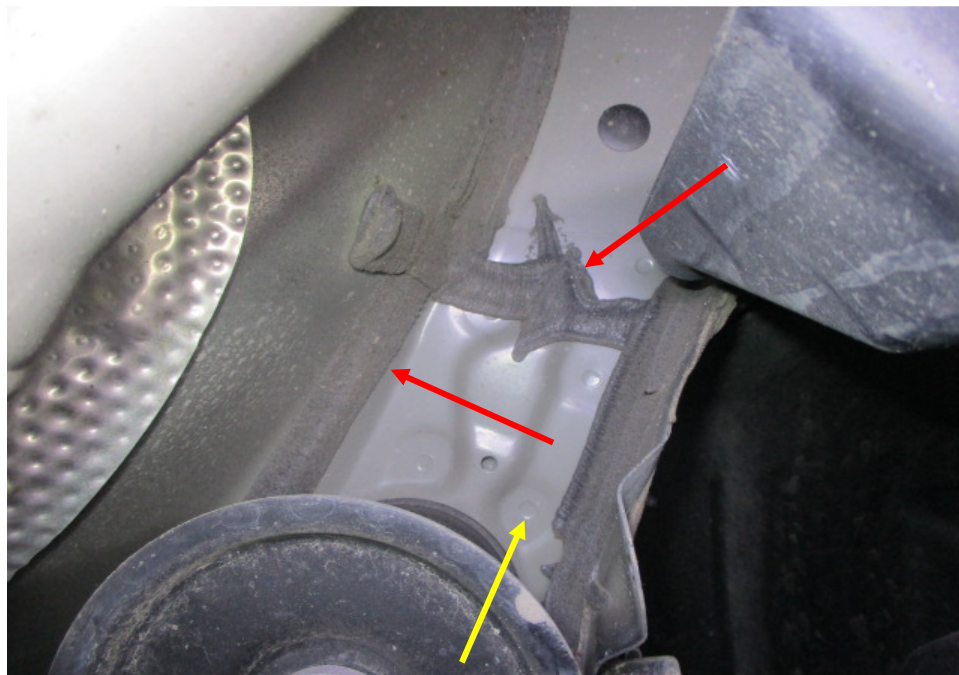
**Photo 27** shows the chassis/structural body at the underside rear right of the Motor Car. I did not find any weld marks other than original spot weld marks (yellow arrow) on the chassis/structural body of the Motor Car. The original factory sealant (red arrow) at the joints along the chassis/structural body was untouched, indicating no work was done on the chassis/structural body of the Motor Car and that the chassis/structural body was originally fitted.

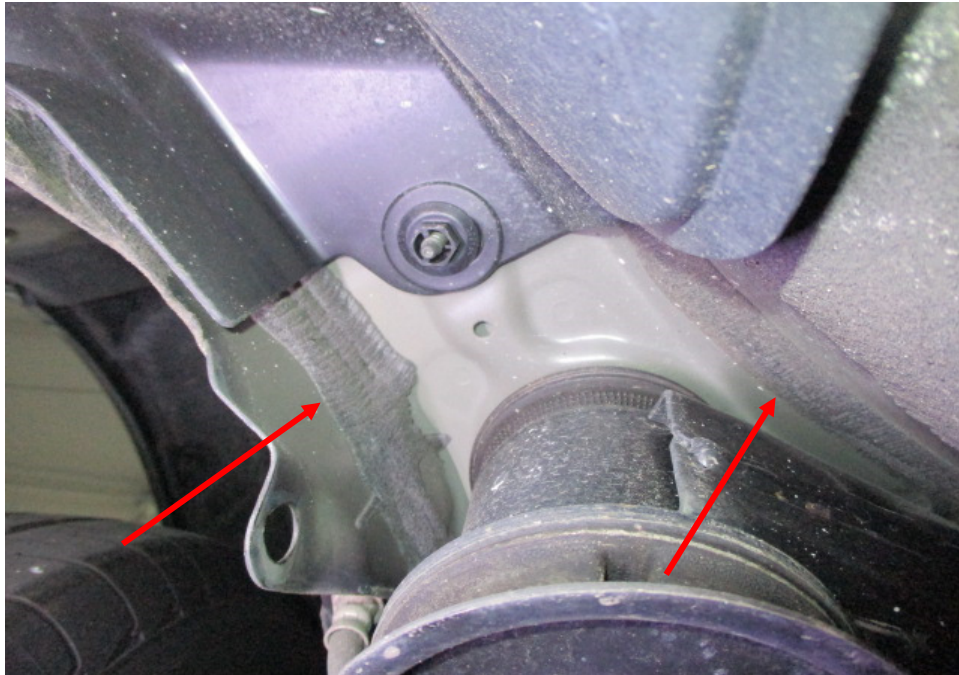
**Photo 28** shows the chassis/structural body at the underside rear left of the Motor Car. The original factory sealant (arrowed) at the joints along the chassis/structural body was observed to be untouched. In general, I had found no work was carried out on the chassis/structural body of the Motor Car. The chassis/structural body of the Motor Car was originally fitted

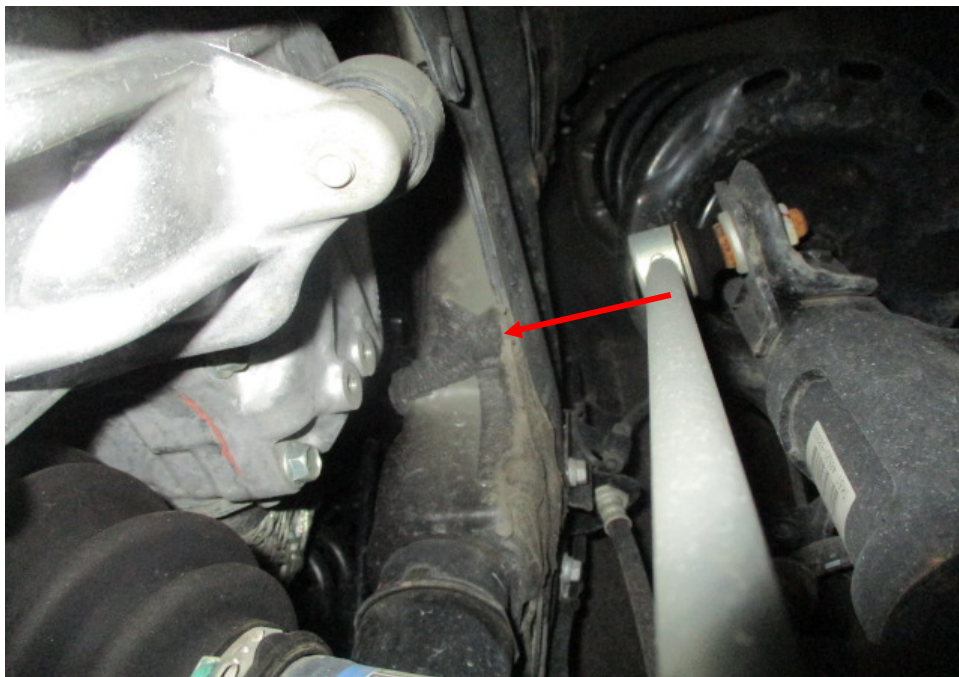
**Photo 29** shows the chassis/structural body at the underside front left of the Motor Car. The original factory sealant (arrowed) at the joints along the chassis/structural body was observed to be untouched. In general, I had found no work was carried out on the chassis/structural body of the Motor Car. The chassis/structural body of the Motor Car was originally fitted.

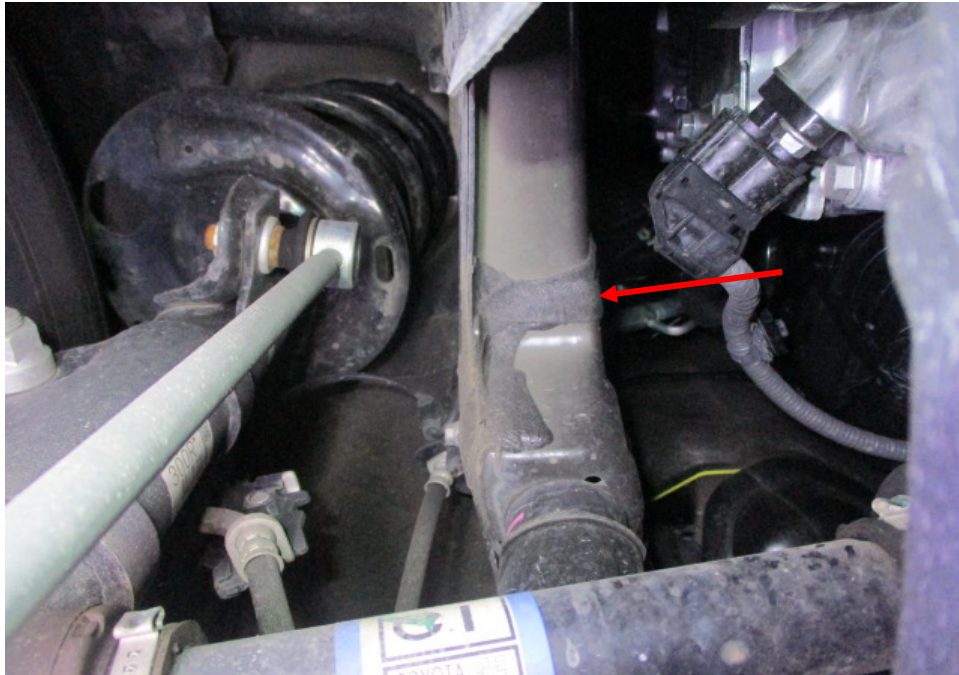
**Photo 30** shows the chassis/structural body at the underside front right of the Motor Car. The original factory sealant (arrowed) at the joints along the chassis/structural body was observed to be untouched. In general, I had found no work was carried out on the chassis/structural body of the Motor Car. The chassis/structural body of the Motor Car was originally fitted.
