Your Ref: Toyota Alphard  
(chassis number AYH300144116)  
Our Ref : CI/TP23001515/D

13 February 2023

### **INSPECTION REPORT OF AN UNREGISTERED TOYOTA ALPHARD MOTOR CAR WITH CHASSIS NUMBER AYH300144116**

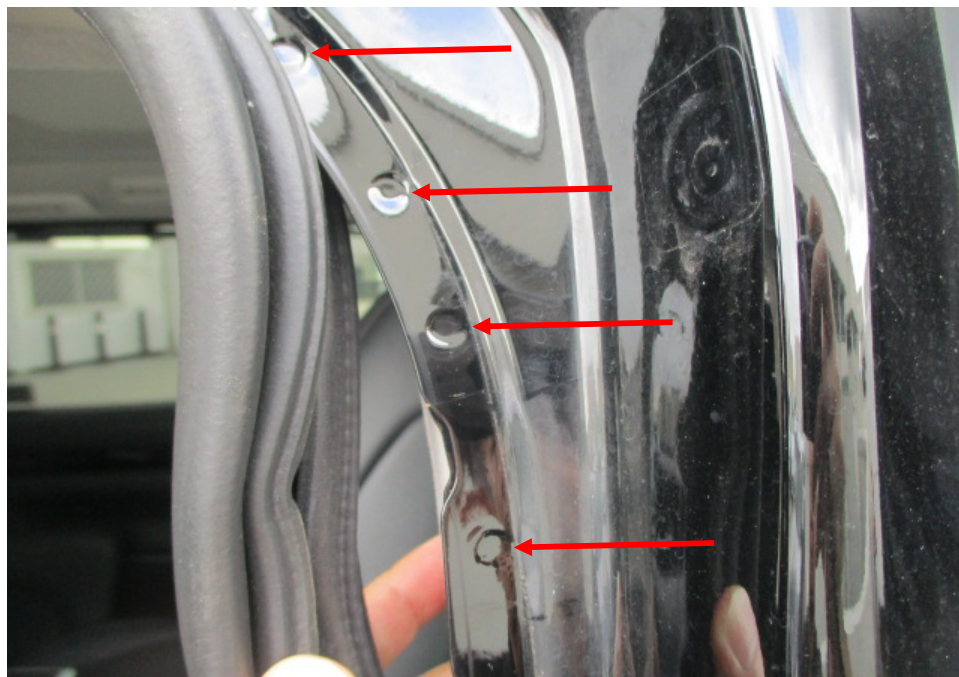
**Photo 31** shows the right side "B" pillar of the Motor Car. I did not find any weld marks other than original spot weld marks (arrowed) on the right side "B" pillar of the Motor Car, which indicates that there was no re-welding works carried out. In general, I had found all the non-detachable body panels of the Motor Car to be originally fitted at the time of my inspection.

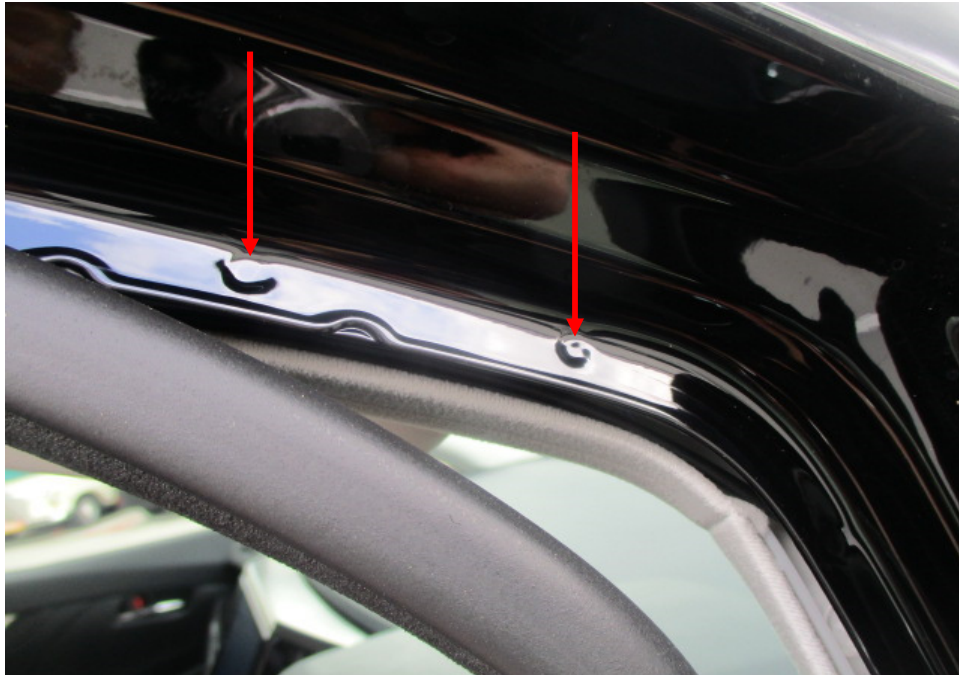
**Photo 32** shows the right side "A" pillar of the Motor Car. I did not find any weld marks other than original spot weld marks (arrowed) on the right side "A" pillar of the Motor Car, which indicates that there was no re-welding works carried out. In general, I had found all the non-detachable body panels of the Motor Car to be originally fitted at the time of my inspection.

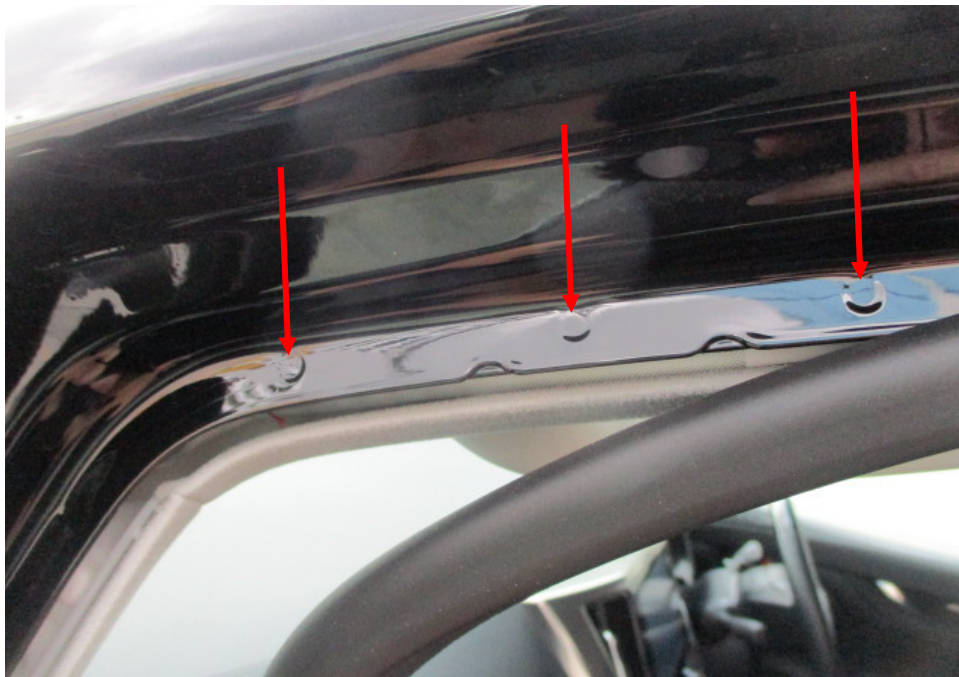
**Photo 33** shows the left side "A" pillar of the Motor Car. I did not find any weld marks other than original spot weld marks (arrowed) on the left side "A" pillar of the Motor Car, which indicates that there was no re-welding works carried out. In general, I had found all the non-detachable body panels of the Motor Car to be originally fitted at the time of my inspection.

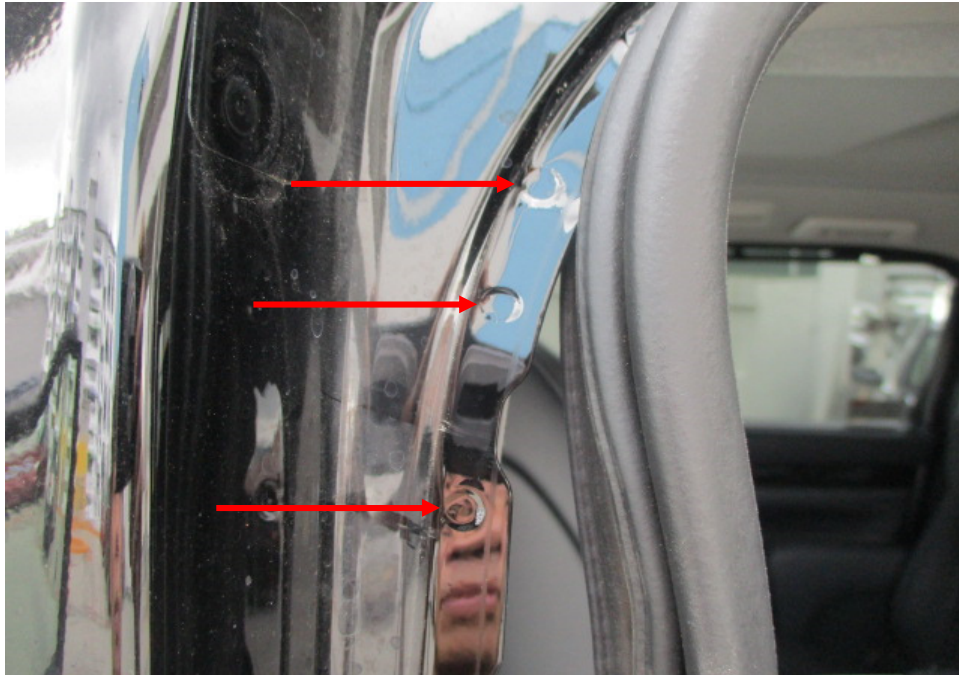
**Photo 34** shows the left side "B" pillar of the Motor Car. I did not find any weld marks other than original spot weld marks (arrowed) on the left side "B" pillar of the Motor Car, which indicates that there was no re-welding works carried out. In general, I had found all the non-detachable body panels of the Motor Car to be originally fitted at the time of my inspection.
