Your Ref: Toyota Alphard  
(chassis number AYH300146939)  
Our Ref : CI/TP23001523/D

12 February 2023

**INSPECTION REPORT OF AN UNREGISTERED TOYOTA ALPHARD MOTOR CAR WITH CHASSIS NUMBER AYH300146939**

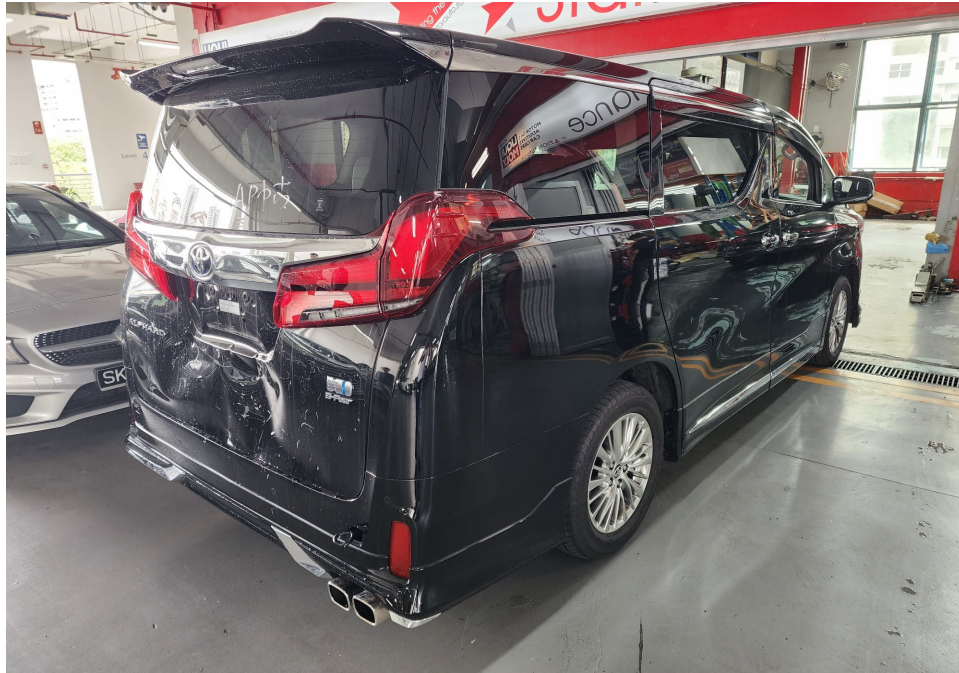
**Photo 1** shows the rear right body of the Motor Car (photograph provided to me). The Motor Car was observed to have sustained damage at its rear portion. The rear bumper, rear tailgate, rear tailgate upper chrome moulding, rear tailgate left reflector lamp, rear tailgate right reflector lamp and rear tailgate emblems were amongst the body parts that were observed to have been damaged.

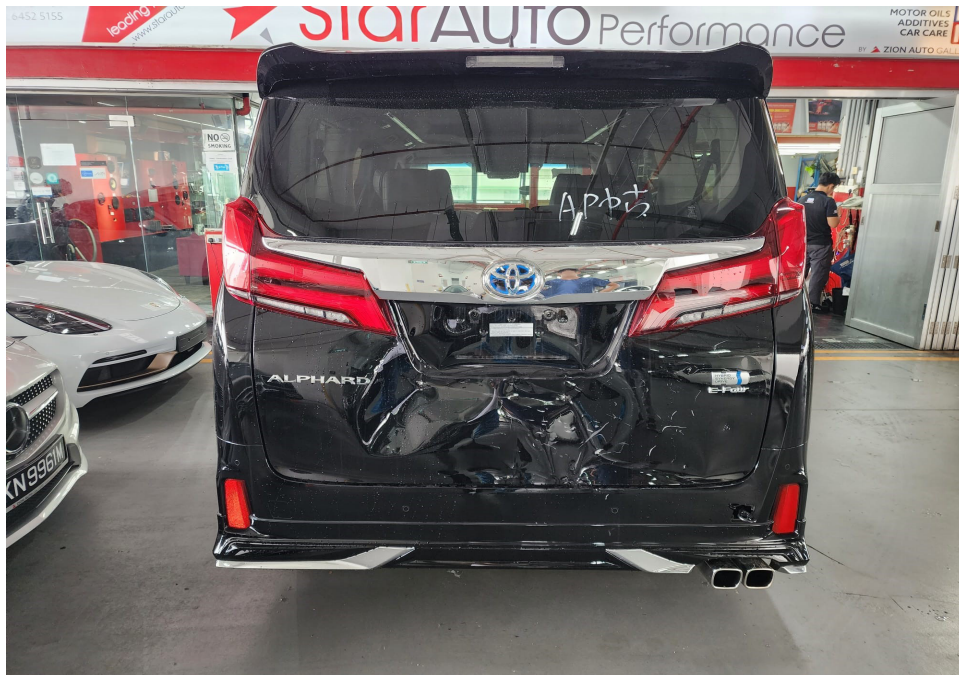
**Photo 2** shows the rear body of the Motor Car (photograph provided to me). The Motor Car was observed to have sustained damage at its rear portion. The rear bumper, rear tailgate, rear tailgate upper chrome moulding, rear tailgate left reflector lamp, rear tailgate right reflector lamp and rear tailgate emblems were amongst the body parts that were observed to have been damaged.

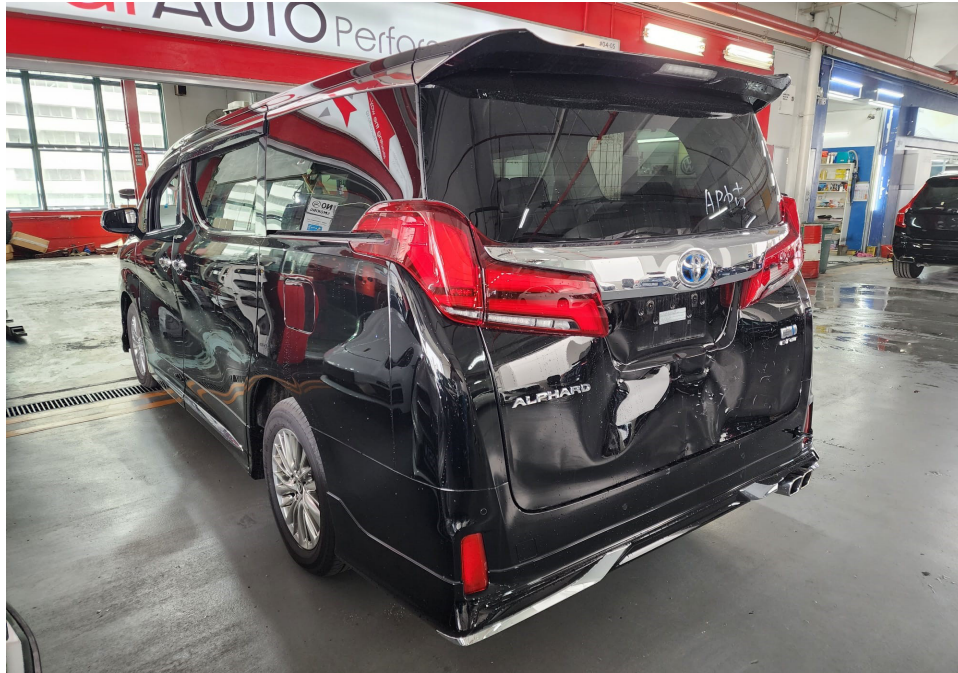
**Photo 3** shows the rear left body of the Motor Car (photograph provided to me). The Motor Car was observed to have sustained damage at its rear portion. The rear bumper, rear tailgate, rear tailgate upper chrome moulding, rear tailgate left reflector lamp, rear tailgate right reflector lamp and rear tailgate emblems were amongst the body parts that were observed to have been damaged.

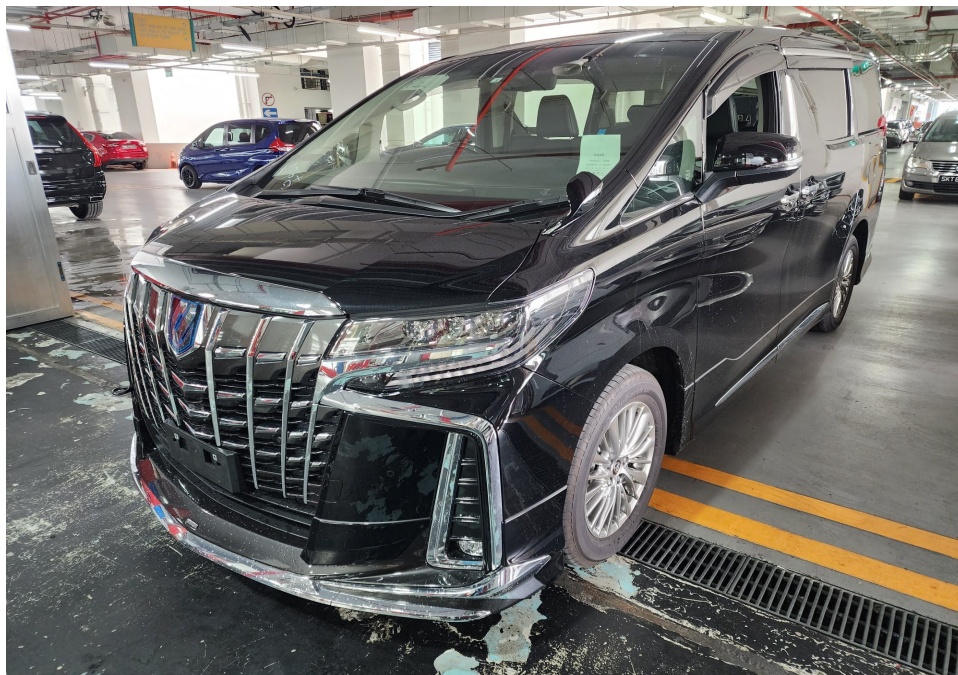
**Photo 4** shows the front left body of the Motor Car (photograph provided to me). Apart for the rear portion, the photographs provided to me did not show physical damage to other areas of the Motor Car. The Motor Car's airbag(s) was not deployed.

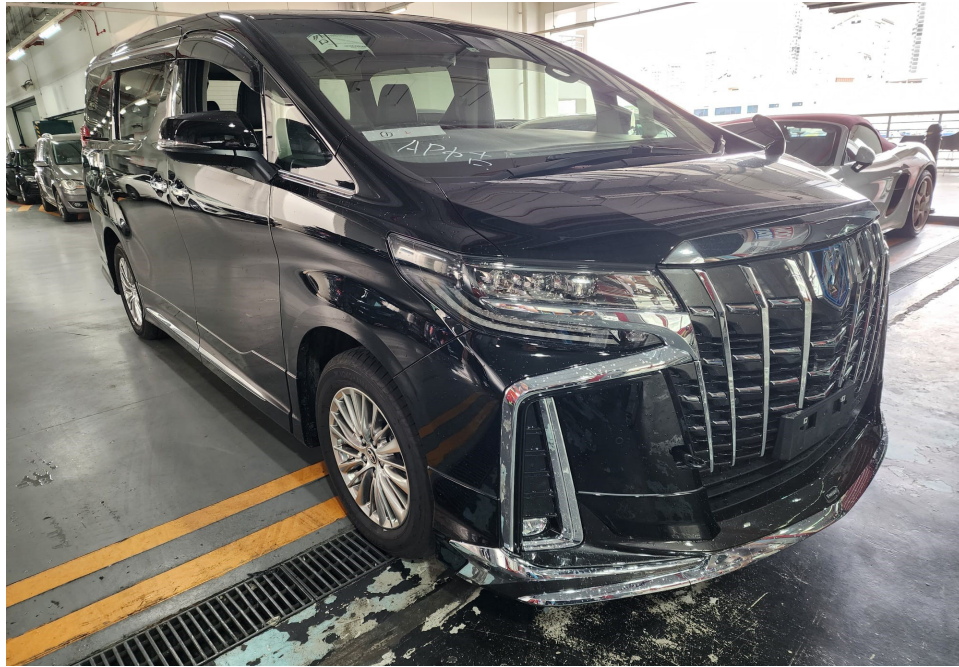
**Photo 5** shows the front right body of the Motor Car (photograph provided to me). Apart for the rear portion, there was no physical damage observed to other areas of the Motor Car. The Motor Car's airbag(s) was not deployed.

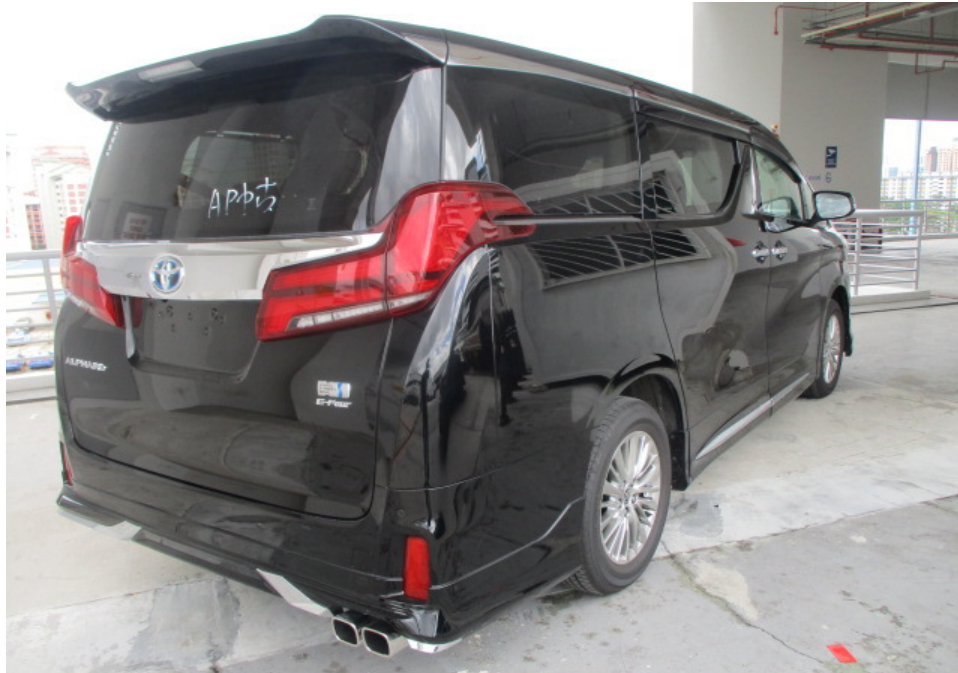
**Photo 6** shows a general view of the rear right body of the Motor Car at the time of my inspection. The Motor Car was observed to be in a relatively good general condition with no loose exterior fittings observed. The body parts at the rear portion of the Motor Car were visually examined and it was observed that the repair/restoration works carried out to the damaged area of the Motor Car (refer to photograph 1 - 3 above) were reasonably adequate and in order.

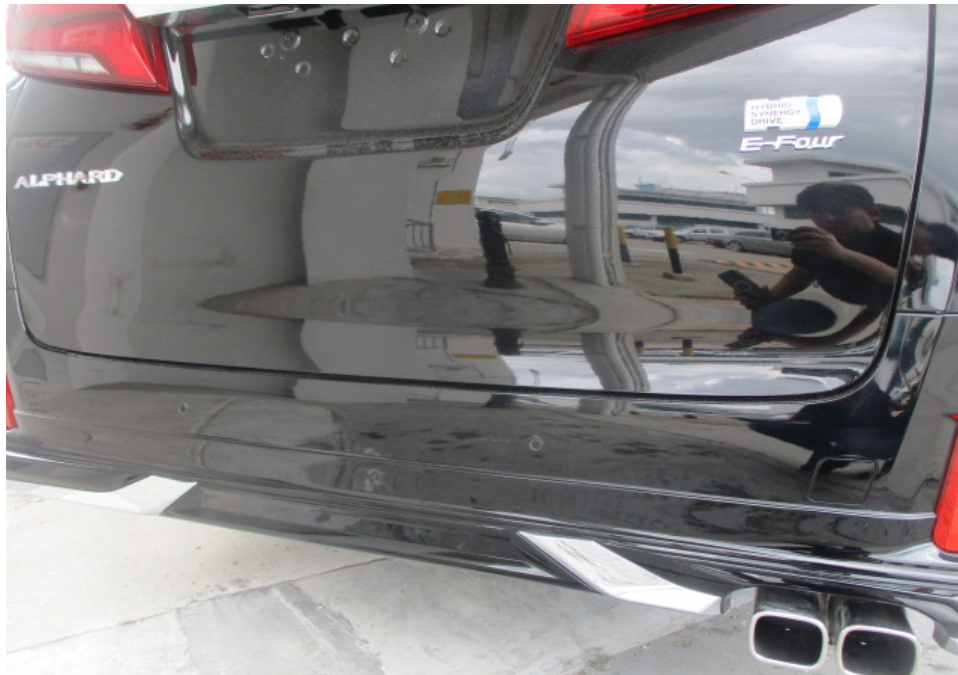
**Photo 7** shows a closer view of the Motor Car's rear bumper, rear bumper lower cover, rear bumper reverse sensors and rear tailgate. The body parts at the rear portion of the Motor Car were visually examined and it was observed that the repair/restoration works carried out to the damaged area of the Motor Car (refer to photograph 1 - 3 above) were reasonably adequate and in order.

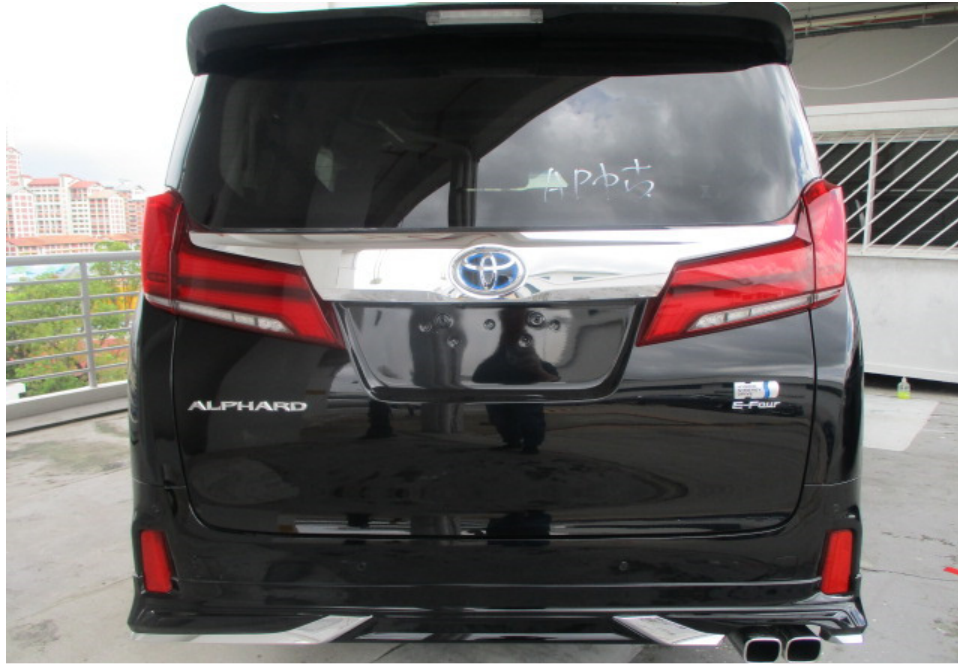
**Photo 8** shows a general view of the rear body of the Motor Car at the time of my inspection. The Motor Car was observed to be in a relatively good general condition with no loose exterior fittings observed. The body parts at the rear portion of the Motor Car were visually examined and it was observed that the repair/restoration works carried out to the damaged area of the Motor Car (refer to photograph 1 - 3 above) were reasonably adequate and in order.

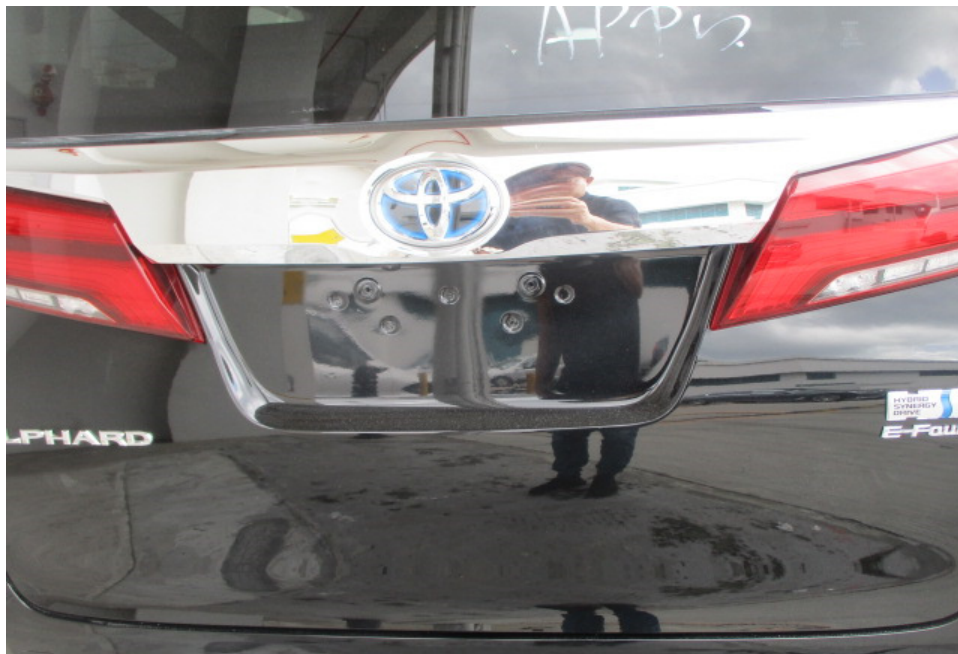
**Photo 9** shows a closer view of the Motor Car's rear tailgate, rear tailgate upper chrome moulding, rear tailgate left reflector lamp and rear tailgate right reflector lamp. The body parts at the rear portion of the Motor Car were visually examined and it was observed that the repair/restoration works carried out to the damaged area of the Motor Car (refer to photograph 1 - 3 above) were reasonably adequate and in order.

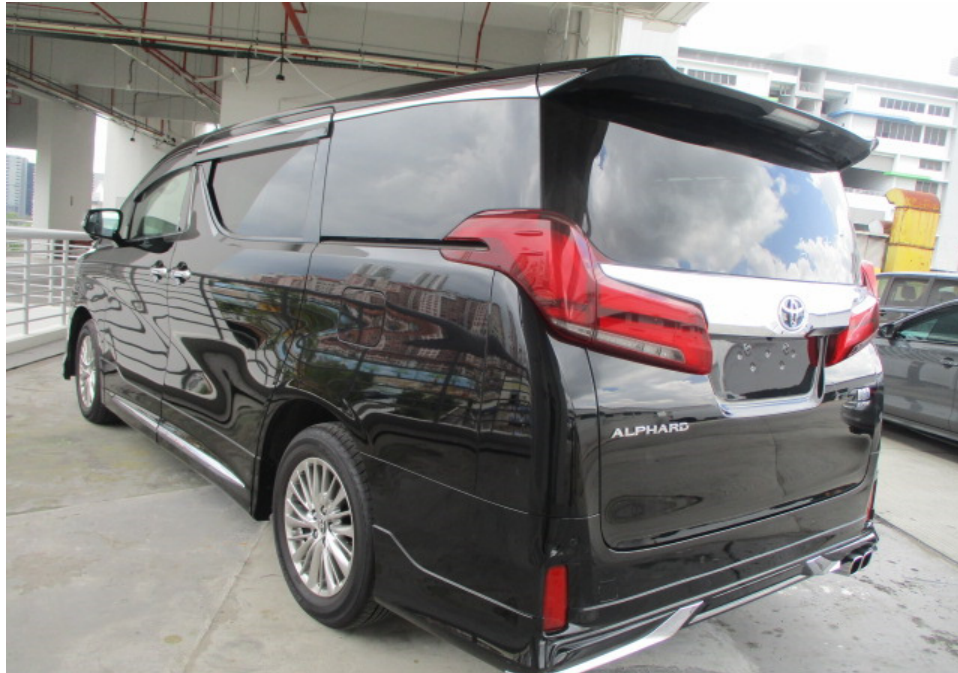
**Photo 10** shows a general view of the rear right body of the Motor Car at the time of my inspection. The Motor Car was observed to be in a relatively good general condition with no loose exterior fittings observed. The body parts at the rear portion of the Motor Car were visually examined and it was observed that the repair/restoration works carried out to the damaged area of the Motor Car (refer to photograph 1 - 3 above) were reasonably adequate and in order.

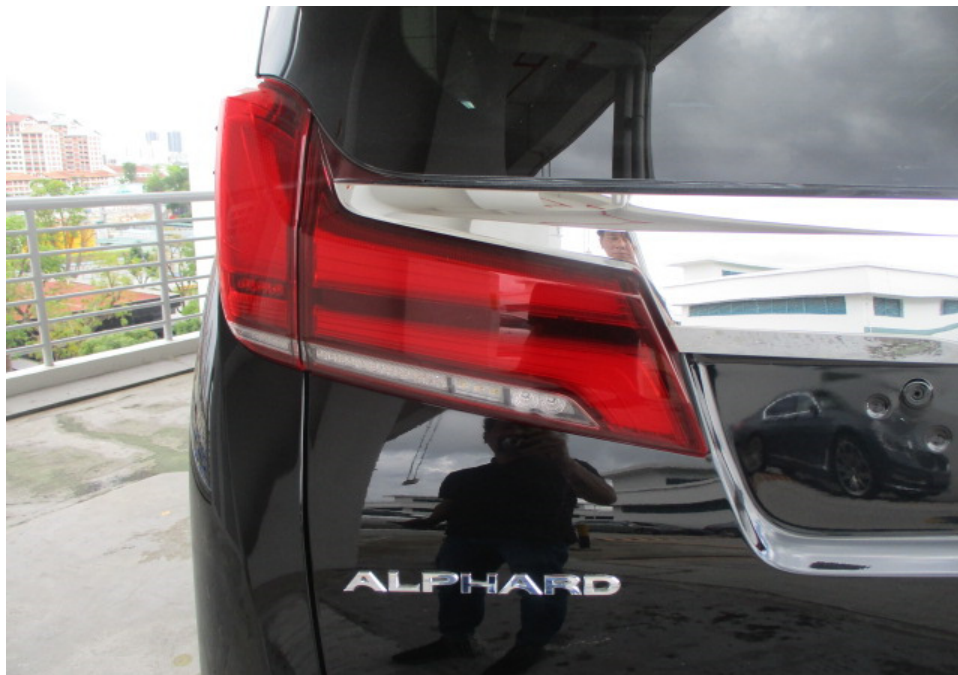
**Photo 11** shows a closer view of the Motor Car's rear tailgate upper chrome moulding and rear tailgate left reflector lamp. The body parts at the rear portion of the Motor Car were visually examined and it was observed that the repair/restoration works carried out to the damaged area of the Motor Car (refer to photograph 1 - 3 above) were reasonably adequate and in order.

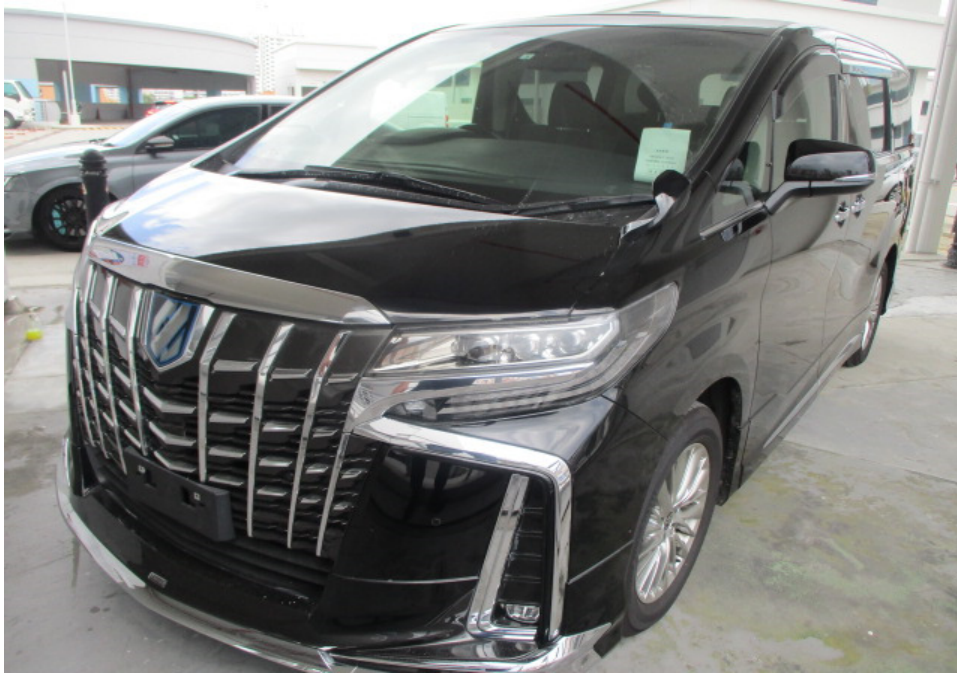
**Photo 12** shows a general view of the front left body of the Motor Car at the time of my inspection. The Motor Car was observed to be in a relatively good general condition with no loose exterior fittings observed. The mileage of the Motor Car recorded at the time of my inspection was 451km.

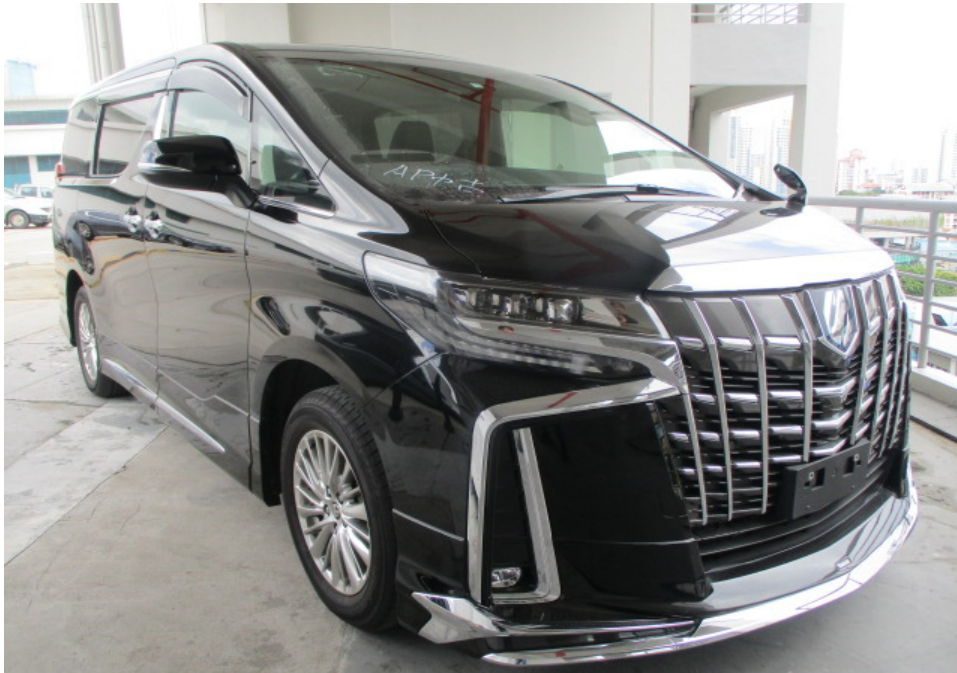
**Photo 13** shows a general view of the front right body of the Motor Car at the time of my inspection. The Motor Car was observed to be in a relatively good general condition with no loose exterior fittings observed. The mileage of the Motor Car recorded at the time of my inspection was 451km.

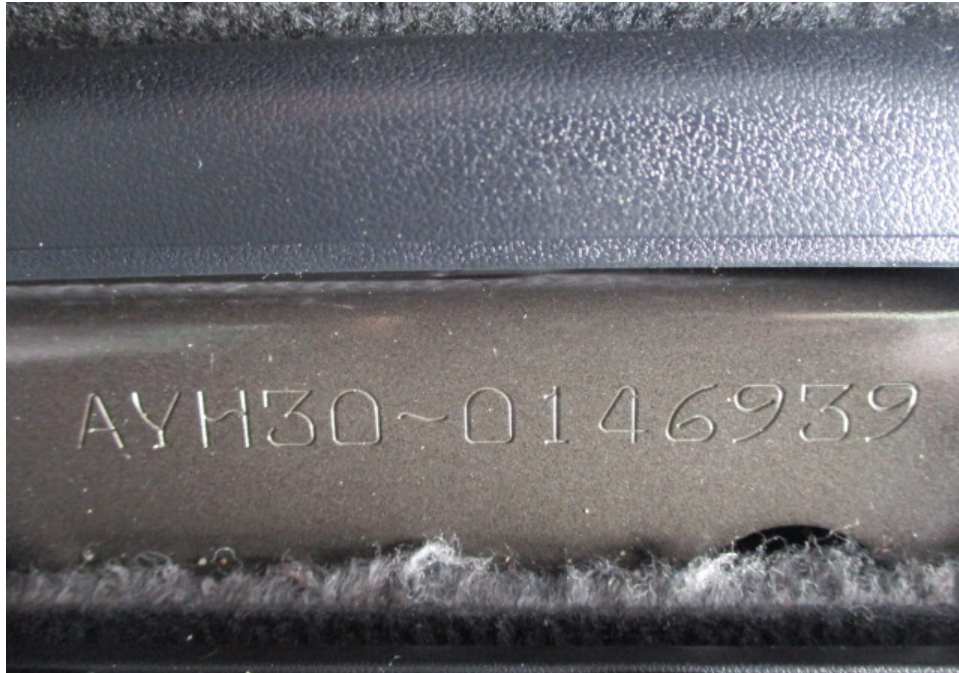
**Photo 14** shows the chassis number of the Motor Car. The chassis number recorded was AYH300146939.

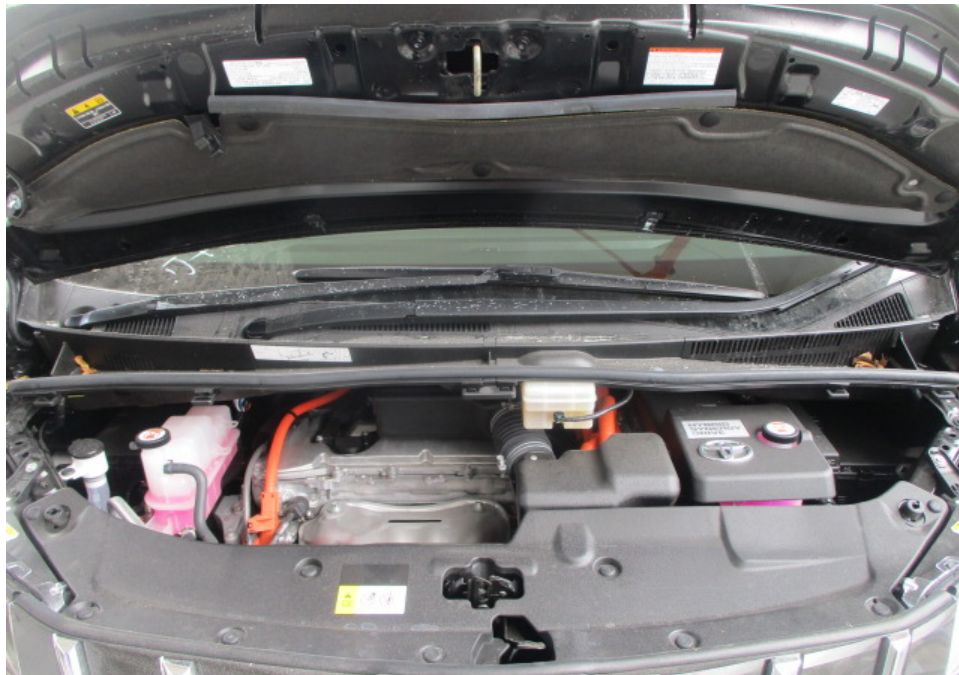
**Photo 15** shows a general view of the engine compartment of the Motor Car at the time of my inspection. The various parts and components inside the engine compartment were all observed to be intact and properly fitted. There was also no sign(s) or indication(s) of fluid leak and/or fluid stain found inside the engine compartment.

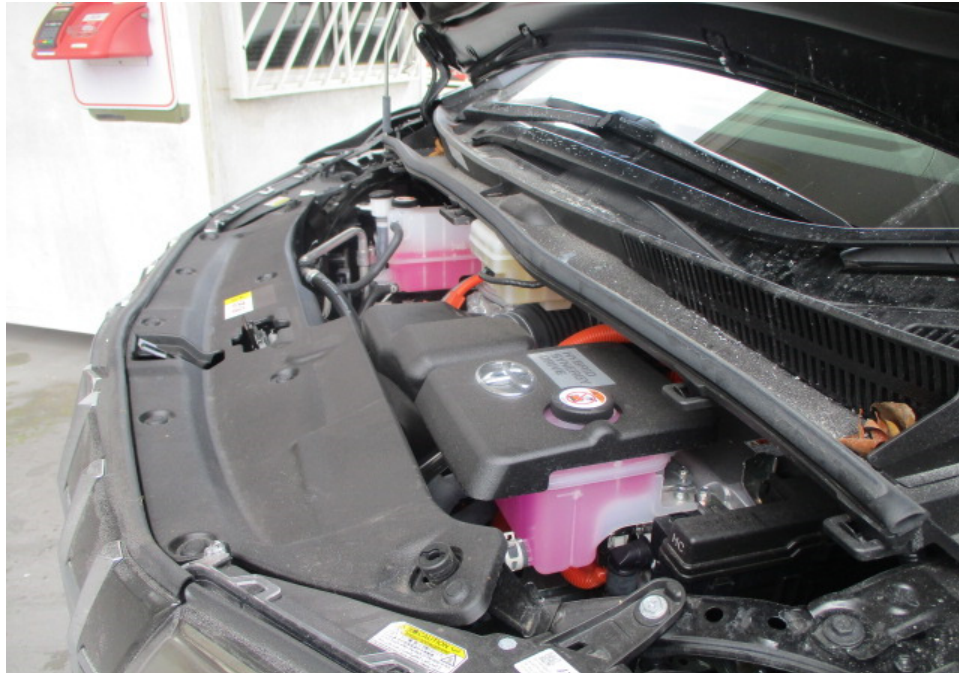
**Photo 16** shows another view of the engine compartment of the Motor Car at the time of my inspection. The various parts and components inside the engine compartment were all observed to be intact and properly fitted. There was also no sign(s) or indication(s) of fluid leak and/or fluid stain found inside the engine compartment.

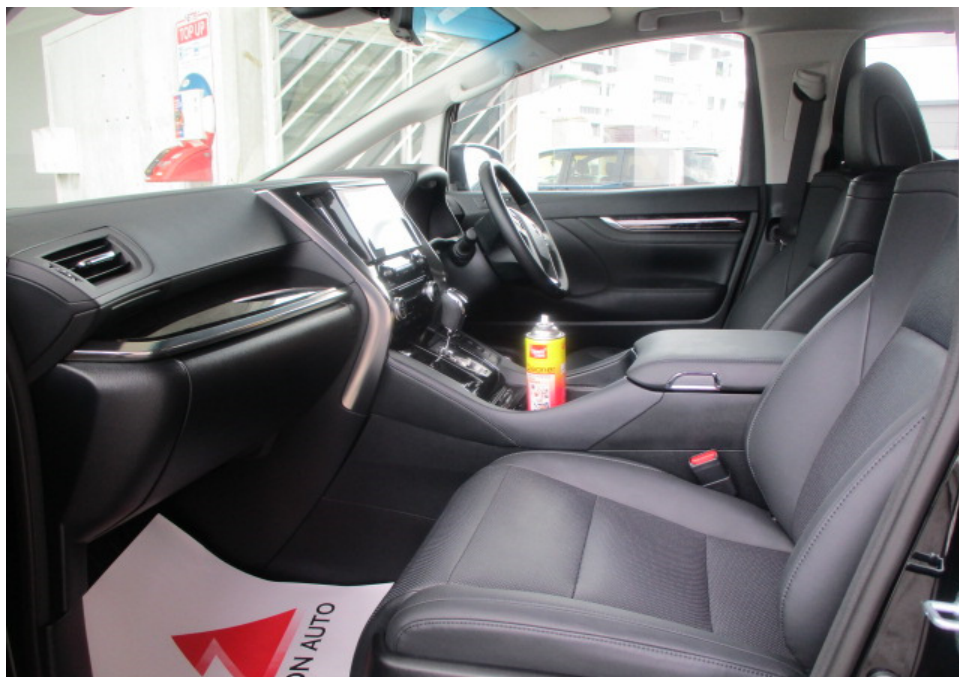
**Photo 17** shows the interior compartment of the Motor Car at the time of my inspection. The various parts and components, trims, carpet and upholstery inside the interior compartment were all observed to be intact and properly fitted.

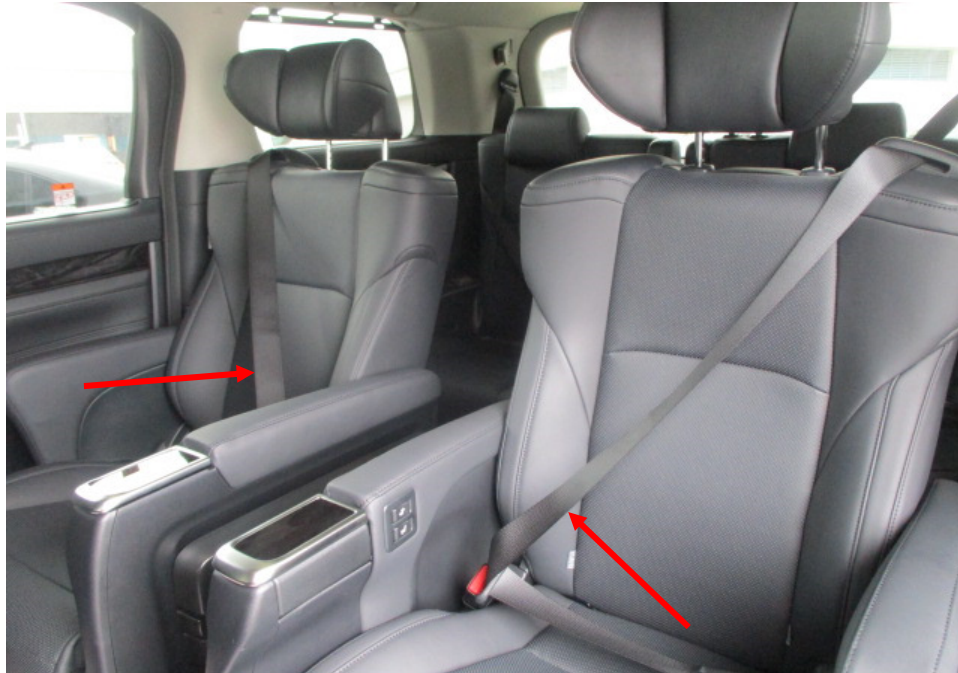
**Photo 18** shows the rear seats at the 1<sup>st</sup> row of the Motor Car. All the seats of the Motor Car were secured via seat rails to the floorboard. They were also fitted with a retractable seat belt reel and a pre-tensioner. The seat belts (arrowed) were tested and were able to be fastened into the respective pre-tensions that were fitted on the side of each individual seat.

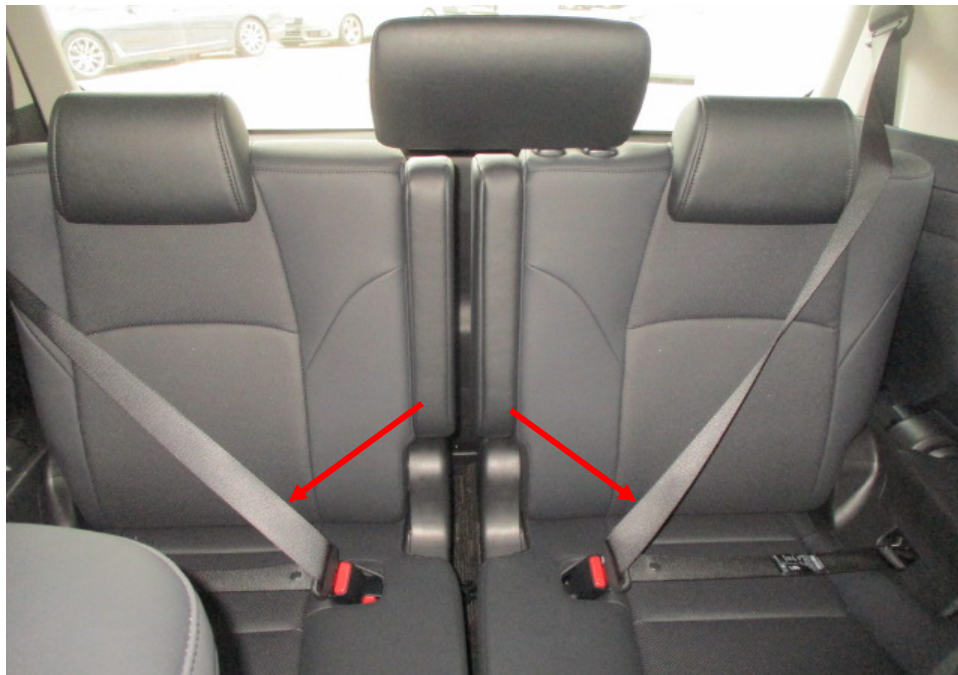
**Photo 19** shows the rear seats at the 2<sup>nd</sup> row of the Motor Car. All the seats of the Motor Car were secured via seat rails to the floorboard. They were also fitted with a retractable seat belt reel and a pre-tensioner. The seat belts (arrowed) were tested and were able to be fastened into the respective pre-tensions that were fitted on the side of each individual seat.

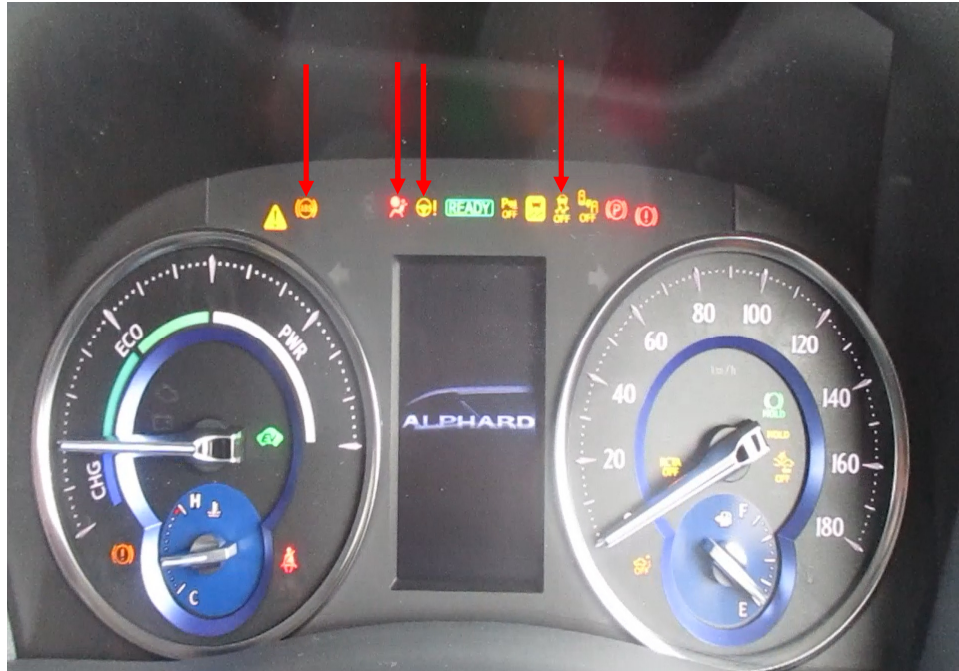
**Photo 20** shows the warning lights for the various electronic safety features appearing on the instrument panel of the Motor Car during its self-test when the engine is cranked, in particular the lights for the ABS, SRS, EPS, VSC (arrowed) and the various collision prevention systems.

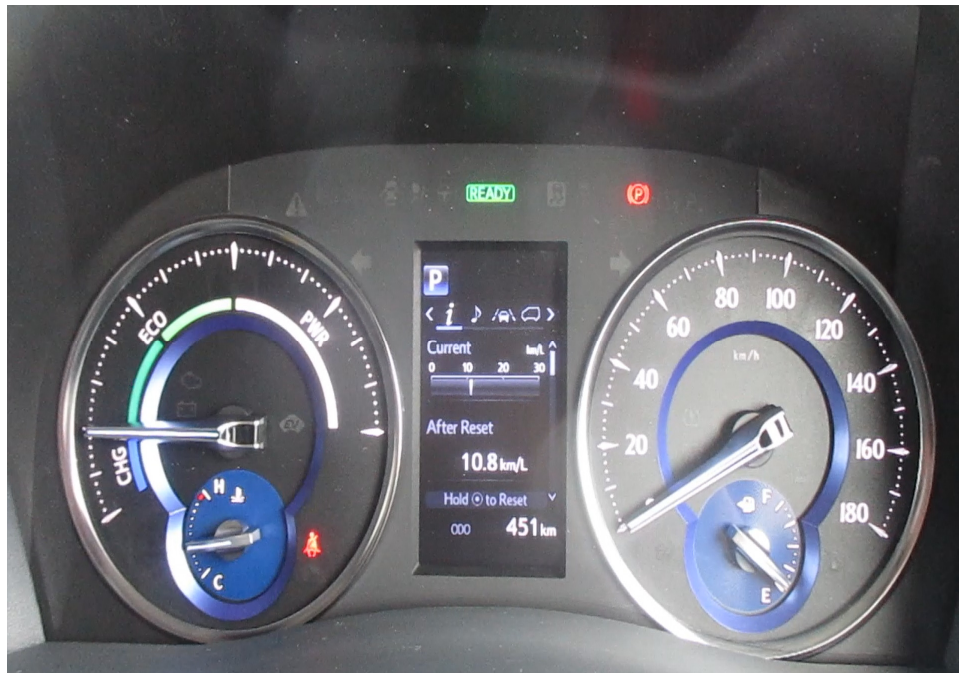
**Photo 21** shows the respective warning lights no longer illuminated, indicating that there is no fault detected to the ABS, SRS, EPS, VSC and the various collision prevention systems of the Motor Car during the self-test. These electronic systems were hence in working condition at the time of my inspection.

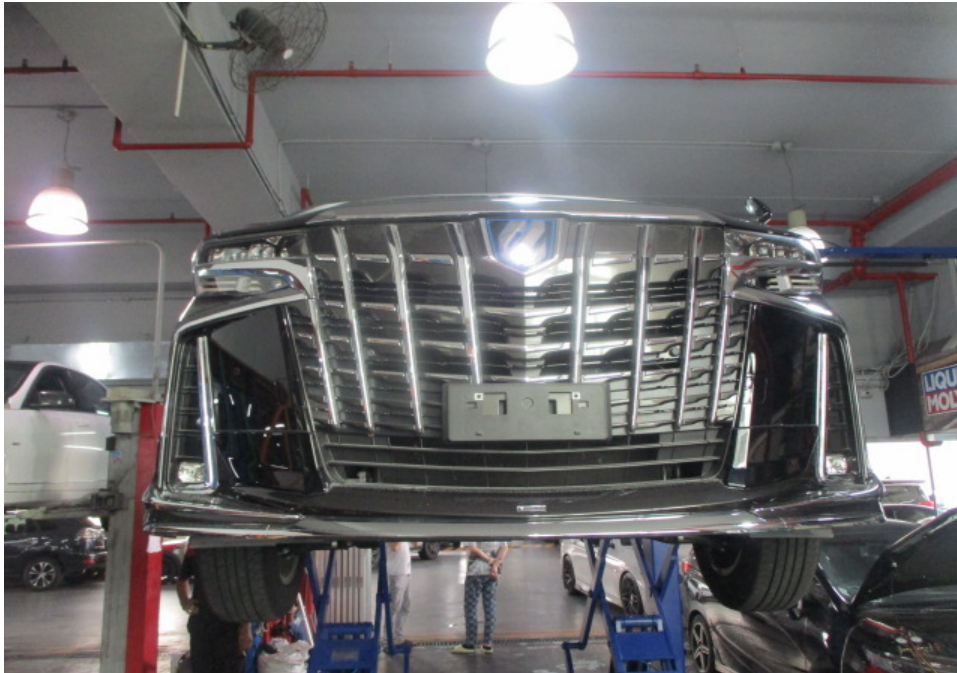
**Photo 22** shows the Motor Car hoisted up for checks on its undercarriage. There was no sign(s) or indication(s) of fluid leakage and/or fluid stain(s) on the underside of the Motor Car. The undercarriage components of the Motor Car were also all observed to be intact and secured in an appropriate manner.

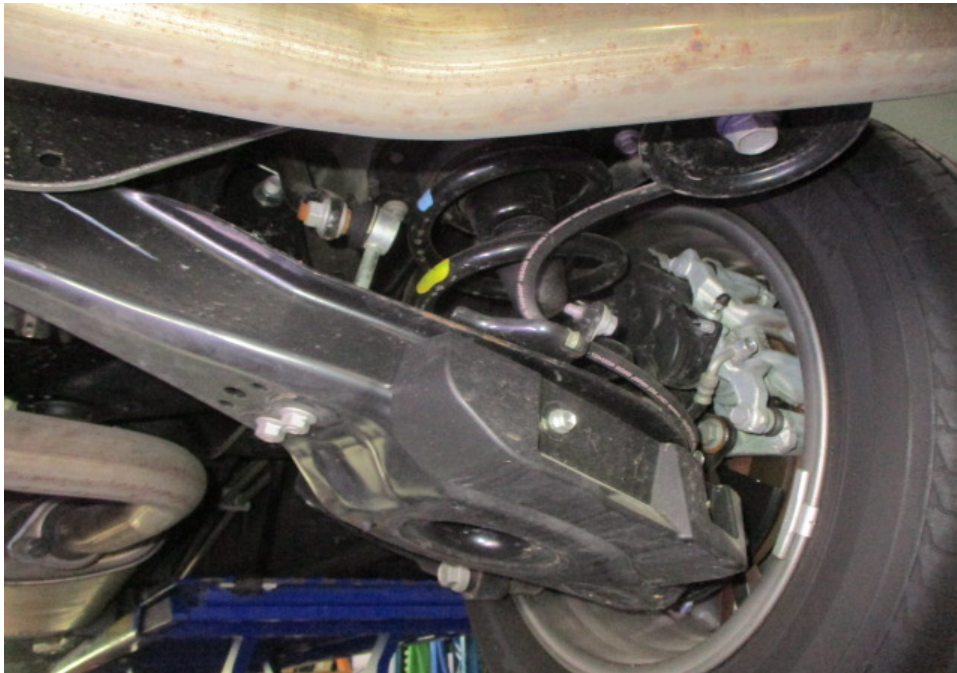
**Photo 23** shows a general view of the control arms and linkages at the rear right wheel of the Motor Car. I did not observe any fluid leak and/or fluid stain on the underside of the Motor Car. All of the Motor Car's undercarriage components were observed to be intact and secured in an appropriate manner.

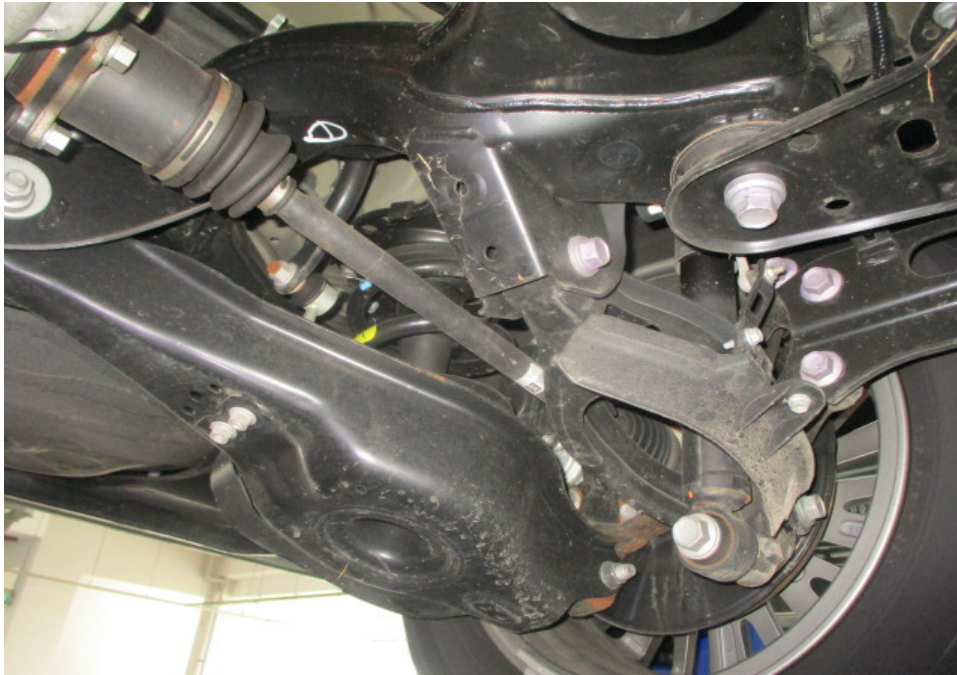
**Photo 24** shows a general view of the control arms and linkages at the rear left wheel of the Motor Car. I did not observe any fluid leak and/or fluid stain on the underside of the Motor Car. All of the Motor Car's undercarriage components were observed to be intact and secured in an appropriate manner.

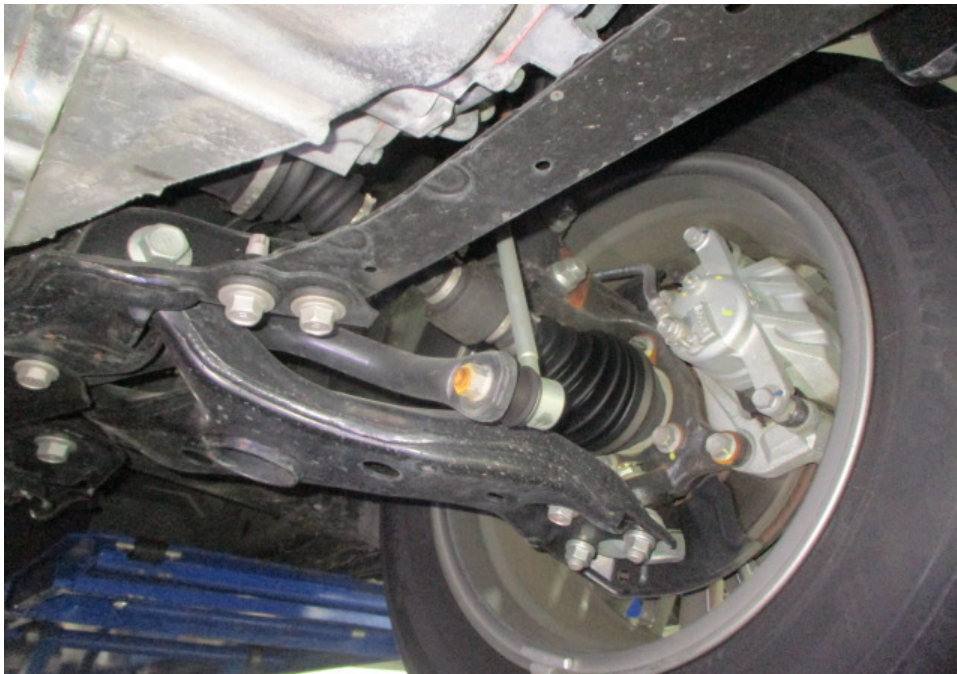
**Photo 25** shows the various undercarriage components at the front left wheel of the Motor Car. The mechanical components, control arms and linkages were all found to be intact and secured in an appropriate manner.

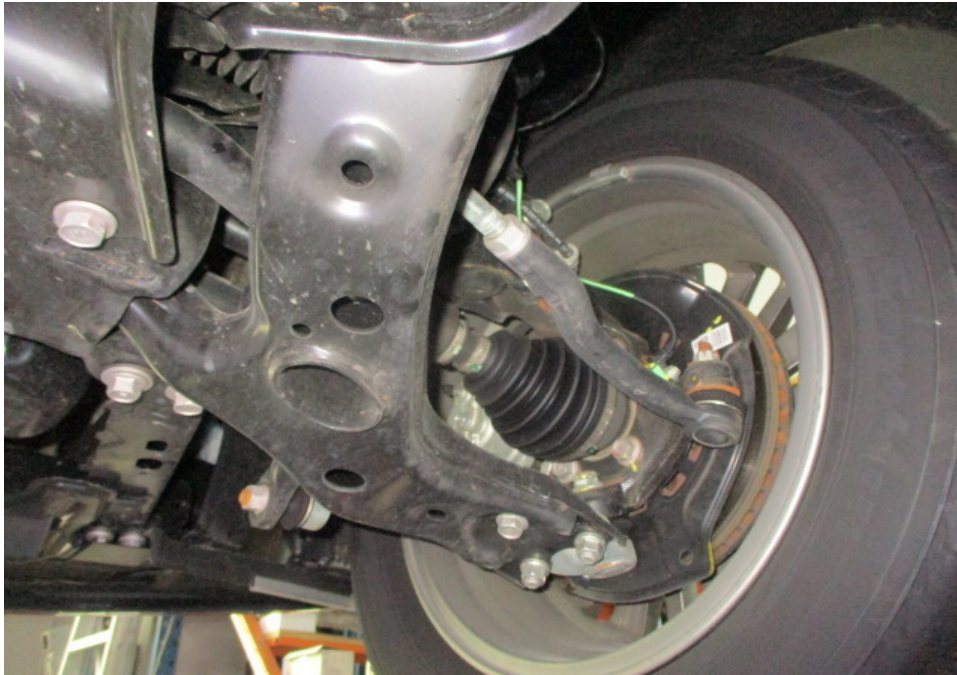
**Photo 26** shows the various undercarriage components at the front right wheel of the Motor Car. The mechanical components, control arms and linkages were all found to be intact and secured in an appropriate manner. I also did not observe any fluid leak and/or fluid stain on the underside of the Motor Car.

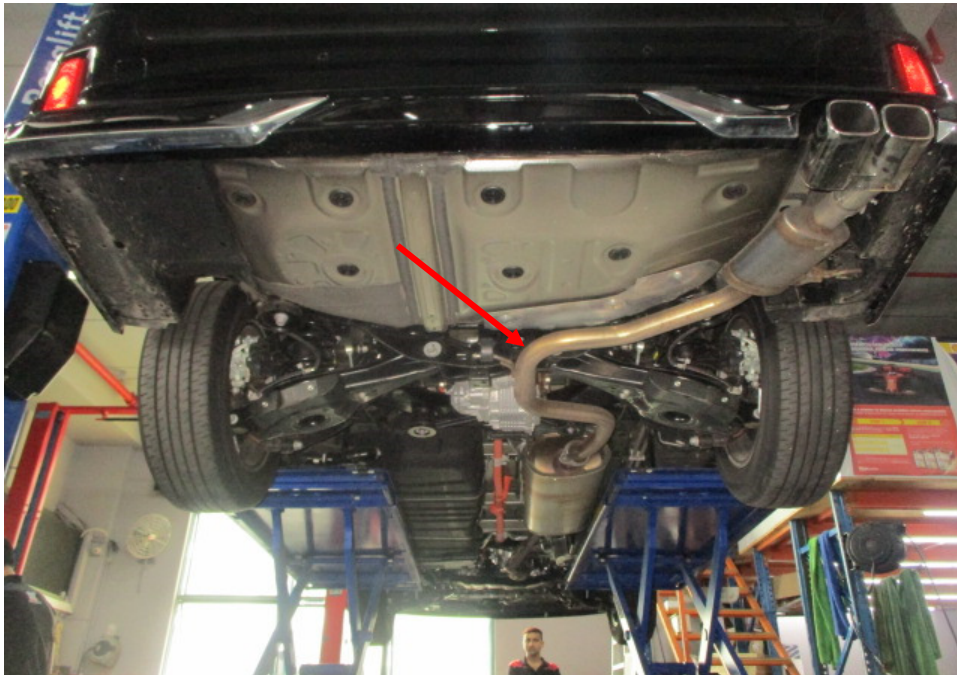
**Photo 27** shows a general view of the rear section of the Motor Car's exhaust system. My examination of the Motor Car's exhaust system revealed no sign(s) or indication(s) of any cut or weld marks along its exhaust pipe (arrowed), on its catalytic converter, on its centre resonator box and on its rear muffler.

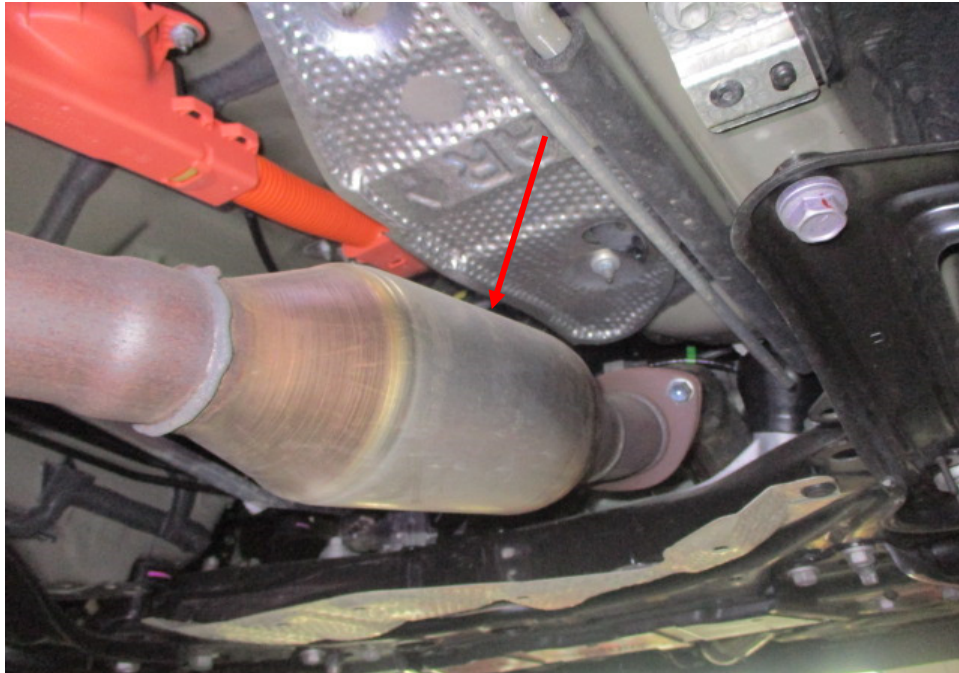
**Photo 28** shows a general view of the front section of the Motor Car's exhaust system. My examination of the Motor Car's exhaust system revealed no sign(s) or indication(s) of any cut or weld marks along its exhaust pipe, on its catalytic converter (arrowed), on its centre resonator box and on its rear muffler.

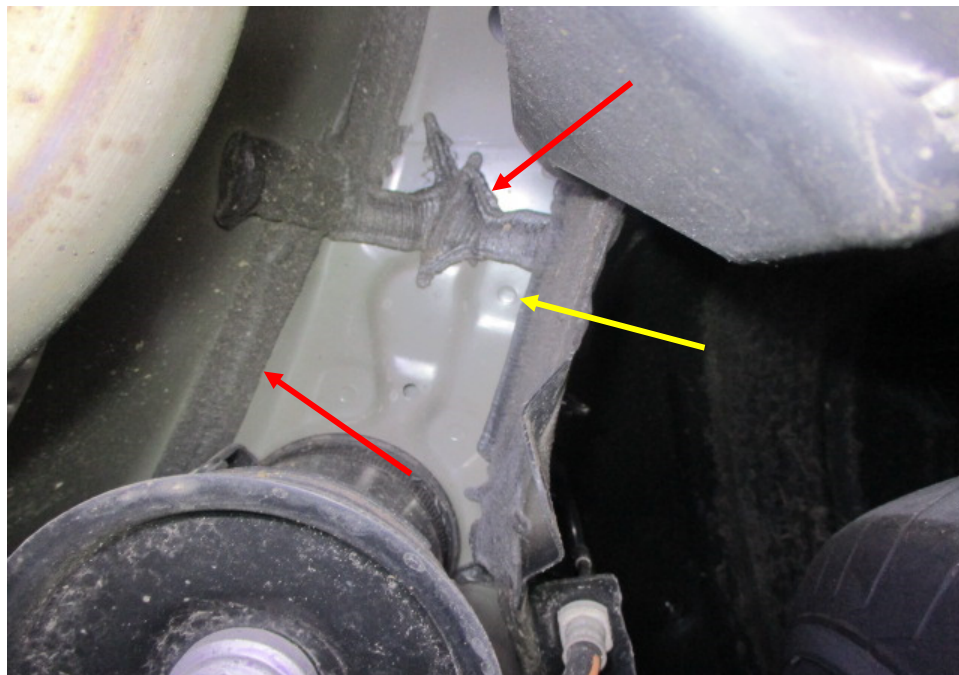
**Photo 29** shows the chassis/structural body at the underside rear right of the Motor Car. I did not find any weld marks other than original spot weld marks (yellow arrow) on the chassis/structural body of the Motor Car. The original factory sealant (red arrow) at the joints along the chassis/structural body was untouched, indicating no work was done on the chassis/structural body of the Motor Car and that the chassis/structural body was originally fitted.

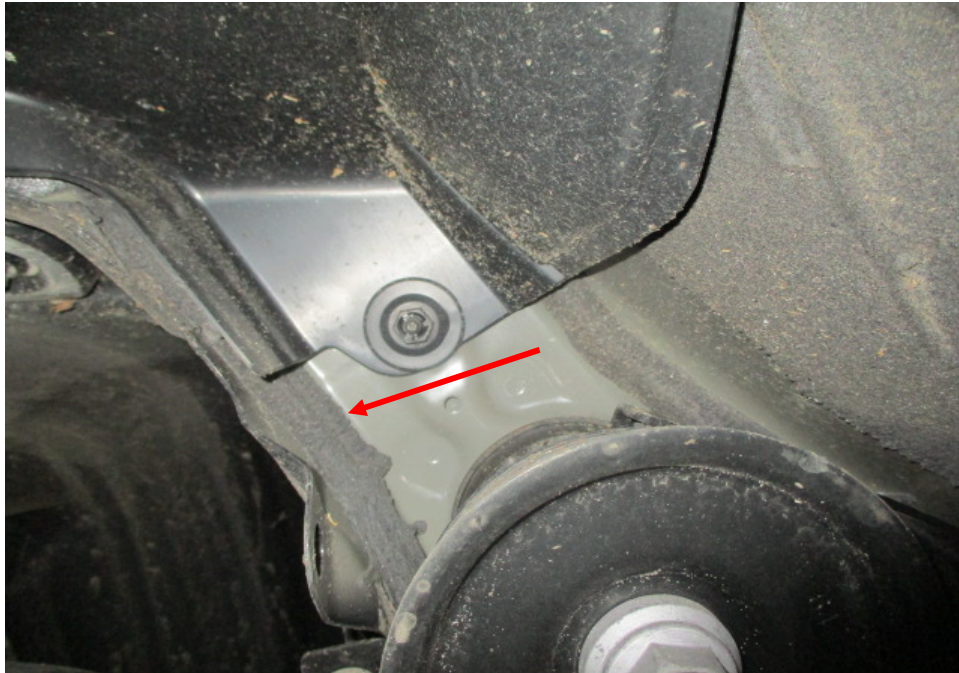
**Photo 30** shows the chassis/structural body at the underside rear left of the Motor Car. The original factory sealant (arrowed) at the joints along the chassis/structural body was observed to be untouched. In general, I had found no work was carried out on the chassis/structural body of the Motor Car. The chassis/structural body of the Motor Car was originally fitted

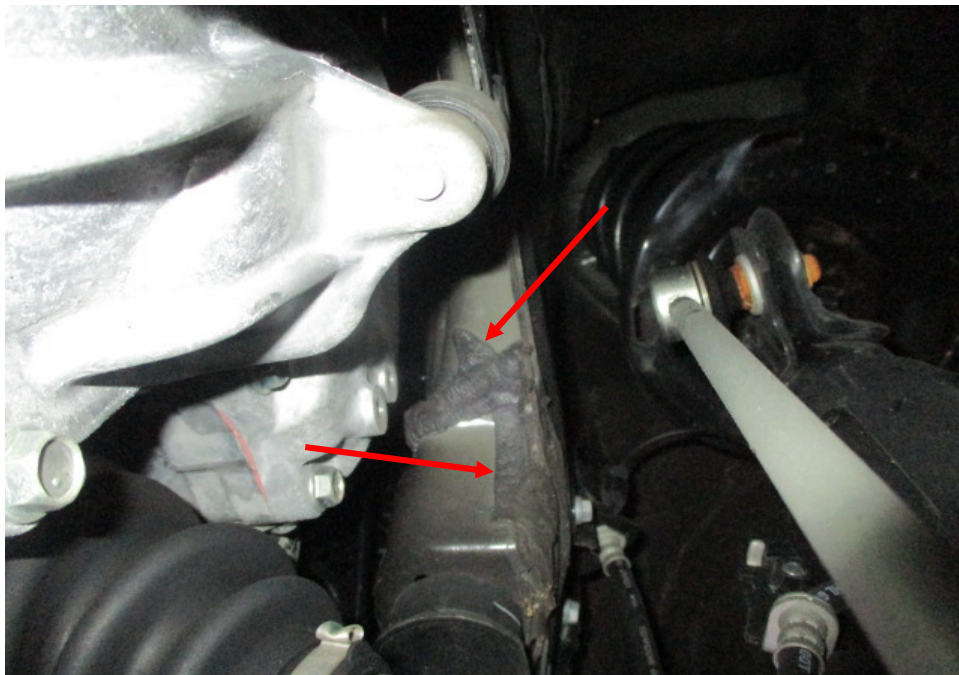
**Photo 31** shows the chassis/structural body at the underside front left of the Motor Car. The original factory sealant (arrowed) at the joints along the chassis/structural body was observed to be untouched. In general, I had found no work was carried out on the chassis/structural body of the Motor Car. The chassis/structural body of the Motor Car was originally fitted.
