Your Ref: Toyota Alphard  
(chassis number AYH300146939)  
Our Ref : CI/TP23001523/D

12 February 2023

**INSPECTION REPORT OF AN UNREGISTERED TOYOTA ALPHARD MOTOR CAR WITH CHASSIS NUMBER AYH300146939**

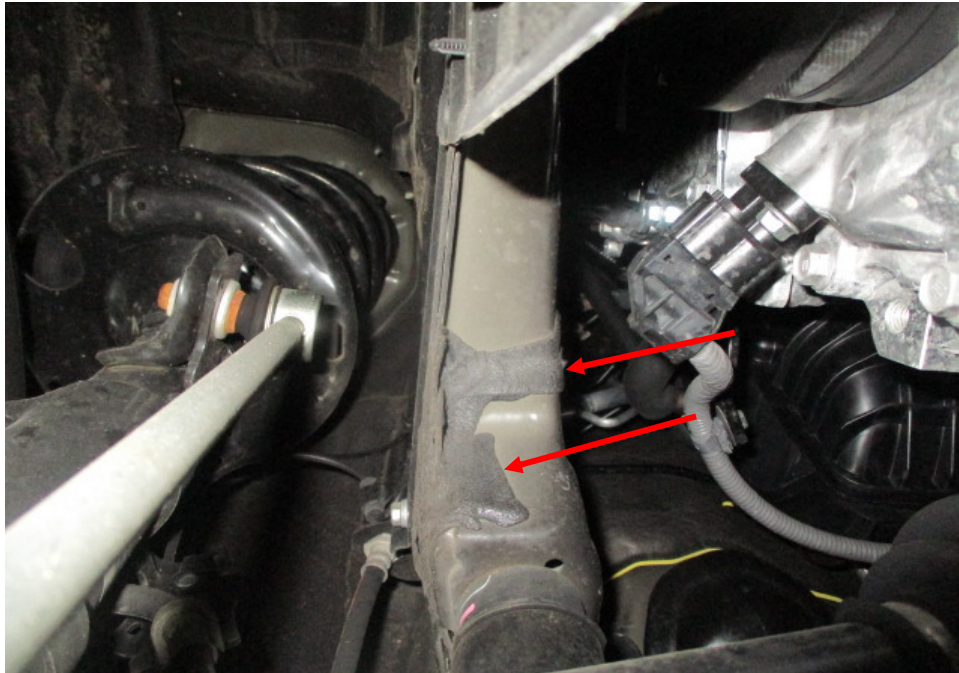
**Photo 32** shows the chassis/structural body at the underside front right of the Motor Car. The original factory sealant (arrowed) at the joints along the chassis/structural body was observed to be untouched. In general, I had found no work was carried out on the chassis/structural body of the Motor Car. The chassis/structural body of the Motor Car was originally fitted.

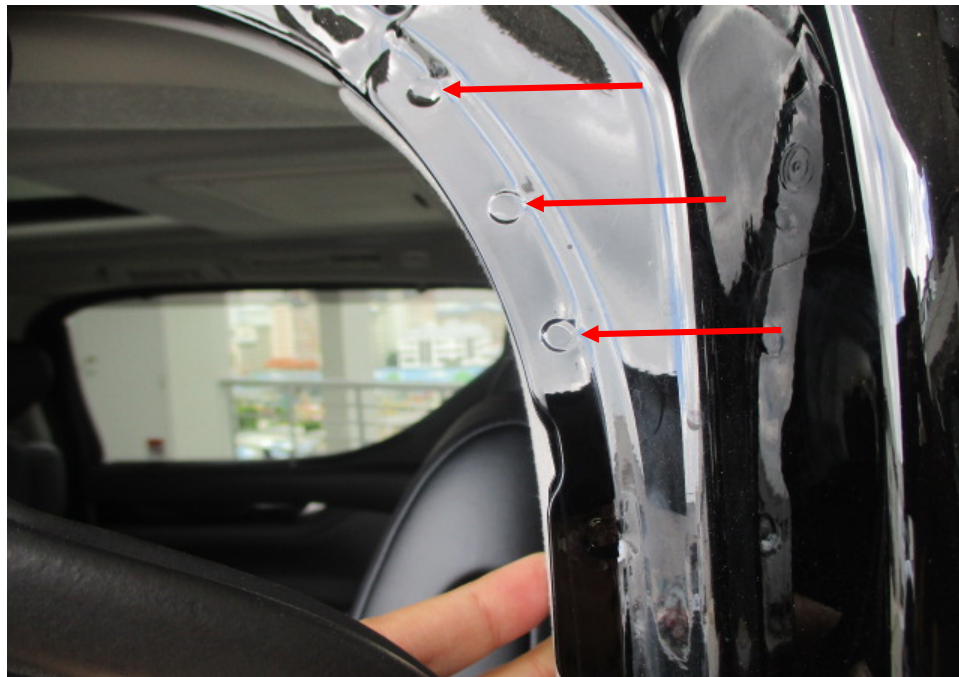
**Photo 33** shows the right side "B" pillar of the Motor Car. I did not find any weld marks other than original spot weld marks (arrowed) on the right side "B" pillar of the Motor Car, which indicates that there was no re-welding works carried out. In general, I had found all the non-detachable body panels of the Motor Car to be originally fitted at the time of my inspection.

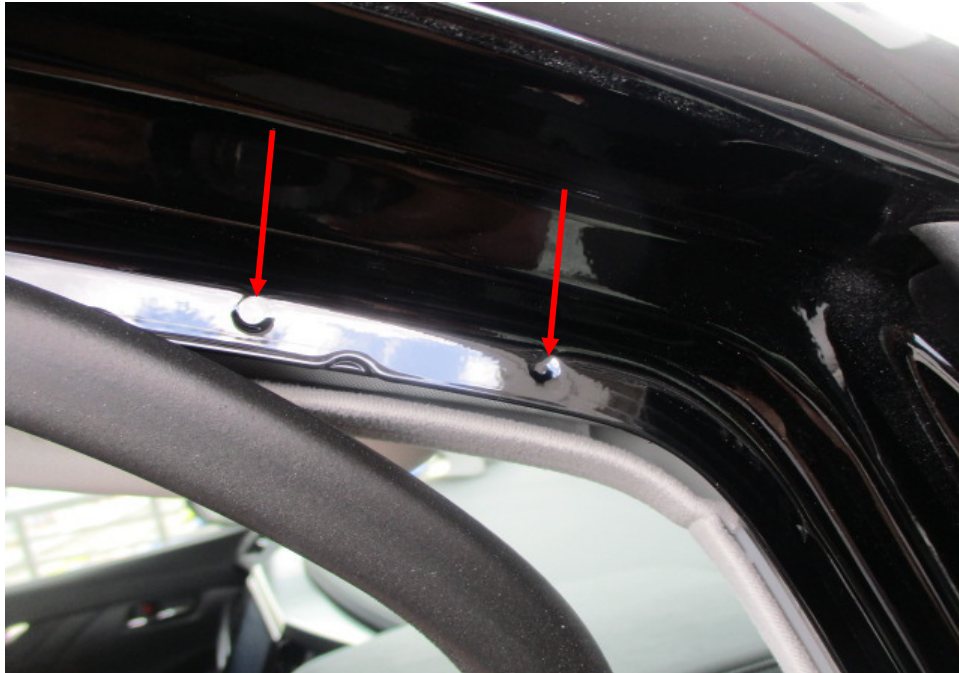
**Photo 34** shows the right side "A" pillar of the Motor Car. I did not find any weld marks other than original spot weld marks (arrowed) on the right side "A" pillar of the Motor Car, which indicates that there was no re-welding works carried out. In general, I had found all the non-detachable body panels of the Motor Car to be originally fitted at the time of my inspection.

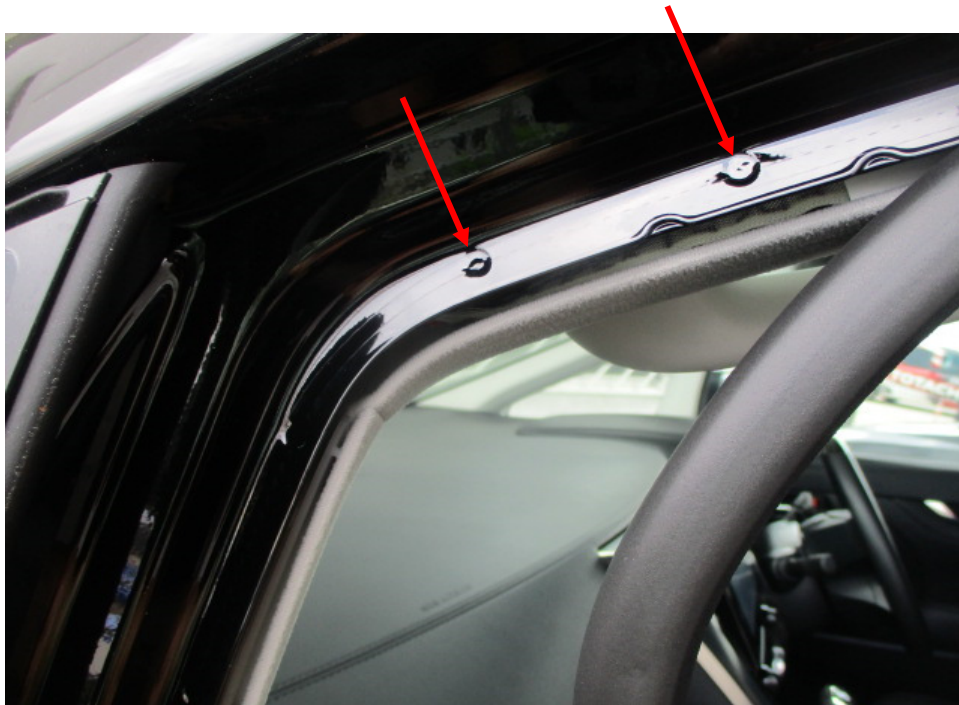
**Photo 35** shows the left side "A" pillar of the Motor Car. I did not find any weld marks other than original spot weld marks (arrowed) on the left side "A" pillar of the Motor Car, which indicates that there was no re-welding works carried out. In general, I had found all the non-detachable body panels of the Motor Car to be originally fitted at the time of my inspection.

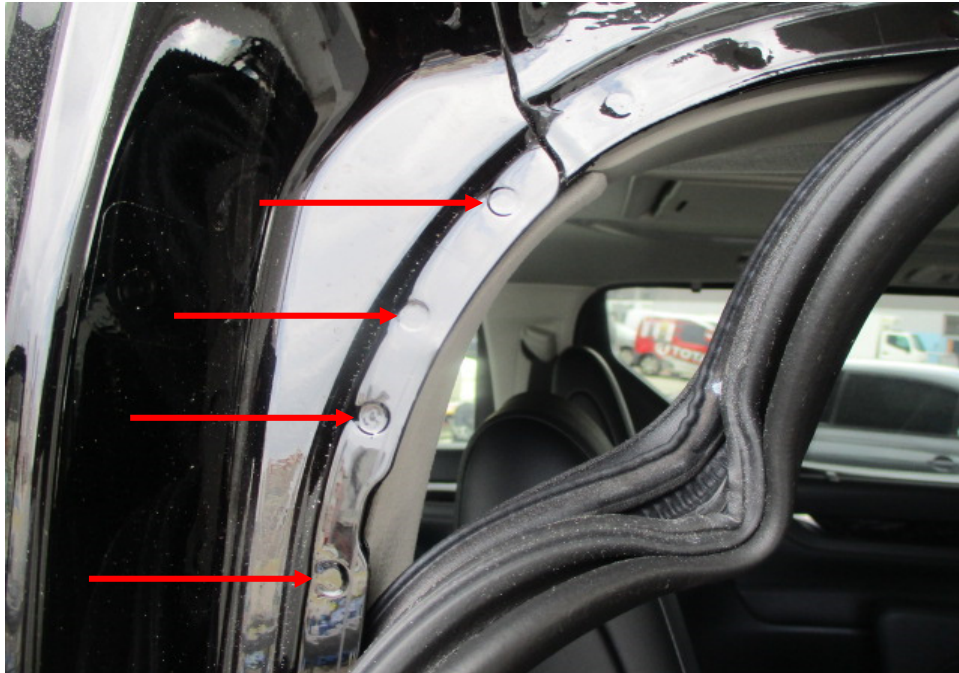
**Photo 36** shows the left side "B" pillar of the Motor Car. I did not find any weld marks other than original spot weld marks (arrowed) on the left side "B" pillar of the Motor Car, which indicates that there was no re-welding works carried out. In general, I had found all the non-detachable body panels of the Motor Car to be originally fitted at the time of my inspection.
