You're Ref: TP/IP/30024/2022  
Our Ref: CI/TPD23001583/P

28<sup>th</sup> February 2023

**Fatal Accident Investigation Team**

**MECHANICAL INSPECTION REPORT OF MOTOR CAR SGG 6805K**

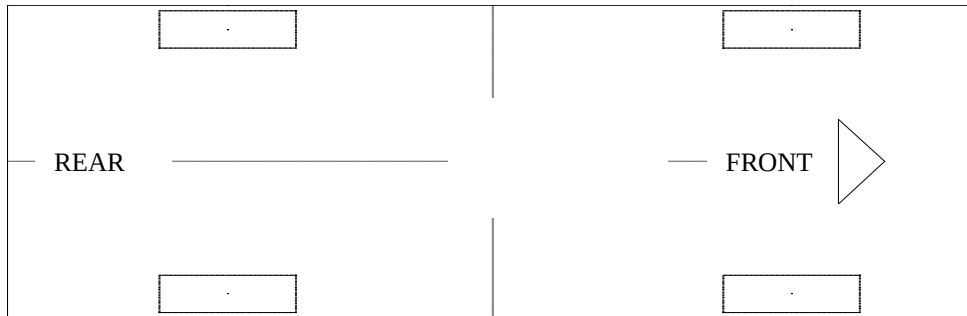
6. The condition of the Motor Car's 4 tyres was observed to be in serviceable condition. I did not find any tear, cut or burst mark(s) on the outer and the inner sidewalls as well as across the tread of the 4 tyres. The 4 tyres were also observed to be sufficiently inflated for vehicular operation. The tyre brand, tyre size and remaining tread depth of the 4 tyres were recorded as follows:-

Pirelli 195/65R15 (4.8mm)

Aplus 195/65R15 (5mm)

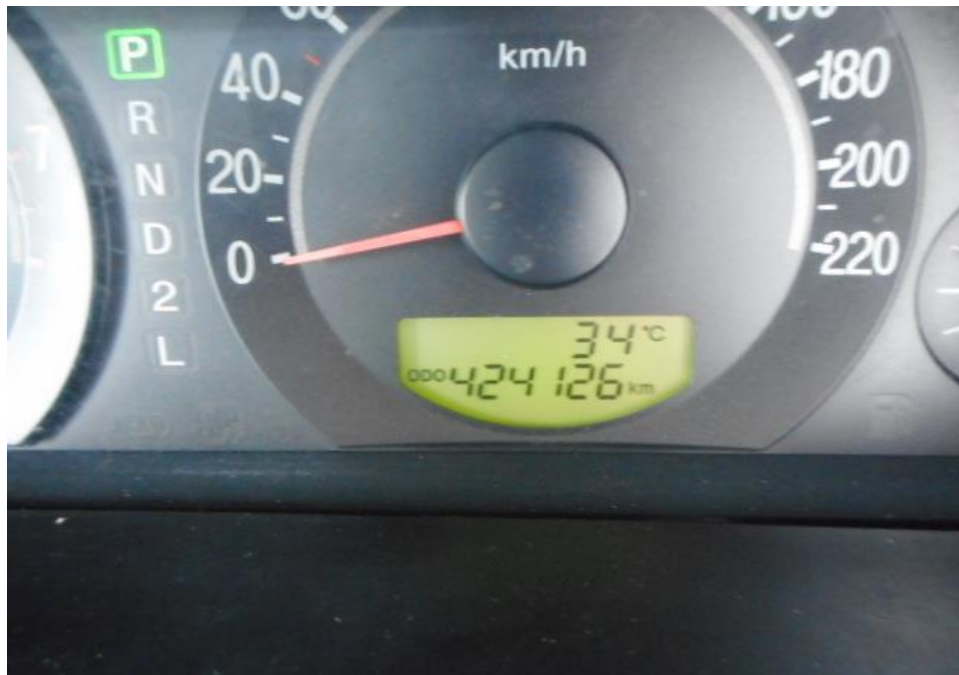
**Photo 1** shows the mileage of the Motor Car at the time of my inspection. The mileage observed was 424,126km.

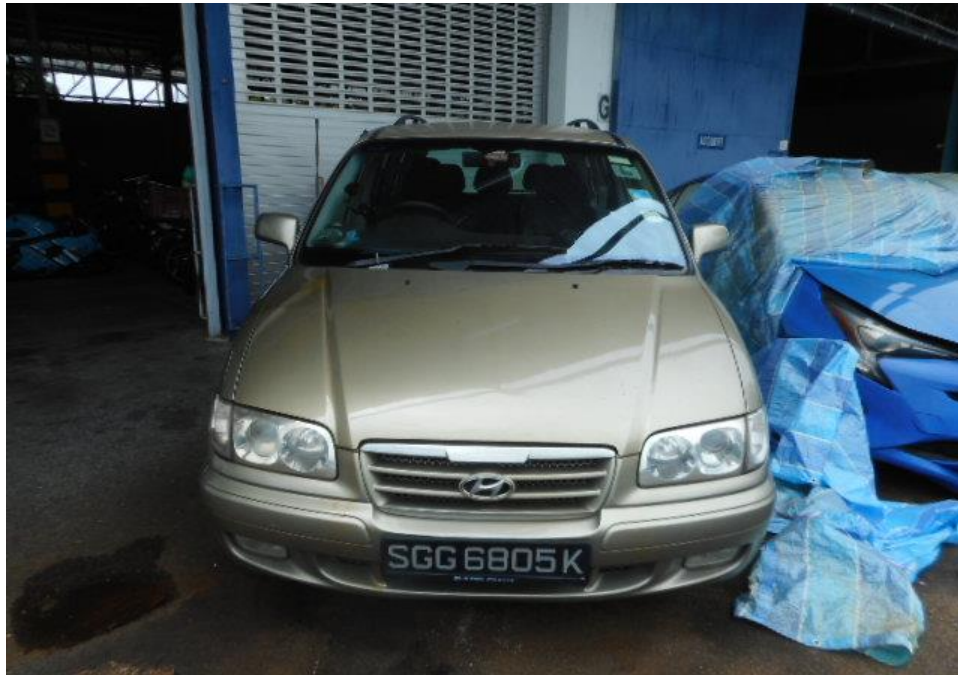
**Photo 2** shows the general view of the Motor Car's front body at the time of my inspection. The Motor Car rear was observed to be unaffected by the accident.

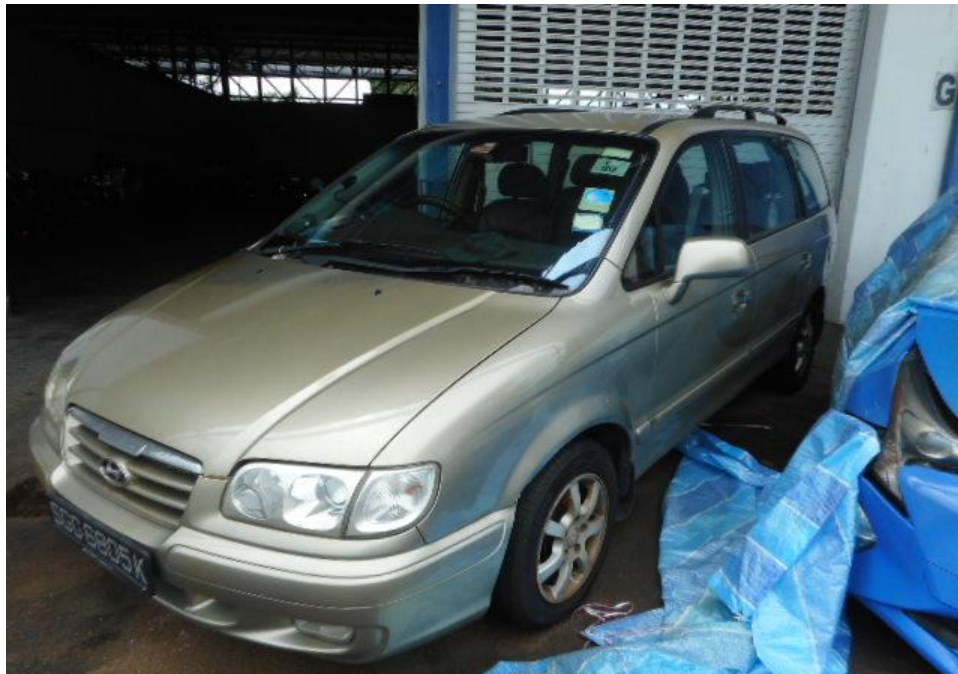
**Photo 3** shows a general view of the Motor Car's left body at the time of my inspection. The Motor Car was observed to have sustained damage at its left portion. Its left rear door was the body part that were damaged as a result of the accident.

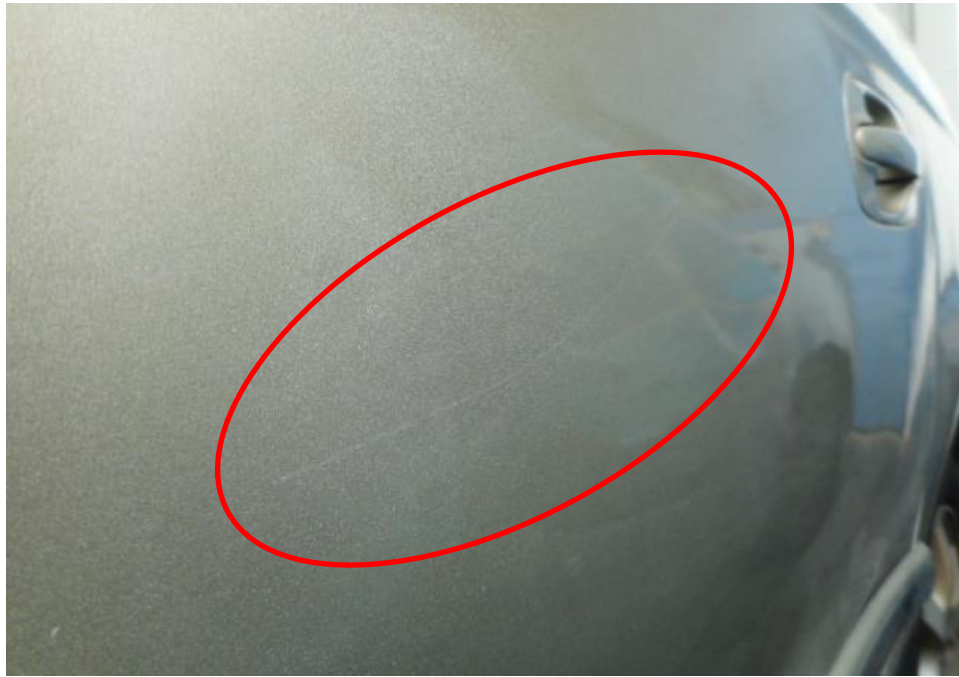
**Photo 4** shows a close up view of the Motor Car's left body at the time of my inspection. The left portion of the Motor Car was observed to have sustained damage. Its left rear door (circled) was the body part that were damaged as a result of the accident.

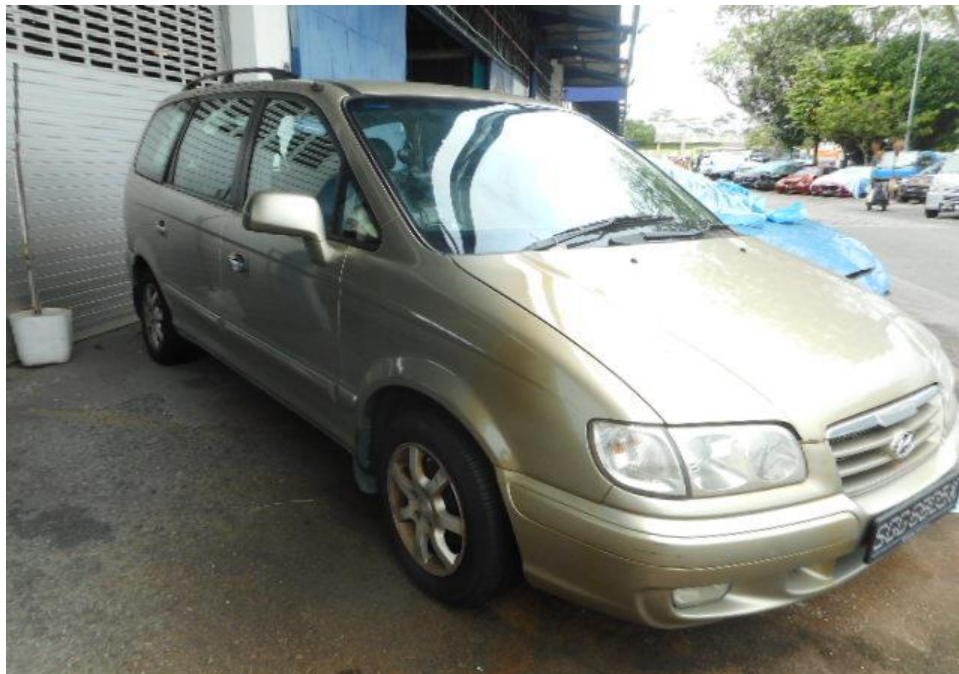
**Photo 5** shows a general view of the Motor Car's right body at the time of my inspection. The Motor Car rear was observed to be unaffected by the accident.

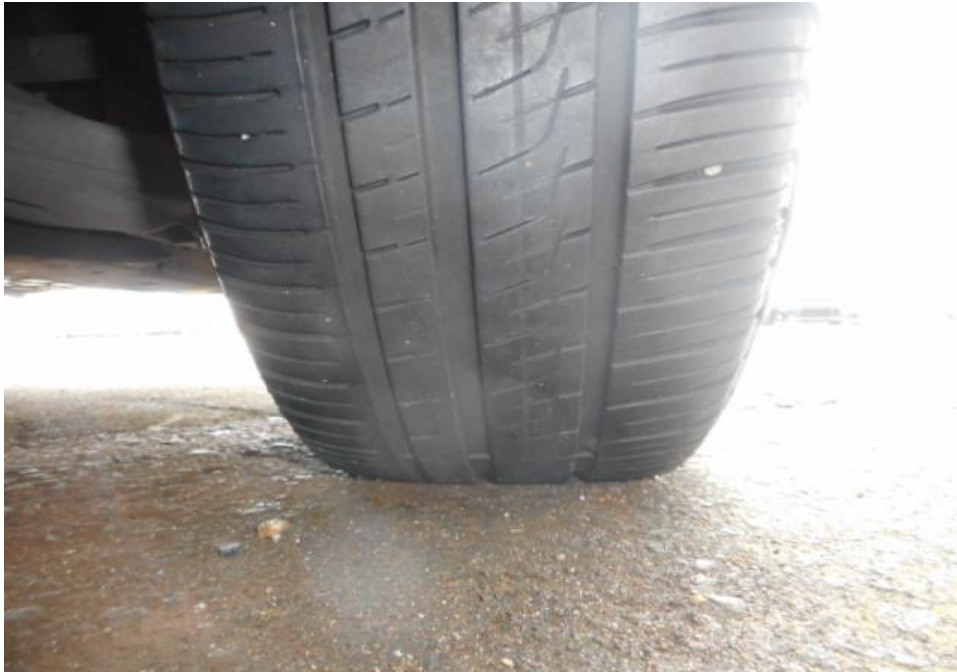
**Photo 6** shows the condition of the front right tyre of the Motor Car, which was observed to be in serviceable condition with remaining tread depth of approximately 4.8mm. The tyre was also observed to be sufficiently inflated for vehicular operation with no tear, cut or burst mark(s).

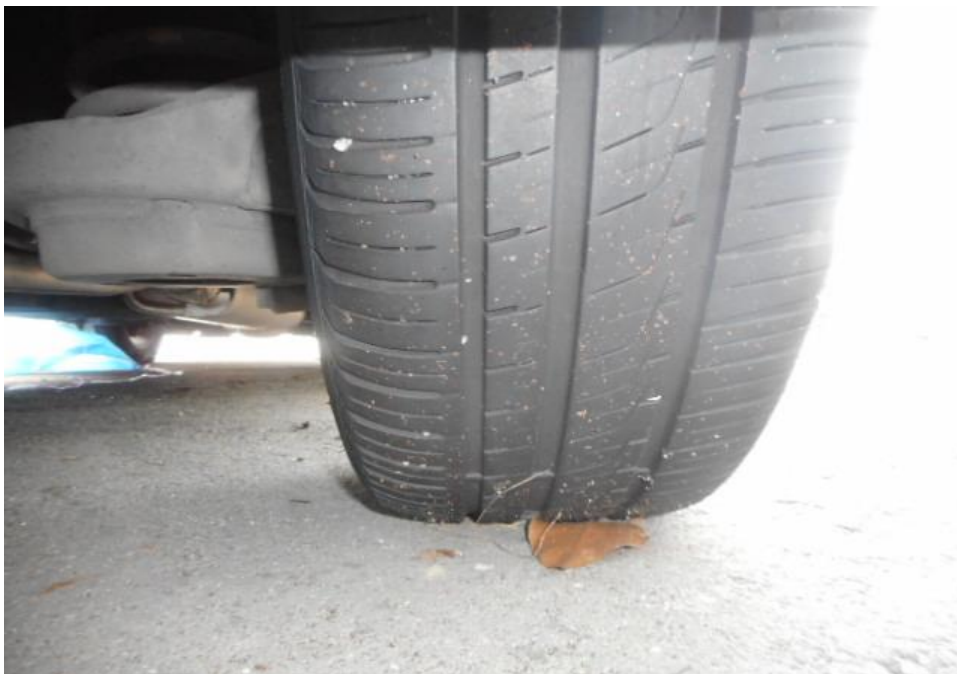
**Photo 7** shows the condition of the rear right tyre of the Motor Car, which was observed to be in serviceable condition with remaining tread depth of approximately 4.8mm. The tyre was also observed to be sufficiently inflated for vehicular operation with no tear, cut or burst mark(s).

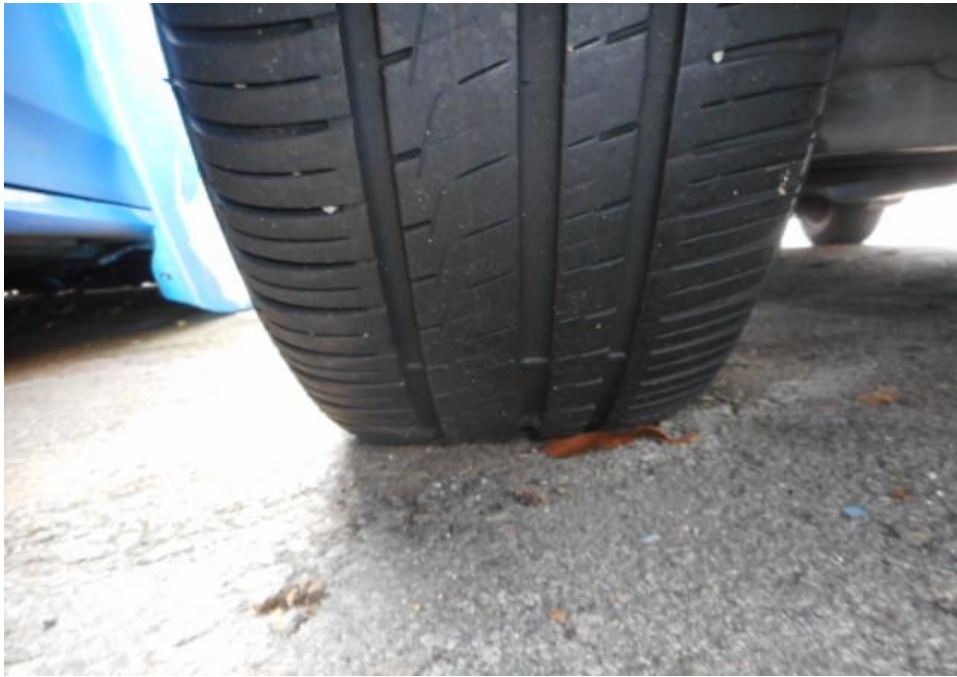
**Photo 8** shows the condition of the rear left tyre of the Motor Car, which was observed to be in serviceable condition with remaining tread depth of approximately 4.8mm. The tyre, which was wrapped around alloy wheel rim, was also observed to be sufficiently inflated for vehicular operation. The 4 tyres of the Motor Car were wrapped around standard alloy wheel rims.

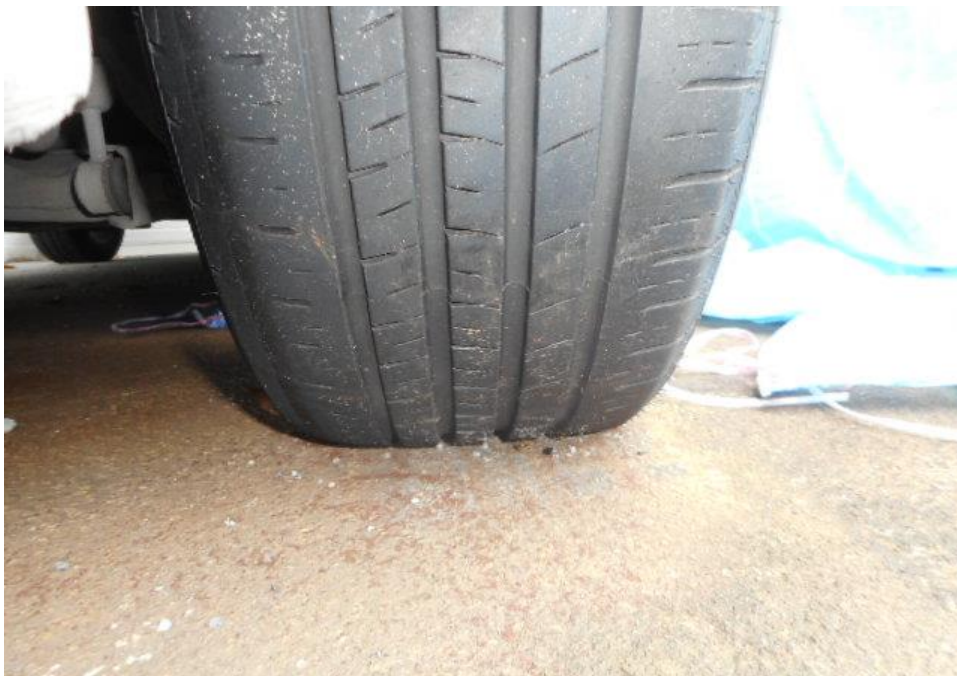
**Photo 9** shows the condition of the front left tyre of the Motor Car, which was observed to be in serviceable condition with remaining tread depth of approximately 5mm. There was also no tear, cut or burst mark(s) on the outer and the inner sidewalls as well as across the tread of the Motor Car's 4 tyres.

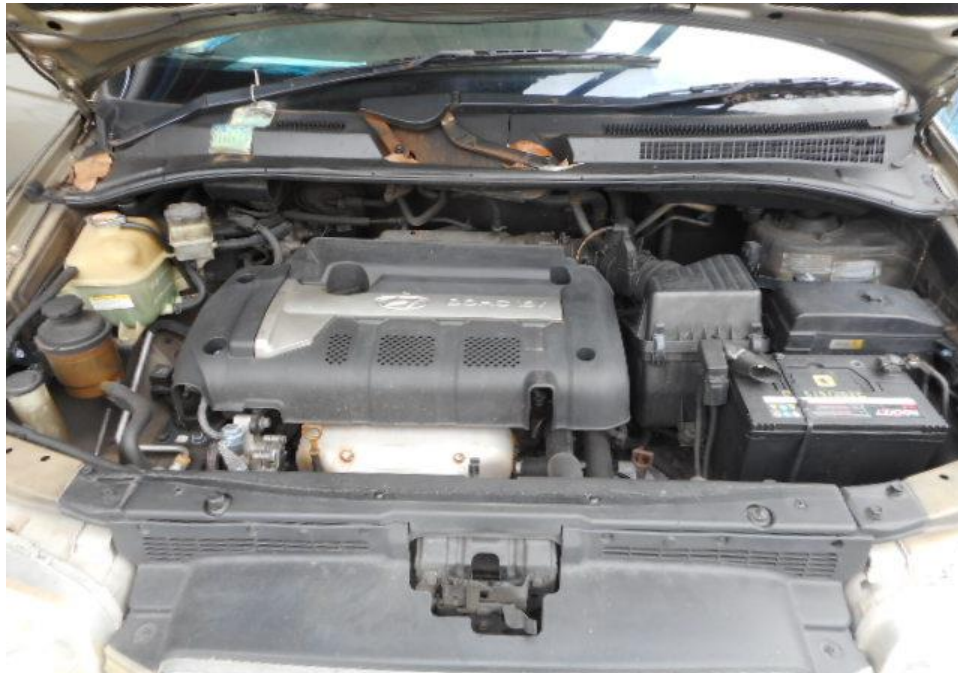
**Photo 10** shows a general view of the Motor Car's engine compartment. The various parts and components inside the engine compartment were unaffected by the accident. There was also no sign(s) or indication(s) of fluid leakage and/or fluid stain within the engine compartment.

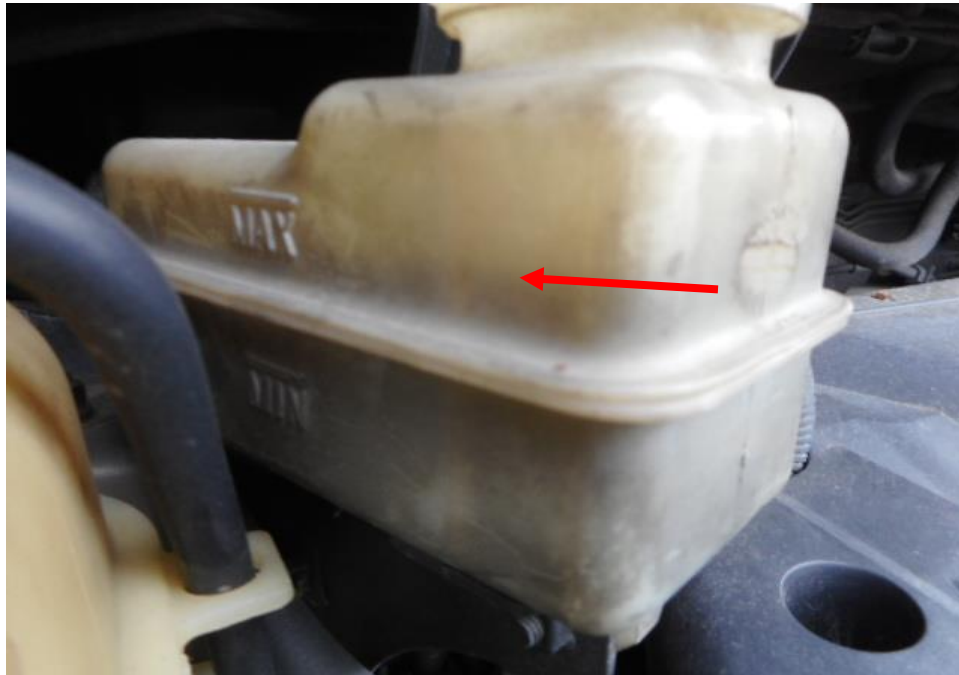
**Photo 11** shows the brake fluid reservoir of the Motor Car at the time of my inspection. The brake fluid was observed to be of sufficient level (arrowed) and without any visible contamination.

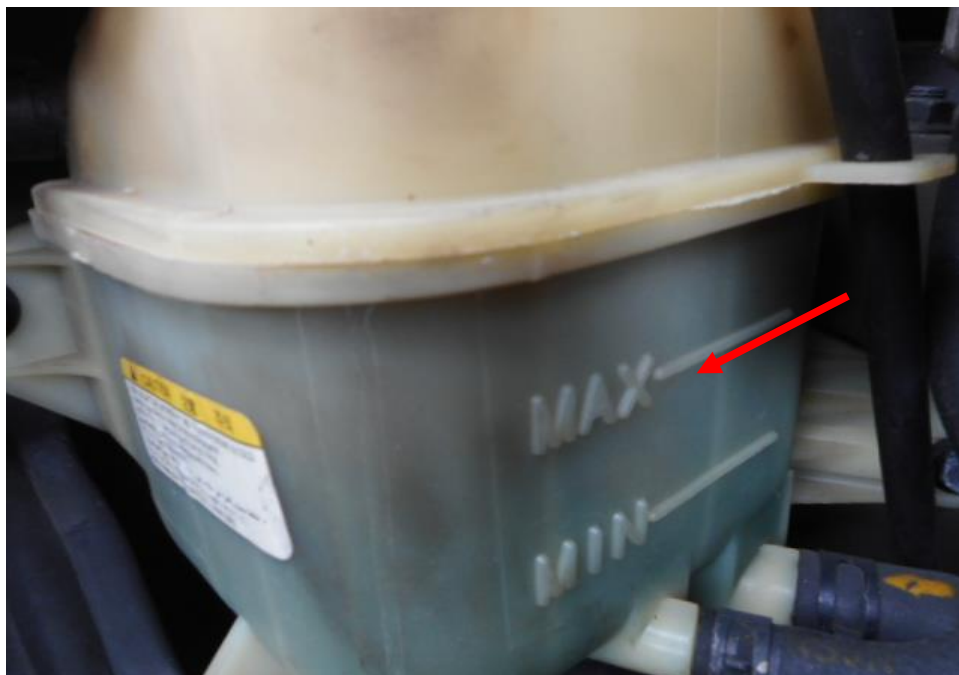
**Photo 12** shows checks being carried out to the engine coolant of the Motor Car at the time of my inspection. The engine coolant was observed to be of sufficient level (arrowed) and without any visible contamination.

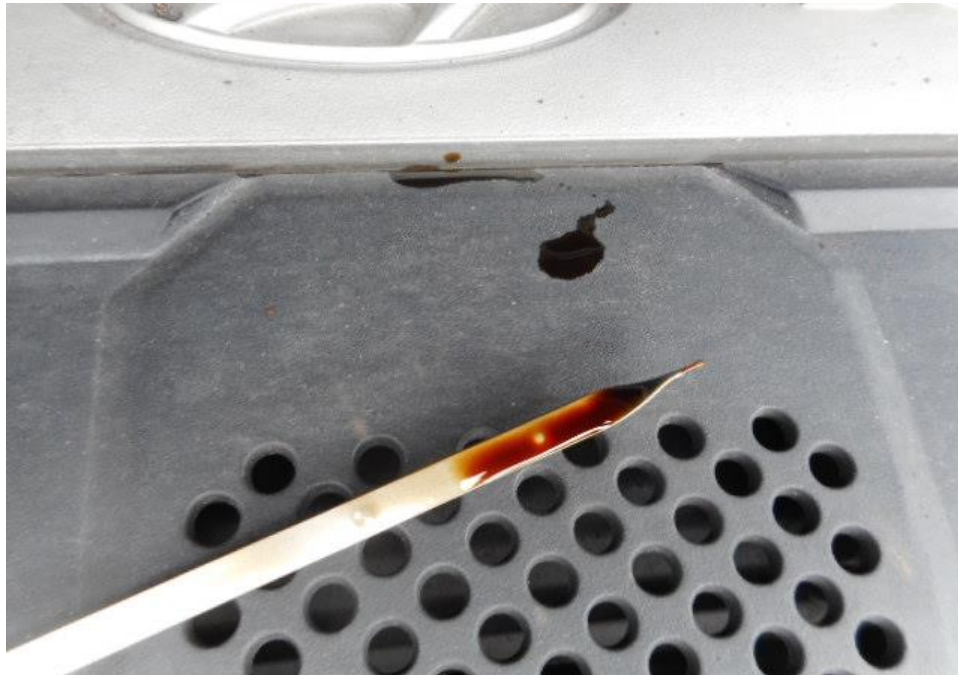
**Photo 13** shows the engine oil level dipstick of the Motor Car at the time of my inspection. The engine oil was observed to be of sufficient level and without any visible contamination.

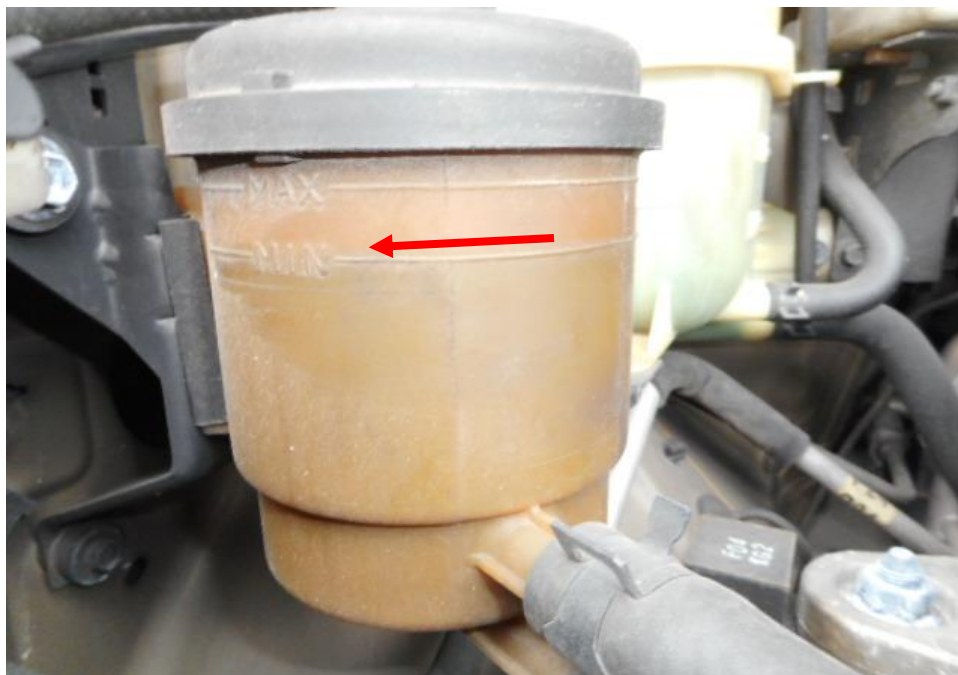
**Photo 14** shows the power steering fluid level dipstick of the Motor Car at the time of my inspection. The power steering fluid was observed to be of sufficient level and without any visible contamination.

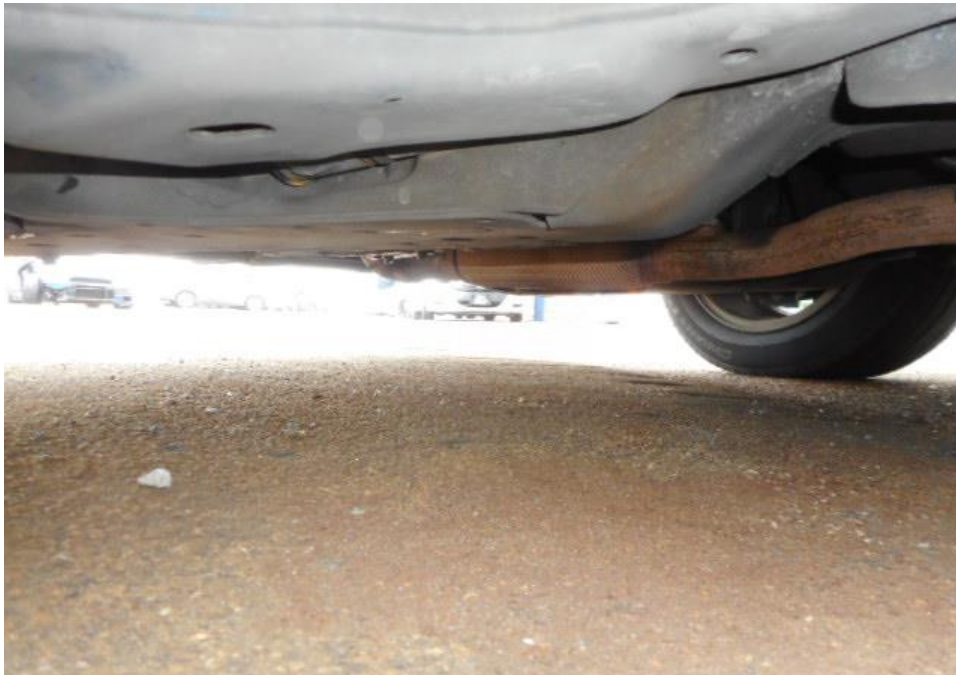
**Photo 15** shows the undercarriage of the Motor Car, at the area where the engine housing and transmission housing are located. I did not find any sign(s) or indication(s) of fluid leak and/or fluid stain(s) on the underside of the Motor Car.

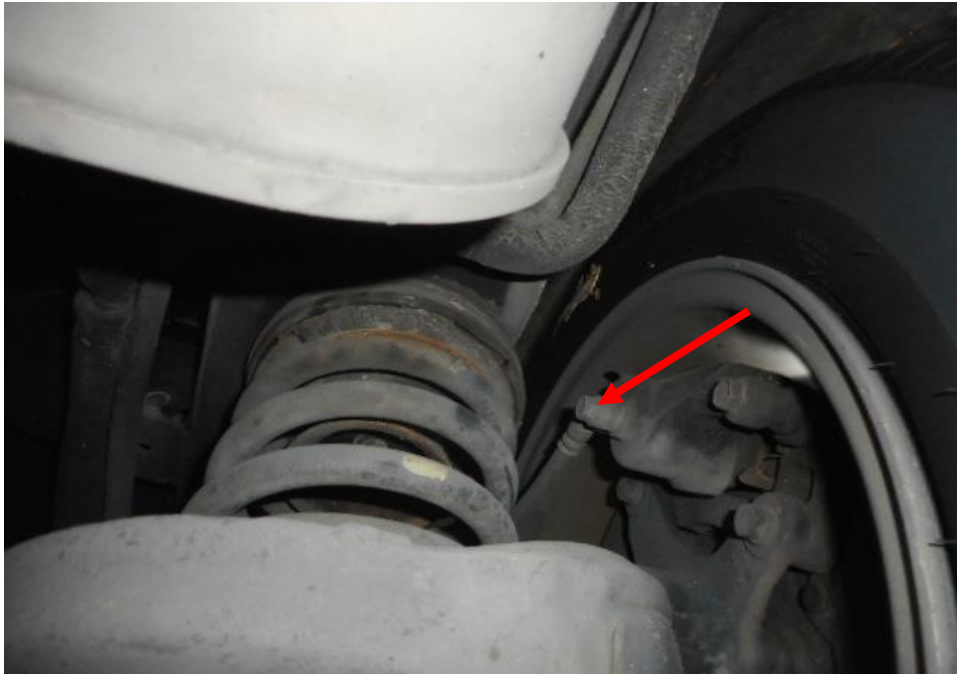
**Photo 16** shows the brake hose/pipe (arrowed) at the rear right wheel of the Motor Car. No leakage of brake fluid was observed. Visual examination of the various components of the braking system like the drum brake, brake booster, brake pedal etc. had revealed all to be intact and without visible damage.

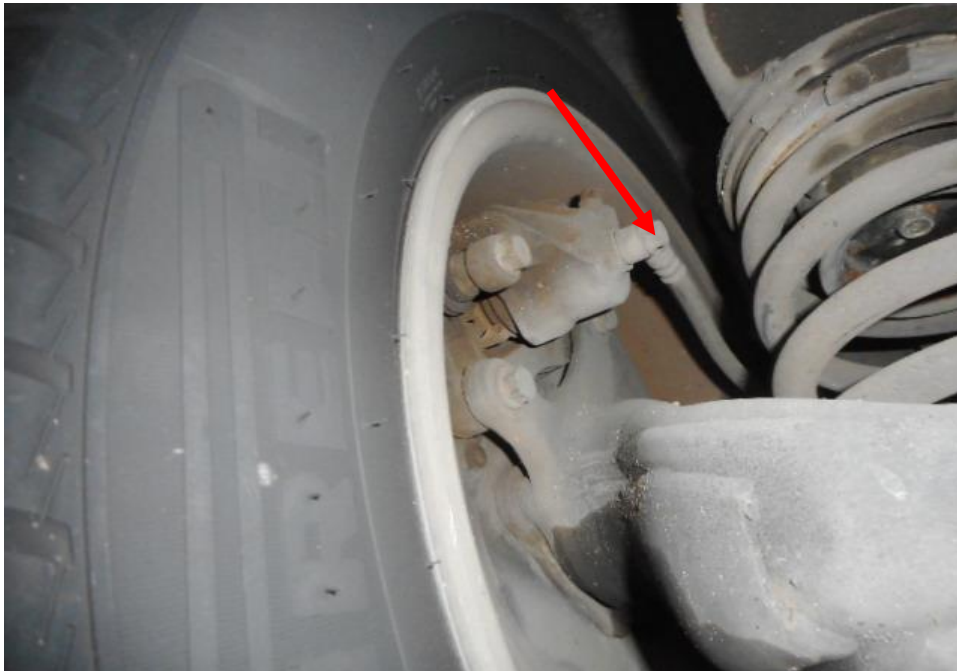
**Photo 17** shows the brake hose/pipe (arrowed) at the rear left wheel of the Motor Car. I did not observe any leakage of brake fluid at the time of my inspection of the Motor Car. Static tests of the Motor Car's braking system had indicated that there was no internal leakage of pressure/vacuum. The undercarriage components of the Motor Car were also all found to be intact and without any visible damage.

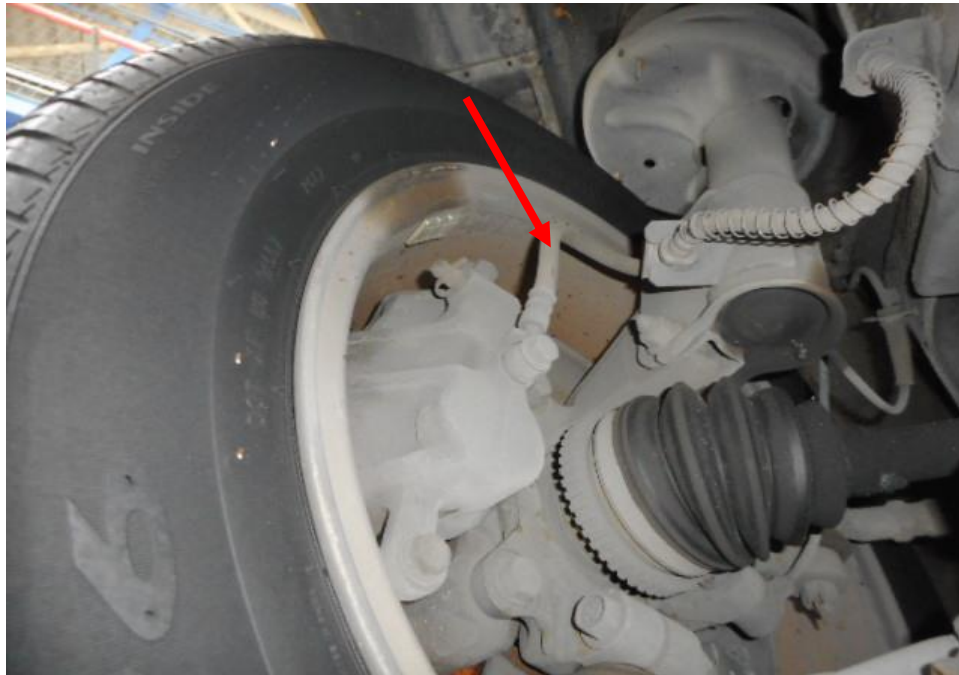
**Photo 18** shows the brake hose/pipe (arrowed) at the front right wheel of the Motor Car. I did not observe any leakage of brake fluid at the time of my inspection of the Motor Car. Static tests of the Motor Car's braking system had indicated that there was no internal leakage of pressure/vacuum.

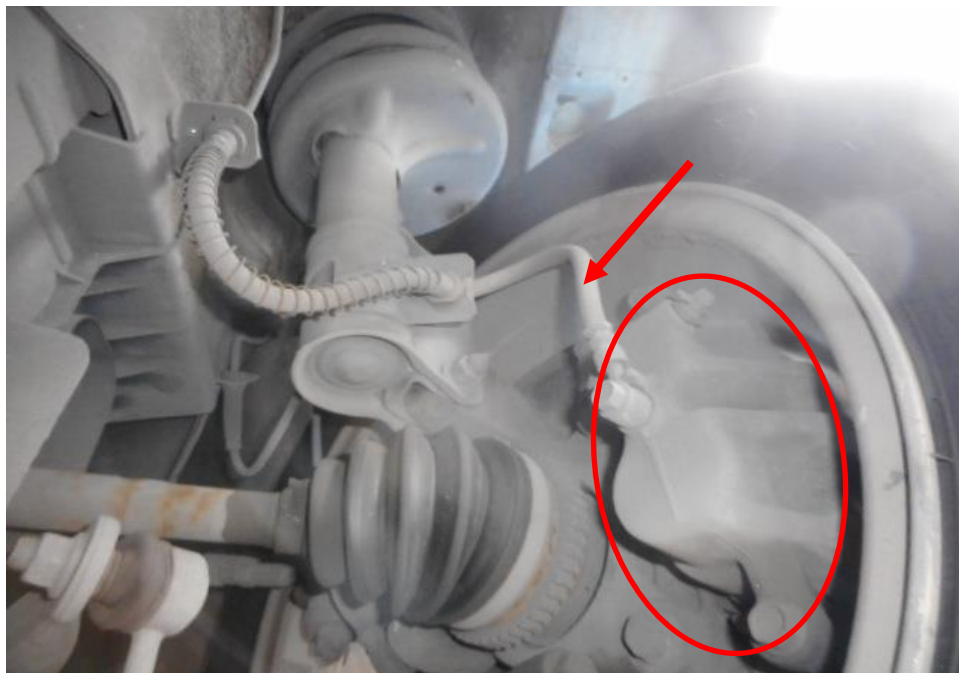
**Photo 19** shows the brake hose/pipe (arrowed) at the front left wheel of the Motor Car. No leakage of brake fluid was observed. Visual examination of the various components of the braking system like the brake caliper (circled), brake booster, brake pedal etc had revealed all to be intact and without visible damage.

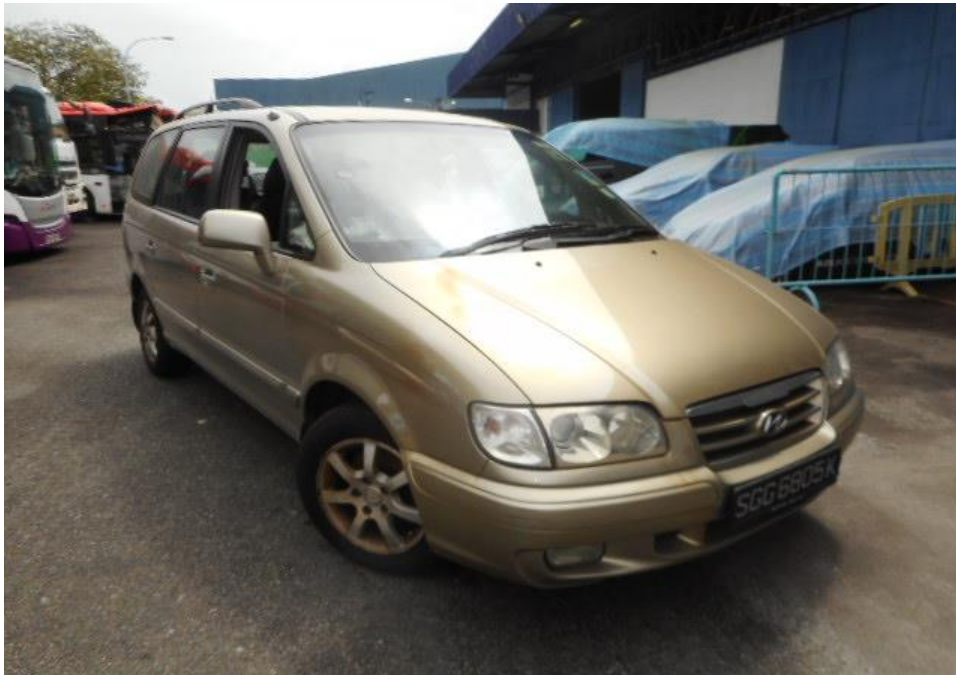
**Photo 20** shows the front right wheel of the Motor Car turned to its full left. During my steering system test, I did not experience any abnormal free play and/or resistance when I had turned the steering wheel towards the left and right. This would suggest that the steering system of the Motor Car was likely to be in serviceable condition at the material time of accident.

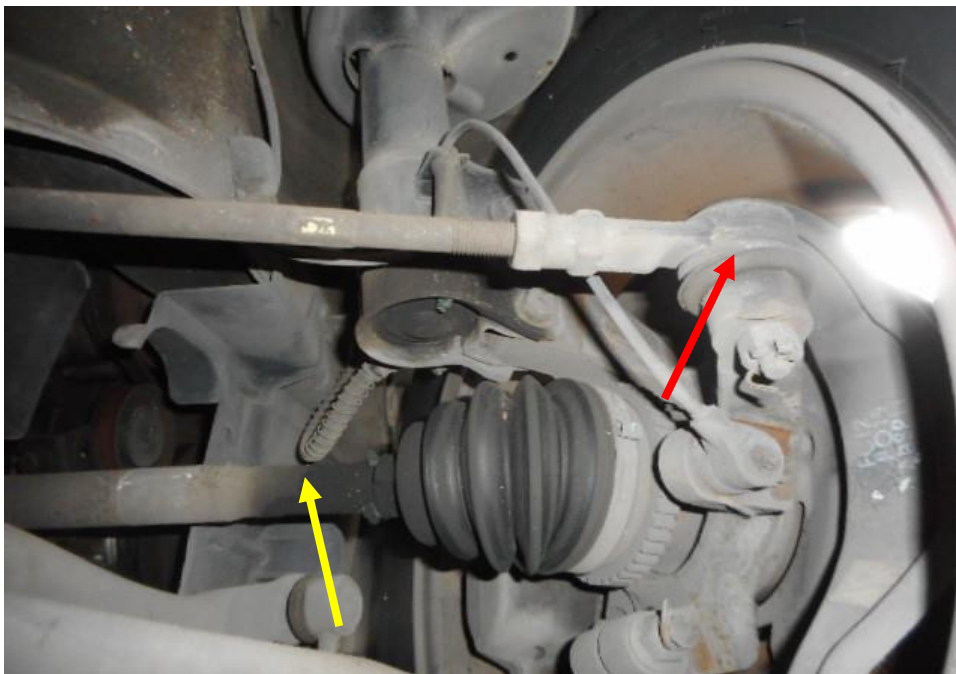
**Photo 21** shows the various undercarriage components at the front right wheel of the Motor Car, in particular the steering tie rod (red arrow) and in particular the drive shaft (yellow arrow). The various steering components were all found to be intact, suggesting that the steering system of the Motor Car was likely to be in serviceable condition at the material time of accident. There was also no sign of fluid stain observed on the various undercarriage components at the front right wheel of the Motor Car.

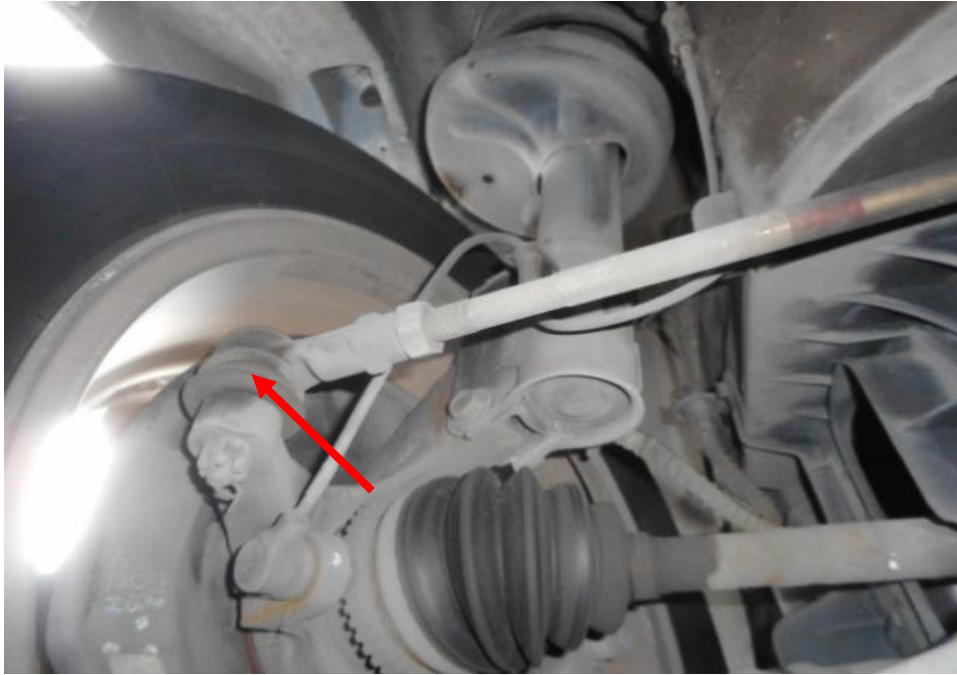
**Photo 22** shows the various undercarriage components at the front left wheel of the Motor Car, which had included the steering tie rod (arrowed). The various undercarriage components of the Motor Car were all found to be intact without any visible damage.

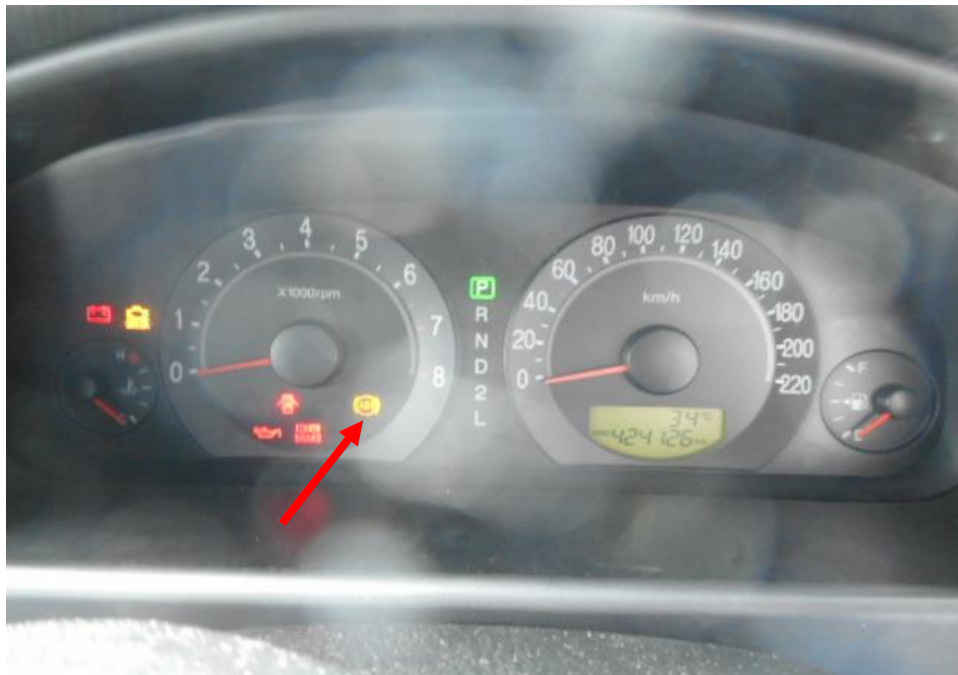
**Photo 23** shows the warning light for Anti-Lock Brake System (ABS) (arrowed) appearing on the instrument panel of the Motor Car during the self-test of its various electronic operating systems when its engine was cranked.

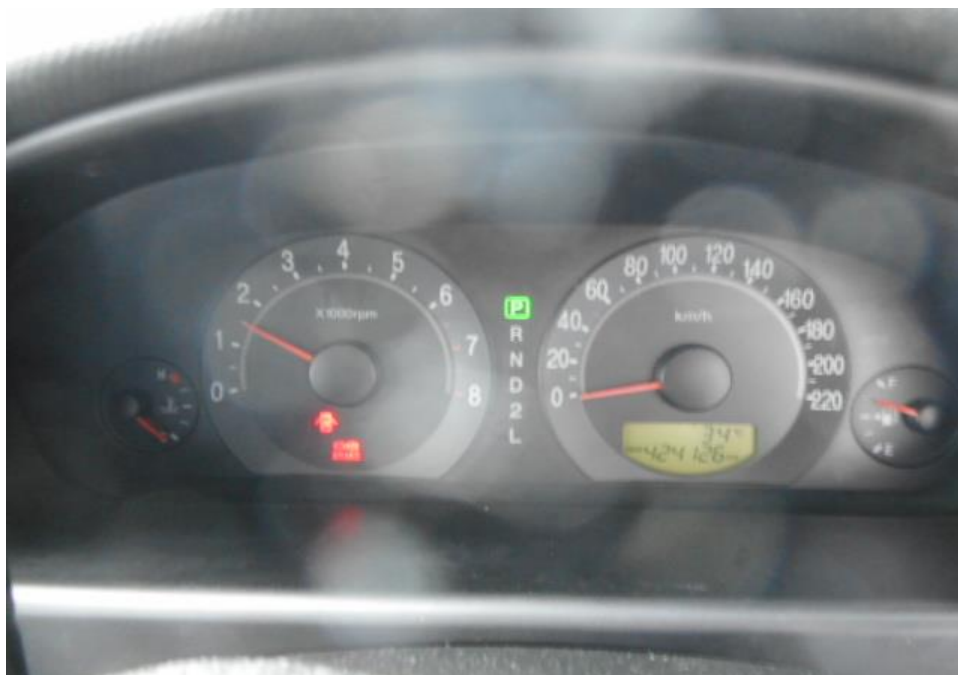
**Photo 24** shows no warning lights illuminated on the instrument panel of the Motor Car after the engine was cranked. This would suggest that there was no abnormality to the electronic operating system of the Motor Car, like the ABS etc.
