You're Ref: TP IP/02559/2023  
Our Ref: CI/TPD23001584/P

**Fatal Accident Investigation Team**

**MECHANICAL INSPECTION REPORT OF MOTOR VAN GBL 1182P**

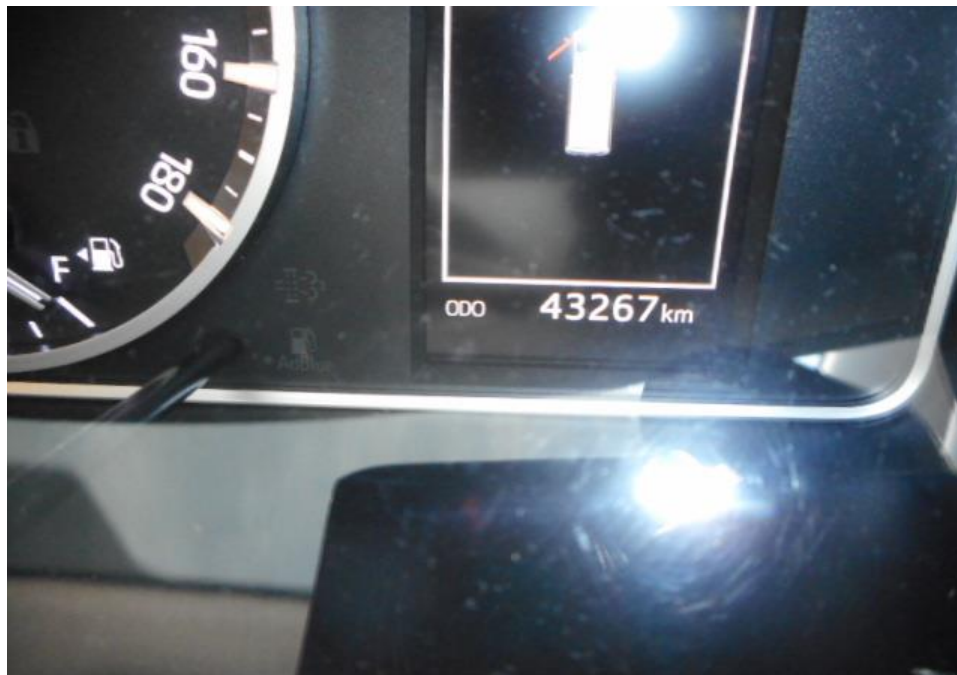
**Photo 1** shows the mileage of the Motor Van at the time of my inspection. The mileage observed was 43,267km.

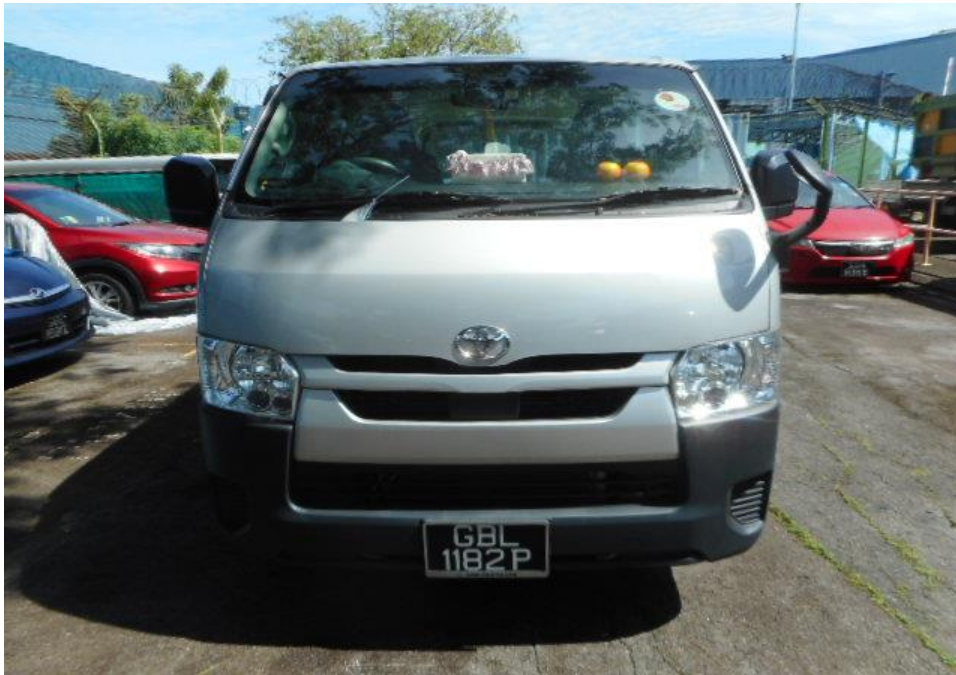
**Photo 2** shows a general view of the Motor Van's front body at the time of my inspection. The front portion of the Motor Van was observed to have been unaffected by the accident.

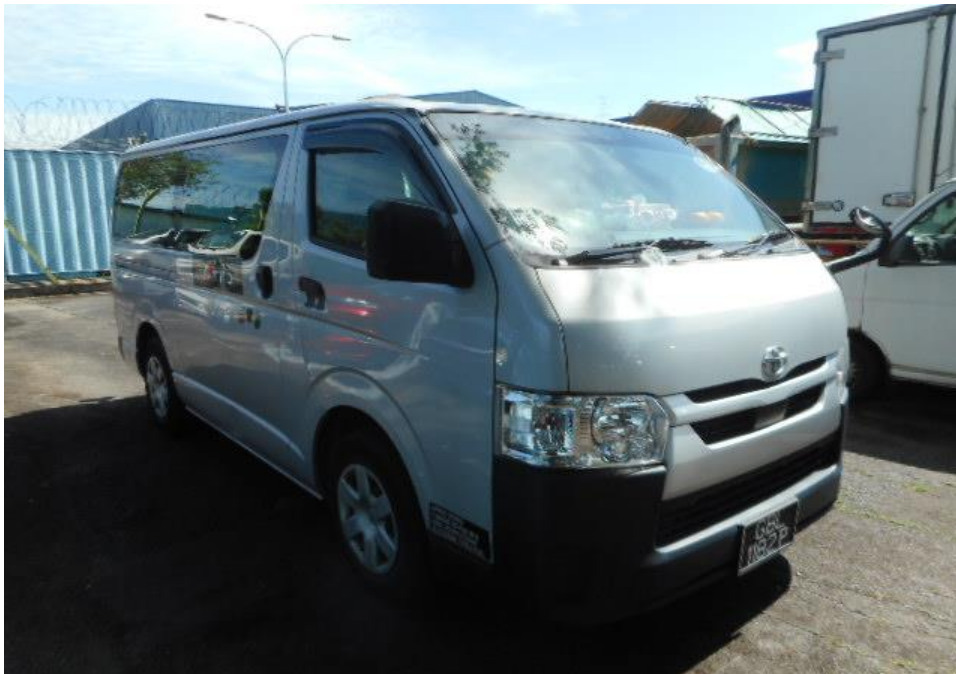
**Photo 3** shows a general view of the Motor Van's right body at the time of my inspection. The right portion of the Motor Van was observed to have been unaffected by the accident.

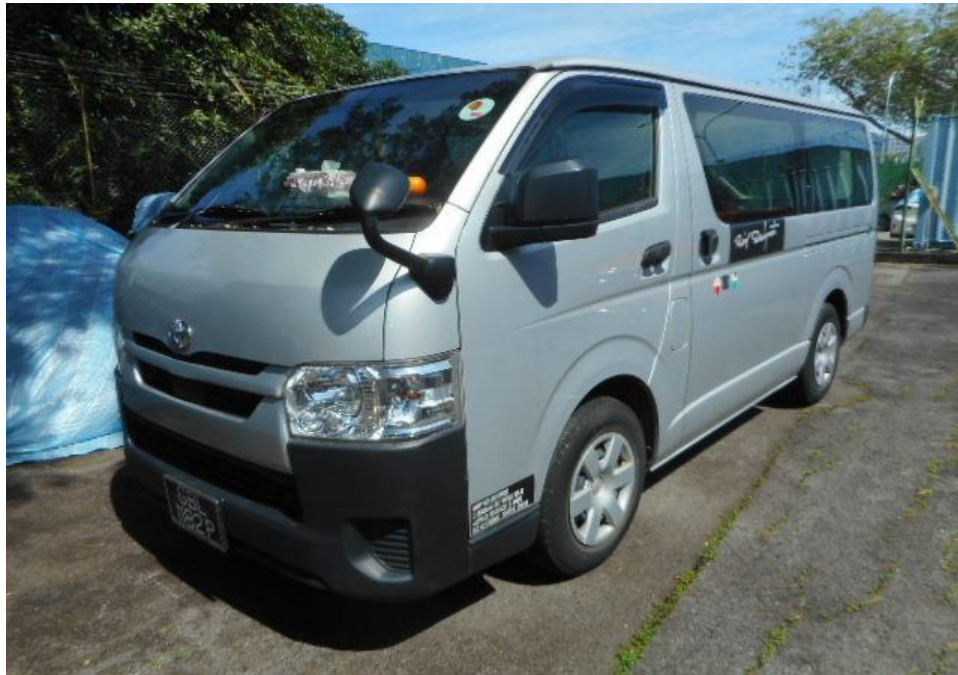
**Photo 4** shows a general view of the Motor Van's left body at the time of my inspection. The left portion of the Motor Van was observed to have been unaffected by the accident.

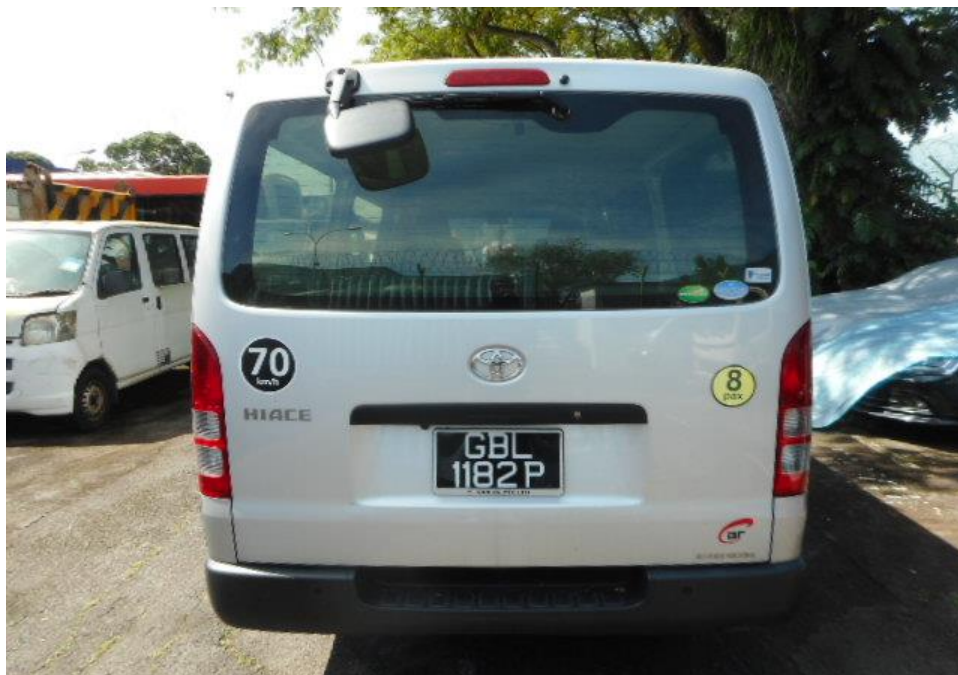
**Photo 5** shows the general view of the Motor Van's rear body at the time of my inspection. The Motor Van rear was observed to be unaffected by the accident.

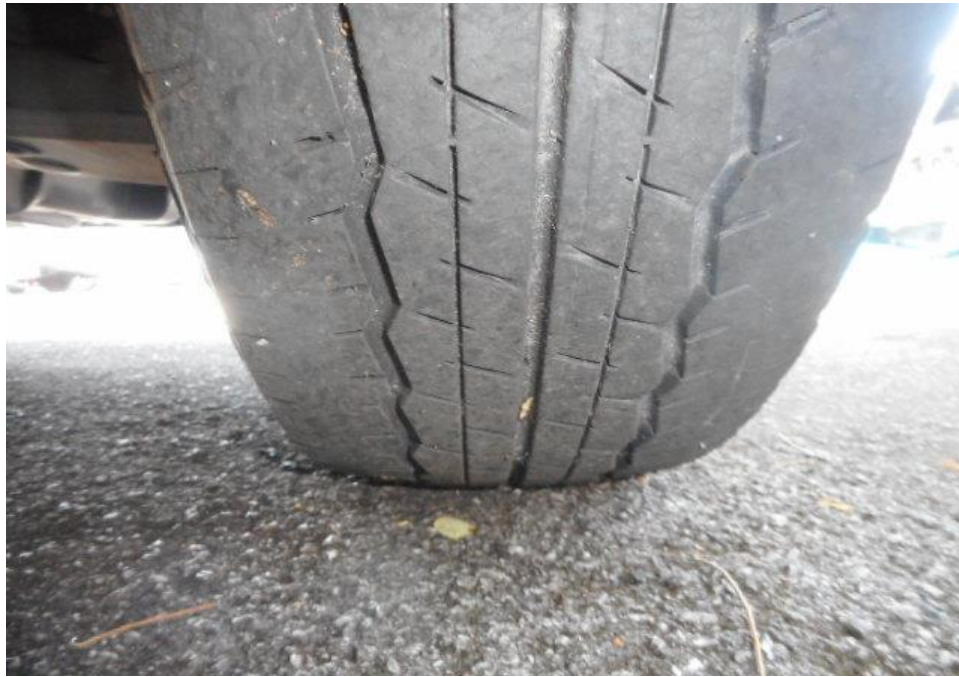
**Photo 6** shows the condition of the front right tyre of the Motor Van, which was observed to be in serviceable condition with remaining tread depth of approximately 5.4mm. The tyre was sufficiently inflated for vehicular operation with no tear, cut or burst mark(s) on the outer and the inner sidewalls as well as across the tread. The 4 tyres of the Motor Van were wrapped around standard steel wheel rims without any damage.

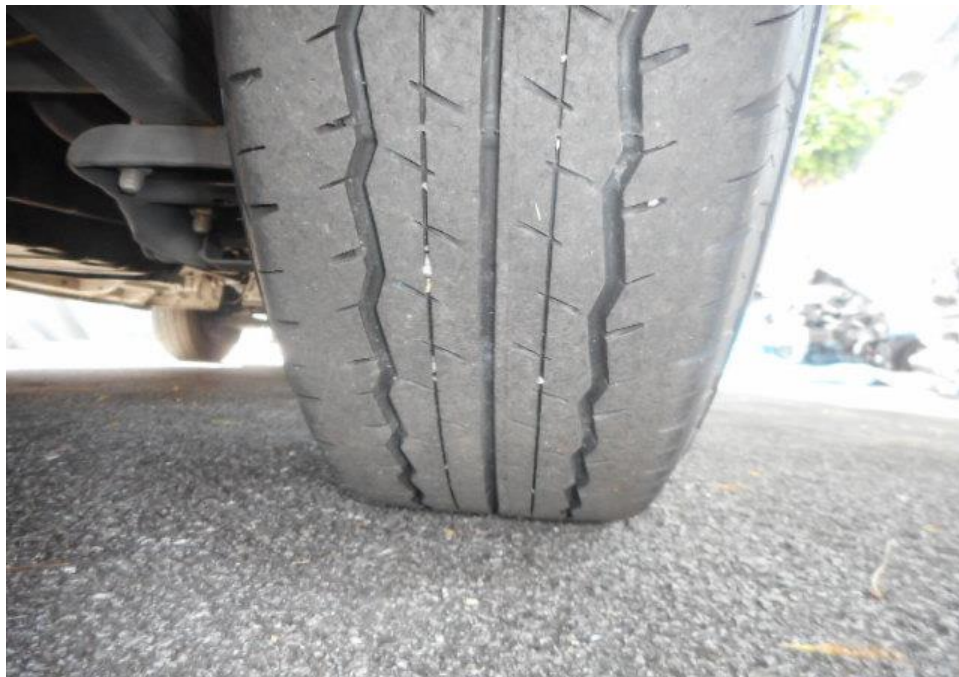
**Photo 7** shows the condition of the rear right tyre of the Motor Van, which was observed to be in serviceable condition with remaining tread depth of approximately 4.5mm. The tyre was also observed to be sufficiently inflated for vehicular operation with no tear, cut or burst mark(s).

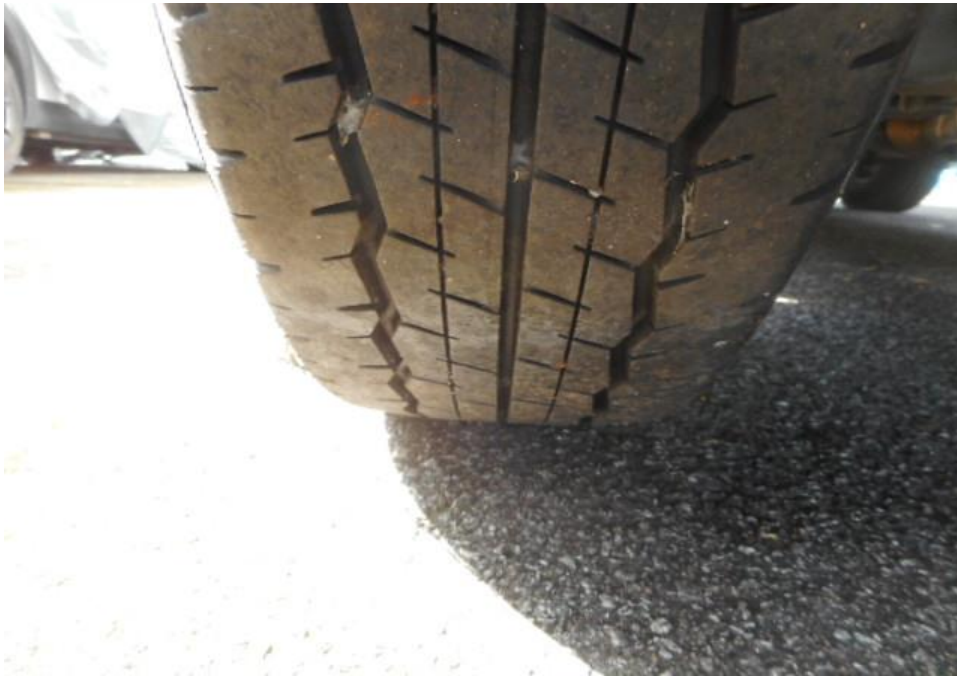
**Photo 8** shows the condition of the rear left tyre of the Motor Van, which was observed to be in serviceable condition with remaining tread depth of approximately 5.6mm. The tyre, which was wrapped around steel wheel rim, was also observed to be sufficiently inflated for vehicular operation. The 4 tyres of the Motor Van were wrapped around standard steel wheel rims.

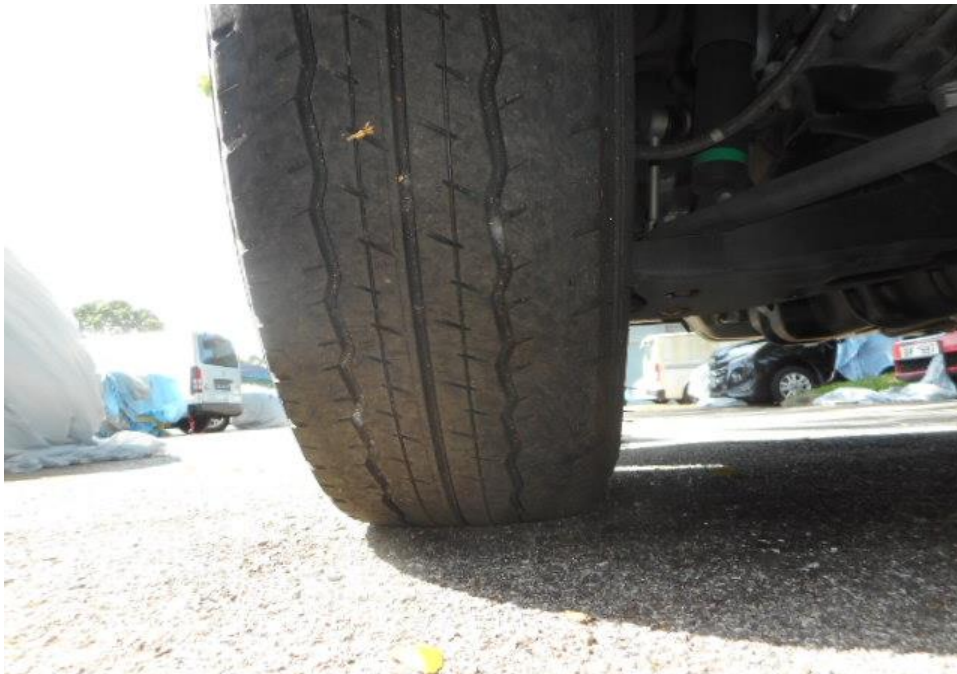
**Photo 9** shows the condition of the front left tyre of the Motor Van, which was observed to be in serviceable condition with remaining tread depth of approximately 5mm. There was also no tear, cut or burst mark(s) on the outer and the inner sidewalls as well as across the tread of the Motor Van's 4 tyres.

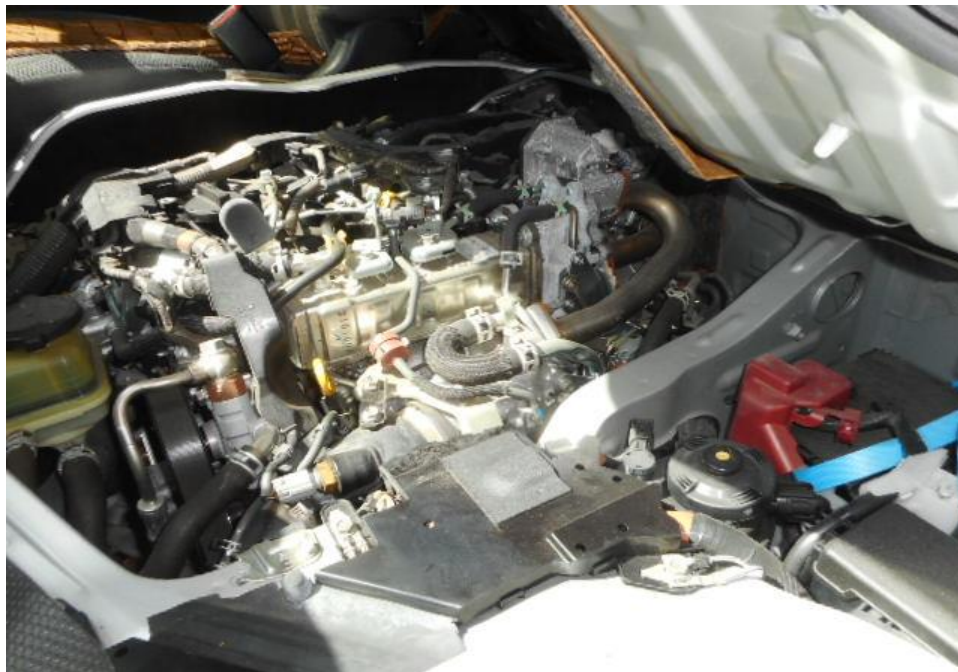
**Photo 10** shows a general view of the Motor Van's engine compartment. The various parts and components inside the engine compartment were unaffected by the accident. There was also no sign(s) or indication(s) of fluid leakage and/or fluid stain within the engine compartment.

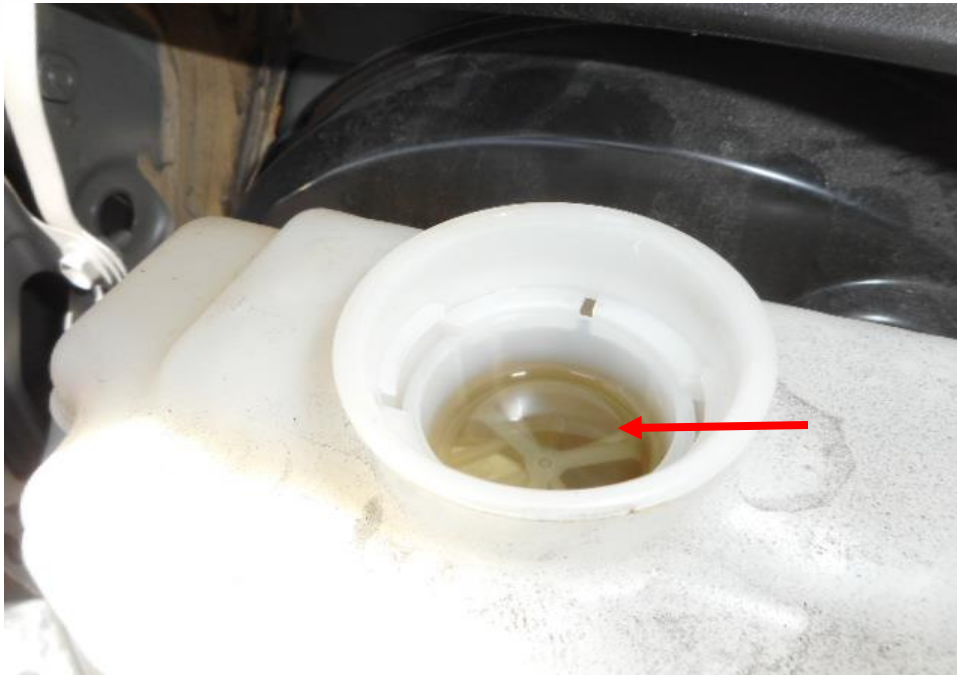
**Photo 11** shows the brake fluid reservoir of the Motor Van at the time of my inspection. The brake fluid was observed to be of sufficient level (arrowed) and without any visible contamination.

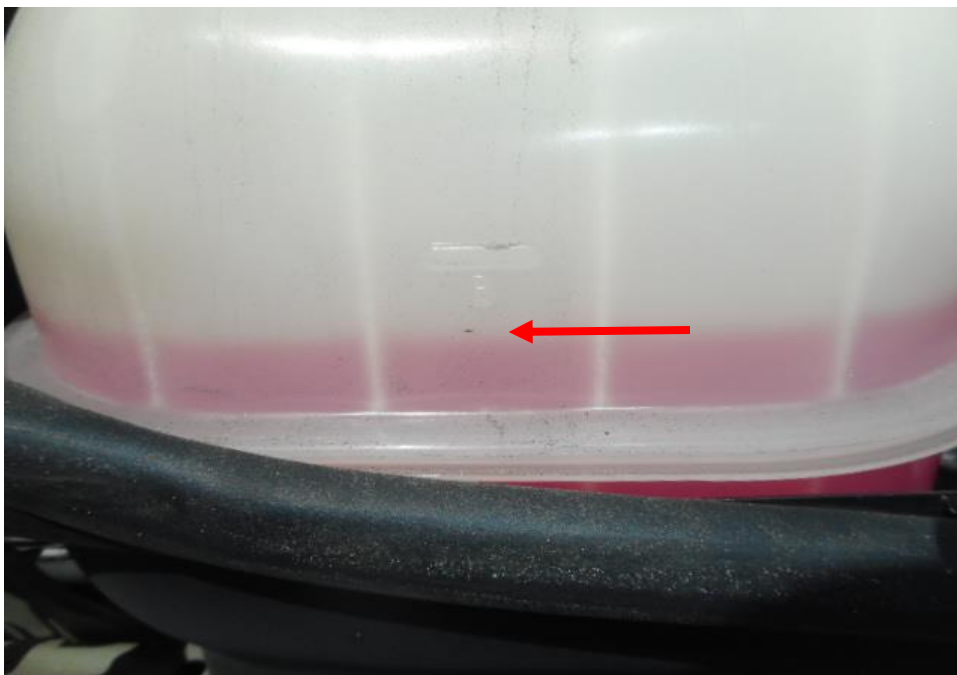
**Photo 12** shows checks being carried out to the engine coolant of the Motor Van at the time of my inspection. The engine coolant was observed to be of sufficient level (arrowed) and without any visible contamination.

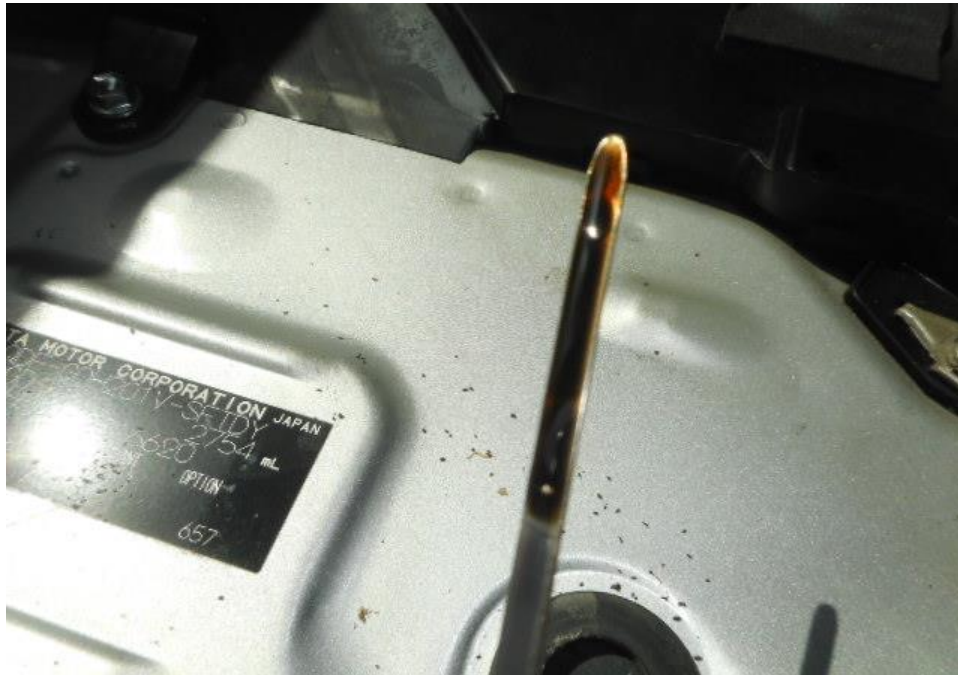
**Photo 13** shows the engine oil dip stick of the Motor Van at the time of my inspection. The engine oil was observed to be of sufficient level and without any visible contamination.

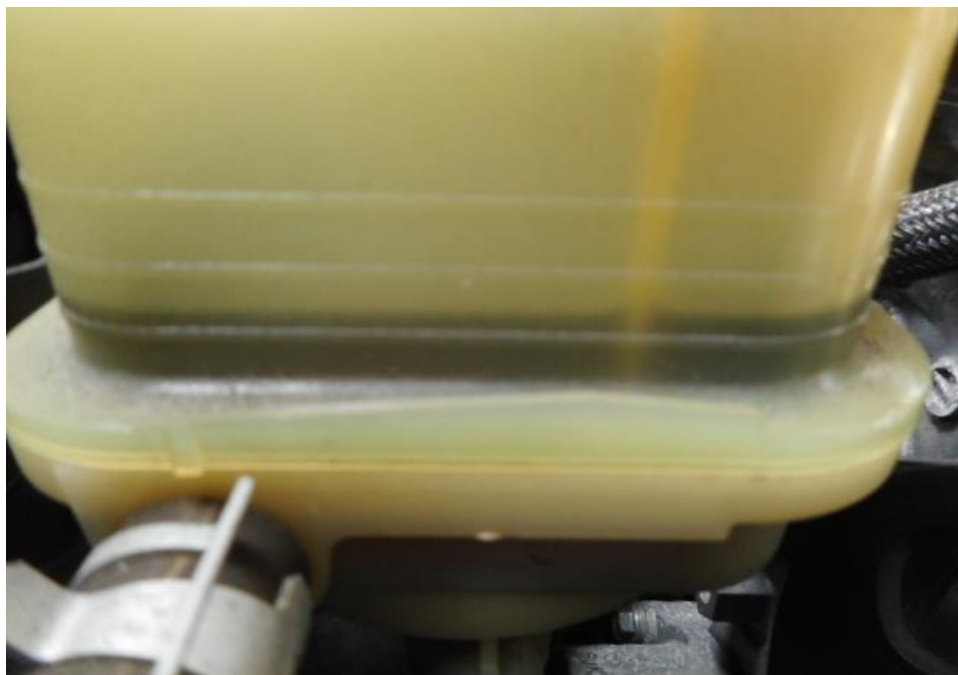
**Photo 14** shows the power steering fluid dip stick of the Motor Van at the time of my inspection. The power steering fluid was observed to be of sufficient level and without any visible contamination.

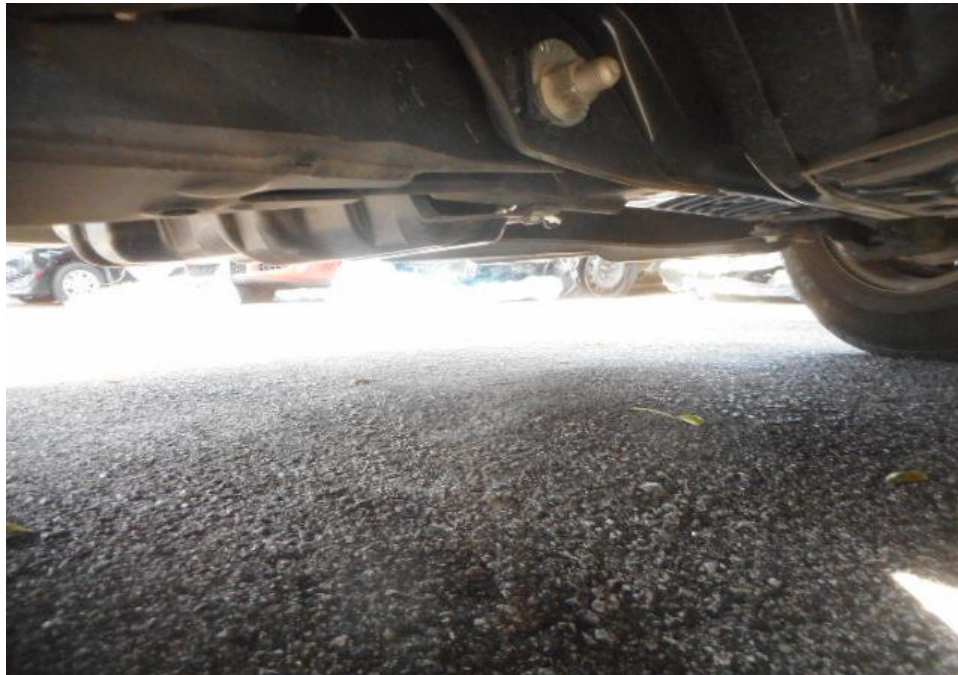
**Photo 15** shows the undercarriage of the Motor Van, at the area where the engine housing and transmission housing are located. I did not find any sign(s) or indication(s) of fluid leak and/or fluid stain(s) on the underside of the Motor Van.

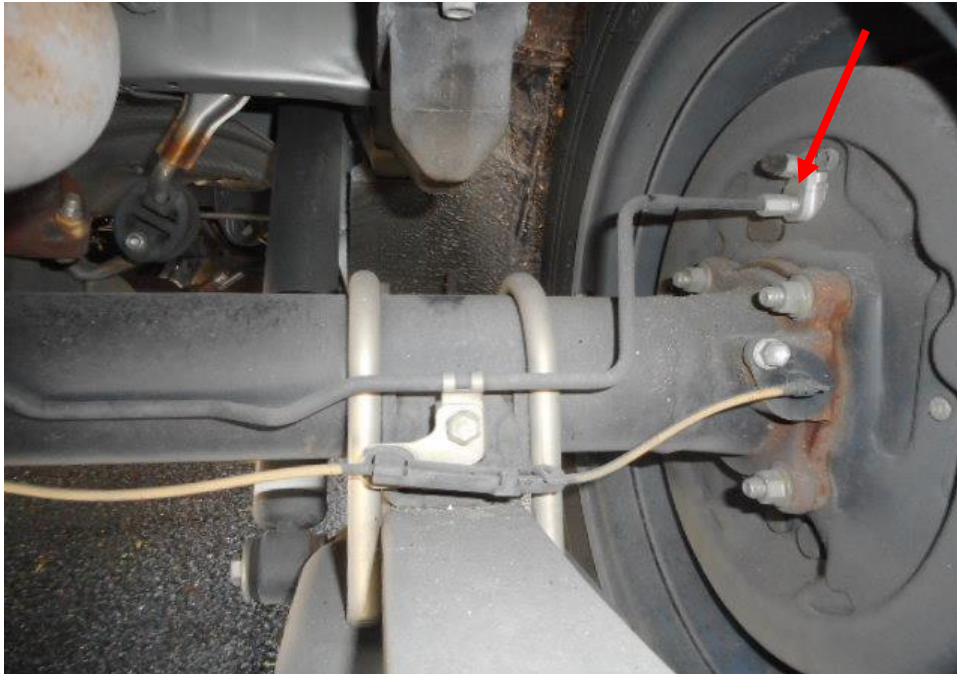
**Photo 16** shows the brake hose/pipe (arrowed) at the rear right wheel of the Motor Van. No leakage of brake fluid was observed. Visual examination of the various components of the braking system like the drum brake, brake booster, brake pedal etc. had revealed all to be intact and without visible damage.

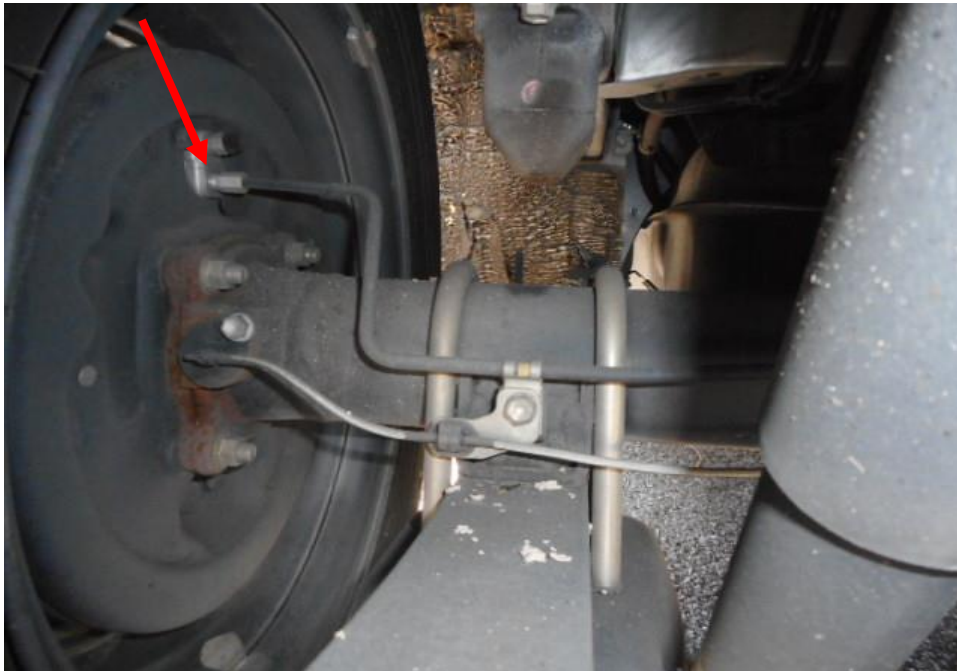
**Photo 17** shows the brake hose/pipe (arrowed) at the rear left wheel of the Motor Van. I did not observe any leakage of brake fluid at the time of my inspection of the Motor Van. Static tests of the Motor Van's braking system had indicated that there was no internal leakage of pressure/vacuum. The undercarriage components of the Motor Van were also all found to be intact and without any visible damage.

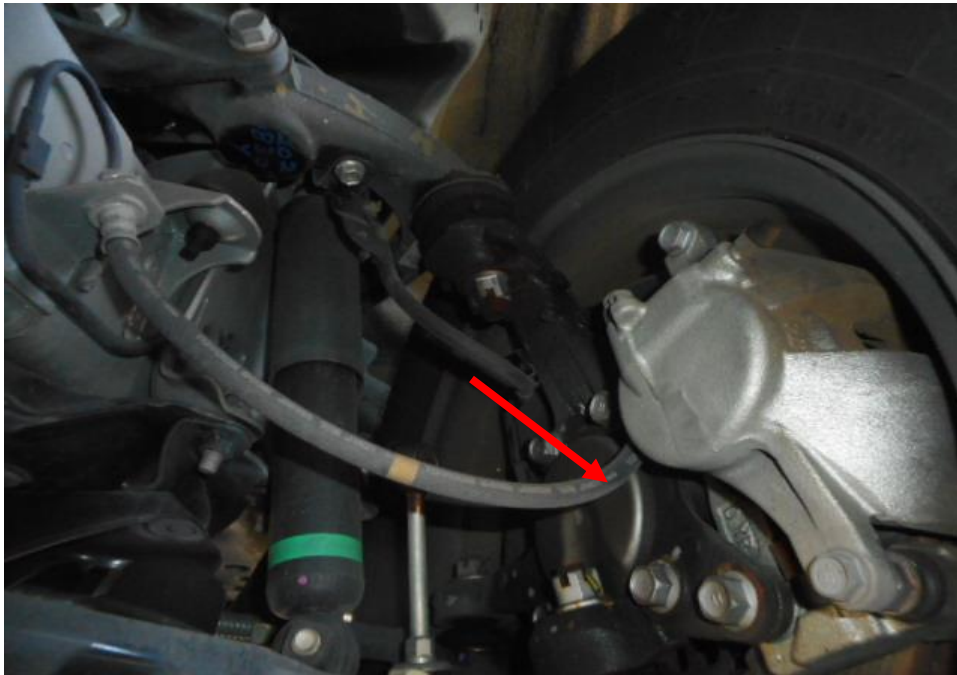
**Photo 18** shows the brake hose/pipe (arrowed) at the front right wheel of the Motor Van. I did not observe any leakage of brake fluid at the time of my inspection of the Motor Van. Static tests of the Motor Van's braking system had indicated that there was no internal leakage of pressure/vacuum. The undercarriage components of the Motor Van were also all found to be intact and without any visible damage.

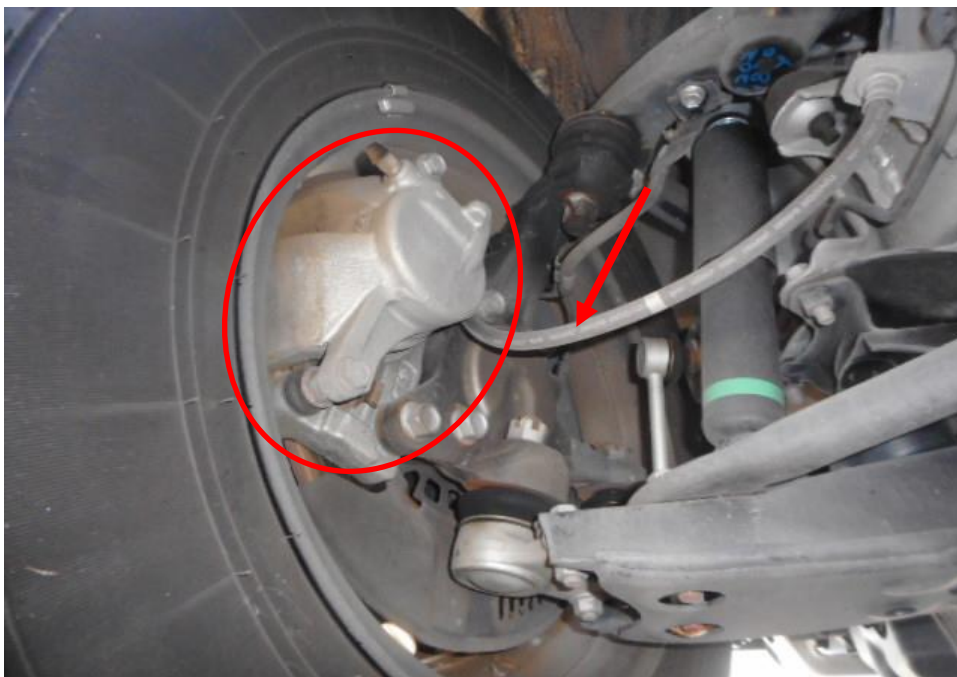
**Photo 19** shows the brake hose/pipe (arrowed) at the front left wheel of the Motor Van. No leakage of brake fluid was observed. Visual examination of the various components of the braking system like the brake caliper (circled), brake booster, brake pedal etc had revealed all to be intact and without visible damage.

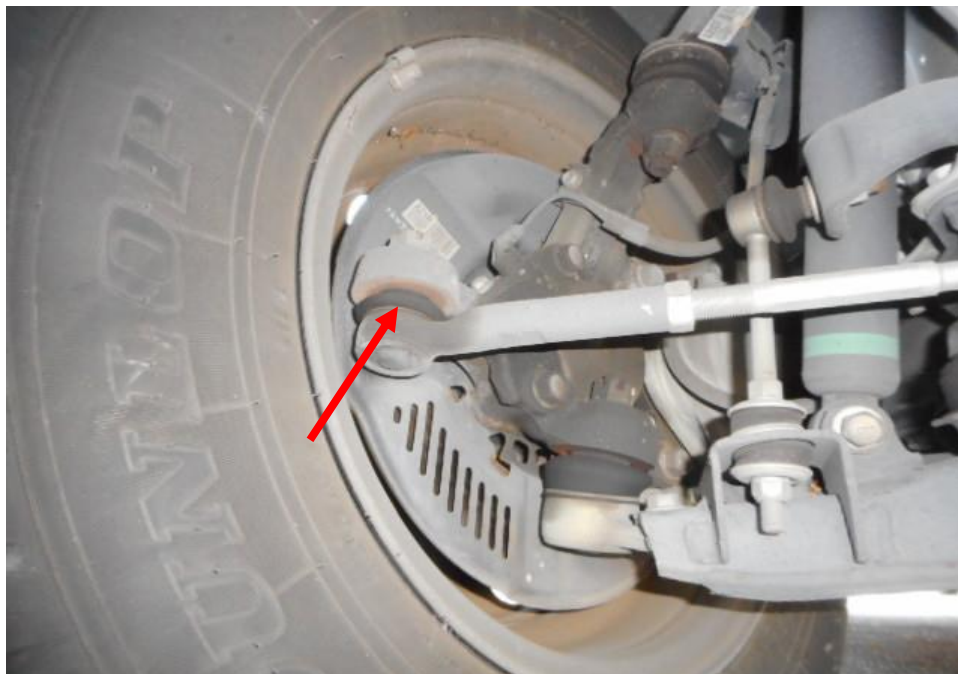
**Photo 21** shows the various undercarriage components at the front right wheel of the Motor Van, in particular the steering tie rod (arrowed). The various steering components were all found to be intact, suggesting that the steering system of the Motor Van was likely to be in serviceable condition at the material time of accident. There was also no sign of fluid stain observed on the various undercarriage components at the front right wheel of the Motor Van.

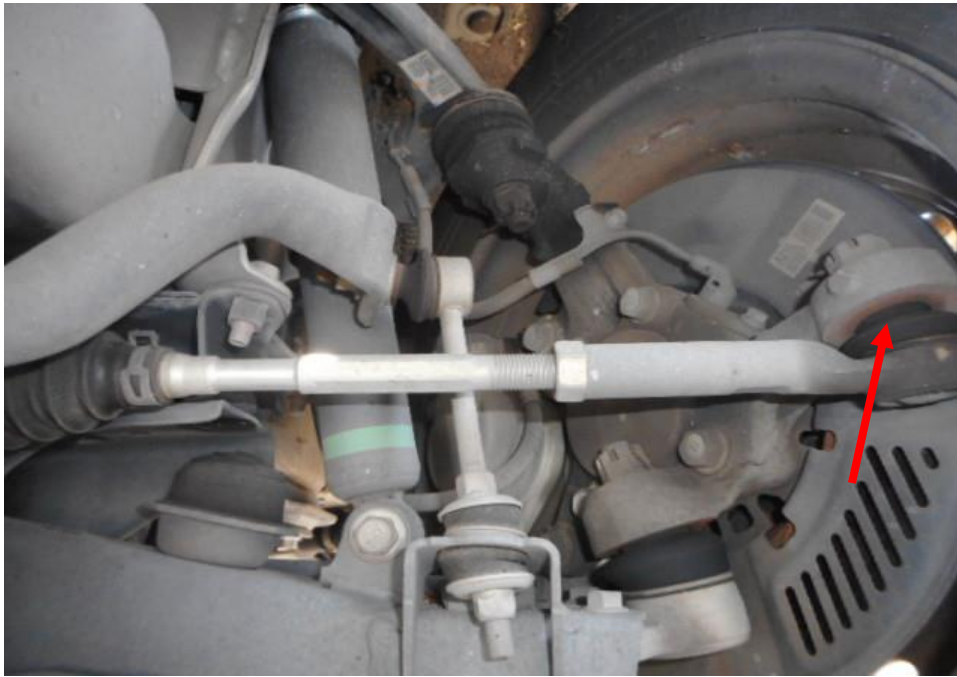
**Photo 22** shows the various undercarriage components at the front left wheel of the Motor Van, which had included the steering tie rod (arrowed). The various undercarriage components of the Motor Van were all found to be intact without any visible damage.

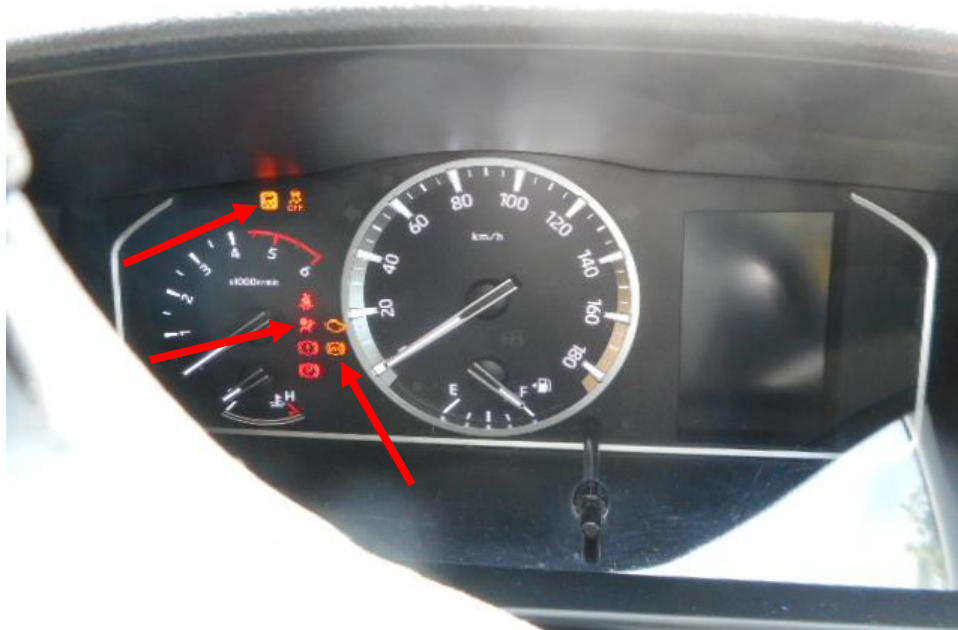
**Photo 23** shows the warning light for Supplemental Restraint System (SRS), Traction Control System (TCS) and Anti-Lock Braking System (ABS) (arrowed) appearing on the instrument panel of the Motor Van during the self-test of its various electronic operating systems when its engine was cranked.

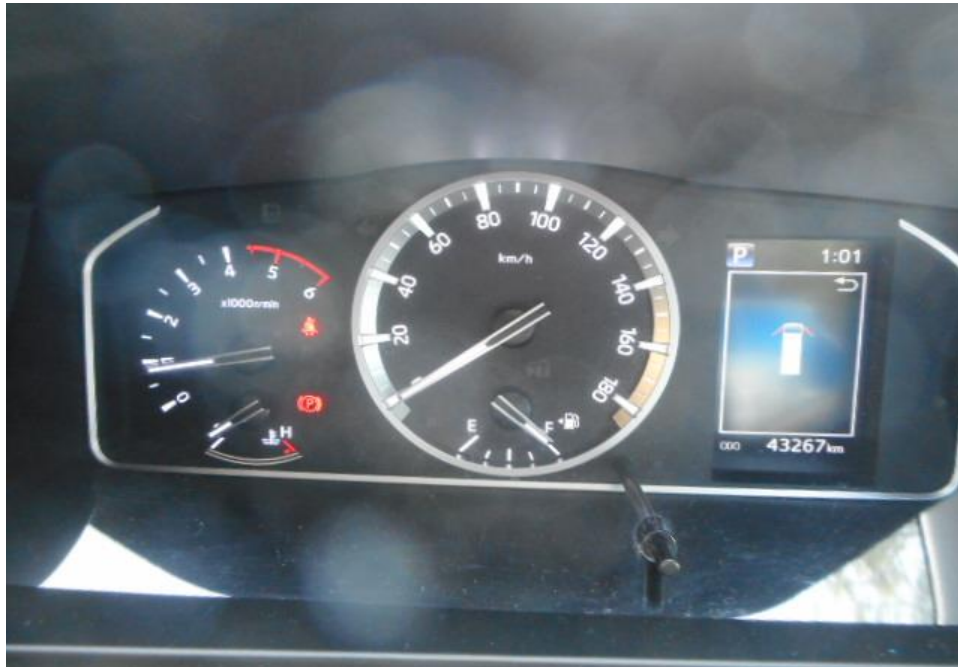
**Photo 24** shows no warning lights illuminated on the instrument panel of the Motor Van after the engine was cranked. This would suggest that there was no abnormality to the electronic operating system of the Motor Van, like the SRS, TCS, ABS and etc.
