**MECHANICAL INSPECTION REPORT OF MOTOR BUS SBS 8183D**

1. I refer to your request on 7<sup>th</sup> February 2023 to conduct a physical inspection of a Motor Bus bearing registration number SBS 8183D (herein referred to as "**Motor Bus**"), which was involved in a fatal road traffic accident on 18<sup>th</sup> December 2022.
2. The objective of this inspection is to determine if there was any possible mechanical failure to the Motor Bus that may have contributed to the accident.
3. Following the request, I had carried out a physical inspection of the Motor Bus on 24<sup>th</sup> February 2023 at the premises of Traffic Police vehicle pound, 517 Airport Road Singapore 539942. I now set out below my observations and comments with respect to this inspection.

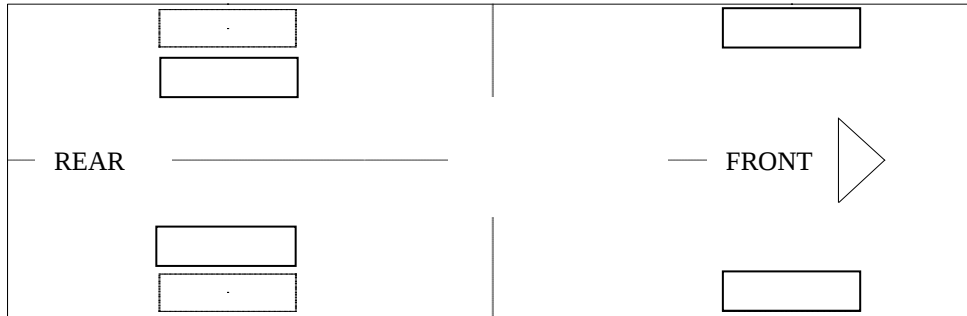
6. The 2 front tyres and 4 rear tyres of the Motor Bus were observed to be in serviceable condition and sufficiently inflated for vehicular operation. I did not find any tear, cut or burst mark(s) on the outer and the inner sidewalls as well as across the tread of the 6 tyres. The tyre brand, tyre size and remaining tread depth of the 6 tyres of the Motor Bus were recorded as follows:-

Bridgestone 275/70R22.5 (13.7mm)

Bridgestone 275/70R22.5 (12.3mm)

Bridgestone 275/70R22.5 (8mm)

Bridgestone 275/70R22.5 (14.1mm)

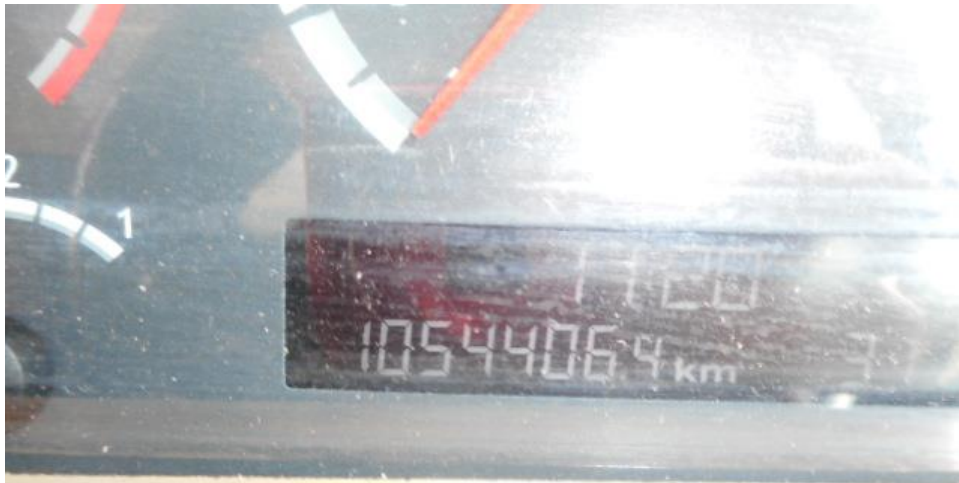
**Photo 1** shows a general view of the instrument cluster of the Motor Bus at the time of my inspection. The mileage of the Motor Bus was 1,054,406km

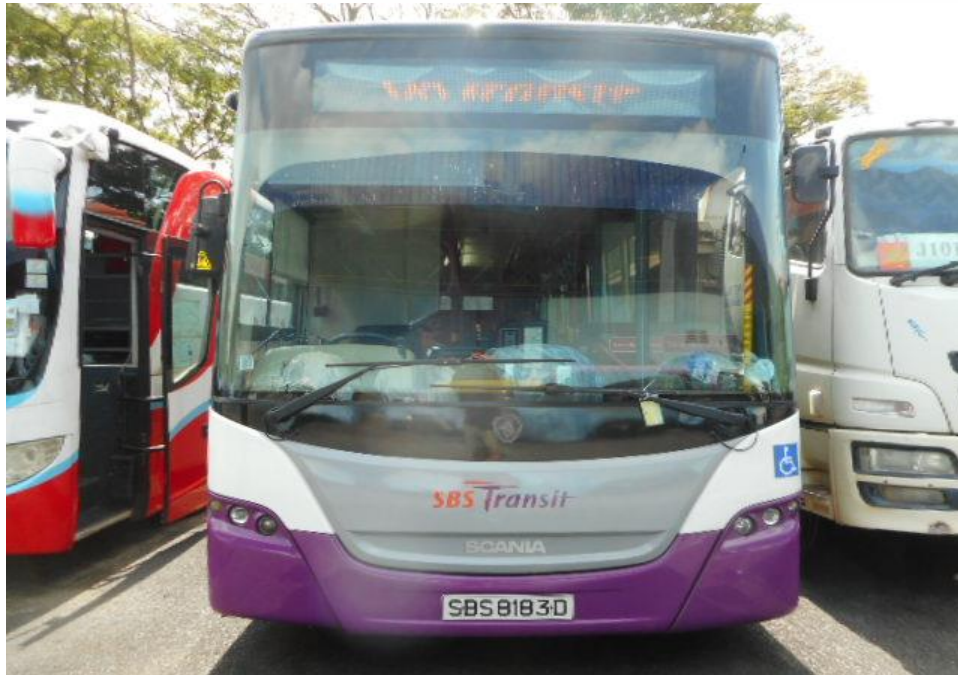
4. The mileage of the Motor Bus at the time of my inspection was 1,054,406km.
5. The Motor Bus was observed to have sustained damage at its front portion. Its front windscreen was the body part that were damaged at the time of inspection.

**Photo 2** shows a general view of the front body of the Motor Bus at the time of my inspection. The Motor Bus was observed to have sustained damages at its front windscreen was observed to be damaged at time of our inspection.

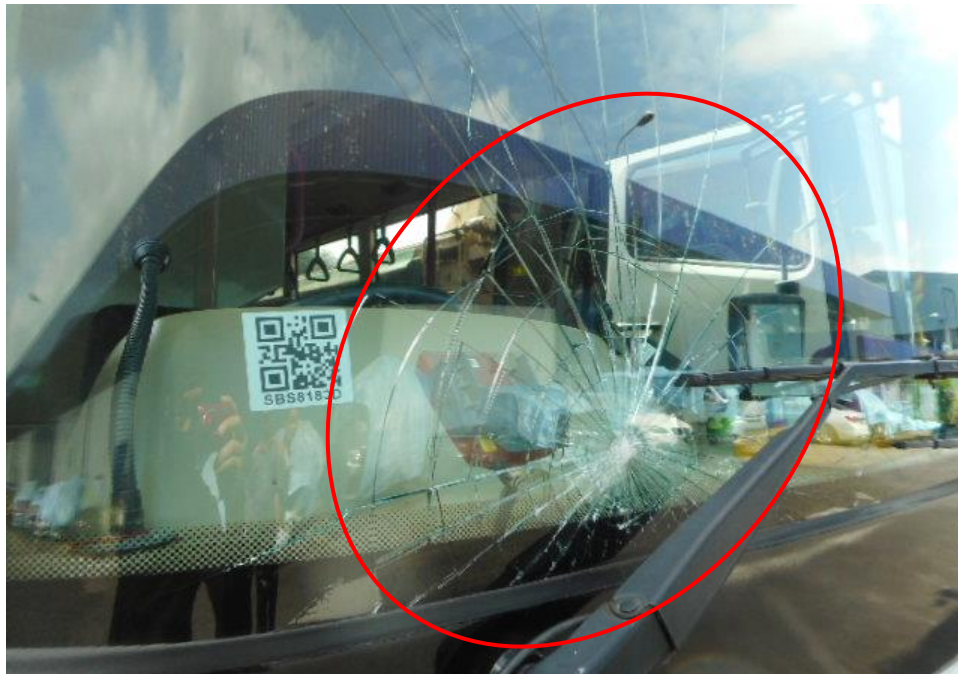
**Photo 3** shows a close up view of the front body of the Motor Bus at the time of my inspection. The Motor Bus was observed to have sustained damages at its front windscreen was observed to be damaged at time of our inspection.

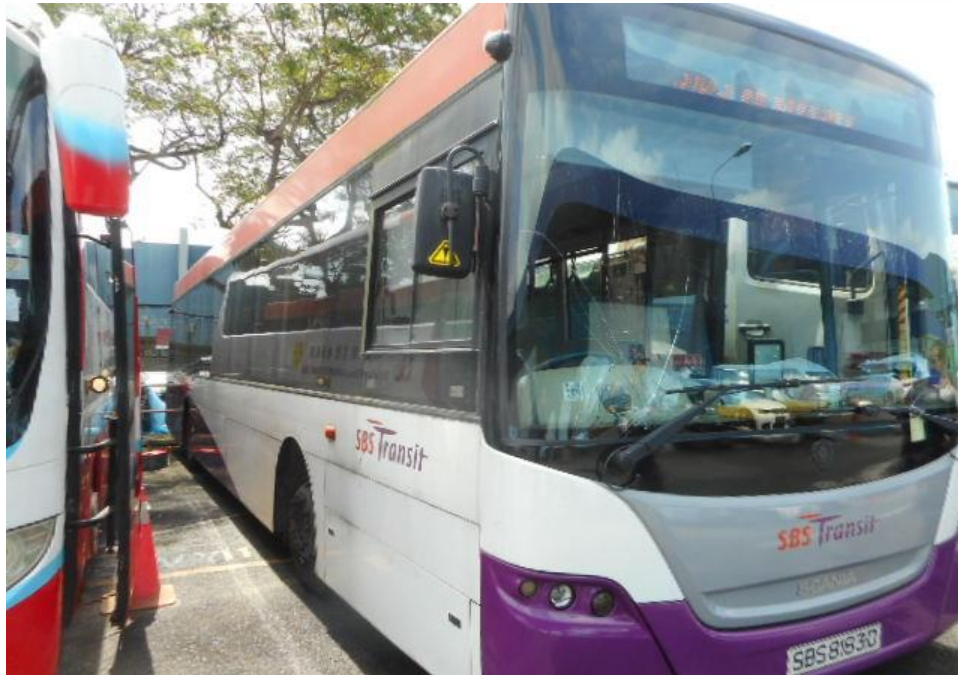
**Photo 4** shows a general view of the right body of the Motor Bus at the time of my inspection. The Motor Bus was observed to be intact and unaffected by the accident.

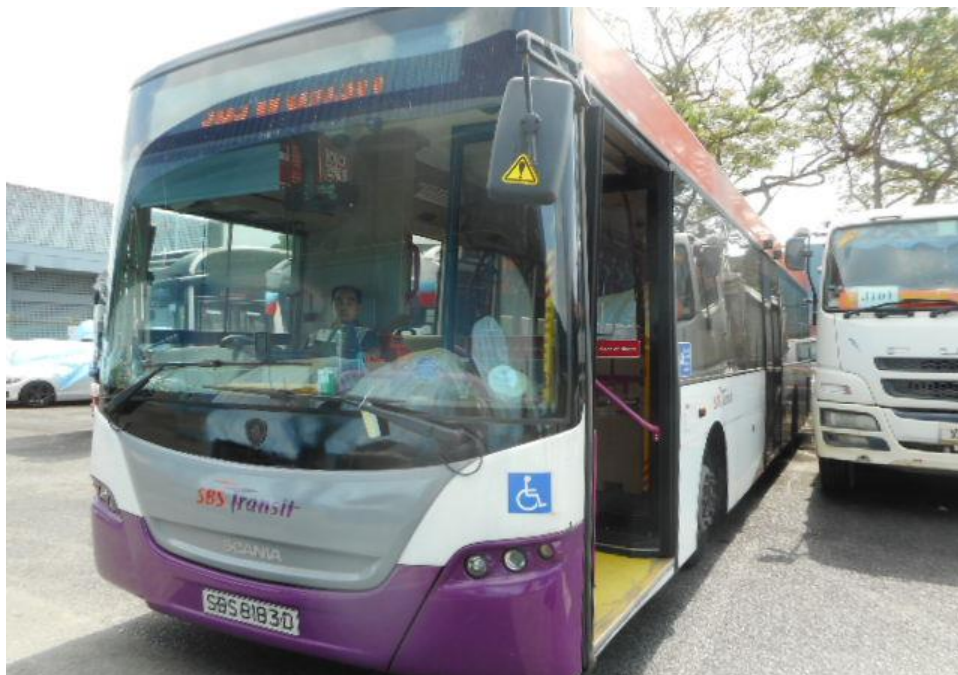
**Photo 5** shows a general view of the left body of the Motor Bus at the time of my inspection. The Motor Bus was observed to be intact and unaffected by the accident.

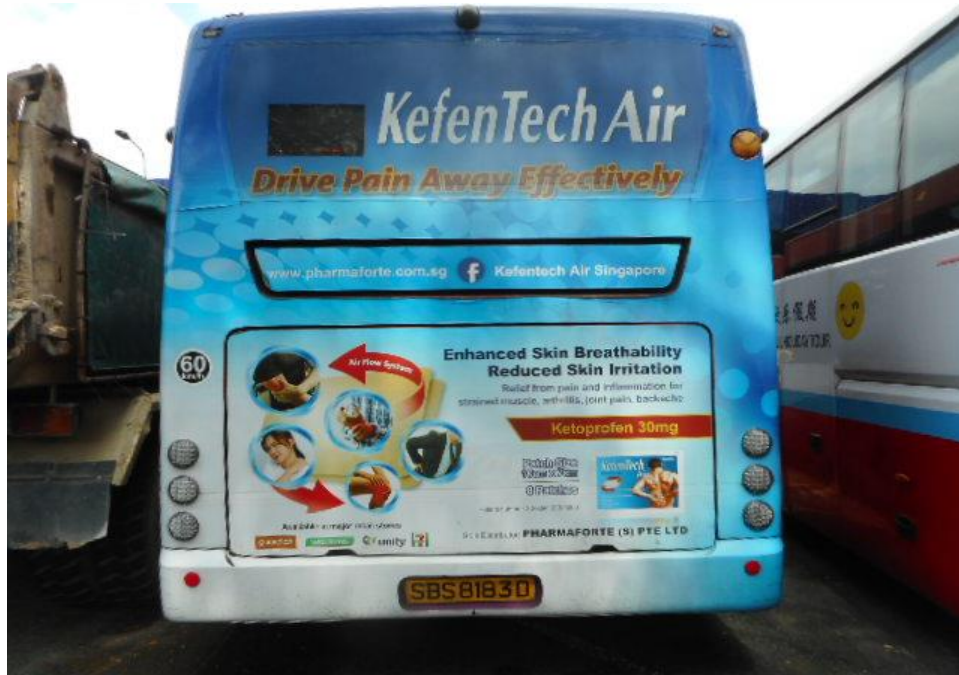
**Photo 6** shows a general view of the rear body of the Motor Bus at the time of my inspection. The Motor Bus was observed to be intact and unaffected by the accident.

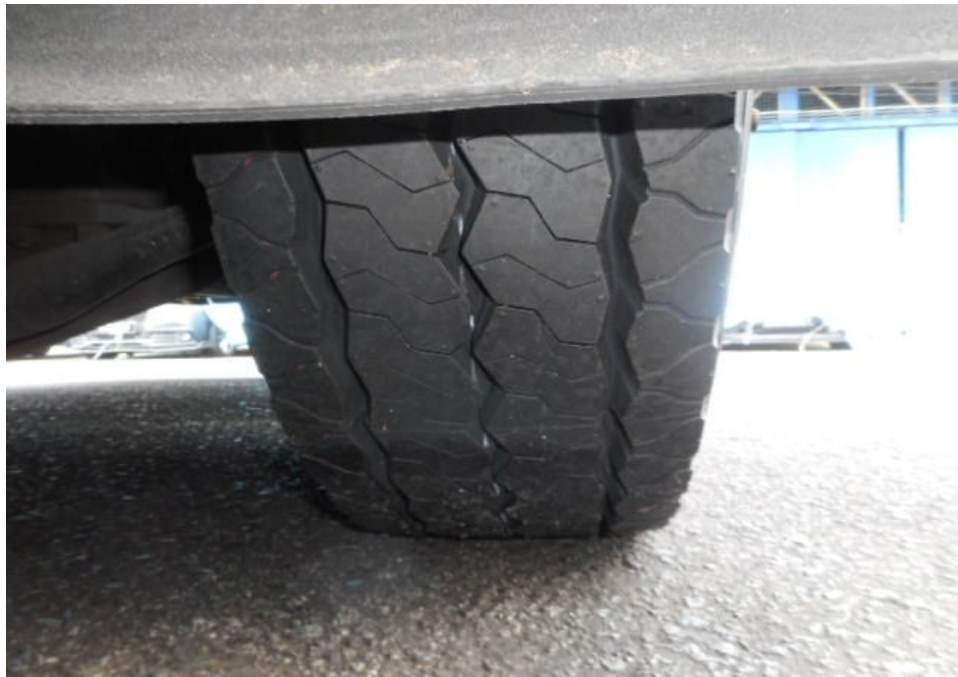
**Photo 7** shows the condition of the front right tyre of the Motor Bus, which was observed to be in serviceable condition with remaining tread depth of approximately 14.1mm. The tyre, which was wrapped around standard steel wheel rim, was also observed to be sufficiently inflated for vehicular operation. There was no tear, cut or burst mark(s) on the outer and the inner sidewalls as well as across the tread of the 6 tyres that were fitted on the Motor Bus.

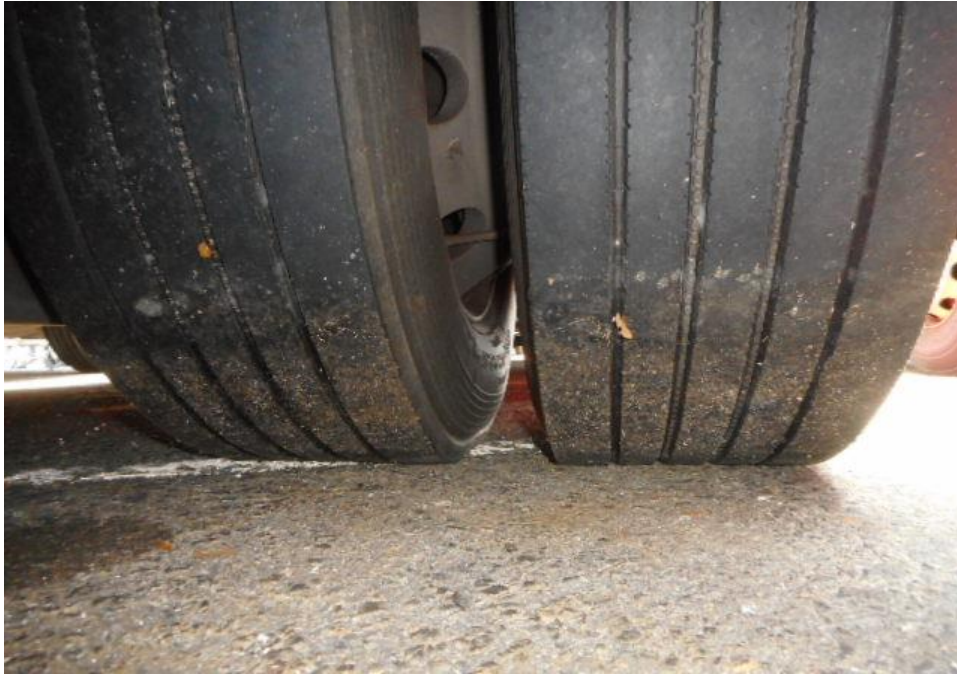
**Photo 8** shows the condition of the rear right tyre of the Motor Bus, which was observed to be in serviceable condition with remaining tread depth of approximately 8mm. The tyre, which was wrapped around standard steel wheel rim, was also observed to be sufficiently inflated for vehicular operation.

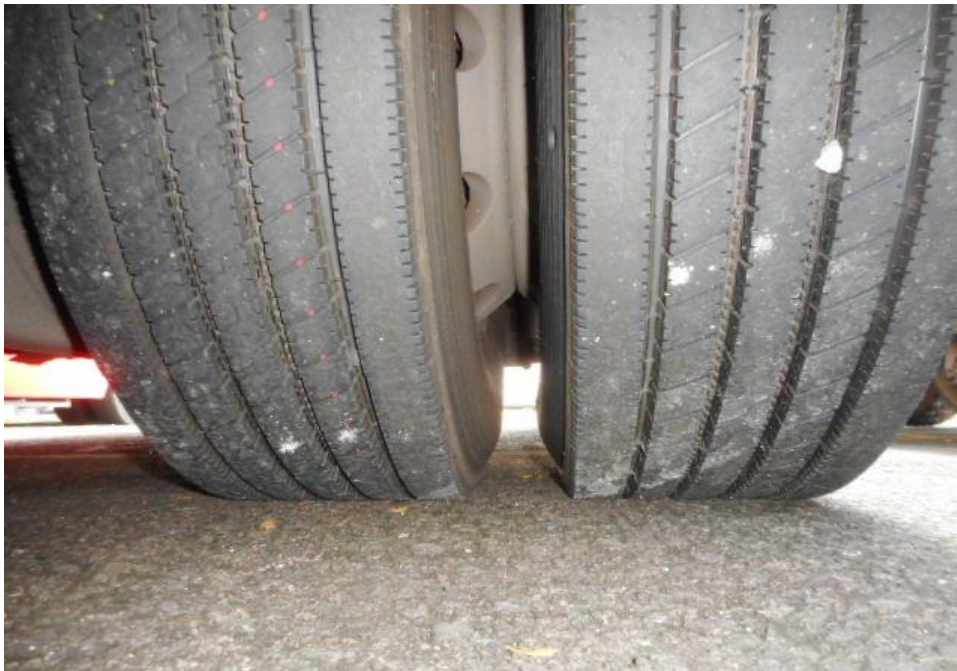
**Photo 9** shows the condition of the rear left tyres of the Motor Bus, which was observed to be in serviceable condition with remaining tread depth of approximately 13.7mm. The tyres, which were wrapped around standard steel wheel rim, were also observed to be sufficiently inflated for vehicular operation. There was also no damage found on all 6 steel wheel rims of the Motor Bus.

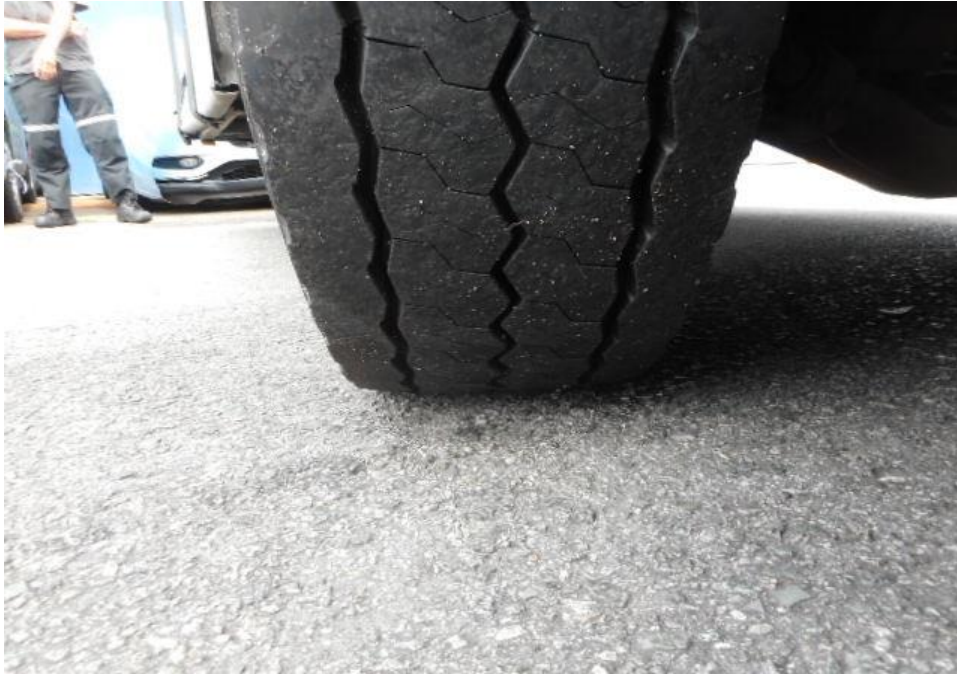
**Photo 10** shows the condition of the front left tyres of the Motor Bus, which were observed to be in serviceable condition with remaining tread depth of approximately 12.3mm. There was also no tear, cut or burst mark(s) on the outer and the inner sidewalls as well as across the tread of the 6 tyres that were fitted on the Motor Bus.

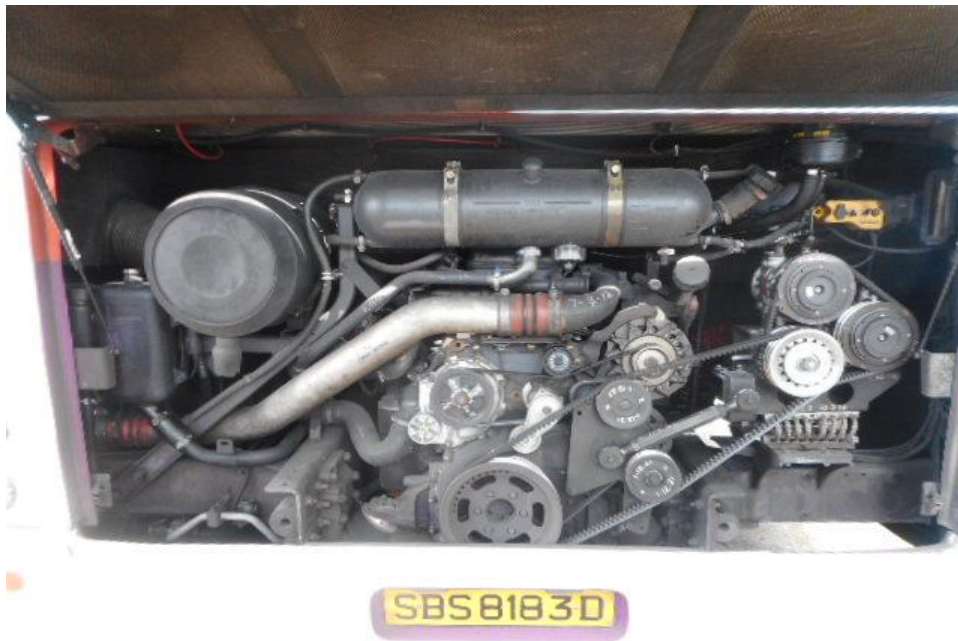
**Photo 11** shows a general view of the Motor Bus's engine compartment, which was accessed by lifting the rear of the Motor Bus. The various parts and components inside the engine compartment were unaffected by the accident. There was also no sign(s) or indication(s) of fresh fluid leakage and/or fluid stain within the engine compartment

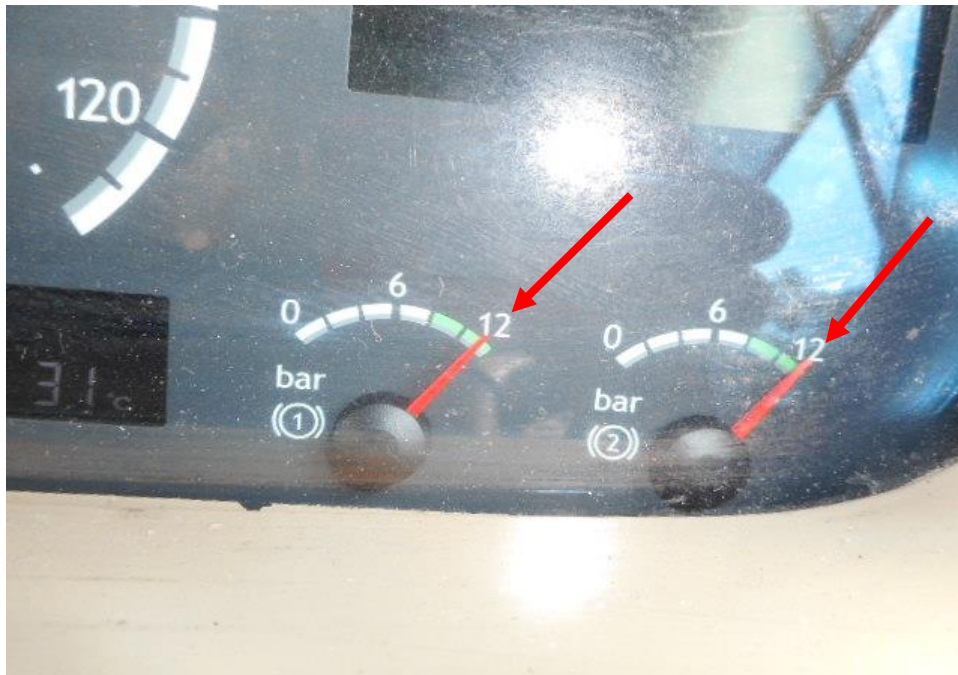
**Photo 12** shows the air in the air brake cylinder of the Motor Bus at the time of my inspection. The air in the cylinder was observed to be of sufficient level & serviceable at the time of the accident.

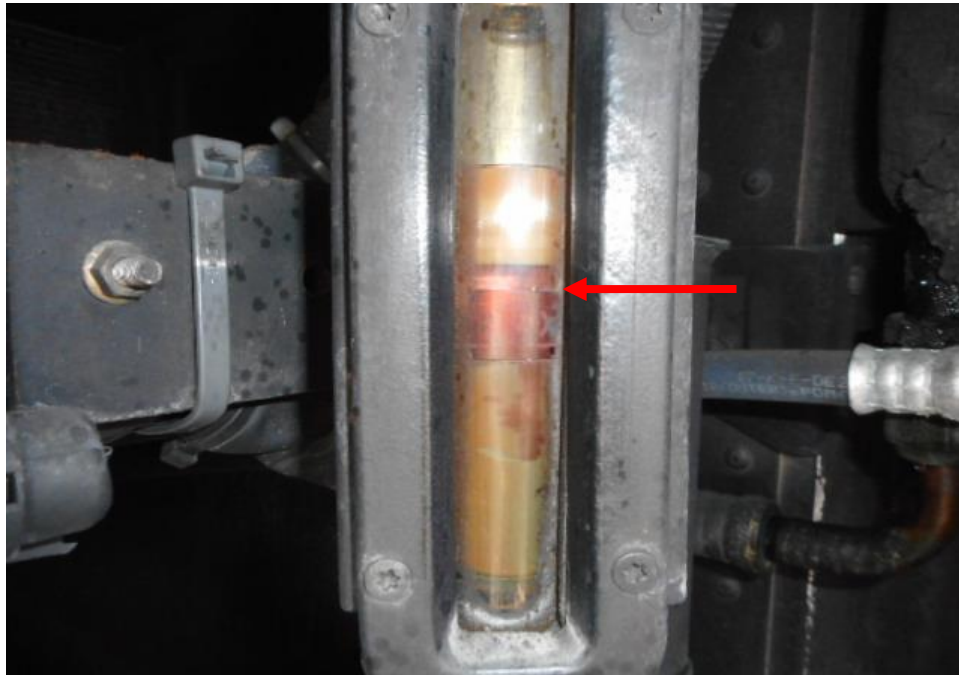
**Photo 13** shows the engine coolant reservoir of the Motor Bus at the time of my inspection. The engine coolant was observed to be of sufficient level (arrowed) and without any visible contamination.

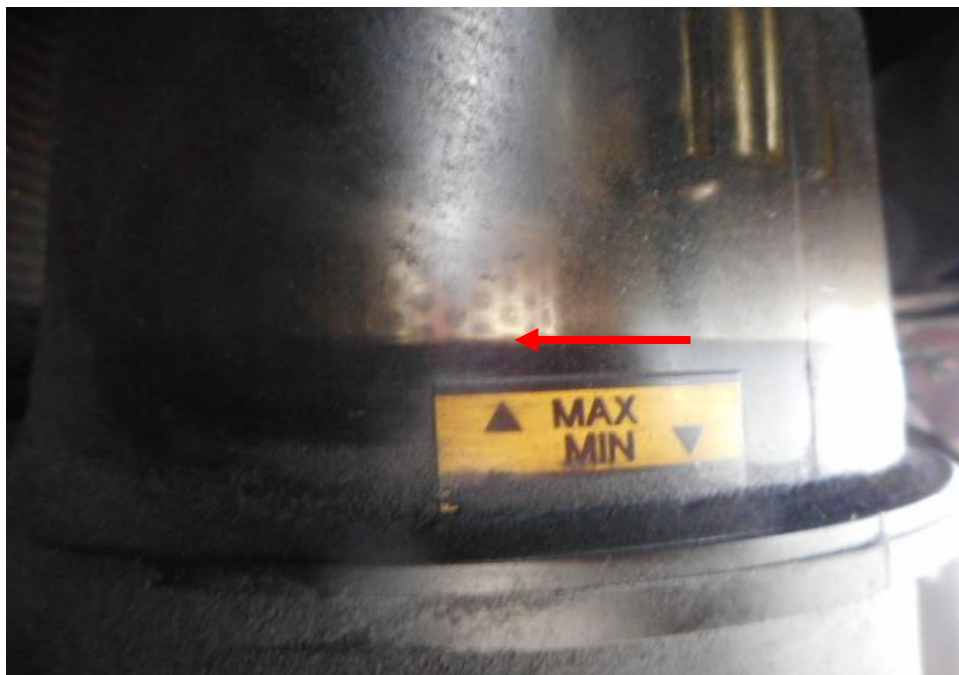
**Photo 14** shows the power steering fluid reservoir of the Motor Bus at the time of my inspection. The power steering fluid was observed to be of sufficient level and without any visible contamination.

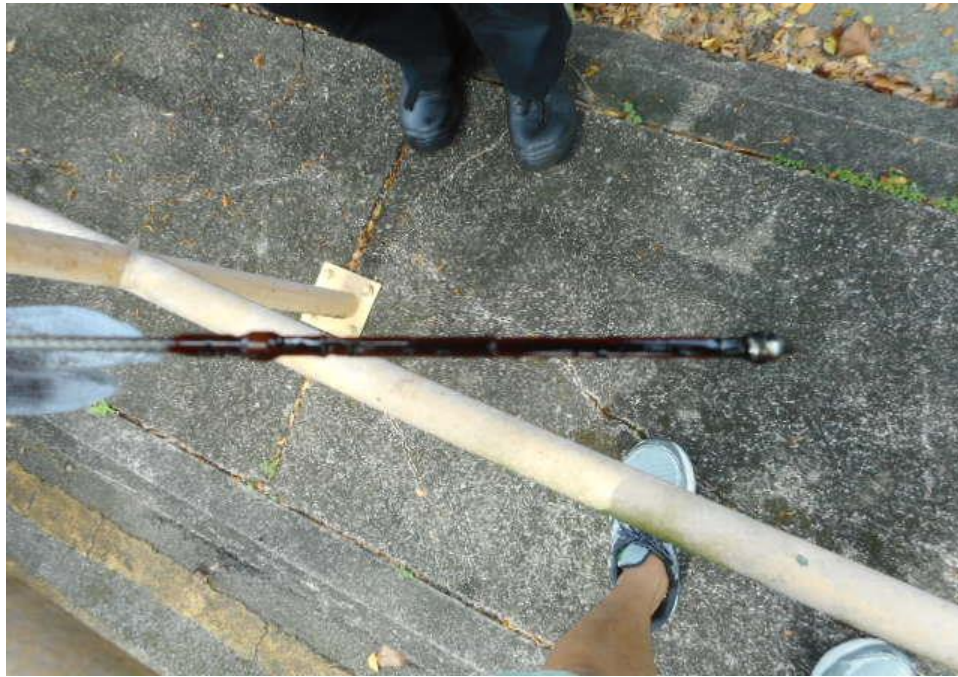
**Photo 15** shows the engine oil dip stick system of the Motor Bus at the time of my inspection. The engine oil was observed to be sufficient for operation and without any visible contamination.

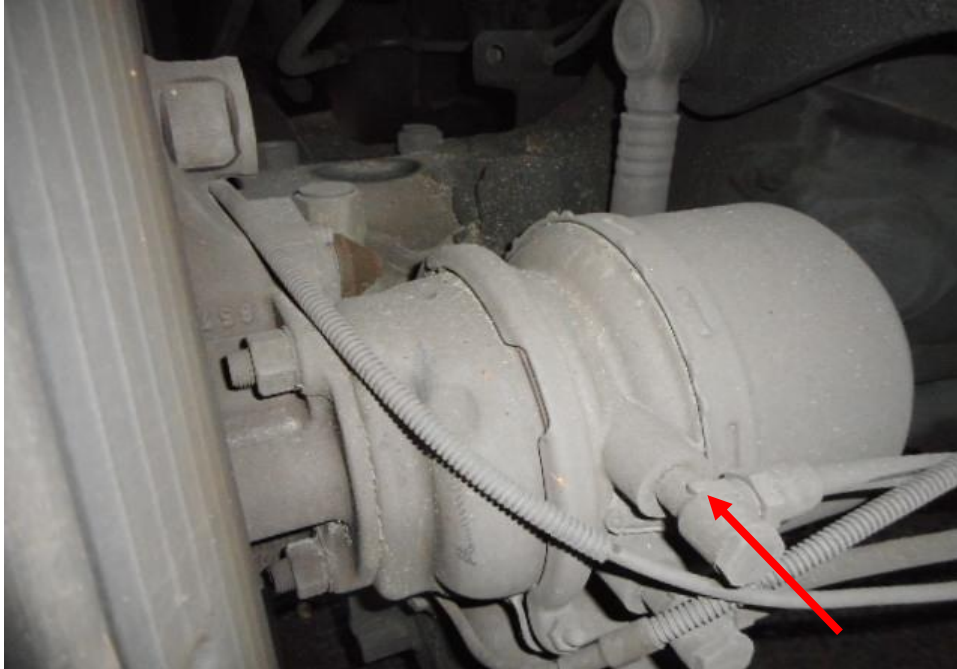
**Photo 16** shows the brake pipe (arrowed) at the rear right wheel of the Motor Bus. I did not observe any leakage of brake fluid at the time of my inspection of the Motor Bus. My static tests of the Motor Bus's braking system, along with my visual examination of the various mechanical components in the braking system, had indicated that there was no internal leakage of pressure/vacuum. Hence the braking system of the Motor Bus was likely to be in serviceable condition at the material time of accident.

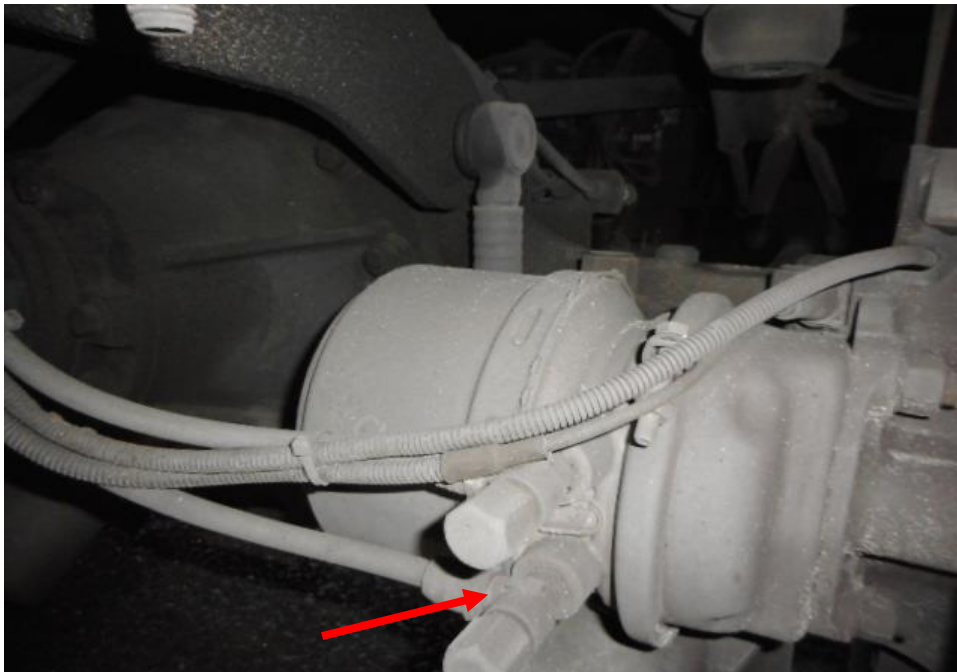
**Photo 17** shows the brake pipe (arrowed) at the rear left wheel of the Motor Bus. I did not observe any leakage of brake fluid at the time of my inspection of the Motor Bus. My static tests of the Motor Bus's braking system, along with my visual examination of the various mechanical components in the braking system, had indicated that there was no internal leakage of pressure/vacuum. Hence the braking system of the Motor Bus was likely to be in serviceable condition at the material time of accident.

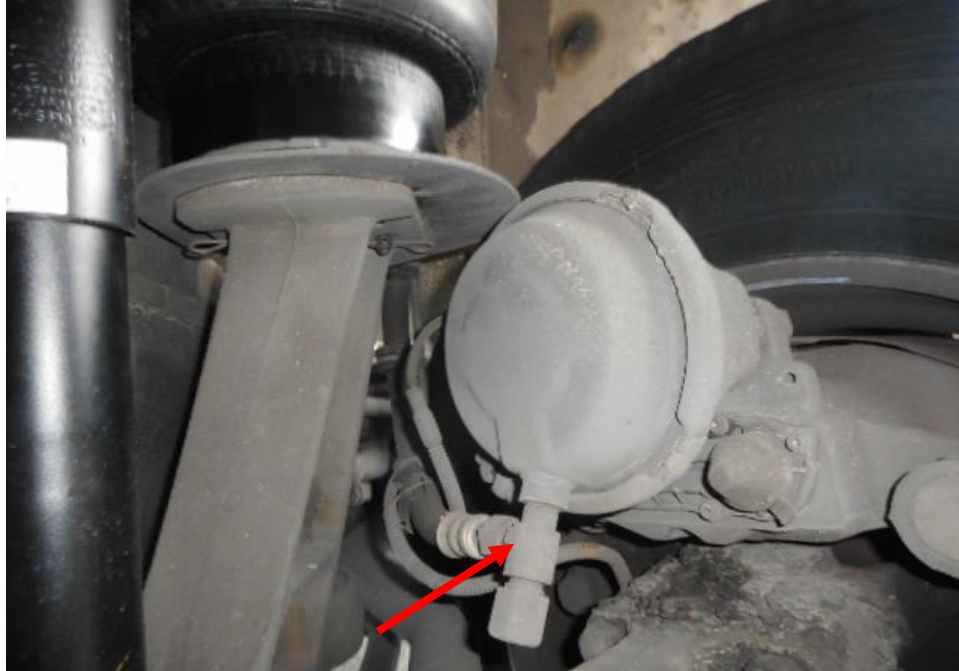
**Photo 18** shows the brake pipe (arrowed) at the front right wheel of the Motor Bus. I did not observe any leakage of brake fluid at the time of my inspection of the Motor Bus. My static tests of the Motor Bus's braking system, along with my visual examination of the various mechanical components in the braking system, had indicated that there was no internal leakage of pressure/vacuum. Hence the braking system of the Motor Bus was likely to be in serviceable condition at the material time of accident.

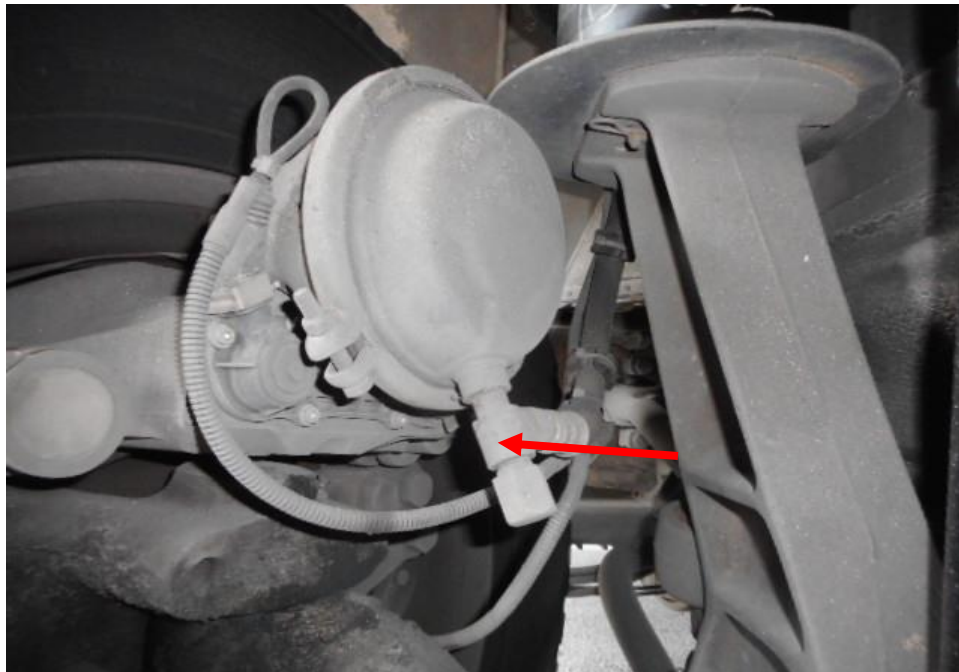
**Photo 19** shows the brake pipe (arrowed) at the front left wheel of the Motor Bus. I did not observe any leakage of brake fluid at the time of my inspection of the Motor Bus. My static tests of the Motor Bus's braking system, along with my visual examination of the various mechanical components in the braking system had indicated that there was no internal leakage of pressure/vacuum. Hence the braking system of the Motor Bus was likely to be in serviceable condition at the material time of accident.

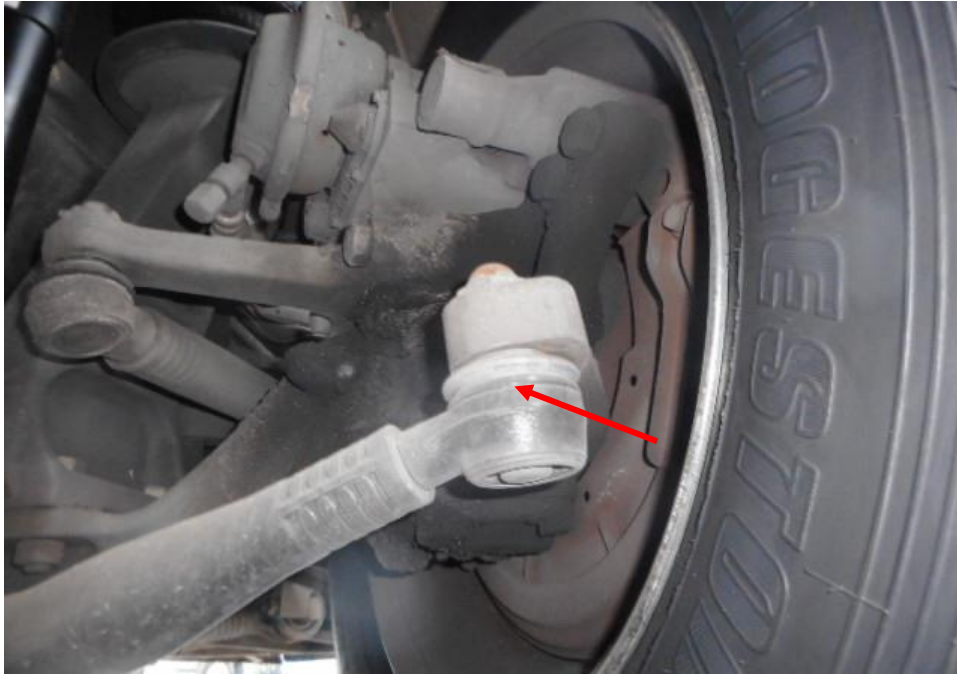
**Photo 20** shows the various undercarriage components at the front right wheel of the Motor Bus, in particular the steering tie rod end (arrowed). The various steering components were all found to be intact, suggesting that the steering system of the Motor Bus was likely to be in serviceable condition at the material time of accident. There was also no sign of fluid stain(s) observed on the various undercarriage components.

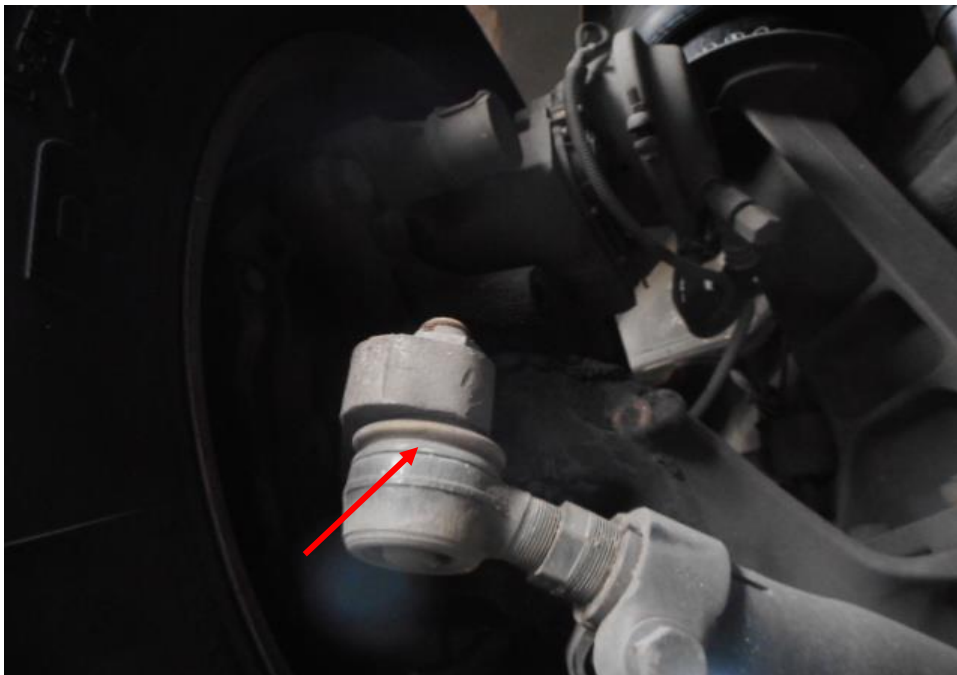
**Photo 21** shows the various undercarriage components at the front left wheel of the Motor Bus, in particular the steering tie rod end (arrowed). The various undercarriage components of the Motor Bus were all found to be intact without any visible damage. There was also no sign of fluid stain(s) observed on the various undercarriage components.

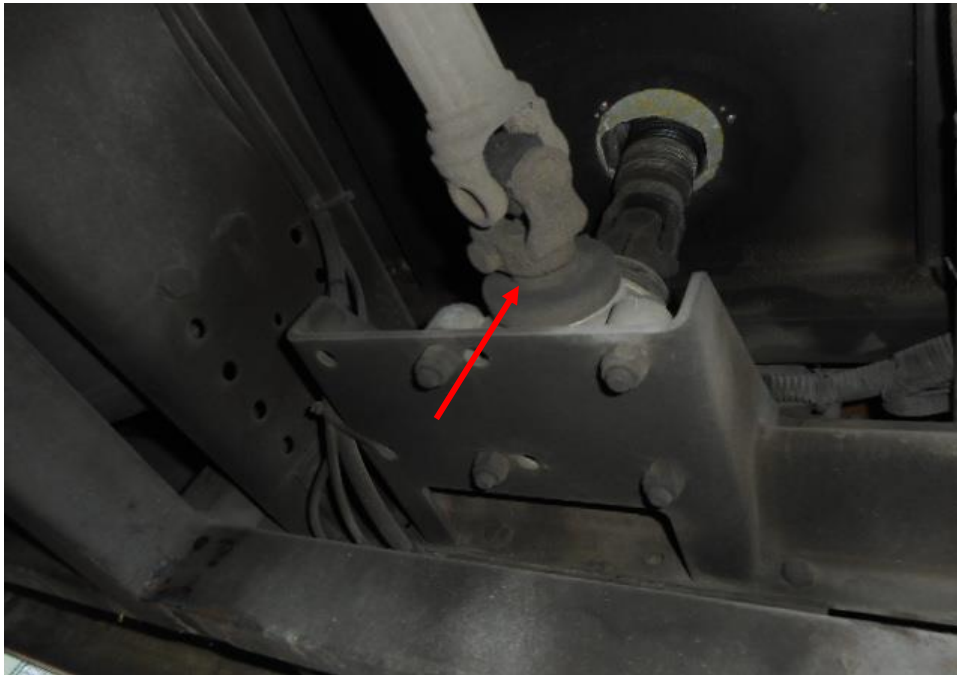
**Photo 22** shows the steering box component (arrowed) at the undercarriage of the Motor Bus was found to be intact without any visible damage. There was also no sign of fluid stain(s) observed on the various undercarriage components.

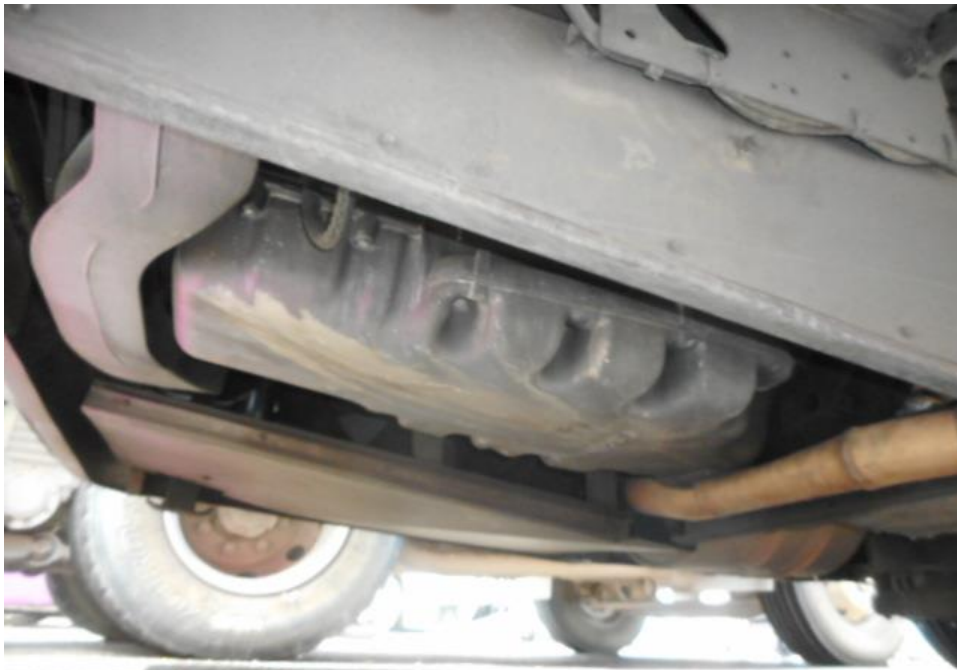
**Photo 23** shows the undercarriage of the Motor Bus, at the area where the engine housing and transmission housing are located. I did not find any sign(s) or indication(s) of fluid leak and/or fluid stain(s) on the underside of the Motor Bus.

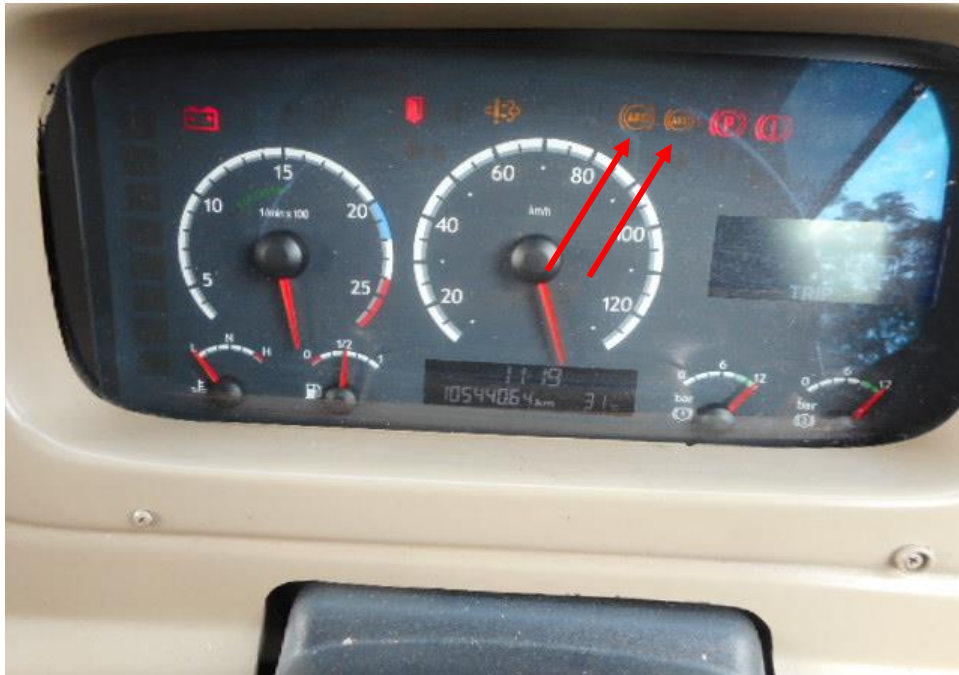
**Photo 25** shows the warning light for Anti-Lock Braking System (ABS) and Anti-Slip Regulation (ASR) appearing on the instrument panel of the Motor Bus during the self-test of its various electronic operating systems when its engine was cranked.

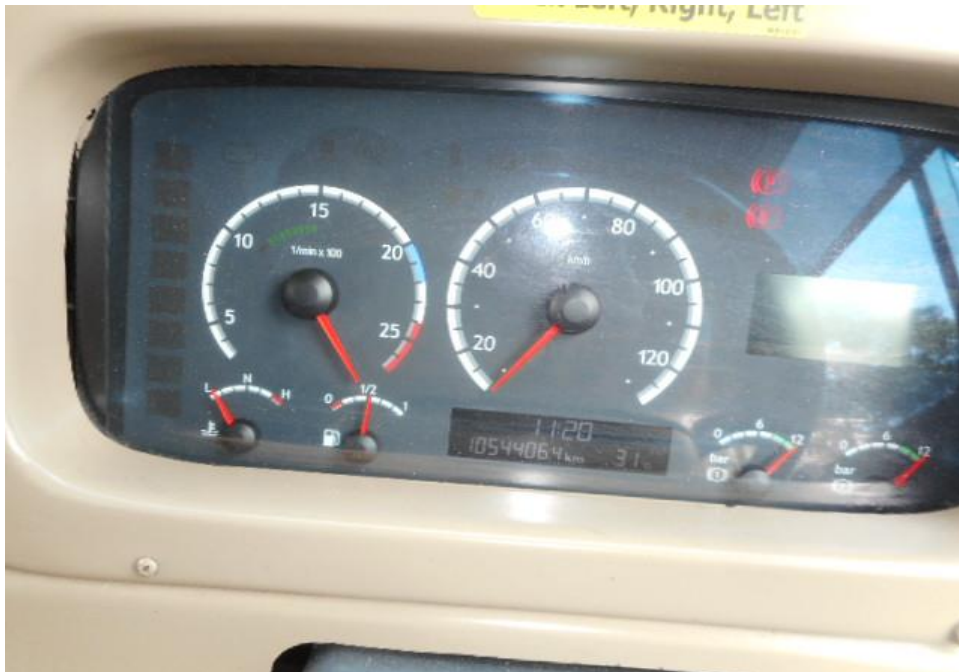
**Photo 26** shows no warning lights illuminated on the instrument panel of the Motor Bus after the engine was cranked. This would suggest that there was no abnormality to the various electronic operating systems of the Motor Bus, like the ABS, ASR and etc.
