Your Ref: TP/IP/02096/2023
Our Ref : CI/TPD23001587/P

Fatal Accident Investigation Team

MECHANICAL INSPECTION REPORT OF MOTOR CAR SLU 5837S

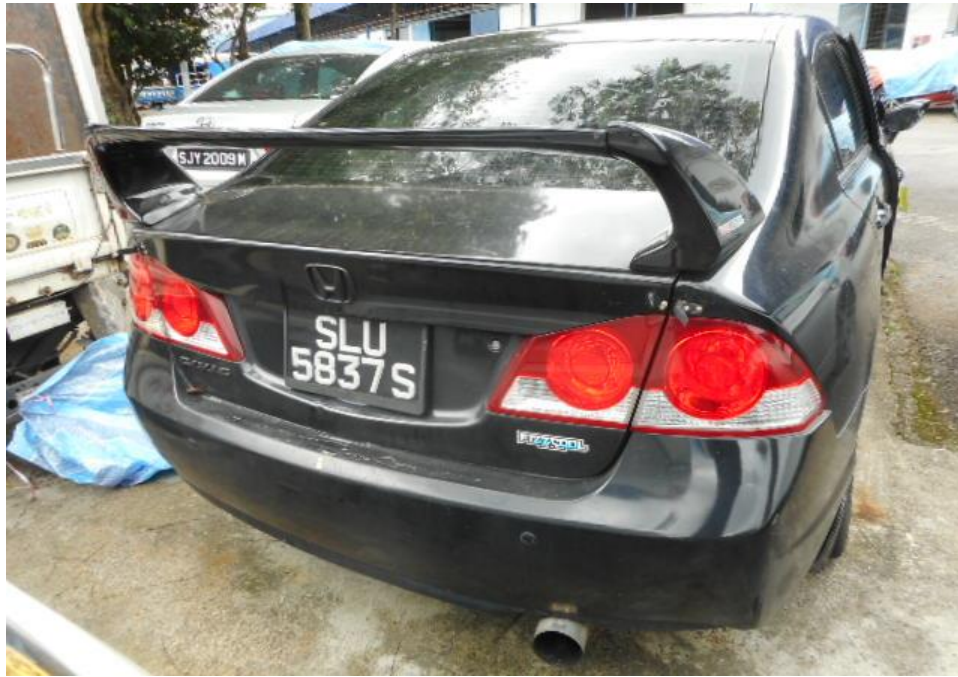
Photo 1 shows a general view of the Motor Car's rear body at the time of my inspection. The rear portion of the Motor Car was observed to have been undamaged by the accident.

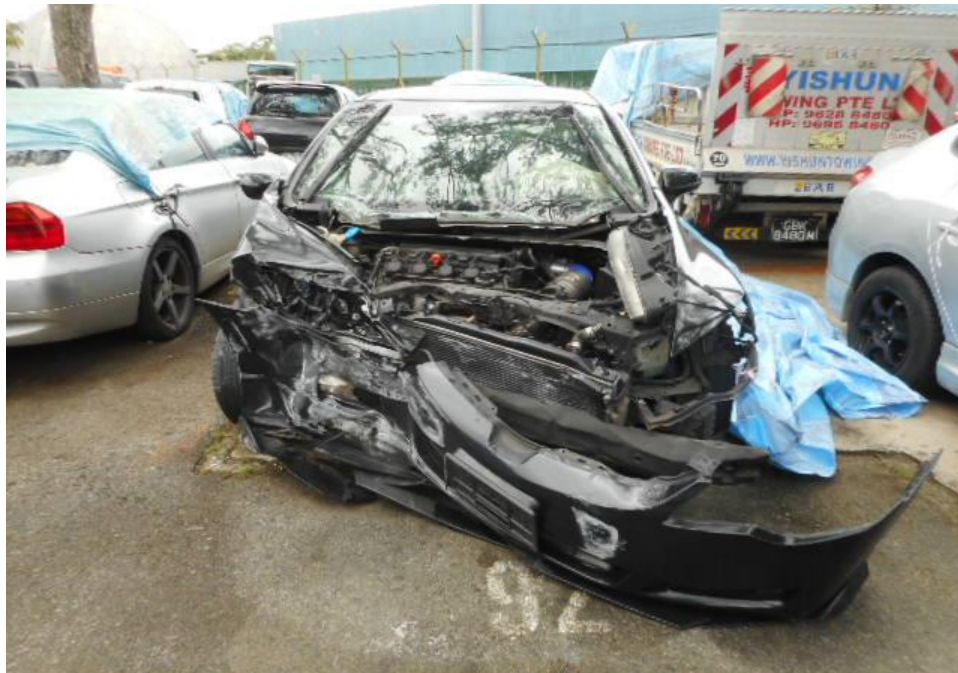
4. The mileage of the Motor car was not recorded as the engine and ignition system of the Motor Car was damaged as a result of the accident.
5. The Motor car was observed to have sustained damage at its front portion. Its front windscreen, front bumper, both front fender and both front headlamp was amongst the body parts and various engine components were also damaged as a result of the accident. The Supplemental Restraint System (SRS) was activated as a result of the accident.

Photo 2 shows a general view of the Motor Car's front body at the time of my inspection. The Motor car was observed to have sustained damage at its front portion. Its front windscreen, front bumper, both front fender and both front headlamp was amongst the body parts and various engine components were also damaged as a result of the accident. The Supplemental Restraint System (SRS) was activated as a result of the accident.

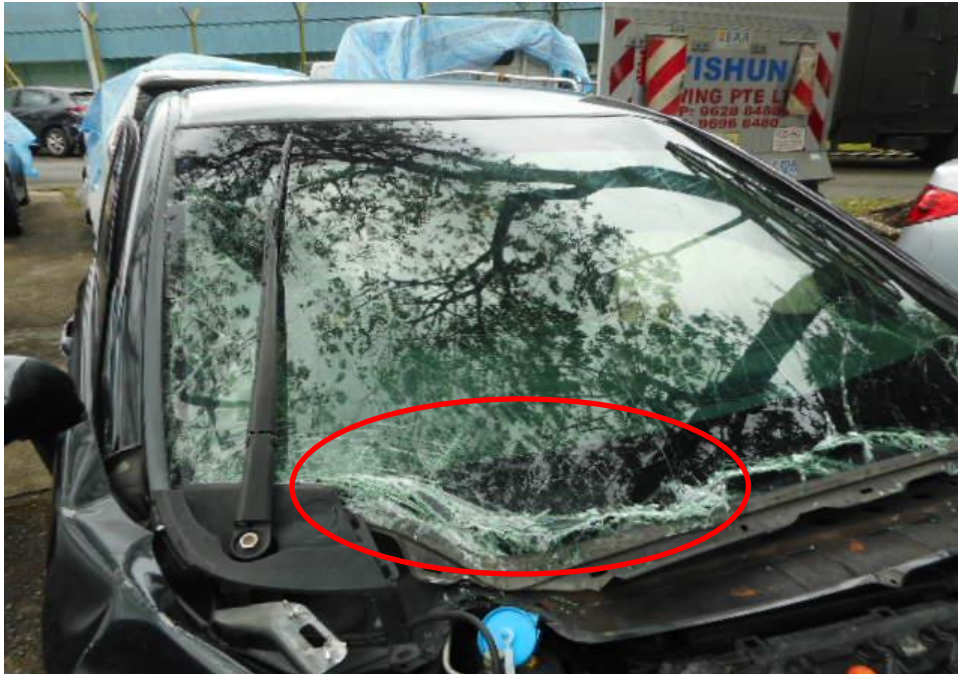
Photo 3 shows the close up view of the Motor Car's front body at the time of my inspection. The Motor car was observed to have sustained damage at its front portion. Its front windscreen (circled) was damaged as a result of the accident.

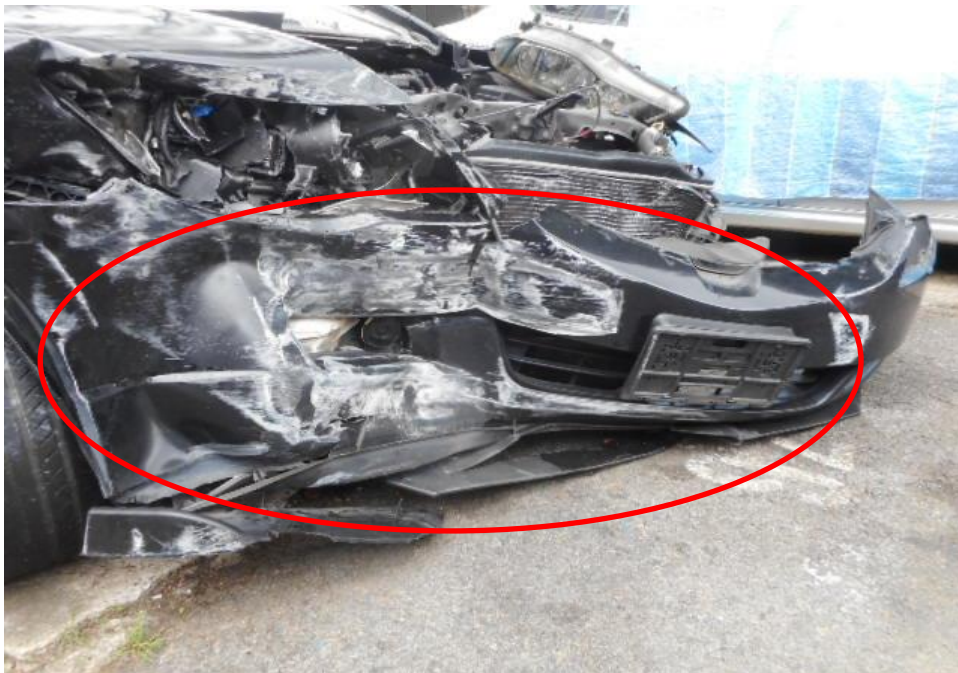
Photo 4 shows the close up view of the Motor Car's front body at the time of my inspection. The Motor car was observed to have sustained damage at its front portion. Its front bumper (circled) was damaged as a result of the accident.

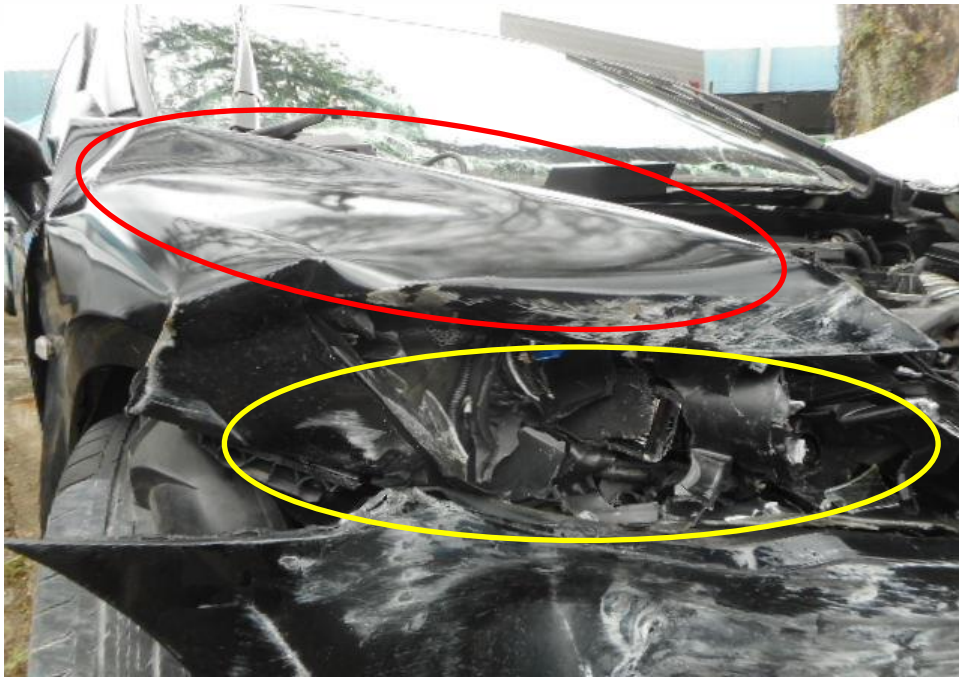
Photo 5 shows the close up view of the Motor Car's front body at the time of my inspection. The Motor car was observed to have sustained damage at its front portion. Its front fender (red circle) and front right headlamp (yellow circle) was damaged as a result of the accident.

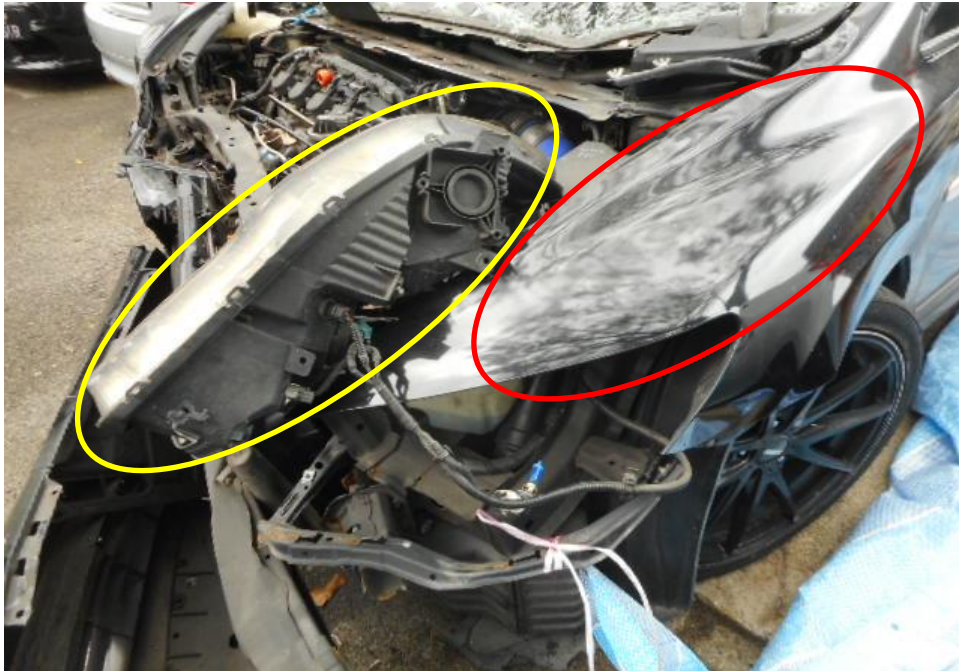
Photo 6 shows the close up view of the Motor Car's front body at the time of my inspection. The Motor car was observed to have sustained damage at its front portion. Its front fender (red circle) and front left headlamp (yellow circle) was damaged as a result of the accident.

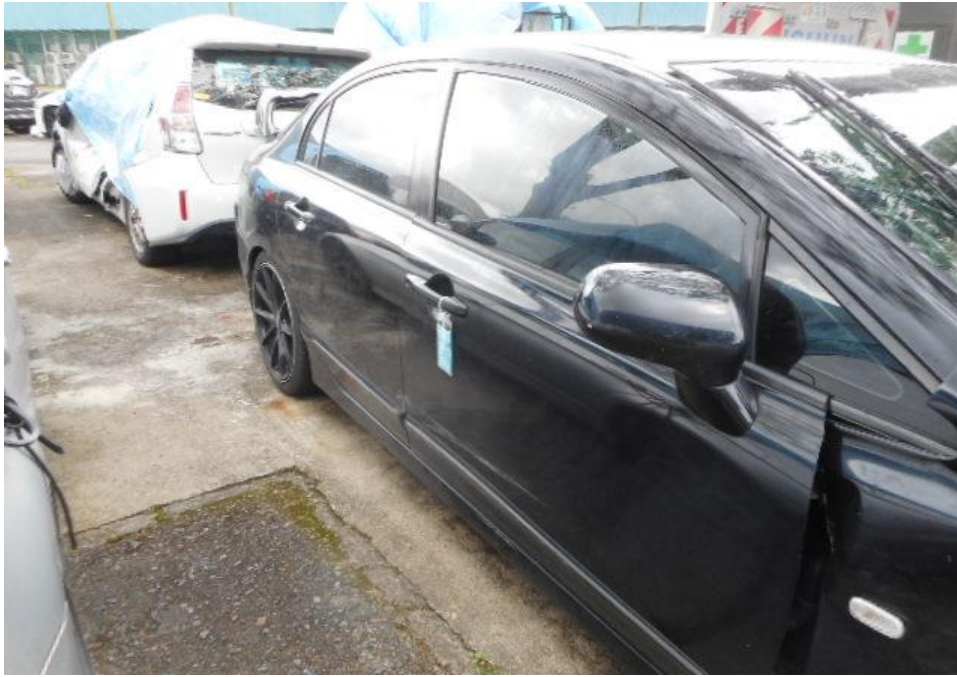
Photo 7 shows a general view of the Motor Car's right body at the time of my inspection. The right portion of the Motor Car was observed to have been undamaged by the accident.

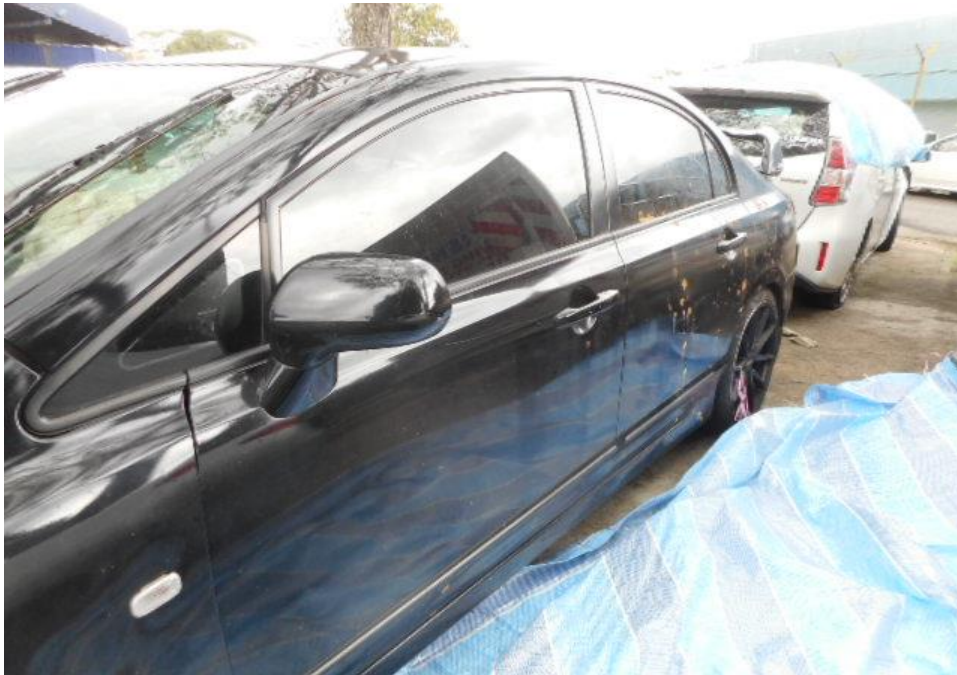
Photo 8 shows a general view of the Motor Car's left body at the time of my inspection. The left portion of the Motor Car was observed to have been undamaged by the accident.

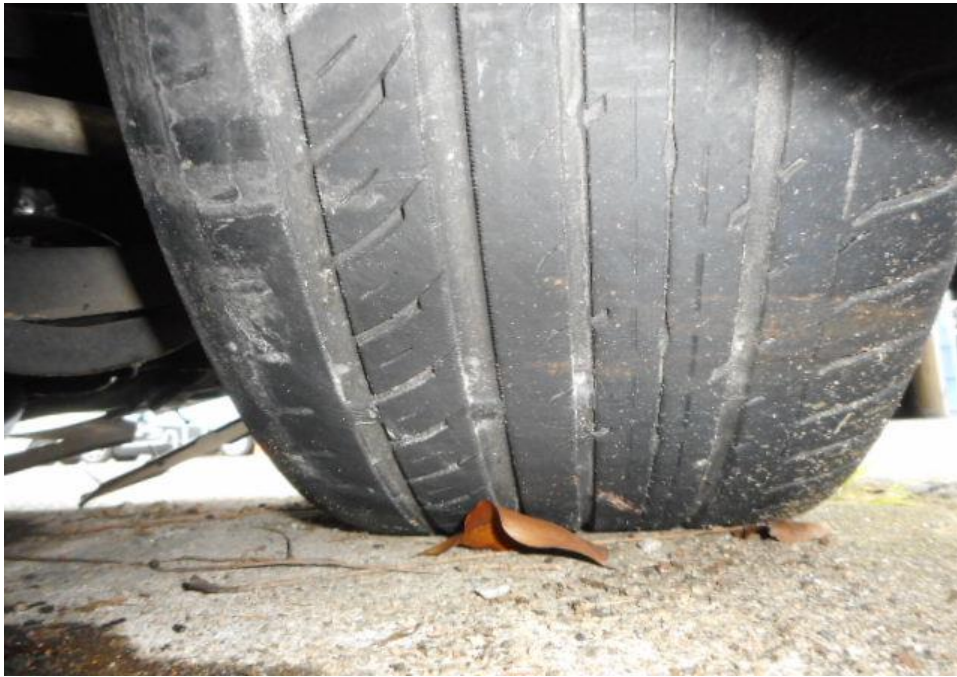
Photo 9 shows the condition of the front right tyre of the Motor Car, which was observed to be in serviceable condition with remaining tread depth of approximately 2.9mm. The tyre, which was wrapped around alloy wheel rim, was also observed to be sufficiently inflated for vehicular operation.

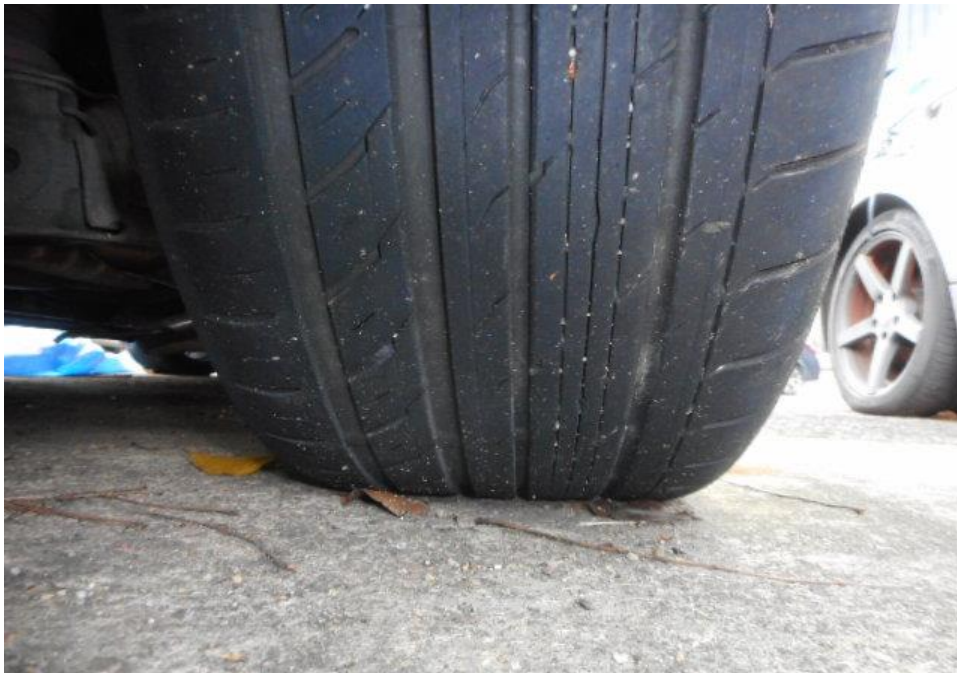
Photo 10 shows the condition of the rear right tyre of the Motor Car, which was observed to be in serviceable condition with remaining tread depth of approximately 5.4mm. The tyre was also observed to be sufficiently inflated for vehicular operation with no tear, cut or burst mark(s).

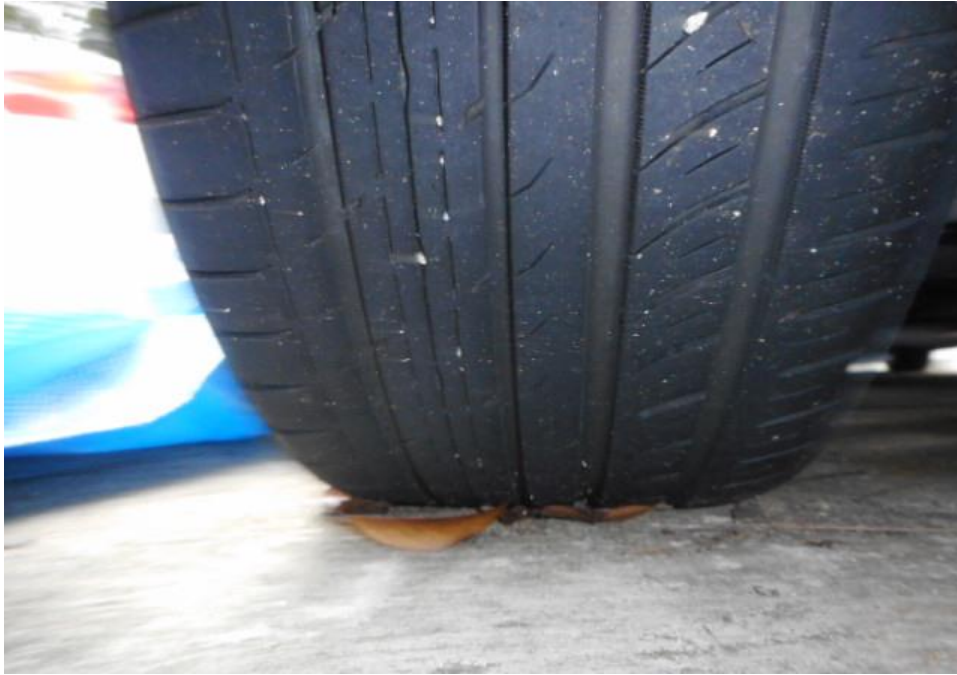
Photo 11 shows the condition of the rear left tyre of the Motor Car, which was observed to be in serviceable condition with remaining tread depth of approximately 4.9mm. The tyre was also observed to be sufficiently inflated for vehicular operation with no tear, cut or burst mark(s).

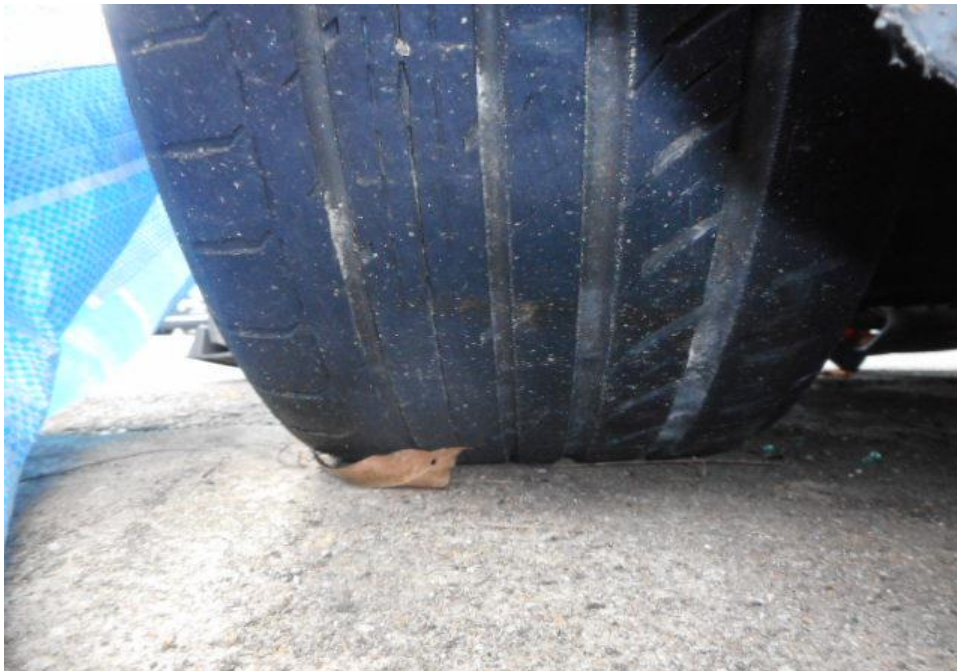
Photo 12 shows the condition of the front left tyre of the Motor Car, which was observed to be in serviceable condition with remaining tread depth of approximately 2.7mm. The tyre was also observed to be sufficiently inflated for vehicular operation with no tear, cut or burst mark(s).

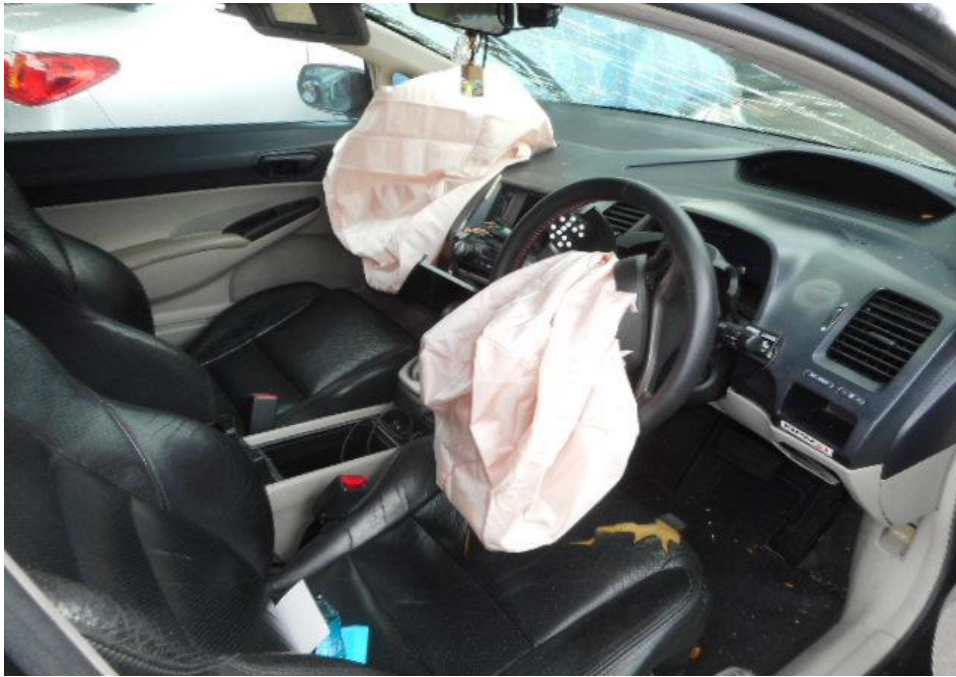
Photo 13 shows the deployment of the Supplemental Restraint System (SRS) airbag in the Motor Car as a result of the accident.

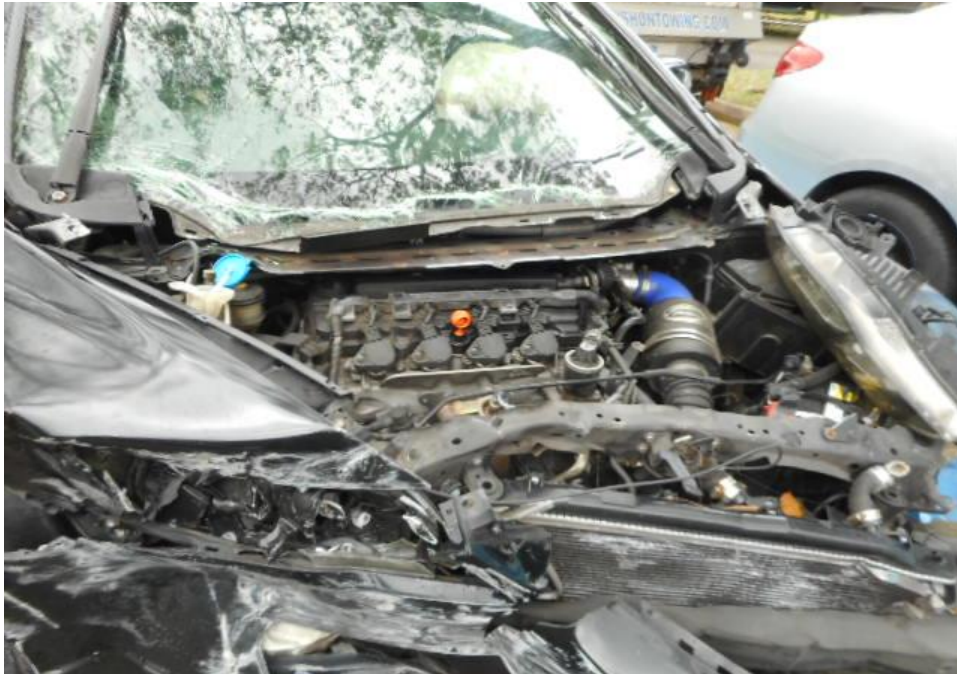
Photo 14 shows a general view of the Motor Car's engine compartment. The various parts and components inside the engine compartment were observed that the engine and ignition system was damaged as a result of the induced impact from the accident.

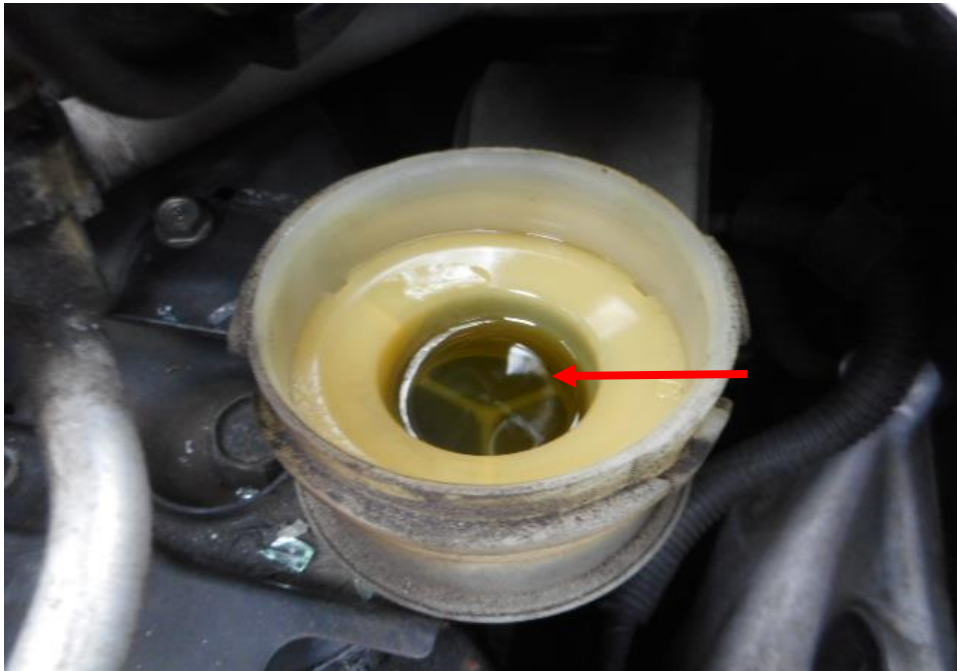
Photo 15 shows the brake fluid reservoir of the Motor Car at the time of my inspection. The brake fluid was observed to be of sufficient level (arrowed) and without any visible contamination.

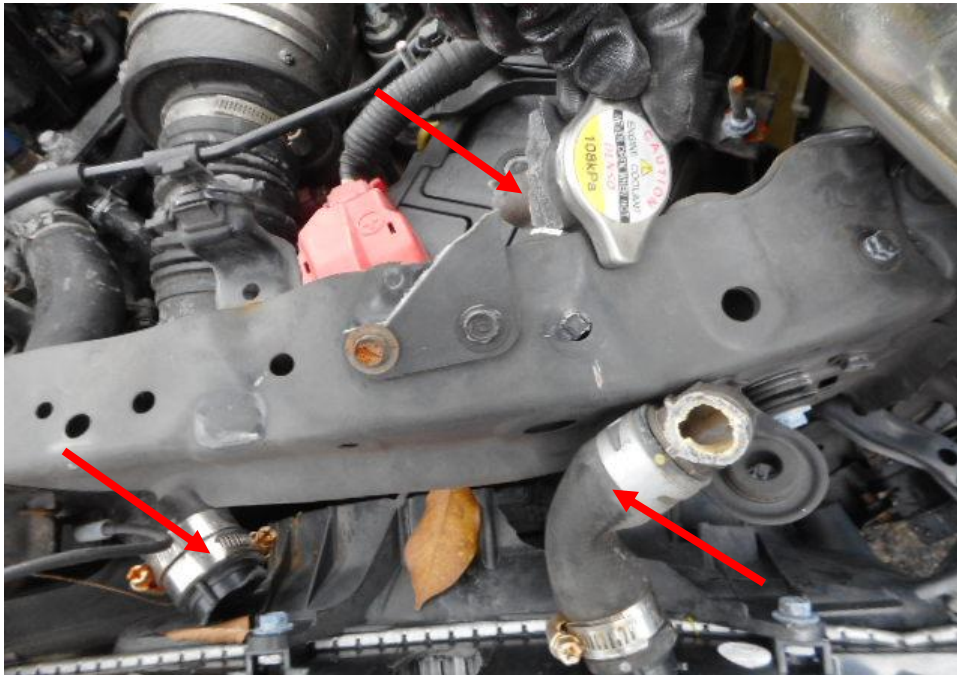
Photo 16 shows checks being carried out to the engine coolant of the Motor Car at the time of my inspection. The engine coolant was observed to be of insufficient level due to the damage sustained to the coolant hoses (arrowed) as a result of the accident.

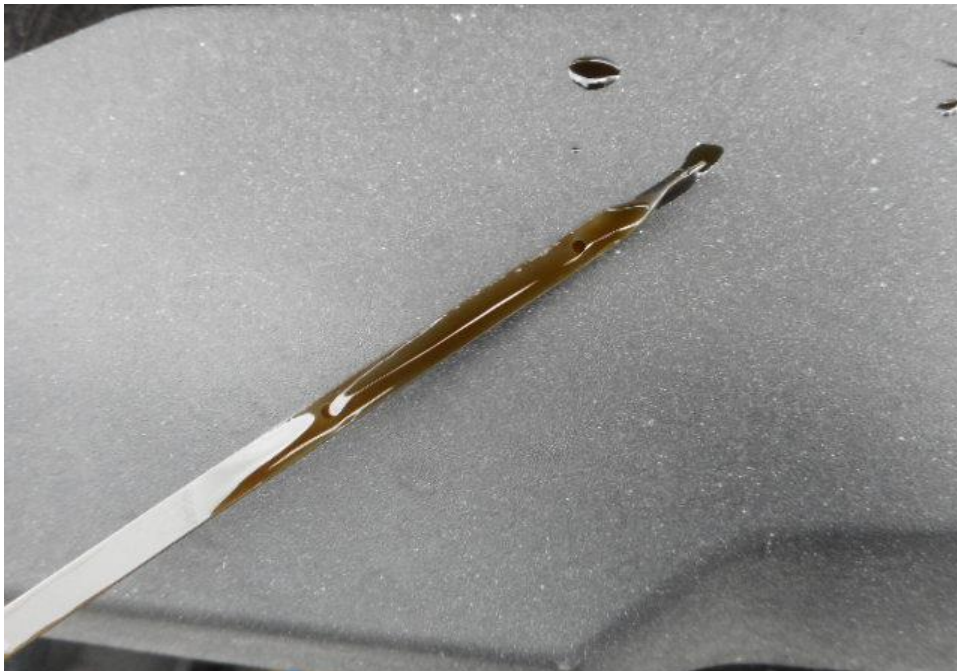
Photo 17 shows the engine oil dipstick of the Motor Car at the time of my inspection. The engine oil was observed to be of sufficient level and without any visible contamination.

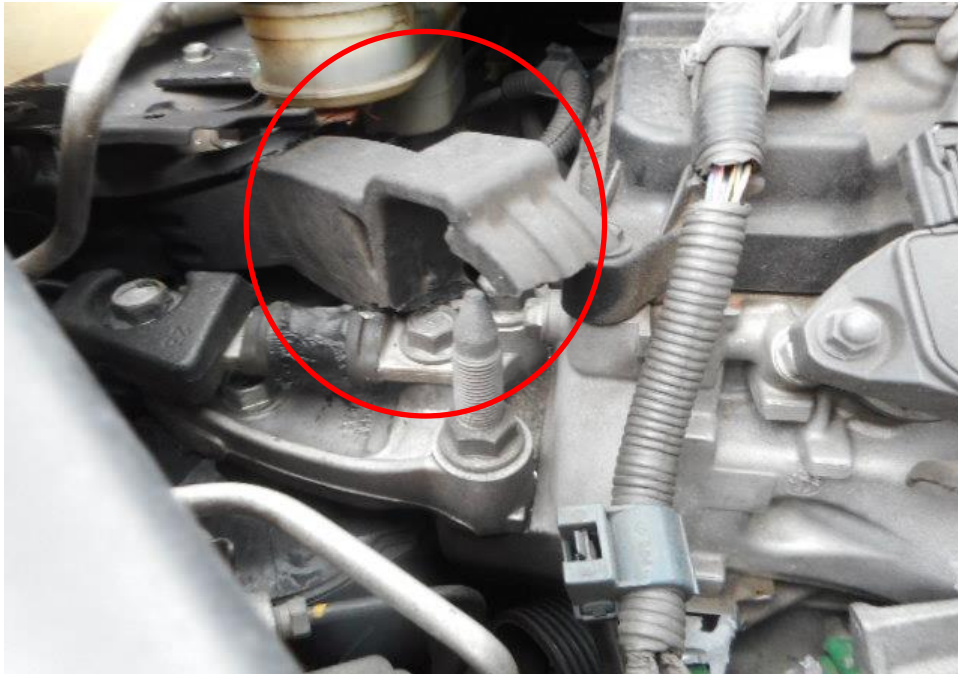
Photo 18 shows the close up view of the Motor Car's front body at the time of my inspection. The Motor car was observed to have sustained damage at its front portion. Its engine mounting (circled) was amongst the various components in the engine compartments were also damaged as a result of the accident.

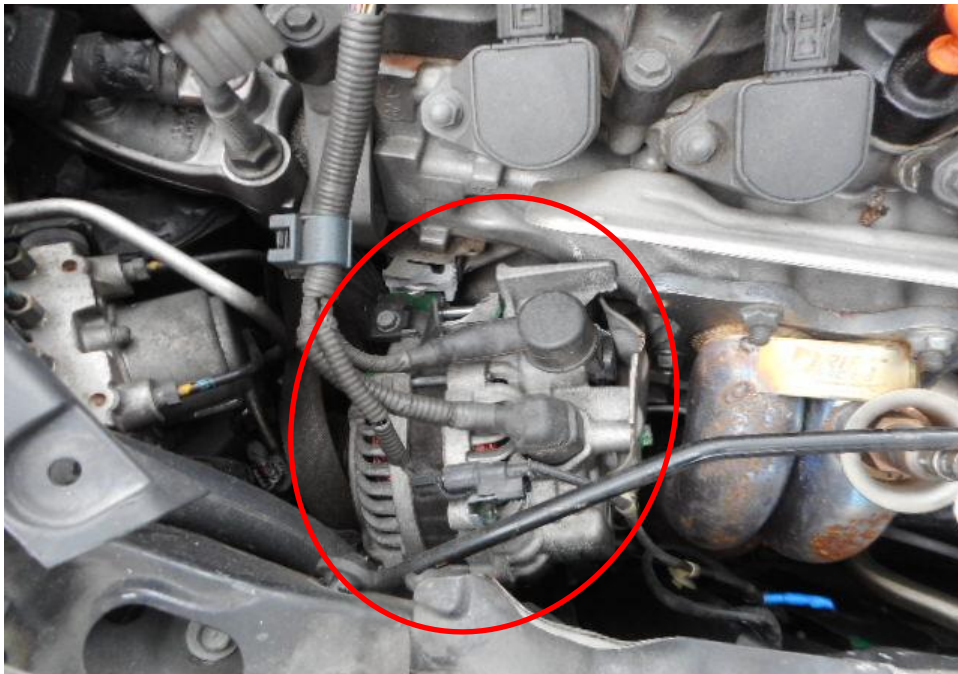
Photo 19 shows the close up view of the Motor Car's front body at the time of my inspection. The Motor car was observed to have sustained damage at its front portion. Its ignition system (circled) was amongst the various components in the engine compartments were also damaged as a result of the accident.

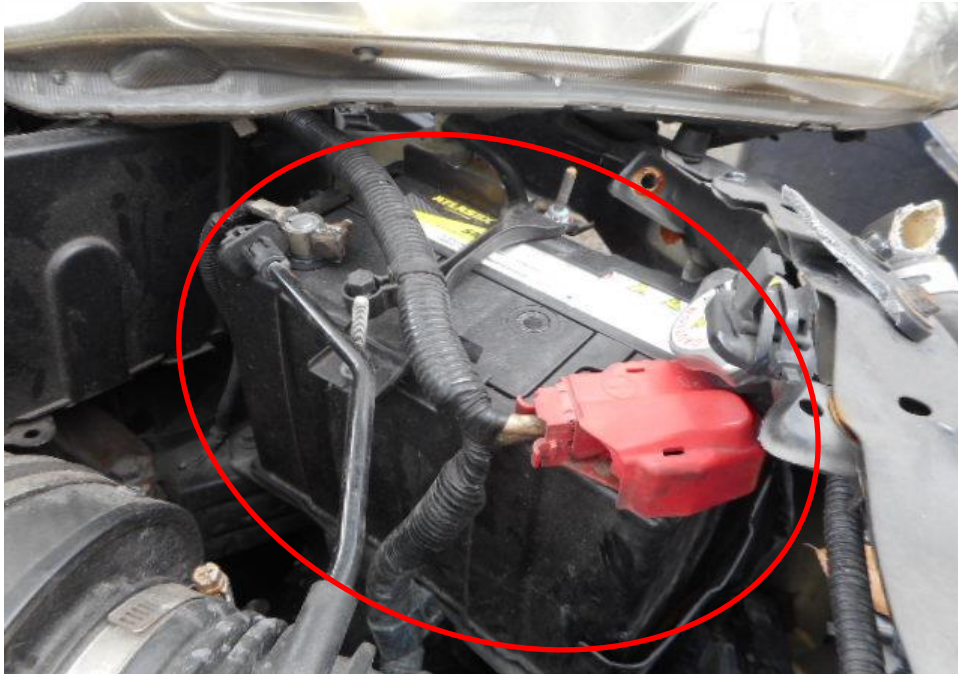
Photo 20 shows the close up view of the Motor Car's front body at the time of my inspection. The Motor car was observed to have sustained damage at its front portion. Its ignition system battery (circled) was amongst the various components in the engine compartments were also damaged as a result of the accident.

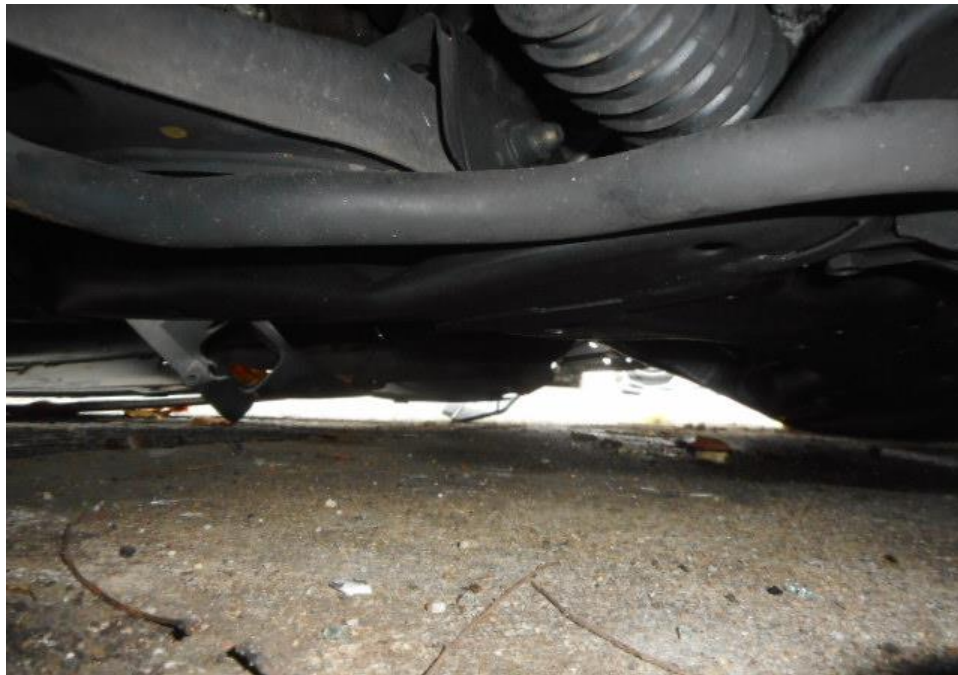
Photo 21 shows the undercarriage of the Motor Car, at the area where the engine housing and transmission housing are located. I did not find any sign(s) or indication(s) of fluid leak and/or fluid stain(s) on the underside of the Motor Car.

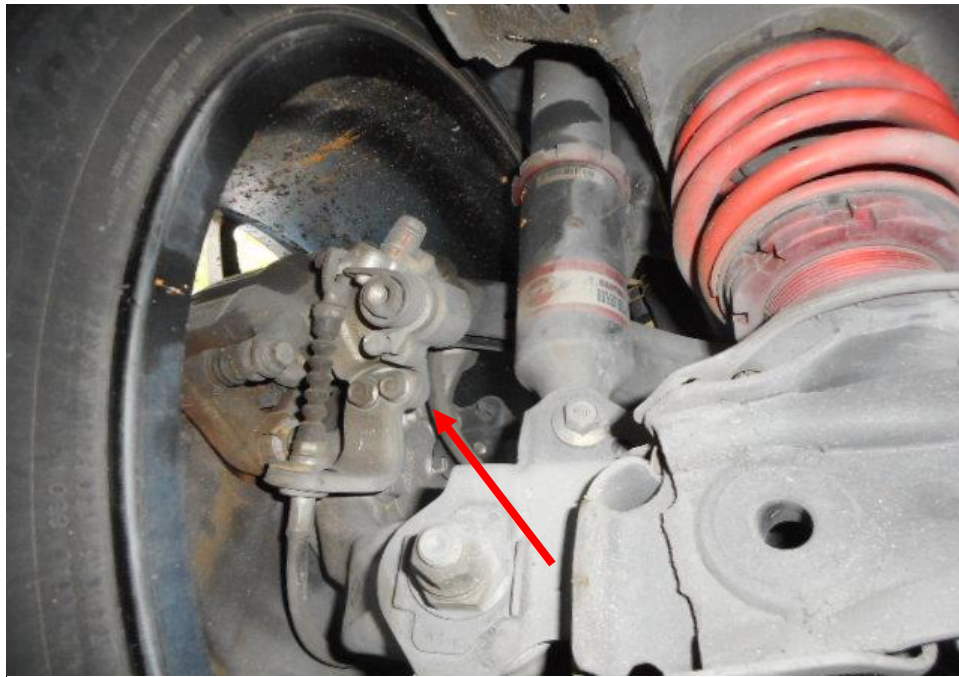
Photo 22 shows the brake hose/pipe (arrowed) at the rear left wheel of the Motor Car. No leakage of brake fluid was observed. Visual examination of the various components of the braking system like the drum brake and brake pedal etc had revealed all to be intact and without visible damage.

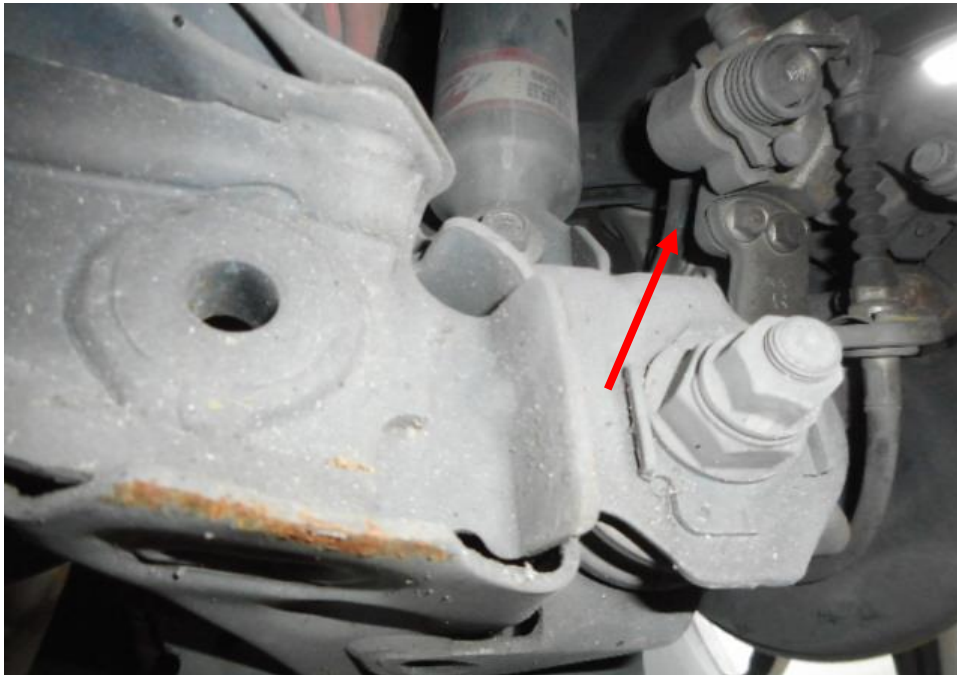
Photo 23 shows the brake hose/pipe (arrowed) at the rear right wheel of the Motor Car. No leakage of brake fluid was observed. Visual examination of the various components of the braking system like the drum brake and brake pedal etc had revealed all to be intact and without visible damage.

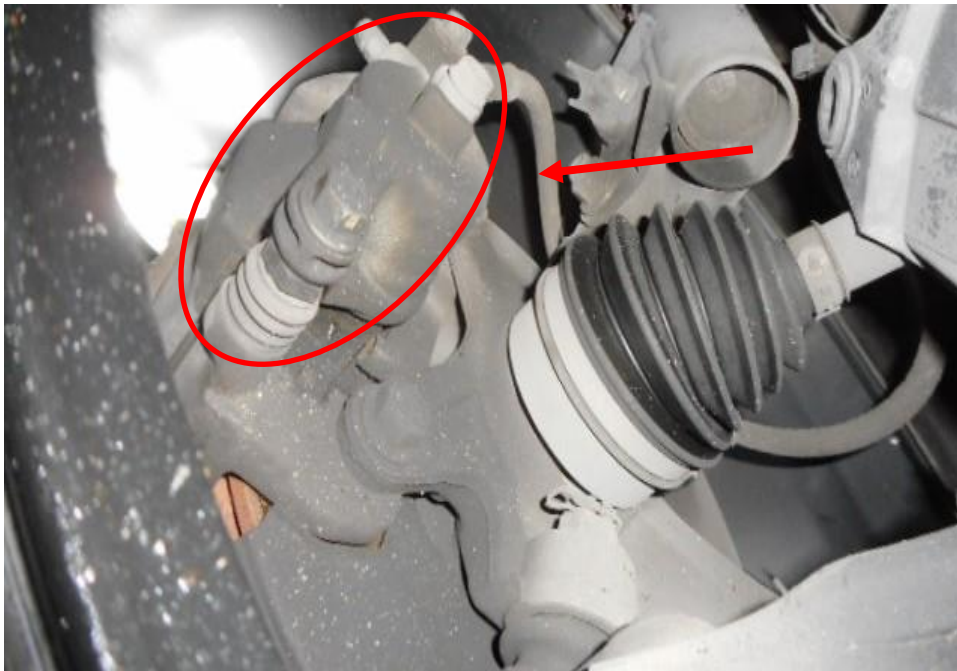
Photo 24 shows the brake hose/pipe (arrowed) at the front right wheel of the Motor Car. I did not observe any leakage of brake fluid at the time of my inspection of the Motor Car. Visual examination of the various components of the braking system like the brake caliper and brake hose etc had revealed all to be intact and without visible damage.

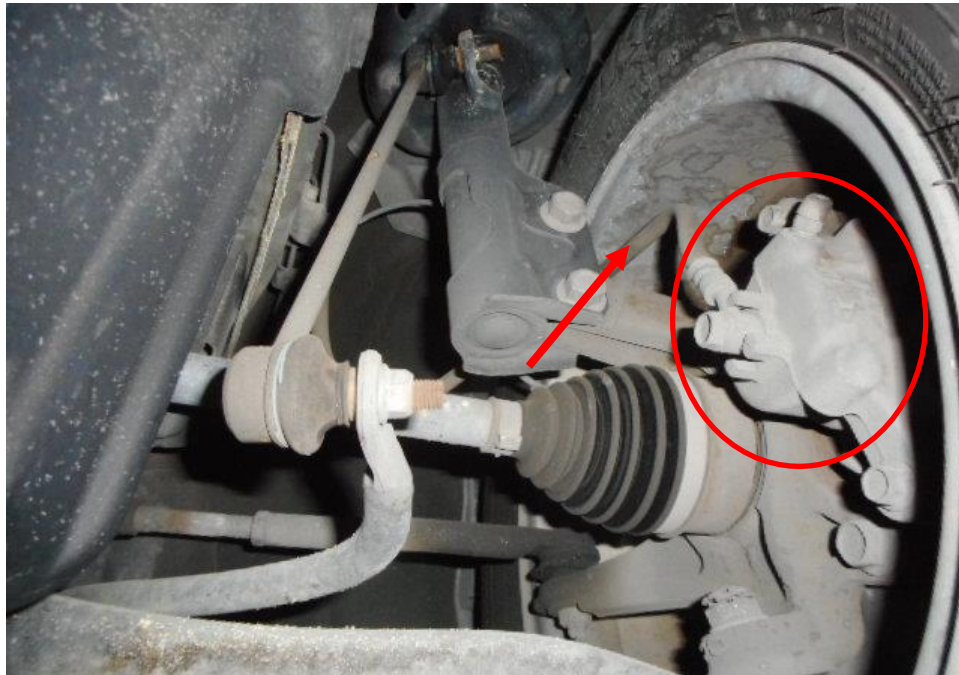
Photo 25 shows the brake hose/pipe (arrowed) at the front left wheel of the Motor Car. No leakage of brake fluid was observed. Visual examination of the various components of the braking system like the brake caliper (circled) and brake hose etc had revealed all to be intact and without visible damage.

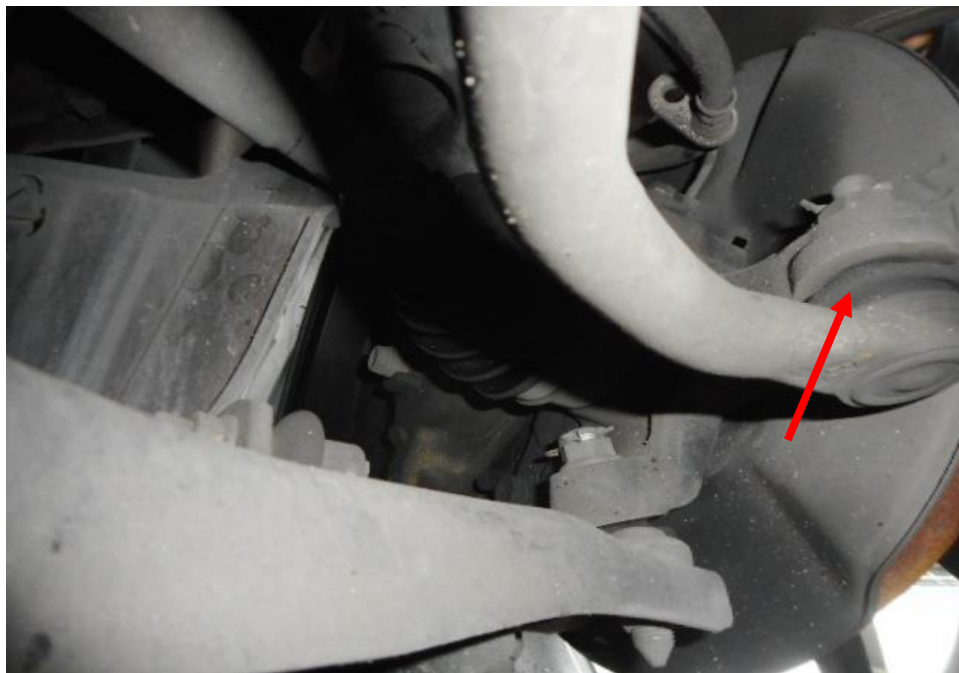
Photo 26 shows the various undercarriage components at the front right wheel of the Motor Car, in particular the steering tie rod (arrowed). The various steering components were all found to be intact. There was also no sign of fluid stain observed on the various undercarriage components at the front right wheel of the Motor Car.

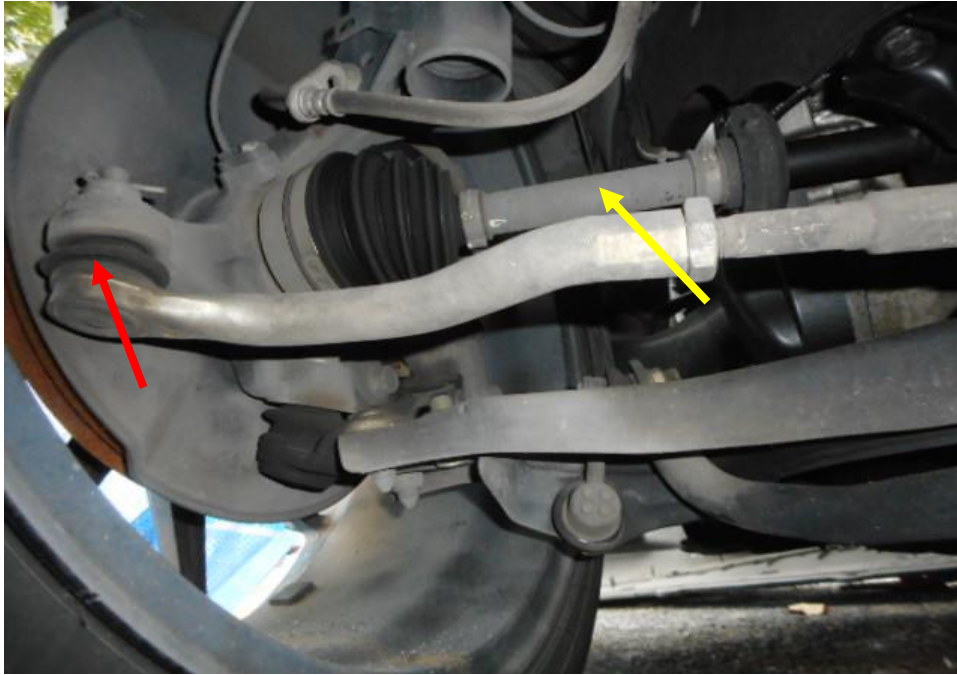
Photo 27 shows the various undercarriage components at the front left wheel of the Motor Car, in particular the steering tie rod end (red arrow) and the driveshaft (yellow arrow). The various undercarriage components of the Motor Car were all found to be intact without any visible damage. There was also no sign of fluid stain(s) observed on the various undercarriage components.

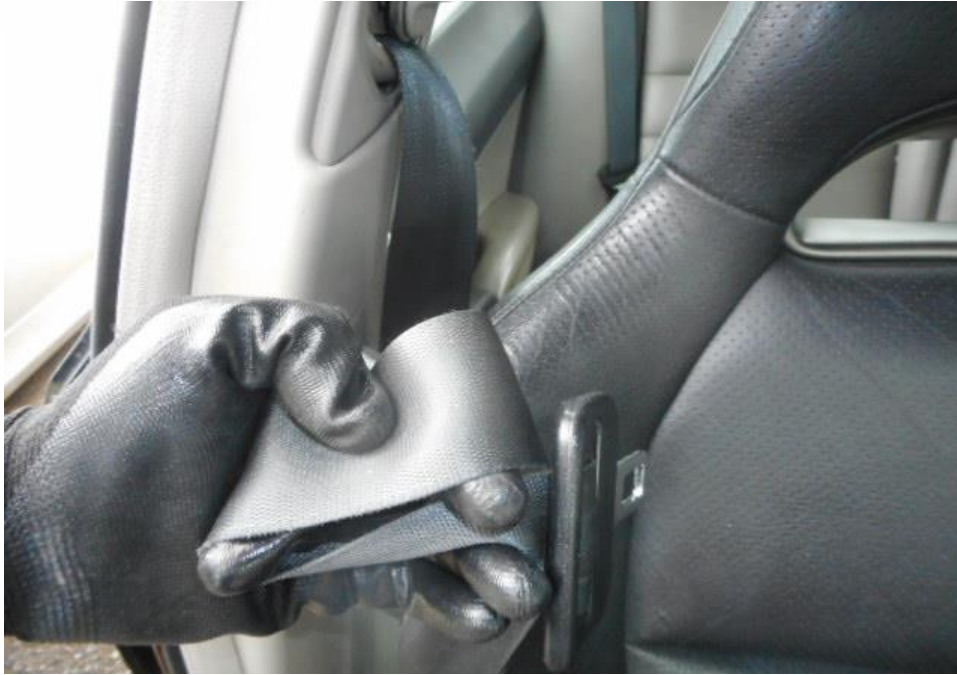
Photo 28 shows that the seat belt on the right seat was worn at the material time of accident as the safety pre-tensioners was activated at the moment of impact and caused the seat belt to be locked into the last position.

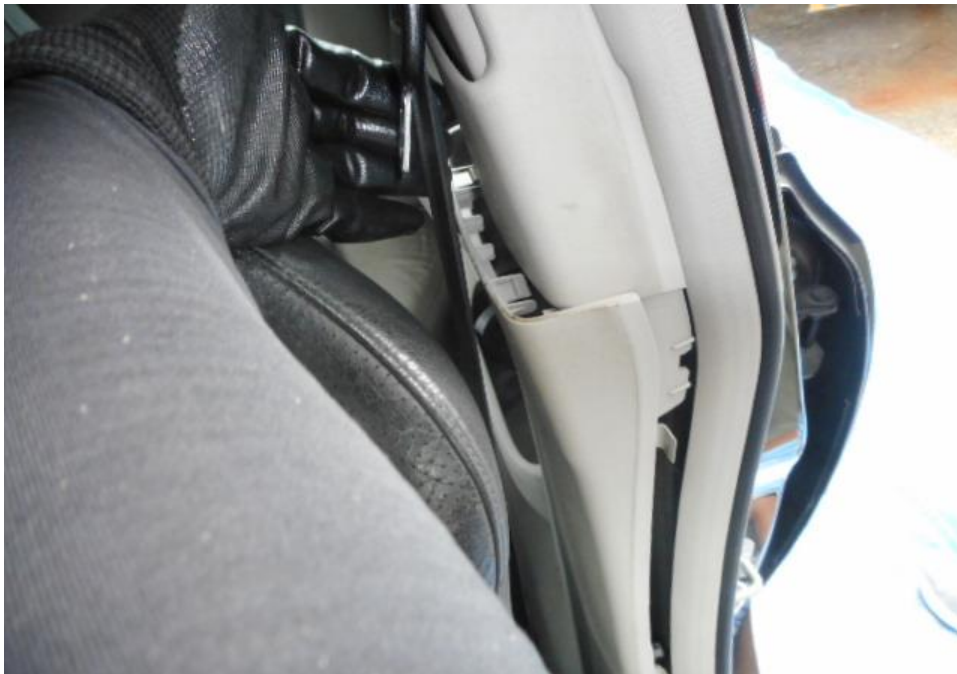
Photo 29 shows that the seat belt on the left seat was not worn at the material time of accident as the safety pre-tensioners was activated at the moment of impact and caused the seat belt to be locked into the last position.
