Your Ref: TP/IP/01105/2023  
Our Ref : CI/TPD23001590/P

**Fatal Accident Investigation Team**

**MECHANICAL INSPECTION REPORT OF MOTOR CAR SLT 2012E**

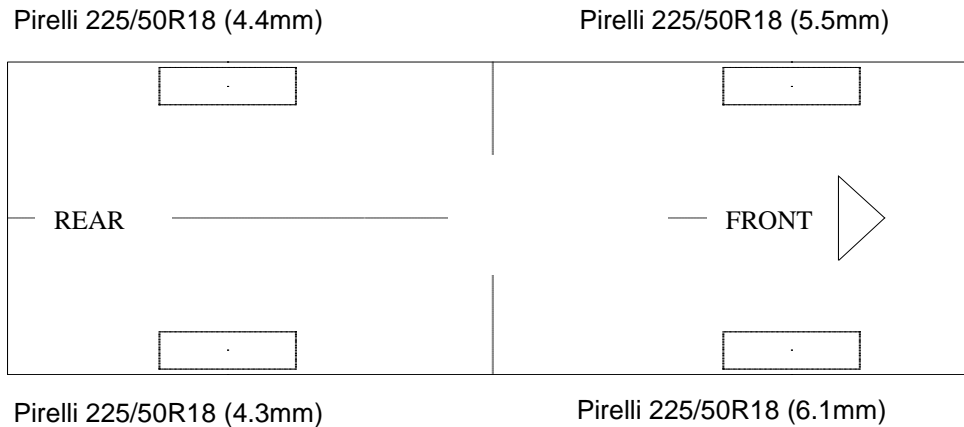
6. The condition of the Motor Car's 4 tyres was observed to be in serviceable condition. I did not find any tear, cut or burst mark(s) on the outer and the inner sidewalls as well as across the tread of the 4 tyres. The 4 tyres were also observed to be sufficiently inflated for vehicular operation. The tyre brand, tyre size and remaining tread depth of the 4 tyres were recorded as follows:-

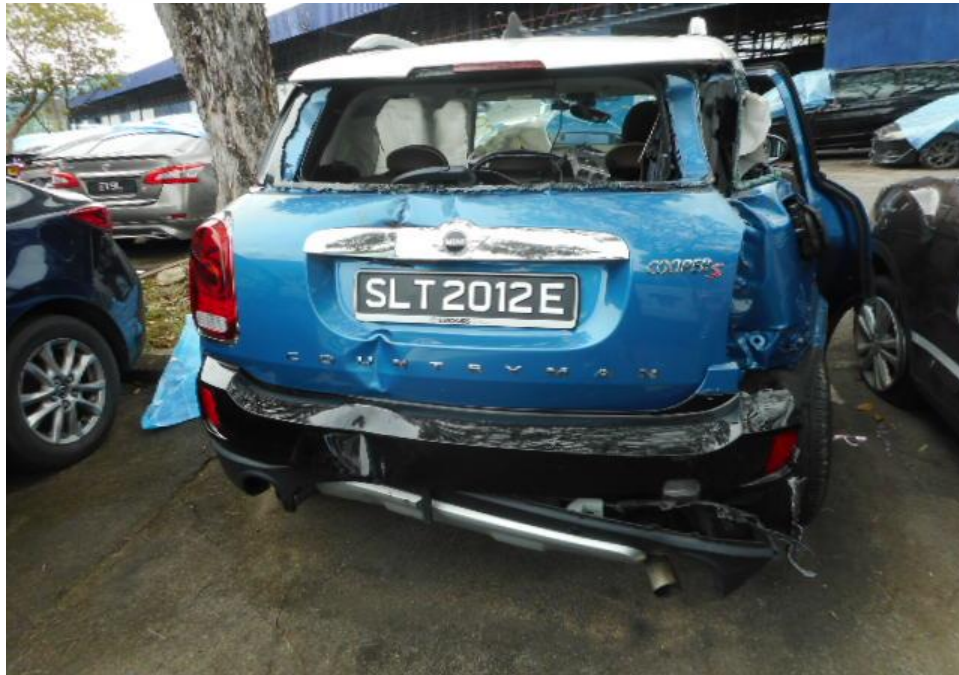
**Photo 1** shows a general view of the Motor Car's rear body at the time of my inspection. The rear portion of the Motor Car was observed to sustain damages as a result of the accident. Its rear windscreen, rear boot, rear bumper and right rear brake lamp were damaged as a result of the accident.

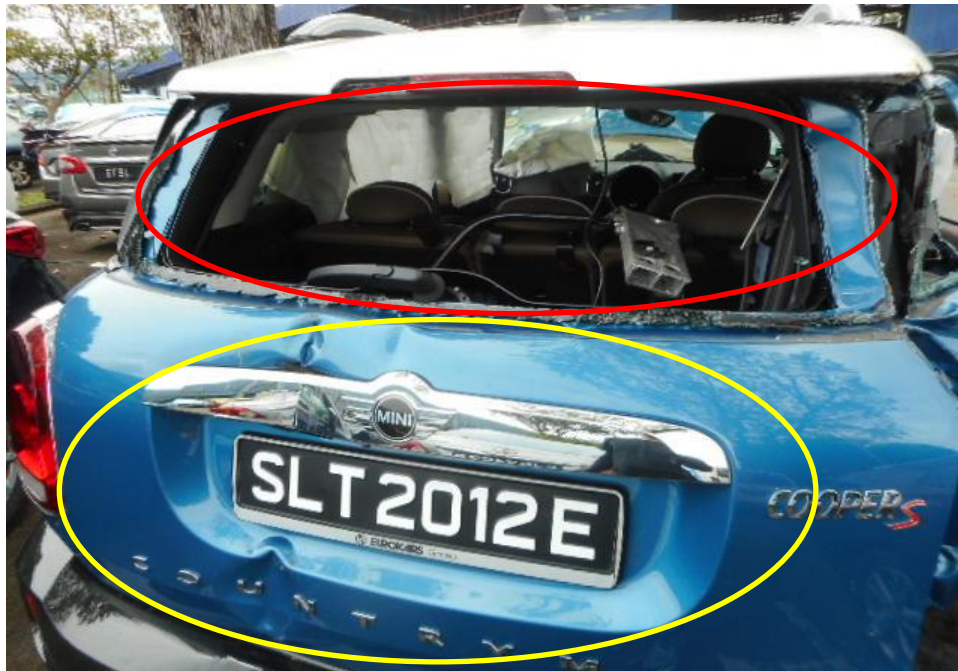
**Photo 2** shows a close up view of the Motor Car's rear body at the time of my inspection. The rear portion of the Motor Car was observed to sustain damages as a result of the accident. Its rear windscreen (red circle) and rear boot (yellow arrow) were damaged as a result of the accident.

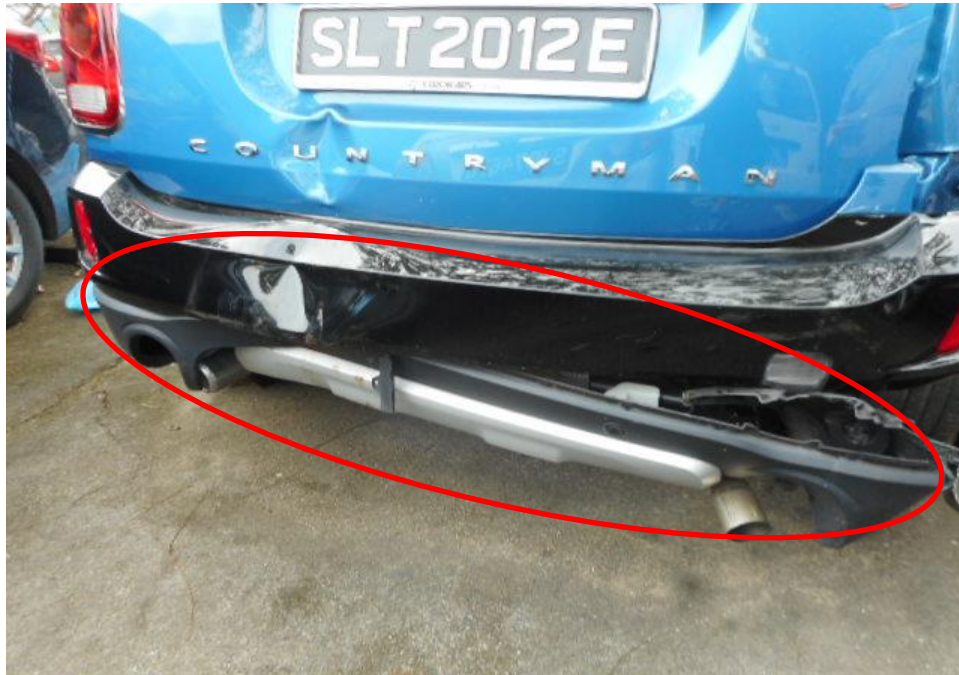
**Photo 3** shows a close up view of the Motor Car's rear body at the time of my inspection. The rear portion of the Motor Car was observed to sustain damages as a result of the accident. Its rear bumper (circled) were damaged as a result of the accident.

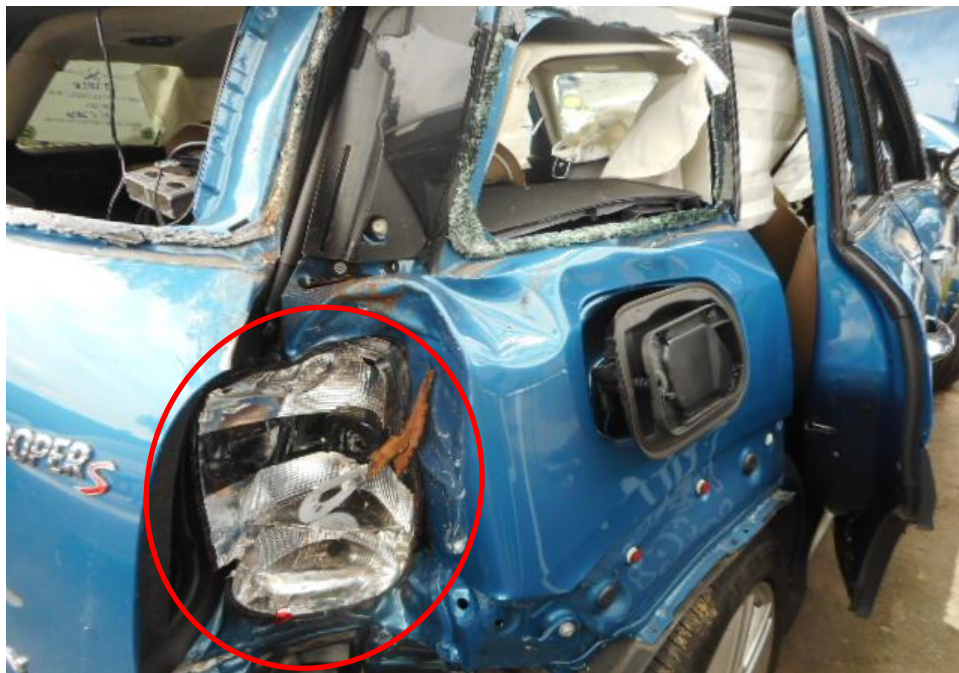
**Photo 4** shows a close up view of the Motor Car's rear body at the time of my inspection. The rear portion of the Motor Car was observed to sustain damages as a result of the accident. Its rear right brake lamp (circled) were damaged as a result of the accident.

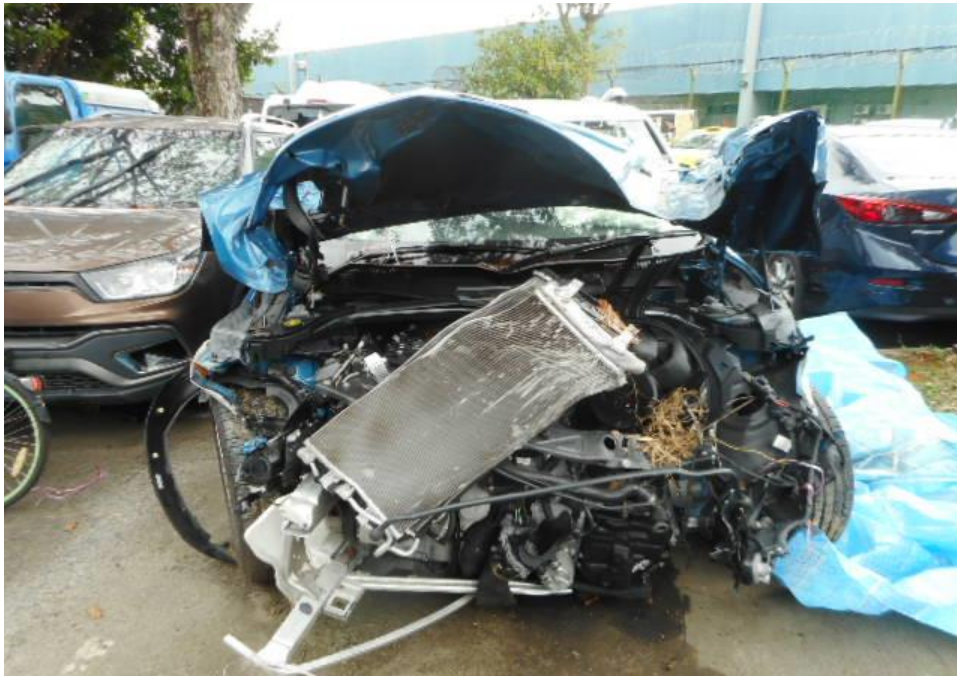
**Photo 5** shows a general view of the Motor Car's front body at the time of my inspection. The Motor car was observed to have sustained damage at its front portion. Its front windscreen, front bonnet, front left and right fender, was amongst the body parts that were damaged as a result of the accident. The Supplemental Restraint System (SRS) was activated as a result of the accident.

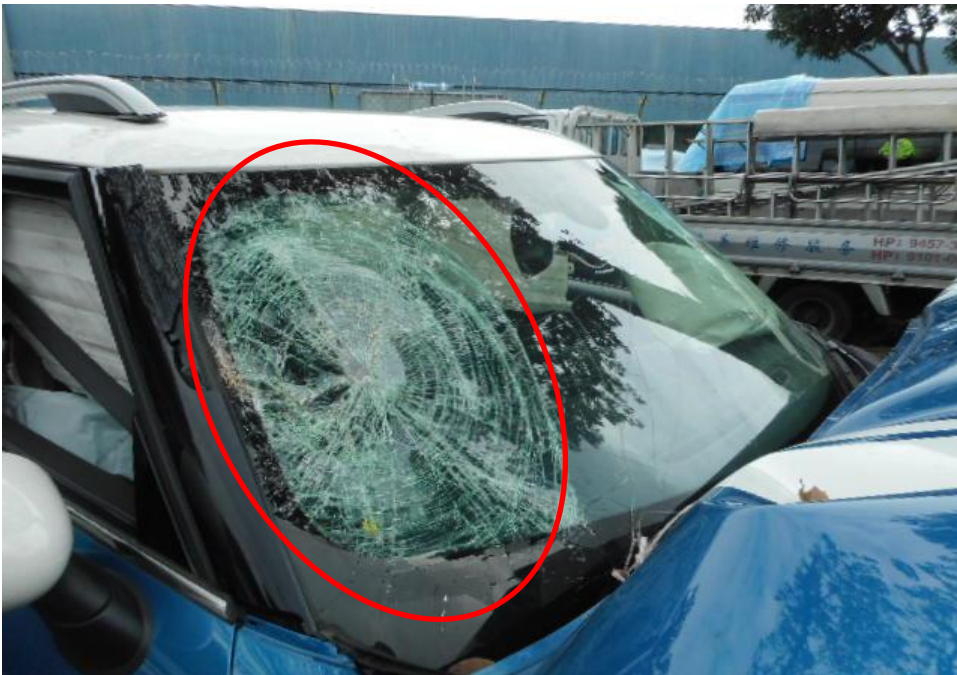
**Photo 6** shows the close up view of the Motor Car's front body and roof panel at the time of my inspection. The Motor car was observed to have sustained damage at its front portion. Its front windscreen (circled) was damaged as a result of the accident.

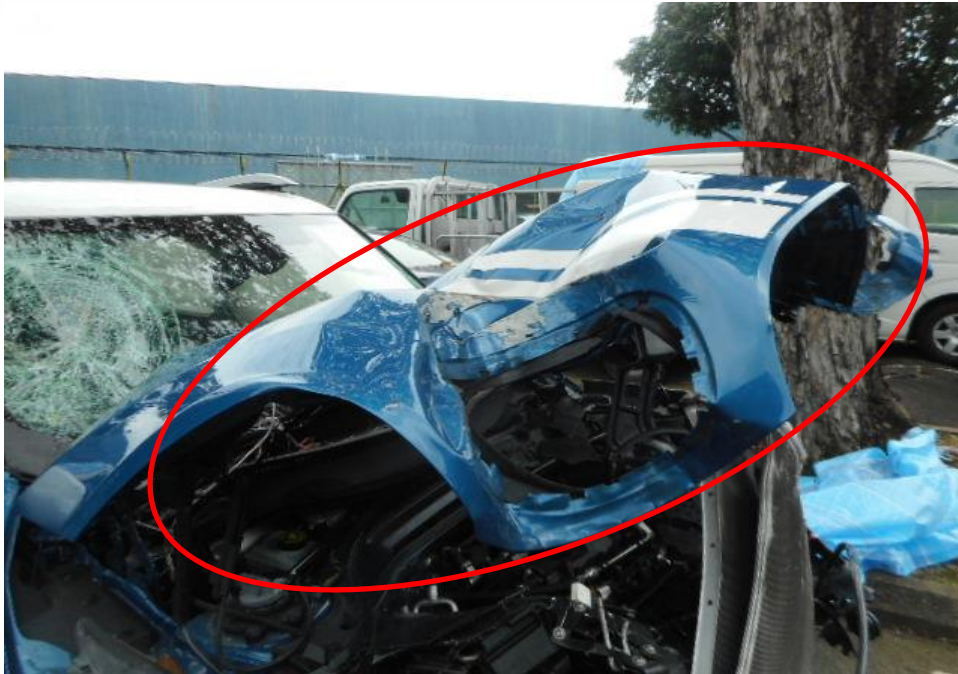
**Photo 7** shows the close up view of the Motor Car's front body at the time of my inspection. The Motor car was observed to have sustained damage at its front portion. Its front bonnet (circled) was damaged as a result of the accident.

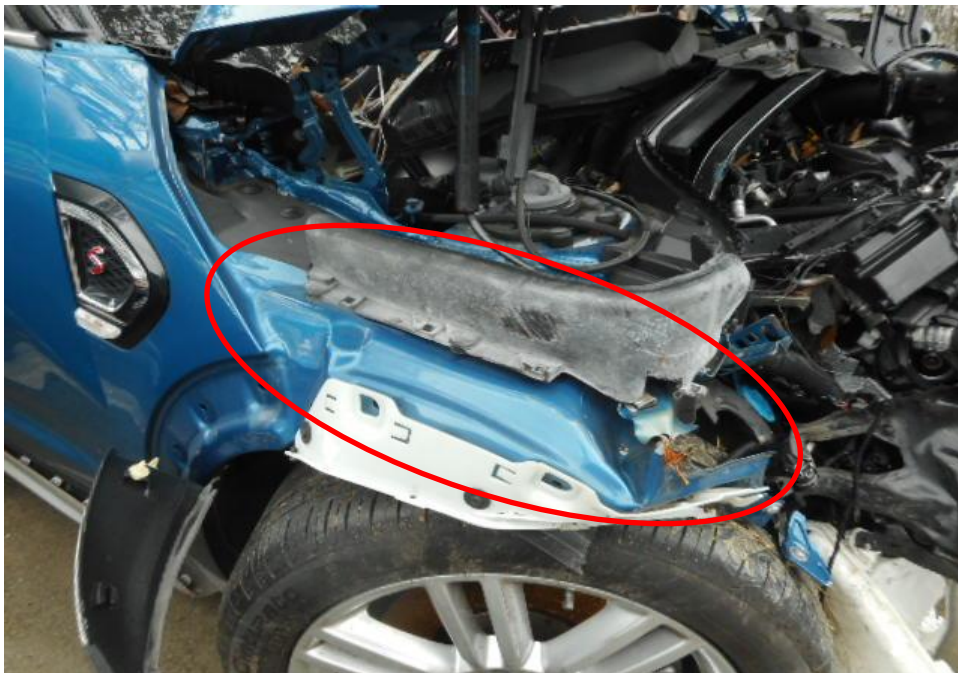
**Photo 8** shows the close up view of the Motor Car's front body at the time of my inspection. The Motor car was observed to have sustained damage at its front portion. Its front right fender (circled) was amongst the body part damaged as a result of the accident.

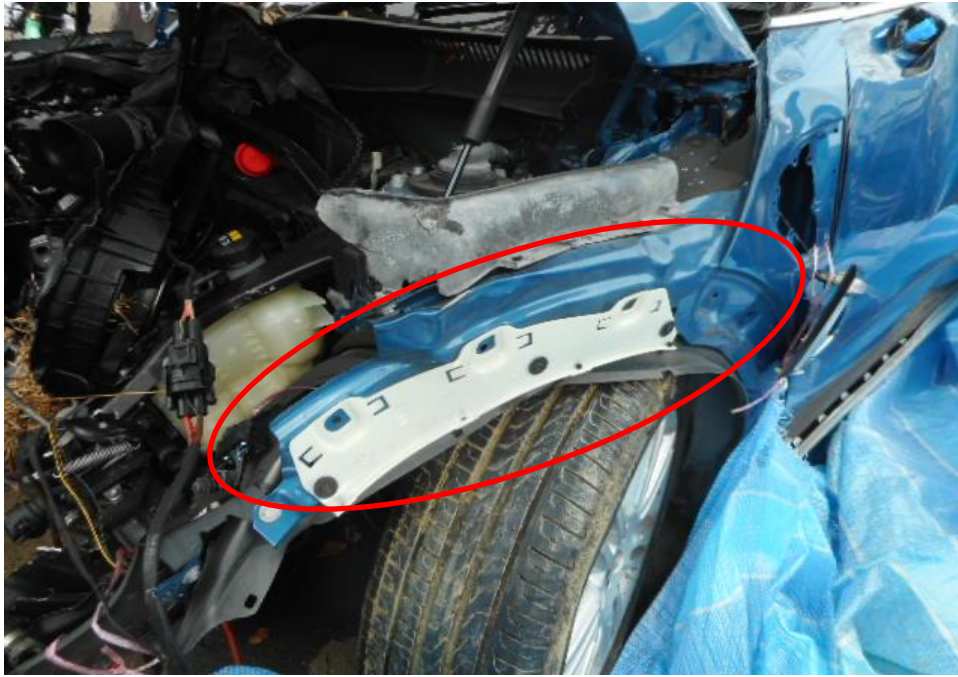
**Photo 9** shows the close up view of the Motor Car's front body at the time of my inspection. The Motor car was observed to have sustained damage at its front portion. Its front left fender (circled) was amongst the body part damaged as a result of the accident.

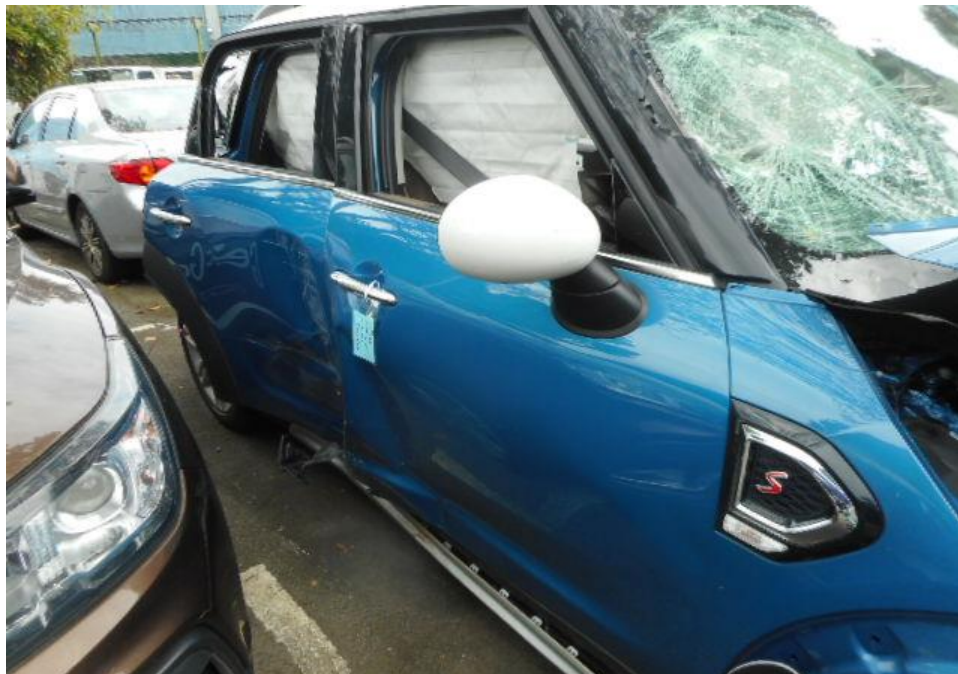
**Photo 10** shows a general view of the Motor Car's right body at the time of my inspection. The Motor car was observed to have sustained damage at its right portion. Its right doors (circled) was amongst the body parts damaged as a result of the accident.

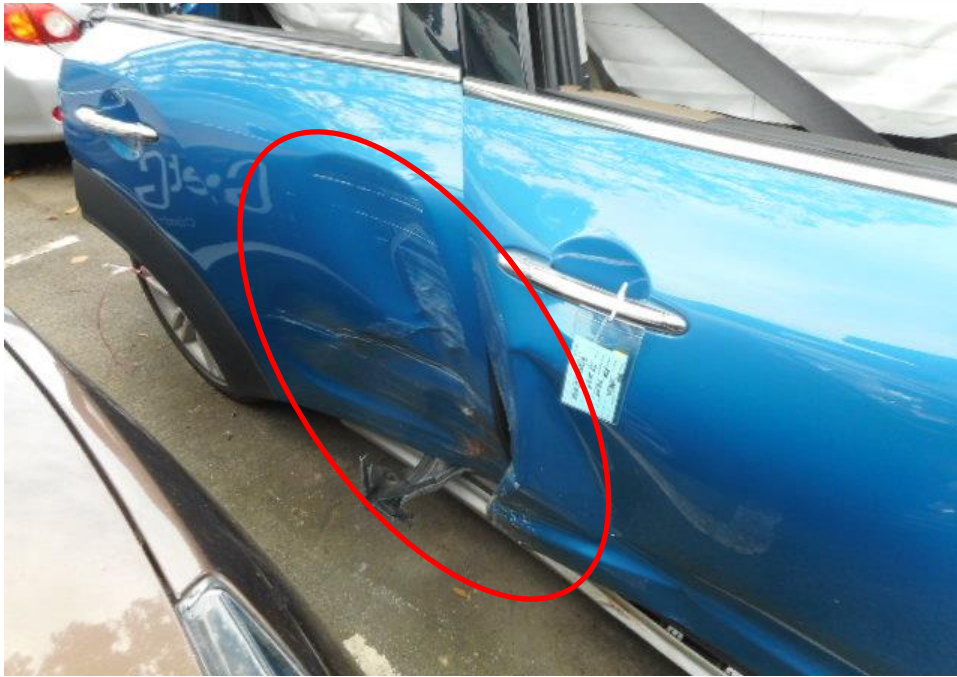
**Photo 11** shows a close up view of the Motor Car's right body at the time of my inspection. The Motor car was observed to have sustained damage at its right portion. Its right doors (circled) was amongst the body parts damaged as a result of the accident.

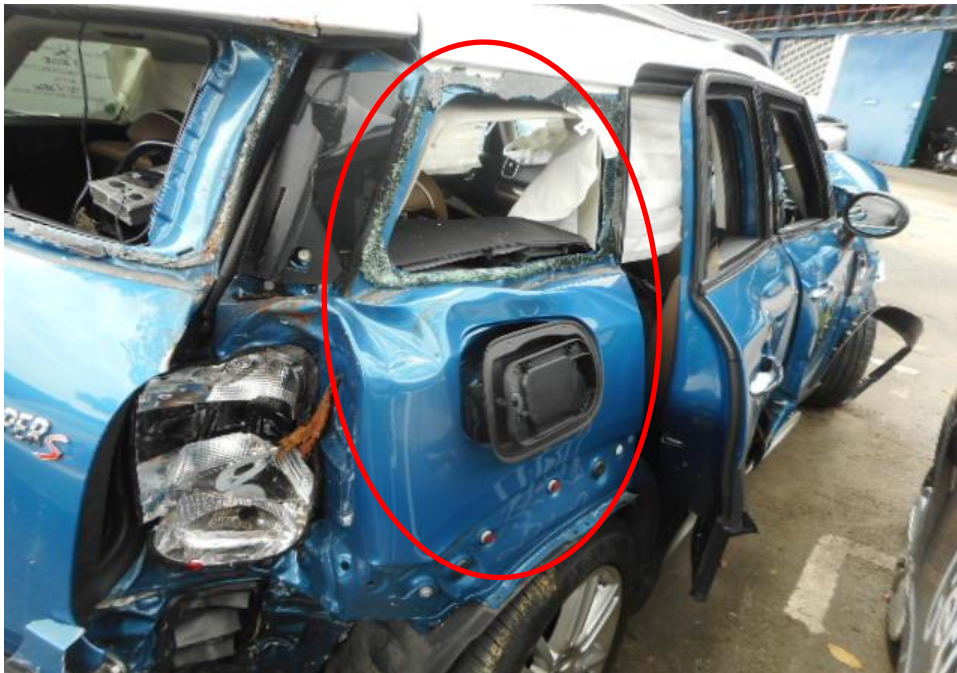
**Photo 12** shows a close up view of the Motor Car's right body at the time of my inspection. The Motor car was observed to have sustained damage at its right portion. Its right door panel (circled) was amongst the body parts damaged as a result of the accident.

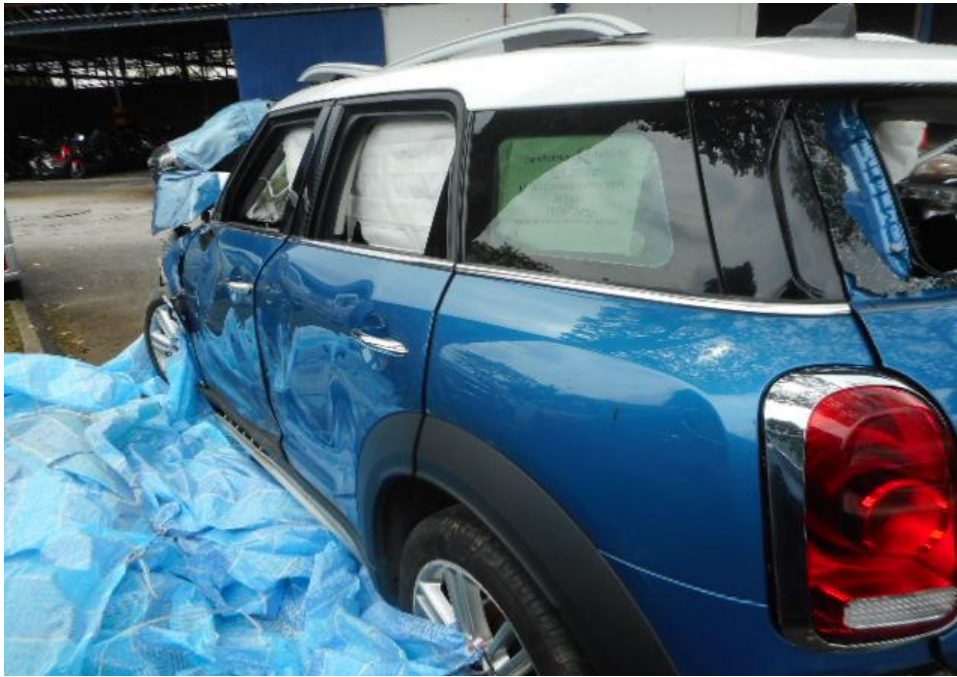
**Photo 13** shows a general view of the Motor Car's left body at the time of my inspection. The Motor car was observed to have sustained damage at its right portion. Its left doors (circled) was amongst the body parts damaged as a result of the accident.

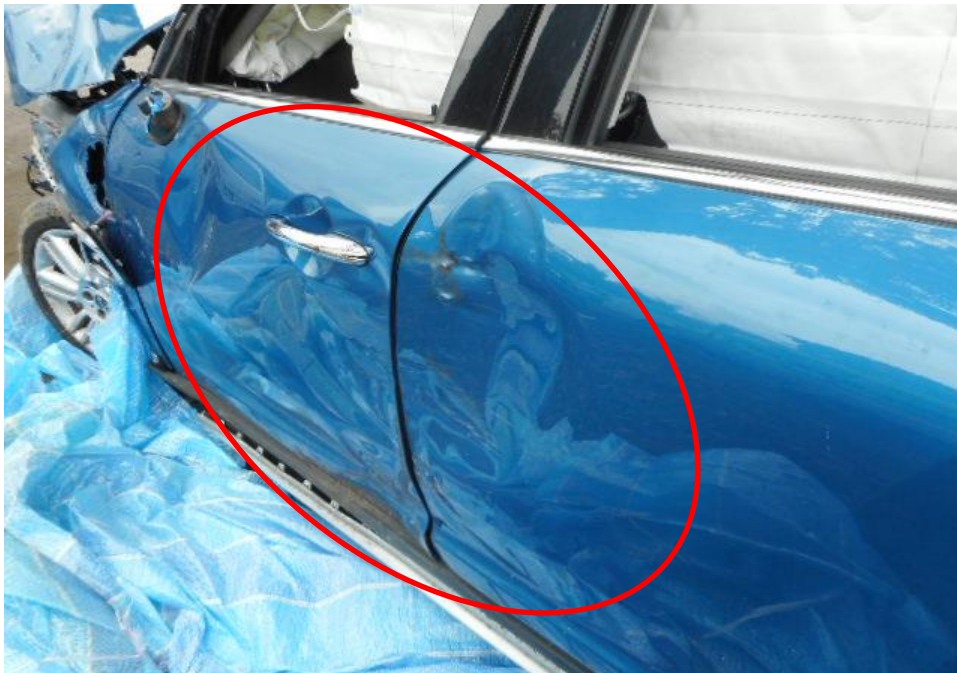
**Photo 14** shows a close up view of the Motor Car's left body at the time of my inspection. The Motor car was observed to have sustained damage at its right portion. Its left doors (circled) was amongst the body parts damaged as a result of the accident.

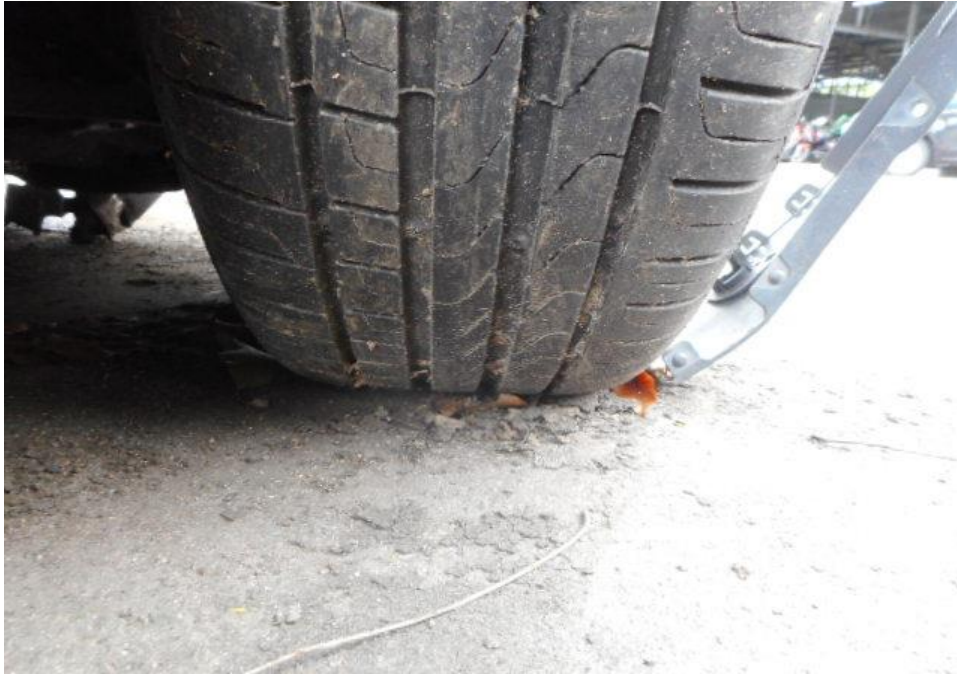
**Photo 15** shows the condition of the front right tyre of the Motor Car, which was observed to be in serviceable condition with remaining tread depth of approximately 6.1mm. The tyre, which was wrapped around alloy wheel rim, was also observed to be sufficiently inflated for vehicular operation.

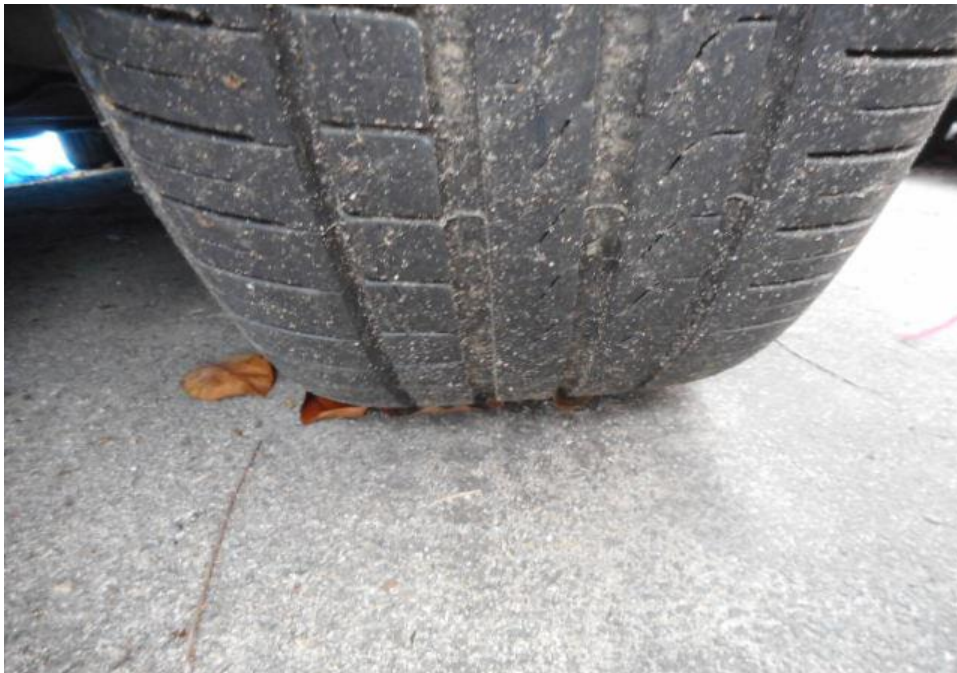
**Photo 16** shows the condition of the rear right tyre of the Motor Car, which was observed to be in serviceable condition with remaining tread depth of approximately 4.3mm. The tyre was also observed to be sufficiently inflated for vehicular operation with no tear, cut or burst mark(s).

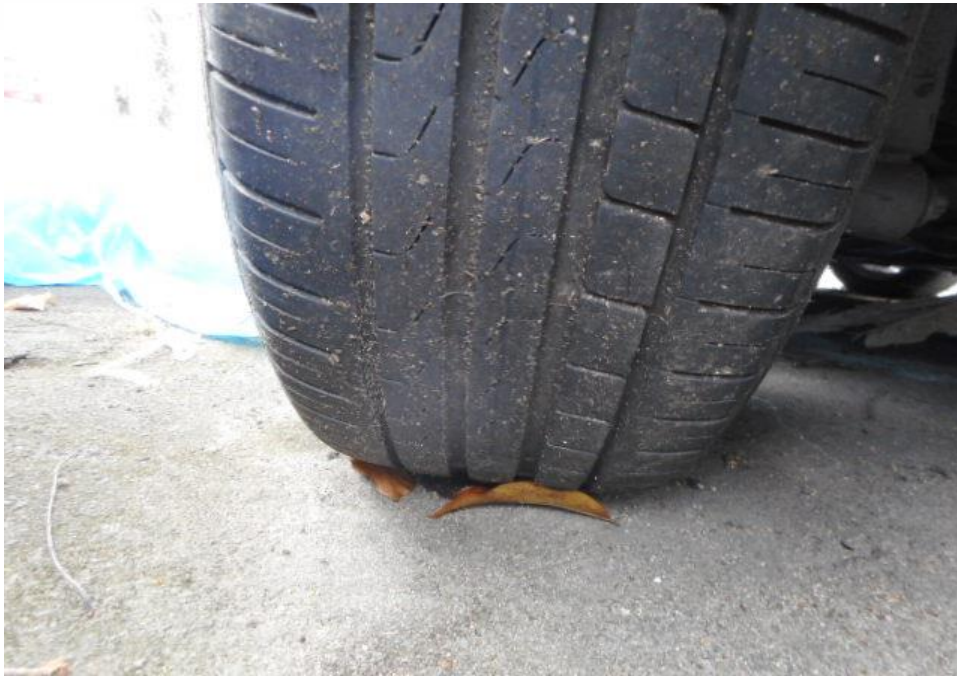
**Photo 17** shows the condition of the rear left tyre of the Motor Car, which was observed to be in serviceable condition with remaining tread depth of approximately 4.4mm. The tyre was also observed to be sufficiently inflated for vehicular operation with no tear, cut or burst mark(s).

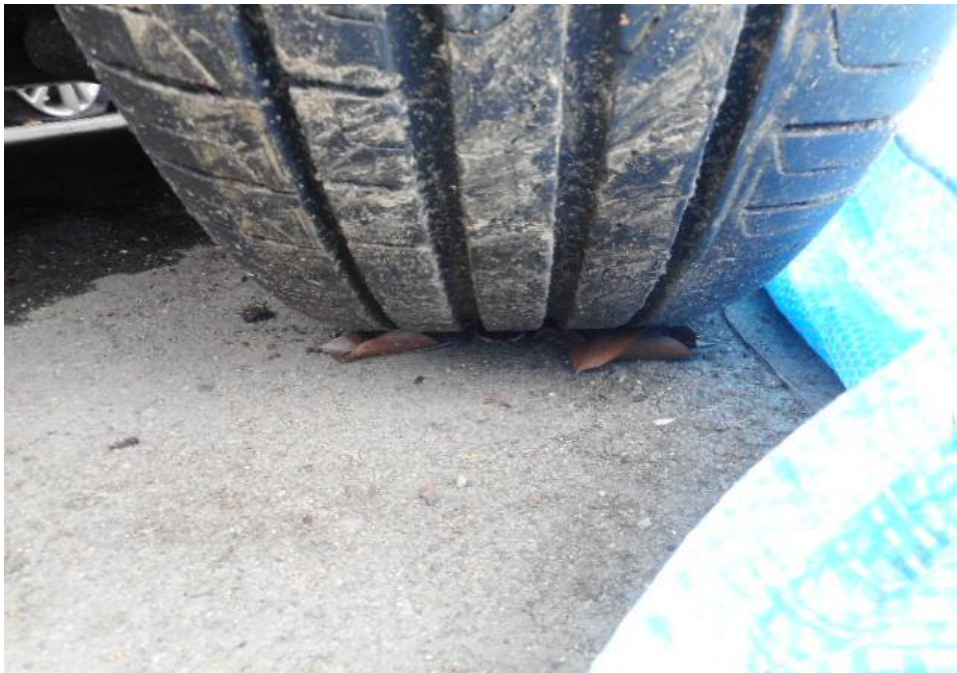
**Photo 18** shows the condition of the front left tyre of the Motor Car, which was observed to be in serviceable condition with remaining tread depth of approximately 5.5mm. The tyre was also observed to be sufficiently inflated for vehicular operation with no tear, cut or burst mark(s).

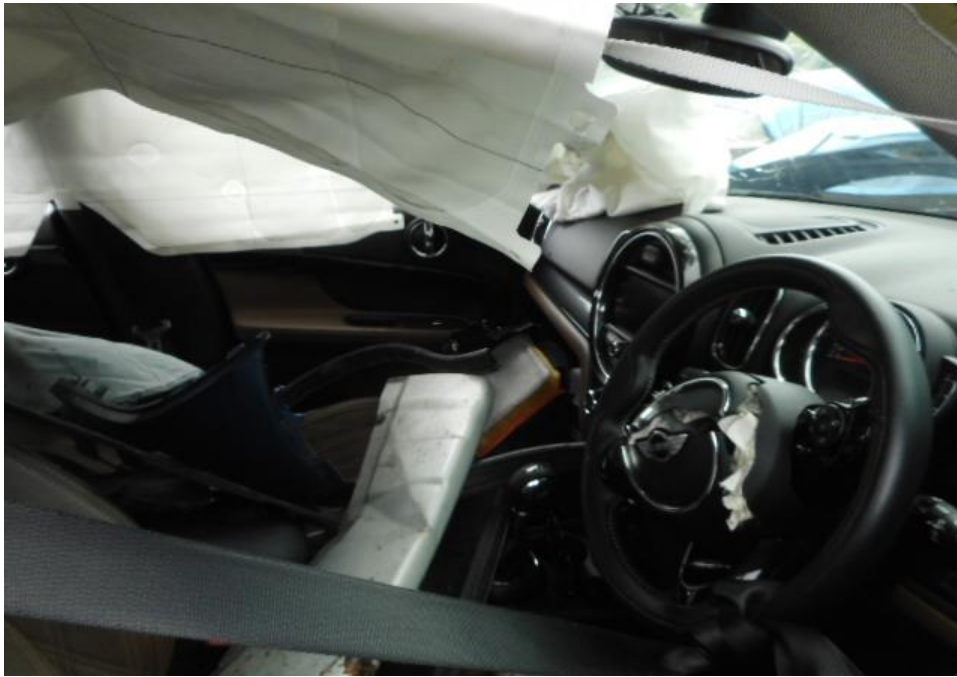
**Photo 19** shows the deployment of the Supplemental Restraint System (SRS) airbag in the Motor Car as a result of the accident.

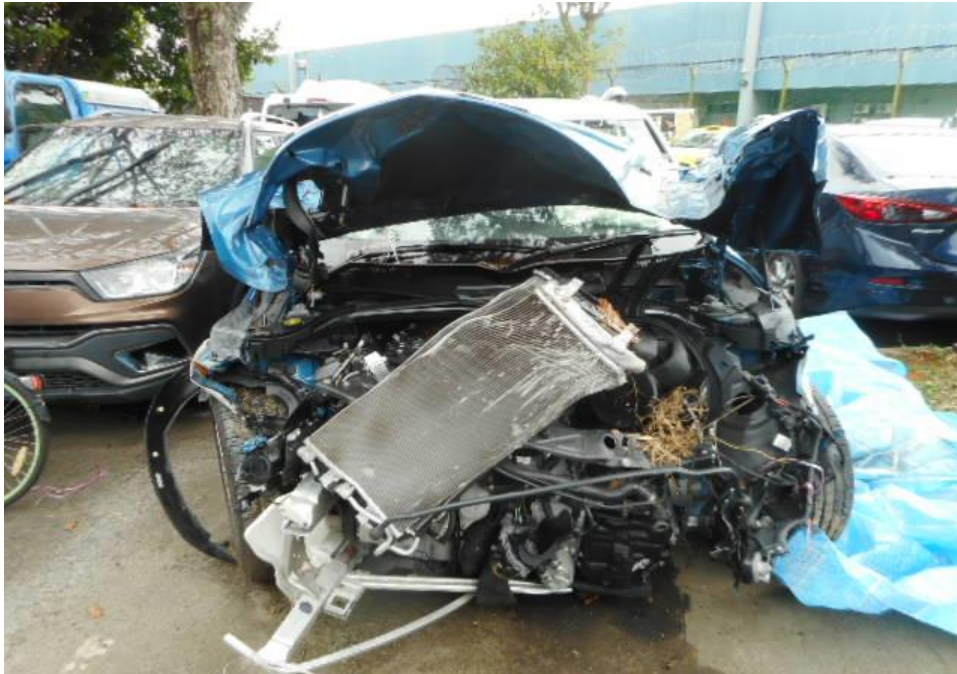
**Photo 20** shows a general view of the Motor Car's engine compartment. The various parts and components inside the engine compartment were observed that the engine and ignition system was damaged as a result of the induced impact from the accident.

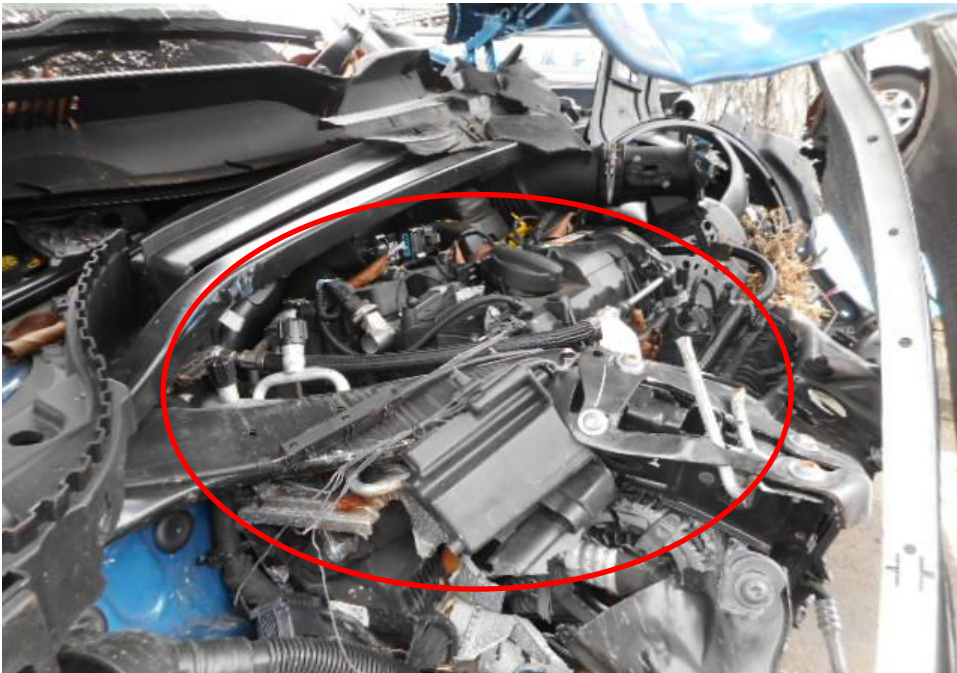
**Photo 21** shows the close up view of the Motor Car's front body at the time of my inspection. The Motor car was observed to have sustained damage at its front portion. Its engine components (circled) was amongst the various components in the engine compartments were also damaged as a result of the accident.

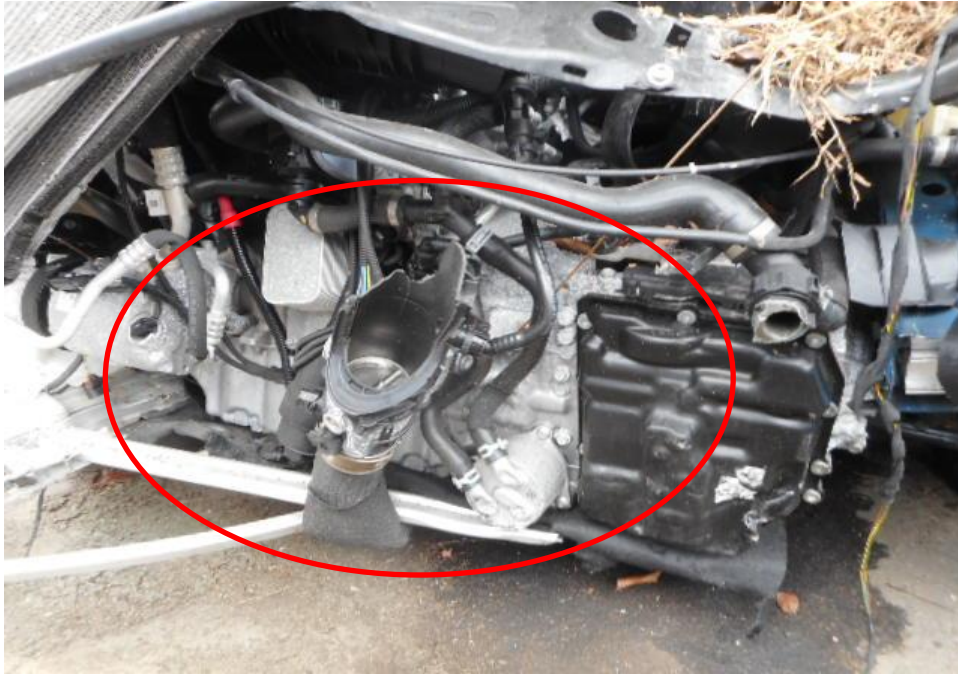
**Photo 22** shows the close up view of the Motor Car's front body at the time of my inspection. The Motor car was observed to have sustained damage at its front portion. Its engine components (circled) was amongst the various components in the engine compartments were also damaged as a result of the accident.

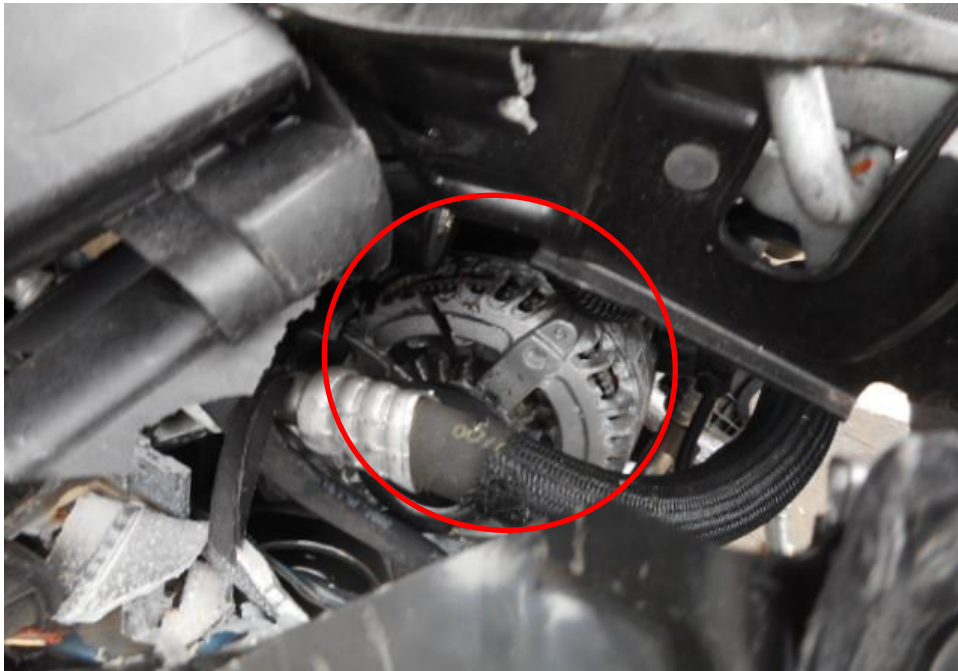
**Photo 23** shows the close up view of the Motor Car's front body at the time of my inspection. The Motor car was observed to have sustained damage at its front portion. Its ignition system (circled) was amongst the various components in the engine compartments were also damaged as a result of the accident.

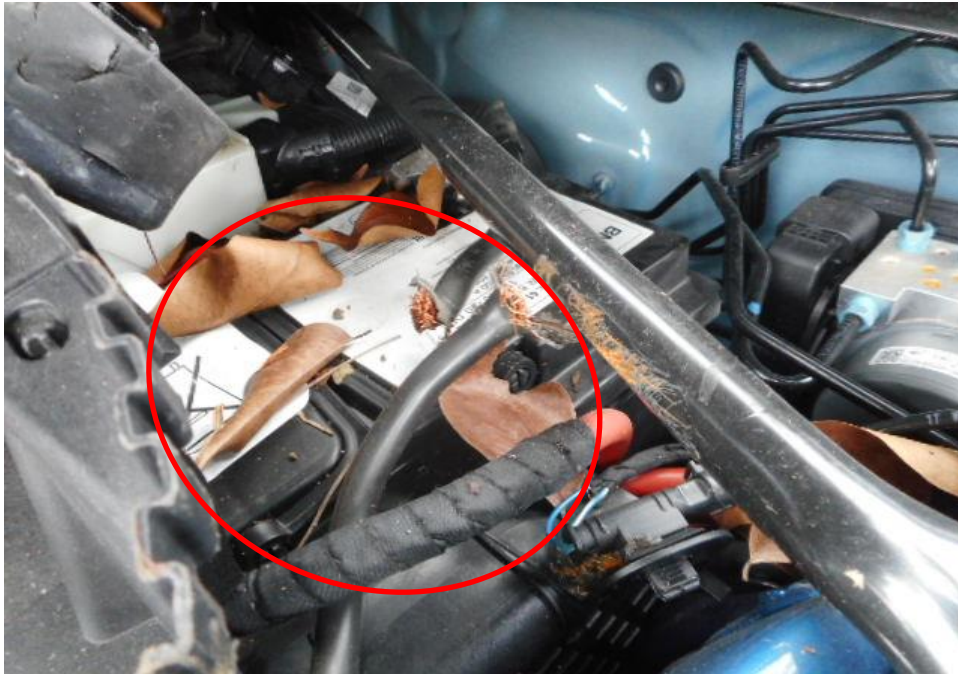
**Photo 24** shows the close up view of the Motor Car's front body at the time of my inspection. The Motor car was observed to have sustained damage at its front portion. Its ignition system battery (circled) was amongst the various components in the engine compartments were also damaged as a result of the accident.

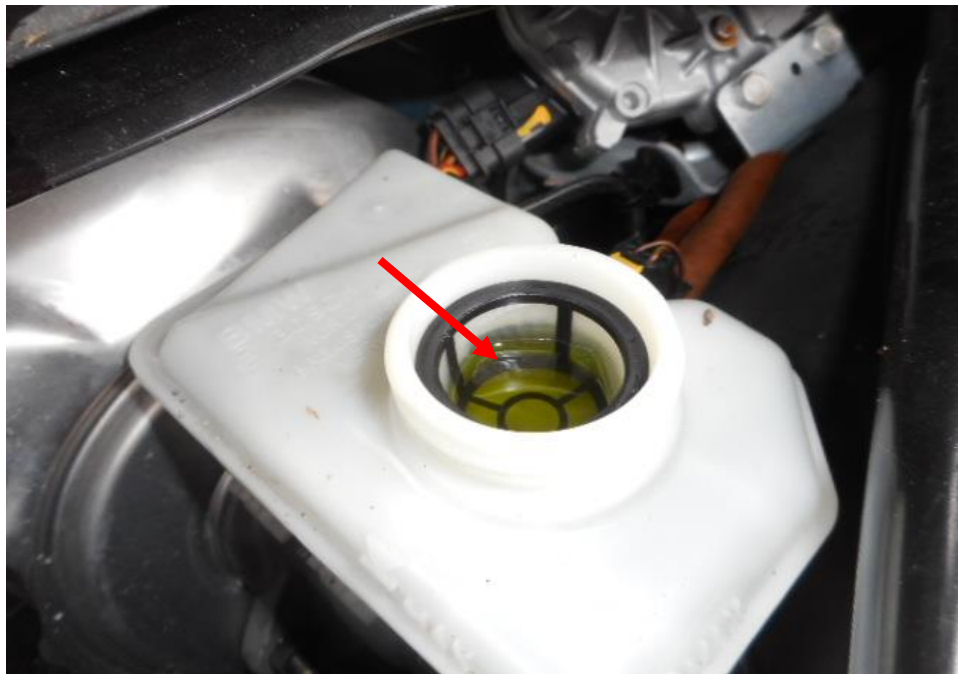
**Photo 25** shows the brake fluid reservoir of the Motor Car at the time of my inspection. The brake fluid was observed to be of sufficient level (arrowed) and without any visible contamination.

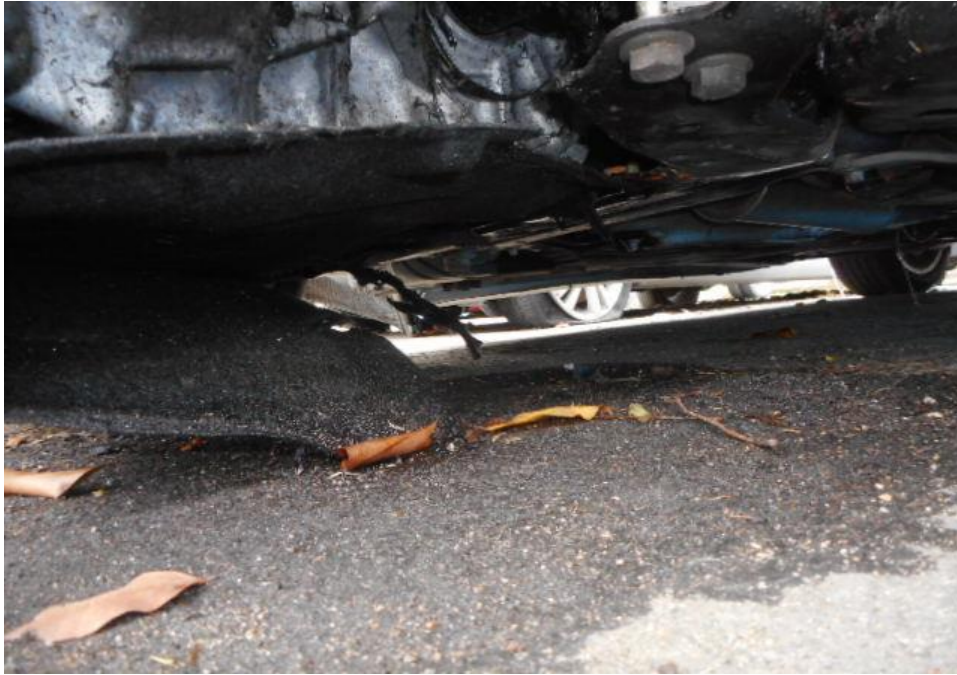
**Photo 26** shows the undercarriage of the Motor Car, at the area where the engine housing and transmission housing are located. I found engine oil leakage on the underside of the Motor Car as a result of the accident.

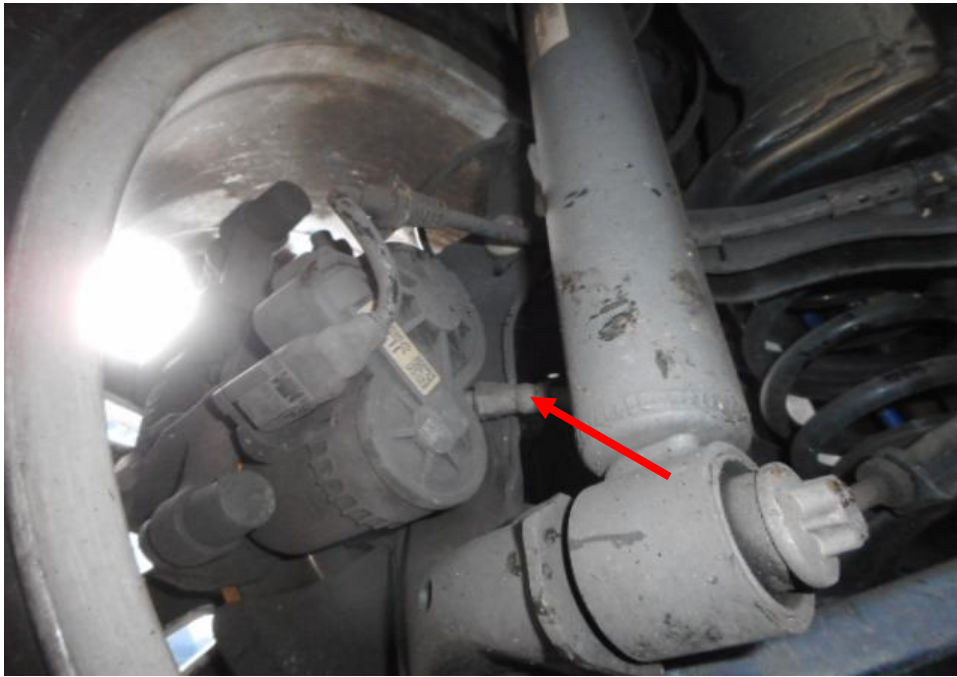
**Photo 27** shows the brake hose/pipe (arrowed) at the rear left wheel of the Motor Car. No leakage of brake fluid was observed. Visual examination of the various components of the braking system like the brake caplier to be intact and without visible damage.

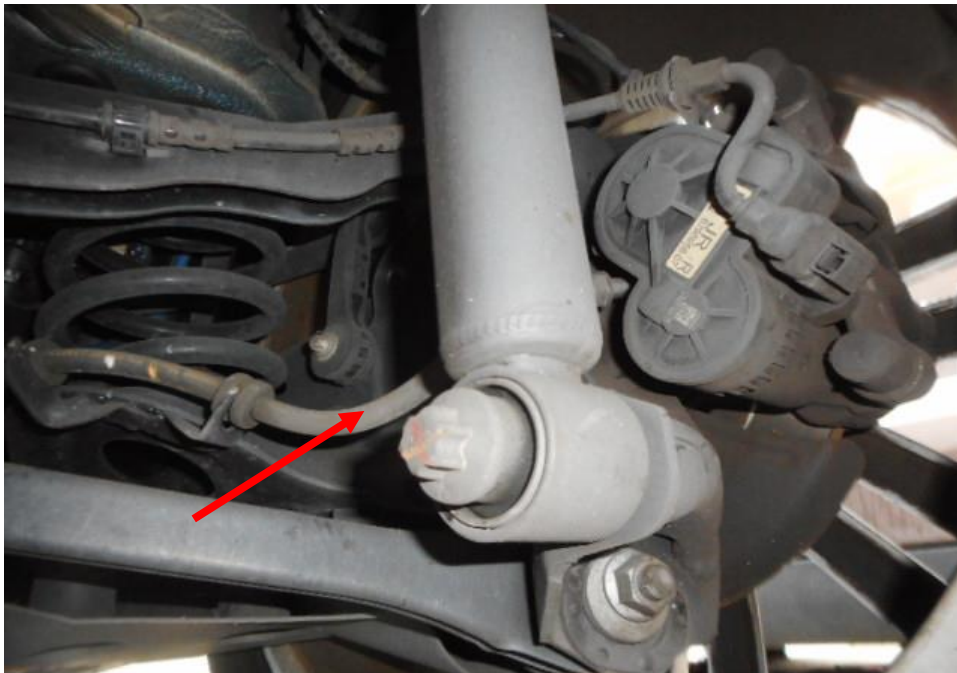
**Photo 28** shows the brake hose/pipe (arrowed) at the rear right wheel of the Motor Car. No leakage of brake fluid was observed. Visual examination of the various components of the braking system like the brake caplier to be intact and without visible damage.

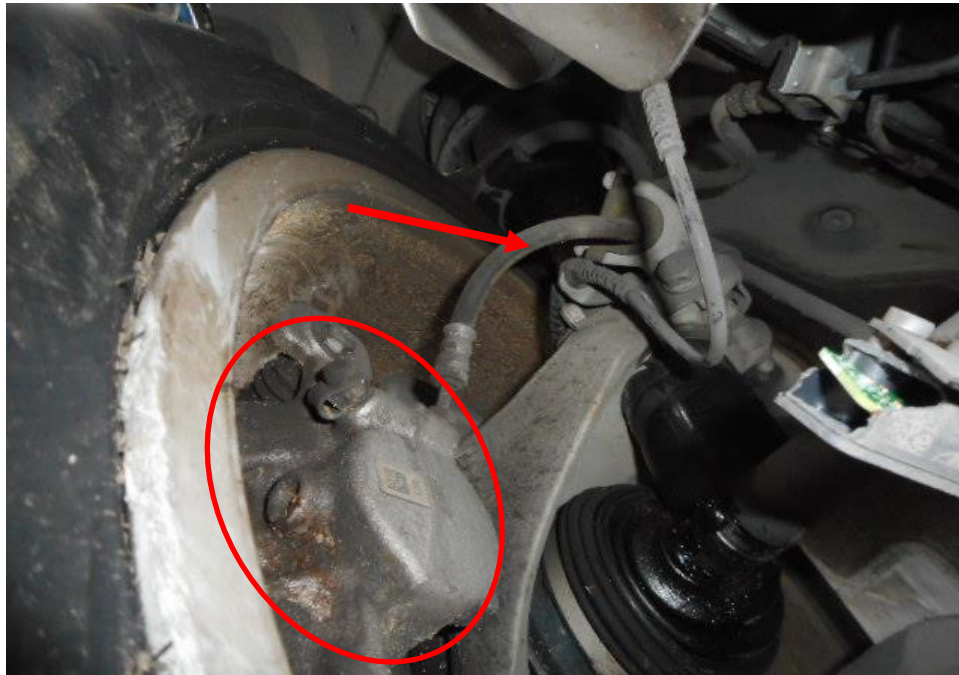
**Photo 29** shows the brake hose/pipe (arrowed) at the front right wheel of the Motor Car. I did not observe any leakage of brake fluid at the time of my inspection of the Motor Car. Visual examination of the various components of the braking system the brake caliper (circled) to be intact and without visible damage.

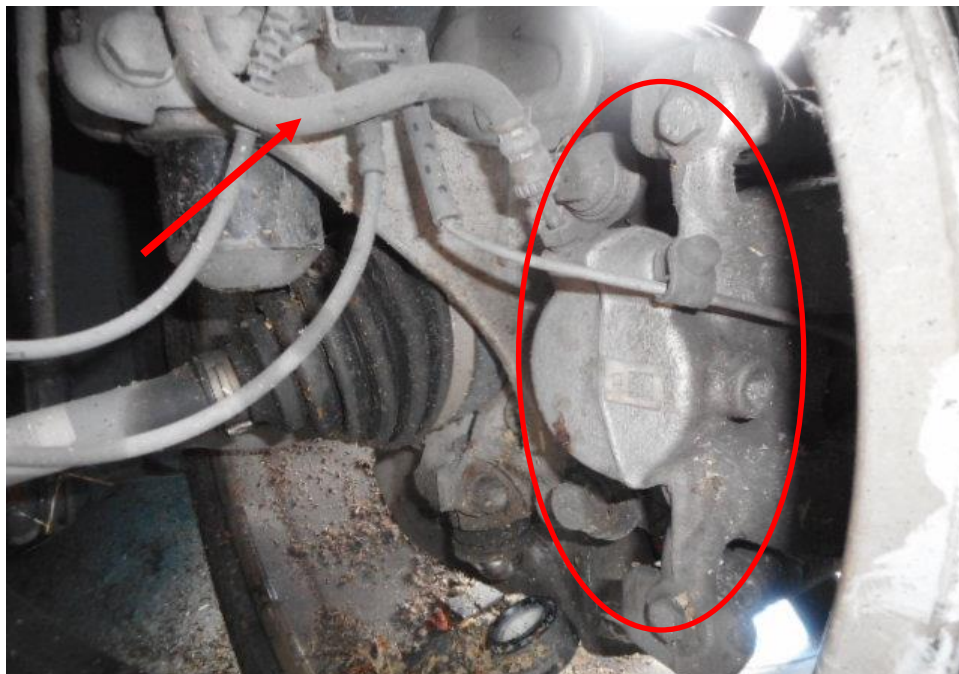
**Photo 30** shows the brake hose/pipe (arrowed) at the front left wheel of the Motor Car. No leakage of brake fluid was observed. Visual examination of the various components of the braking system like the brake caliper (circled), brake booster, brake pedal etc had revealed all to be intact and without visible damage.

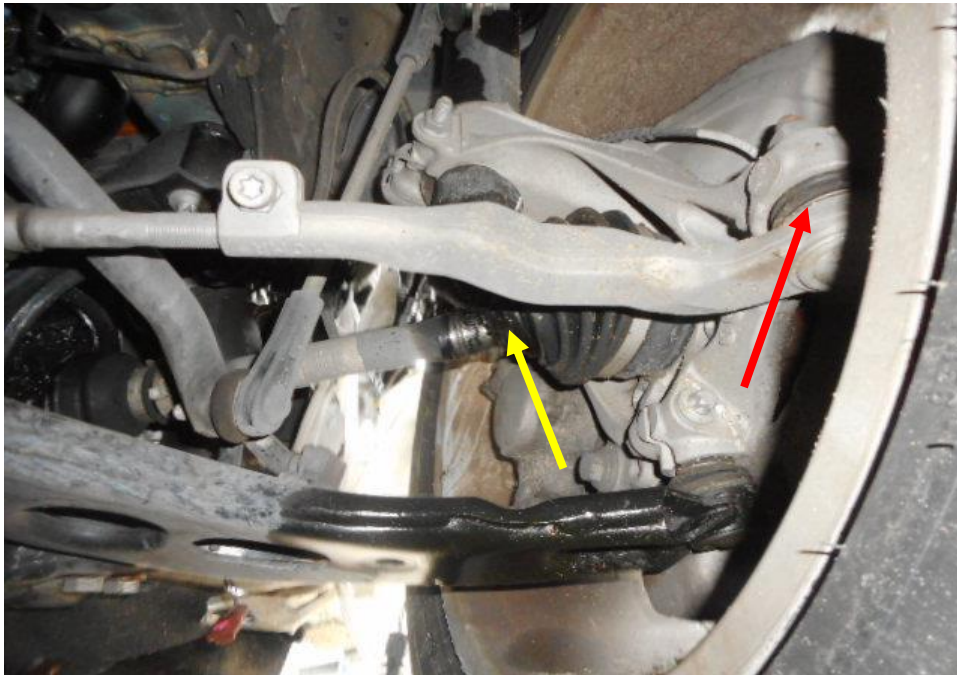
**Photo 31** shows the various undercarriage components at the front right wheel of the Motor Car, in particular the steering tie rod (red arrow) the various steering components were all found to be intact, however the driveshaft (yellow arrow) was observed to be damaged as a result of the accident.
