Your Ref: TP/IP/01105/2023  
Our Ref : CI/TPD23001590/P

**Fatal Accident Investigation Team**

**MECHANICAL INSPECTION REPORT OF MOTOR CAR SLT 2012E**

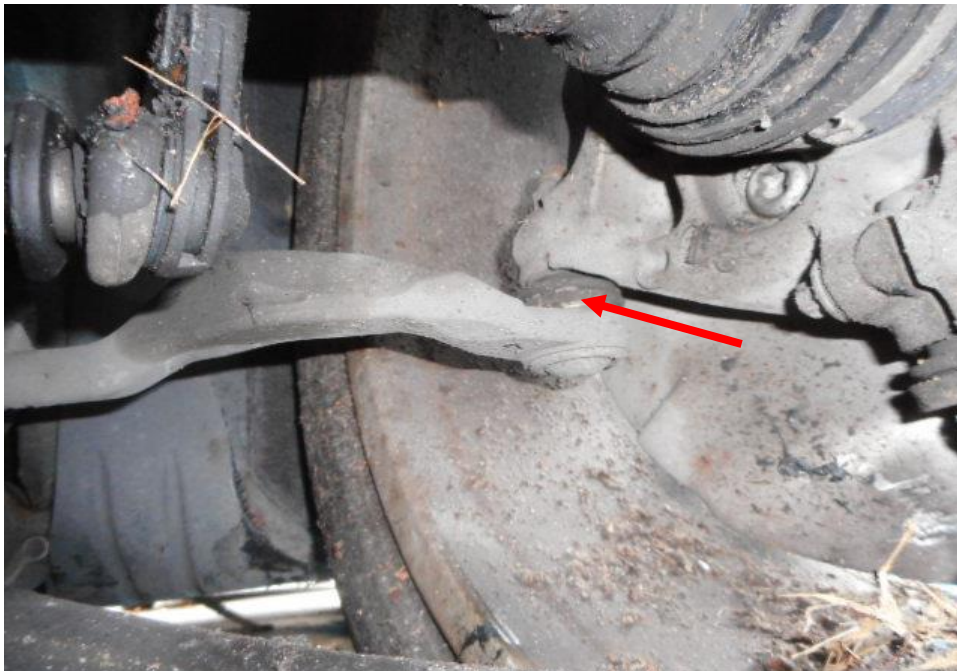
**Photo 32** shows the various undercarriage components at the front right wheel of the Motor Car, in particular the steering tie rod (arrowed) were found to be intact.

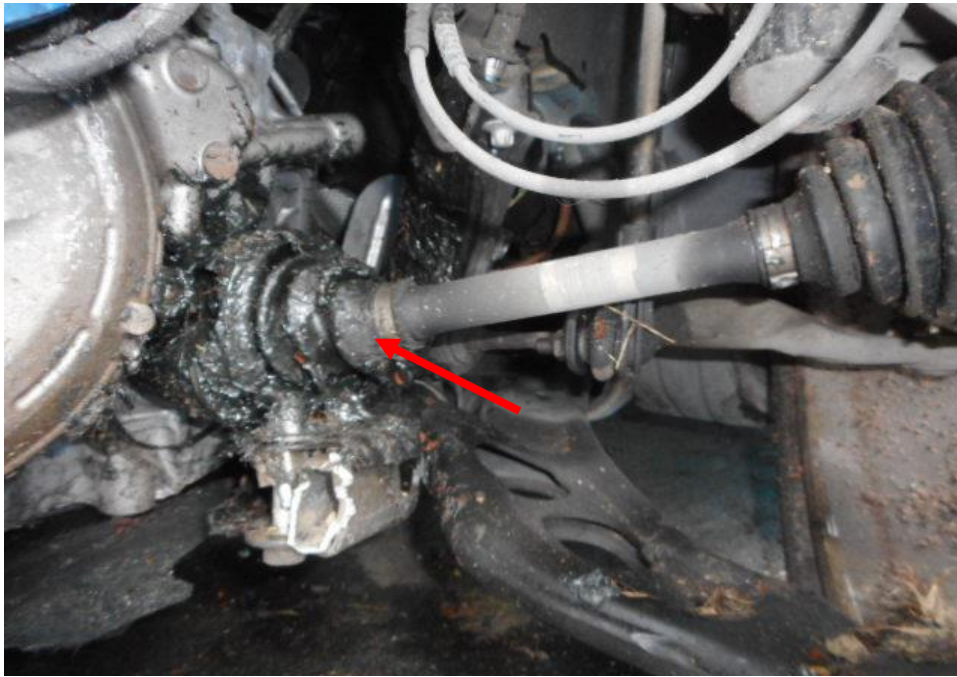
**Photo 33** shows the various undercarriage components at the front right wheel of the Motor Car, in particular the driveshaft (arrowed) was observed to be damaged as a result of the accident.

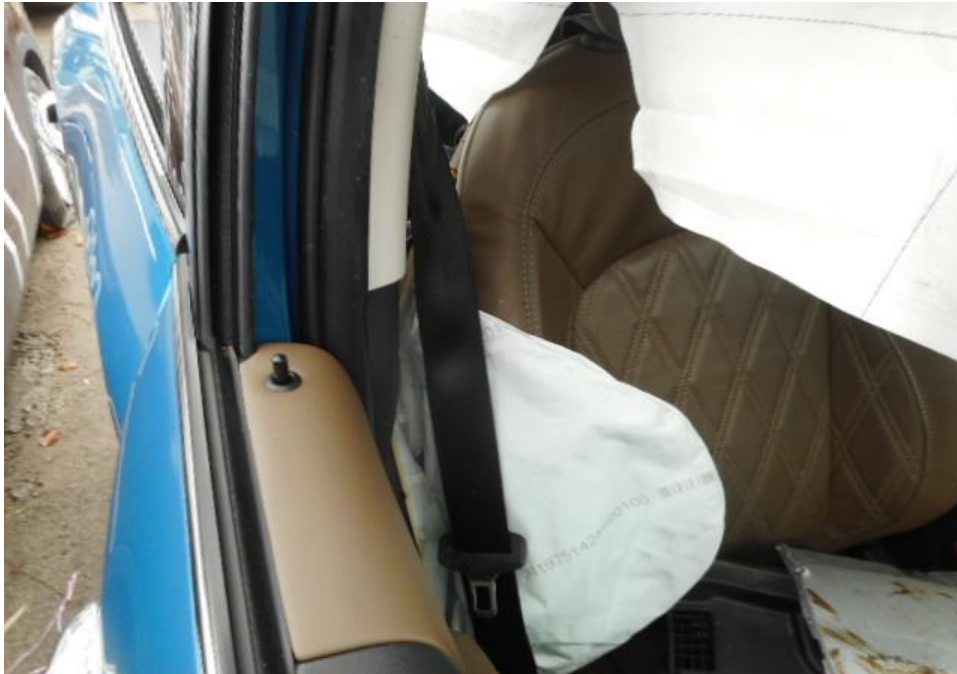
**Photo 34** shows that the seat belt on the right seat was worn at the material time of accident as the safety pre-tensioners was activated at the moment of impact and caused the seat belt to be locked into the last position.

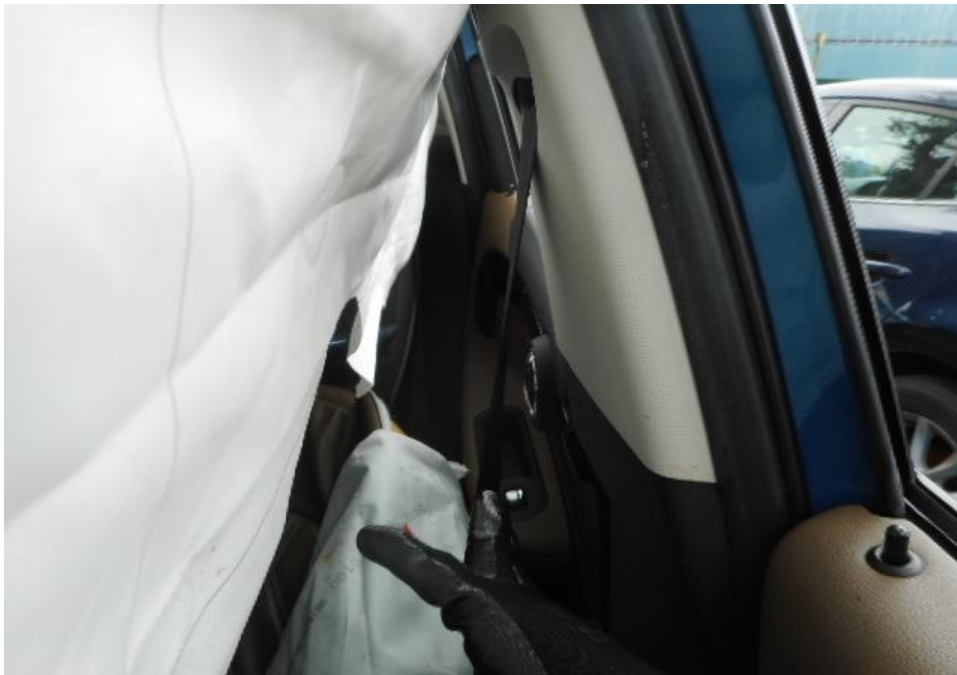
**Photo 35** shows that the seat belt on the left seat was not worn at the material time of accident as the safety pre-tensioners was activated at the moment of impact and caused the seat belt to be locked into the last position.
