Your Ref: TP/IP/24772/2022
Our Ref : CI/TPD23001592/P

Fatal Accident Investigation Team

MECHANICAL INSPECTION REPORT OF MOTOR VAN GBD 7875B

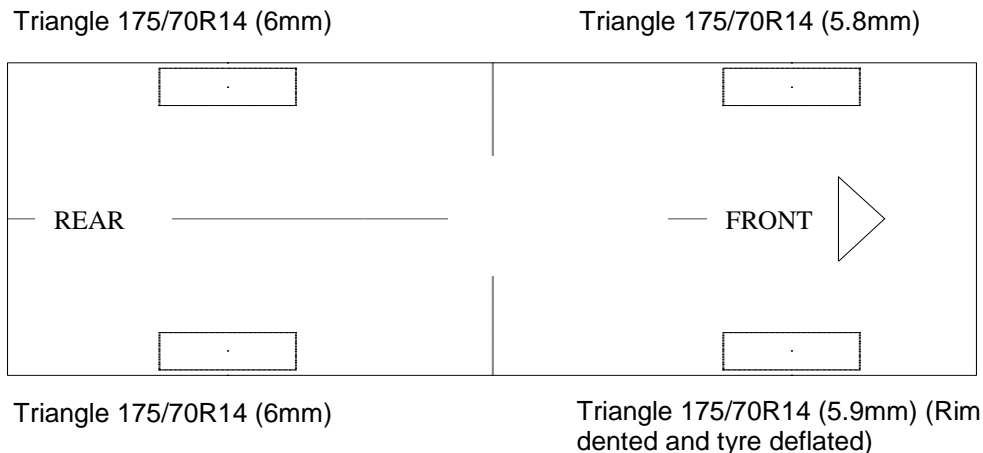
6. The Motor Van's front right wheel rim was observed to be dented and its tyre was observed to be deflated as a result of the accident. The front left, rear left and right tyres and wheel rims was observed to be in serviceable condition. I did not find any tear, cut or burst mark(s) on the outer and the inner sidewalls as well as across the tread of the 4 tyres. The front left, rear left and right tyres were observed to be sufficiently inflated for vehicular operation. The tyre brand, tyre size and remaining tread depth of the 4 tyres were recorded as follows:-

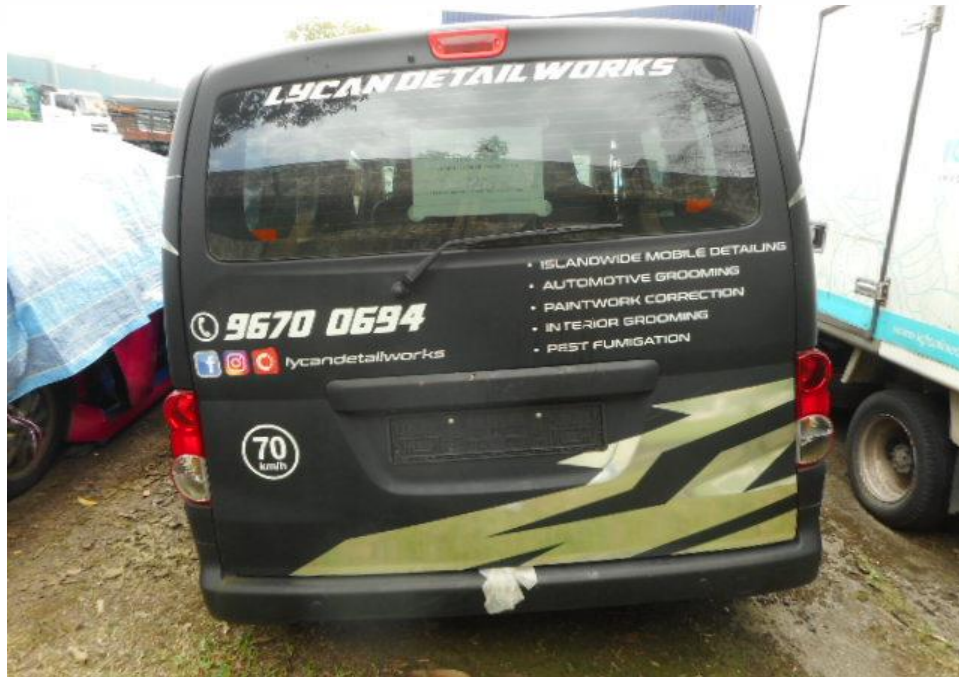
Photo 1 shows a general view of the Motor Van's rear body at the time of my inspection. The rear portion of the Motor Van was observed to have been undamaged by the accident.

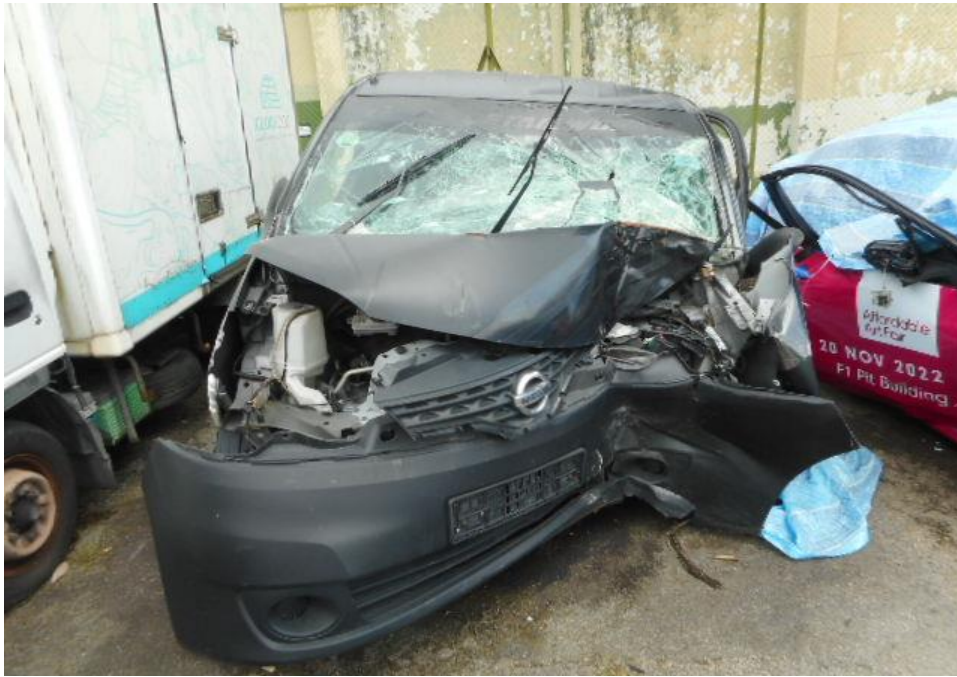
Photo 3 shows a general view of the Motor Van's front body at the time of my inspection. The Motor Van was observed to have sustained damage at its front and left portion. Its windscreen, front bonnet, front bumper, front left fender and left door was the body parts and various engine compartments were also damaged as a result of the accident. The Supplemental Restraint System (SRS) was activated as a result of the accident.

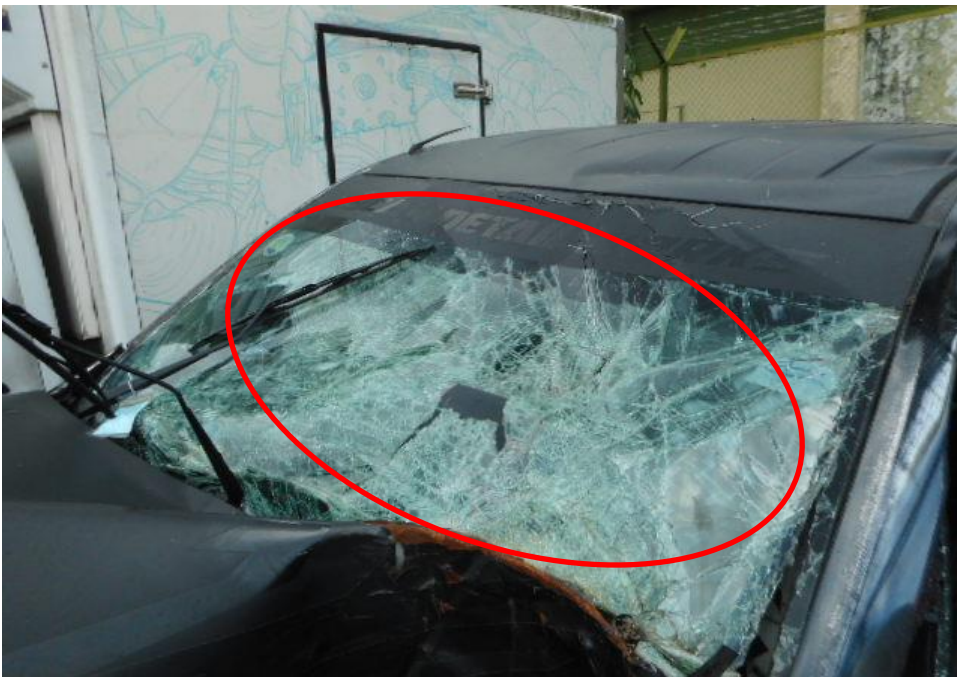
Photo 4 shows the close up view of the Motor Van's front body at the time of my inspection. The Motor Van was observed to have sustained damage at its front portion. Its front windscreen (circled) was damaged as a result of the accident.

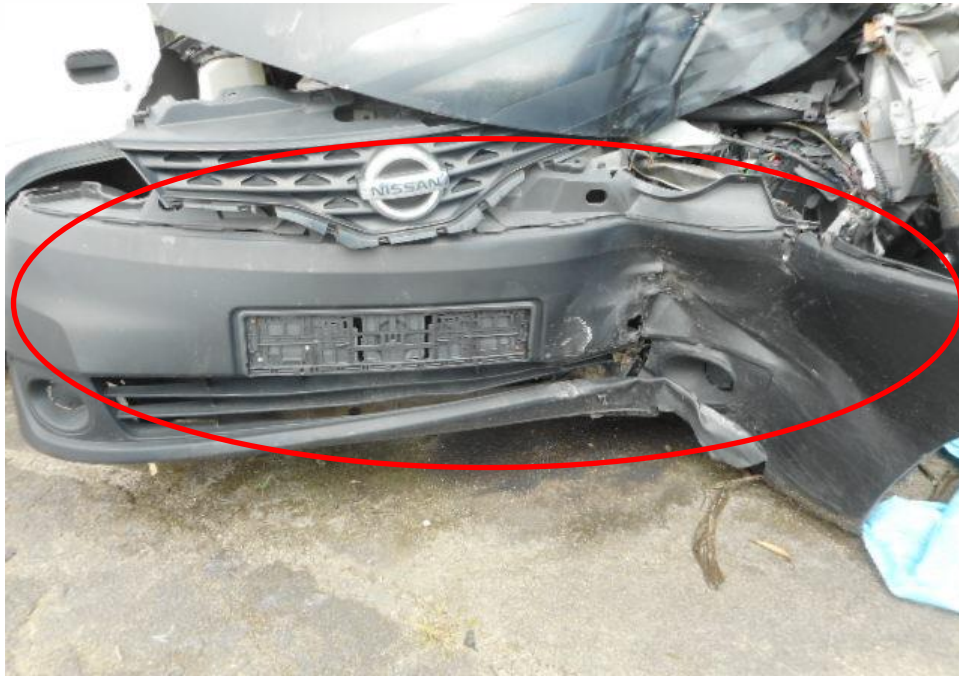
Photo 5 shows the close up view of the Motor Van's front body at the time of my inspection. The Motor Van was observed to have sustained damage at its front portion. Its front bumper (circled) was damaged as a result of the accident.

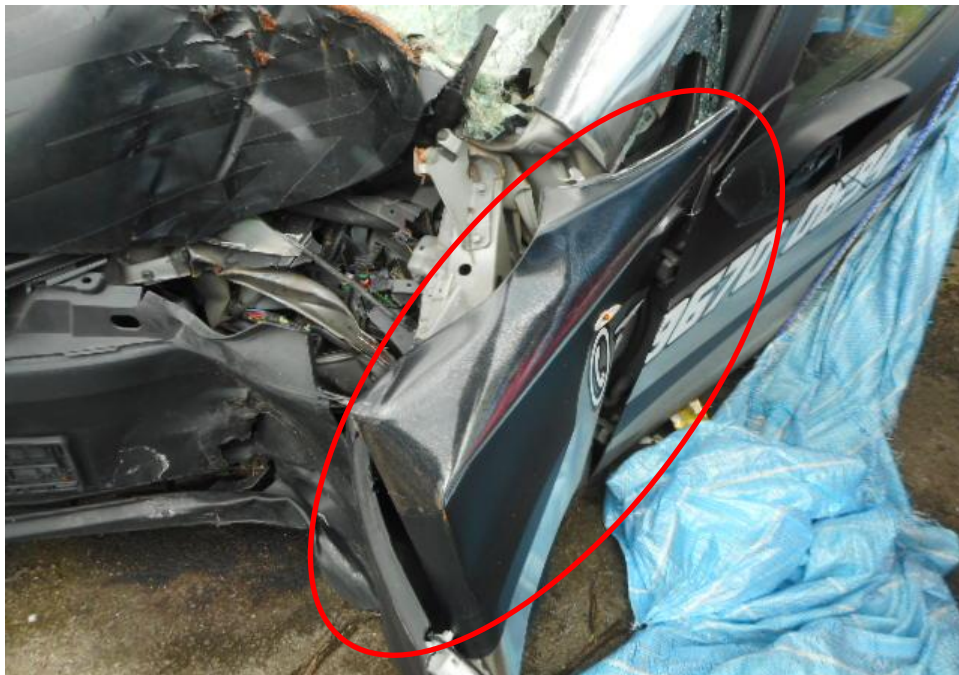
Photo 6 shows the close up view of the Motor Van's front body at the time of my inspection. The Motor Van was observed to have sustained damage at its front portion. Its front left fender (circled) was damaged as a result of the accident.

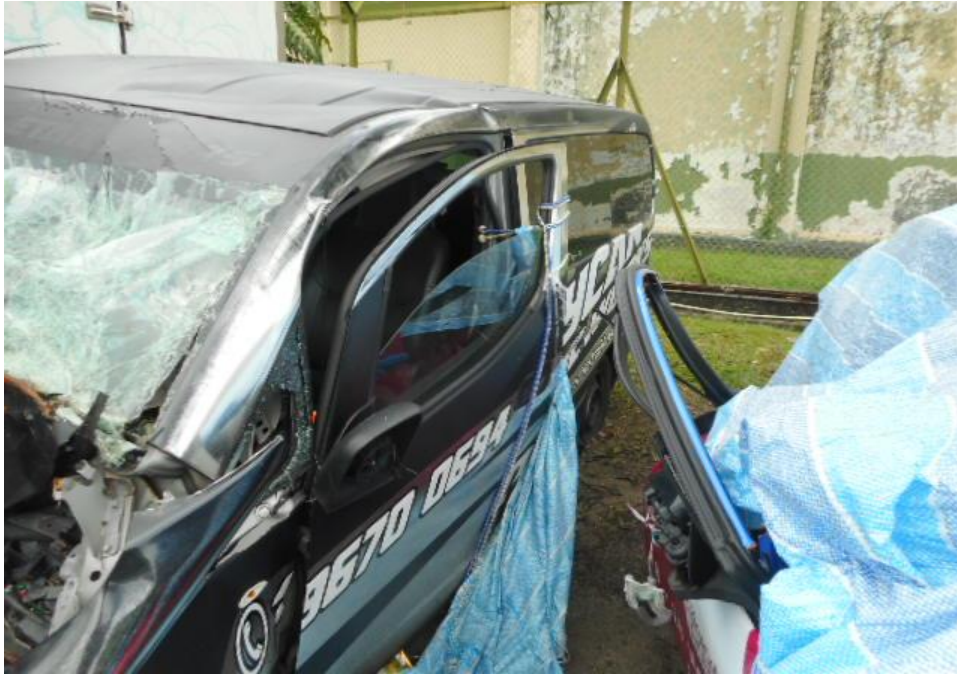
Photo 7 shows a general view of the Motor Van's left body at the time of my inspection. The Motor Van was observed to have sustained damage at its left portion. Its left door (circled) was damaged as a result of the accident.

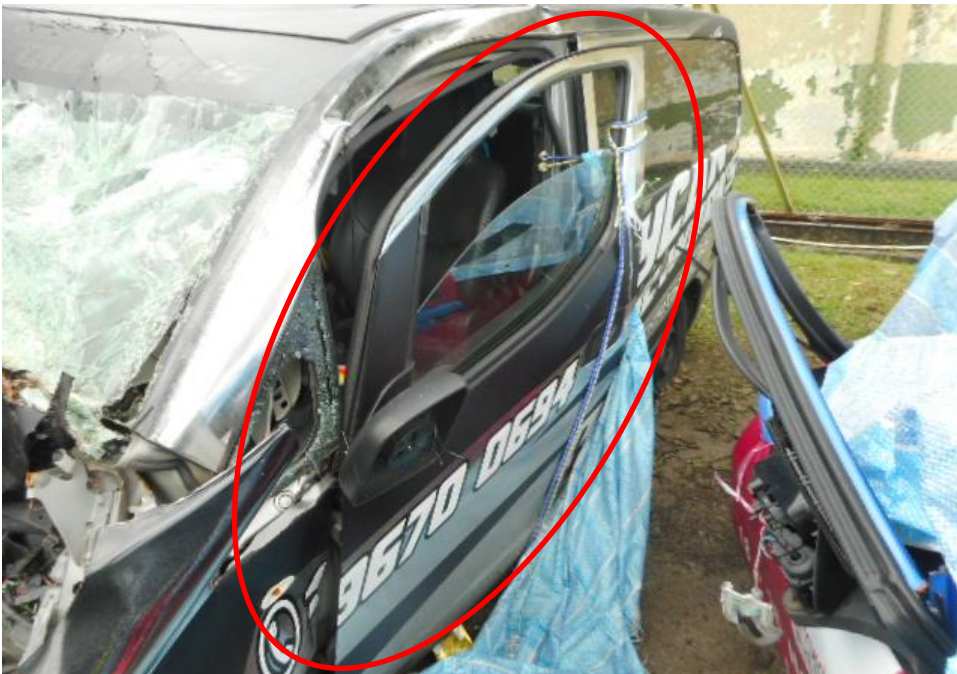
Photo 8 shows the close up view of the Motor Van's left body at the time of my inspection. The Motor Van was observed to have sustained damage at its left portion. Its left door (circled) was damaged as a result of the accident.

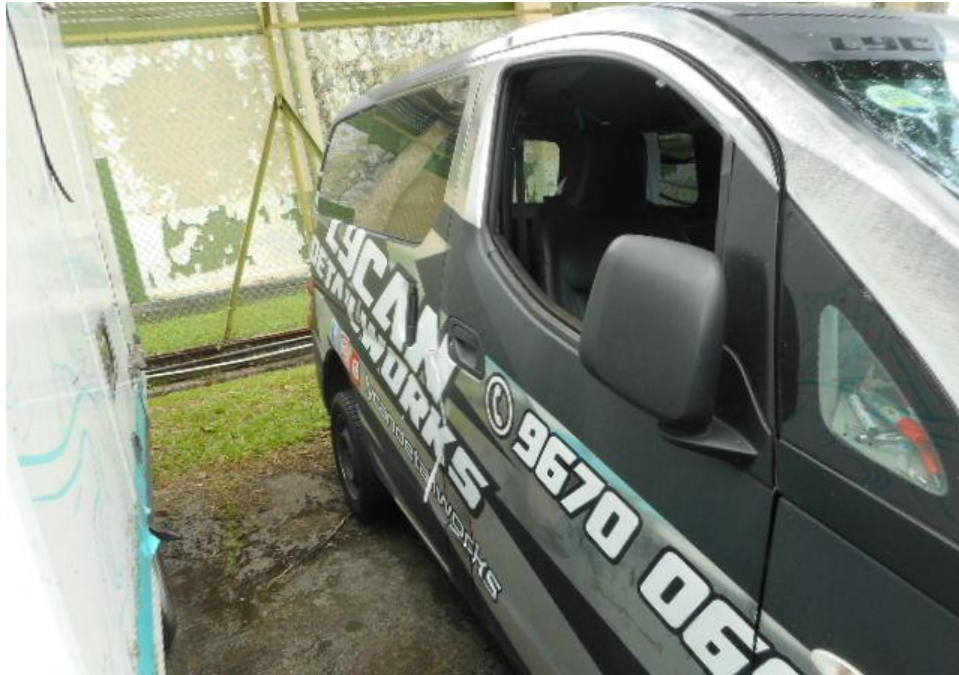
Photo 9 shows a general view of the Motor Van's right body at the time of my inspection. The right portion of the Motor Van was observed to have been undamaged by the accident.

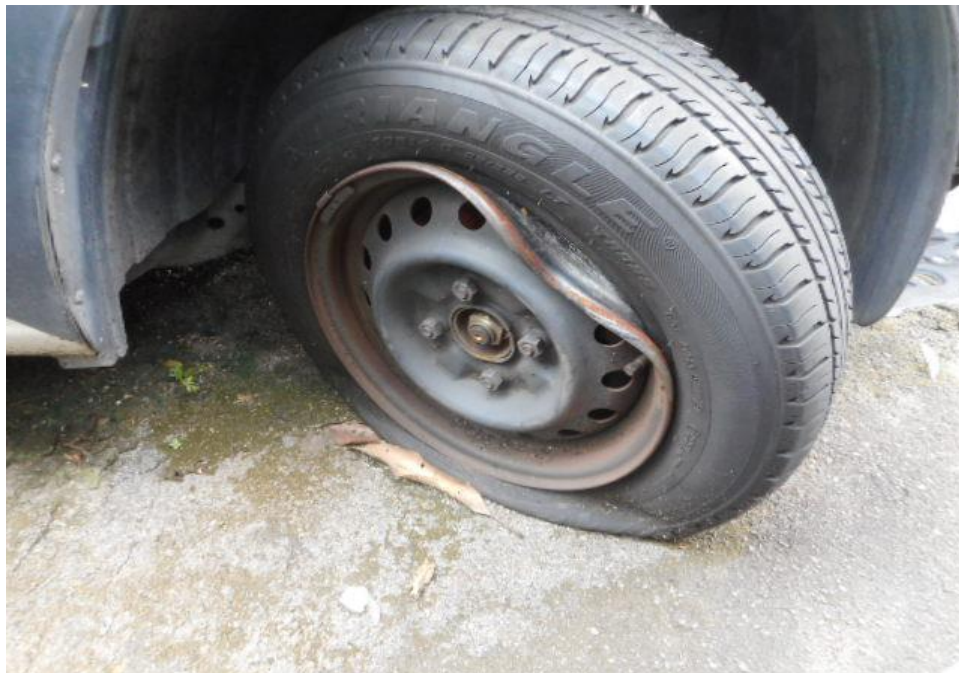
Photo 10 shows the general condition of the front right tyre and wheel rim of the Motor Van. The wheel rim was observed to be dented and its tyre was observed deflated as a result of the accident.

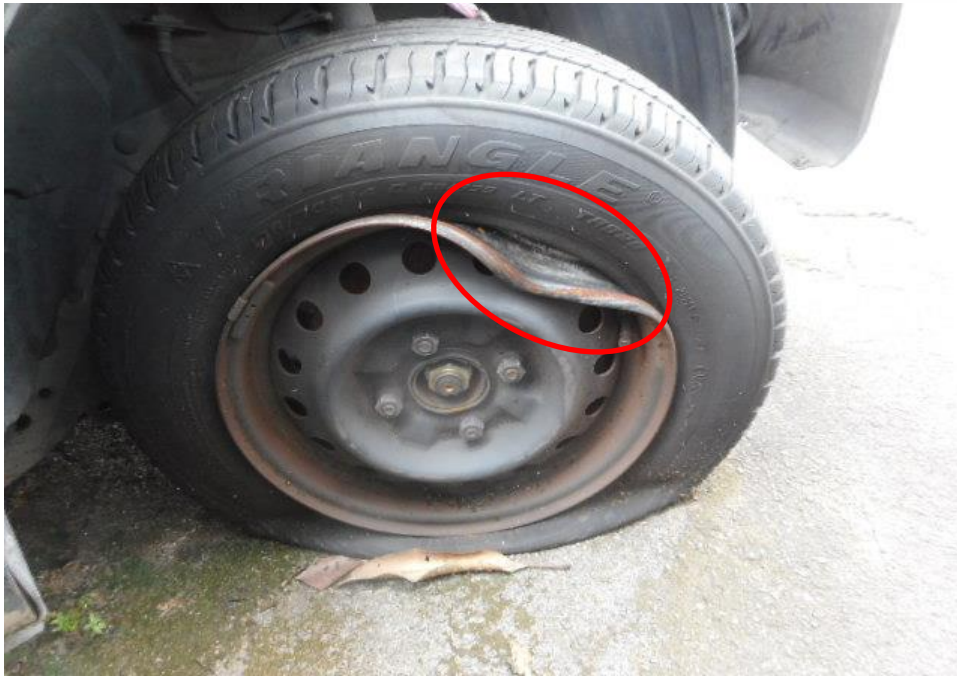
Photo 11 shows the close up condition of the front right tyre and wheel rim of the Motor Van, the wheel rim was dented and the tyre was observed to be and deflated (circled) as a result of the accident with remaining tread depth of approximately 5.9mm.

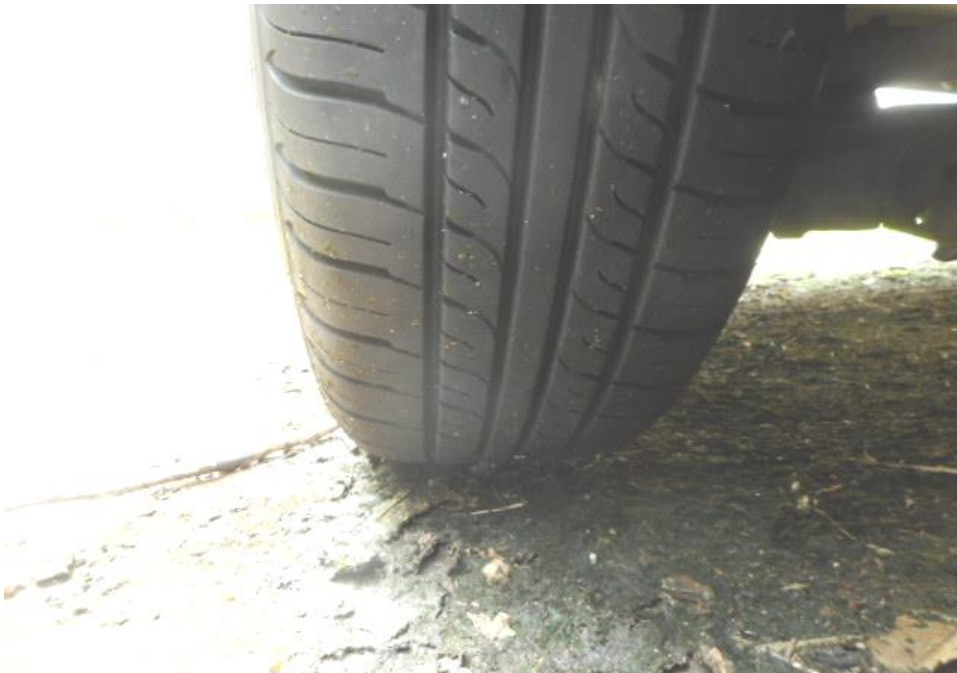
Photo 12 shows the general condition of the rear right tyre of the Motor Van, which was observed to be in serviceable condition with remaining tread depth of approximately 6m. The tyre was also observed to be sufficiently inflated for vehicular operation with no tear, cut or burst mark(s).

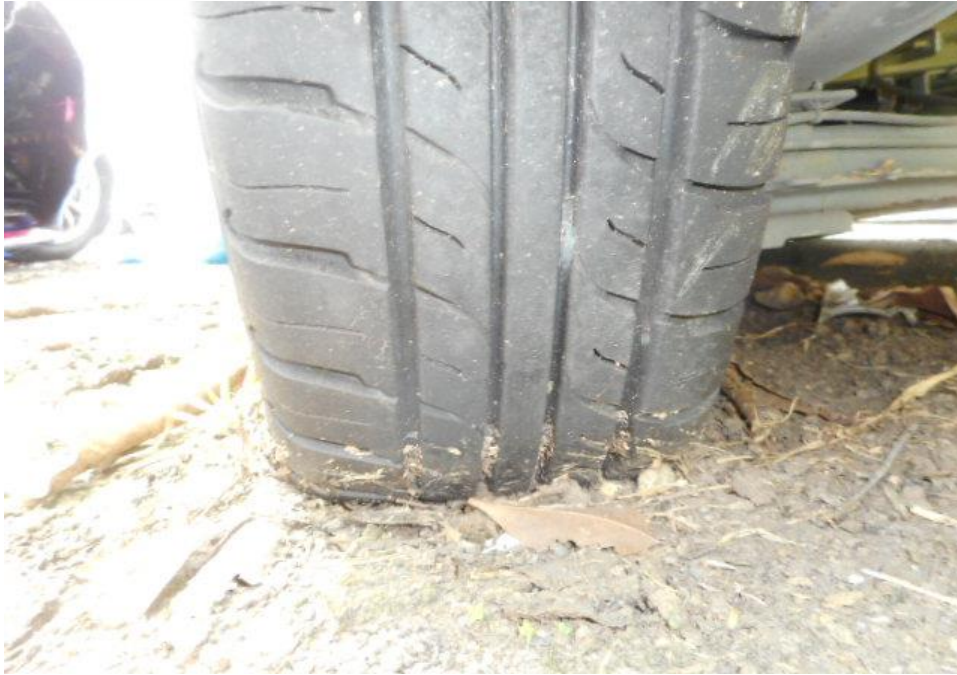
Photo 13 shows the condition of the rear left tyre of the Motor Van, which was observed to be in serviceable condition with remaining tread depth of approximately 6mm. The tyre was also observed to be sufficiently inflated for vehicular operation with no tear, cut or burst mark(s).

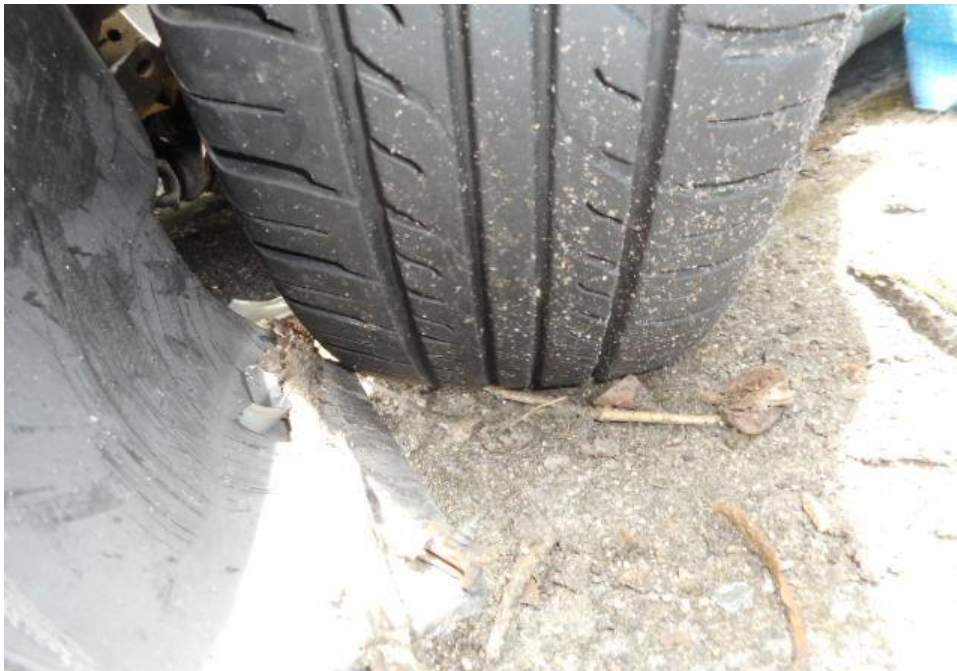
Photo 14 shows the condition of the front left tyre of the Motor Van, which was observed to be in serviceable condition with remaining tread depth of approximately 5.8mm. The tyre was also observed to be sufficiently inflated for vehicular operation with no tear, cut or burst mark(s).

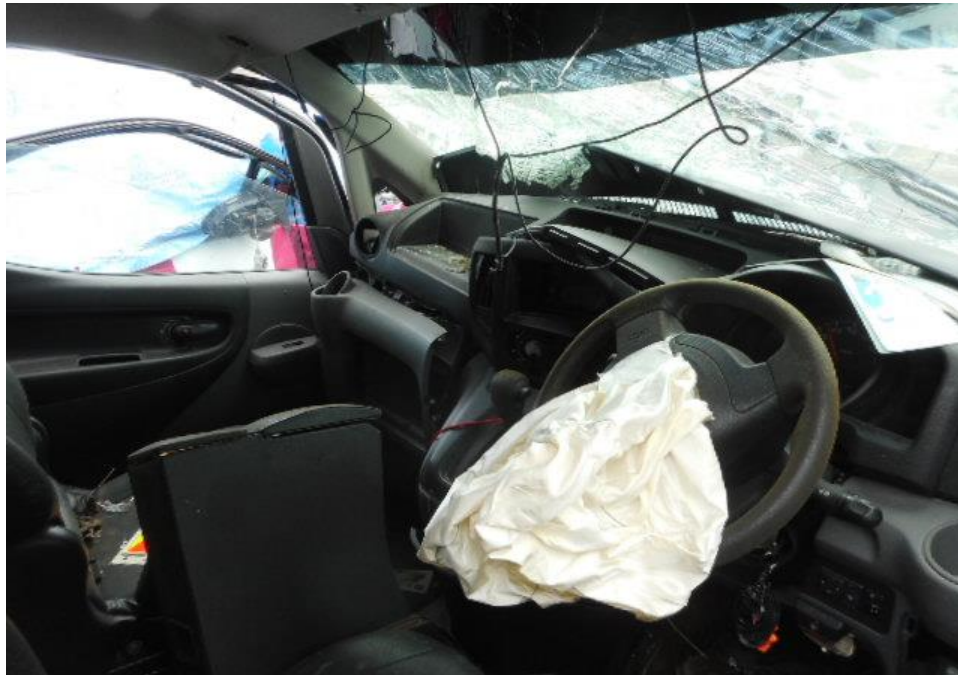
Photo 15 shows the deployment of the Supplemental Restraint System (SRS) airbag in the Motor Van as a result of the accident.

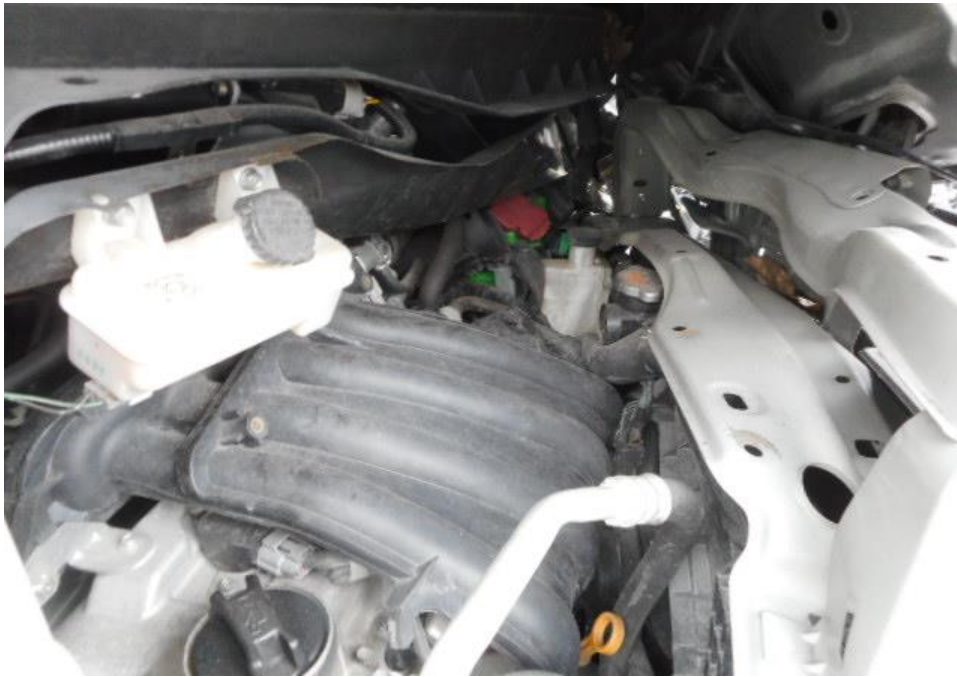
Photo 16 shows a general view of the Motor Van's engine compartment. The various parts and components inside the engine compartment were observed that the engine and ignition system was damaged as a result of the induced impact from the accident.

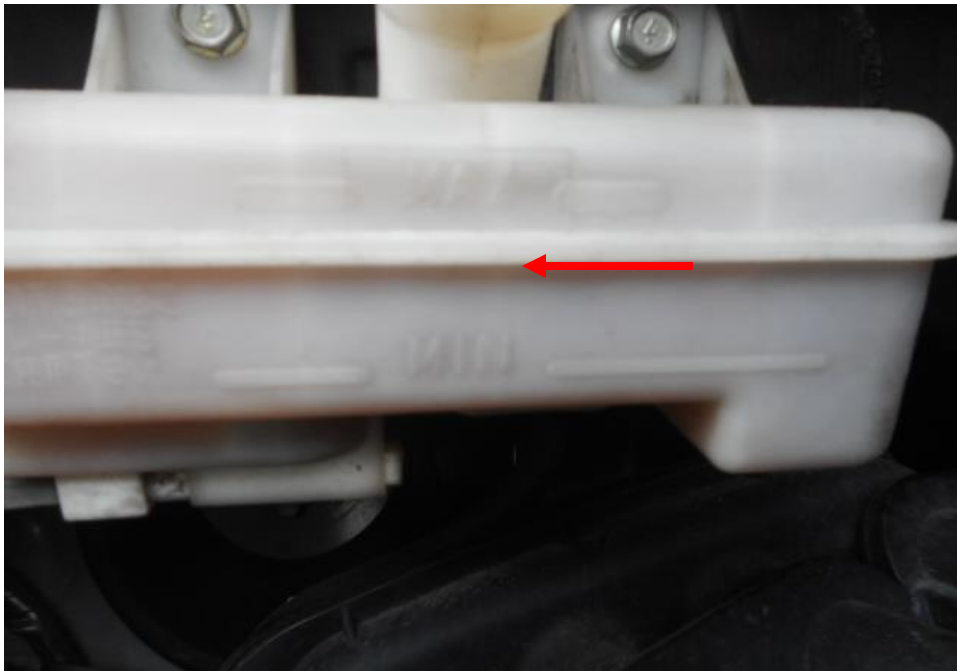
Photo 17 shows checks being carried out to the brake fluid reservoir of the Motor Van at the time of my inspection. The brake fluid was observed to be of sufficient level (arrowed) and without any visible contamination.

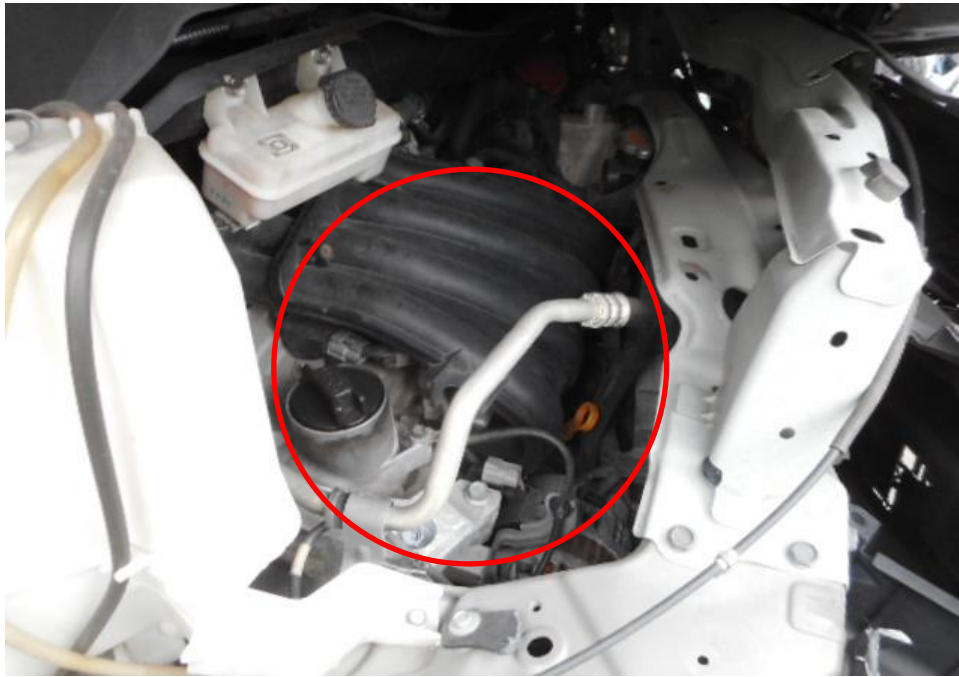
Photo 18 shows the close up view of the Motor Van's front body at the time of my inspection. The Motor Van was observed to have sustained damage at its front portion. Its engine (circled) was amongst the various components in the engine compartments were also damaged as a result of the accident.

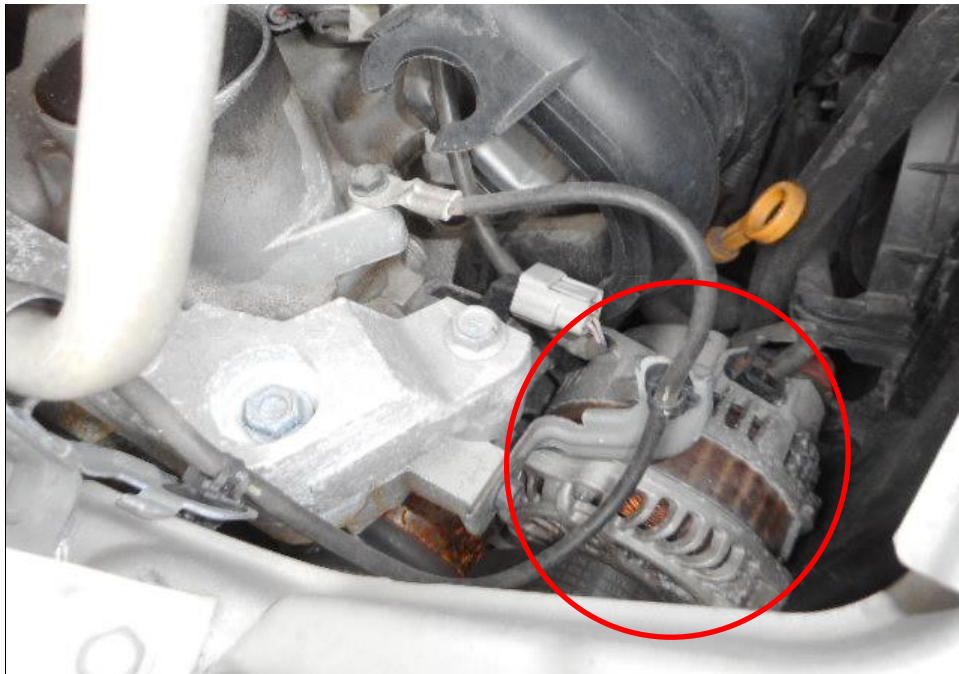
Photo 19 shows the close up view of the Motor Van's front body at the time of my inspection. The Motor Van was observed to have sustained damage at its front portion. Its ignition system (circled) was amongst the various components in the engine compartments were also damaged as a result of the accident.

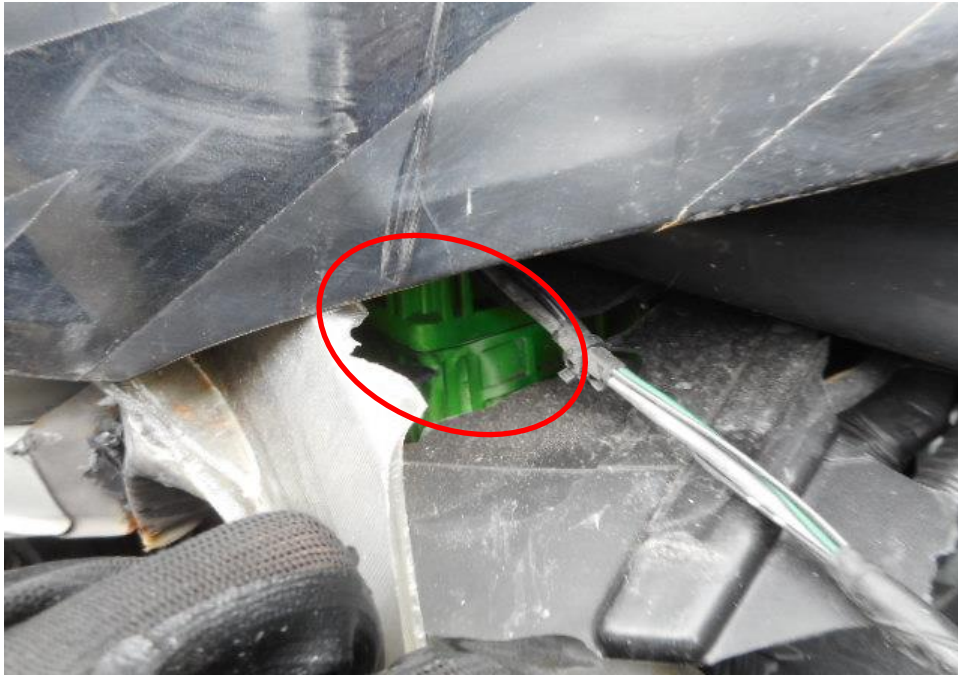
Photo 20 shows the close up view of the Motor Van's front body at the time of my inspection. The Motor Van was observed to have sustained damage at its front portion. Its ignition system battery (circled) was amongst the various components in the engine compartments were also damaged as a result of the accident.

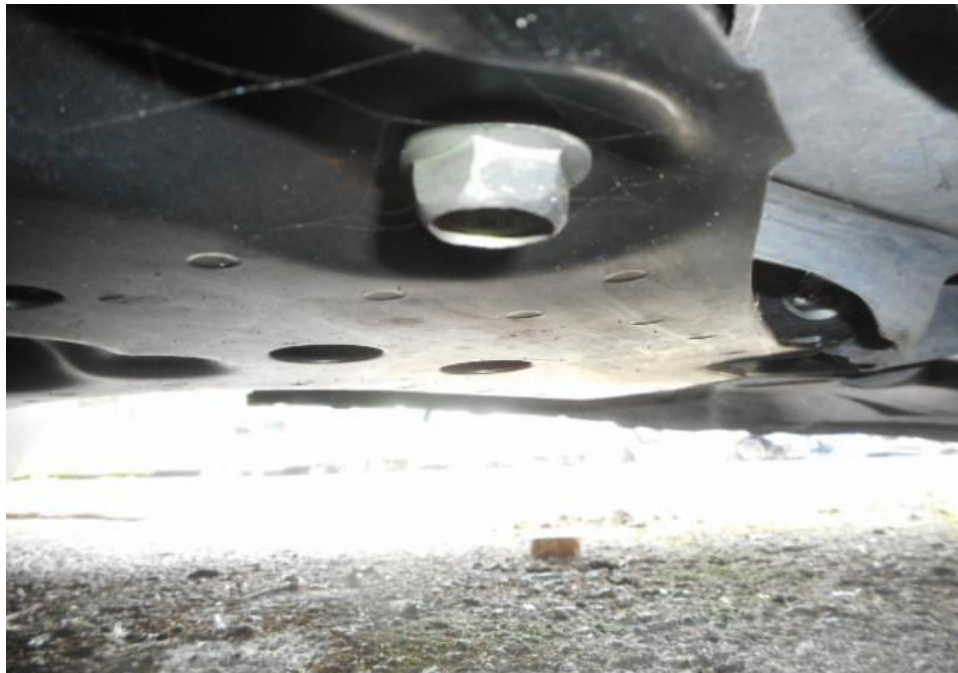
Photo 21 shows the undercarriage of the Motor Van, at the area where the engine housing and transmission housing are located. I did not find any sign(s) or indication(s) of fluid leak and/or fluid stain(s) on the underside of the Motor Van.

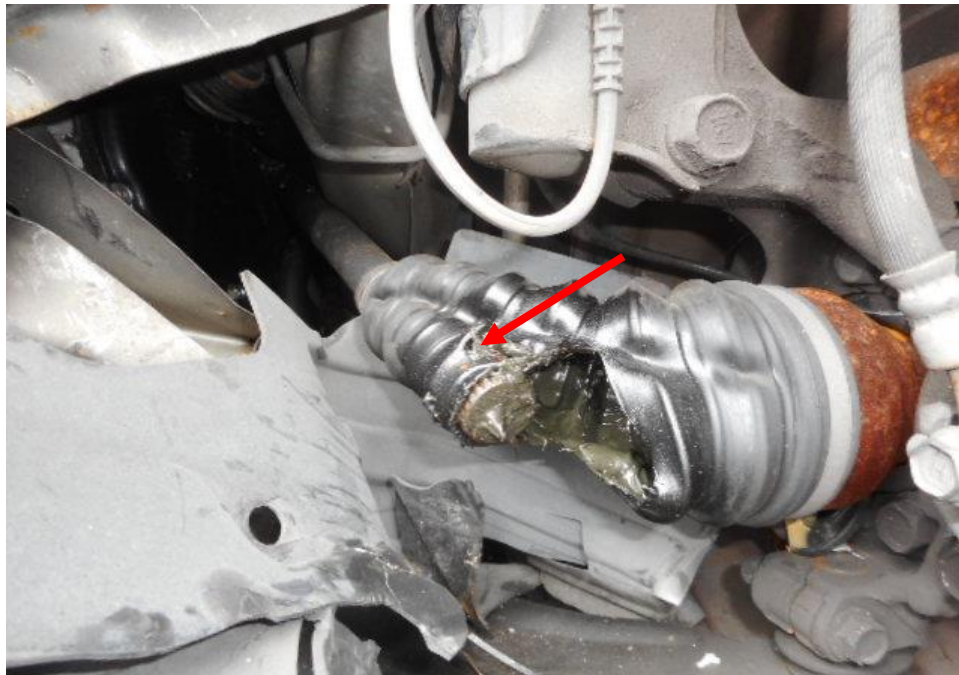
Photo 22 shows the various undercarriage components at the front left wheel of the Motor Van, in particular the left driveshaft (arrowed) was observed to be broken off as a result of the accident.

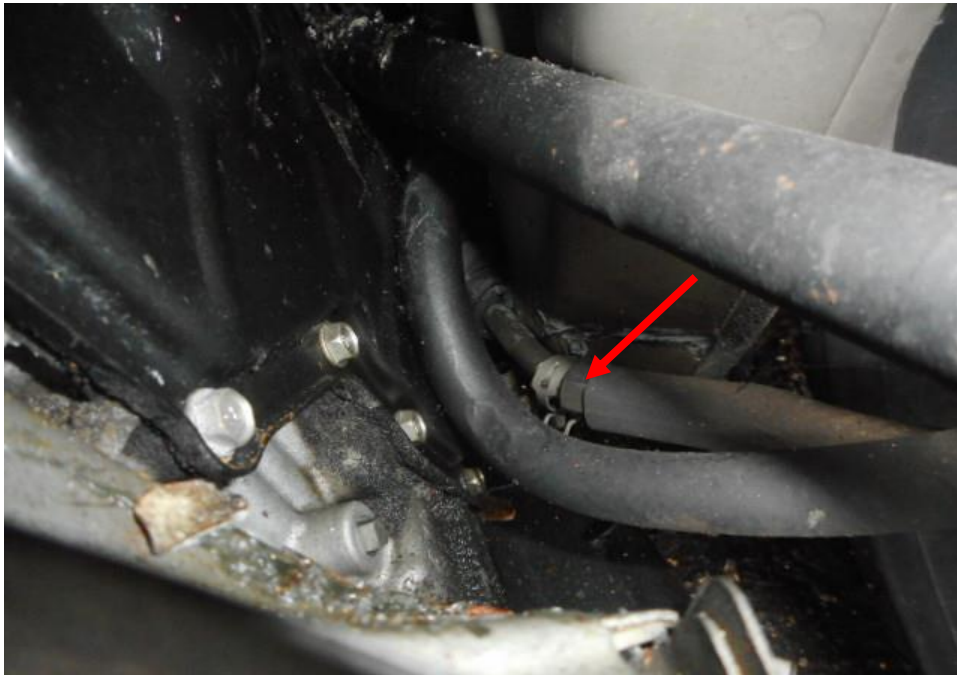
Photo 23 shows the various undercarriage components at the front left wheel of the Motor Van, in particular the steering tie rod (arrowed) was observed to be bent as a result of the accident.

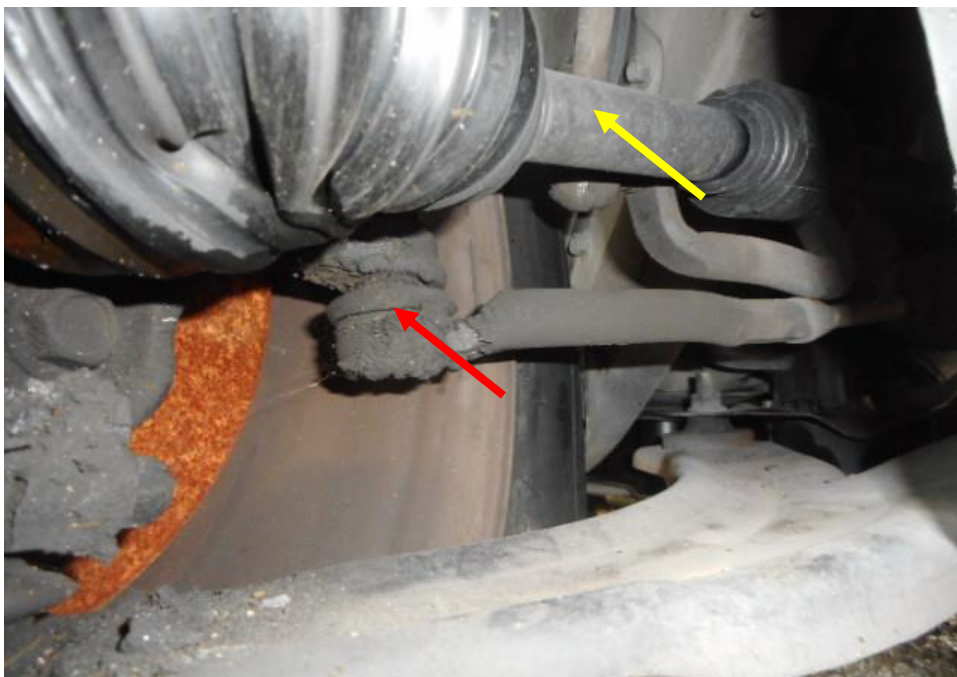
Photo 24 shows the various undercarriage components at the front right wheel of the Motor Van, in particular the steering tie rod (red arrow) and right driveshaft (yellow arrow) was observed to be intact.

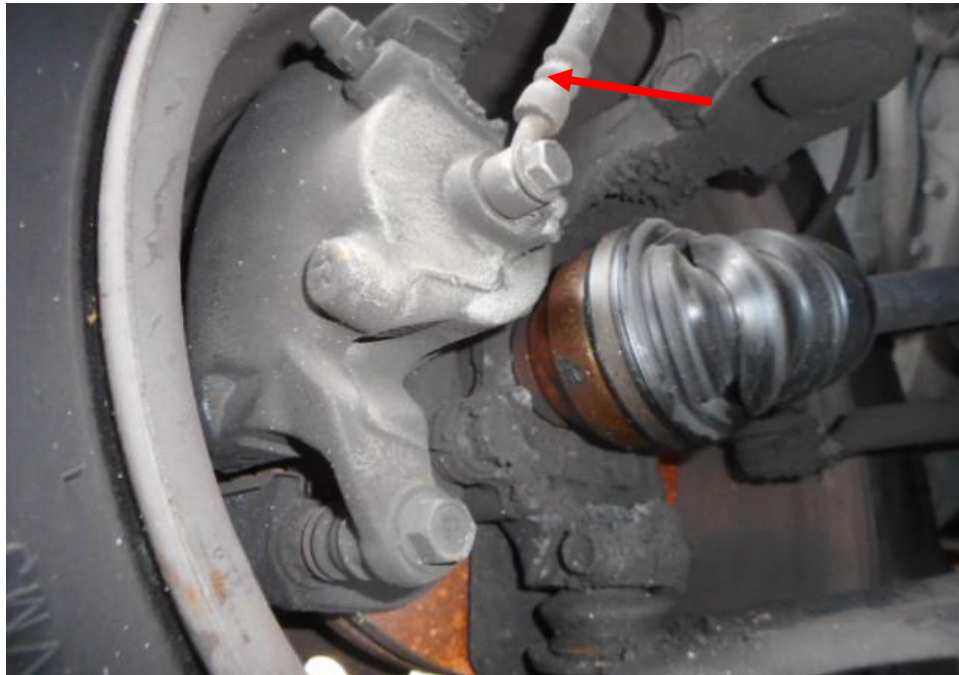
Photo 25 shows the brake hose/pipe (arrowed) at the front right wheel of the Motor Van. No leakage of brake fluid was observed. Visual examination of the various components of the braking system like the brake caliper (circled) etc had revealed all to be intact and without visible damage.

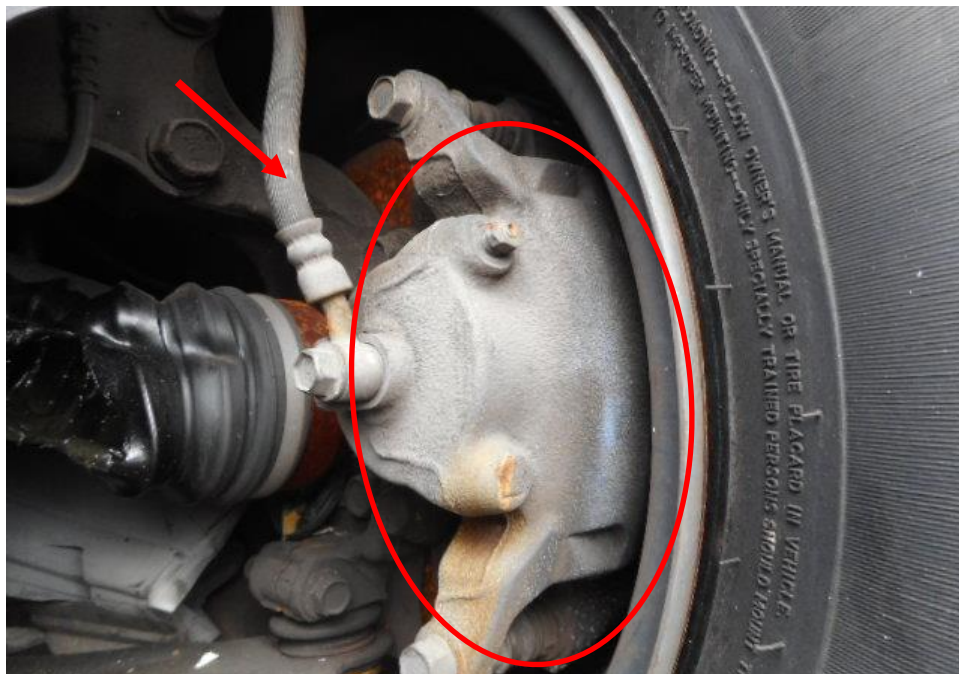
Photo 26 shows the brake hose/pipe (arrowed) at the front left wheel of the Motor Van. No leakage of brake fluid was observed. Visual examination of the various components of the braking system like the brake caliper (circled) etc had revealed all to be intact and without visible damage.

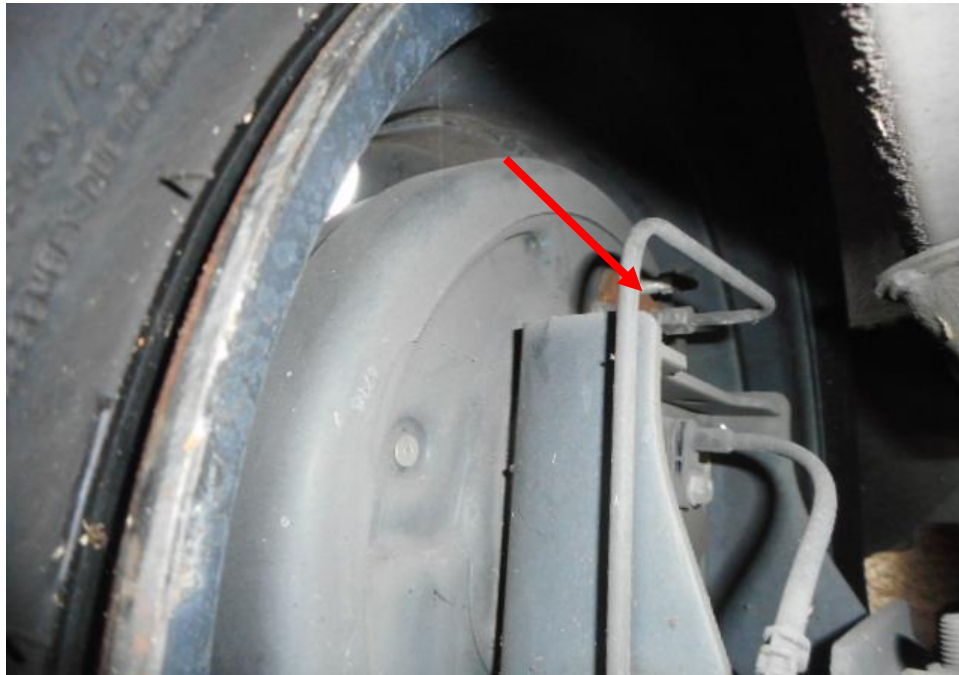
Photo 27 shows the brake hose/pipe (arrowed) at the rear left wheel of the Motor Van. No leakage of brake fluid was observed. Visual examination of the various components of the braking system like the drum brake etc. had revealed all to be intact and without visible damage.

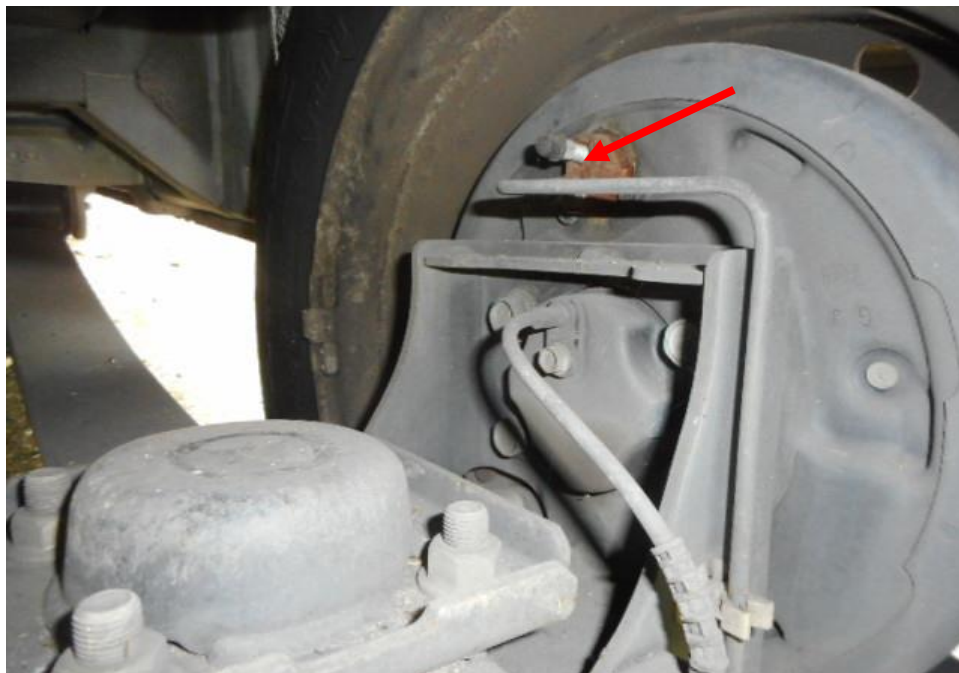
Photo 28 shows the brake hose/pipe (arrowed) at the rear right wheel of the Motor Van. No leakage of brake fluid was observed. Visual examination of the various components of the braking system like the drum brake etc. had revealed all to be intact and without visible damage.

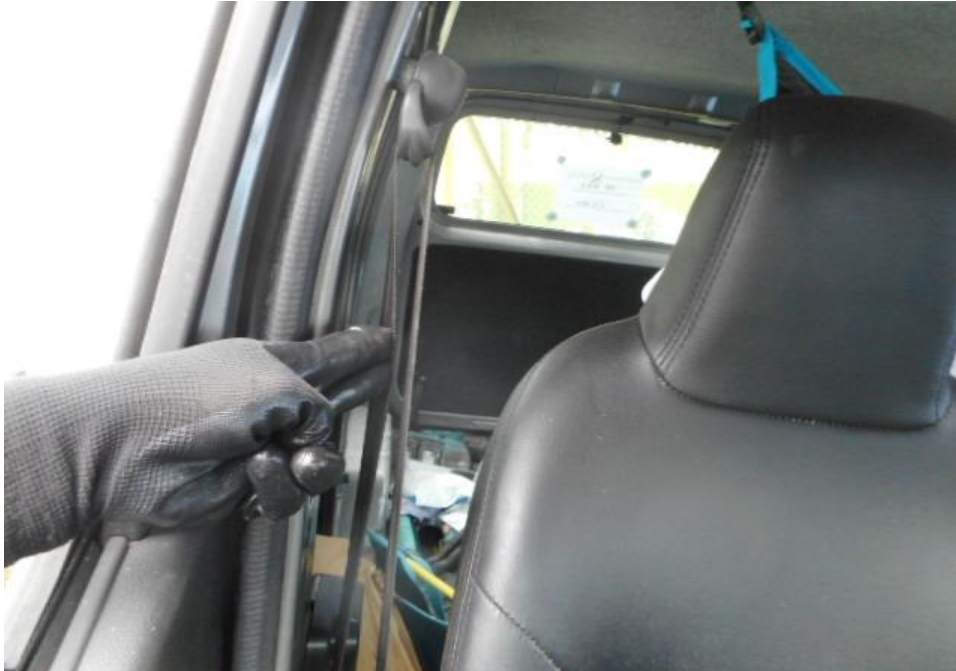
14. The front right and left seat belt of the "Motor Van" was not worn at the material time of accident as the respective pre-tensioners that were fitted at the side of each seat was activated upon the material time. See photo 29 and 30 below.

Photo 29 shows that the seat belt on the right seat was not worn at the material time of accident as the safety pre-tensioners was activated at the moment of impact and caused the seat belt to be locked into the last position.

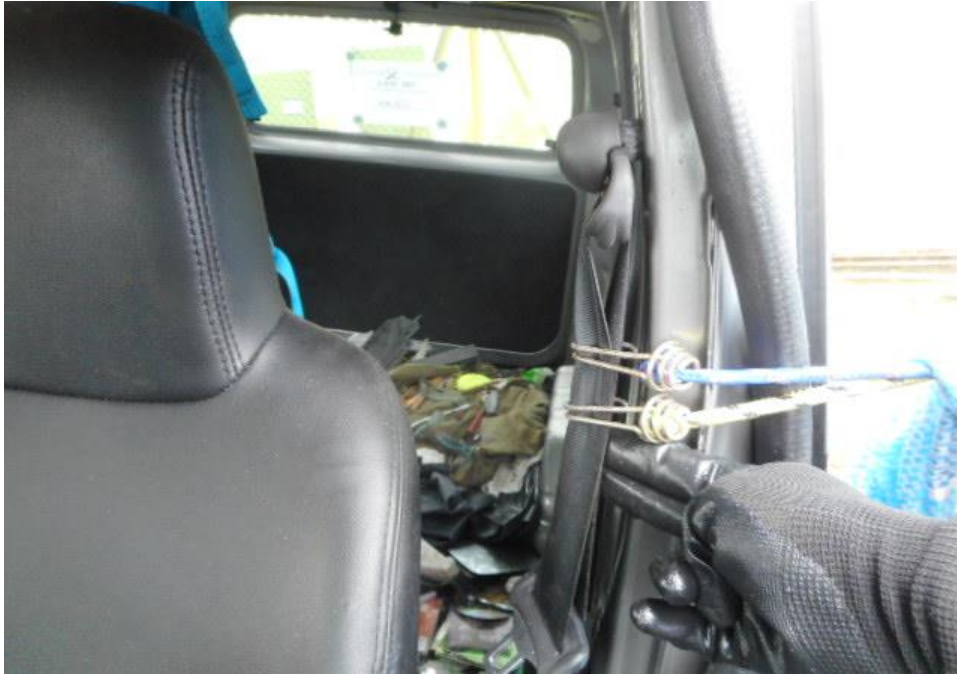
Photo 30 shows that the seat belt on the left seat was not worn at the material time of accident as the safety pre-tensioners was activated at the moment of impact and caused the seat belt to be locked into the last position.
