Your Ref: TP IP/32241/2022  
Our Ref : CI/TPD23001594/P

**Fatal Accident Investigation Team**

**MECHANICAL INSPECTION REPORT OF LORRY, BQU 2351**

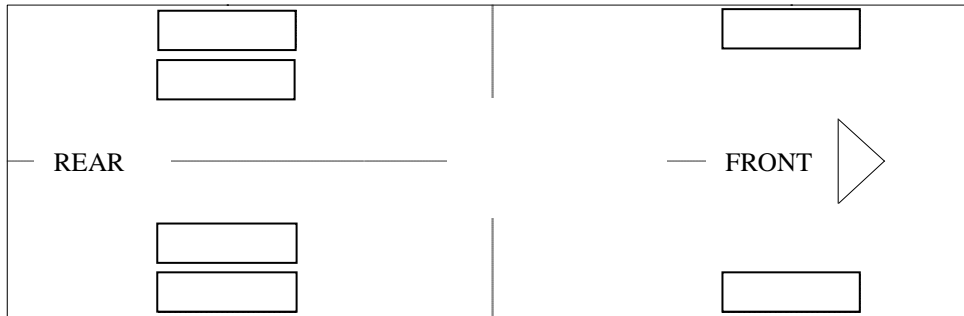
6. The 2 front tyres and 4 rear tyres of the Lorry were observed to be in serviceable condition and sufficiently inflated for vehicular operation. I did not find any tear, cut or burst mark(s) on the outer and the inner sidewalls as well as across the tread of the 6 tyres of the Lorry. The tyre brand, tyre size and remaining tread depth of the 6 tyres of the Lorry were recorded as follows:-

Bridgestone 295/80R22.5 (13.4mm)

Bridgestone 295/80R22.5 (12.7mm)

Bridgestone 295/80R22.5 (12.9mm)

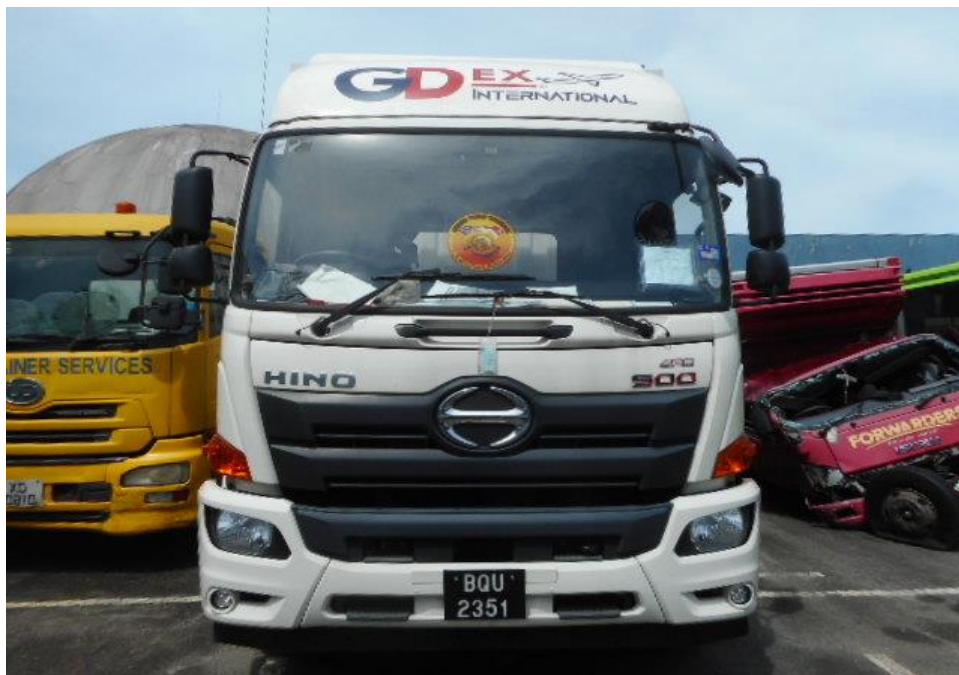
**Photo 1** shows a general view of the front body of the Lorry at the time of my inspection. The Lorry was observed to be intact and unaffected by the accident.

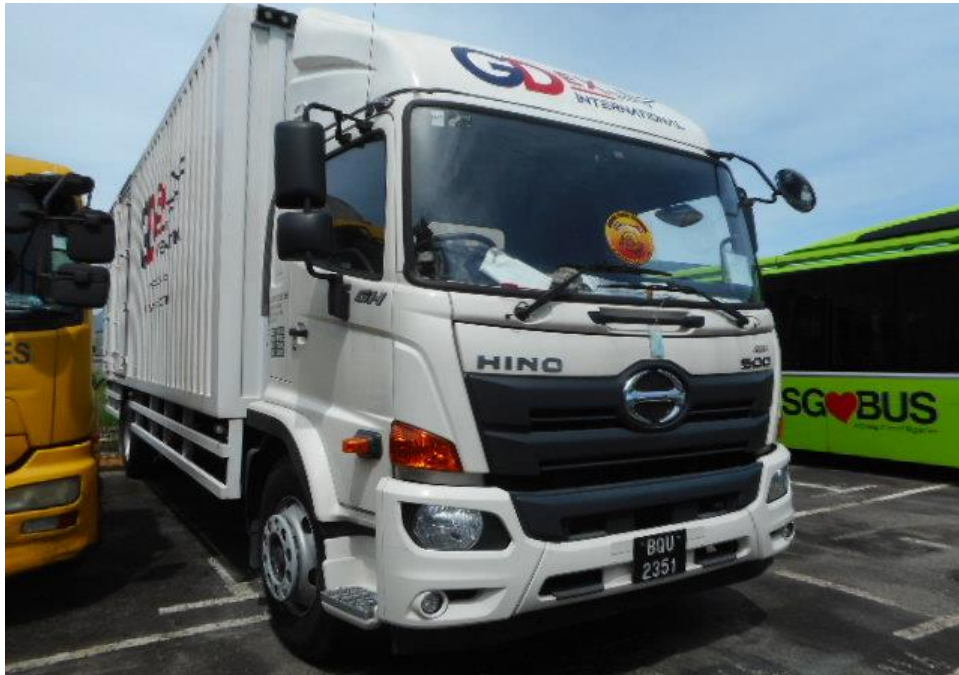
**Photo 2** shows a general view of the right body of the Lorry at the time of my inspection. The Lorry was observed to be intact and unaffected by the accident.

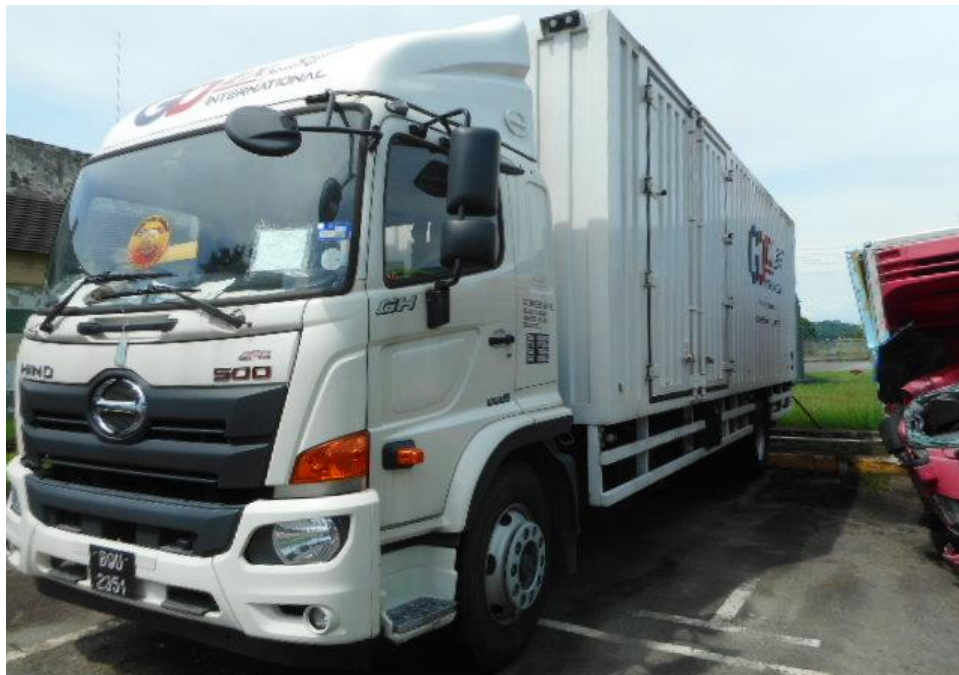
**Photo 3** shows a general view of the left body of the Lorry at the time of my inspection. The Lorry was observed to be intact and unaffected by the accident.

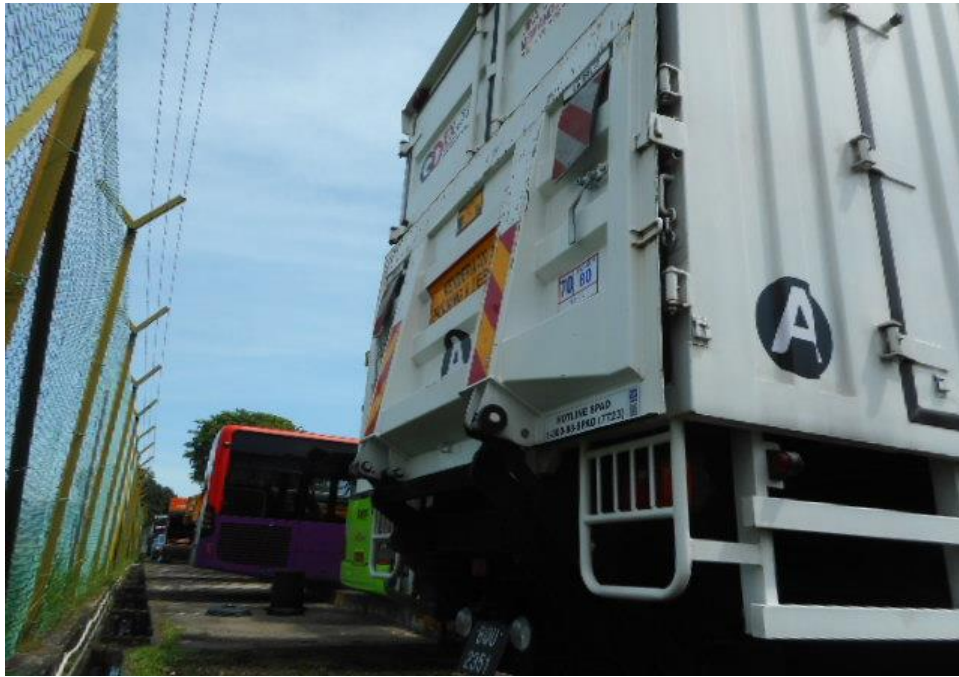
**Photo 4** shows a general view of the Lorry's rear body at the time of my inspection. The Lorry was observed to be intact and unaffected by the accident.

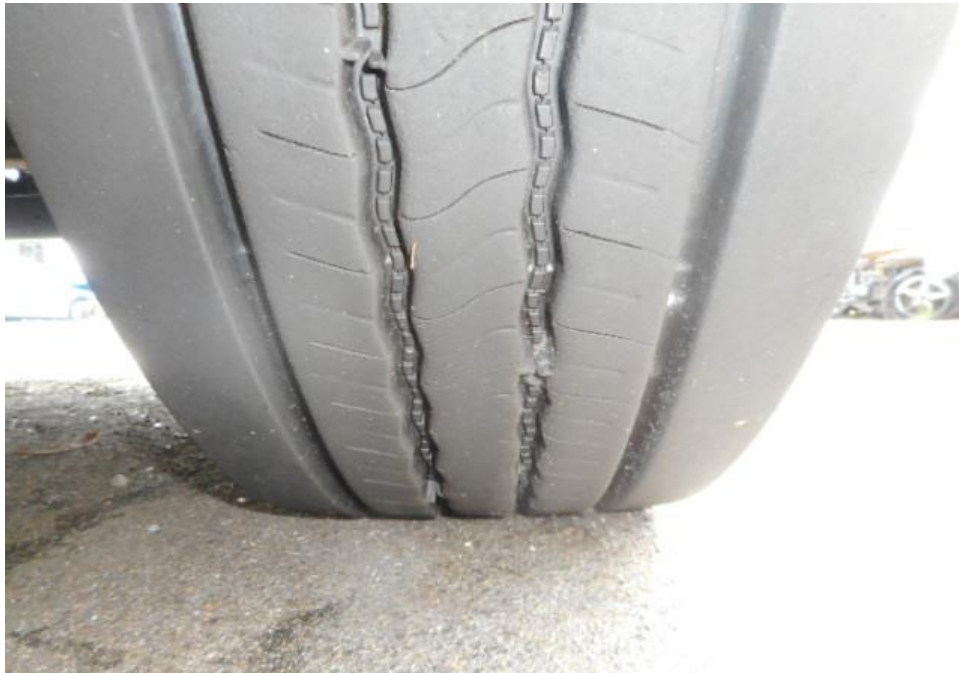
**Photo 5** shows the condition of the front right tyre of the Lorry, which was observed to be in serviceable condition with remaining tread depth of approximately 12.7 mm. The tyre, which was wrapped around standard steel wheel rim, was also observed to be sufficiently inflated for vehicular operation. There was no tear, cut or burst mark(s) on the outer and the inner sidewalls as well as across the tread of the 6 tyres that were fitted on the Lorry.

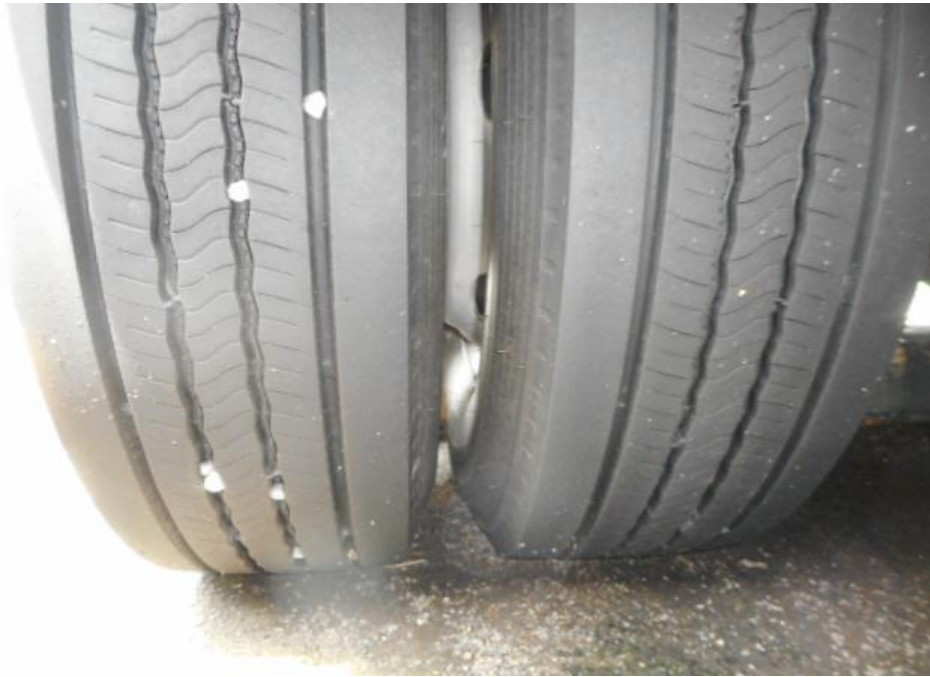
**Photo 6** shows the condition of the rear right tyre of the Lorry, which was observed to be in serviceable condition with remaining tread depth of approximately 12.9mm. The tyre, which was wrapped around standard steel wheel rim, was also observed to be sufficiently inflated for vehicular operation.

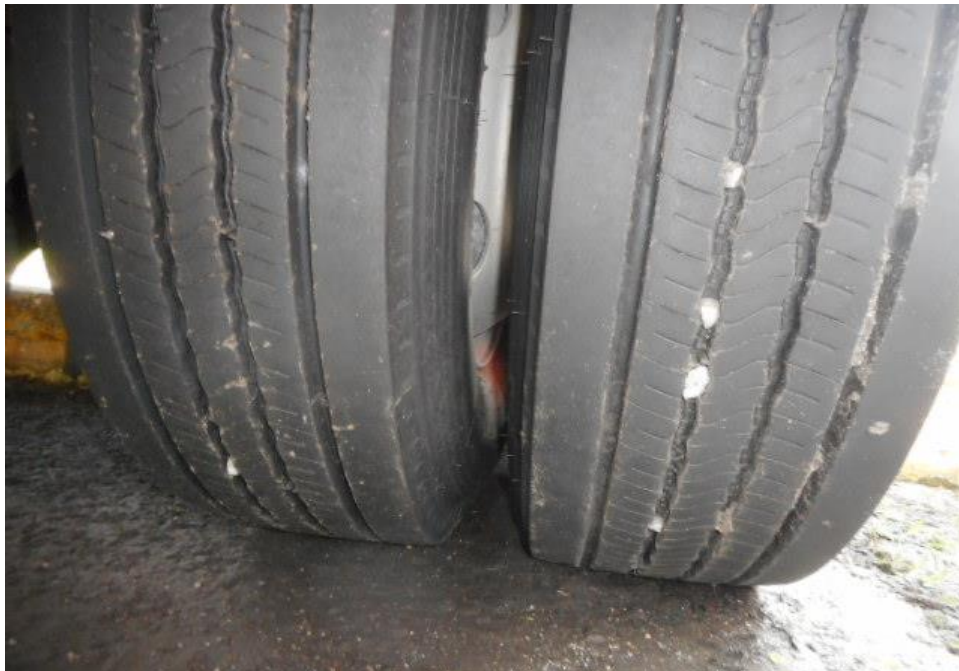
**Photo 7** shows the condition of the rear left tyres of the Lorry, which was observed to be in serviceable condition with remaining tread depth of approximately 1.4mm. The tyres, which were wrapped around standard steel wheel rim, were also observed to be sufficiently inflated for vehicular operation. There was also no damage found on all 6 steel wheel rims of the Lorry.

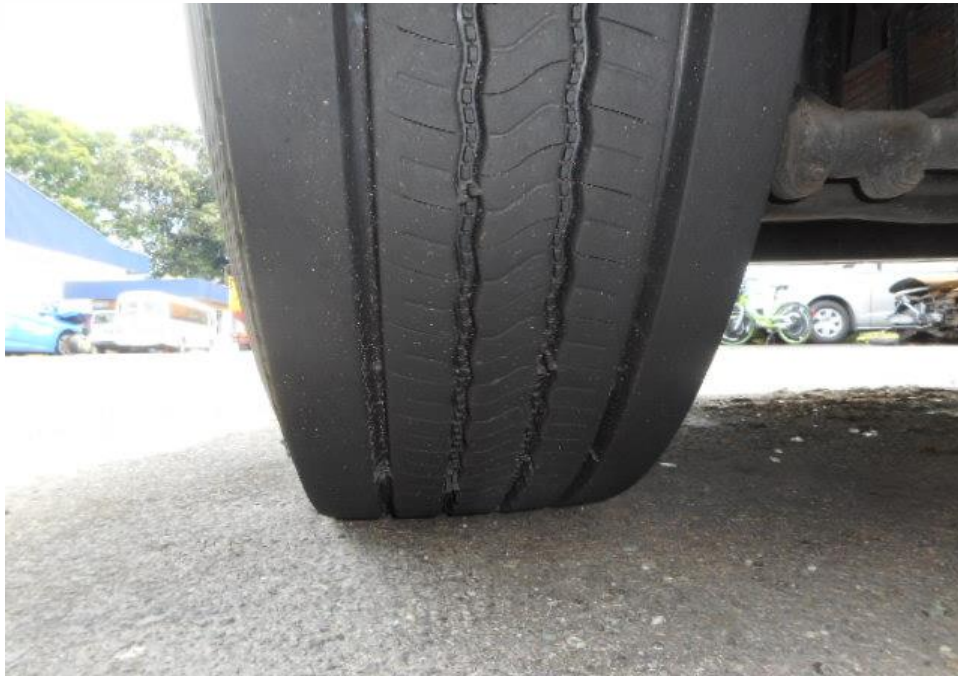
**Photo 8** shows the condition of the front left tyres of the Lorry, which were observed to be in serviceable condition with remaining tread depth of approximately 12.7mm. There was also no tear, cut or burst mark(s) on the outer and the inner sidewalls as well as across the tread of the 12 tyres that were fitted on the Lorry.

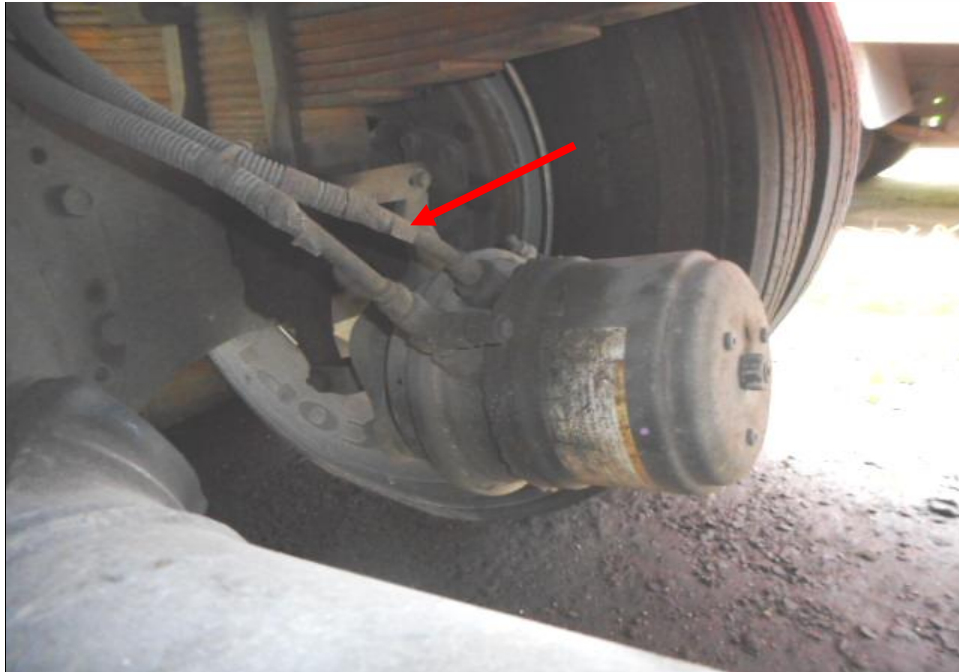
**Photo 9** shows the brake pipe (arrowed) at the rear right wheel of the Lorry. I did not observe any leakage of brake fluid at the time of my inspection of the Lorry. My visual examination of the various mechanical components in the braking system, had indicated that there was no internal leakage of pressure/vacuum and there components were generally in good condition.

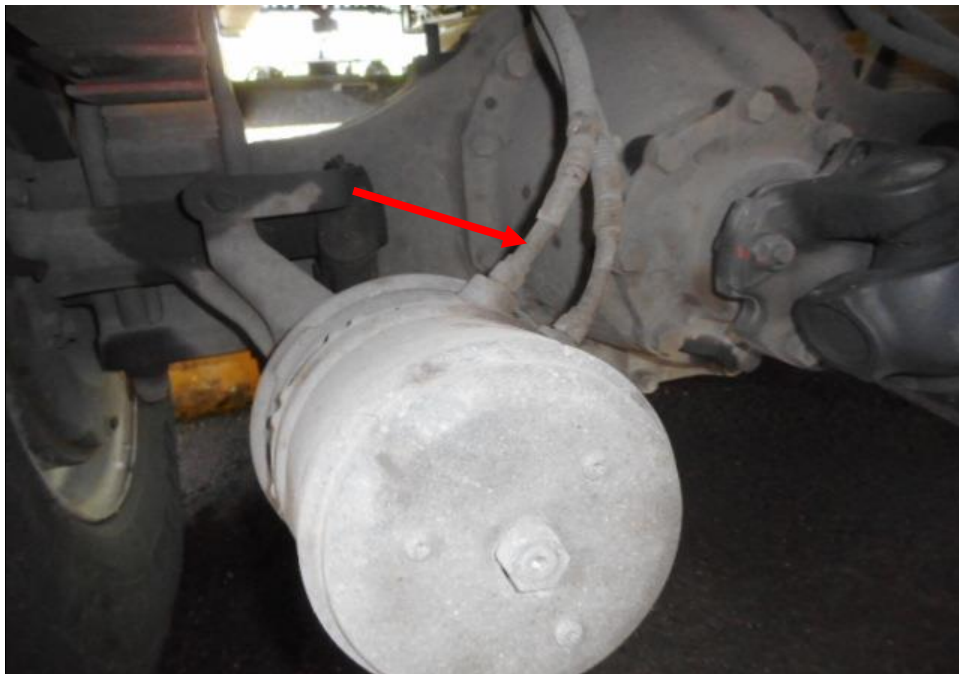
**Photo 10** shows the brake pipe (arrowed) at the rear left wheel of the Lorry. I did not observe any leakage of brake fluid at the time of my inspection of the Lorry. My static tests of the Lorry's braking system, along with my visual examination of the various mechanical components in the braking system, had indicated that there was no internal leakage of pressure/vacuum and there components were generally in good condition.

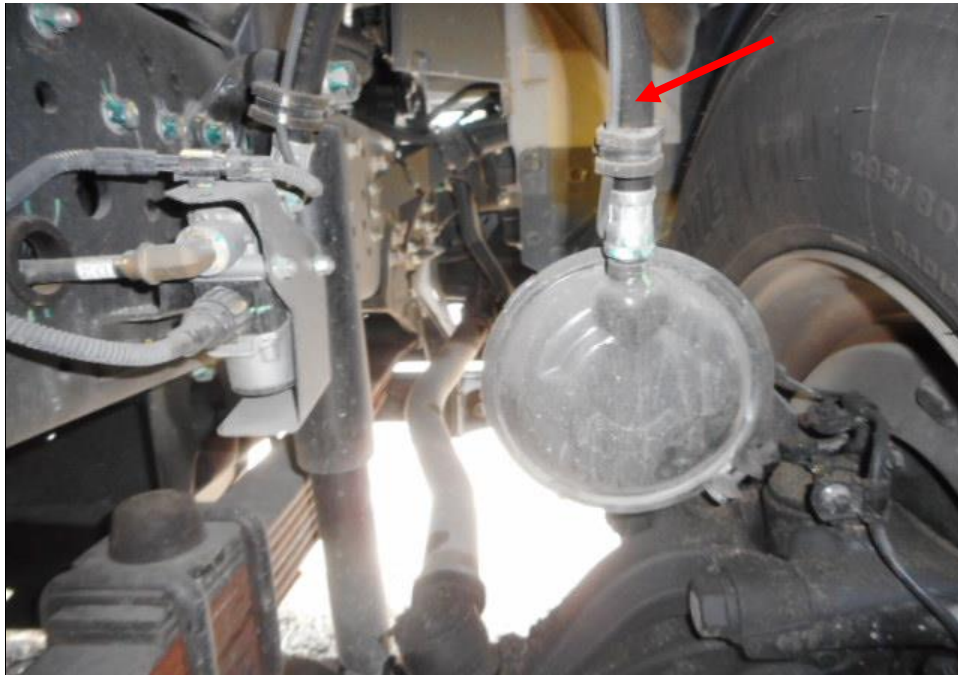
**Photo 11** shows the brake pipe (arrowed) at the front right wheel of the Lorry. I did not observe any leakage of brake fluid at the time of my inspection of the Lorry. My static tests of the Lorry's braking system, along with my visual examination of the various mechanical components in the braking system, had indicated that there was no internal leakage of pressure/vacuum and there components were generally in good condition.

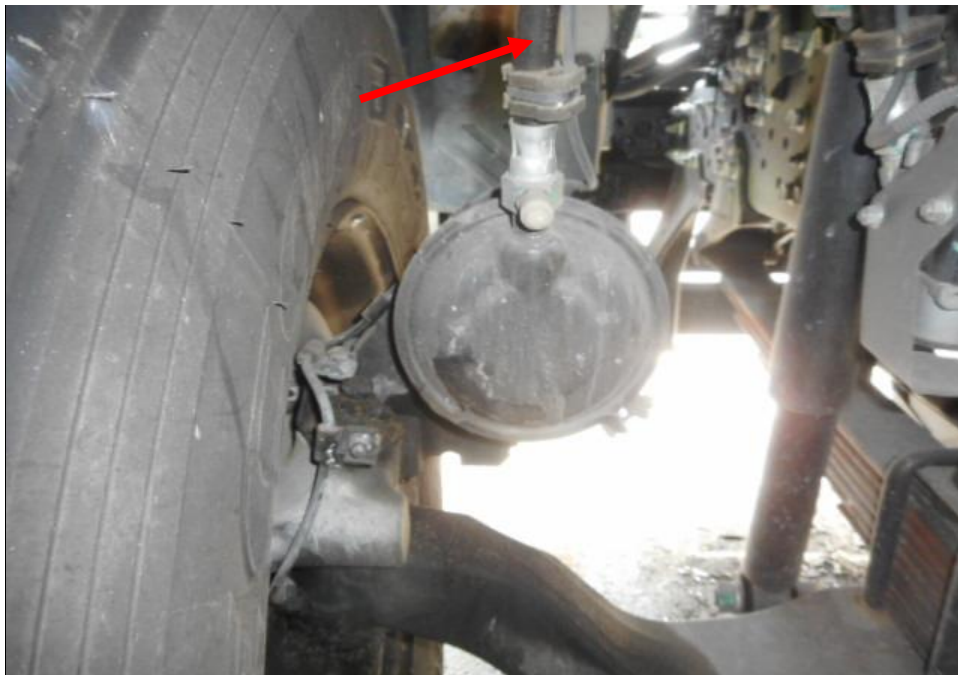
**Photo 12** shows the brake pipe (arrowed) at the front left wheel of the Lorry. I did not observe any leakage of brake fluid at the time of my inspection of the Lorry. My visual examination of the various mechanical components in the braking system had indicated that there was no internal leakage of pressure/vacuum and there components were generally in good condition.

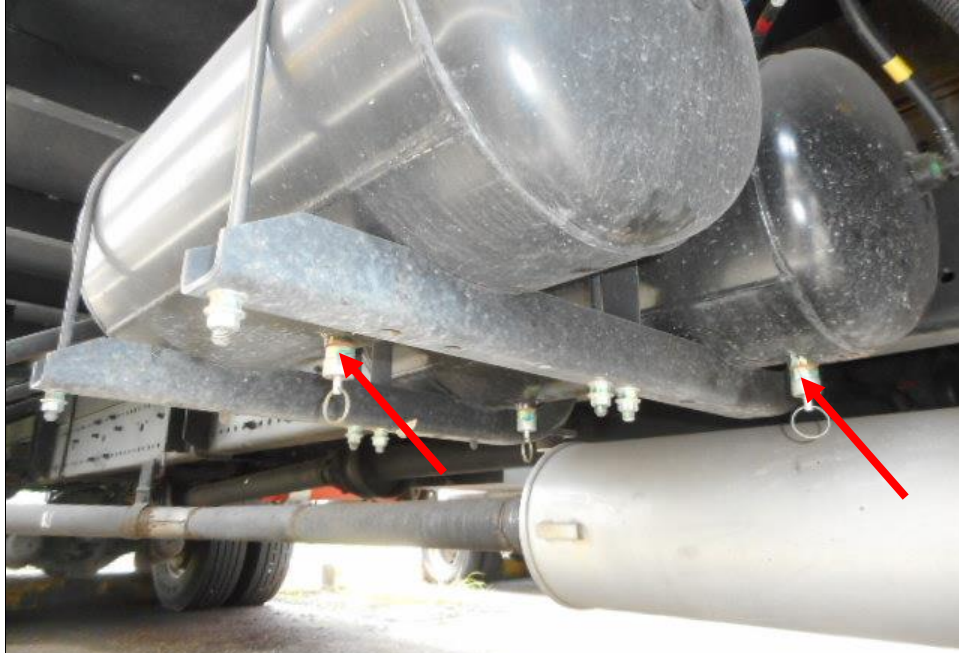
**Photo 13** shows the air brake cylinders (arrowed) at the undercarriage of the Lorry. I did not observe any leakage of air brake fluid at the time of my inspection of the Lorry. My visual examination of the various mechanical components in the braking system had indicated that there was no internal leakage of pressure/vacuum and these components were generally in good condition.

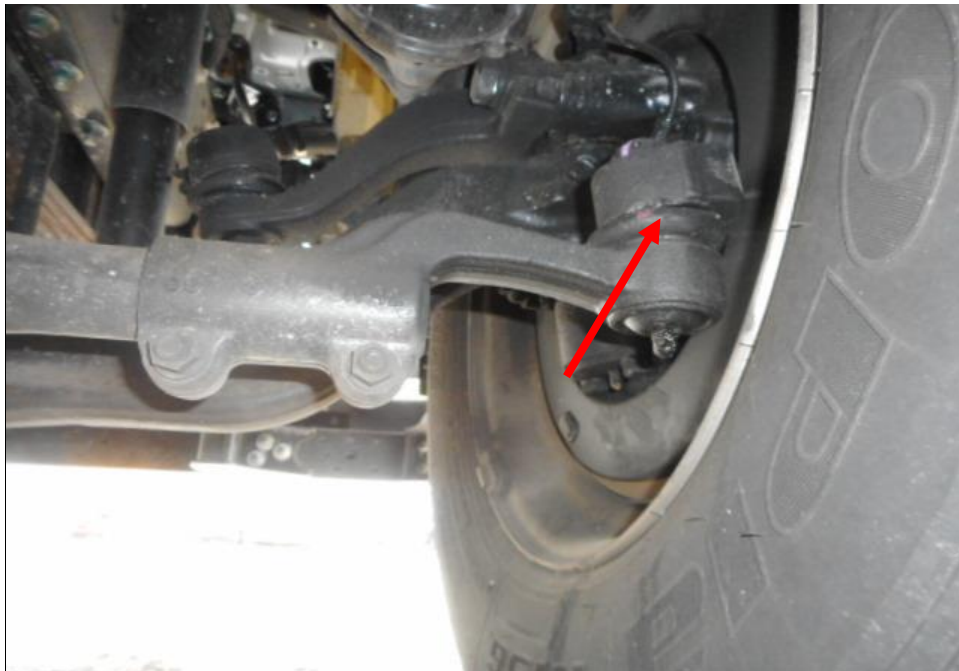
**Photo 14** shows the various undercarriage components at the front right wheel of the Lorry, in particular the steering tie rod end (arrowed). The various steering components were all found to be intact, suggesting that the steering system of the Lorry was likely to be in serviceable condition at the material time of accident. There was also no sign of fluid stain(s) observed on the various undercarriage components.

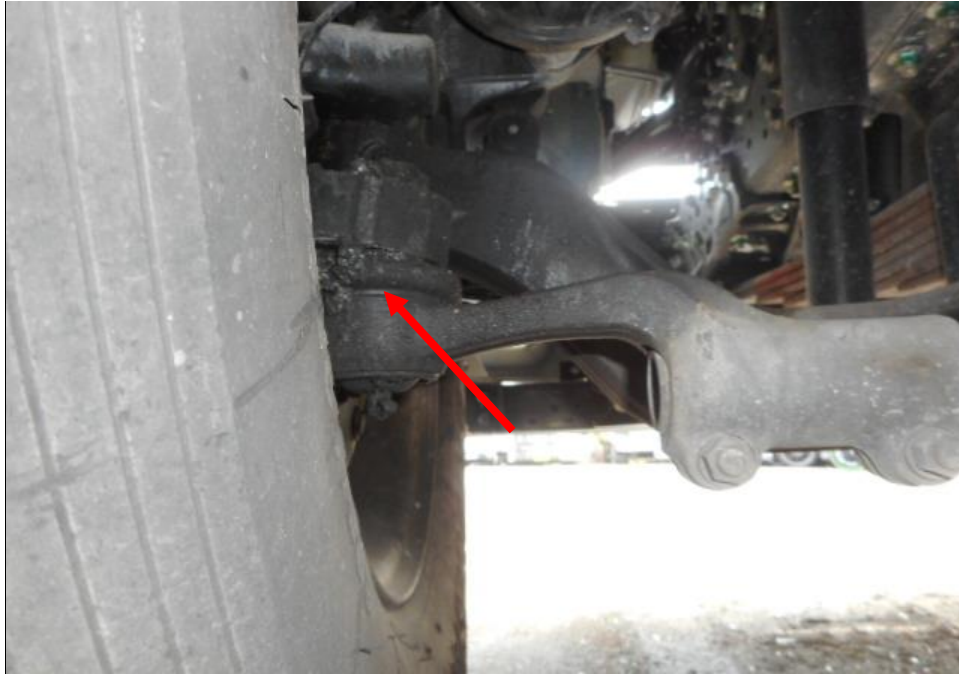
**Photo 15** shows the various undercarriage components at the front left wheel of the Lorry, in particular the steering tie rod end (arrowed). The various undercarriage components of the Lorry were all found to be intact without any visible damage. There was also no sign of fluid stain(s) observed on the various undercarriage components.

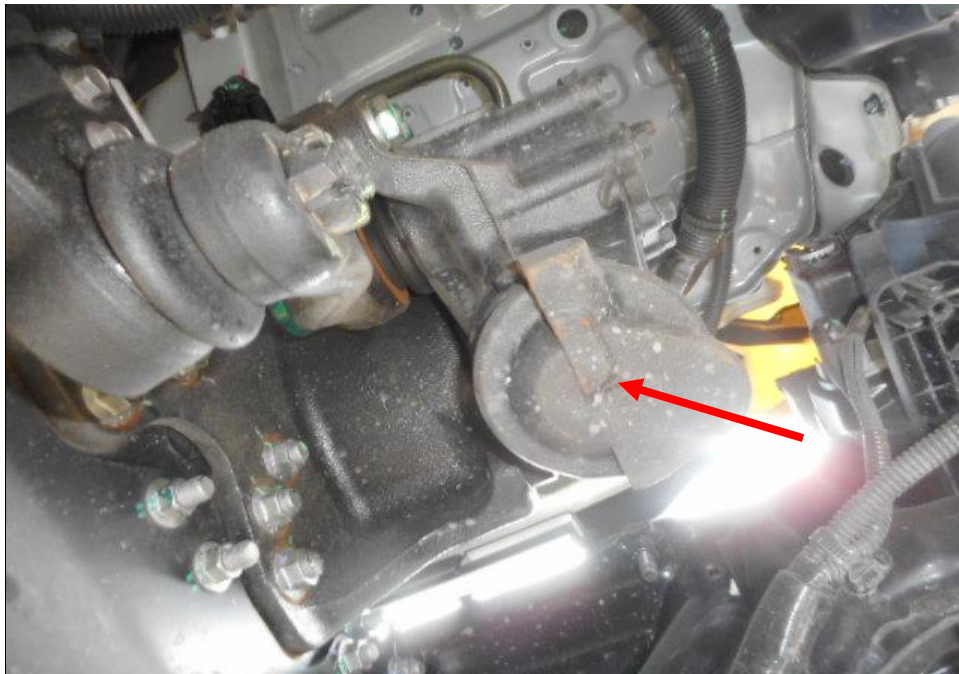
**Photo 16** shows the steering box component (arrowed) at the undercarriage of the Lorry was found to be intact without any visible damage. There was also no sign of fluid stain(s) observed on the various undercarriage components.
