You're Ref: TP/IP/29296/2022  
Our Ref: CI/TPD23001595/P

**Fatal Accident Investigation Team**

**MECHANICAL INSPECTION REPORT OF MOTOR CAR SLR 9713E**

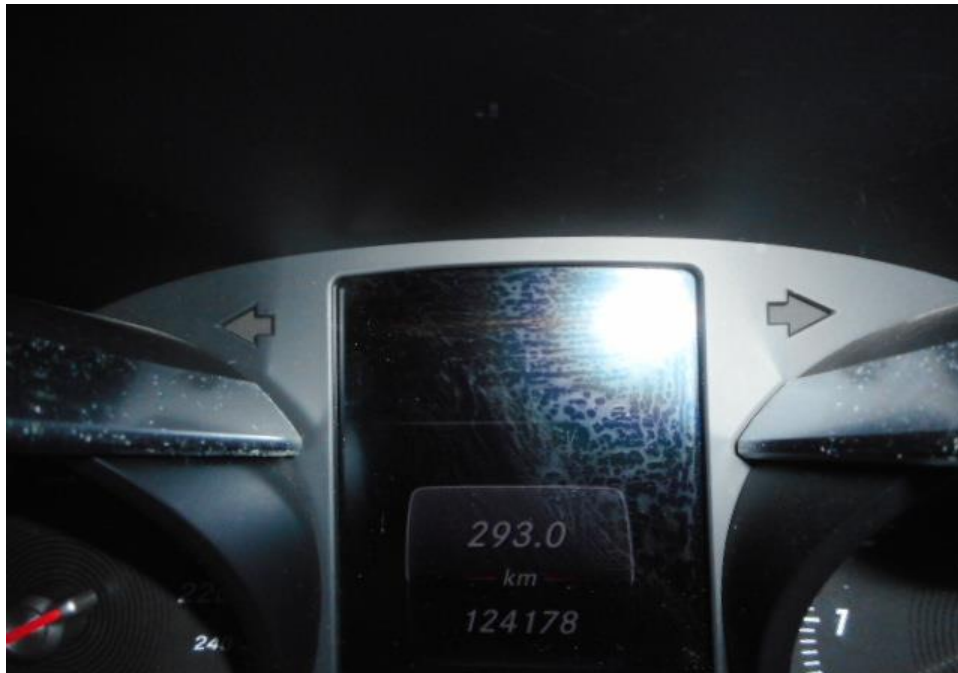
4. The mileage of the Motor Car at the time of my inspection was 124,178km.
5. The Motor Car was observed to have sustained damage at its front portion. Its front windscreen, front bonnet and front bumper was amongst the body parts that were damaged as a result of the accident.

**Photo 1** shows the mileage of the Motor Car at the time of my inspection. The mileage observed was 124,178km.

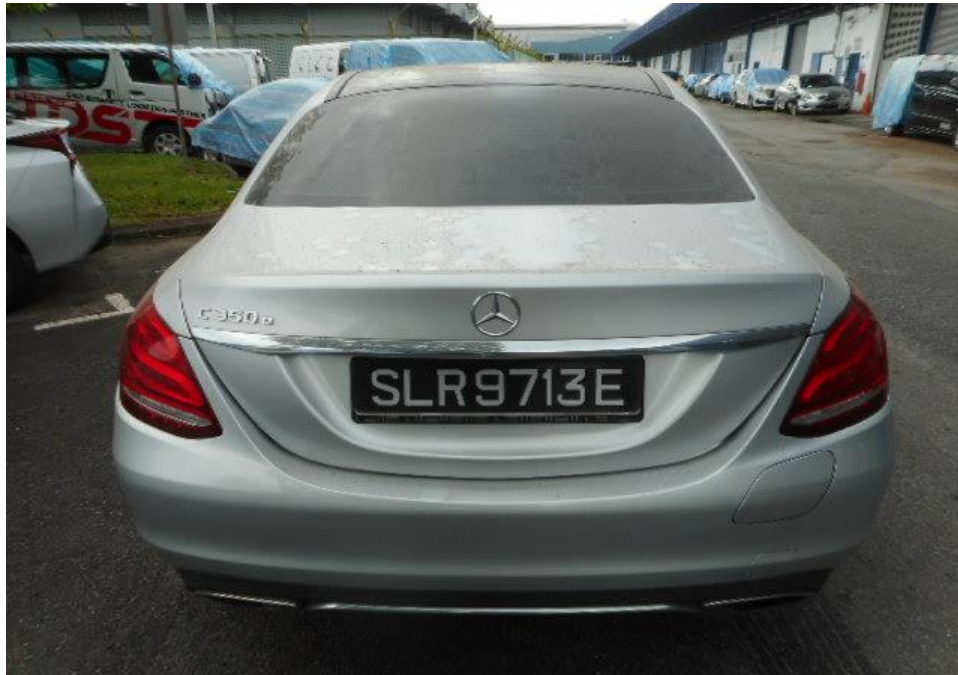
**Photo 2** shows the general view of the Motor Car's rear body at the time of my inspection. The Motor Car rear was observed to be unaffected by the accident.

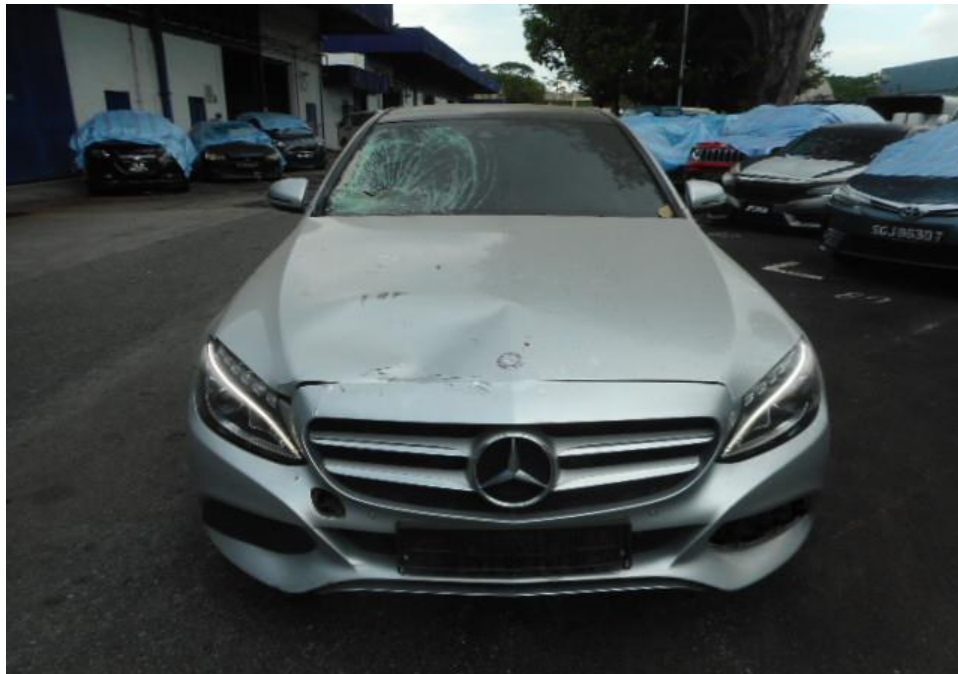
**Photo 3** shows a general view of the Motor Car's front body at the time of my inspection. The front portion of the Motor Car was observed to have sustained damage. Its front windscreen, front bonnet and front bumper was amongst the body parts that were damaged as a result of the accident.

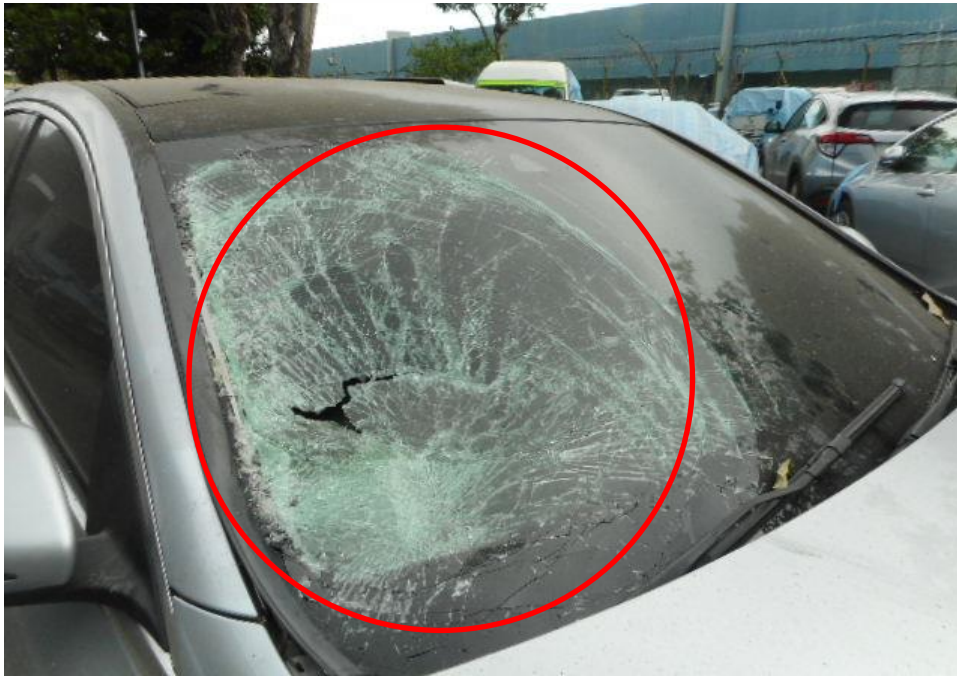
**Photo 4** shows a close up view of the Motor Car's front body at the time of my inspection. The front portion of the Motor Car was observed to have sustained damage. Its front windscreen (circled) was the body parts that were damaged as a result of the accident.

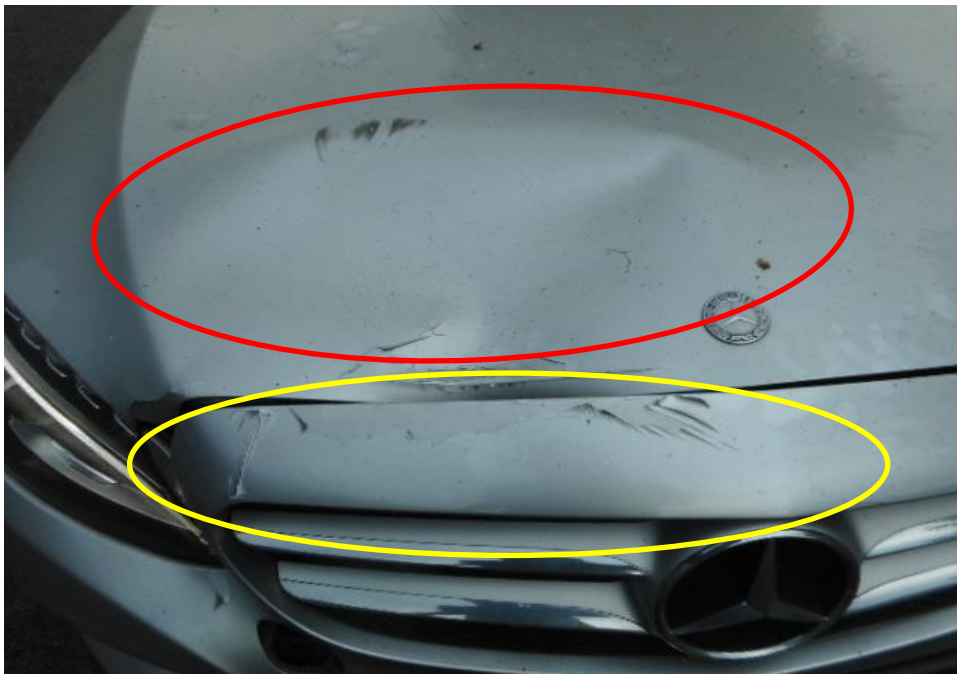
**Photo 5** shows a close up view of the Motor Car's front body at the time of my inspection. The front portion of the Motor Car was observed to have sustained damage. Its front bonnet (red circle) and front bumper (yellow circle) was the body parts that were damaged as a result of the accident.

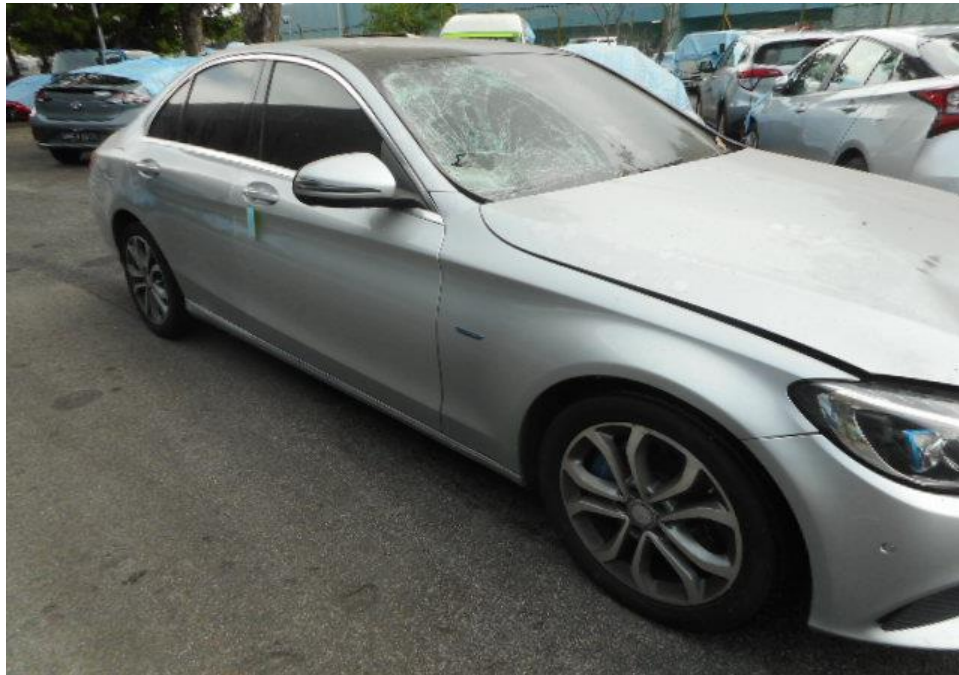
**Photo 6** shows a general view of the Motor Car's right body at the time of my inspection. The right portion of the Motor Car was observed to have been unaffected by the accident.

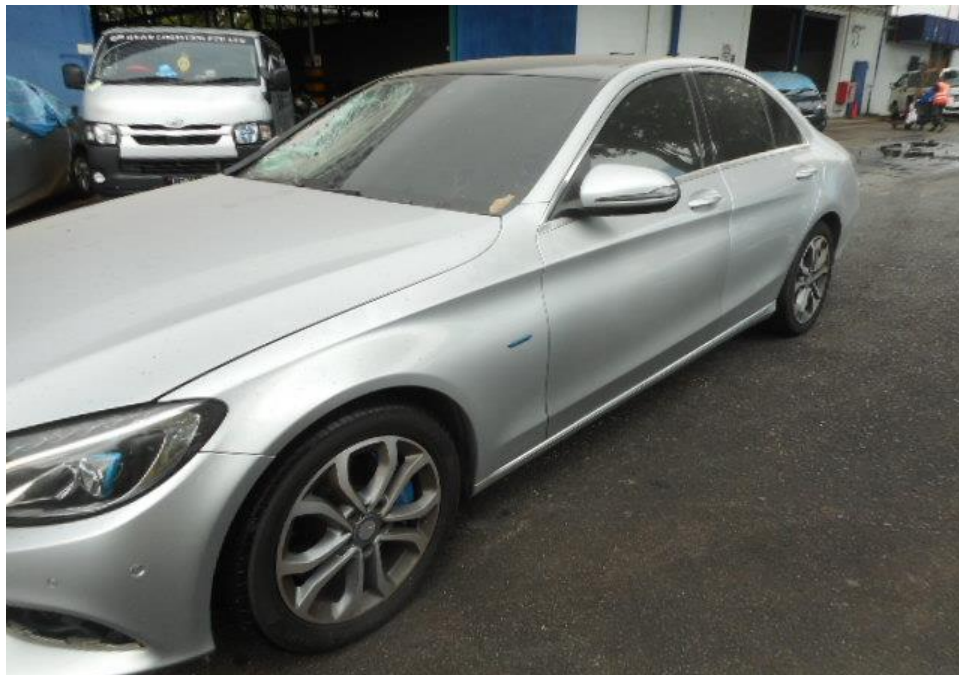
**Photo 7** shows a general view of the Motor Car's left body at the time of my inspection. The left portion of the Motor Car was observed to have been unaffected by the accident.

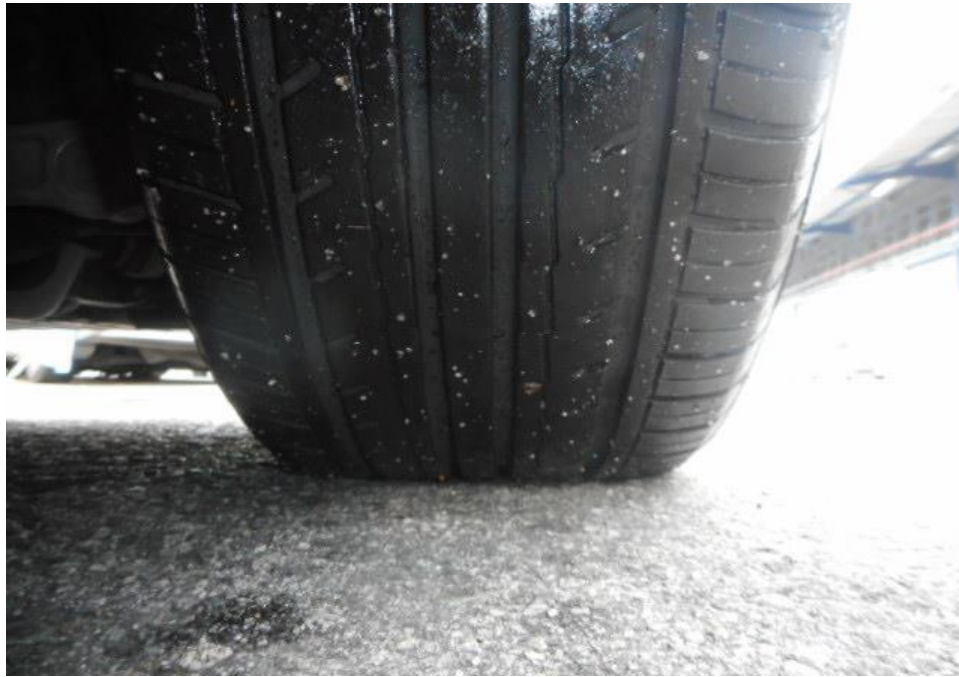
**Photo 8** shows the condition of the front right tyre of the Motor Car, which was observed to be in serviceable condition with remaining tread depth of approximately 5.9mm. The tyre was sufficiently inflated for vehicular operation with no tear, cut or burst mark(s) on the outer and the inner sidewalls as well as across the tread. The 4 tyres of the Motor Car were wrapped around standard alloy wheel rims without any damage.

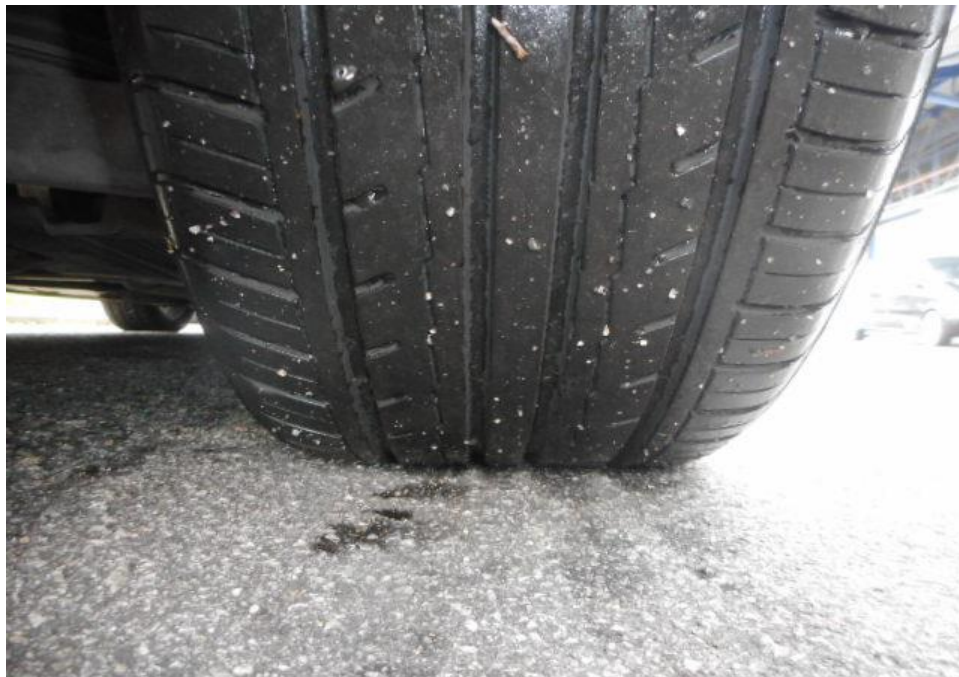
**Photo 9** shows the condition of the rear right tyre of the Motor Car, which was observed to be in serviceable condition with remaining tread depth of approximately 5.3mm. The tyre was also observed to be sufficiently inflated for vehicular operation with no tear, cut or burst mark(s).

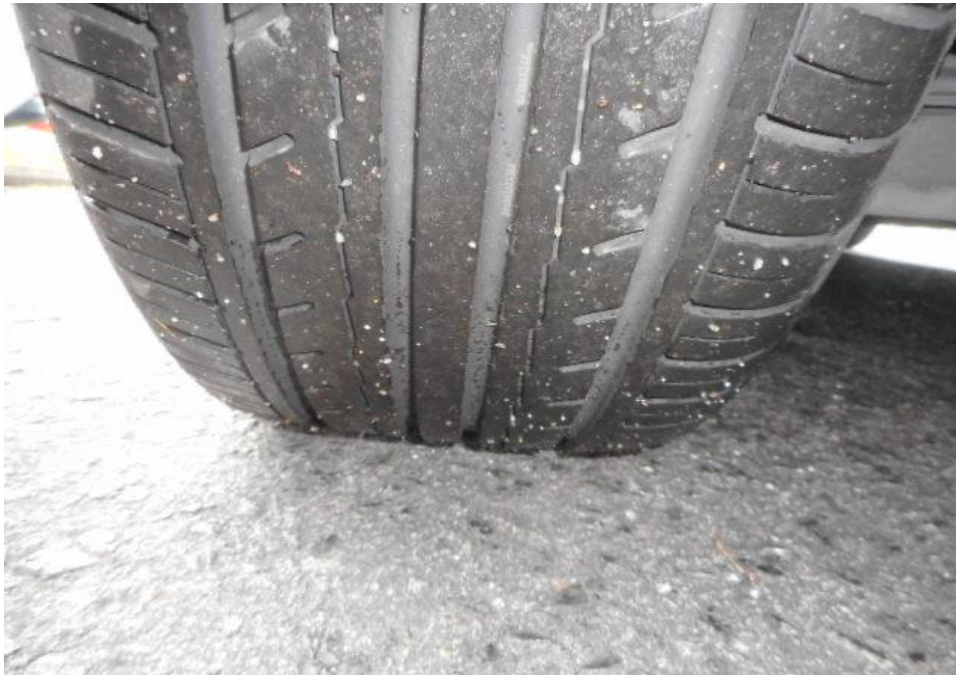
**Photo 10** shows the condition of the rear left tyre of the Motor Car, which was observed to be in serviceable condition with remaining tread depth of approximately 5.8mm. The tyre, which was wrapped around alloy wheel rim, was also observed to be sufficiently inflated for vehicular operation. The 4 tyres of the Motor Car were wrapped around standard alloy wheel rims.

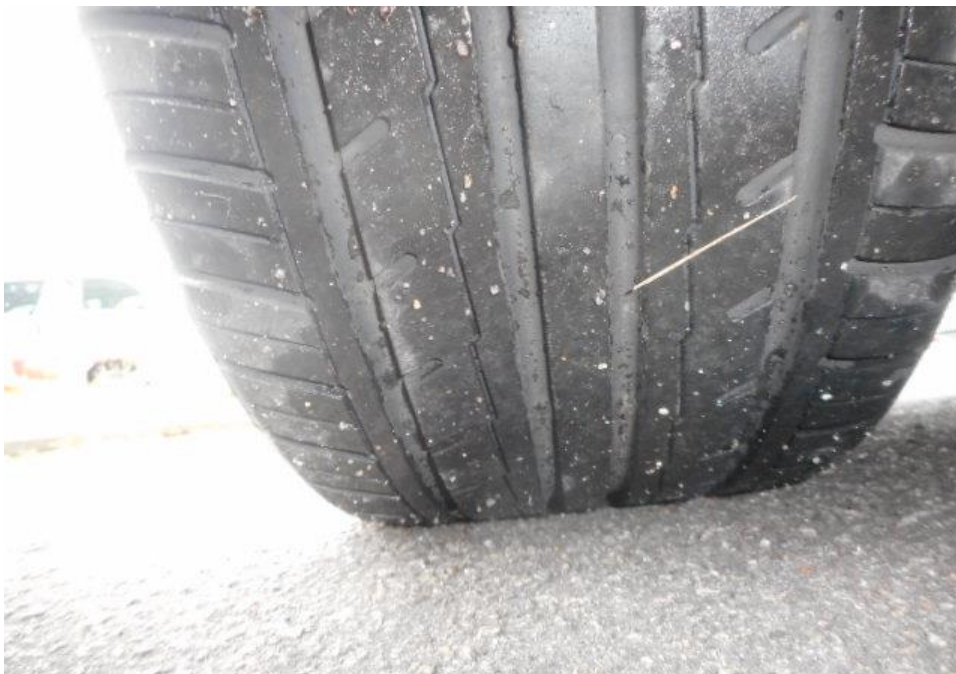
**Photo 11** shows the condition of the front left tyre of the Motor Car, which was observed to be in serviceable condition with remaining tread depth of approximately 5.7mm. There was also no tear, cut or burst mark(s) on the outer and the inner sidewalls as well as across the tread of the Motor Car's 4 tyres.

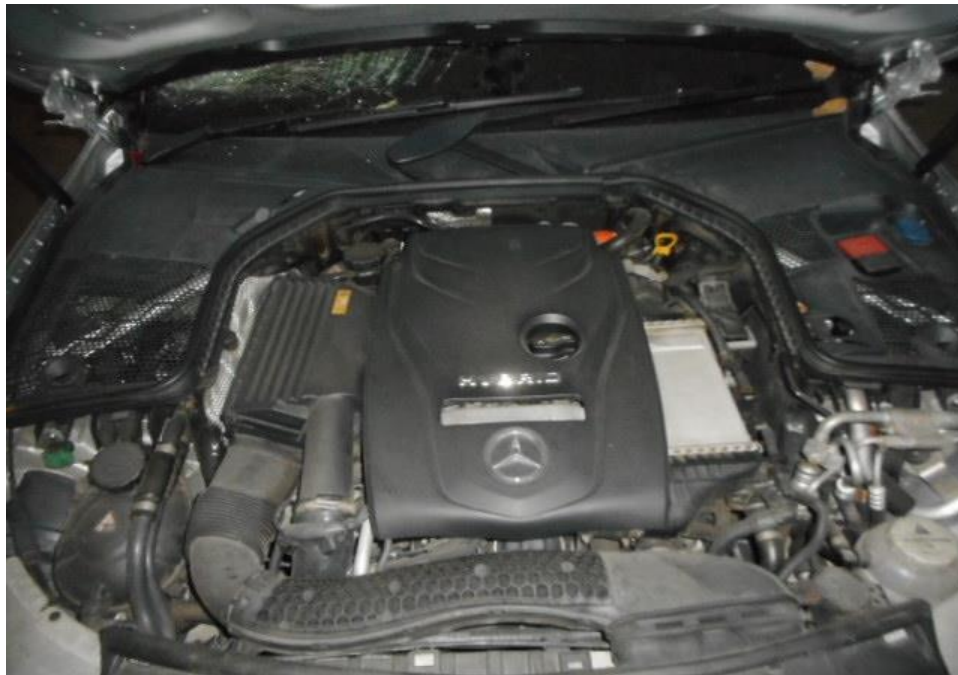
**Photo 12** shows a general view of the Motor Car's engine compartment. The various parts and components inside the engine compartment were unaffected by the accident. There was also no sign(s) or indication(s) of fluid leakage and/or fluid stain within the engine compartment.

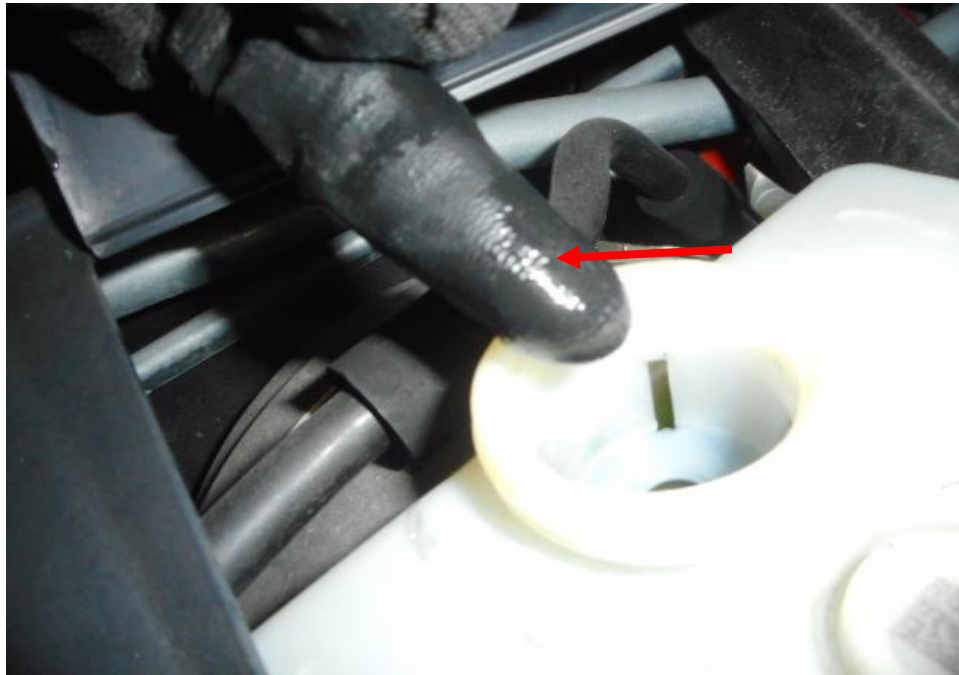
**Photo 13** shows the brake fluid reservoir of the Motor Car at the time of my inspection. The brake fluid was observed to be of sufficient level (arrowed) and without any visible contamination.

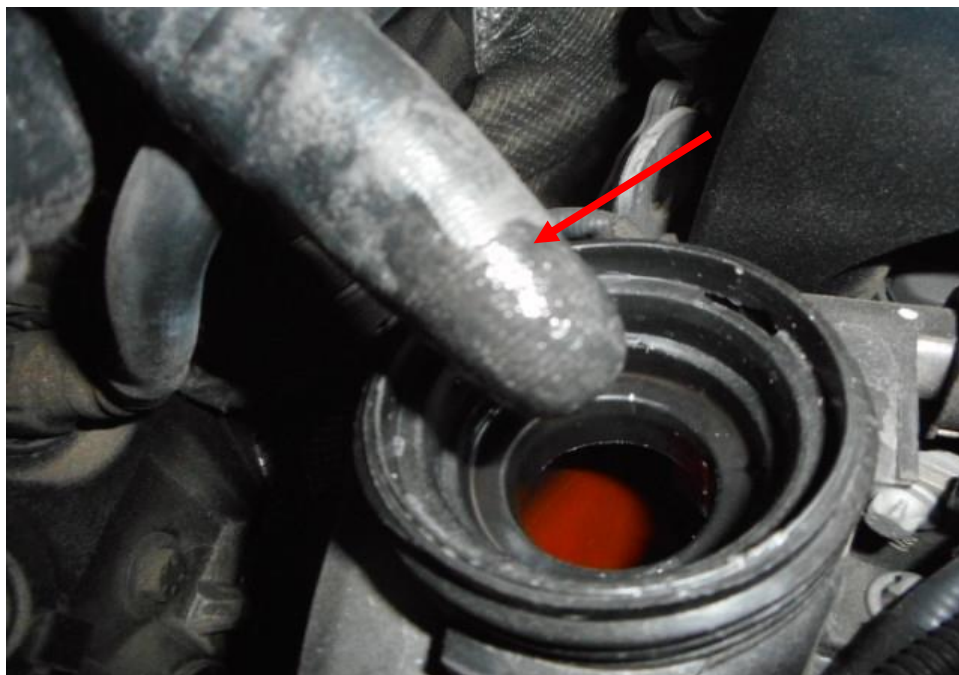
**Photo 14** shows checks being carried out to the engine coolant of the Motor Car at the time of my inspection. The engine coolant was observed to be of sufficient level (arrowed) and without any visible contamination.

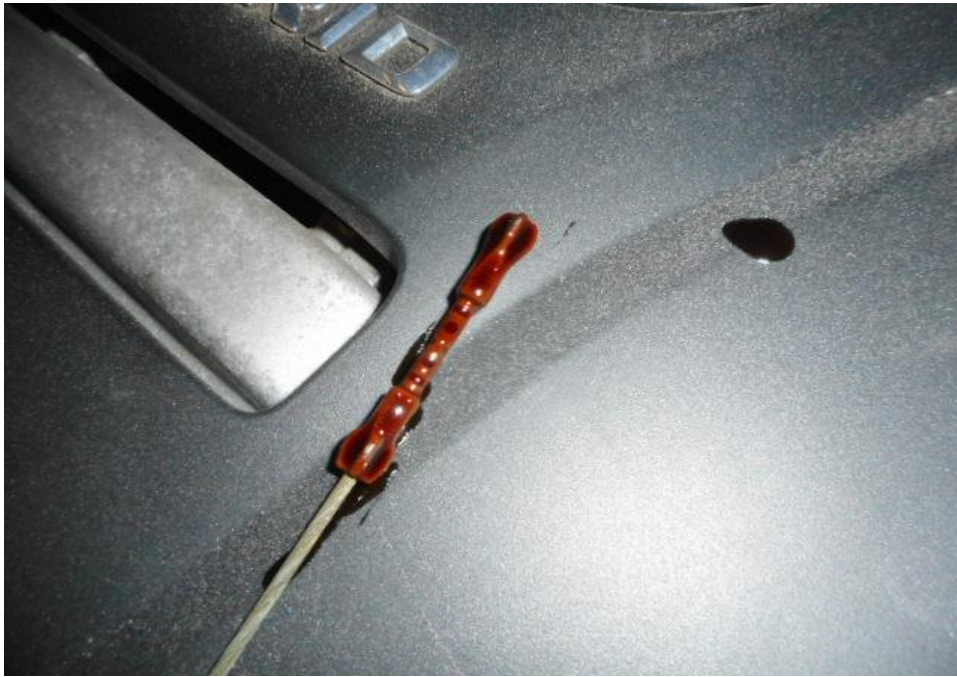
**Photo 15** shows the engine oil dipstick of the Motor Car at the time of my inspection. The engine oil was observed to be of sufficient level and without any visible contamination.

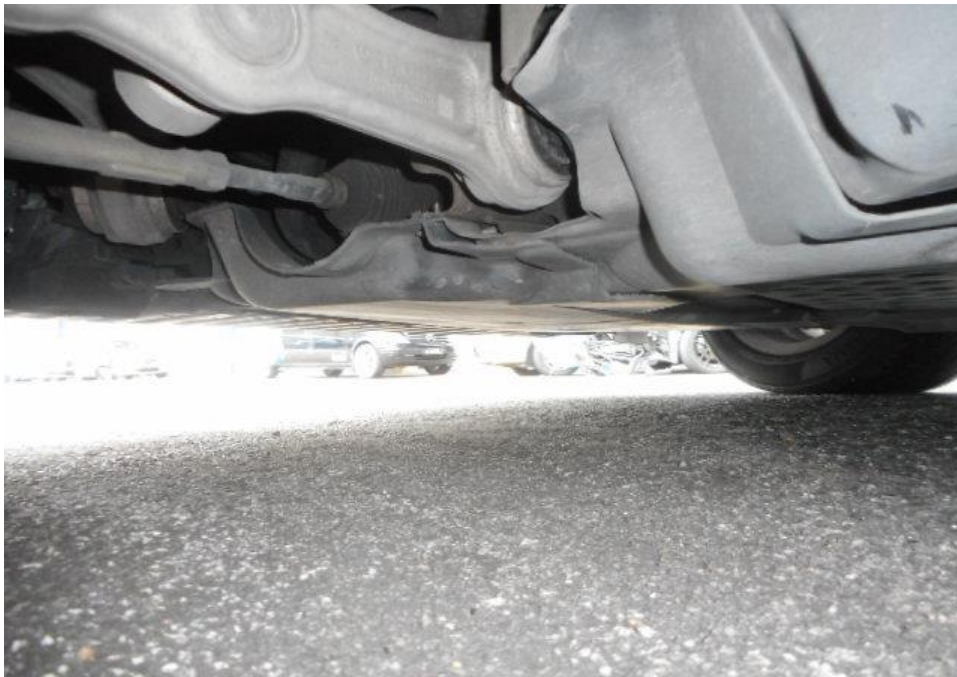
**Photo 16** shows the undercarriage of the Motor Car, at the area where the engine housing and transmission housing are located. I did not find any sign(s) or indication(s) of fluid leak and/or fluid stain(s) on the underside of the Motor Car.

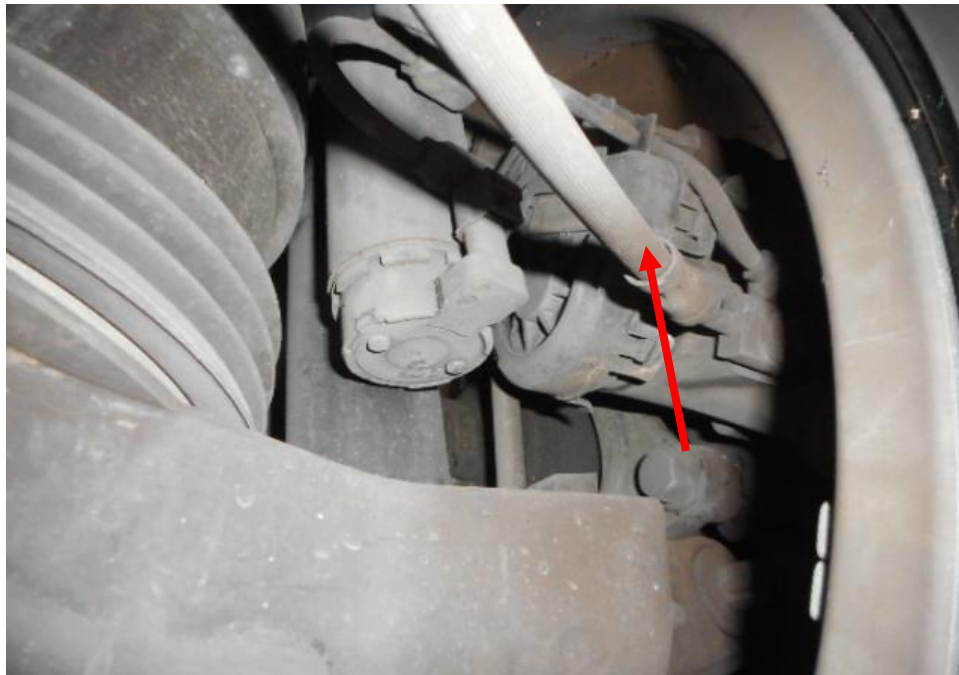
**Photo 17** shows the brake hose/pipe (arrowed) at the rear right wheel of the Motor Car. No leakage of brake fluid was observed. Visual examination of the various components of the braking system like the drum brake, brake booster, brake pedal etc. had revealed all to be intact and without visible damage.

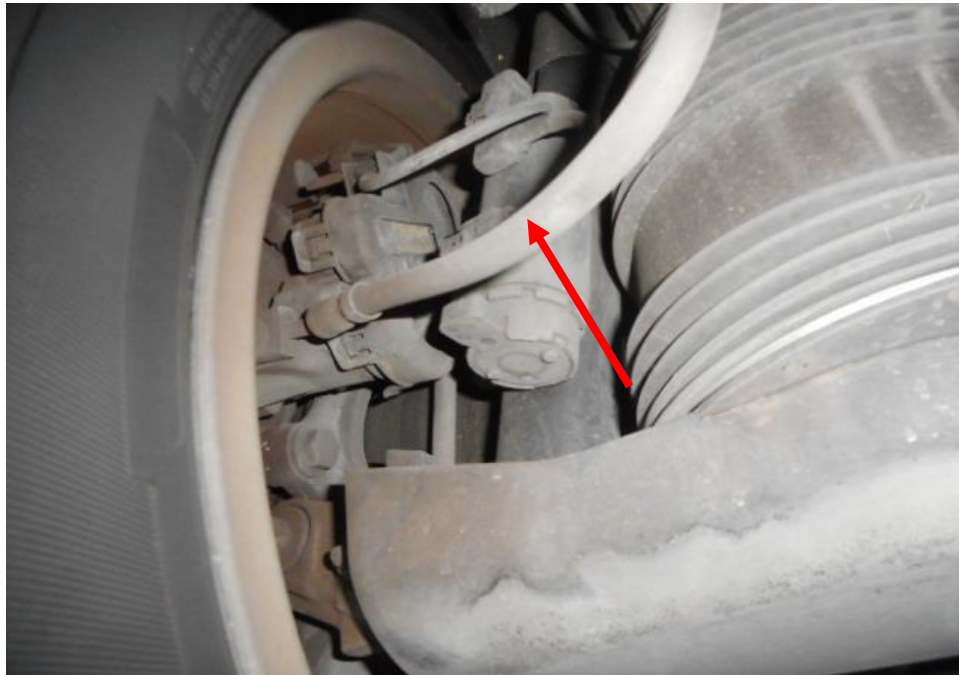
**Photo 18** shows the brake hose/pipe (arrowed) at the rear left wheel of the Motor Car. I did not observe any leakage of brake fluid at the time of my inspection of the Motor Car. Static tests of the Motor Car's braking system had indicated that there was no internal leakage of pressure/vacuum. The undercarriage components of the Motor Car were also all found to be intact and without any visible damage.

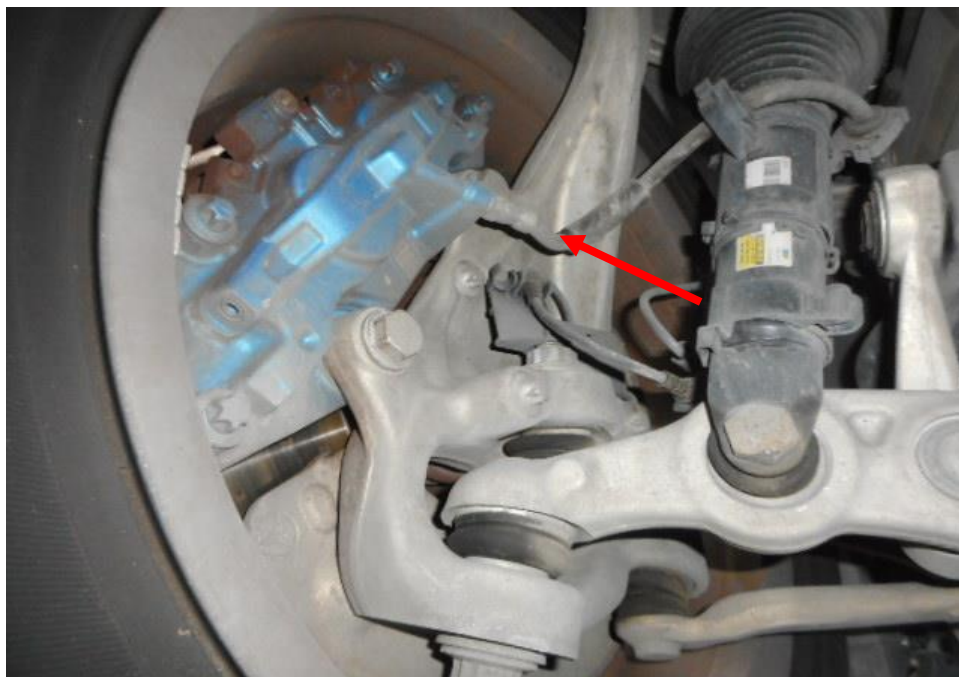
**Photo 19** shows the brake hose/pipe (arrowed) at the front right wheel of the Motor Car. I did not observe any leakage of brake fluid at the time of my inspection of the Motor Car. Static tests of the Motor Car's braking system had indicated that there was no internal leakage of pressure/vacuum. The undercarriage components of the Motor Car were also all found to be intact and without any visible damage.

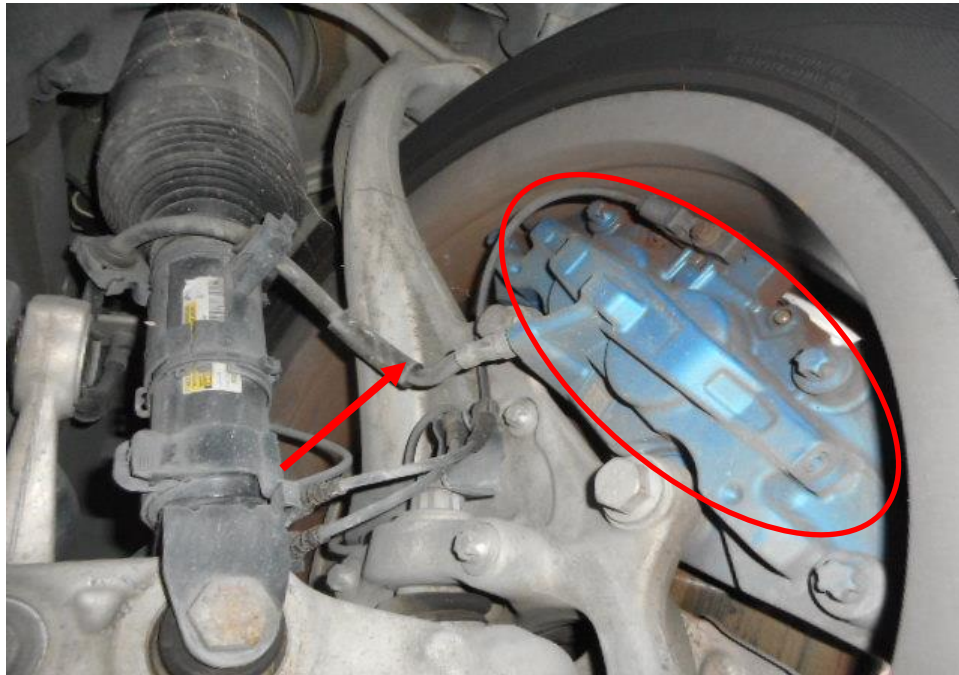
**Photo 20** shows the brake hose/pipe (arrowed) at the front left wheel of the Motor Car. No leakage of brake fluid was observed. Visual examination of the various components of the braking system like the brake caliper (circled), brake booster, brake pedal etc had revealed all to be intact and without visible damage.

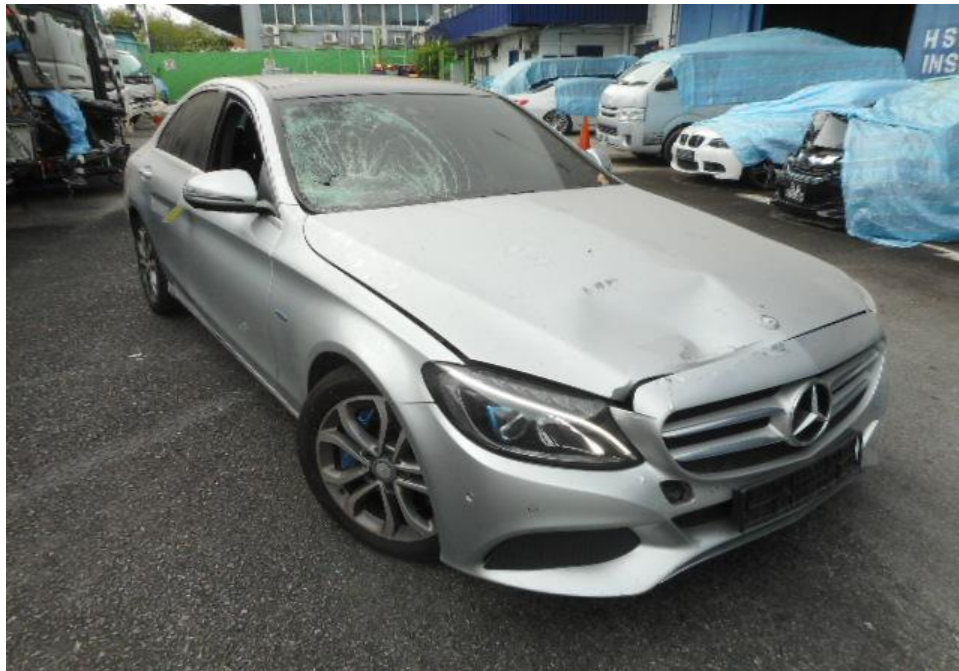
**Photo 21** shows the front right wheel of the Motor Car turned to its full left. During my steering system test, I did not experience any abnormal free play and/or resistance when I had turned the steering wheel towards the left and right. This would suggest that the steering system of the Motor Car was likely to be in serviceable condition at the material time of accident.

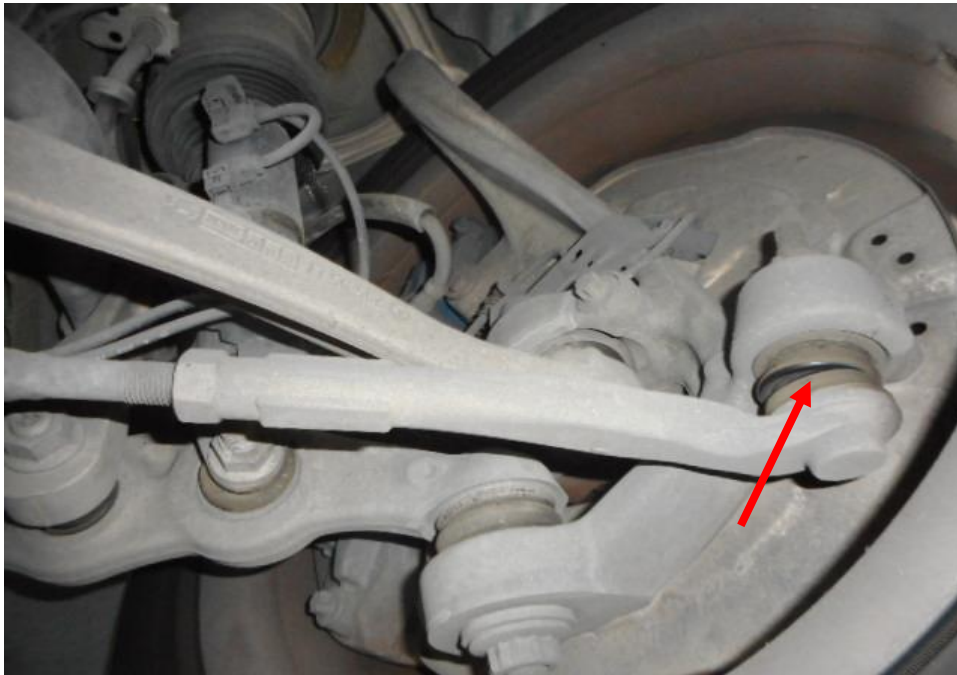
**Photo 22** shows the various undercarriage components at the front right wheel of the Motor Car, in particular the steering tie rod (arrowed). The various steering components were all found to be intact, suggesting that the steering system of the Motor Car was likely to be in serviceable condition at the material time of accident. There was also no sign of fluid stain observed on the various undercarriage components at the front right wheel of the Motor Car.

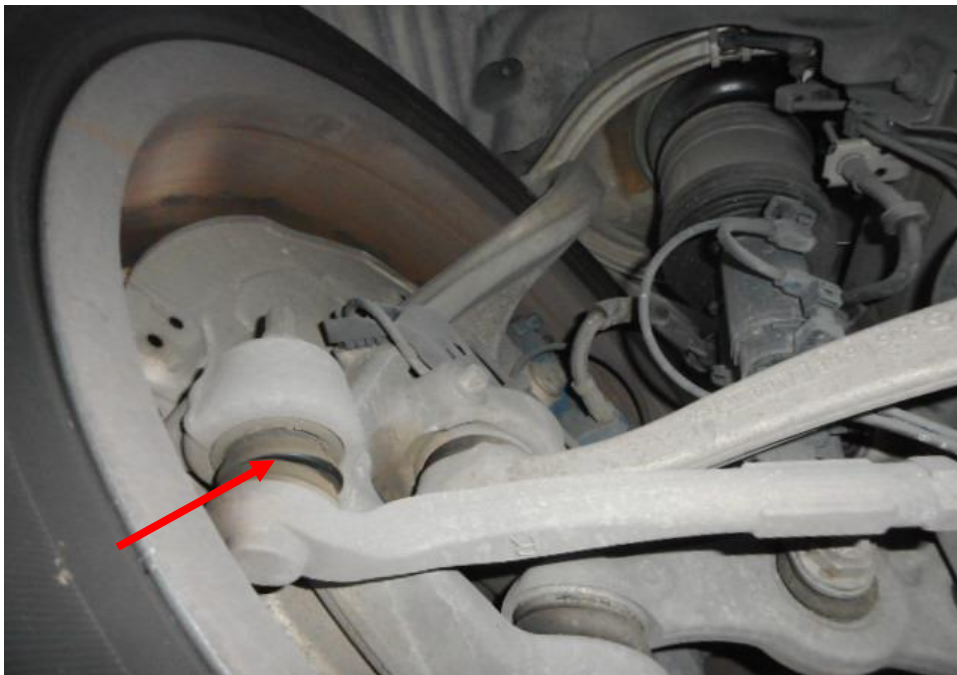
**Photo 23** shows the various undercarriage components at the front left wheel of the Motor Car, which had included the steering tie rod (arrowed). The various undercarriage components of the Motor Car were all found to be intact without any visible damage.

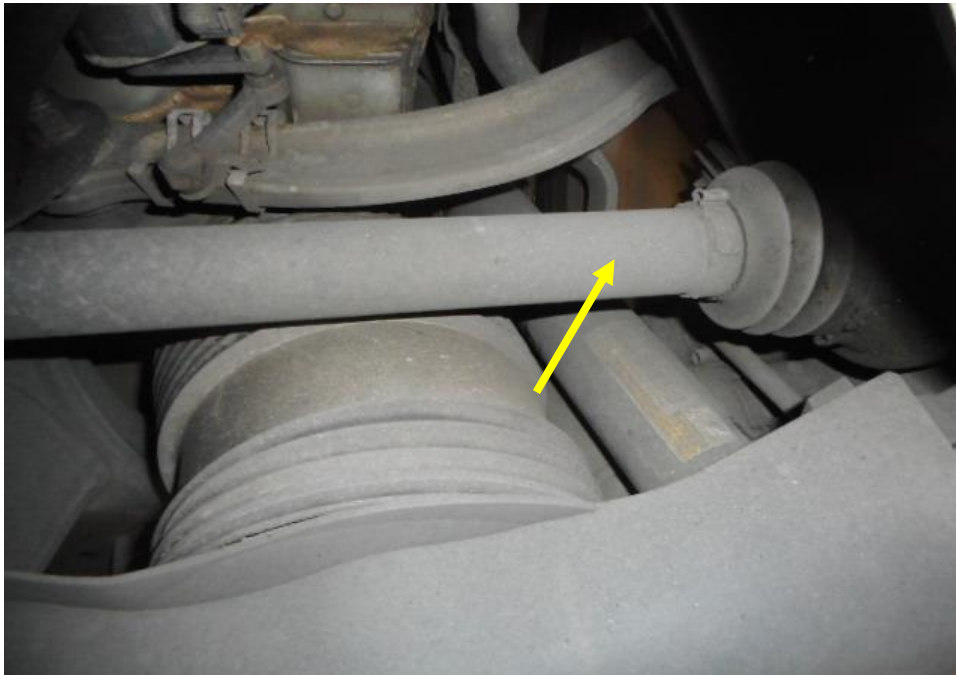
**Photo 24** shows the various undercarriage components at the rear right wheel of the Motor Car, in particular the drive shaft (arrowed) the various components were all found to be intact, suggesting that the drive system of the Motor Car was likely to be in serviceable condition at the material time of accident. There was also no sign of fluid stain observed on the various undercarriage components at the rear right wheel of the Motor Car.

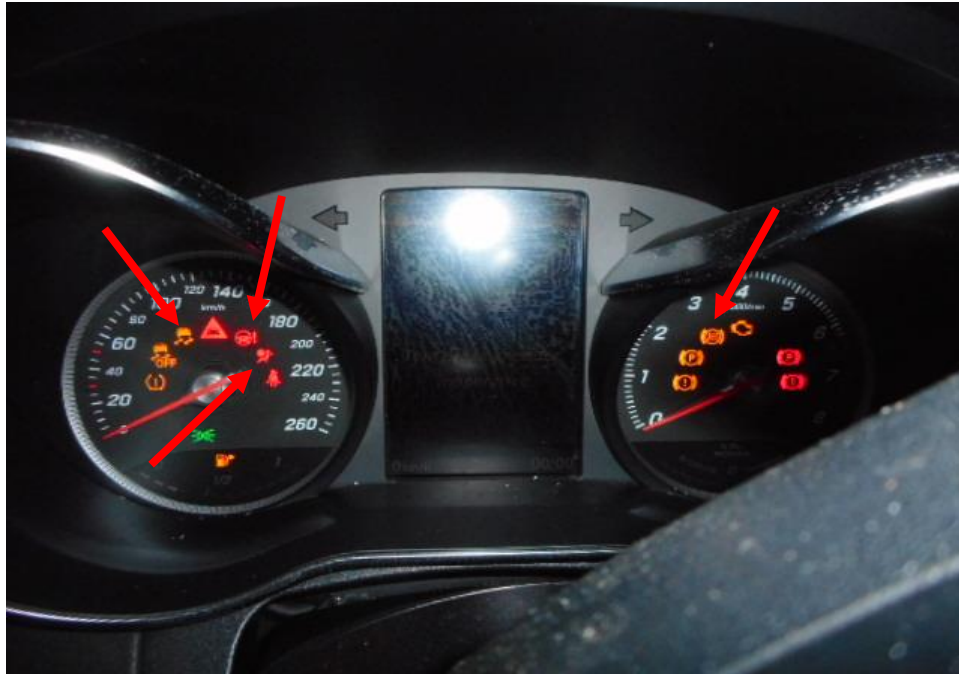
**Photo 25** shows the warning light for Anti-Lock Brake System (ABS), Electric Power Steering System (EPS), Traction Control System (TCS) and Supplemental Restraint System (SRS) (arrowed) appearing on the instrument panel of the Motor Car during the self-test of its various electronic operating systems when its engine was cranked.

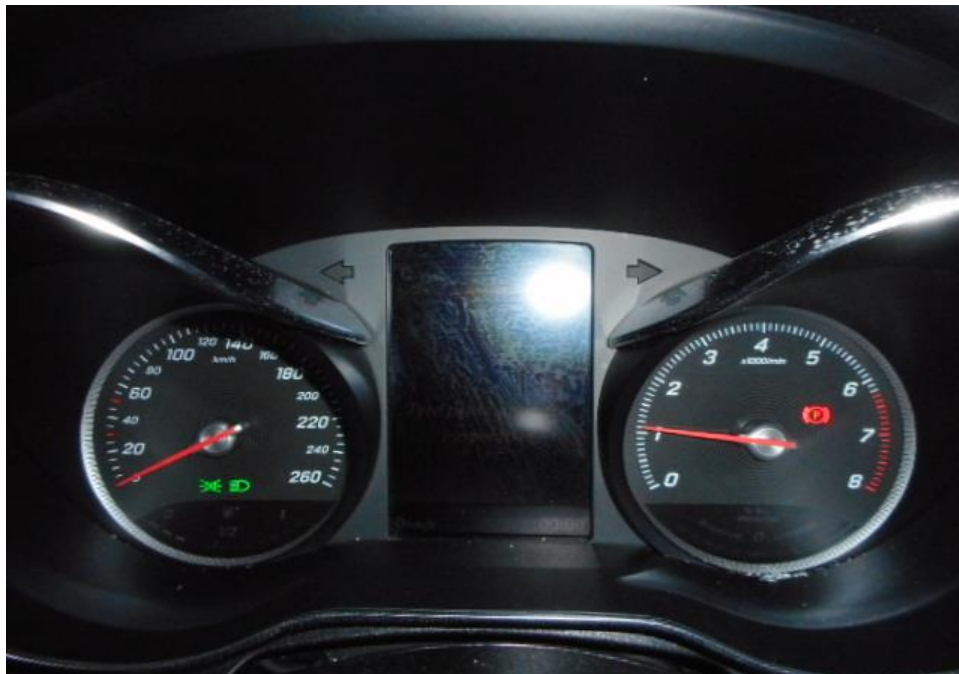
**Photo 26** shows no warning lights illuminated on the instrument panel of the Motor Car after the engine was cranked. This would suggest that there was no abnormality to the electronic operating system of the Motor Car, like the ABS, EPS, TCS and SRS etc.
