Your Ref: TP/IP/35254/2022
Our Ref : CI/TPD23001596/P

15th May 2023

MECHANICAL INSPECTION REPORT OF PICK-UP TRUCK JPD 2844

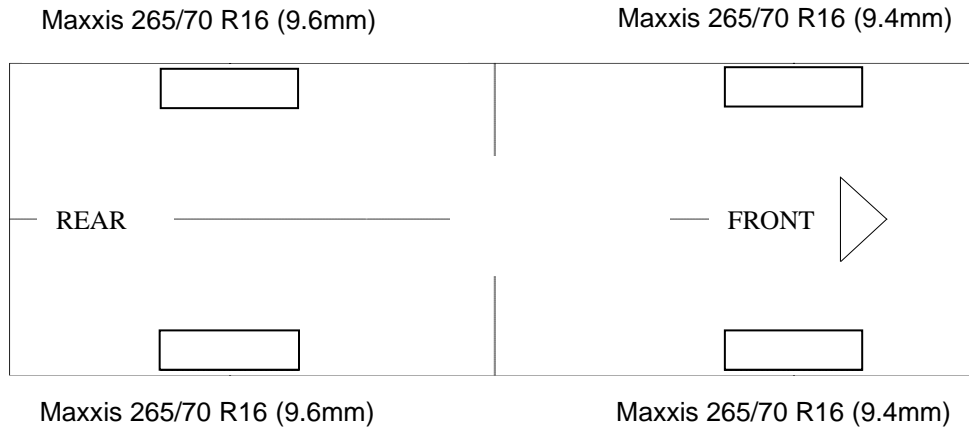
6. The 4 tyres of the Pick-up truck were observed to be in serviceable condition and sufficiently inflated for vehicular operation. I did not find any tear, cut or burst mark(s) on the outer and the inner sidewalls as well as across the tread of the 4 tyres. The tyre brand, tyre size and remaining tread depth of the 4 tyres of the Pick-up truck were recorded as follows:-

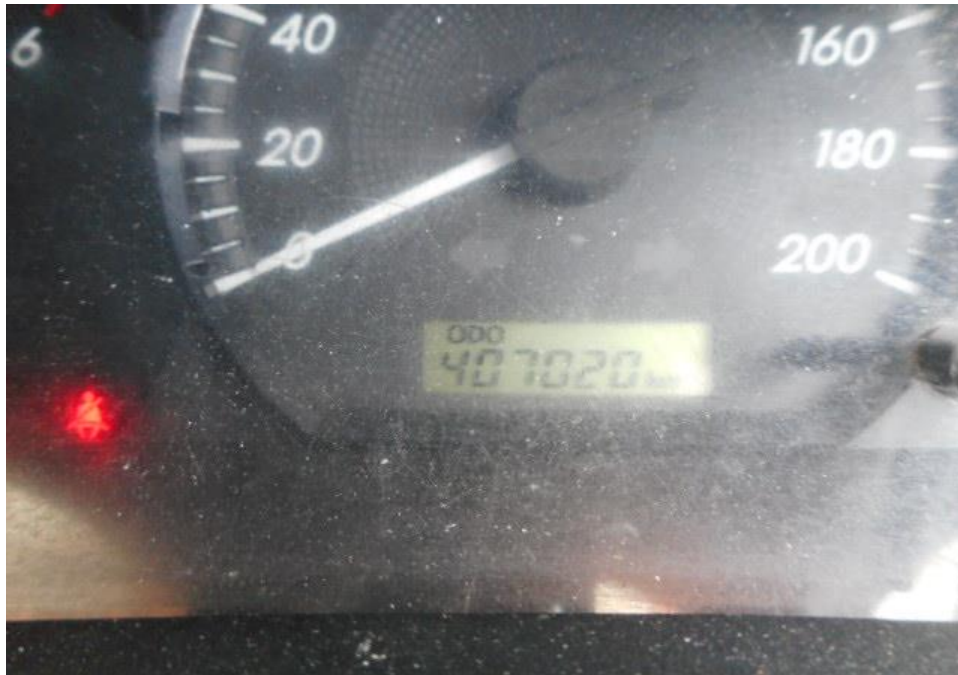
Photo 1 shows a general view of the instrument cluster of the Pick-up truck at the time of my inspection. The mileage of the Pick-up truck was 407,020km.

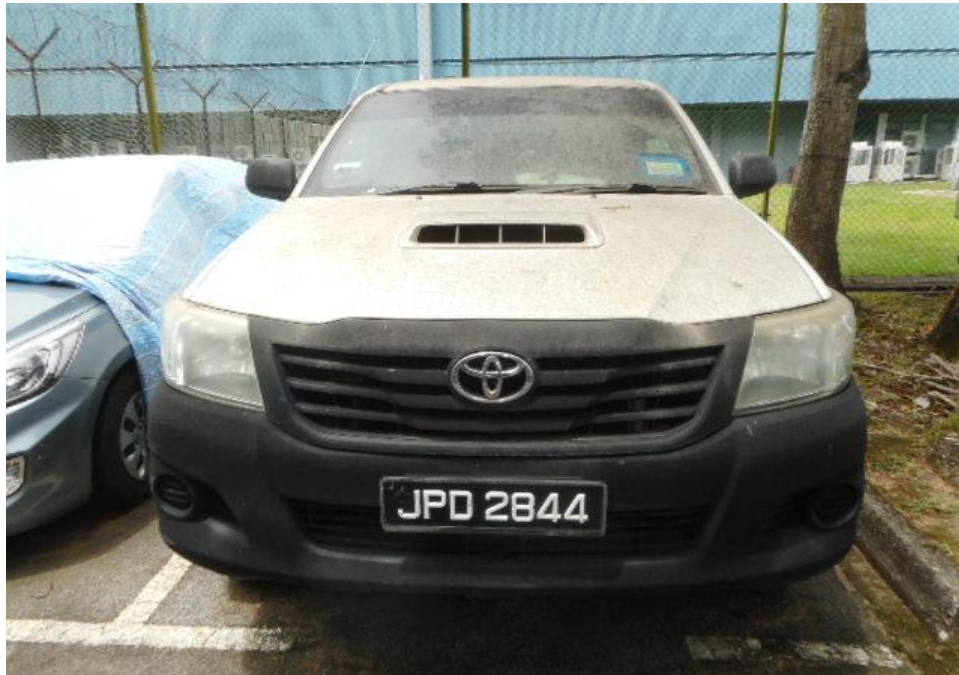
Photo 2 shows a general view of the Pick-up truck at the time of my inspection. The Pick-up truck was observed to be intact and unaffected by the accident.

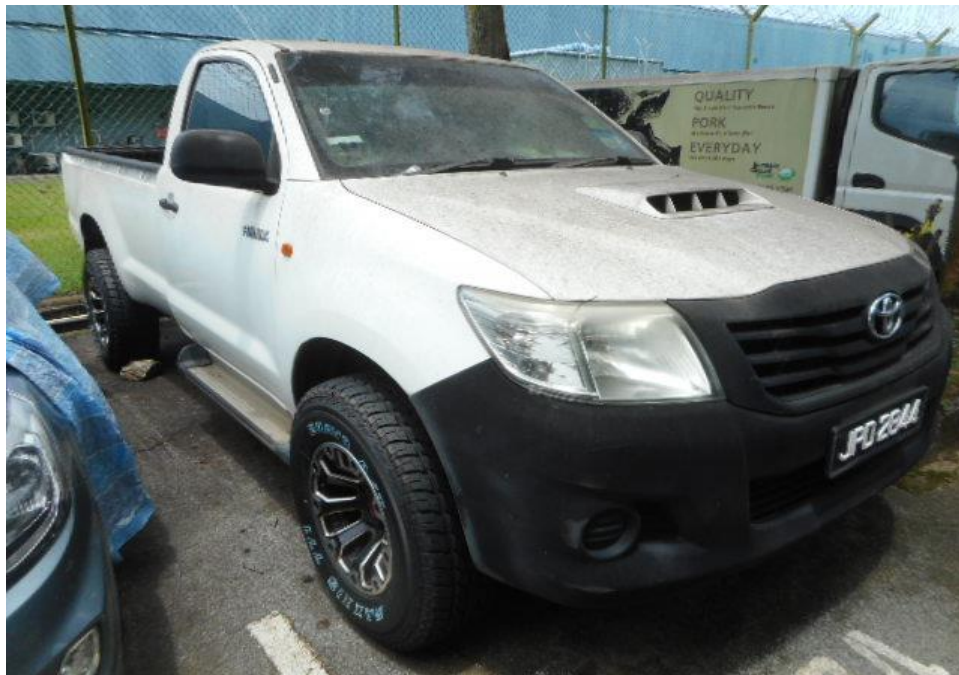
Photo 3 shows a general view of the right body of the Pick-up truck at the time of my inspection. The Pick-up truck was observed to be intact and unaffected by the accident.

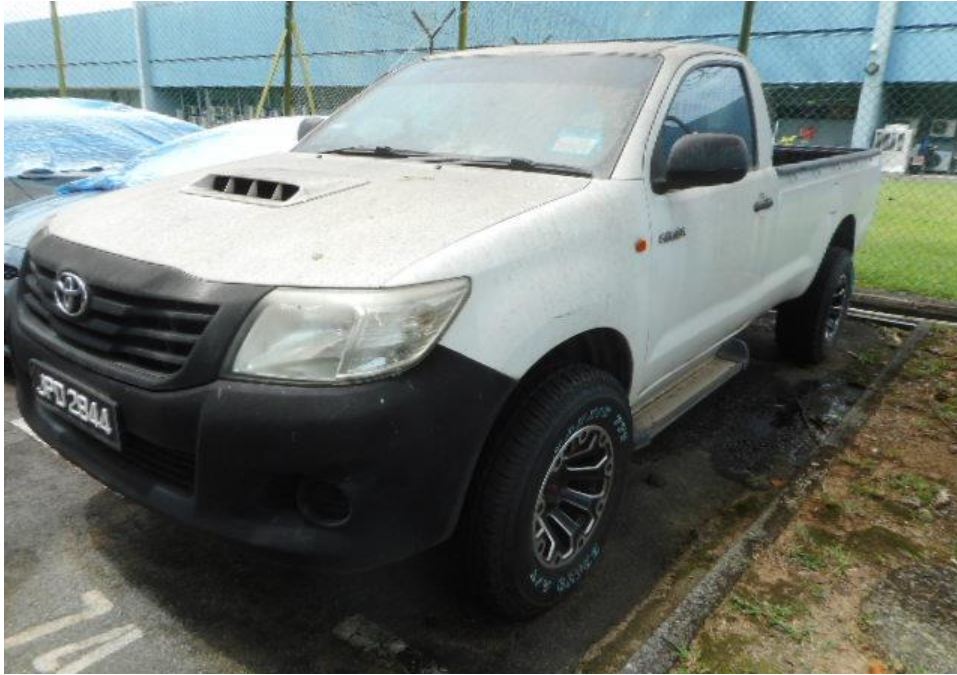
Photo 4 shows a general view of the left body of the Pick-up truck at the time of my inspection. The Pick-up truck was observed to be intact and unaffected by the accident.

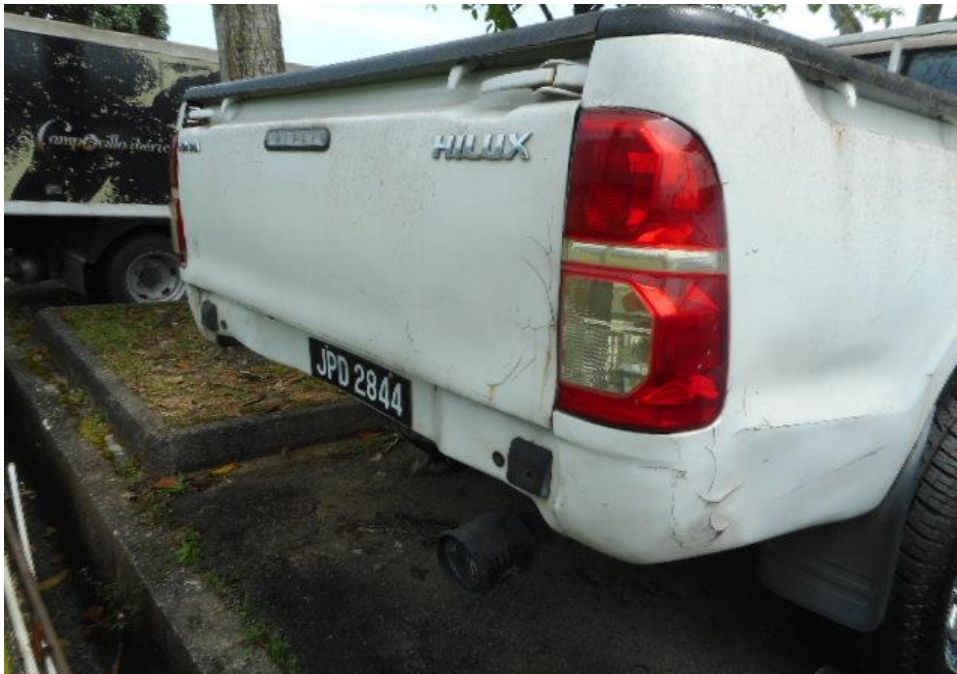
Photo 5 shows a general view of the rear body of the Pick-up truck at the time of my inspection. The Pick-up truck was observed to be intact and unaffected by the accident.

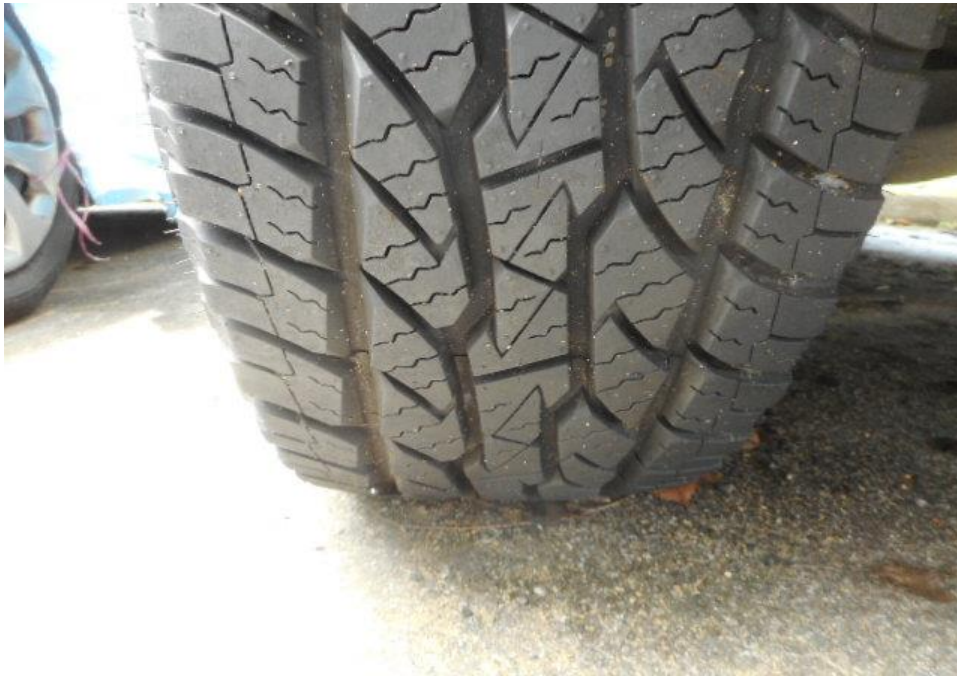
Photo 6 shows the condition of the front right tyre of the Pick-up truck, which was observed to be in serviceable condition with remaining tread depth of approximately 9.4mm. The tyre, which was wrapped around standard alloy wheel rim, was also observed to be sufficiently inflated for vehicular operation. There was no tear, cut or burst mark(s) on the outer and the inner sidewalls as well as across the tread of the 4 tyres that were fitted on the Pick-up truck.

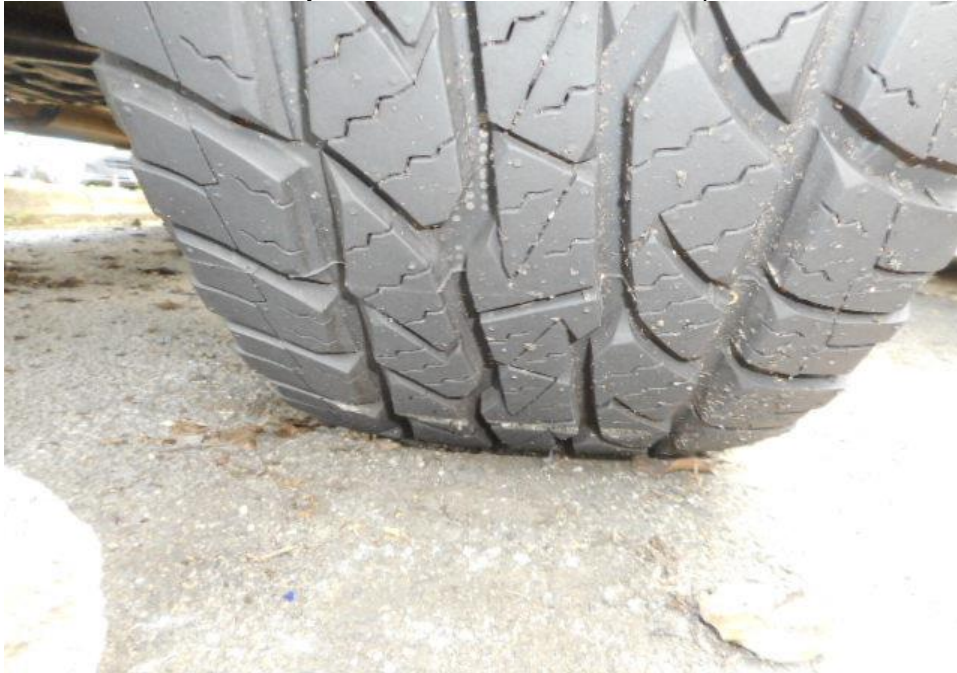
Photo 7 shows the condition of the rear right tyre of the Pick-up truck, which was observed to be in serviceable condition with remaining tread depth of approximately 9.6mm. The tyre, which was wrapped around standard alloy wheel rim, was also observed to be sufficiently inflated for vehicular operation.

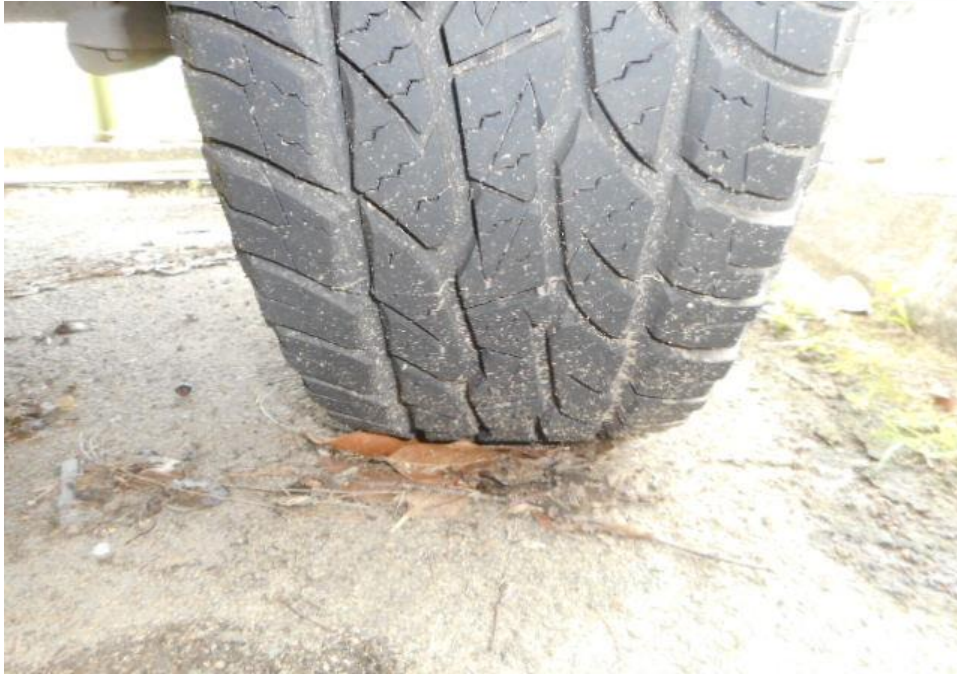
Photo 8 shows the condition of the rear left tyres of the Pick-up truck, which was observed to be in serviceable condition with remaining tread depth of approximately 9.6mm. The tyres, which were wrapped around standard alloy wheel rim, were also observed to be sufficiently inflated for vehicular operation. There was also no damage found on all 4 alloy wheel rims of the Pick-up truck.

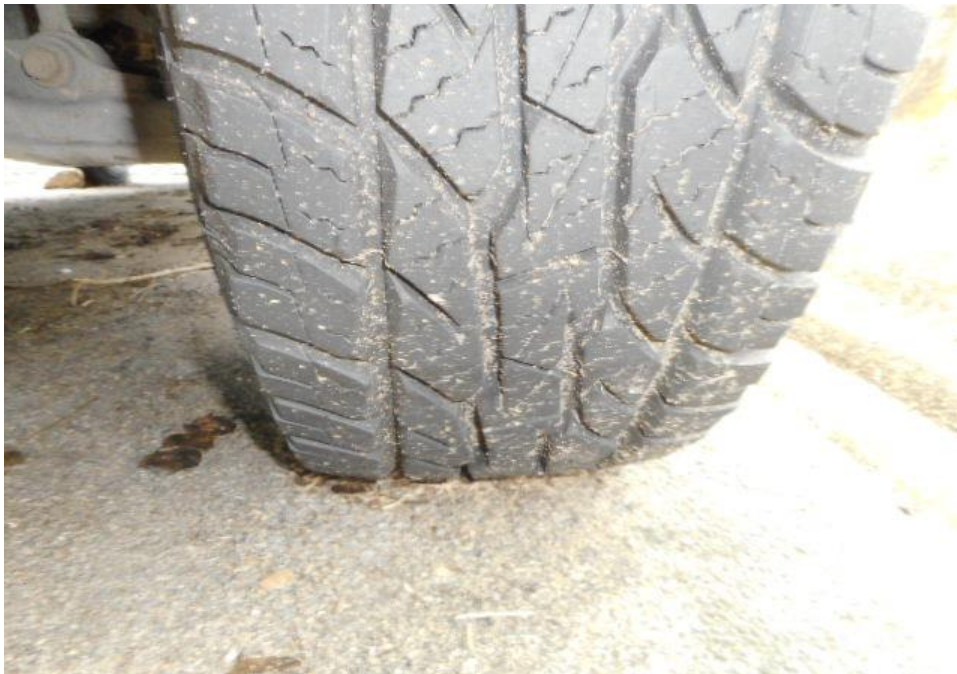
Photo 9 shows the condition of the rear right tyres of the Pick-up truck, which were observed to be in serviceable condition with remaining, tread depth of approximately 9.4mm. There was also no tear, cut or burst mark(s) on the outer and the inner sidewalls as well as across the tread of the 4 tyres that were fitted on the Pick-up truck.

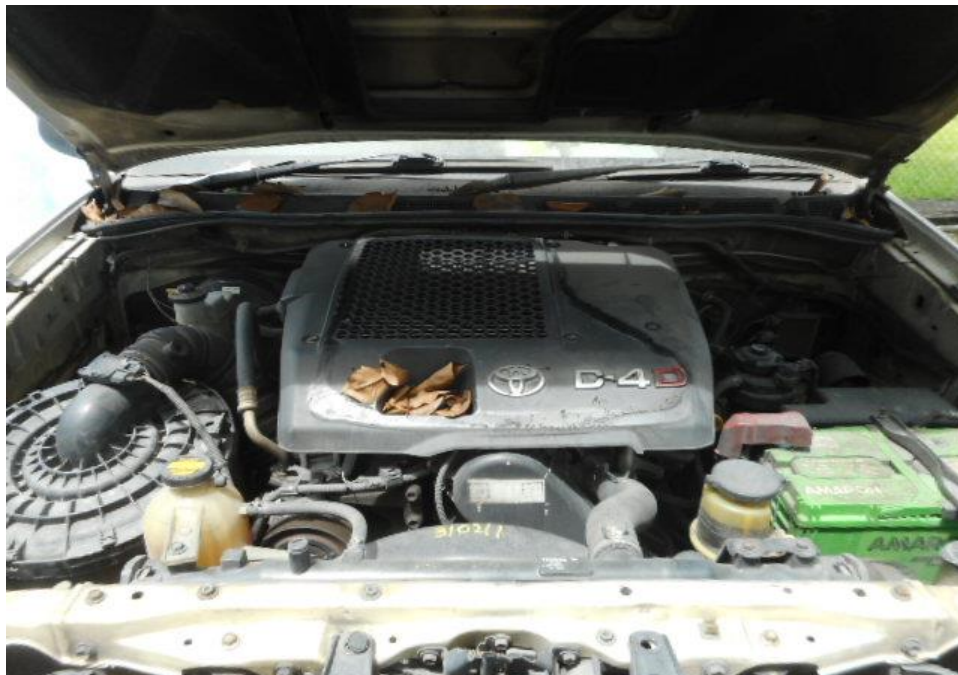
Photo 10 shows a general view of the Pick-up truck's engine compartment, which was accessed by lifting the front cabin of the Pick-up truck. The various parts and components inside the engine compartment were unaffected by the accident. There was also no sign(s) or indication(s) of fresh fluid leakage and/or fluid stain within the engine compartment

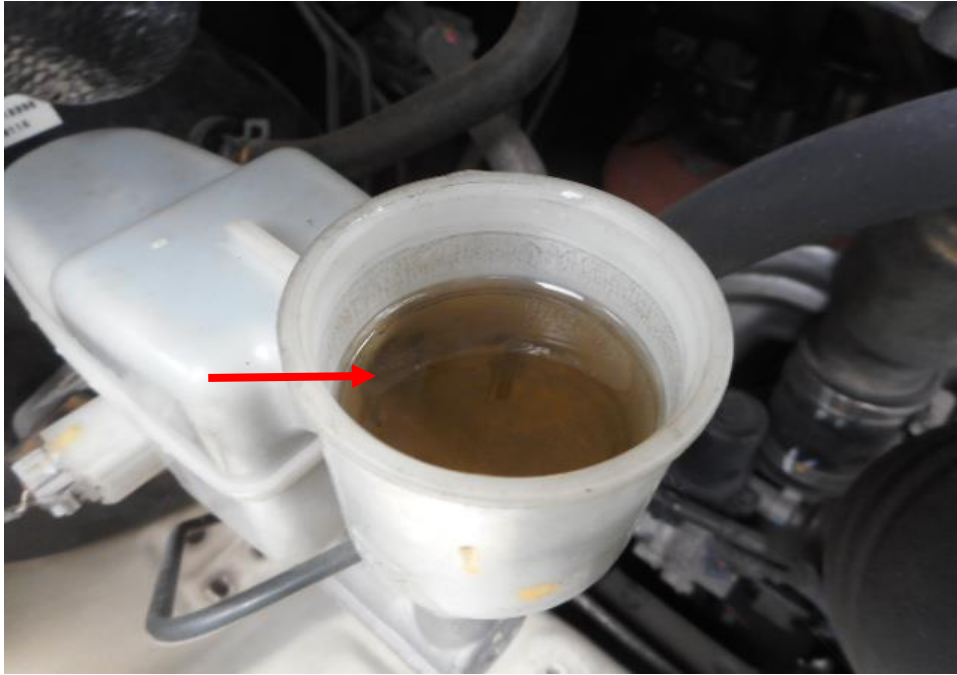
Photo 11 shows the brake fluid reservoir of the Pick-up truck at the time of my inspection. The brake fluid was observed to be of sufficient level (arrowed) and without any visible contamination.

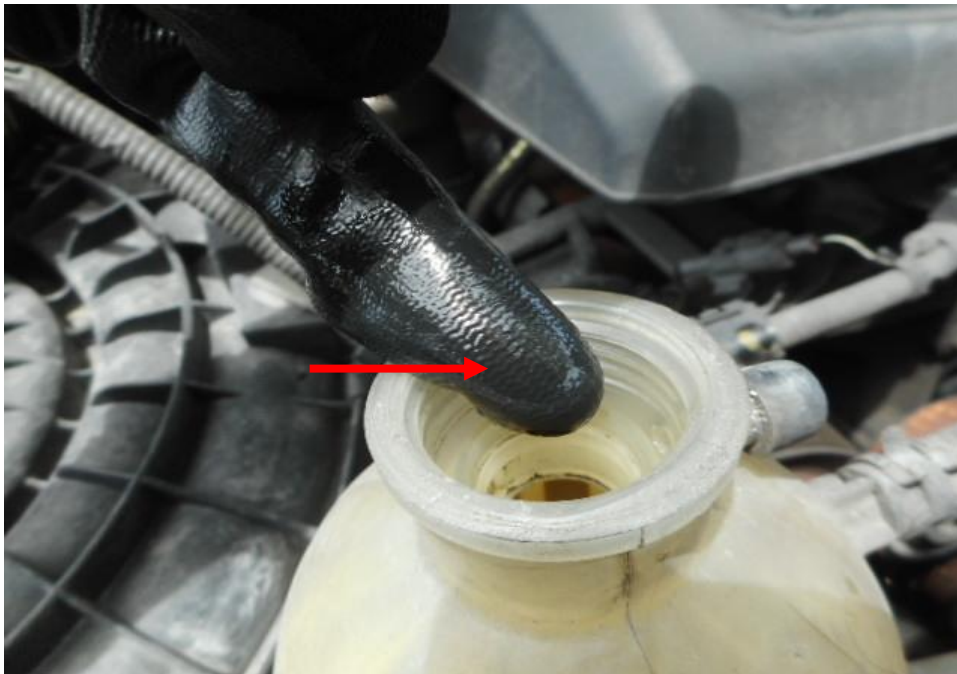
Photo 12 shows the engine coolant reservoir of the Pick-up truck at the time of my inspection. The engine coolant was observed to be of sufficient level (arrowed) and without any visible contamination.

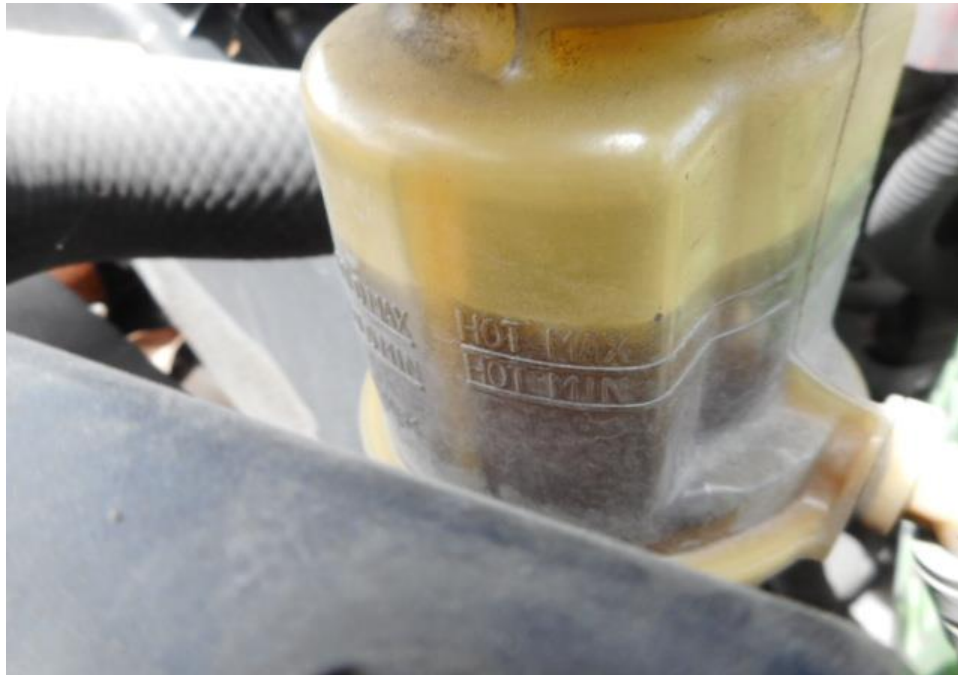
Photo 13 shows the power steering fluid of the Pick-up truck at the time of my inspection. The power steering fluid was observed to be of sufficient level and without any visible contamination.

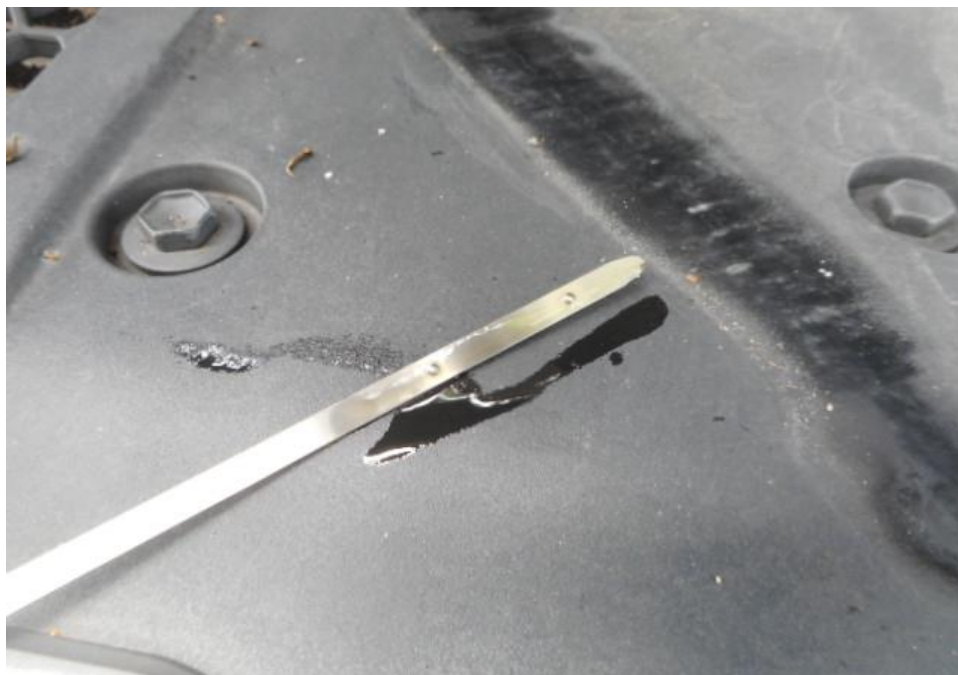
Photo 14 shows the engine oil dip stick of the Pick-up truck at the time of my inspection. The engine oil was observed to be of sufficient level and without any visible contamination.

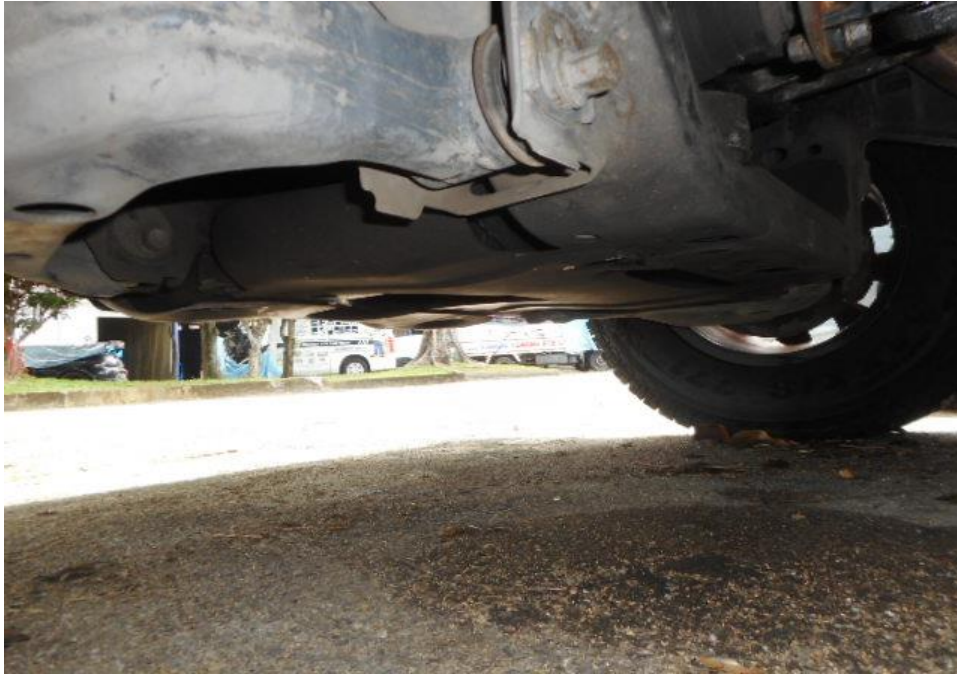
Photo 15 shows the undercarriage of the Pick-up truck, at the area where the engine housing and transmission housing are located. . I did not find any sign(s) or indication(s) of fluid leak and/or fluid stain(s) on the underside of the Pick-up truck.

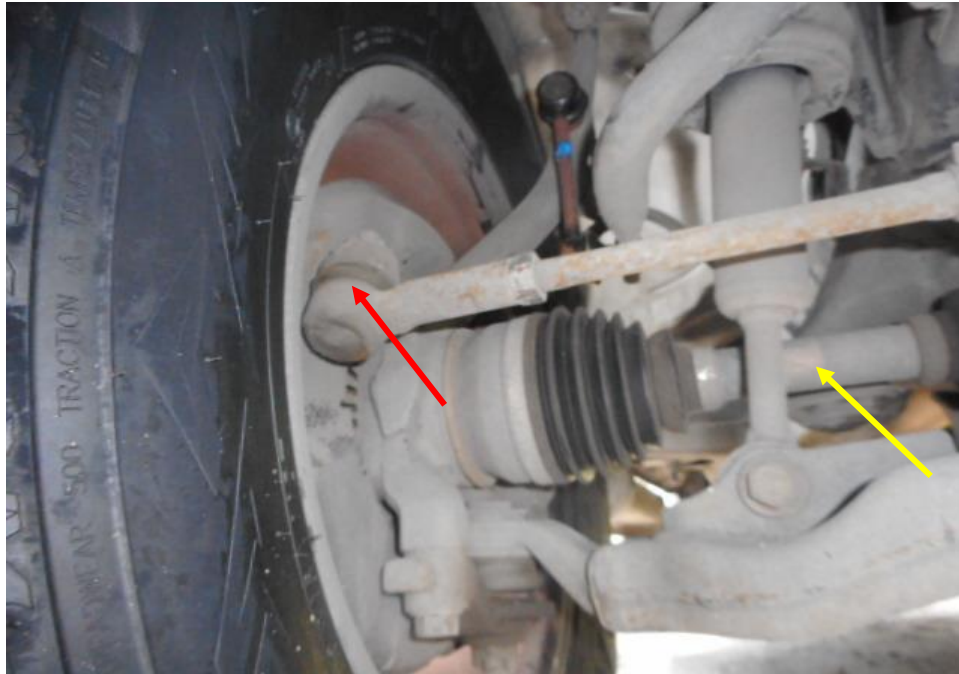
Photo 16 shows the various undercarriage components at the front right wheel of the Pick-up truck, in particular the steering tie rod end (red arrowed) and drive shaft (yellow arrow). The various steering components were all found to be intact, suggesting that the steering system of the Pick-up truck was likely to be in serviceable condition at the material time of accident. There was also no sign of fluid stain(s) observed on the various undercarriage components.

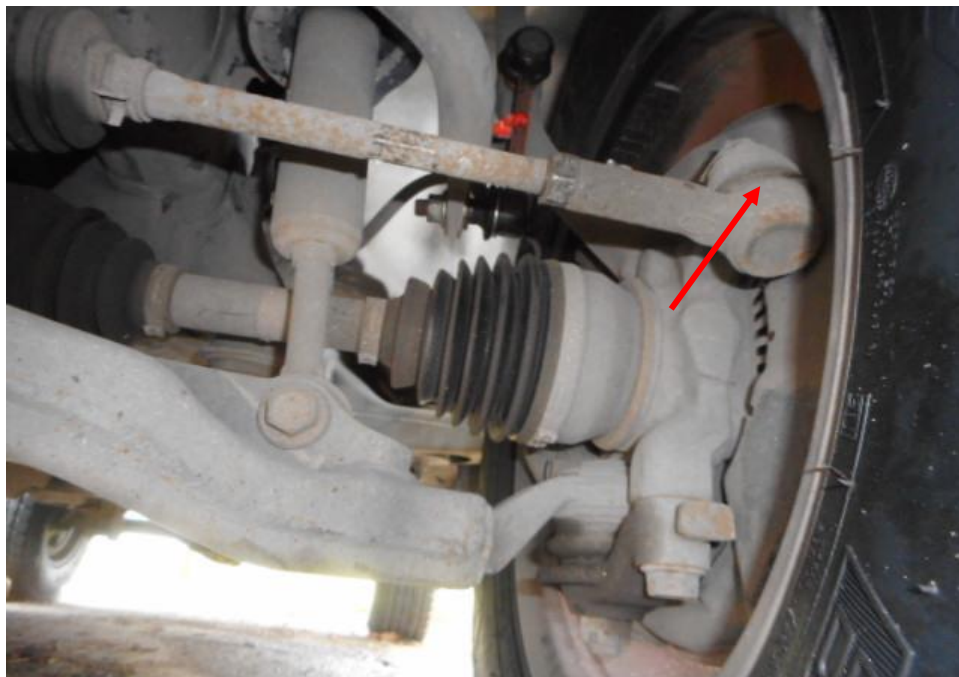
Photo 17 shows the various undercarriage components at the front left wheel of the Pick-up truck, in particular the steering tie rod end (arrowed). The various Undercarriage components of the Pick-up truck were all found to be intact without any visible damage. There was also no sign of fluid stain(s) observed on the various undercarriage components.

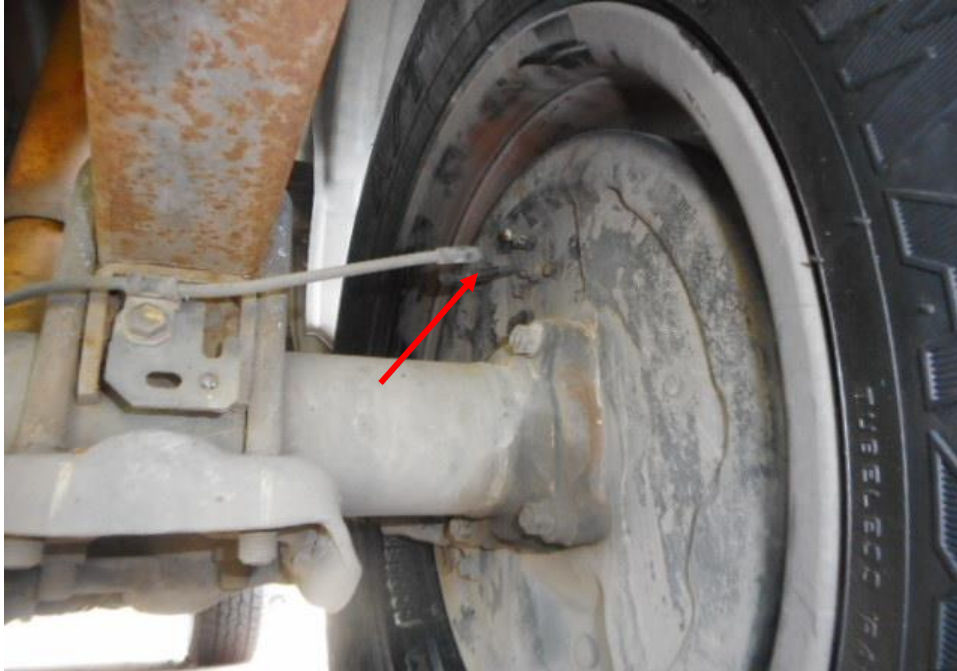
Photo 18 shows the brake pipe (arrowed) at the rear right wheel of the Pick-up truck. I did not observe any leakage of brake fluid at the time of my inspection of the Pick-up truck. My static tests of the Pick-up truck's braking system, along with my visual examination of the various mechanical components in the braking system, had indicated that there was no internal leakage of pressure/vacuum. Hence the braking system of the Pick-up truck was likely to be in serviceable condition at the material time of accident.

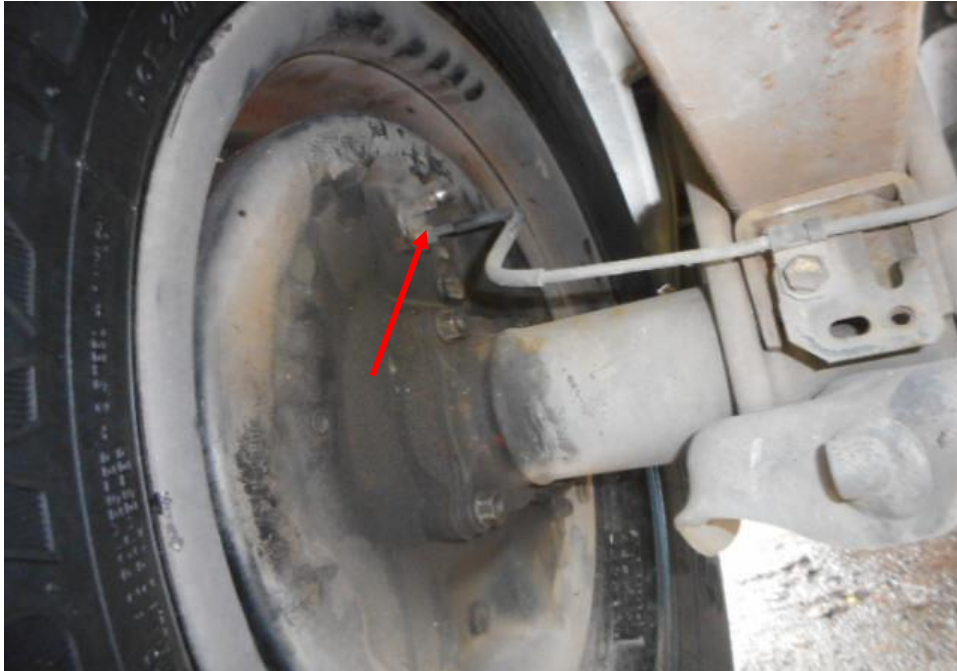
Photo 19 shows the brake pipe (arrowed) at the rear left wheel of the Pick-up truck. I did not observe any leakage of brake fluid at the time of my inspection of the Pick-up truck. My static tests of the Pick-up truck's braking system, along with my visual examination of the various mechanical components in the braking system had indicated that there was no internal leakage of pressure/vacuum. Hence the braking system of the Pick-up truck was likely to be in serviceable condition at the material time of accident.

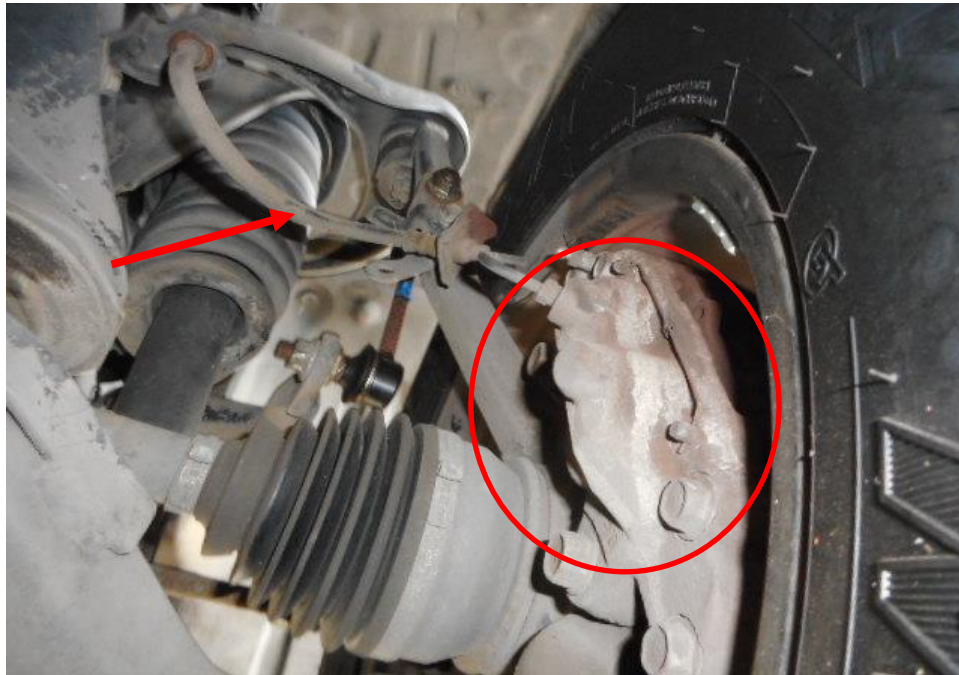
Photo 20 shows the brake hose/pipe (arrowed) at the front right wheel of the Pick-up truck. No leakage of brake fluid was observed. Visual examination of the various components of the braking system like the brake caliper (circled), brake booster, brake pedal etc had revealed all to be intact and without visible damage at the time of accident. There was also no sign of fluid stain(s) observed on the various undercarriage components.

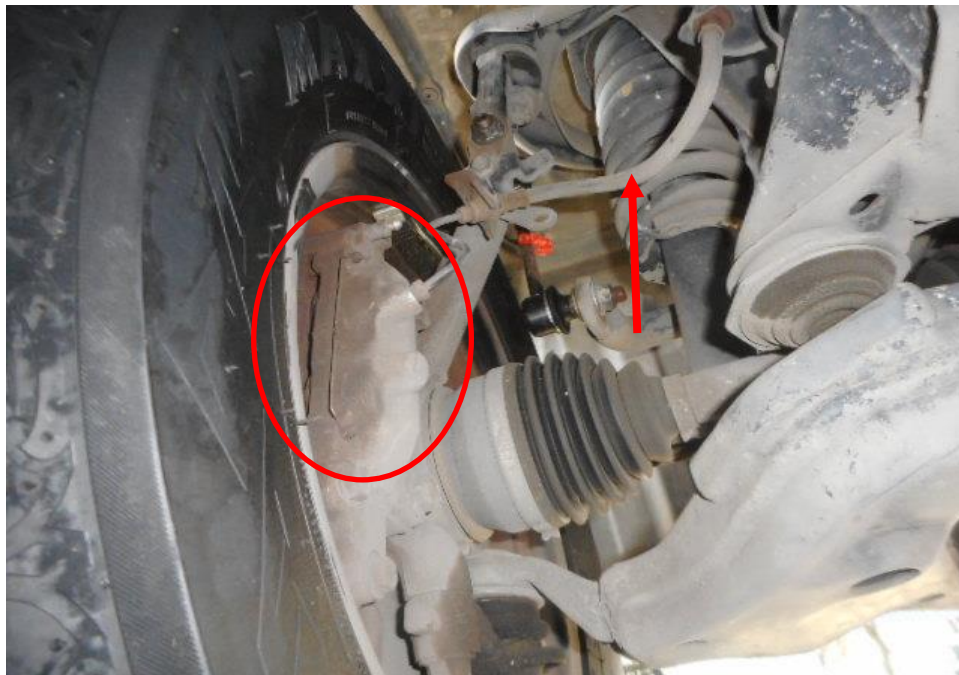
Photo 21 shows the brake hose/pipe (arrowed) at the front left wheel of the Pick-up truck. No leakage of brake fluid was observed. Visual examination of the various components of the braking system like the brake caliper (circled), brake booster, brake pedal etc had revealed all to be intact and without visible damage at the time of accident. There was also no sign of fluid stain(s) observed on the various undercarriage components.

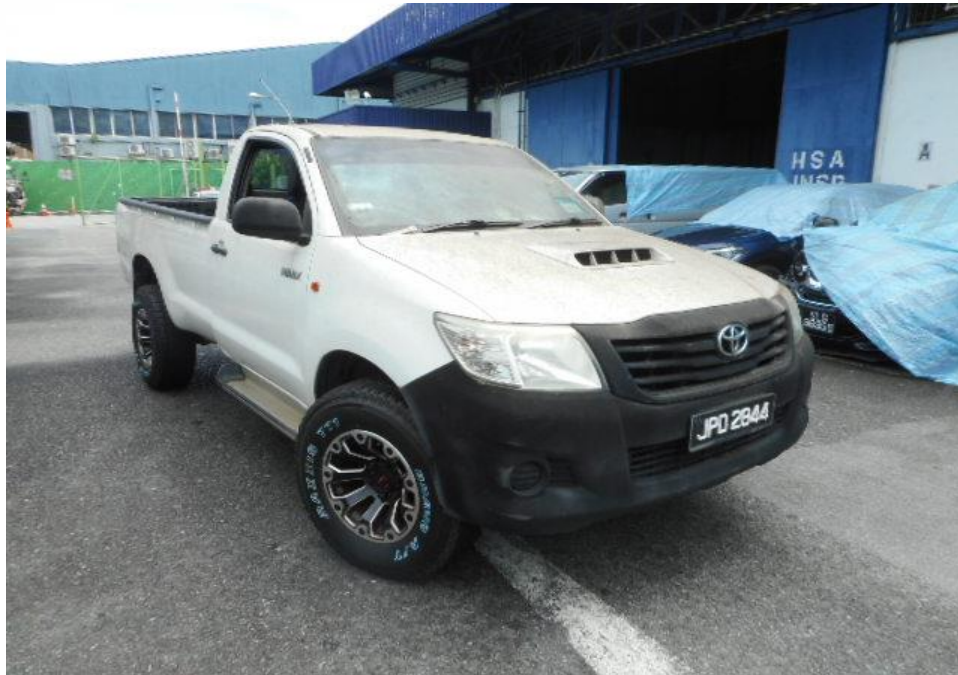
Photo 22 shows the front right wheel of the Pick-up truck turned to its full left. During my steering system test, I did not experience any abnormal free play and/or resistance when I had turned the steering wheel towards full left and full right. This would suggest that the steering system of the Pick-up truck was likely to be in serviceable condition at the material time of accident.
