You're Ref: TP/IP/01307/2023  
Our Ref: CI/TPD22010882/P

28<sup>th</sup> February 2023

**MECHANICAL INSPECTION REPORT OF MOTOR CAR SJZ 2612R**

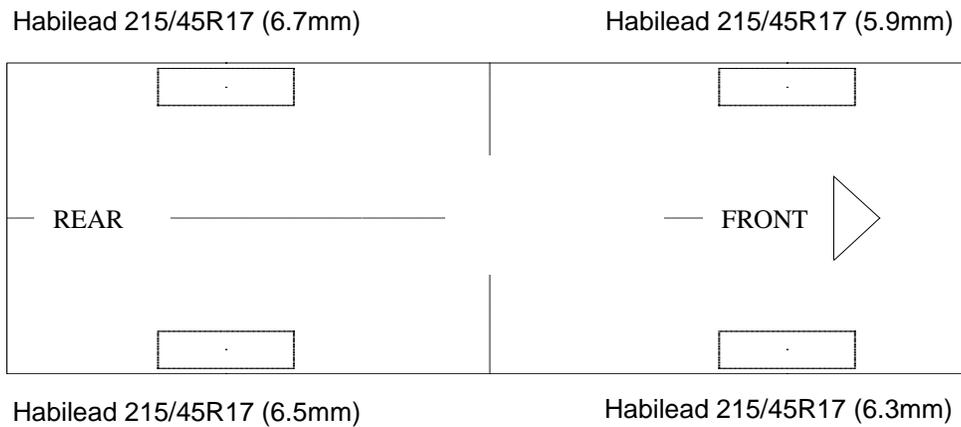
6. The front right and rear left wheel rim was observed to be damaged as a result of the accident. However, the condition of the Motor Car's 4 tyres was observed to be in serviceable condition. I did not find any tear, cut or burst mark(s) on the outer and the inner sidewalls as well as across the tread of the 4 tyres. The 4 tyres were also observed to be sufficiently inflated for vehicular operation. The tyre brand, tyre size and remaining tread depth of the 4 tyres were recorded as follows:-

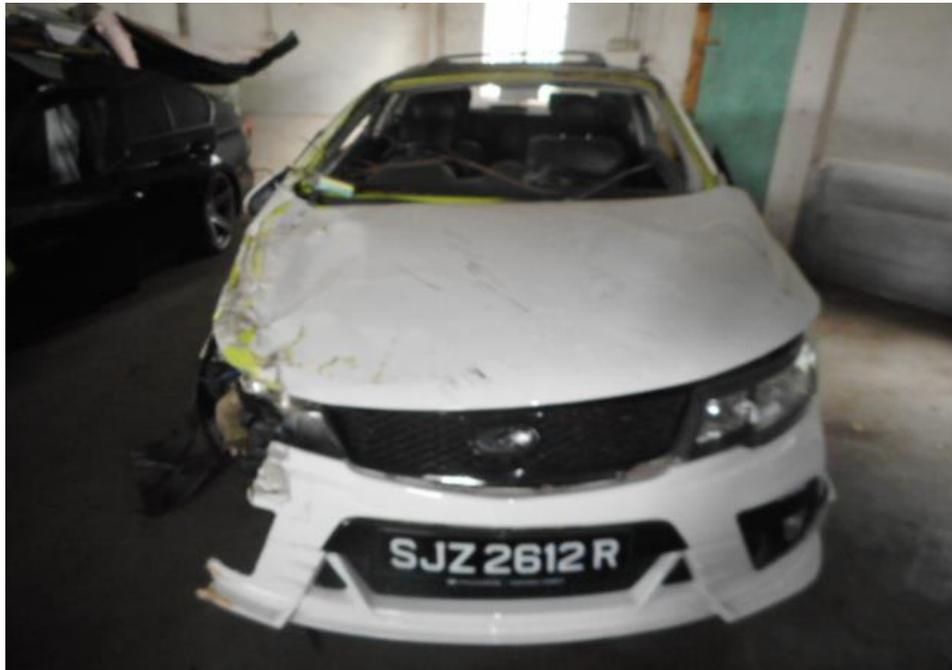
**Photo 1** shows a general view of the Motor Car's front body at the time of my inspection. The Motor Car was observed to have sustained damage at its front portion. Its front, left, right, rear and roof portion. Its front windscreen, front bumper, front right headlamp, front left and right fender, front left and right rear view mirror and rear windscreen, rear bonnet and rear right brake lamp was amongst the body parts that were damaged as a result of the accident.

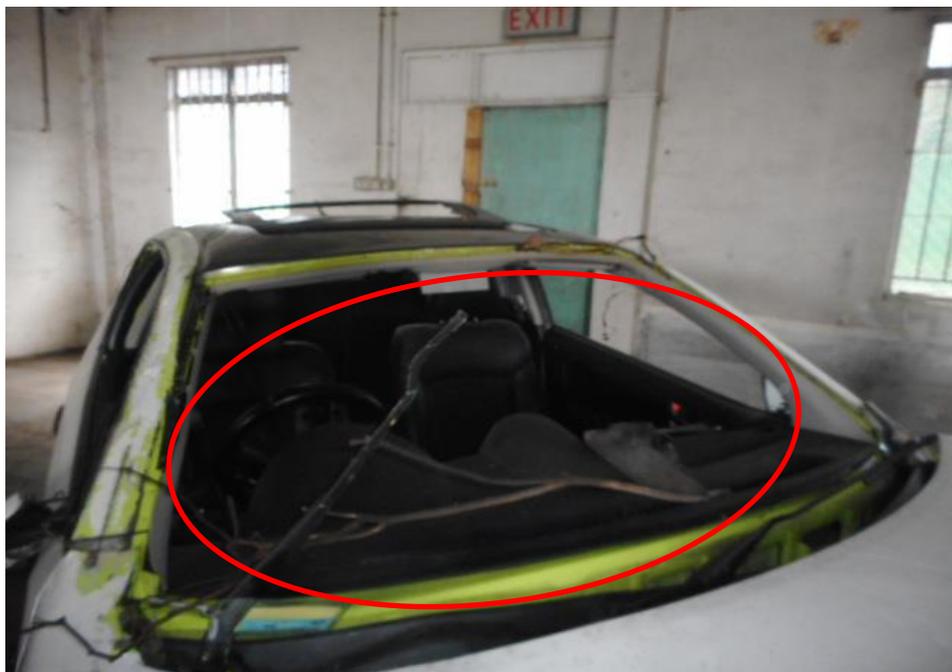
**Photo 2** shows a close up view of the Motor Car's front body at the time of my inspection. The front portion of the Motor Car was observed to have sustained damage. Its front windscreen (circled) was amongst the body parts that were damaged as a result of the accident.

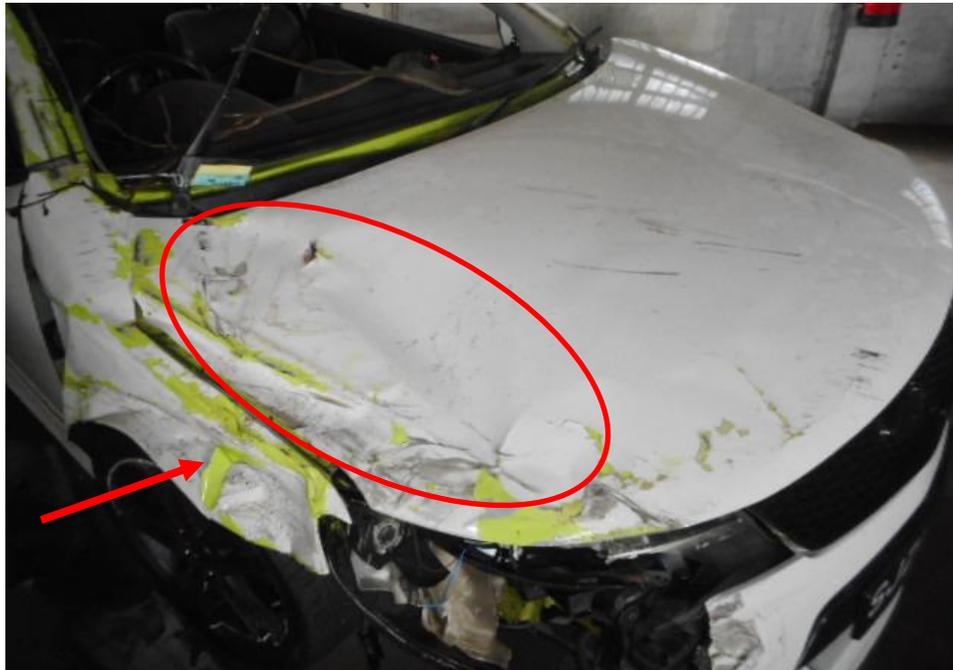
**Photo 3** shows a close up view of the Motor Car's front body at the time of my inspection. The front portion of the Motor Car was observed to have sustained damage. Its front bonnet (circled) and front right fender (arrowed) was amongst the body parts that were damaged as a result of the accident.

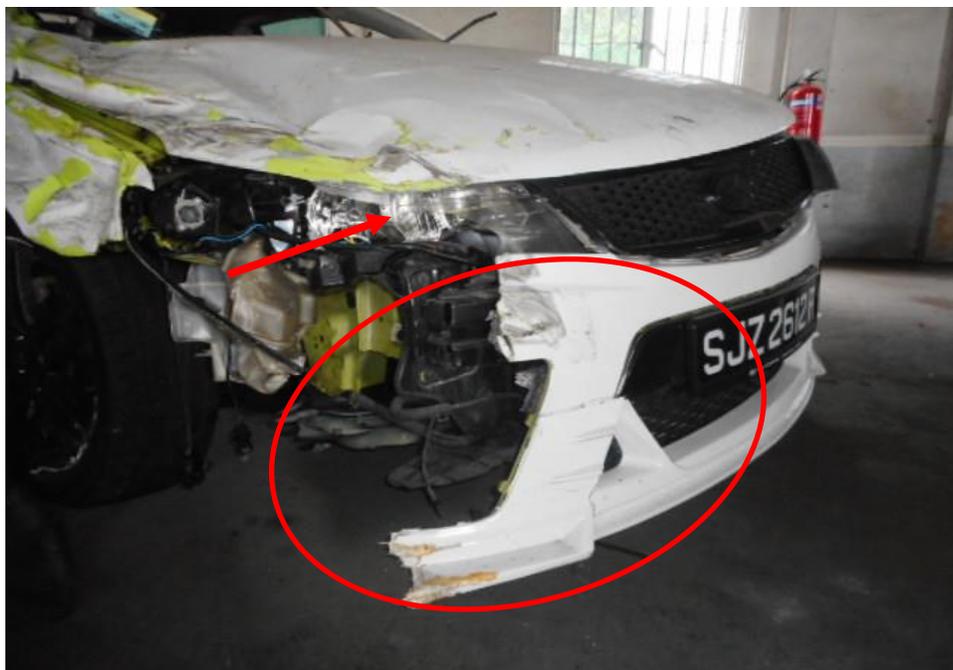
**Photo 4** shows a close up view of the Motor Car's front body at the time of my inspection. The front portion of the Motor Car was observed to have sustained damage. Its front bumper (circled) and front right headlamp (arrowed) was amongst the body parts that were damaged as a result of the accident.

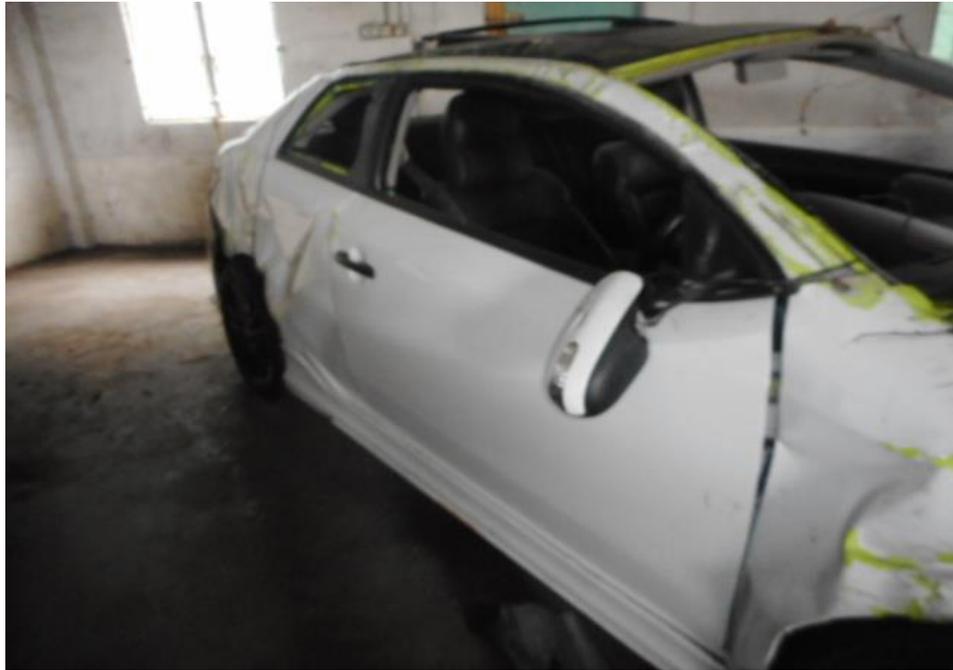
**Photo 5** shows a general up view of the Motor Car's right body at the time of my inspection. The right portion of the Motor Car was observed to have sustained damage. Its right rear view mirror and right door panel was amongst the body parts that were damaged as a result of the accident.

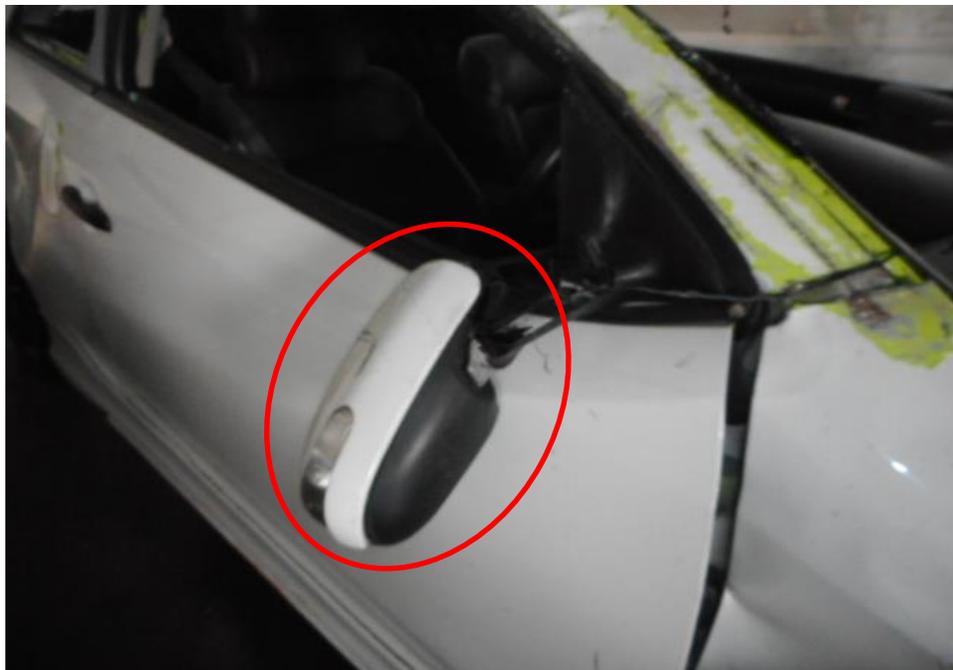
**Photo 6** shows a close up view of the Motor Car's right body at the time of my inspection. The right portion of the Motor Car was observed to have sustained damage. Its right rear view mirror (circled) was amongst the body parts that were damaged as a result of the accident.

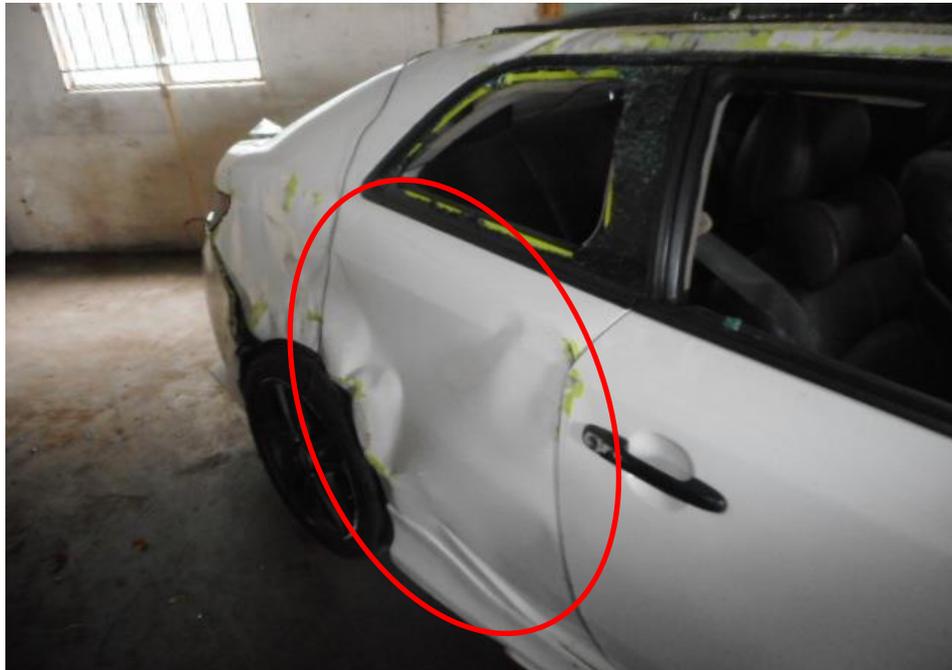
**Photo 7** shows a close up view of the Motor Car's right body at the time of my inspection. The right portion of the Motor Car was observed to have sustained damage. Its right door panel (circled) was amongst the body parts that were damaged as a result of the accident.

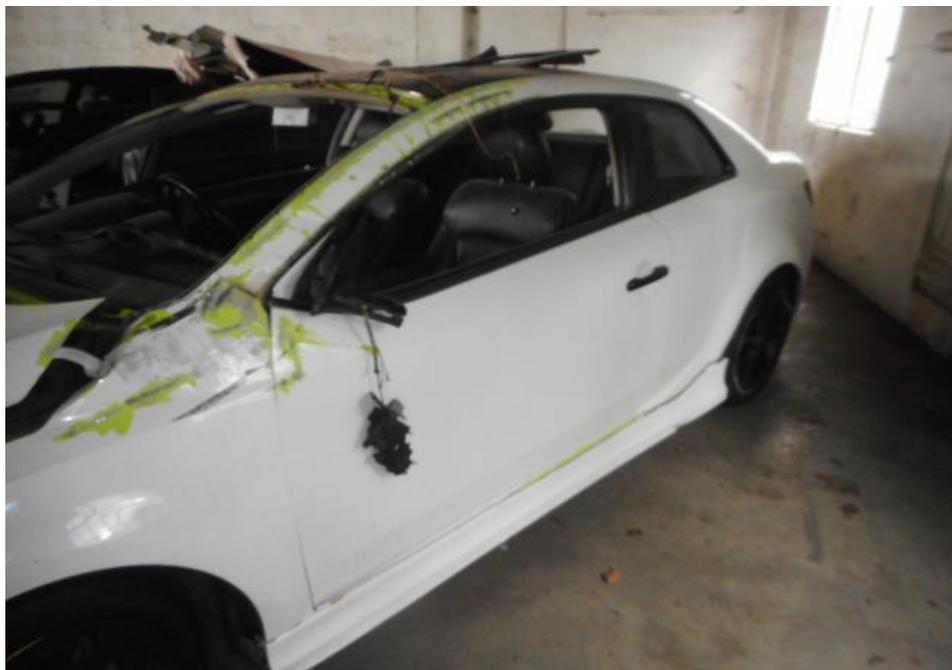
**Photo 8** shows a general up view of the Motor Car's left body at the time of my inspection. The left portion of the Motor Car was observed to have sustained damage. Its left rear view mirror and left fender was amongst the body parts that were damaged as a result of the accident.

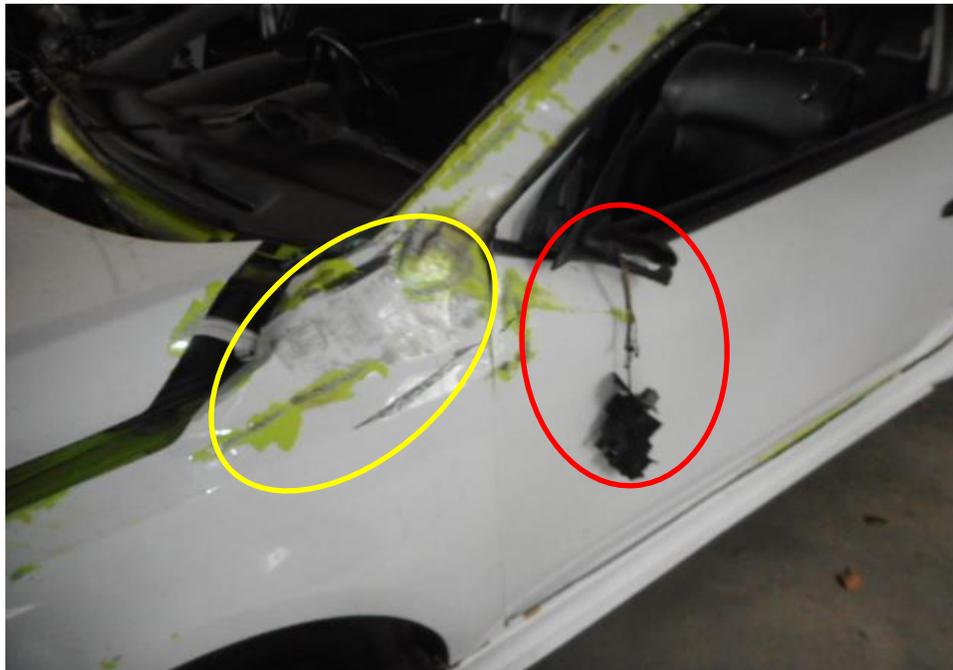
**Photo 9** shows a close up view of the Motor Car's left body at the time of my inspection. The left portion of the Motor Car was observed to have sustained damage. Its left rear view mirror (red circle) and left fender (yellow circle) was amongst the body parts that were damaged as a result of the accident.

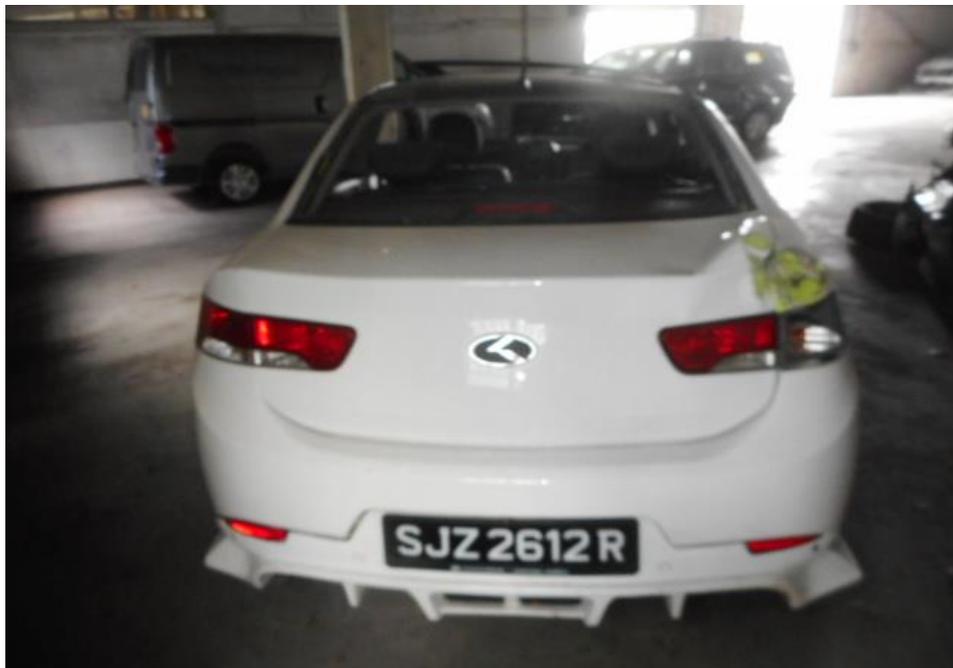
**Photo 10** shows a general up view of the Motor Car's rear body at the time of my inspection. The rear portion of the Motor Car was observed to have sustained damage. Its rear windscreen, rear bonnet and rear right brake lamp was amongst the body parts that were damaged as a result of the accident.

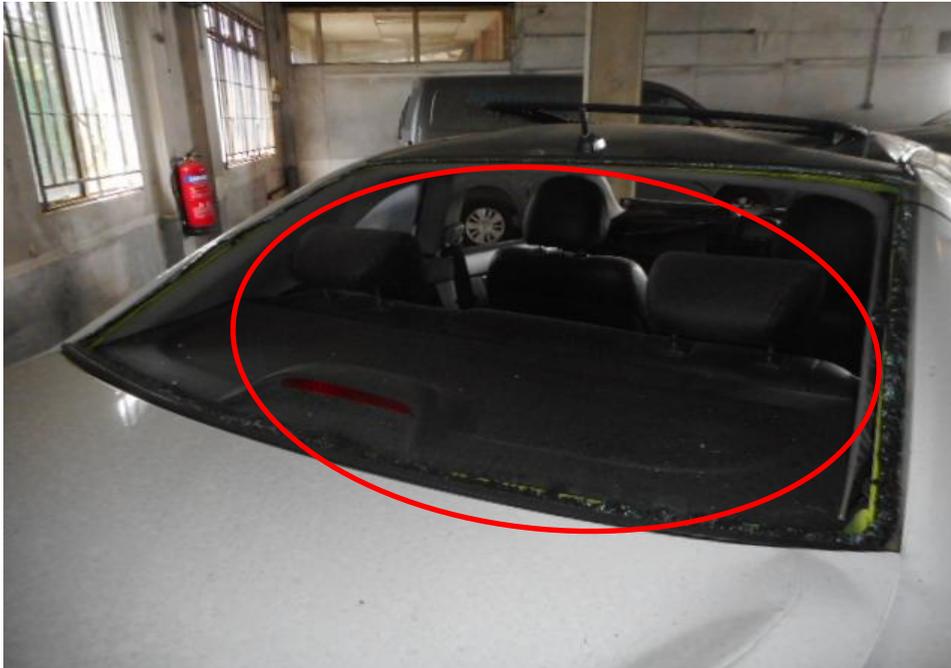
**Photo 11** shows a close up view of the Motor Car's rear body at the time of my inspection. The rear portion of the Motor Car was observed to have sustained damage. Its rear windscreen (circled) was amongst the body parts that were damaged as a result of the accident.

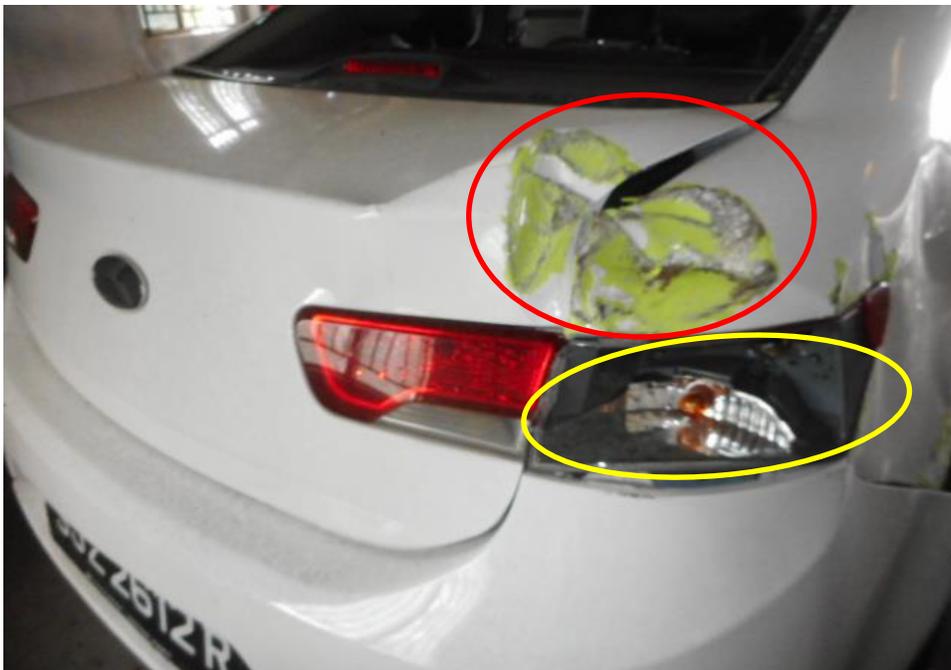
**Photo 12** shows a close up view of the Motor Car's rear body at the time of my inspection. The rear portion of the Motor Car was observed to have sustained damage. Its rear bonnet (red circle) and rear right brake lamp (yellow circle) was amongst the body parts that were damaged as a result of the accident.

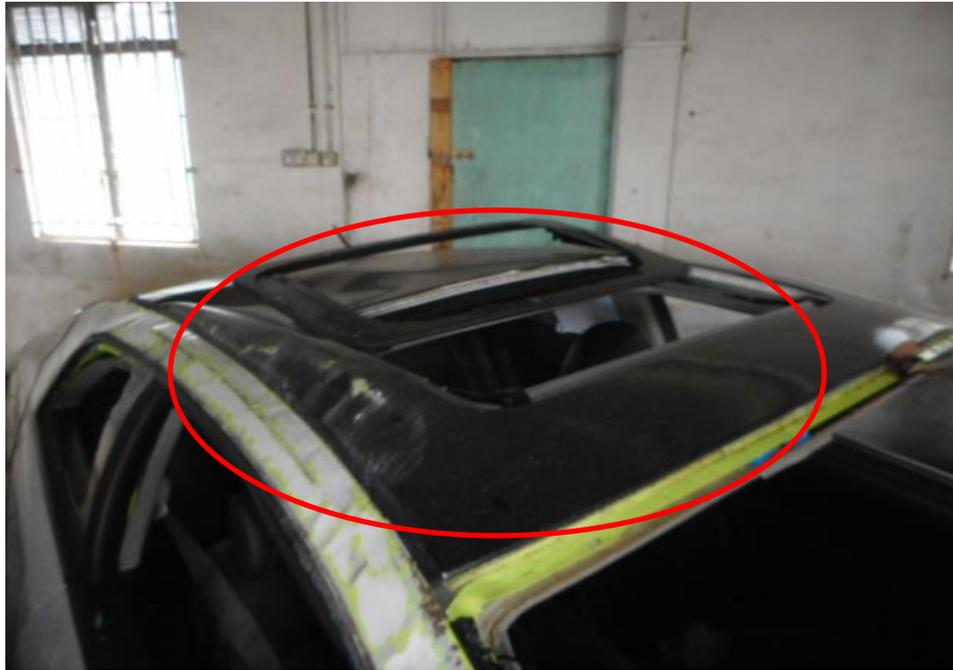
**Photo 13** shows a close up view of the Motor Car's roof portion at the time of my inspection. The roof portion of the Motor Car was observed to have sustained damage. Its roof (circled) was amongst the body parts that were damaged as a result of the accident.

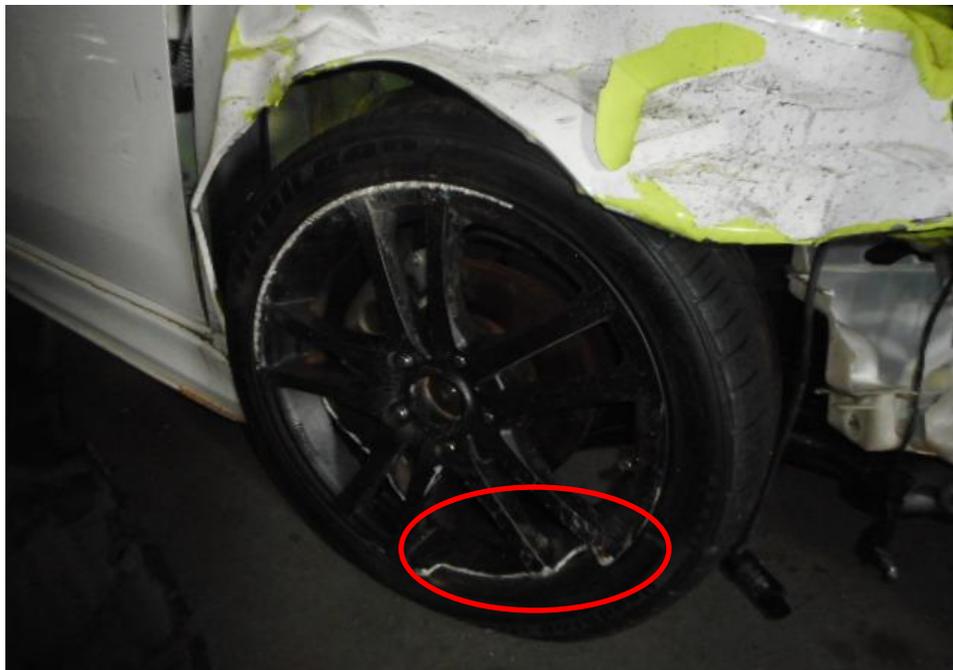
**Photo 14** shows the condition of the front right tyre of the Motor Car, which was observed to be in serviceable condition with remaining tread depth of approximately 6.3mm. The wheel rim (circled) was observed to be damaged as a result of the accident.

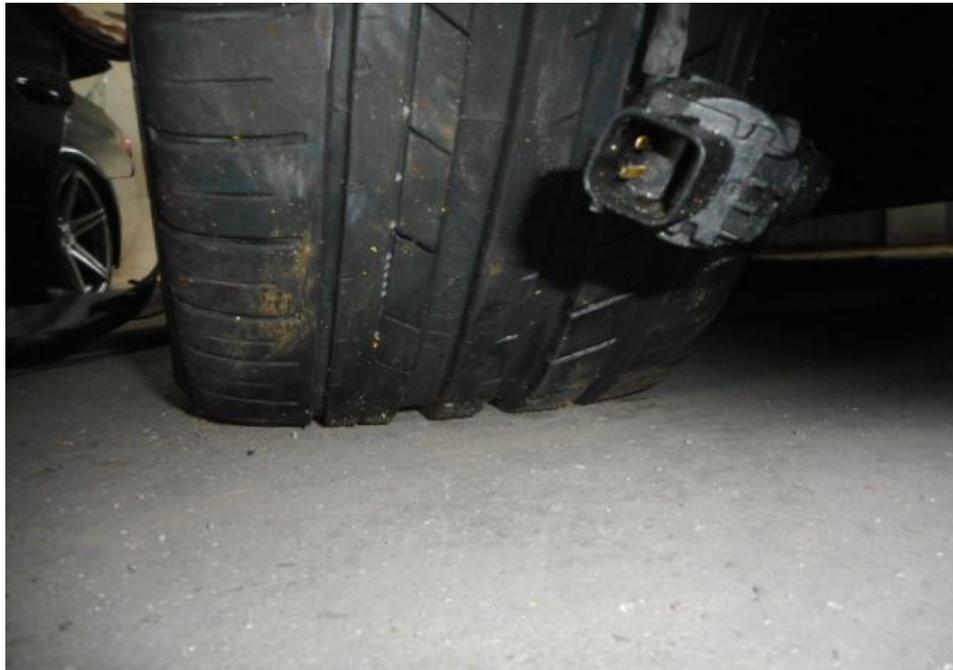
**Photo 15** shows the condition of the front right tyre of the Motor Car, which was observed to be in serviceable condition with remaining tread depth of approximately 6.3mm. The tyre was also observed to be sufficiently inflated for vehicular operation with no tear, cut or burst mark(s).

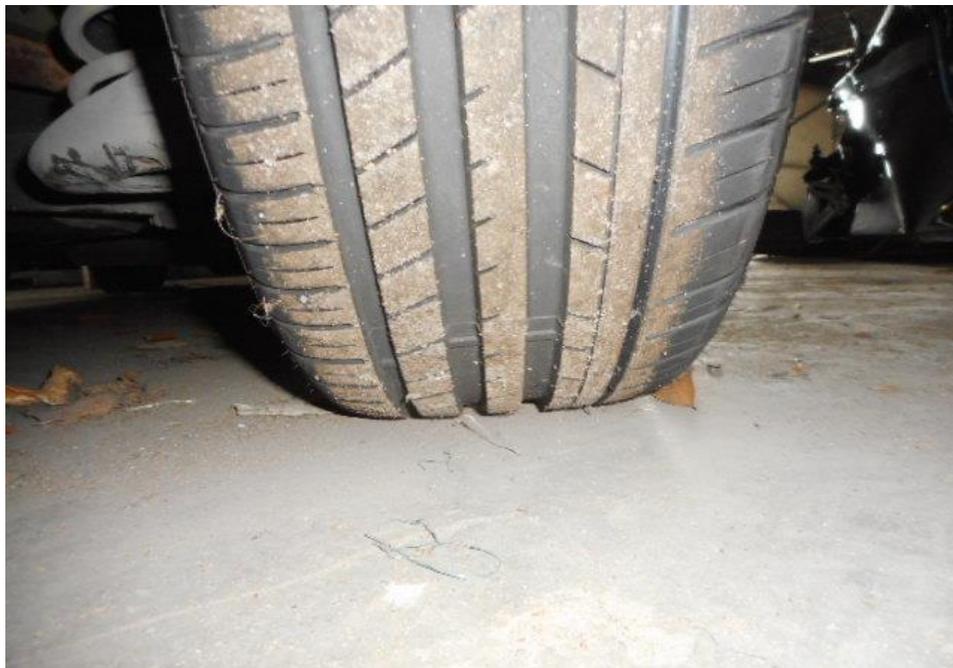
**Photo 16** shows the condition of the rear right tyre of the Motor Car, which was observed to be in serviceable condition with remaining tread depth of approximately 6.5mm. The tyre was also observed to be sufficiently inflated for vehicular operation with no tear, cut or burst mark(s).

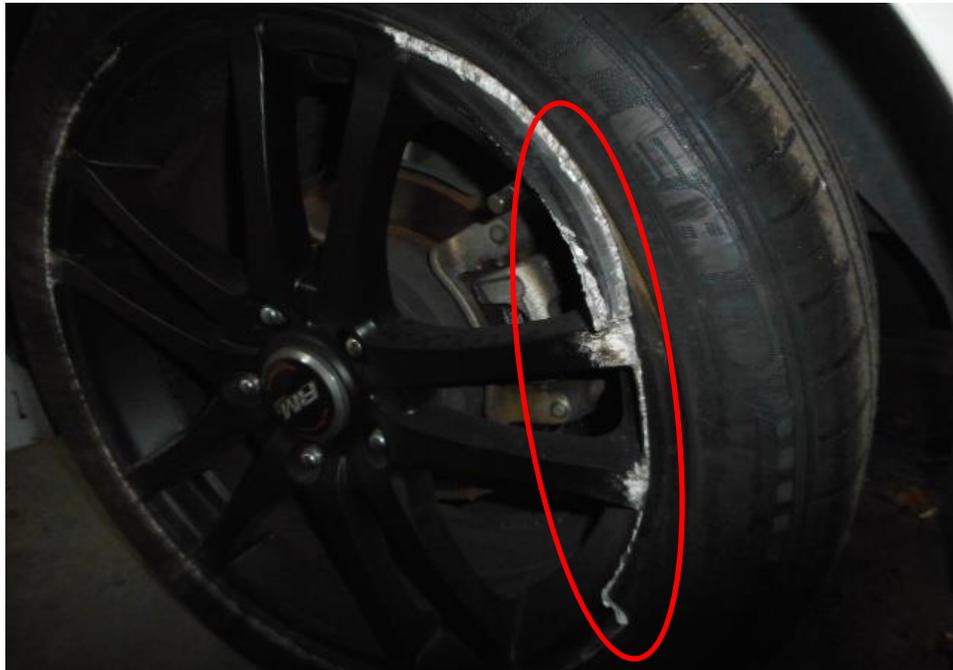
**Photo 17** shows the condition of the rear left tyre of the Motor Car, which was observed to be in serviceable condition with remaining tread depth of approximately 6.7mm. The wheel rim (circled) was observed to be damaged as a result of the accident.

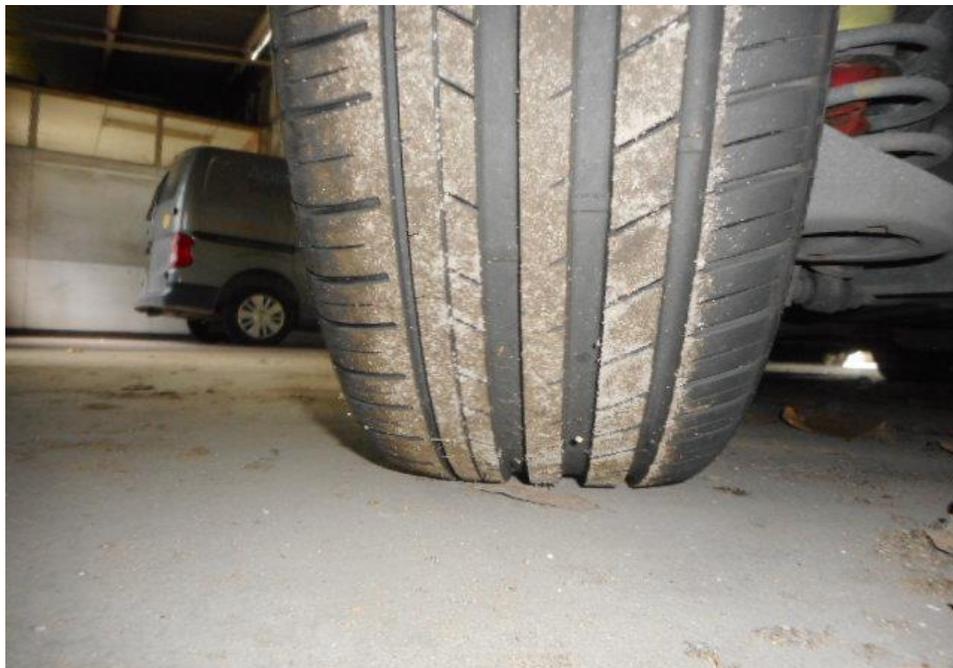
**Photo 18** shows the condition of the rear left tyre of the Motor Car, which was observed to be in serviceable condition with remaining tread depth of approximately 6.7mm. The tyre was also observed to be sufficiently inflated for vehicular operation with no tear, cut or burst mark(s).

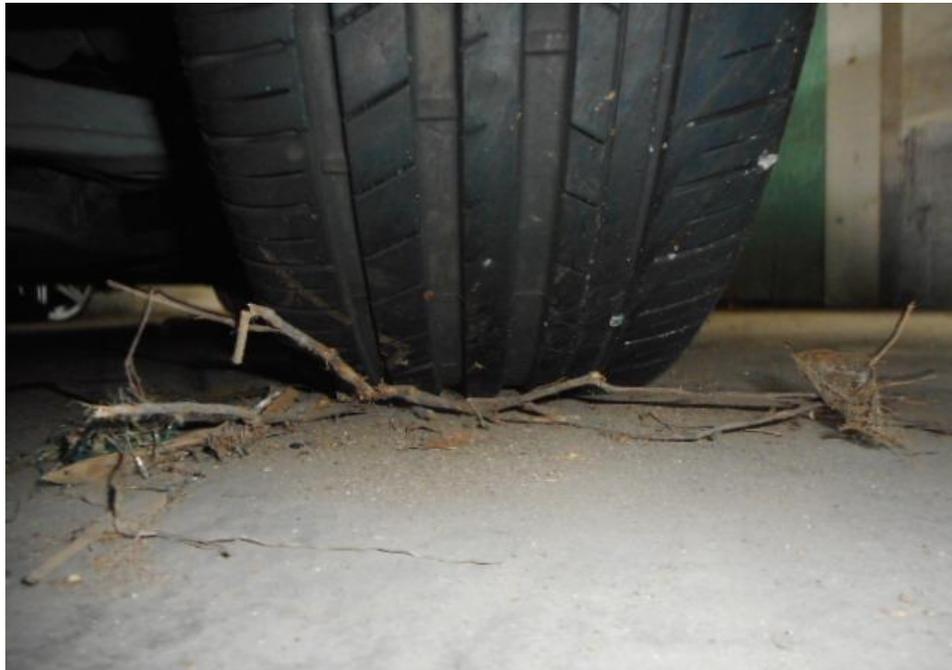
**Photo 19** shows the condition of the front left tyre of the Motor Car, which was observed to be in serviceable condition with remaining tread depth of approximately 5.9mm. There was also no tear, cut or burst mark(s) on the outer and the inner sidewalls as well as across the tread of the Motor Car's 4 tyres.

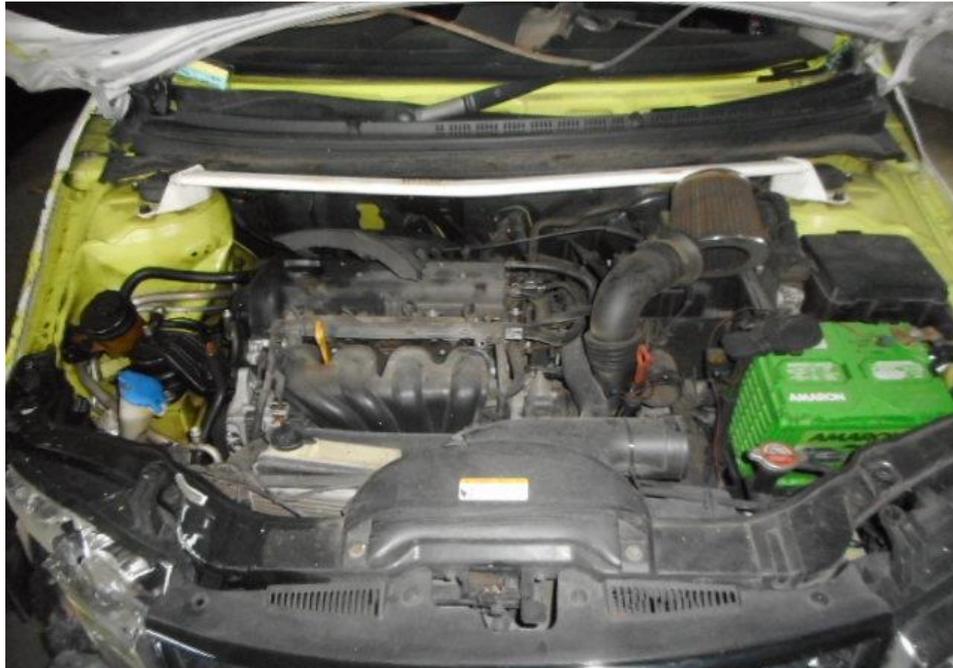
**Photo 20** shows a general view of the Motor Car's engine compartment. The power steering fluid reservoir and hose inside the engine compartment were unaffected by the accident. There was also no sign(s) or indication(s) of fluid leakage and/or fluid stain within the engine compartment.

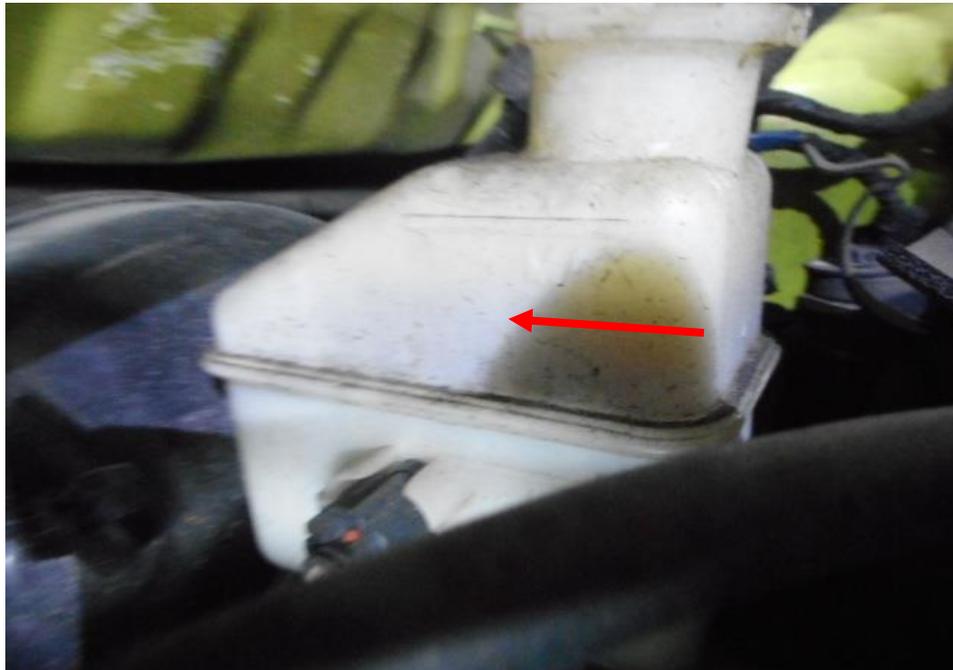
**Photo 21** shows the brake fluid reservoir of the Motor Car at the time of my inspection. The brake fluid was observed to be of sufficient level (arrowed) and there was also no contamination found to the fluid.

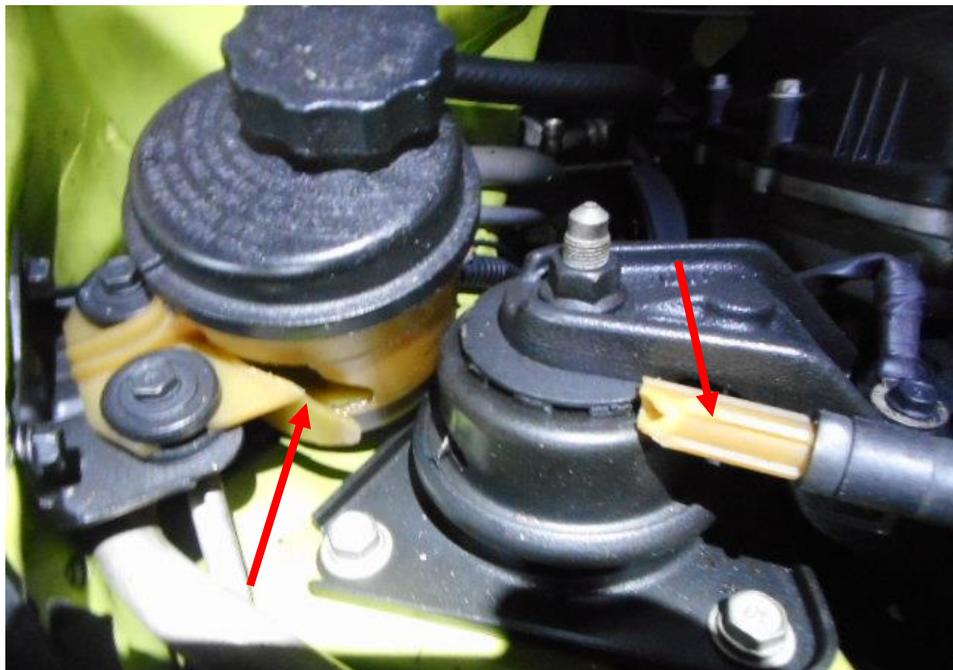
8. Upon examination of the engine compartment of the Motor Car, I had observed that the engine oil, engine coolant and power steering fluid was observed to be insufficient. The brake fluid were found to be of sufficient level for operating purposes. Visually, there was also no contamination found to the fluid. The engine oil, engine coolant and was observed to be insufficient however we did not find any leakage to the these components
9. Further examination of the engine compartment revealed that the power steering fluid reservoir and a hose belonging to the power steering fluid reservoir was observed to be broken off and had resulted the power steering fluid to leak out and become insufficient. From our understanding, the damages to the power steering reservoir was due to induced impact from the accident that have cause the hoses to be broken off and the reservoir to crack at the bottom

**Photo 22** shows the power steering fluid level of the Motor Car at the time of my inspection. The power steering fluid was observed to be of insufficient level as its hose and reservoir was broken due to the induced impact as a result of the accident.

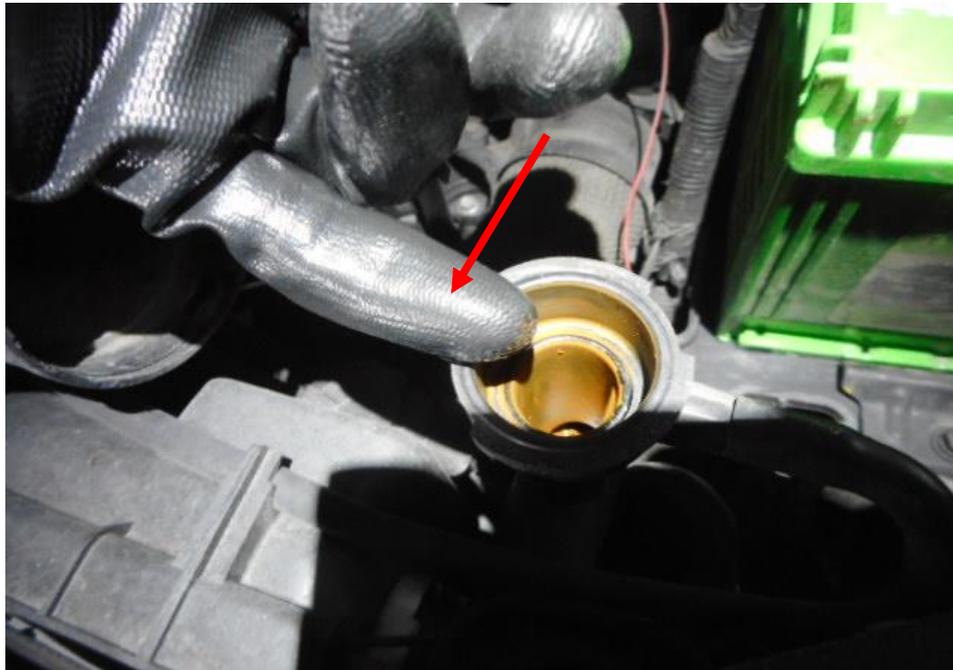
**Photo 23** shows checks being carried out to the engine coolant of the Motor Car at the time of my inspection. The engine coolant was observed to be of insufficient level (arrowed).

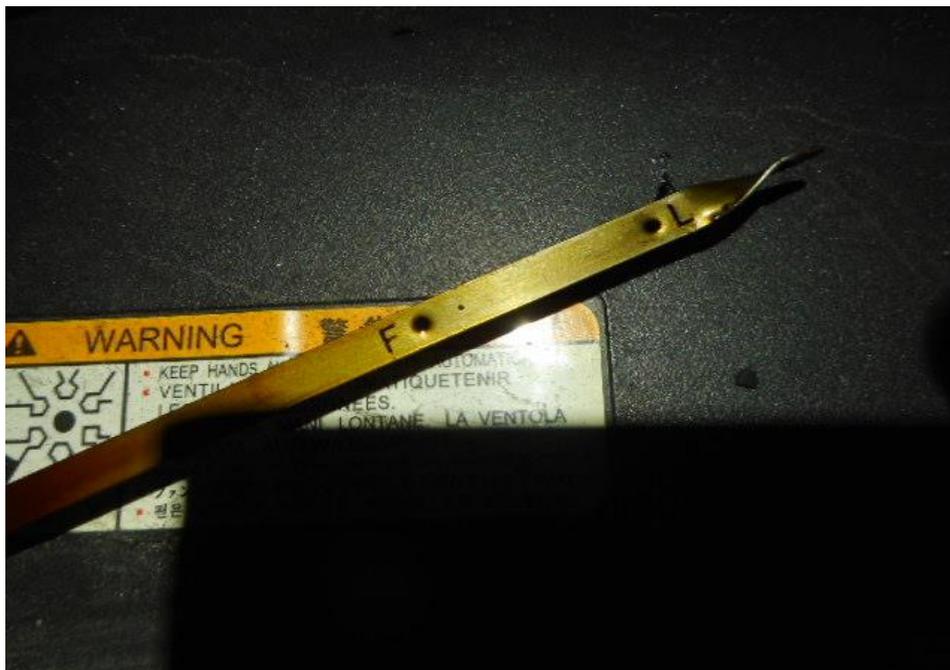
**Photo 24** shows the engine oil level dipstick of the Motor Car at the time of my inspection. The engine oil was observed to be of insufficient level.

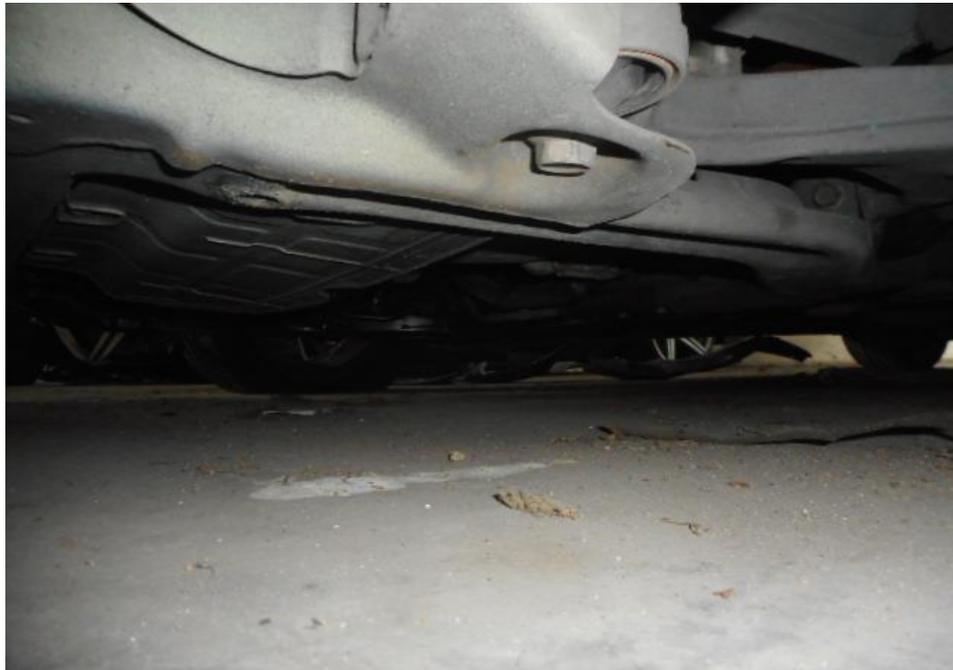
**Photo 25** shows the undercarriage of the Motor Car, at the area where the engine housing and transmission housing are located. I did not find any sign(s) or indication(s) of fluid leak and/or fluid stain(s) on the underside of the Motor Car.

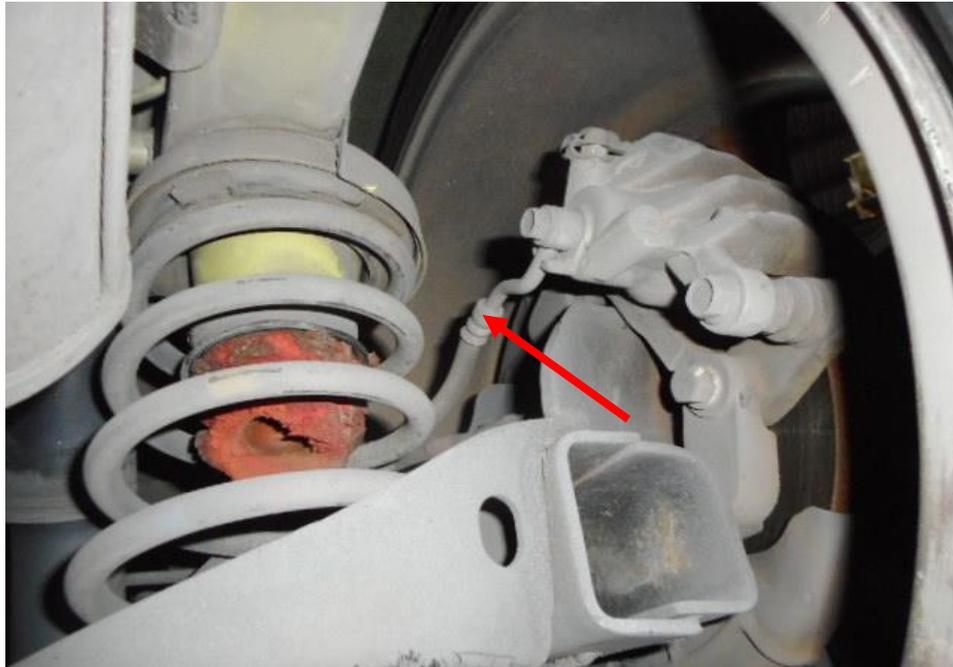
**Photo 26** shows the brake hose/pipe (arrowed) at the rear right wheel of the Motor Car. No leakage of brake fluid was observed. The undercarriage components of the Motor Car were also all found to be intact and without any visible damage.

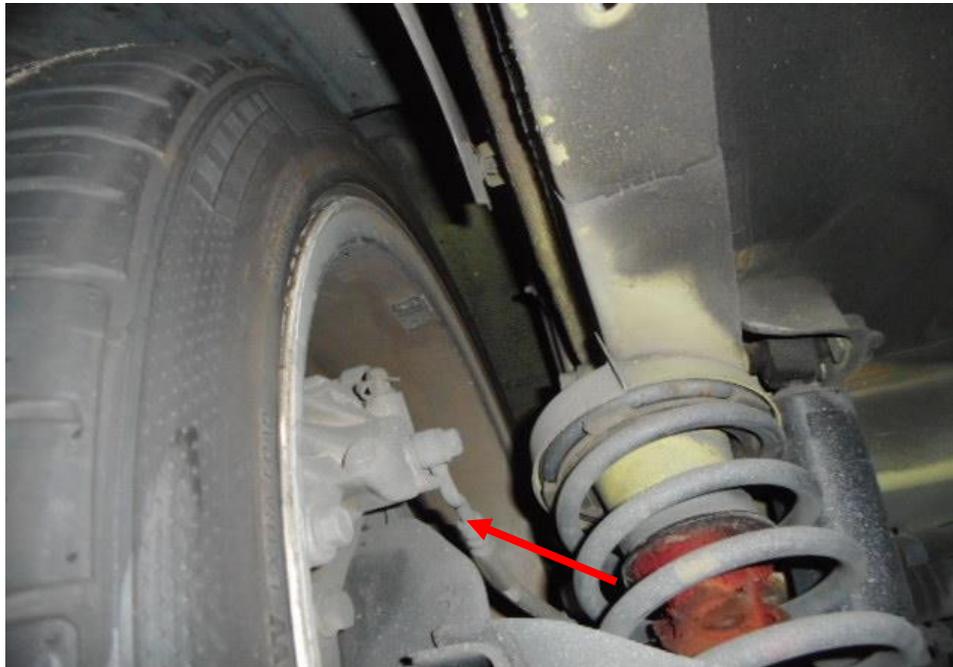
**Photo 27** shows the brake hose/pipe (arrowed) at the rear left wheel of the Motor Car. I did not observe any leakage of brake fluid at the time of my inspection of the Motor Car. The undercarriage components of the Motor Car were also all found to be intact and without any visible damage.

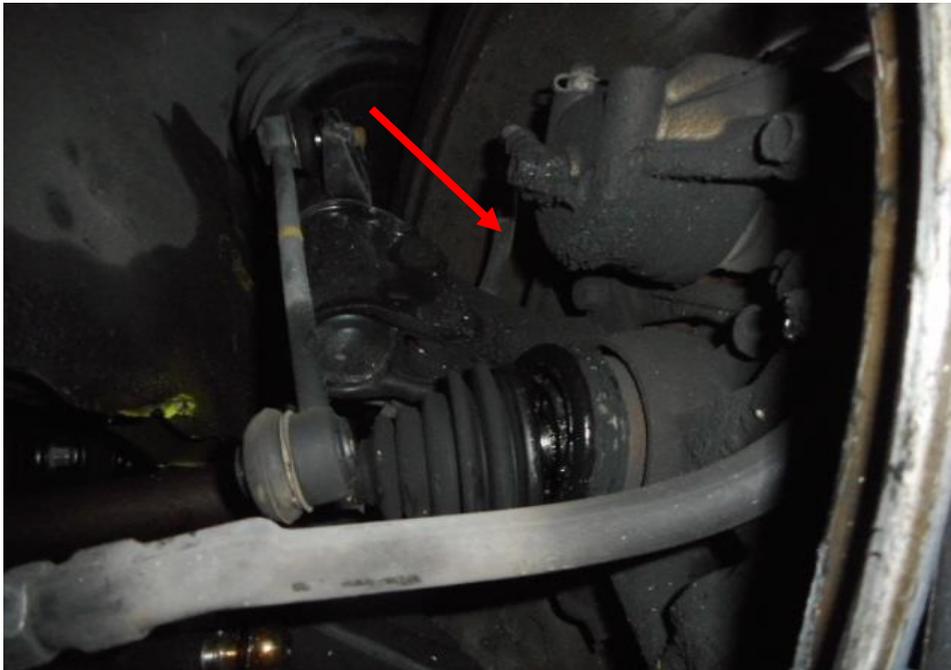
**Photo 28** shows the brake hose/pipe (arrowed) at the front right wheel of the Motor Car. I did not observe any leakage of brake fluid however, I observed old fluid stains on it at the time of my inspection of the Motor Car. The undercarriage components of the Motor Car were also all found to be intact and without any visible damage.

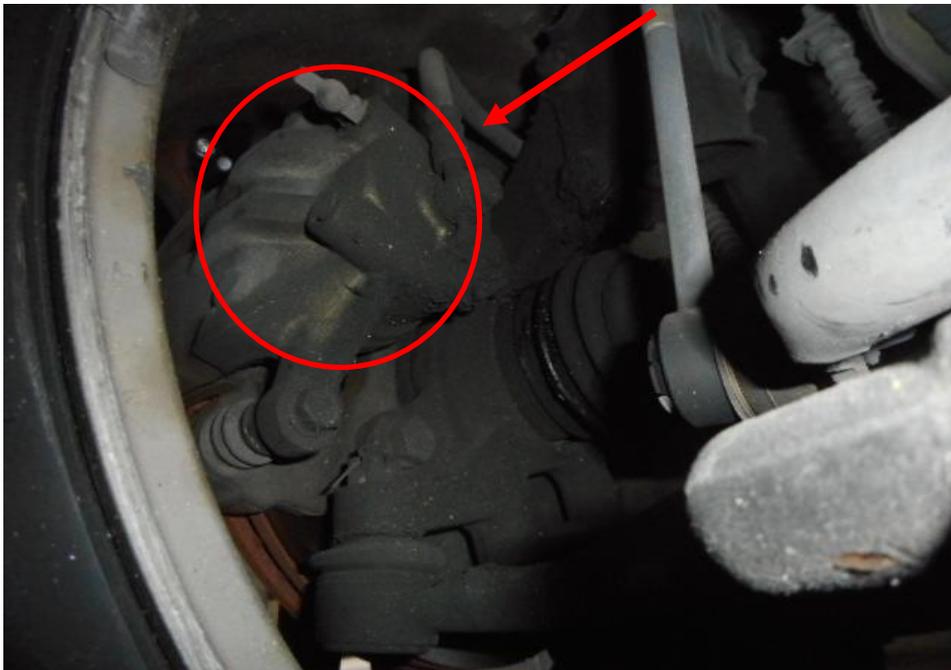
**Photo 29** shows the brake hose/pipe (arrowed) at the front left wheel of the Motor Car. No leakage of brake fluid was observed however, I observed old fluid stains on it at the time of my inspection of the Motor Car. Visual examination of the various components of the braking system like the brake caliper (circled), brake booster, brake pedal etc had revealed all to be intact and without visible damage.

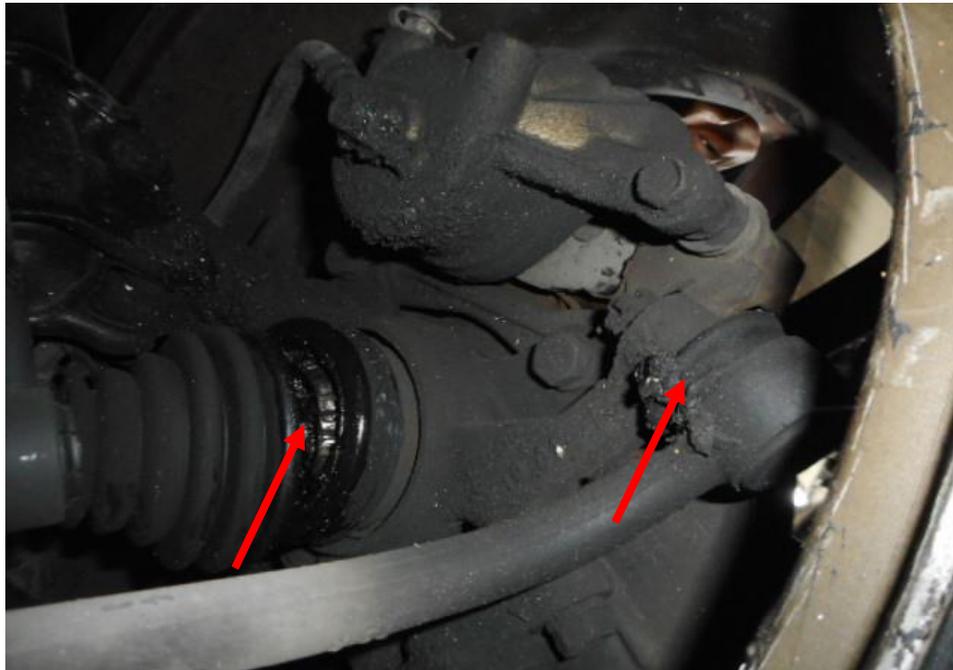
**Photo 30** shows the various undercarriage components at the front right wheel of the Motor Car, in particular the steering tie rod (arrowed) the drive shaft (arrowed) was observed to be intact however, there was grease coming out from it. The various steering components were all found to be intact. There was also no sign of fluid stain observed on the various undercarriage components at the front right wheel of the Motor Car.
