You're Ref: TP/IP/01307/2023  
Our Ref: CI/TPD22010882/P

28<sup>th</sup> February 2023

**MECHANICAL INSPECTION REPORT OF MOTOR CAR SJZ 2612R**

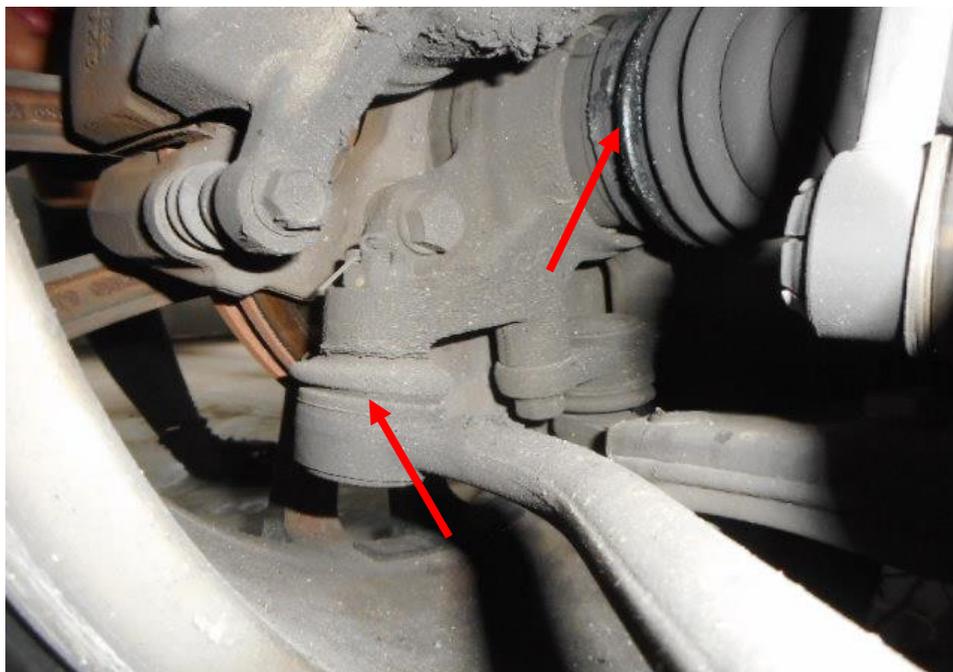
**Photo 31** shows the various undercarriage components at the front left wheel of the Motor Car, which had included the steering tie rod (arrowed). The various undercarriage components of the Motor Car were all found to be intact without any visible damage. There was grease come out from the driveshaft. However, the various steering components were all found to be intact.
