You're Ref: TP/IP/01307/2023
Our Ref: CI/TPD23001598/P

General Investigation Team

MECHANICAL INSPECTION REPORT OF MOTOR CAR SLQ 7295M

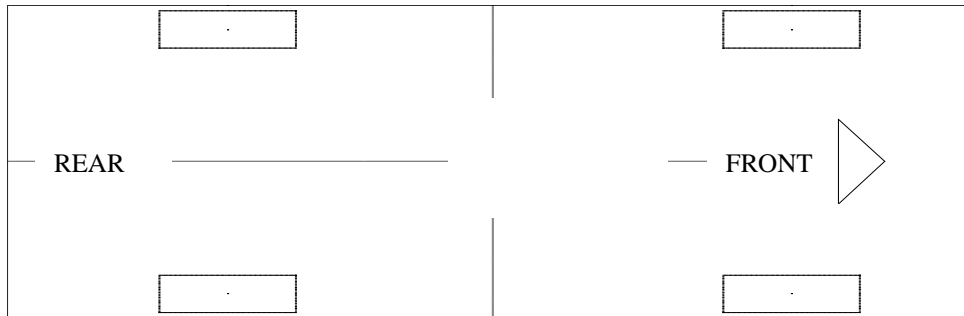
6. The condition of the Motor Car's 4 tyres was observed to be in serviceable condition. I did not find any tear, cut or burst mark(s) on the outer and the inner sidewalls as well as across the tread of the 4 tyres. The 4 tyres were also observed to be sufficiently inflated for vehicular operation. The tyre brand, tyre size and remaining tread depth of the 4 tyres were recorded as follows:-

Yokohama 215/60R16 (3.7mm)

Yokohama 215/60R16 (4.1mm)

Yokohama 215/60R16 (2.6mm)

Yokohama 215/60R16 (3.4mm)

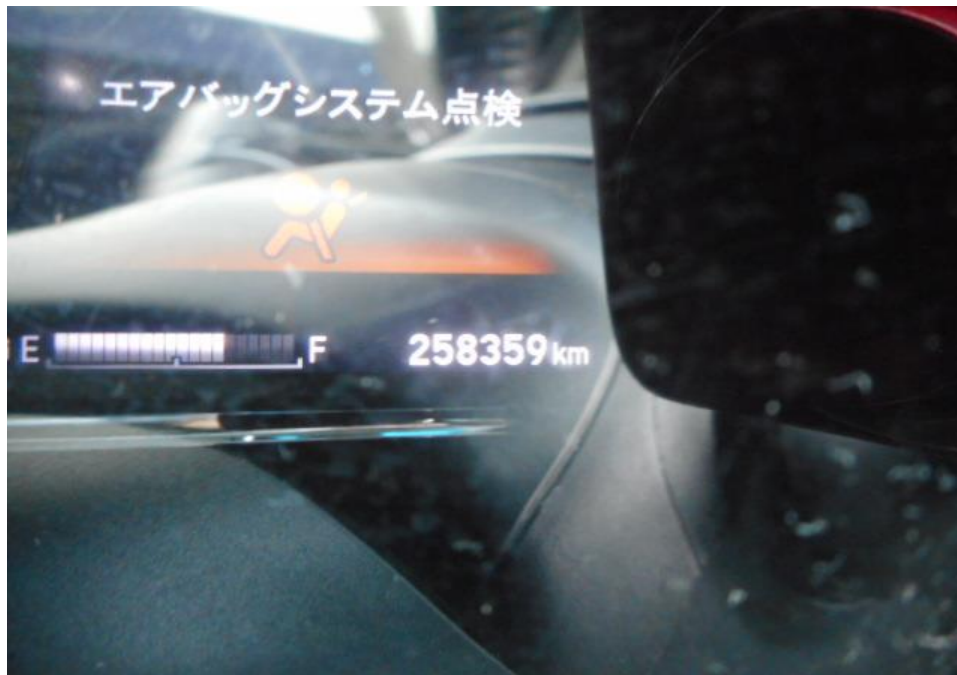
Photo 1 shows the mileage of the Motor Car at the time of my inspection. The mileage observed was 258,359km.

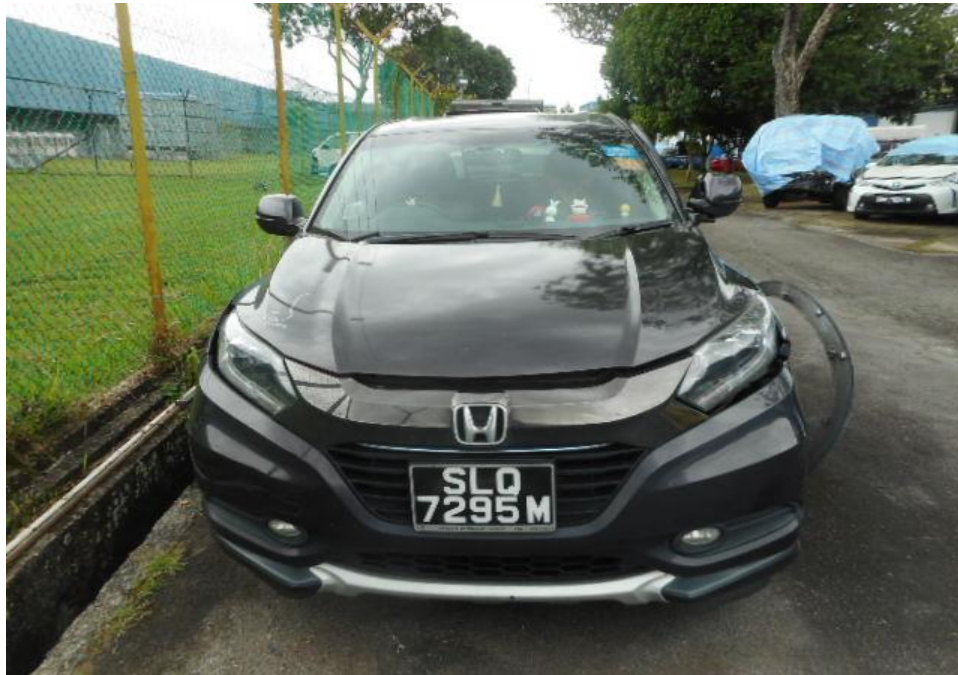
Photo 2 shows a general view of the Motor Car's front body at the time of my inspection. The Motor Car rear was observed to be unaffected by the accident.

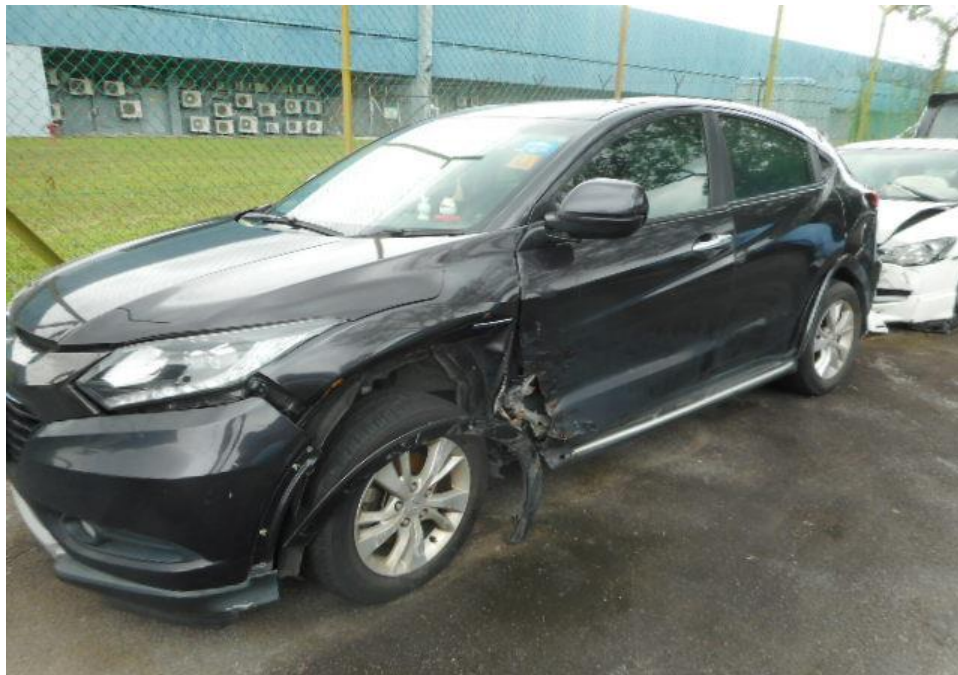
4. The mileage of the Motor Car at the time of my inspection was 258,359km.
5. The Motor Car was observed to have sustained damage at its left portion. Its left front and rear fender, left front door, left rear view mirror was the body parts that were damaged as a result of the accident.

Photo 3 shows a general view of the Motor Car's left body at the time of my inspection. The Motor Car was observed to have sustained damage at its left portion. Its front and rear left fender, left front door, left rear view mirror was the body parts that were damaged as a result of the accident.

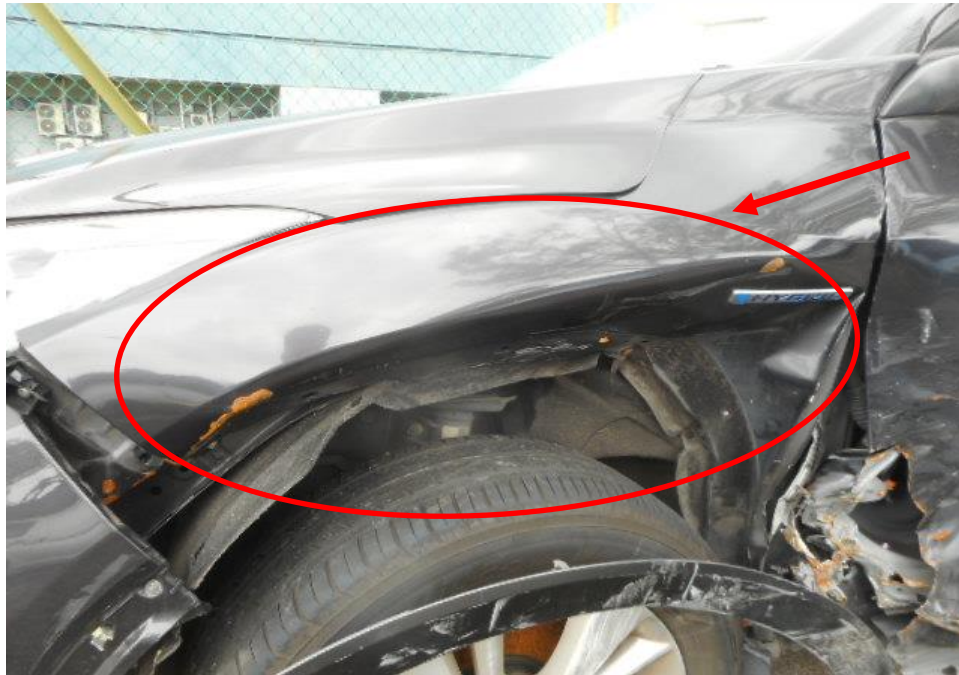
Photo 4 shows a close up view of the Motor Car's left body at the time of my inspection. The left portion of the Motor Car was observed to have sustained damage. Its left front fender (circled) was the body parts that were damaged as a result of the accident.

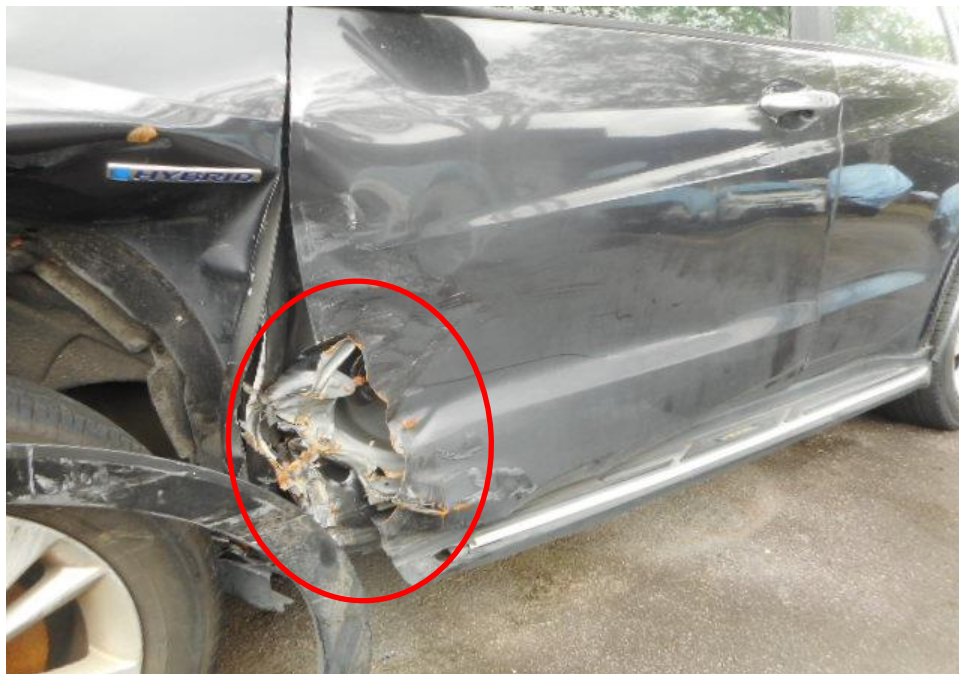
Photo 5 shows a close up view of the Motor Car's left body at the time of my inspection. The left portion of the Motor Car was observed to have sustained damage. Its front left door (circled) was the body parts that were damaged as a result of the accident.

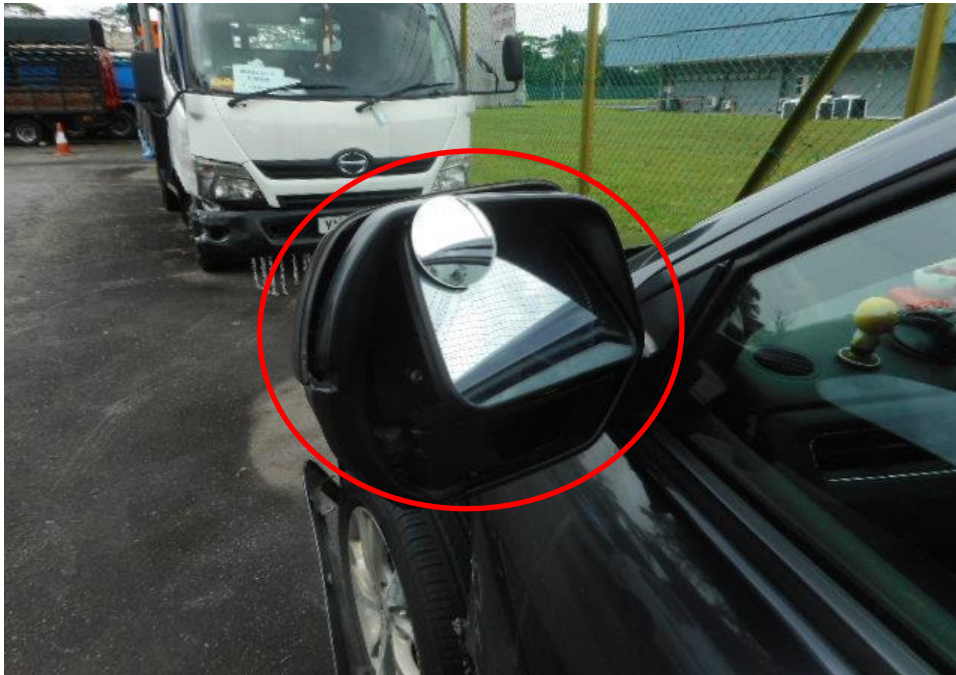
Photo 6 shows a close up view of the Motor Car's left body at the time of my inspection. The left portion of the Motor Car was observed to have sustained damage. Its left rear view mirror (circled) was the body parts that were damaged as a result of the accident.

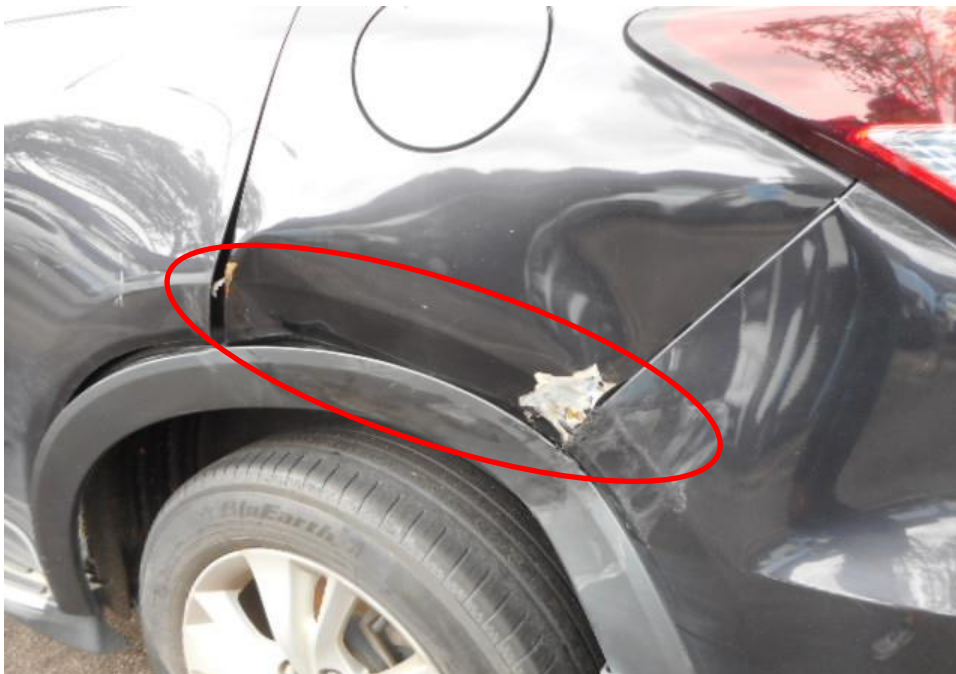
Photo 7 shows a close up view of the Motor Car's left body at the time of my inspection. The left portion of the Motor Car was observed to have sustained damage. Its left rear fender (circled) was the body parts that were damaged as a result of the accident.

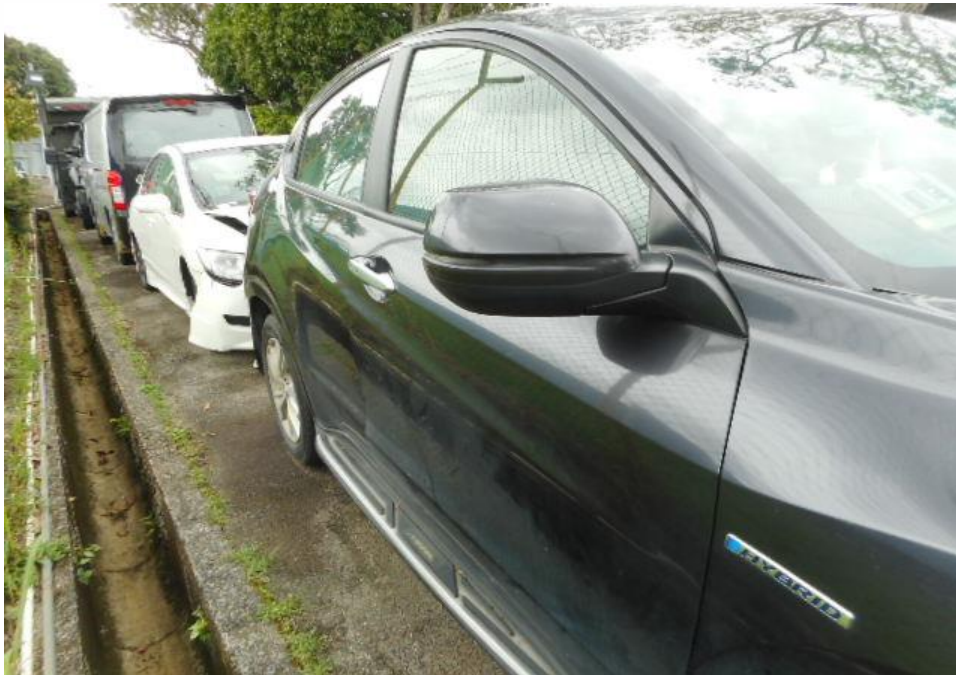
Photo 8 shows the general view of the Motor Car's right body at the time of my inspection. The Motor Car right was observed to be unaffected by the accident.

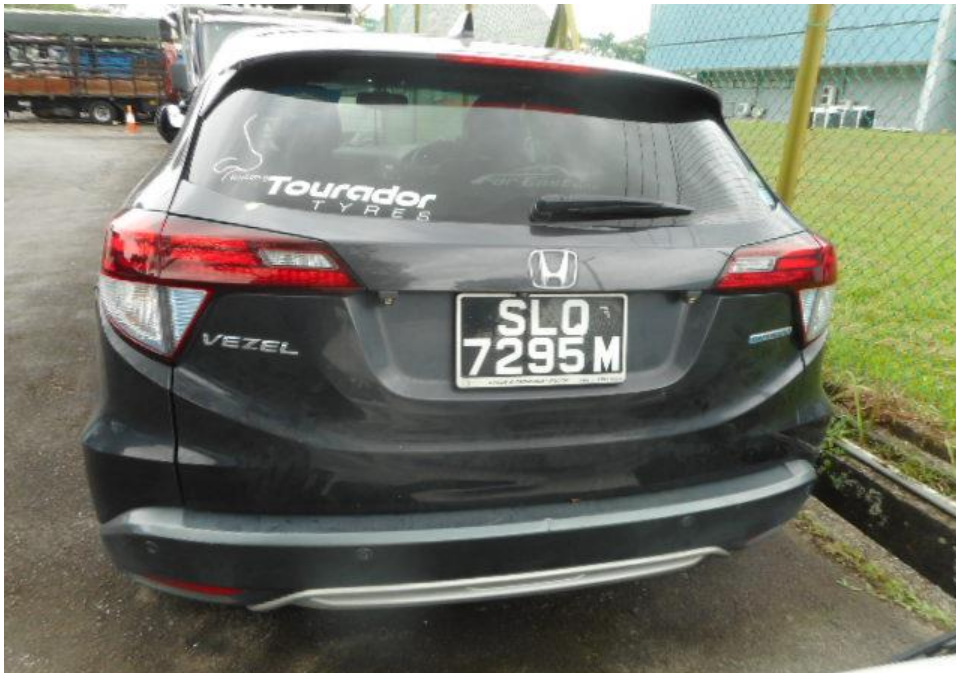
Photo 9 shows the general view of the Motor Car's rear body at the time of my inspection. The Motor Car rear was observed to be unaffected by the accident.

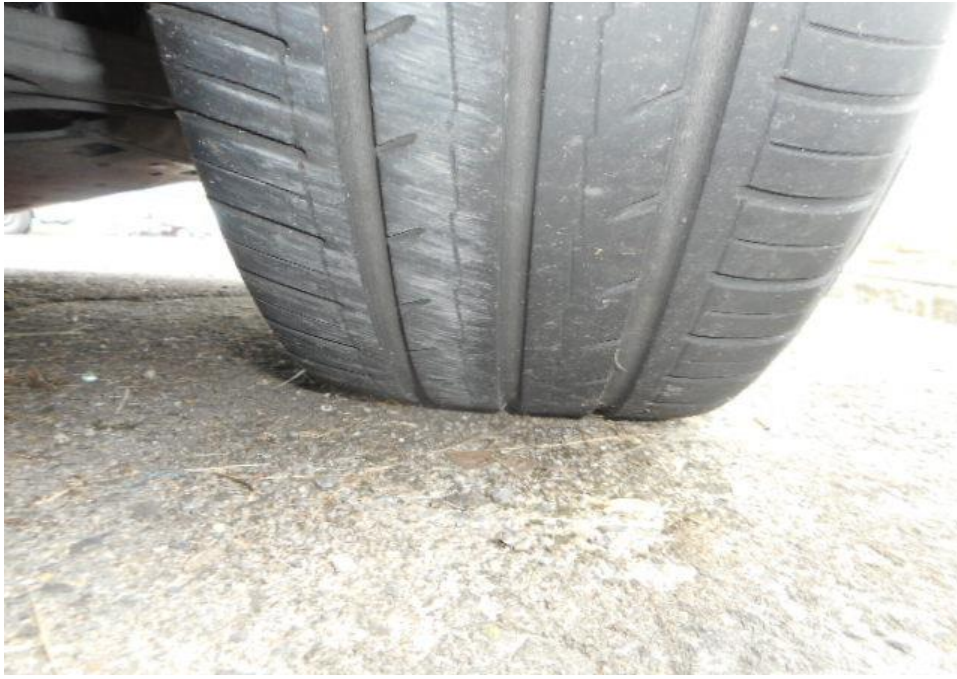
Photo 10 shows the condition of the front right tyre of the Motor Car, which was observed to be in serviceable condition with remaining tread depth of approximately 3.4mm. The tyre was also observed to be sufficiently inflated for vehicular operation with no tear, cut or burst mark(s).

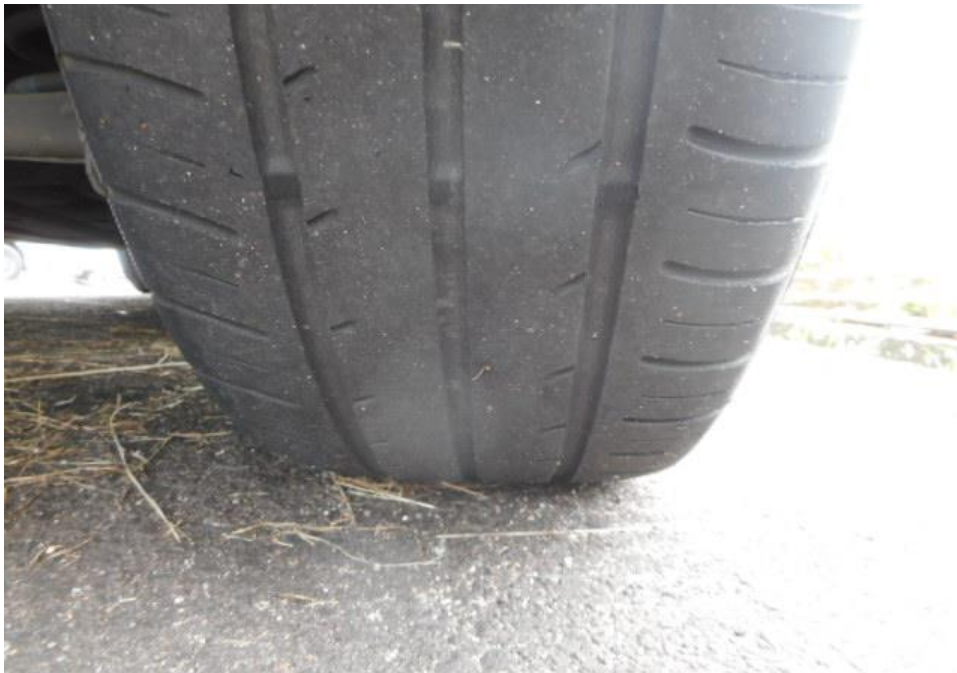
Photo 11 shows the condition of the rear right tyre of the Motor Car, which was observed to be in serviceable condition with remaining tread depth of approximately 2.6mm. The tyre was also observed to be sufficiently inflated for vehicular operation with no tear, cut or burst mark(s).

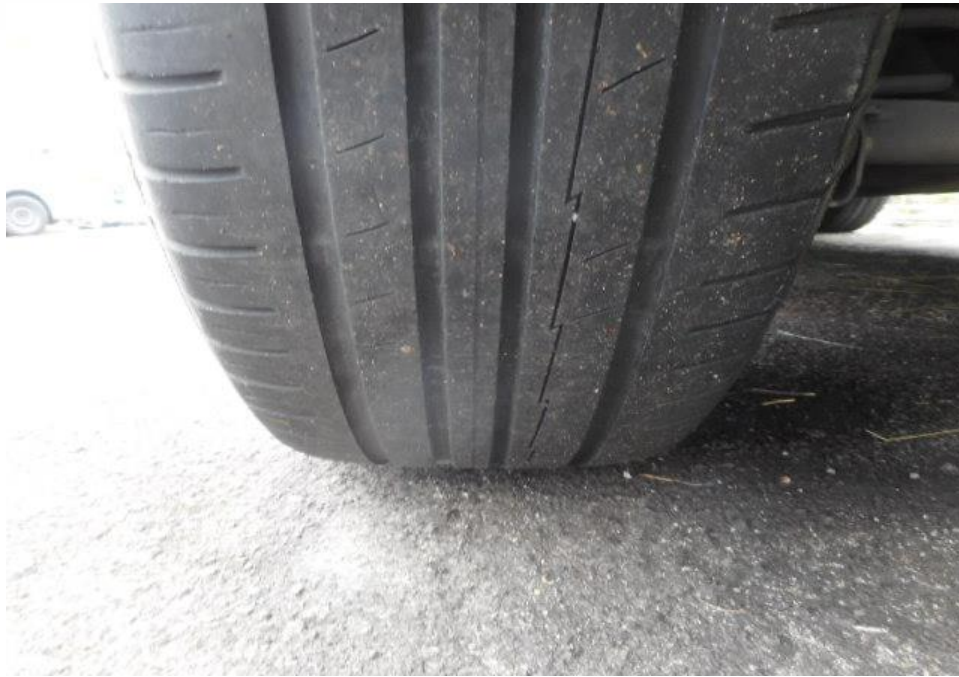
Photo 12 shows the condition of the rear left tyre of the Motor Car, which was observed to be in serviceable condition with remaining tread depth of approximately 3.7mm. The tyre, which was wrapped around alloy wheel rim, was also observed to be sufficiently inflated for vehicular operation. The 4 tyres of the Motor Car were wrapped around standard alloy wheel rims.

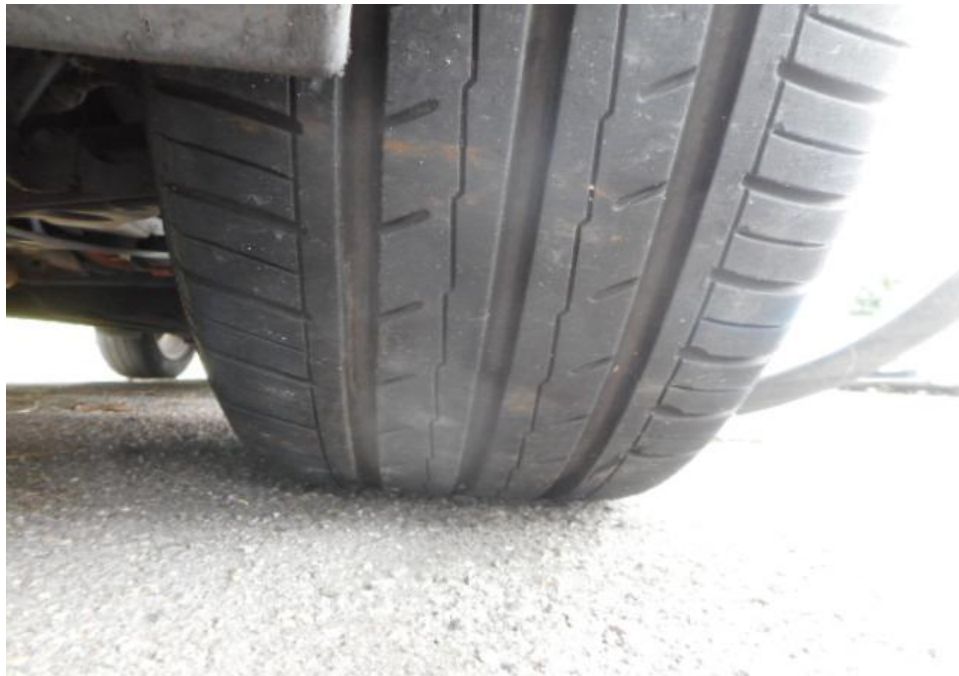
Photo 13 shows the condition of the front left tyre of the Motor Car, which was observed to be in serviceable condition with remaining tread depth of approximately 4.1mm. There was also no tear, cut or burst mark(s) on the outer and the inner sidewalls as well as across the tread of the Motor Car's 4 tyres.

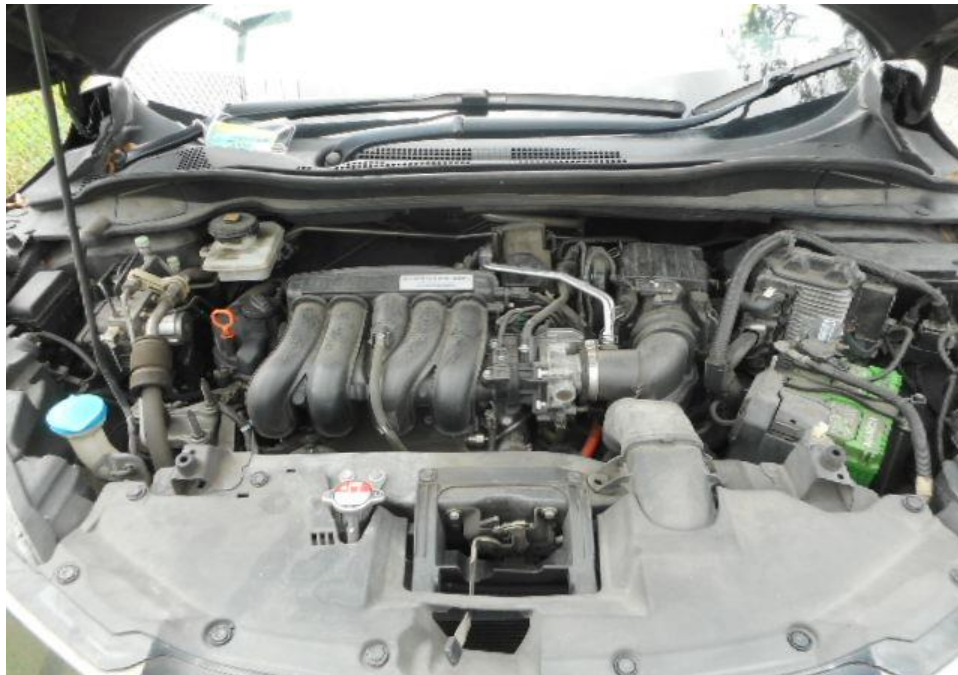
Photo 14 shows a general view of the Motor Car's engine compartment. The various parts and components inside the engine compartment were unaffected by the accident. There was also no sign(s) or indication(s) of fluid leakage and/or fluid stain within the engine compartment.

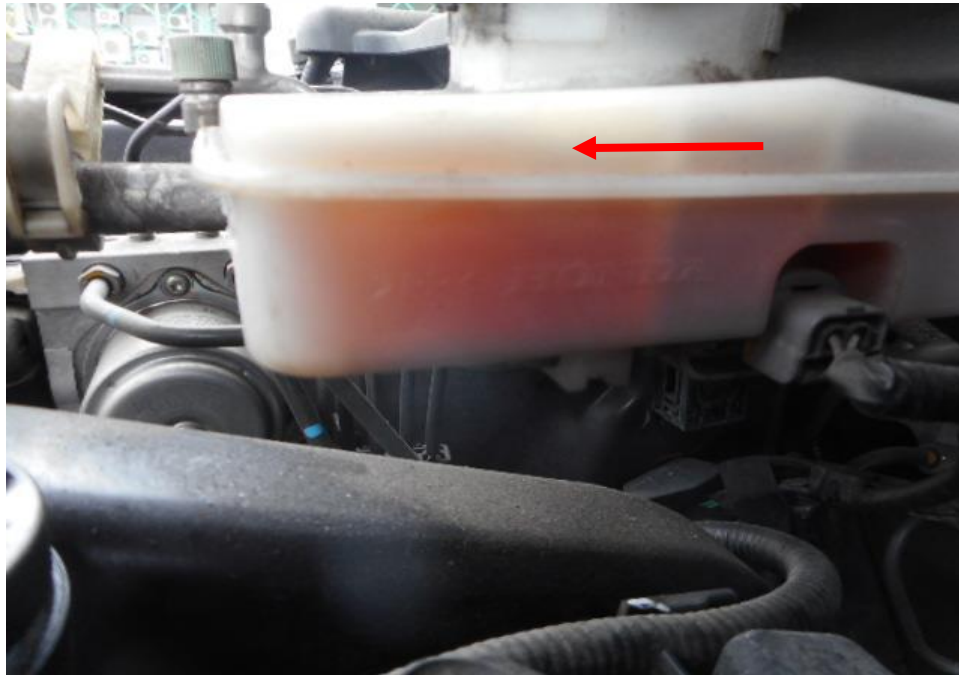
Photo 15 shows the brake fluid reservoir of the Motor Car at the time of my inspection. The brake fluid was observed to be of sufficient level (arrowed) and without any visible contamination.

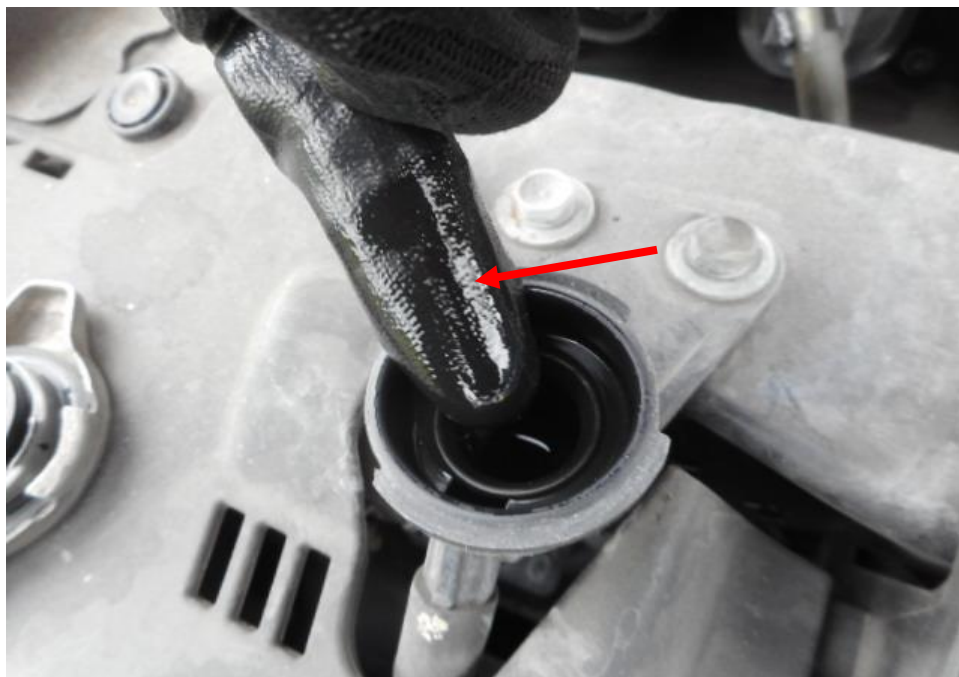
Photo 16 shows checks being carried out to the engine coolant of the Motor Car at the time of my inspection. The engine coolant was observed to be of sufficient level (arrowed) and without any visible contamination.

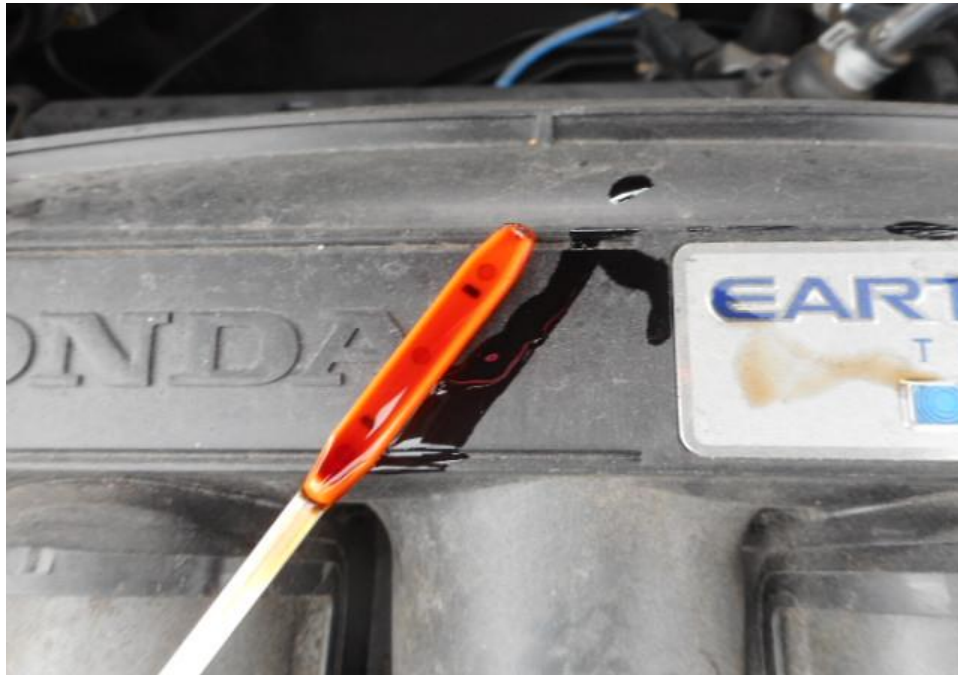
Photo 17 shows the engine oil level dipstick of the Motor Car at the time of my inspection. The engine oil was observed to be of sufficient level and without any visible contamination.

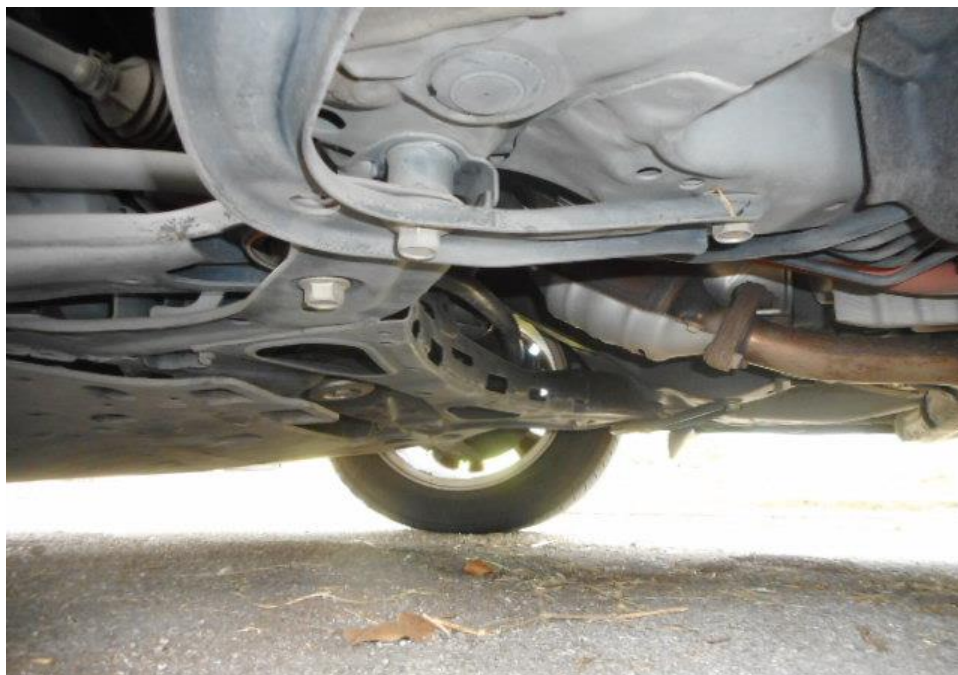
Photo 18 shows the undercarriage of the Motor Car, at the area where the engine housing and transmission housing are located. I did not find any sign(s) or indication(s) of fluid leak and/or fluid stain(s) on the underside of the Motor Car.

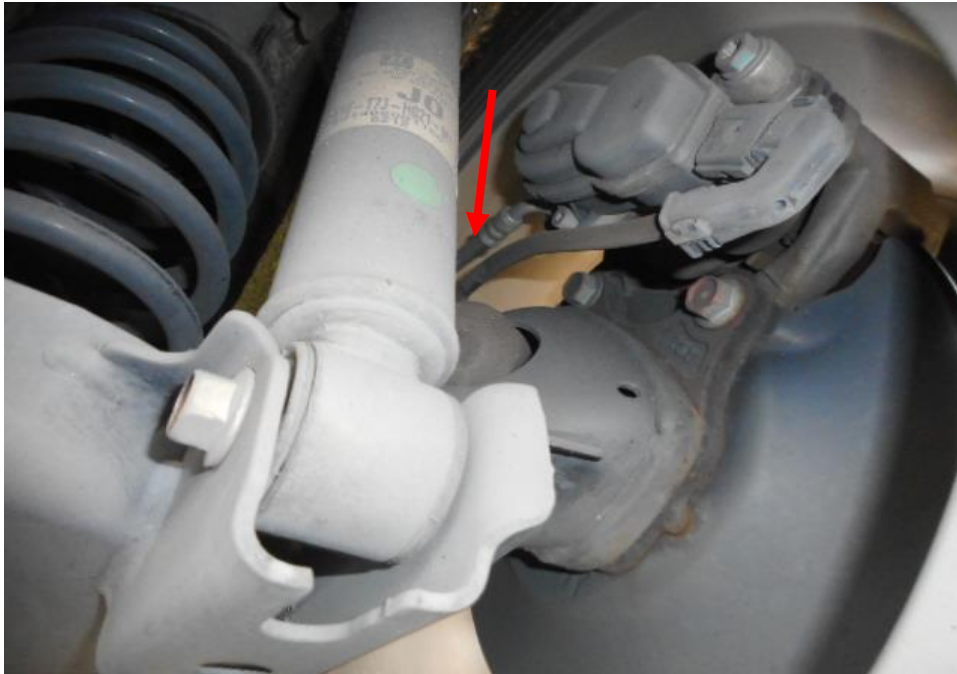
Photo 19 shows the brake hose/pipe (arrowed) at the rear right wheel of the Motor Car. No leakage of brake fluid was observed. Visual examination of the various components of the braking system like the drum brake, brake booster, brake pedal etc. had revealed all to be intact and without visible damage.

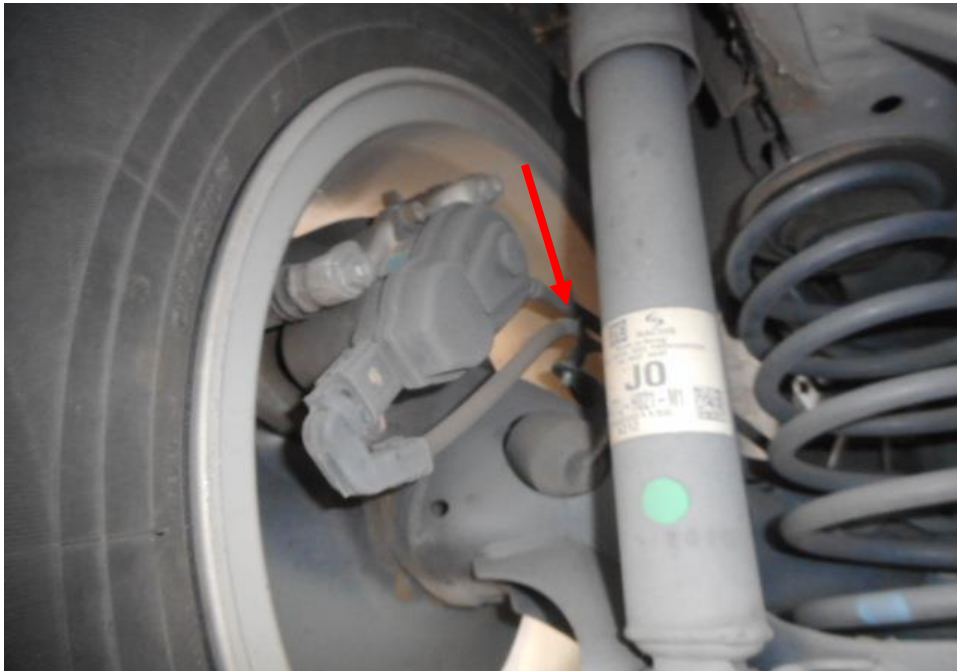
Photo 20 shows the brake hose/pipe (arrowed) at the rear left wheel of the Motor Car. I did not observe any leakage of brake fluid at the time of my inspection of the Motor Car. Static tests of the Motor Car's braking system had indicated that there was no internal leakage of pressure/vacuum. The undercarriage components of the Motor Car were also all found to be intact and without any visible damage.

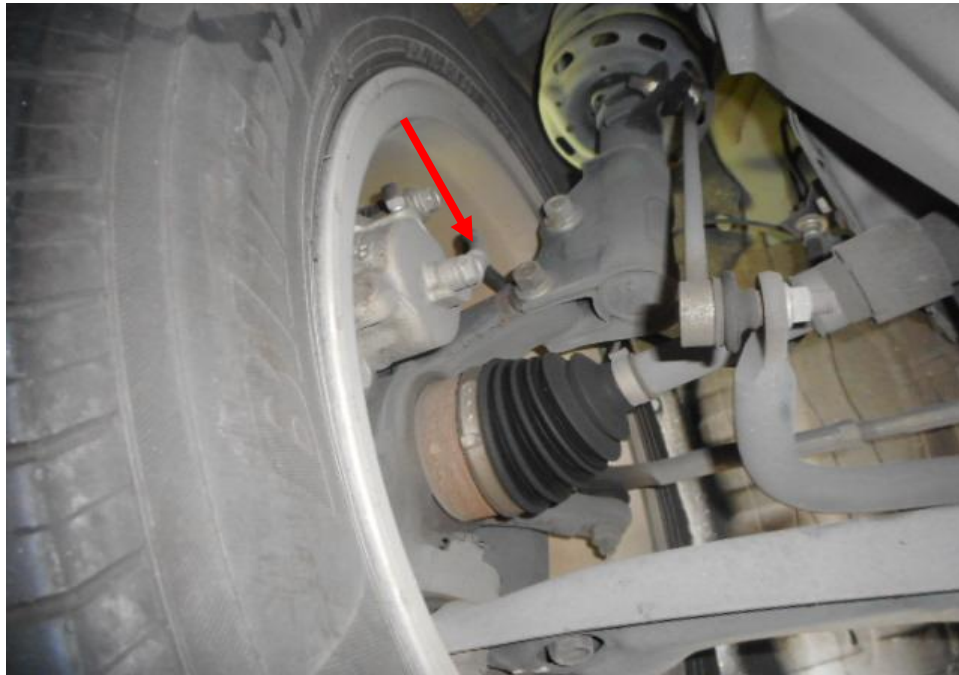
Photo 21 shows the brake hose/pipe (arrowed) at the front right wheel of the Motor Car. I did not observe any leakage of brake fluid at the time of my inspection of the Motor Car. Static tests of the Motor Car's braking system had indicated that there was no internal leakage of pressure/vacuum.

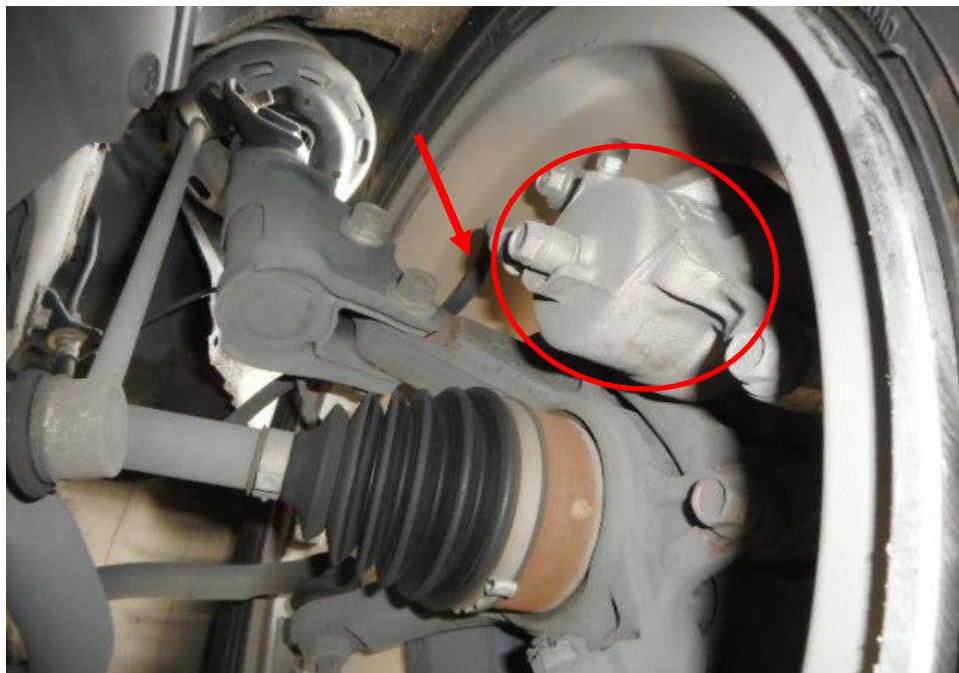
Photo 22 shows the brake hose/pipe (arrowed) at the front left wheel of the Motor Car. No leakage of brake fluid was observed. Visual examination of the various components of the braking system like the brake caliper (circled), brake booster, brake pedal etc had revealed all to be intact and without visible damage.

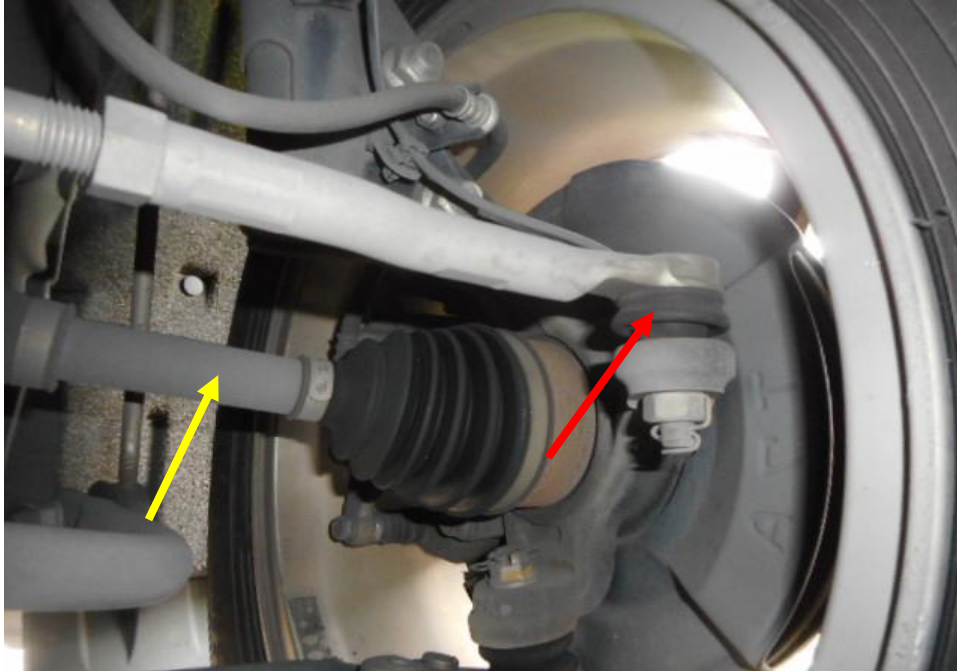
Photo 23 shows the various undercarriage components at the front right wheel of the Motor Car, in particular the steering tie rod (red arrow) and in particular the drive shaft (yellow arrow). The various steering components were all found to be intact, suggesting that the steering system of the Motor Car was likely to be in serviceable condition at the material time of accident. There was also no sign of fluid stain observed on the various undercarriage components at the front right wheel of the Motor Car.

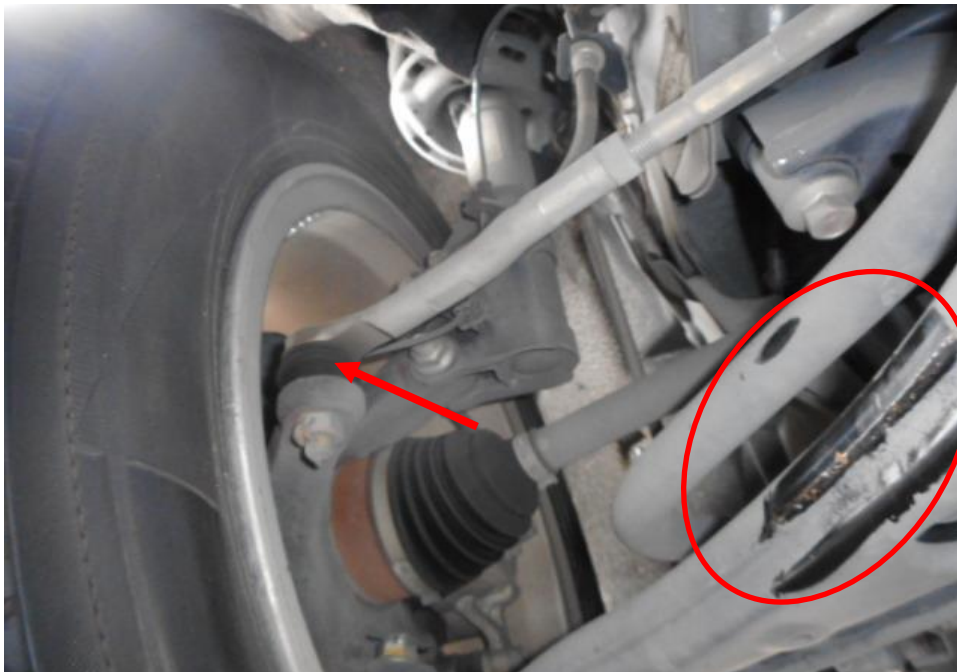
12. Static test on the steering system of the Motor Car also revealed abnormality to the steering system. I experienced abnormal free play when the steering wheel was spinning 360 degrees when turning the steering wheel left and right to full lock positions and also observed that the front left and right wheels was not moving at all when the steering wheel was turning. My visual examination of the various steering components which had included the steering rack and pinion, tie rods, tie rod ends and ball joints revealed that these components were all visually intact, however we observed that on the front left lower control arm of the Motor Car has sustained tyre rubbing marks on it, from our understanding in normal steering operations the range of motion for the front left tyre will not touch the front left lower control arm of the Motor Car.

13. For this particular case, the Motor Car was hit at the front left wheel well area and the induced impact from the accident had likely also hit the front left tyre of the Motor Car causing the tyre that was connected to the steering rack and pinion to move inwards and exceeded its normal range of motion causing the tyre to rub against the front left lower control arm which had caused the tyre marks on the surface of the front left lower control arm.

14. In addition, the exceeded range of motion sustained from the induced impact had caused internal damages to the steering rack and pinion and the whole steering column that had likely resulted in the abnormal free play of the steering wheel spinning 360 degrees when it was turned to its left and right and also observed that the front left and right wheels was not moving at all when the steering wheel was turned either ways. See photo 19 - 24 below.

Photo 24 shows the various undercarriage components at the front left wheel of the Motor Car, which had included the steering tie rod (arrowed). The various undercarriage components of the Motor Car were all found to be intact without any visible damage. However, the left lower control arm was observed with tyre rubbing marks (circled) as a result of the induced impact from the accident that had caused the front left tyre that was connected to the steering rack and pinion to exceed its range of motion.

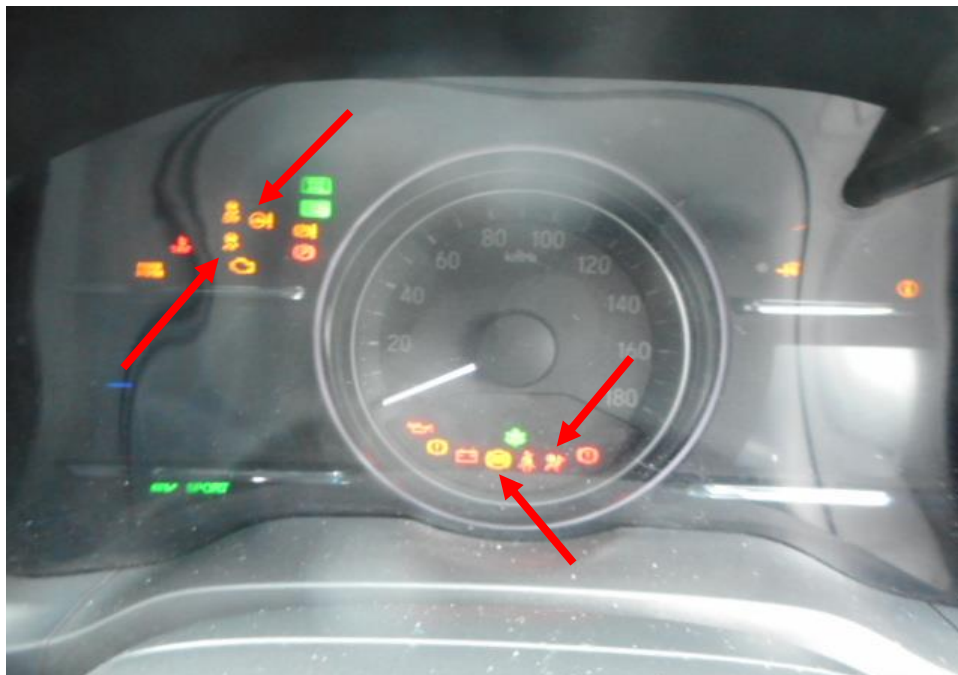
Photo 25 shows the warning light for Anti-Lock Brake System (ABS), Electronic Power Steering System (EPS), Traction Control System (TCS), and Supplemental Restraint System (SRS) (arrowed) appearing on the instrument panel of the Motor Car during the self-test of its various electronic operating systems when its engine was cranked.

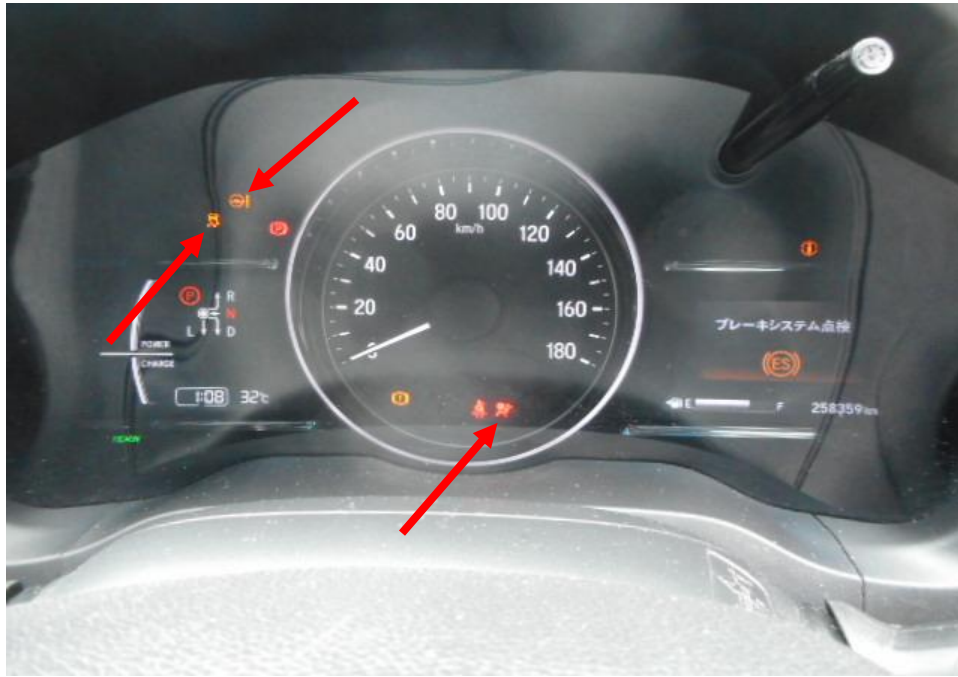
15. Motor Car 's automatic self-test of the functionality of its electronic operating systems like the Anti-Lock Brake System (ABS), during cranking of the engine had indicated that the system were in working condition and without abnormality. This can be established from the warning lights disappearing from the instrument panel after the self-test.
16. However, the Electronic Power Steering System (EPS), Traction Control System (TCS), and Supplemental Restraint System (SRS) are all part of the steering system components and they had all remained illuminated up after the engine had cranked up due as a result of the induced impact from the accident that had damaged the rack and pinion, the steering column where these components are located inside. See photo 25 & 26 below.

Photo 26 shows the Electronic Power Steering System (EPS), Traction Control System (TCS), and Supplemental Restraint System (SRS) (arrowed) warning lights remained illuminated on the instrument panel of the Motor Car after the engine was cranked. This was due to the damages sustained to the steering rack and pinion, steering column where these components are located inside.
