Your Ref: TP/IP/00604/2023  
Our Ref : CI/TPD23001604/P

6<sup>th</sup> April 2023

**MECHANICAL INSPECTION REPORT OF MALAYSIAN TIPPER JKK 2899**

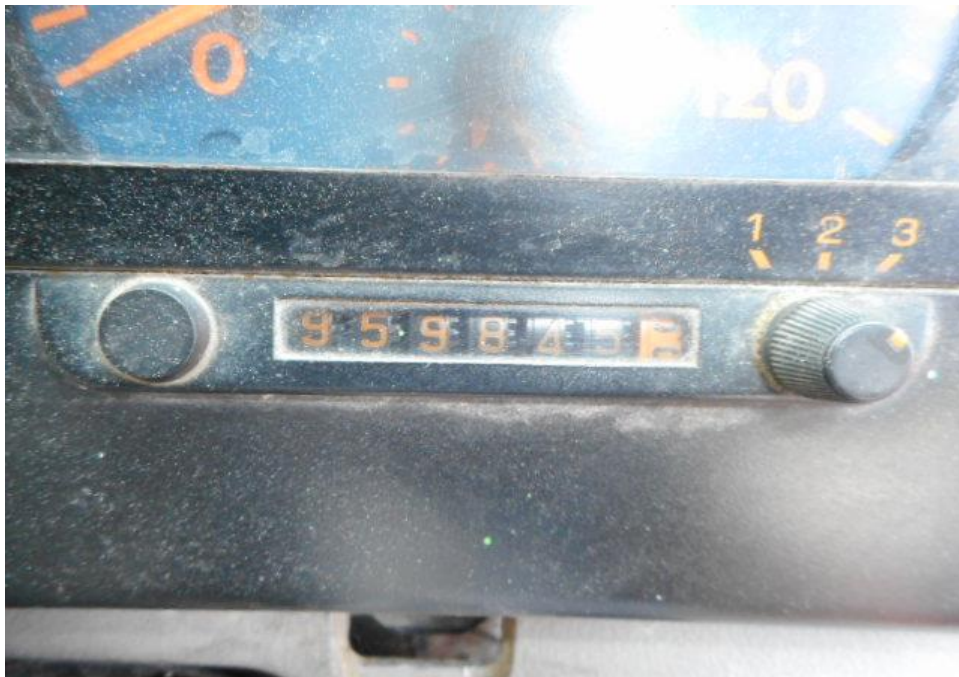
**Photo 1** shows a general view of the instrument cluster of the Malaysian Tipper at the time of my inspection. The mileage of the Malaysian Tipper was 959,845km

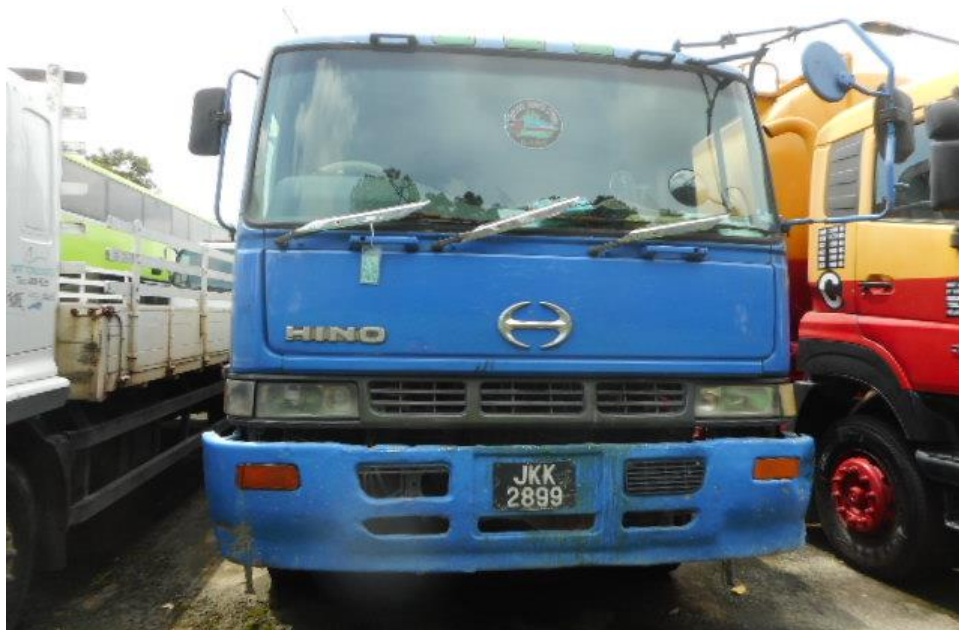
**Photo 2** shows a general view of the front body of the Malaysian Tipper at the time of my inspection. The Malaysian Tipper was observed to sustain damaged at its front portion. Its front bumper left portion was damaged at the time of my inspection.

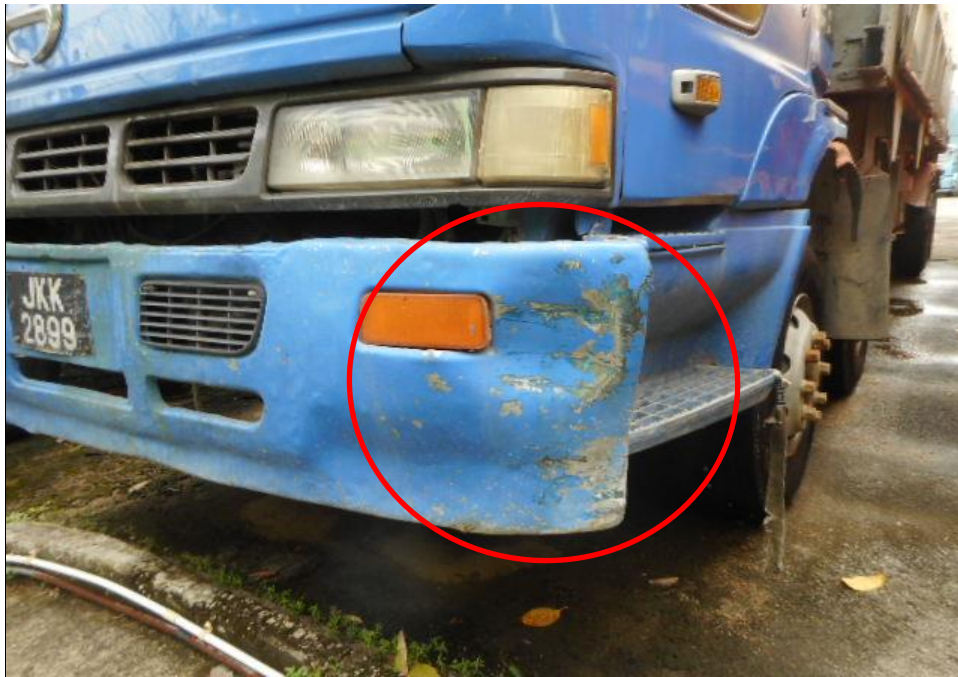
**Photo 3** shows a general view of the front body of the Malaysian Tipper at the time of my inspection. The Malaysian Tipper was observed to sustain damaged on its front portion. Its front bumper left portion (circled) was damaged at the time of my inspection.

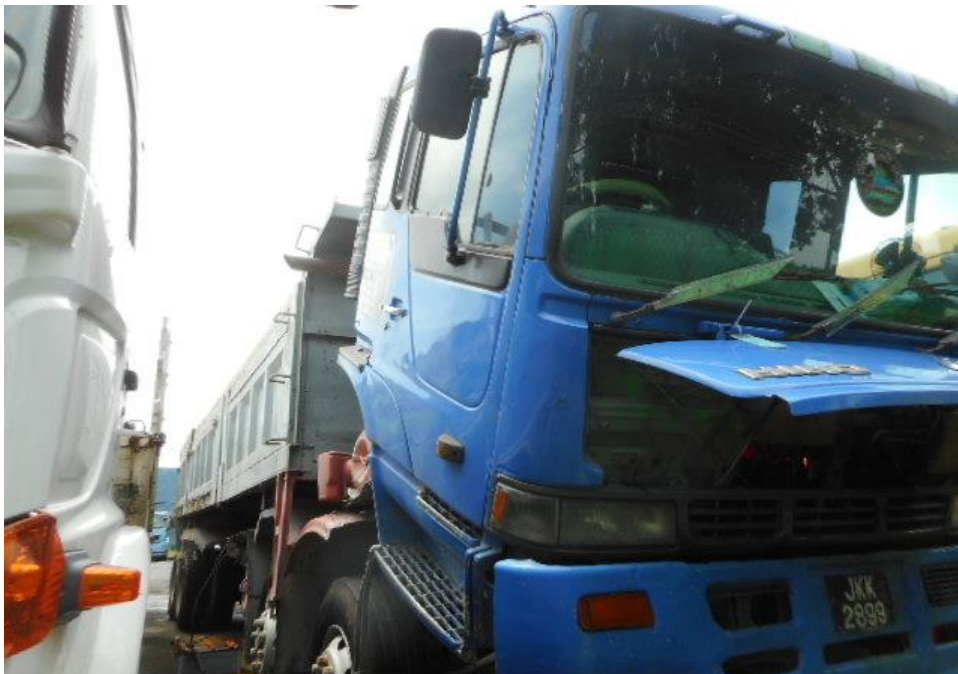
**Photo 4** shows a general view of the front right body of the Malaysian Tipper at the time of my inspection. The Malaysian Tipper was observed to be intact and unaffected by the accident.

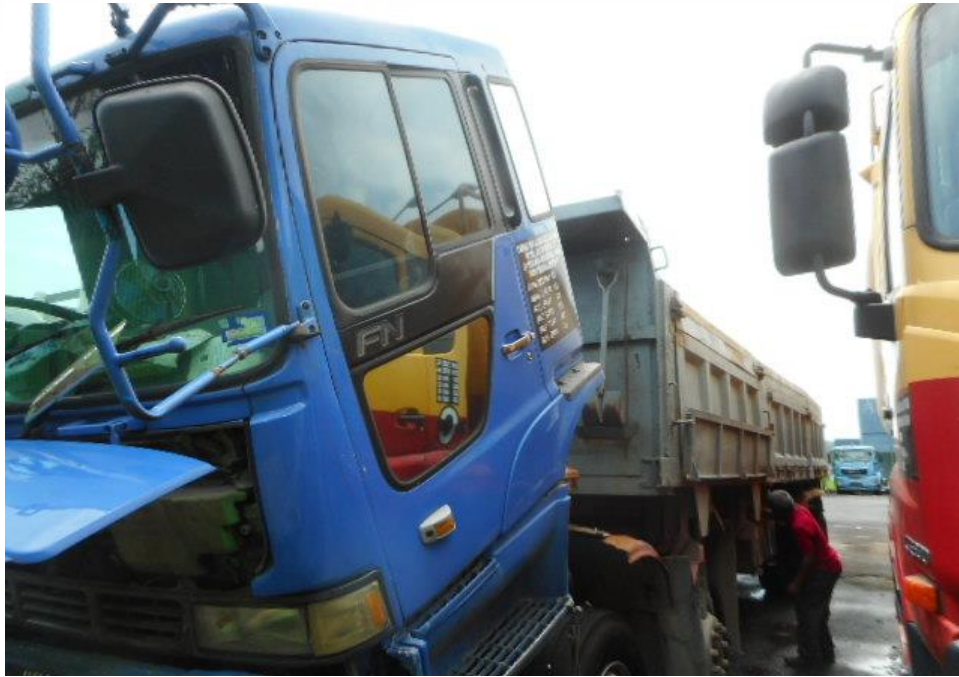
**Photo 5** shows a general view of the front left body of the Malaysian Tipper at the time of my inspection. The Malaysian Tipper was observed to be intact and unaffected by the accident.

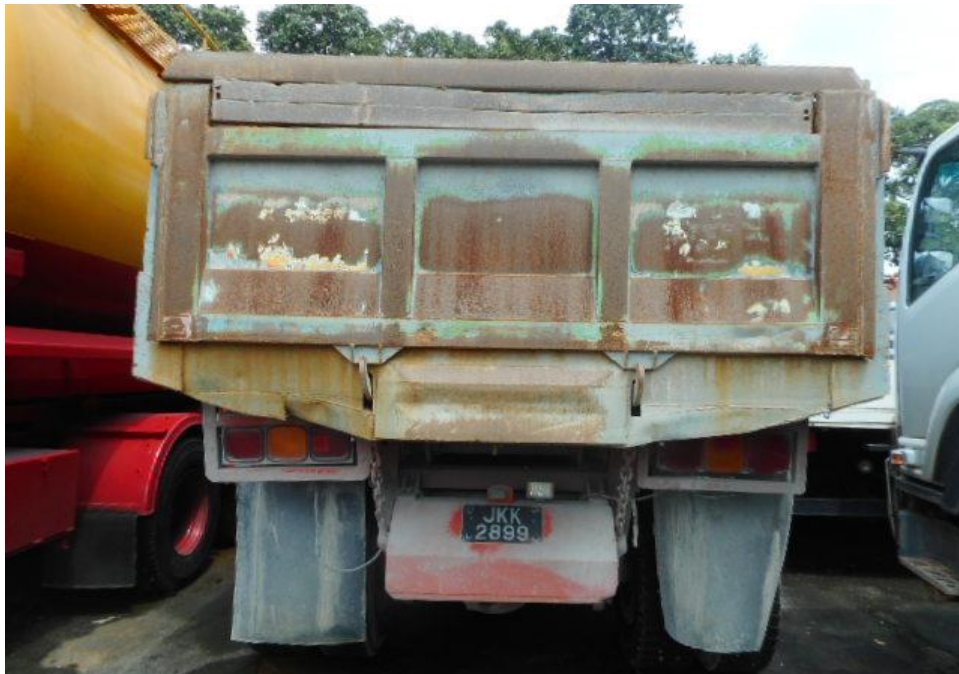
**Photo 6** shows a general view of the Malaysian Tipper's rear body at the time of my inspection. The Malaysian Tipper was observed to be intact and unaffected by the accident.

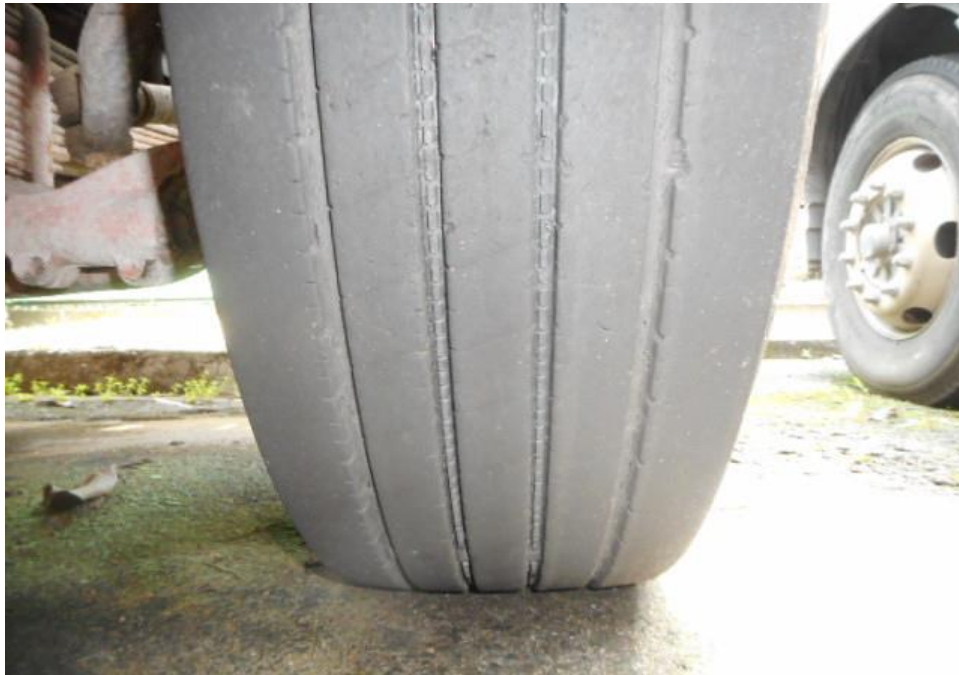
**Photo 7** shows the condition of the front right tyre of the Malaysian Tipper, which was observed to be in serviceable condition with remaining tread depth of approximately 7.2mm. The tyre, which was wrapped around standard steel wheel rim, was also observed to be sufficiently inflated for vehicular operation. There was no tear, cut or burst mark(s) on the outer and the inner sidewalls as well as across the tread of the 12 tyres that were fitted on the Malaysian Tipper.

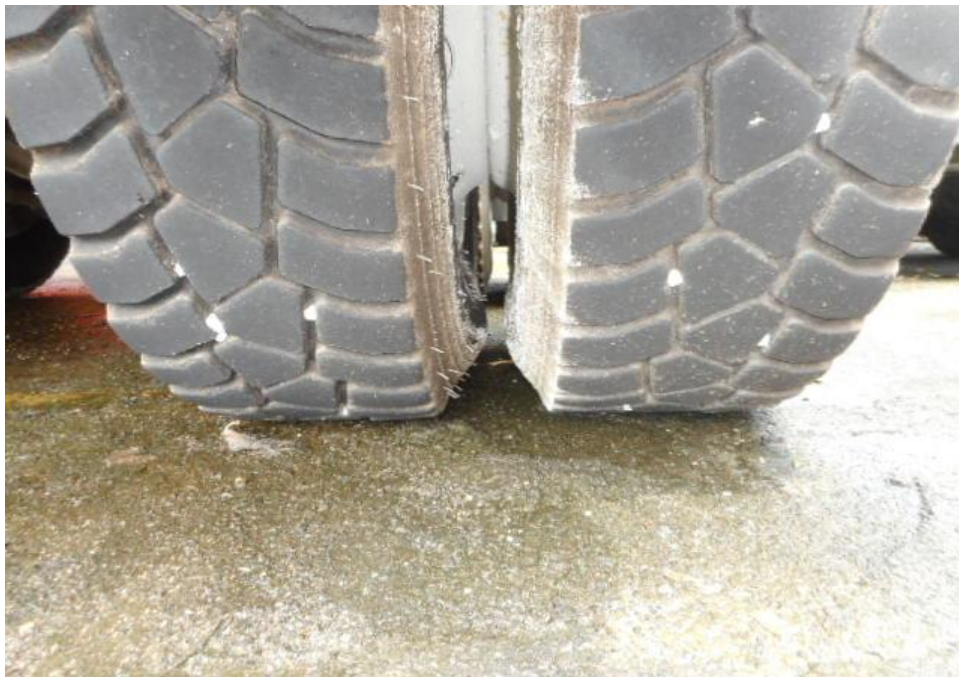
**Photo 8** shows the condition of the rear right tyres of the Malaysian Tipper, which was observed to be in serviceable condition with remaining tread depth of approximately 14.3mm. The tyre, which was wrapped around standard steel wheel rim, was also observed to be sufficiently inflated for vehicular operation.

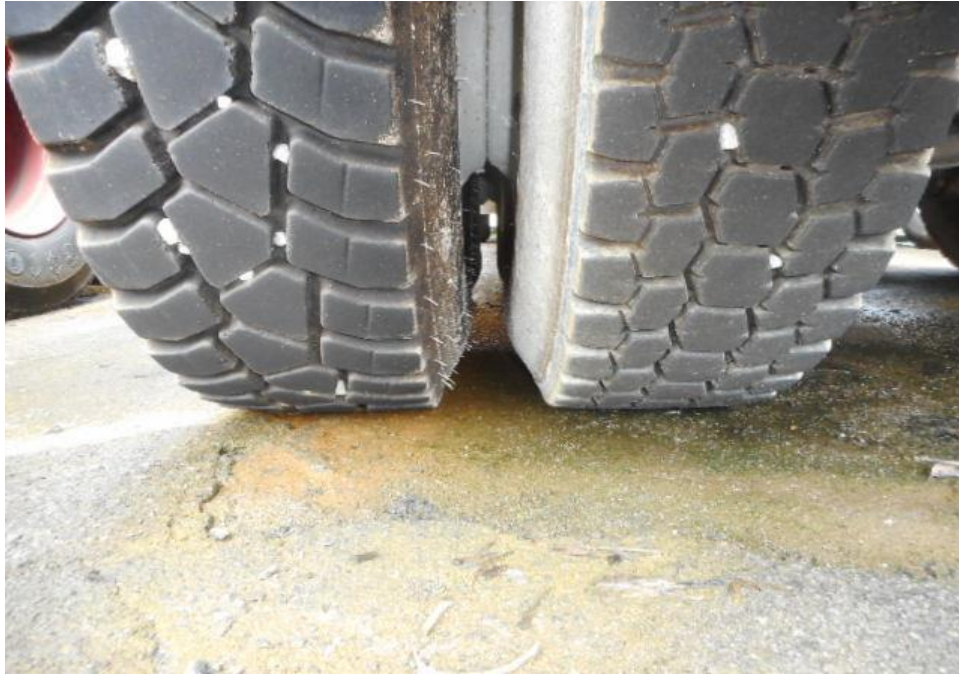
**Photo 9** shows the condition of the rear left tyres of the Malaysian Tipper, which was observed to be in serviceable condition with remaining tread depth of approximately 12.7mm. The tyres, which were wrapped around standard steel wheel rim, were also observed to be sufficiently inflated for vehicular operation. There was also no damage found on all 12 steel wheel rims of the Malaysian Tipper.

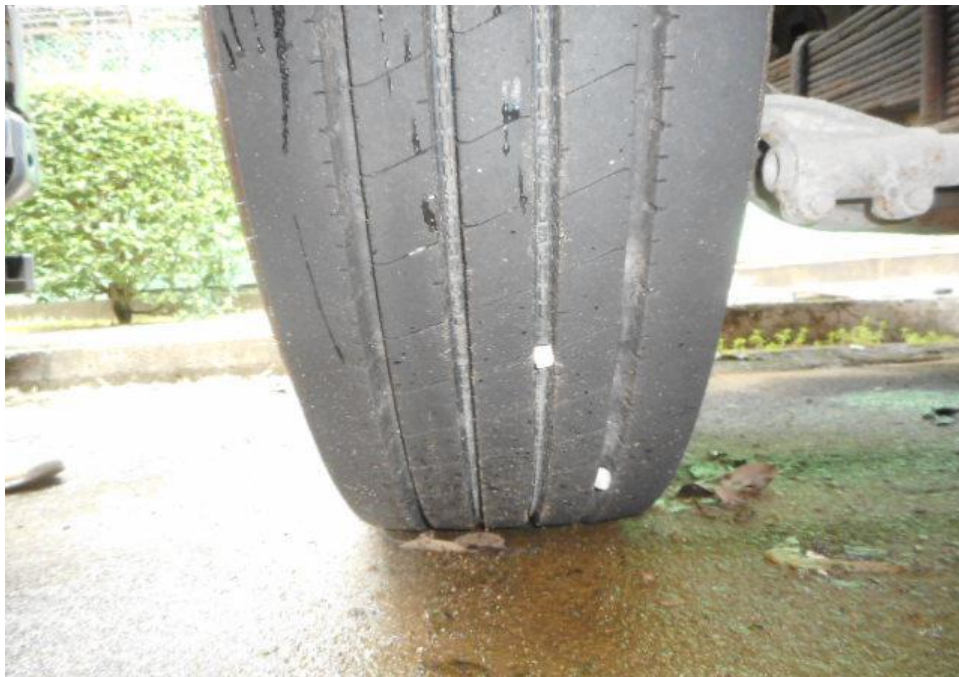
**Photo 10** shows the condition of the front left tyres of the Malaysian Tipper, which were observed to be in serviceable condition with remaining tread depth of approximately 11.6mm. There was also no tear, cut or burst mark(s) on the outer and the inner sidewalls as well as across the tread of the 12 tyres that were fitted on the Malaysian Tipper.

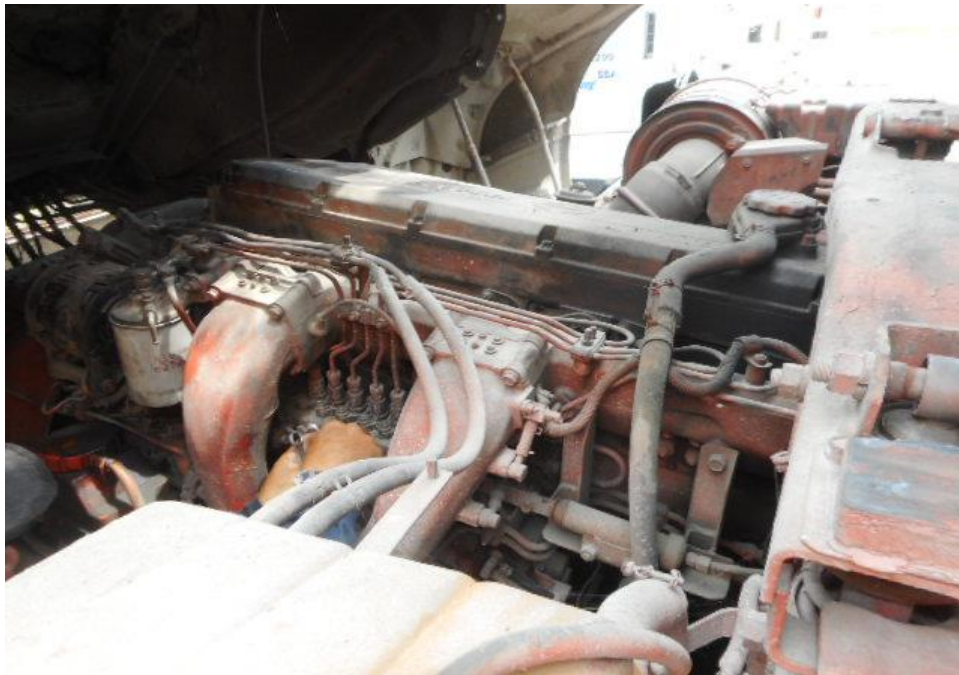
**Photo 11** shows a general view of the Malaysian Tipper's engine compartment, which was accessed by lifting the front cabin of the Malaysian Tipper. The various parts and components inside the engine compartment were unaffected by the accident. There was also no sign(s) or indication(s) of fresh fluid leakage and/or fluid stain within the engine compartment

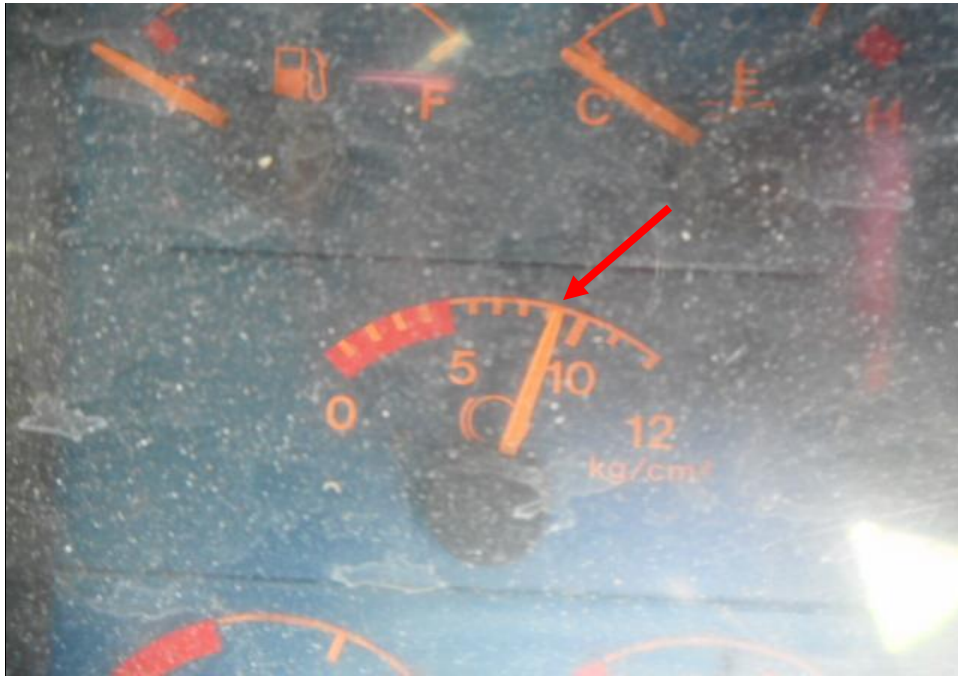
**Photo 12** shows the air in the air brake cylinders of the Malaysian Tipper at the time of my inspection. The air in the cylinder was observed to be of sufficient level & serviceable at the time of the accident.

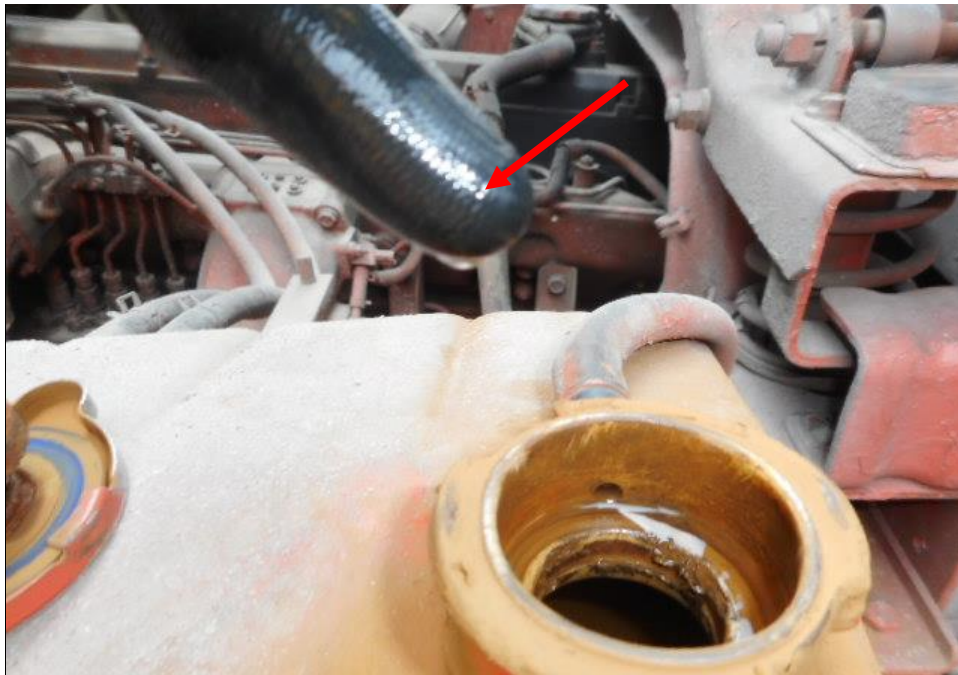
**Photo 13** shows the engine coolant reservoir of the Malaysian Tipper at the time of my inspection. The engine coolant was observed to be of sufficient level (arrowed) and without any visible contamination.

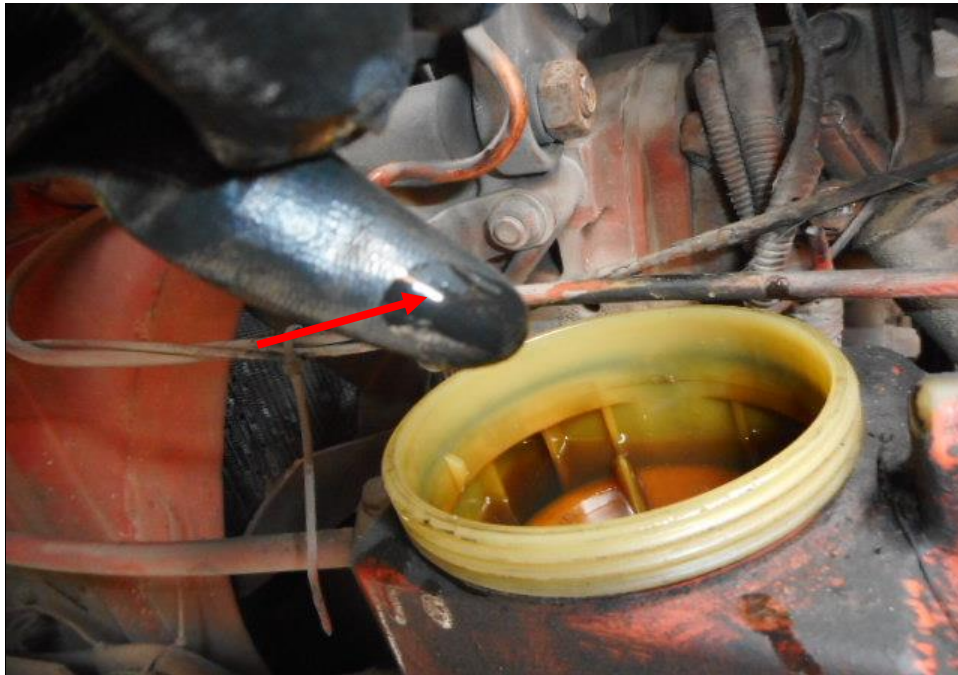
**Photo 14** shows the power steering fluid reservoir of the Malaysian Tipper at the time of my inspection. The power steering fluid was observed to be of sufficient level (arrowed) and without any visible contamination.

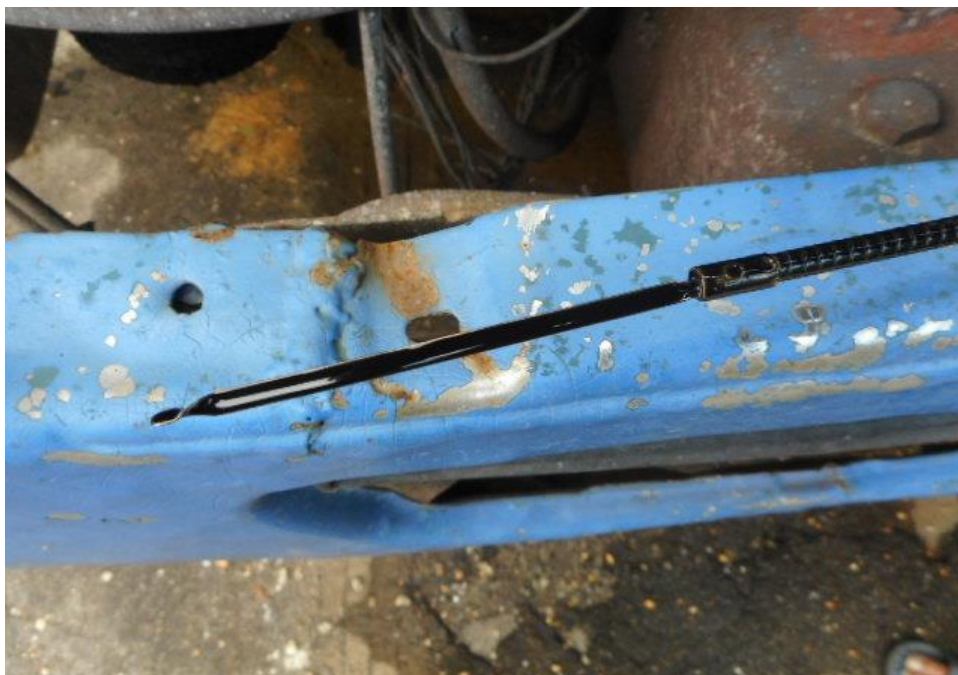
**Photo 15** shows the engine oil dip stick of the Malaysian Tipper at the time of my inspection. The engine oil was observed to be of insufficient level at the time of our inspection.

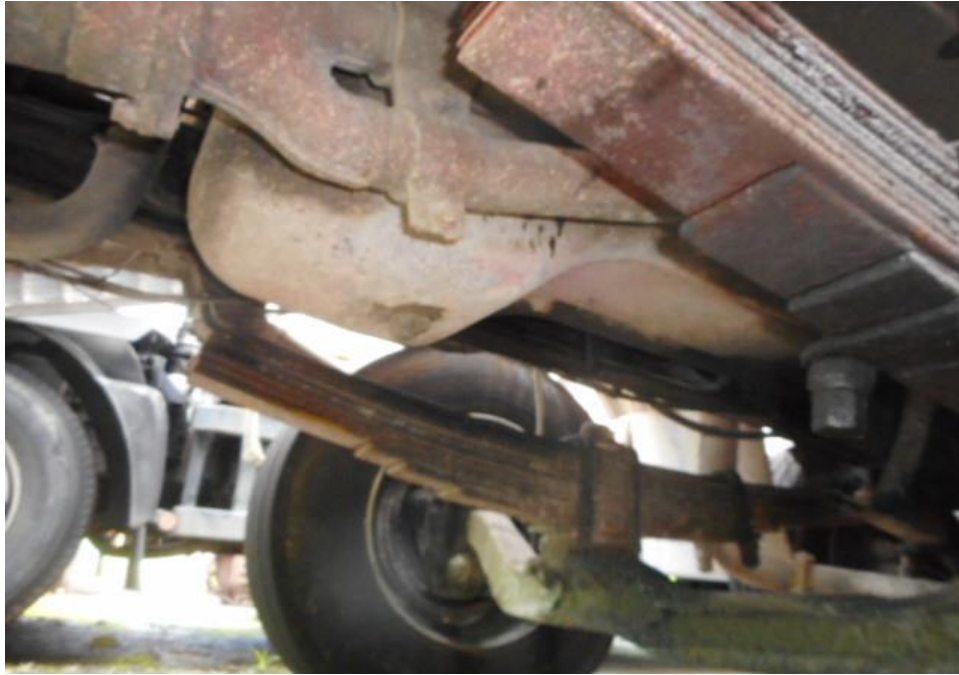
**Photo 16** shows the undercarriage of the Malaysian Tipper, at the area where the engine housing located. I did not find any sign(s) or indication(s) of fluid leak on the underside of the Malaysian Tipper.

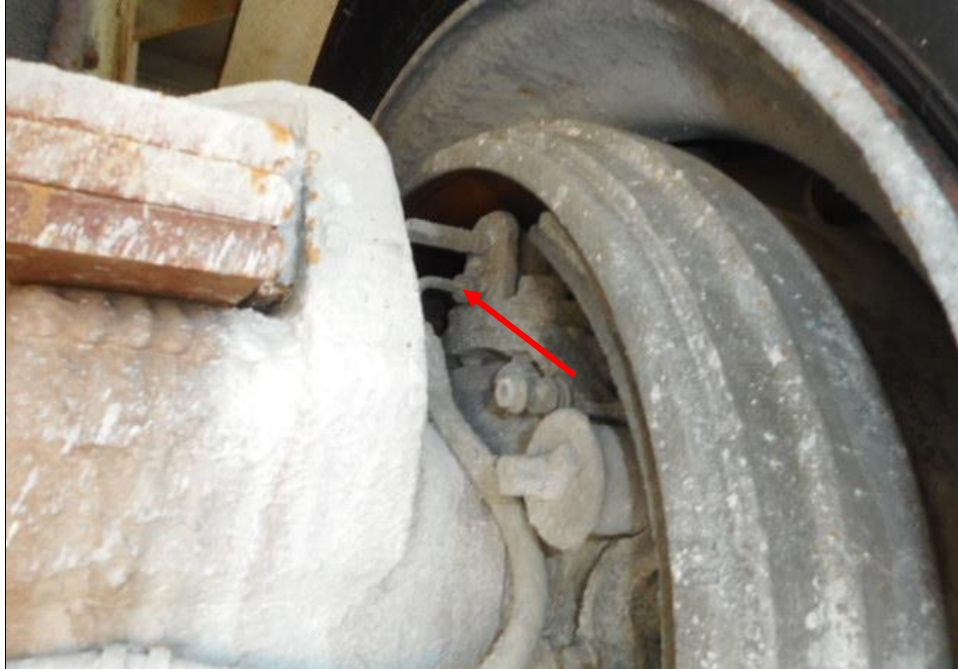
**Photo 17** shows the brake pipe (arrowed) at the rear right wheel of the Malaysian Tipper. I did not observe any leakage of brake fluid at the time of my inspection of the Malaysian Tipper. My static tests of the Malaysian Tipper's braking system, along with my visual examination of the various mechanical components in the braking system, had indicated that there was no internal leakage of pressure/vacuum. Hence the braking system of the Malaysian Tipper was likely to be in serviceable condition at the material time of accident.

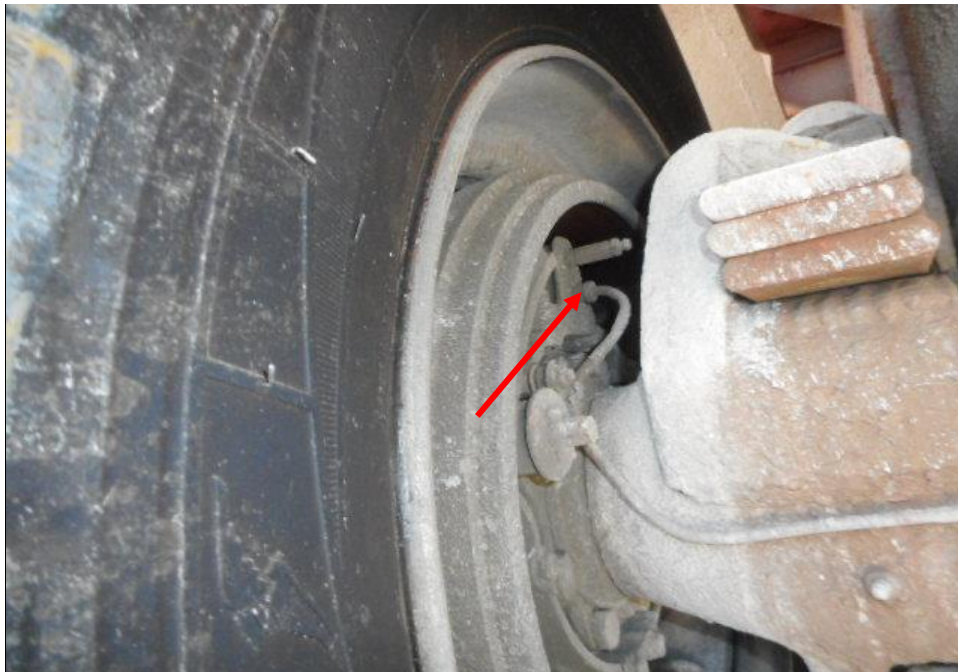
**Photo 18** shows the brake pipe (arrowed) at the rear left wheel of the Malaysian Tipper. I did not observe any leakage of brake fluid at the time of my inspection of the Malaysian Tipper. My static tests of the Malaysian Tipper's braking system, along with my visual examination of the various mechanical components in the braking system, had indicated that there was no internal leakage of pressure/vacuum. Hence the braking system of the Malaysian Tipper was likely to be in serviceable condition at the material time of accident.

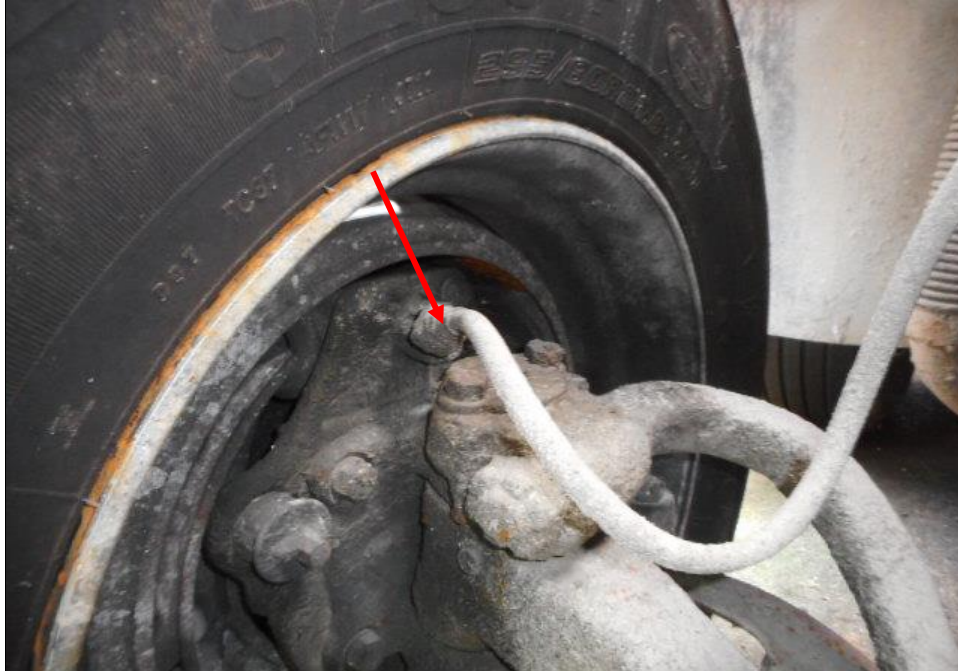
**Photo 19** shows the brake pipe (arrowed) at the front right wheel of the Malaysian Tipper. I did not observe any leakage of brake fluid at the time of my inspection of the Malaysian Tipper. My static tests of the Malaysian Tipper's braking system, along with my visual examination of the various mechanical components in the braking system, had indicated that there was no internal leakage of pressure/vacuum. Hence the braking system of the Malaysian Tipper was likely to be in serviceable condition at the material time of accident.

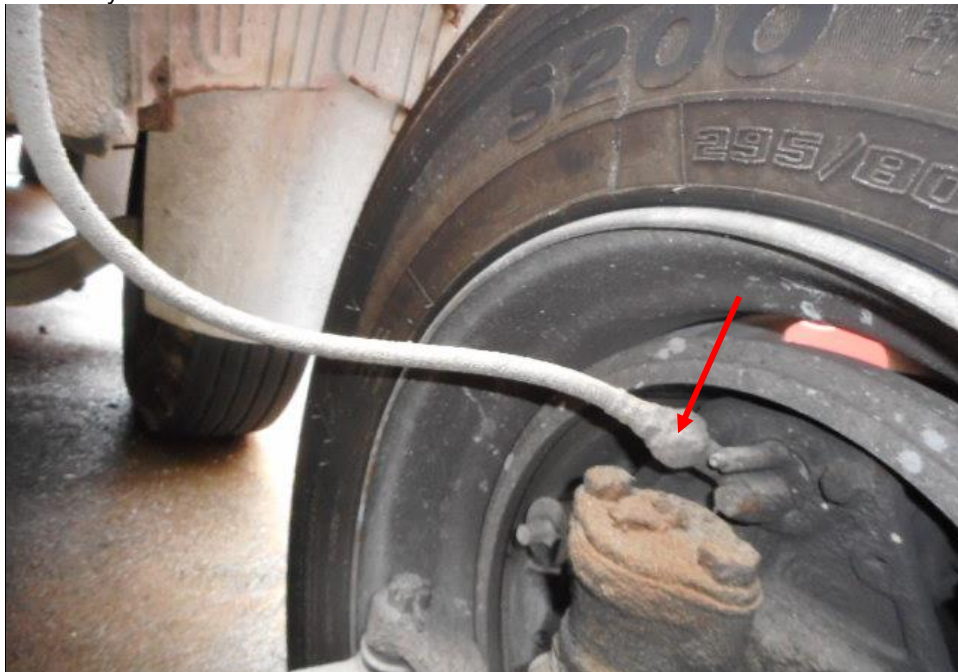
**Photo 20** shows the brake pipe (arrowed) at the front left wheel of the Malaysian Tipper. I did not observe any leakage of brake fluid at the time of my inspection of the Malaysian Tipper. My static tests of the Malaysian Tipper's braking system, along with my visual examination of the various mechanical components in the braking system had indicated that there was no internal leakage of pressure/vacuum. Hence the braking system of the Malaysian Tipper was likely to be in serviceable condition at the material time of accident.

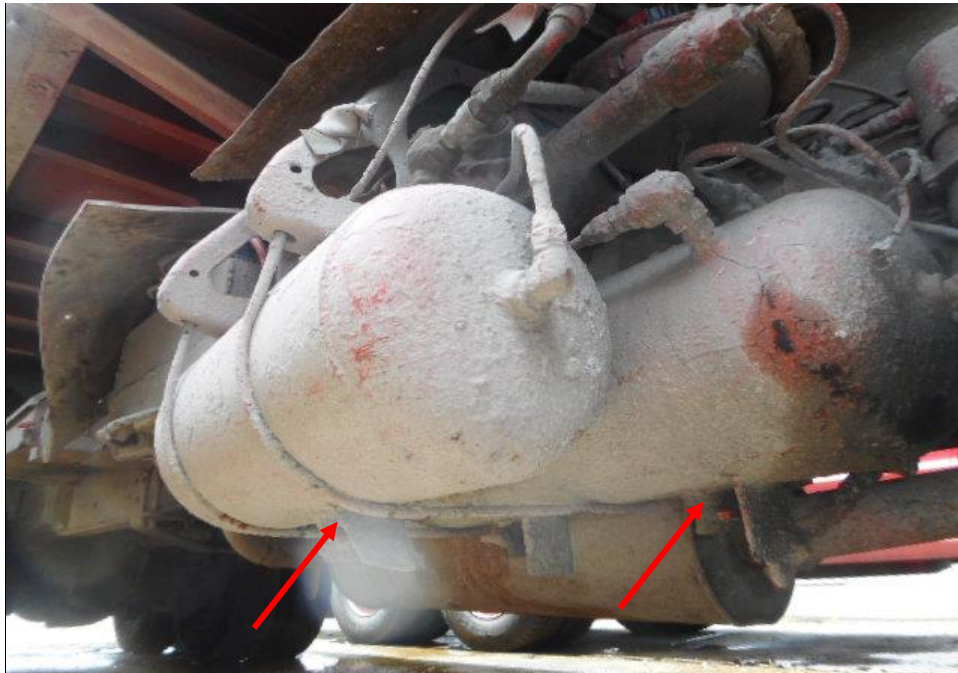
**Photo 21** shows the air brake cylinders (arrowed) at the undercarriage of the Malaysian Tipper. I did not observe any leakage of air brake fluid at the time of my inspection of the Malaysian Tipper. My static tests of the Malaysian Tipper's braking system, along with my visual examination of the various mechanical components in the braking system had indicated that there was no internal leakage of pressure/vacuum. Hence the braking system of the Malaysian Tipper was likely to be in serviceable condition at the material time of accident.

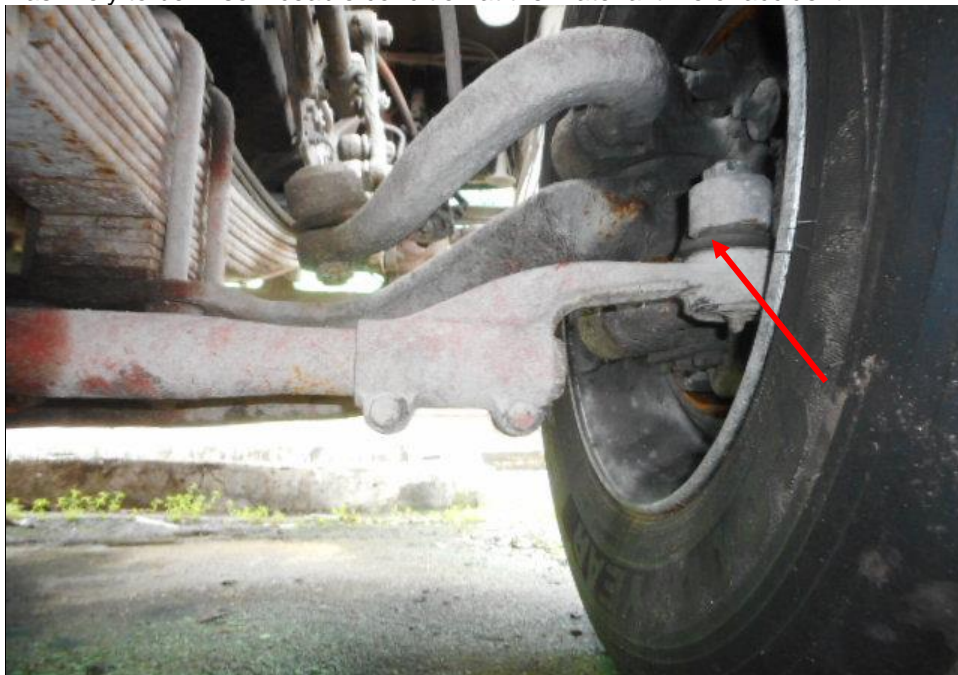
**Photo 22** shows the various undercarriage components at the front right wheel of the Malaysian Tipper, in particular the steering tie rod end (arrowed). The various steering components were all found to be intact, suggesting that the steering system of the Malaysian Tipper was likely to be in serviceable condition at the material time of accident. There was also no sign of fluid stain(s) observed on the various undercarriage components.

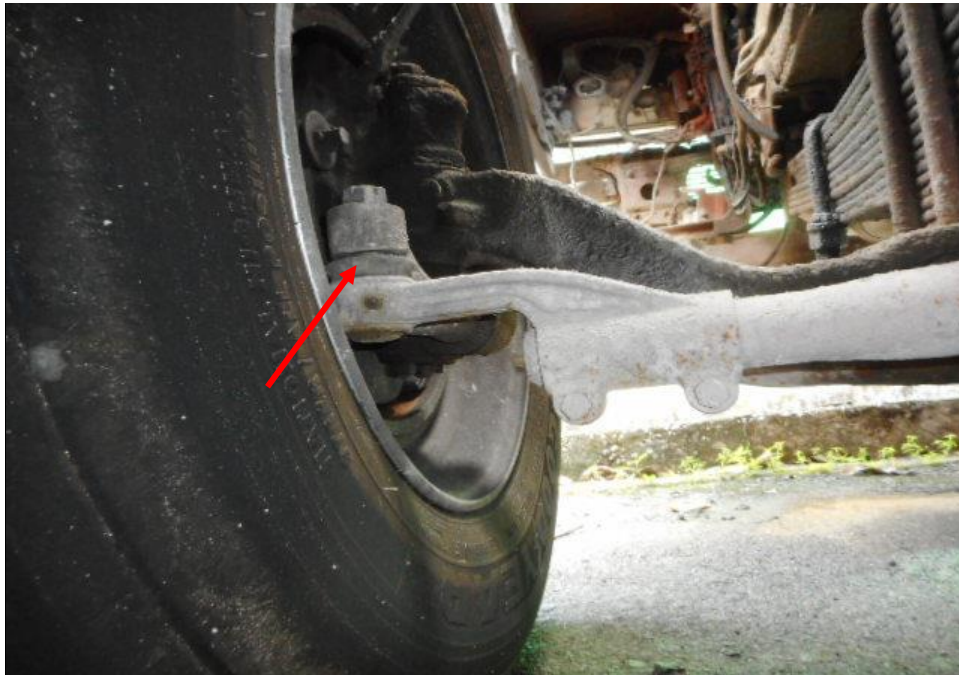
**Photo 23** shows the various undercarriage components at the front left wheel of the Malaysian Tipper, in particular the steering tie rod end (arrowed). The various undercarriage components of the Malaysian Tipper were all found to be intact without any visible damage. There was also no sign of fluid stain(s) observed on the various undercarriage components.

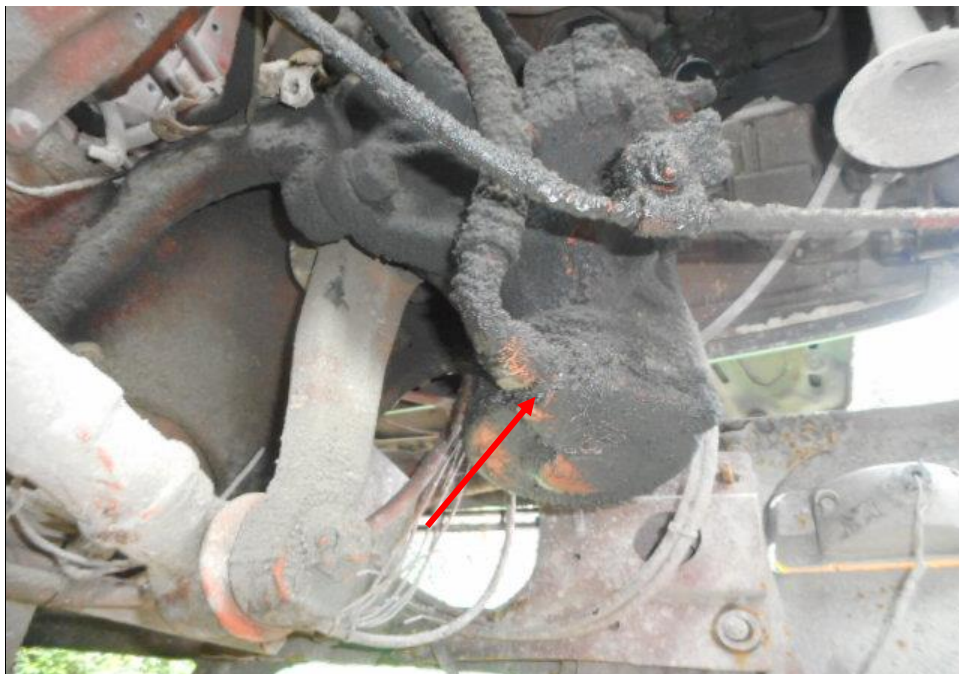
**Photo 24** shows the steering box component (arrowed) at the undercarriage of the Malaysian Tipper was found to be intact without any visible damage. There was also no sign of fluid stain(s) observed on the various undercarriage components.

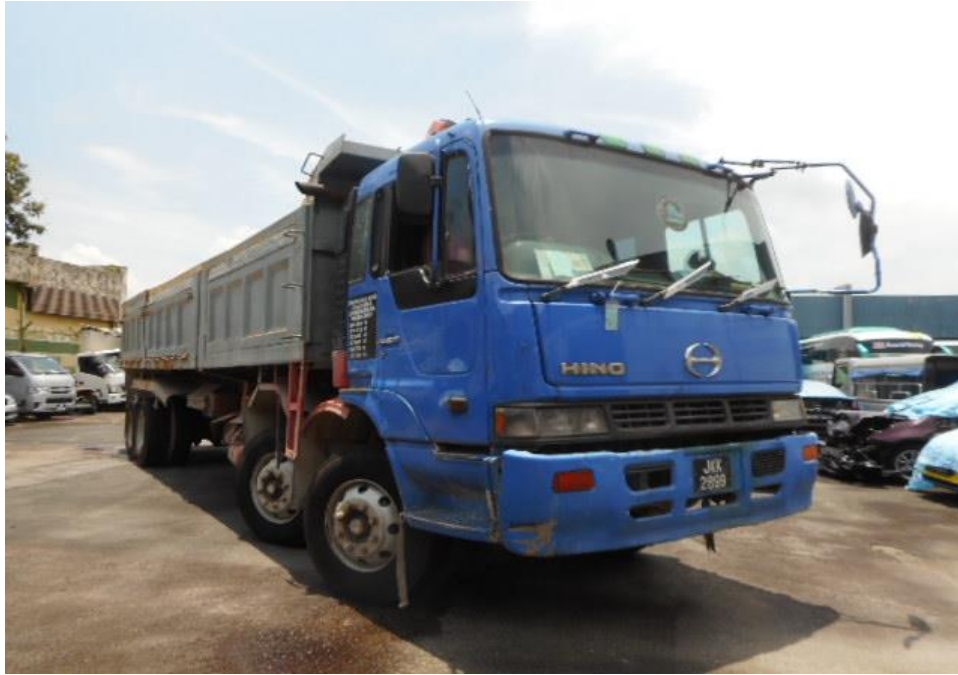
**Photo 25** shows the front left wheel of the Malaysian Tipper turned to its full left. During my steering system test, I did not experience any abnormal free play and/or resistance when I had turned the steering wheel towards full left and full right. This would suggest that the steering system of the Malaysian Tipper was likely to be in serviceable condition at the material time of accident.
