You're Ref: TP/IP/28153/2022
Our Ref: CI/TPD23001606/P

Fatal Accident Investigation Team

MECHANICAL INSPECTION REPORT OF MOTOR CAR SNC 2124G

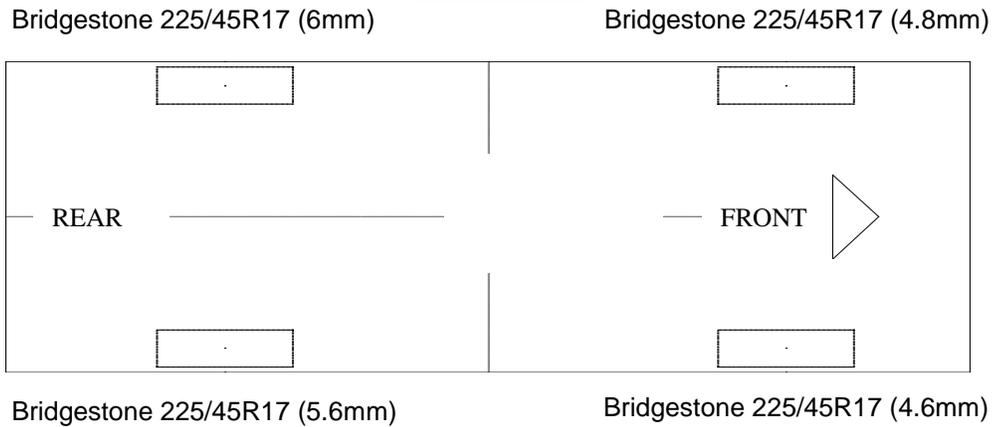
6. The condition of the Motor Car's 4 tyres was observed to be in serviceable condition. I did not find any tear, cut or burst mark(s) on the outer and the inner sidewalls as well as across the tread of the 4 tyres. The 4 tyres were also observed to be sufficiently inflated for vehicular operation. The tyre brand, tyre size and remaining tread depth of the 4 tyres were recorded as follows:-

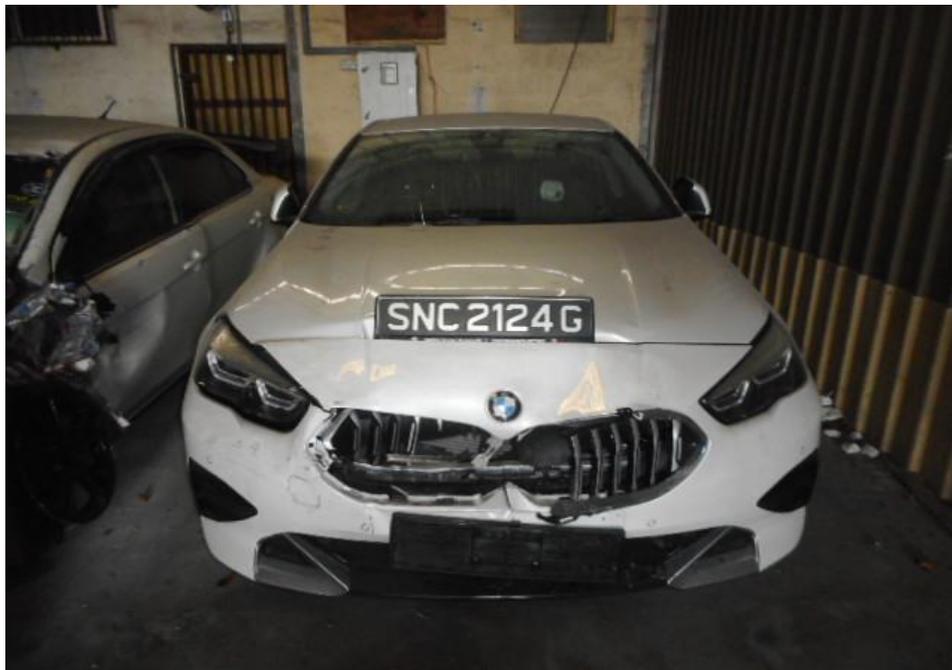
4. The mileage of the Motor Car at the time of my inspection was not recorded.
5. The Motor Car was observed to have sustained damage at its front and rear portion. Its front bonnet, front bumper, front grille, front right headlamp, rear boot and rear bumper was amongst the body parts that were damaged as a result of the accident.

Photo 1 shows a general view of the Motor Car's front body at the time of my inspection. The front portion of the Motor Car was observed to have sustained damage. Its front bonnet, front bumper, front grille, front right headlamp was amongst the body parts that were damaged as a result of the accident.

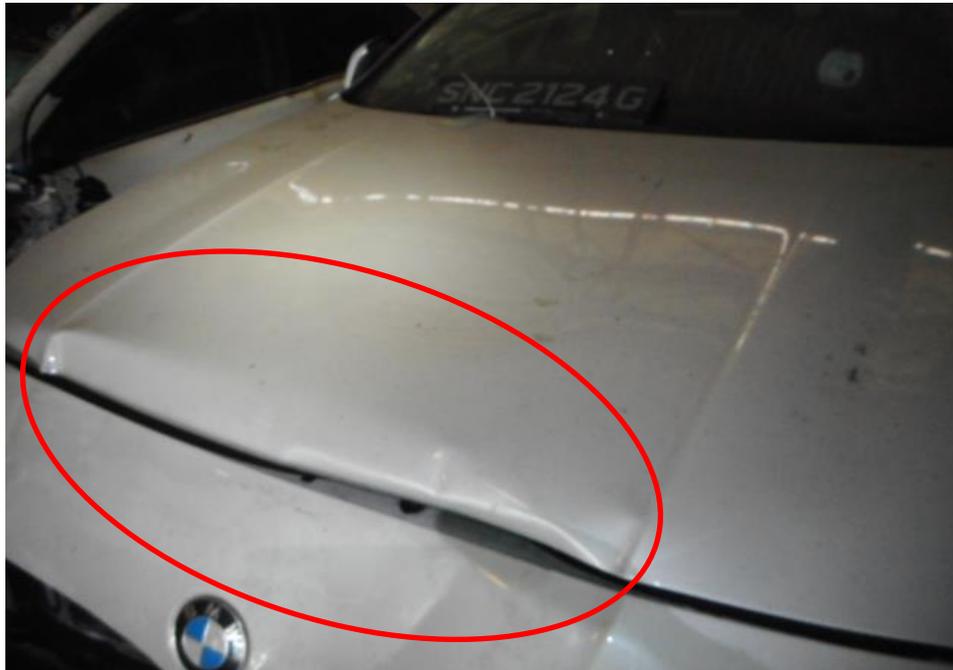
Photo 2 shows a close up view of the Motor Car's front body at the time of my inspection. The front portion of the Motor Car was observed to have sustained damage. Its front bonnet (circled) was the body parts that were damaged as a result of the accident.

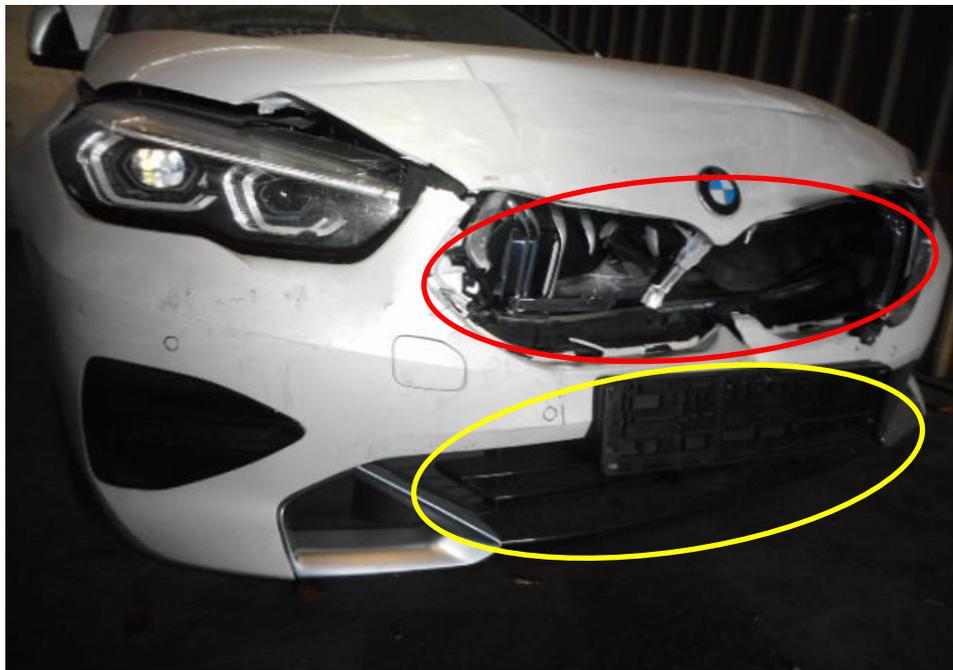
Photo 3 shows a close up view of the Motor Car's front body at the time of my inspection. The front portion of the Motor Car was observed to have sustained damage. Its front grille (red circle) and front bumper (yellow circle) was the body parts that were damaged as a result of the accident.

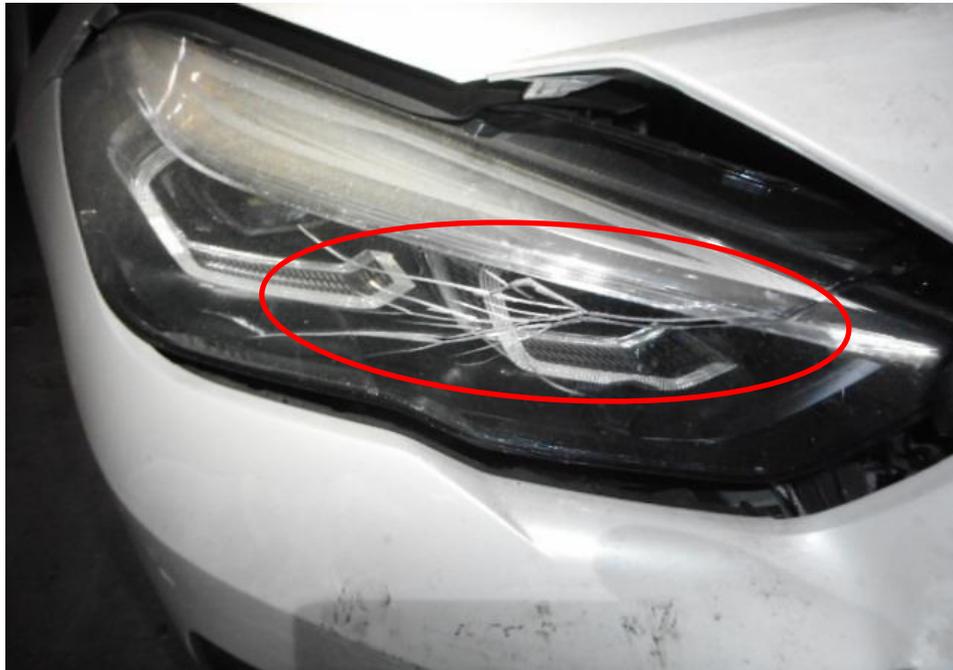
Photo 4 shows a close up view of the Motor Car's front body at the time of my inspection. The front portion of the Motor Car was observed to have sustained damage. Its front right headlamp (circled) was the body parts that were damaged as a result of the accident.

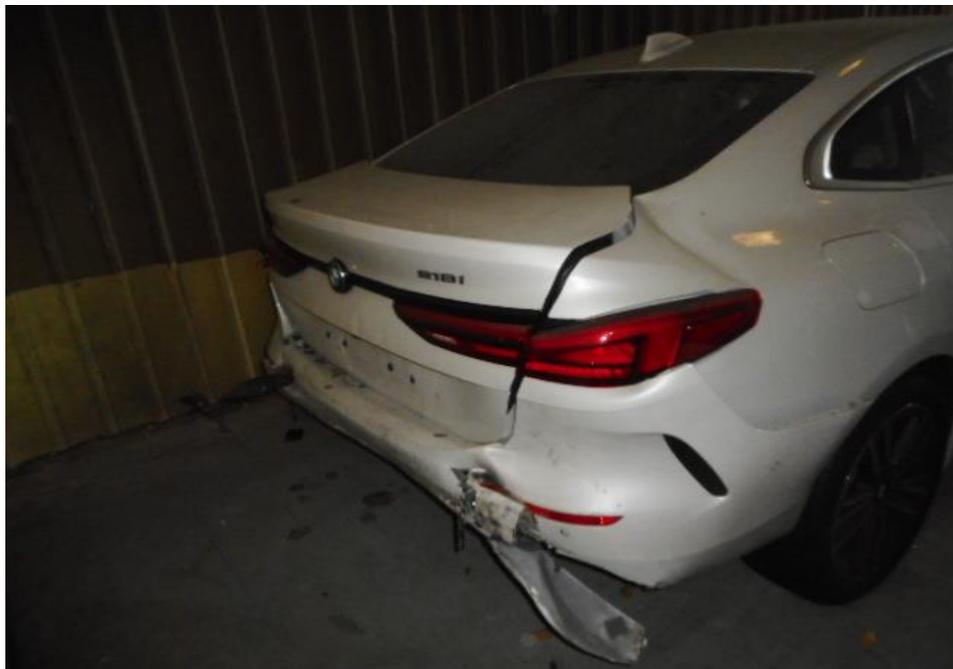
Photo 5 shows the general view of the Motor Car's rear body at the time of my inspection. The rear portion of the Motor Car was observed to have sustained damage. Its rear boot and rear bumper was the body parts that were damaged as a result of the accident.

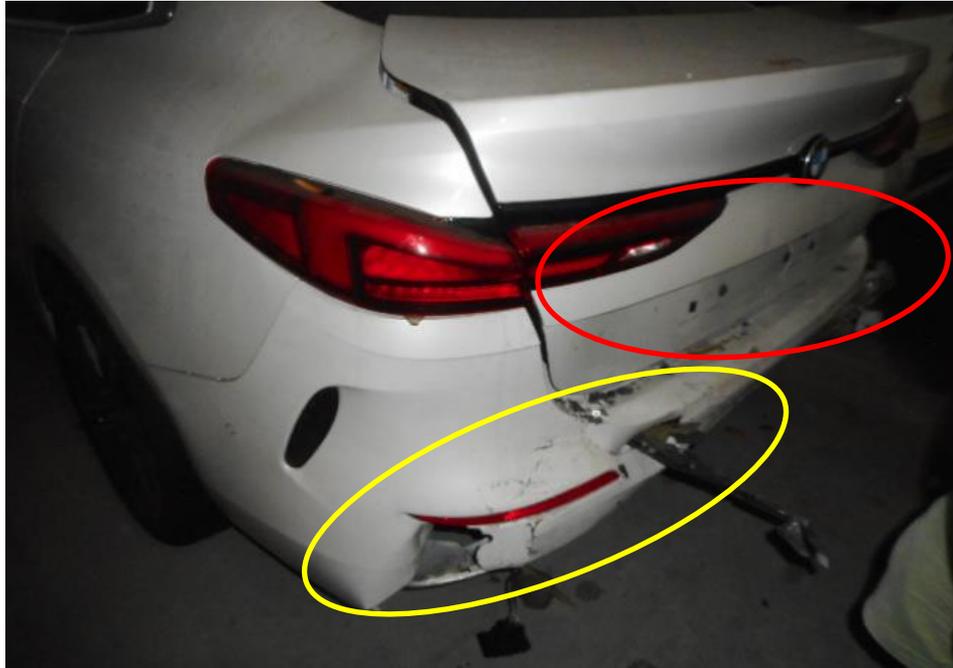
Photo 6 shows the close up view of the Motor Car's rear body at the time of my inspection. The rear portion of the Motor Car was observed to have sustained damage. Its rear boot (red circle) and rear bumper (yellow circle) was the body parts that were damaged as a result of the accident.

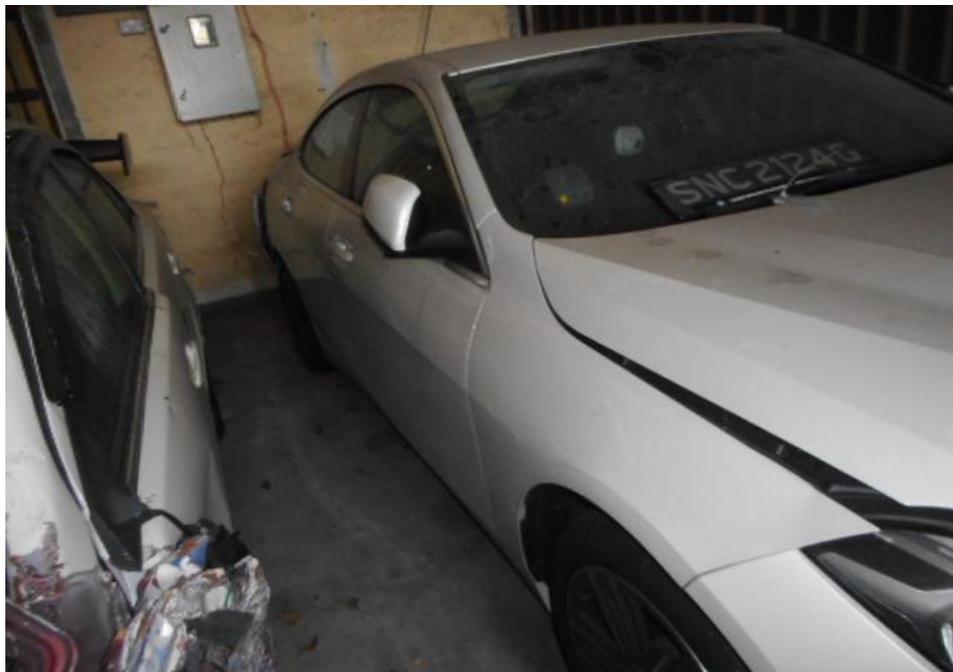
Photo 7 shows a general view of the Motor Car's right body at the time of my inspection. The right portion of the Motor Car was observed to have been unaffected by the accident.

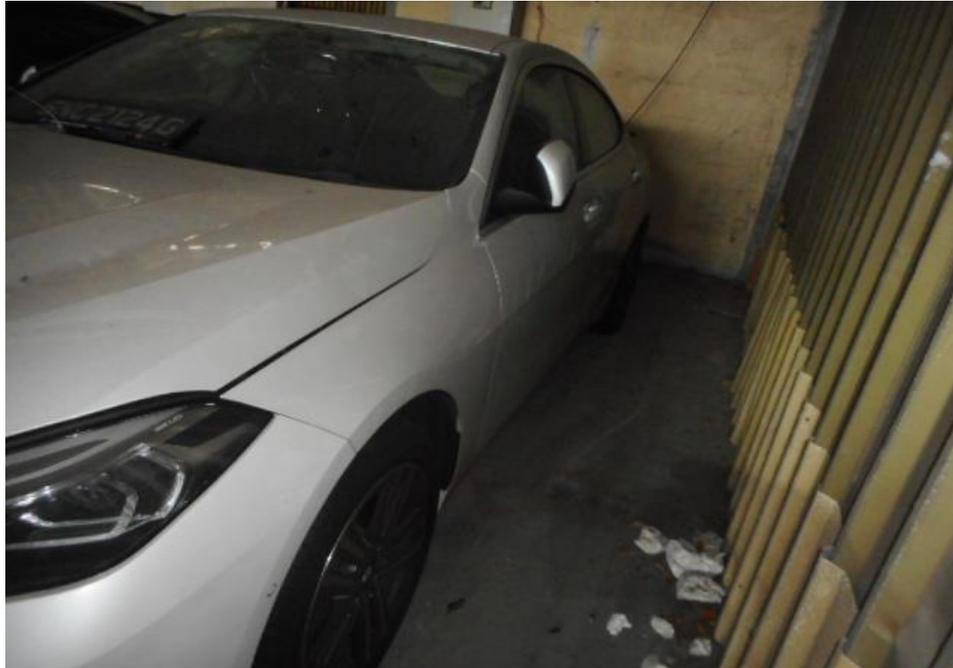
Photo 8 shows a general view of the Motor Car's left body at the time of my inspection. The left portion of the Motor Car was observed to have been unaffected by the accident.

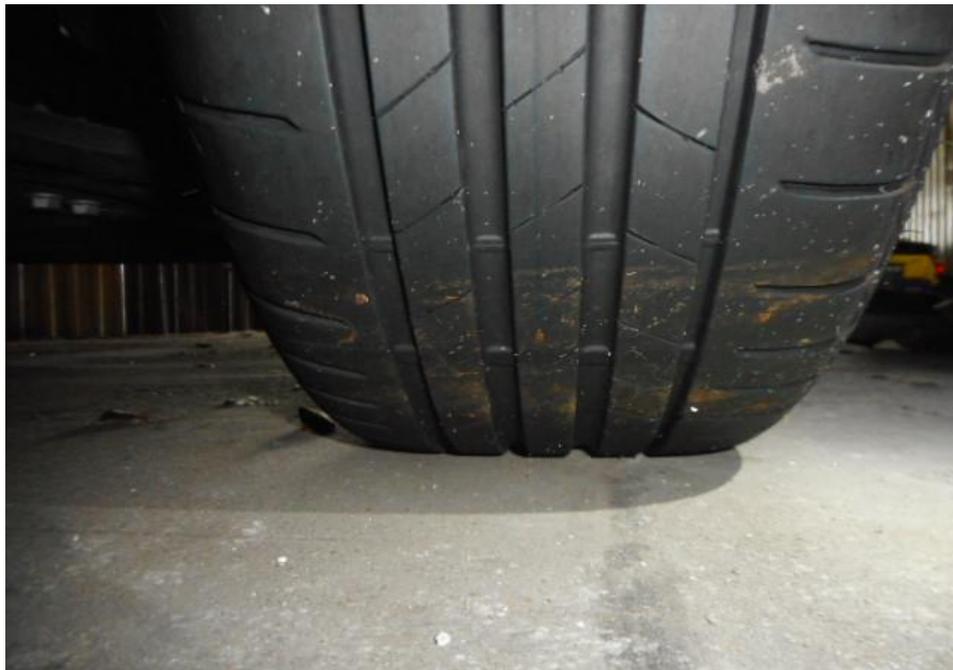
Photo 9 shows the condition of the front right tyre of the Motor Car, which was observed to be in serviceable condition with remaining tread depth of approximately 4.6mm. The tyre was sufficiently inflated for vehicular operation with no tear, cut or burst mark(s) on the outer and the inner sidewalls as well as across the tread. The 4 tyres of the Motor Car were wrapped around standard steel wheel rims without any damage.

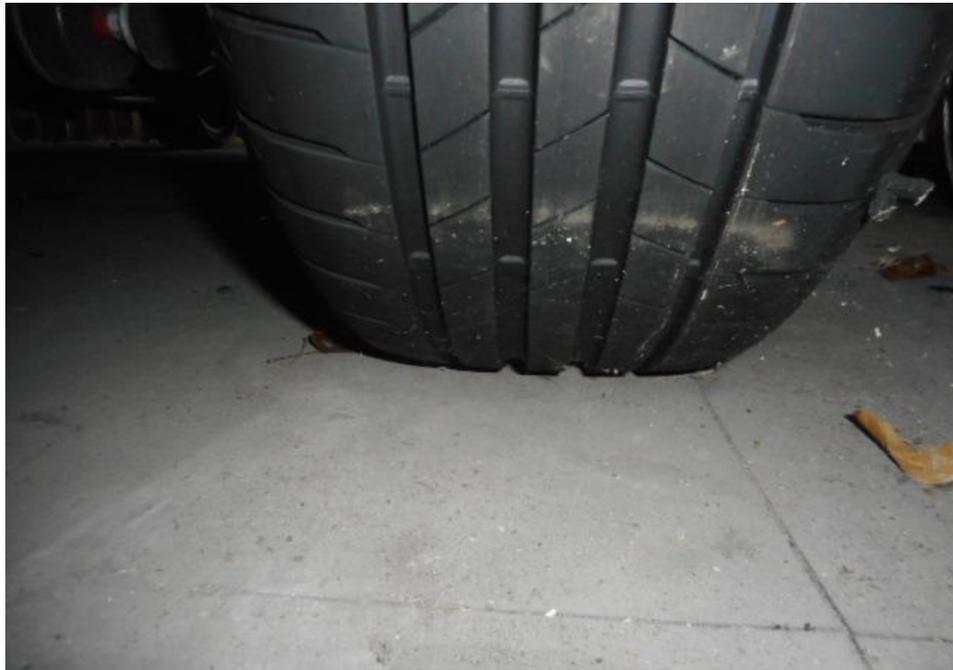
Photo 10 shows the condition of the rear right tyre of the Motor Car, which was observed to be in serviceable condition with remaining tread depth of approximately 5.6mm. The tyre was also observed to be sufficiently inflated for vehicular operation with no tear, cut or burst mark(s).

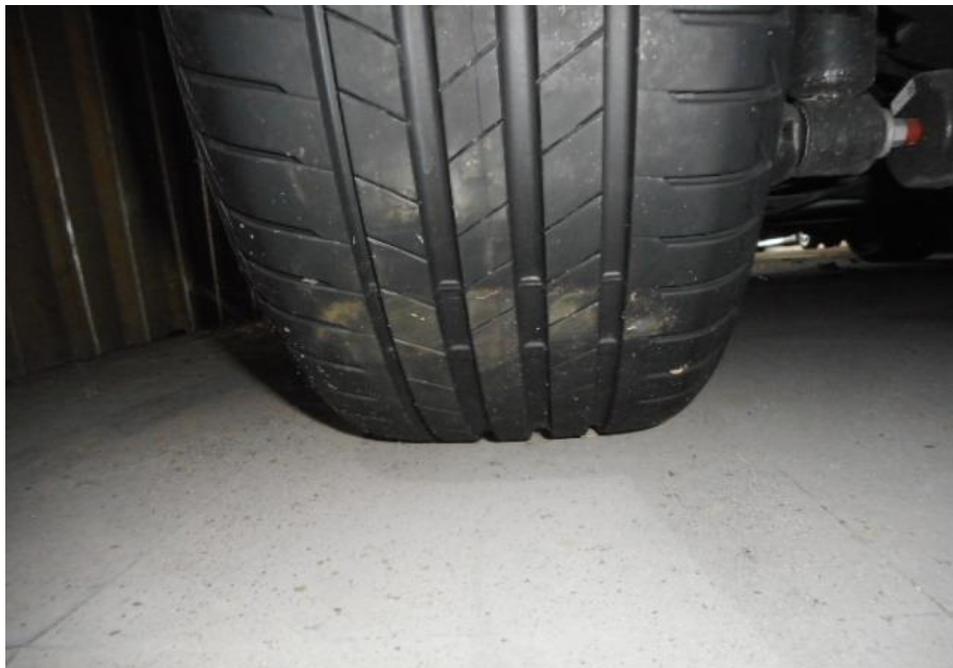
Photo 11 shows the condition of the rear left tyre of the Motor Car, which was observed to be in serviceable condition with remaining tread depth of approximately 6mm. The tyre, which was wrapped around steel wheel rim, was also observed to be sufficiently inflated for vehicular operation. The 4 tyres of the Motor Car were wrapped around standard steel wheel rims.

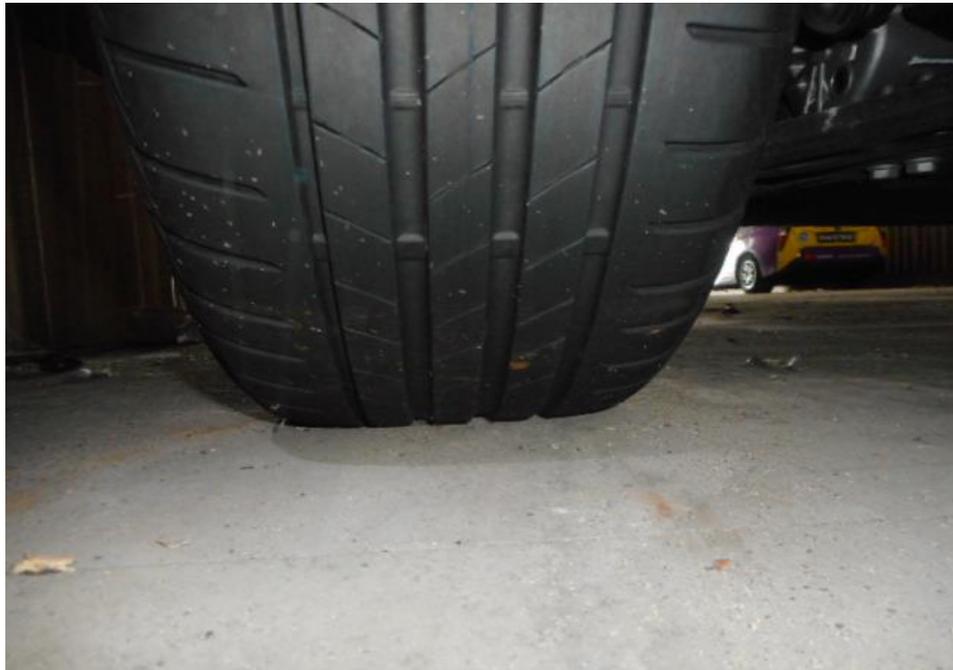
Photo 12 shows the condition of the front left tyre of the Motor Car, which was observed to be in serviceable condition with remaining tread depth of approximately 4.6mm. There was also no tear, cut or burst mark(s) on the outer and the inner sidewalls as well as across the tread of the Motor Car's 4 tyres.

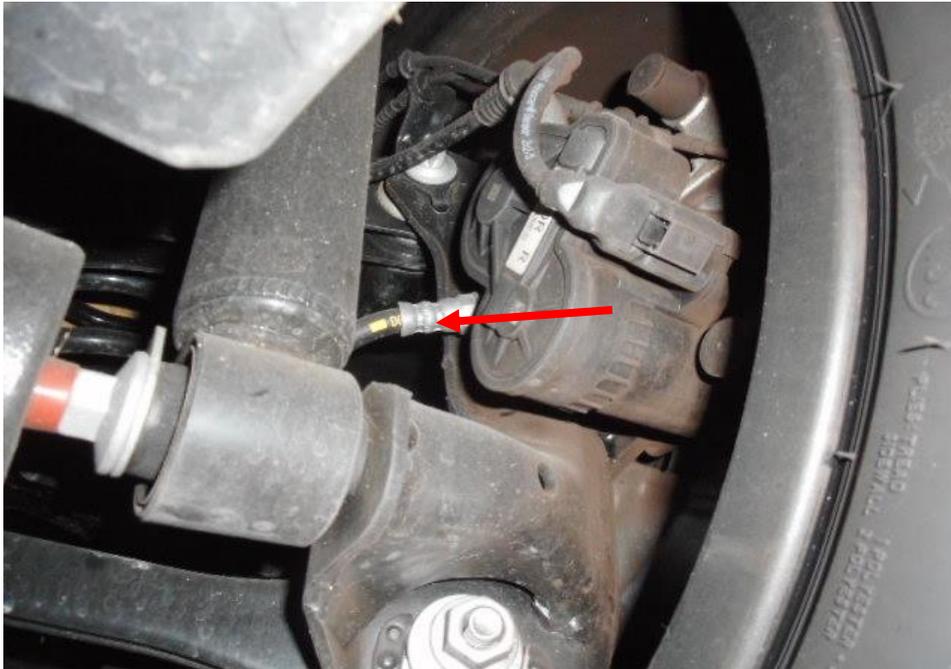
Photo 13 shows the brake hose/pipe (arrowed) at the rear right wheel of the Motor Car. No leakage of brake fluid was observed. Visual examination of the various components of the braking system like the brake calliper and hose had revealed to be intact and without visible damage.

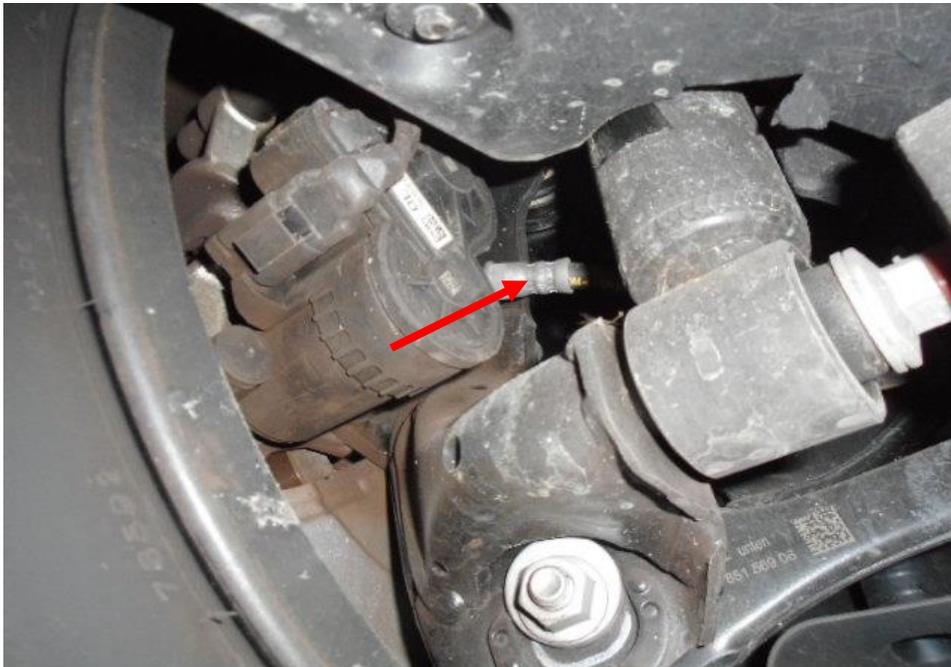
Photo 14 shows the brake hose/pipe (arrowed) at the rear left wheel of the Motor Car. No leakage of brake fluid was observed. Visual examination of the various components of the braking system like the brake calliper and hose had revealed to be intact and without visible damage.

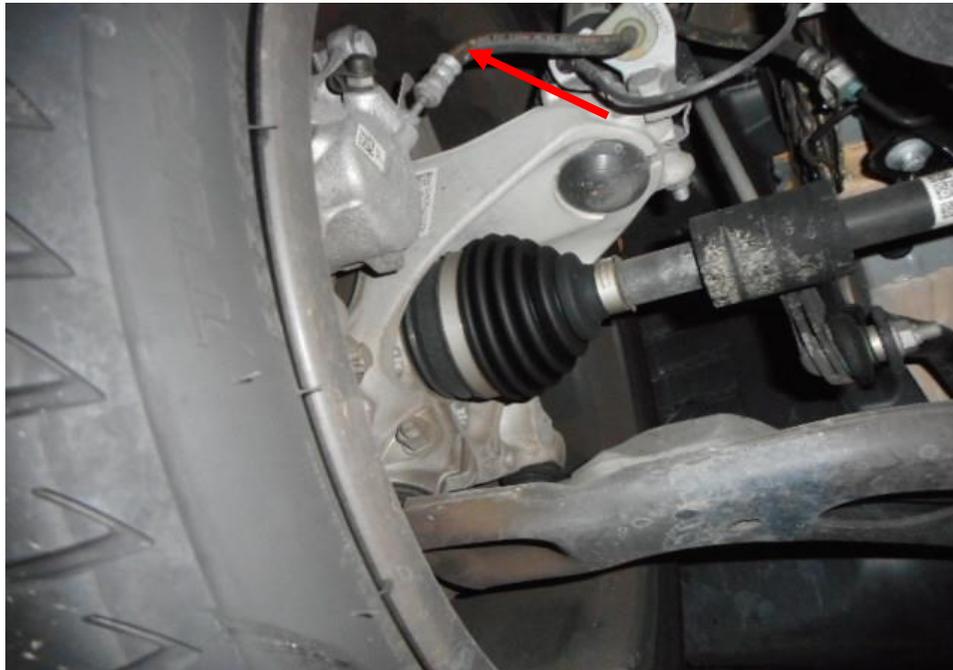
Photo 15 shows the brake hose/pipe (arrowed) at the front right wheel of the Motor Car. I did not observe any leakage of brake fluid at the time of my inspection of the Motor Car. The undercarriage components of the Motor Car were also all found to be intact and without any visible damage.

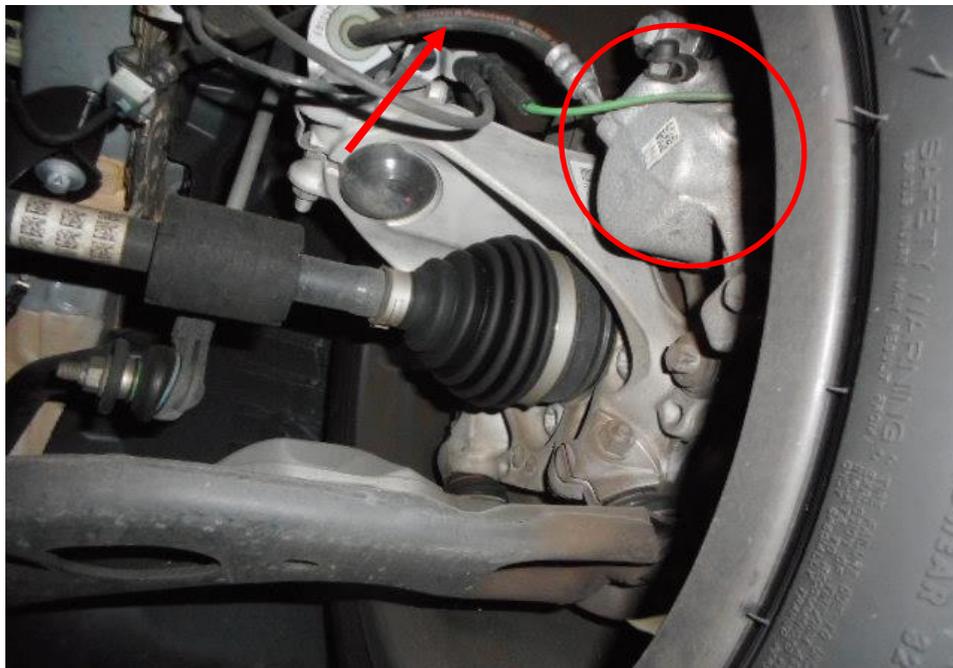
Photo 16 shows the brake hose/pipe (arrowed) at the front left wheel of the Motor Car. No leakage of brake fluid was observed. Visual examination of the various components of the braking system like the brake calliper (circled) and hoses had revealed to be intact and without visible damage.

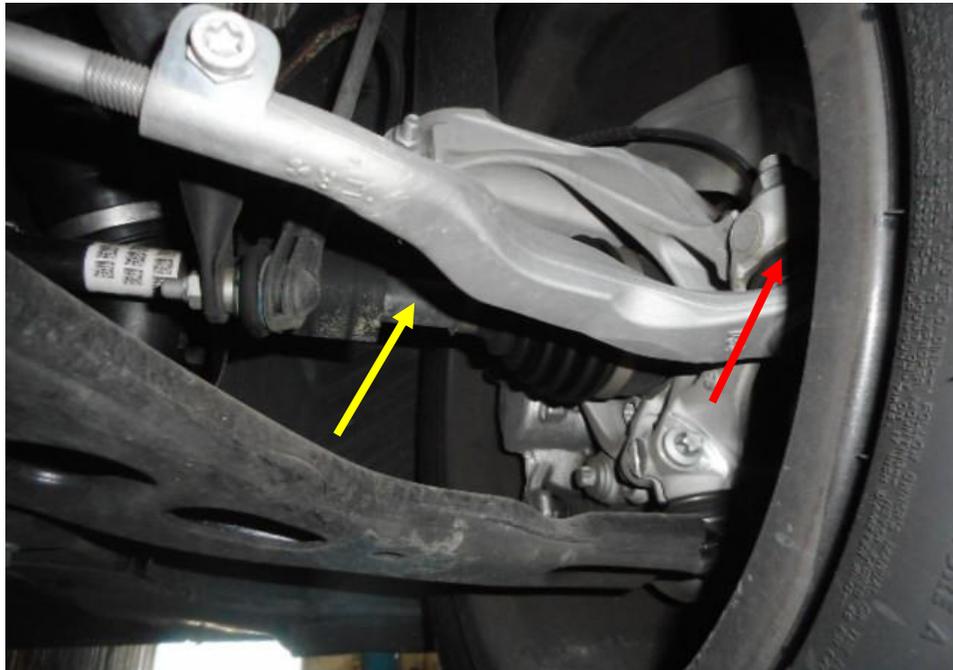
Photo 17 shows the various undercarriage components at the front right wheel of the Motor Car, in particular the steering tie rod (red arrow) and drive shaft (yellow arrow). The various steering components were all found to be intact, suggesting that the steering system of the Motor Car was likely to be in serviceable condition at the material time of accident. There was also no sign of fluid stain observed on the various undercarriage components at the front right wheel of the Motor Car.

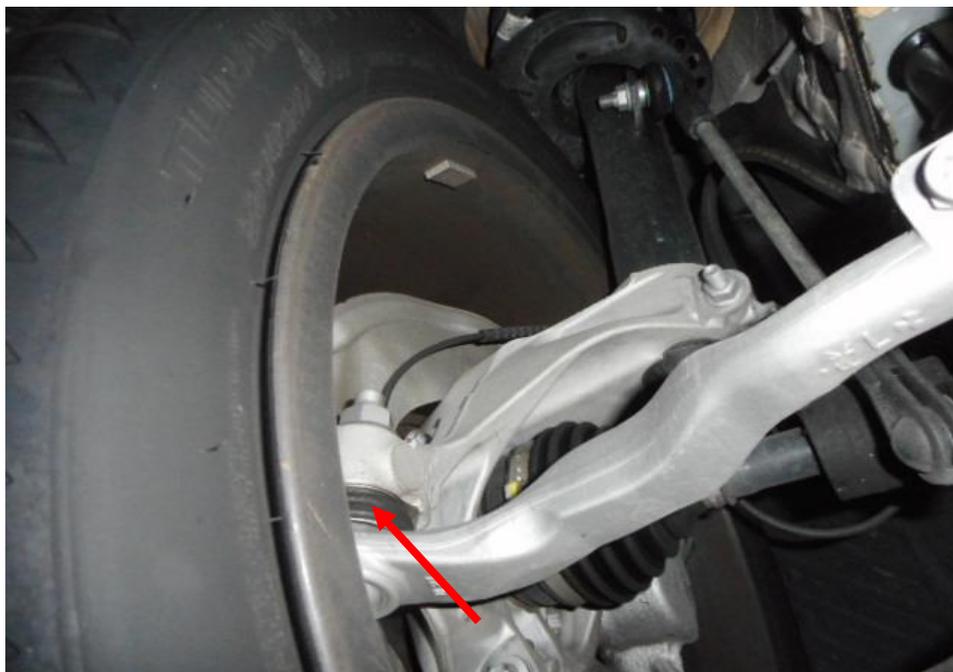
Photo 18 shows the various undercarriage components at the front left wheel of the Motor Car, which had included the steering tie rod (red arrow). The various undercarriage components of the Motor Car were all found to be intact without any visible damage.
