Your Ref: E/20221028/0020  
Our Ref : CISP/TPD23001612/N

14 February 2023

**INSPECTION REPORT OF PERSONAL MOBILITY AID (PMA) - SINGAPORE  
POLICE FORCE REPORT NO. E/20221028/0020**

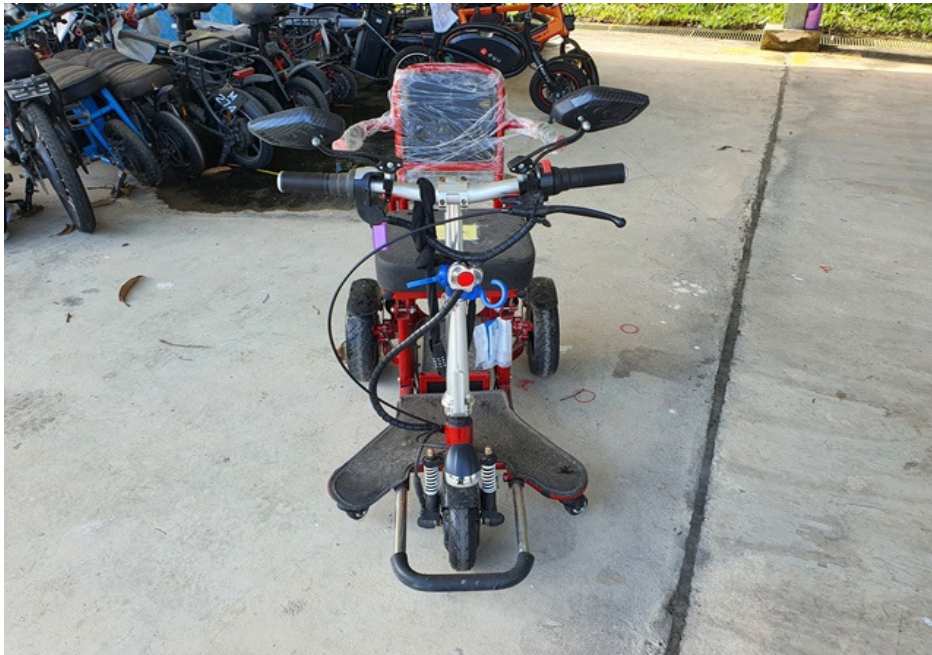
**Photo 2** shows a general view of the frontal portion of the PMA at the time of our inspection. The PMA was observed to have sustained damages all around.

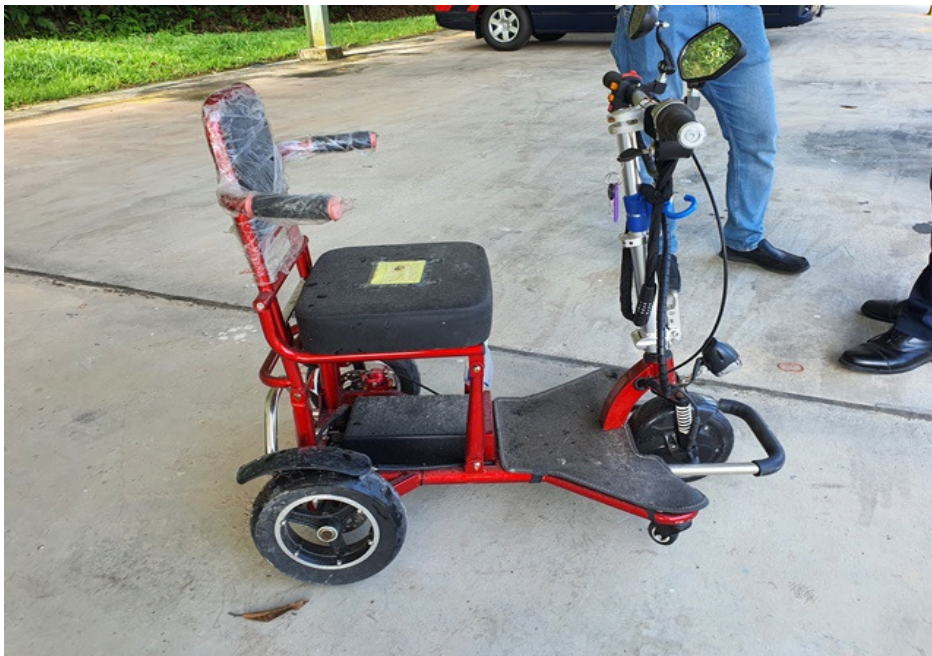
**Photo 3** shows a general view of the right body of the PMA at the time of our inspection. The PMA was observed to have sustained damages all around.

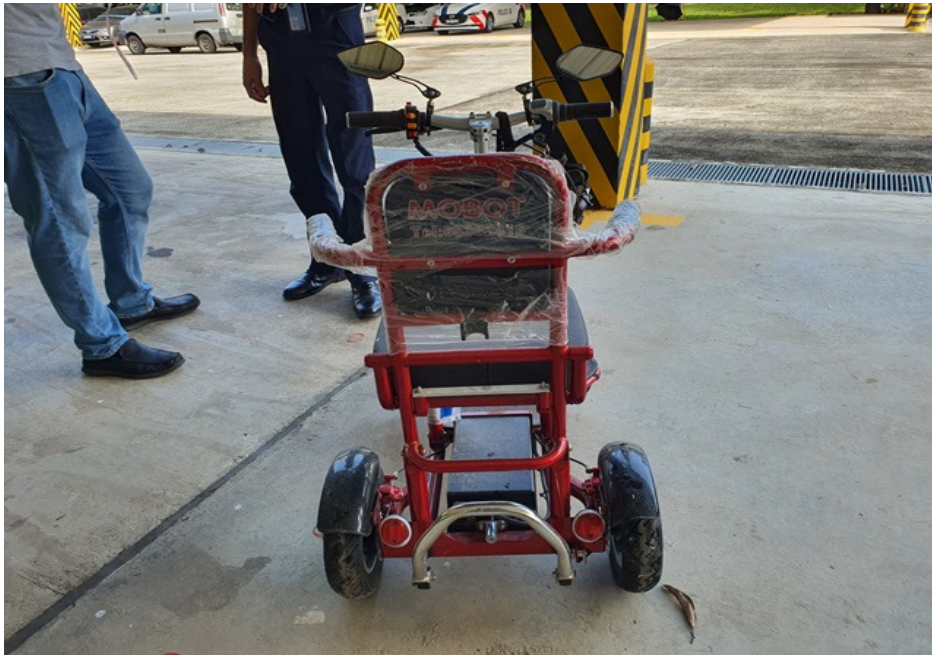
**Photo 4** shows a general view of the rear portion of the PMA at the time of our inspection. The PMA was observed to have sustained damages all around. The body parts that were found to have been damaged include its right handlebar end, right side mirror and bottom cowlings, amongst others as a result of the accident.

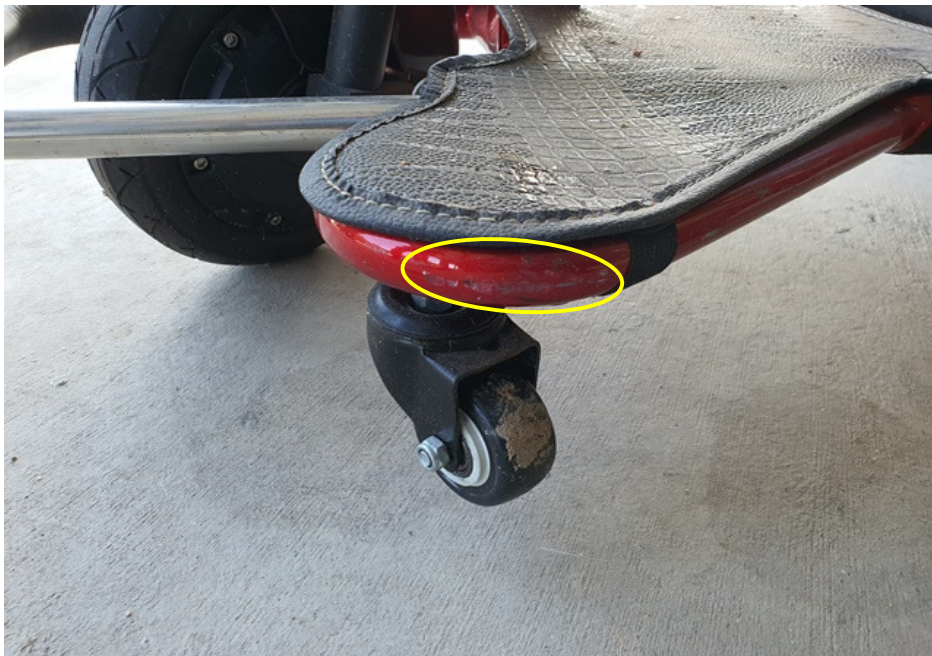
**Photo 5** shows a closer view of the left bottom cowl (circled) of the PMA which was observed to be damaged due to the accident.

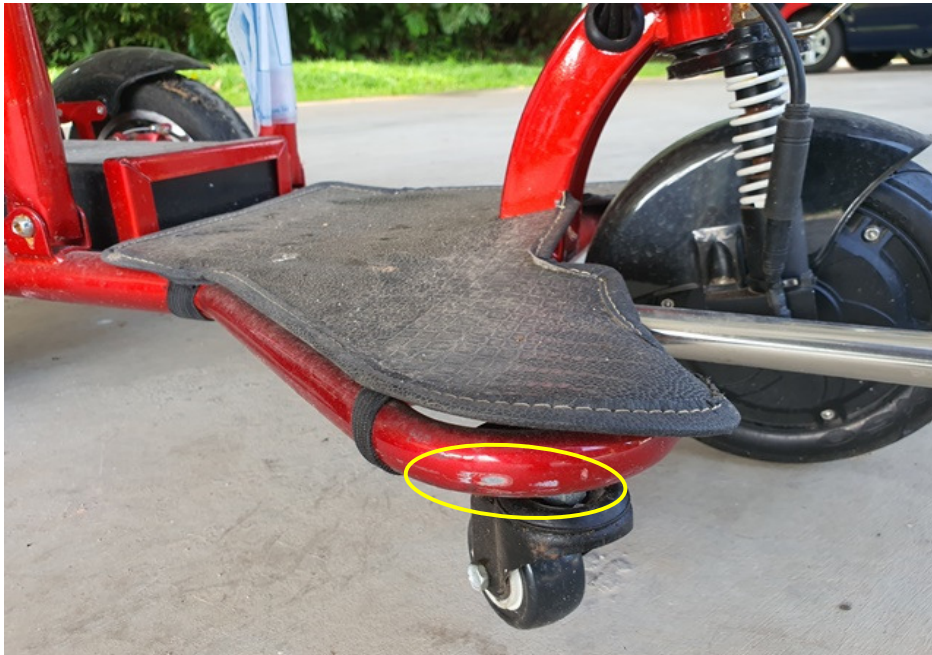
**Photo 6** shows a closer view of the right bottom cowling (circled) of the PMA which was observed to be damaged due to the accident.

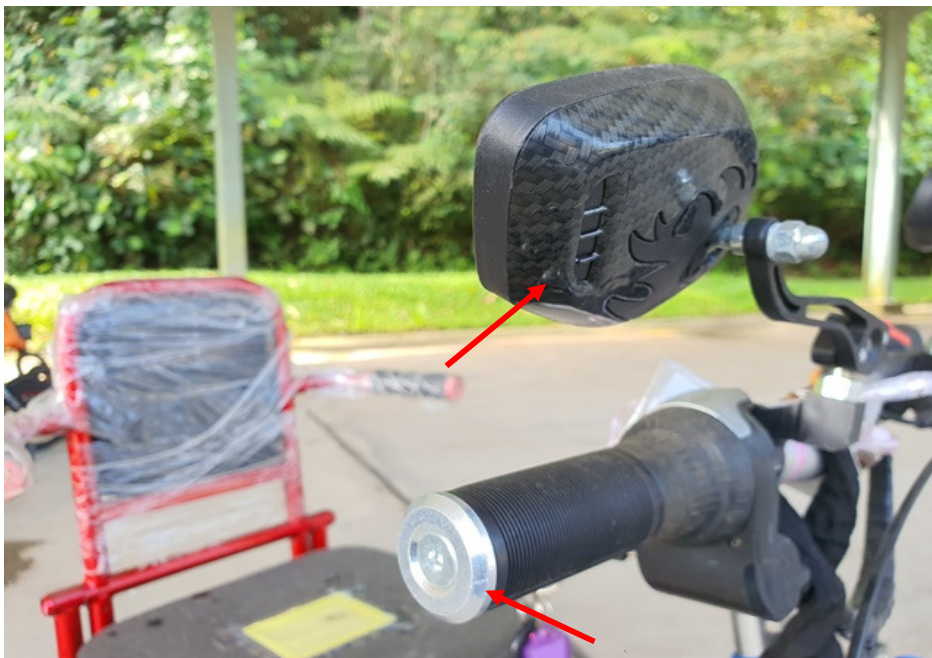
**Photo 7** shows a closer view of the right handlebar end and right side mirror (arrowed) of the PMA which were observed to be damaged due to the accident

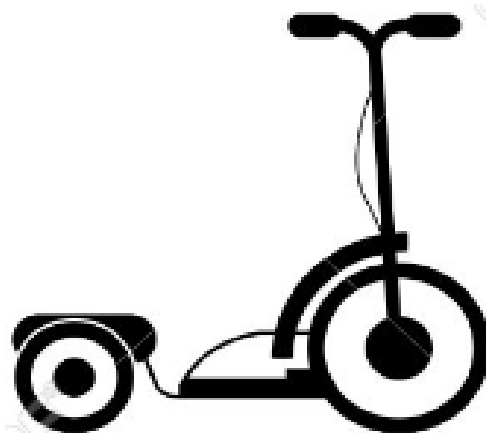
Z Ghua 10 X 2.50 (2mm) (RLT)  
(Grazed)

Xu Zhuo Rising Sun Tyre Co. Ltd.  
200 X 50 (0mm)

Z Ghua 10 X 2.50 (2mm) (RRT)

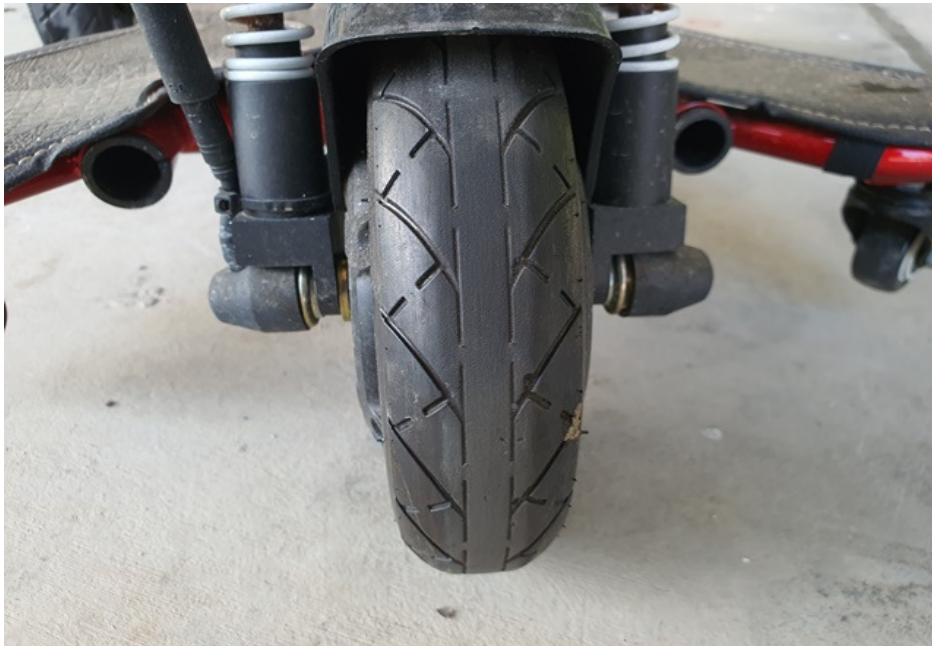
**Photo 8** shows the condition of the PMA's front tyre. The front tyre was observed to be in serviceable condition. There was no tear, burst mark(s) and/or punctured hole(s) on the sidewalls as well as across the tread of the front tyre. However the front tyre was observed to be bald.

13. The 3 tyres of the PMA were also found to be in serviceable condition. We did not observe any tear, burst mark(s) and/or punctured hole(s) on the sidewalls as well as across the tread of the 3 tyres. The 3 tyres were observed to be sufficiently inflated for vehicular operation. The tread pattern of the 2 rear tyres was clearly visible with remaining tread depth of approximately 2mm each, which had included the grazed left rear tyre. However the front tyre was observed to be bald at the time of our inspection.

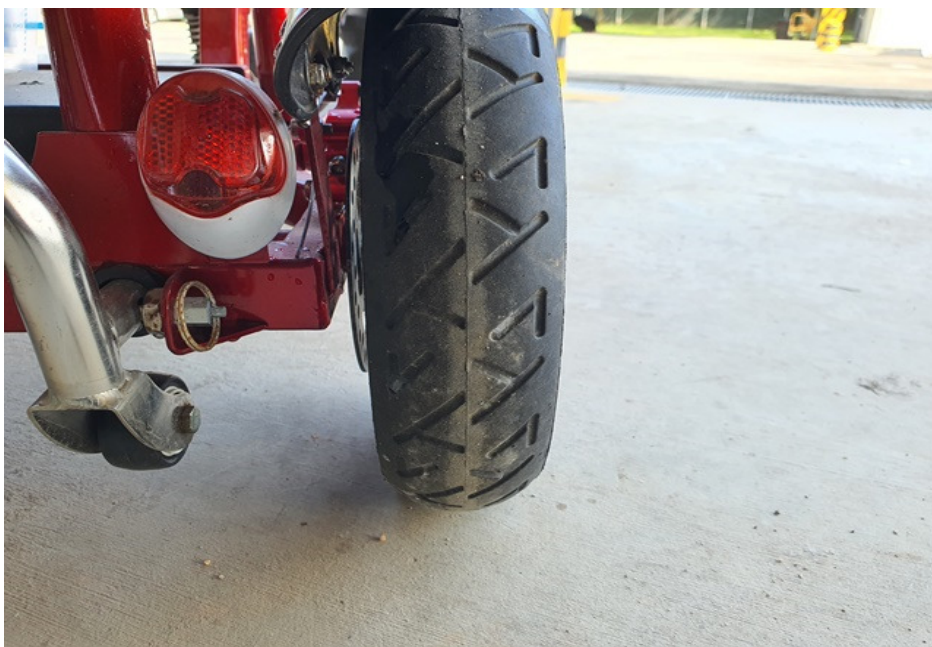
**Photo 9** shows the condition of the PMA's right rear tyre. The right rear tyre was observed to be in serviceable condition with remaining tread depth of approximately 2mm. The right rear tyre was also observed to be sufficiently inflated for vehicular operation. There was no tear, burst mark(s) and/or punctured hole(s) on the sidewalls as well as across the tread of the right rear tyre.

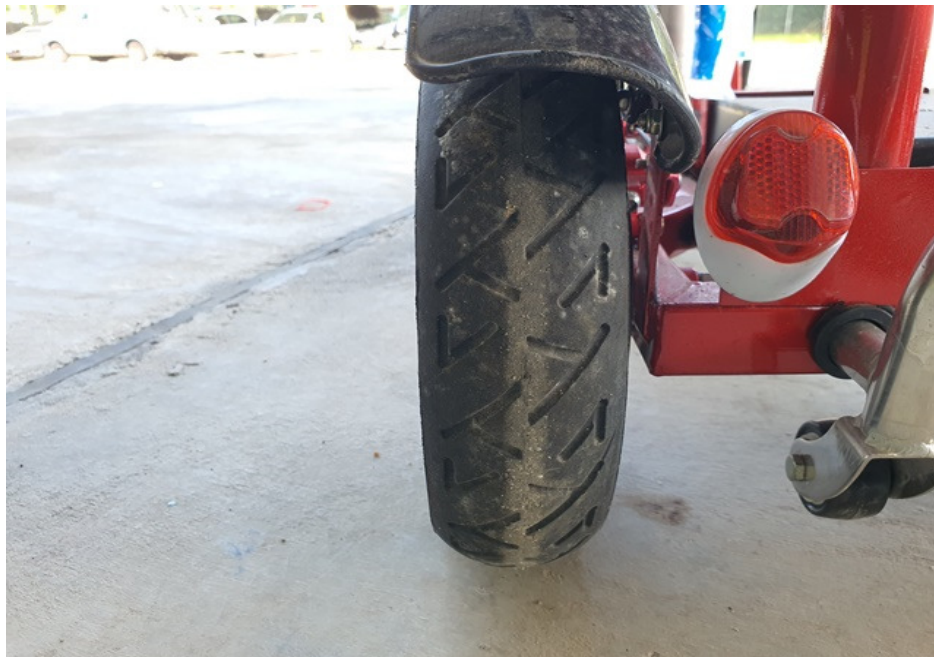
**Photo 10** shows the condition of the PMA's left rear tyre. The left rear tyre was observed to have remaining tread depth of approximately 2mm. The left rear tyre was also observed to be sufficiently inflated for vehicular operation. However we found the left sidewall of the left rear tyre to be grazed.

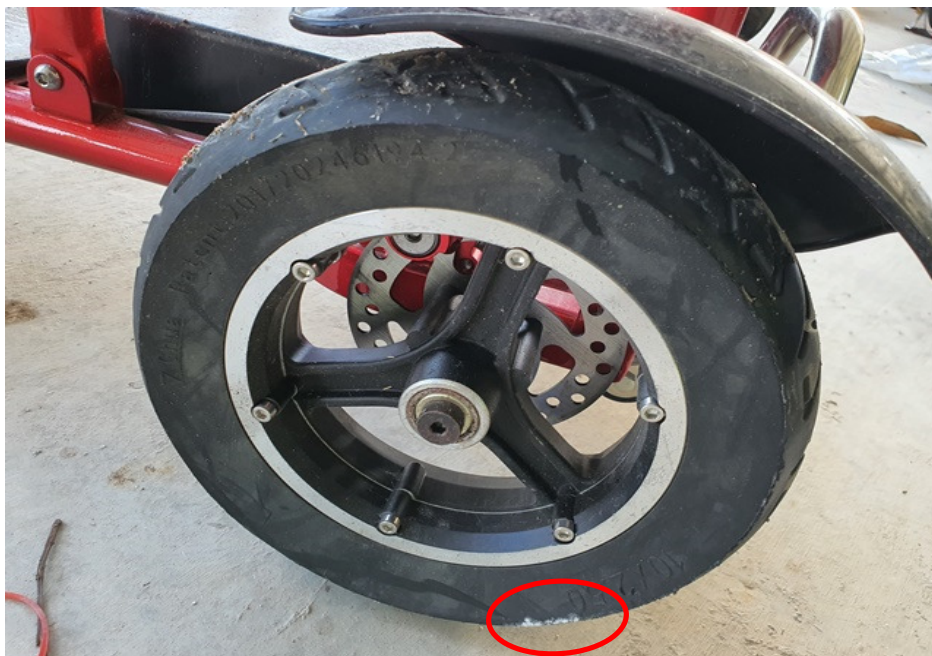
**Photo 11** shows the left rear wheel rim and tyre of the PMA at the time of our inspection. Marks of grazing nature were observed on the left sidewall of the left rear tyre of the PMA (circled).

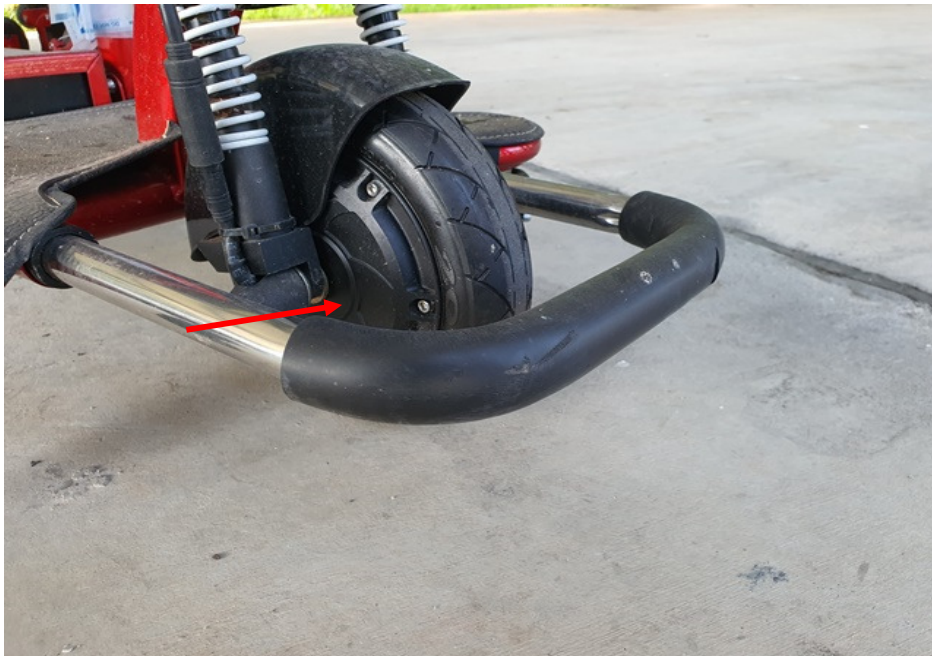
**Photo 12** shows the general view of the brushless motor (arrowed) of the PMA which was observed to be intact with no misalignment.

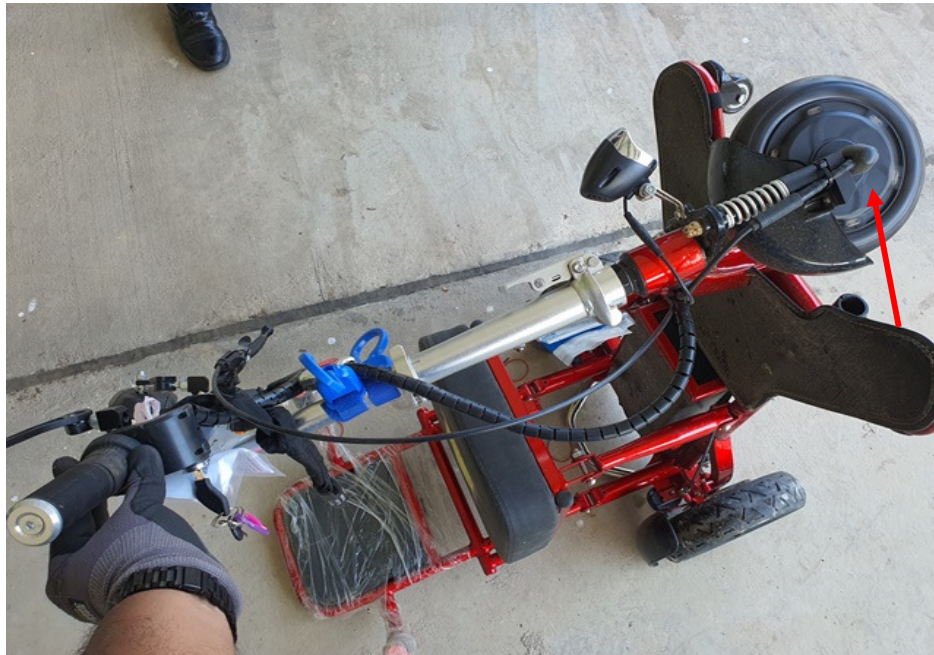
**Photo 13** shows the general view of the brushless motor of the PMA which was observed to be in operational condition (arrowed).

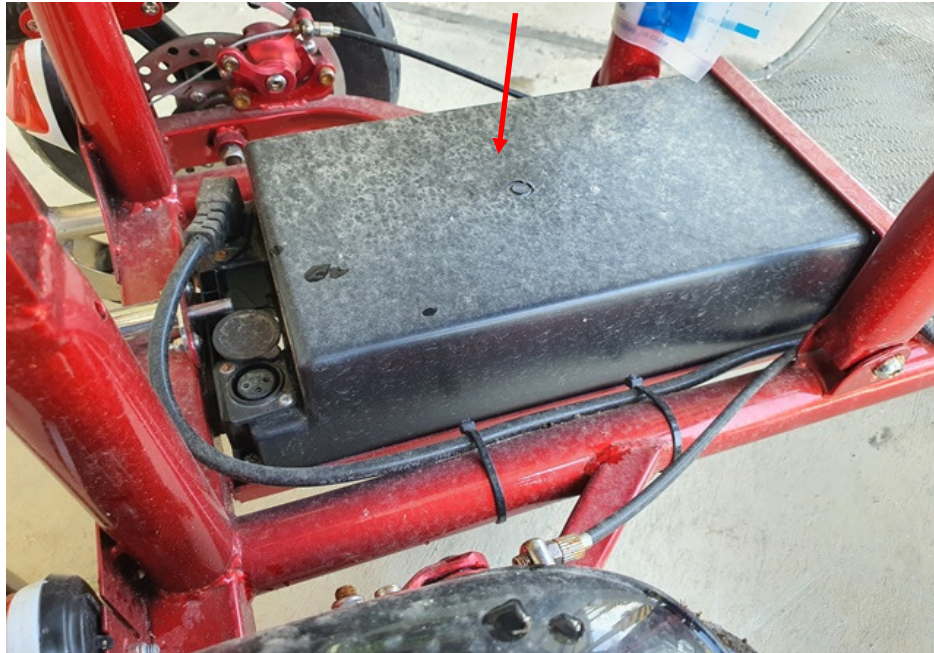
**Photo 14** shows the wireless battery pack of the PMA (arrowed) which was found to be intact without any misalignment.

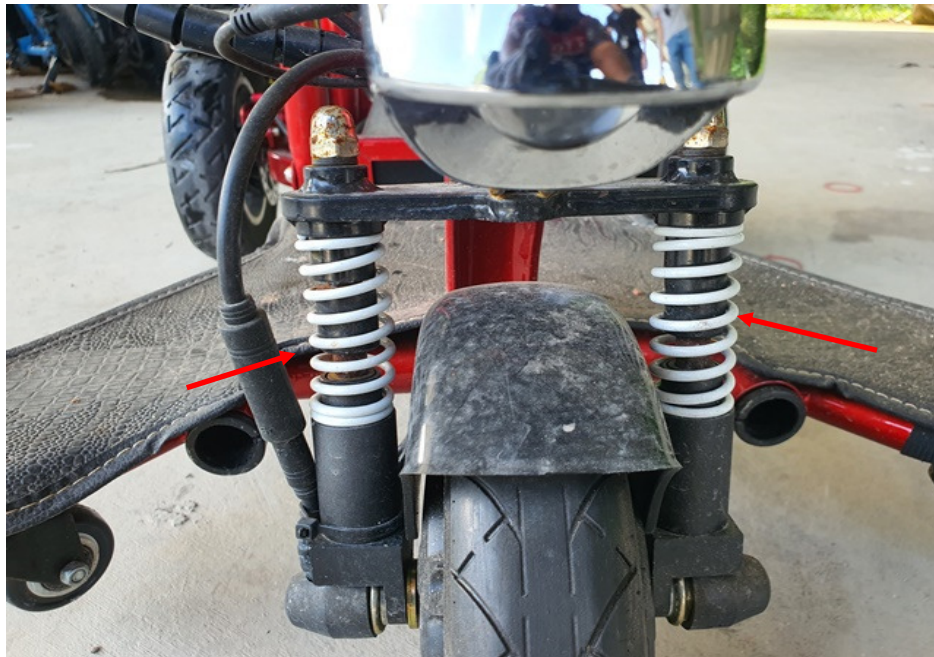
**Photo 15** shows the steering handlebar (arrowed) of the PMA. The steering handlebar of the PMA was found to be intact and undamaged. Turning the PMA's steering handlebar towards the left and right did not produce any abnormal free play. The steering system of the PMA was in serviceable condition at the time of our inspection.

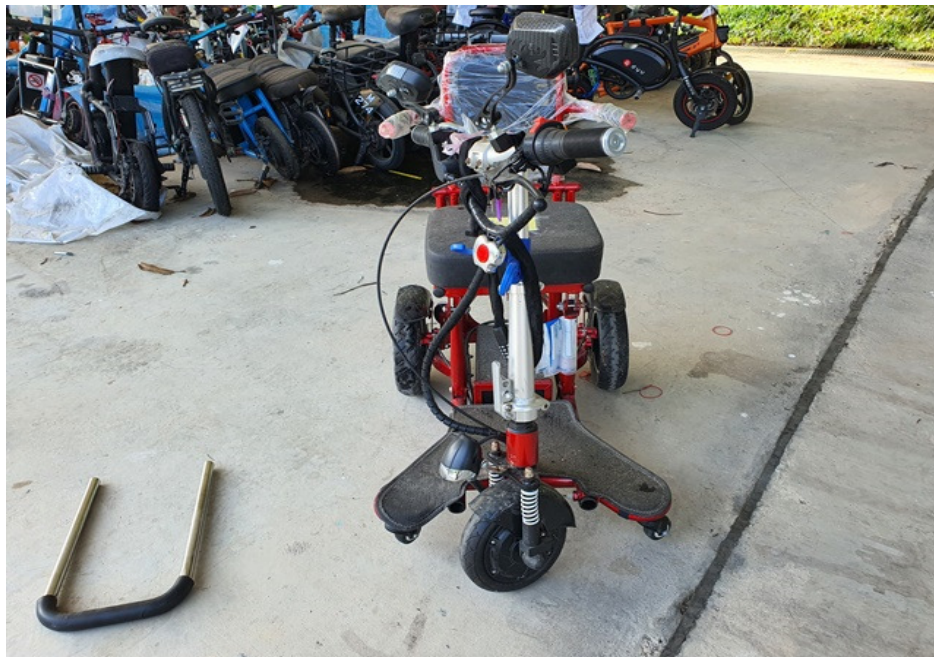
**Photo 16** shows the front wheel of the PMA turned towards its full right. Turning the PMA's steering handlebar towards the right did not produce any abnormal free play and/or resistance. This would indicate that the steering system of the PMA was in serviceable condition at the time of our inspection.

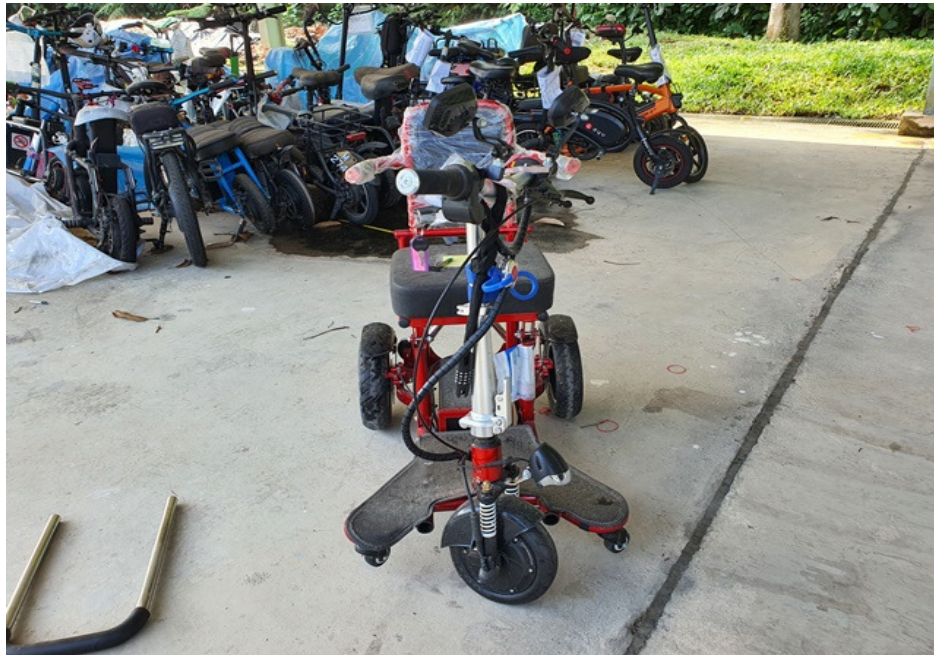
**Photo 17** shows the front wheel of the PMA turned towards its full left. Turning the PMA's steering handlebar towards the left did not produce any abnormal free play and/or resistance. This would indicate that the steering system of the PMA was in serviceable condition at the time of our inspection.

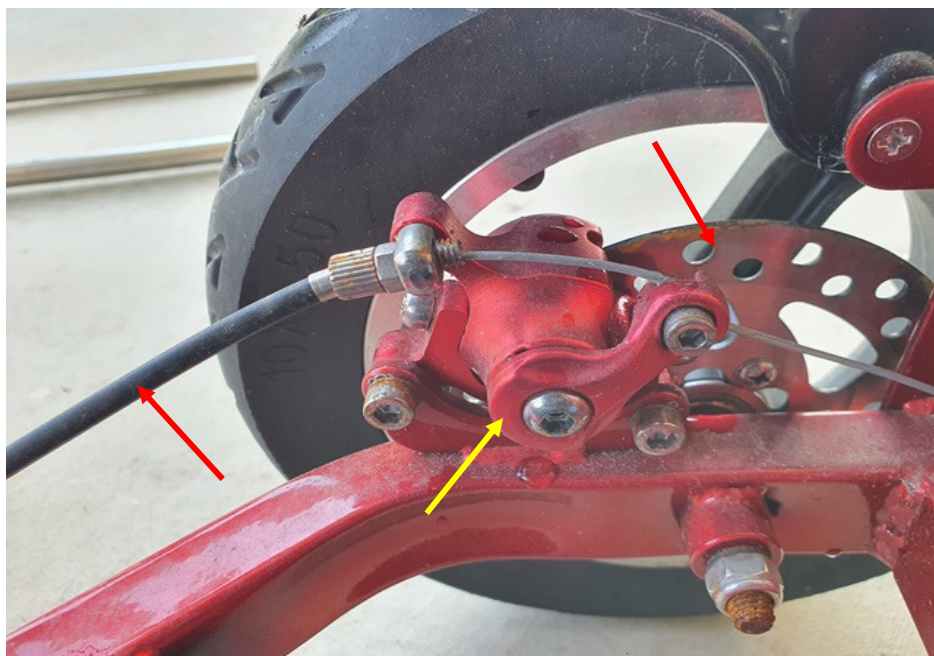
**Photo 18** shows the rear right wheel of the PMA. The type of brake system for the rear right wheel was of a mechanical type, controlled by the left hand lever of the PMA. Our checks on the cable, calliper and right rear brake disc which are all part of the components in the right rear brake system of the PMA reveal all to be intact and without damage (arrowed).

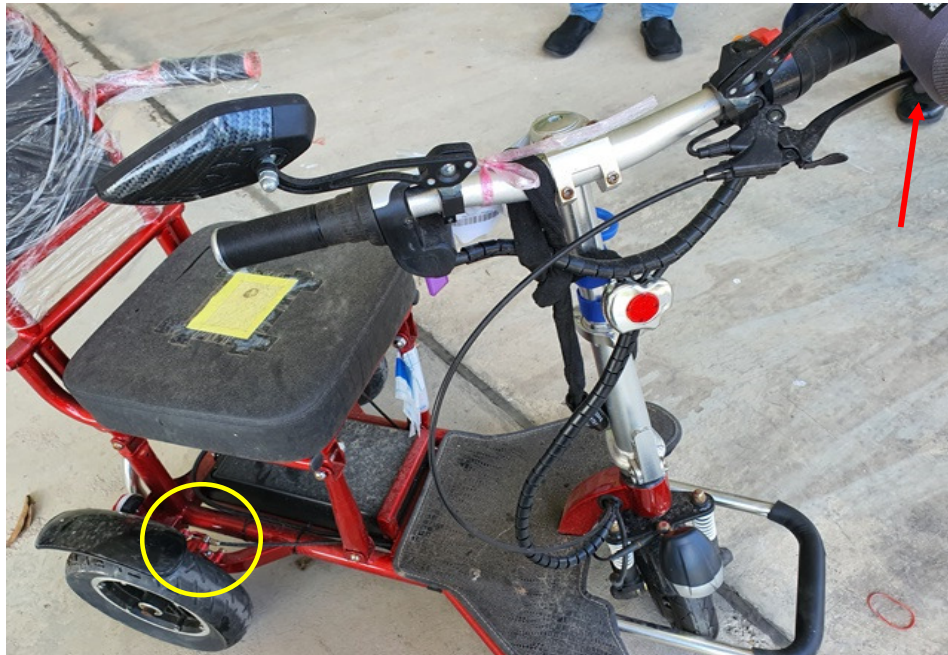
**Photo 19** shows a static brake test conducted on the PAB's rear right brake. There was some resistance felt upon pressing the left hand brake lever (arrowed). It also shows that the rear brake pads responded to the gripping action (circled) after depressing the left hand brake lever.

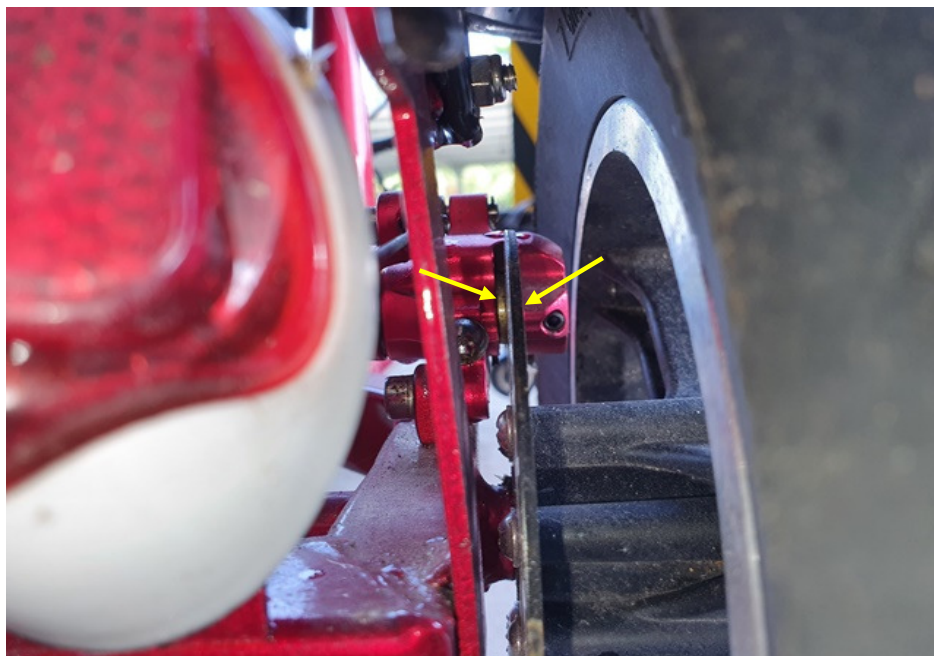
**Photo 20** shows a close up view of the right rear brake pads responding to the gripping action. The rear right brake pads pressed against the right rear brake disc (arrowed) upon depressing the left hand brake lever. This had appeared to indicate that the right rear brake of the PMA was in serviceable condition.

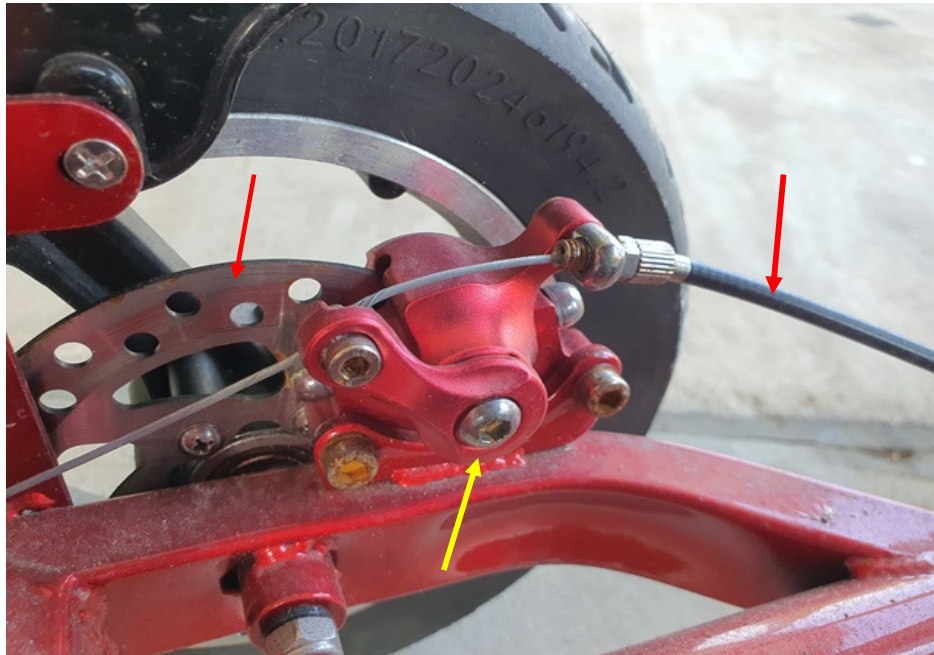
**Photo 21** shows the left rear wheel of the PMA. The type of brake system for the rear right wheel was of a mechanical type, controlled by the left hand lever of the PMA. Our checks on the cable, calliper and left rear brake disc which are all part of the components in the left rear brake system of the PMA reveal all to be intact and without damage (arrowed).

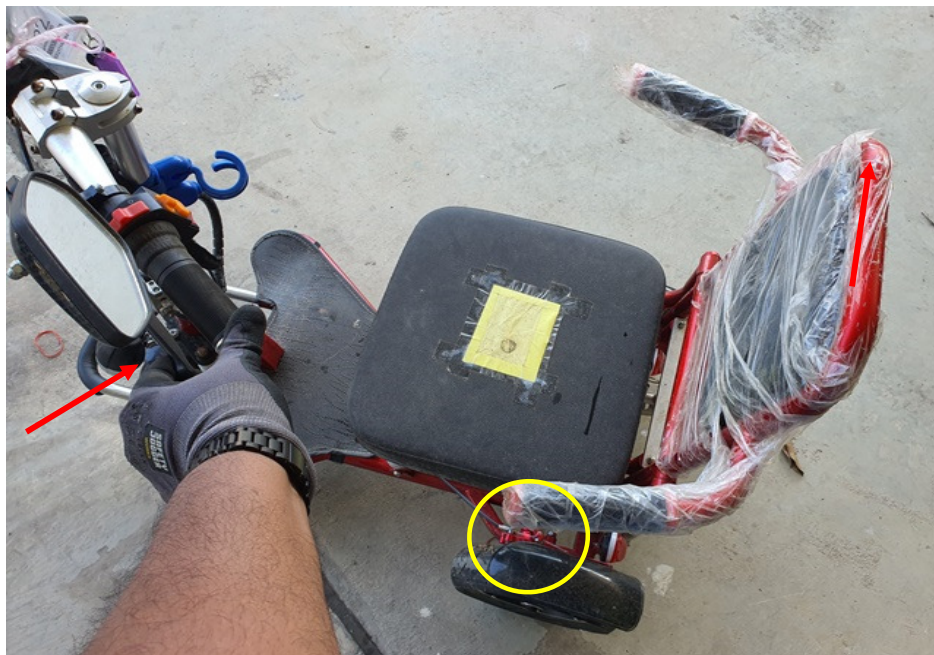
**Photo 22** shows a static brake test conducted on the PAB's left rear brake. There was some resistance felt upon pressing the left hand brake lever (arrowed). It also shows that the rear left brake pads responded to the gripping action (circled) after depressing the left hand brake lever.

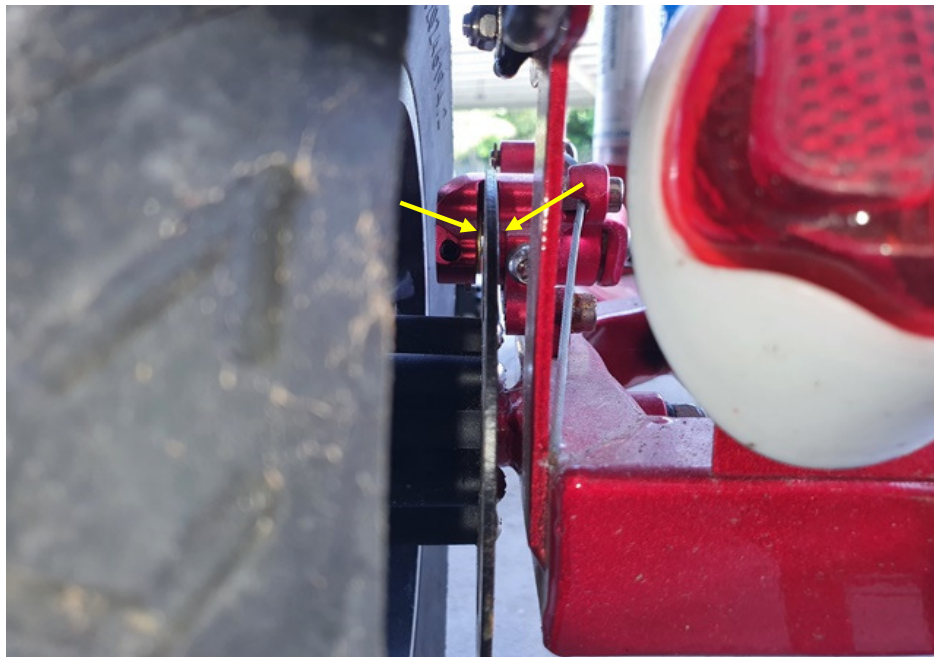
**Photo 23** shows a close up view of the left rear brake pads responding to the gripping action. The left rear brake pads pressed against the left rear brake disc (arrowed) upon depressing the left hand brake lever. This had appeared to indicate that the left rear brake of the PMA was in serviceable condition.
