Your Ref: TP/IP/29690/2022
Our Ref : CI/TPD23001713/N

17 February 2023

INSPECTION REPORT OF MOTORCYCLE FBM 221L

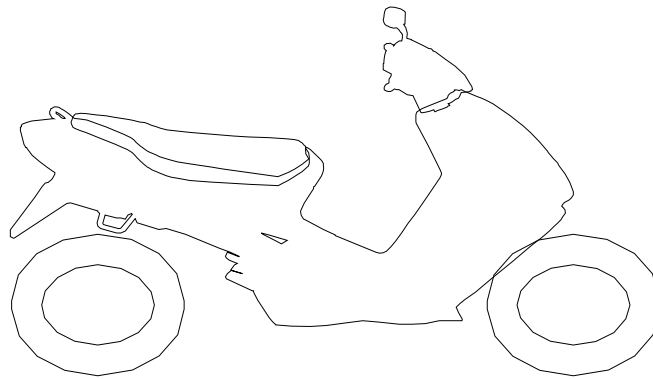
Metzeler 130/70 - 17 (3mm)

Metzeler 100/80 - 17 (2mm)
(Deflated)

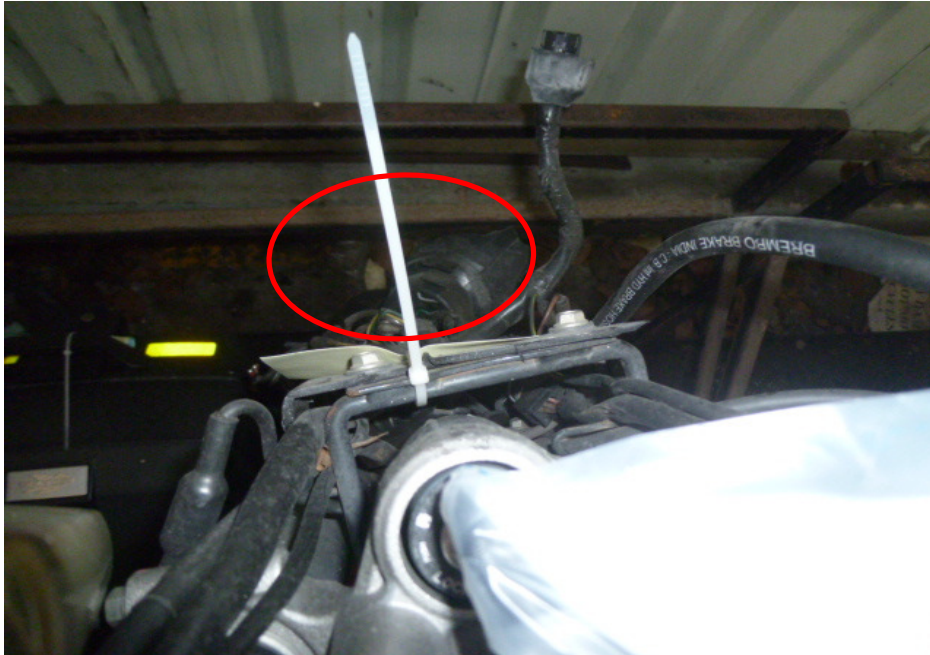
Photo 1 shows the mileage of the Motorcycle could not be recorded at the time of our inspection due to a missing speedometer gauge (circled).

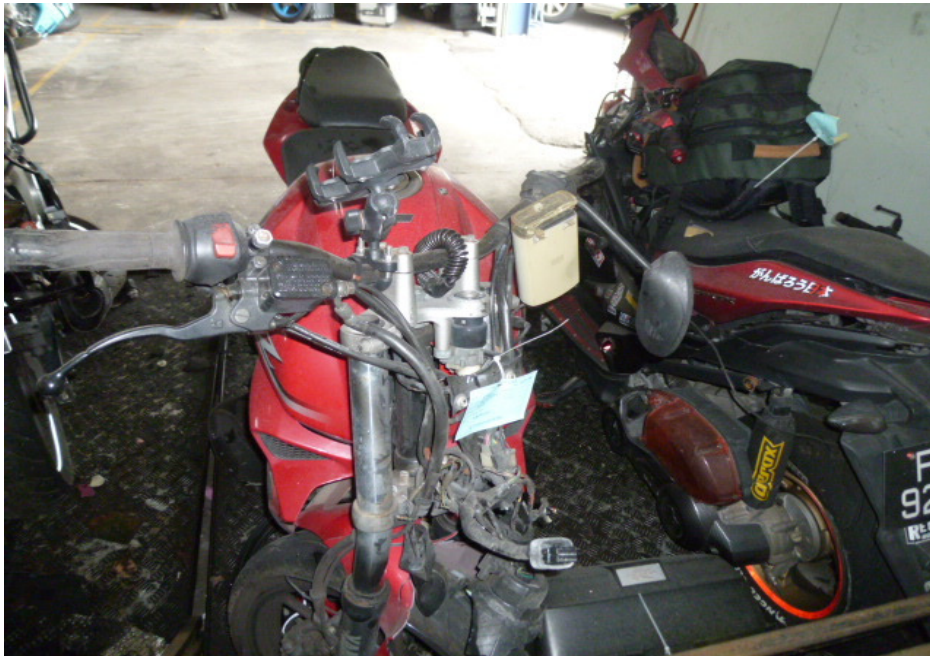
Photo 2 shows a general view of the frontal portion of the Motorcycle at the time of our inspection. The Motorcycle was observed to have sustained damages all around.

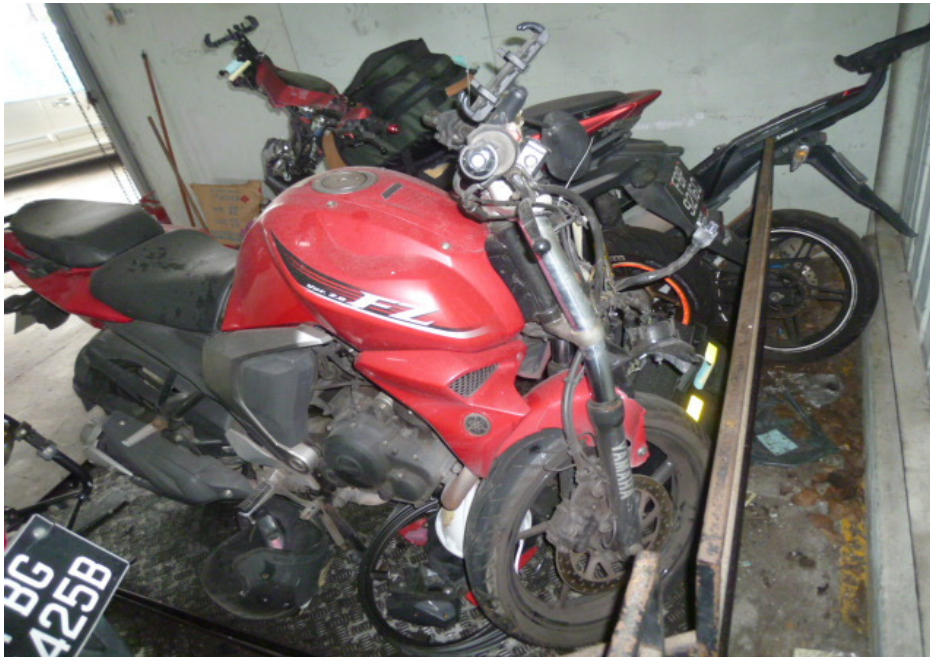
Photo 3 shows a general view of the right frontal portion of the Motorcycle at the time of our inspection. The Motorcycle was observed to have sustained damages all around. The body parts that were found to have been damaged include it headlight, front mudguard, front brake lever, clutch lever, side mirrors, rear brake pedal, right front footrest, top box rack and exhaust muffler heat shield, amongst others.

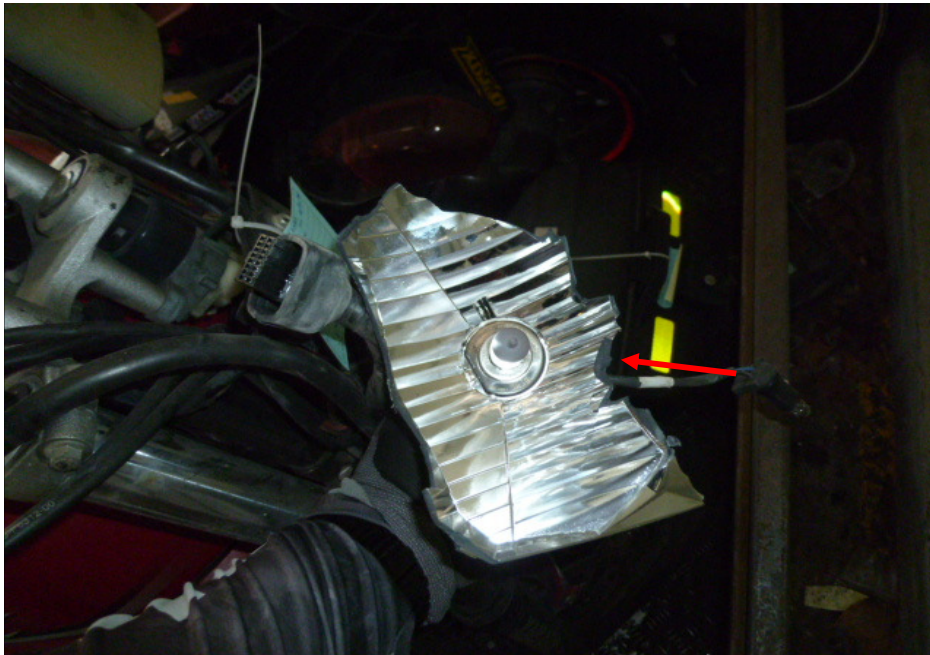
Photo 4 shows a closer view of the cracked headlight (arrowed) of the Motorcycle as a result of the accident.

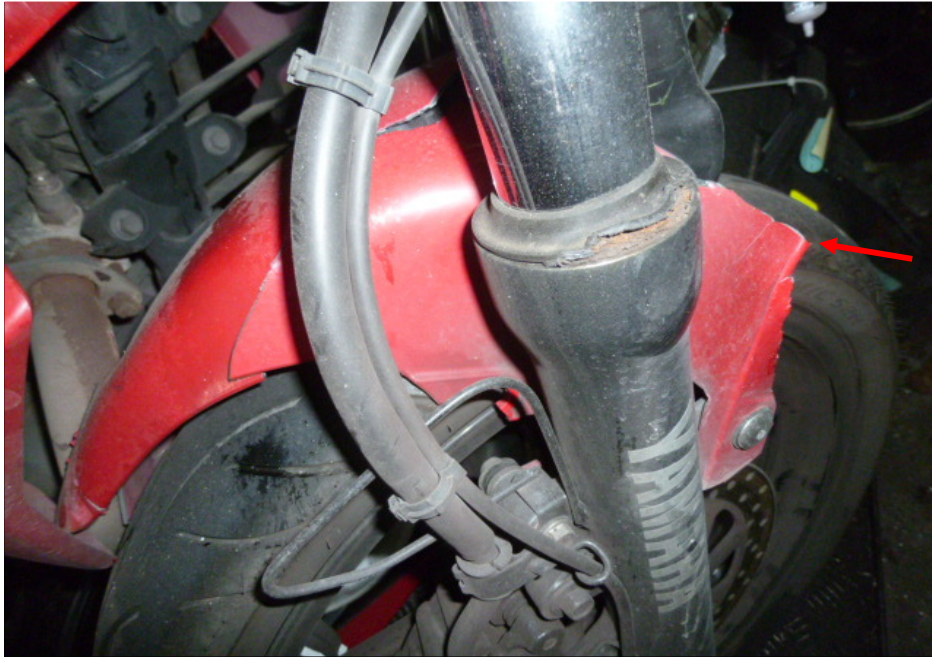
Photo 5 shows a closer view of the cracked front mudguard of the Motorcycle as

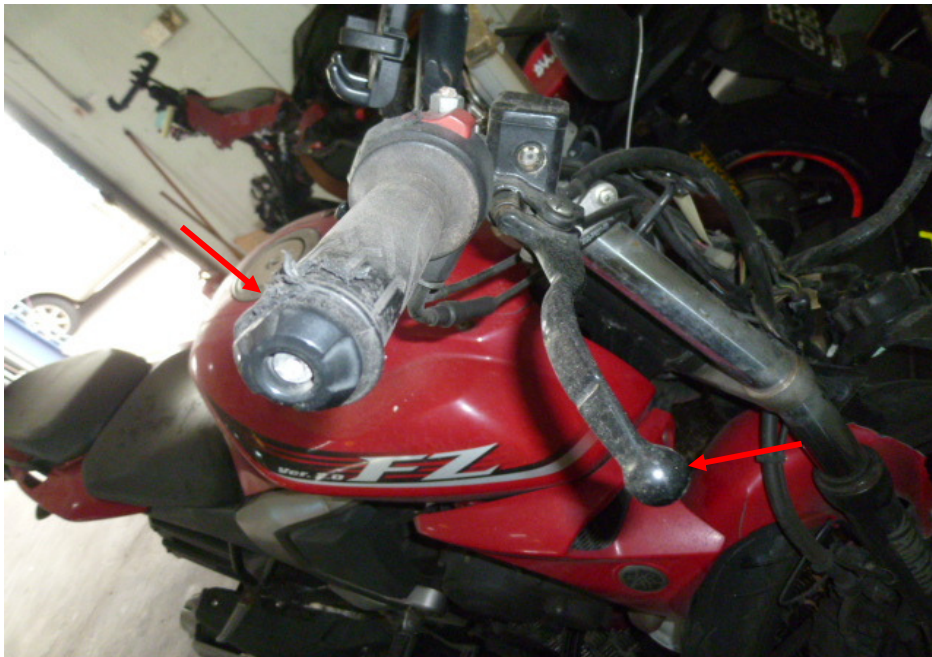
Photo 6 shows the front brake lever and right handlebar end (arrowed), which were amongst the body parts of the Motorcycle that had sustained damage as a result of the accident.

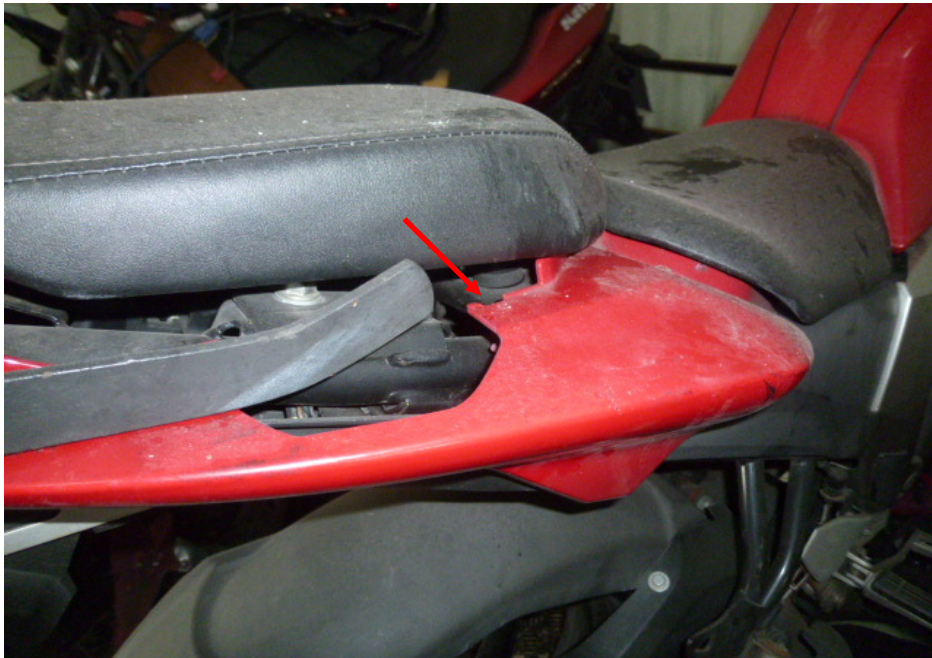
Photo 7 shows a closer view of the dislodged right rear side cover (arrowed) of the Motorcycle as a result of the accident.

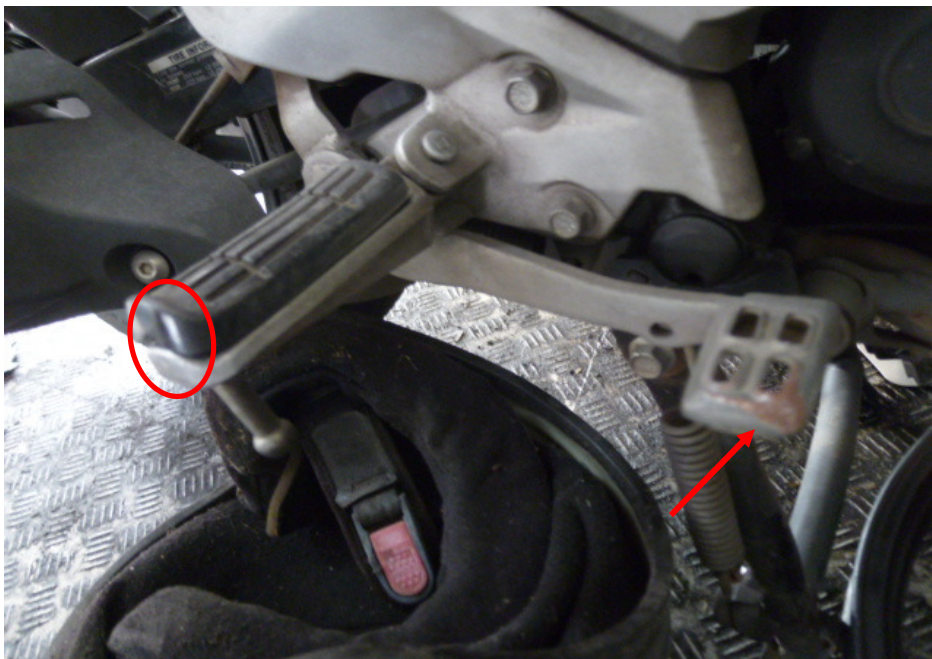
Photo 8 shows a closer view of the grazed rear brake pedal (arrowed) and right front footrest (circled) of the Motorcycle as a result of the accident.

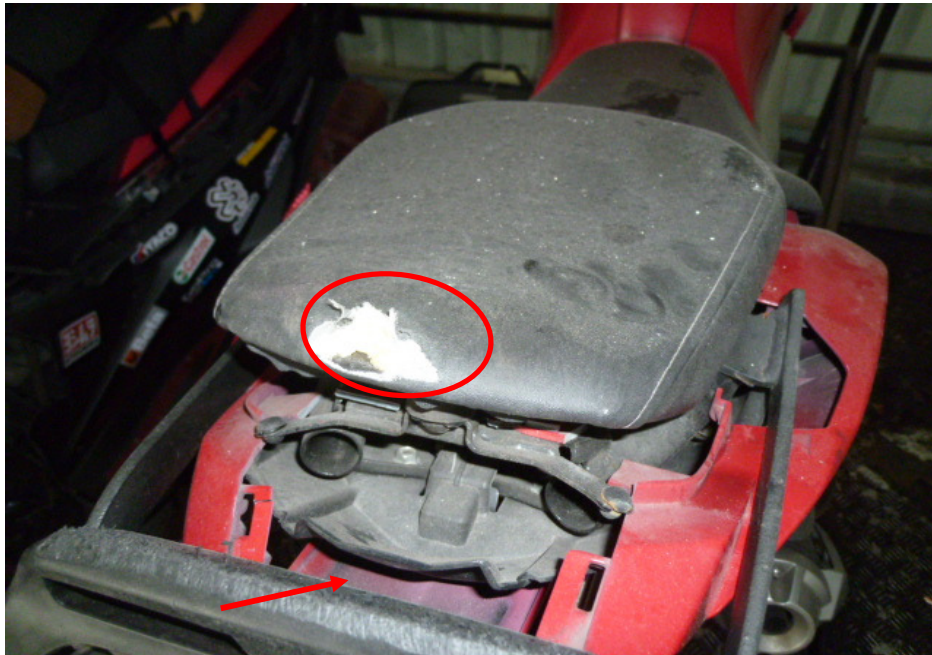
Photo 9 shows a closer view of the torn pillion seat circled) and missing tail light cover (arrowed) of the Motorcycle as a result of the accident.

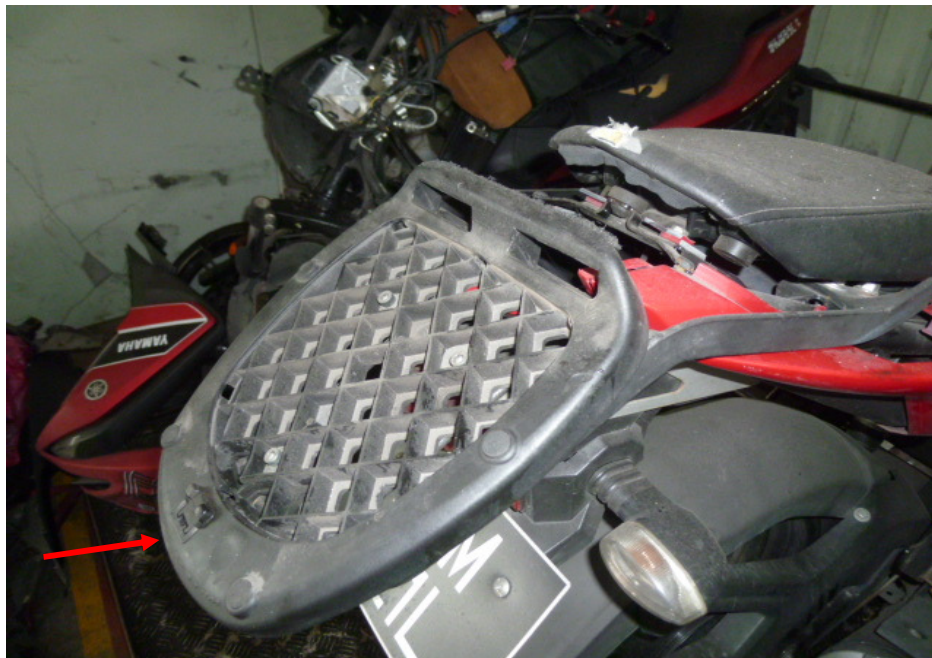
Photo 10 shows the deformed top box rack (arrowed) of the Motorcycle as a result of the accident.

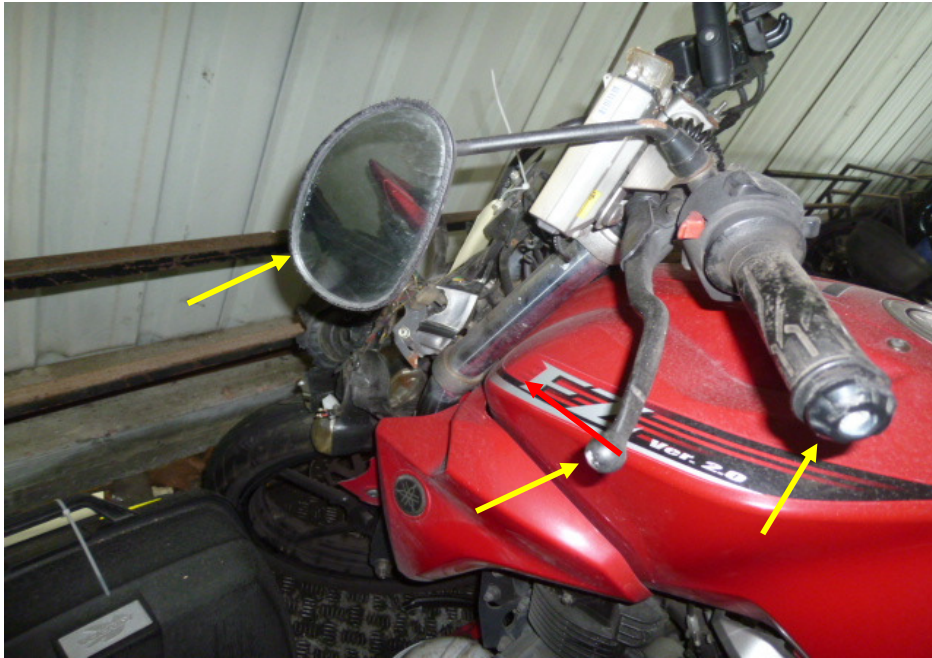
Photo 11 shows the left side mirror, clutch lever and left handlebar end (arrowed) of the Motorcycle that had sustained damage as a result of the accident.

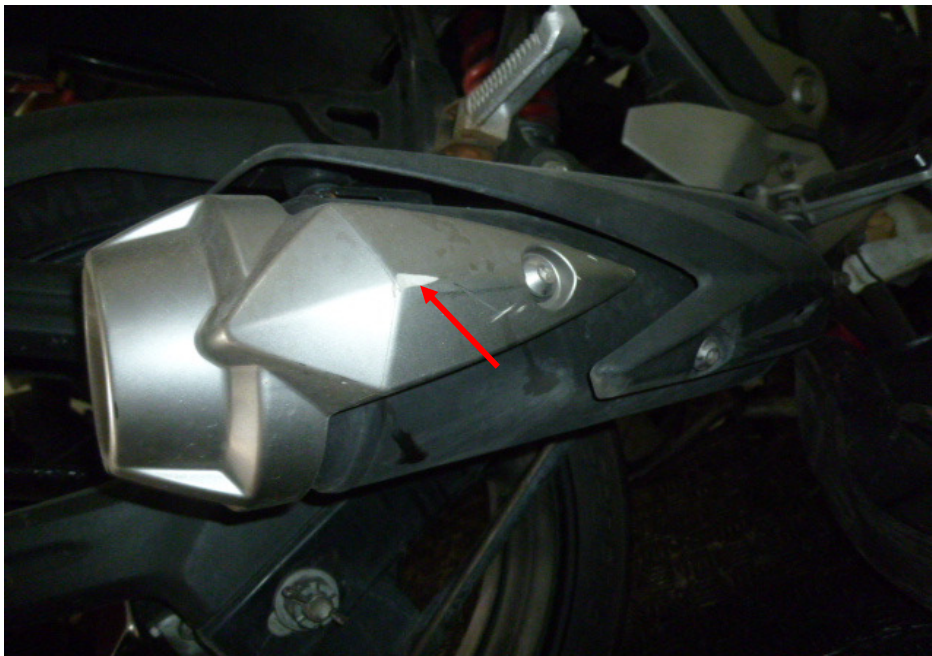
Photo 12 shows a closer view of the exhaust muffler heat shield which was amongst the body parts of the Motorcycle that had sustained damages of grazing nature as a result of the accident (arrowed).

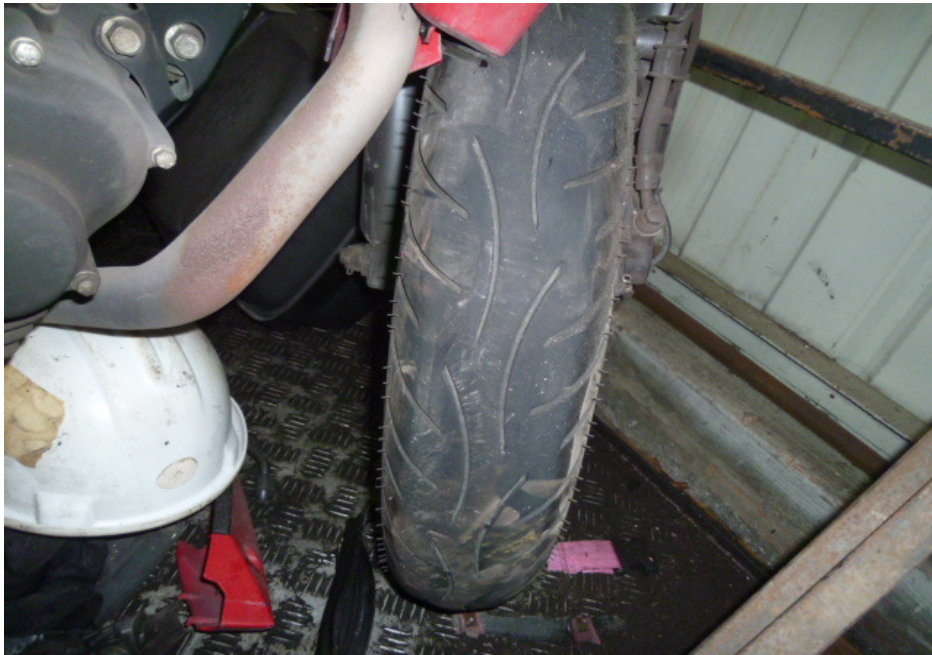
Photo 13 shows the condition of the Motorcycle's front tyre. The front tyre was observed to be in serviceable condition with remaining tread depth of approximately 3mm. There was no tear, burst mark(s) and/or punctured hole(s) on the sidewalls as well as across the tread of the front tyre. However the front tyre was observed to be deflated..

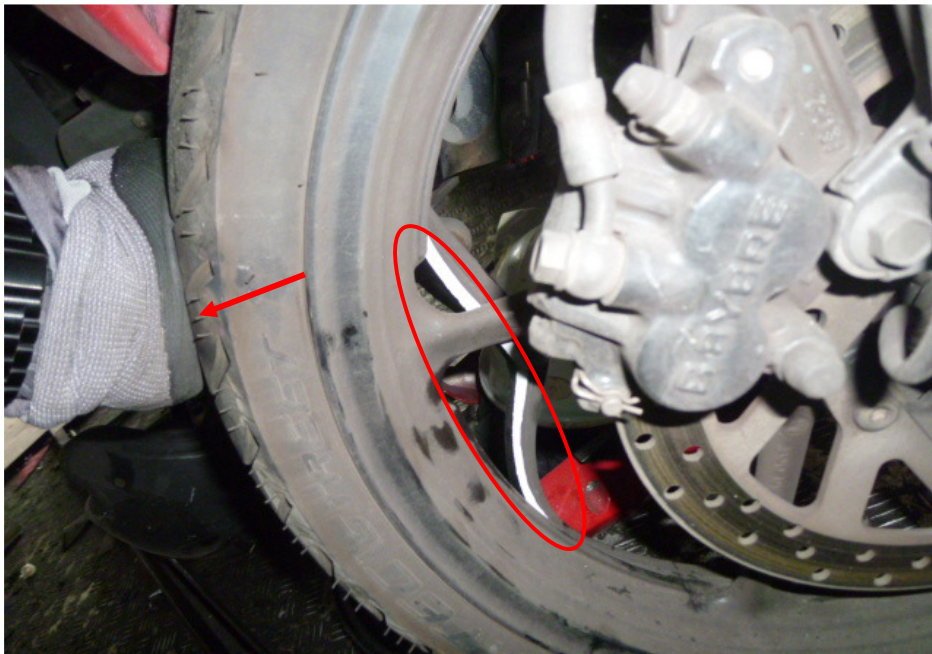
Photo 14 shows the broken front wheel rim (circled) and deflated front tyre (arrowed) of the Motorcycle at the time of our inspection.

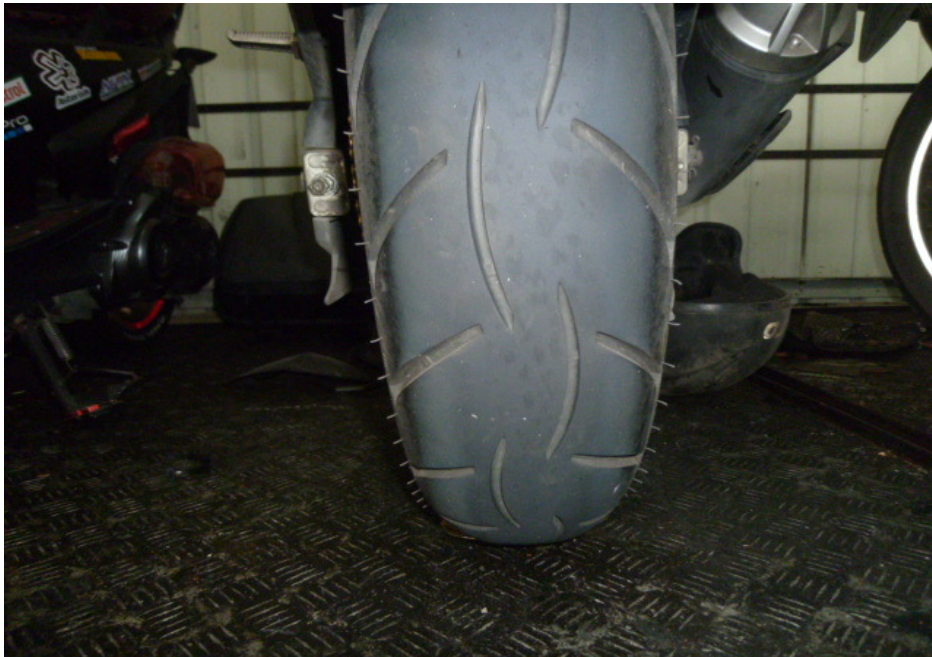
Photo 15 shows the condition of the Motorcycle's rear tyre. The rear tyre was observed to be in serviceable condition with remaining tread depth of approximately 3mm. The tyre was also observed to be sufficiently inflated for vehicular operation. We did not observe any tear, burst mark(s) and/or punctured hole(s) on the sidewalls as well as across the tread of the rear tyre.

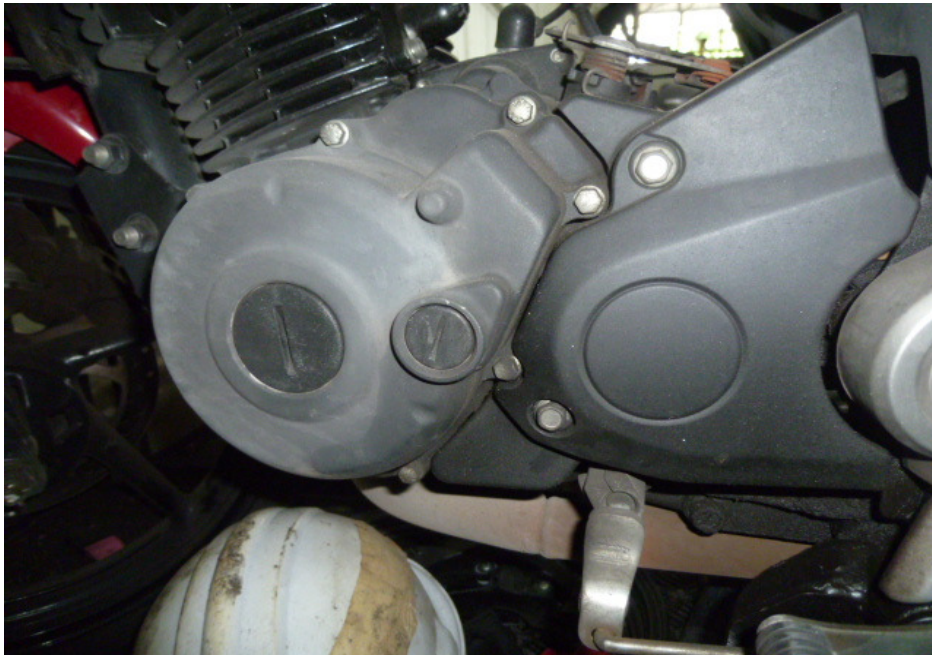
Photo 16 shows the left side of the engine of the Motorcycle at the time of our inspection. The various engine related parts and components were found to be intact with no visible damage. There was also no sign(s) or indication(s) of fluid leak observed around the left engine area of the Motorcycle.

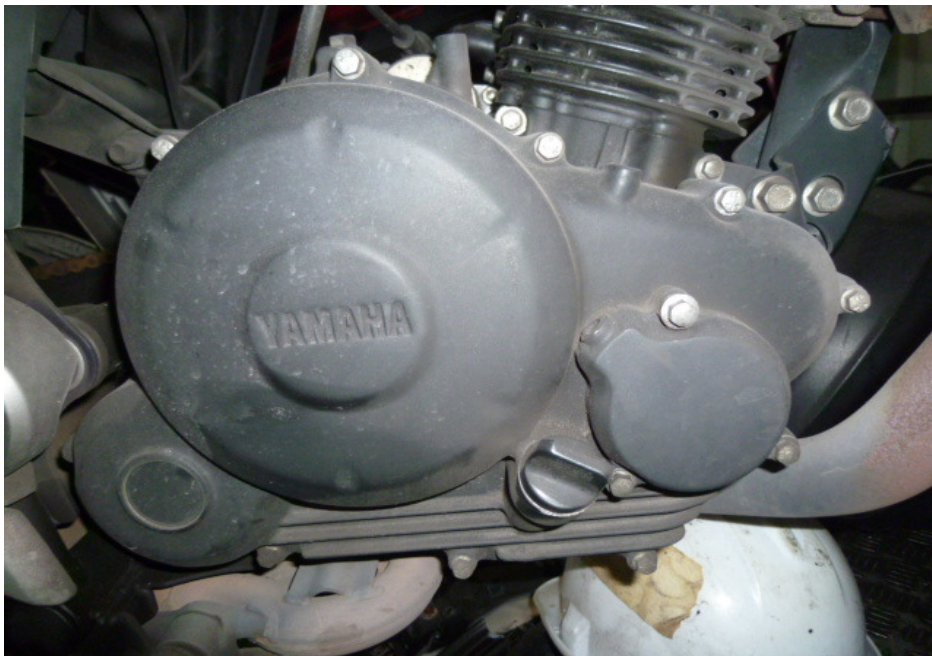
Photo 17 shows the right side of the engine of the Motorcycle at the time of our inspection. The various engine related parts and components were found to be intact with no visible damage. There was also no sign(s) or indication(s) of fluid leak observed around the right engine area of the Motorcycle.

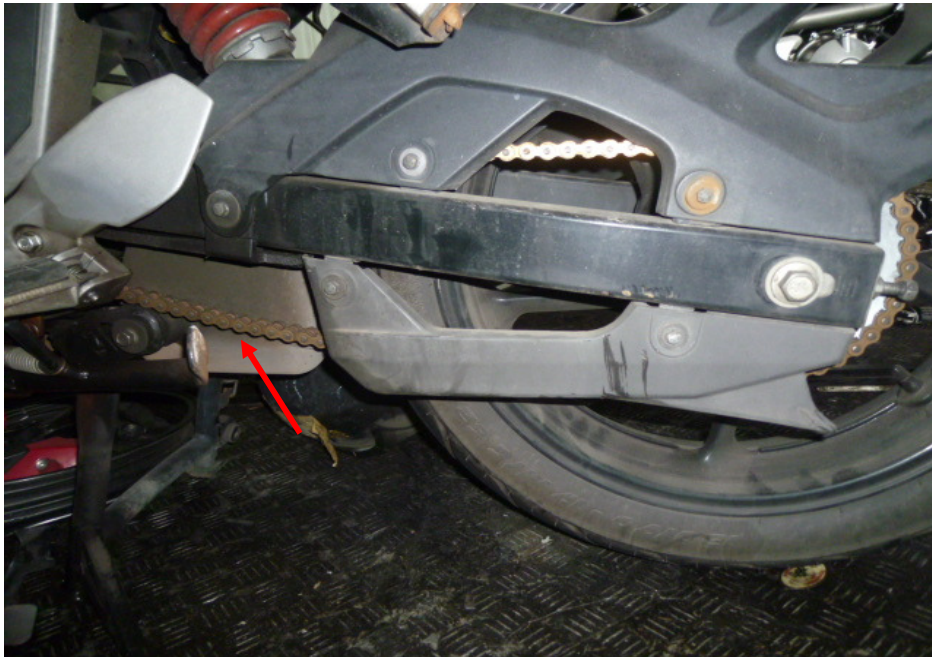
Photo 18 shows the general view of the gear train (arrowed) of the Motorcycle, which was observed to be intact with no misalignment. It was also adequately lubricated for operating purposes.

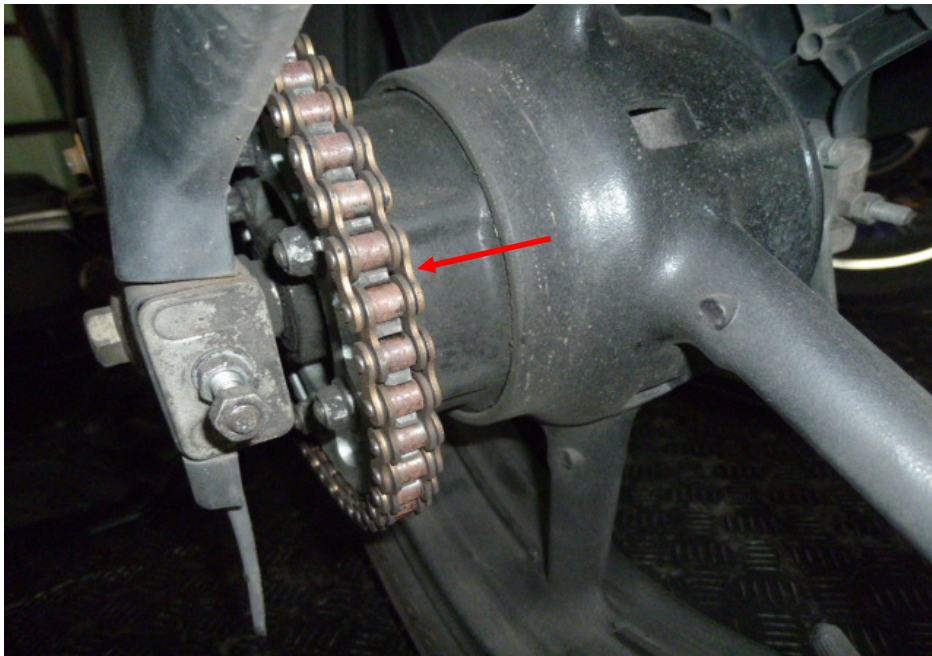
Photo 19 shows a closer view of the gear train (arrowed) of the Motorcycle, which was observed to be intact with no misalignment. It was also adequately lubricated for operating purposes.

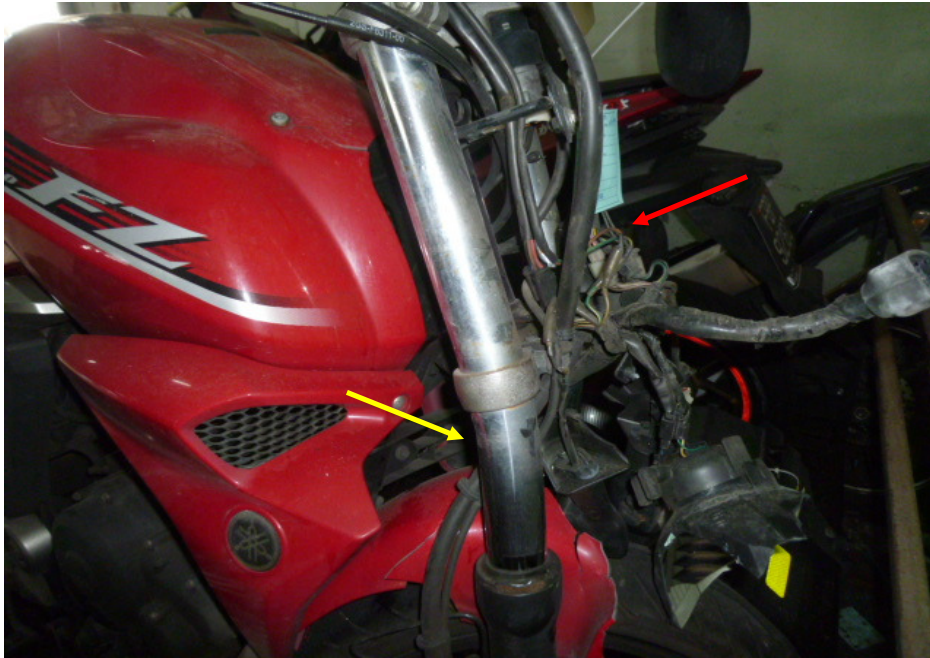
11. For this case, we were not able to conduct any test(s) on the steering system of the Motorcycle due to the damage of its fork assembly. The front forks were found to be bent as a result of the accident.

Photo 20 shows the front forks of the Motorcycle. The front forks were observed to be bent inwards as a result of the accident (arrowed). We were hence not able to conduct any tests on the steering system of the Motorcycle.

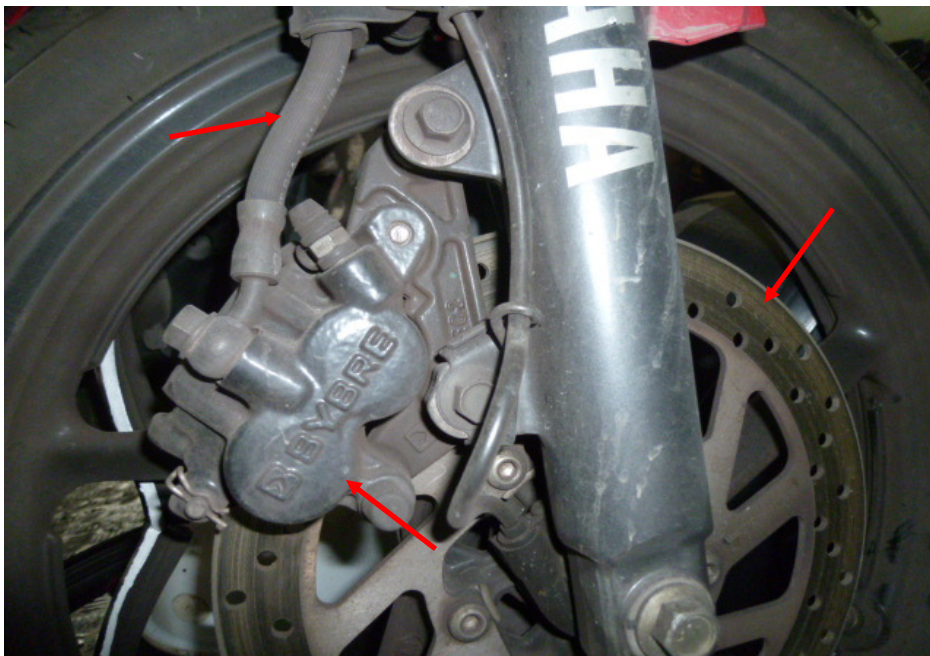
Photo 21 shows a close up view of the front brake caliper, front brake disc and front brake hose (arrowed) of the Motorcycle, which are all part of the components in the hydraulic front brake system of the Motorcycle. Our visual checks of these various components had revealed all to be intact with no visible damage. No leakage of brake fluid was also observed.

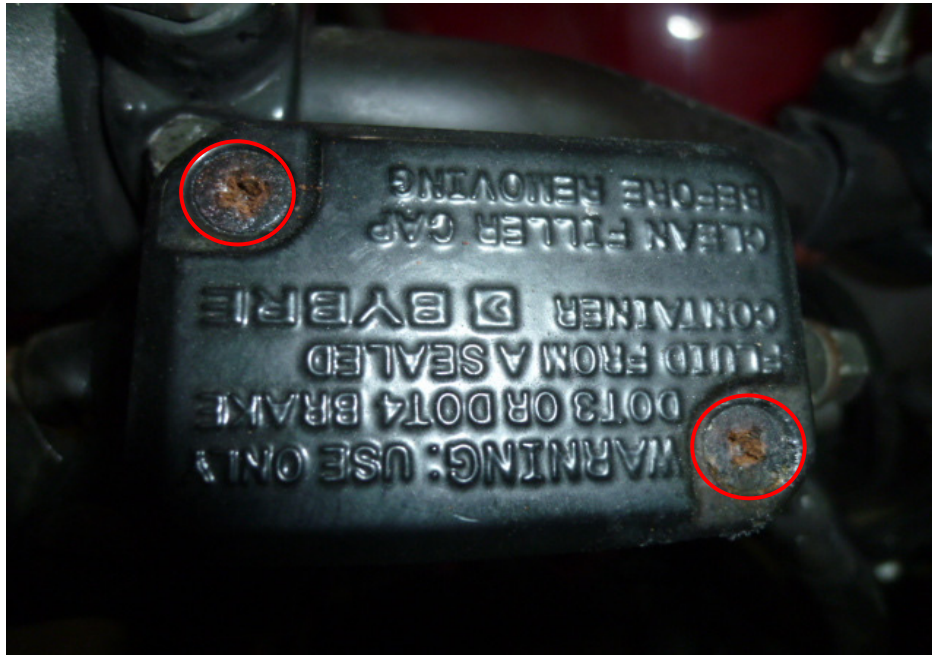
13. We were unable remove the front brake reservoir cover to examine whether the front brake fluid was without contamination due to worn out screws. However the front brake fluid was observed to be of sufficient level for operational purposes. There was also no visible tear or cut observed on the connecting hoses and cables.

Photo 22 shows the brake fluid reservoir cover for the front brake of the Motorcycle. We were unable to examine whether the front brake fluid was without contamination due to worn out screws (circled).

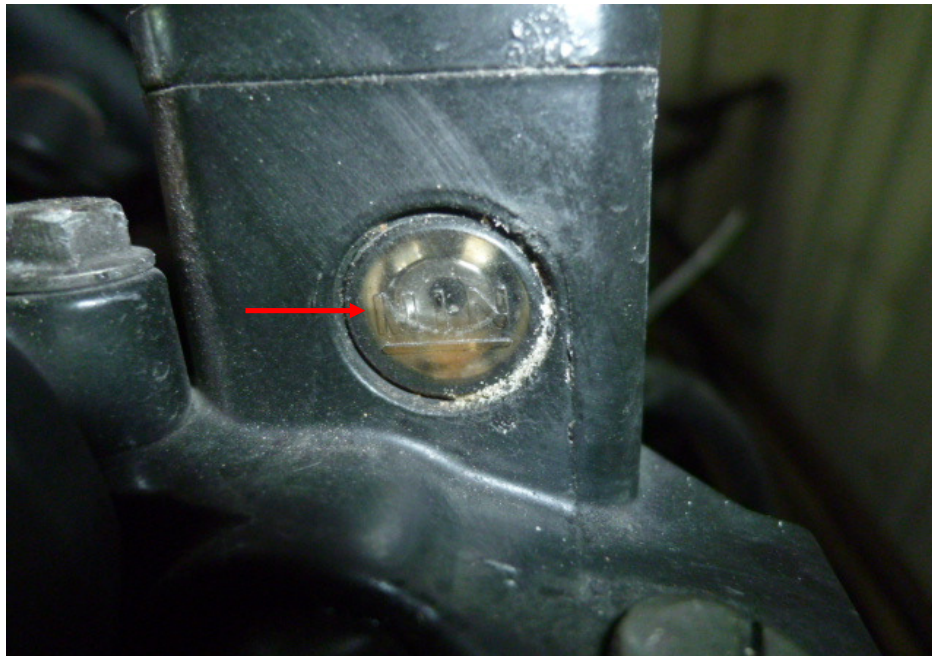
Photo 23 shows a close up view of the brake fluid reservoir for the front brake of the Motorcycle. The brake fluid was observed to be of sufficient level for operational purposes (arrowed).

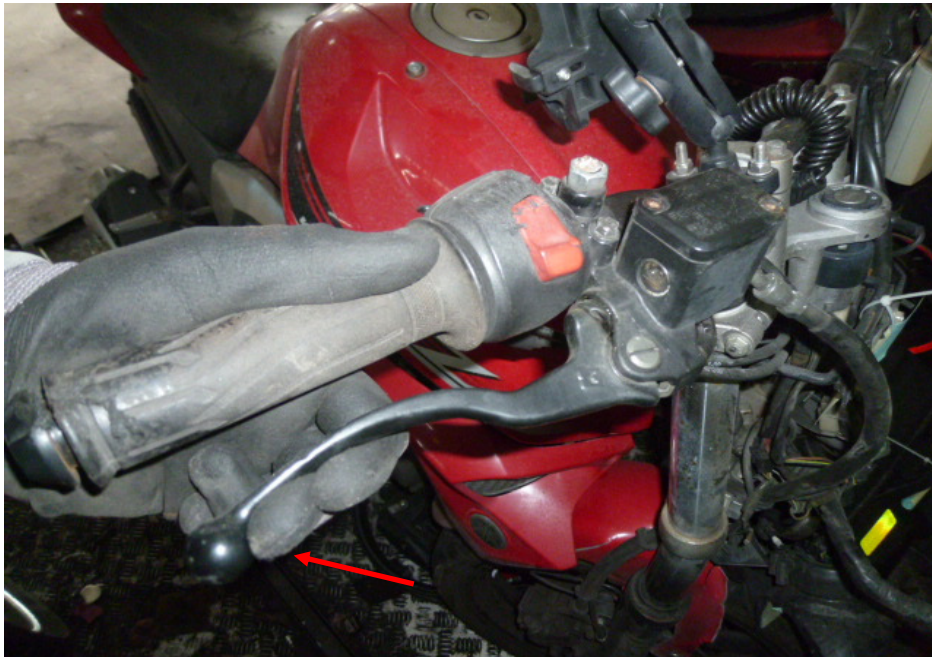
14. Static brake tests conducted on the Motorcycle had appeared to indicate that the front brake system of the Motorcycle was in serviceable condition. There was some resistance felt (spongy like feel) upon pressing the front brake lever. This would indicate that there's no leakage of pressure/vacuum in the front brake system.

Photo 24 shows the front brake lever being depressed. There was some resistance felt (spongy like feel) upon pressing the front brake lever (arrowed). This would indicate that there is no leakage of pressure/vacuum in the brake system.

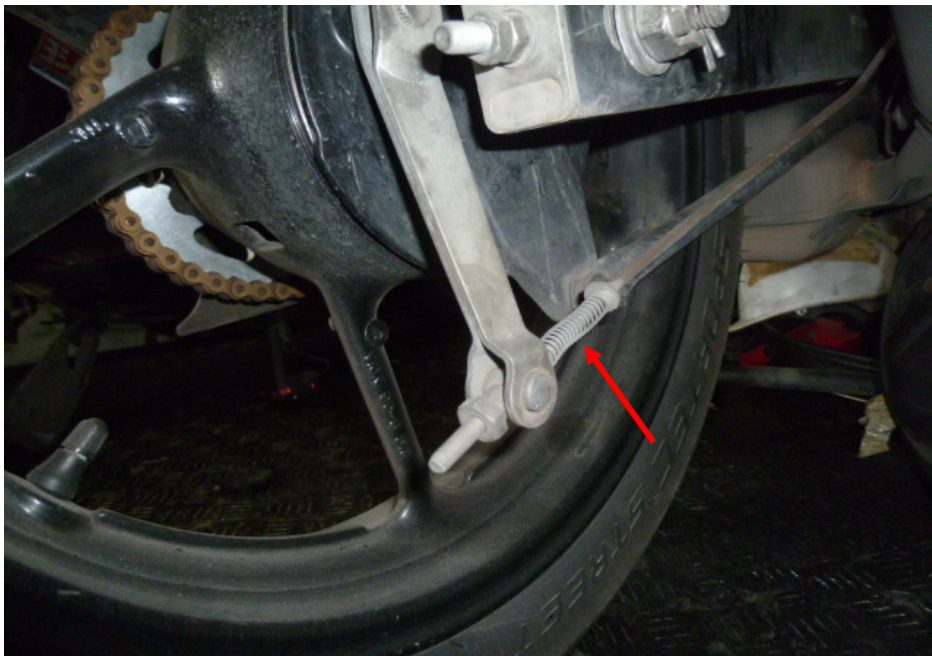
Photo 25 shows the rear wheel of the Motorcycle. The type of brake system for the rear wheel was of a mechanical type, controlled by the brake foot pedal of the Motorcycle. Our checks of the cable (arrowed), spring and drum which are all part of the components in the rear brake system of the Motorcycle reveal all to be intact and without damage.
