Your Ref: TP/IP/32286/2022
Our Ref : CI/TPD23001715/N

17 February 2023

**INSPECTION REPORT OF BICYCLE (BLUE CANYON) - TRAFFIC POLICE
POUND REPORT NO. 4625/22**

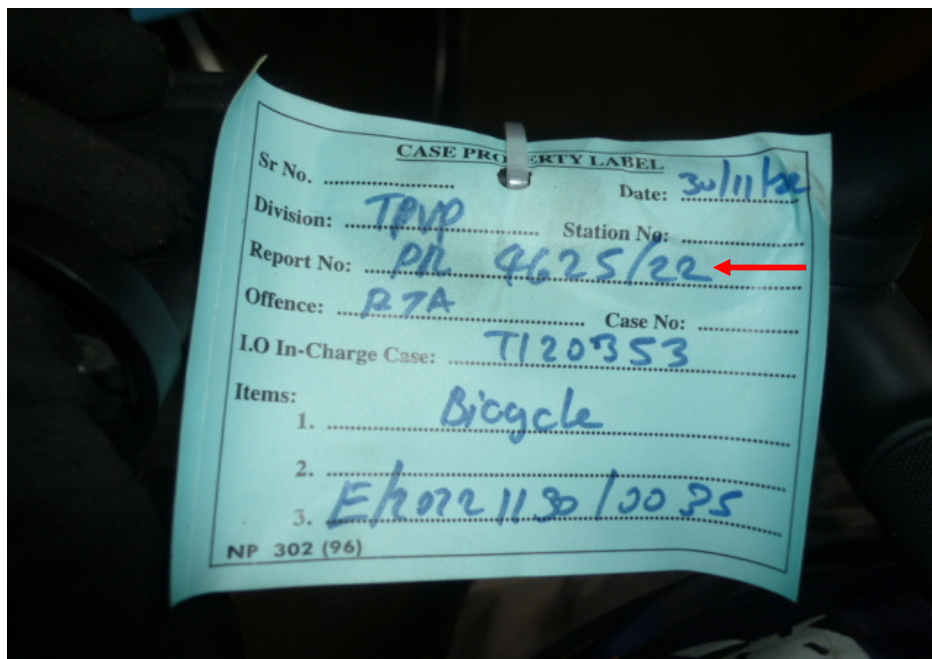
Photo 1 shows the identification of the Bicycle with reference to Traffic Police Pound Report No. 4625/22 (arrowed).

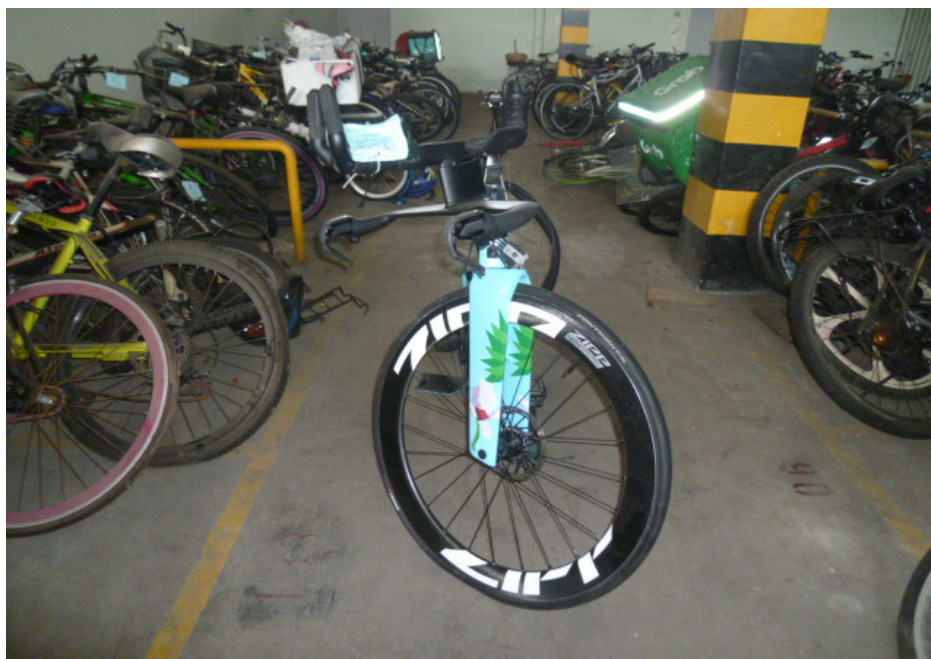
Photo 2 shows the right body of the Bicycle at time of our inspection. The Bicycle had sustained damages all around.

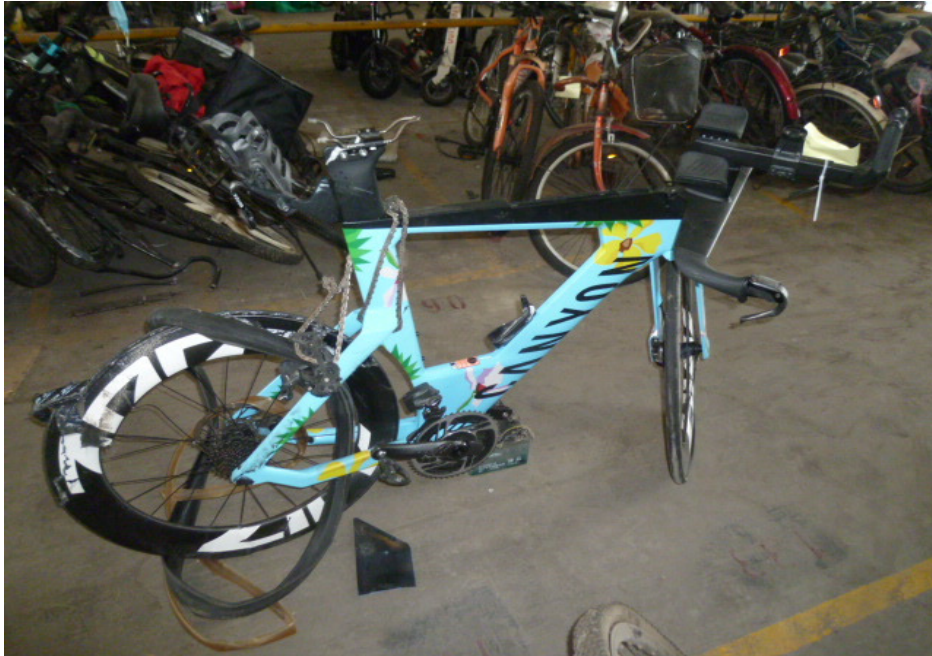
Photo 3 shows the right body of the Bicycle at time of our inspection. The Bicycle had sustained damages all around. The body parts that were found to have been damaged include its front basket, rear sub frame, pedals, braking components, gear train and rack, amongst others as a result of the accident.

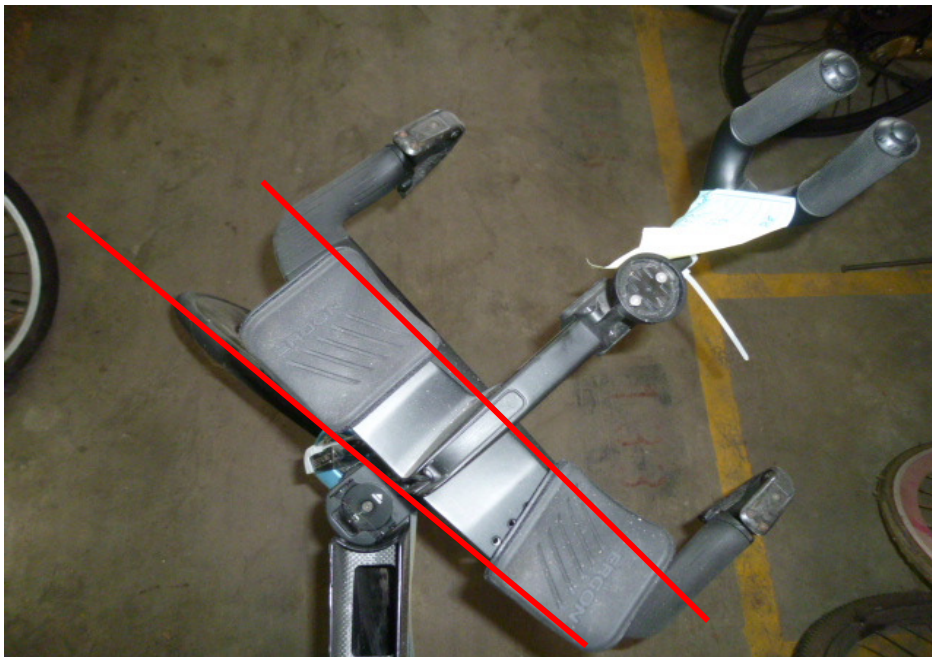
Photo 4 shows the frontal portion of the Bicycle (top view) at the time of our inspection. A misalignment of the handle bar & front tyre was observed.

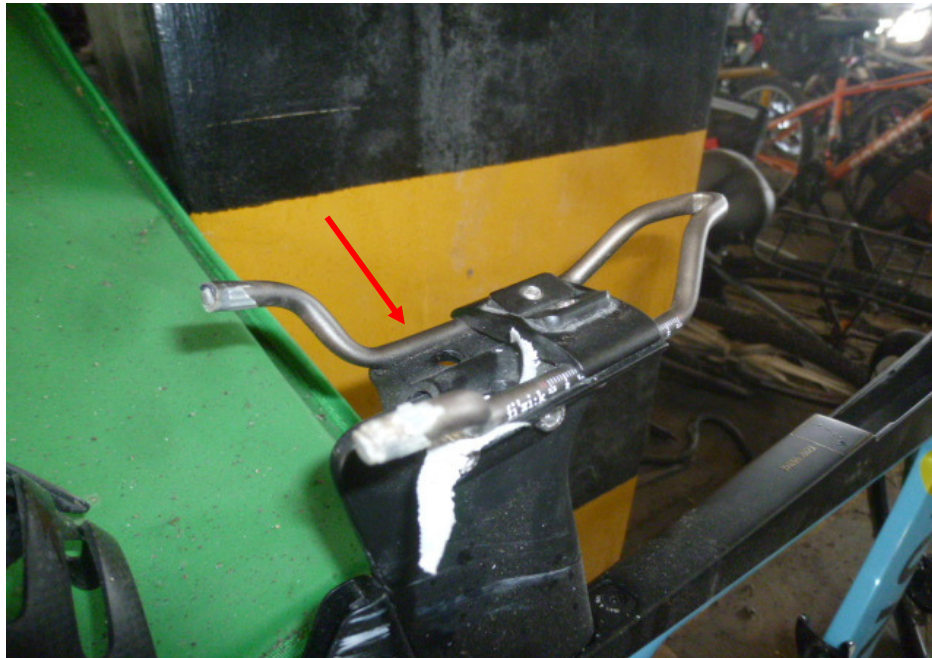
Photo 5 shows the dislodged seat of the Bicycle at the time of our inspection (arrowed).

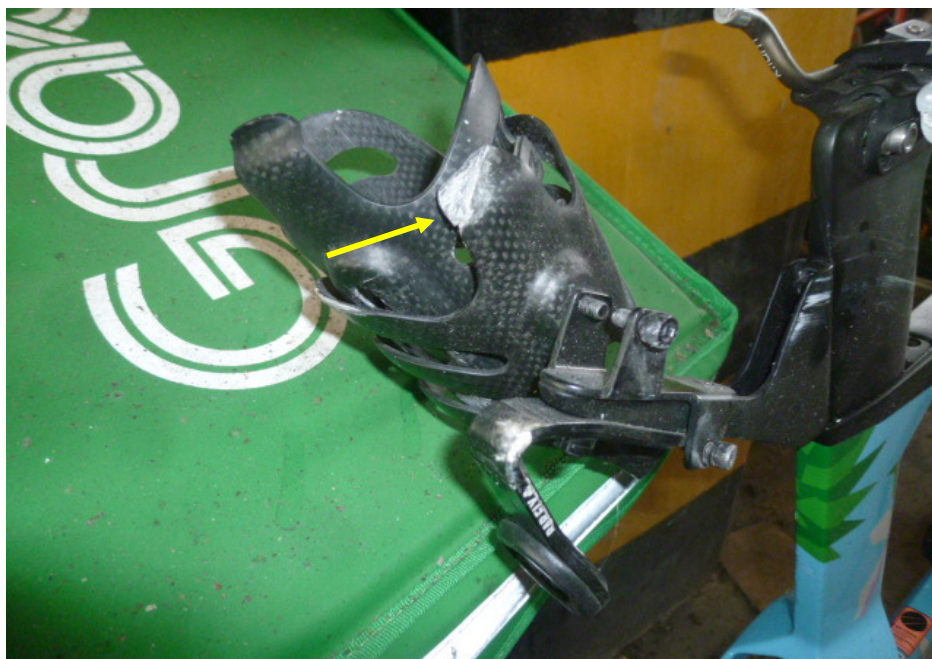
Photo 6 shows a close-up view of the deformed water bottle holder of the Bicycle as a result of the accident (arrowed).

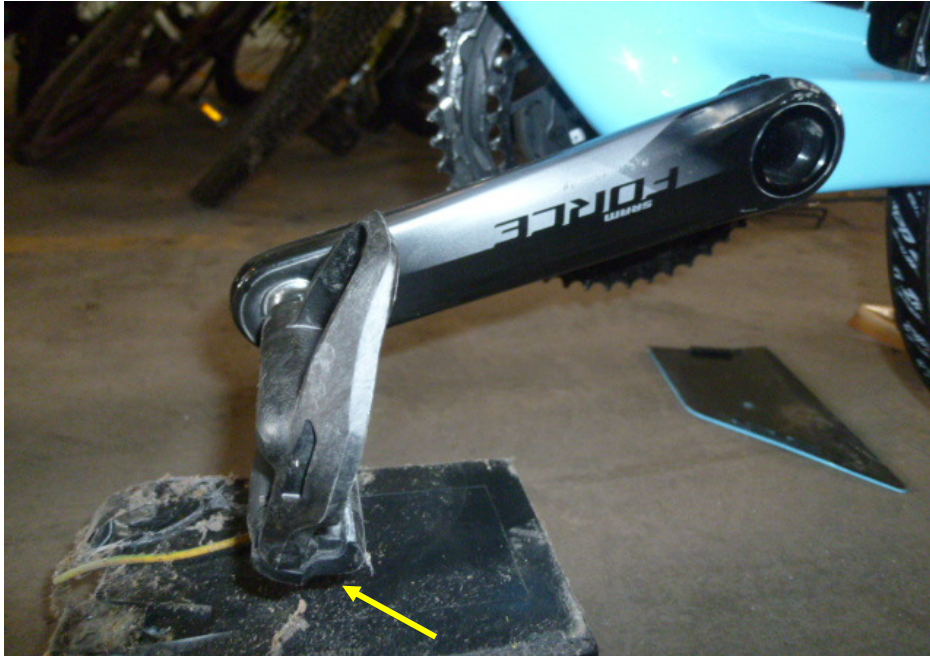
Photo 7 shows the grazed left pedal of the Bicycle as a result of the accident (arrowed).

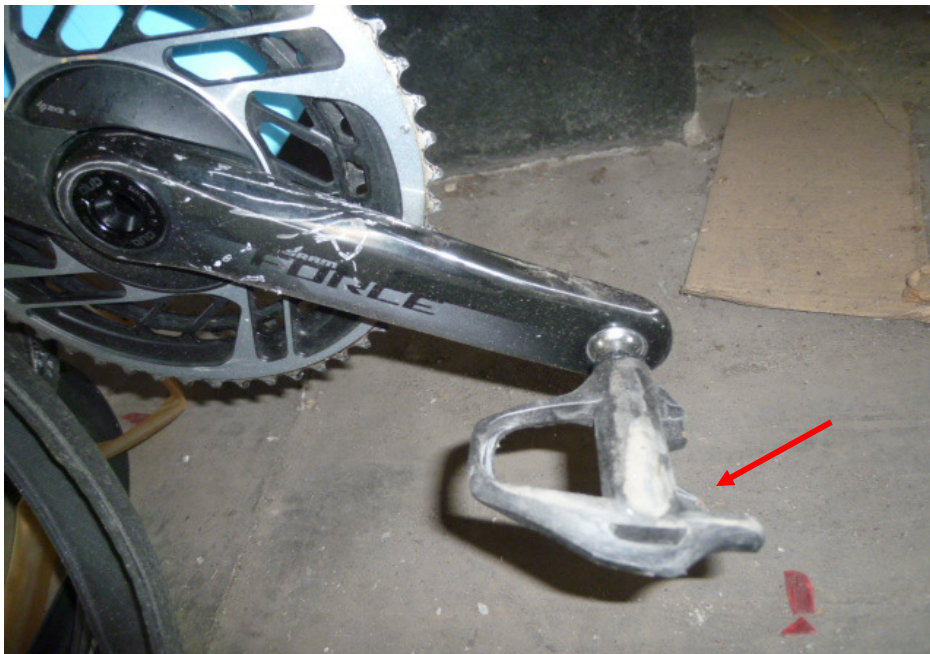
Photo 8 shows a close-up view of the broken right pedal of the Bicycle as a result of the accident (arrowed).

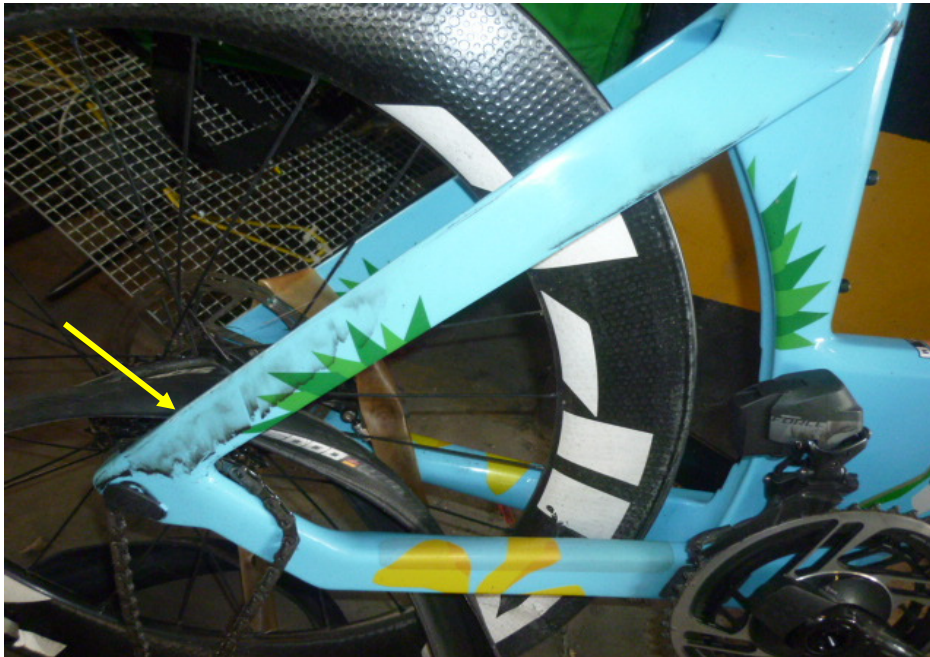
Photo 9 shows the grazed right rear sub frame of the Bicycle as a result of the accident (arrowed).

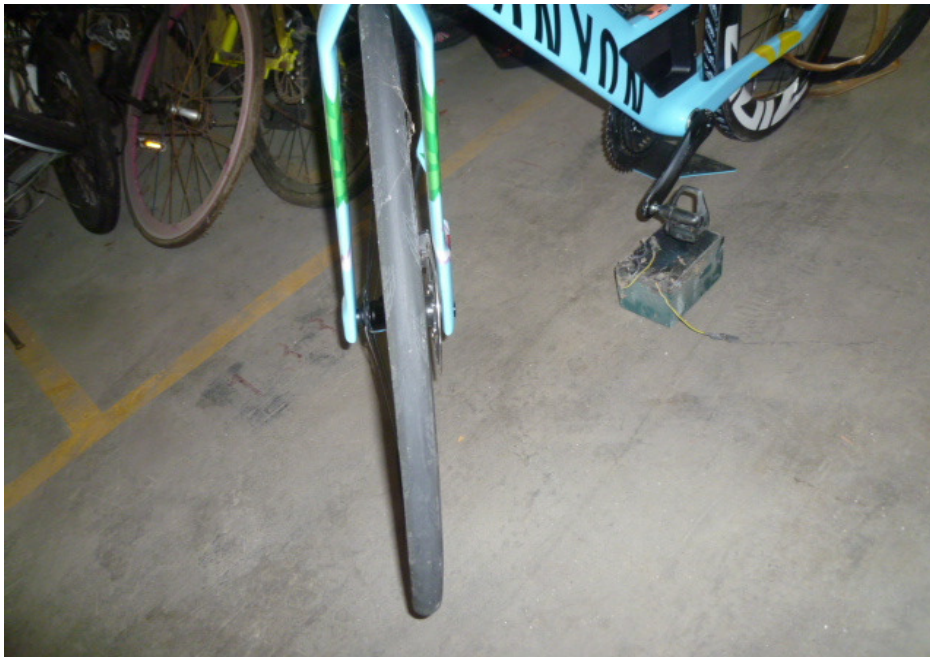
5. The condition of the Bicycle's front & rear tyres was observed to be in serviceable condition. The tread pattern of the 2 tyres was clearly visible. We did not observe any tear, burst mark(s) and/or punctured hole(s) on the sidewalls as well as across the tread of the 2 tyres. However both the front & rear tyres were observed to be deflated as a result of the accident. The tyre brand, tyre size and remaining tread depth of the 2 tyres were recorded as follows:-

Photo 10 shows the front tyre of the Bicycle most likely as a result of the accident. The pattern of the tread was clearly visible. There was no tear, burst mark(s) and/or punctured hole(s) on the sidewalls as well as across the tread of the front tyre.

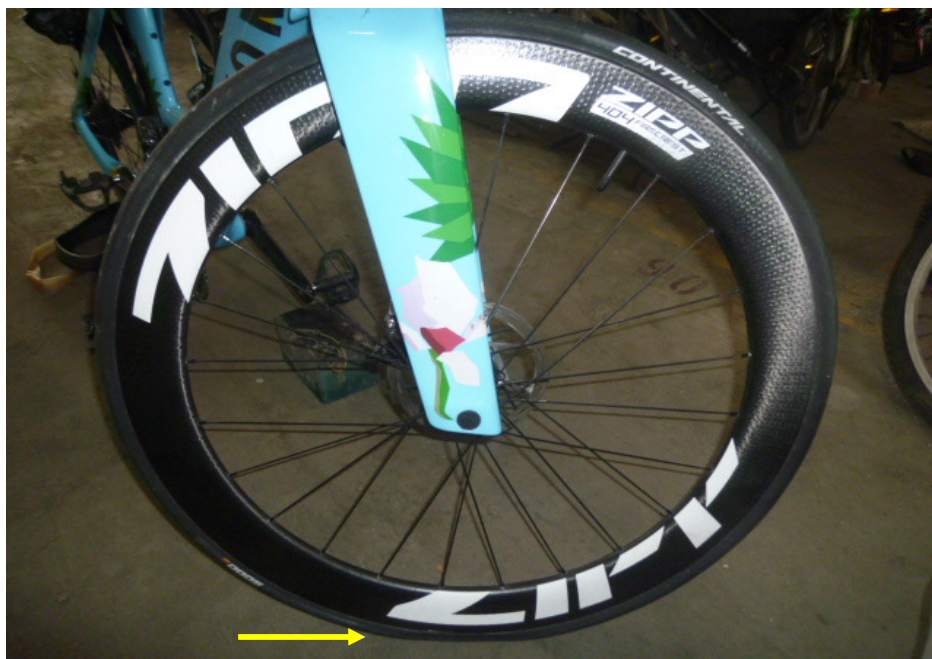
Photo 11 shows the deflated front tyre of the Bicycle at the time of our inspection (arrowed).

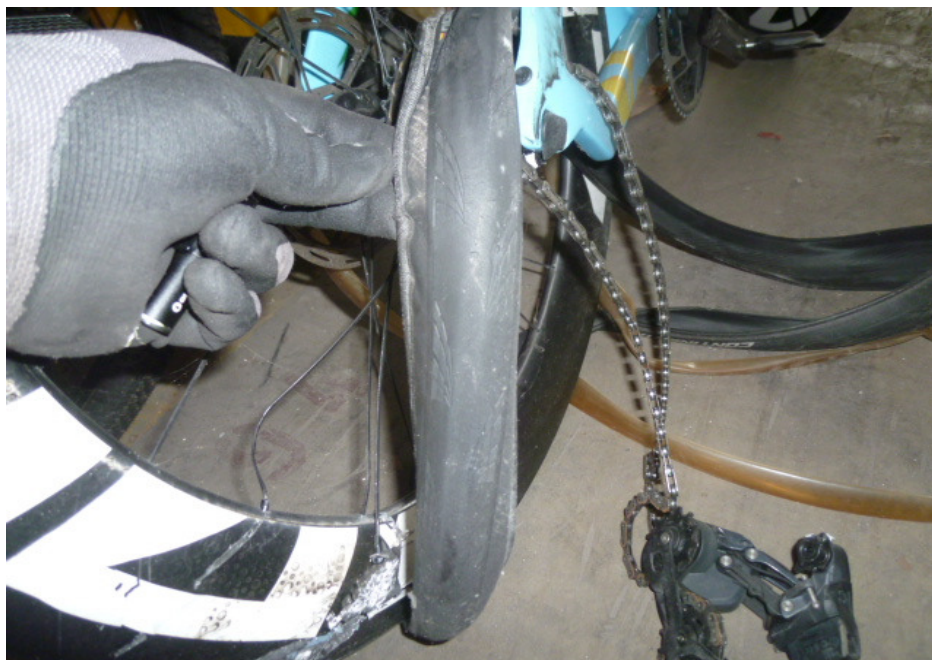
Photo 12 shows the deflated rear tyre of the Bicycle most likely as a result of the accident. The pattern of the tread was clearly visible. There was no tear, burst mark(s) and/or punctured hole(s) on the sidewalls as well as across the tread of the rear tyre.

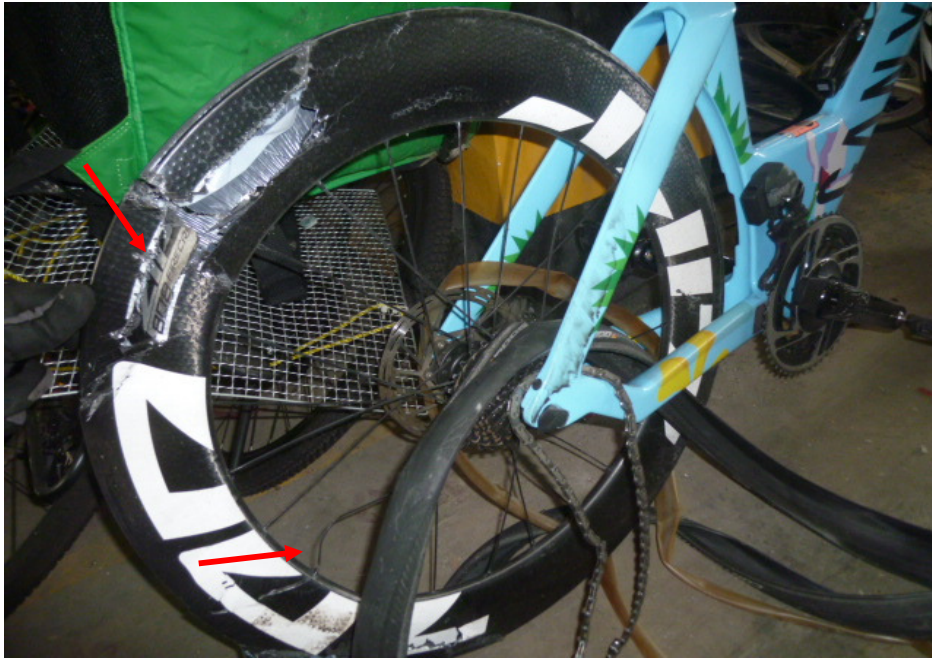
6. Both tyres were wrapped around alloy spoke wheel rims. At the time of our inspection, we did not observe any visible damage on the front wheel rim of the Bicycle. However we did observe that the rear wheel rim was broken and the spokes on the rear wheel rim were bent as a result of the accident. See photos 10 - 13 below.

Photo 13 shows the bent spokes and broken rear wheel rim of the Bicycle at the time of our inspection (arrowed).

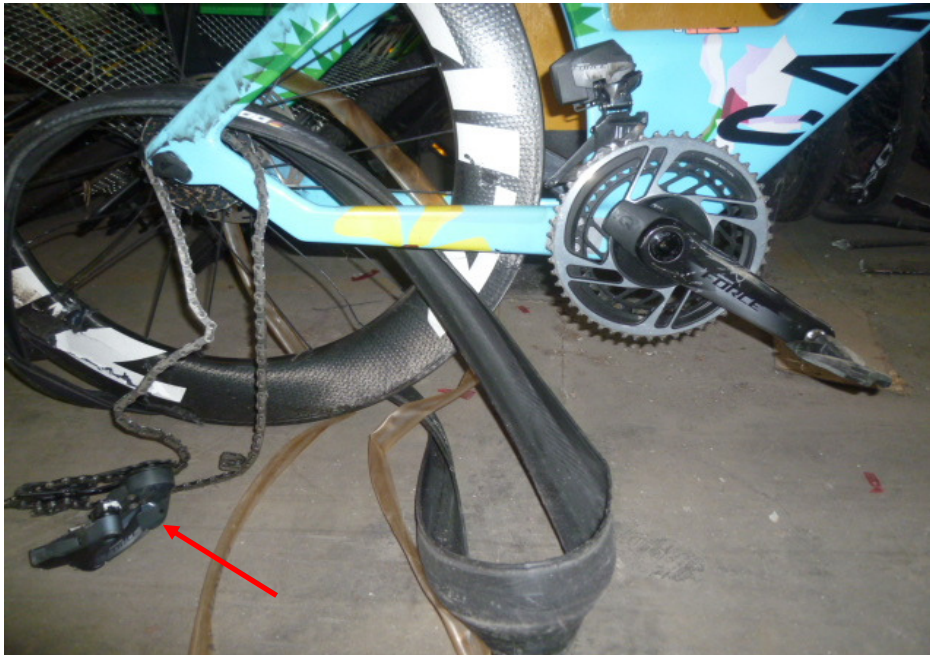
7. The gear train of the Bicycle was found to be broken as a result of the accident. The chain was also observed to be dislodged from the gear train most likely as a result of the accident. No free play tension test can be conducted due to the extensive damages. See photos 14 & 15 below.

Photo 14 shows the general view of the gear train of the Bicycle which was found to be broken as a result of the accident (arrowed). The chain was also observed to be dislodged from the gear train most likely as a result of the accident.

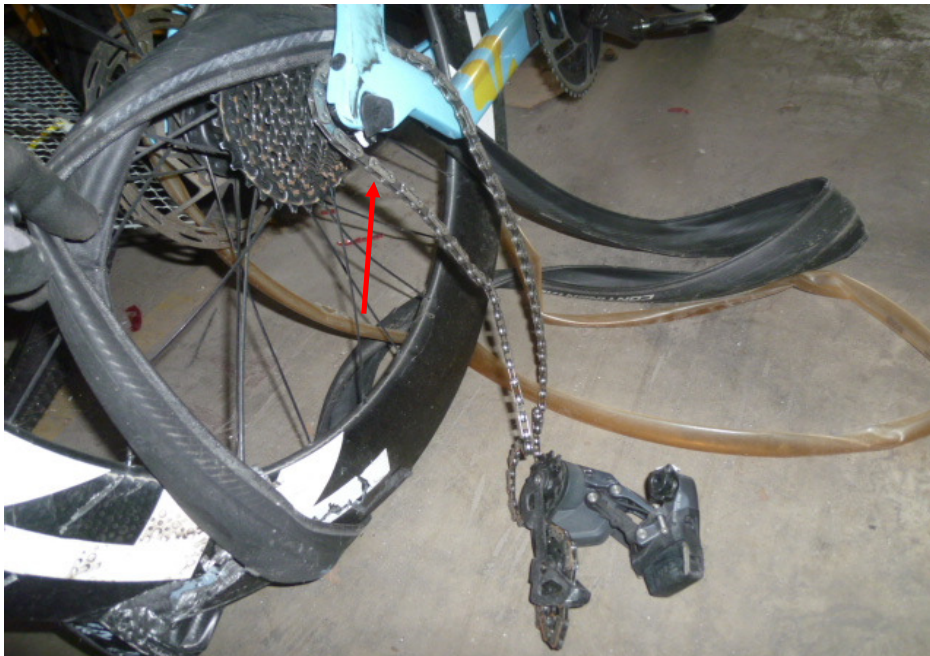
Photo 15 shows a close up view of the dislodged chain of the Bicycle as a result of the accident (arrowed). No free play tension test can be conducted due to the extensive damages.

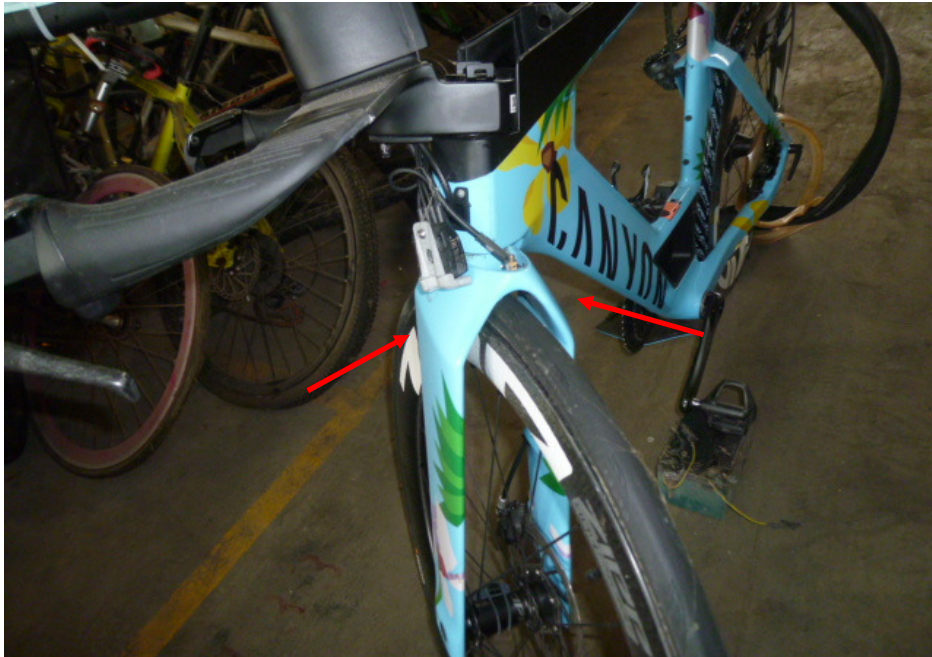
8. For this case, we were not able to conduct any test(s) on the steering system of the Bicycle due to the damages on its front forks. The front forks were found to be bent as a result of the accident, hence causing the whole steering system to be out of alignment and rendering the Bicycle immobile for any static or operational tests.

Photo 16 shows the front fork assembly (arrowed) of the Bicycle. The front forks and fork bracket of the Bicycle were both found to be bent as a result of the accident, hence causing the whole steering system to be out of alignment and rendering the Bicycle immobile for any static or operational tests.

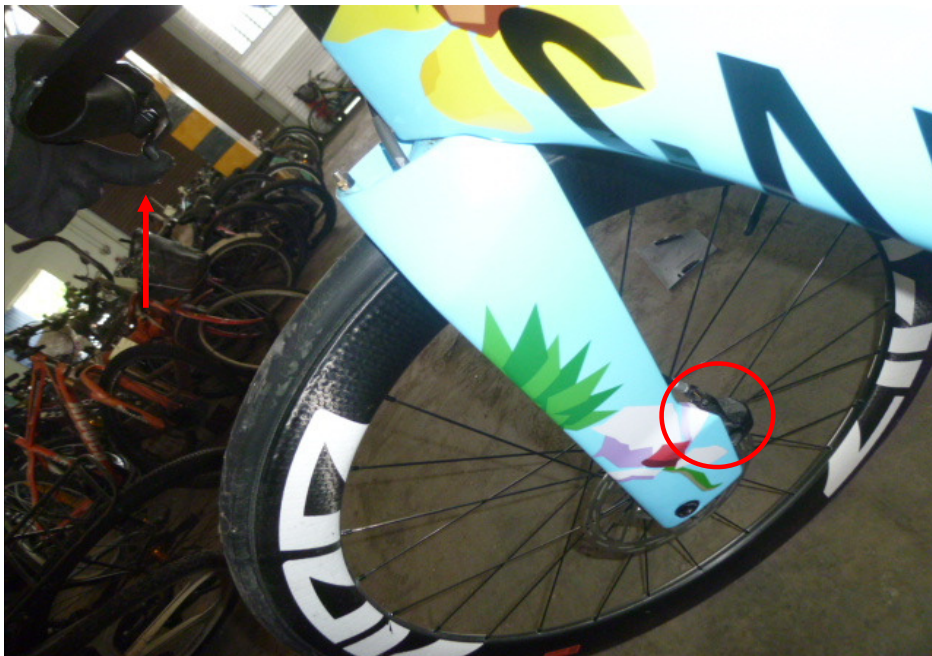
10. A static brake test was conducted on the front brake of the Bicycle. There was no resistance felt upon pressing the left hand brake lever. This was further confirmed by looking at the front brake pads while we pressed the left hand brake lever. It shows that the front brake pads had not responded to the gripping action. The front brake pads did not press against the front brake disc. This had appeared to indicate that the front brake of the Bicycle was not in serviceable condition.

Photo 17 shows a static brake test conducted on the Bicycle's front brake. There was no resistance felt upon pressing the left hand brake lever (arrowed). It also shows that the front brake clamps had not responded to the gripping action (circled) after depressing the left hand brake lever.

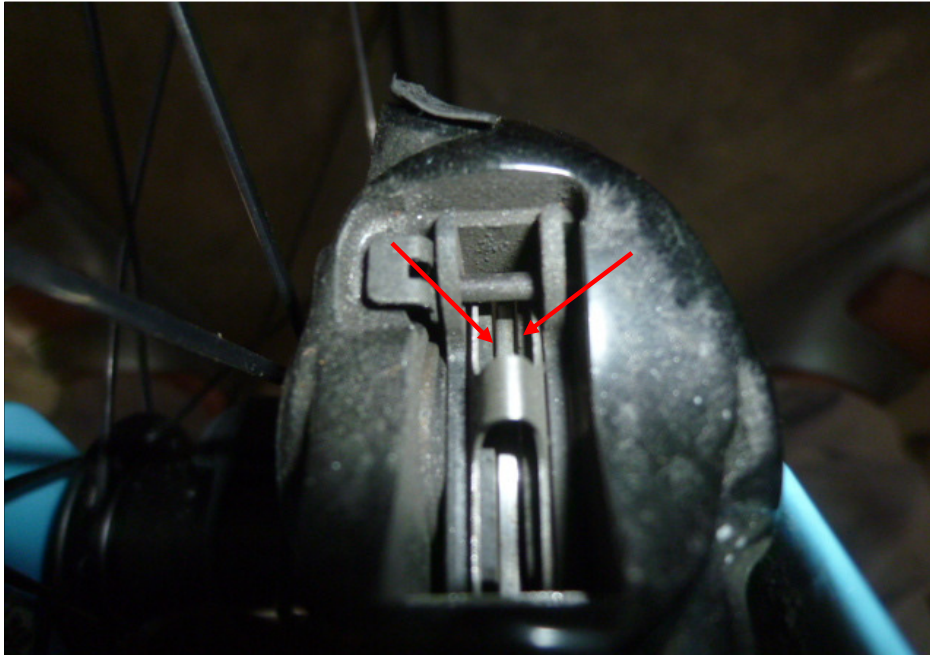
Photo 18 shows a close up view of the front brake pads not responding to the gripping action. The front brake pads did not press against the front brake disc (arrowed) upon depressing the left hand brake lever. This had appeared to indicate that the front brake of the Bicycle was not in serviceable condition.

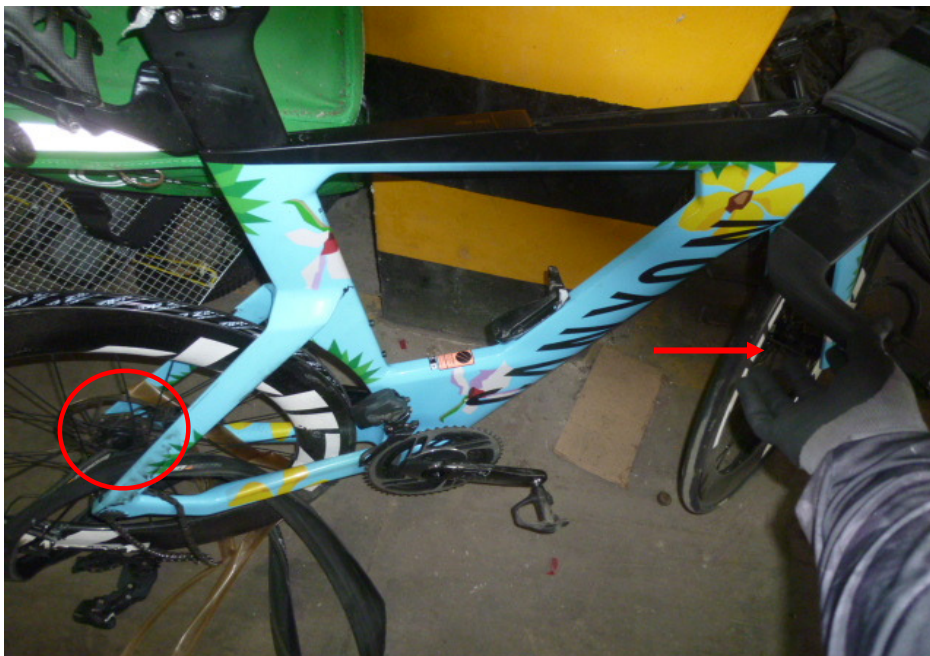
11. A static brake test was conducted on the rear brake of the Bicycle. There was no resistance felt upon pressing the right hand brake lever. This was further confirmed by looking at the rear brake pads while we pressed the right hand brake lever. It shows that the rear brake pads had not responded to the gripping action. The rear brake pads did not press against the rear brake disc. This had appeared to indicate that the rear brake of the Bicycle was not in serviceable condition.

Photo 19 shows a static brake test conducted on the Bicycle's rear brake. There was no resistance felt upon pressing the right hand brake lever (arrowed). It also shows that the rear brake clamps had not responded to the gripping action (circled) after depressing the right hand brake lever.

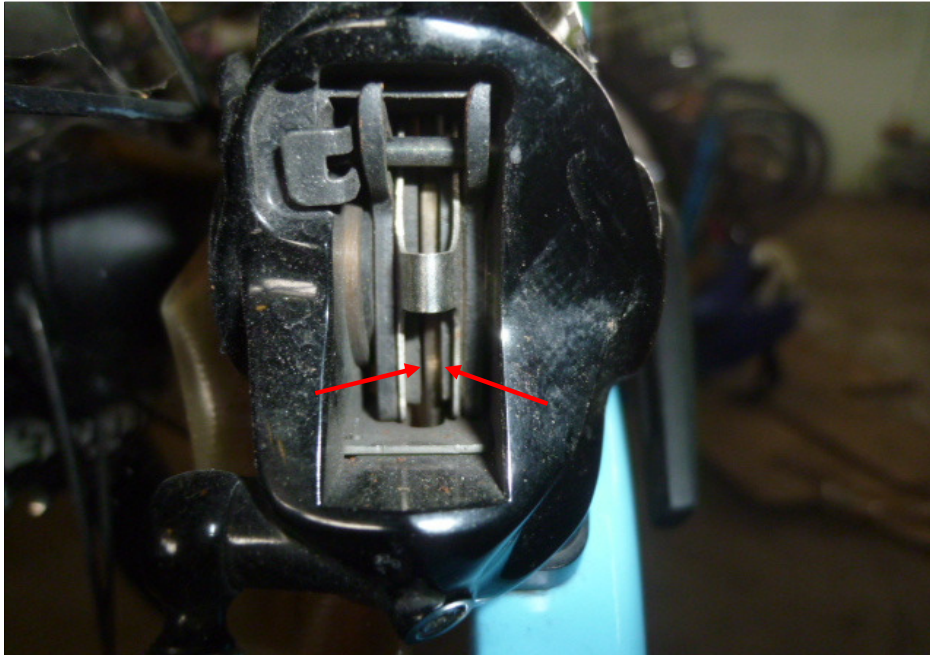
Photo 20 shows a close up view of the rear brake pads not responding to the gripping action. The rear brake pads did not press against the rear brake disc (arrowed) upon depressing the right hand brake lever. This had appeared to indicate that the rear brake of the Bicycle was not in serviceable condition.
