Your Ref: TP/IP/32680/2022
Our Ref : CI/TPD23001716/N

INSPECTION REPORT OF MOTORCYCLE FBM 6563K

1. We refer to your request dated 13 December 2022 to conduct a physical inspection of a motorcycle bearing registration number FBM 6563K (herein referred to as “**Motorcycle**”), which was involved in a fatal road traffic accident on 3 December 2022.
2. The purpose of this inspection is to primarily determine if there was any possible mechanical failure to the Motorcycle that may have contributed to the accident.
3. Following the request, we had carried out a physical inspection of the Motorcycle on 8 February 2023 at the premises of Traffic Police vehicle pound, 517 Airport Road Singapore 539942. We now set out below our observations and comments with respect to this inspection.

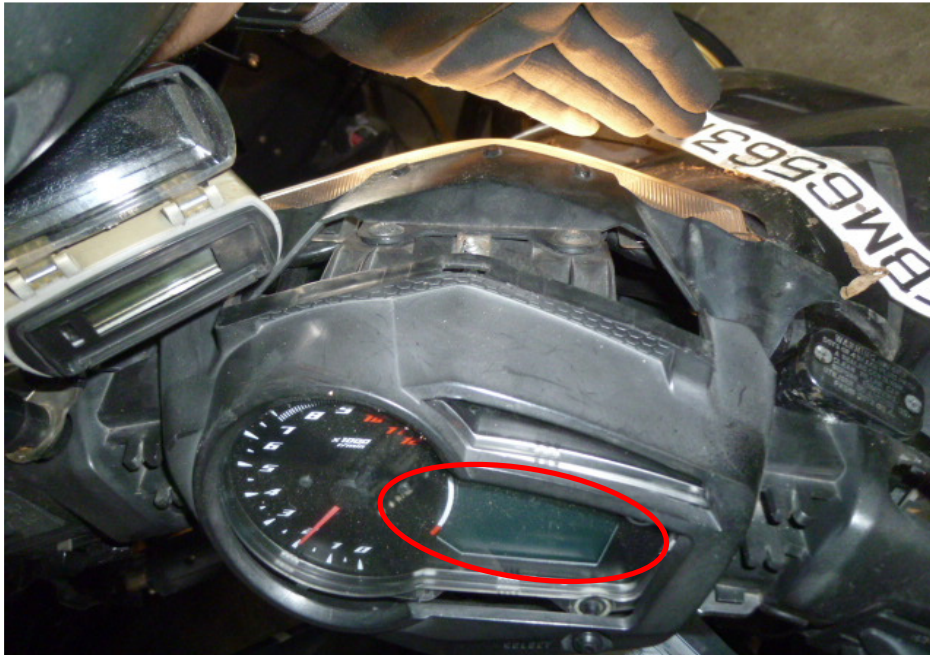
4. The mileage of the Motorcycle could not be recorded at the time of our inspection due to damages sustained to the speedometer gauge.
5. The Motorcycle was observed to have sustained damages all around. The body parts that were found to have been damaged include its headlight assembly, steering stem, side cowlings, front brake lever, centre cover, left rear side cover, exhaust muffler heat shield and top box, amongst others.

Photo 1 shows the speedometer gauge of the Motorcycle. The mileage of the Motorcycle could not be recorded at the time of our inspection due to a damaged display screen (circled).

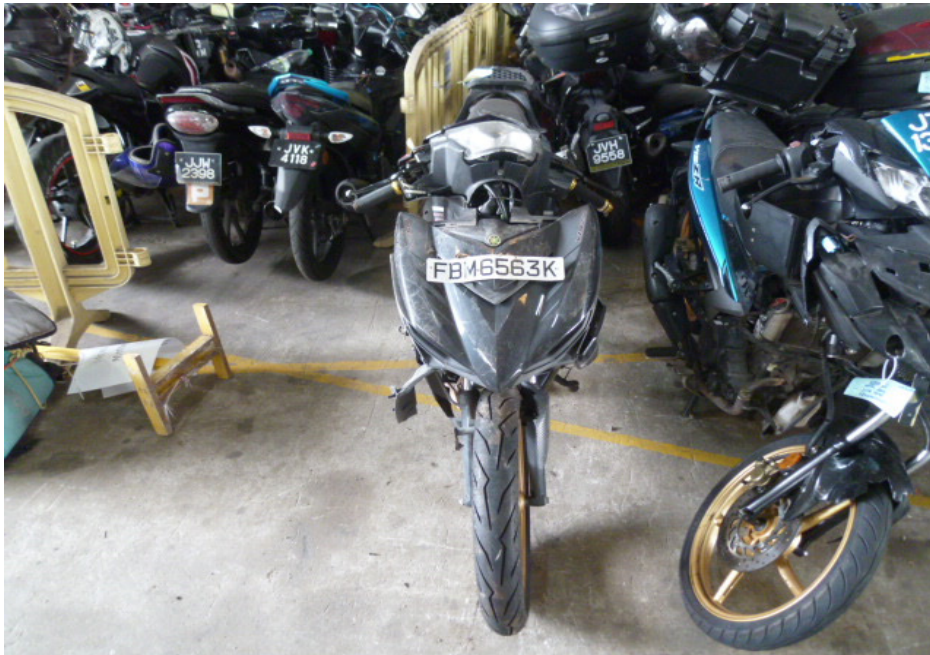
Photo 2 shows a general view of the frontal portion of the Motorcycle at the time of our inspection. The Motorcycle was observed to have sustained damages all around.

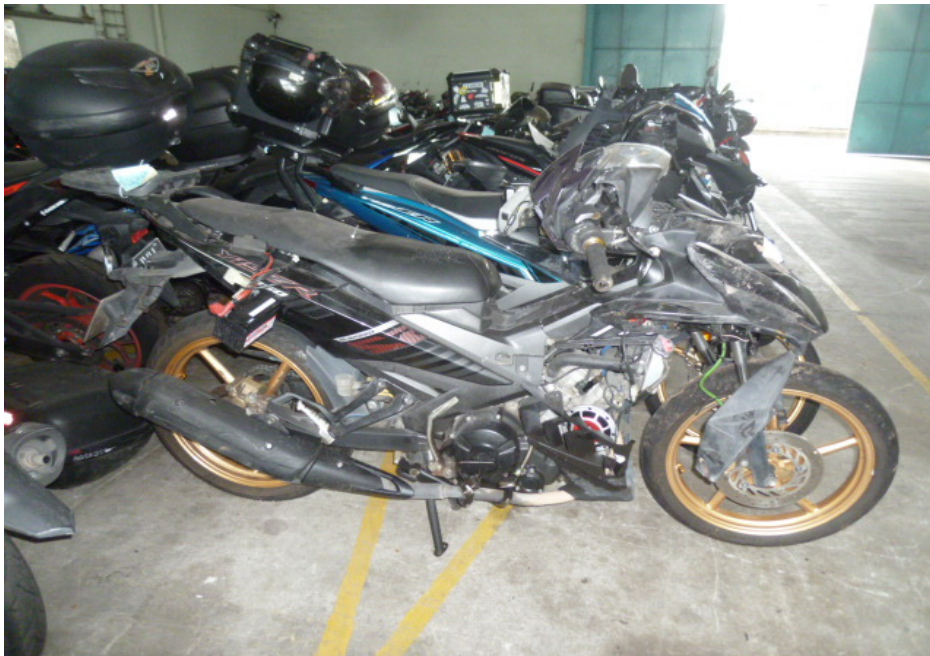
Photo 3 shows a general view of the right body of the Motorcycle at the time of our inspection. The Motorcycle was observed to have sustained damages all around.

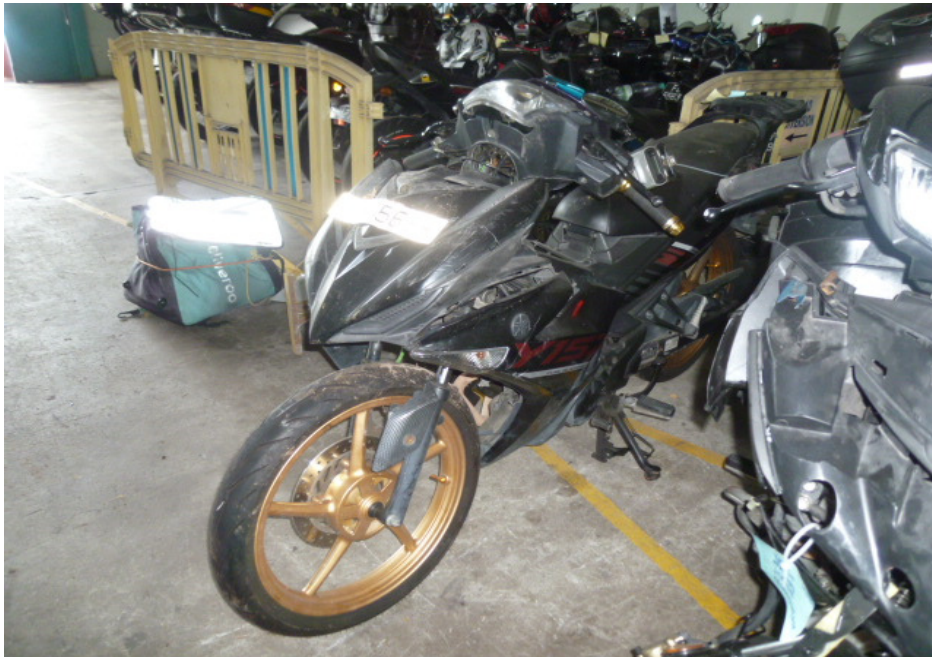
Photo 4 shows a general view of the left body of the Motorcycle at the time of our inspection. The Motorcycle was observed to have sustained damages all around. The body parts that were found to have been damaged include its headlight assembly, steering stem, side cowlings, front brake lever, centre cover, left rear side cover, exhaust muffler heat shield and top box, amongst others.

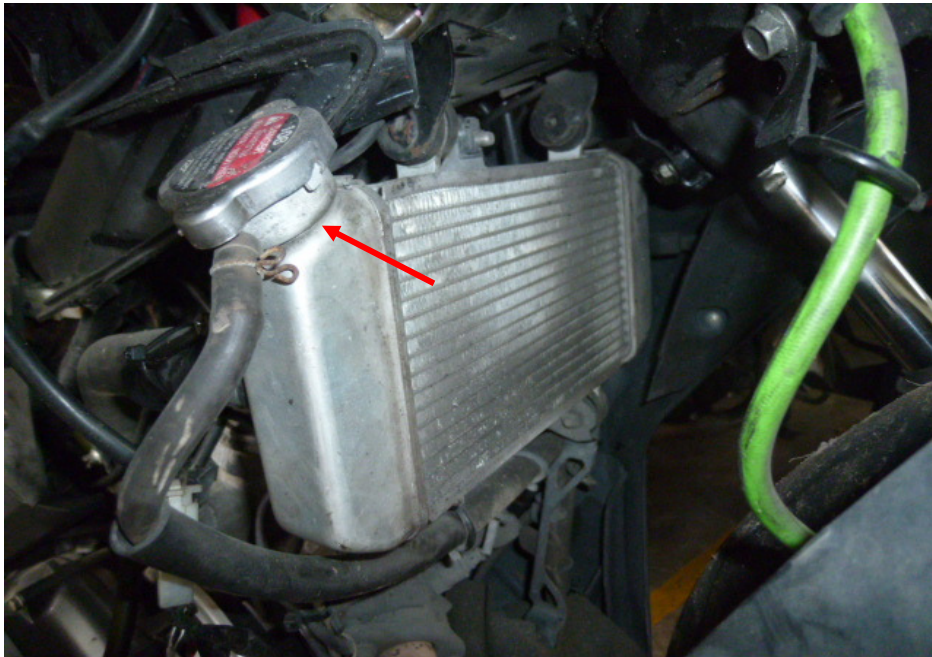
Photo 5 shows a closer view of the deformed radiator of the Motorcycle as a result of the accident (arrowed).

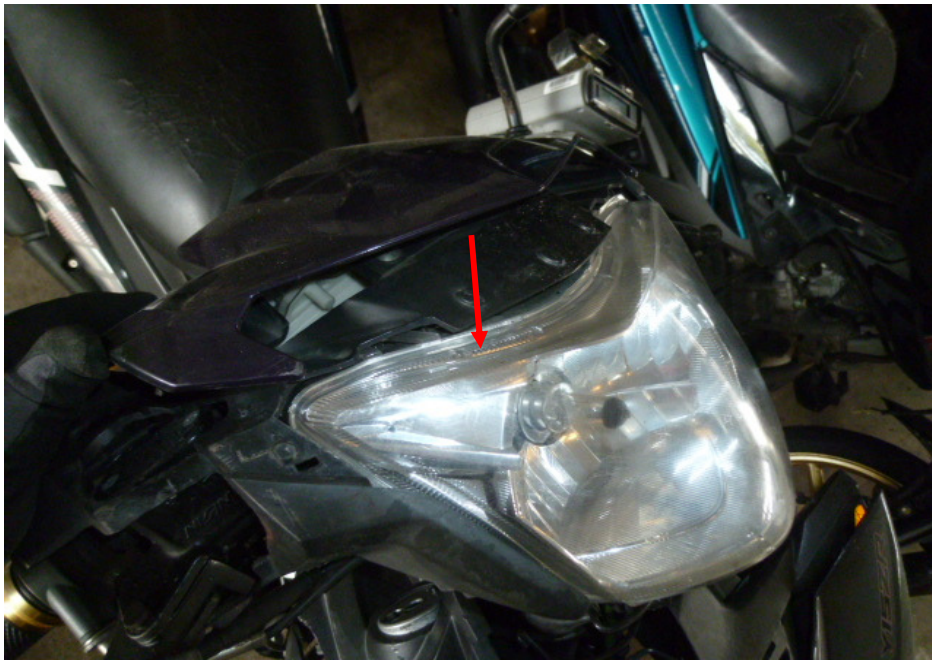
Photo 6 shows the dislodged headlight assembly (arrowed) of the Motorcycle as a result of the accident.

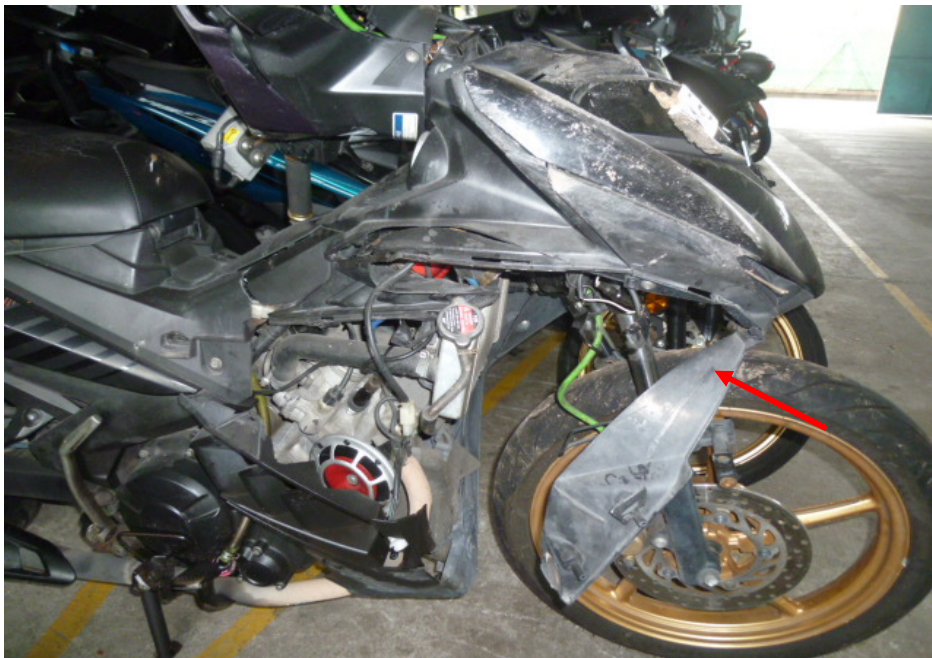
Photo 7 shows a closer view of the cracked right cowling of the Motorcycle as a result of the accident (arrowed).

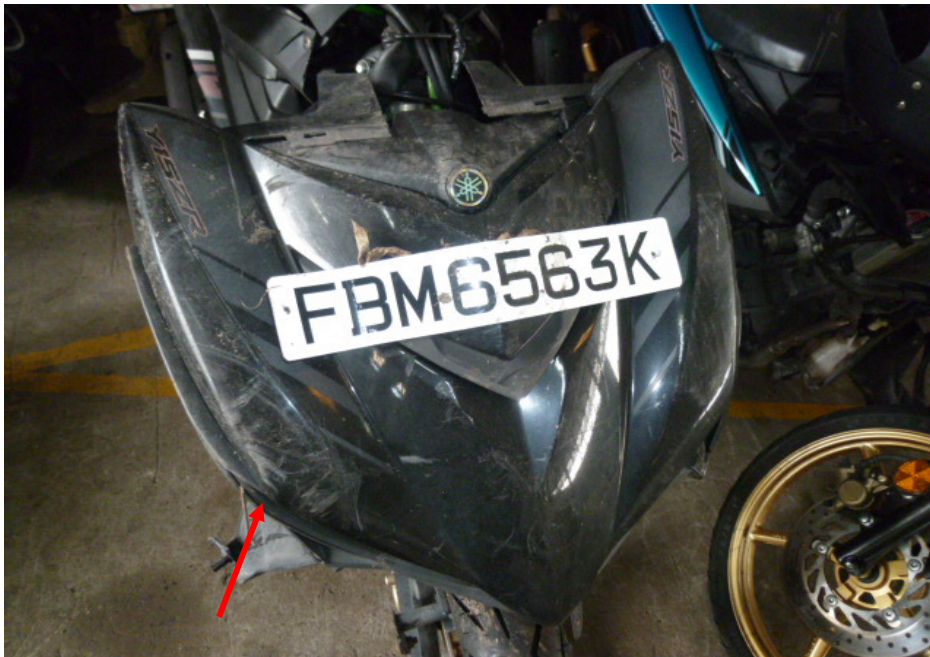
Photo 8 shows a closer view of the grazed front cowling of the Motorcycle as a result of the accident (arrowed).

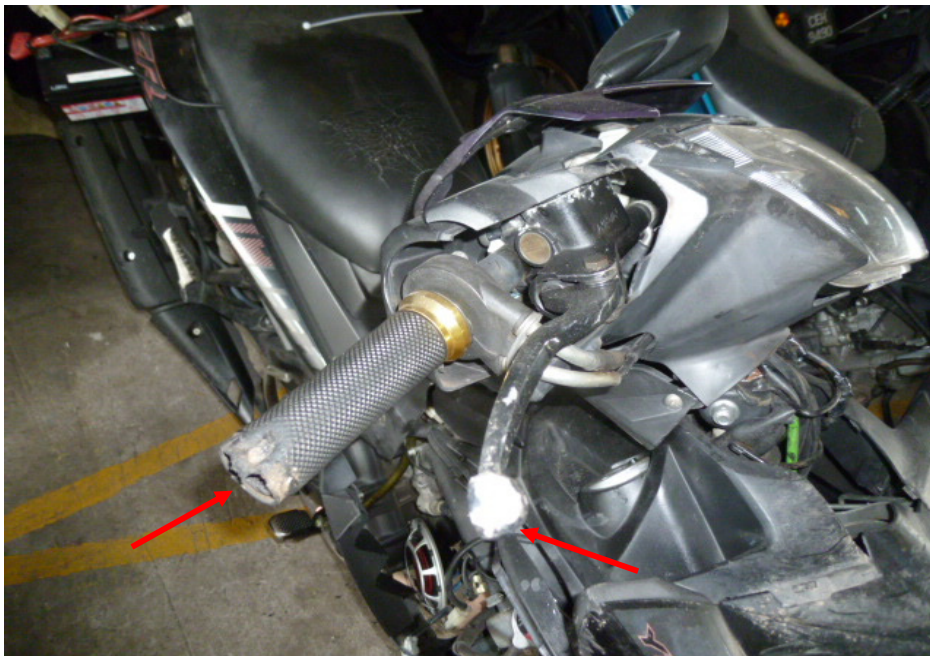
Photo 9 shows the right handlebar end and front brake lever (arrowed), which were amongst the body parts of the Motorcycle that had sustained damage as a result of the accident.

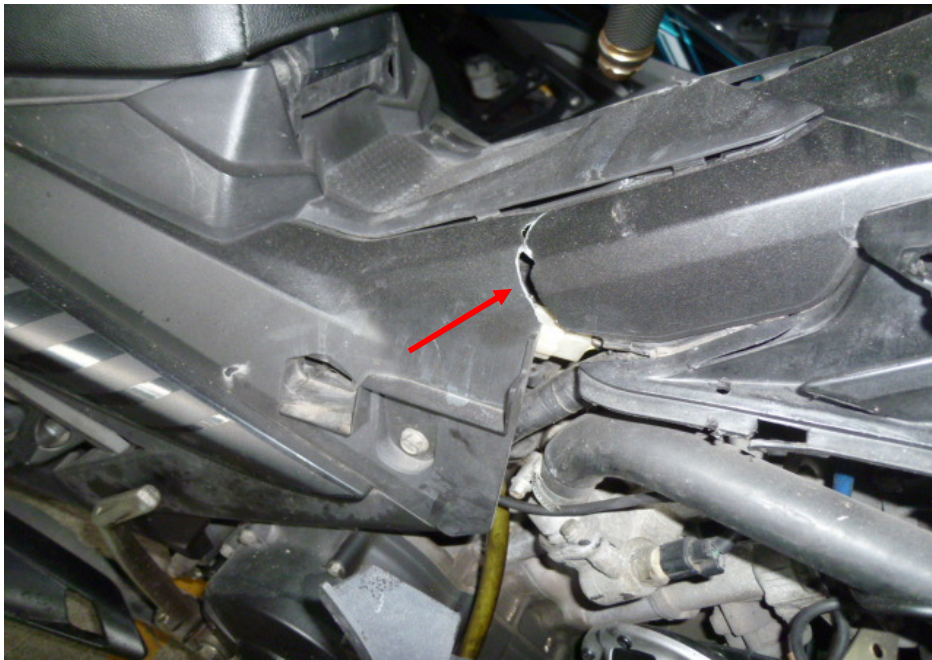
Photo 10 shows the centre cover (arrowed), which was amongst the body parts of the Motorcycle that had sustained damage as a result of the accident.

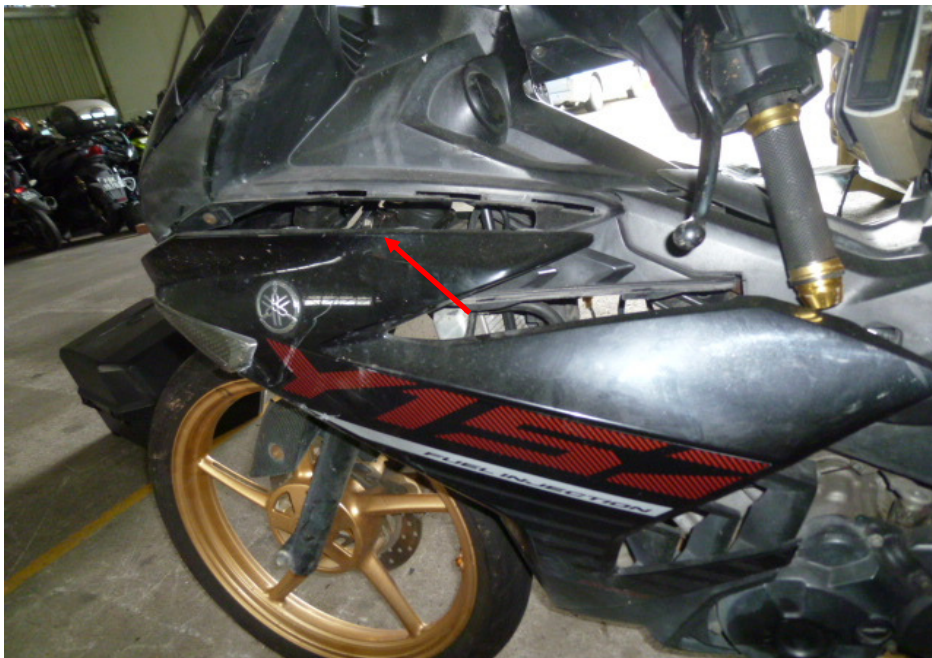
Photo 11 shows a closer view of the dislodged left cowling of the Motorcycle as a result of the accident (arrowed).

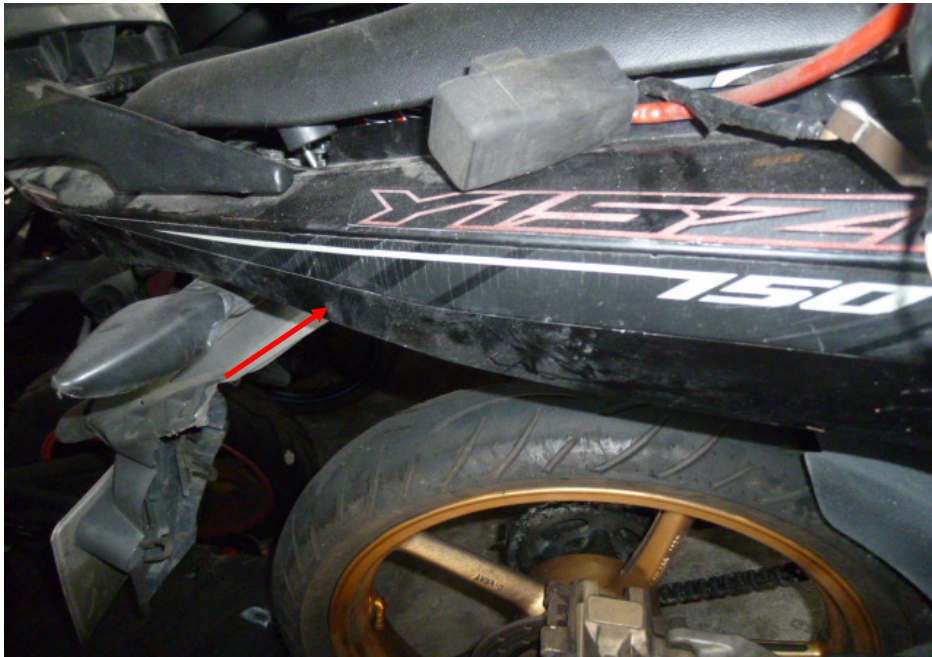
Photo 12 shows a closer view of the grazed right rear side cover of the Motorcycle as a result of the accident (arrowed).

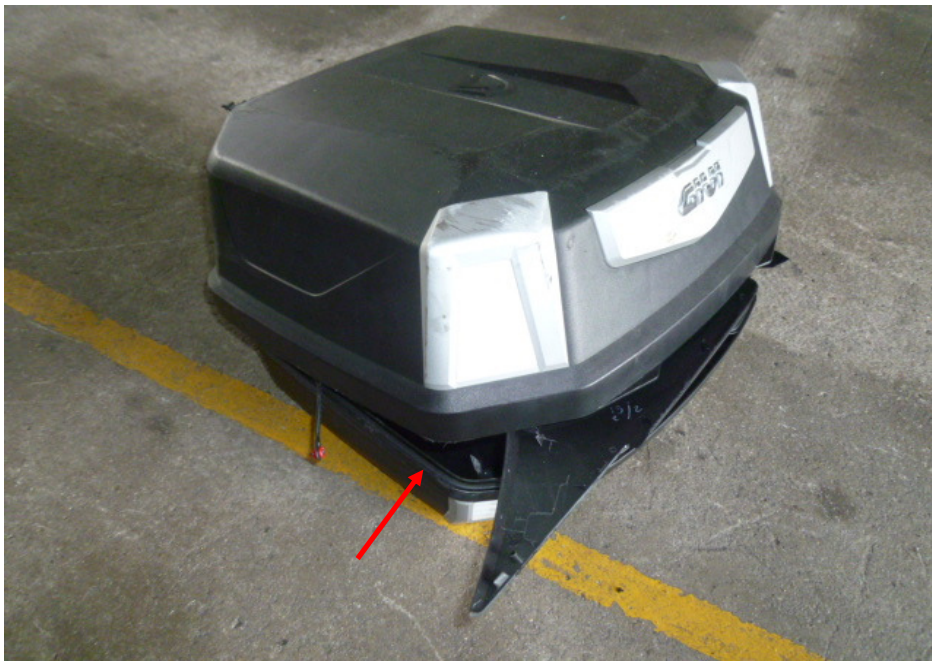
Photo 13 shows the broken top box (arrowed) of the Motorcycle a result of the accident.

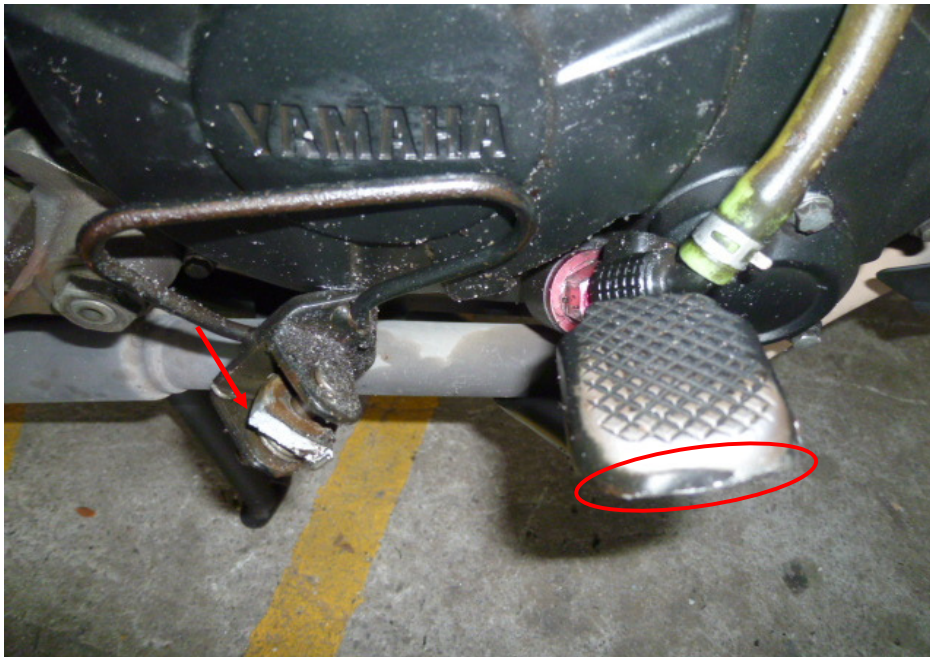
Photo 14 shows the grazed rear brake pedal (circled) and broken right front footrest (arrowed) of the Motorcycle as a result of the accident.

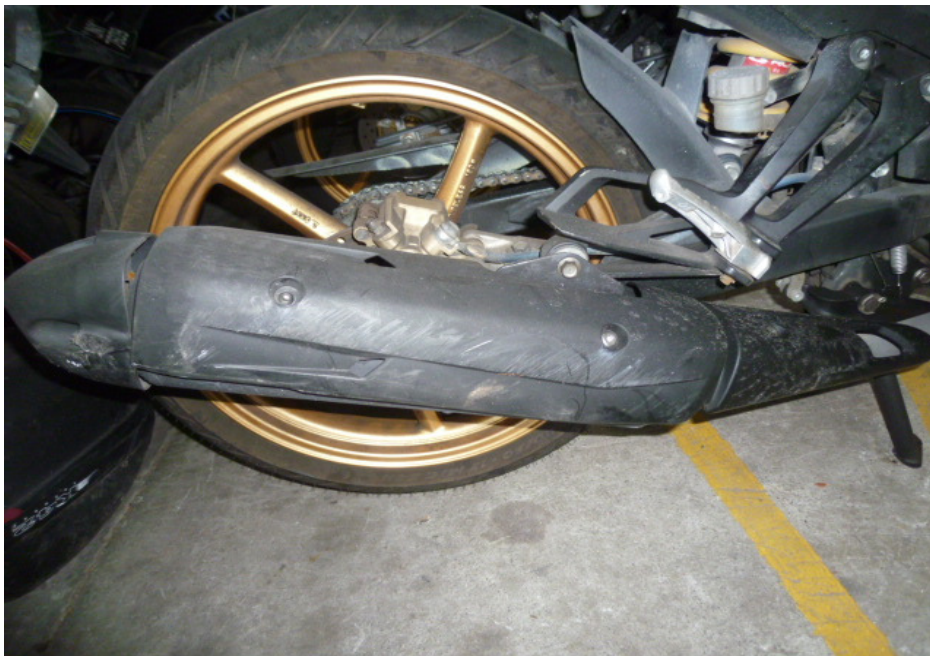
Photo 15 shows the grazed exhaust muffler heat shield of the Motorcycle as a result of the accident.

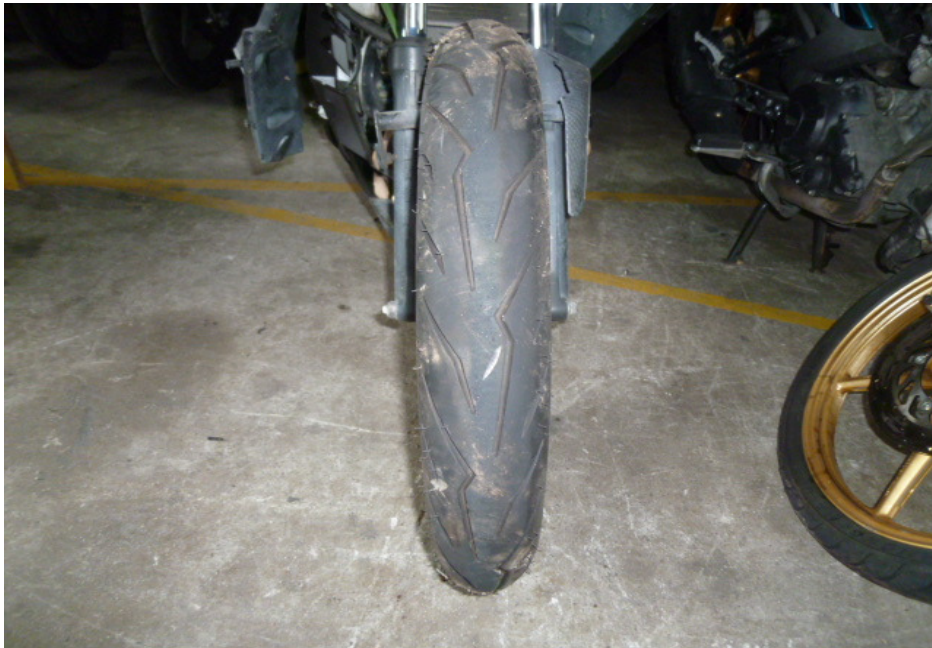
Photo 16 shows the condition of the Motorcycle's front tyre. The front tyre was observed to be in serviceable condition with remaining tread depth of approximately 4mm. The tyre was also observed to be sufficiently inflated for vehicular operation. We did not observe any tear, burst mark(s) and/or punctured hole(s) on the sidewalls as well as across the tread of the front tyre.

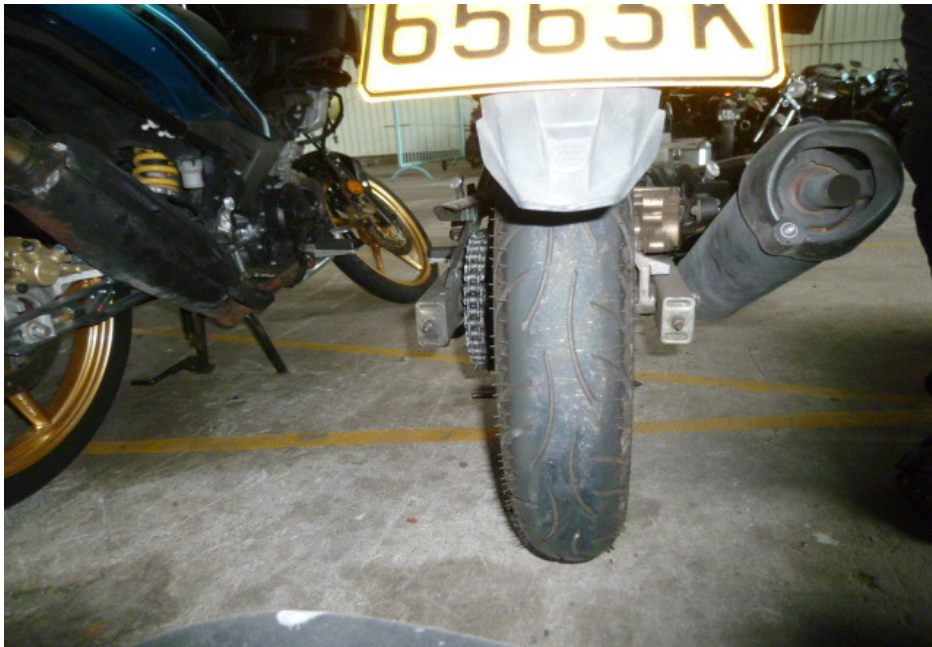
Photo 17 shows the condition of the Motorcycle's rear tyre. The pattern of the tread was clearly visible with remaining tread depth of approximately 2mm. We did not observe any tear, burst mark(s) and/or punctured hole(s) on the sidewalls as well as across the tread of the rear tyre. The tyre was also observed to be sufficiently inflated for vehicular operation.

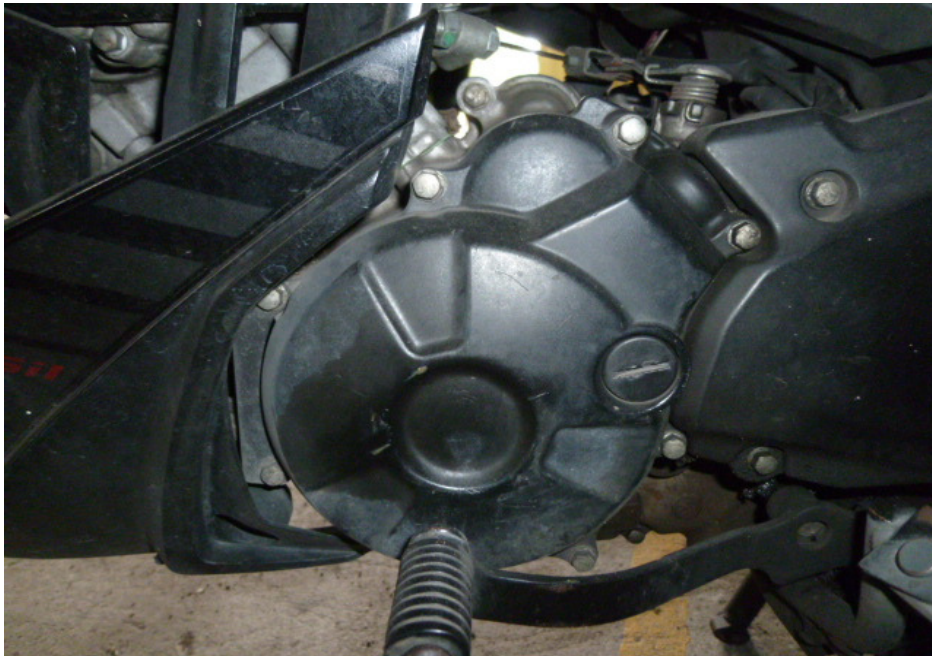
Photo 18 shows the left side of the engine of the Motorcycle at the time of our inspection. The various engine related parts and components were found to be intact with no visible damage. There was also no sign(s) or indication(s) of fluid leak observed around the left engine area of the Motorcycle.

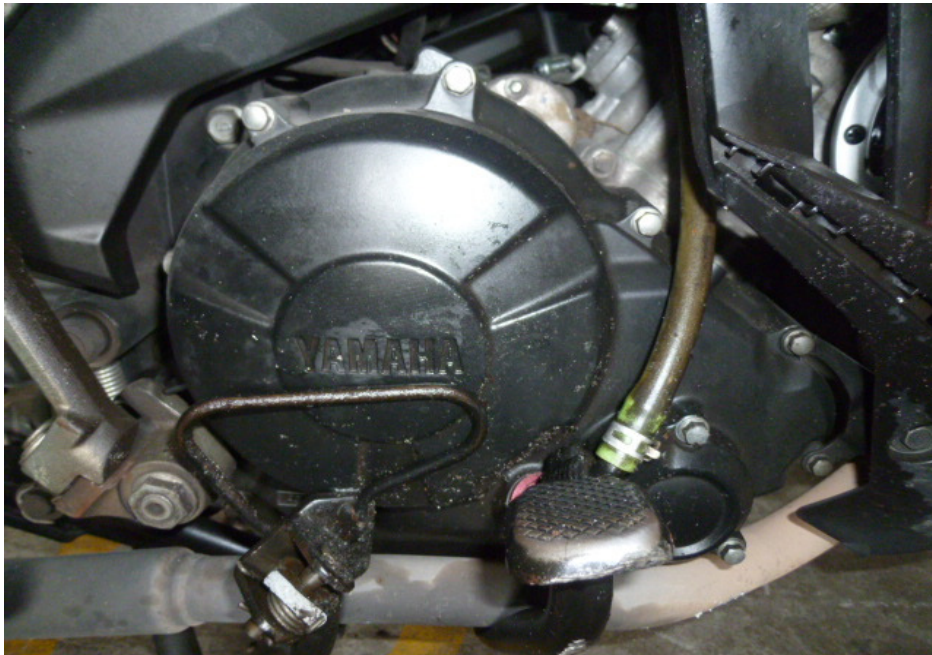
Photo 19 shows the right side of the engine of the Motorcycle at the time of our inspection. The various engine related parts and components were found to be intact with no visible damage. There was also no sign(s) or indication(s) of fluid leak observed around the right engine area of the Motorcycle.

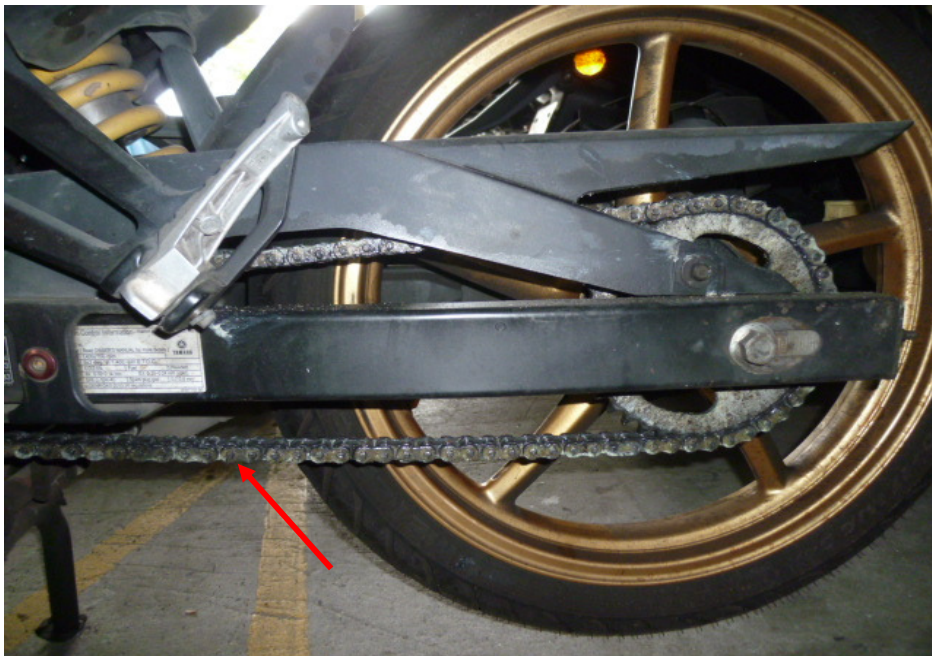
Photo 20 shows the general view of the gear train (arrowed) of the Motorcycle, which was observed to be intact with no misalignment. It was also adequately lubricated for operating purposes.

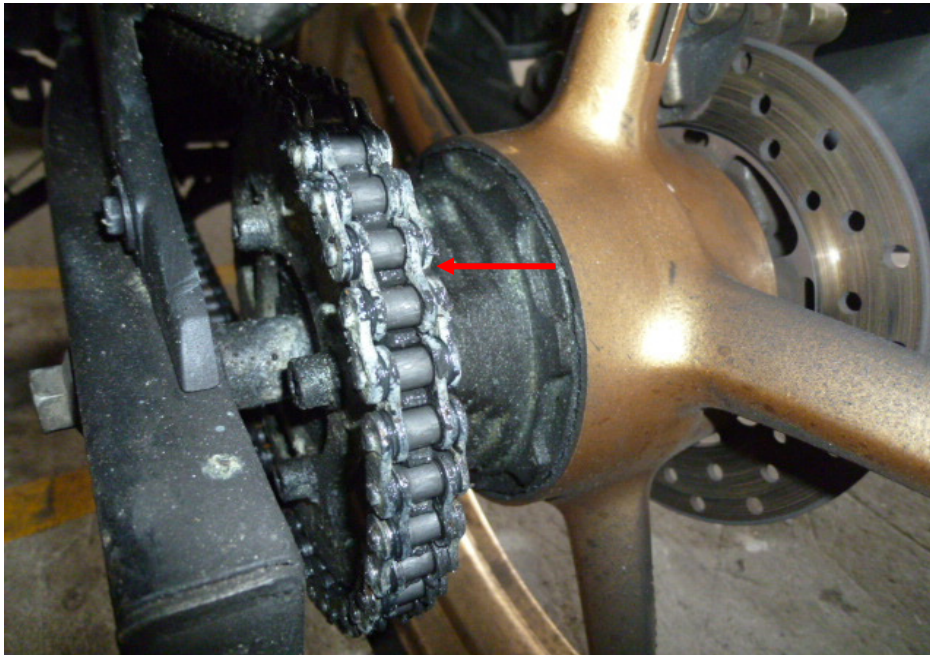
Photo 21 shows a closer view of the gear train (arrowed) of the Motorcycle, which was observed to be intact with no misalignment. It was also adequately lubricated for operating purposes.

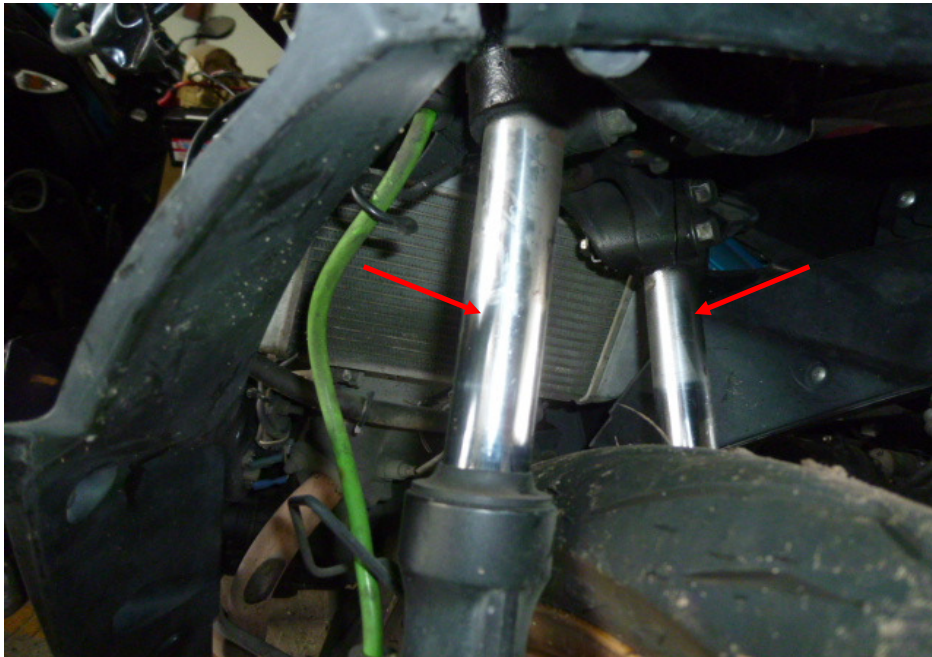
11. For this case, we were not able to conduct any test(s) on the steering system of the Motorcycle due to the damage to its front forks and steering stem. The front forks were observed to be bent and the steering stem was observed to be broken as a result of the accident.

Photo 22 shows the front forks of the Motorcycle. The front forks were observed to be bent as a result of the accident (arrowed). We were hence not able to conduct any tests on the steering system of the Motorcycle.

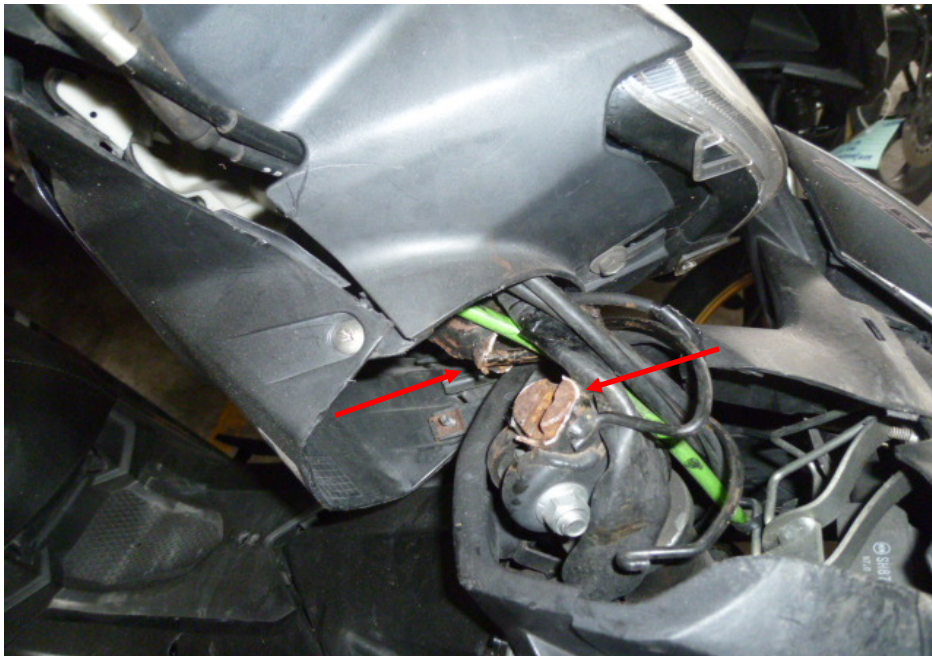
Photo 23 shows the steering stem of the Motorcycle. The steering stem was observed to be broken as a result of the accident (arrowed). We were hence not able to conduct any tests on the steering system of the Motorcycle.

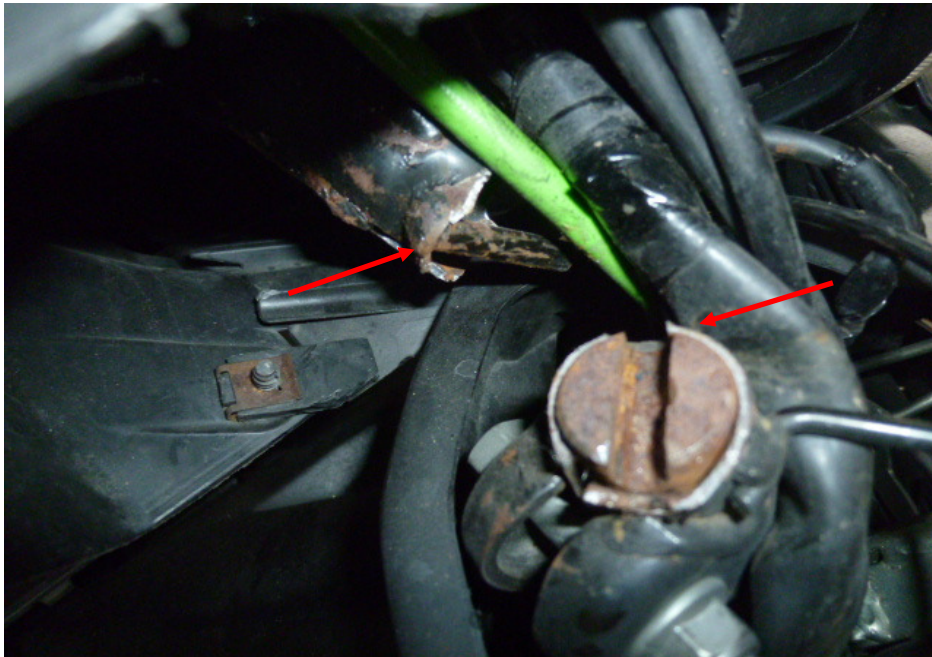
Photo 24 shows a close up view of the broken steering stem of the Motorcycle as a result of the accident (arrowed). We were hence not able to conduct any tests on the steering system of the Motorcycle.

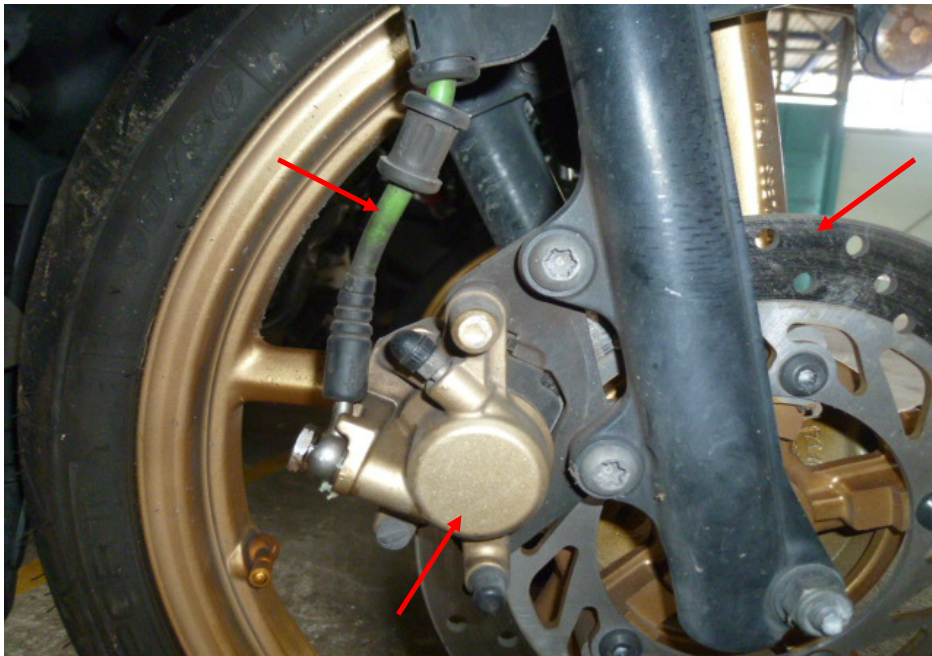
Photo 25 shows a close up view of the front brake caliper, front brake disc and front brake hose (arrowed) of the Motorcycle, which are all part of the components in the hydraulic front brake system of the Motorcycle. Our visual checks of these various components had revealed all to be intact with no visible damage. No leakage of brake fluid was also observed.

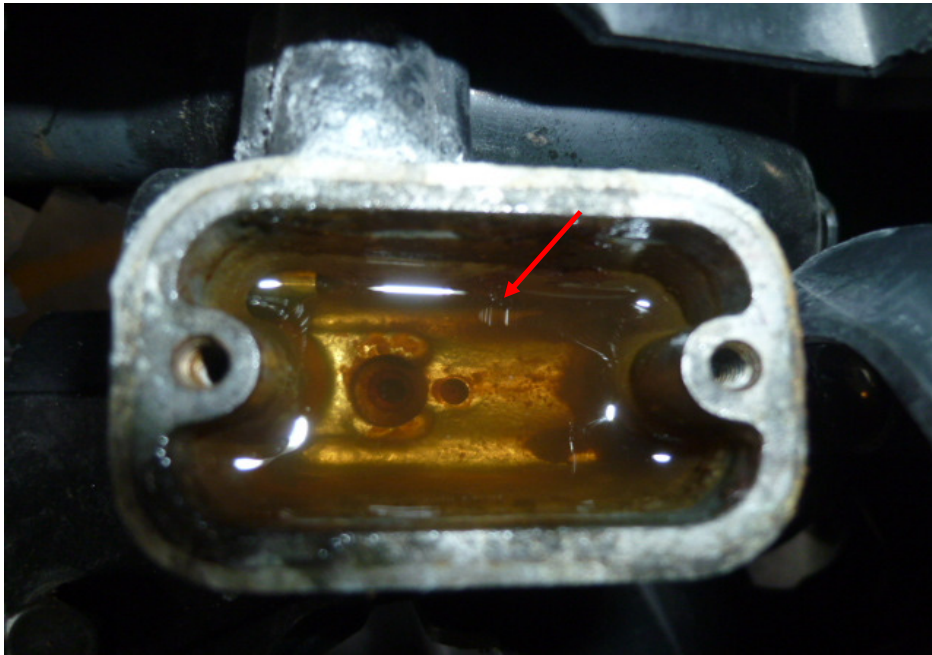
14. The brake fluid for the front brake was observed to be of sufficient level for operational purposes. However it was found to be slightly contaminated. The brake fluid for the rear brake was observed to be of sufficient level for operating purposes and without any contamination.

Photo 26 shows the brake fluid reservoir for the front brake of the Motorcycle. The brake fluid was found to be of sufficient level for operating purposes. However the brake fluid was found to be slightly contaminated (arrowed).

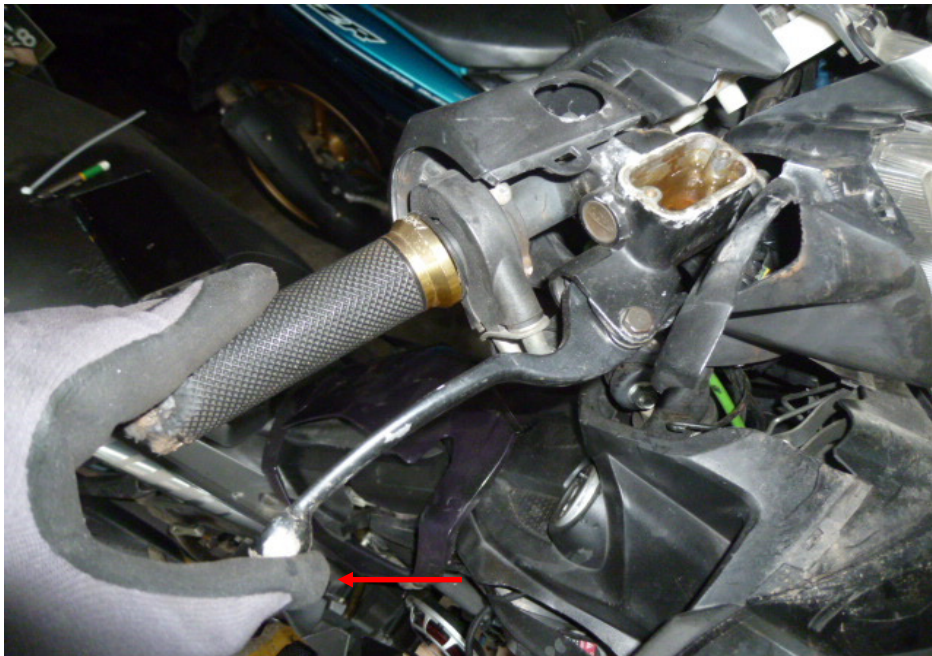
15. Static brake tests conducted on the Motorcycle had appear to indicate that the braking system of the Motorcycle was in serviceable condition. There was some resistance felt (spongy like feel) upon pressing the brake lever and upon stepping on the brake pedal. This would indicate that there was no leakage of pressure/vacuum in the brake system.

Photo 27 shows the front brake lever being depressed. There was some resistance felt (spongy like feel) upon pressing the front brake lever (arrowed). This would indicate that there is no leakage of pressure/vacuum in the front brake system.

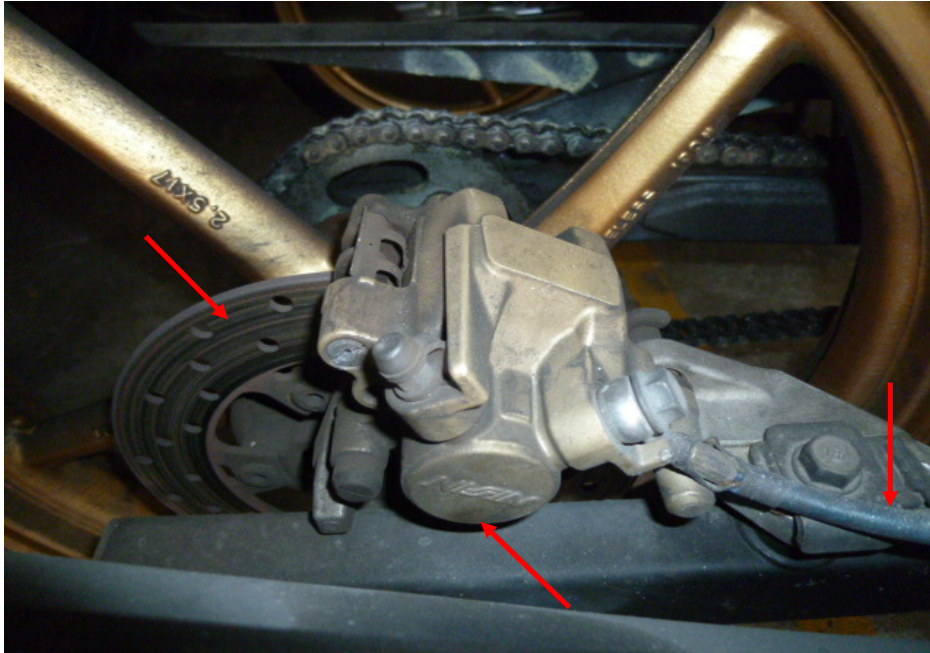
Photo 28 shows a close up view of the rear brake caliper, rear brake disc and rear brake hose (arrowed) of the Motorcycle, which are all part of the components in the hydraulic rear brake system of the Motorcycle. Our visual checks of these various components had revealed all to be intact with no visible damage. No leakage of brake fluid was also observed.

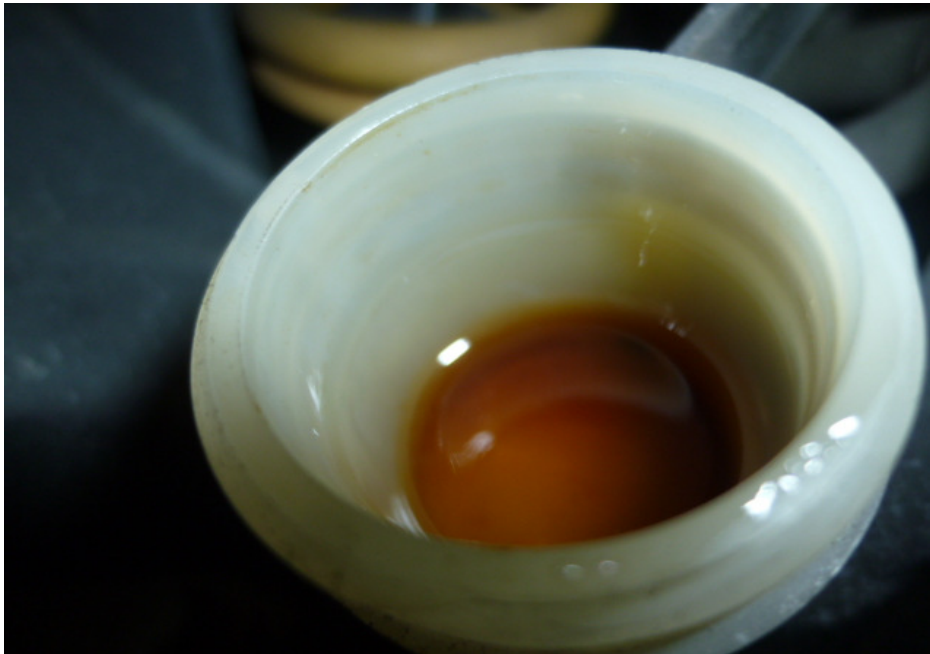
Photo 29 shows the brake fluid reservoir for the rear brake of the Motorcycle. The brake fluid was observed to be of sufficient level for operating purposes and without any contamination.
