Your Ref: s58nqhgWcY
Our Ref : CI/III23001781/P

**TECHNICAL INVESTIGATION REPORT OF WARRANTY CLAIM INVOLVING
THE INSURED VEHICLE SNC 636J ON 15th December 2022**

Vehicle Registration No.	: SNC 636J
Make / Model	: MERCEDES BENZ E300 MILD HYBRID
Chassis No	: W1K2384832F163834
Year of Registration	: APRIL 2021
Mileage	: 16,233KM

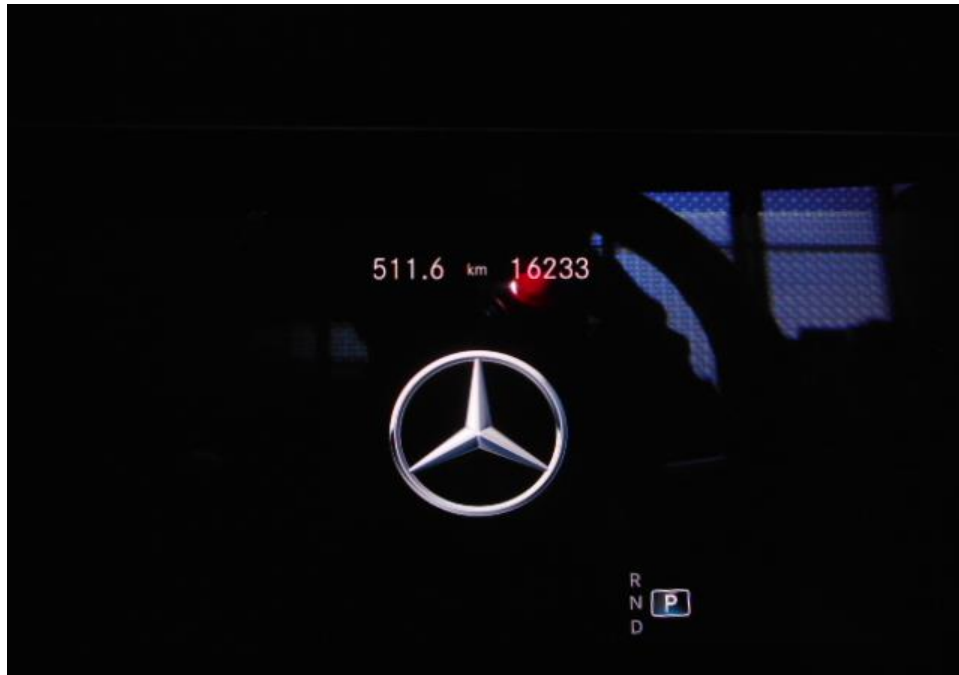
Photo 1 shows the mileage of the Insured Vehicle recorded at the time inspection at 16,233KM

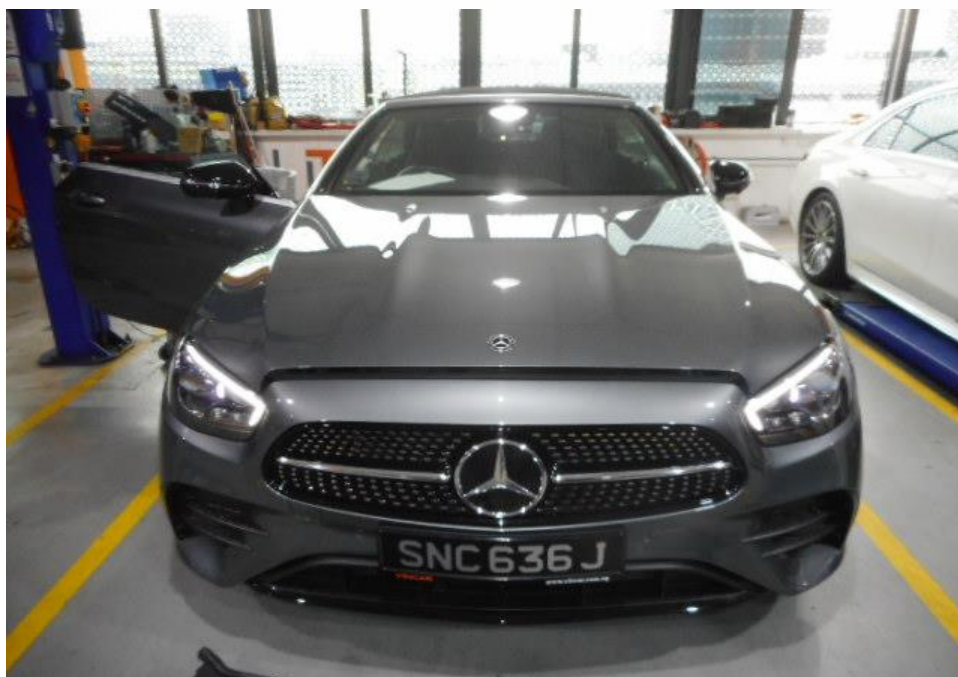
Photo 2 shows the general view of the front portion of the Insured Vehicle at the time of our inspection. The Insured Vehicle is observed to be unaffected by any signs of accident.

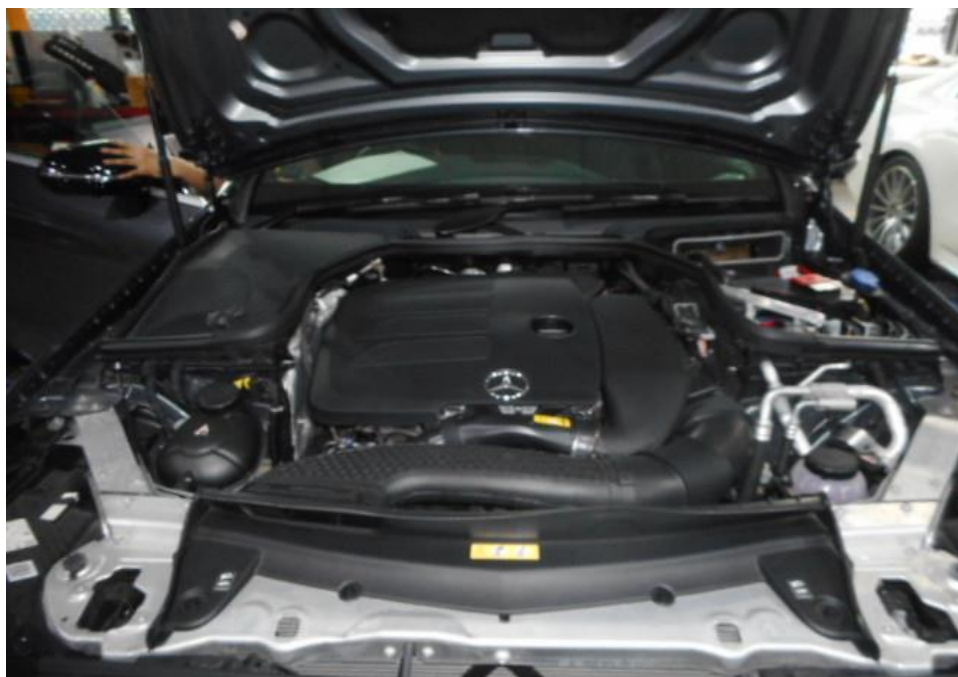
Photo 3 shows the general view of the engine portion of the Insured Vehicle at the time of our inspection. The engine compartment is observed to be unaffected by any signs of accident.

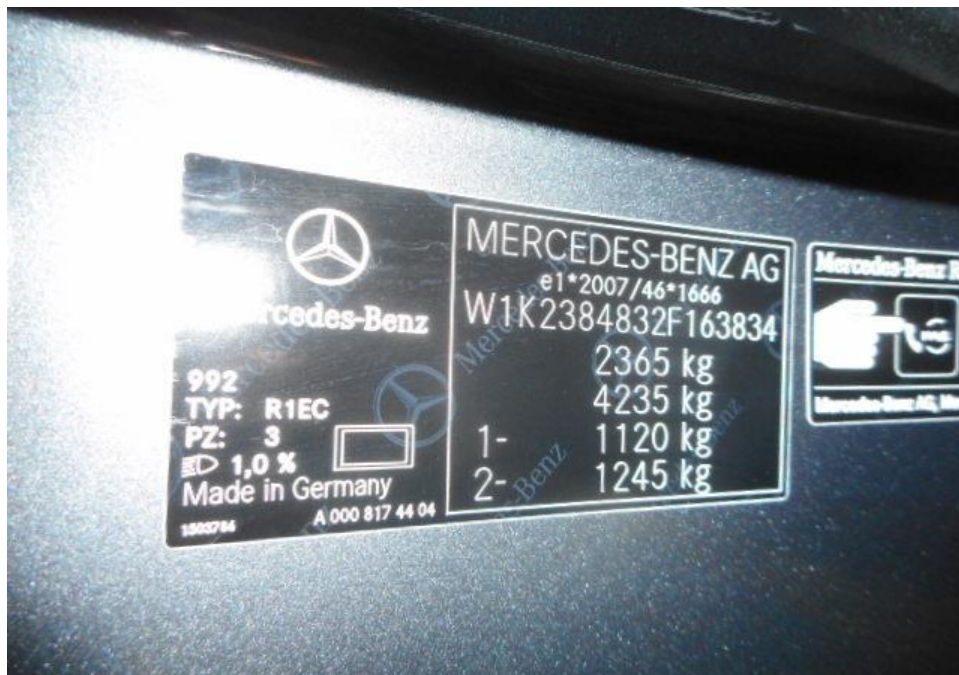
Photo 4 shows the chassis number of the Insured Vehicle at the time of our inspection.

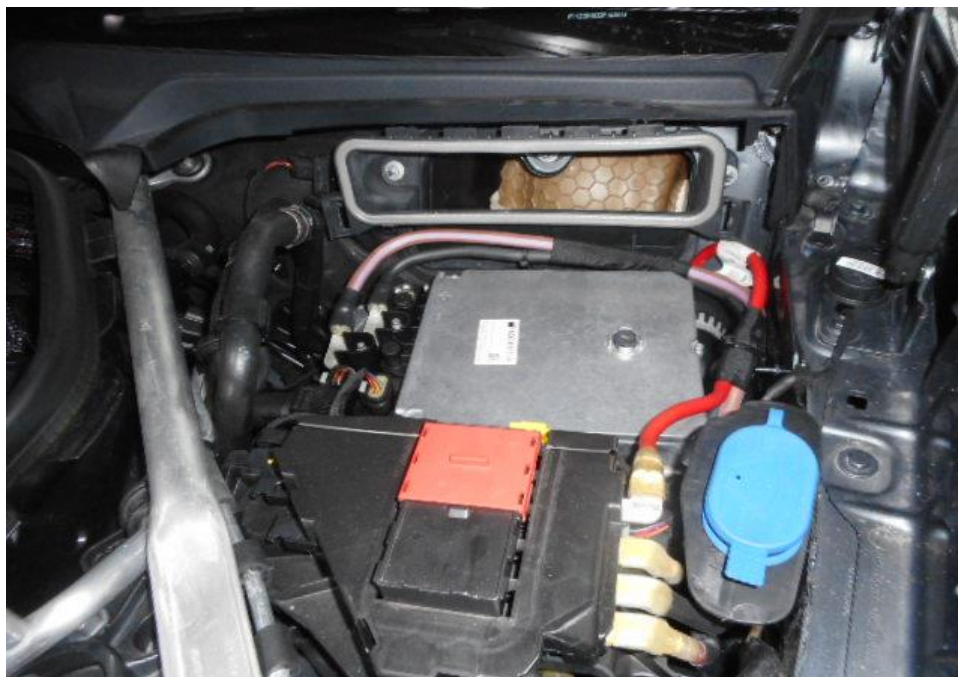
Photo 5 shows the general view of the 48v battery and its components in the engine compartment portion of the Insured Vehicle at the time of our inspection. The 48v battery and its components is observed to be unaffected and by any signs of accident.

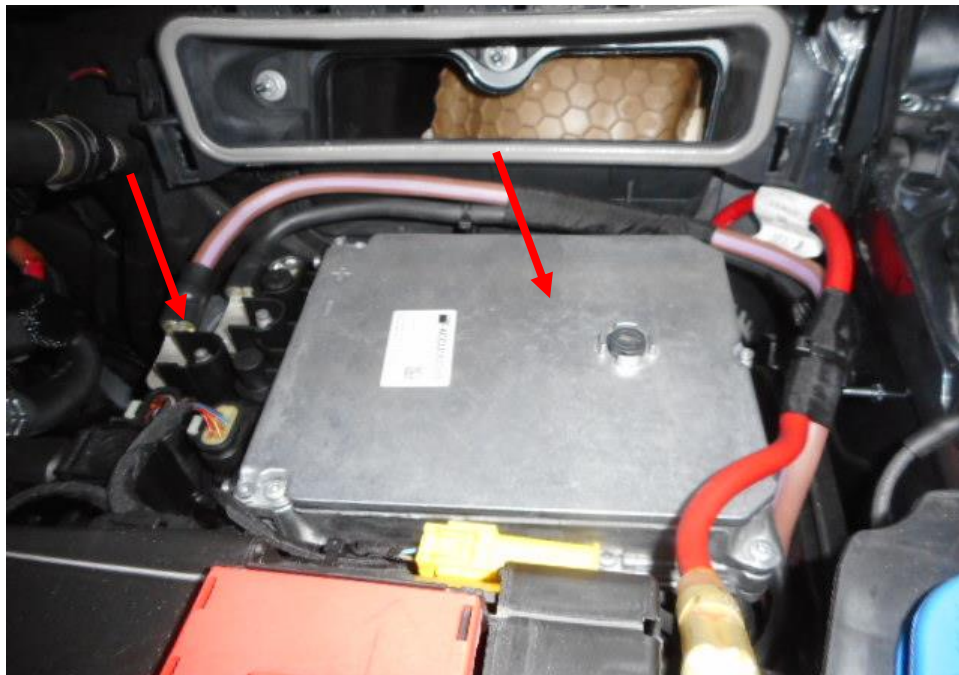
Photo 6 shows the close up view of the 48v battery and its components (arrowed) in the engine compartment portion of the Insured Vehicle at the time of our inspection. The 48v battery and its components is observed to be unaffected and by any signs of accident.

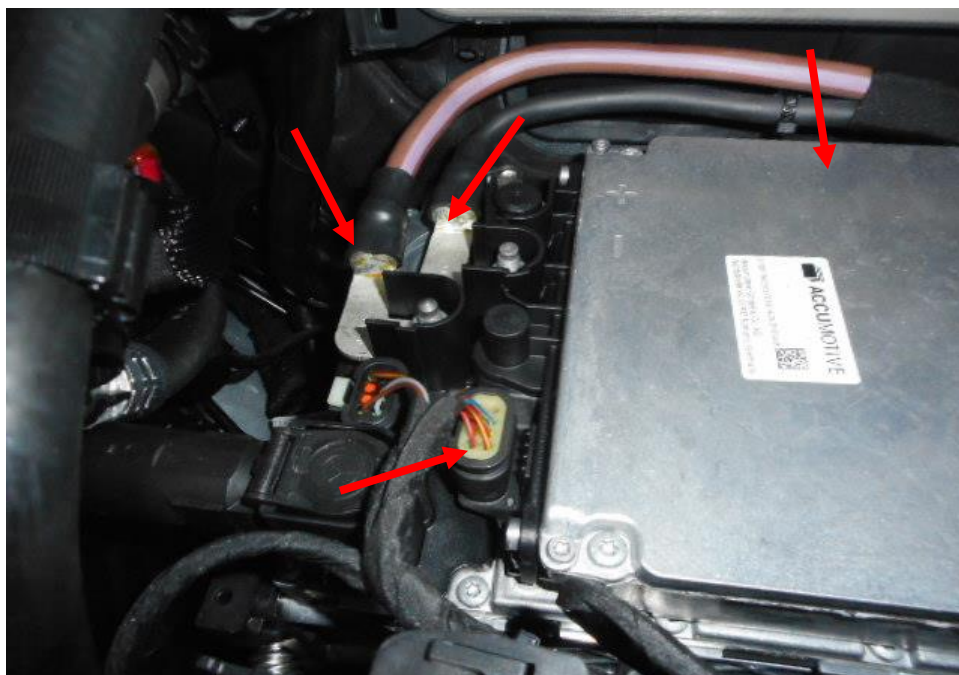
Photo 7 shows the close up view of the 48v battery and its components (arrowed) in the engine compartment portion of the Insured Vehicle at the time of our inspection. The 48v battery and its components is observed to be unaffected and by any signs of accident.

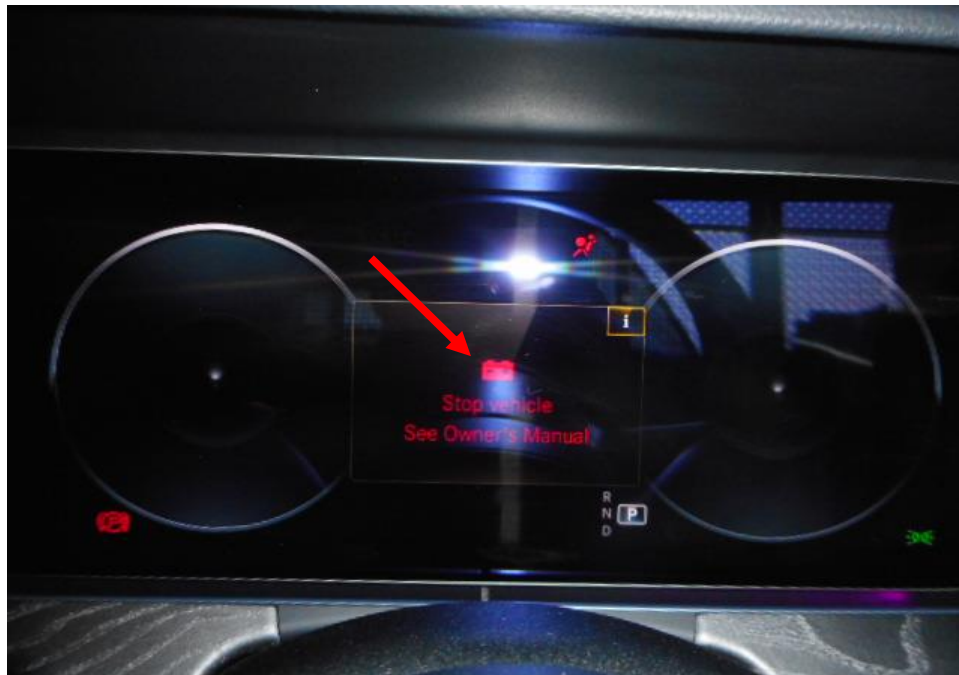
Photo 8 shows the conducted ECU diagnosis of the Insured Vehicle at the time of our inspection. There was an electronic error (arrowed) on the 48v battery integrated starter system (ISG) of the Insured Vehicle.

Fault	Text	Status
B183319	The battery for the 48V on-board electrical system has a malfunction. The limit value for current has been exceeded. ←	S
	Name	First occurrence
	Frequency counter	---
	Main odometer reading	16208.00km
	Number of ignition cycles since the last occurrence of the fault	13.00
B183349	The battery for the 48V on-board electrical system has a malfunction. There is an internal electrical fault. ←	A+S
	Name	First occurrence
	Frequency counter	---
	Main odometer reading	16224.00km
	Number of ignition cycles since the last occurrence of the fault	0.00
B183371	The battery for the 48V on-board electrical system has a malfunction. The actuator is blocked.	A+S
	Name	First occurrence
	Frequency counter	---
	Main odometer reading	16224.00km
	Number of ignition cycles since the last occurrence of the fault	0.00

8. We did not find any evidence which had suggested that the cause of abnormalities to the Insured Vehicle was due to poor maintenance and/or recurring problem.
9. The recommendation to replace the 48V battery at \$3,654.05 is justifiable as all the relevant checks has been conducted.
