# PRECISION APPRAISAL SERVICES

## AUTOMOBILE INSPECTION REPORT

Assigned By : As above  
Accident Date : 15 December 2022  
Assignment Date : 16 December 2022  
Inspection Date : 16 November 2022  
Our Reference No. : PAS/HH/230108/TP

Registration No. : SMQ9215U  
Make/Model : HONDA CIVIC 1.6 VTI CVT  
Yr of Manuf/Regn : 10 Dec 2019  
Carrying Capacity : 4Seater  
Chassis No. : MRHFC5650KT001171  
Engine No. : R16B25511344  
Colour : Metallic Blue  
Class : Passenger (Private)

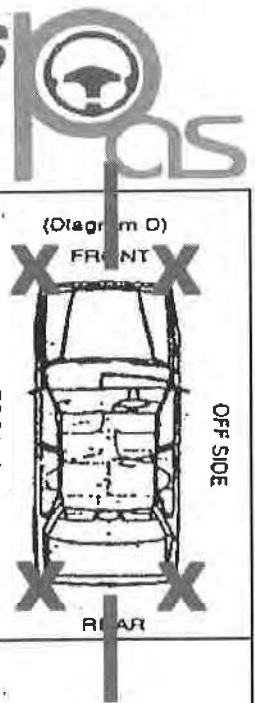
## POINT OF IMPACT (Diagram A)

Direction of impact/damage marked (→) (X)

The vehicle sustained impact on its Front & Rear Portion (see Diagram D)

Parts damaged were: The front and rear bumpers, both front and rear fenders and chassis, rear panel and reinforcement, front support panel were dented.
