Your Ref: SNB 1806J
Our Ref : CI/TP23001954/D

AUTOMOBILE INSPECTION REPORT OF MOTOR CAR SNB 1806J

Vehicle Registration No.	: SNB 1806J
Make / Model	: Nissan Skyline 2.5A
Chassis No	: ER34023845
Year of Registration	: 2000 (January)
Mileage	: 6,468km

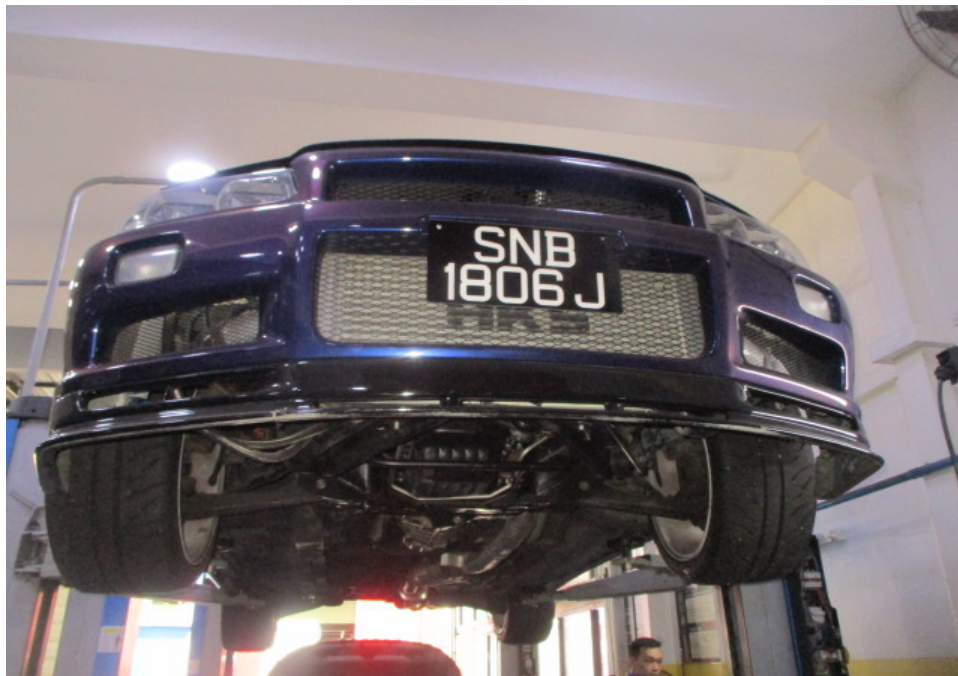
Photo 1 shows the Motor Car hoisted up for checks on its undercarriage, in particular to its transmission assembly.

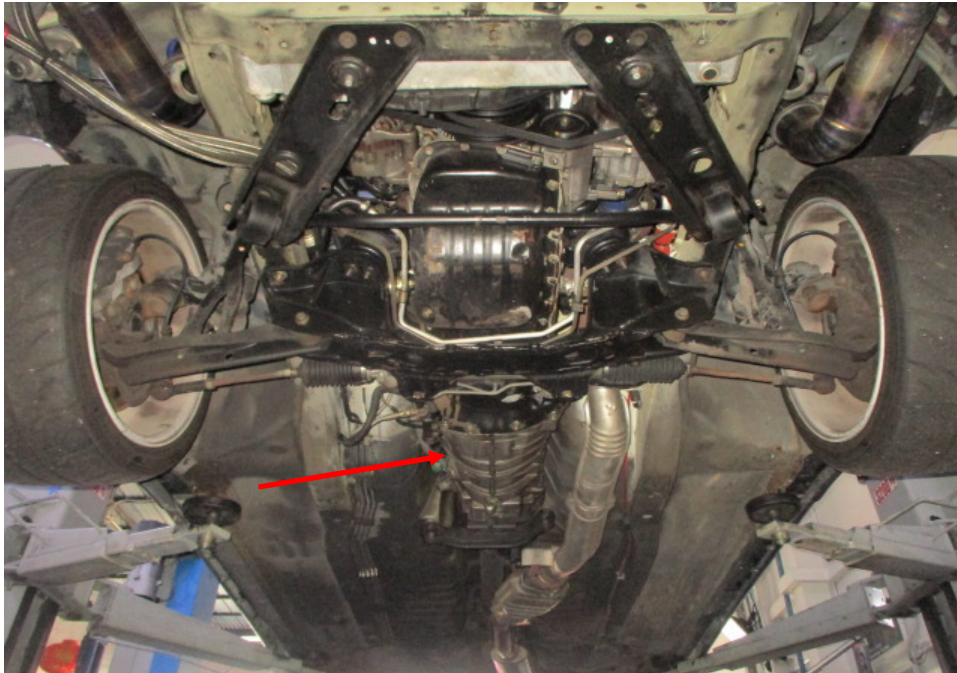
Photo 2 shows a general view of the transmission assembly (arrowed) that was fitted on the Motor Car, as viewed from the front to rear. The front (input) side of the transmission assembly is bolted to the crankshaft side of the engine block while the rear (output) side of the transmission assembly, connects to the propeller shaft, which links to the differential at the rear axle of the Motor Car.

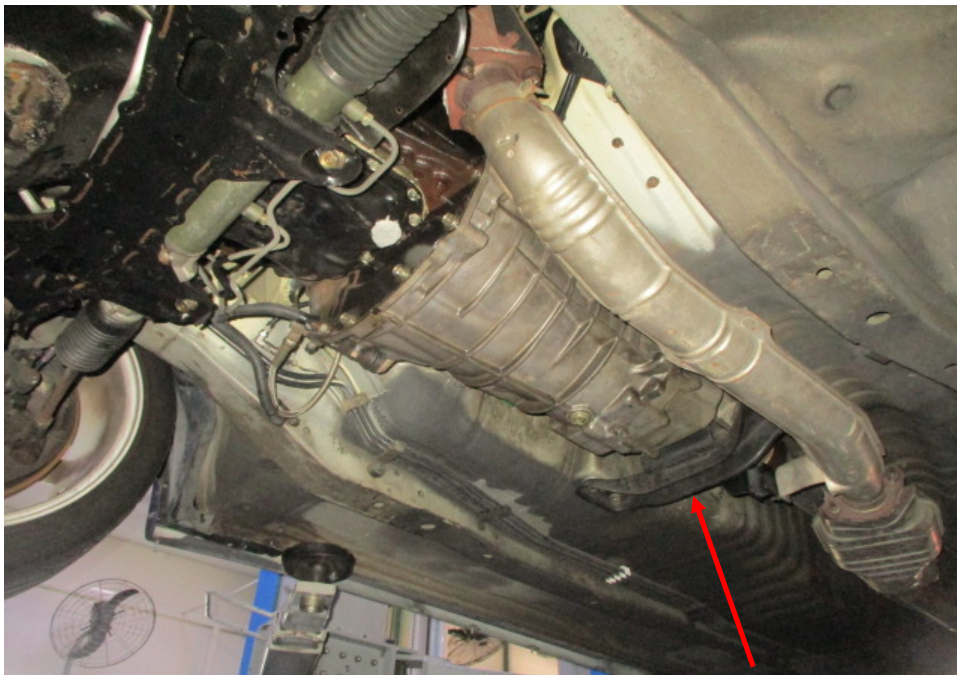
Photo 3 shows a general view of the bracket (arrowed) that was mounted to the underside of the Motor Car's floorboard, via bolts and nuts. The bracket supports the rear (output) side of the transmission assembly.

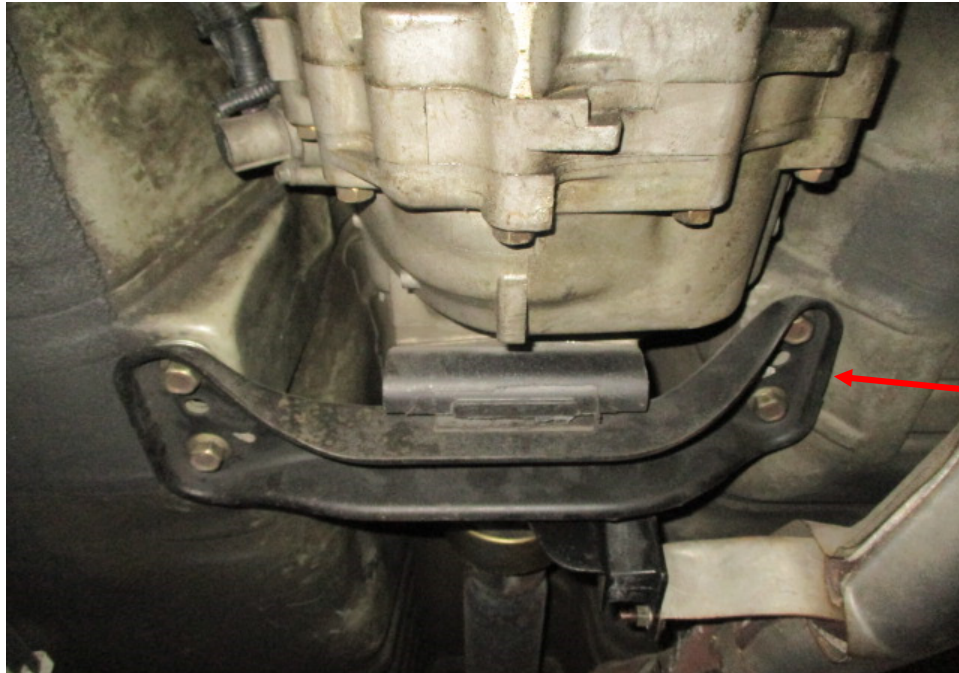
Photo 4 shows a closer view of the bracket (arrowed) that was mounted to the underside of the Motor Car's floorboard, via bolts and nuts. The bracket supports the rear (output) side of the transmission assembly. The bracket was also with rubber bushings that absorbs any vibrations arising from the rotation of the transmission gears, minimising any stress to the bracket.

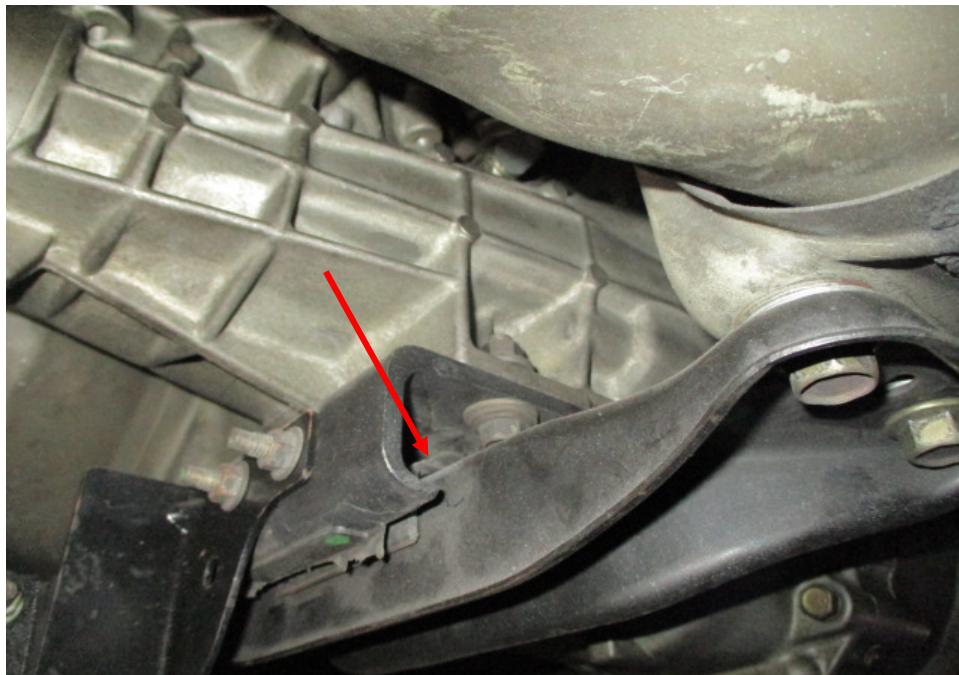
Photo 5 shows the rubber bushing (arrowed), sitting between the transmission assembly and the bracket. The rubber bushing absorbs any vibrations arising from the rotation of the transmission gears, minimising any stress to the bracket.

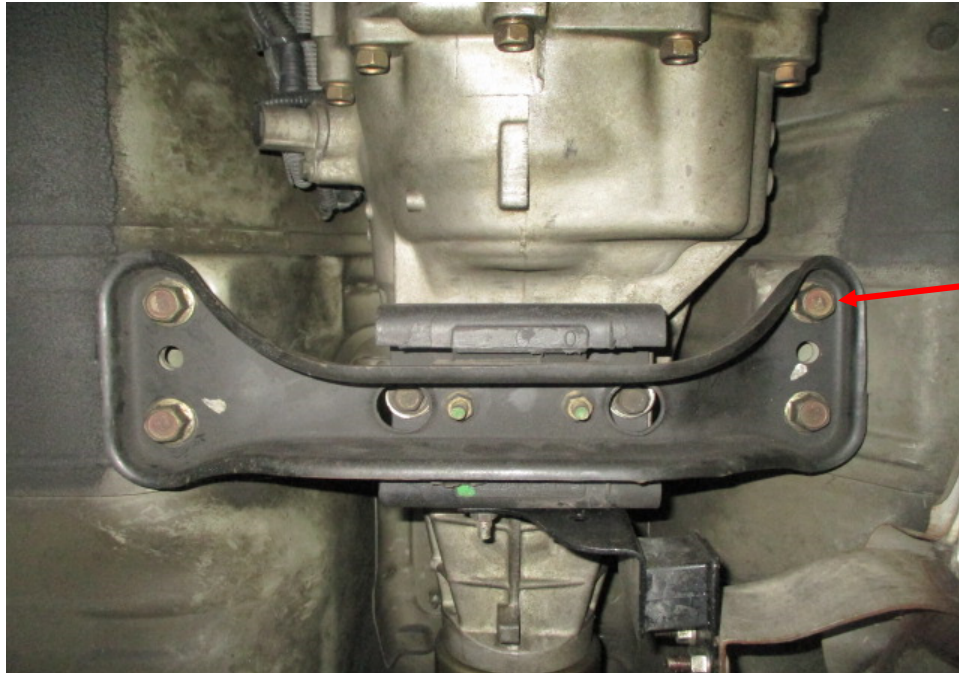
Photo 6 shows the bracket mounted to the underside of the Motor Car's floorboard, via bolts and nuts (arrowed).

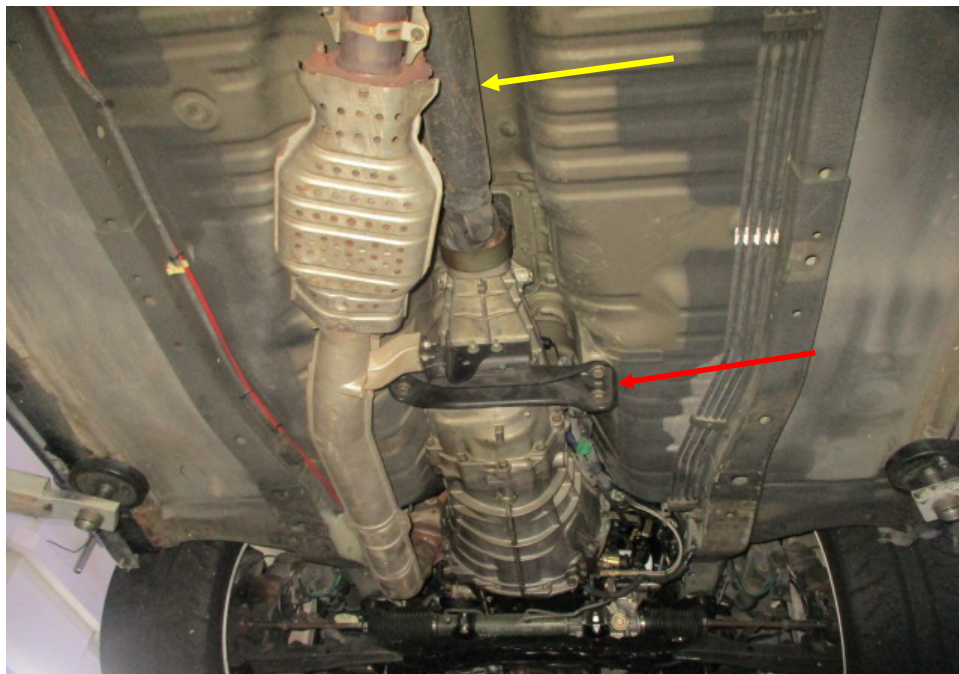
Photo 7 shows a general view of the transmission assembly that was fitted on the Motor Car, as viewed from the rear to front. The transmission assembly is supported by a bracket (red arrow) that is mounted to the underside of the Motor Car's floorboard, via bolts and nuts. The front (input) side of the transmission assembly is bolted to the crankshaft of the engine block while the rear (output) side of the transmission assembly, connects to the propeller shaft (yellow arrow), which links to the differential at the rear axle of the Motor Car.

10. In general, the transmission assembly of the Motor Car was found to be secured properly. It was not mounted onto the chassis body or any integral body part of the Motor Car. The structural integrity of the Motor Car is not compromised by the fitment of this particular transmission assembly. Overall, the operating condition of the Motor Car's transmission system was satisfactory throughout the Motor Car's test drive.

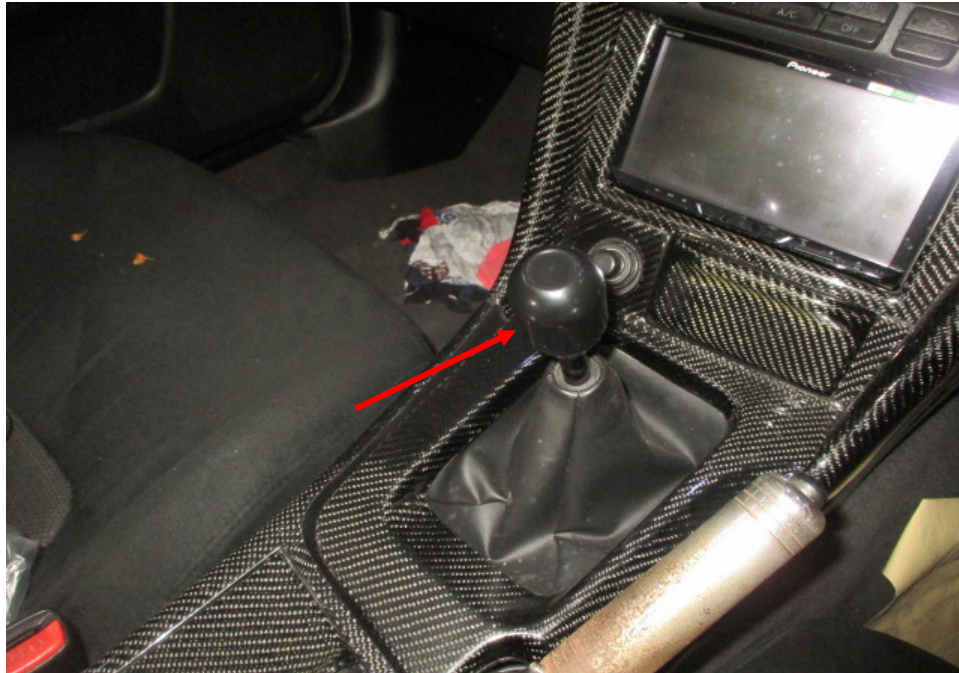
Photo 8 shows the manual gear shifter (arrowed) for manually selecting the transmission gear to be engaged.

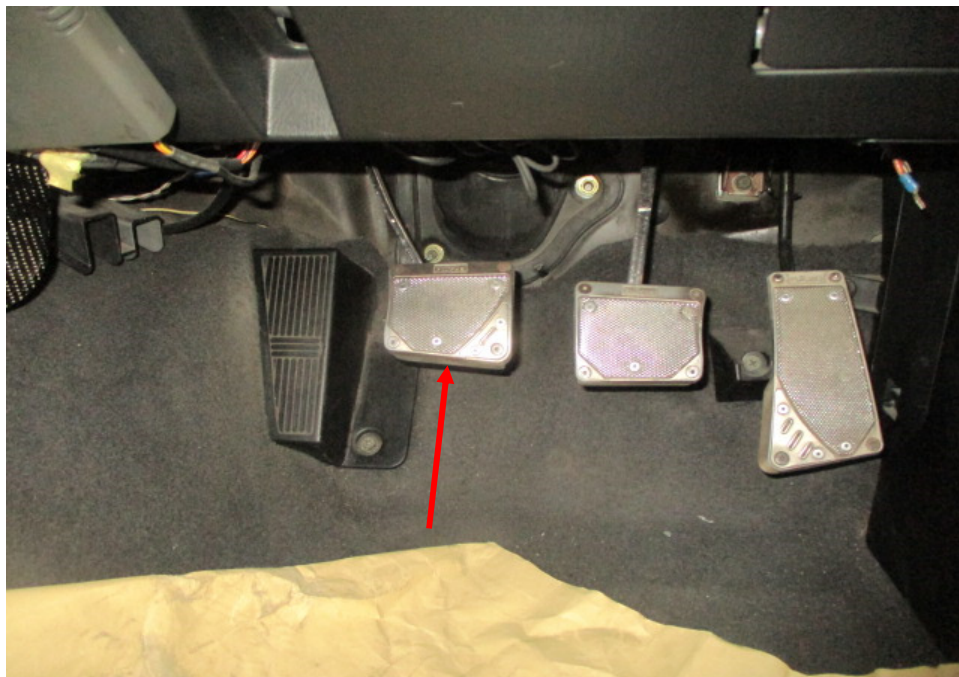
Photo 9 shows the clutch pedal (arrowed) for engaging and disengaging the transmission gears.
