Tommie Lim Appraisal

VEHICLE INSPECTION REPORT

Ref. no.	: TLA/2022/12/009	3rd party Veh.	: QX1209G
Accident on	: 11 Dec 2022	Claim tyre	: Third Party
Assign on	: 13 Dec 2022	Claim number	: To be advice
Inspection on	: 13 Dec 2022	Policy number	: To be advice
Workshop name	: Team AutoPro Pte Ltd	Finalize on	: 17 Dec 2022
Inspection at	: 160 Sin Ming Drive #02-12 Sin Ming AutoCity Singapore 575722	Final report on	: 19 Dec 2022

Vehicle number	: SLQ3540G	Registration date	: 5 Jul 2017
Make	: HONDA	Chassis number	: RU31249576
Model	: VEZEL HYBRID	Engine number	: LEB5949594
Body colour	: WHITE	Engine capacity	: 1496 CC
Odometer	: 85079 KM	Transmission	: AUTOMATIC

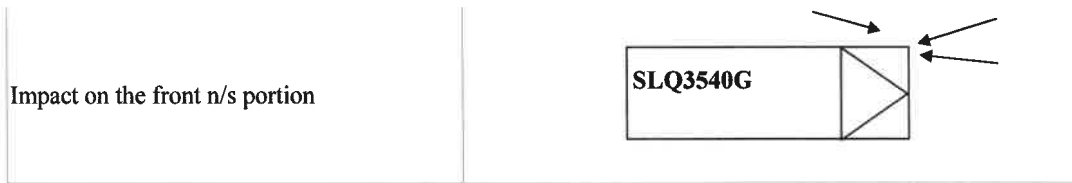
POINT OF IMPACT

The impact of the collision has damaged/affected the front n/s head lamp. Front bumper assy and etc...
