SLM 7789B Yr Regn: 04, 19

Make: Toy Voxy C.G. 1797

Repair Estimates

SINGAPORE ACCIDENT STATEMENT

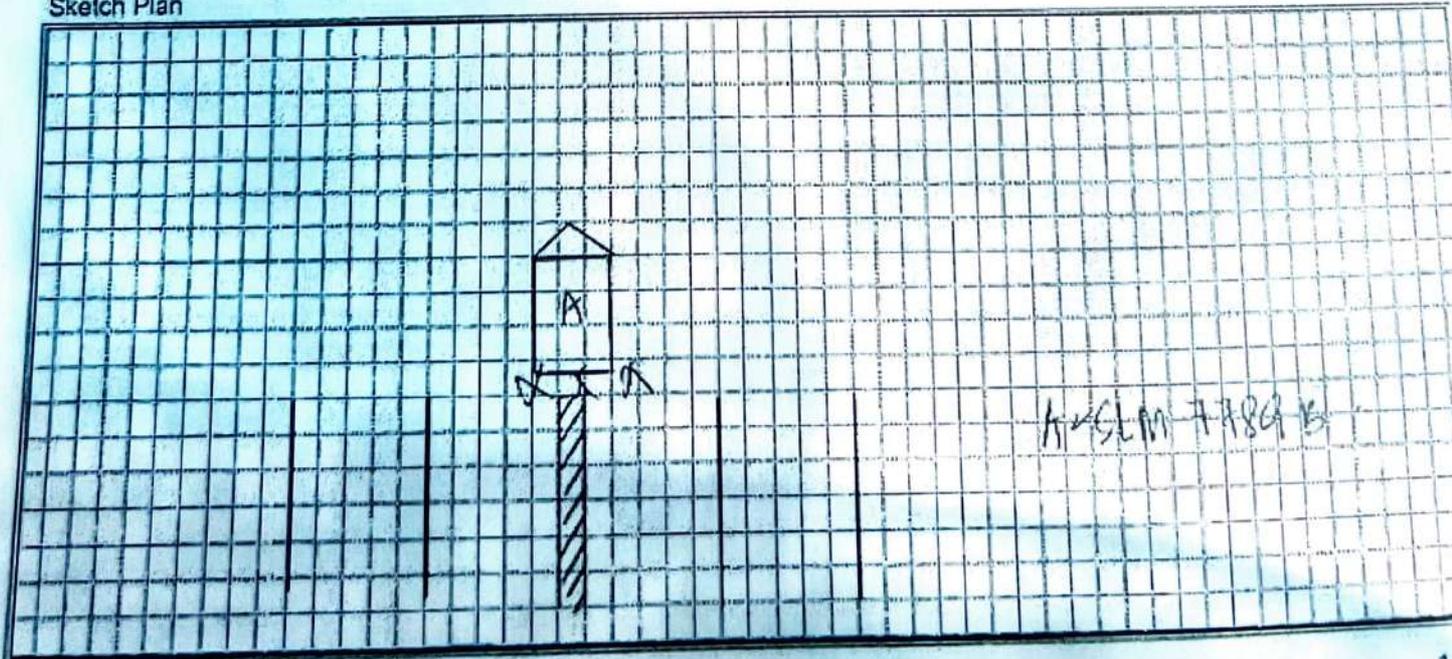
Sketch Plan

I was driving along Chinatown Hawker Centre 2nd floor Carpark. When I was reversing park into the Carpark lot, I accidently hit on to the wall.
