Your Ref: Mercedes Benz GT 43  
(chassis number W1K2906592A033355)  
Our Ref : CI/TP23002450/D

08 March 2023

**GC International Import Pte Ltd**

**INSPECTION REPORT OF AN UNREGISTERED MERCEDES BENZ GT 43  
MOTOR CAR WITH CHASSIS NUMBER W1K2906592A033355**

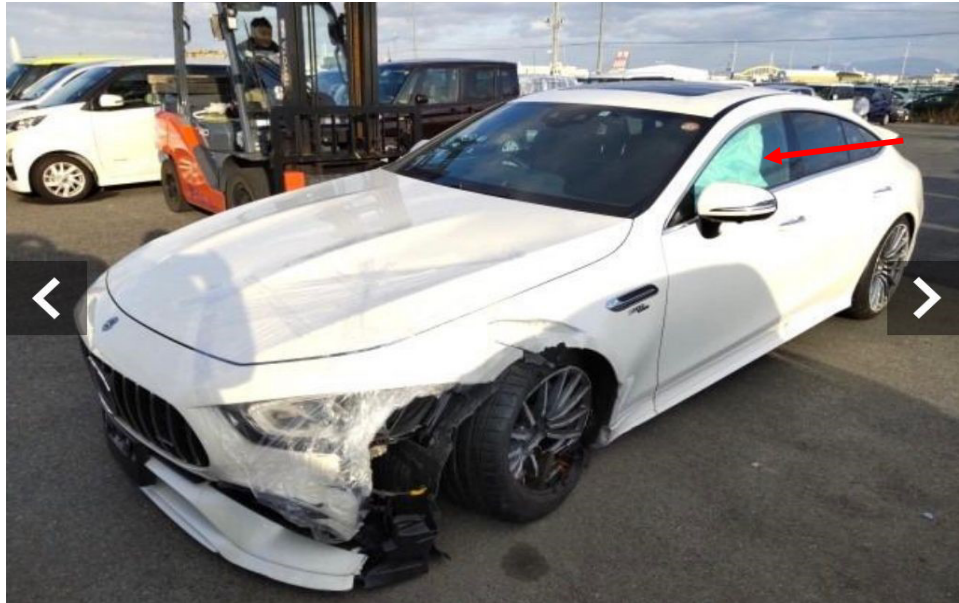
3. The photographs provided to me had showed damage to the front left portion of the Motor Car. Body parts damaged include the front bumper, front bumper centre lower garnish, front bumper left bracket, front bumper left lower grille, front bumper left lower grille garnish, front bumper left sensors, front left headlamp, front left fender, front left fender inner shield, front left wheel rim, front left tyre and left side rocker panel garnish amongst others.

5. Apart for the front left portion, there was no physical damage observed to other areas of the Motor Car. The driver's airbag, driver's knee airbag and front left curtain airbag were deployed. See photo 1 – 7 below.

**Photo 1** shows the front left body of the Motor Car (photograph provided to me). The photographs provided to me had showed damage to the front left portion of the Motor Car. The front bumper, front bumper centre lower garnish, front bumper left bracket, front bumper left lower grille, front bumper left lower grille garnish, front bumper left sensors, front left headlamp and front left fender were amongst the body parts that were observed to have been damaged. The left curtain airbag was deployed (arrowed).

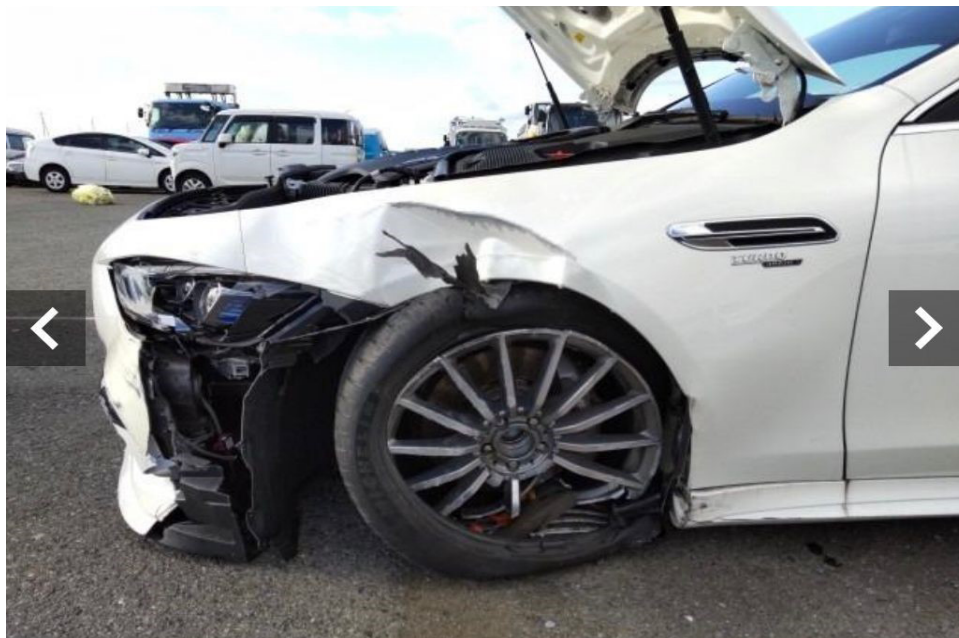
4. The front left wheel was observed to be pushed backwards, contacting onto the body of the Motor Car. This would indicate damage to the undercarriage parts at the front left wheel of the Motor Car. Undercarriage parts that may possibly be damaged include the front left lower arm, front left knuckle arm, front left shock absorber and front left steering tie rod end amongst others.

**Photo 2** shows a closer view of the damage at the front left body of the Motor Car (photograph provided to me). The front bumper, front left headlamp, front left fender, front left fender inner shield, front left wheel rim, front left tyre and left side rocker panel garnish were amongst the body parts that were observed to have been damaged. The front left wheel was observed to be pushed backwards, contacting onto the body of the Motor Car. This would indicate damage to the undercarriage parts at the front left wheel of the Motor Car.

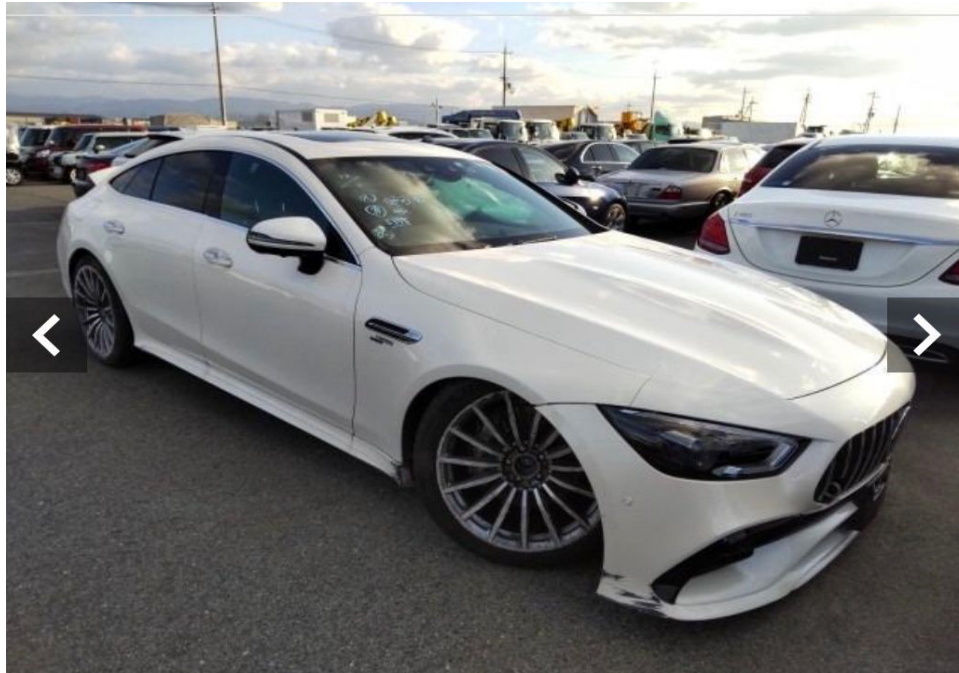
**Photo 3** shows the front right body of the Motor Car (photograph provided to me). Apart for the front left portion, there was no physical damage observed to other areas of the Motor Car.

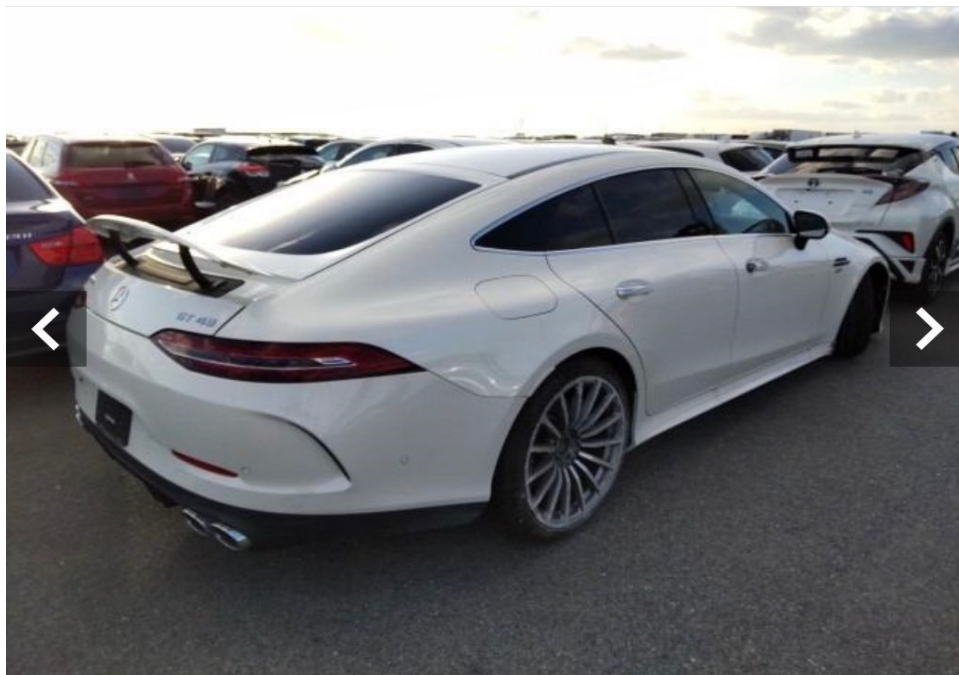
**Photo 4** shows the rear right body of the Motor Car (photograph provided to me). Apart for the front left portion, there was no physical damage observed to other areas of the Motor Car.

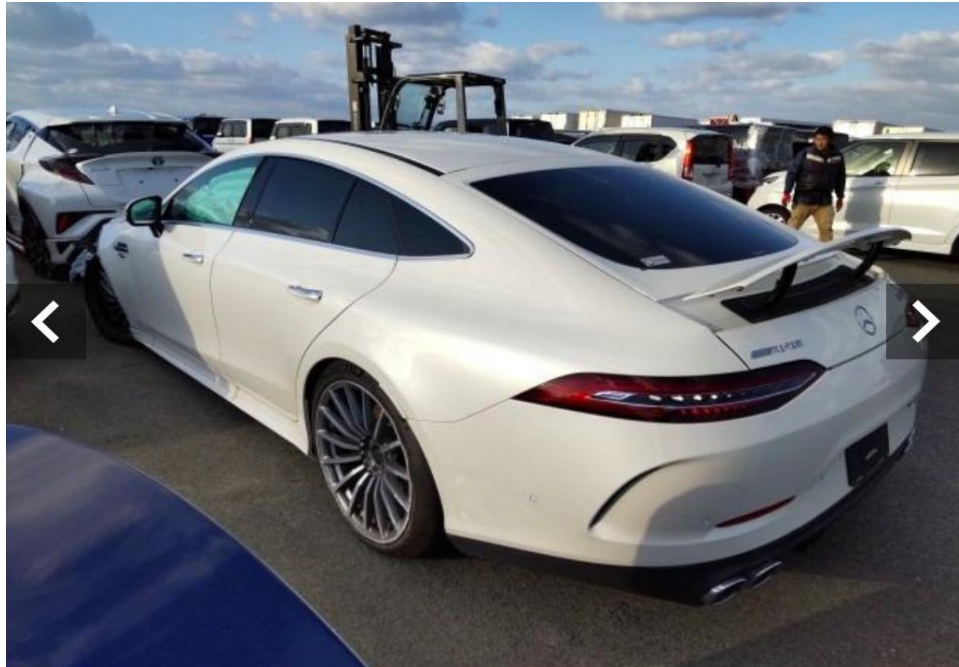
**Photo 5** shows the rear left body of the Motor Car (photograph provided to me). Apart for the front left portion, there was no physical damage observed to other areas of the Motor Car.

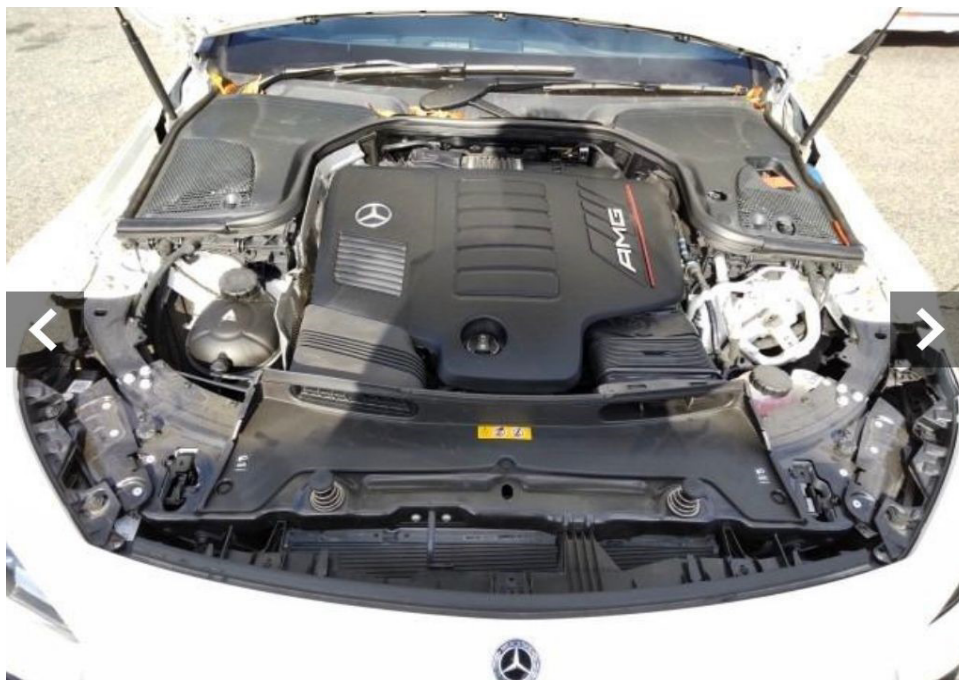
**Photo 6** shows the engine compartment of the Motor Car (photograph provided to me). The various parts and components within the engine compartment were all intact and unaffected.

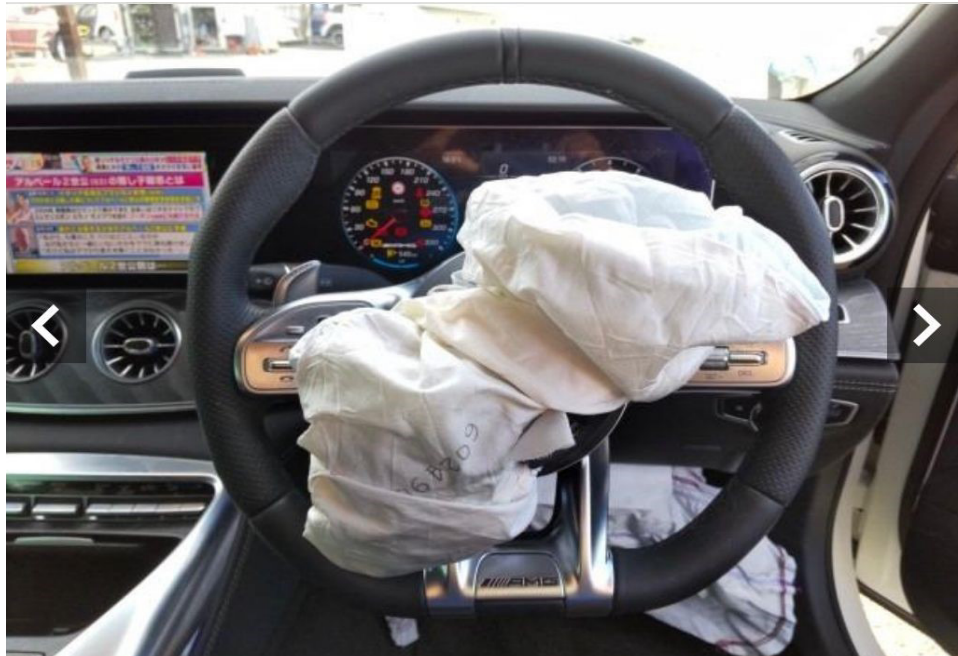
**Photo 7** shows the interior compartment of the Motor Car (photograph provided to me). The driver's airbag and driver's knee airbag were deployed.

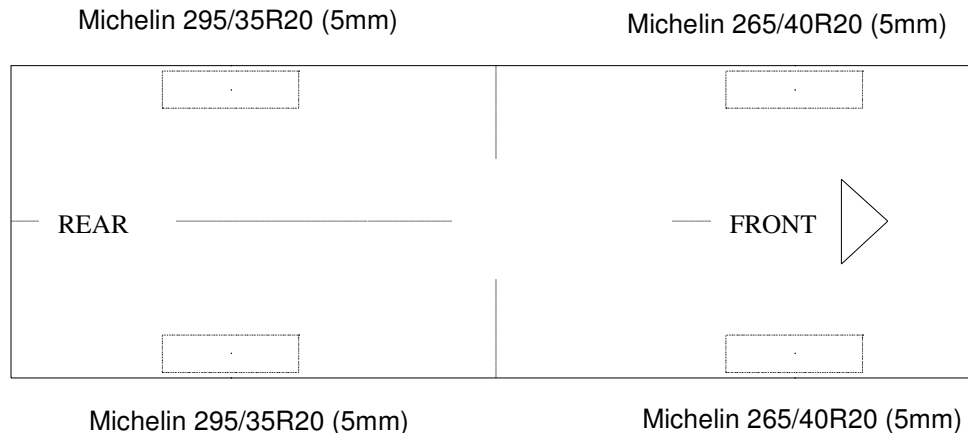
9. The Motor Car was fitted with 20inch sport wheel rims that were wrapped with tyres that were observed to be of serviceable condition. The tyres were also sufficiently inflated for vehicular operation. The tyre brand, tyre size and approximate remaining tread depth of the 4 tyres of the Motor Car were recorded as follows: -

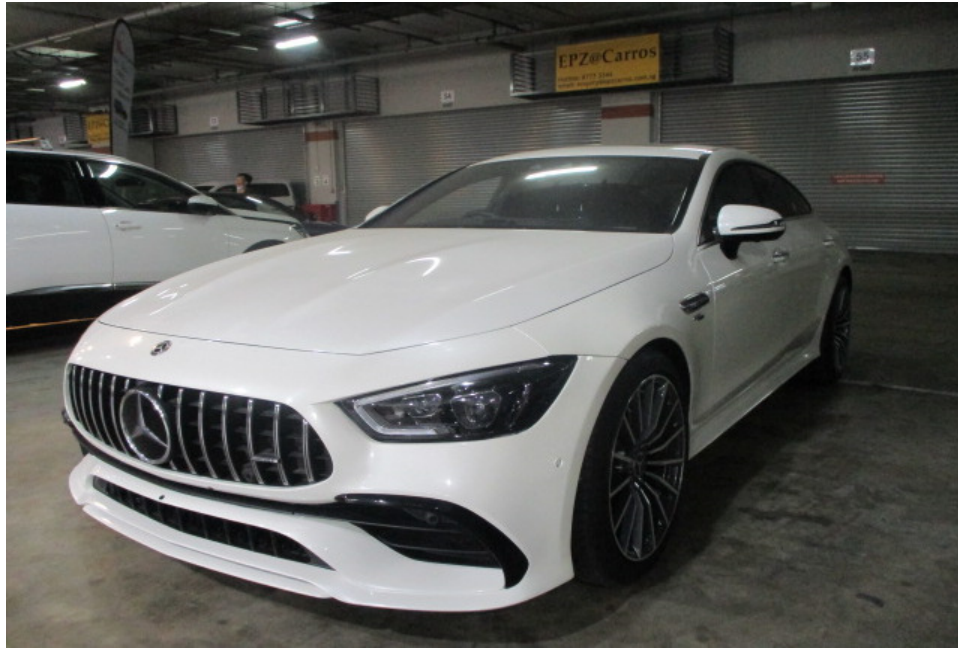
23. The body parts at the front left portion and the undercarriage parts at the front left wheel of the Motor Car were visually examined and it was noted that the repair/restoration works carried out to the damaged area of the Motor Car (refer to photograph 1 & 2 above) were reasonably adequate and in order.

**Photo 8** shows a general view of the front left body of the Motor Car at the time of my inspection. The Motor Car was observed to be in a relatively good general condition with no loose exterior fittings observed. The body parts at the front left portion of the Motor Car were visually examined and it was observed that the repair/restoration works carried out to the damaged area of the Motor Car (refer to photograph 1 & 2 above) were reasonably adequate and in order.

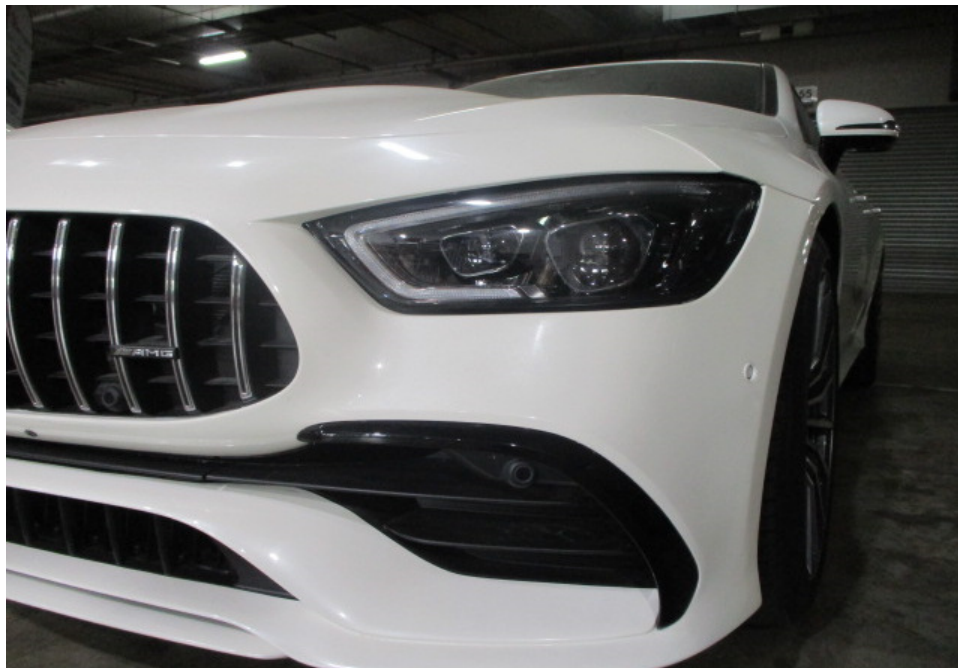
**Photo 9** shows a closer view of the Motor Car's front bumper, front bumper centre lower garnish, front bumper left lower grille, front bumper left lower grille garnish, front bumper left sensors and front left headlamp. The body parts at the front left portion of the Motor Car were visually examined and it was observed that the repair/restoration works carried out to the damaged area of the Motor Car (refer to photograph 1 & 2 above) were reasonably adequate and in order.

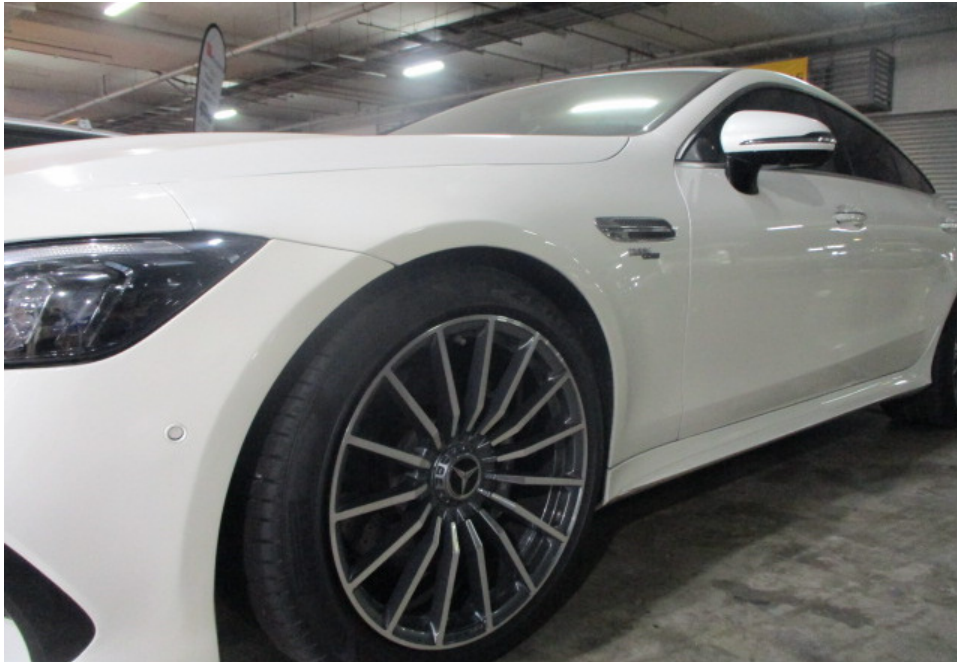
**Photo 10** shows a closer view of the Motor Car's front left headlamp, front left fender, front left wheel rim and front left tyre. The body parts at the front left portion of the Motor Car were visually examined and it was observed that the repair/restoration works carried out to the damaged area of the Motor Car (refer to photograph 1 & 2 above) were reasonably adequate and in order.

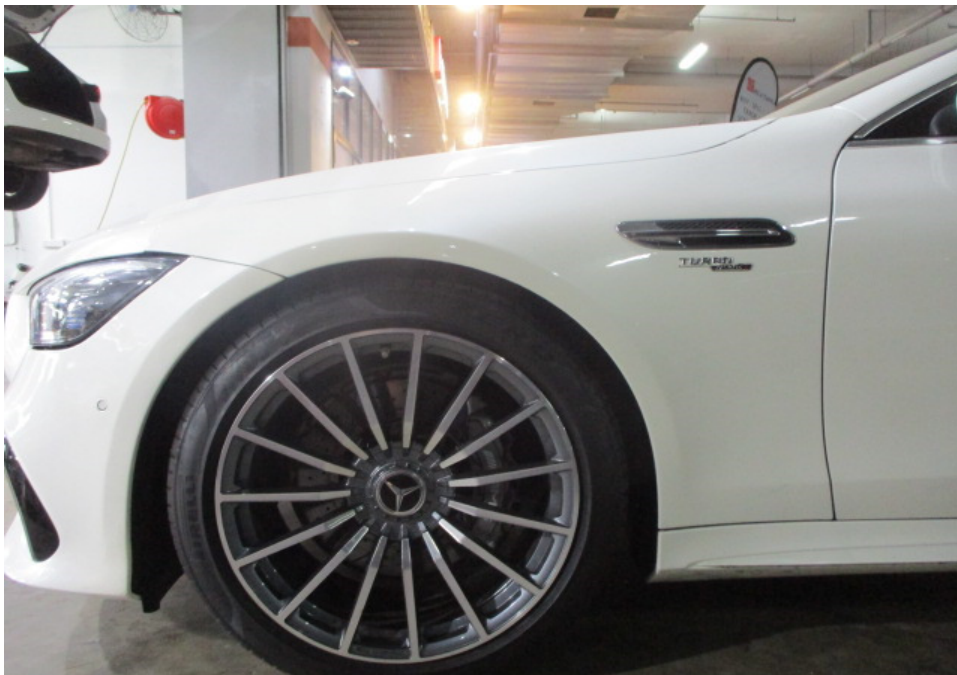
**Photo 11** shows a closer view of the Motor Car's front bumper, front left headlamp, front left fender, front left wheel rim, front left tyre and left side rocker panel garnish. The body parts at the front left portion of the Motor Car were visually examined and it was observed that the repair/restoration works carried out to the damaged area of the Motor Car (refer to photograph 1 & 2 above) were reasonably adequate and in order.

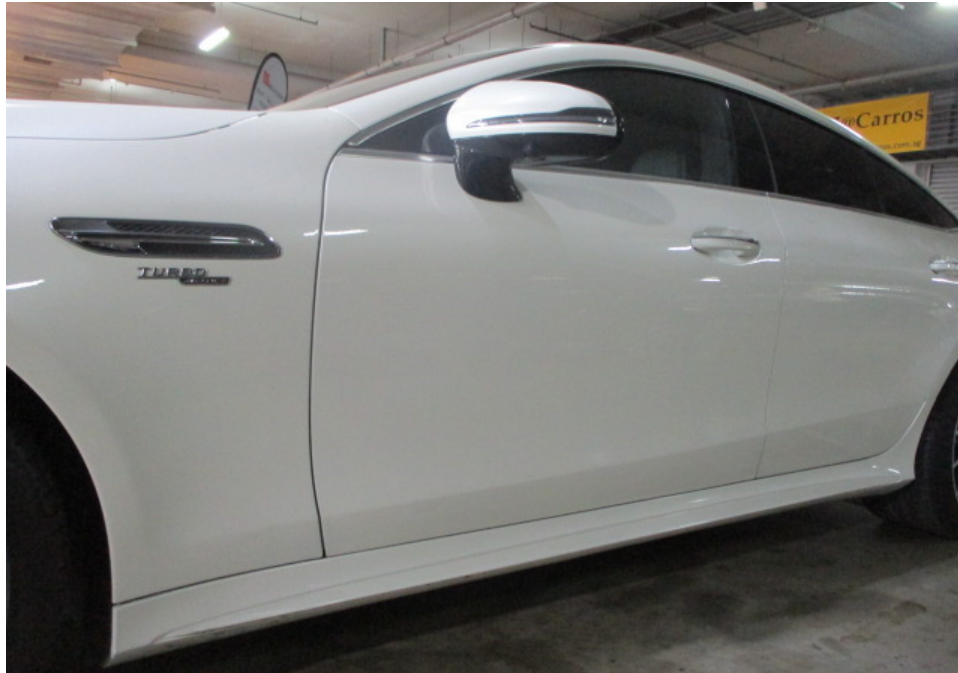
**Photo 12** shows a closer view of the Motor Car's front left door, left side rocker panel garnish and left side wing mirror. The body parts at the front left portion of the Motor Car were visually examined and it was observed that the repair/restoration works carried out to the damaged area of the Motor Car (refer to photograph 1 & 2 above) were reasonably adequate and in order.

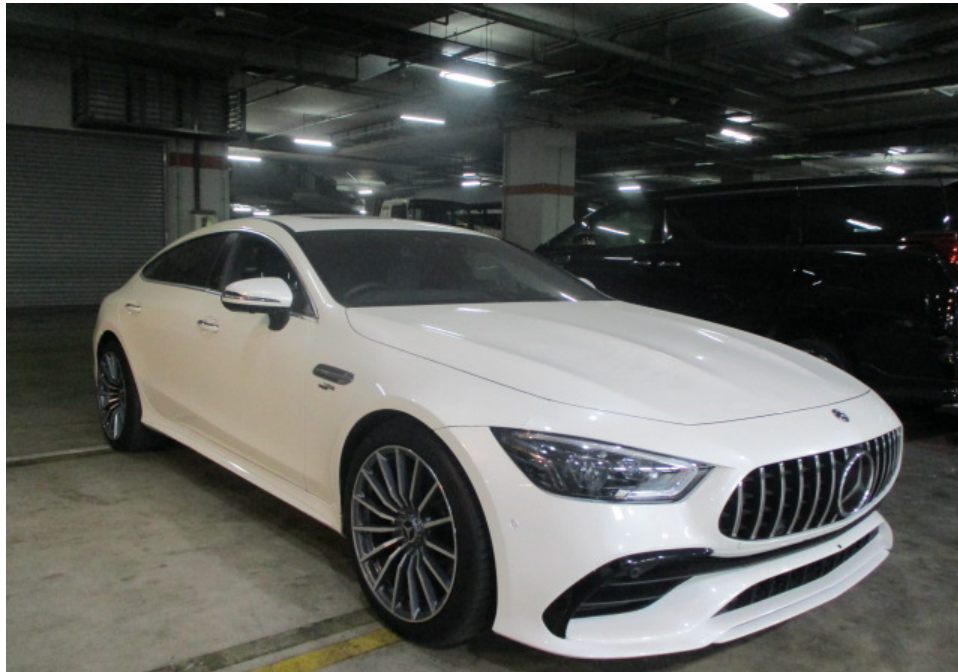
**Photo 13** shows a general view of the front right body of the Motor Car at the time of my inspection. The Motor Car was observed to be in a relatively good general condition with no loose exterior fittings observed. The mileage of the Motor Car recorded at the time of my inspection was 16,386km.

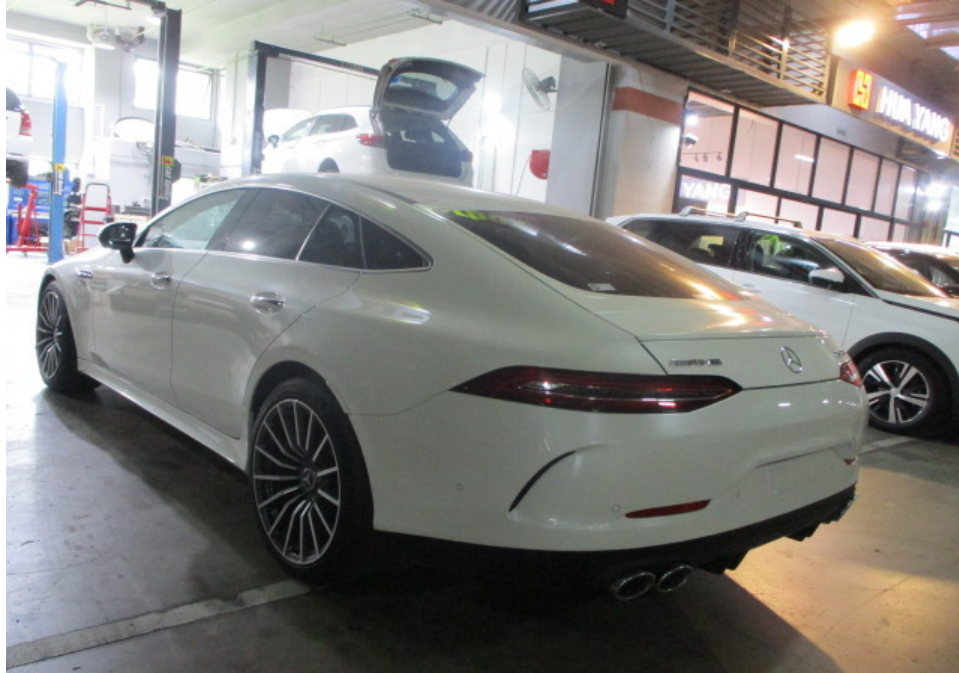
**Photo 14** shows a general view of the rear left body of the Motor Car at the time of my inspection. The Motor Car was observed to be in a relatively good general condition with no loose exterior fittings observed. The mileage of the Motor Car recorded at the time of my inspection was 16,386km.

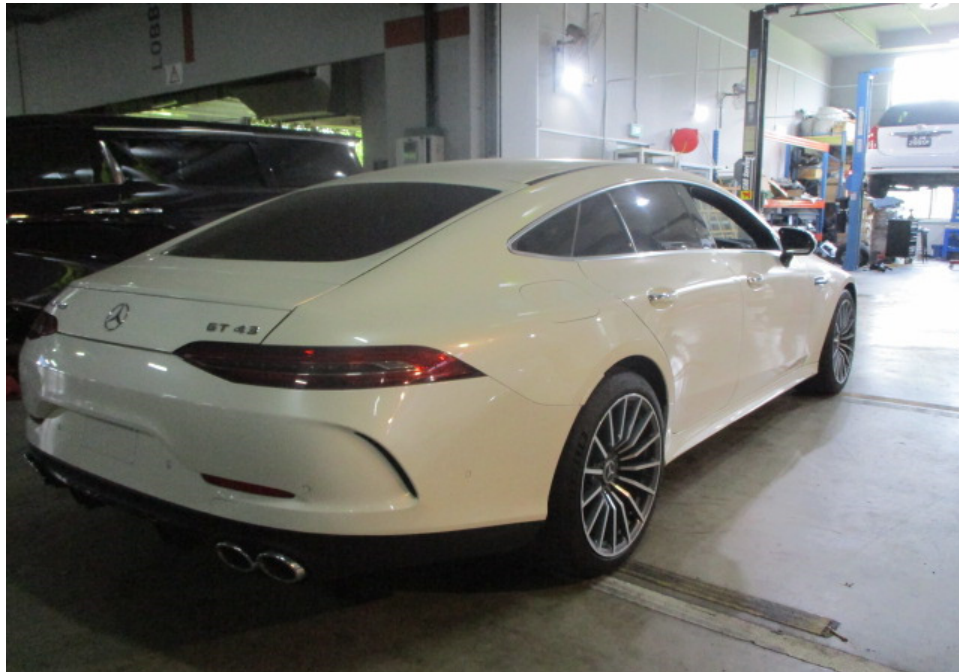
**Photo 15** shows a general view of the rear right body of the Motor Car at the time of my inspection. The Motor Car was observed to be in a relatively good general condition with no loose exterior fittings observed. The mileage of the Motor Car recorded at the time of my inspection was 16,386km.

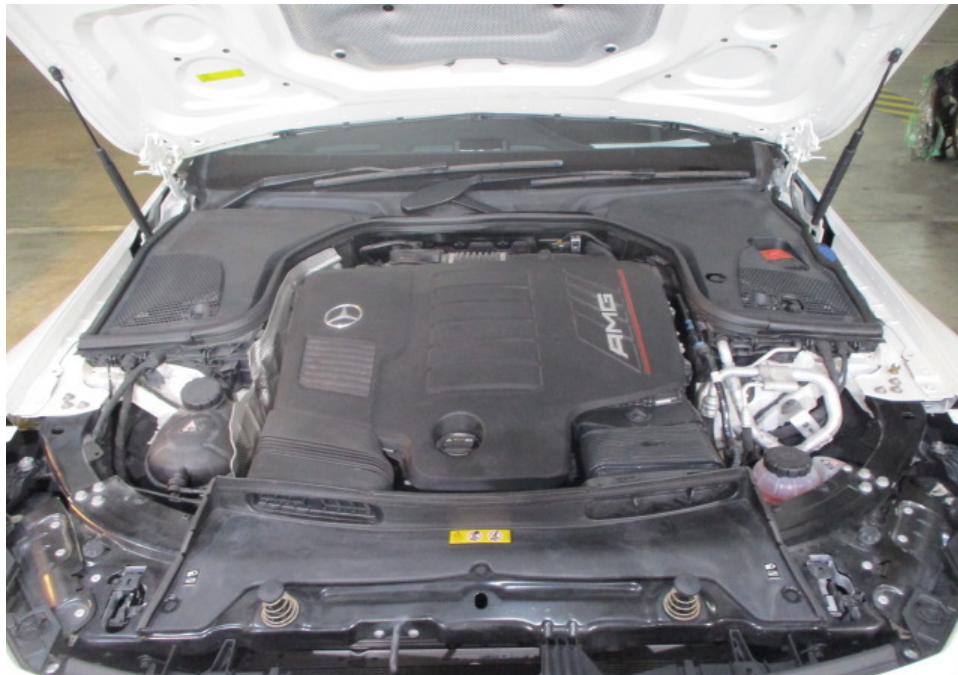
15. My examination of the engine compartment of the Motor Car revealed that the various parts and components inside the engine compartment were all intact and properly fitted. The engine oil, brake fluid and engine coolant were all found to be of sufficient level for operating purposes. Visually, there was also no contamination found to these fluids.

**Photo 17** shows a general view of the Motor Car's engine compartment at the time of my inspection. The various parts and components inside the engine compartment were all observed to be intact and properly fitted. There was also no sign(s) or indication(s) of fluid leak and/or fluid stain found inside the engine compartment.

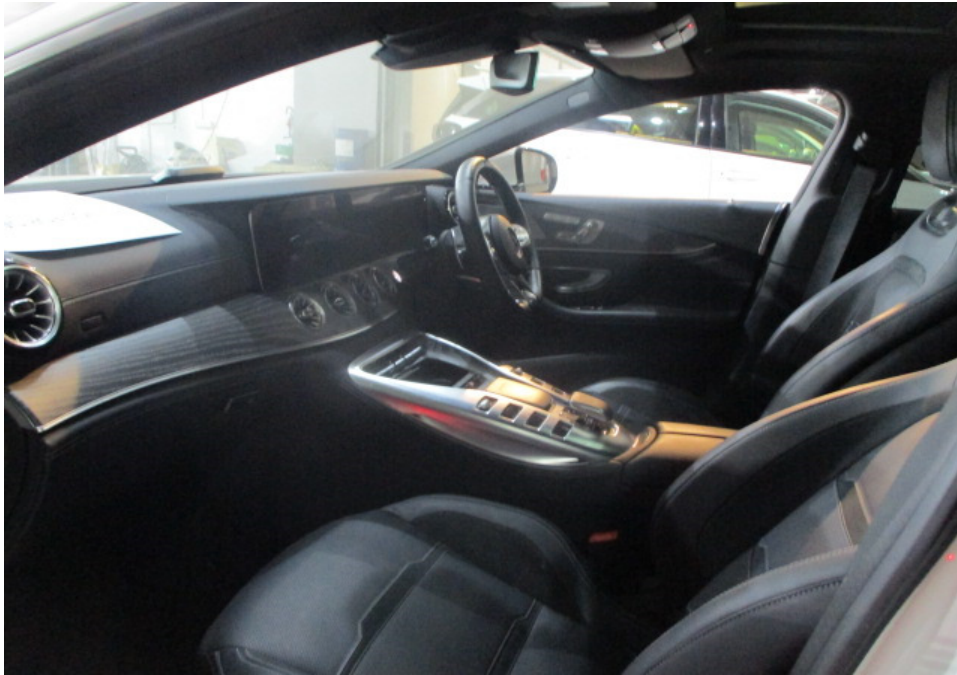
**Photo 18** shows the interior compartment of the Motor Car at the time of my inspection. The various parts and components, trims, carpet, and upholstery inside the interior compartment were all observed to be intact and properly fitted.

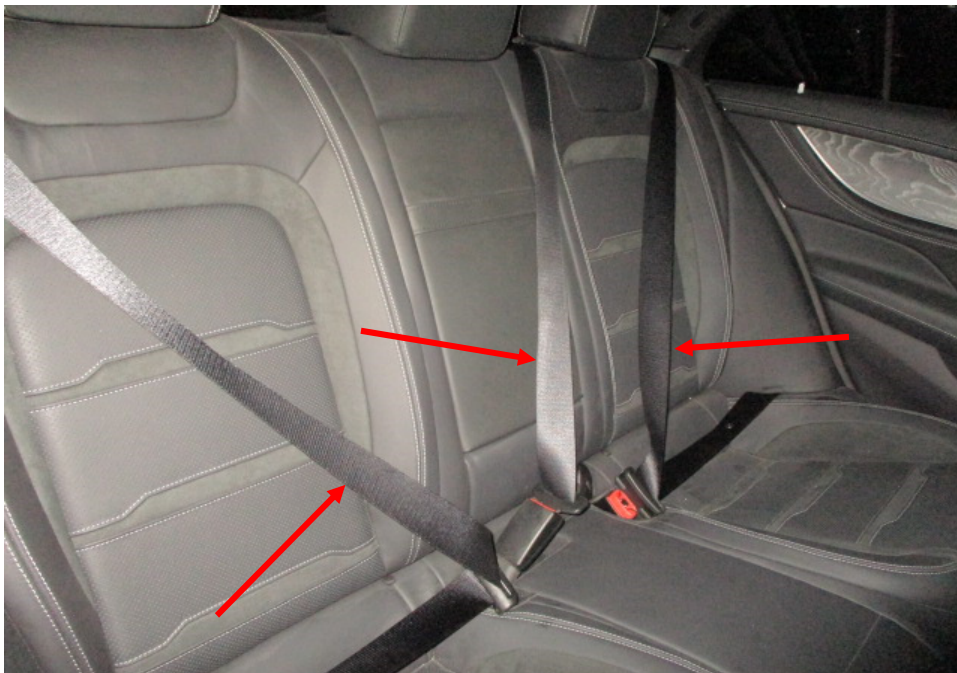
13. The seats of the Motor Car were found to be secured to the floorboard of the Motor Car via seat rails bolted onto the floorboard. Retractable seat belt reels and pre-tensioners were fitted on all seats of the Motor Car. The seat belts were tested and were able to be fastened securely into the respective pre-tensioners that were fixed to the side of all the seats.

**Photo 19** shows the rear seats of the Motor Car. All the seats of the Motor Car were secured via seat rails to the floorboard. They were also fitted with a retractable seat belt reel and a pre-tensioner. The seat belts (arrowed) were tested and were able to be fastened into the respective pre-tensions that were fitted on the side of each individual seat.

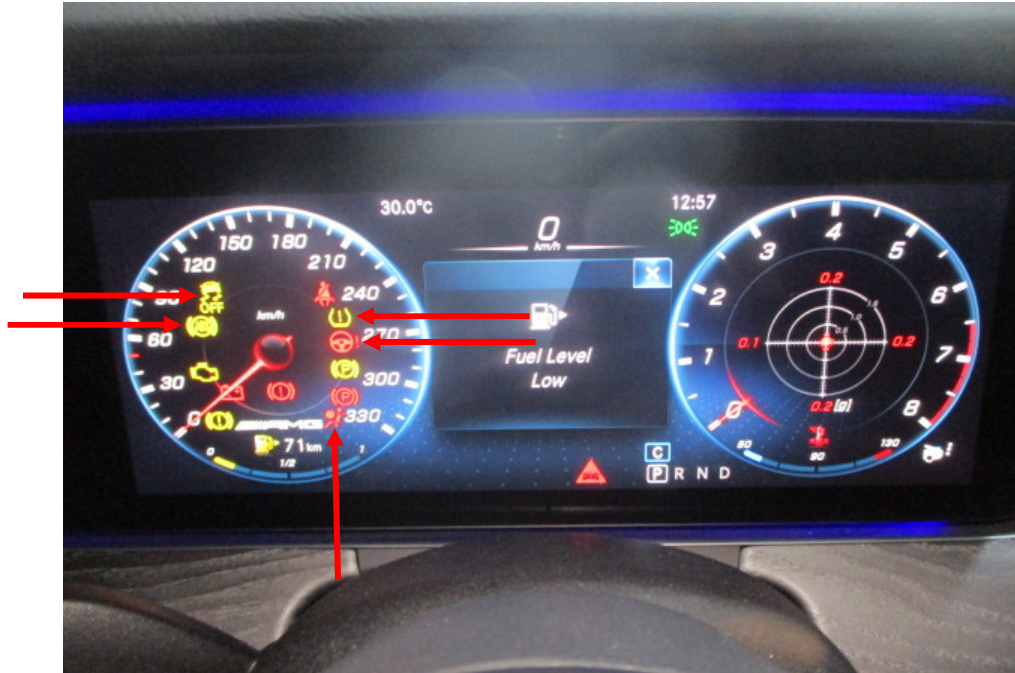
**Photo 20** shows the warning lights for the various electronic safety features appearing on the instrument panel of the Motor Car during its self-test when the engine is cranked, in particular the ABS, SRS, EPS, TPM and TCS lights (arrowed).

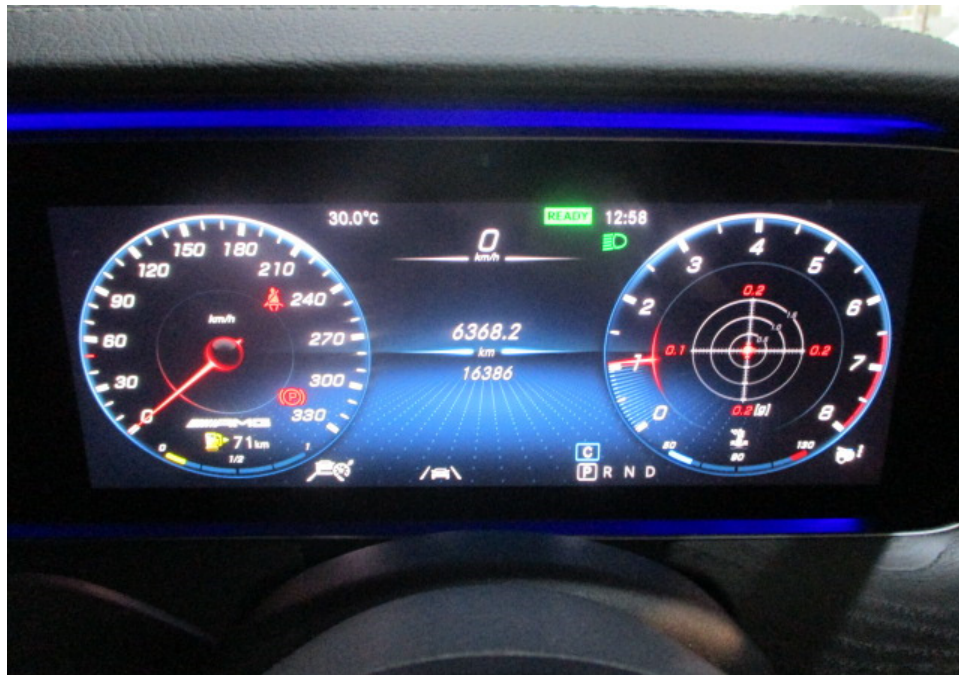
14. The Motor Car's automatic self-test of the functionality of its various electronic safety features like the Anti-Lock Brake System (ABS), Supplemental Restraint System (SRS), Electric Power Steering (EPS), Tyre Pressure Monitor (TPM) and Traction Control System (TCS) during cranking of the engine had indicated that these electronic systems were in working condition. This was determined from the respective warning lights disappearing from the instrument panel after the self-test.

**Photo 21** shows the respective warning lights no longer illuminated, indicating that there is no fault detected to the ABS, SRS, EPS, TPM and TCS systems of the Motor Car during the self-test. These electronic systems were hence in working condition at the time of my inspection.

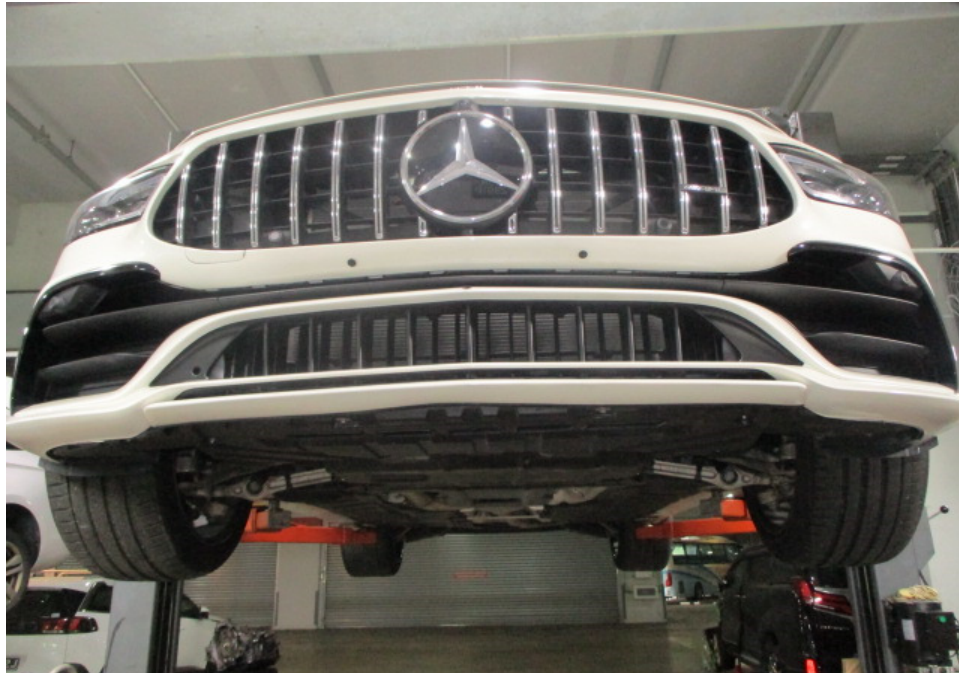
16. My checks on the underside of the Motor Car revealed no sign(s) or indication(s) of fluid leakage and/or fluid stain(s). The engine block and automatic transmission assembly were both secured properly. All undercarriage components of the Motor Car were also observed to be intact and secured in an appropriate manner.

**Photo 22** shows the Motor Car hoisted up for checks on its undercarriage. There was no sign(s) or indication(s) of fluid leakage and/or fluid stain(s) on the underside of the Motor Car. The undercarriage components of the Motor Car were also all observed to be intact and secured in an appropriate manner.

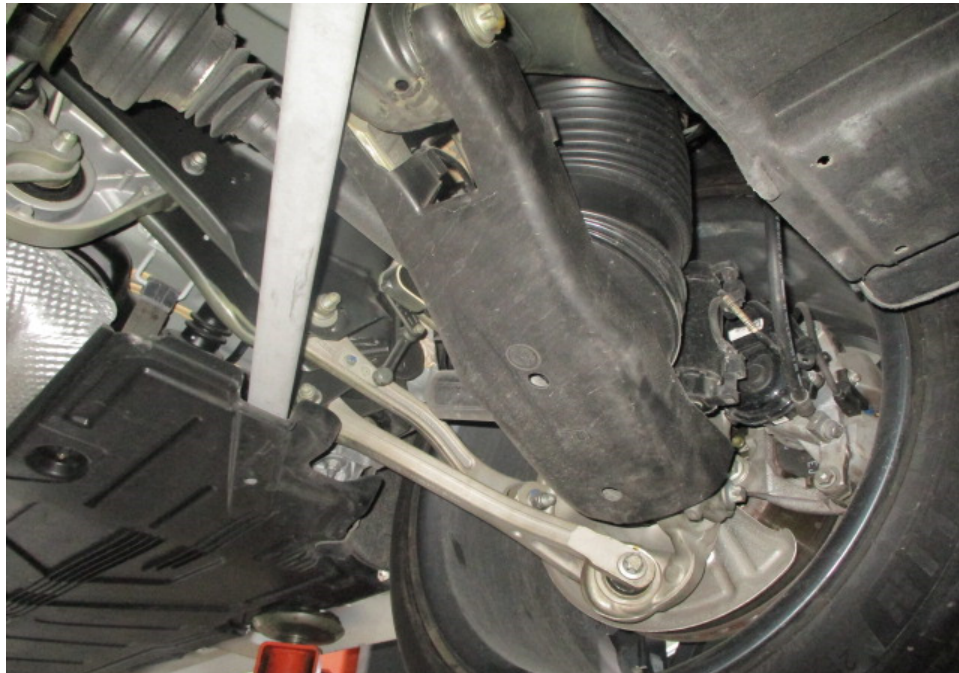
**Photo 23** shows a general view of the control arms and linkages at the rear right wheel of the Motor Car. I did not observe any fluid leak and/or fluid stain on the underside of the Motor Car. All of the Motor Car's undercarriage components were observed to be intact and secured in an appropriate manner.

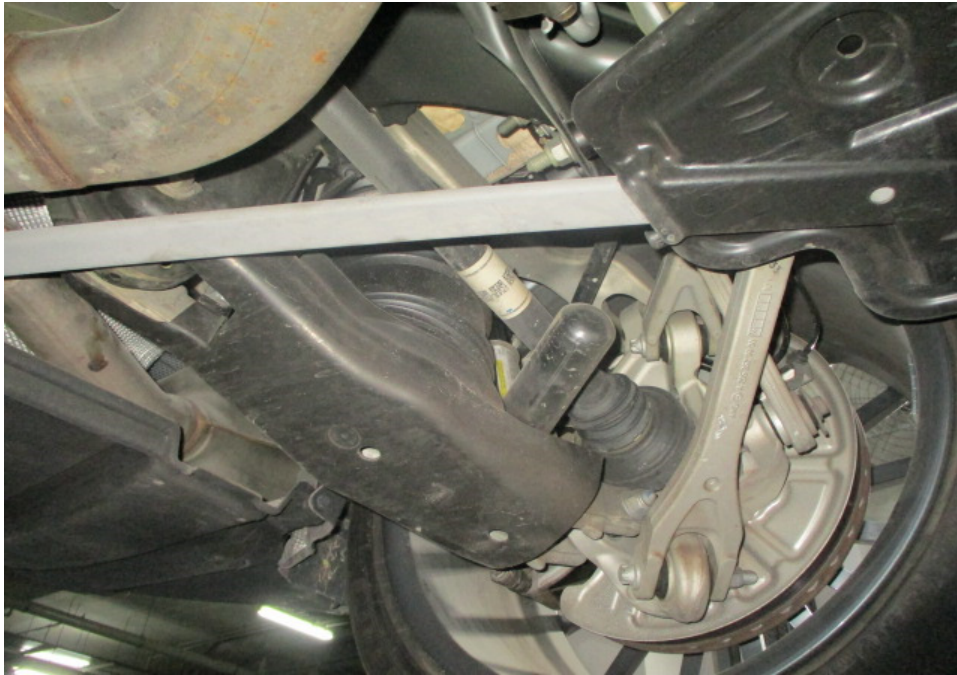
**Photo 24** shows a general view of the control arms and linkages at the rear left wheel of the Motor Car. I did not observe any fluid leak and/or fluid stain on the underside of the Motor Car. All of the Motor Car's undercarriage components were observed to be intact and secured in an appropriate manner.

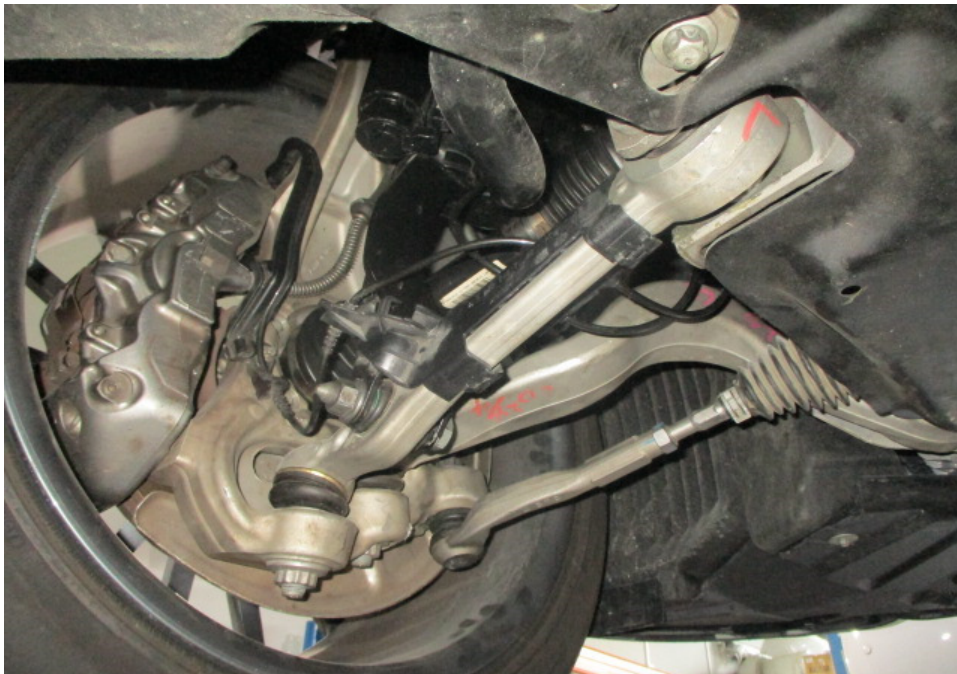
**Photo 25** shows the various undercarriage components at the front left wheel of the Motor Car. The mechanical components, control arms and linkages were all found to be intact and secured in an appropriate manner.

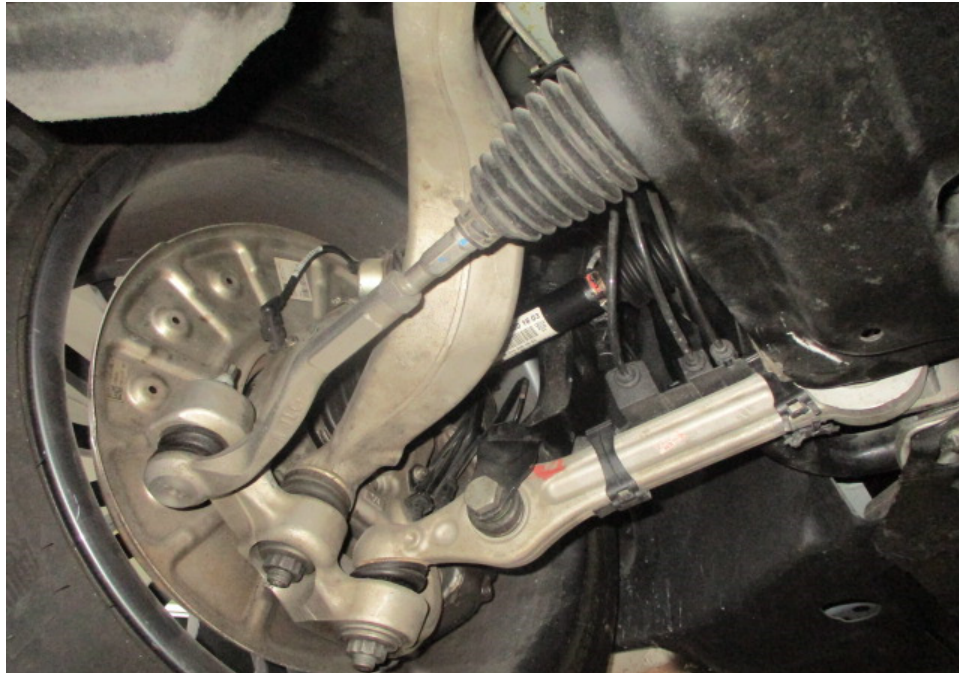
**Photo 26** shows the various undercarriage components at the front right wheel of the Motor Car. The mechanical components, control arms and linkages were all found to be intact and secured in an appropriate manner. I also did not observe any fluid leak and/or fluid stain on the underside of the Motor Car.

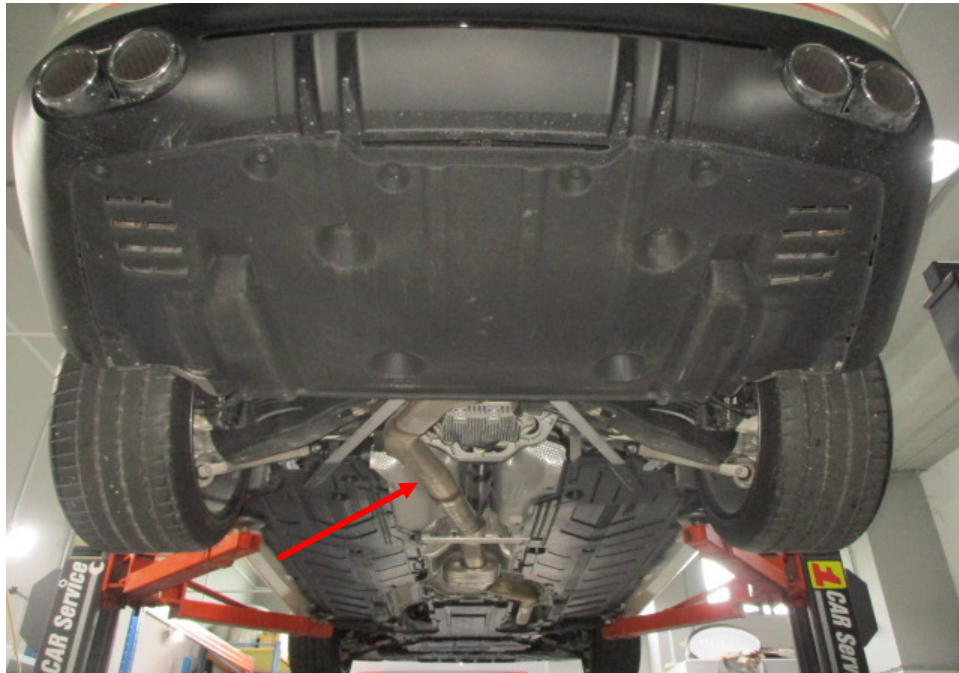
**Photo 27** shows the rear section of the Motor Car's exhaust system. My examination of the Motor Car's exhaust system revealed no sign(s) or indication(s) of any cut or weld marks along its exhaust pipes (arrowed), on its rear mufflers, on its centre resonator and on its catalytic converter.

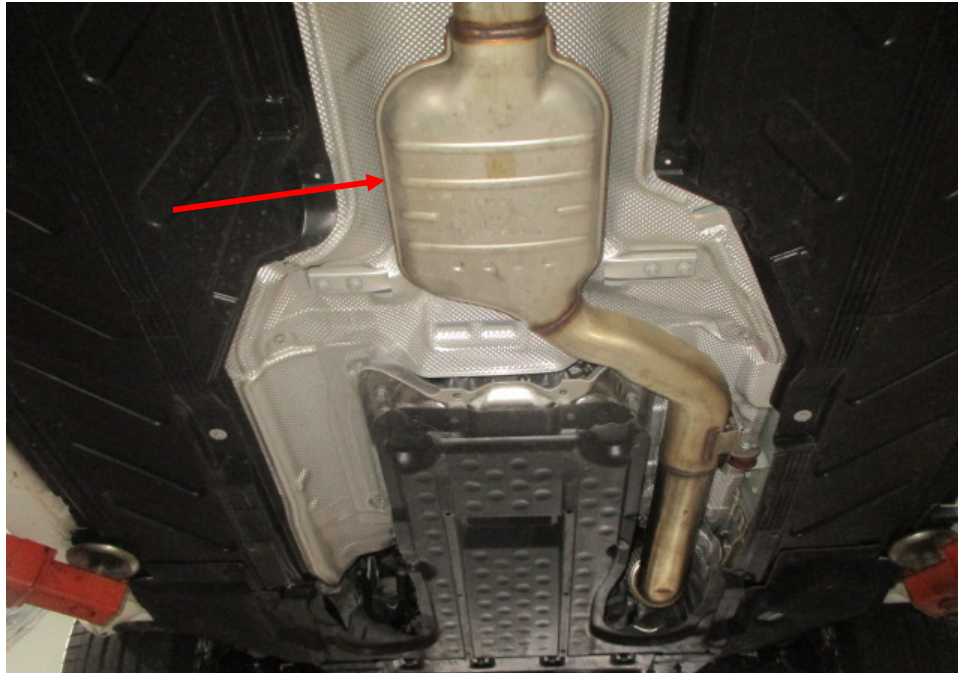
**Photo 28** shows the front section of the Motor Car's exhaust system. My examination of the Motor Car's exhaust system revealed no sign(s) or indication(s) of any cut or weld marks along its exhaust pipes, on its rear mufflers, on its centre resonator (arrowed) and on its catalytic converter.

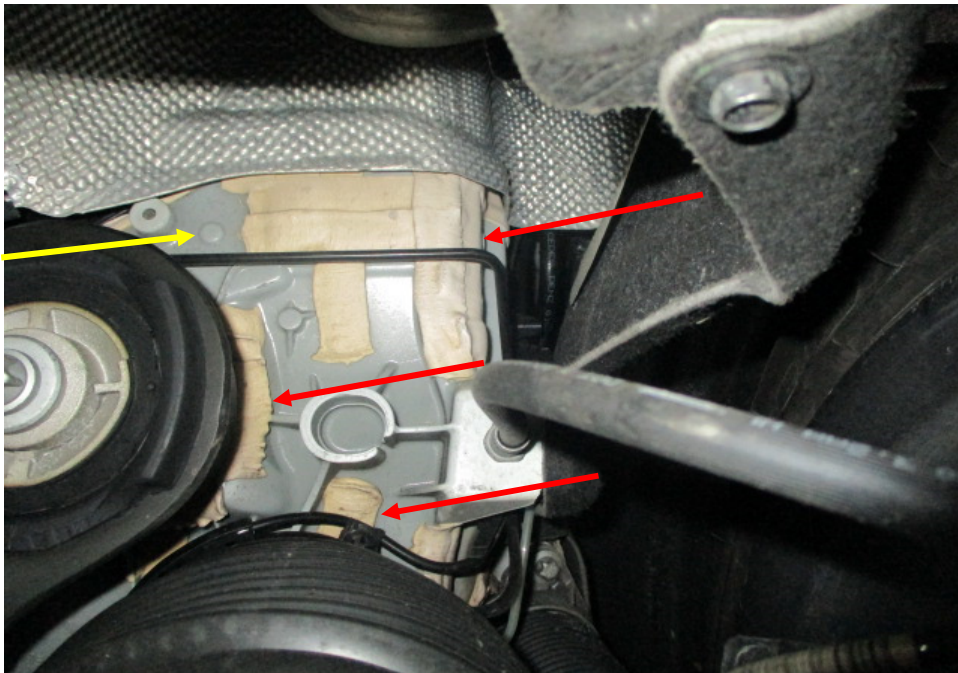
12. Visually, I did not find any weld marks, other than the original spot weld marks, on the chassis/structural body of the Motor Car. The original factory sealant at the joints along the chassis/structural body was also untouched, again indicating that no replacement of the chassis/structural body was carried out; and that the chassis/structural body was originally fitted.

**Photo 29** shows the chassis/structural body at the underside rear right of the Motor Car. I did not find any weld marks other than original spot weld marks (yellow arrow) on the chassis/structural body of the Motor Car. The original factory sealant (red arrow) at the joints along the chassis/structural body was untouched, indicating no work was done on the chassis/structural body of the Motor Car and that the chassis/structural body was originally fitted.

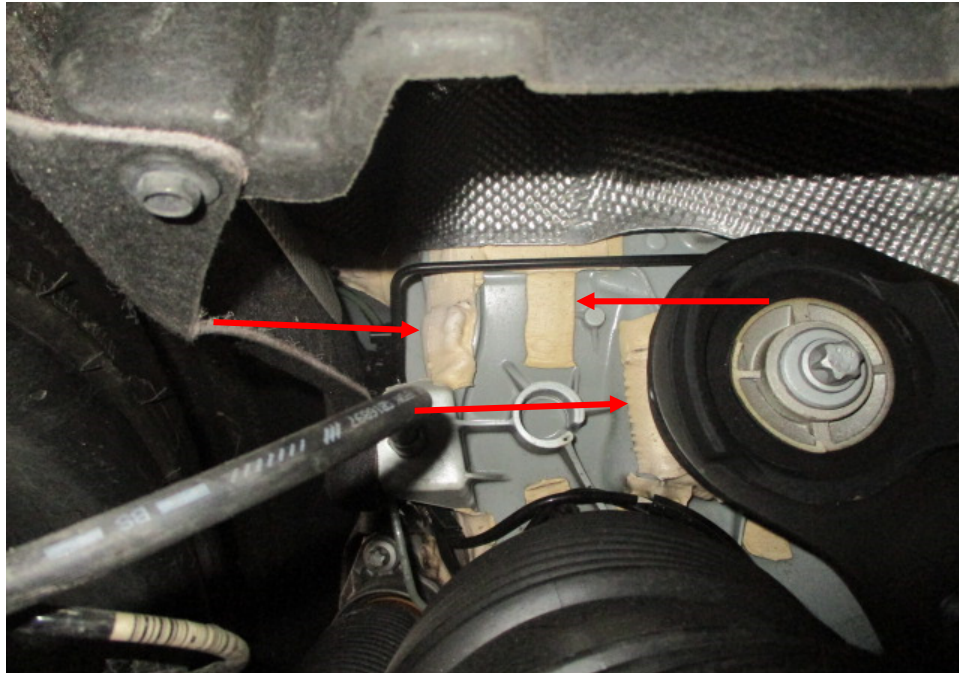
**Photo 30** shows the chassis/structural body at the underside rear left of the Motor Car. The original factory sealant (arrowed) at the joints along the chassis/structural body was observed to be untouched. In general, I had found no work was carried out on the chassis/structural body of the Motor Car. The chassis/structural body of the Motor Car was originally fitted.
