Your Ref: Mercedes Benz GT 43  
(chassis number W1K2906592A033355)  
Our Ref : CI/TP23002450/D

08 March 2023

**GC International Import Pte Ltd**

**INSPECTION REPORT OF AN UNREGISTERED MERCEDES BENZ GT 43  
MOTOR CAR WITH CHASSIS NUMBER W1K2906592A033355**

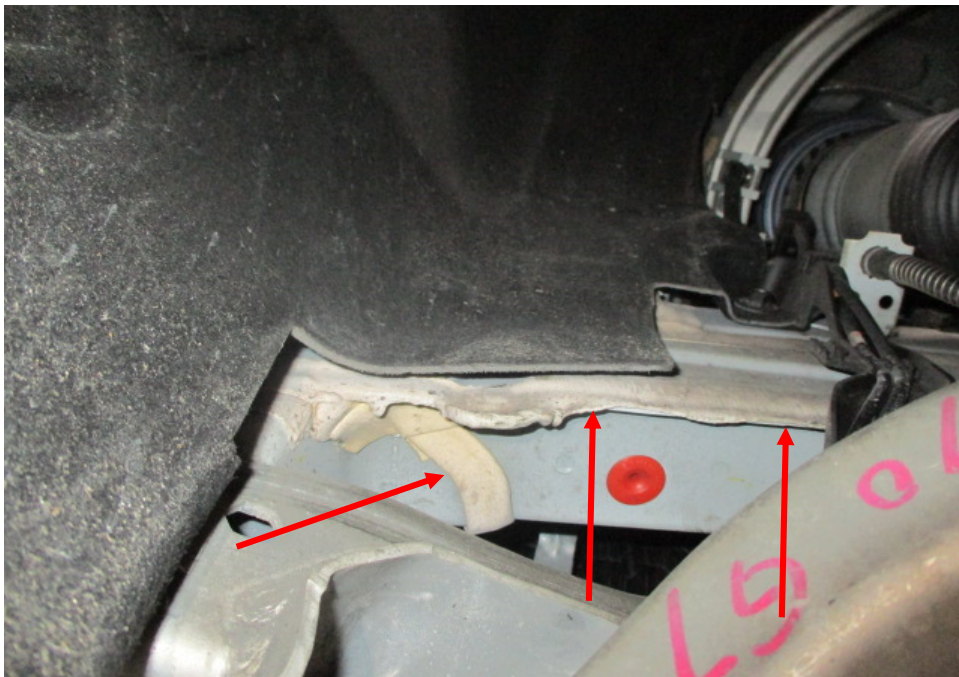
**Photo 31** shows the chassis/structural body at the underside front left of the Motor Car. The original factory sealant (arrowed) at the joints along the chassis/structural body was observed to be untouched. In general, I had found no work was carried out on the chassis/structural body of the Motor Car. The chassis/structural body of the Motor Car was originally fitted.

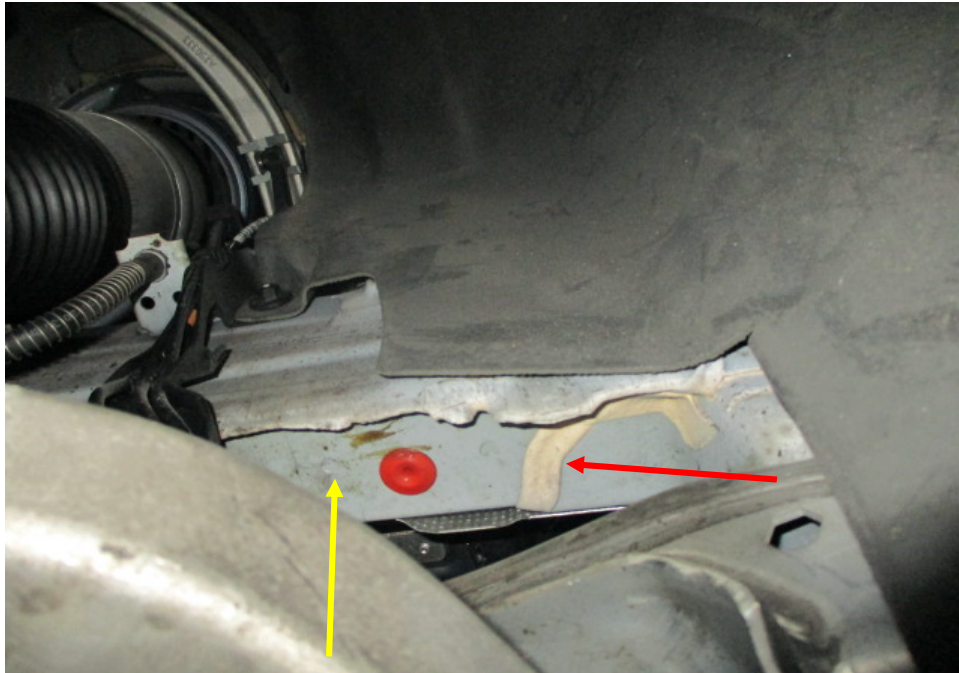
**Photo 32** shows the chassis/structural body at the underside front right of the Motor Car. I did not find any weld marks other than original spot weld marks on the chassis/structural body of the Motor Car. The original factory sealant (arrowed) at the joints along the chassis/structural body was untouched, indicating no work was done on the chassis/structural body of the Motor Car and that the chassis/structural body was originally fitted.

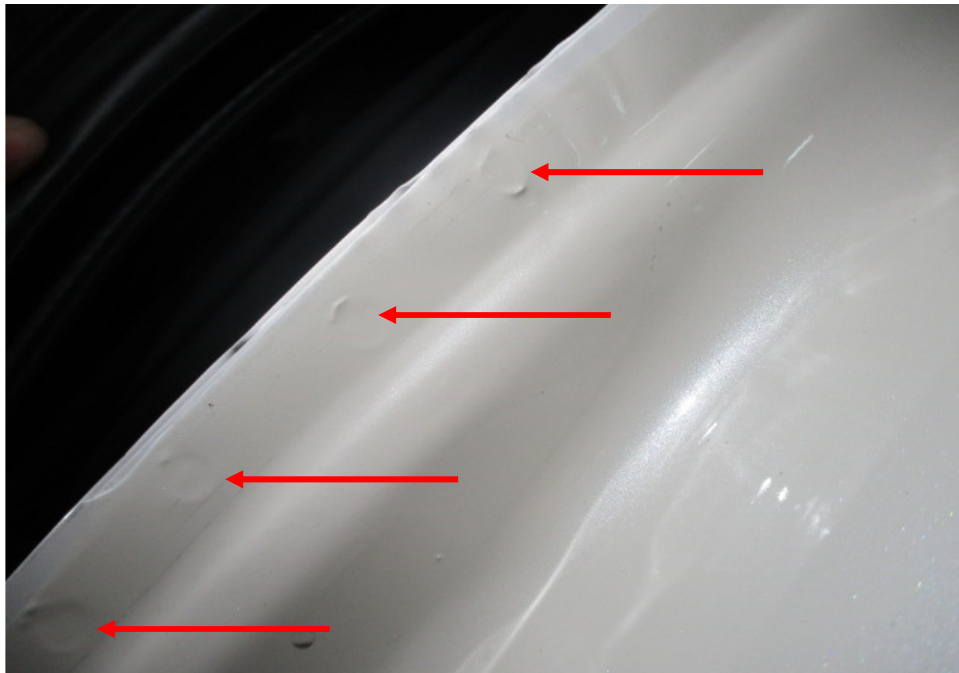
**Photo 33** shows the left side "C" pillar of the Motor Car. I did not find any weld marks other than original spot weld marks (arrowed) on the left side "C" pillar of the Motor Car, which indicates that there was no re-welding works carried out. In general, I had found all the non-detachable body panels of the Motor Car to be originally fitted at the time of my inspection.

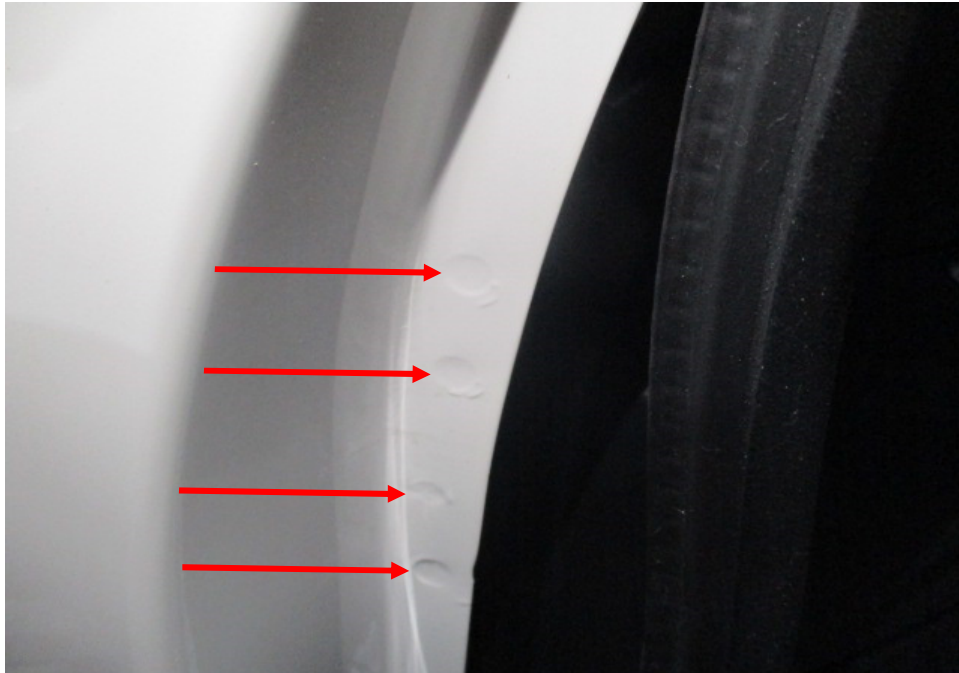
**Photo 34** shows the left side "A" pillar of the Motor Car. I did not find any weld marks other than original spot weld marks (arrowed) on the left side "A" pillar of the Motor Car, which indicates that there was no re-welding works carried out. In general, I had found all the non-detachable body panels of the Motor Car to be originally fitted at the time of my inspection.

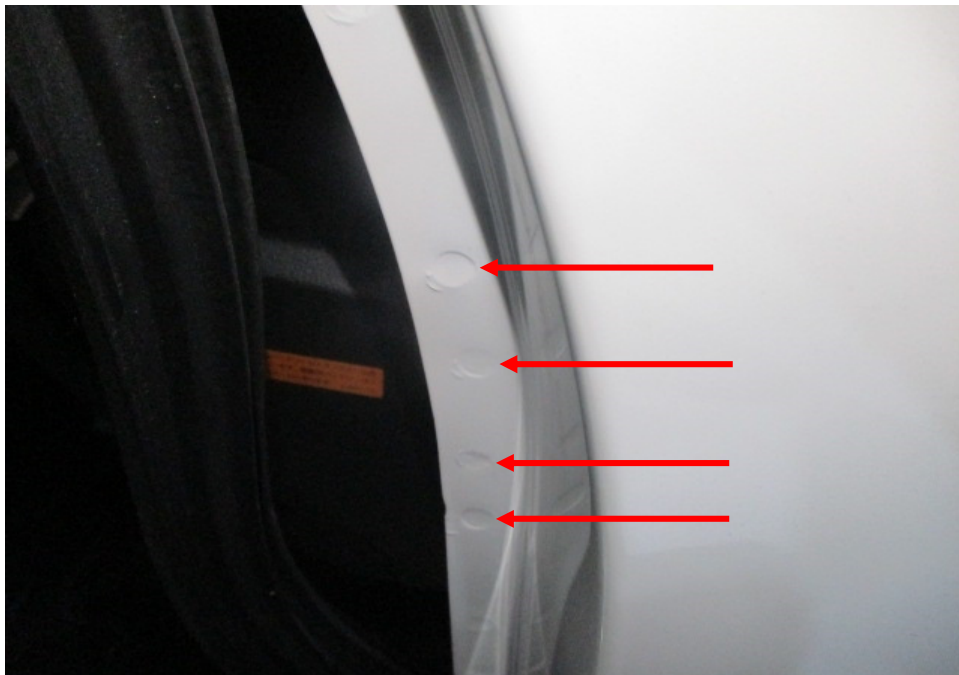
**Photo 35** shows the right side "A" pillar of the Motor Car. I did not find any weld marks other than original spot weld marks (arrowed) on the right side "A" pillar of the Motor Car, which indicates that there was no re-welding works carried out. In general, I had found all the non-detachable body panels of the Motor Car to be originally fitted at the time of my inspection.

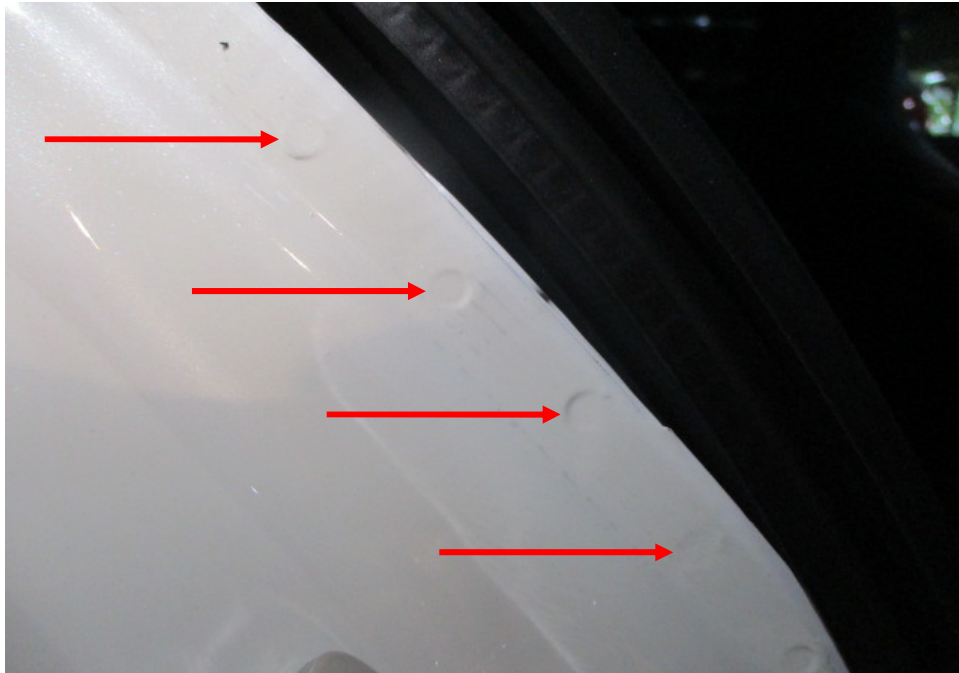
**Photo 36** shows the right side "C" pillar of the Motor Car. I did not find any weld marks other than original spot weld marks (arrowed) on the right side "C" pillar of the Motor Car, which indicates that there was no re-welding works carried out. In general, I had found all the non-detachable body panels of the Motor Car to be originally fitted at the time of my inspection.
