SURVEY OF VEHICLE NO. SLC 2502Y

AUTOMOBILE ASSESSMENT REPORT

Assessment of Vehicle No : **SLC 2502Y**
Date of Accident : **17-June-2021**
Date of Inspection : **23-June-2021**
Address of Inspection : **5032 Ang Mo Kio Industrial Park 2 #01-291 S'569535**

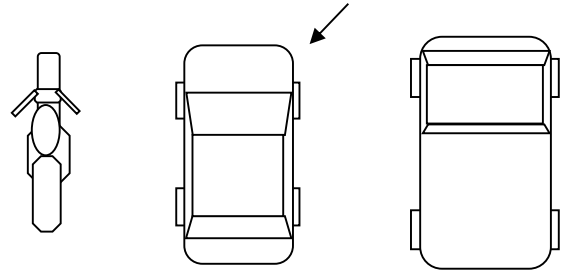
At the time of inspection, this vehicle sustained damages to the **Front O/S** portion. Please see attached scheduled for details.
