Your Ref: Toyota Alphard
(chassis number AYH300121031)
Our Ref : CI/TP23002522/D

13 March 2023

INSPECTION REPORT OF AN UNREGISTERED TOYOTA ALPHARD MOTOR CAR WITH CHASSIS NUMBER AYH300121031

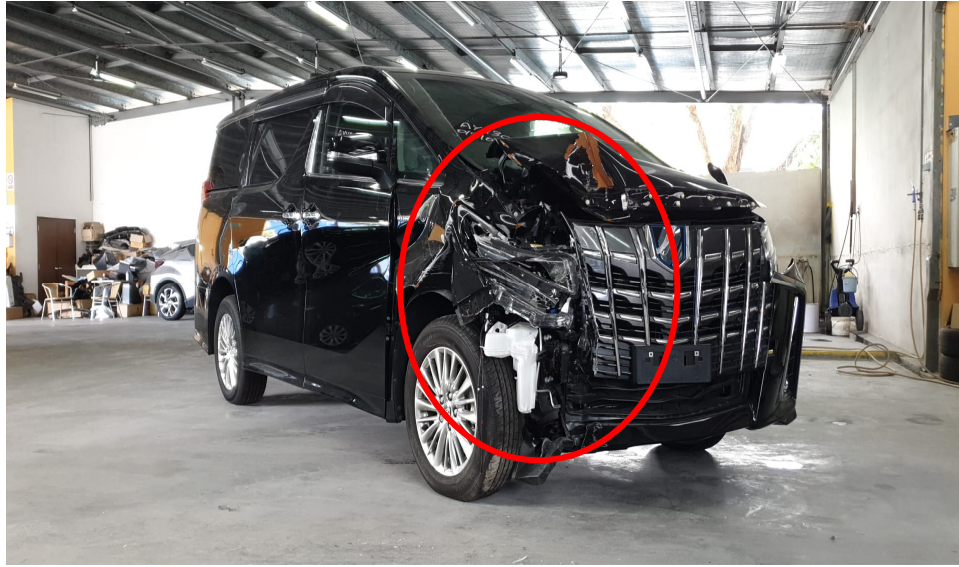
3. The photographs provided to me had showed damage to the front right portion of the Motor Car. Body parts damaged include the front bumper, front bumper centre lower grille, front bumper right lower grille, front bumper right fog lamp, front bumper right chrome garnish, front bumper right sensor, front bumper reinforcement, front grille, front bonnet, front bonnet chrome moulding, front bonnet hinges, front right headlamp, front right headlamp chrome moulding, front right headlamp top panel, front right fender, front right fender inner shield, front support panel, front support panel top cover, aircon condenser, radiator, aircon pipe and wiper washer tank amongst others.

Photo 1 shows the front right body of the Motor Car (photograph provided to me). The Motor Car was observed to have sustained damage at its front right portion (circled).

23. The body parts at the front right portion and the undercarriage parts at the front right wheel of the Motor Car were visually examined and it was noted that the repair/restoration works carried out to the damaged area of the Motor Car (refer to photograph 1 - 3 above) were reasonably adequate and in order.

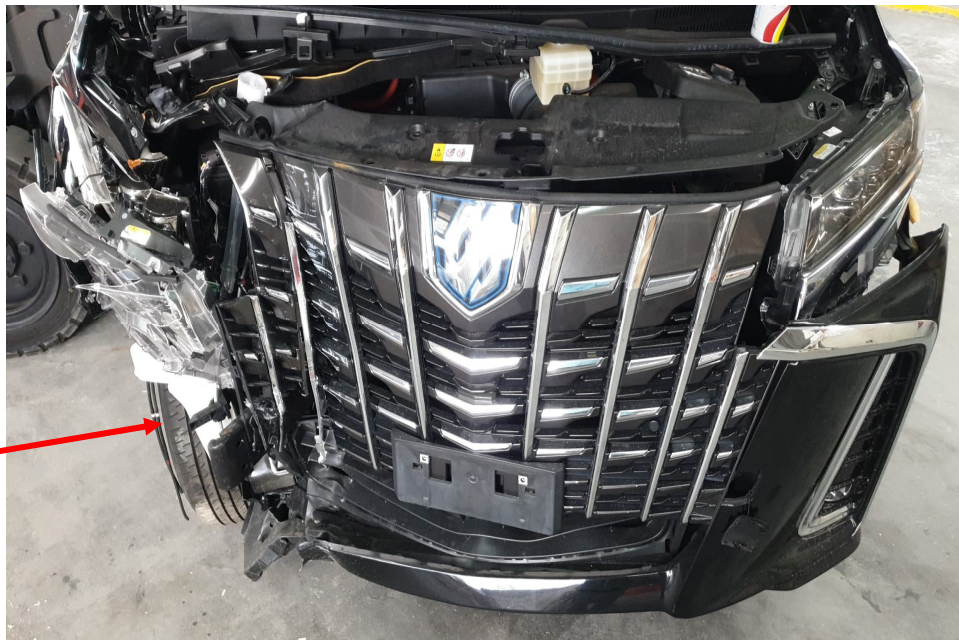
4. The front right wheel and front left wheel were both orientated inwards, suggesting damage to the undercarriage parts at the front right wheel of the Motor Car. Undercarriage parts that may possibly be damaged include the front right lower arm, front right shock absorber, front right knuckle arm and front right steering tie rod end amongst others.

Photo 2 shows a closer view of the damage at the front right portion of the Motor Car (photograph provided to me). The front bumper, front grille, front right headlamp, front right headlamp top panel, front support panel top cover, aircon condenser and radiator were amongst the body parts that were observed to have been damaged. The front right wheel (arrowed) and front left wheel (refer to photograph 4 below) were both orientated inwards, suggesting damage to the undercarriage parts at the front right wheel of the Motor Car.

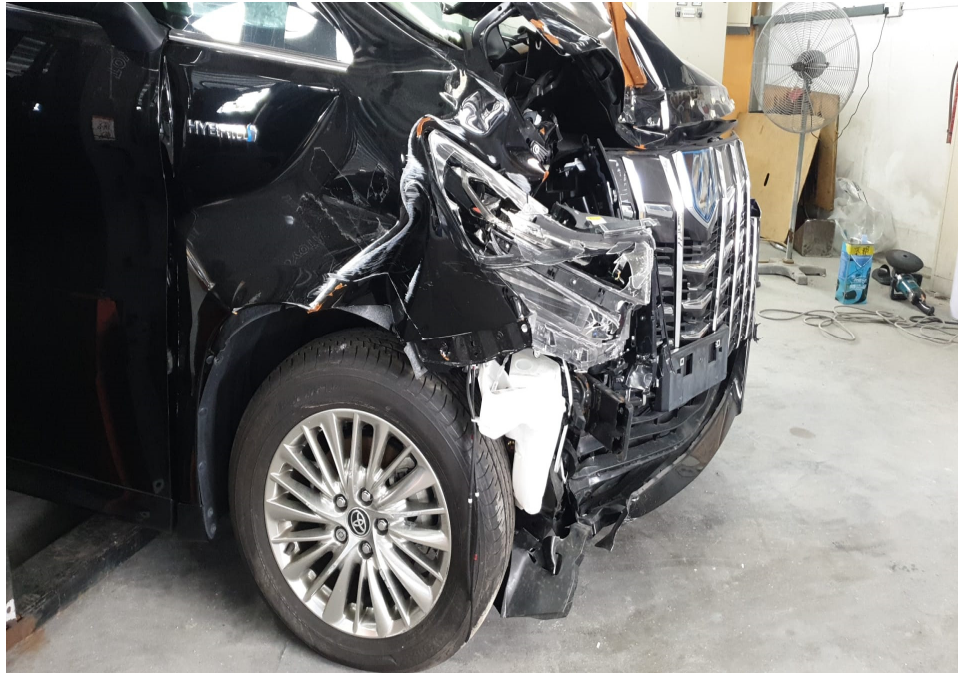
Photo 3 shows another view of the damage at the front right portion of the Motor Car (photograph provided to me). The front bumper, front bumper centre lower grille, front bumper right lower grille, front bumper right fog lamp, front bumper right chrome garnish, front bumper right sensor, front bonnet, front right headlamp, front right fender and front right fender inner shield were amongst the body parts that were observed to have been damaged.

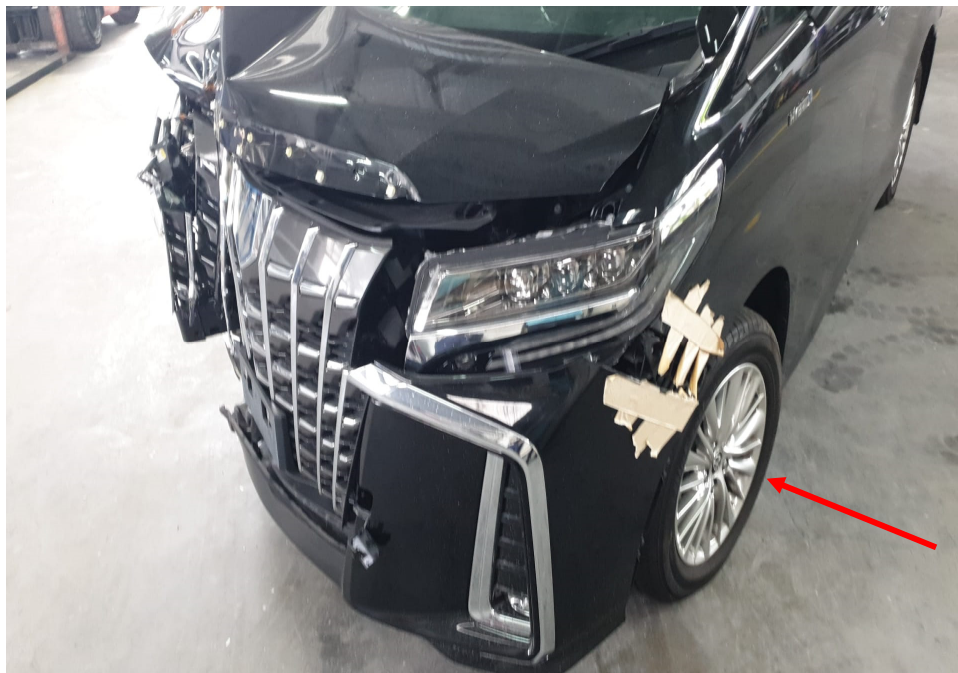
Photo 4 shows the front left body of the Motor Car (photograph provided to me). The front left wheel (arrowed) and front right wheel (refer to photograph 2 above) were both orientated inwards, suggesting damage to the undercarriage parts at the front right wheel of the Motor Car.

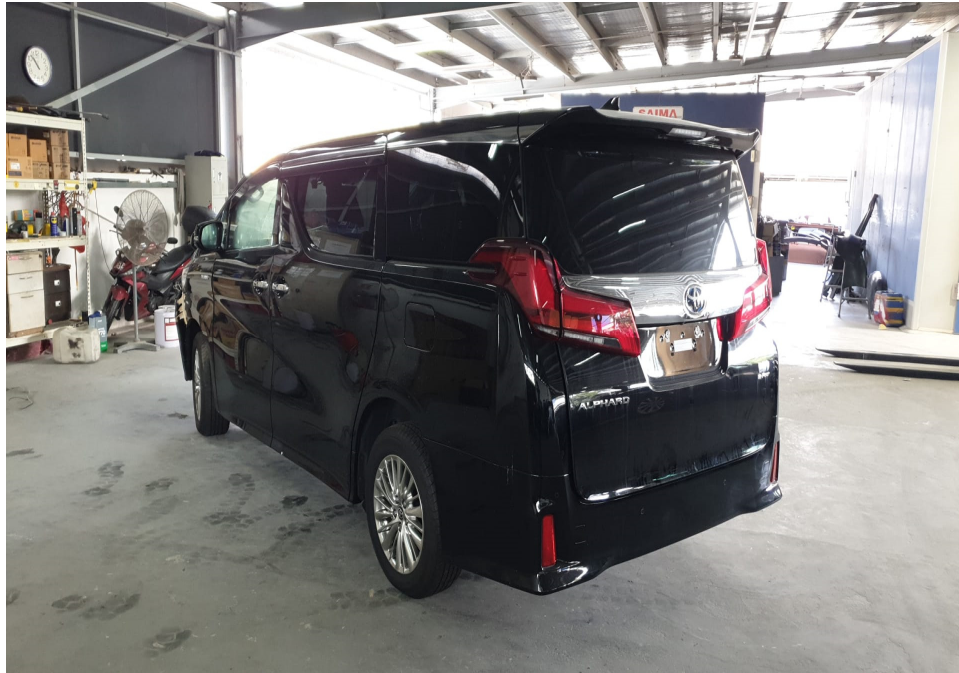
Photo 5 shows the rear left body of the Motor Car (photograph provided to me). Apart for the front right portion, the photographs provided to me did not show physical damage to other areas of the Motor Car. The Motor Car's airbag(s) was not deployed.

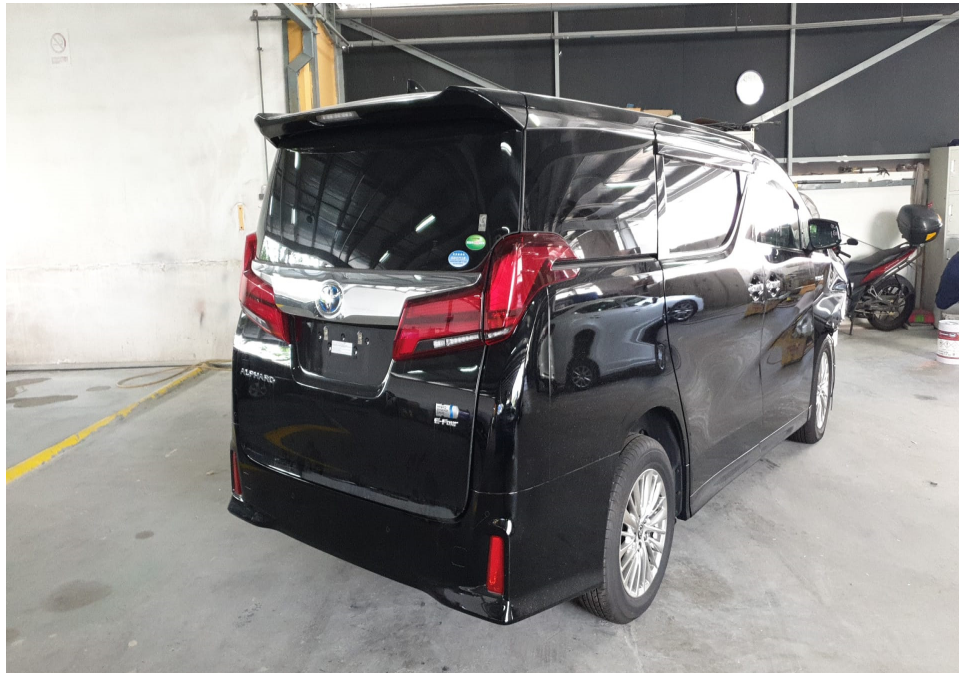
Photo 6 shows the rear right body of the Motor Car (photograph provided to me). Apart for the front right portion, the photographs provided to me did not show physical damage to other areas of the Motor Car. The Motor Car's airbag(s) was not deployed.

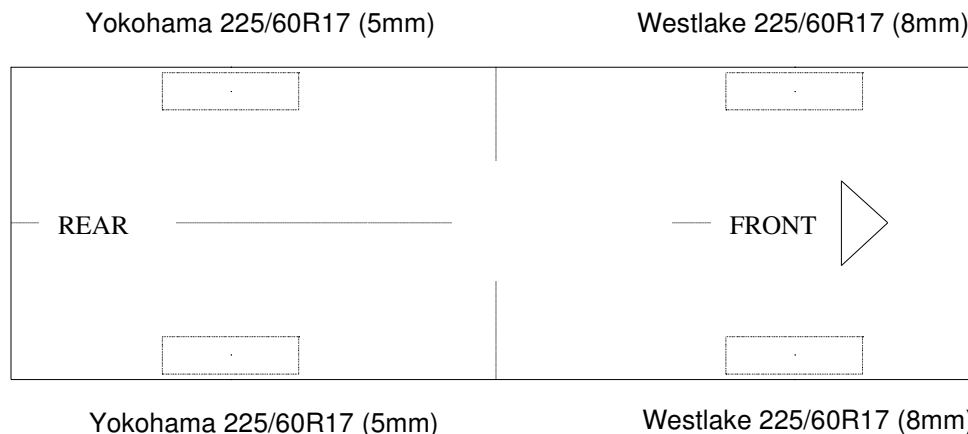
9. It was fitted with 17inch sport wheel rims that were wrapped with tyres that were observed to be of serviceable condition. The tyres were also sufficiently inflated for vehicular operation. The tyre brand, tyre size and approximate remaining tread depth of the 4 tyres of the Motor Car were recorded as follows: -

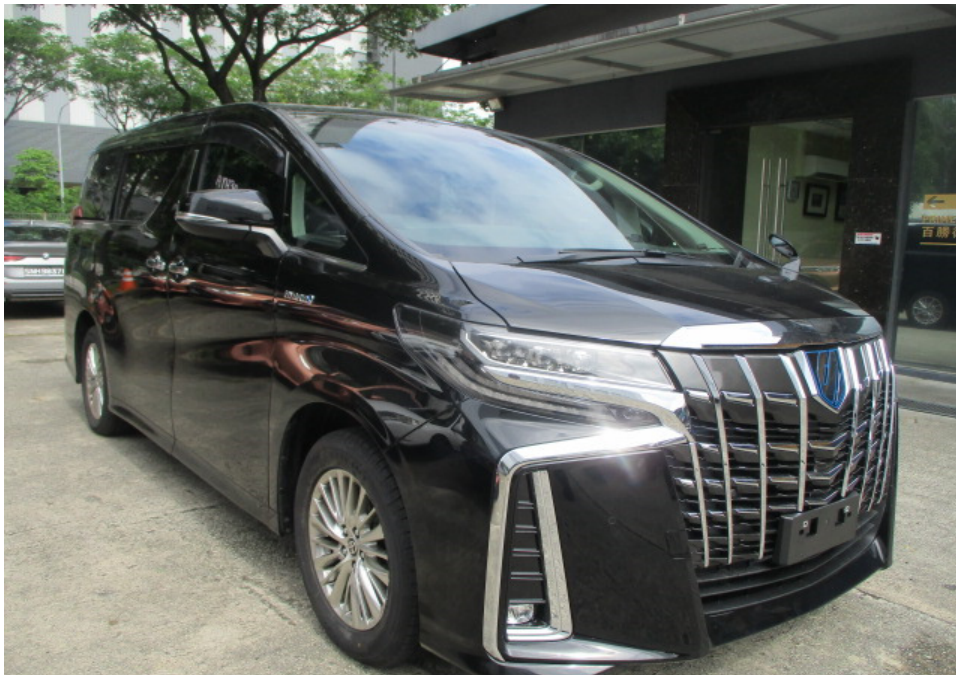
Photo 7 shows a general view of the front right body of the Motor Car at the time of my inspection. The Motor Car was observed to be in a relatively good general condition with no loose exterior fittings observed. The body parts at the front right portion of the Motor Car were visually examined and it was observed that the repair/restoration works carried out to the damaged area of the Motor Car (refer to photograph 1 - 3 above) were reasonably adequate and in order.

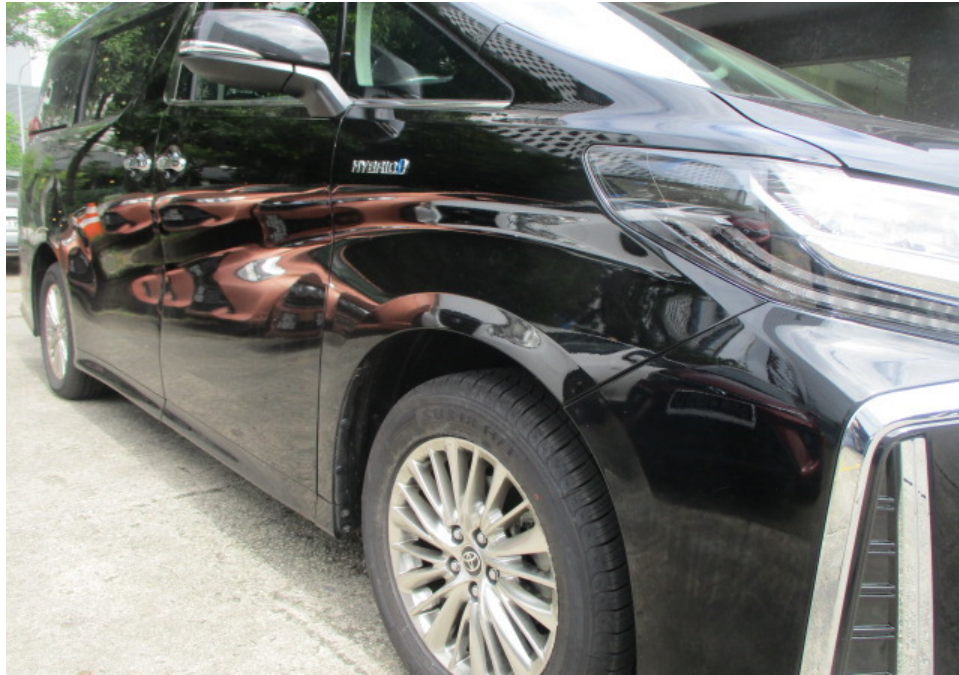
Photo 8 shows a closer view of the Motor Car's front bumper, front right headlamp, front right fender and front right wheel rim. The body parts at the front right portion of the Motor Car were visually examined and it was observed that the repair/restoration works carried out to the damaged area of the Motor Car (refer to photograph 1 - 3 above) were reasonably adequate and in order.

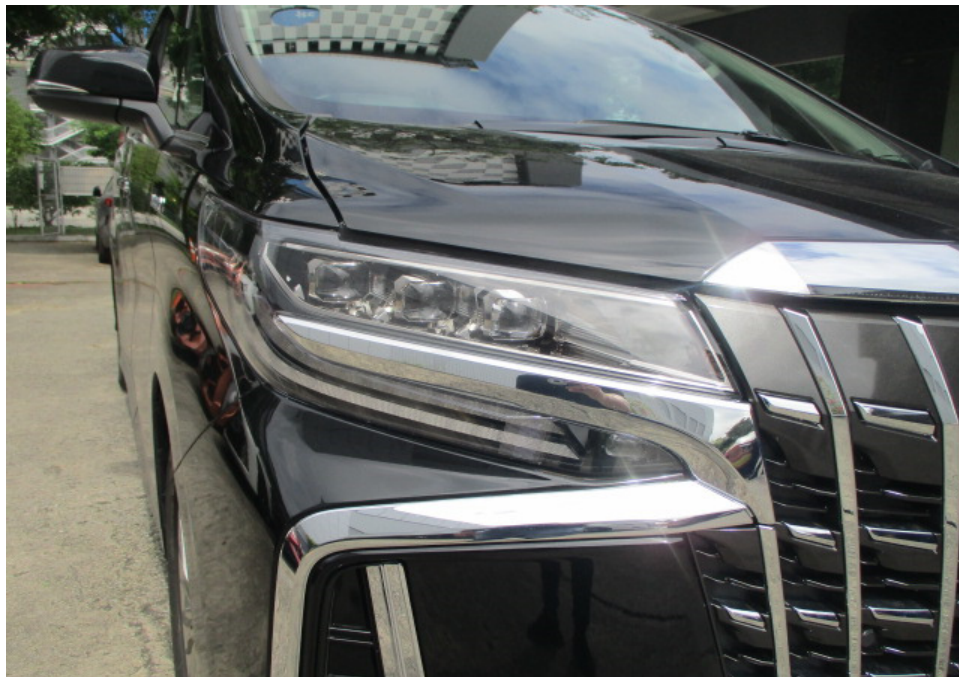
Photo 9 shows a closer view of the Motor Car's front bonnet, front right headlamp and front right headlamp chrome moulding. The body parts at the front right portion of the Motor Car were visually examined and it was observed that the repair/restoration works carried out to the damaged area of the Motor Car (refer to photograph 1 - 3 above) were reasonably adequate and in order.

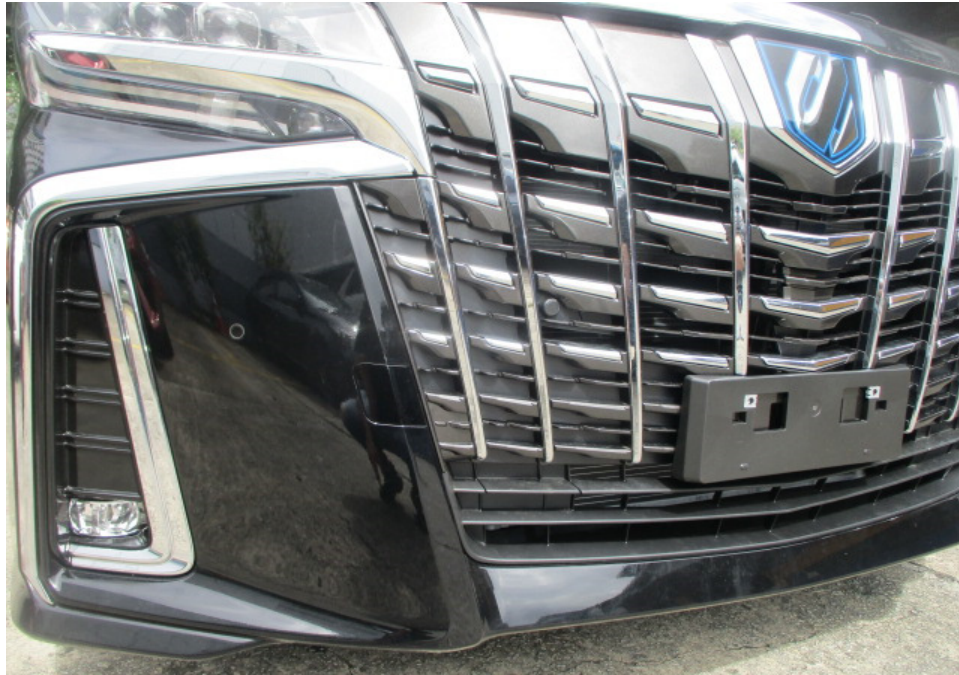
Photo 10 shows a closer view of the Motor Car's front bumper, front bumper centre lower grille, front bumper right lower grille, front bumper right fog lamp, front bumper right chrome garnish and front grille. The body parts at the front right portion of the Motor Car were visually examined and it was observed that the repair/restoration works carried out to the damaged area of the Motor Car (refer to photograph 1 - 3 above) were reasonably adequate and in order.

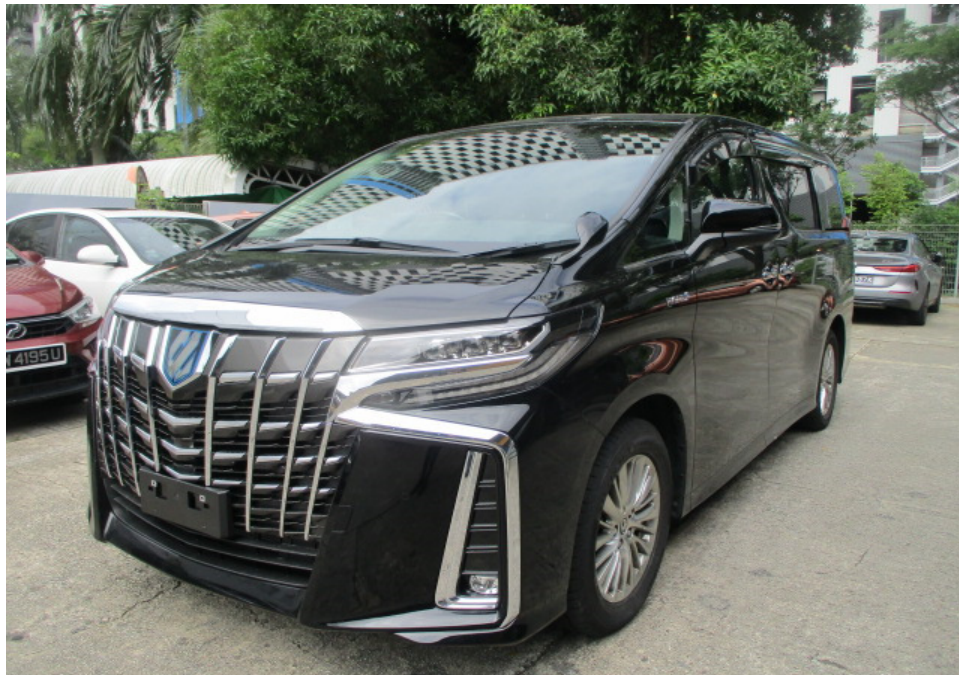
Photo 11 shows a general view of the front left body of the Motor Car at the time of my inspection. The Motor Car was observed to be in a relatively good general condition with no loose exterior fittings observed. The mileage of the Motor Car recorded at the time of my inspection was 9,701km.

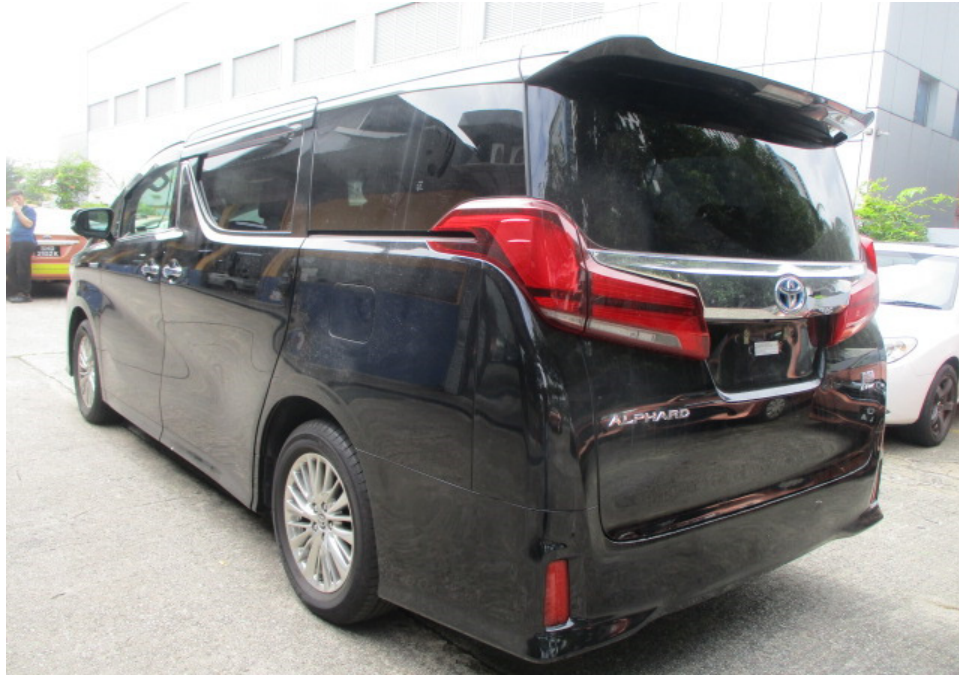
Photo 12 shows a general view of the rear left body of the Motor Car at the time of my inspection. The Motor Car was observed to be in a relatively good general condition with no loose exterior fittings observed. The mileage of the Motor Car recorded at the time of my inspection was 9,701km.

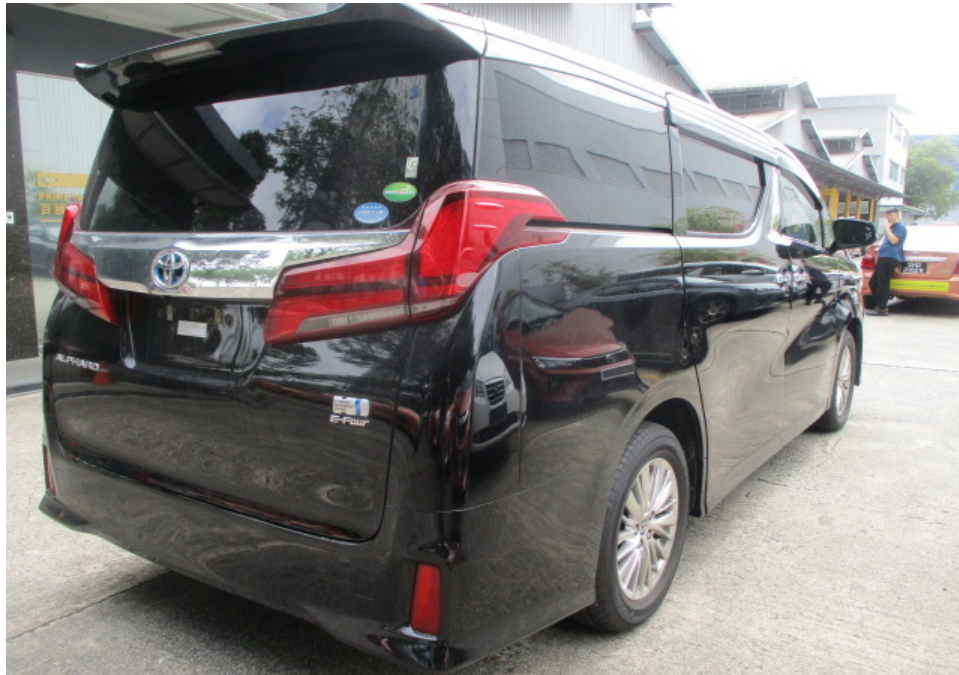
Photo 13 shows a general view of the rear right body of the Motor Car at the time of my inspection. The Motor Car was observed to be in a relatively good general condition with no loose exterior fittings observed. The mileage of the Motor Car recorded at the time of my inspection was 9,701km.

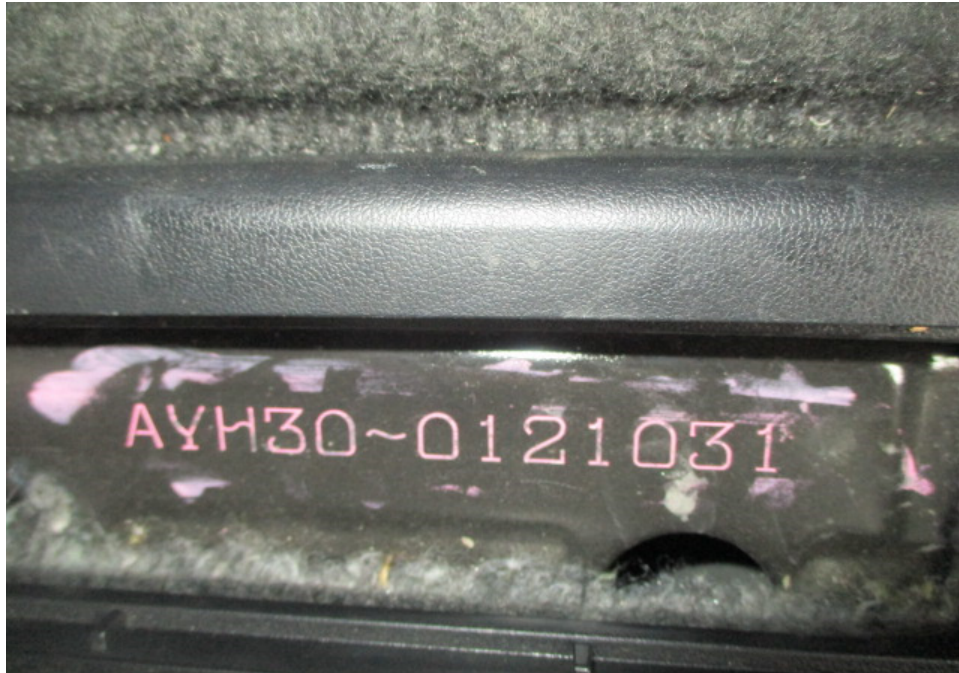
Photo 14 shows the chassis number of the Motor Car. The chassis number recorded was AYH300121031.

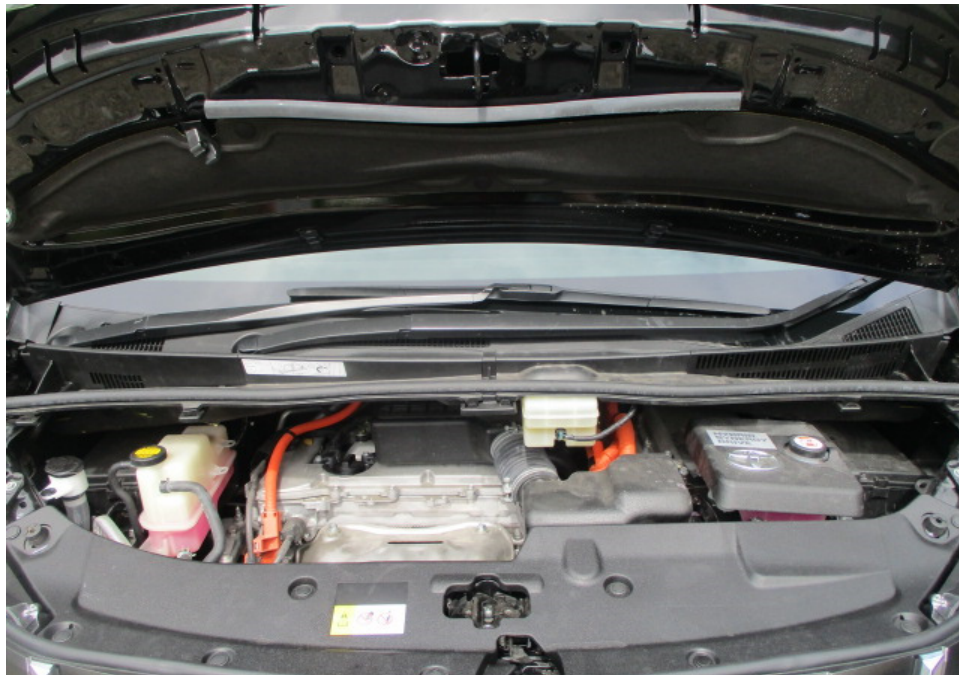
Photo 15 shows a general view of the engine compartment of the Motor Car at the time of my inspection. The various parts and components inside the engine compartment were all observed to be intact and properly fitted. There was also no sign(s) or indication(s) of fluid leak and/or fluid stain found inside the engine compartment.

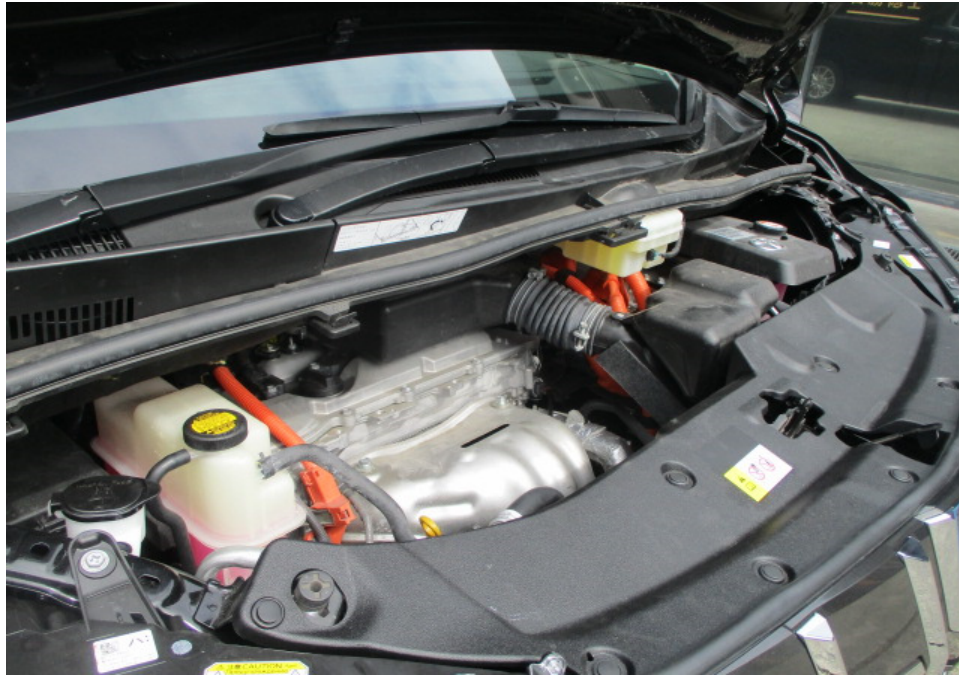
Photo 16 shows another view of the engine compartment of the Motor Car at the time of my inspection. The various parts and components inside the engine compartment were all observed to be intact and properly fitted. There was also no sign(s) or indication(s) of fluid leak and/or fluid stain found inside the engine compartment.

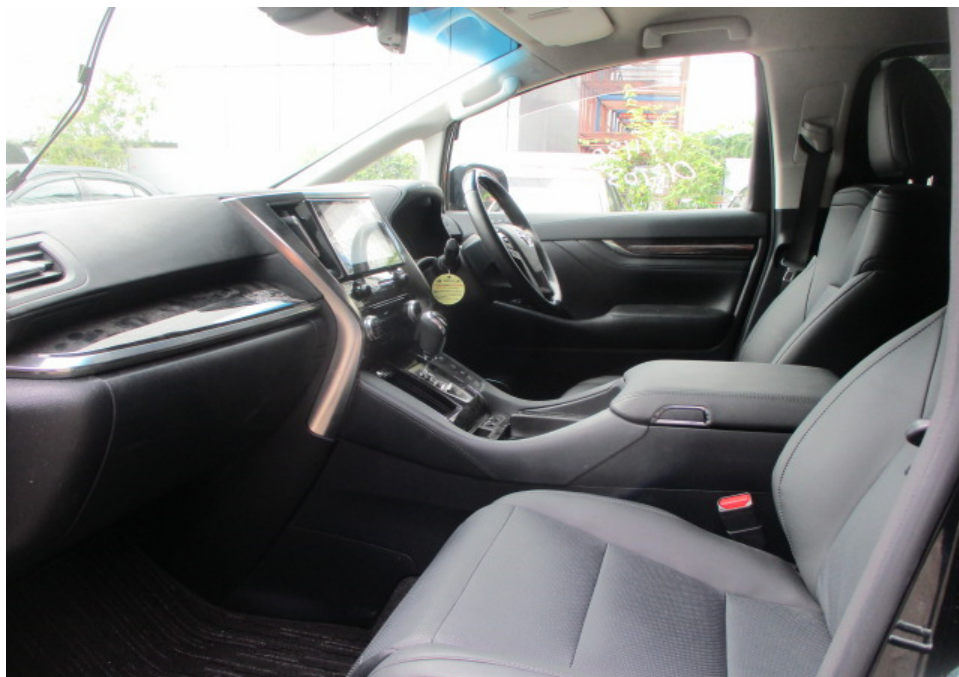
Photo 17 shows the interior compartment of the Motor Car at the time of my inspection. The various parts and components, trims, carpet and upholstery inside the interior compartment were all observed to be intact and properly fitted.

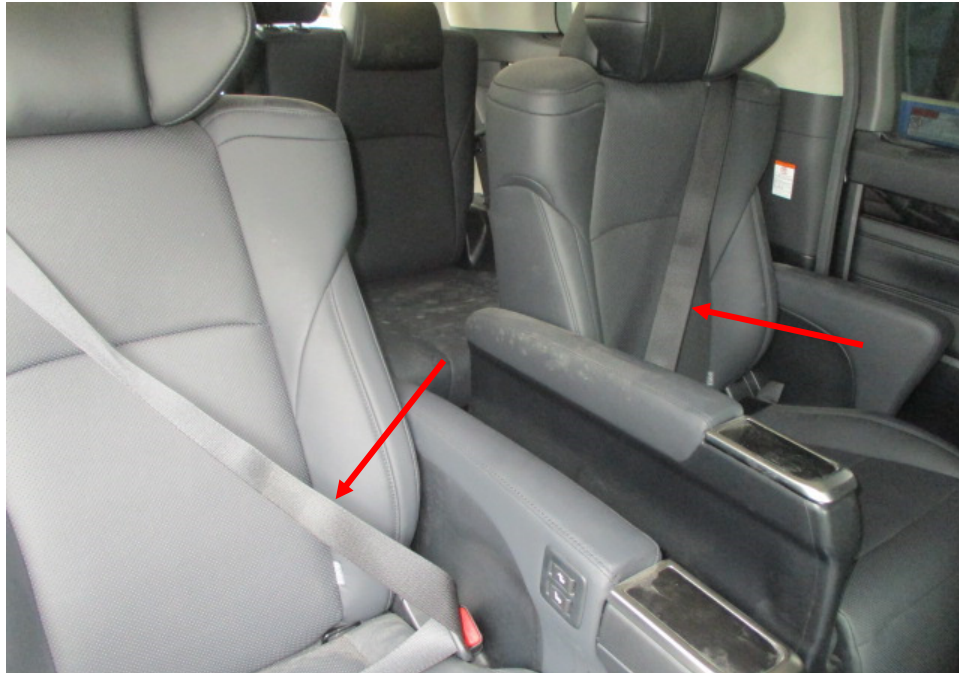
Photo 18 shows the rear seats at the 1st row of the Motor Car. All the seats of the Motor Car were secured via seat rails to the floorboard. They were also fitted with a retractable seat belt reel and a pre-tensioner. The seat belts (arrowed) were tested and were able to be fastened into the respective pre-tensions that were fitted on the side of each individual seat.

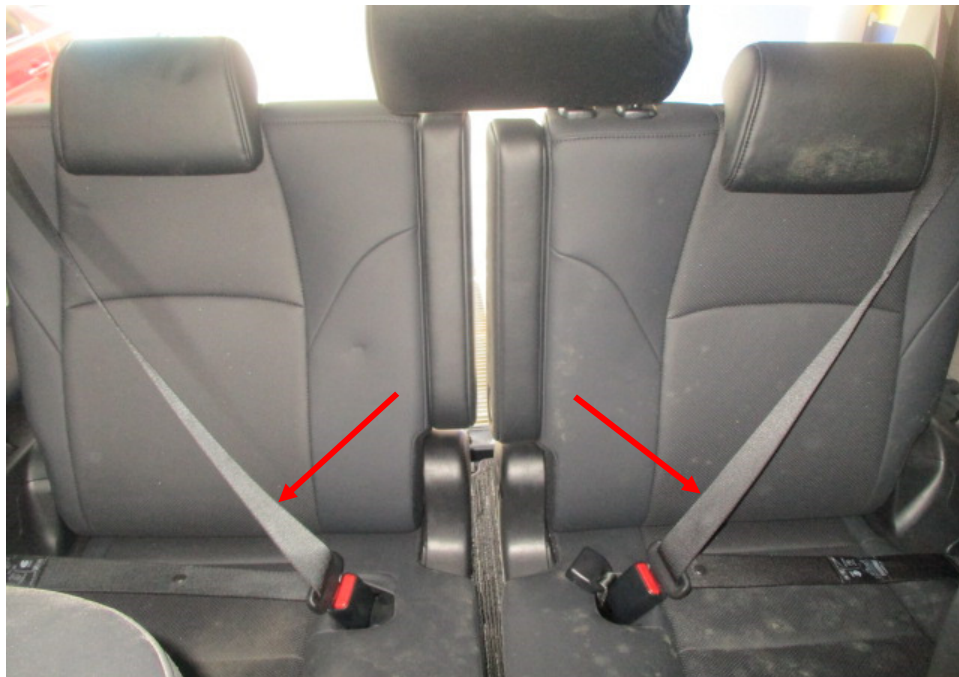
Photo 19 shows the rear seats at the 2nd row of the Motor Car. All the seats of the Motor Car were secured via seat rails to the floorboard. They were also fitted with a retractable seat belt reel and a pre-tensioner. The seat belts (arrowed) were tested and were able to be fastened into the respective pre-tensions that were fitted on the side of each individual seat.

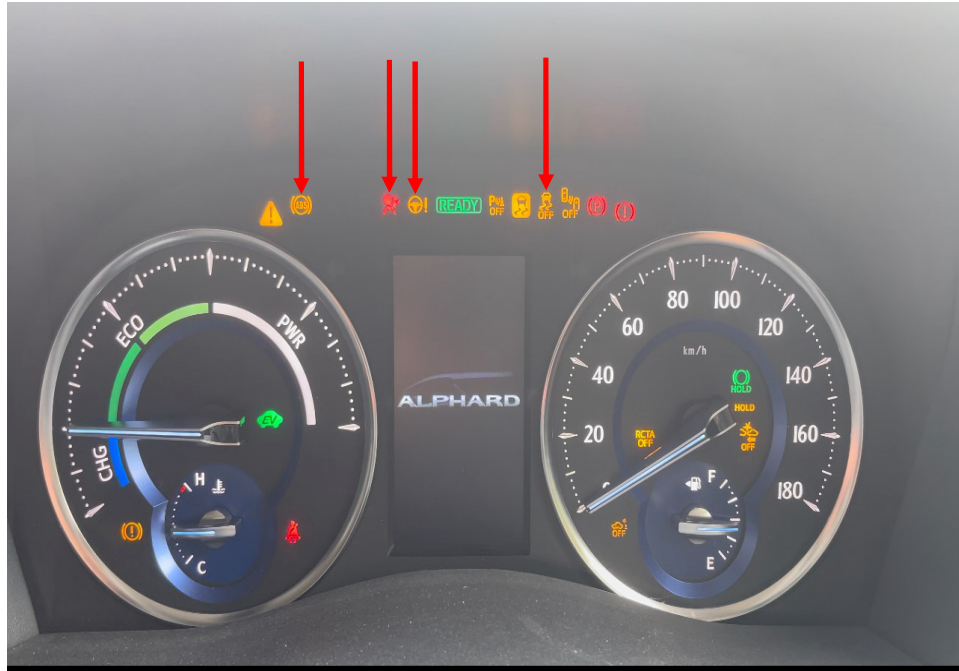
Photo 20 shows the warning lights for the various electronic safety features appearing on the instrument panel of the Motor Car during its self-test when the engine is cranked, in particular the lights for the ABS, SRS, EPS, VSC (arrowed) and the various collision prevention systems.

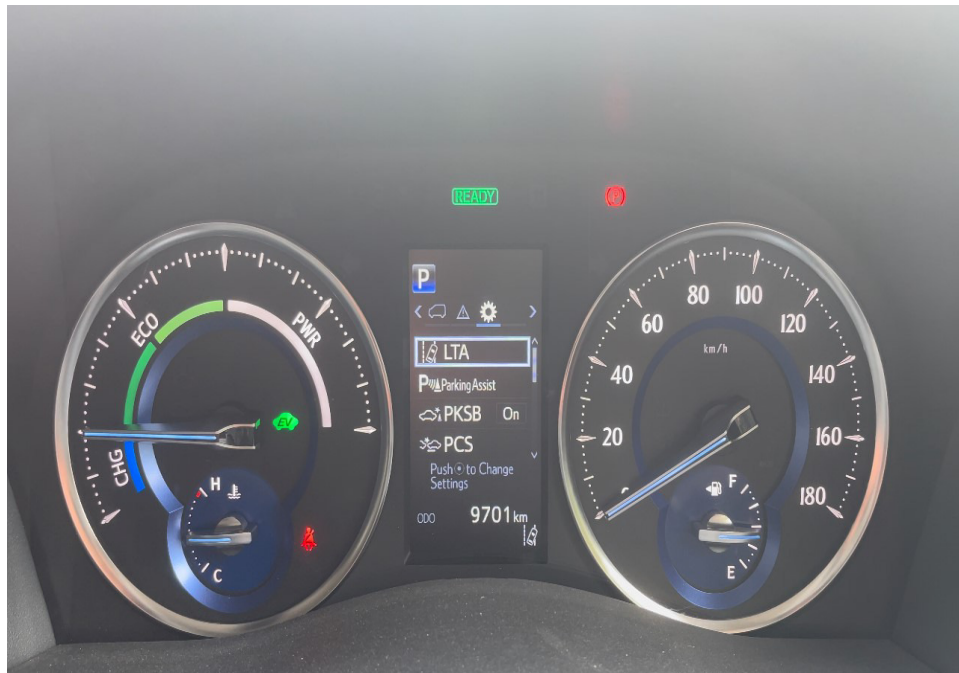
Photo 21 shows the respective warning lights no longer illuminated, indicating that there is no fault detected to the ABS, SRS, EPS, VSC and the various collision prevention systems of the Motor Car during the self-test. These electronic systems were hence in working condition at the time of my inspection.

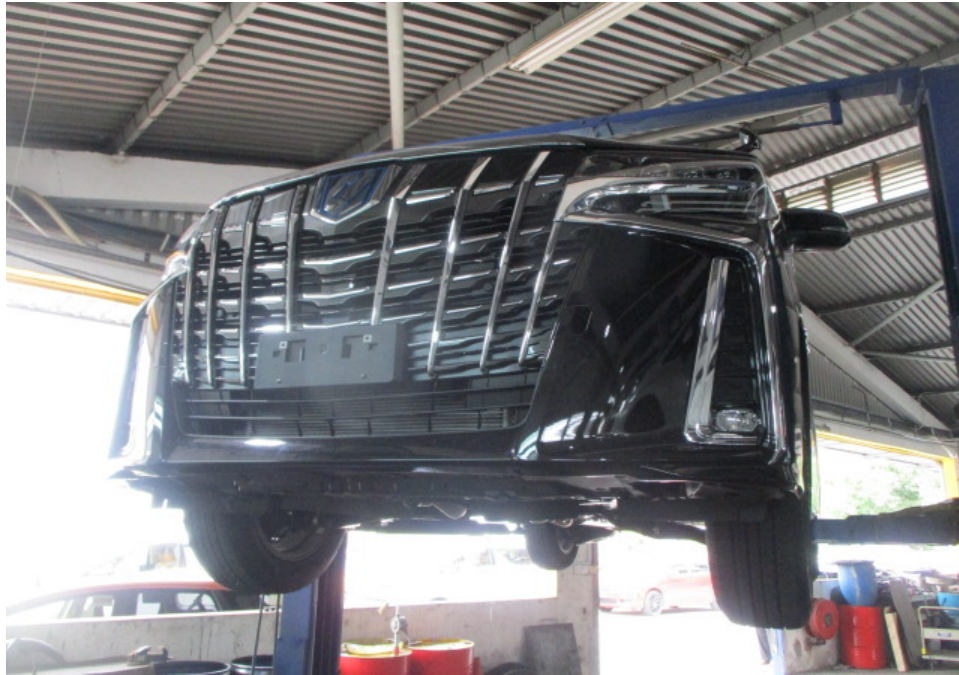
Photo 22 shows the Motor Car hoisted up for checks on its undercarriage. There was no sign(s) or indication(s) of fluid leakage and/or fluid stain(s) on the underside of the Motor Car. The undercarriage components of the Motor Car were also all observed to be intact and secured in an appropriate manner.

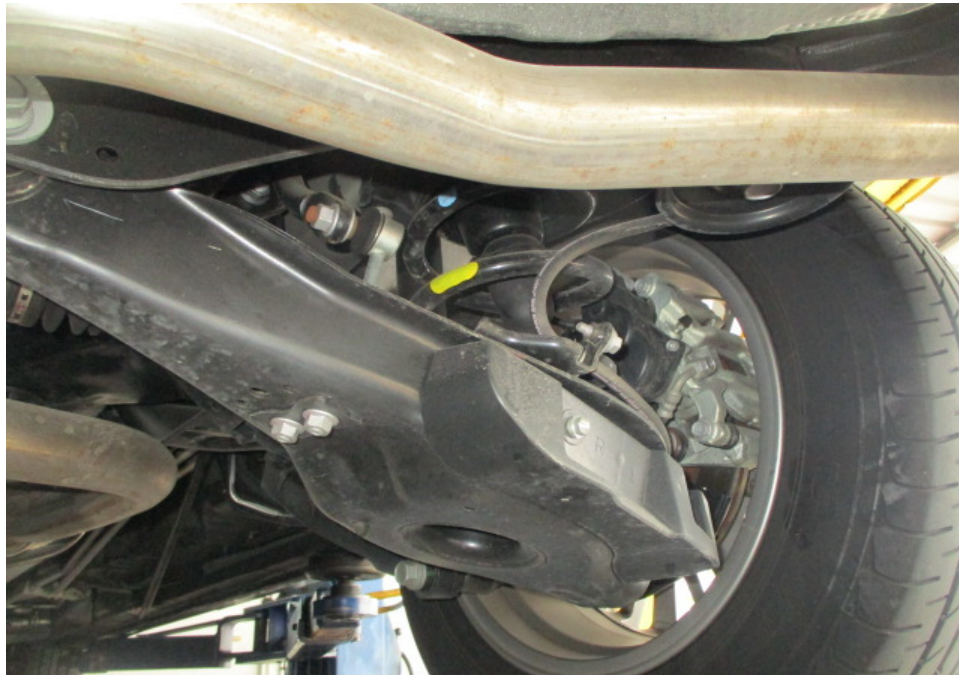
Photo 23 shows a general view of the control arms and linkages at the rear right wheel of the Motor Car. I did not observe any fluid leak and/or fluid stain on the underside of the Motor Car. All of the Motor Car's undercarriage components were observed to be intact and secured in an appropriate manner.

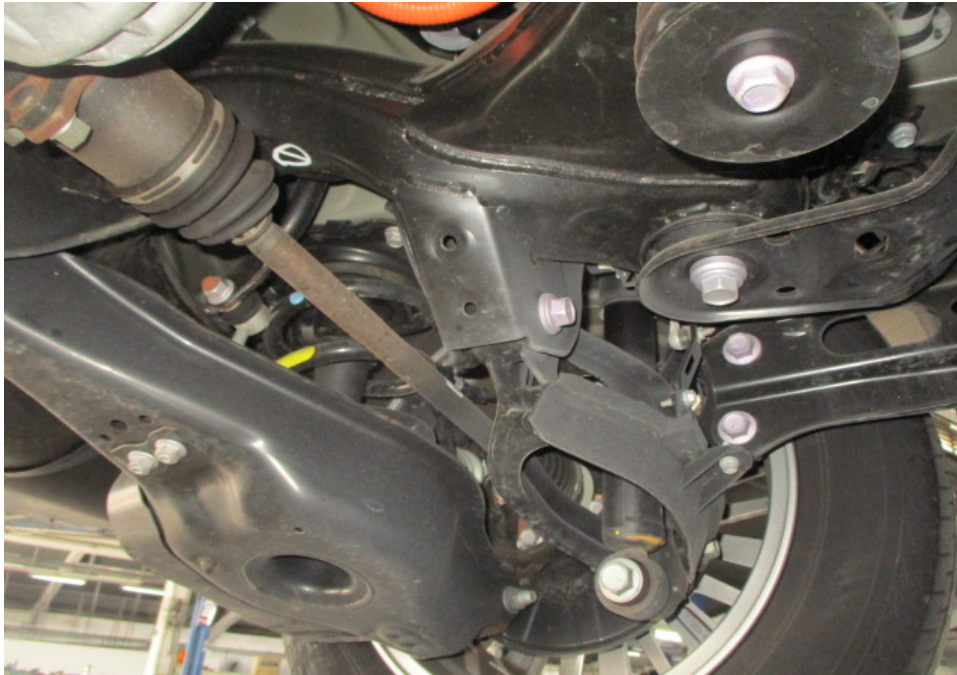
Photo 24 shows a general view of the control arms and linkages at the rear left wheel of the Motor Car. I did not observe any fluid leak and/or fluid stain on the underside of the Motor Car. All of the Motor Car's undercarriage components were observed to be intact and secured in an appropriate manner.

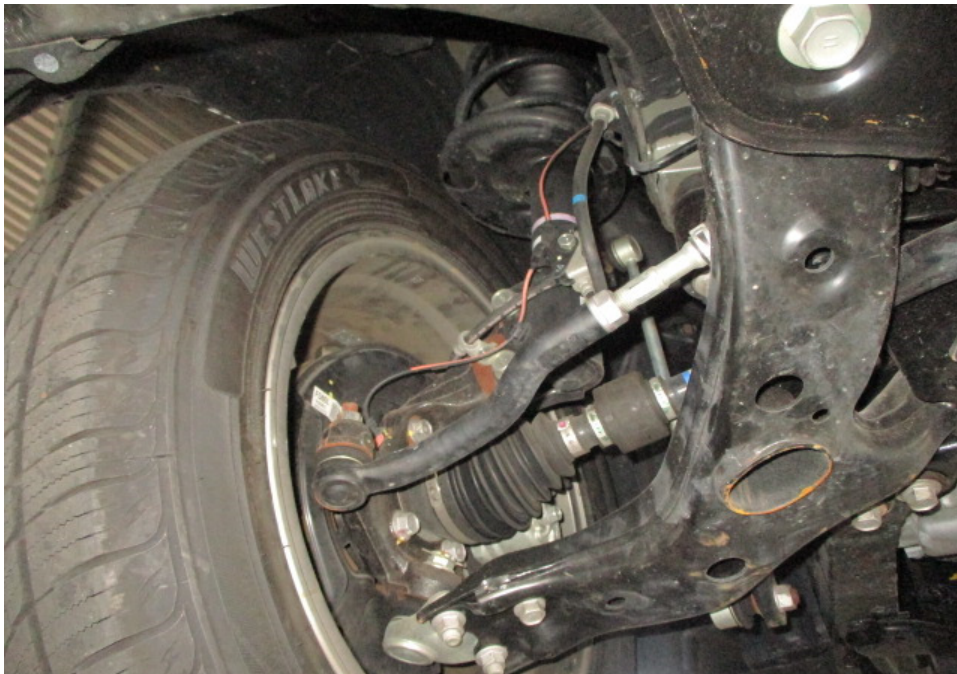
Photo 25 shows the various undercarriage components at the front left wheel of the Motor Car. The mechanical components, control arms and linkages were all found to be intact and secured in an appropriate manner.

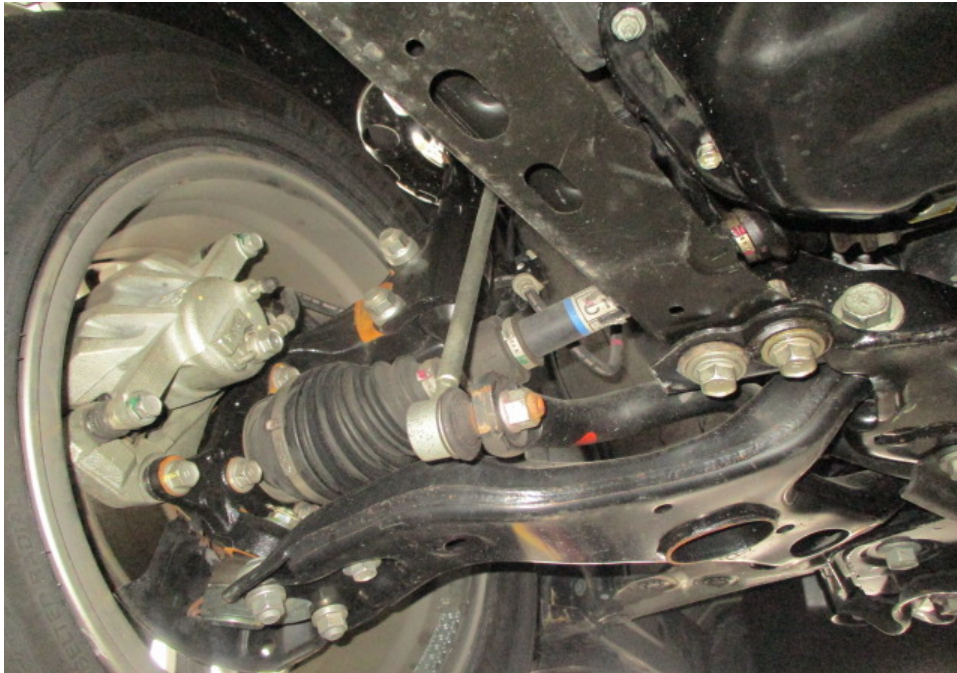
Photo 26 shows the various undercarriage components at the front right wheel of the Motor Car. The mechanical components, control arms and linkages were all found to be intact and secured in an appropriate manner. I also did not observe any fluid leak and/or fluid stain on the underside of the Motor Car.

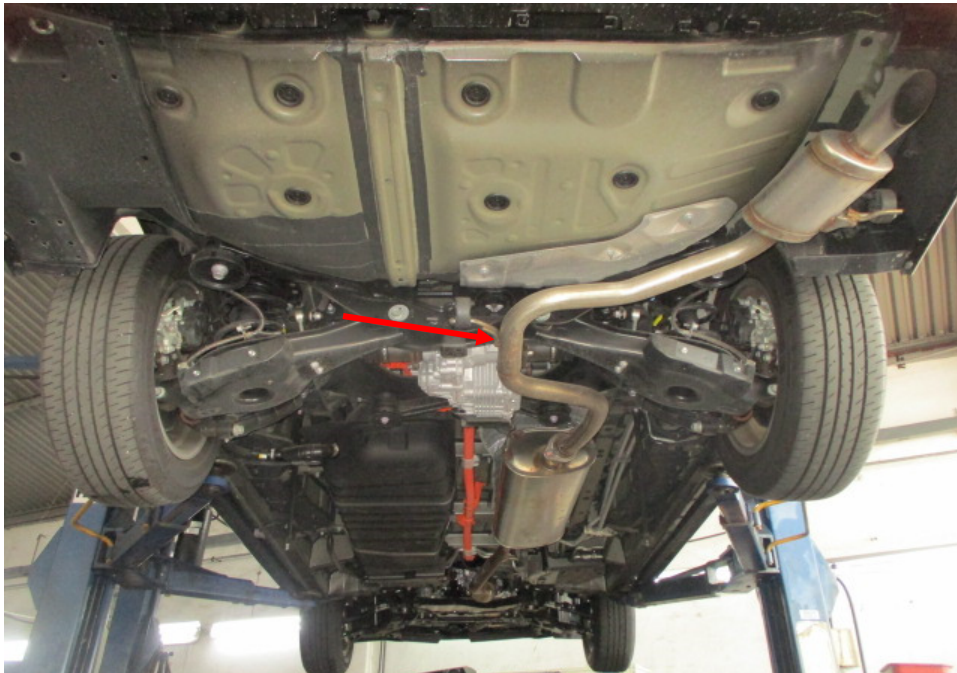
Photo 27 shows a general view of the rear section of the Motor Car's exhaust system. My examination of the Motor Car's exhaust system revealed no sign(s) or indication(s) of any cut or weld marks along its exhaust pipe (arrowed), on its catalytic converter, on its centre resonator box and on its rear muffler.

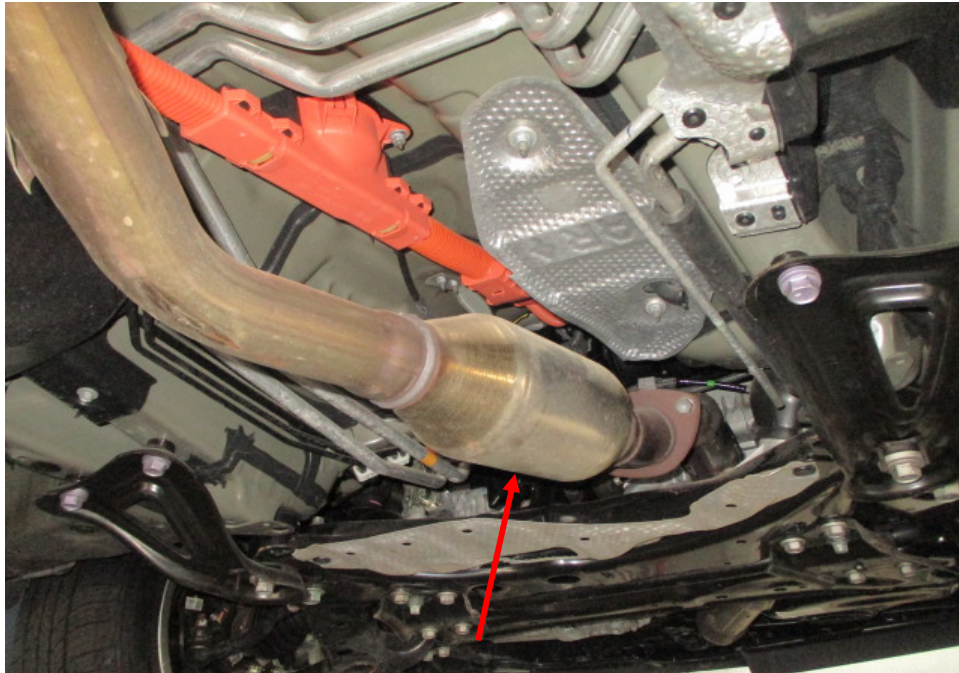
Photo 28 shows a general view of the front section of the Motor Car's exhaust system. My examination of the Motor Car's exhaust system revealed no sign(s) or indication(s) of any cut or weld marks along its exhaust pipe, on its catalytic converter (arrowed), on its centre resonator box and on its rear muffler.

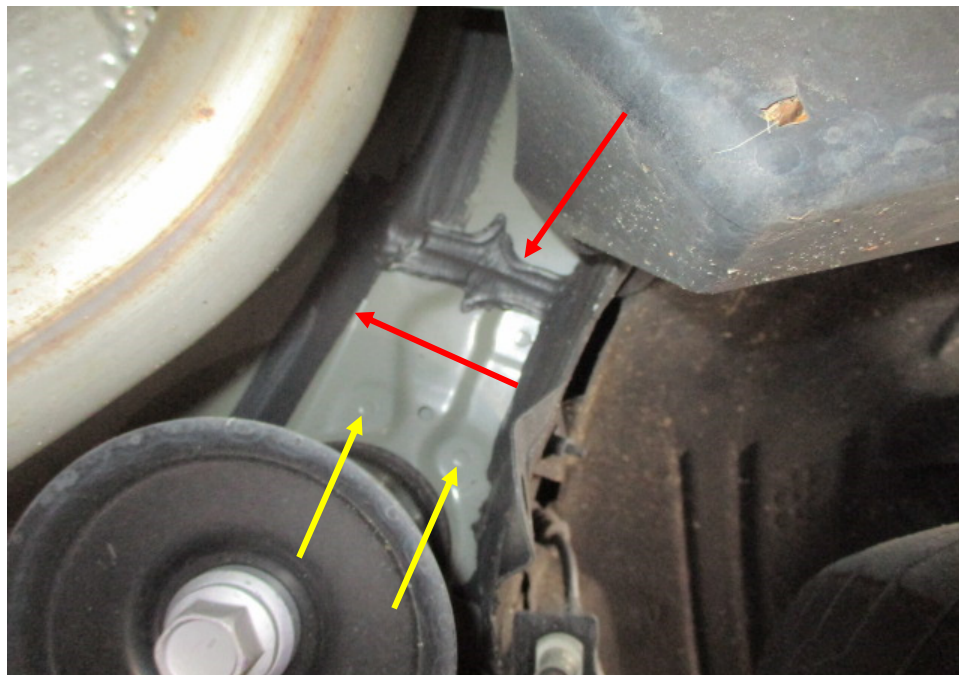
Photo 29 shows the chassis/structural body at the underside rear right of the Motor Car. I did not find any weld marks other than original spot weld marks (yellow arrow) on the chassis/structural body of the Motor Car. The original factory sealant (red arrow) at the joints along the chassis/structural body was untouched, indicating no work was done on the chassis/structural body of the Motor Car and that the chassis/structural body was originally fitted.

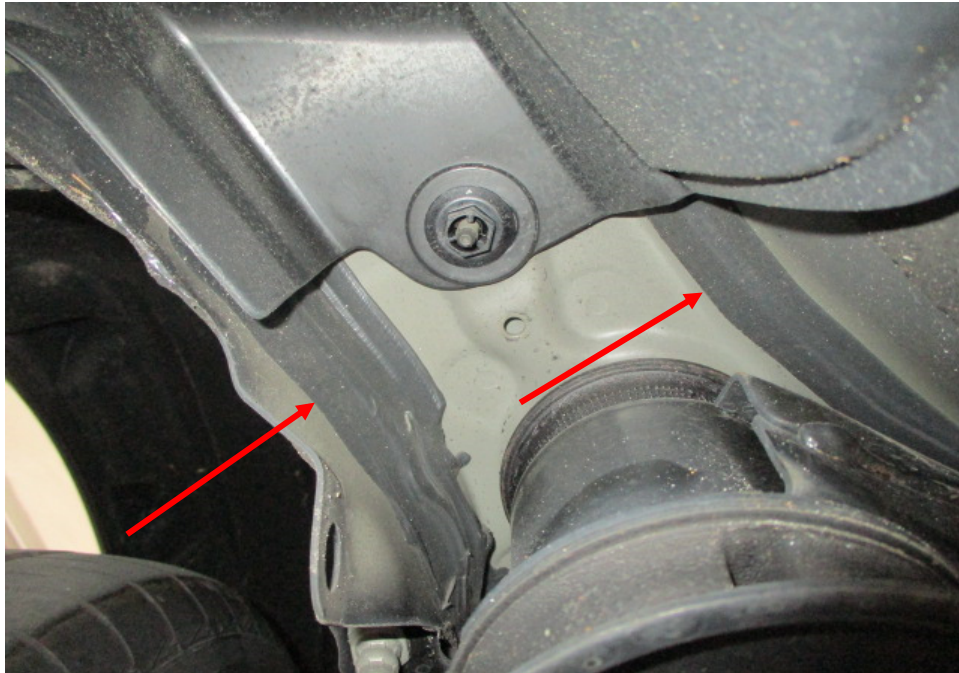
Photo 30 shows the chassis/structural body at the underside rear left of the Motor Car. The original factory sealant (arrowed) at the joints along the chassis/structural body was observed to be untouched. In general, I had found no work was carried out on the chassis/structural body of the Motor Car. The chassis/structural body of the Motor Car was originally fitted.
